Reconnaissance of the Geotechnical and Infrastructure Impacts of Los Angeles Area Wildfires and Subsequent Storms

A report of the NSF-Sponsored Geotechnical Extreme Event Reconnaissance Association

Report GEER-085: <https://doi.org/10.18118/G6X37N>

June 13, 2025

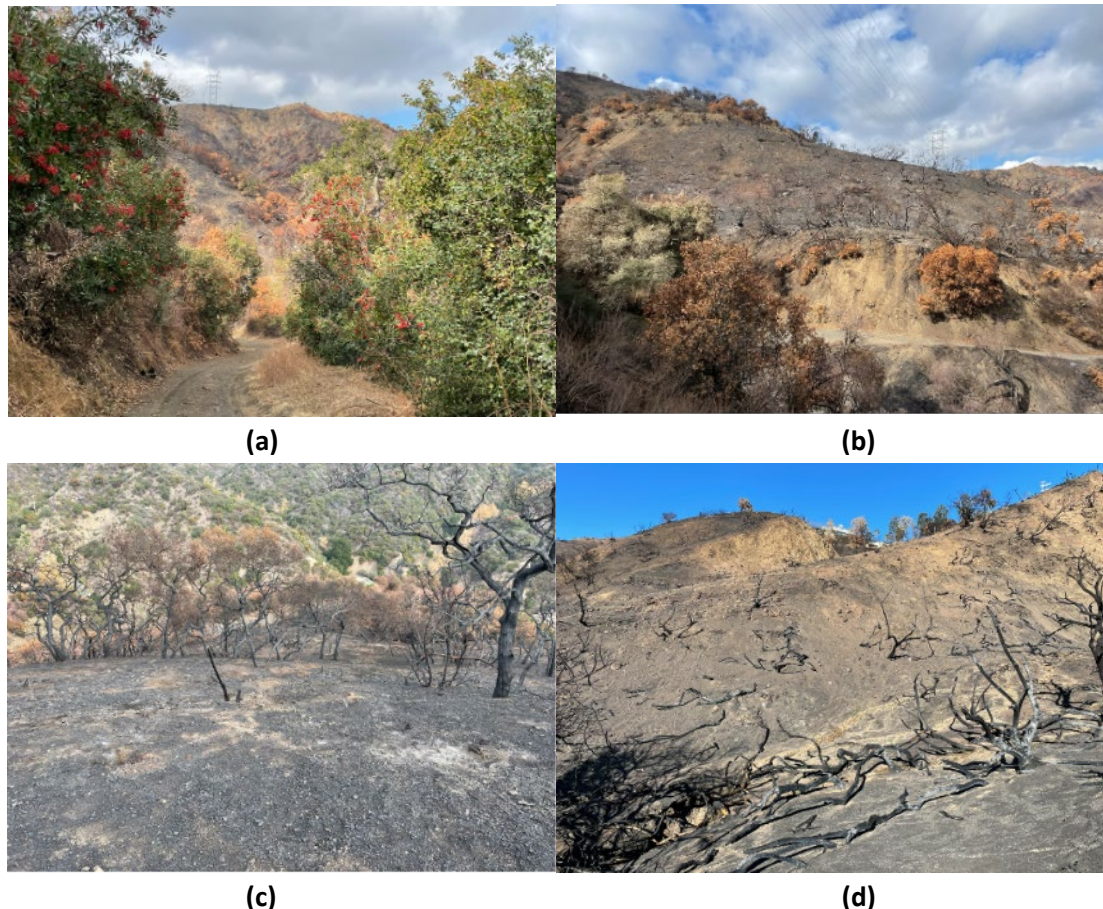
Fig. 2.11. Mixed chaparral, shrubs with different combustion completeness in a,b,c) Mandeville Canyon and d) Los Leones Canyon (coordinates: 34.120225°, -118.505867°; 34.118548°, -118.505496°; 34.118487°, -118.504911°; 34.047040°, -118.559080°).

Shrubs with varying levels of combustion completeness were observed throughout the burn area, some exhibited partially burned canopies but remained in place, while others were completely combusted and had collapsed, and in some cases were displaced downhill (Fig. 2.11).

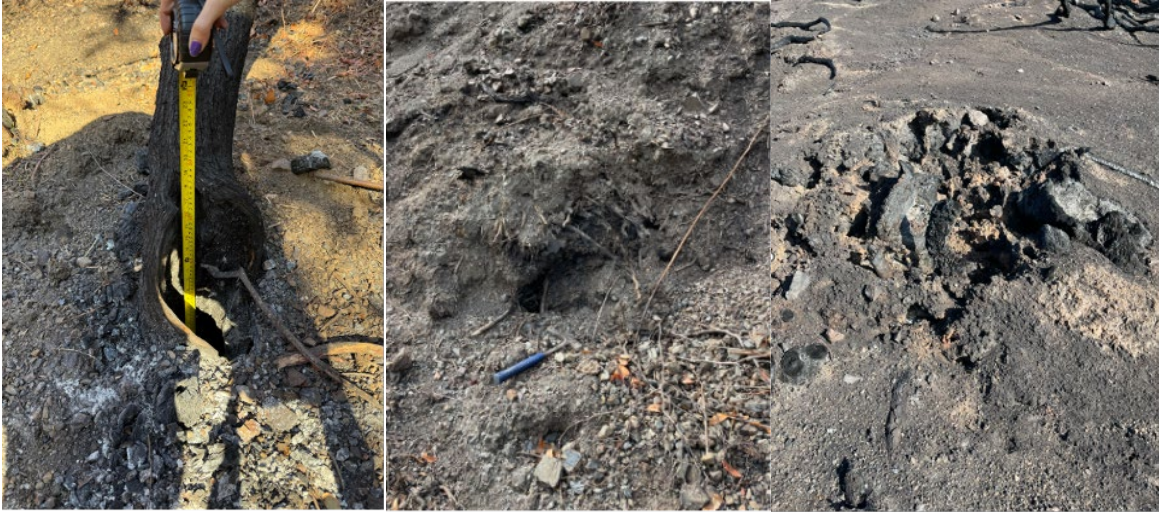
Macropores were widespread at the slopes burned by the Palisade Fire, associated with the combustion of tree trunks and large roots (Fig. 2.12). Macropores can act as preferential pathways for water and ash and change the hydrology of the slopes (e.g., Akin and Akinleye 2021,

Akin et al. 2023). The diameters, shapes, and depths of the macropores varied, and in some cases, remnants of roots could still be identified within the macropores.

Fig. 2.12. Macropores due to combusted roots (coordinates: 34.120597°, -118.506639°; 34.117769°, -118.505200°; 34.046954°, -118.559453°)

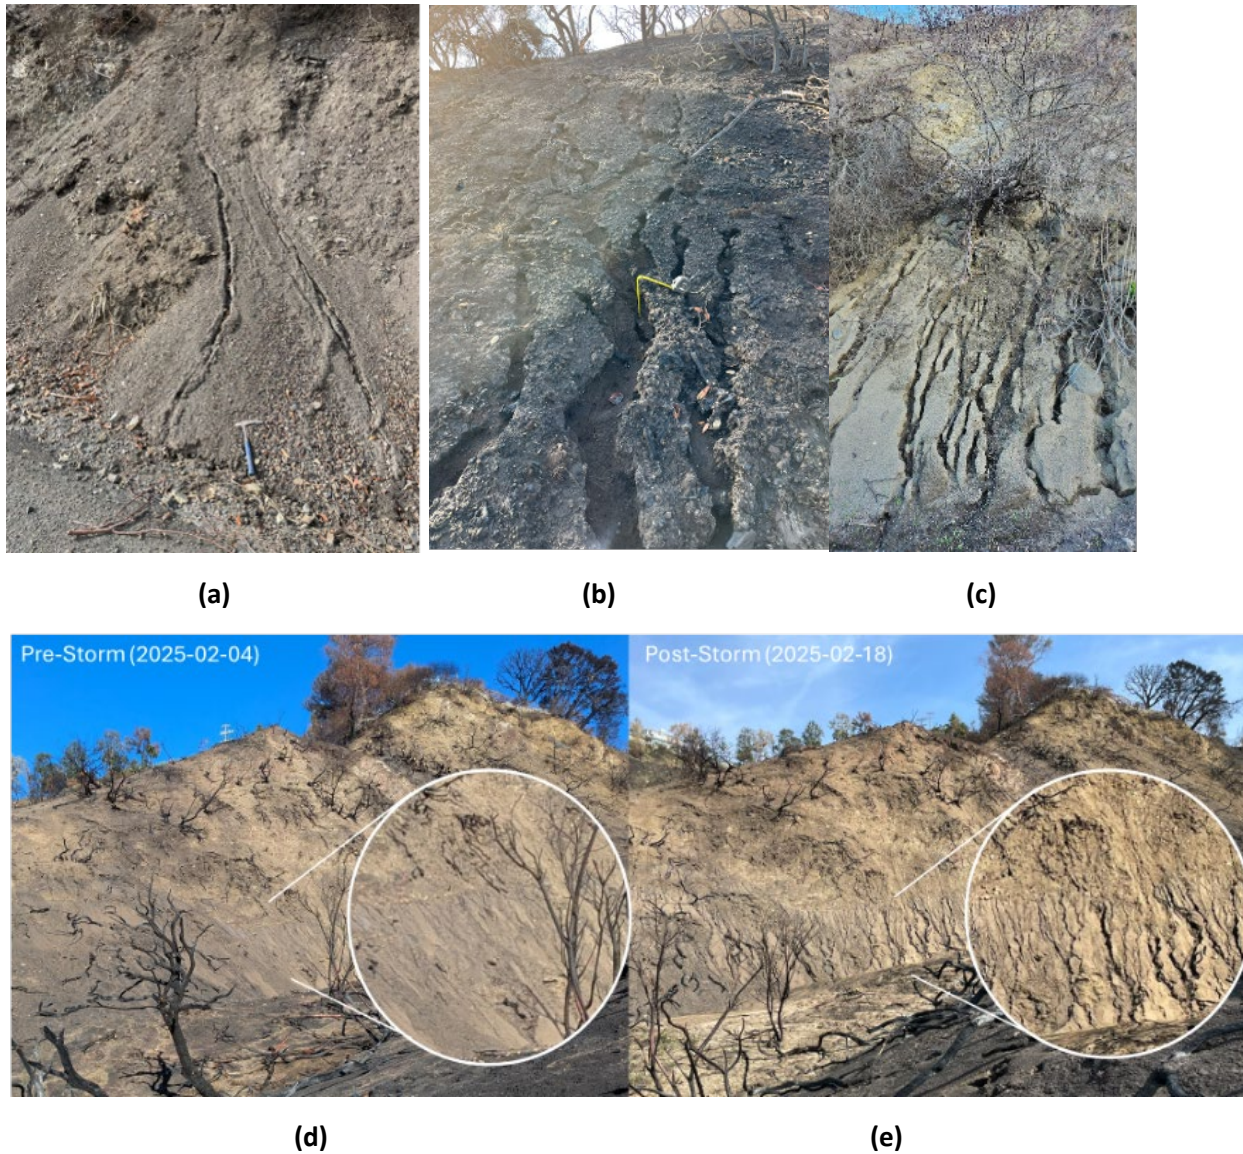
Signs of erosion, particularly in the form of dry ravel and rill erosion, were widespread within the fire perimeter. Extensive rills were documented in all the canyons that were visited. The rills that were documented in Mandeville Canyon after the January storm progressed into gullies after the February storm (Fig 2.15). Similar extensive rilling and progression to gullies were observed in Topanga and Los Leones Canyons.

Fig. 2.15. Rills after the (a) January storm in Mandeville Canyon, (b) after the February storm in Mandeville Canyon (c) after the February storm in Topanga Canyon, and (d) before and (e) after the February storm on north-facing slopes of the Los Leones Canyon (coordinates: 34.117472, -118.505577; 34.118487, -118.504911; 34.062801, -118.587177; 34.047316, -118.559135)

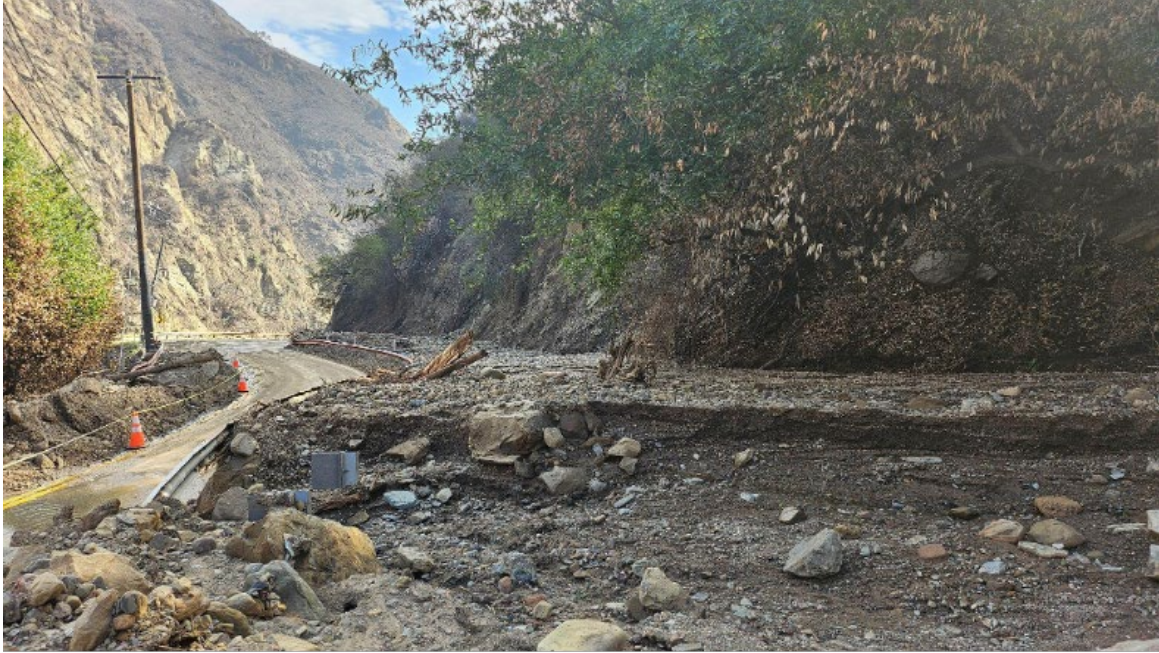
Fig. 2.17. Debris flood deposits near State Route 27 in Topanga Canyon. Damaged roadside rails resulted from flow impacts. The exposed deposit wall reveals stratification in flow near the surface (coordinates: 34.070734°, -118.588038°).

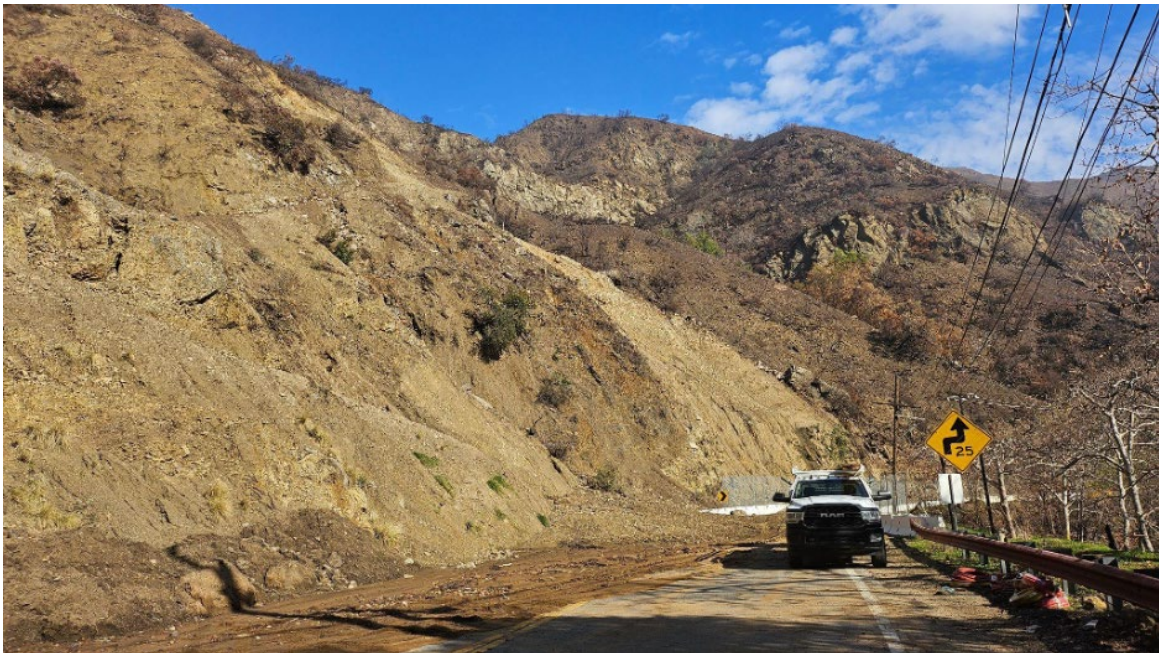
Fig. 2.18. Fine-grained sediments and rock debris from flood/flows accumulated near post mile 1.8 on State Route 27, where a landslide occurred in 2024. Metal mesh walls were damaged, and large boulders were transported downslope from steep terrain, with some remaining unstably positioned on the slope (coordinates: 34.063016°, -118.585803°).

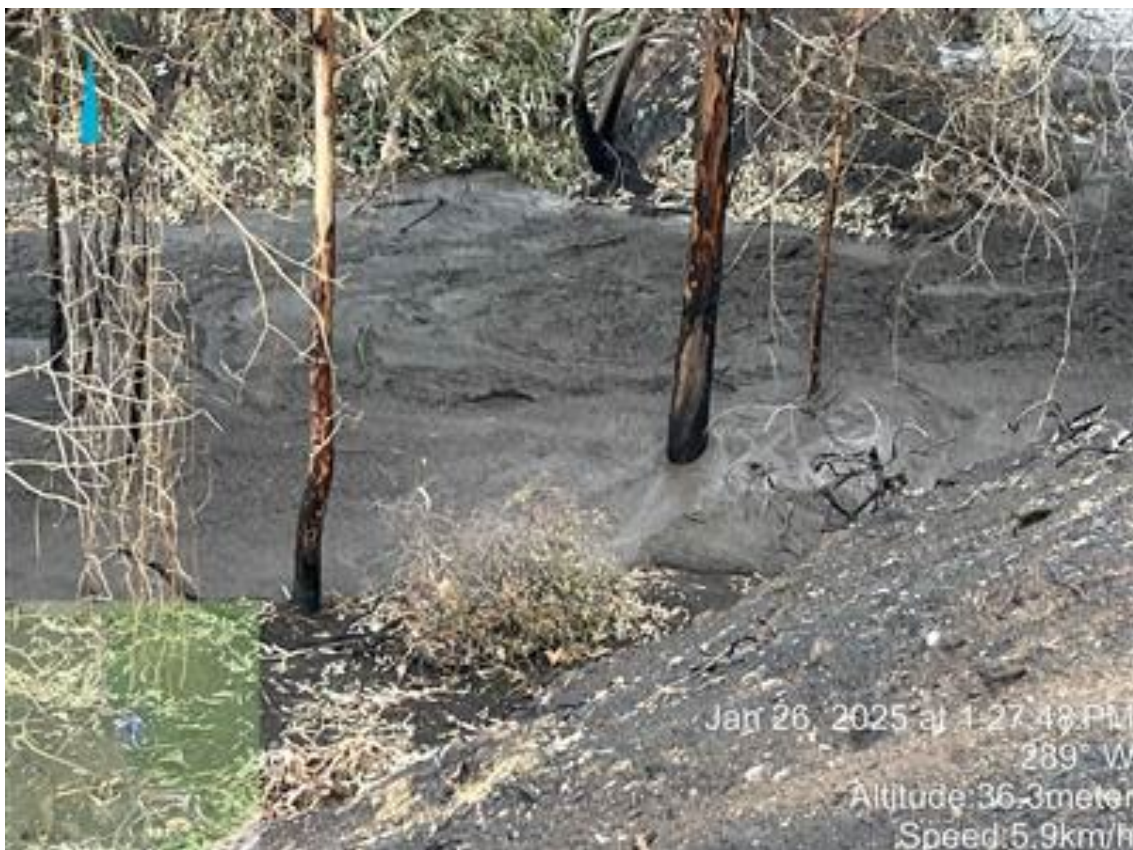
Fig. 2.20. Postfire debris flow triggered during the January 26, 2025 storm and was composed of a slurry of mostly fine-grained sediment. Source: Caltrans (34.05035°, -118.58025°).

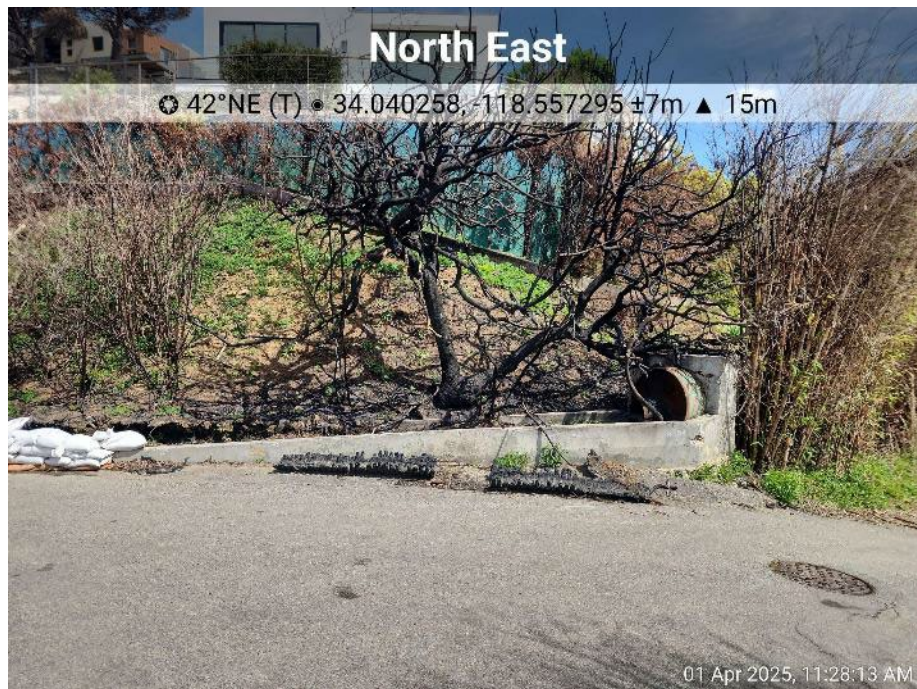
Fig. 2.25. Storm drainpipe completely burned on Revello Dr., upslope of the 2025 Castellammare landslide (4/1/25).

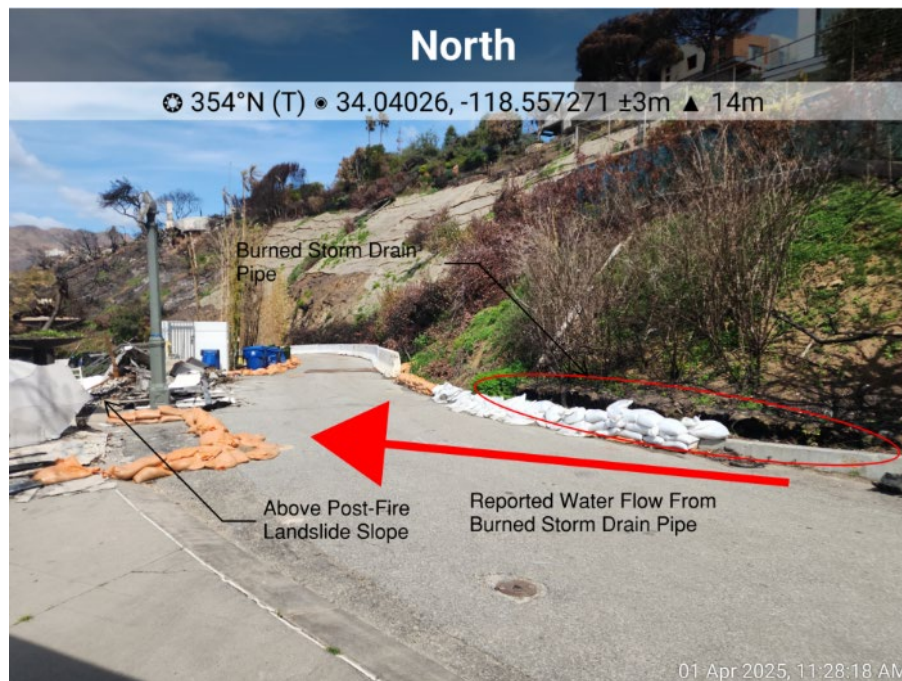
Fig. 2.26. Burned storm drainpipe in relation to the 2025 Castellammare landslide (4/1/25).

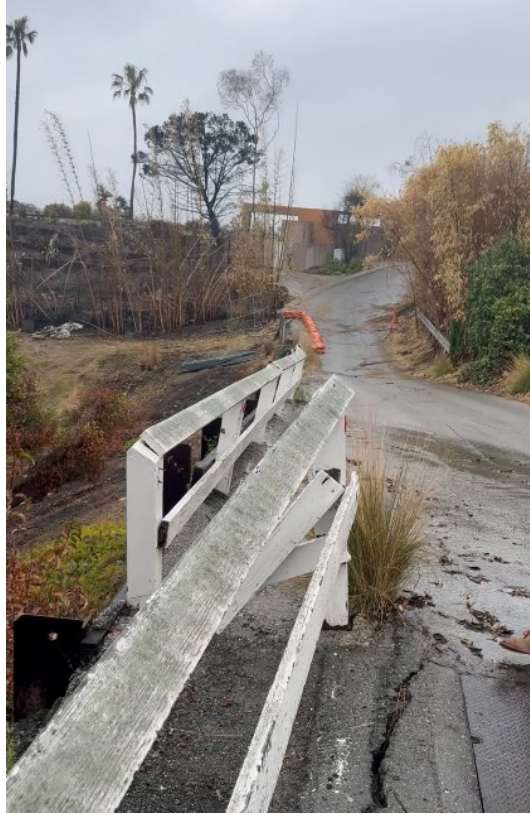
Fig. 2.27. Storm water diverted to descending slope due to burned storm drainpipe (photograph from video courtesy of Elaine Culotti) (coordinates 34.04041667°, -118.5567167°).

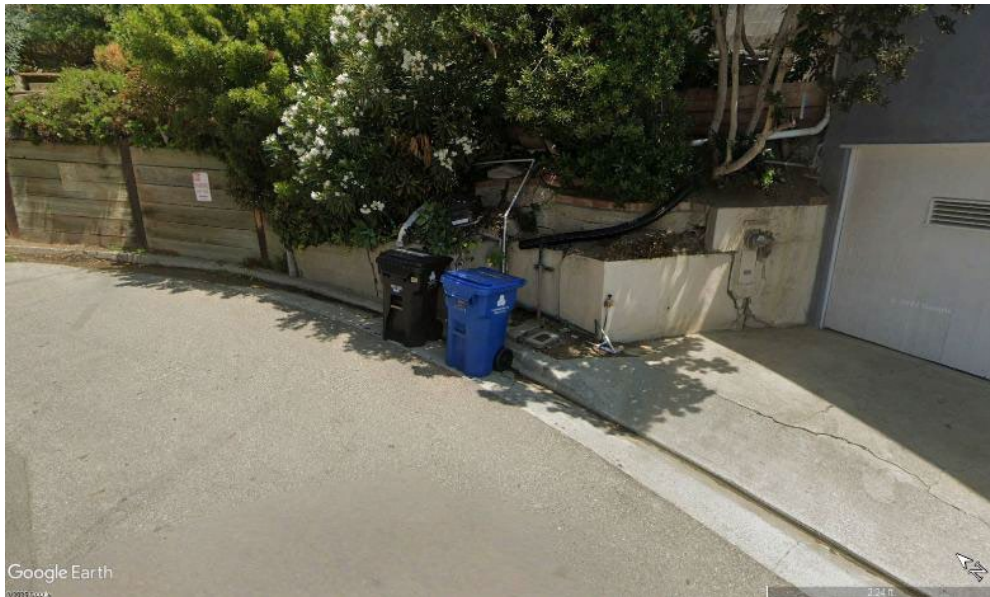
It appears that land movement in this area preceded the fire. A Google Earth image from August 2022 shows a failing retaining wall at rear of the house with several drainpipes draped over the wall (Fig. 2.28). The concrete wall appears to be rotated outward with open fractures showing offset.

Fig. 2.28. Google Earth image from 8/22, showing a failing retaining wall at rear of the house with several drainpipes draped over the wall.

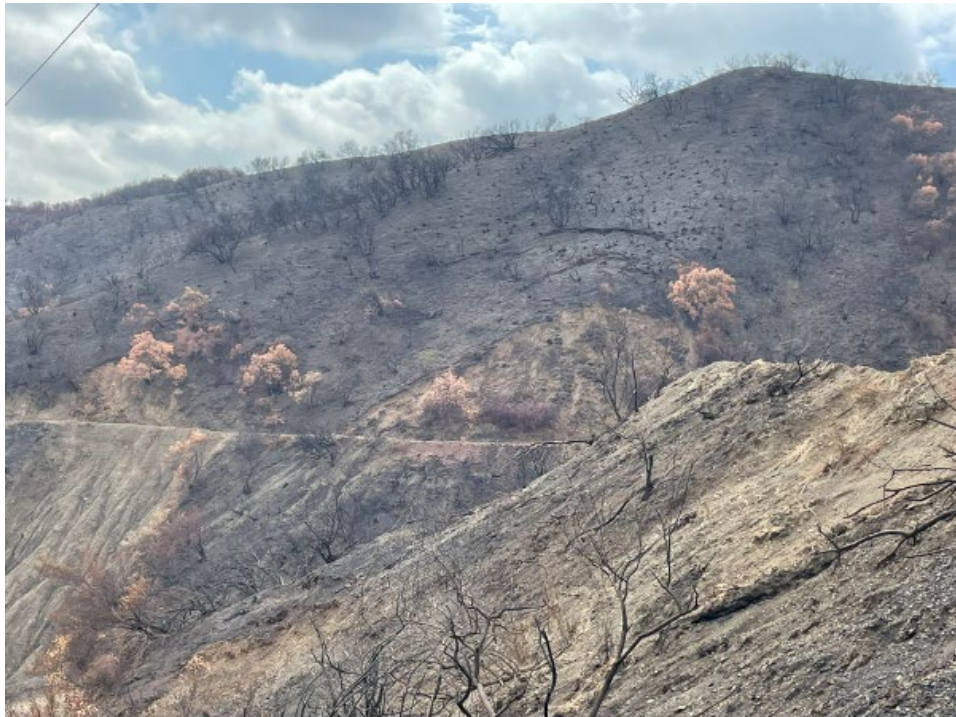
Fig. 2.29. Tension cracks above a roadway cut in Mandeville Canyon (coordinates: 34.116578°, -118.505380°).

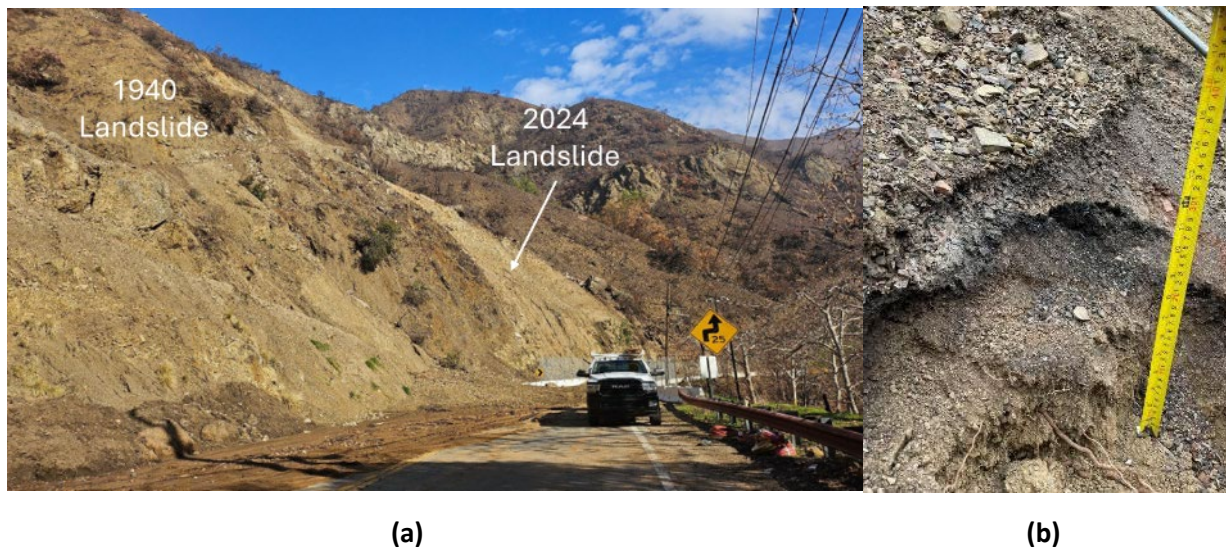
Fig. 2.32. (a) Mud and debris blocking State Route 27 after the February 13, 2025 storm. (b) Debris covering the ash layer in the 1940 landslide area (coordinates: 34.063016°, -118.585803°; 34.063365°, -118.586363°).

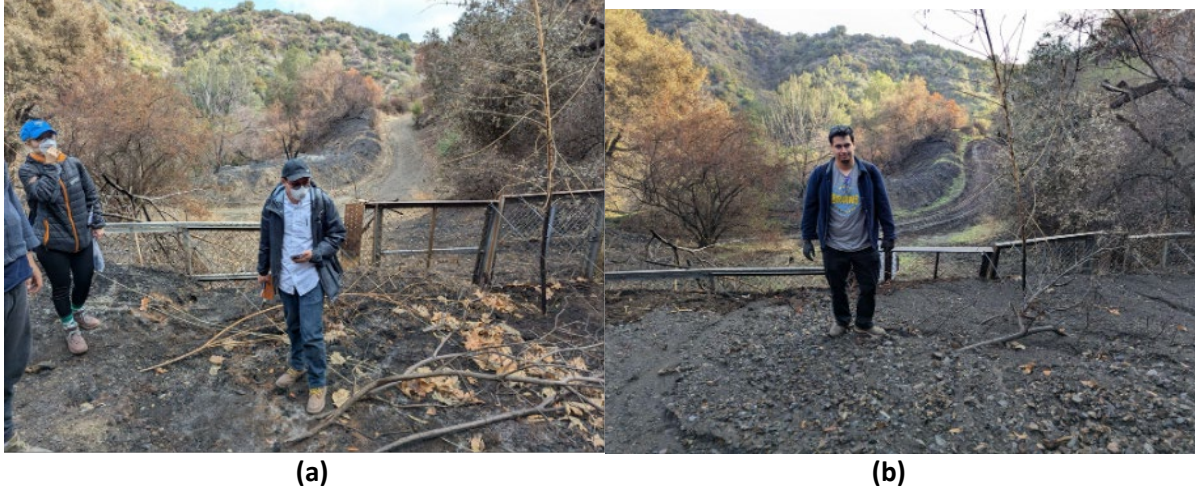
Fig. 2.33. Photographs of debris retention structure (34.120097°, -118.506599°) in Mandeville Canyon (a) before the major rainfall events taken on 2/4/25 and (b) taken on 2/18/25, after significant rainfall events.

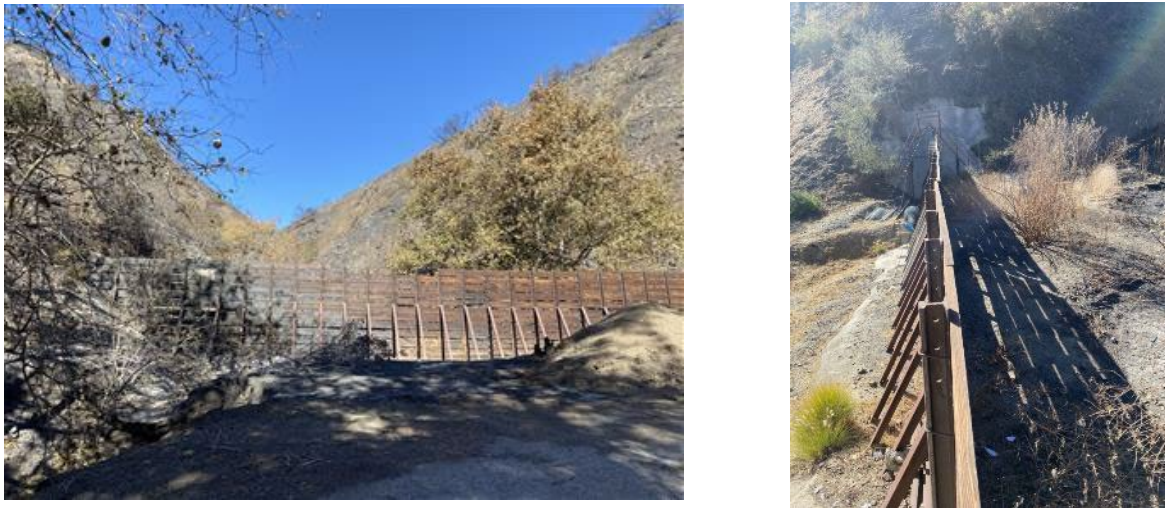
Fig. 2.34. Photograph of a partially burned debris retention structure (34.1061, -118.50564) in Mandeville Canyon before the January storm.

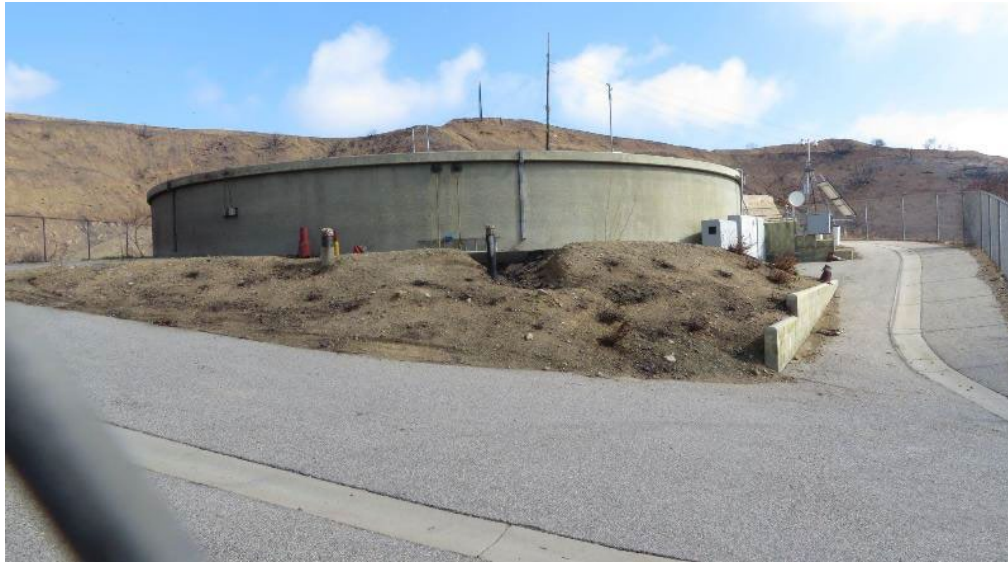
Fig. 2.36. Photographs of the Temescal Tank circular water supply tank in Palisades Highland. Recent slope erosion mitigation (with jute mesh) had been performed behind the tank (likely post-fire), and some of the ancillary equipment attached to the tank may have been recently repaired based on observations, some equipment was scorched by the fire. (34.0777306°, -118.546853°).

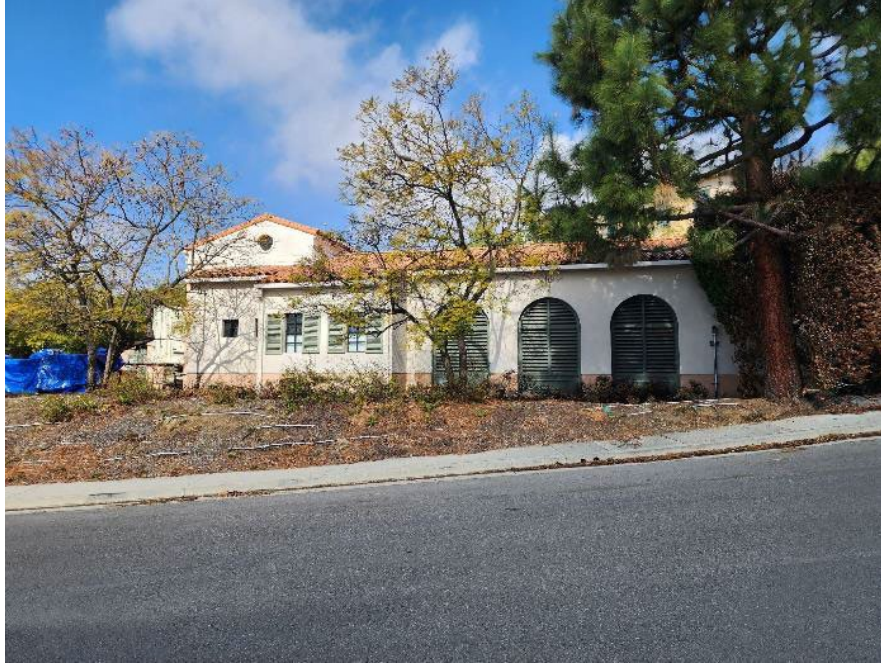
Fig. 2.37. Photograph of the LADWP Trailer Pump Station in Palisades Highlands (architecturally disguised to appear similar to residential structures) in the burn area. Many burned houses were in the vicinity of the pump station (34.07438131°, -118.550311°).

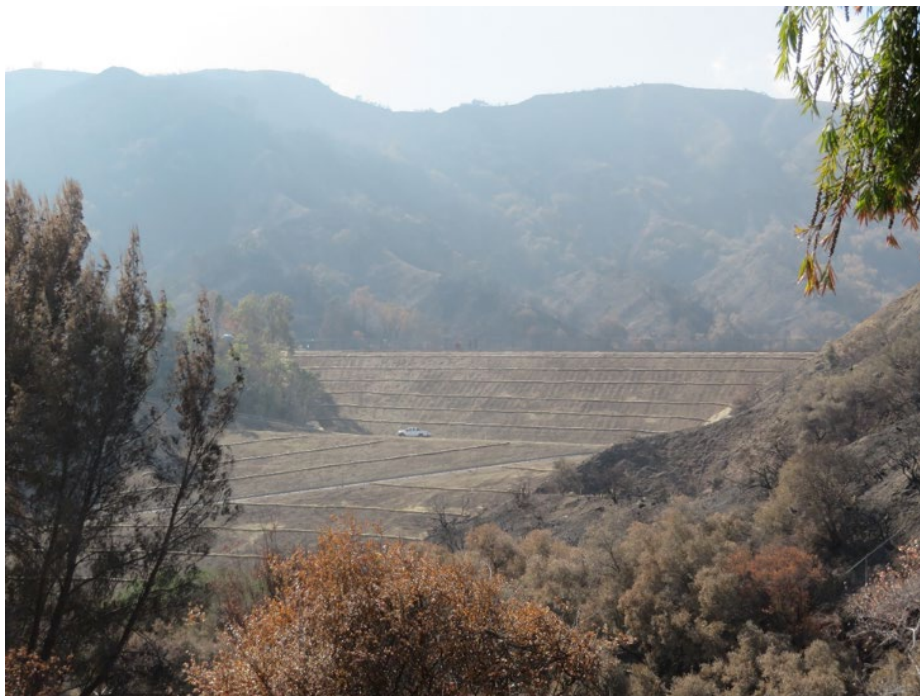
Fig. 2.38. Photograph of the LADWP Santa Ynez Reservoir Dam in Palisades Highlands in the burn area showing straw wattle to protect against future erosion of the compacted earth embankment after the fire burned the natural ground cover (34.073142°, -118.569466°).

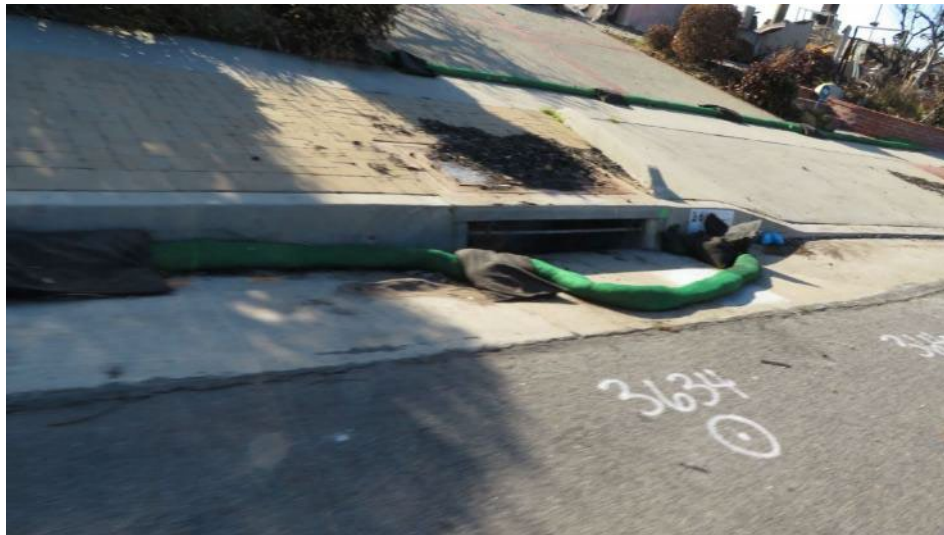
After the fire the drainage basins and surface runoff were protected with waddle as shown in Fig. 2.41 to reduce the spread of contaminants.

Fig. 2.41. Surface runoff and storm drain basins protected against spread of contaminants (2/4/25).

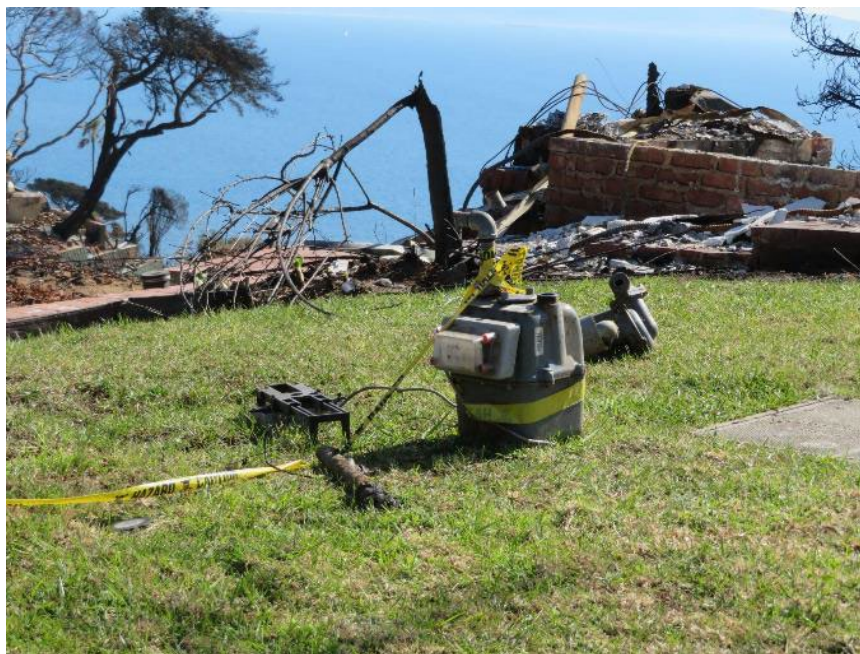
Fig. 2.42. Natural gas meter at burned residence (2/4/25).

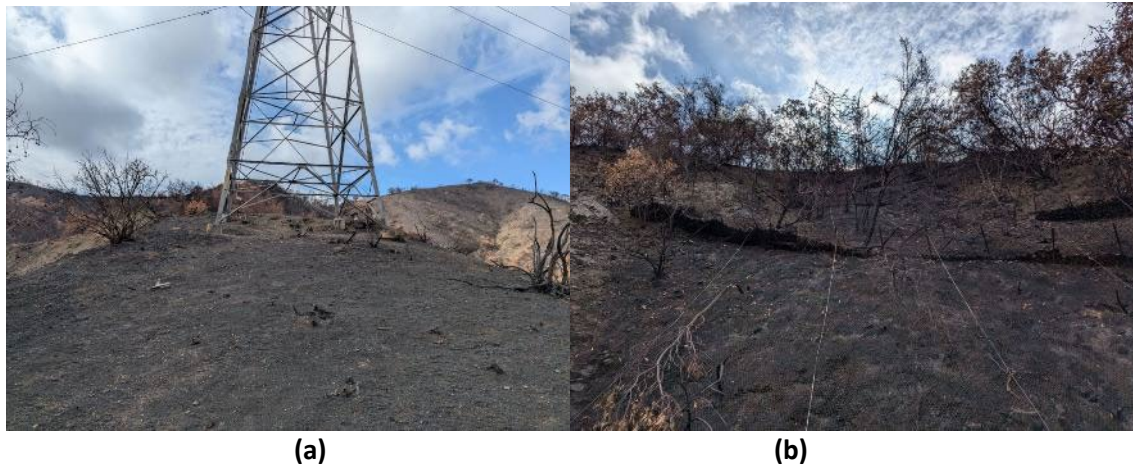
Figure 2.43. High-voltage transmission tower in the burn area adjacent to Mandeville Canyon before major rainfall (2/4/25). (a) Photograph viewing the base of the tower (b) Photograph viewing steep slope with engineered slope-stability mitigations directly beneath the tower (coordinates: 34.118310°, -118.505174°, 34.118533°, -118.505498°).

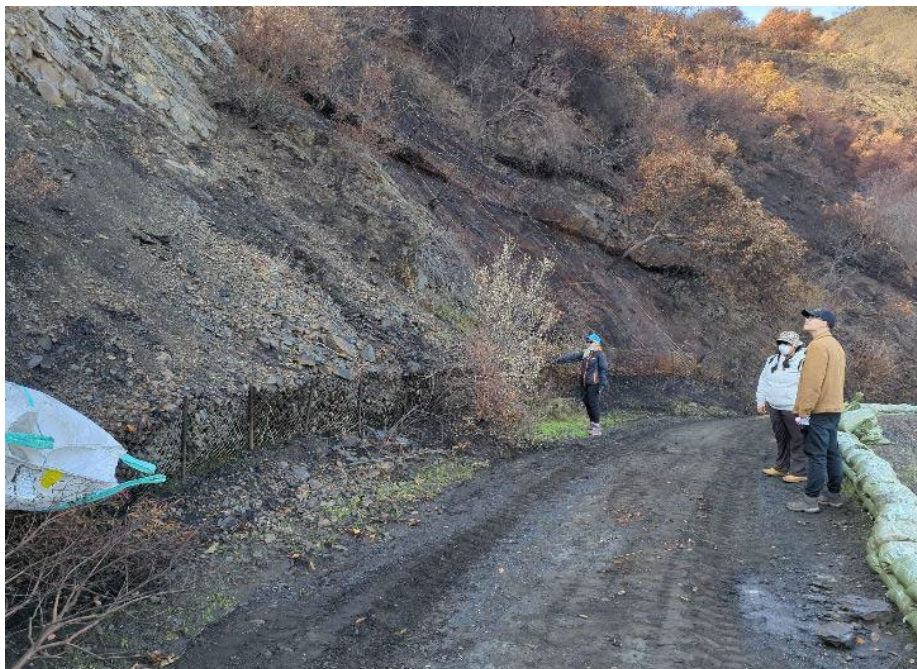
Fig. 2.44. View of fire road below the slope immediately north of the high-voltage tower adjacent to Mandeville Canyon after the major rainfall (coordinates: 34.118533°, -118.505498°).

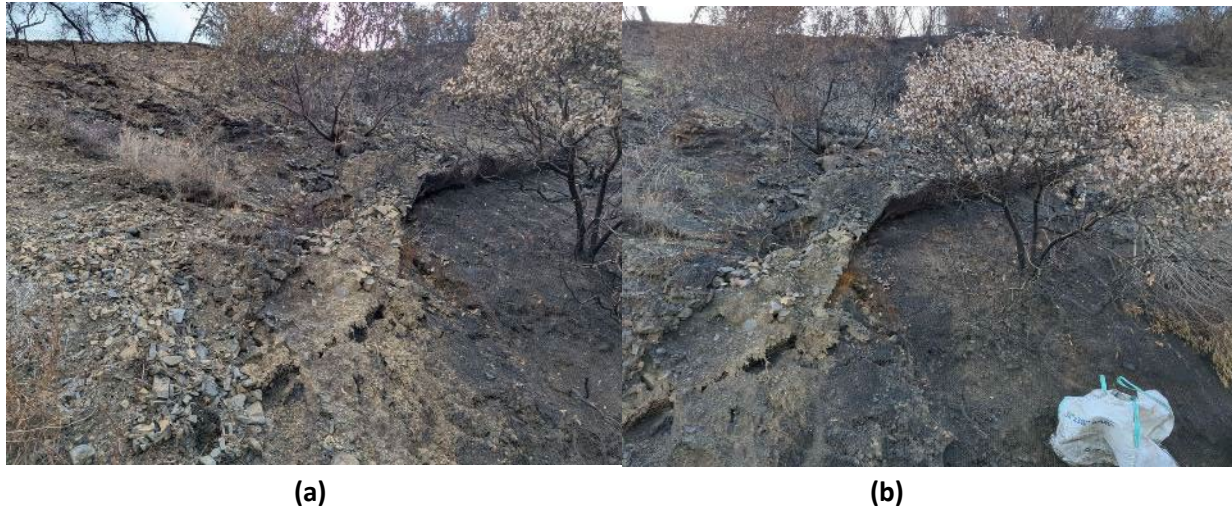
Fig. 2.45. View of the slope immediately north of the high-voltage tower adjacent to Mandeville Canyon (a) before major rainfall (2/4/25) (b) and after major rainfall (2/18/25) (coordinates: 34.118533°, -118.505498°).

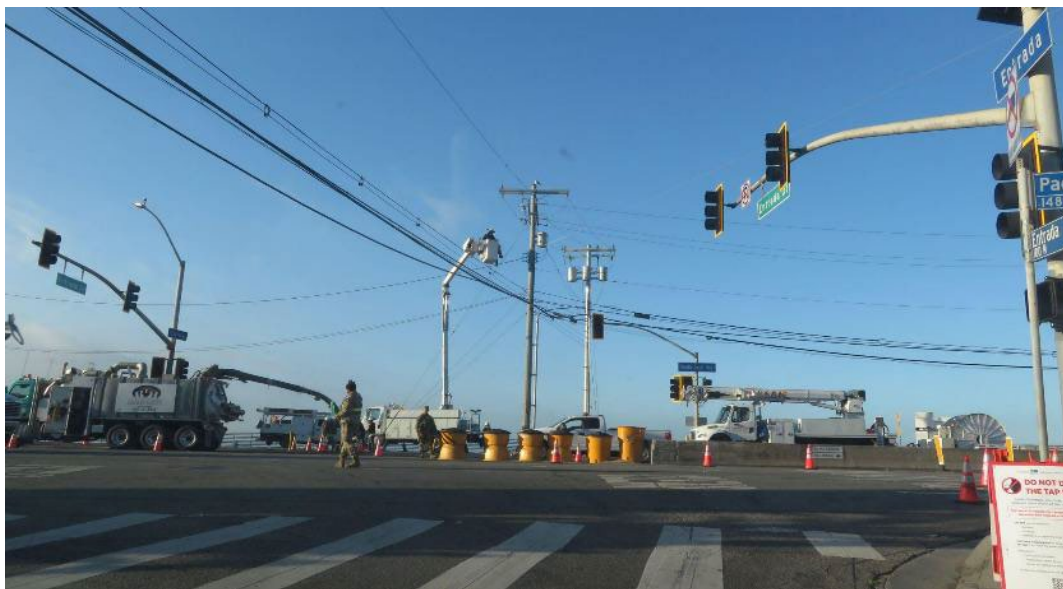
Fig. 2.46. Repair of electric power distribution lines replacing burned wooden poles with steel poles (2/4/25).

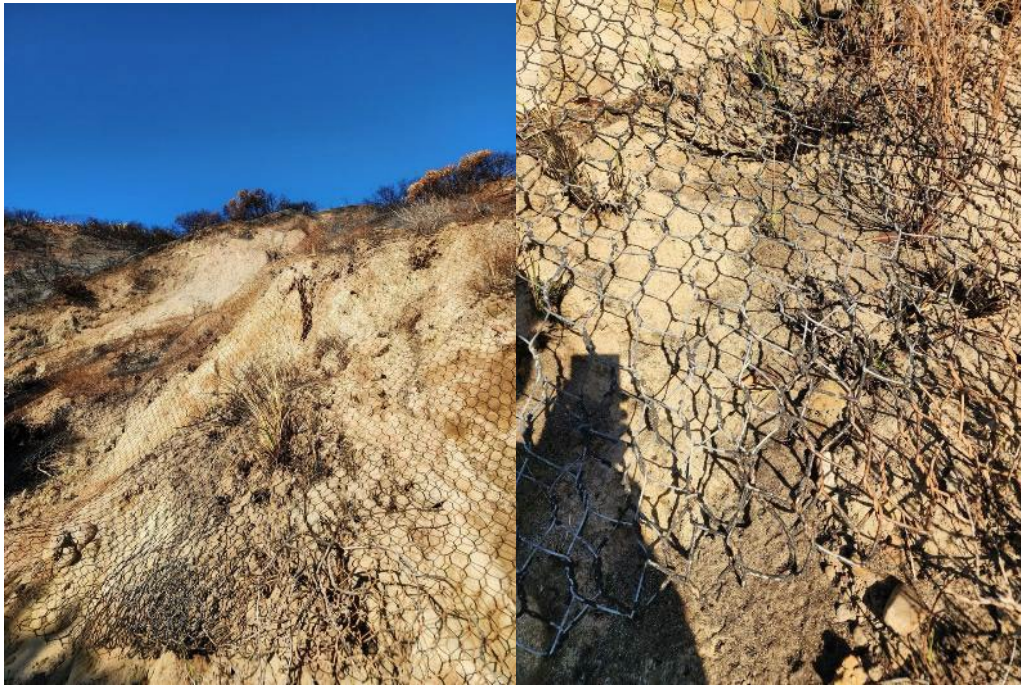
Fig. 2.50. Rock netting with discoloration indicating fire exposure in Palisades Fire. Big Rock Dr., Malibu (2/4/25).

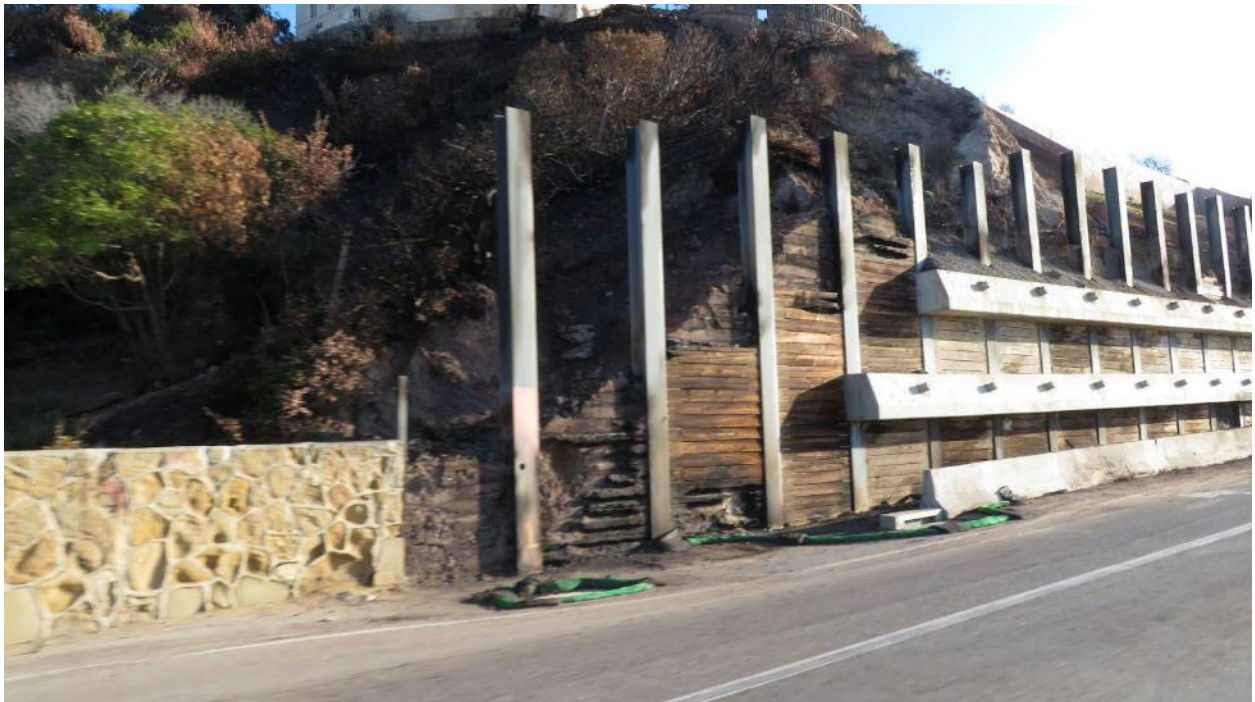
Fig. 2.52. Soldier pile with timber lagging retaining wall with tie-backs along Pacific Coast Highway. The timber lagging was burned in some locations (2/4/25).

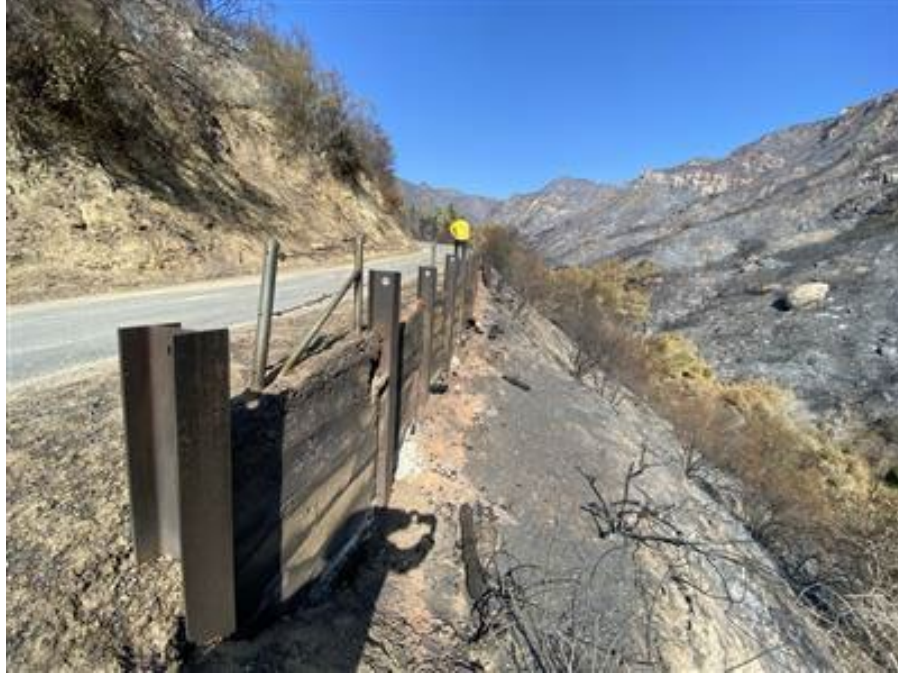
Fig. 2.53. Image of soldier pile wall with damaged timber lagging that retains soil along outside edge of road prism (34.059966°, -118.637916°).

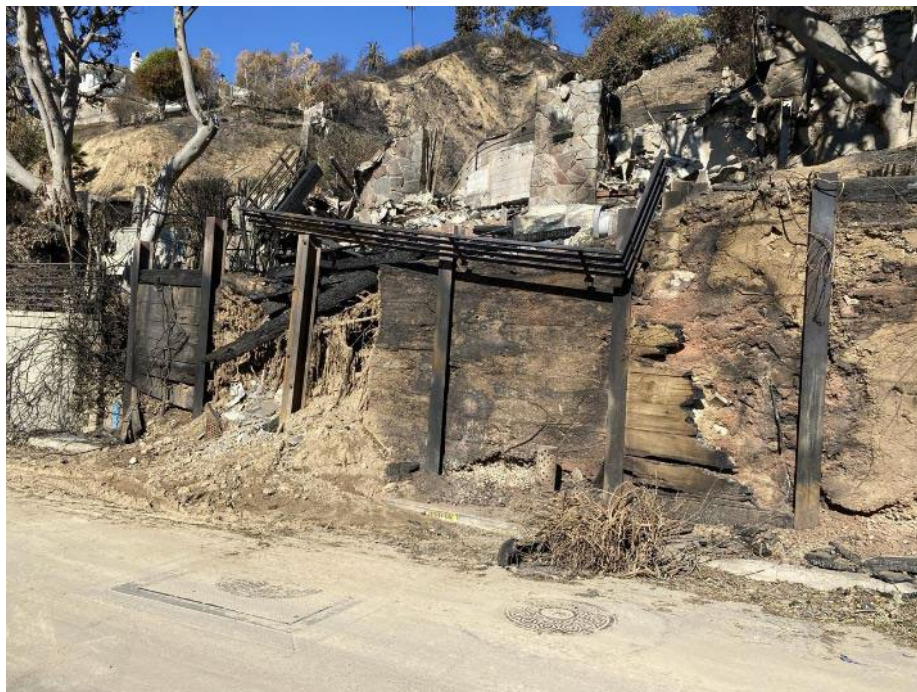
Fig. 2.54. Image of soldier pile wall with damaged timber lagging that retains soil along outside edge of building pad that supports foundation of a burned structure (34.0408°, -118.64546°).

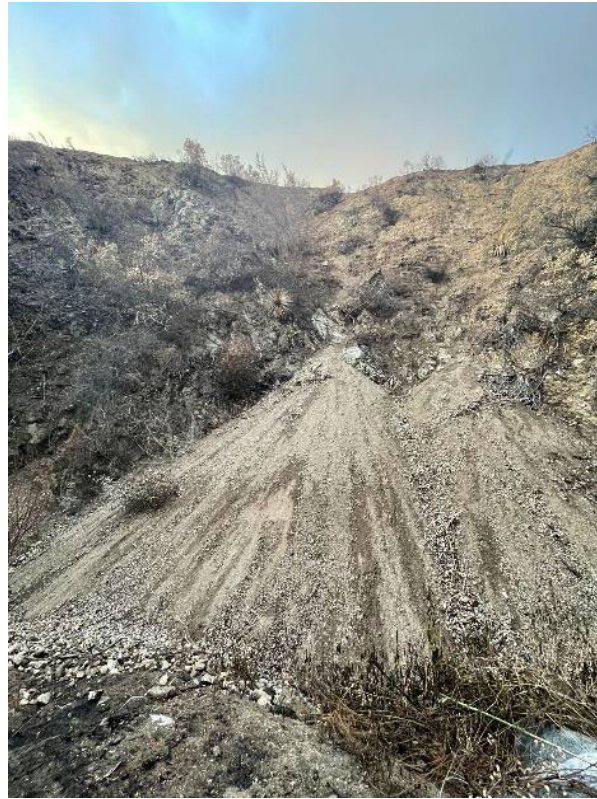
Fig. 3.11. Typical coalescing ravel cones entering channel within the Eaton Fire (34.1768°, 118.0611°).

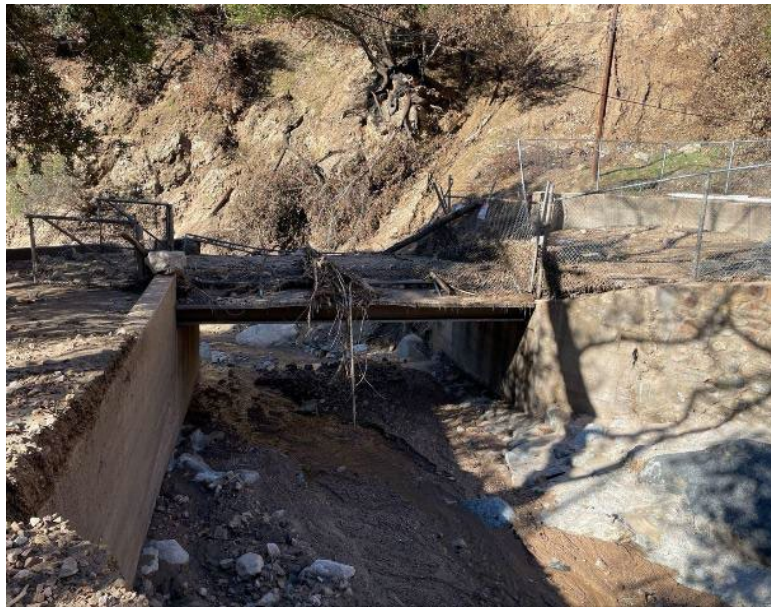
Fig. 3.16. Damage to the bridge and associated fencing (2/19/25, 34.18385°, 118.12288°).

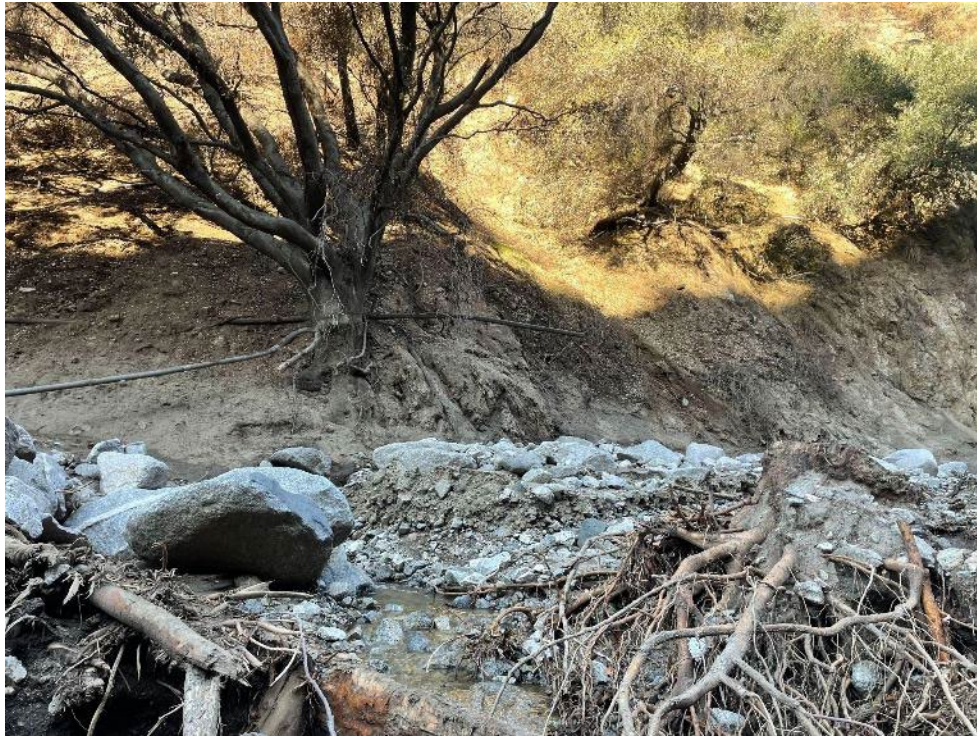
Fig. 3.17. Image showing damaged Kinneloa Irrigation District waterline (opposite bank) within Pasadena Canyon. Several waterlines of different ages exist along this reach. Observed damage occurred during the February 13th, 2025, storm. Photo taken on 2-20-2025. (34.18294°, 118.07856°).
