GEOTECHNICAL IMPACTS OF AUGUST 2018 FLOODS OF KERALA, INDIA

Event: August 2018

Geotechnical Extreme Events Reconnaissance
Turning Disaster into Knowledge
Sponsored by the National Science Foundation
GEER Association Report NO - 058

Date: 10-17-2018

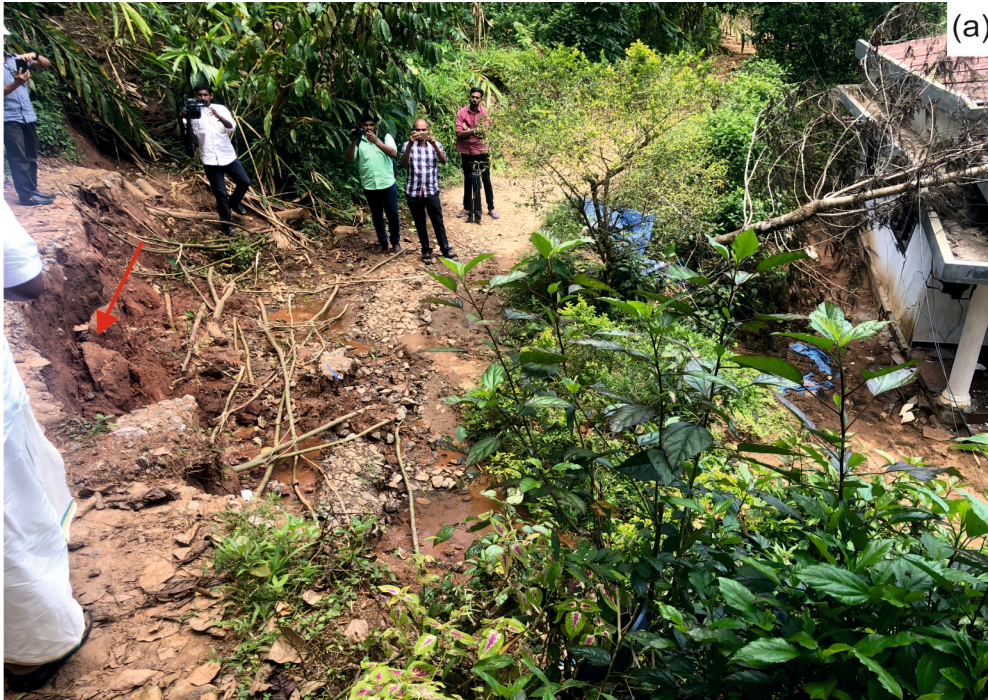
1. Nirmala City landslides (9.7925061°N; 77.0680952°E): Several landslides have occurred in Nirmala City near Kattappana that resulted in destruction of 10 houses. Most of the landslides fall in two categories: (a) Partially failed landslide and (b) Cut-slope failure. The partially failed landslide was confined to a gully of a lower order seasonal stream. Such features are called topographic hollows. The constructional activities along such natural paths blocked the excess water from discharging. Moreover, the hill consists of a shallow abandoned dug well that was meant for domestic purposes. All these facilitated the percolation of rain water and subsequent increase in pore-water pressure. About 10 houses, wholly or partially, was destroyed in this event. A metalled road was displaced for about 1 m (Fig 2.2a).

Figure 2.2: (a) Displaced road due to partially failed landslide 9.7968615° 77.0675334° (b) Cut-slope failure at Nirmala City 9.7925061° 77.0680952° . Note the modified slope behind the house.

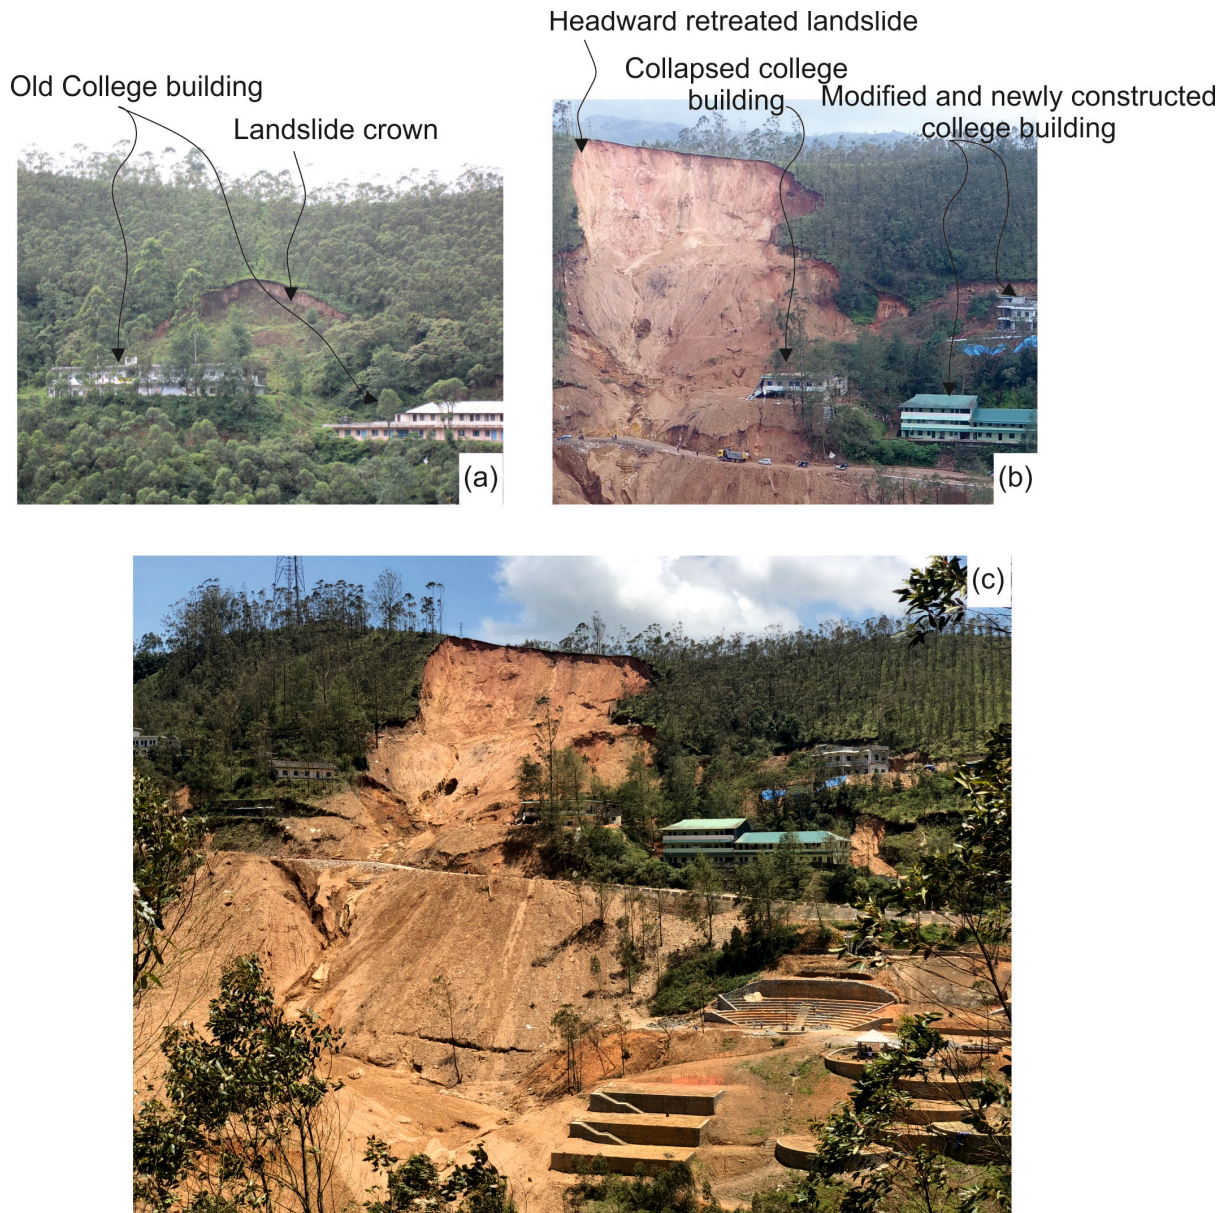
showed that it was a partially failed landslide. The upper part of the landslide has failed whereas the rest of the part was partially failed, manifested as land disturbance. The land disturbance varies from 0.5 m to 2 m. This area has a comparatively gentler slope (15-22°) and hence, is free from landslides during early periods. The rainfall should be the only factor that caused the landslide. The area is expected to receive more rainfall during the North East Monsoon. Hence, such partially failed landslides are the best avenue for further collapse.

Figure 2.4 (a) Landslide scar of 2004 in the vicinity of Government College Munnar. Note the sagging of the crest line. (b) 2018 landslide uprooting the College building (c) Enlarged view of (b) $10.0822468^{\circ}N$; $77.0734293^{\circ}E$

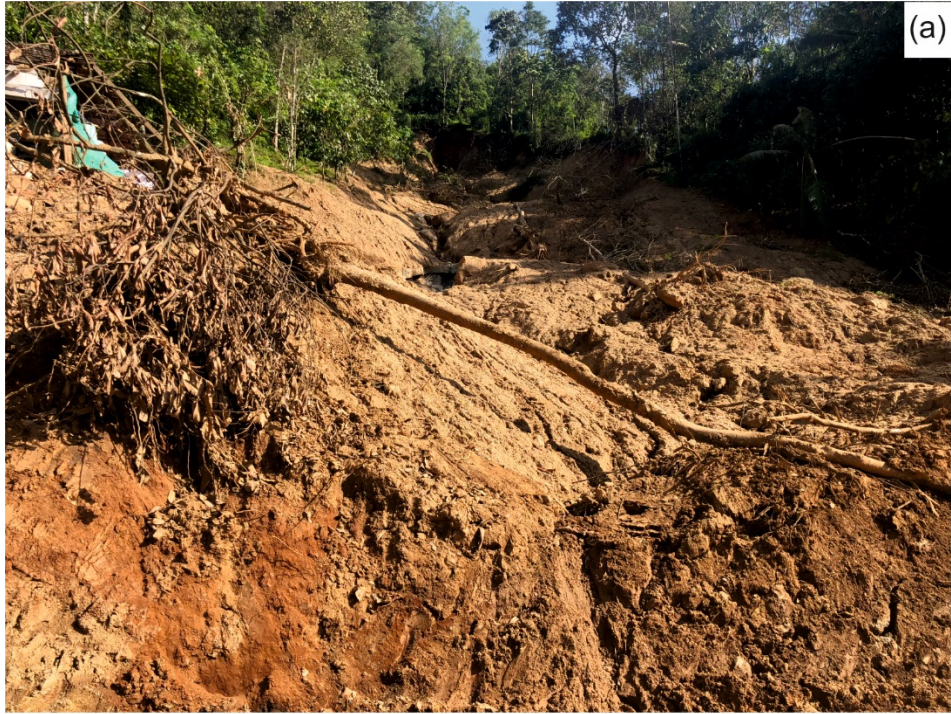
- 3. *Vellathooval landslide (10.0088136°N; 77.0257626°E)*:** The landslide at Vellathooval is a classic example of piping (Fig 2.8a). Small conduits of varying dimensions (10-30 cm) are quite obvious in this area (Fig 2.8b). These subsurface conduits carry water and the dimension of the conduits changes with change in the velocity and discharge. The civil structures resting above such conduits will be under threat.

*Figure 2.8 (a) Landslide at Vellathooval (b) Surface manifestation of a conduit in piping phenomena
10.0088136°N; 77.0257626°E*

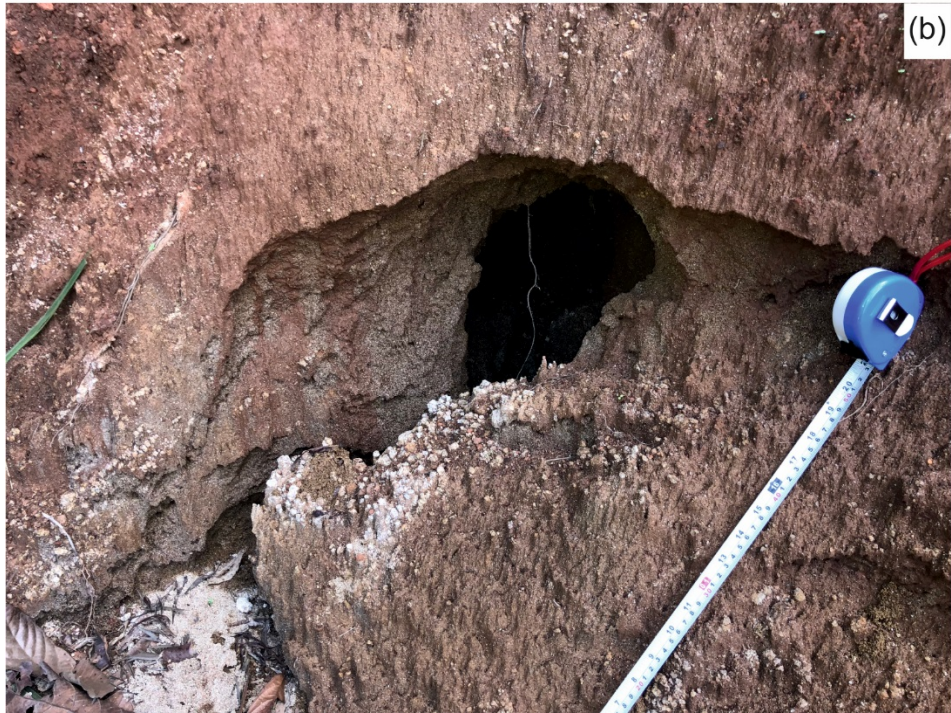
Piping has initiated the landslide and has developed into typical debris flow with approximately 20 m (width), 500 m (length) and 2 m (thick). All the debris was debouched into an adjacent river. This landslide has resulted in 5 deaths and destruction to 5 buildings. Three bodies are yet to be recovered.

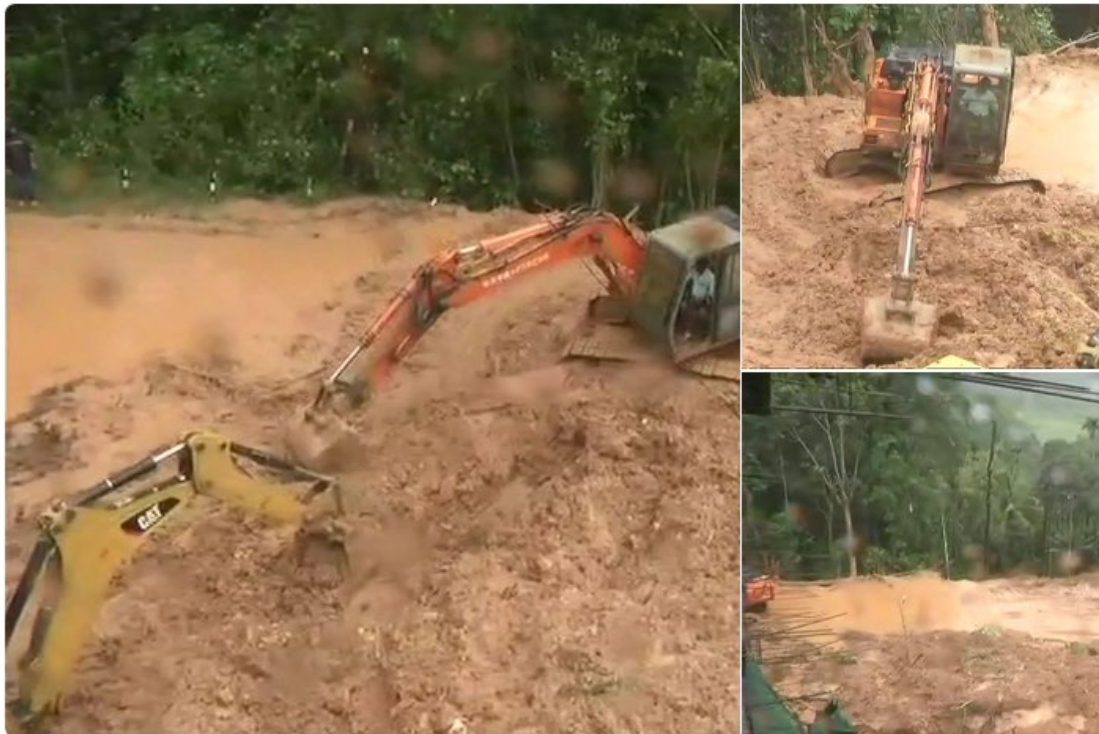
Figure 2.11: Roadway clearing operations at the Kattappana Landslide. The horizontal rebar in the bottom right photograph are also present in many of the photographs taken by the GEER team. Source: Twitter.

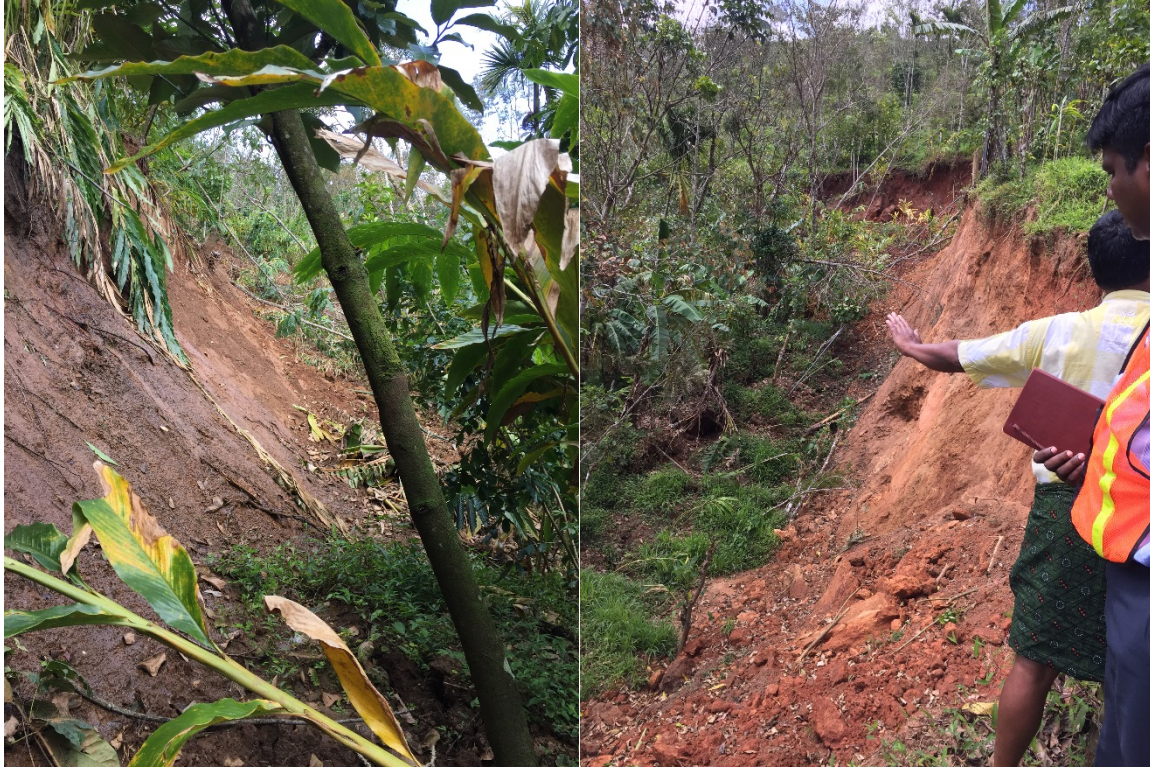
Figure 2.14: Photographs of the main headscarp of the largest landslide in Idukki ($9.7964191^{\circ}\text{N}$; $77.0682762^{\circ}\text{E}$).

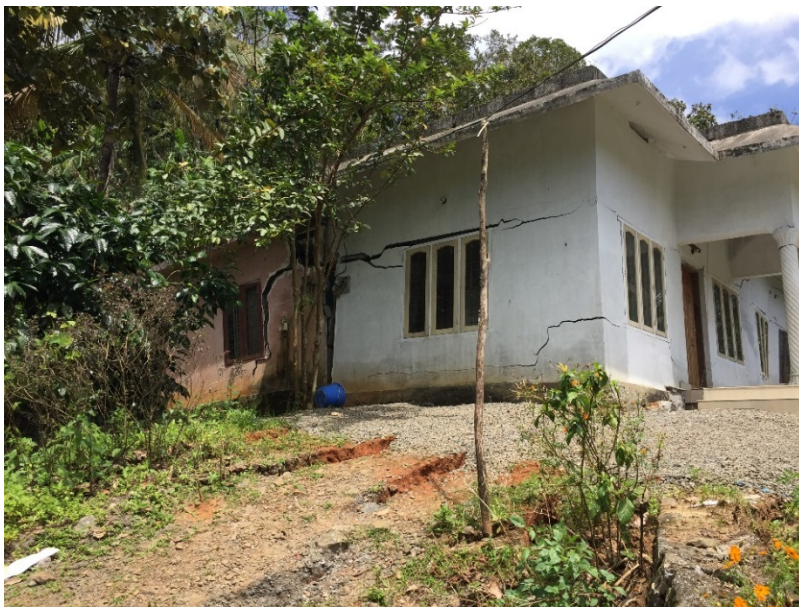
Figure 2.15: Photograph of one of the damaged houses within the Idukki Landslide. Using multiple photographs of this house, this geometry of this house was reconstructed using Photoscan ($9.7962622^{\circ}\text{N}$; $77.0681814^{\circ}\text{E}$).

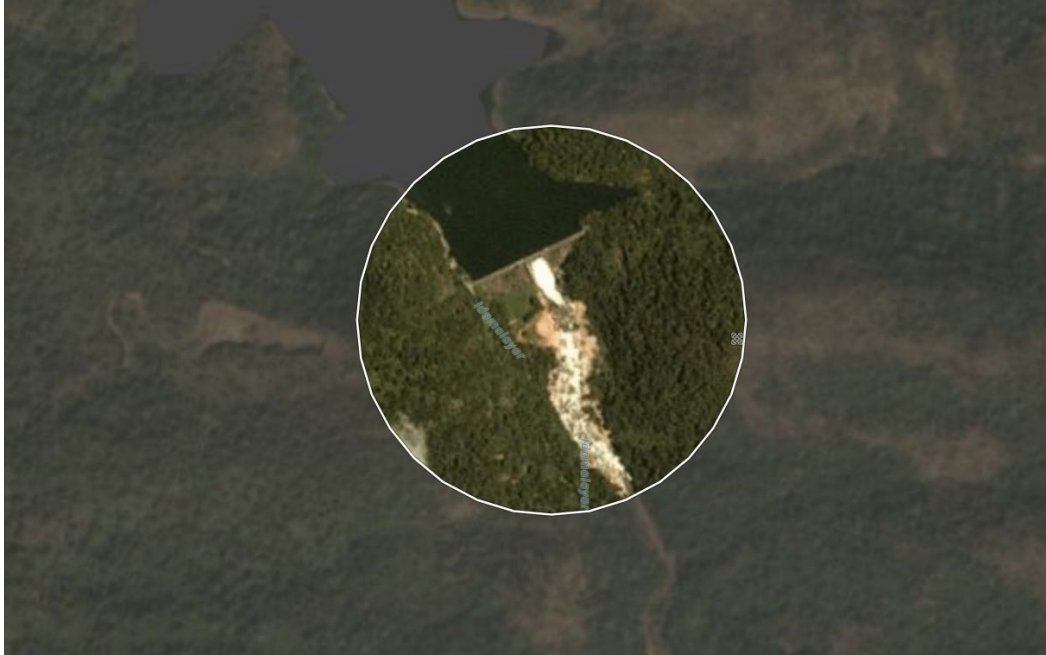
However, looking at the available high-resolution satellite images from Planet lab indicates that these landslides were formed after the opening of the shutters. Figure 3.4 is a planet lab imagery of Idamalayar dam from July 1, 2018. It is evident from the image that the dam shutter is closed and the downstream channel is vegetated. Figure 3.5 is a planet lab imagery of Idamalayar dam on September 3rd, 2018 and it documents the landslides that are occurring in the downstream channel at close vicinity of the dam. The initial estimates indicate that the landslide is occurring less than 150m downstream of the dam. The width of the slide is roughly 100m.

Figure 3.5: Planet lab imagery of Idamalayar dam from September 3, 2018.

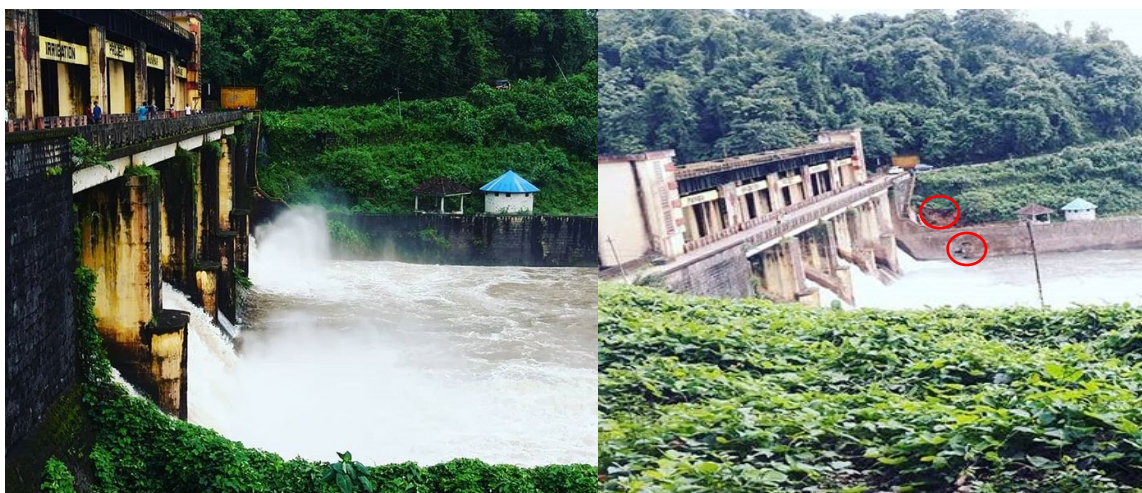
Reviewing the photographs from Instagram shows that the downstream side of the Maniyar dam beside the retaining structure has experienced some failure between August 10th and the 25th, 2018 (Figure 3.8). A closer view of the slope failure obtained from onmanorama indicate that the slope and the retaining structure had failed and material was eroded away (Figure 3.9). It is also evident from these photographs that there is some seepage occurring at the location where the slope failed. It is not clear whether this is seepage of groundwater or water from the upstream reservoir. From the pictures (Figure 3.10 & 3.11), it is also evident that the downstream side of the shutter-2 has experienced damage and the surface blocks have been displaced.

Figure 3.8: (Left) Downstream side of the Maniyar Dam with the shutters open on August 10th. (Right) Similar view as the left image taken on August 25th showing minor slope failure and damage to the retaining structure (failures are circled in red). Source of photograph: Instagram

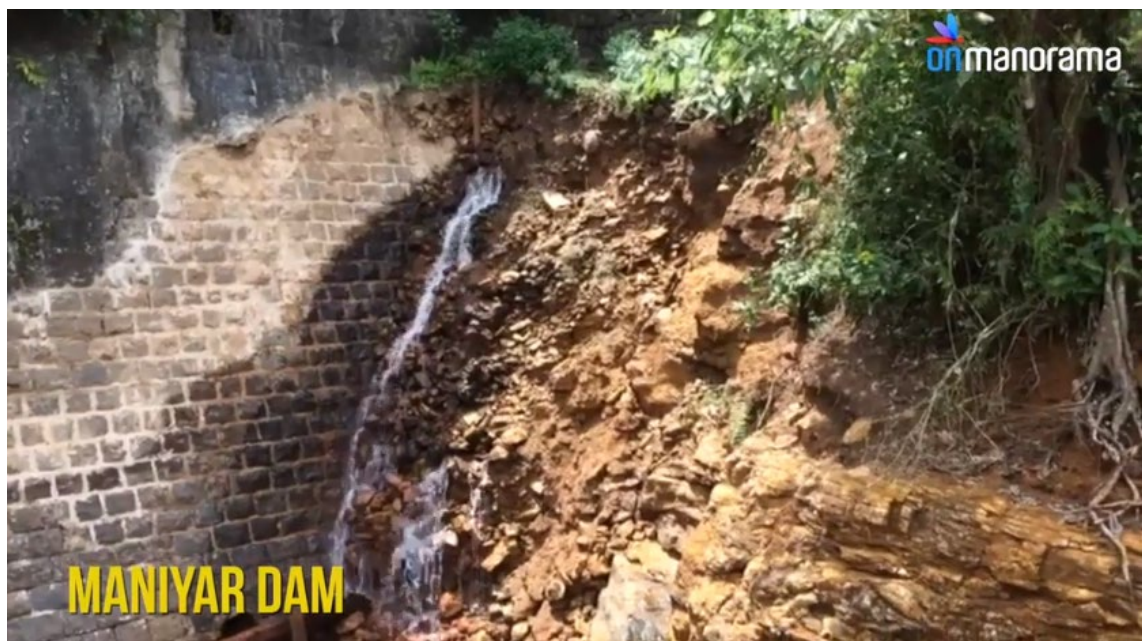
Figure 3.9: Closer view of the slope failure and seepage at the downstream side of the Maniyar dam (Source: manoramaonline.com).

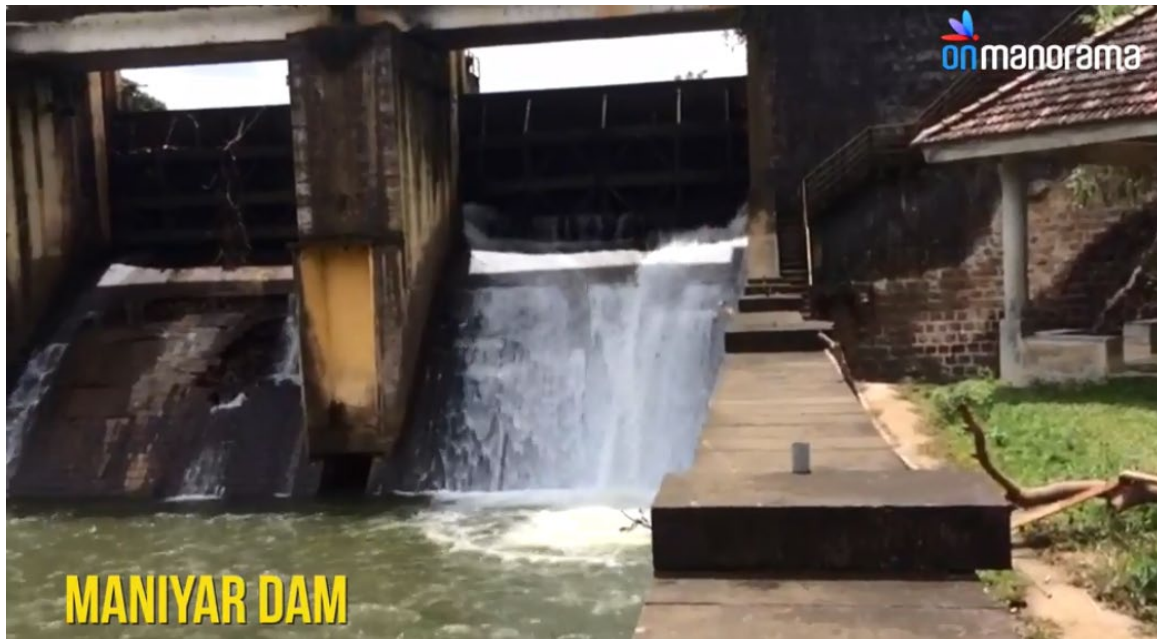
Figure 3.10: Photograph showing one shutter of the dam being closed and the surface concrete blocks been damaged (Source: manoramaonline.com).

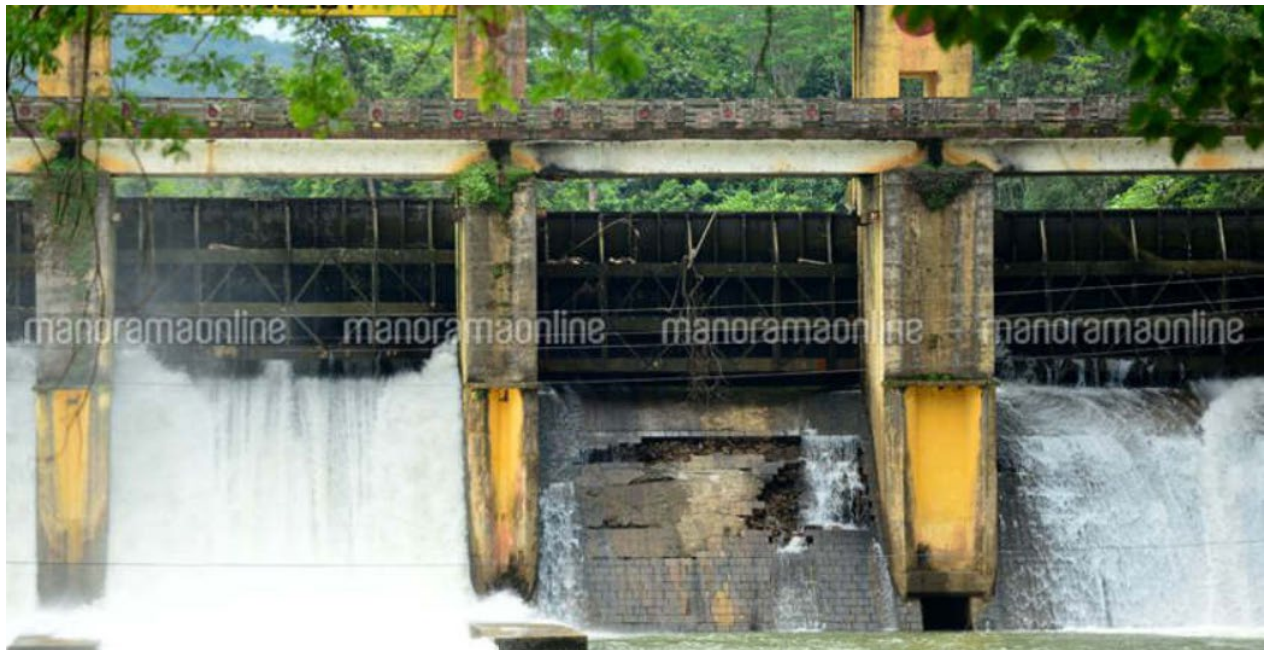
Figure 3.11: Different view of the damage to the downstream surface of shutter-2 at Maniyar Dam (Source: manoramaonline.com).

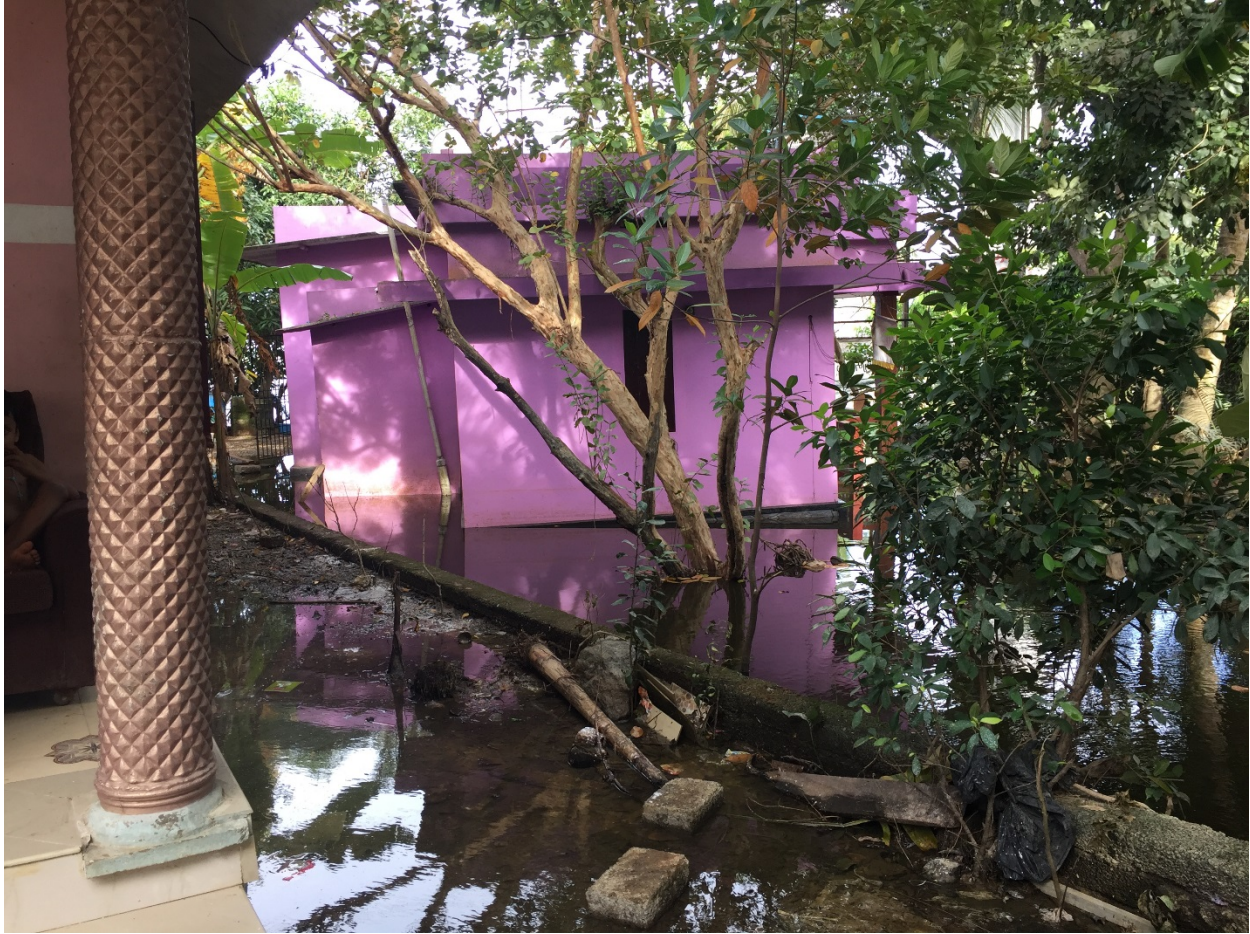
Figure 4.1: Photograph of the subsided purple house located at coordinates Latitude=9.4626°, Longitude=76.3659°.

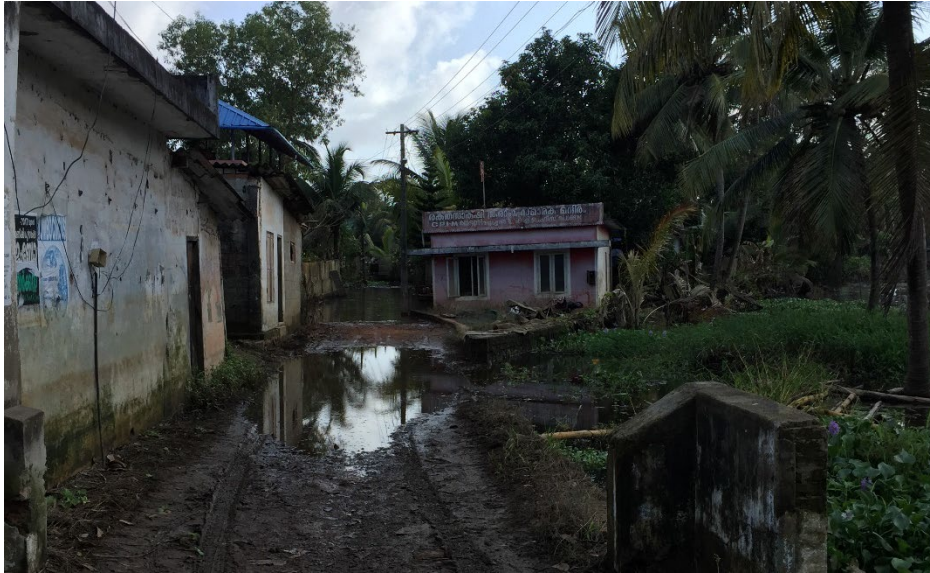
Figure 4.7: Photograph of building that tilted due to differential settlement following floodwater withdrawal (Latitude=9.453415°, Longitude=76.385143°).

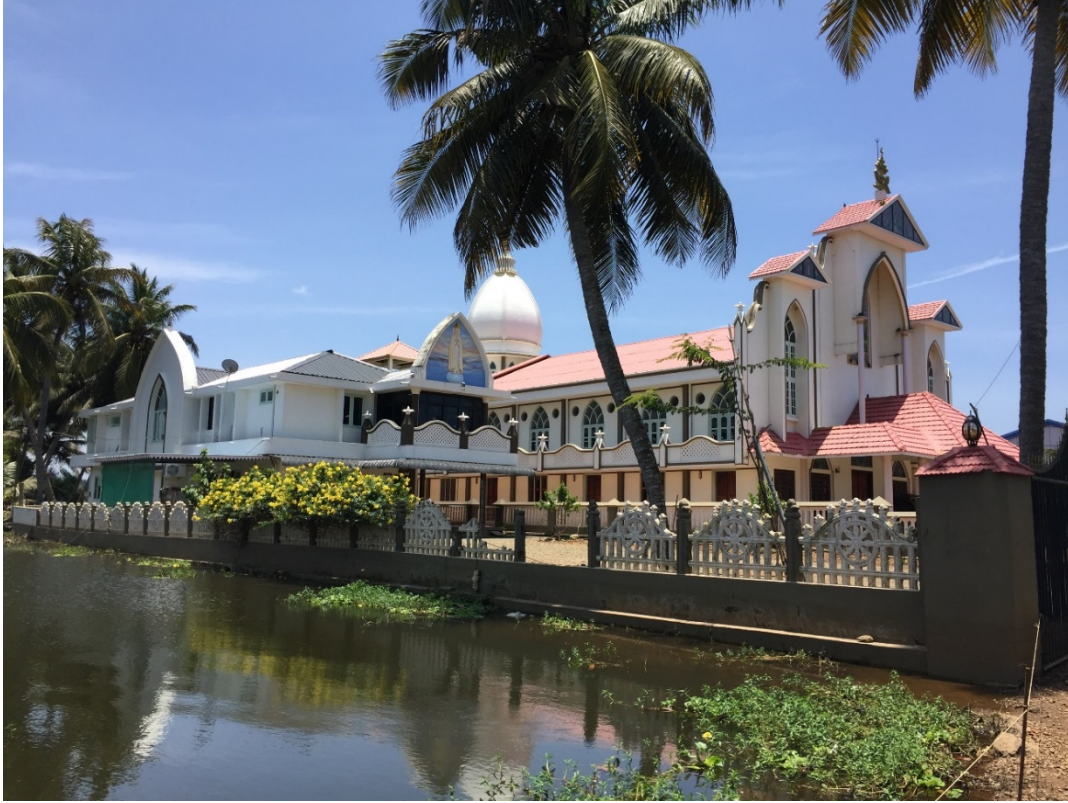
Figure 4.11: Mar Sleeva Church. Original Church constructed on 30-foot long concrete piles; ancillary building constructed on six- to eight-foot long sections of coconut trees placed in nine-pile groups (Latitude=9.450352°, Longitude=76.389449°).

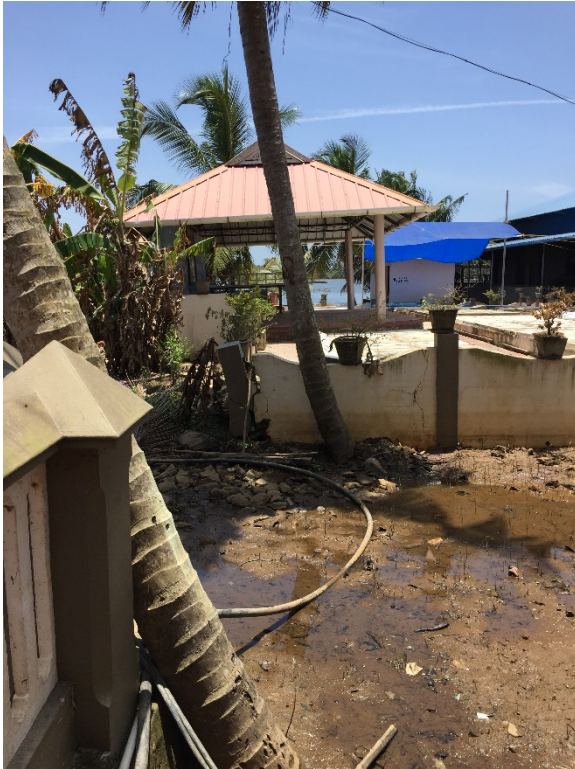
Figure 4.15: Photograph of rotated pavilion located behind the Mar Sleeve Church of Ponga (Latitude=9.449777°, Longitude=76.389598°).

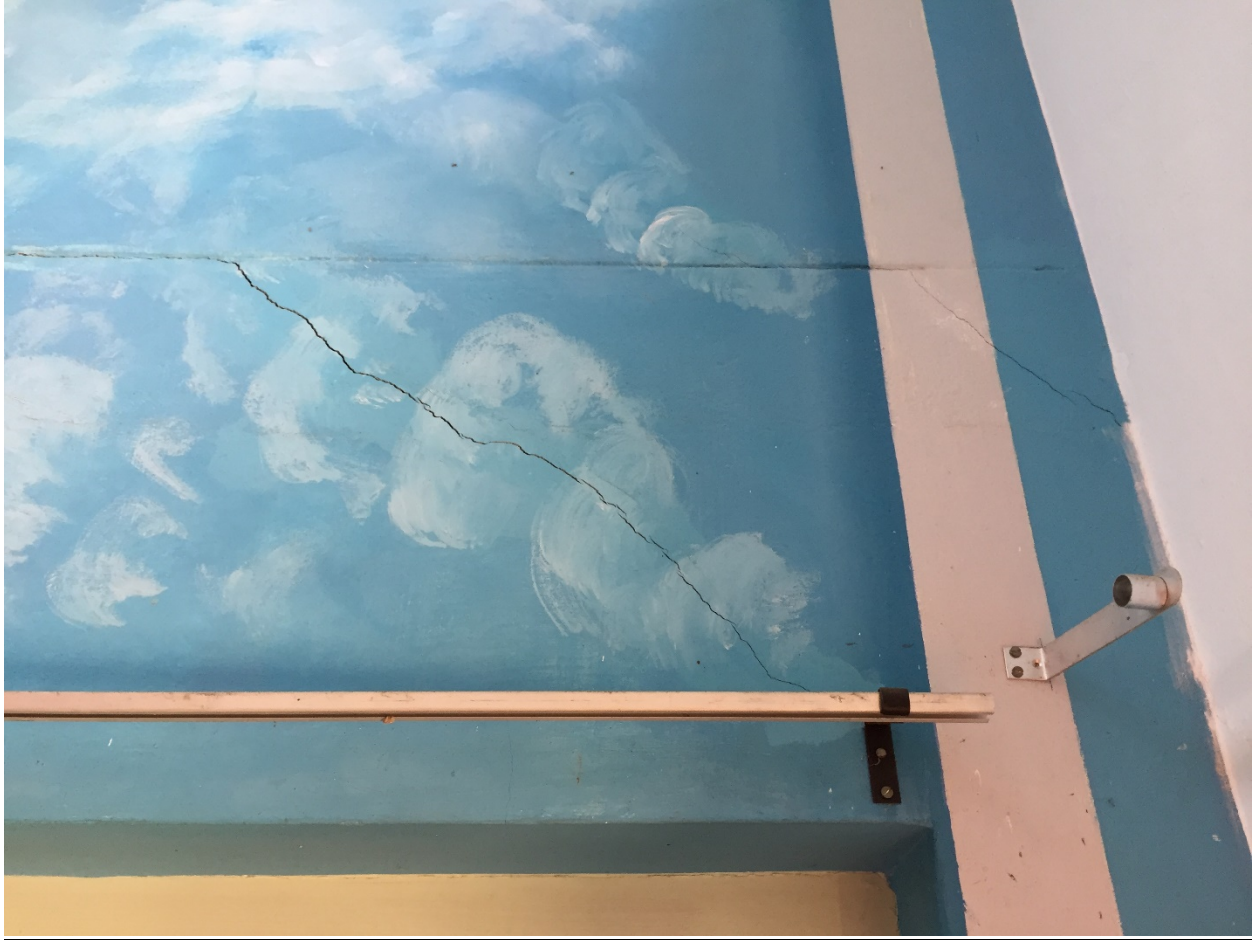
Figure 4.17: Photograph of cracking observed within the back wall of the Mar Sleeva Church or Ponga.

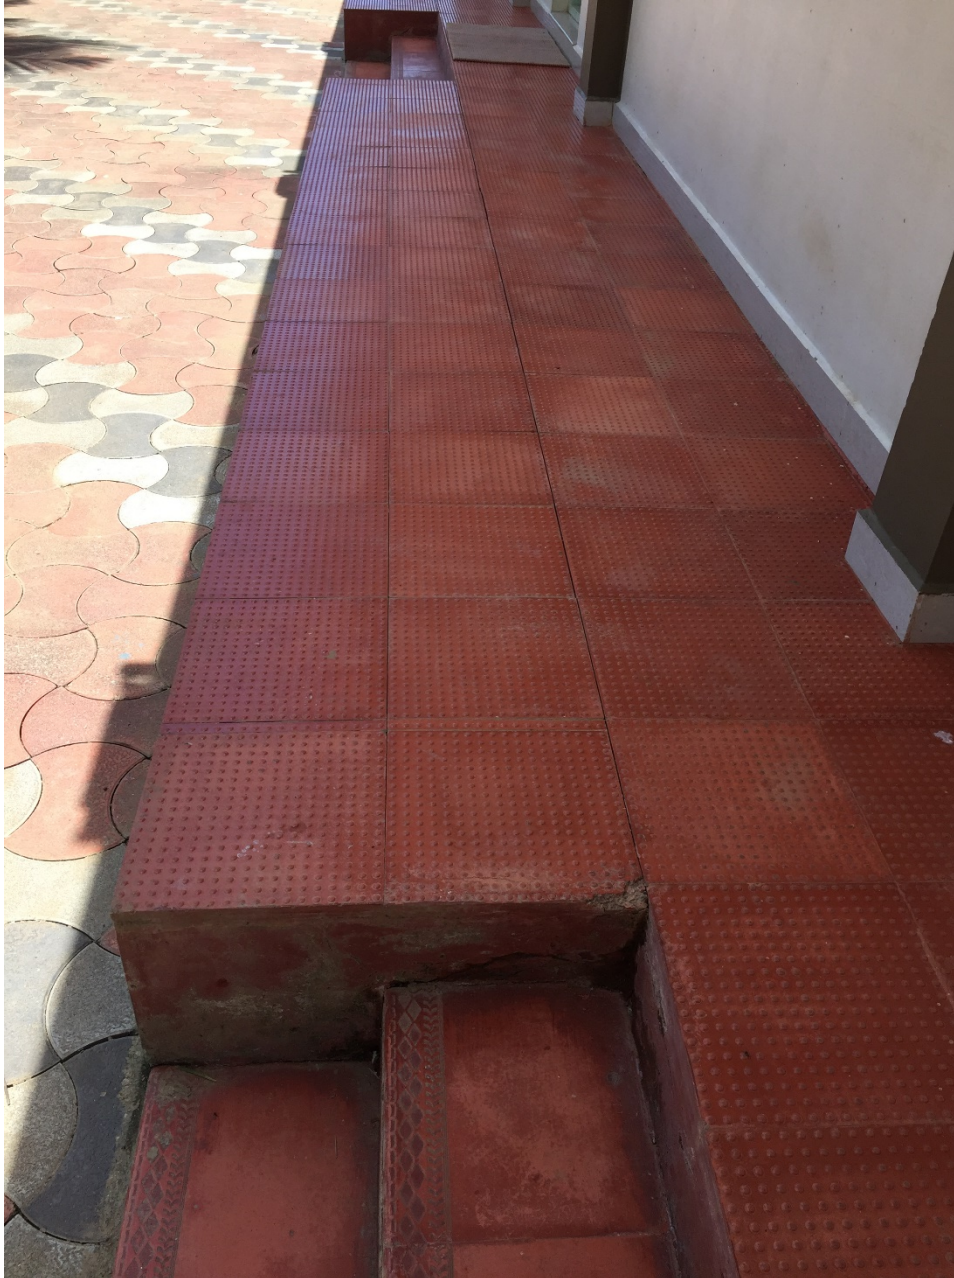
Figure 4.18: Photograph of cracking occurring in the concrete pavers surrounding the pile supported Mar Sleeve Church of Ponga building.

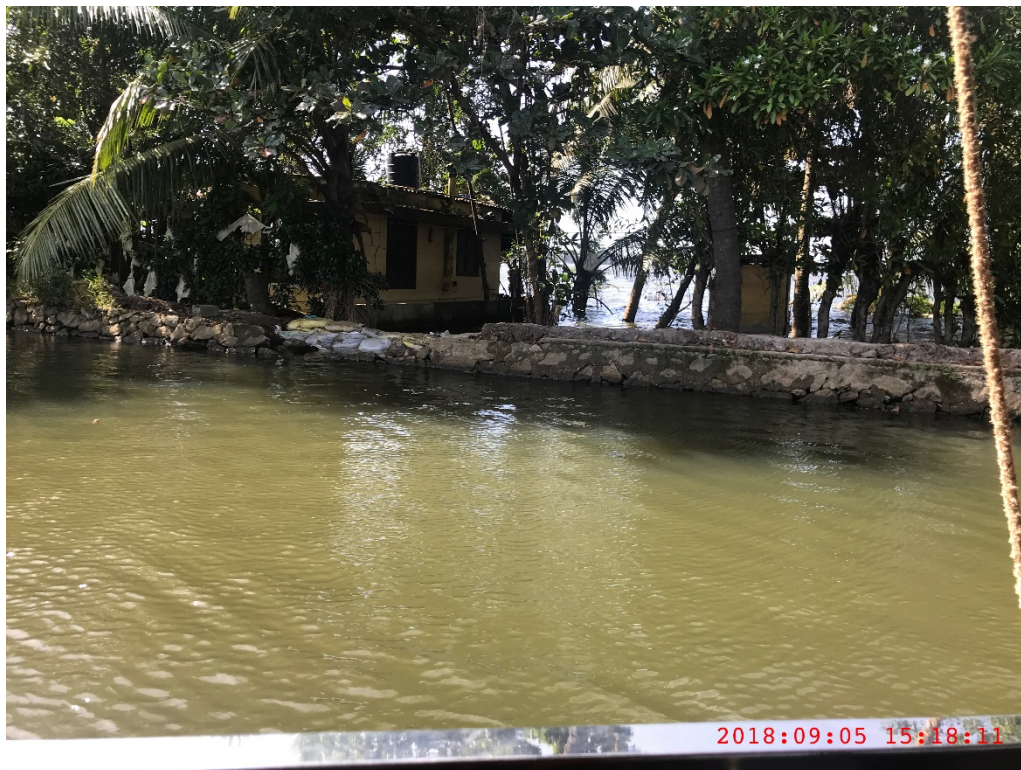
Figure 5.4: A minor bund failure @ 9.5032131⁰N 76.3768638⁰E.

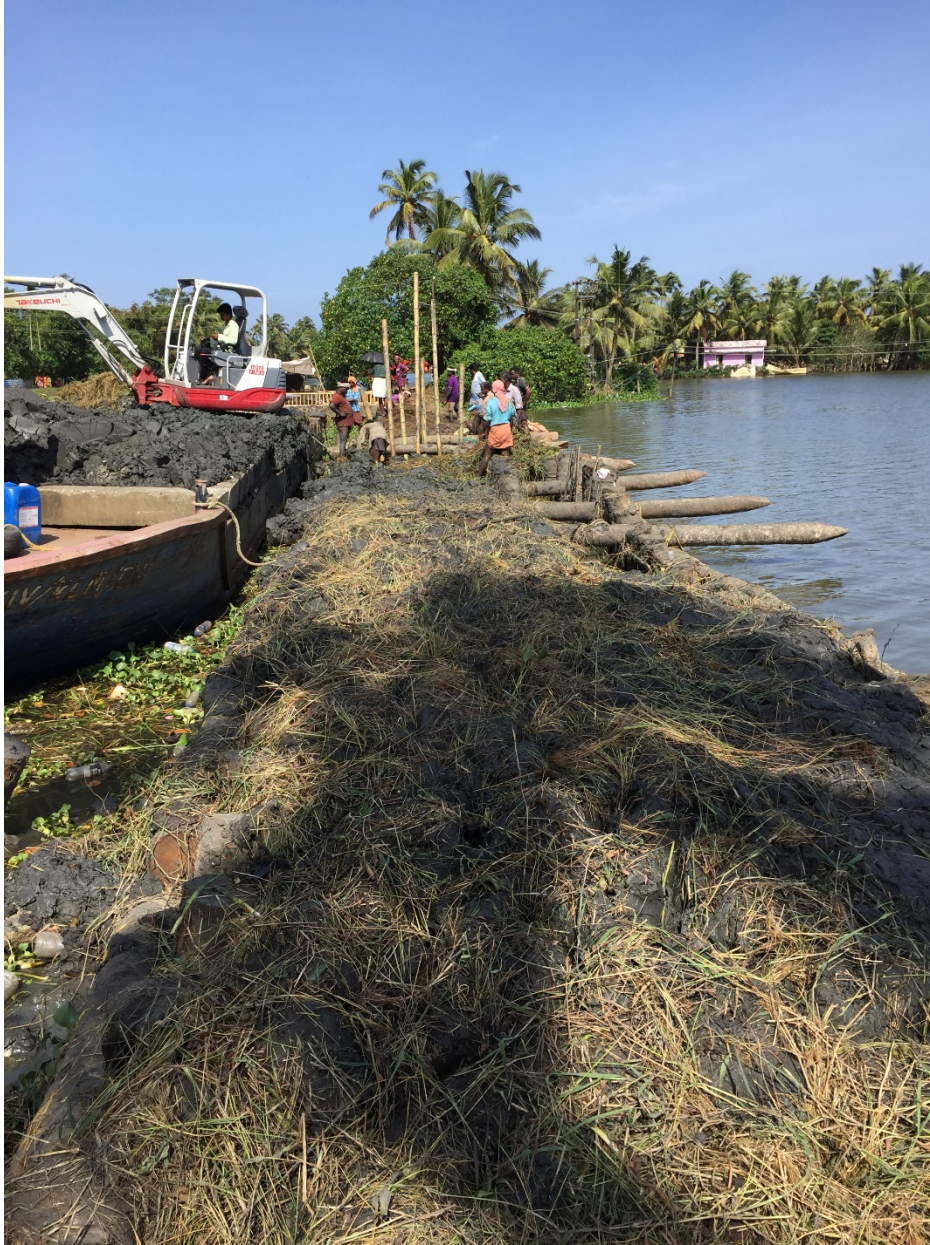
Figure 5.5: A major bund failure of roughly 50m long near Kainakari @ 9.5029947°N 76.3749555°E. The left side of the bund in the photograph is the lake and the right side of the bund is the flooded fields.

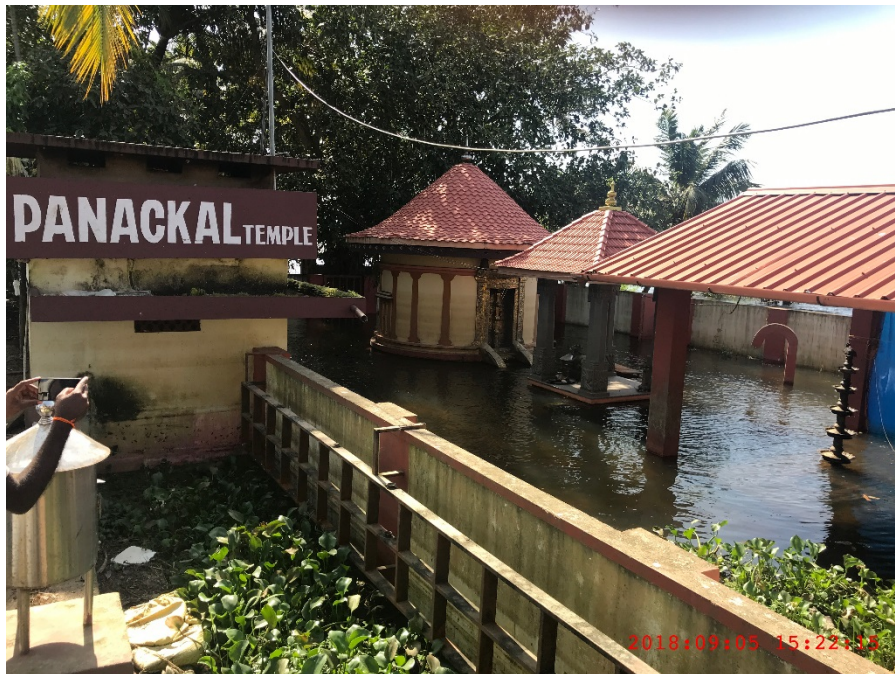
Figure 5.6: Flooded temple complex from the bund failure @ 9.5033596⁰N 76.3771085⁰E

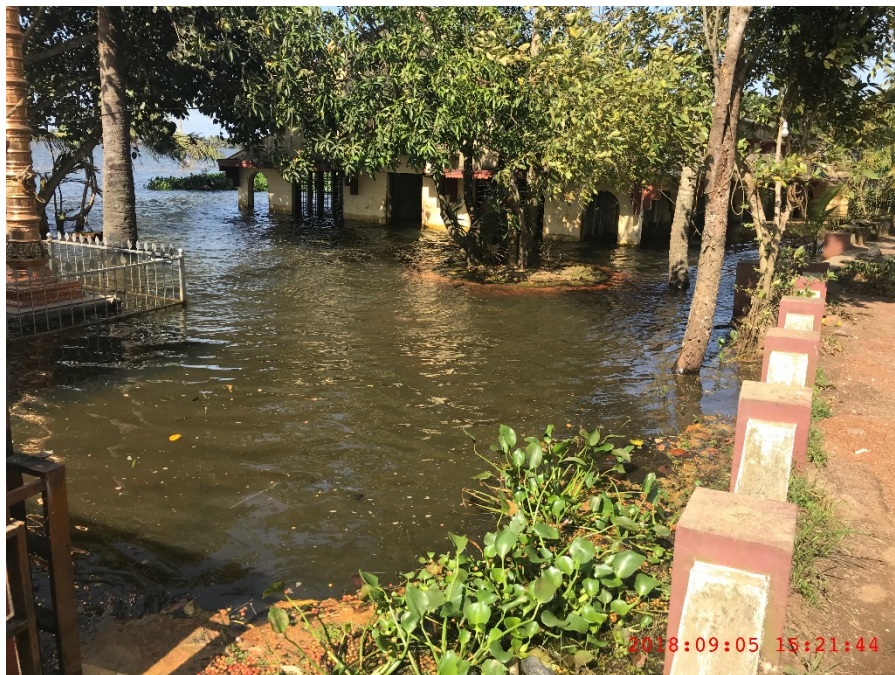
Figure 5.7: Flooded community hall from the bund failure @ 9.5033444⁰N 76.3770758⁰E

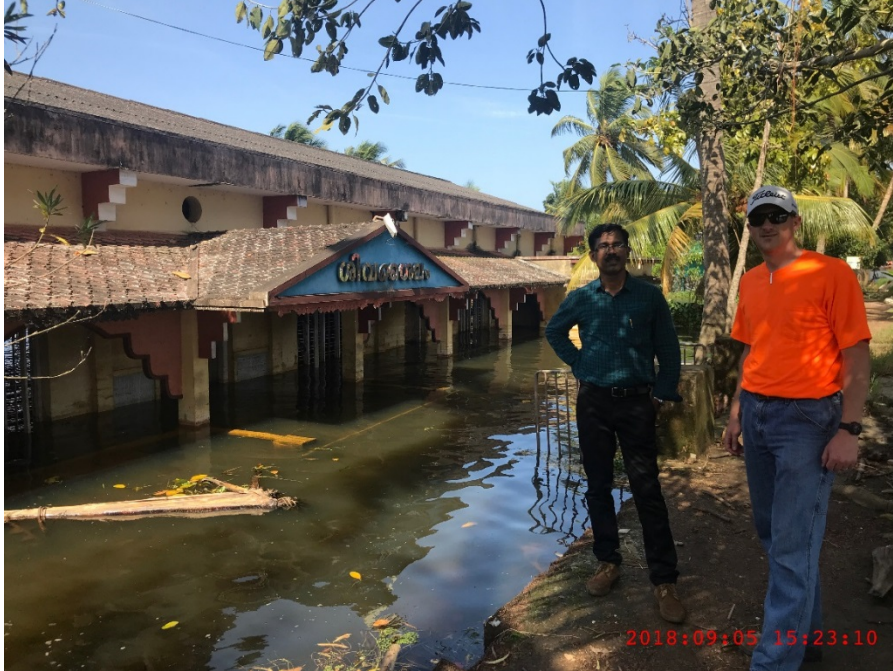
Figure 5.8: Entrance of the flooded community hall @ $9.5033389^{\circ}\text{N } 76.3772861^{\circ}\text{E}$

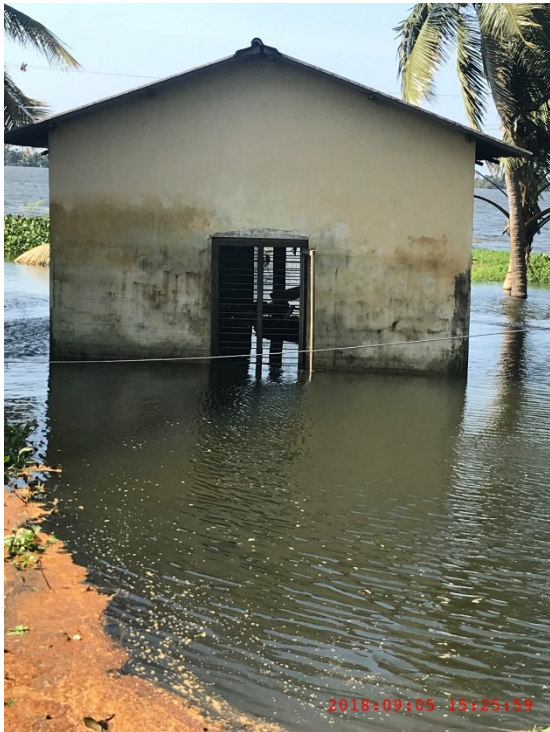
Figure 5.9: Flooded home due to bund failure @ $9.5032691^{\circ}\text{N } 76.3776221^{\circ}\text{E}$

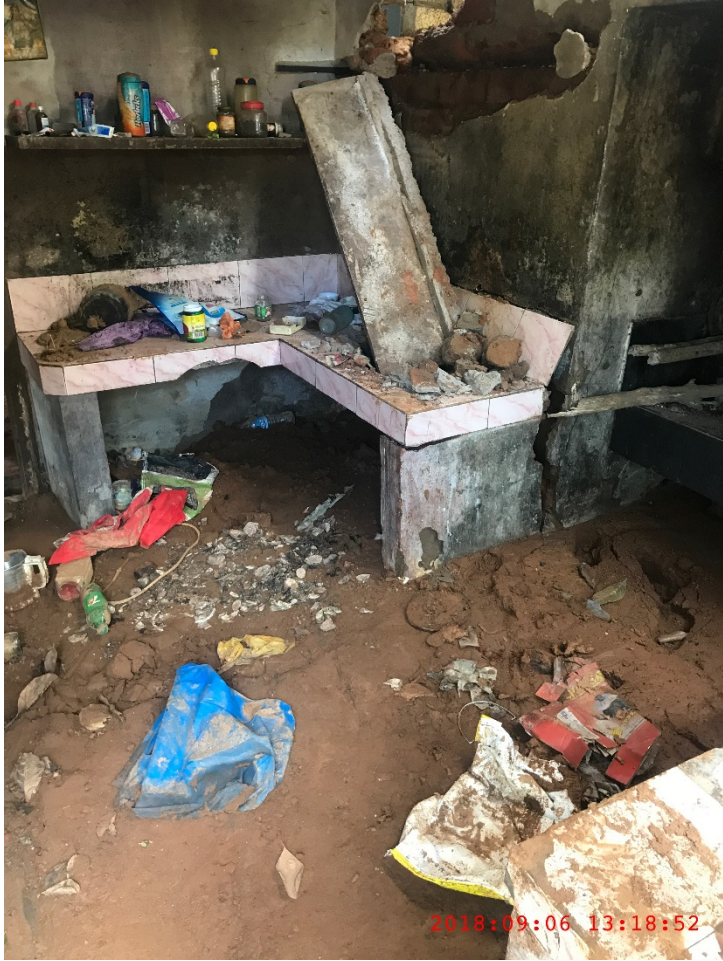
Figure A-7: Interior of a house destroyed in landslide and debris flow @ 9.7966953° N 77.0678775° E

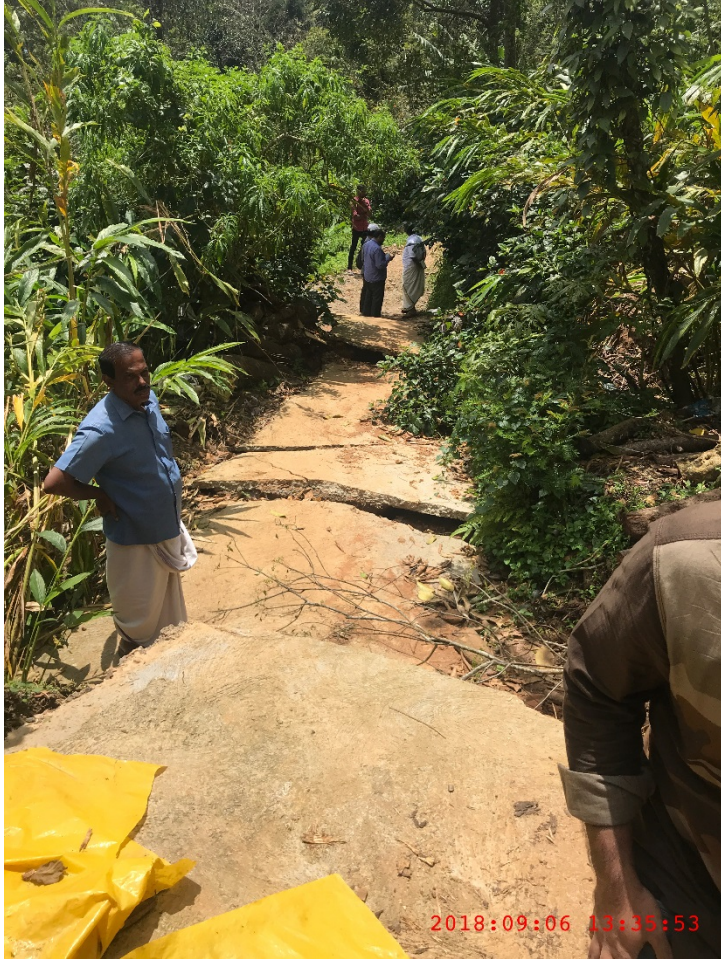
Figure A-8: Driveway to the house destroyed in landslide @ 9.7962622° N 77.0681814° E

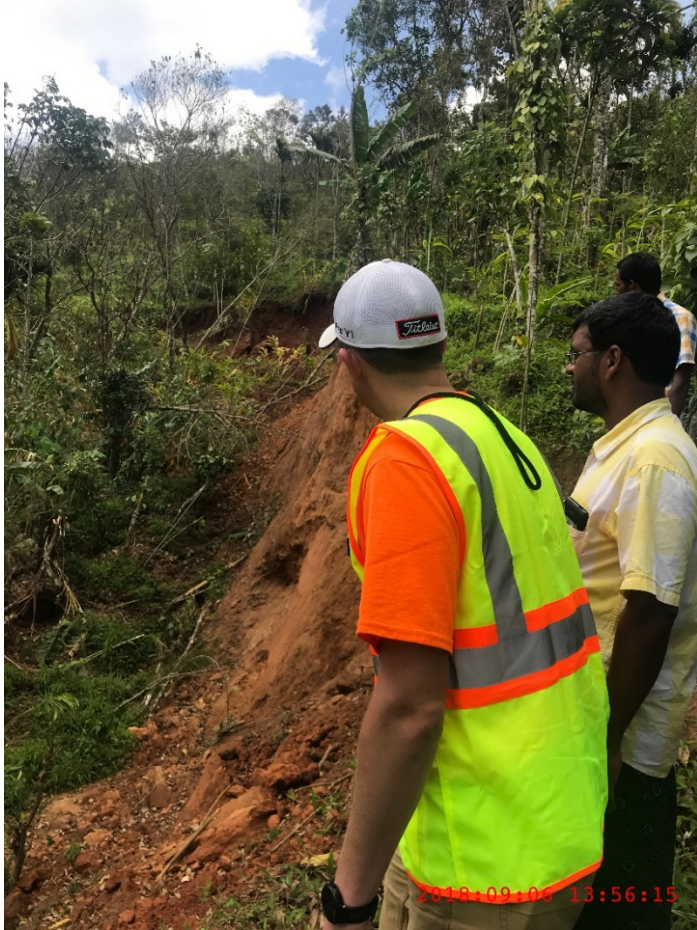
Figure A-9: Landslide scarp @ 9.7966110° N 77.0685257° E
