GEOTECHNICAL IMPACTS OF AUGUST 2018 FLOODS OF KERALA, INDIA

Event: August 2018

Geotechnical Extreme Events Reconnaissance
Turning Disaster into Knowledge
Sponsored by the National Science Foundation
GEER Association Report NO - 058

Date: 10-17-2018

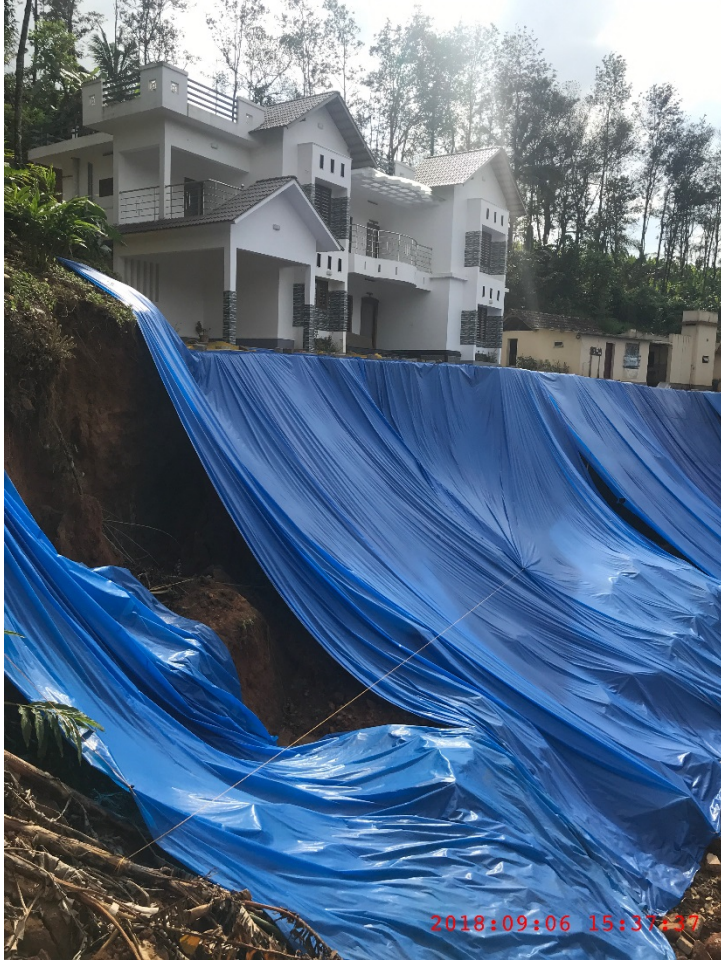
Figure A-11: Large landslide in front of the newly built house @ 9.7925061° N 77.0680952° E

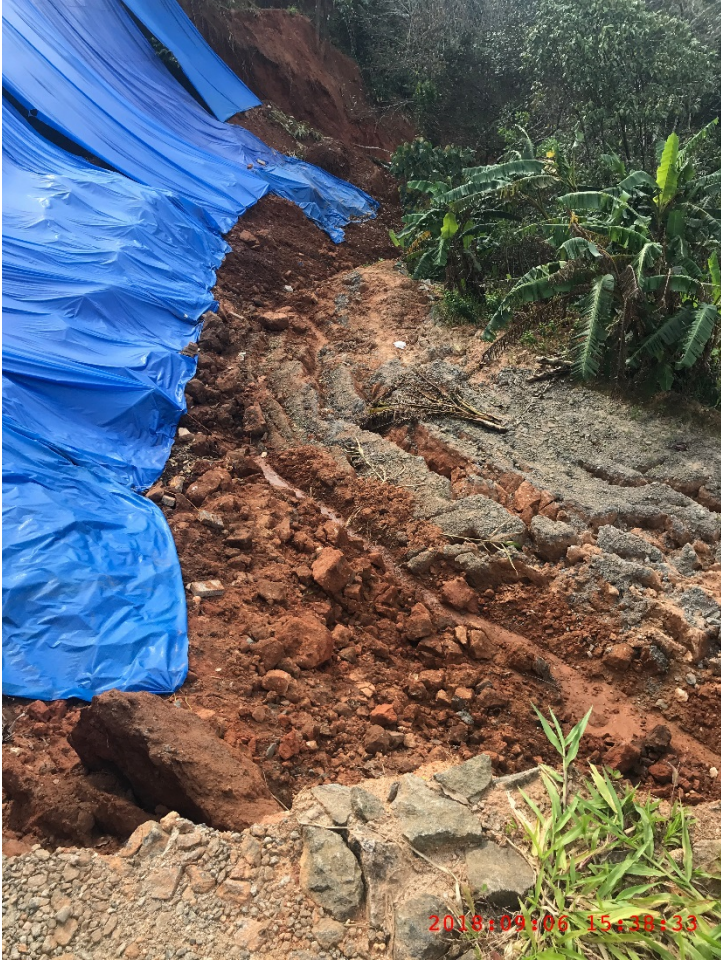
Figure A-12: Head of the landslide @ 9.7925131° N 77.0680889° E

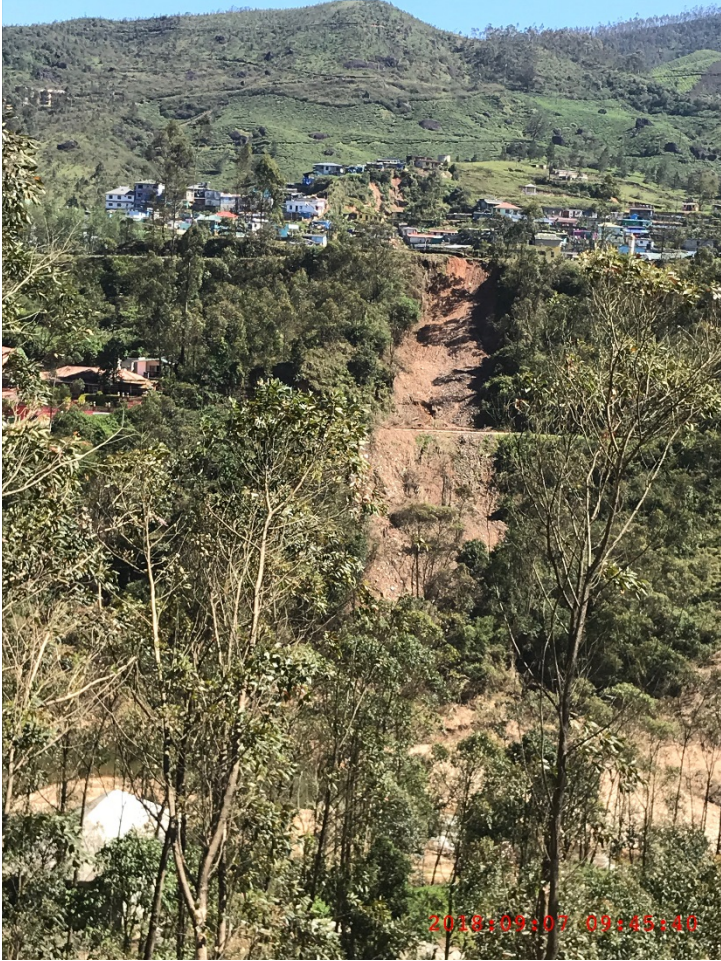
Figure A-15: Debris flow failure @ 10.0830840° N 77.0711627° E

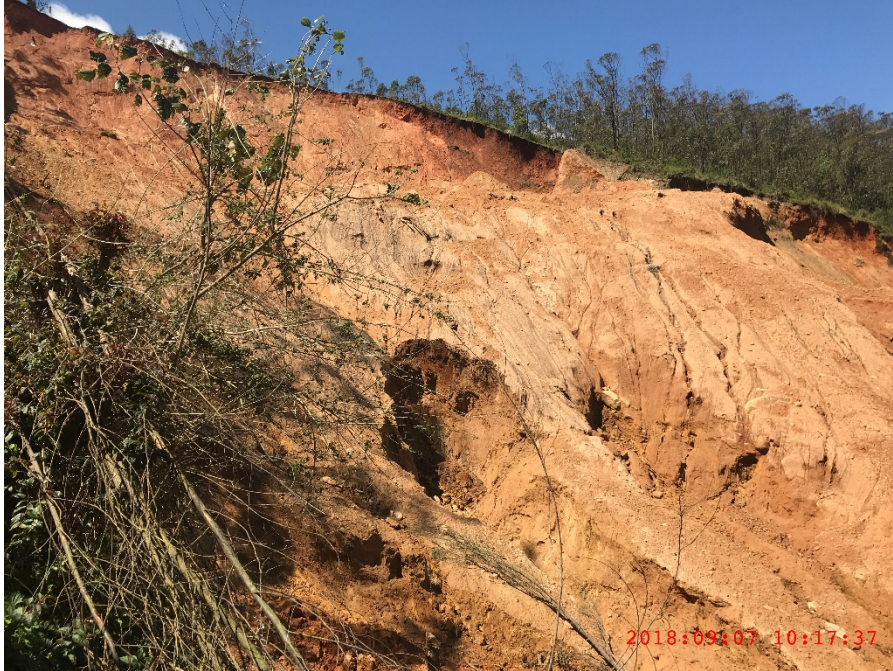
Figure A-16: Munnar college landslide showing piping channels @ 10.0822483° N 77.0734512° E

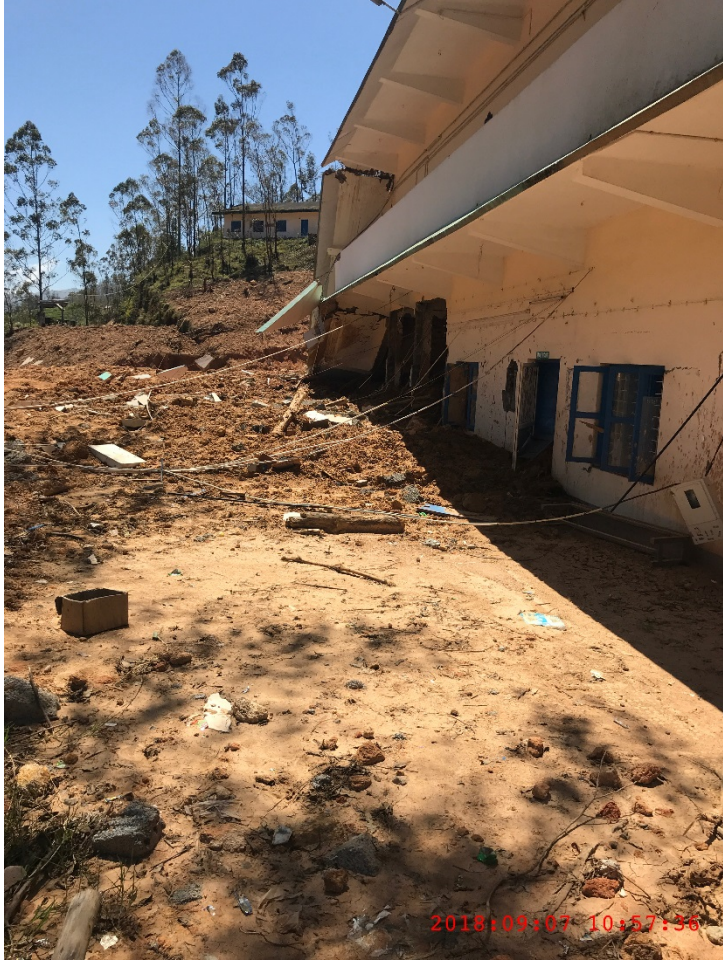
Figure A-18: Destroyed Munnar College building @ 10.0826962° N 77.0726538° E

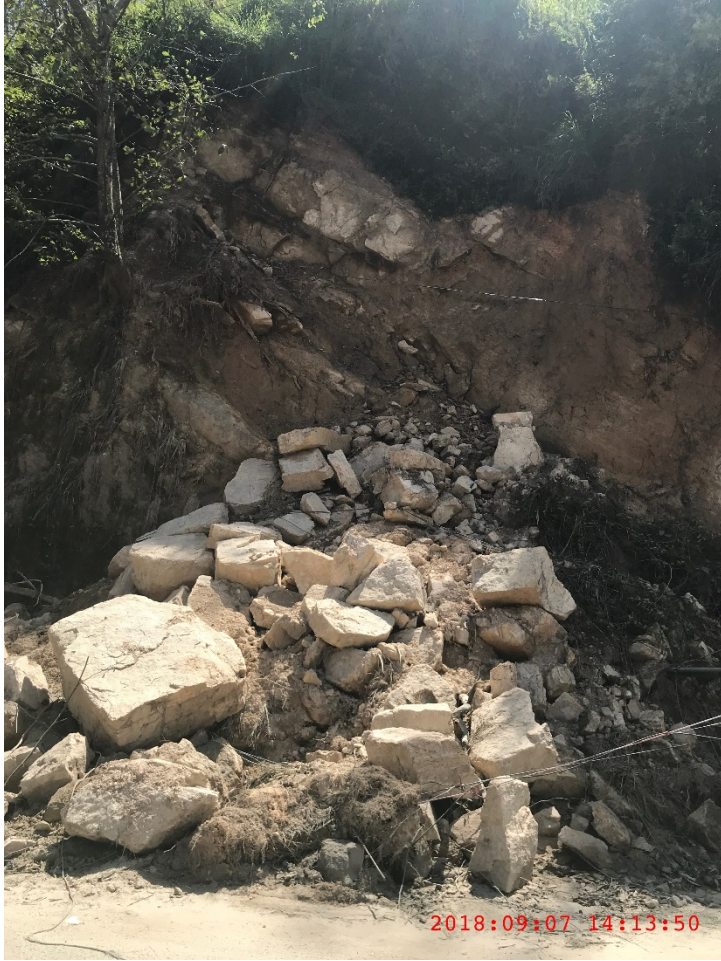
Figure A-19: Rock fall @ 10.0835676° N 77.0615970° E

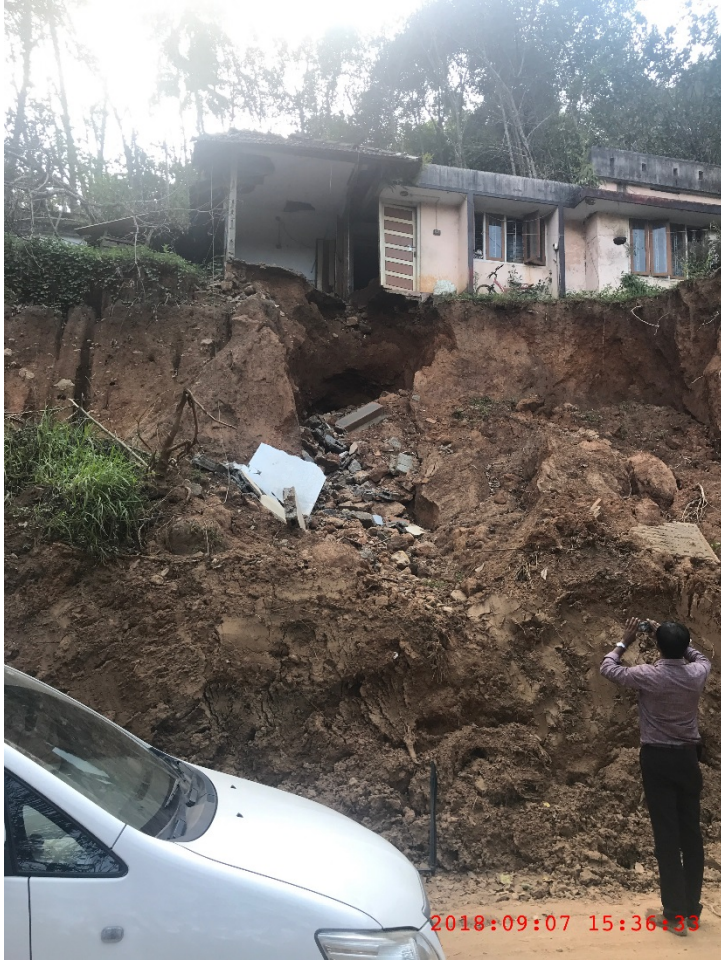
Figure A-24: Another view of the piping channel @ 9.9756741° N 77.0216901° E

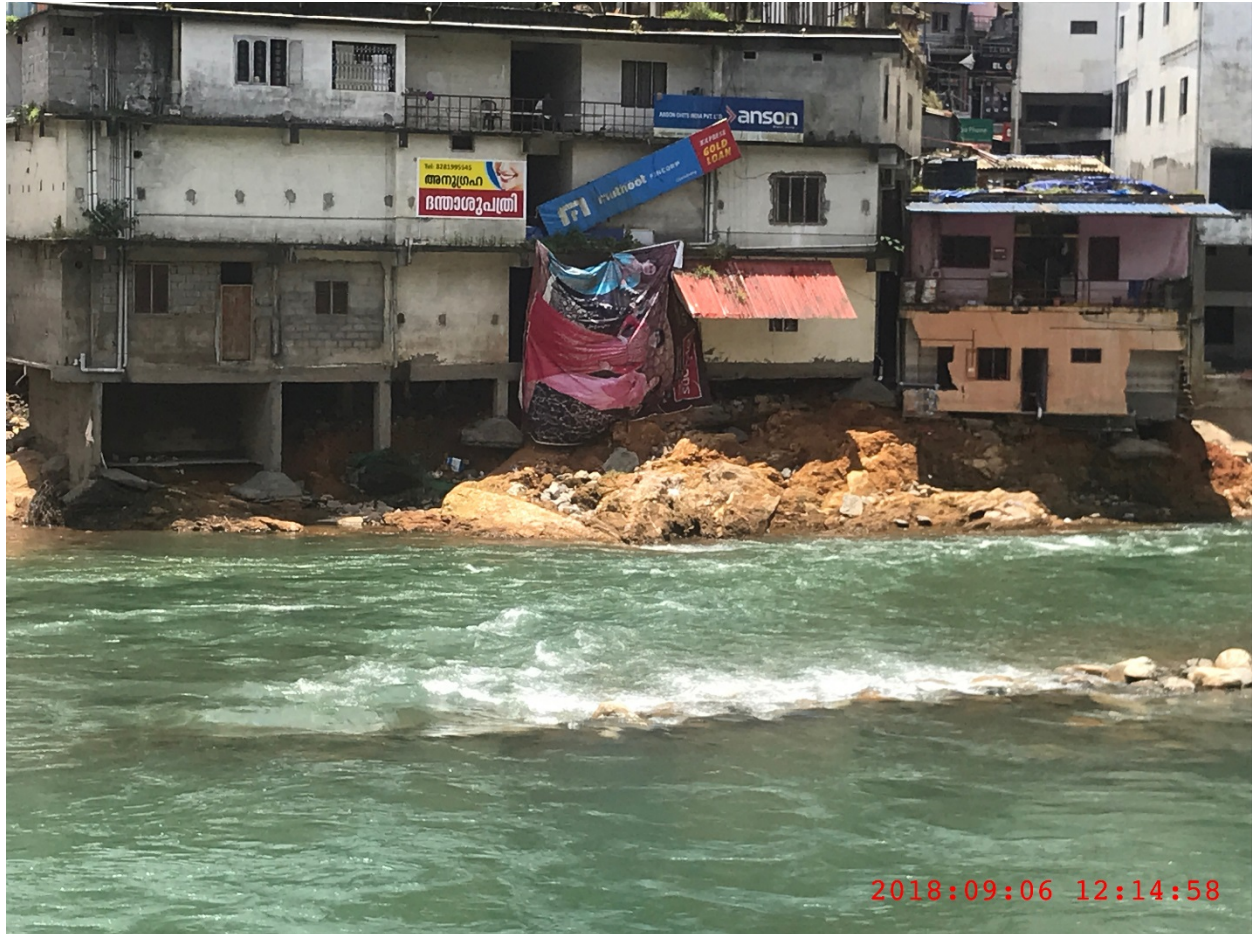
Figure B-1: River erosion @ 9.8575718° N 76.9636035° E

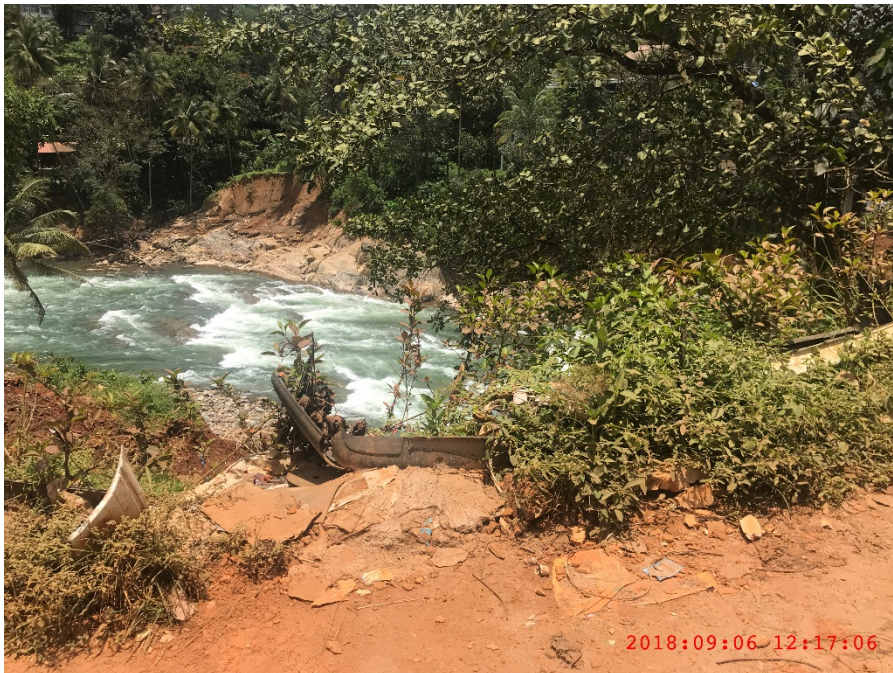
Figure B-3: River erosion @ 9.8585518° N 76.9639427° E

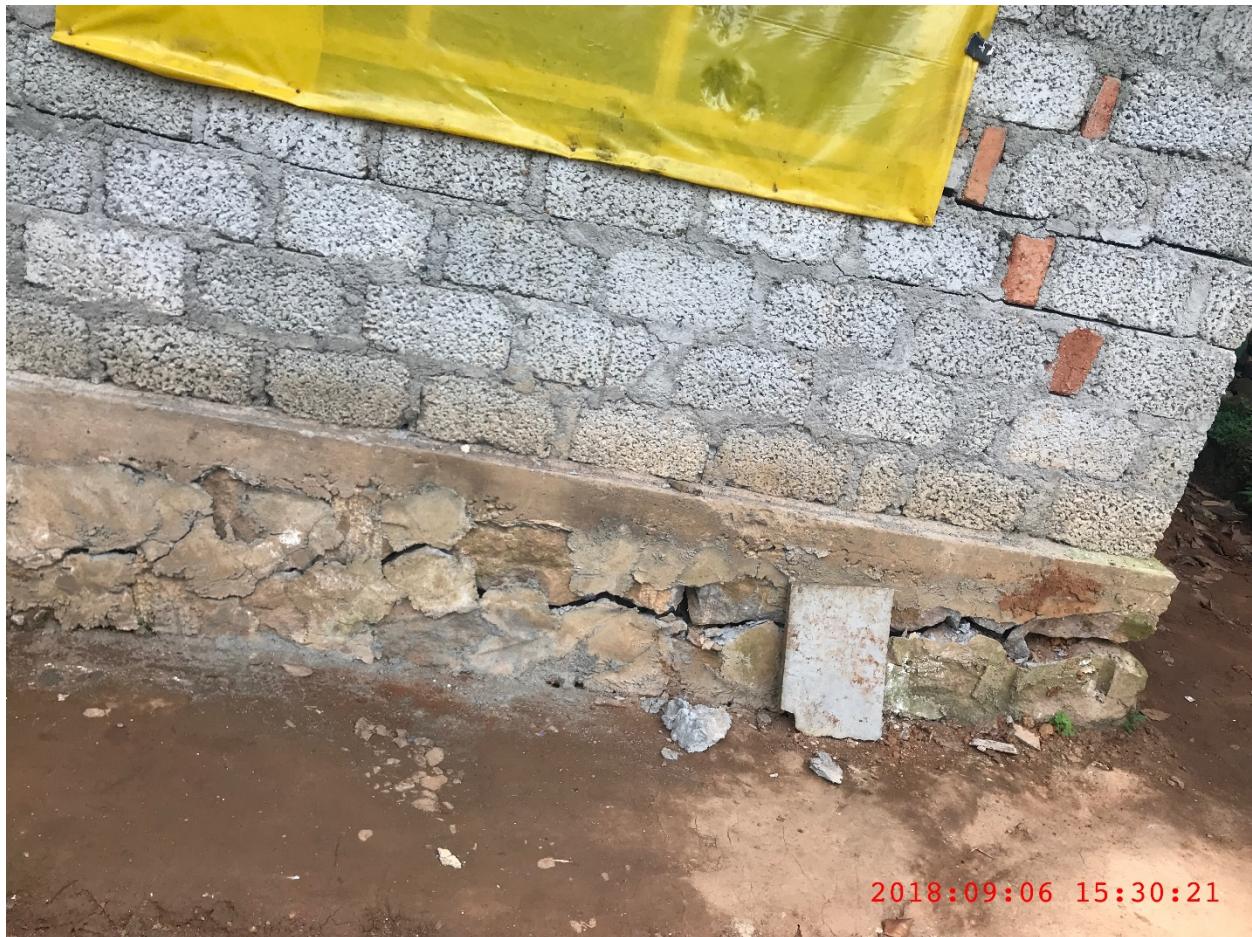
Figure C-1: Foundation of the house cracked due to ground displacement @ 9.7918757° N 77.0687403° E

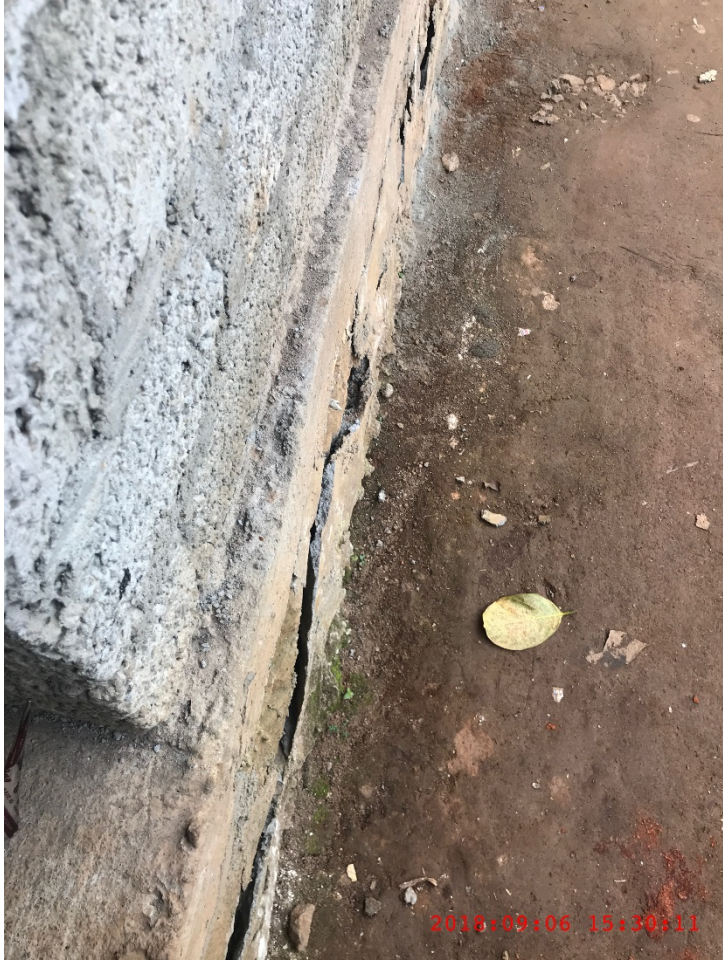
Figure C-2: Another view of the foundation crack @ 9.7918656° N 77.0687362° E

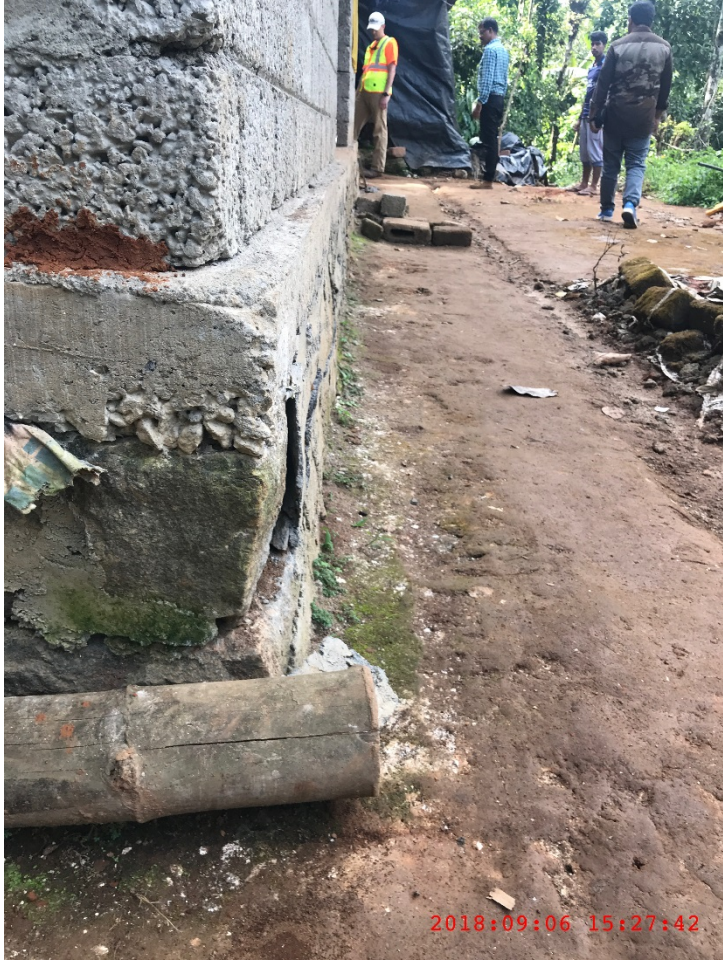
Figure C-3: Another view of the foundation crack @ 9.7918219° N 77.0688023° E

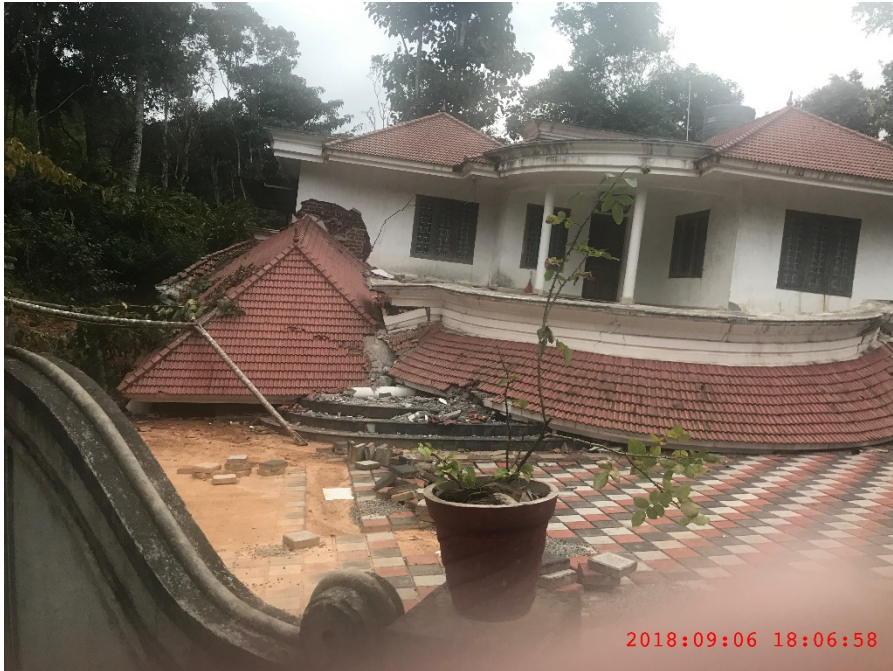
Figure C-4: Building destroyed due to ground movement. An entire floor has been subsided @ 9.8746102° N 77.1193815° E
