GEOTECHNICAL EXTREME EVENTS RECONNAISSANCE (GEER) ASSOCIATION

Geotechnical Aspects of the August 29, 2021, Hurricane Ida in LA, PA, NJ and NY

Report of the NSF Sponsored GEER and NEER Association Teams

GEER/NEER Association Report No. GEER-077

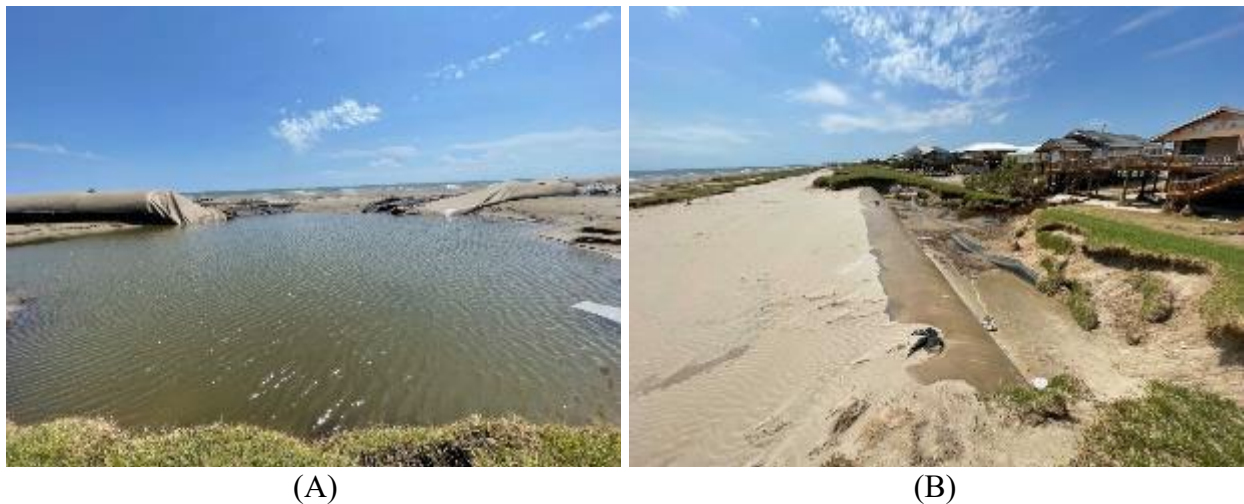
Figure 3.5. Grand Isle levee damage: (A) Breach and scouring of geotube (29.2143639, -90.0246056), and (B) Erosion of overlying grass and sand on geotube (29.2259472, -90.0055778) (Photos: N.H. Jafari).

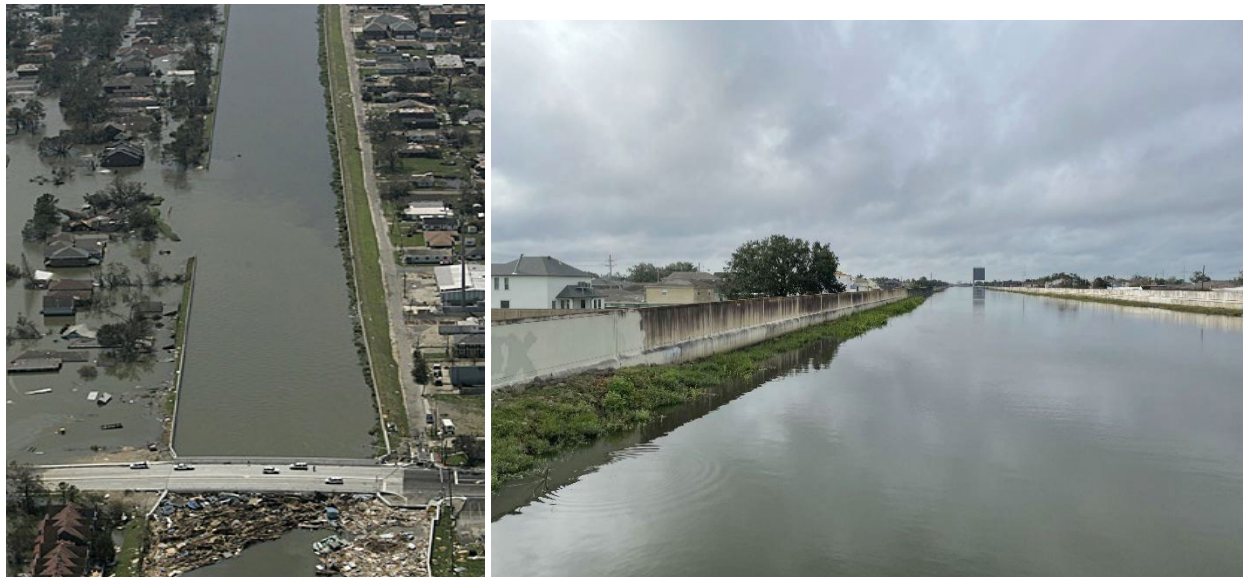
Figure 4.2. 17th Street Levee failure on the east following Hurricane Katrina (left) (ILIT Report, 2006), 17th Street Canal after Hurricane Ida (right) (lat: 30.017342, long: -90.121641) (photo by A. Athanasopoulos-Zekkos).

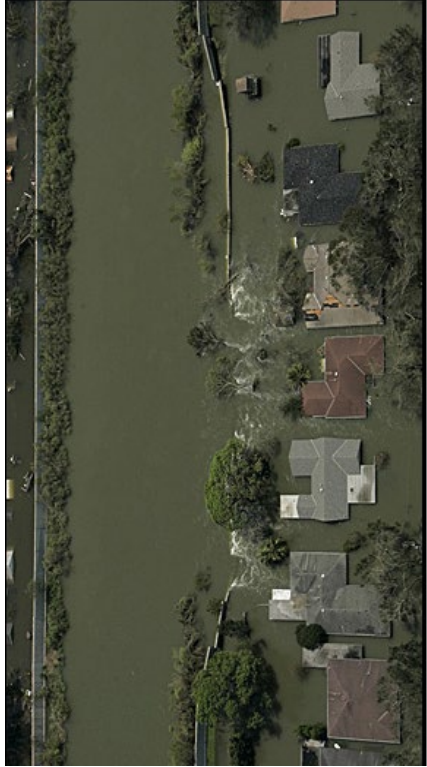
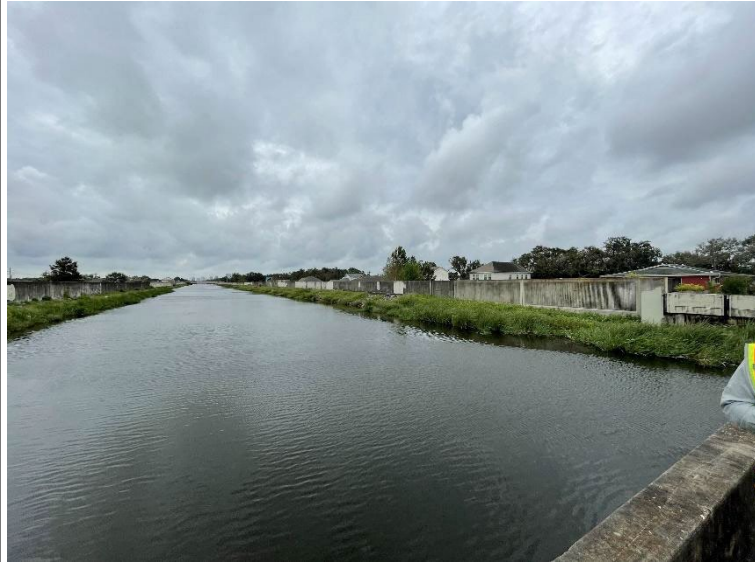
Figure 4.3. London Ave North Levee failure on the west following Hurricane Katrina (left) (ILIT Report, 2006), London Ave Canal North after Hurricane Ida (right) (lat: 30.027667, long: -90.073439) photo by A. Athanasopoulos-Zekkos.

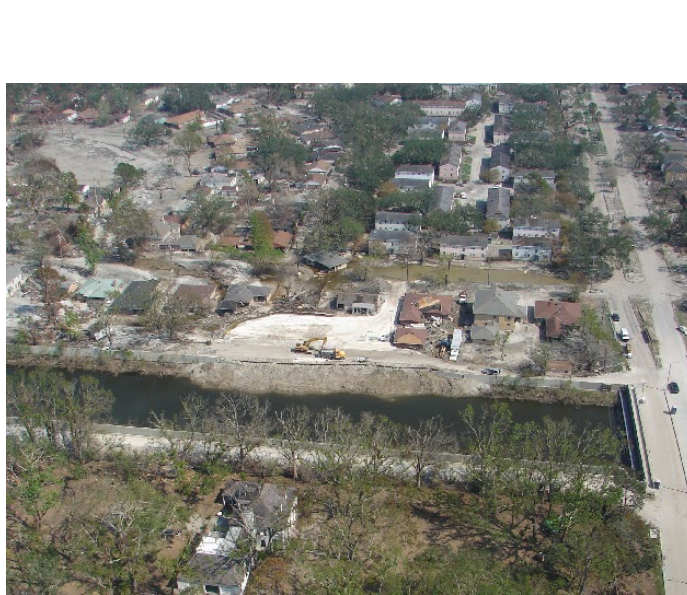
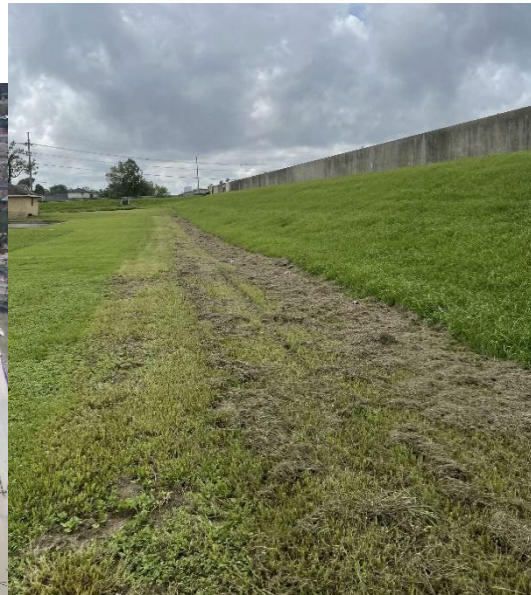
Figure 4.4. London Ave South Levee failure on the west following Hurricane Katrina (left), London Ave Canal South after Hurricane Ida (right) (lat: 30.004702, long: -90.069147) (photo by A. Athanasopoulos-Zekkos).

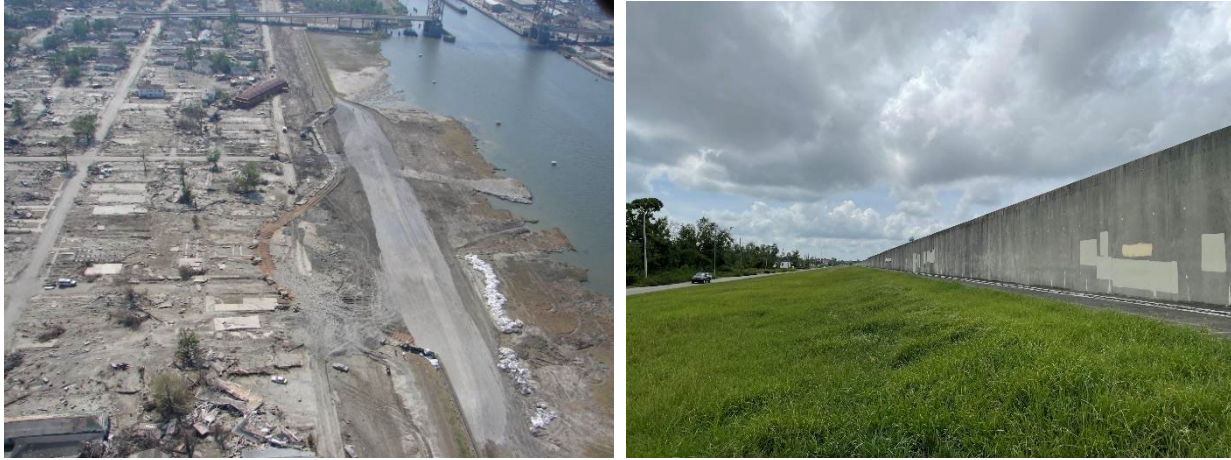
Figure 4.9. IHNC Lower 9th Ward Levee failure following Hurricane Katrina (left) (ILIT Report, 2006), IHNC after Hurricane Ida (right) (lat: 29.978591, long: -90.020675) (photo by A. Athanasopoulos-Zekkos).

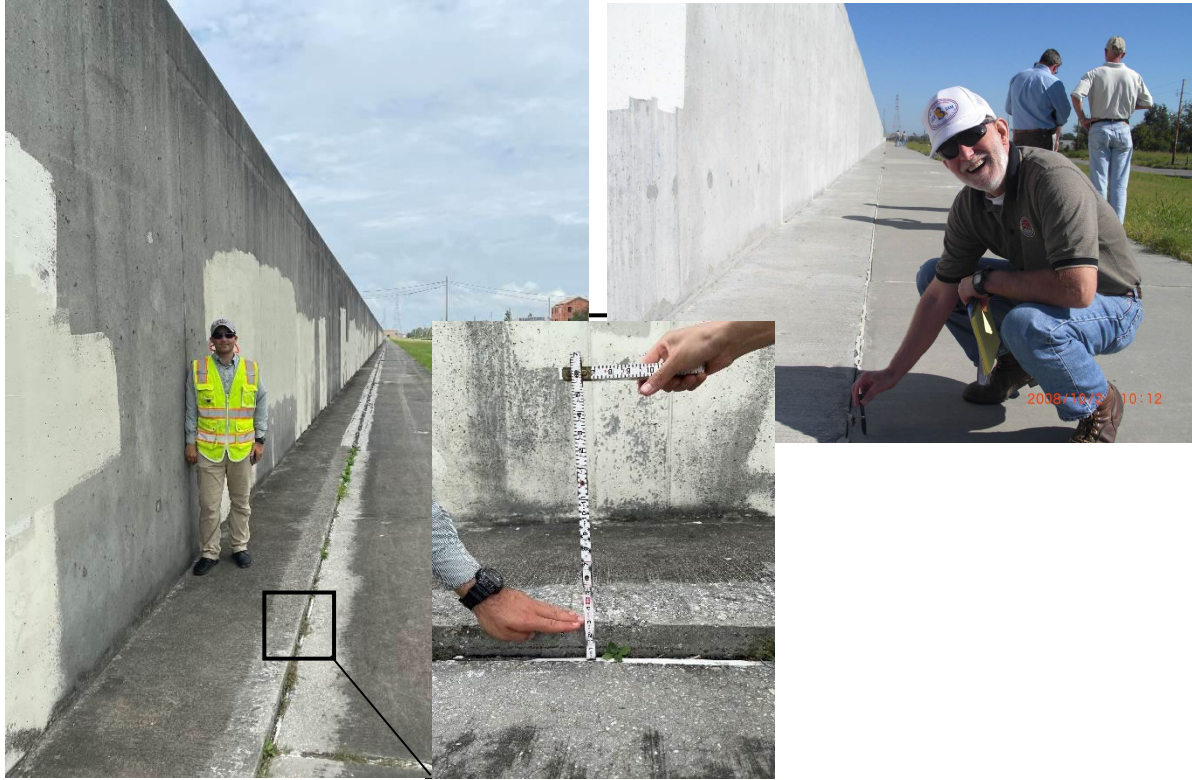
Figure 4.11. Floodwalls at the Lower 9th Ward following Hurricane Ida (left and insert showing measured settlement), same location after Hurricane Gustave showing observed settlement (lat: 29.978591, long: -90.020675) (GEER Report, Gilbert et al. 2009).

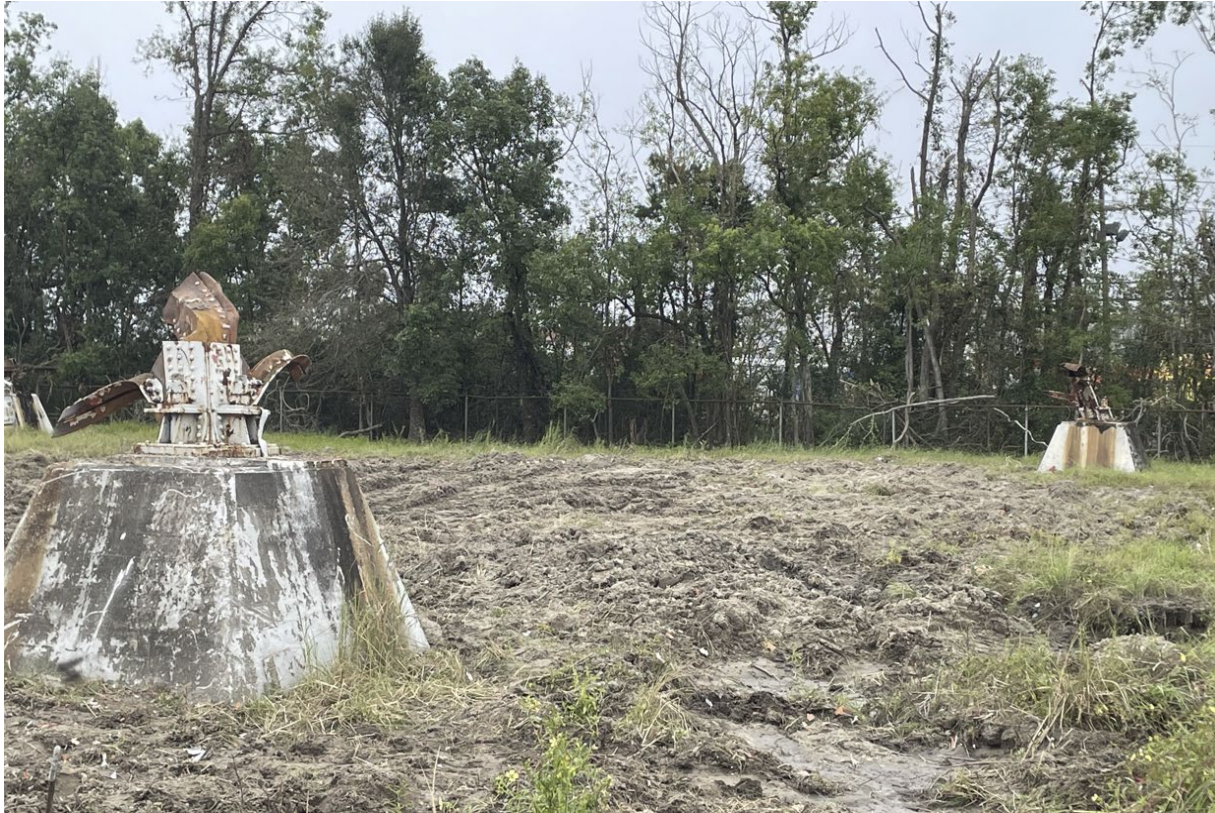
Figure 5.2. View of electric transmission tower foundations following removal of the failed transmission tower. (29.928703, -90.179047). (Photo by: A. Athanasopoulos-Zekkos)

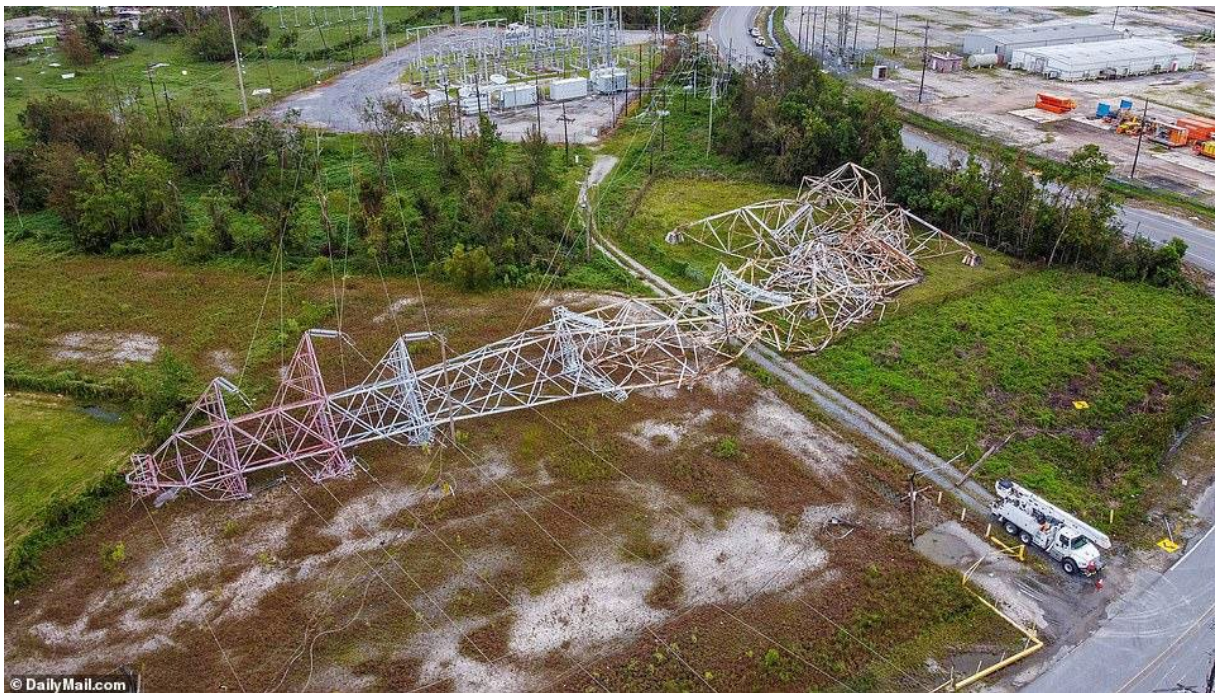
Figure 5.3. Aerial oblique view of the downed transmission tower at Location "A". Photo from DailyMail.com (<https://tinyurl.com/pd8k9t7w>). (29.928703, -90.179047)

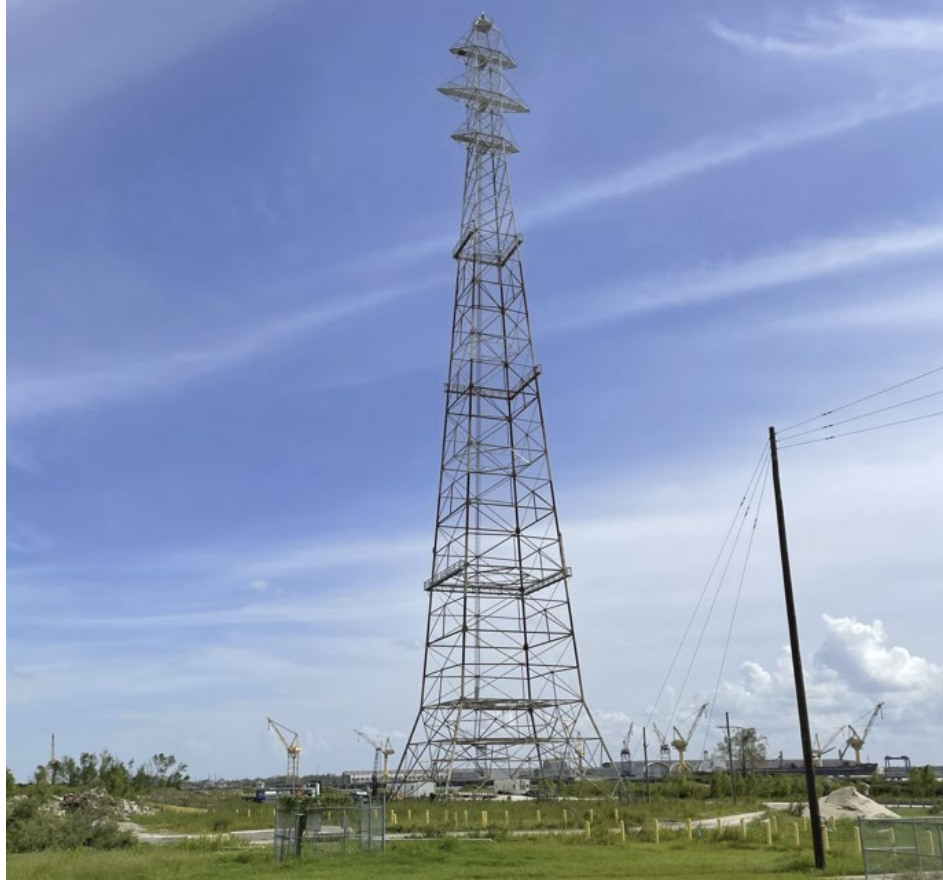
Figure 5.4. North Tower intact and no observable foundation or structural issues. (29.936753, -90.188278). (Photo by: A. Athanasopoulos-Zekkos)

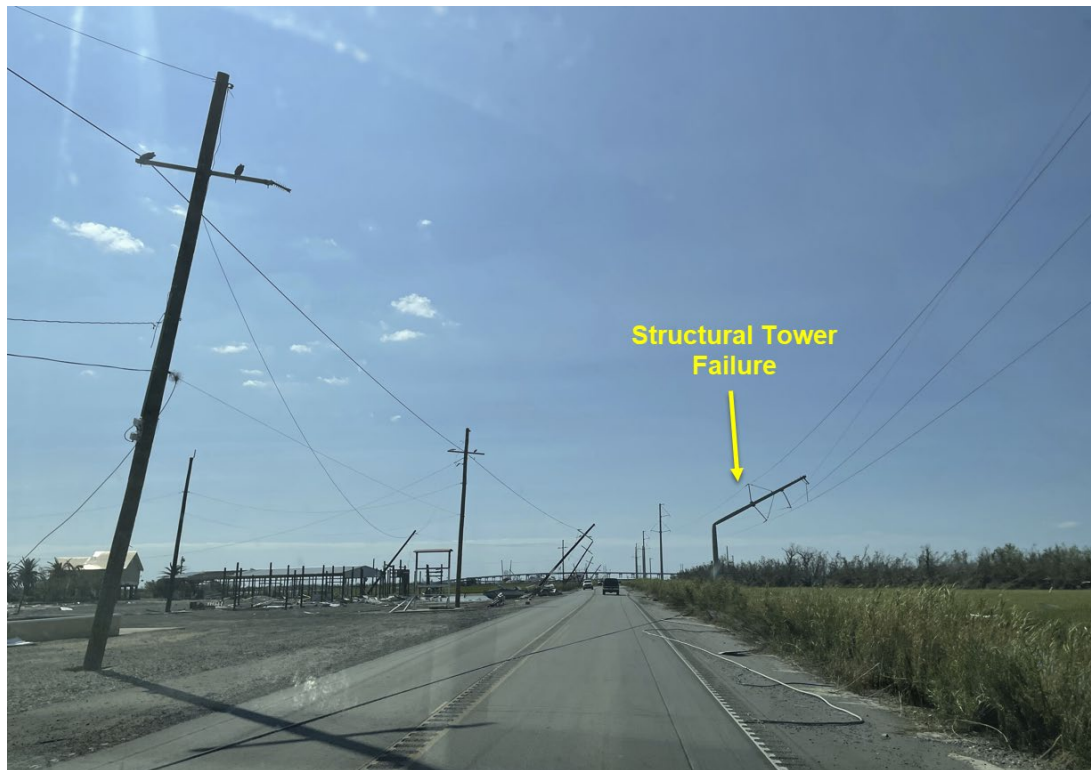
Figure 5.8. Observed structural failure of a transmission pole along Highway 1 near Leeville in Bayou Lafourche. (29.266739, 90.219292). (Photo by: A. Athanasopoulos-Zekkos)

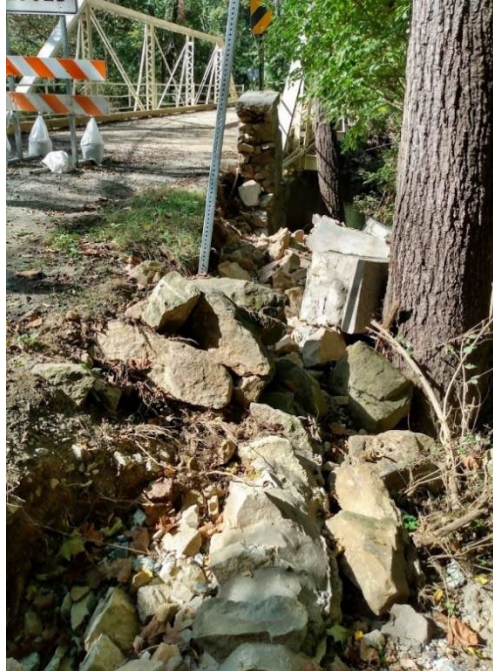
Figure 6.15. Wilson Rd Bridge Abutment and Wingwall Damage Upstream Side (40.082212, -75.456375).

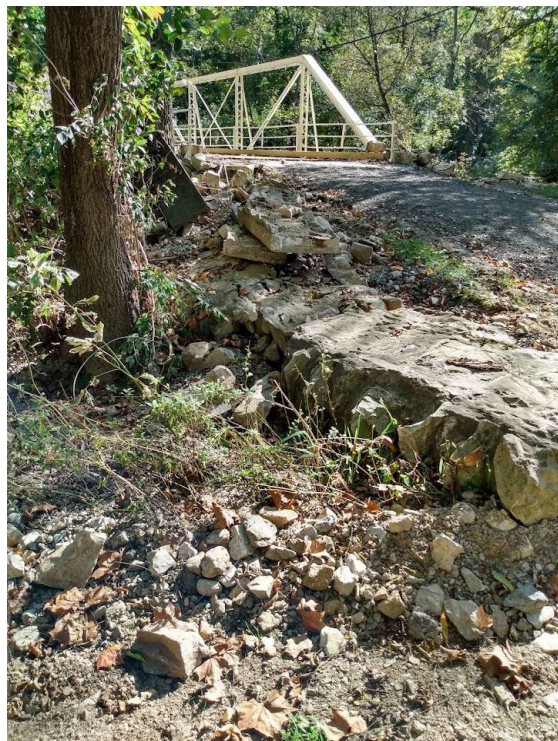
Figure 6.16. Wilson Rd Bridge Abutment and Wingwall Damage Downstream Side (40.082212, -75.456375).

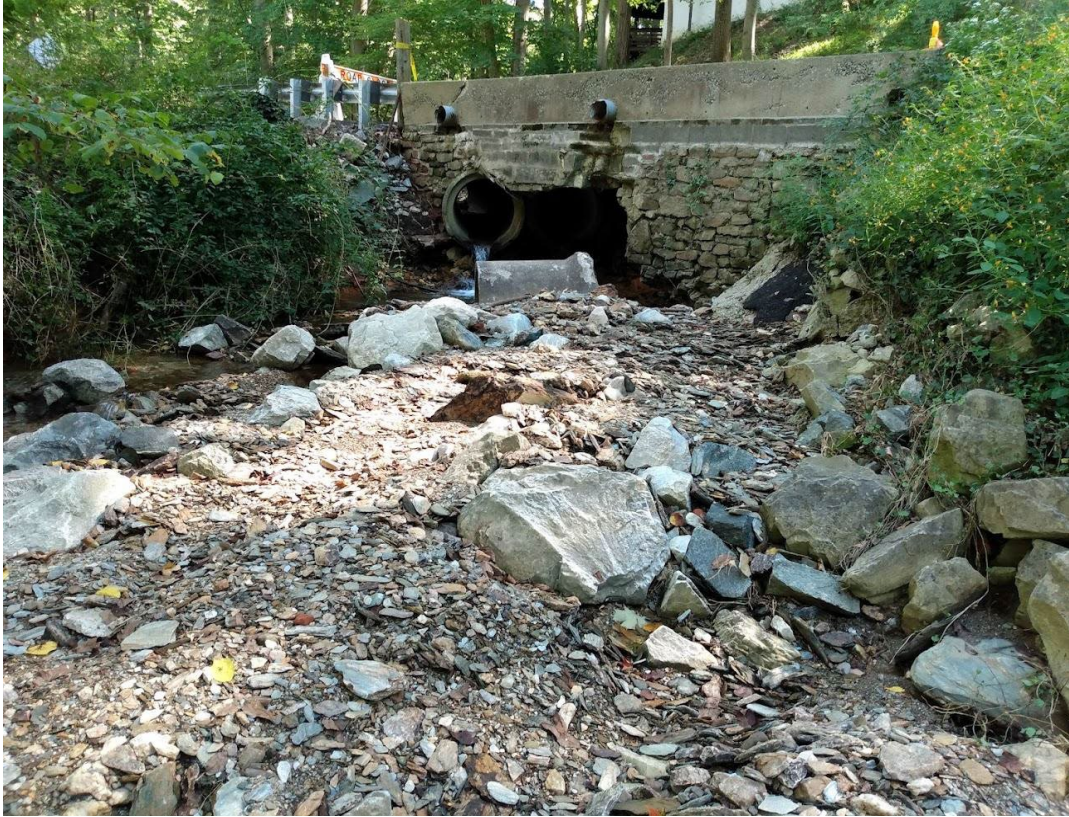
Figure 6.17. Pugh Rd Bridge Damage view from Downstream (40.063619, -75.427464).

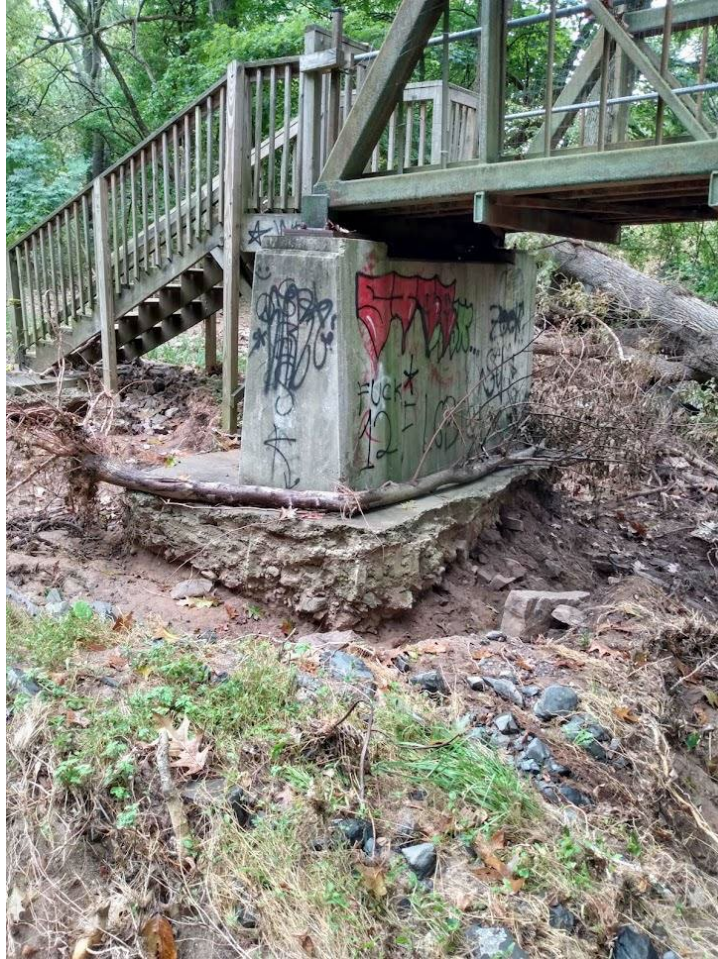
Figure 6.18. Scour at Wissahickon Trails Bridge Abutment (40.150445, -75.228859).

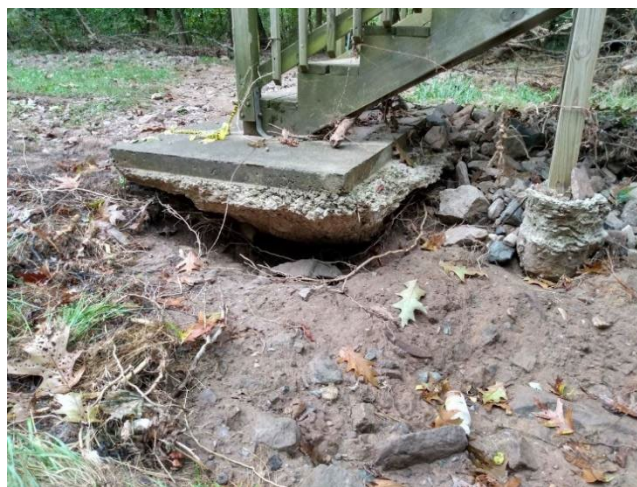
Figure 6.19. Scour at Wissahickon Trails Bridge Foundation for Stairs (40.150445, -75.228859).

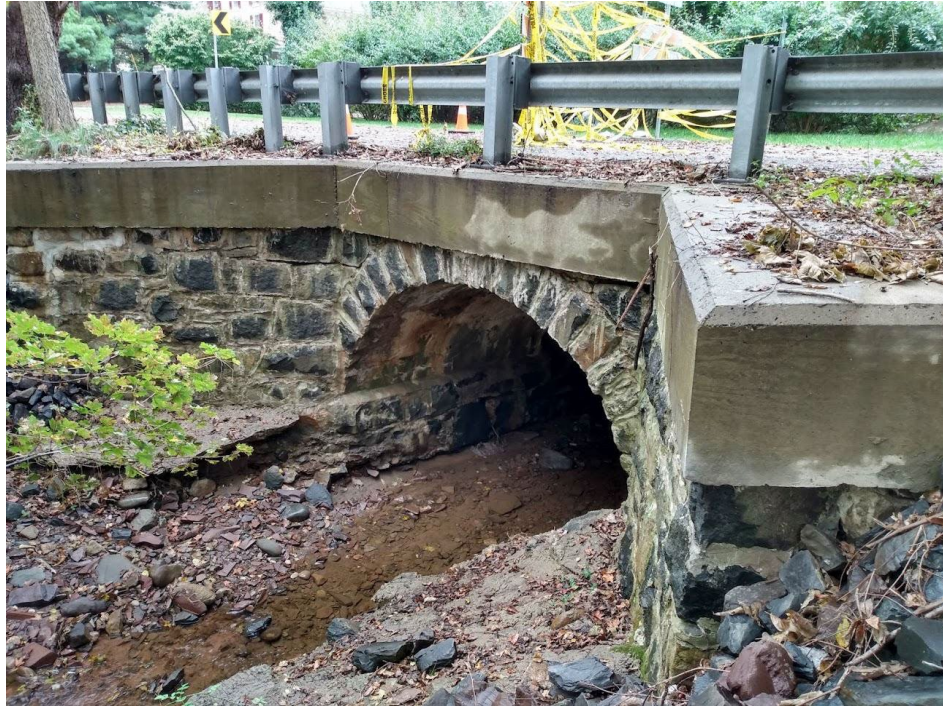
Figure 6.20. River Rd Segment 300 Bridge Scour and Undermining view from upstream (40.323972, -74.9275).

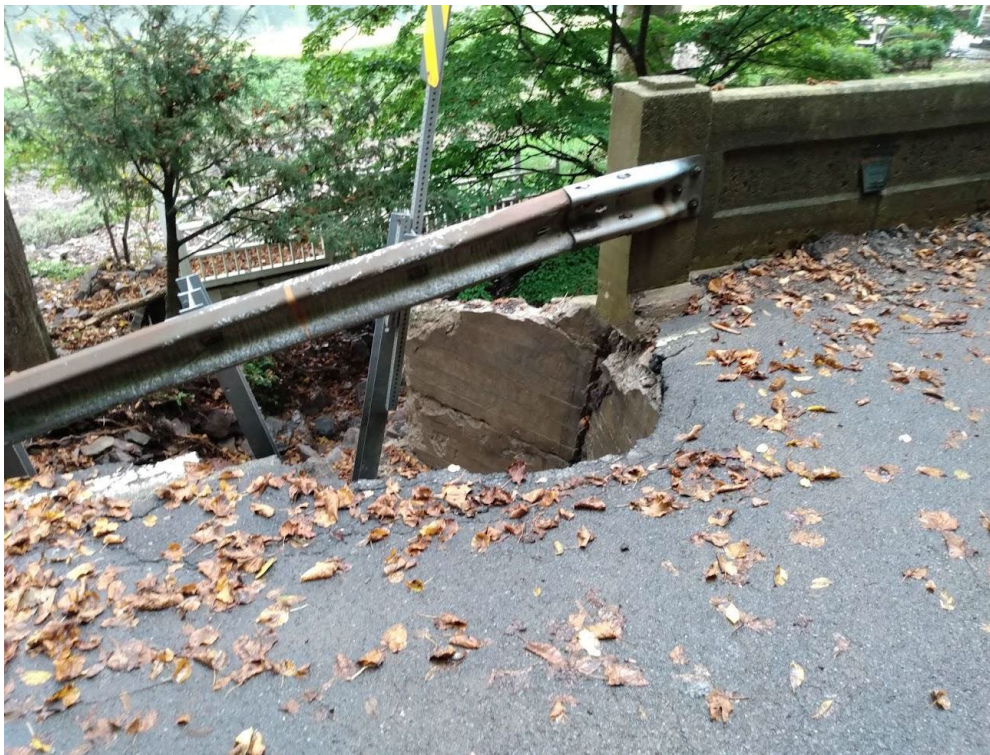
Figure 6.29. River Rd Segment 500 Bridge Abutment Damage (40.413111, -75.047389).

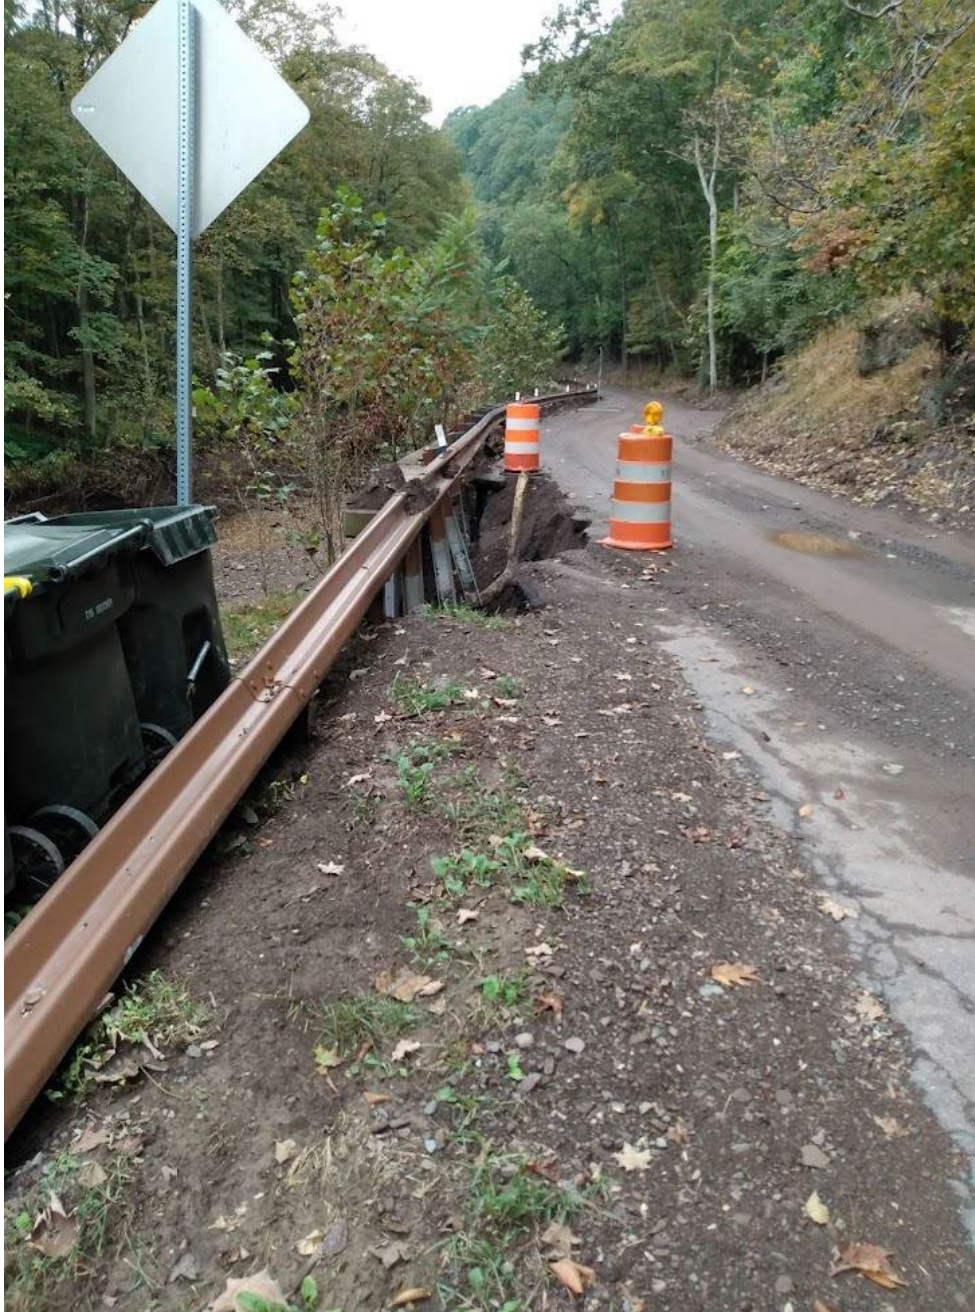
Figure 6.30. Fleecy Dale Rd Erosion behind Soldier Pile Wall (40.397806, -75.05525).

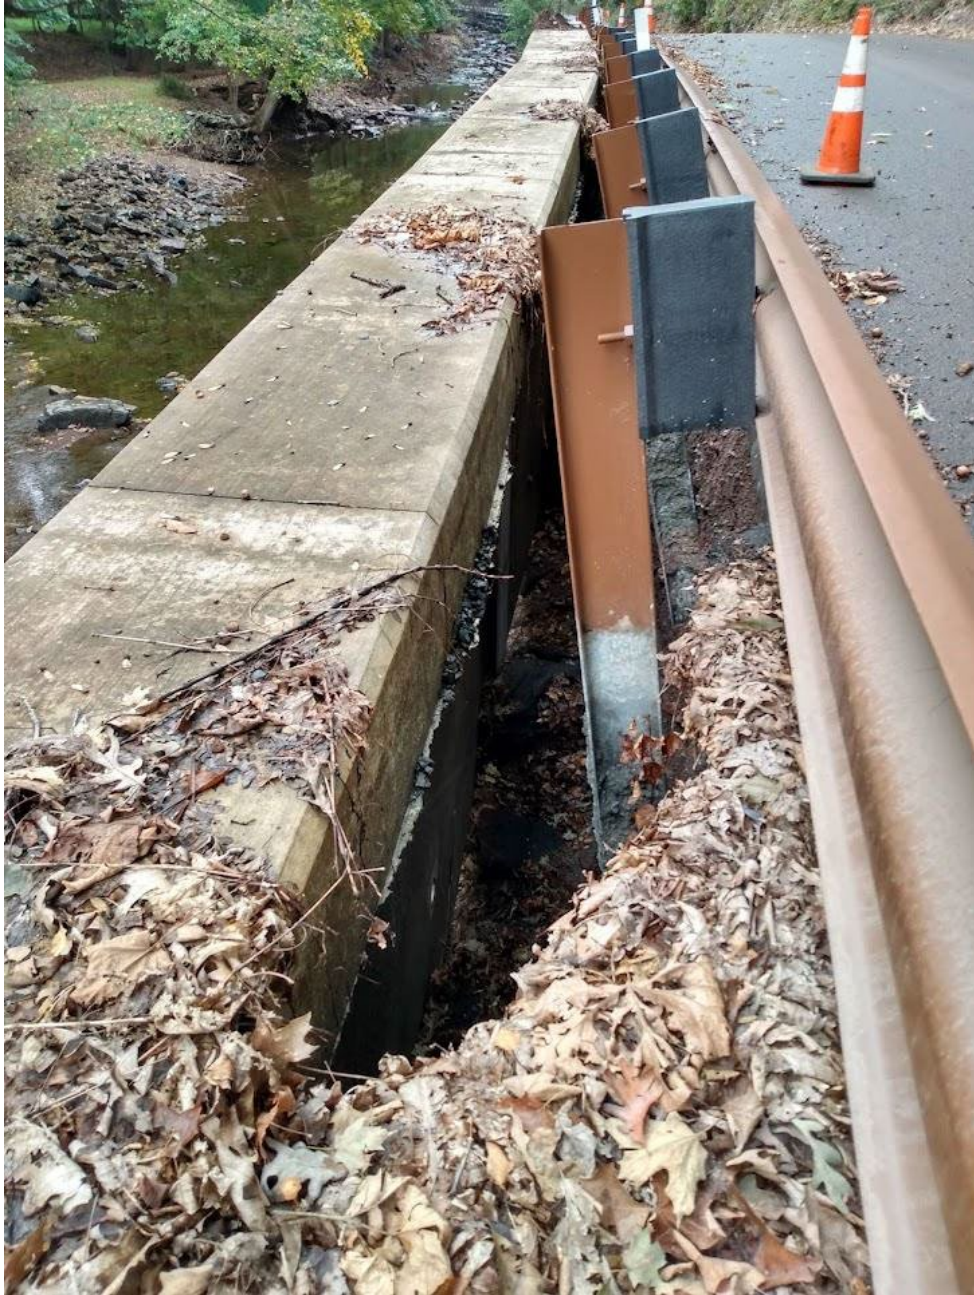
Figure 6.36. Erosion Behind Solider Pile Wall with Lost Support of Guide Rail (40.397806, -75.05525).

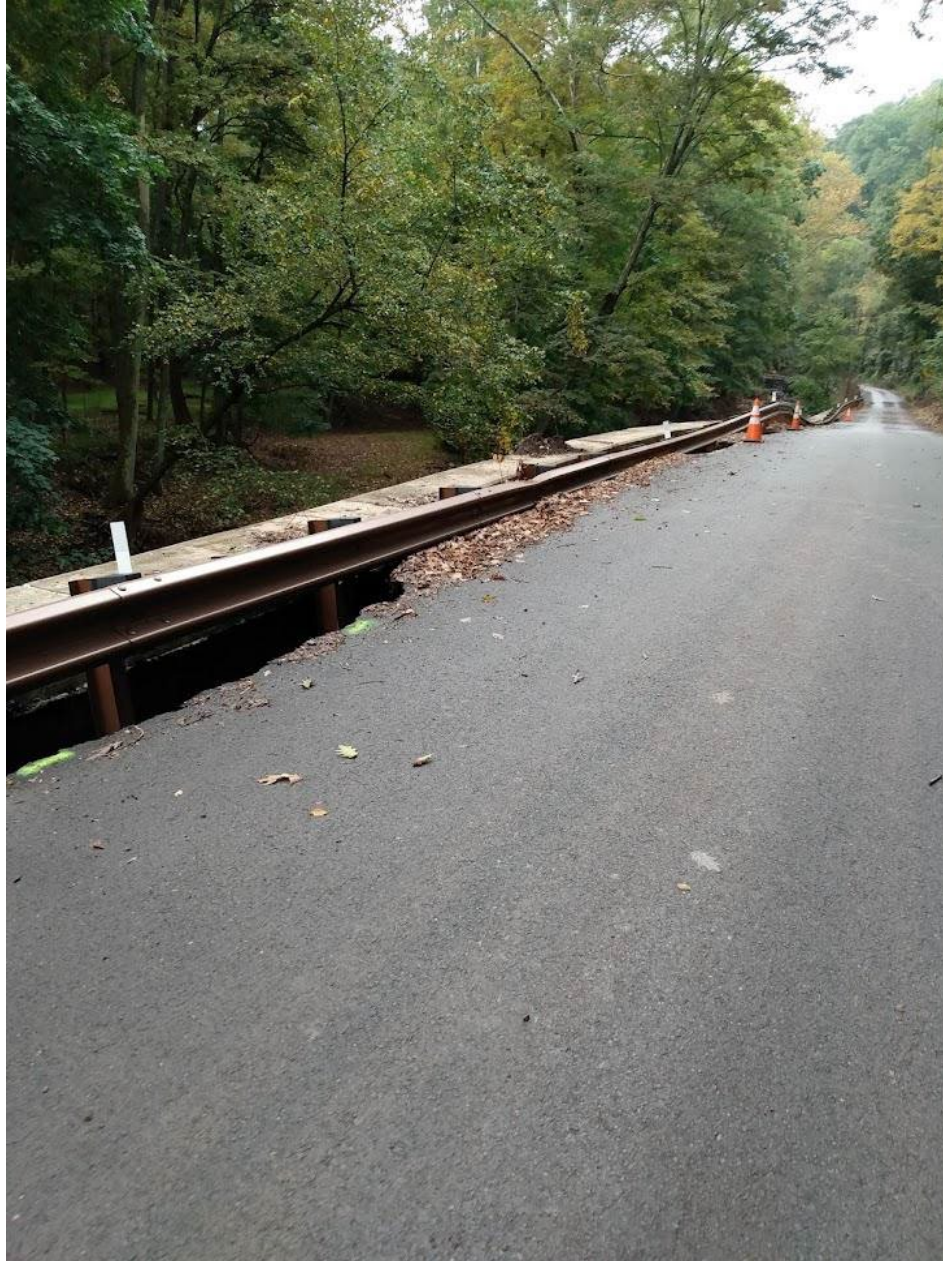
Figure 6.37. Erosion and Washout leading to Lost Support of Guide Rail (40.397806, -75.05525).

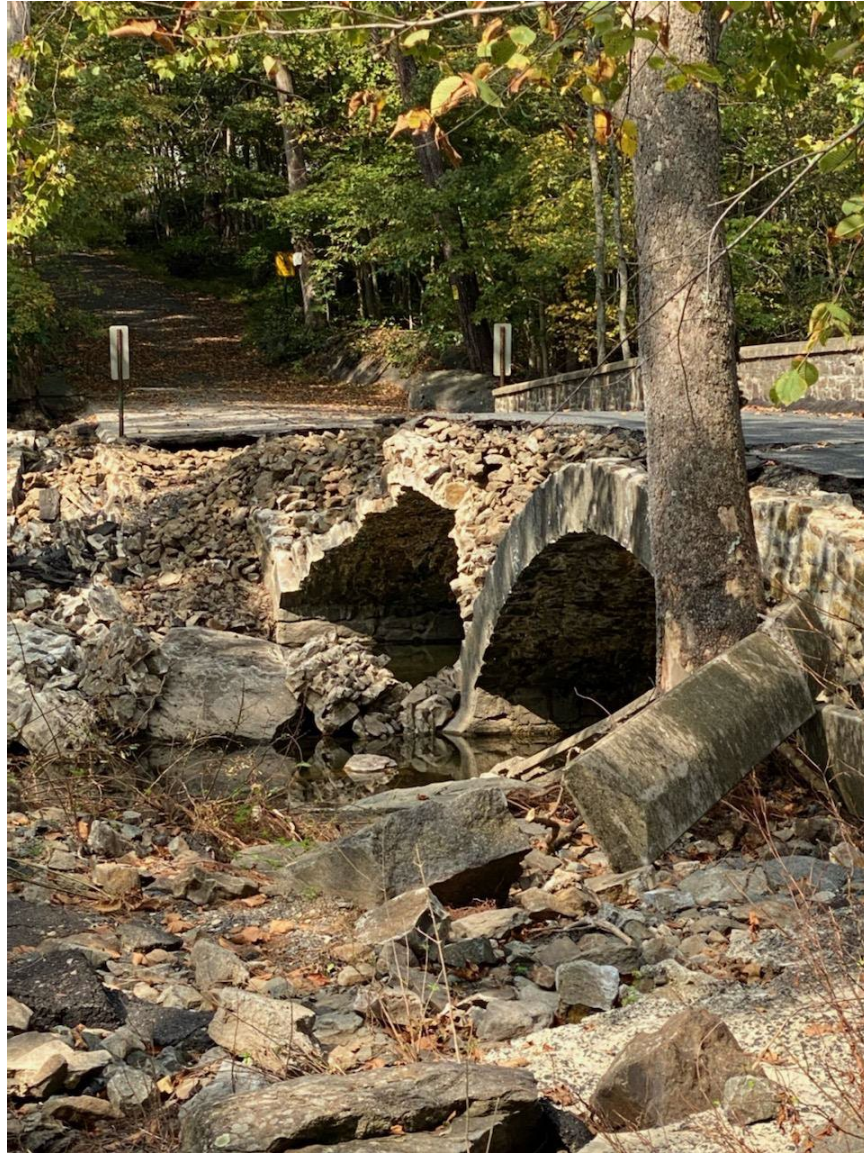
Figure 6.44. Price Rd Bridge Damage (40.357866, -75.426465).

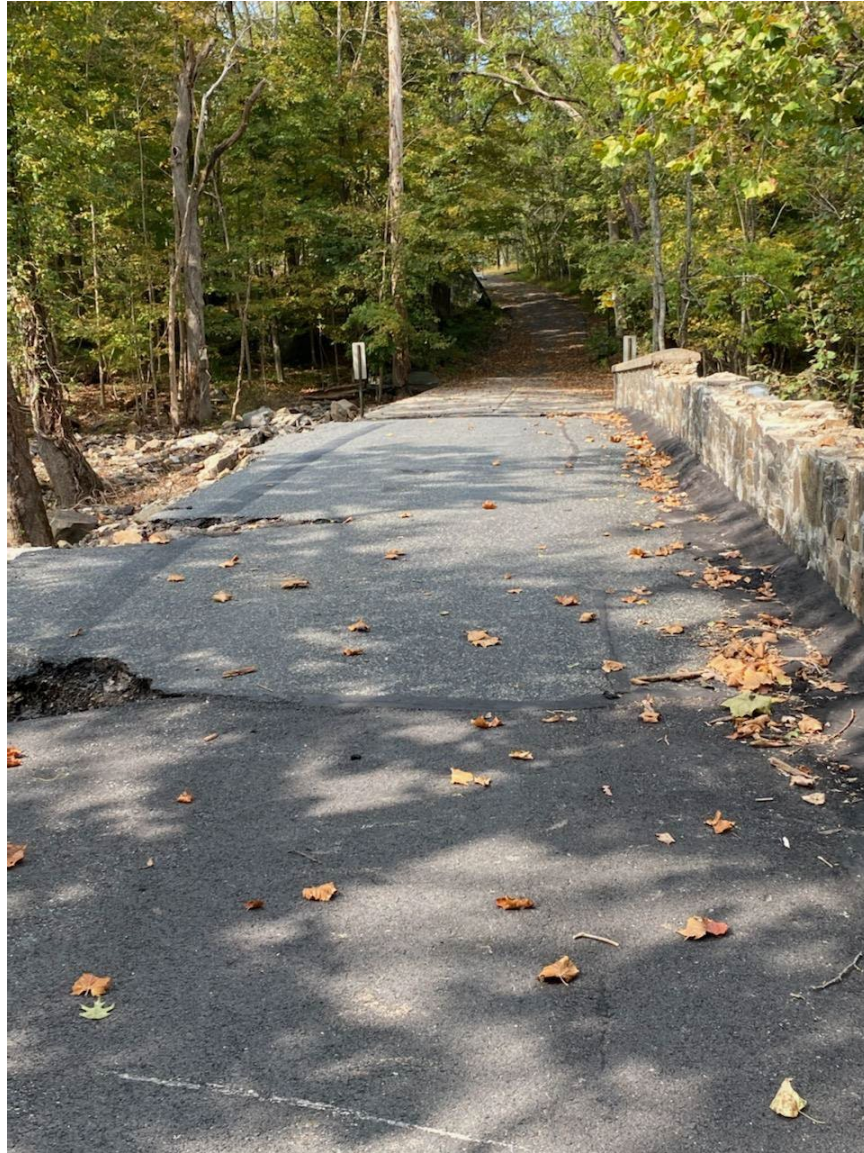
Figure 6.45. Price Rd Bridge View of Roadway and Damage (40.357866, -75.426465).

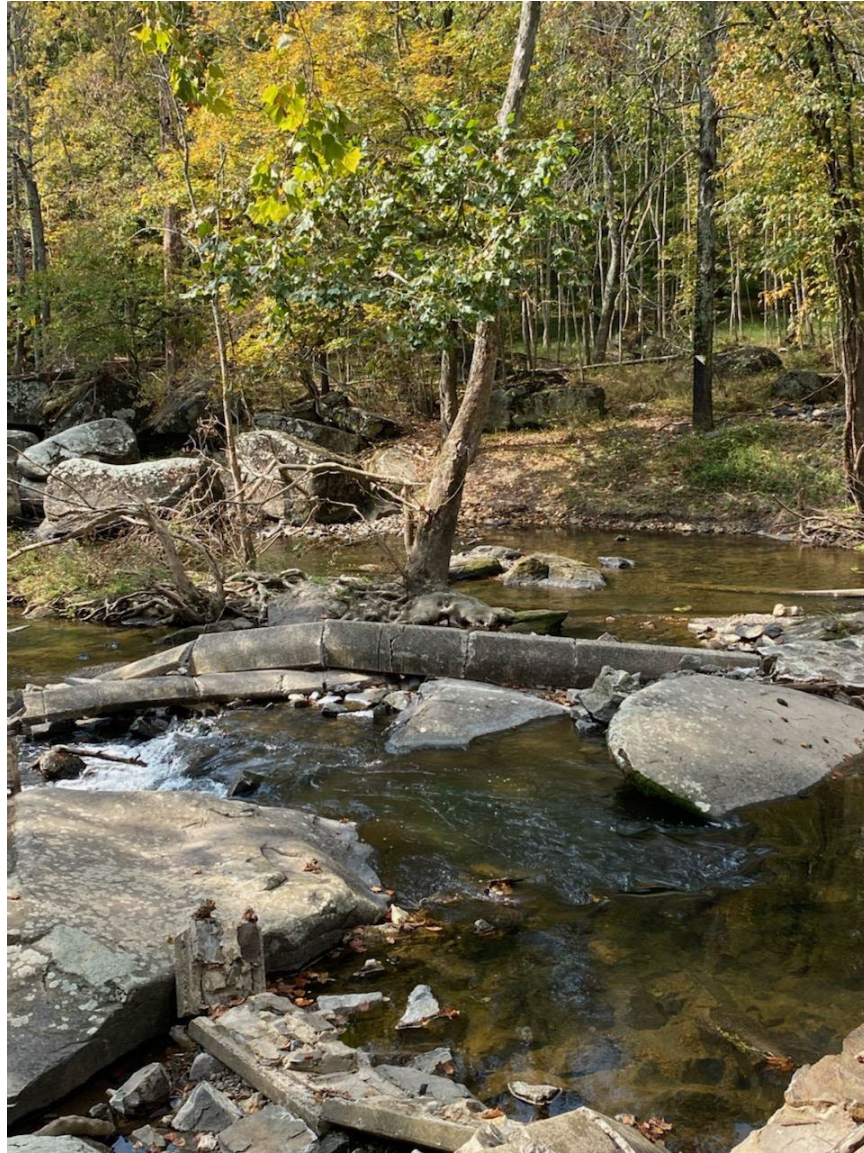
Figure 6.46. Price Rd Bridge View of Section of Bridge Wall Carried Downstream (40.357866, -75.426465).

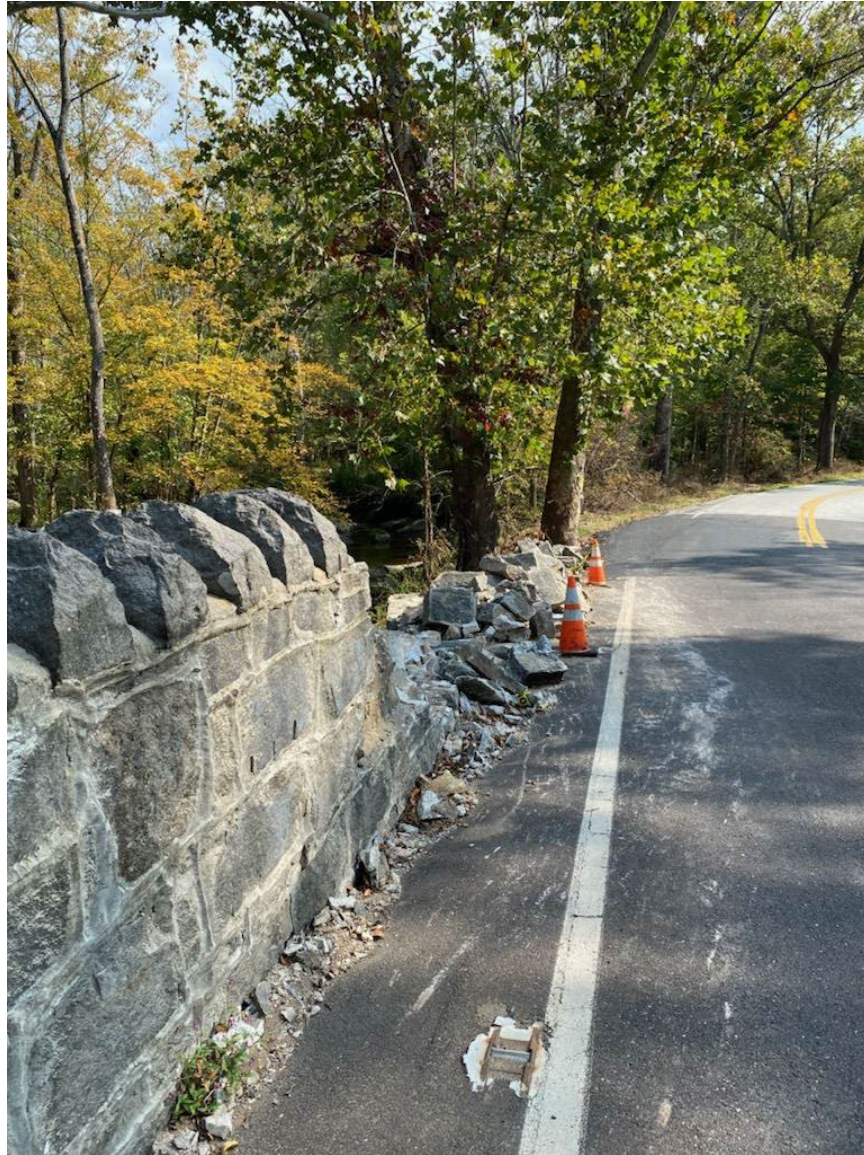
Figure 6.47. Swamp Creek Rd Bridge 2 Damage to Parapet Wall (40.367853, -75.422698).
