GEOTECHNICAL EXTREME EVENTS RECONNAISSANCE (GEER) ASSOCIATION

Turning Disaster into Knowledge

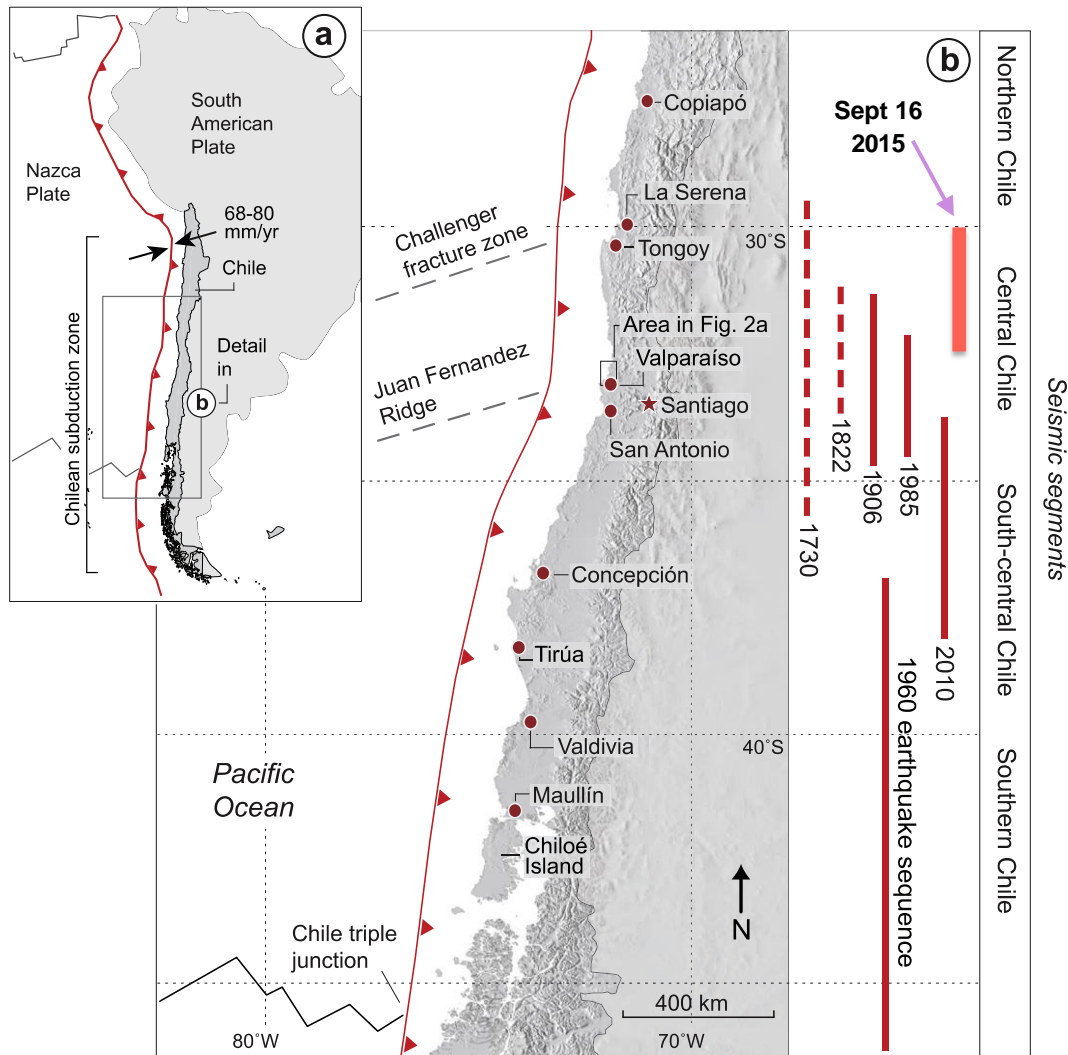
Figure 1.1. Maps showing A) Plate-tectonic setting of Chile and B) estimated rupture lengths of the largest historical earthquakes in central Chile since 1730 compiled from Lomnitz (1970), Kelleher (1972), Comte et al., (1986), Beck et al. (1988) and Melnick et al., (2009). Map after Dura et al. (2015). Note the September 16, 2015 Illapel Earthquake rupture length and the 285 years since the last major earthquake rupture in this area. Note the rupture length of the 2015 Illapel earthquake in orange and how there is not an overlap in rupture areas between the 2010 Maule rupture (see GEER report doi:10.18118/G6NP4W) and the 2015 Illapel Earthquake (this report), which suggests that the region is due for another major event.

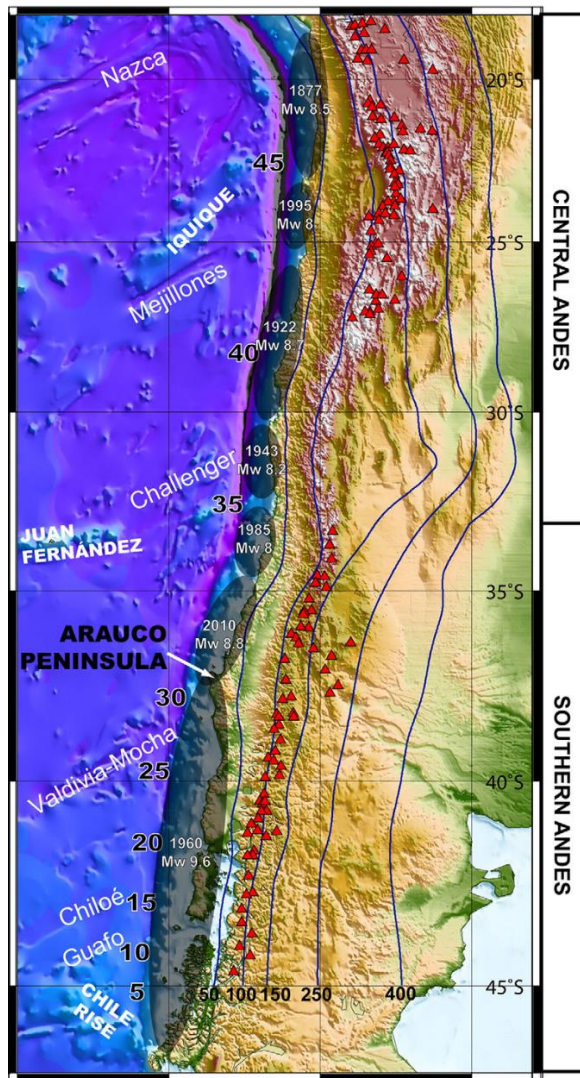
Figure 2.1. Seismic Gap and previous events (Tassara, 2010).

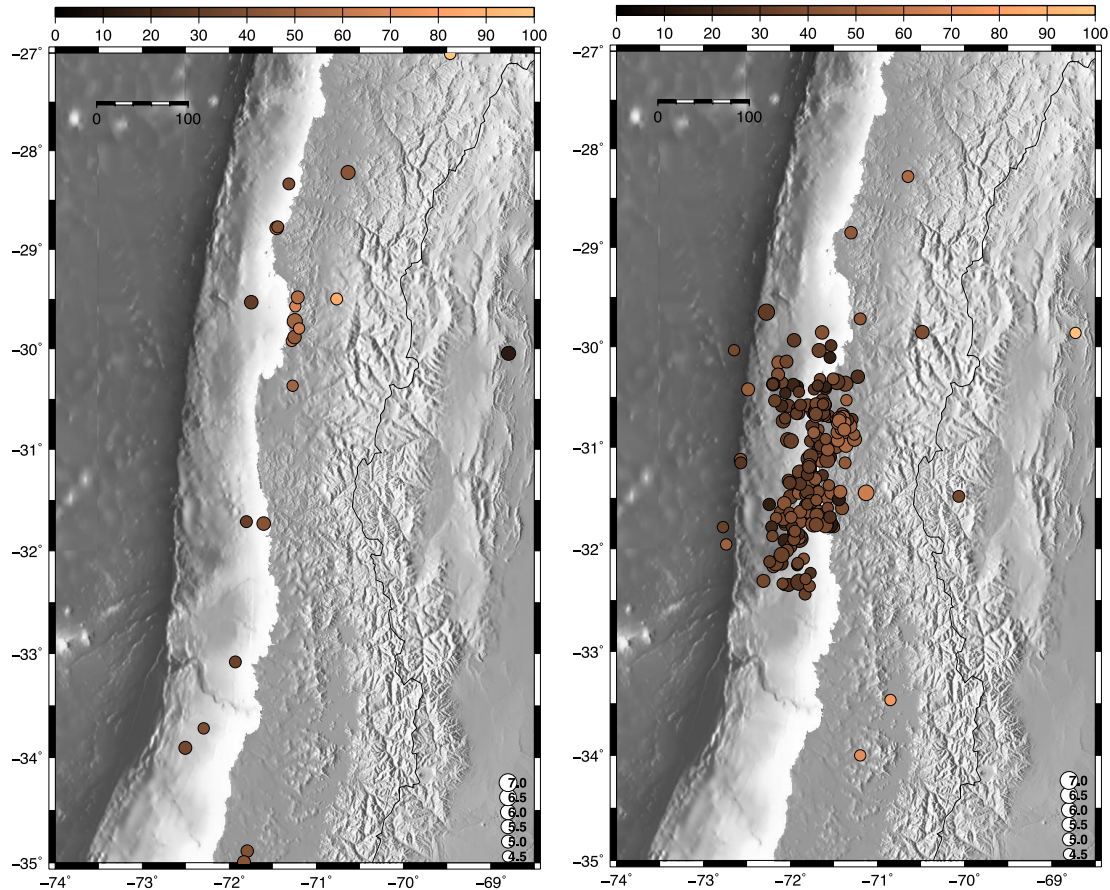
Figure 2.2. Topographic maps showing the seismicity 5 months before the main event (left) and 6 weeks after (right). The color is proportional to the depth, following the scale on the top; while the size is related to the magnitude, according to the scale in the lower right corner.

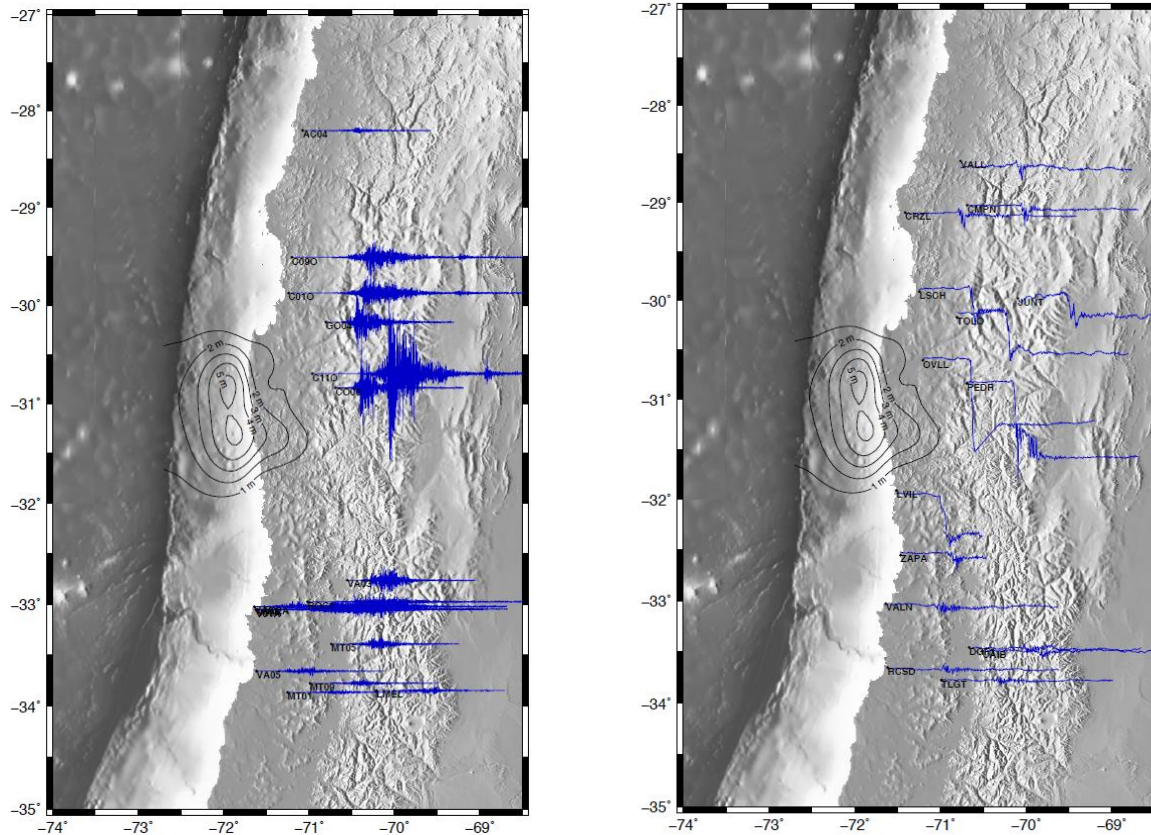
Figure 2.3. Strong motion records (EW component) and kinematic GPS displacements.

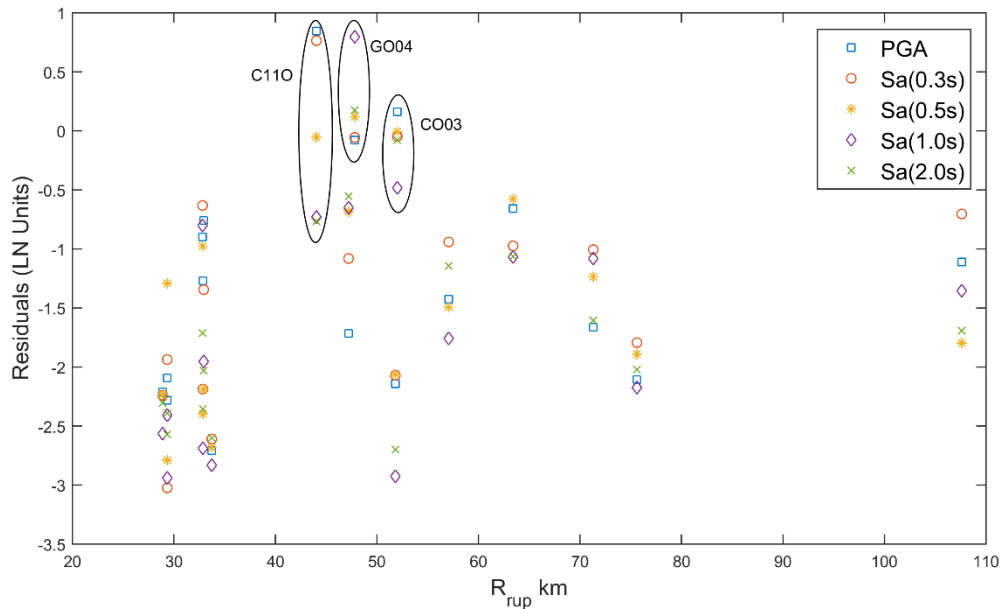
Figure 2.4. Ground Motion Residuals versus Closest Distance (R_{rup}).

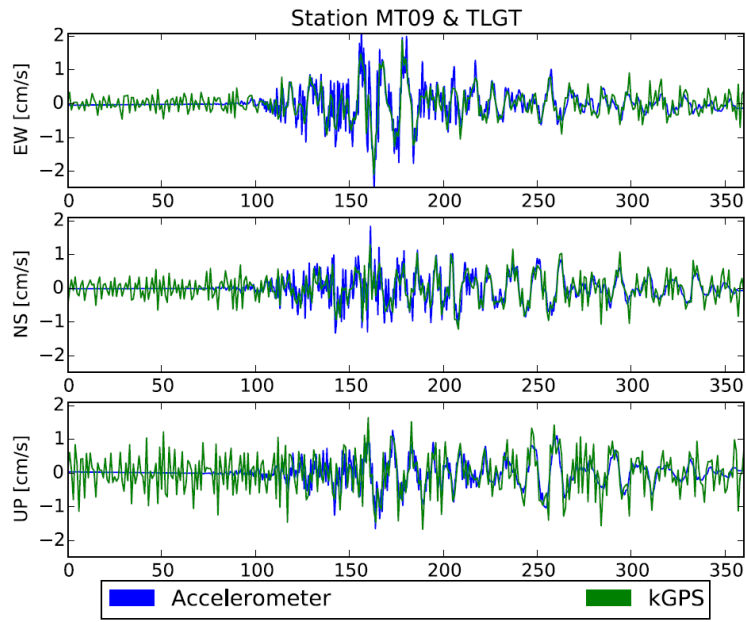
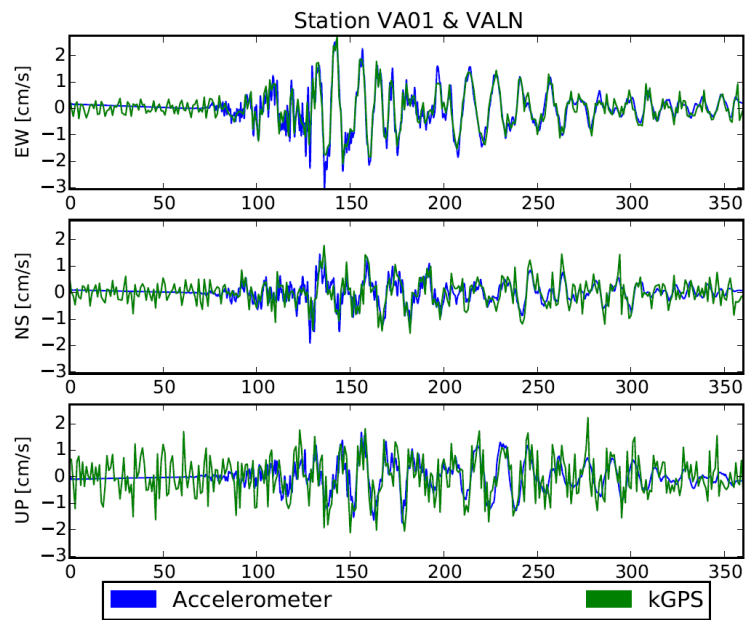
Figure 2.5. Velocity traces comparison for the 2015 Illapel main event.

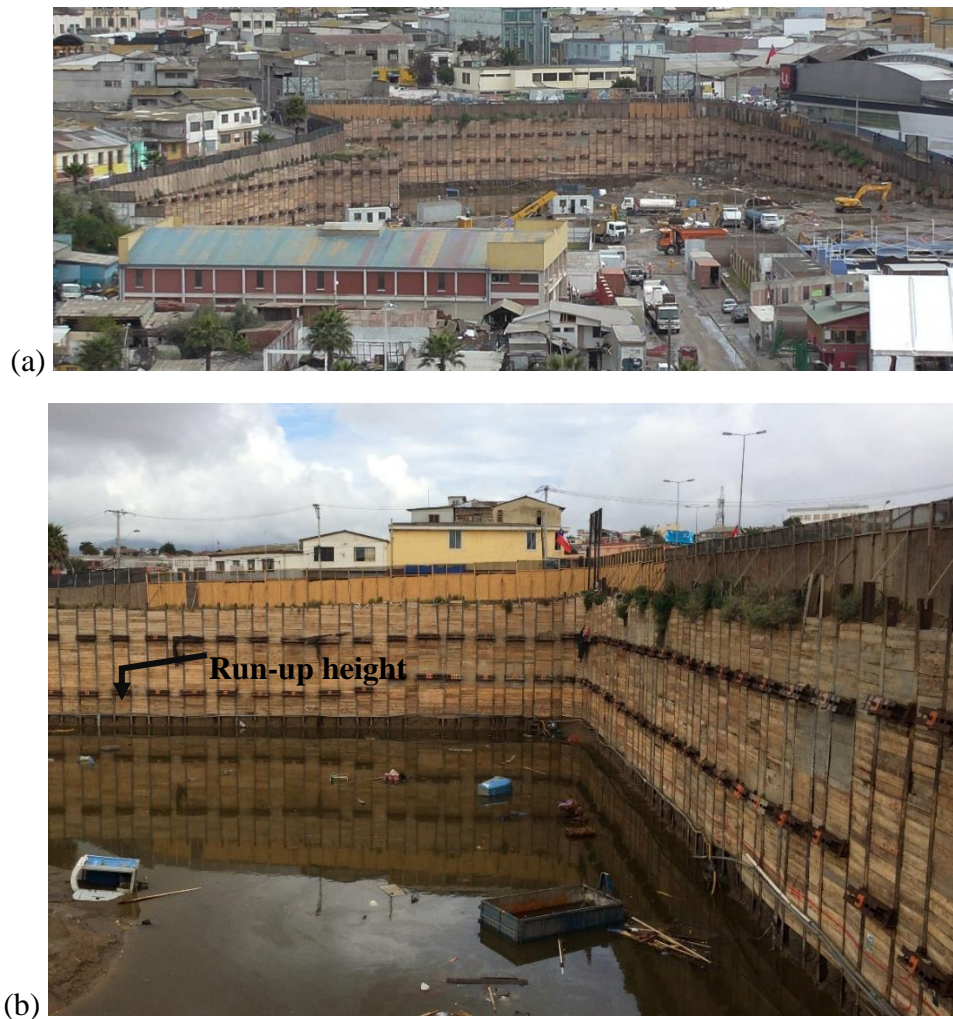
Figure 3.1. Flooded excavation in Coquimbo. No damage observed on the soldier piles and anchors (29.958151S; 71.337849W).

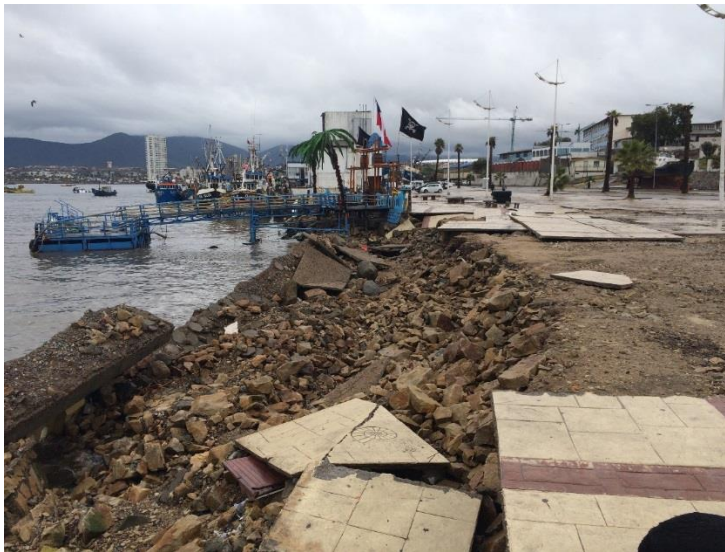
Figure 3.2. Failure of gravity walls at Coquimbo's waterfront (29.951370S; 71.335721W).

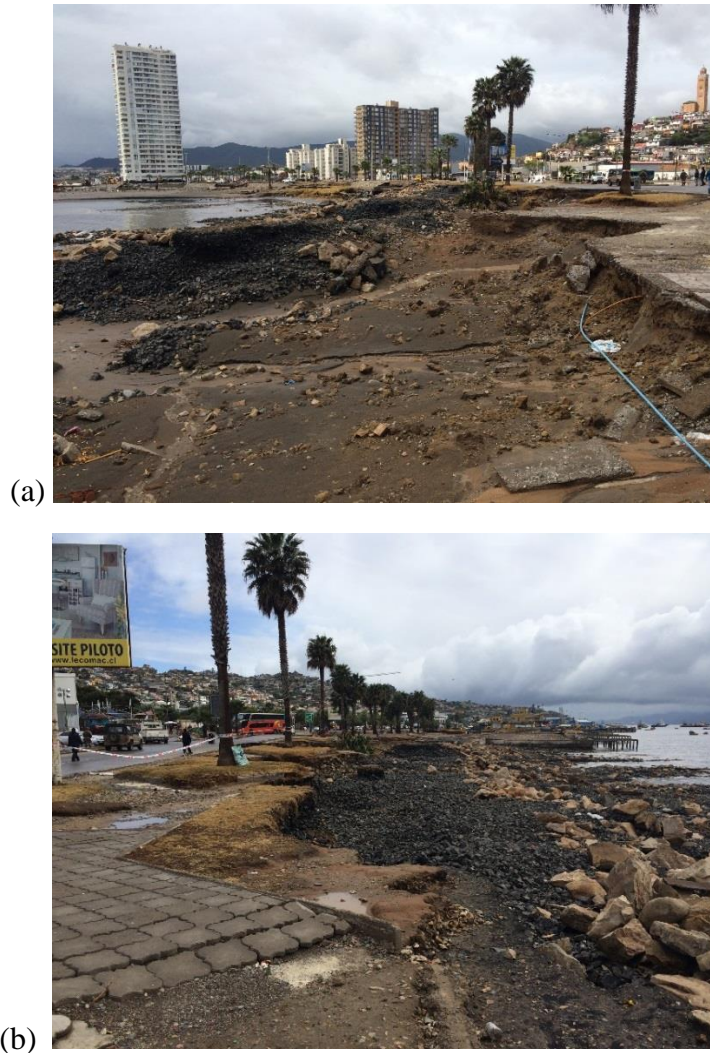
Figure 3.3. Sand and rock fills in Coquimbo’s shoreline washed away by tsunami waves (29.958982S; 71.334789W).

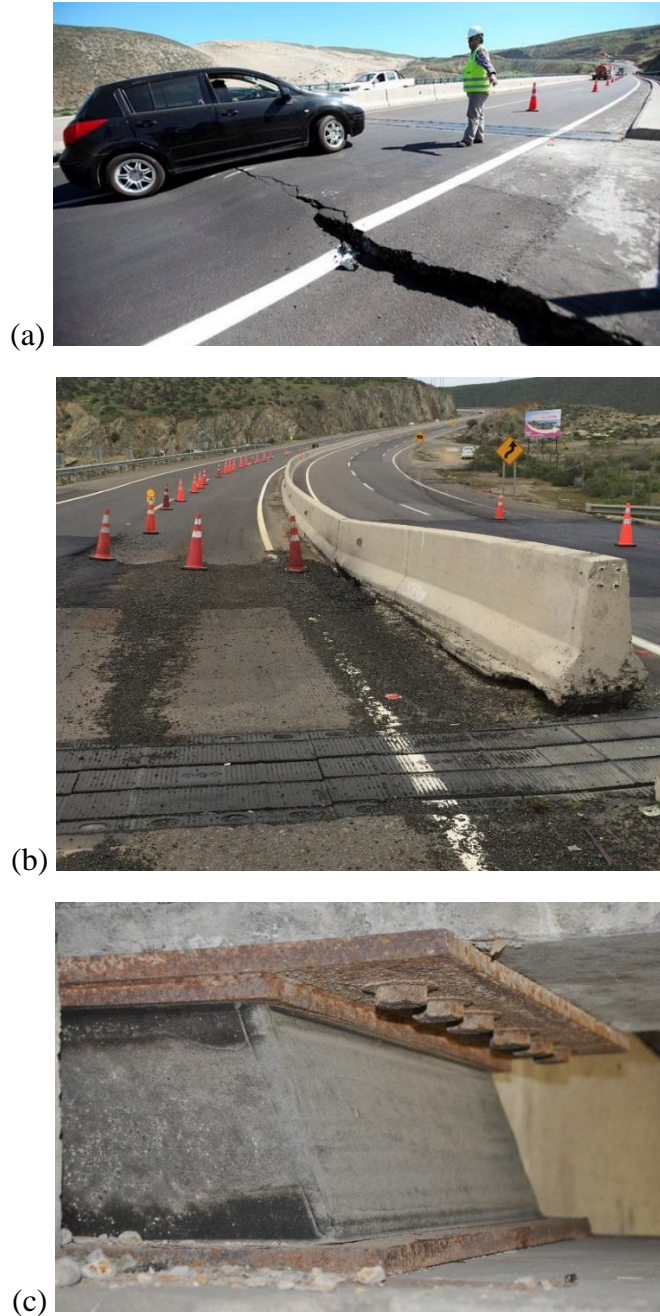
Figure 3.4. Seismically induced displacements (vertical ~20cm, horizontal ~7cm) on the south abutment of El Teniente Viaduct on Route 5 (30.9956500S; 71.6306694W). (a) bridge approach before temporary repairs were made, photo taken on Sept. 17th, source: <http://unionradio.net/dos-nuevos-sismos-sacuden-zona-afectada-por-terremoto-en-chile/> accessed on Oct. 9th 2015. (b) Asphalt ramp placed to mitigate the effects on moving vehicles, (c) Photo courtesy of Rosita Jünemann – CIGIDEN: deformed rubber bearings on the south abutment.

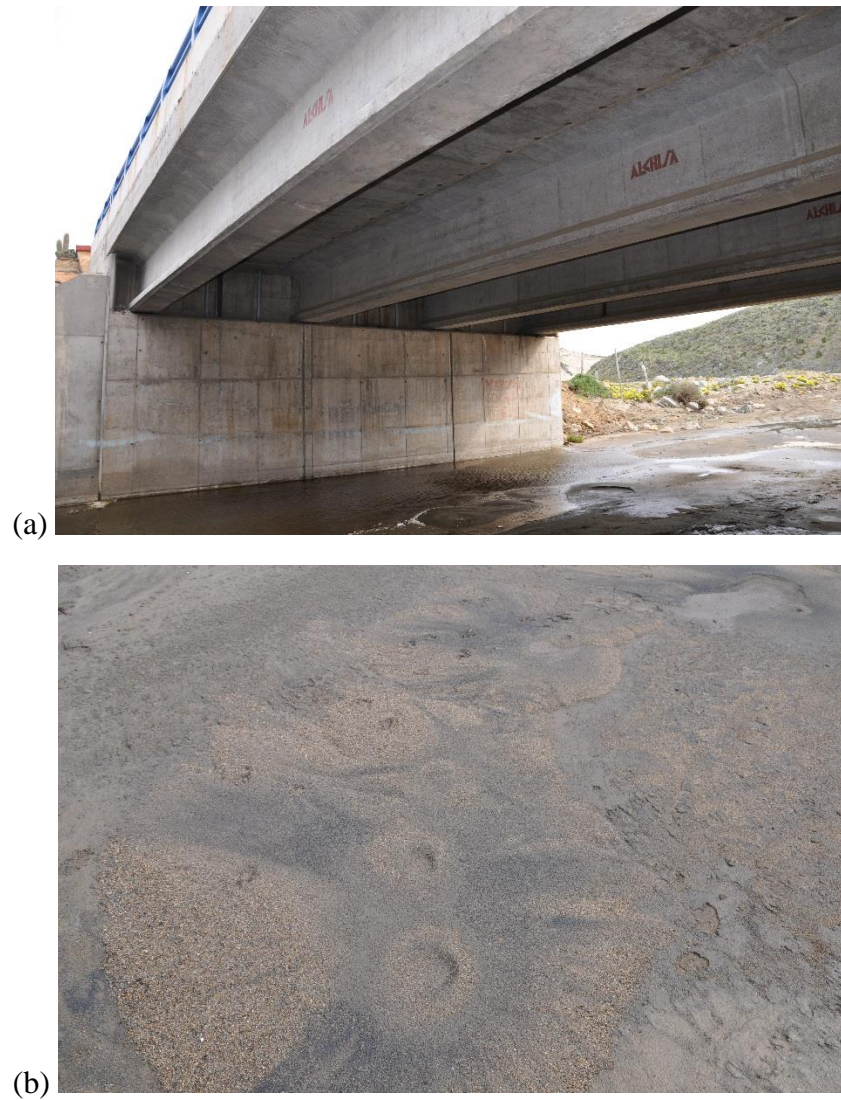
Figure 3.6. Sand boils in the river bed of La Cebada Bridge, Route 5 (30.972870S; 71.642092W). Photo courtesy of Rosita Jünemann – CIGIDEN.

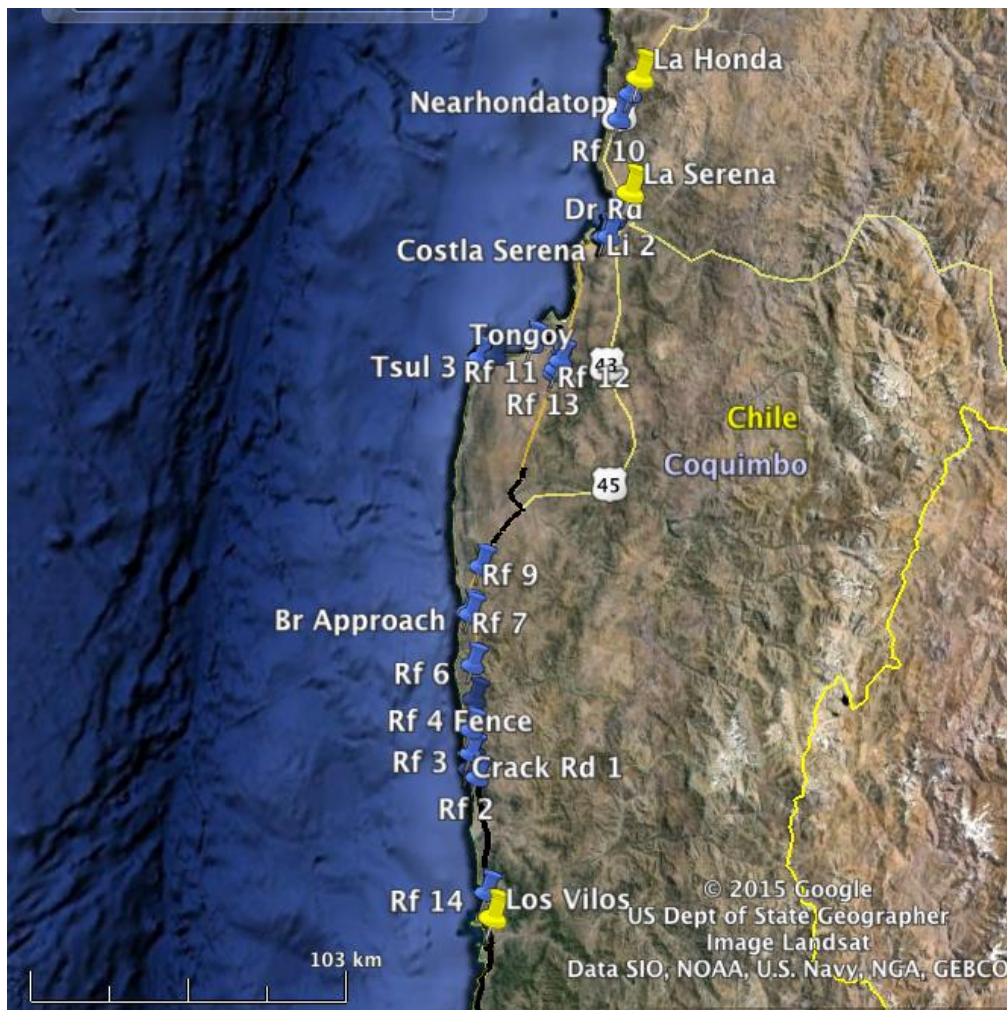
Figure 4.1. Google Earth map of main slope stability sites and associated GPS points (e.g., Rf 6) that impacted the Panamerican highway (Route 5). Yellow pins indicate the towns of Los Vilos and La Serena as well as the La Honda Pass from South to North. No notable rockfall occurred along Route 5 south of Los Vilos and none occurred north of RF10 which is ~30 km north of La Serena; most of the rockfall occurred in a ~ 250 km wide zone near the rupture patch.

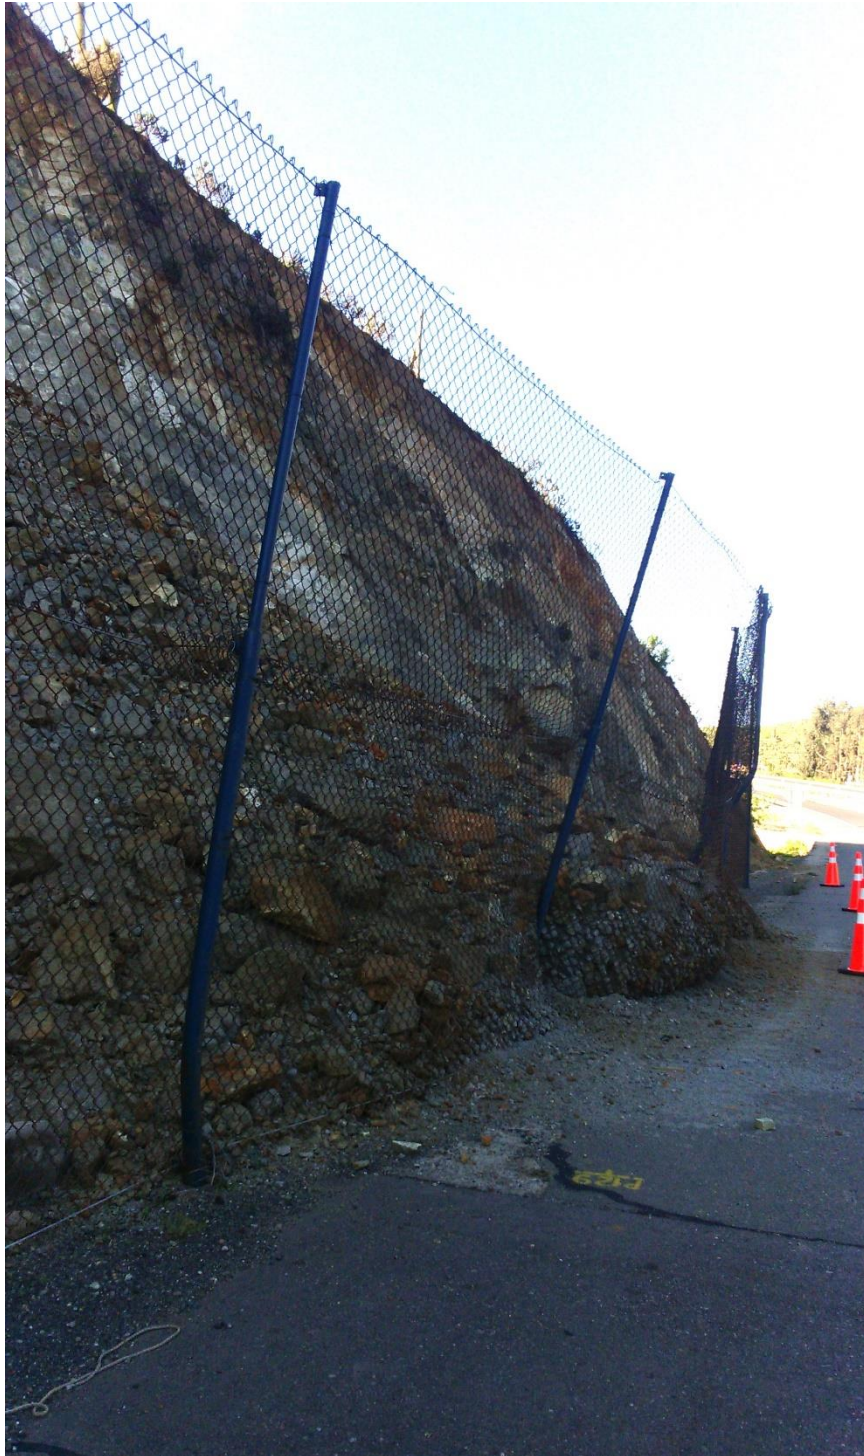
Figure 4.2. Km 295 northbound lane, looking south showing how the rockfall mitigation fences functioned well here and protected the road (GPS RF4: 31.31521S; 71.59444W).

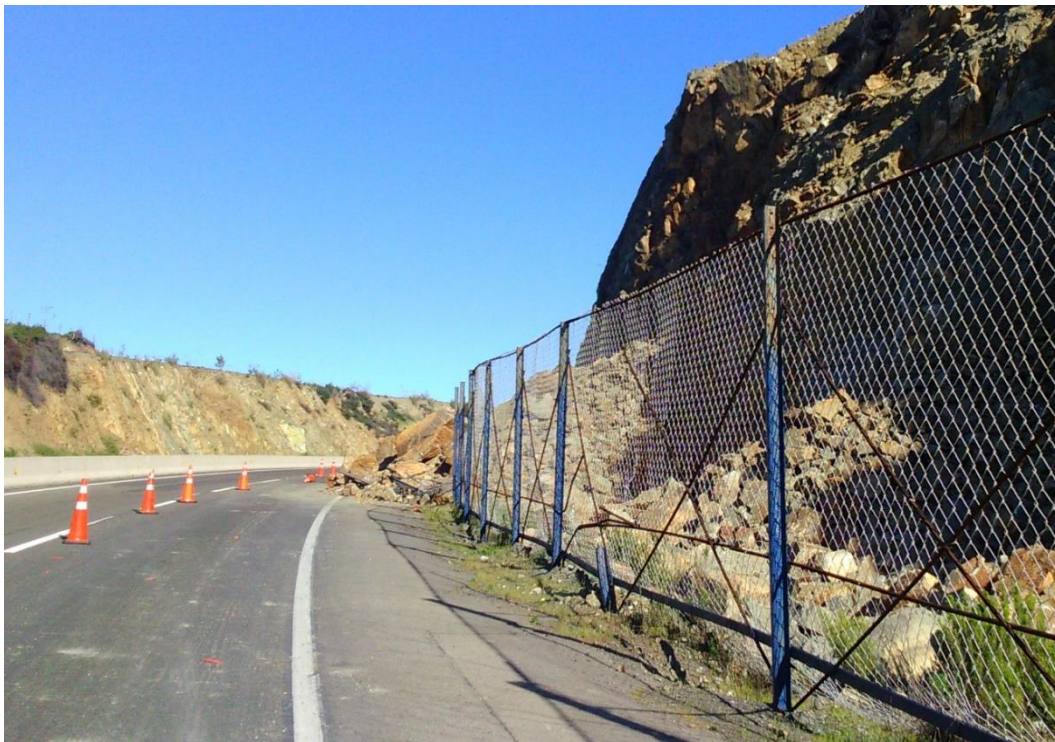
Figure 4.4. Km 305 northbound lane looking north showing how the rockfall fences failed during a cut slope collapse (GPS RF5: 31.23193S; 71.58976W). Note the fresh rockfall in the foreground, behind the fence) of the photo which then builds to a large debris cone in the background.

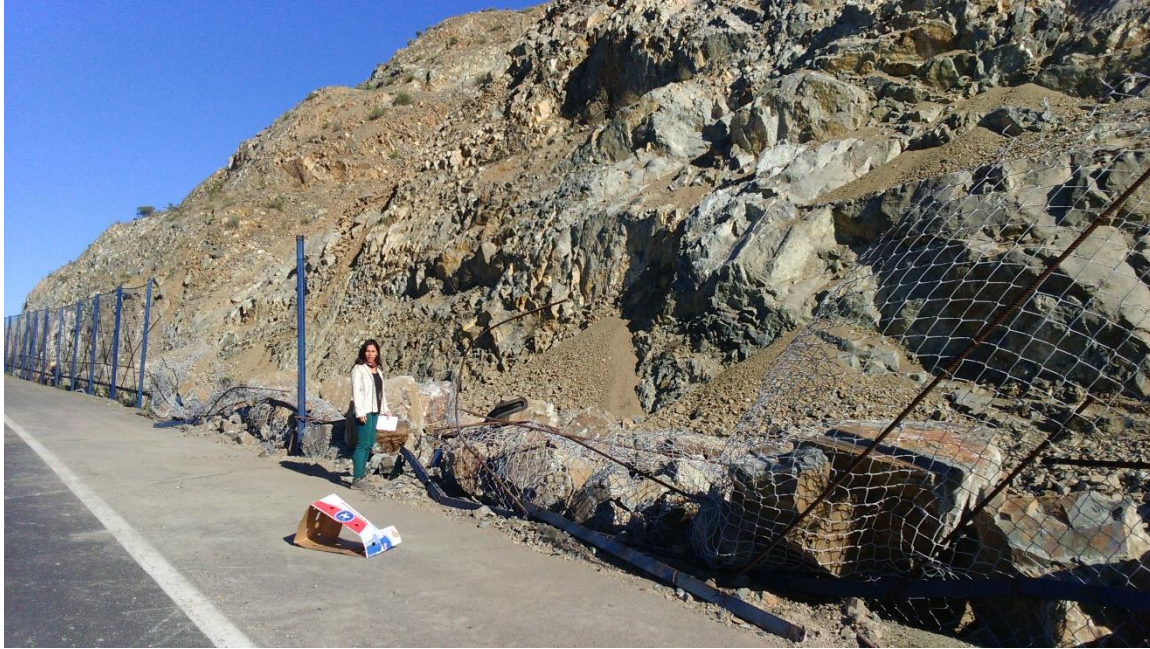
Figure 4.5. Km 305, northbound lane Route 5 showing failed rockfall mitigation fences (debris in the road had previously been cleaned up by highway department (GPS RF5: 31.23193S; 71.58976W).

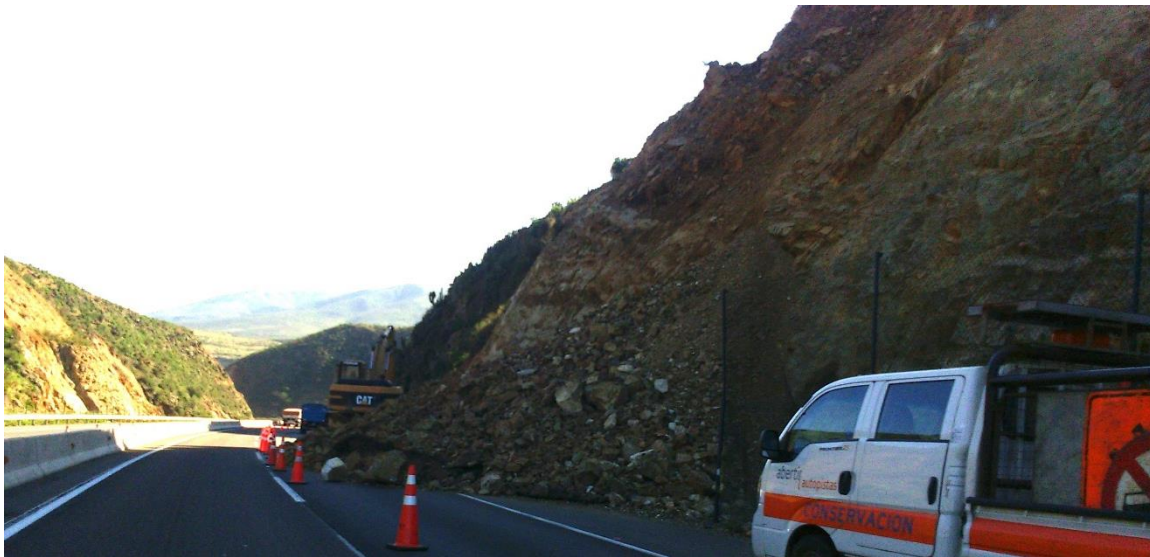
Figure 4.6. Km 316, northbound lane, slope failure impacted the northbound Route 5 and destroyed the mitigation fences closing one lane. Note excavator clearing the road (GPS RF6: 31.13957S; 71.60428W).

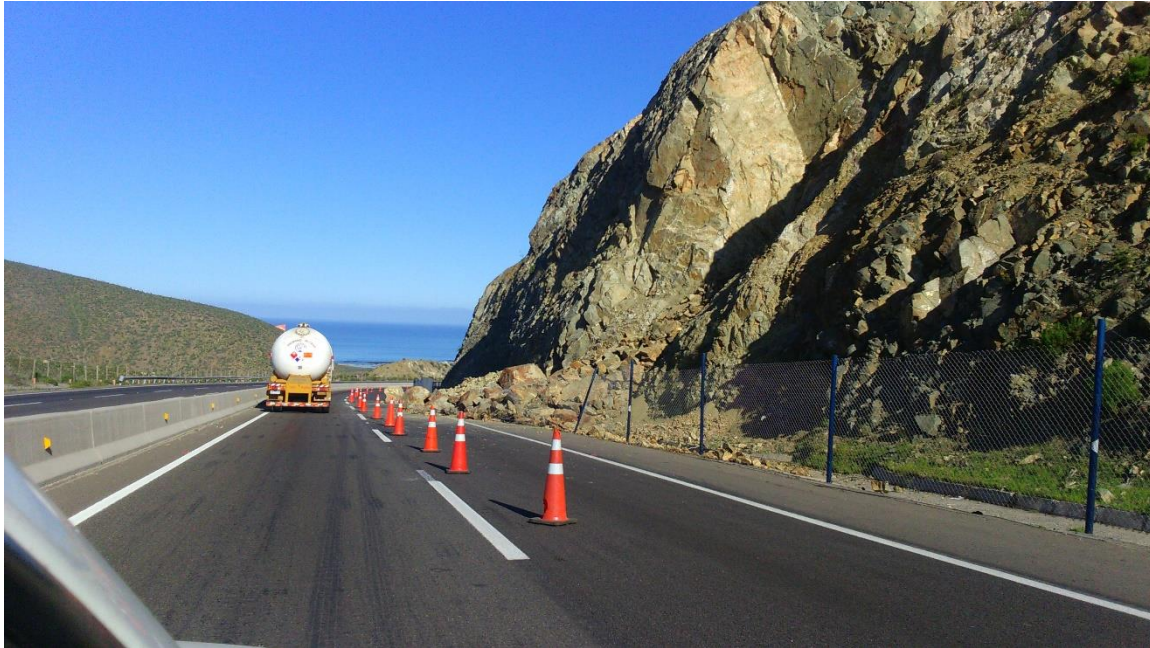
Figure 4.7. Km 334, northbound lane, rock slope failure looking north. Rockfall mitigation fences were destroyed on the northbound Route 5 with closure of both lanes after earthquake and one lane for at least 10 days later (GPS RF7: 31.00348S; 71.62430W).

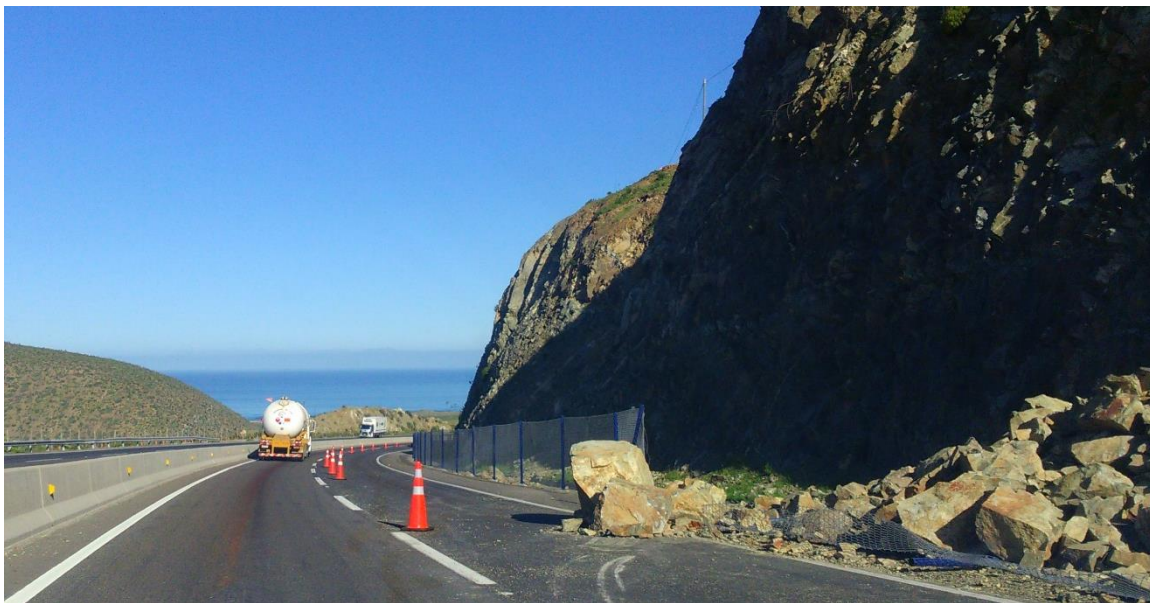
Figure 4.8. Km 334, northbound lane, rock slope failure looking north. Rockfall mitigation fences were destroyed. Note the large size angular blocks (1-2 m³) (GPS RF7: 31.00348S; 71.62430W).

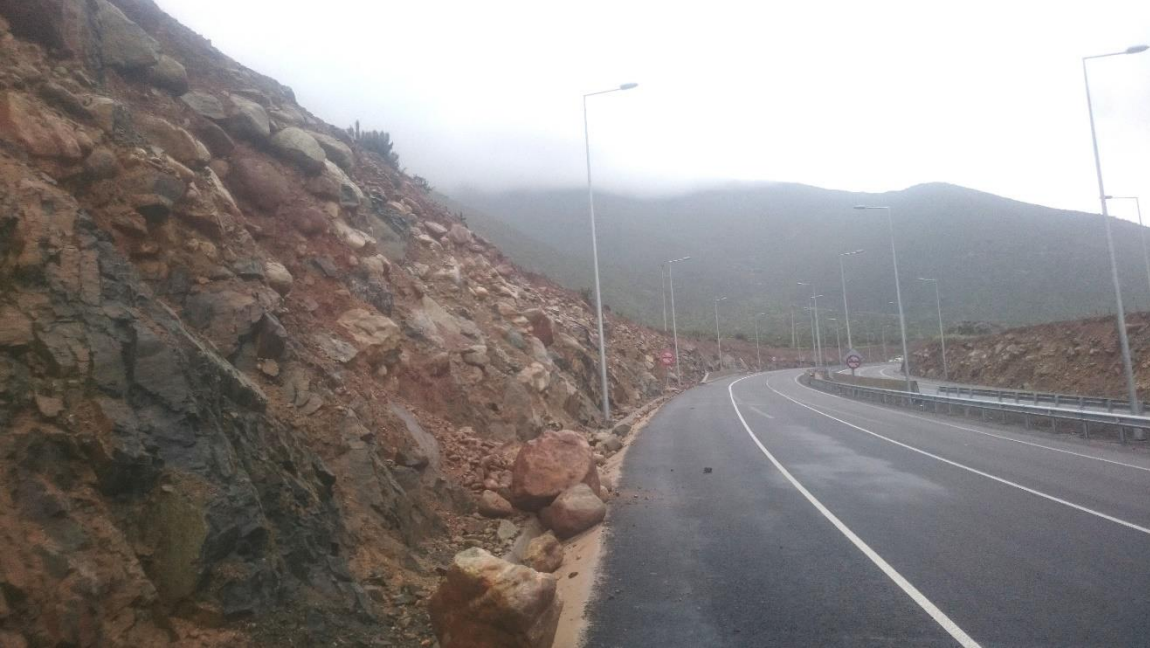
Figure 4.9. Km 508, northbound lane, alluvium (boulders), that fell from the road cut (looking south). Some of these boulders were previously in the road and pushed into the drainage (GPS RF10: 29.62911S; 71.27890W).

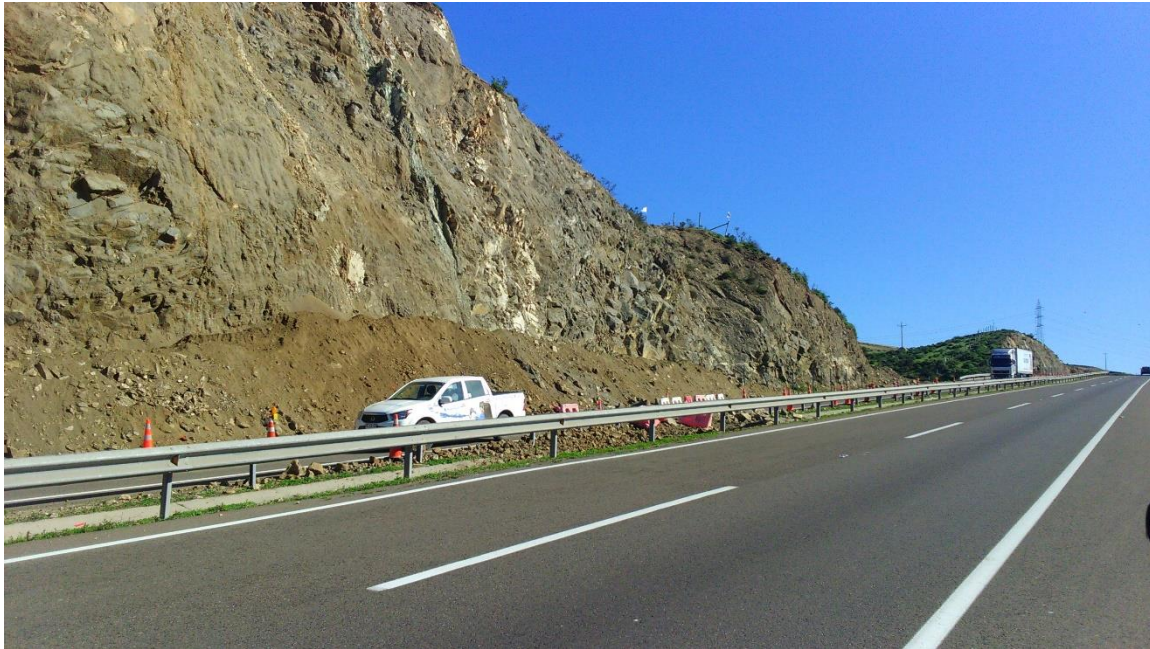
Figure 4.10. Km 350, southbound lane (photo taken looking north from northbound lane) slope failure impacted the northbound Route 5 and destroyed the mitigation fences closing the entire southbound lane. Note the debris in the median between lanes (GPS RF9: 30.87033S; 71.60181W).

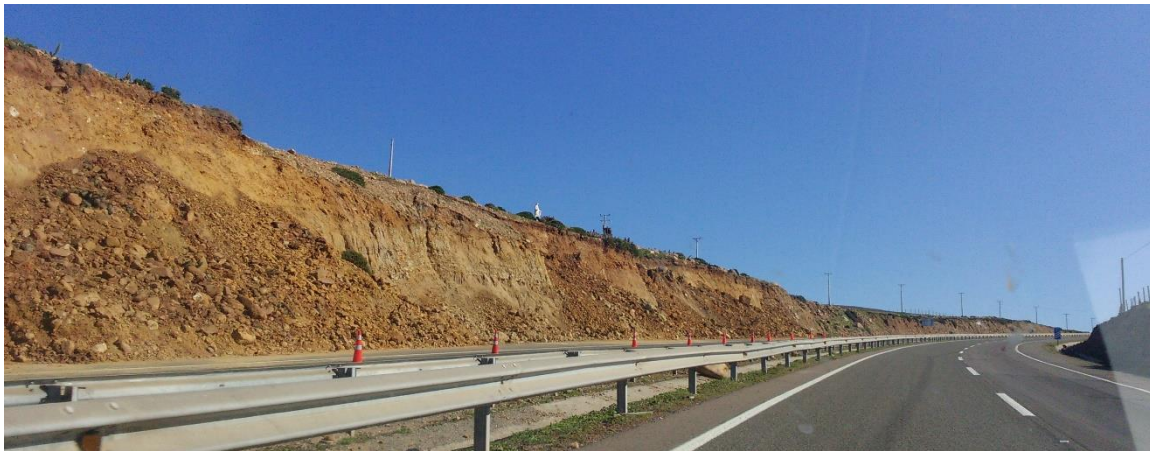
Figure 4.11. Km 338-339, southbound lane half closed from extensive slope collapse along Route 5. Field photograph looking north from the northbound lane. Cones indicate the closed southbound lane.

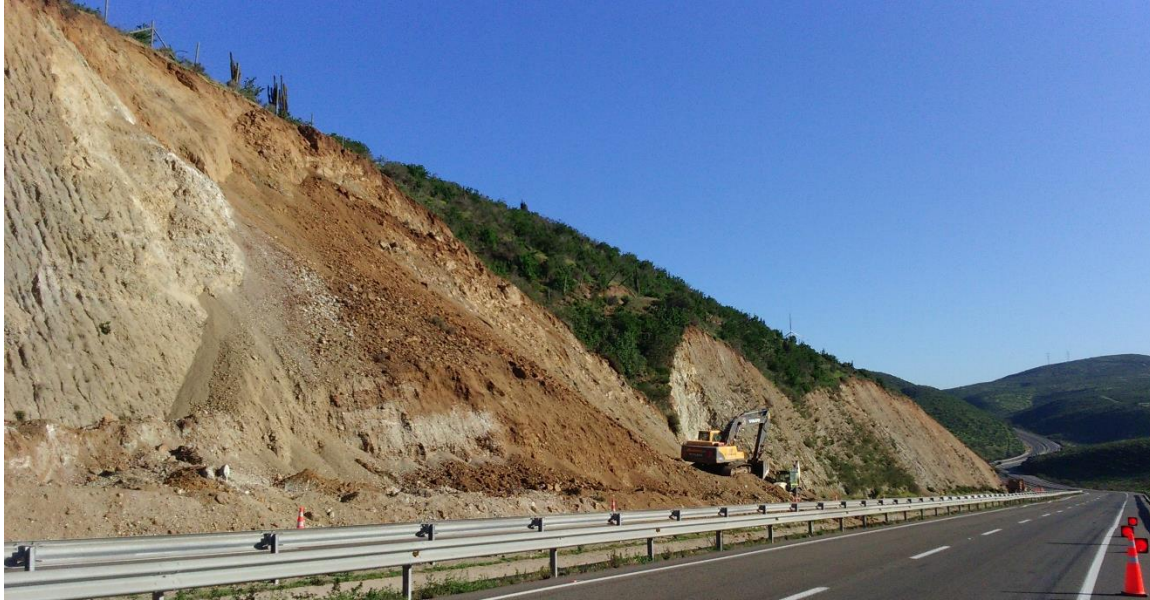
Figure 4.12. Km 287, southbound lane (photo looking north from northbound lane). Slope failure closed entire southbound lane, (note debris in median between lanes and excavator clearly the deposit). Deposit was estimated at 150-200 m³ (based on discussions with clearing crew and evidence on the ground) (GPS RF3: 31.37990S; 71.58963W).

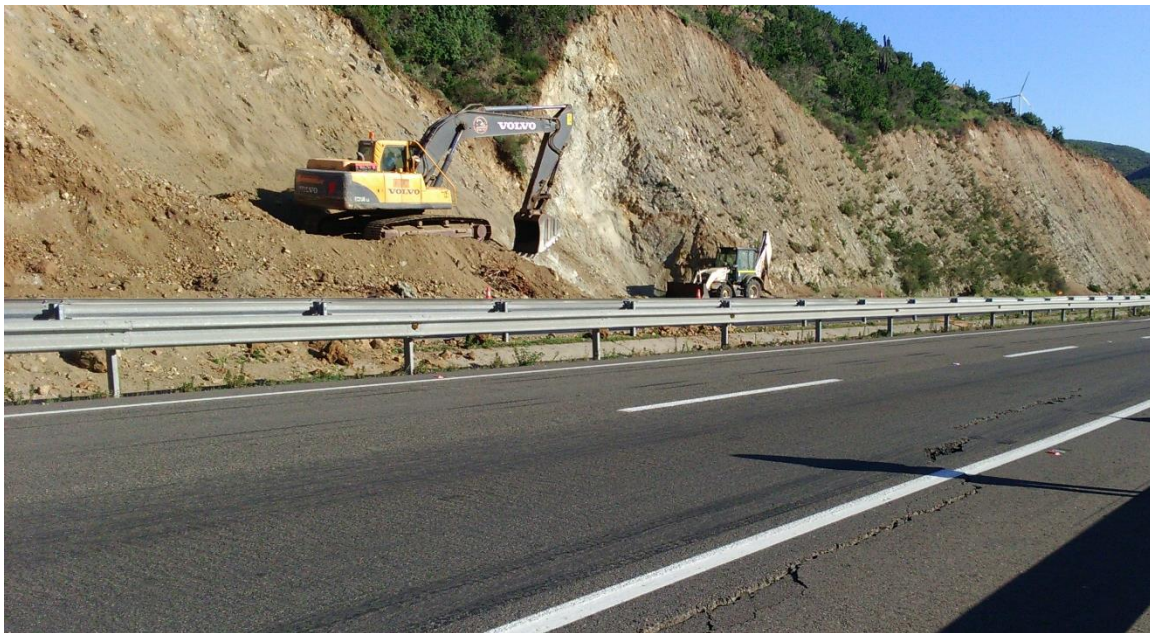
Figure 4.13. Km 287, southbound lane (photo looking north from northbound lane). Slope failure closed entire southbound lane, (note debris in median between lanes and excavator clearly the deposit). Deposit was estimated at 150-200 m³ (based on discussions with clearing crew and evidence on the ground). Although not related to the slope failure note the cracks in the road due to slope settlement to the East in the foreground (GPS RF3: 31.37990S 71.58963W).

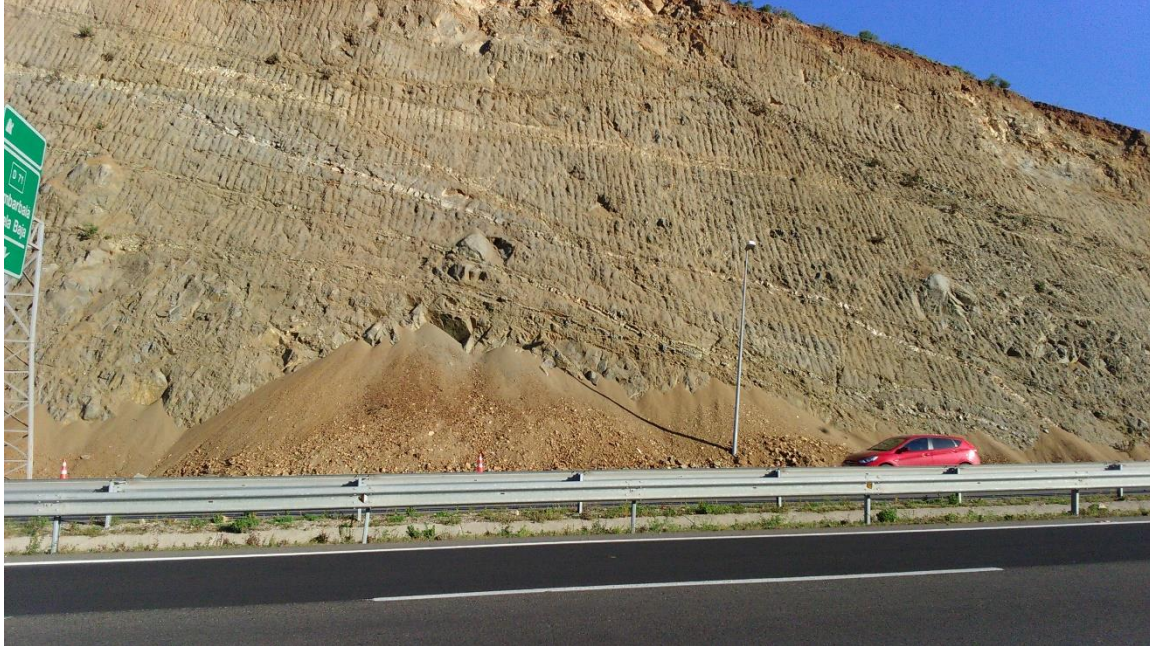
Figure 4.14. Km 280, southbound lane (photograph looking west from northbound lane). Rockfall closed one lane, damaged street light and exit sign (GPS RF2: 31.44367S; 71.56376W).

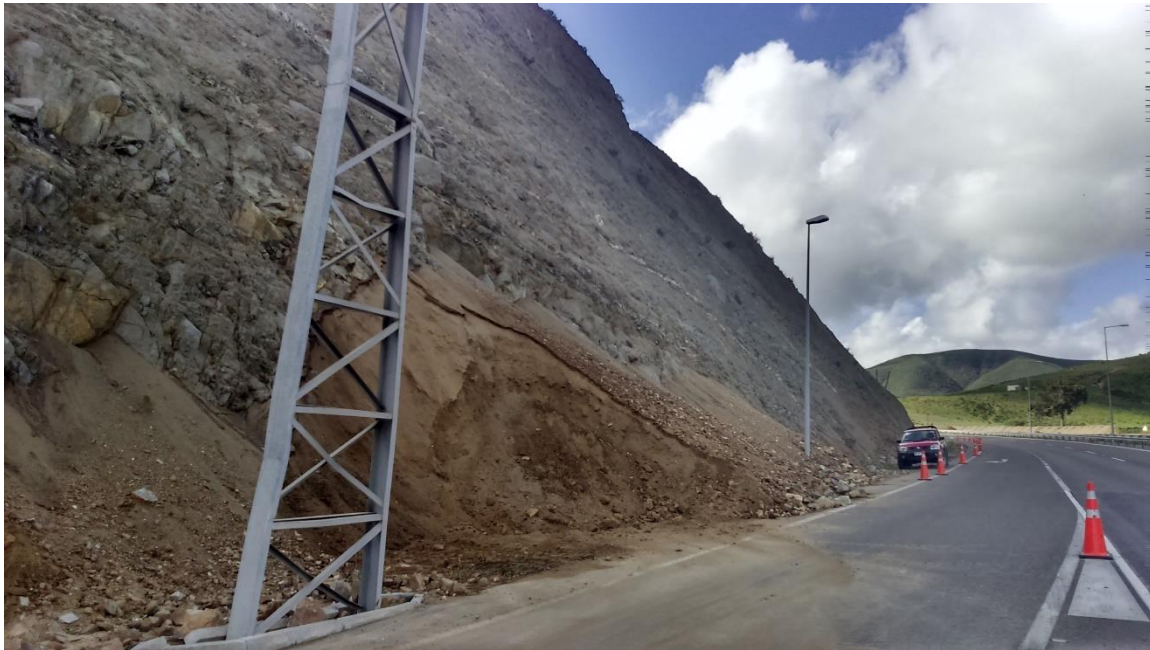
Figure 4.15. Km 280, southbound lane (photograph looking north from the southbound lane). Rockfall closed one lane, damaged streetlight and exit sign (GPS RF2: 31.44367S 71.56376W). Note that much of the deposit had been cleared prior to this photo being taken.

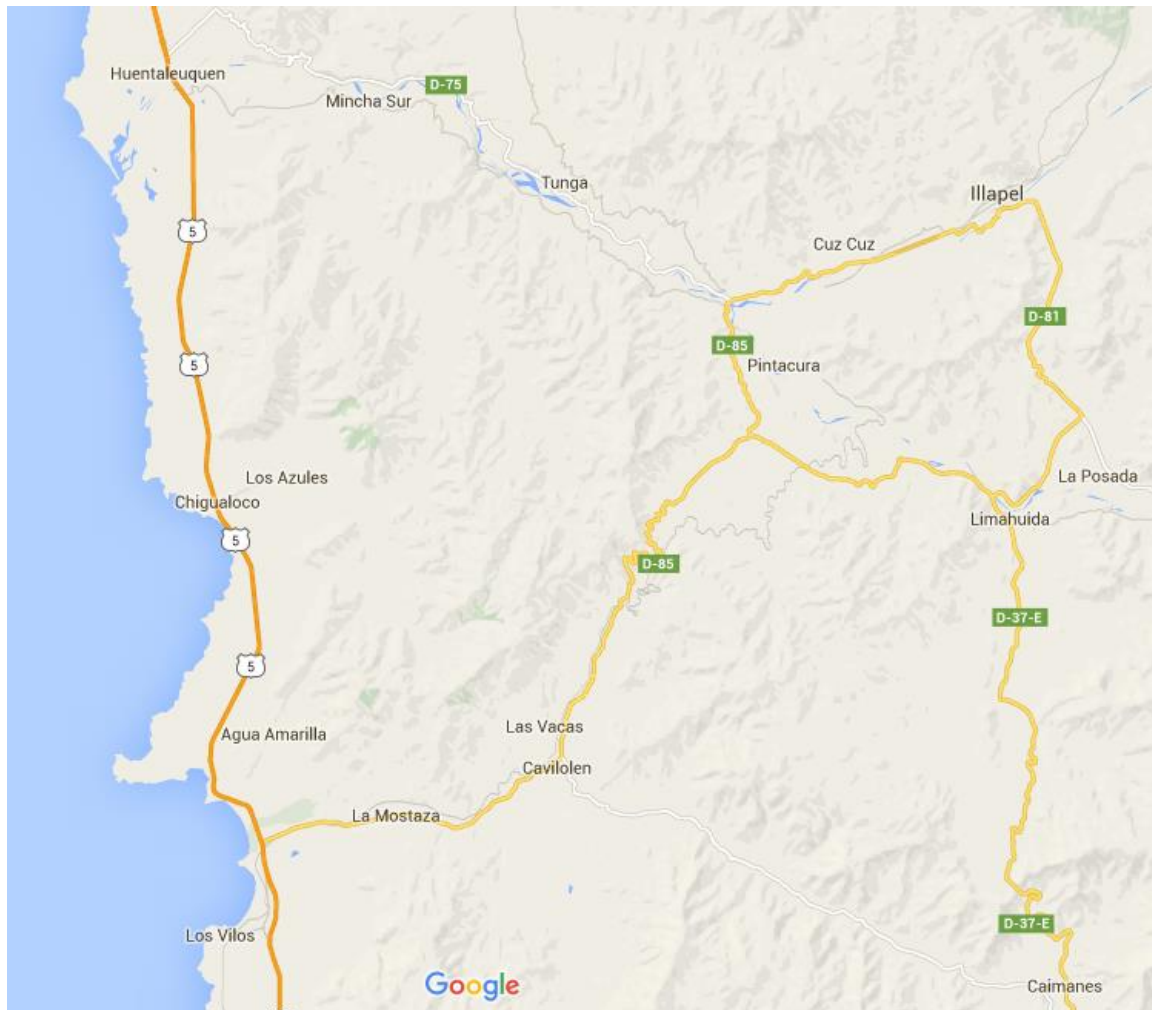
Figure 4.16. Map (from Google Maps) showing inland routes of D-75, D-85, D-81, east and northeast of Los Vilos.
