GEOTECHNICAL EXTREME EVENTS RECONNAISSANCE (GEER) ASSOCIATION

Turning Disaster into Knowledge

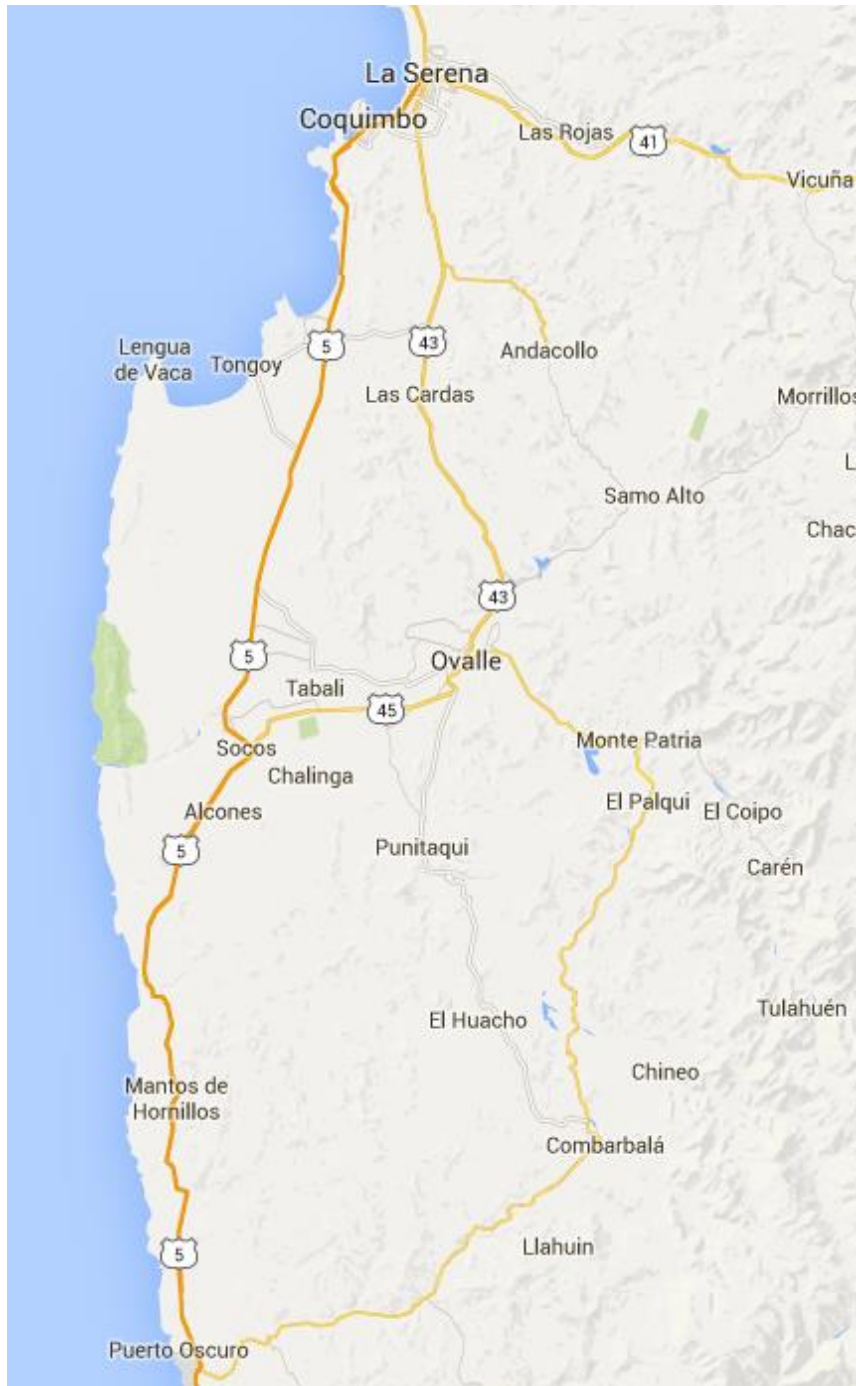
Figure 4.17. Map (from Google Maps) showing inland routes of D-55 (which runs east out of Ovalle and loops back to Puerto Oscuro in the south. Puerto Oscuro is the location where rockfall was observed imbedded in a residential home.

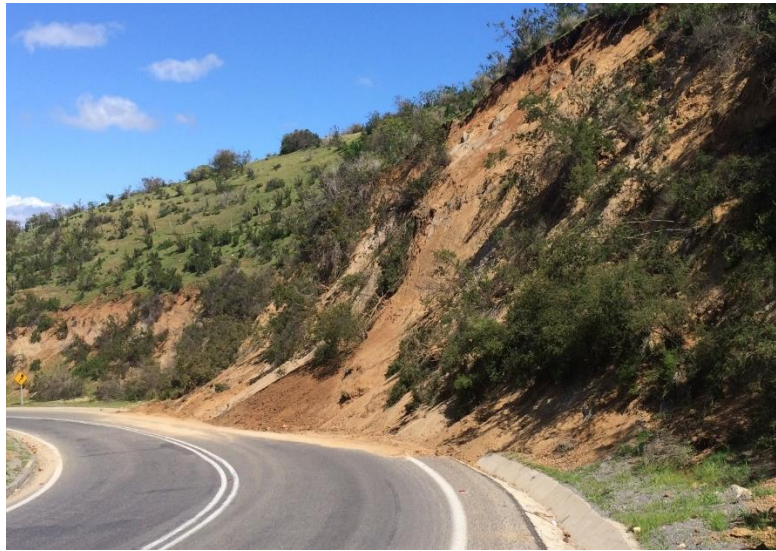
Figure 4.18. Mass-wasting in westbound of route D-85 (31.77599S; 71.32873W).

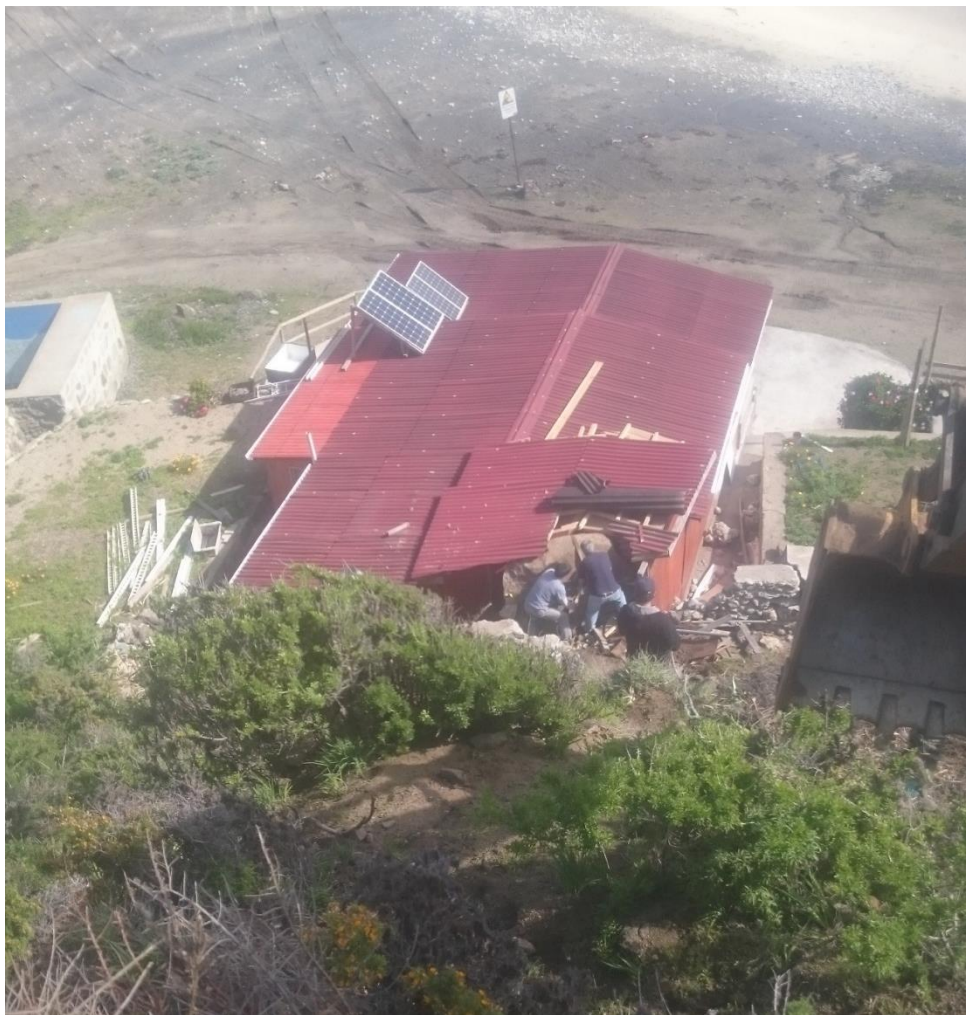
Figure 4.24. Photograph showing a boulder (with two men attaching slings to it), imbedded in the back of a property in Puerto Oscuro that fell from a natural slope above the property (31.42234S; 71.59291W).

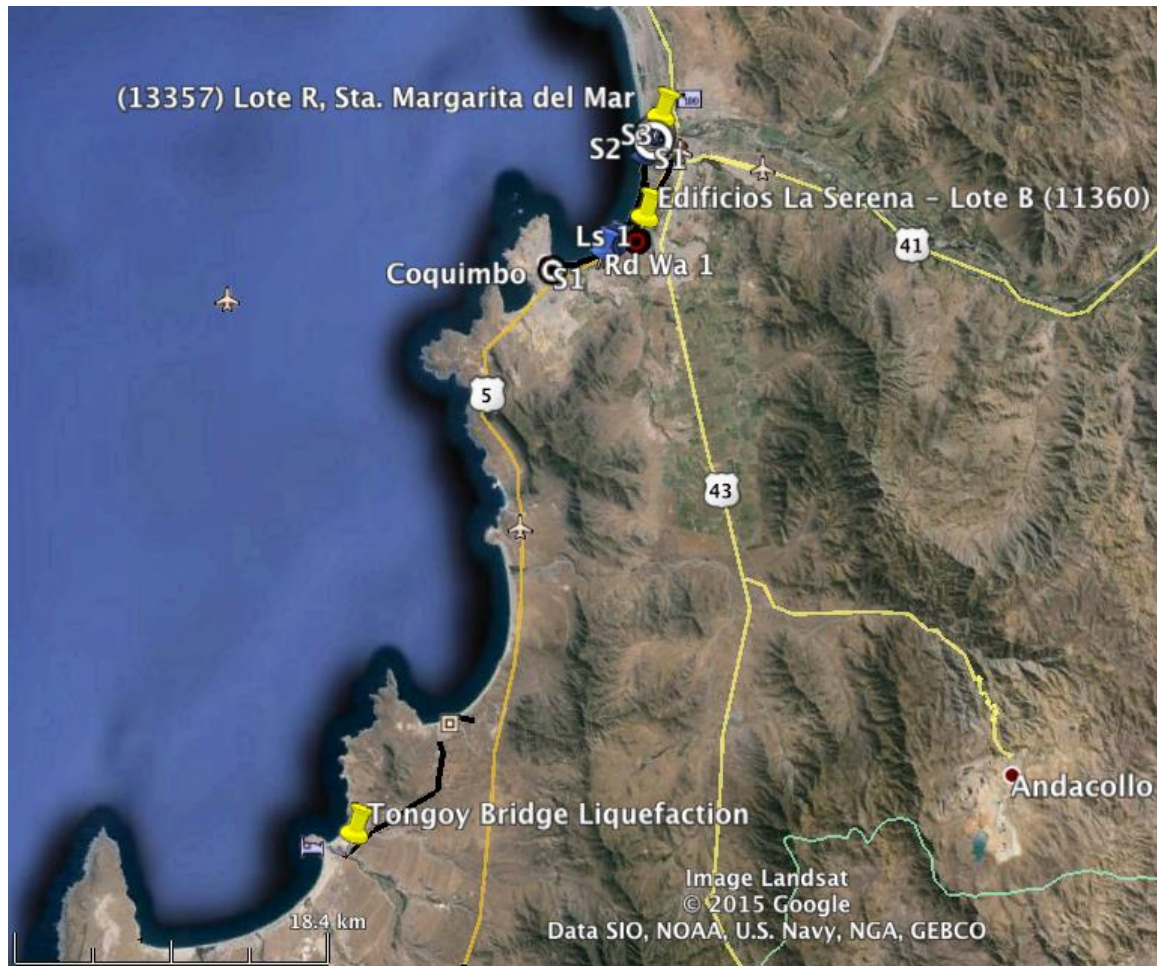
Figure 5.1. Google Earth map of main liquefaction sites and associated GPS points (e.g., Tongoy Bridge Liquefaction). No notable liquefaction was observed by the GEER team south of Tongoy. Population density and thus built structure density is higher here than other areas near the fault rupture place, so thus the likelihood for observing liquefaction is higher in these areas. Also important, having structures built in low-lying, geologically young areas, (e.g. Holocene deposits in this case, coastal lagoons, and beaches near La Serena) also increases the likelihood for liquefaction-induced damage.

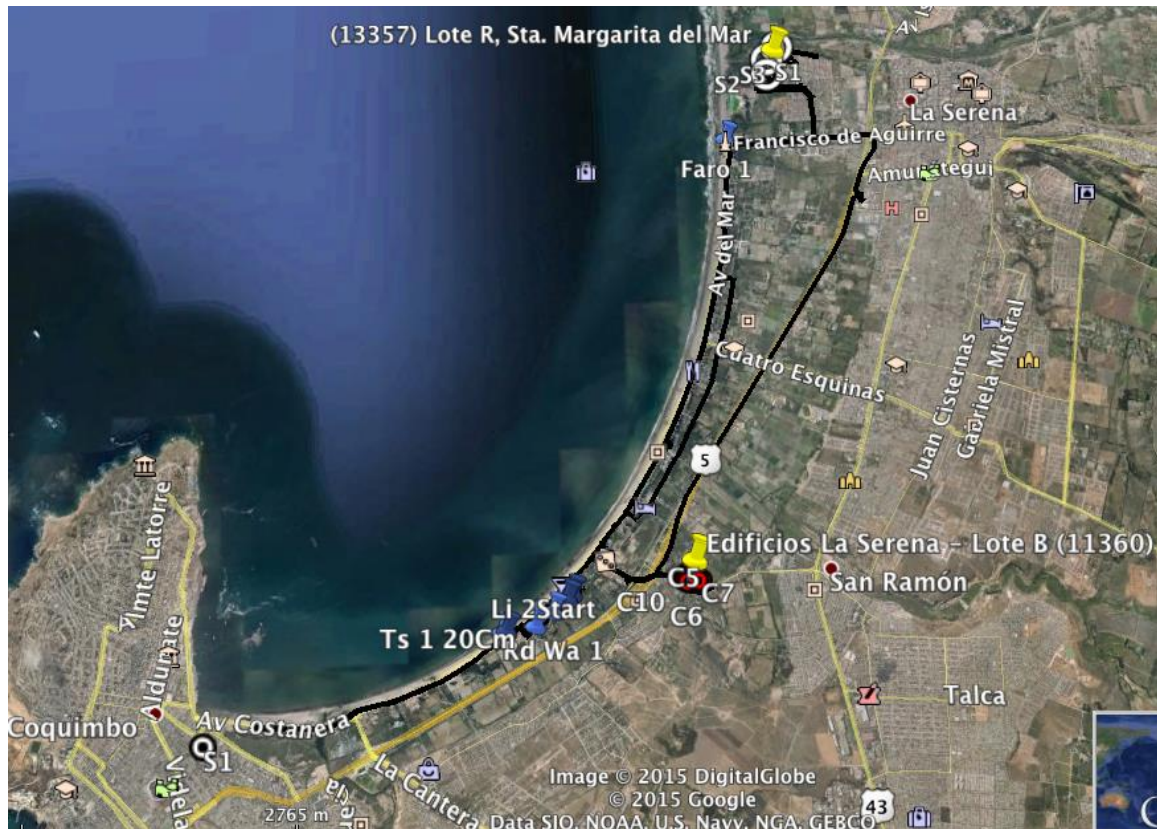
Figure 5.2. Google Earth map of main liquefaction sites and associated GPS points in the La Serena and Coquimbo region. Main observations were near the Li 2 Start GPS points as well as the El Faro along the coast to the north.

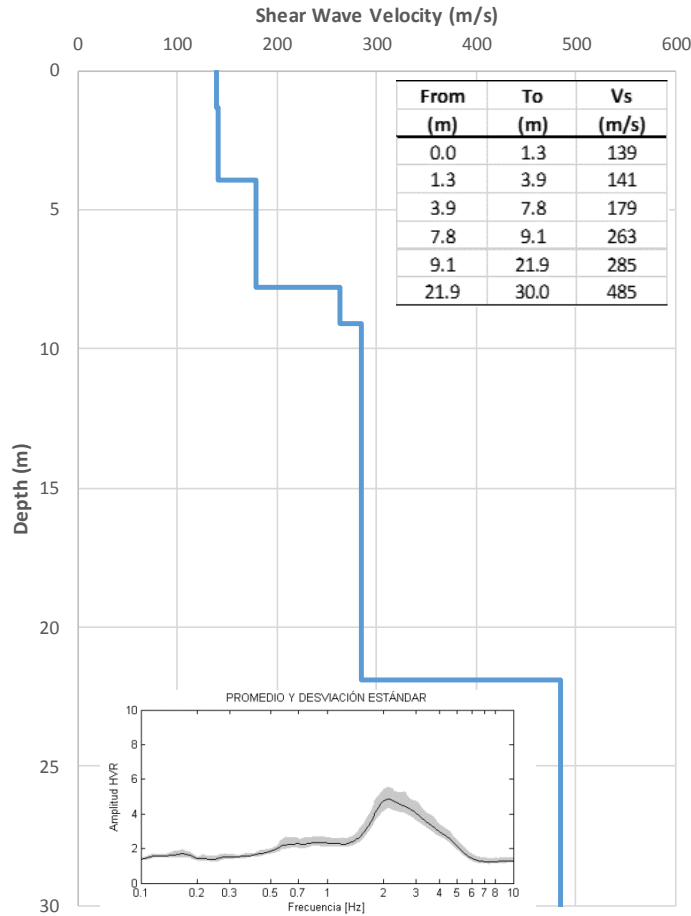
Figure 5.3. Shear wave velocity profiles and H/V spectral ratios at (29.896866S; 71.268320W).

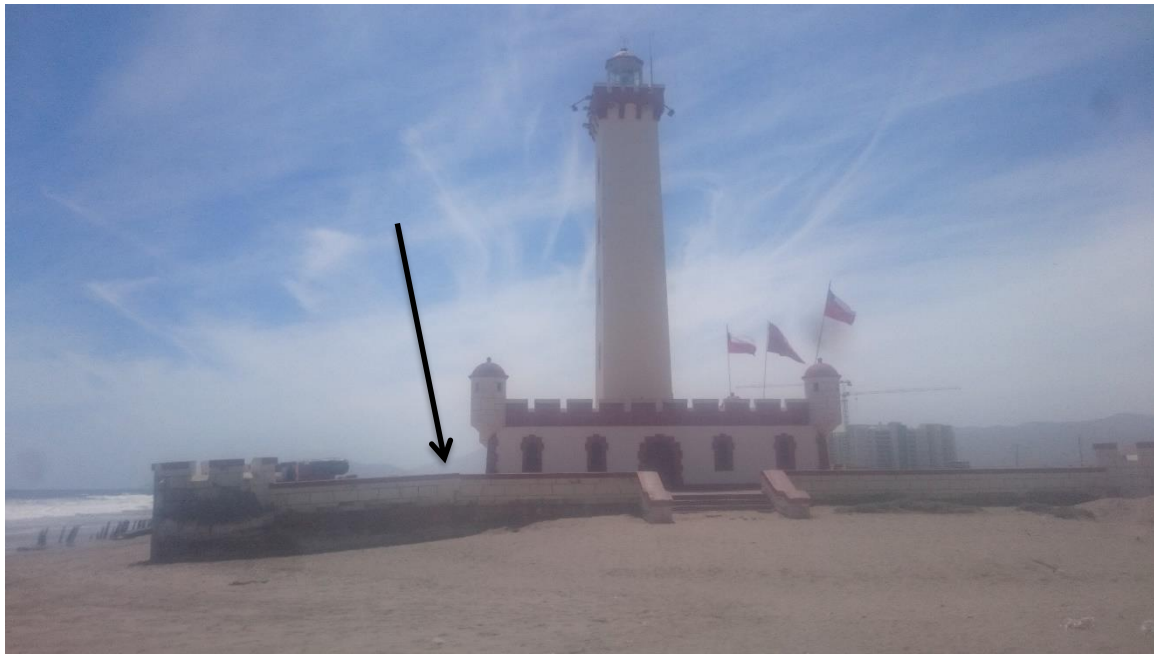
Figure 5.4. El Faro photograph looking north (29.90541S; 71.27411W). Note the break in the outer wall (i.e., change in angle indicated with the black arrow) where the western edge of the El Faro wall subsided with a westward tilt apparent at the top of the wall. This happened prior to this earthquake and was patched and painted over, however during the 2015 earthquake, cracks opened up along these fractures that suggest renewed subsidence.

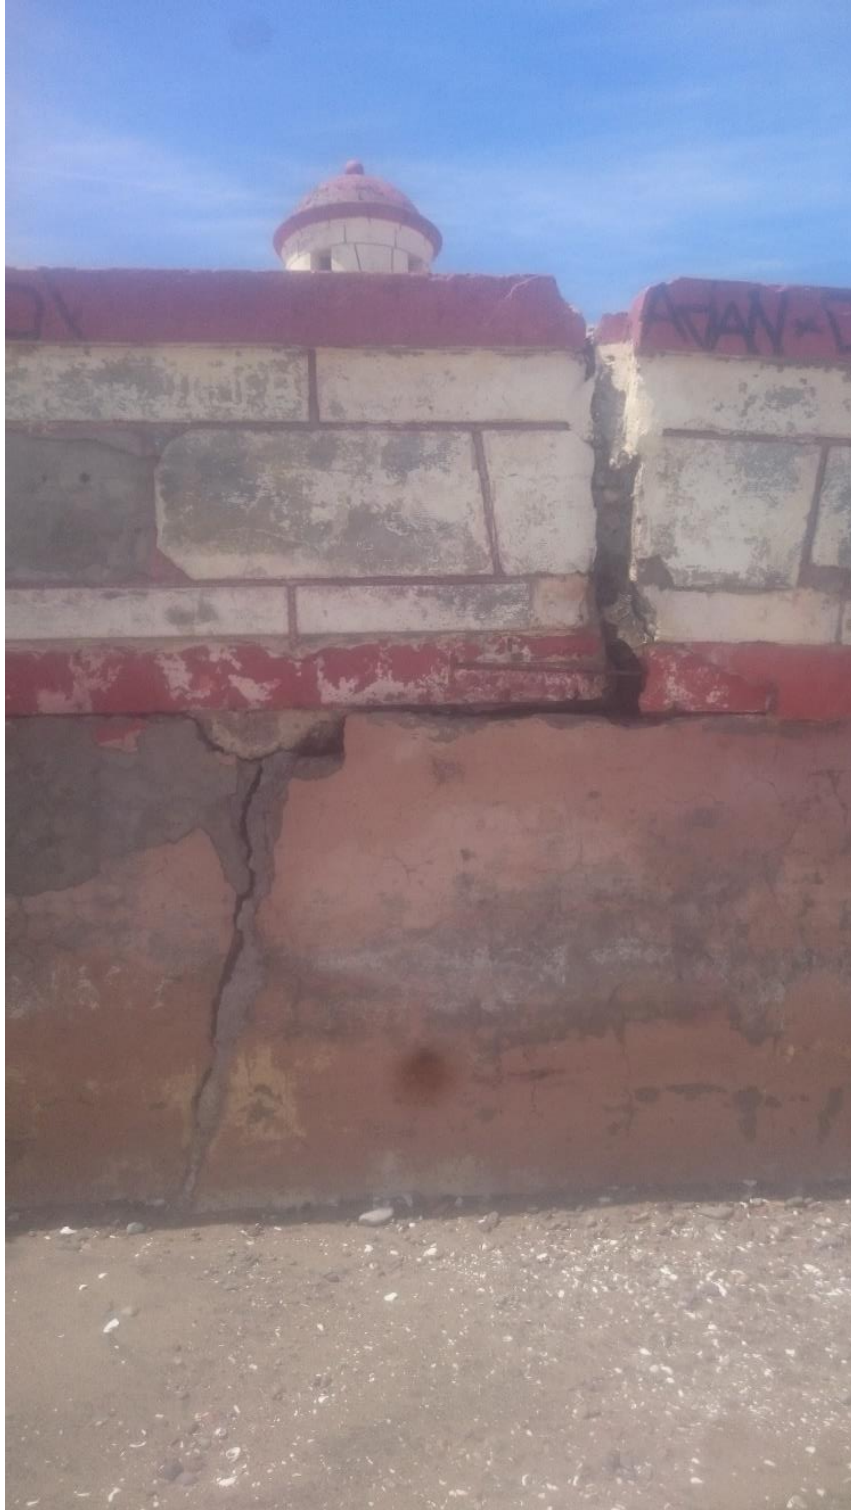
Figure 5.5. El Faro outer wall (Western, adjacent to sea) showing open fractures due to differential settlement during liquefaction perhaps in conjunction with wave scour (29.90541S; 71.27411W).

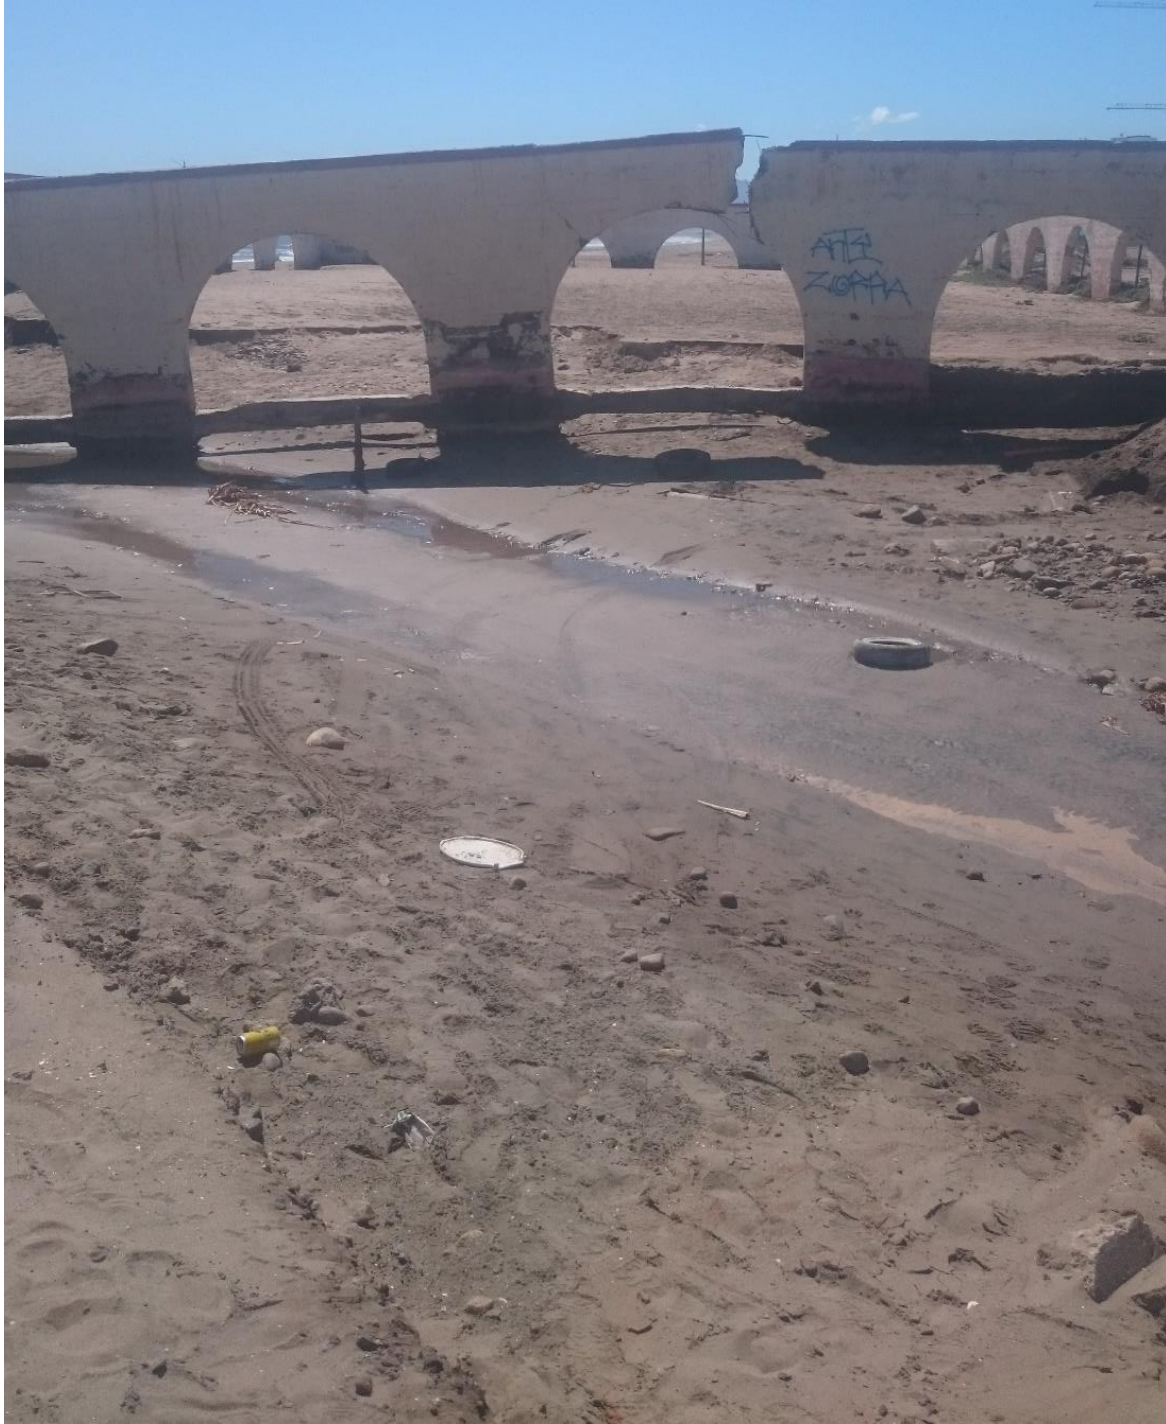
Figure 5.6. Field photograph looking north from El Faro towards the adjacent structure that shows clear differential settlement (down to the Southwest) with damage to the arc. Scour from waves as well as liquefaction was likely at this site (29.90541S; 71.27411W).

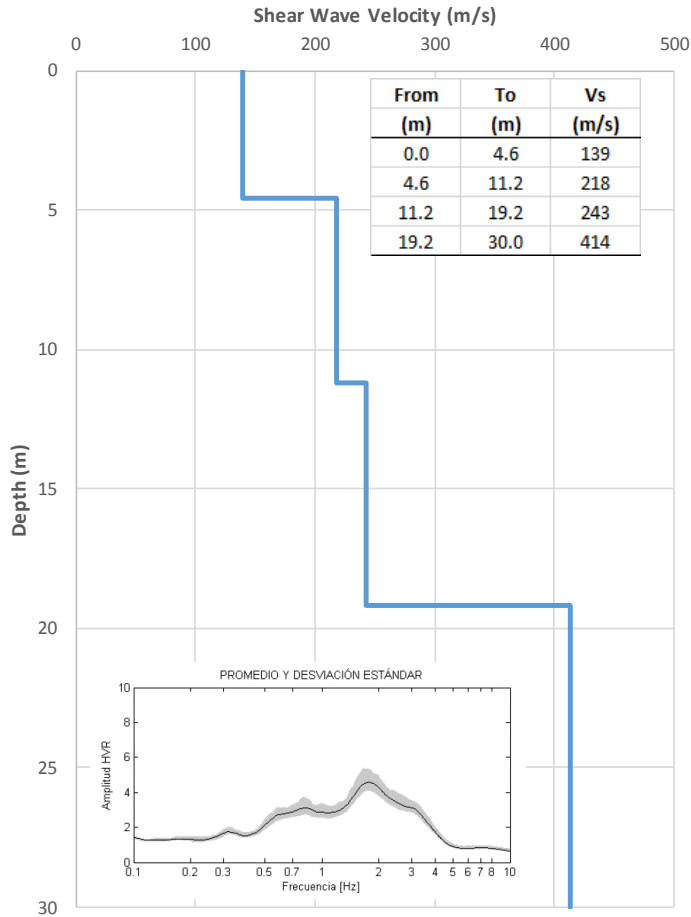
Figure 5.7. Shear wave velocity profiles and H/V spectral ratios at (29.90541S; 71.27411W). Liquefaction likely took place in the upper 5 m.

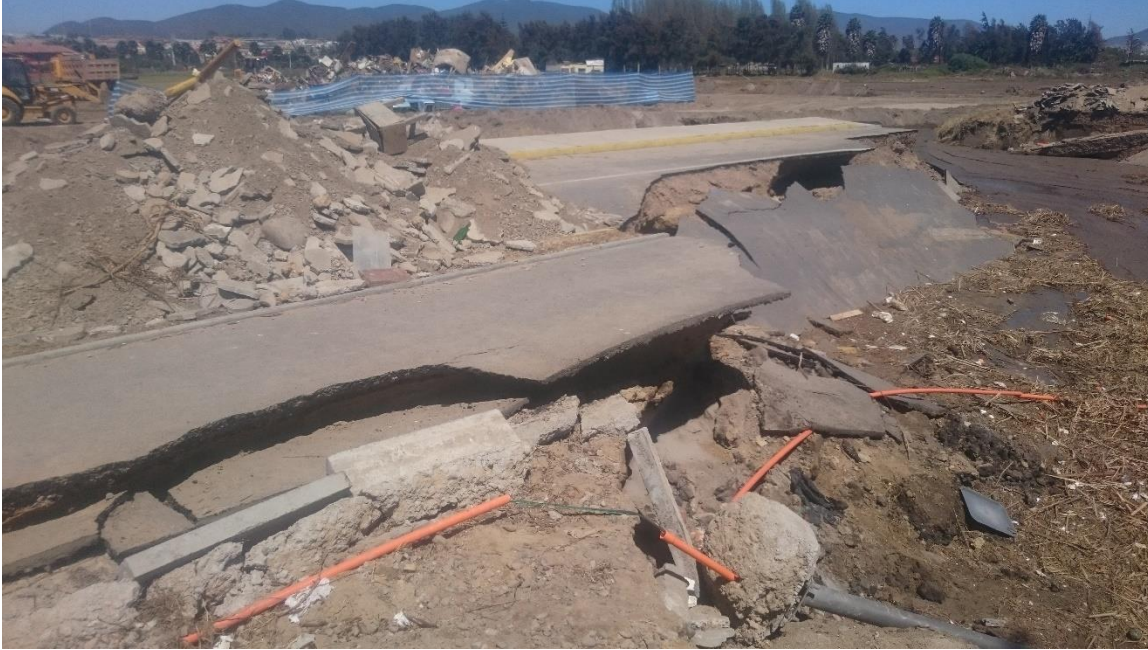
Figure 5.8. Field photograph showing an area that likely experienced liquefaction and was then disturbed by the tsunami. Two-lane road formerly ran along the coast and was completely cut due to damage. Vertical relief from road surface to debris below is 1.5 to 2 m. Note tsunami debris in foreground near orange electric pipe (29.95368S; 71.30173W).

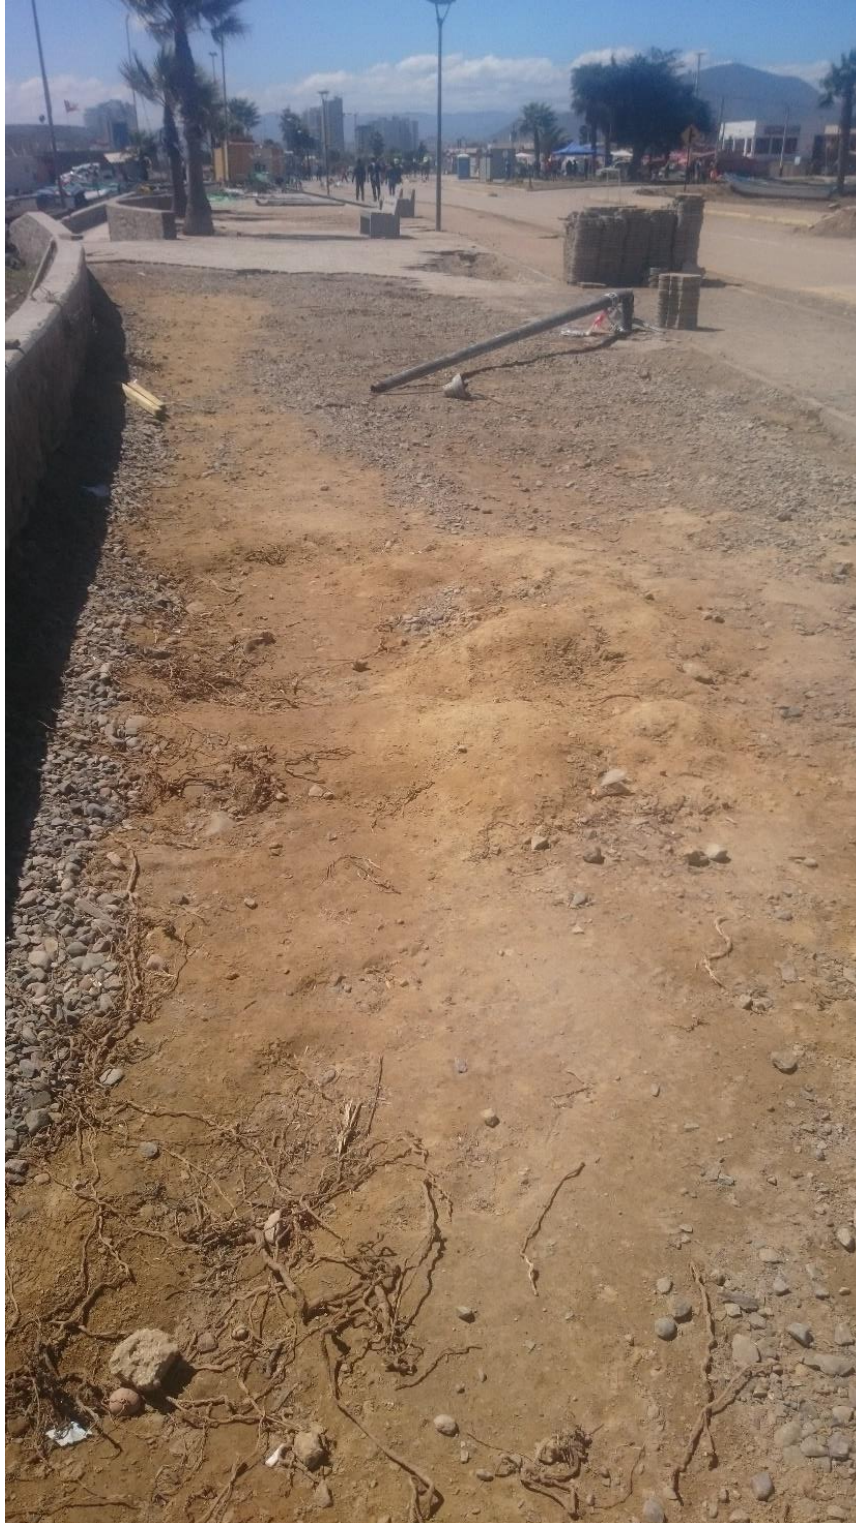
Figure 5.9. Field photograph next to the destroyed road with small mounds of sand that may have been sand boils (29.95368S; 71.30173W).

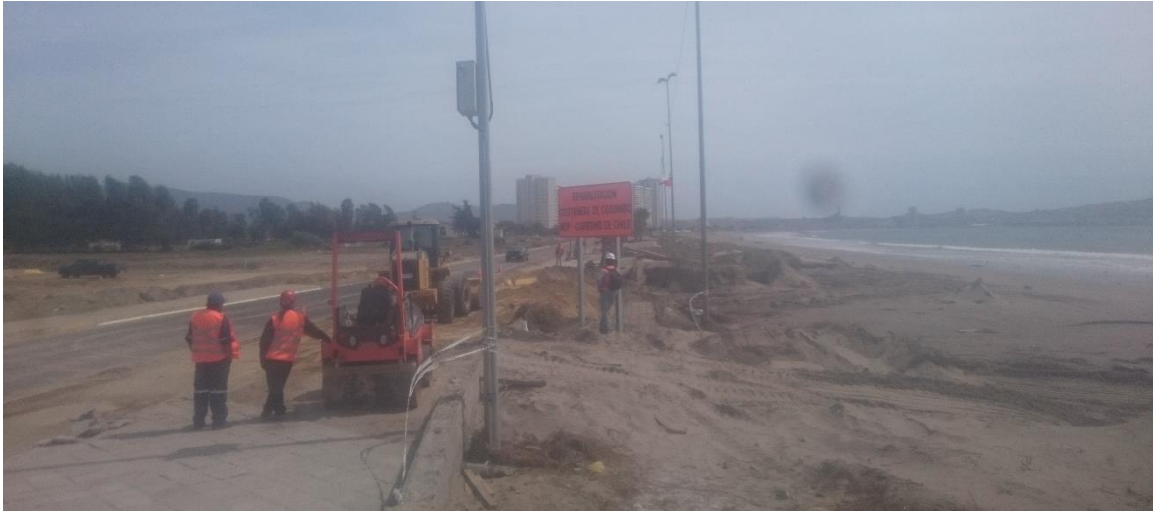
Figure 5.11. Field photograph of the destroyed road location on October 5, after the road was repaired and fully functioning (29.95368S; 71.30173W).

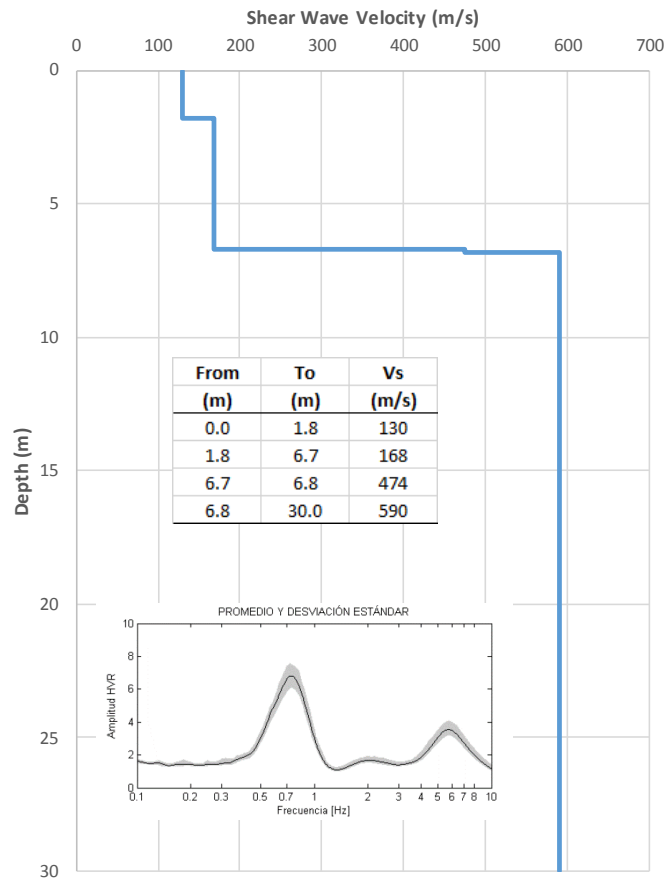
Figure 5.12. Shear wave velocity profiles and H/V spectral ratios at (29.95368S; 71.30173W). Liquefaction likely took place in the upper ~6 m.

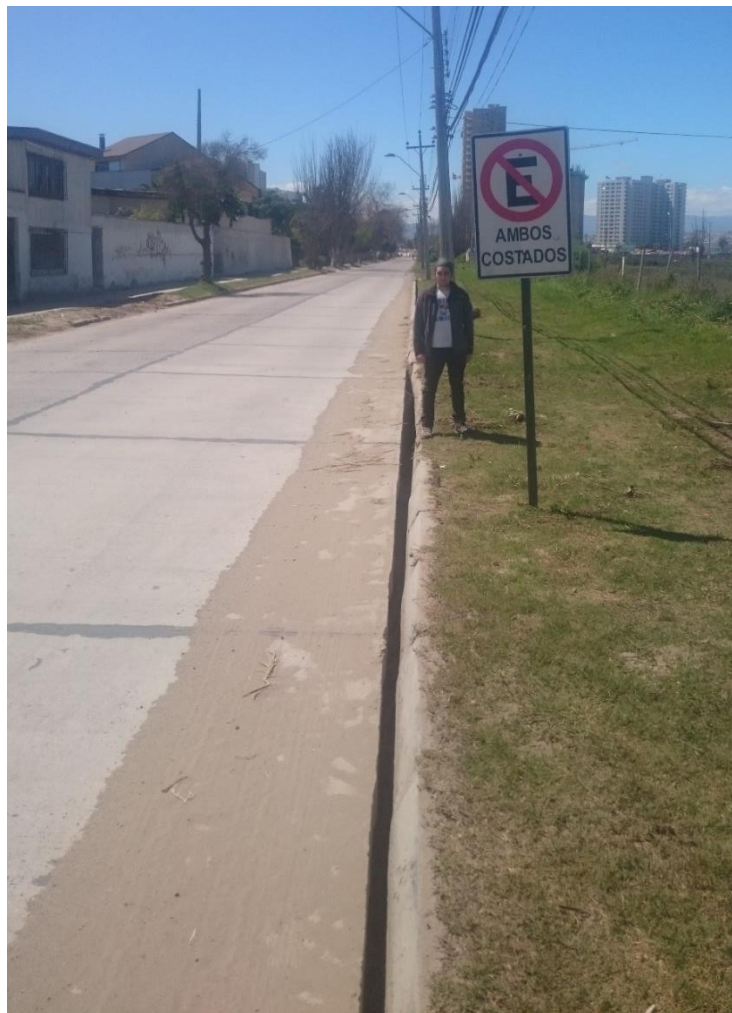
Figure 5.13. Field photograph looking north on Los Pescadores street (29.95068S; 71.29456W) showing the curb with horizontal separations of 5-10 cm (to the southeast), as well as vertical subsidence (at person's feet from 3-6 cm vertical).

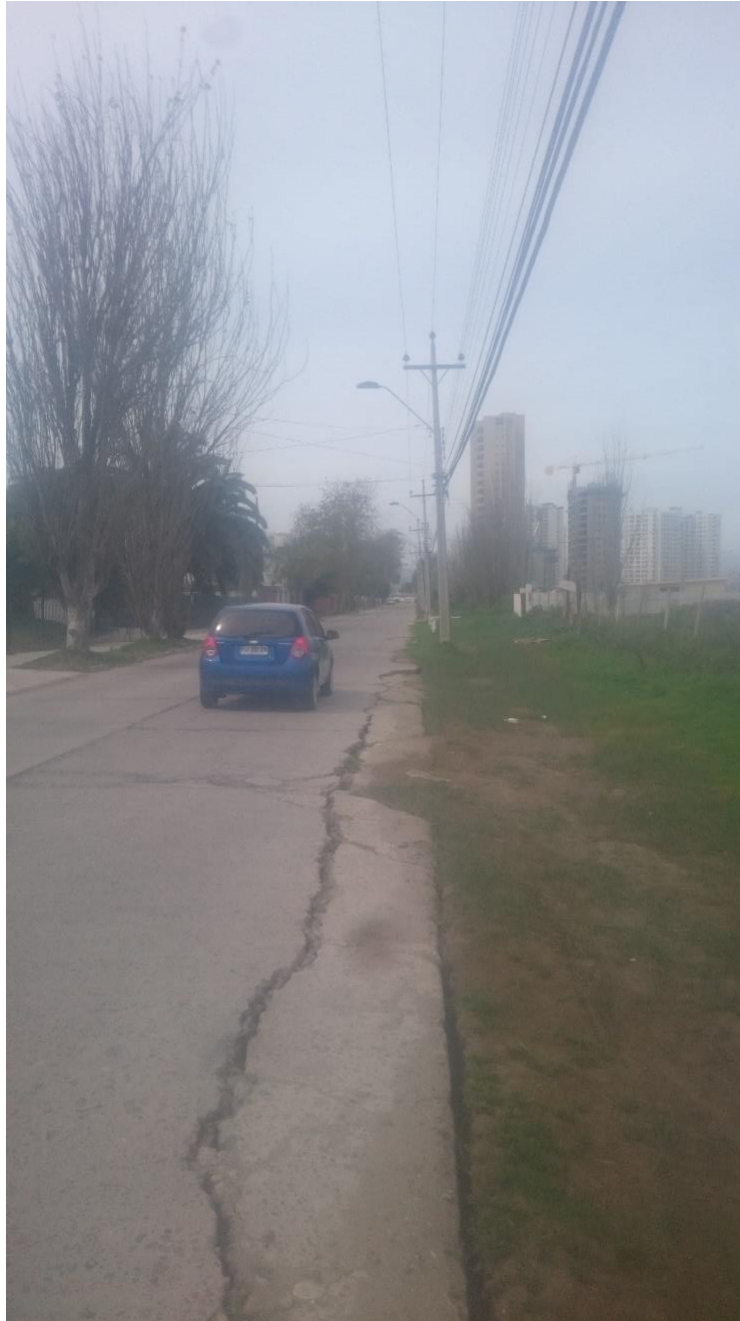
Figure 5.16. Field photograph looking north along Los Pescadores road. Note that the edge of the road has road parallel cracks where the road has failed to accommodate vertical subsidence and horizontal deformation of the soil during lateral spreading. Also note that the power lines in the back are tilted (29.95068S; 71.29456W).

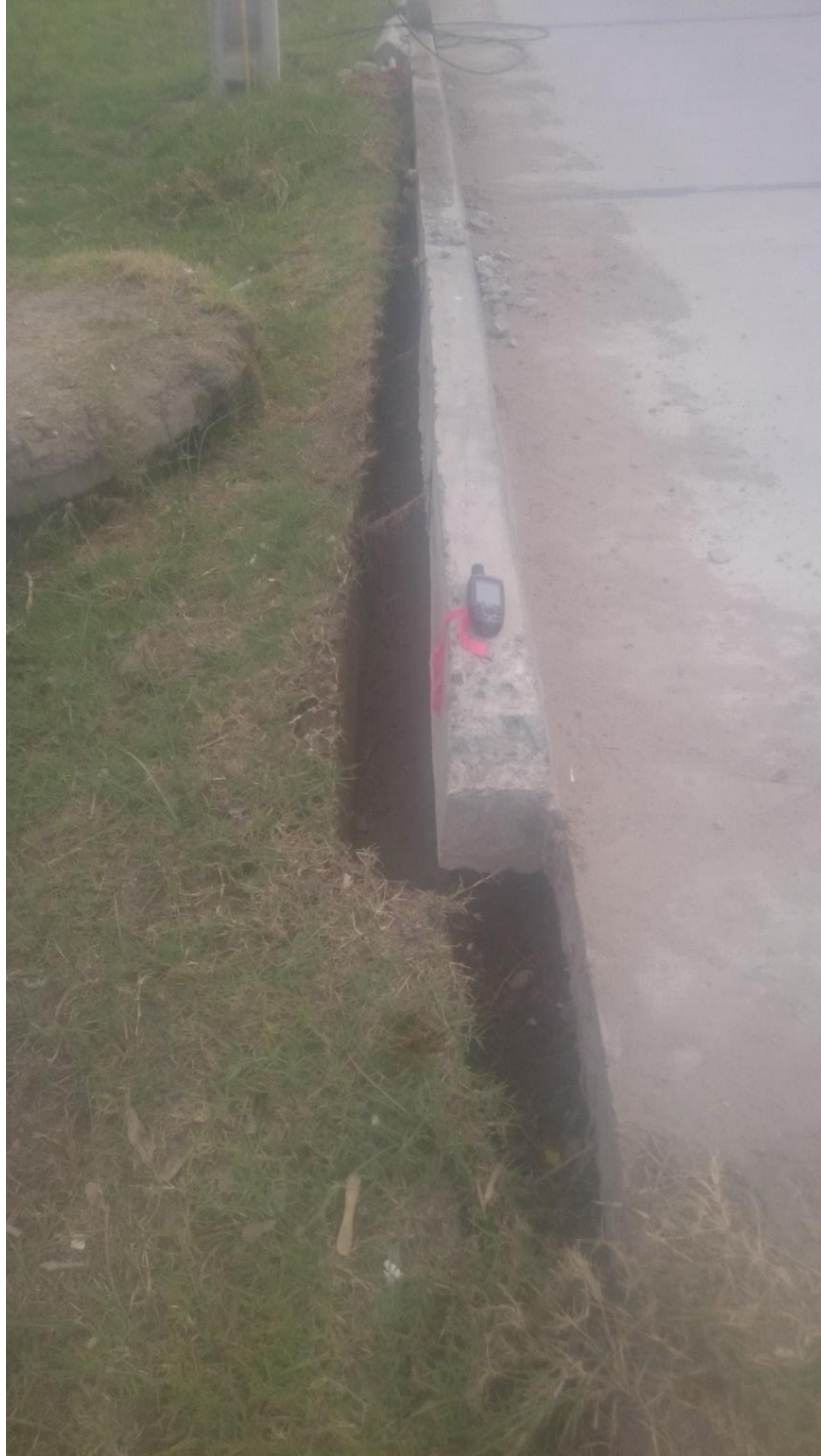
Figure 5.17. Field photograph looking southwest along Los Pescadores street that shows floating services (on left) and vertical soil subsidence and lateral spreading. GPS is 15.0 cm long and 5.5 cm wide for scale. Horizontal displacements of the intact soil range from 2-20 cm here and vertical subsidence from 0 to 10 cm (29.95068S; 71.29456W).

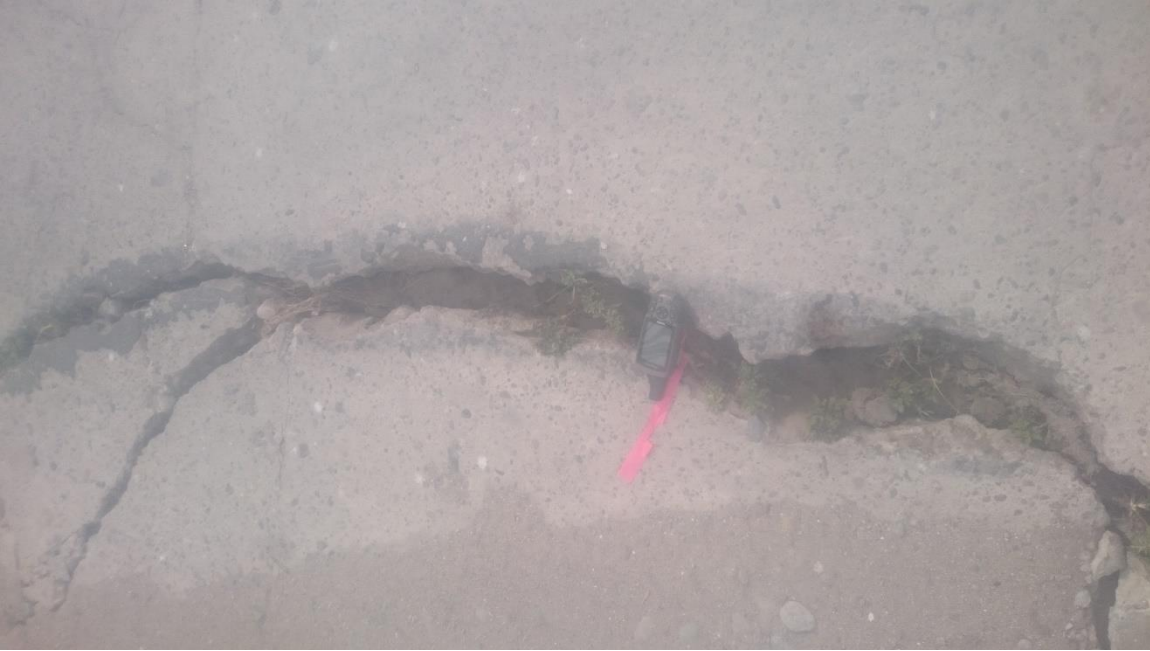
Figure 5.18. Field photograph showing concentric fractures in the concrete roadway which are accommodating the vertical and horizontal soil deformation underneath. GPS is 15.0 cm long and 5.5 cm wide for scale. Note the soil in the cracks and plants growing which suggests these cracks formed during previous earthquakes here (i.e., liquefaction during previous events took place here, which caused the formation of the cracks). The soil and plants lived here until the 2015 earthquake caused another round of liquefaction and further lateral spreading and subsidence (29.95068S; 71.29456W).

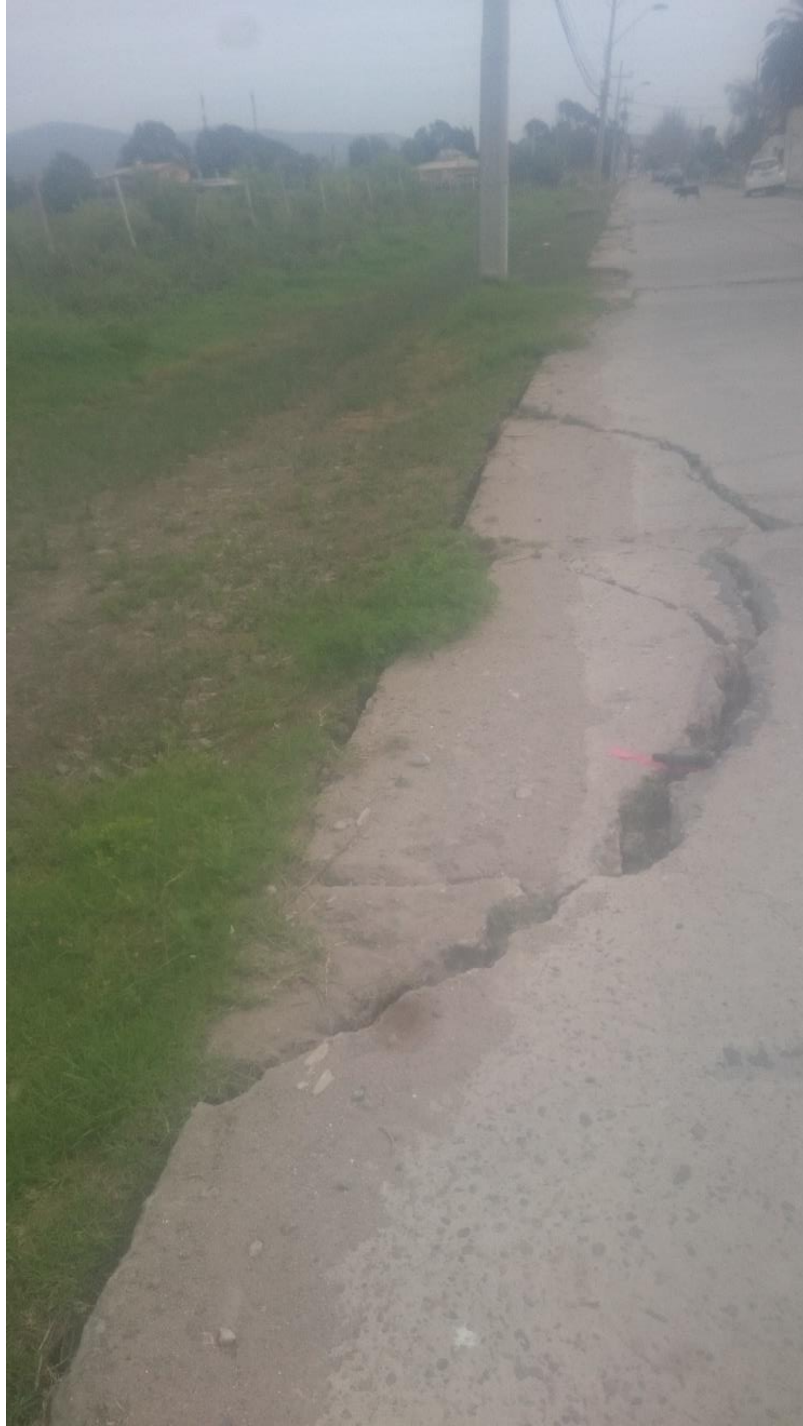
Figure 5.19. Field photograph of same site as above showing concentric ring fractures in the concrete due to liquefaction induced subsidence. Photograph is looking Southwest along Los Pescadores street. GPS is 15.0 cm long and 5.5 cm wide for scale. Note that the ground pre-earthquake was level to the left (southeast) of the round and has now subsided 25-40 cm and been horizontally translated (29.95068S; 71.29456W).

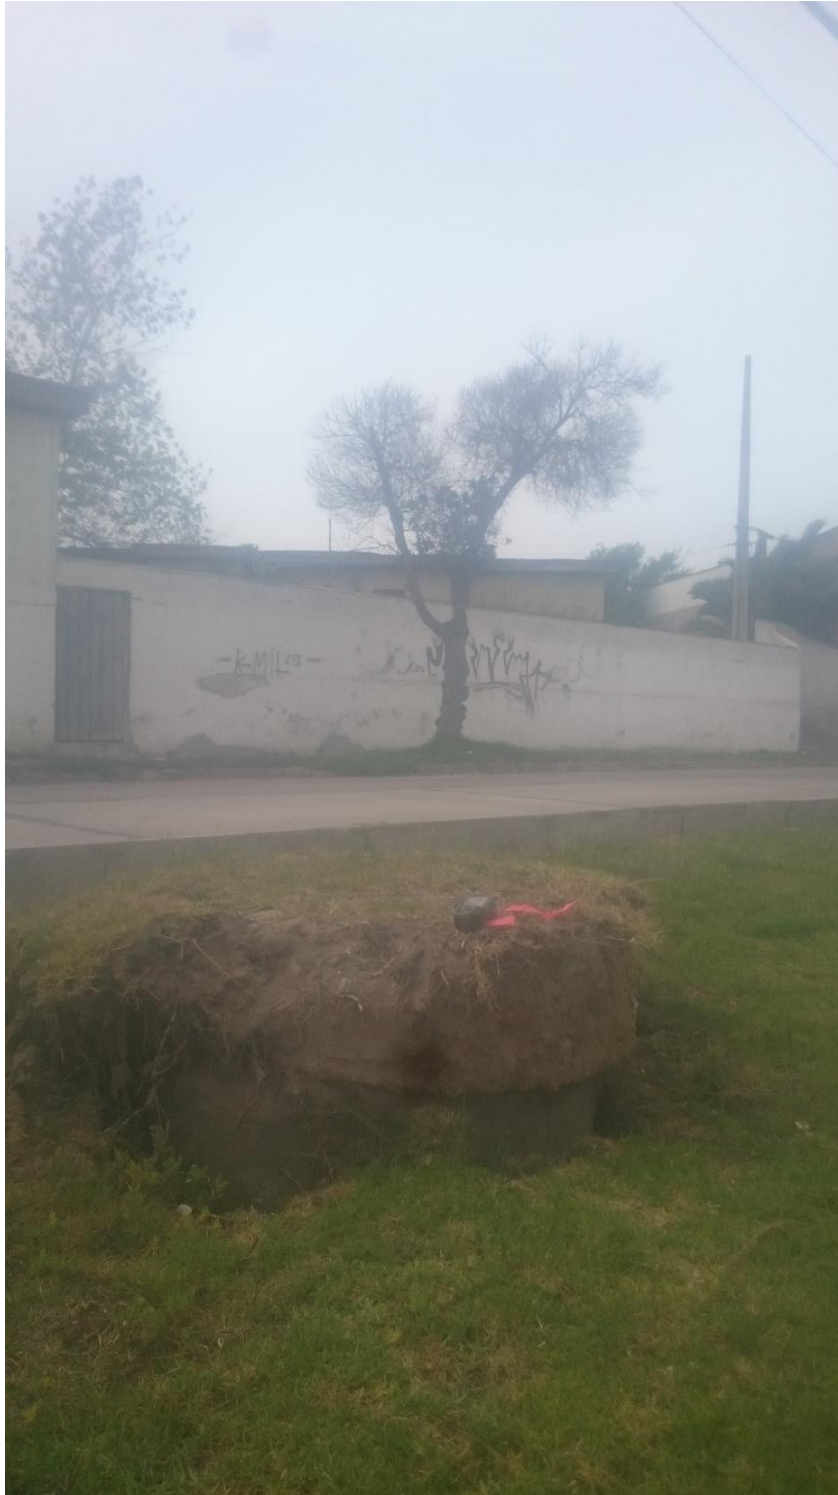
Figure 5.20. Second floating service portal along Los Pescadores Street with ~35-40 cm of combined floating services and subsidence. Note the edge of the road in the background that was flush with the ground surface pre-earthquake (29.95068S; 71.29456W).

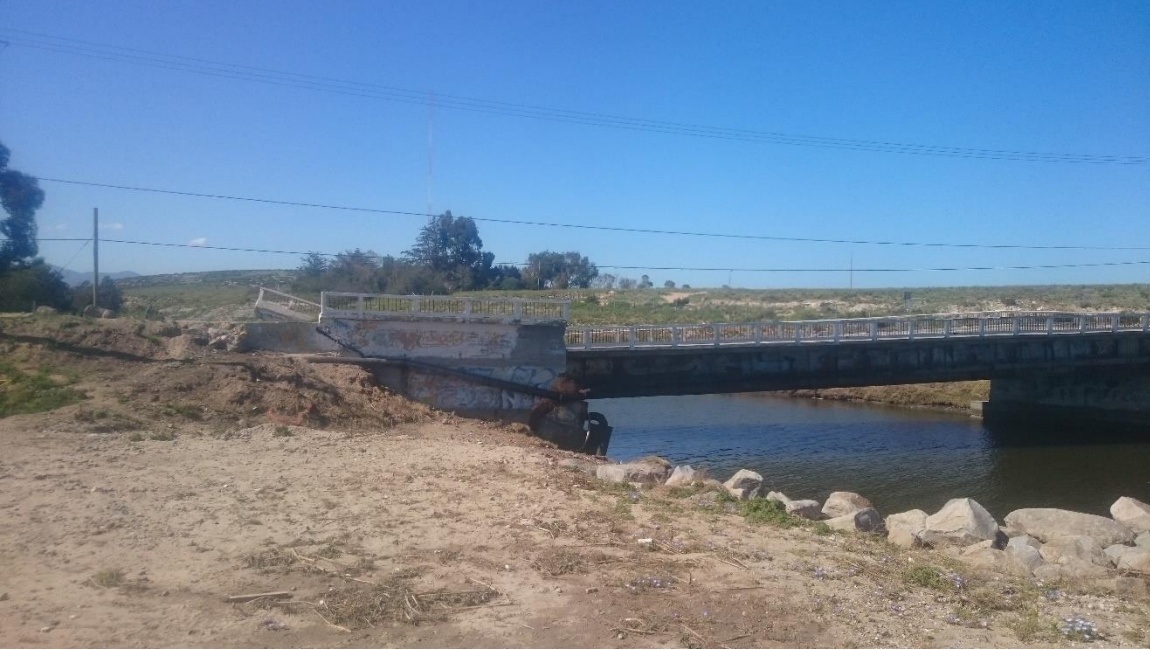
Figure 5.24. Field photograph looking east of the D-420 Bridge. Northern end of the bridge has a vertical step where it failed during the earthquake likely during liquefaction (30.260784S; 71.481196W).

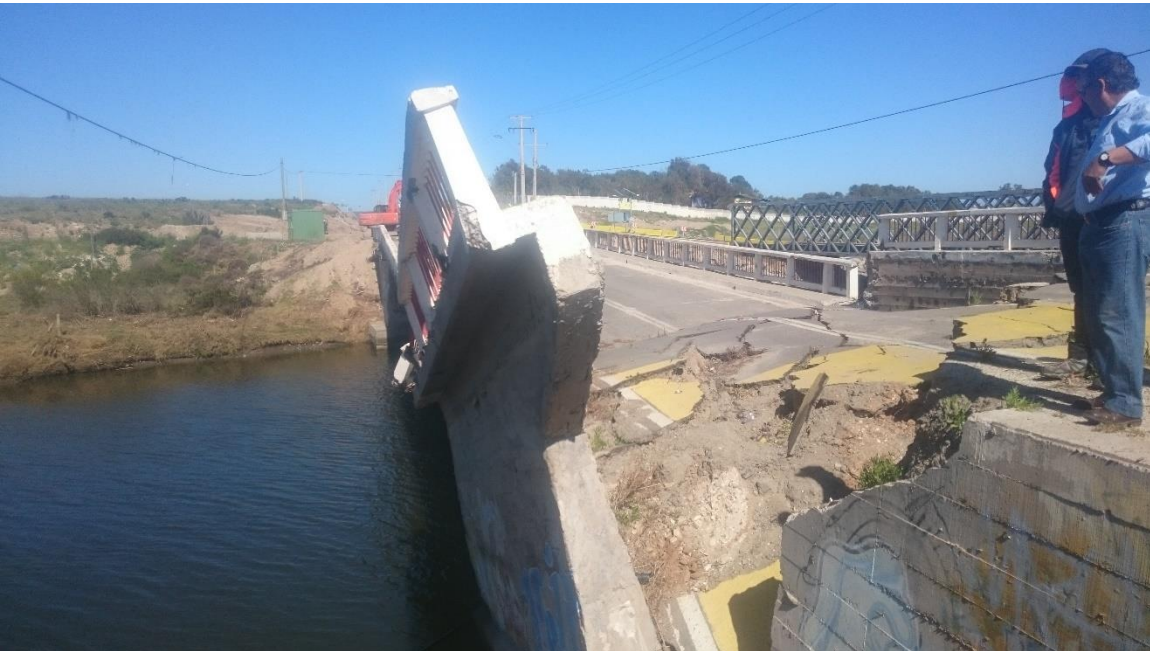
Figure 5.25. Field photograph looking south of the D-420 bridge. Northern end of the bridge has a vertical step where it failed during the earthquake, likely due to lateral spreading during liquefaction. People shown for scale (30.260784S; 71.481196W).
