GEOTECHNICAL EXTREME EVENTS RECONNAISSANCE (GEER) ASSOCIATION

Turning Disaster into Knowledge

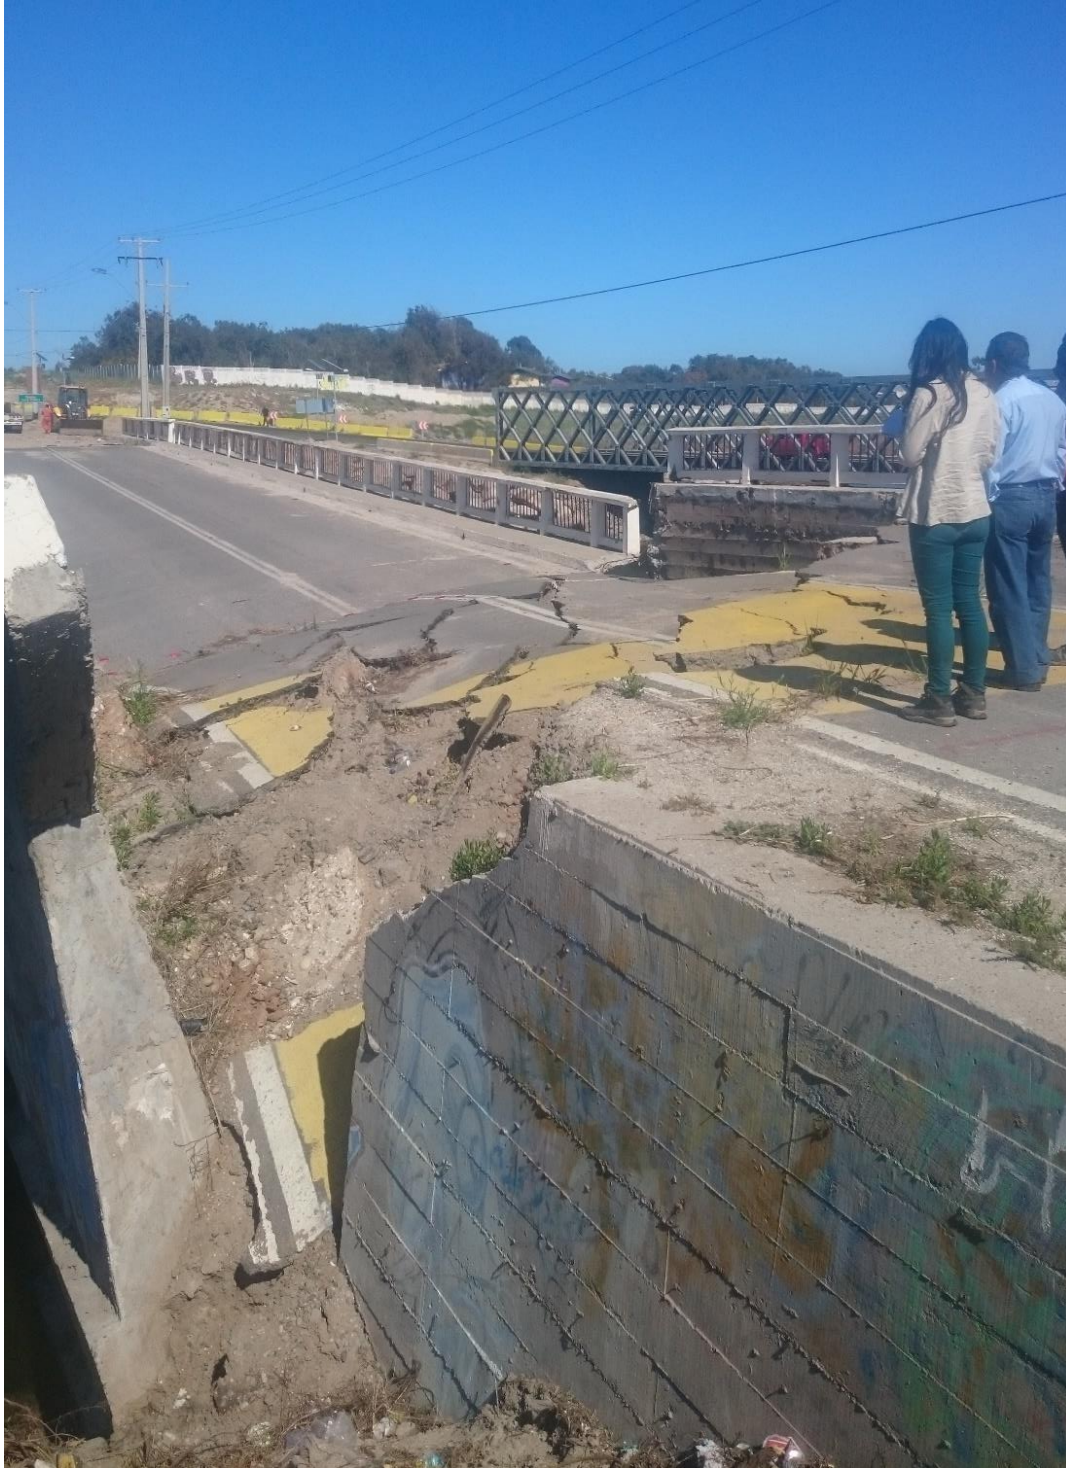
Figure 5.26. Field photograph looking south of the D-420 bridge. Northern end of the bridge has a vertical step where it failed during the earthquake – likely during liquefaction induced lateral spreading. Note the new steel bridge in the background on right (30.260784S; 71.481196W).

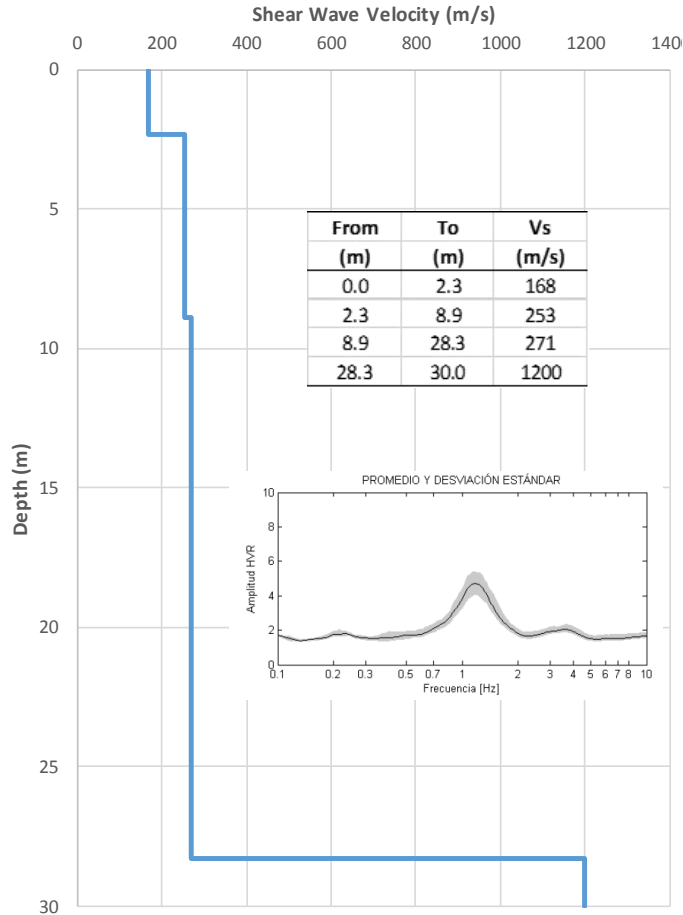
Figure 5.27. Shear wave velocity profiles and H/V spectral ratios at (30.260784S; 71.481196W). Liquefaction likely took place in the upper 2.5 m

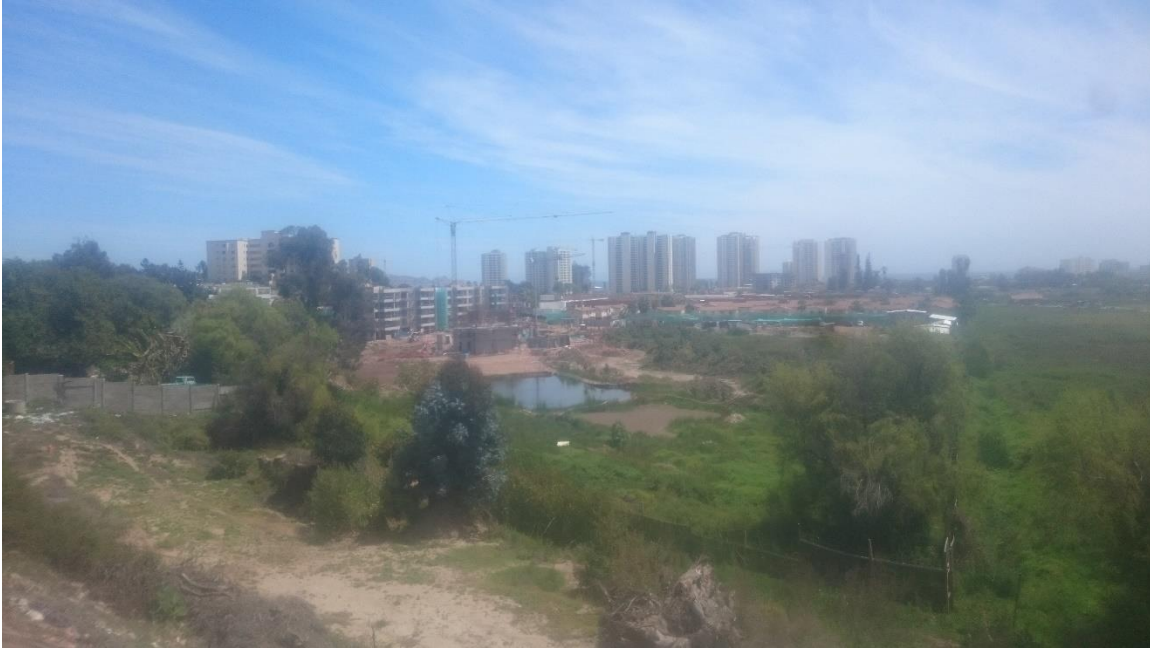
Figure 5.28. View of the site looking NW, as of October 9. No signs of liquefaction were observed. The pond is part of the project, and the building behind the pond towards the coast is under construction.

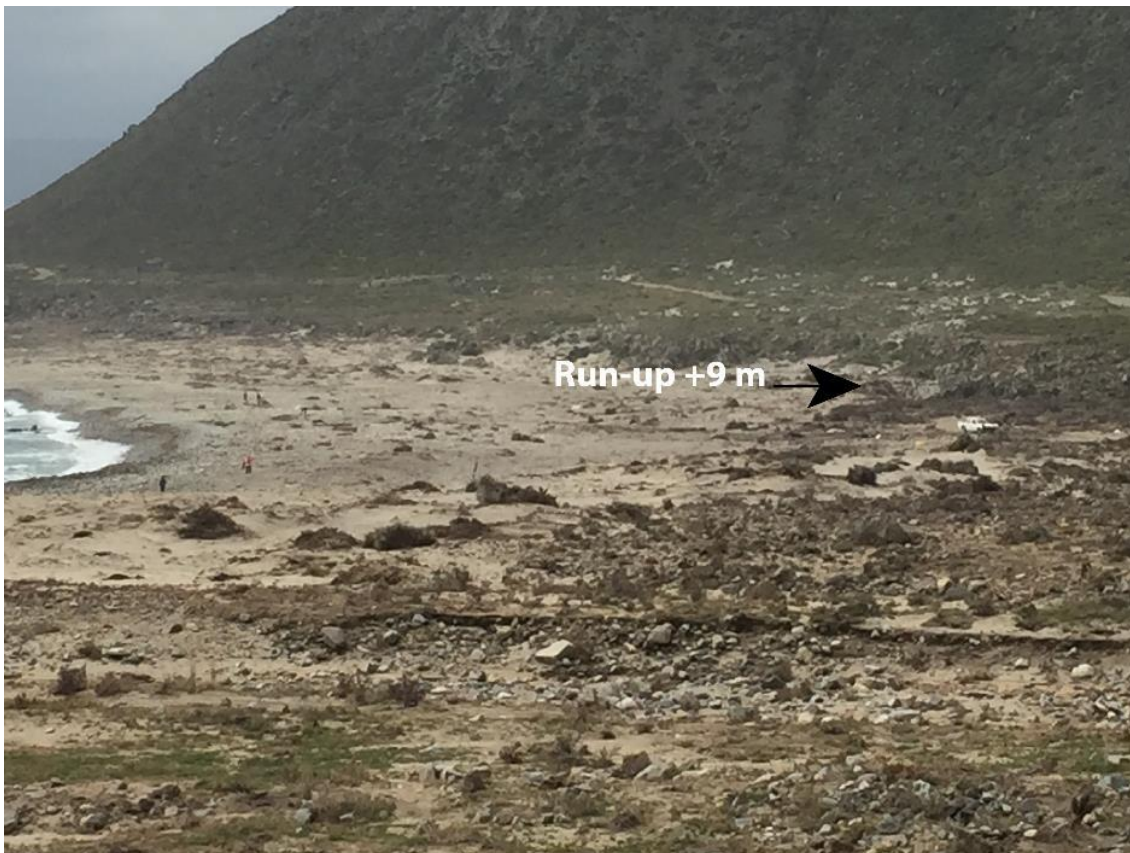
Figure 6.1. Razed dunes and vegetation and accumulation of boulders evidencing the effect of the tsunami waves at El Sauce (30.55S; 71.69W). Note 4x4 truck and people for scale.

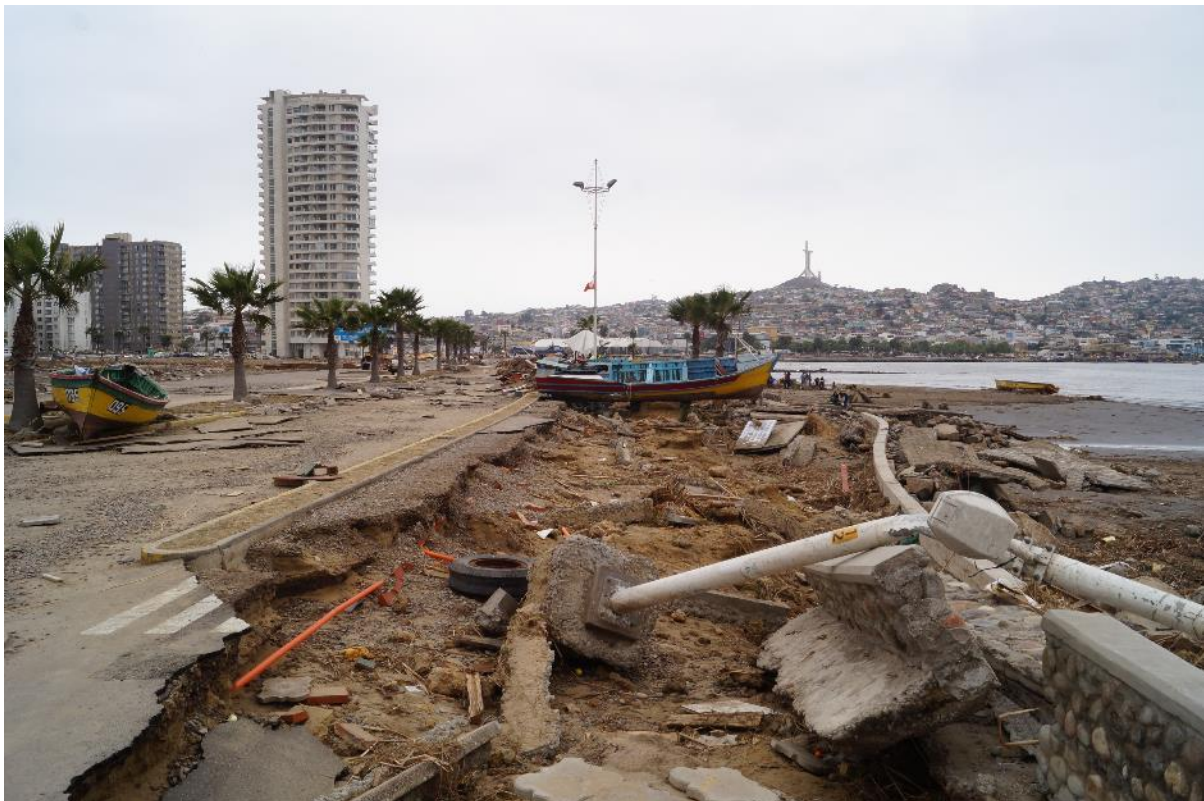
Figure 6.2. Strong erosion at the coastal border of caused by the tsunami in the area of Coquimbo (29.95342S; 71.29860W).

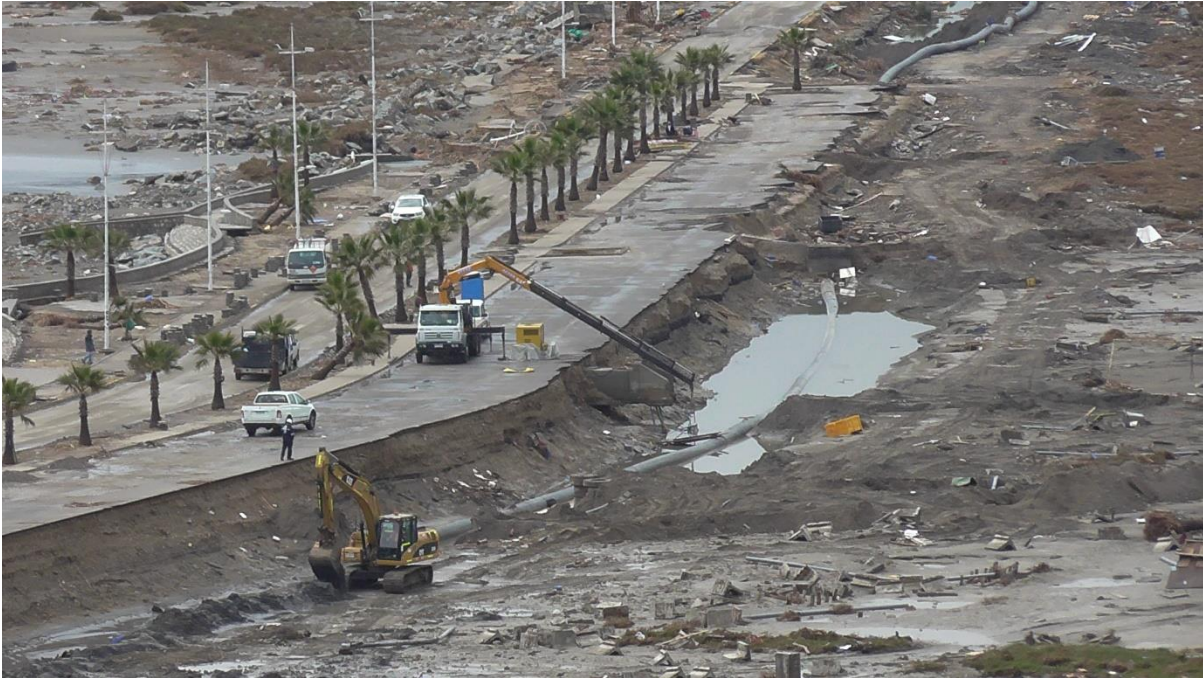
Figure 6.3. Tsunami erosion and scour along Avenida Costanera, Coquimbo (29.960589S; 71.328062W).

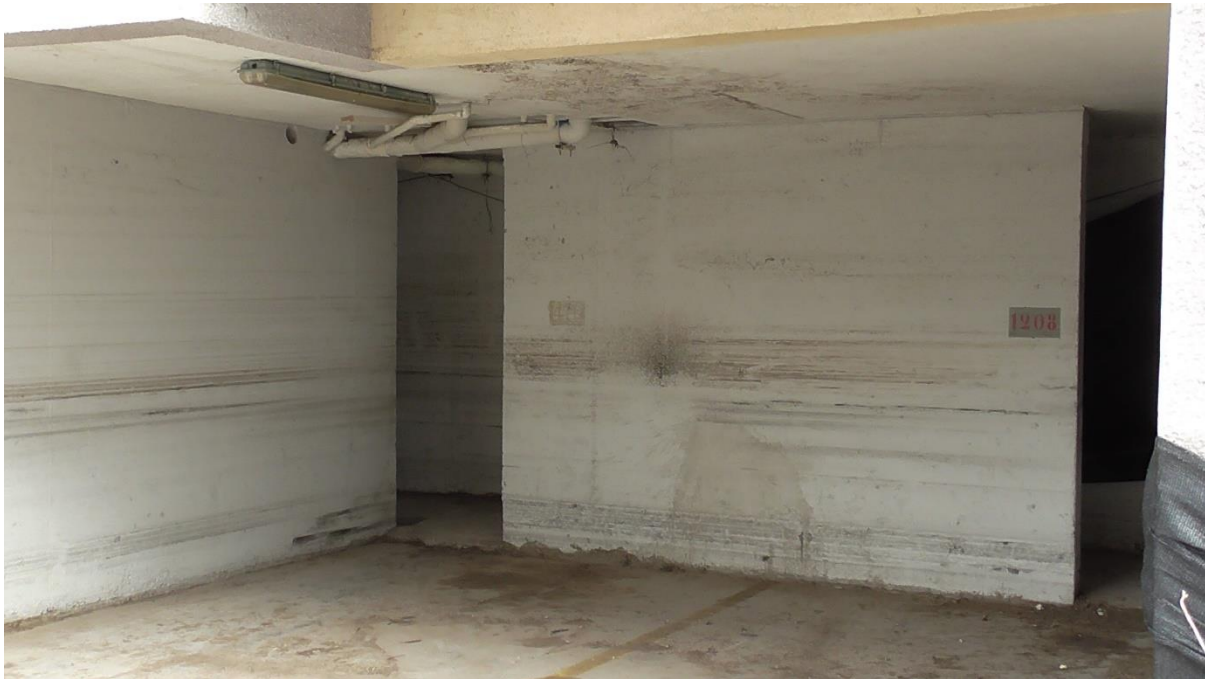
Figure 6.8. Flooding of the first story at Costa Mansa building (29.960144S; 71.332698W). Estimated run-up depth of 4.5 m.a.s.l. The structure, a 26 story RC shear wall building, was not damaged by the ground motion, however basic utilities (water, gas, electricity) were discontinued and residents were forced to move out.

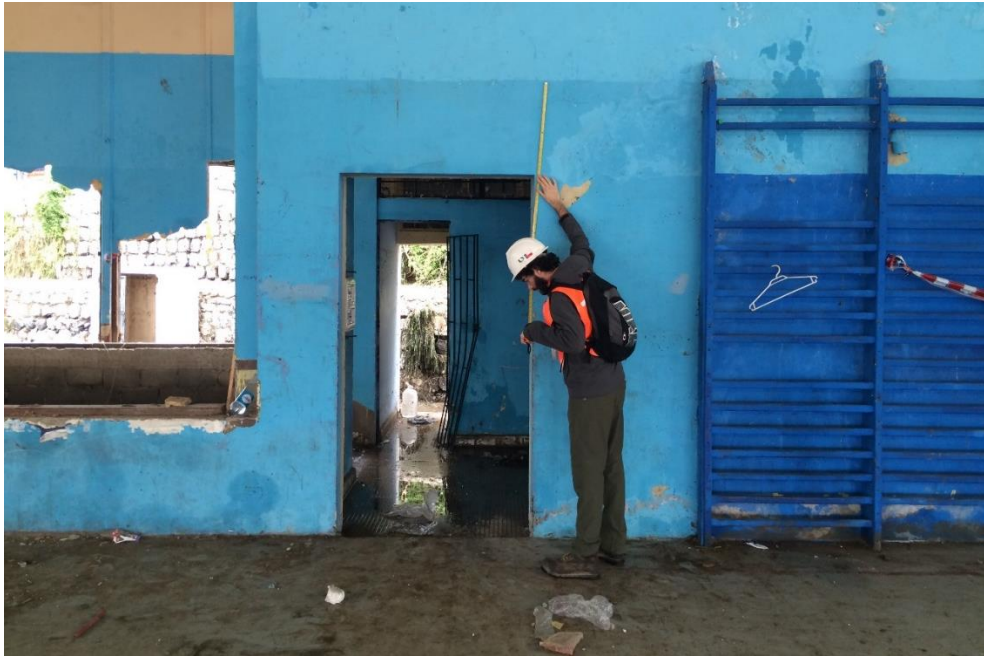
Figure 6.9. Flooding of *Liceo Diego Portales's* gymnasium located in Avenida Costanera, Coquimbo (29.953371S; 71.336161W). The structure is a steel frame building which sustained no structural damage from the earthquake; non-structural components such as division panels, peripheral fences and utilities were washed away by the waves

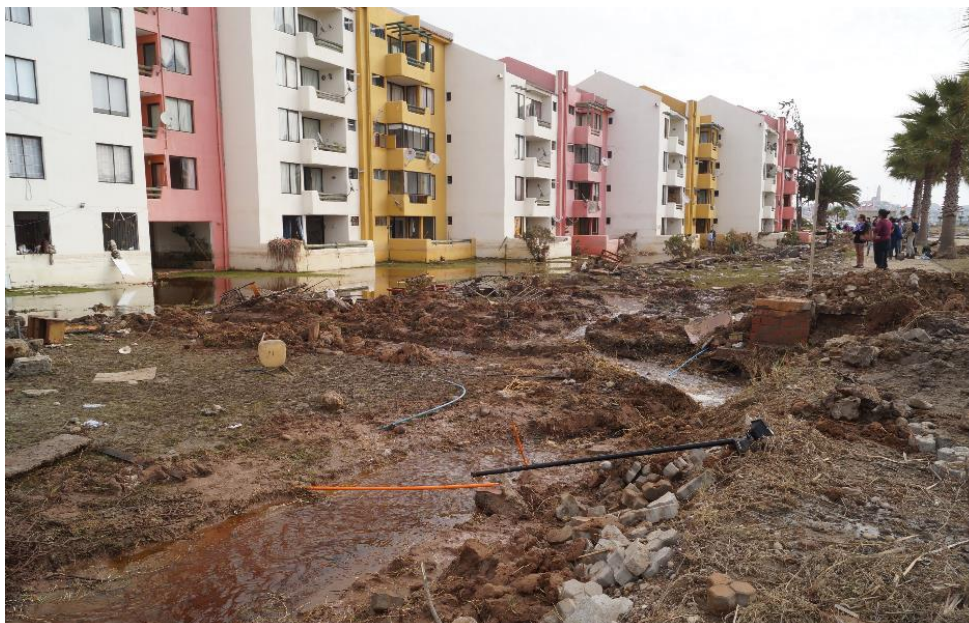
Figure 6.10. Flooded buildings at Avenida Costanera in the area of Coquimbo and tsunami debris.

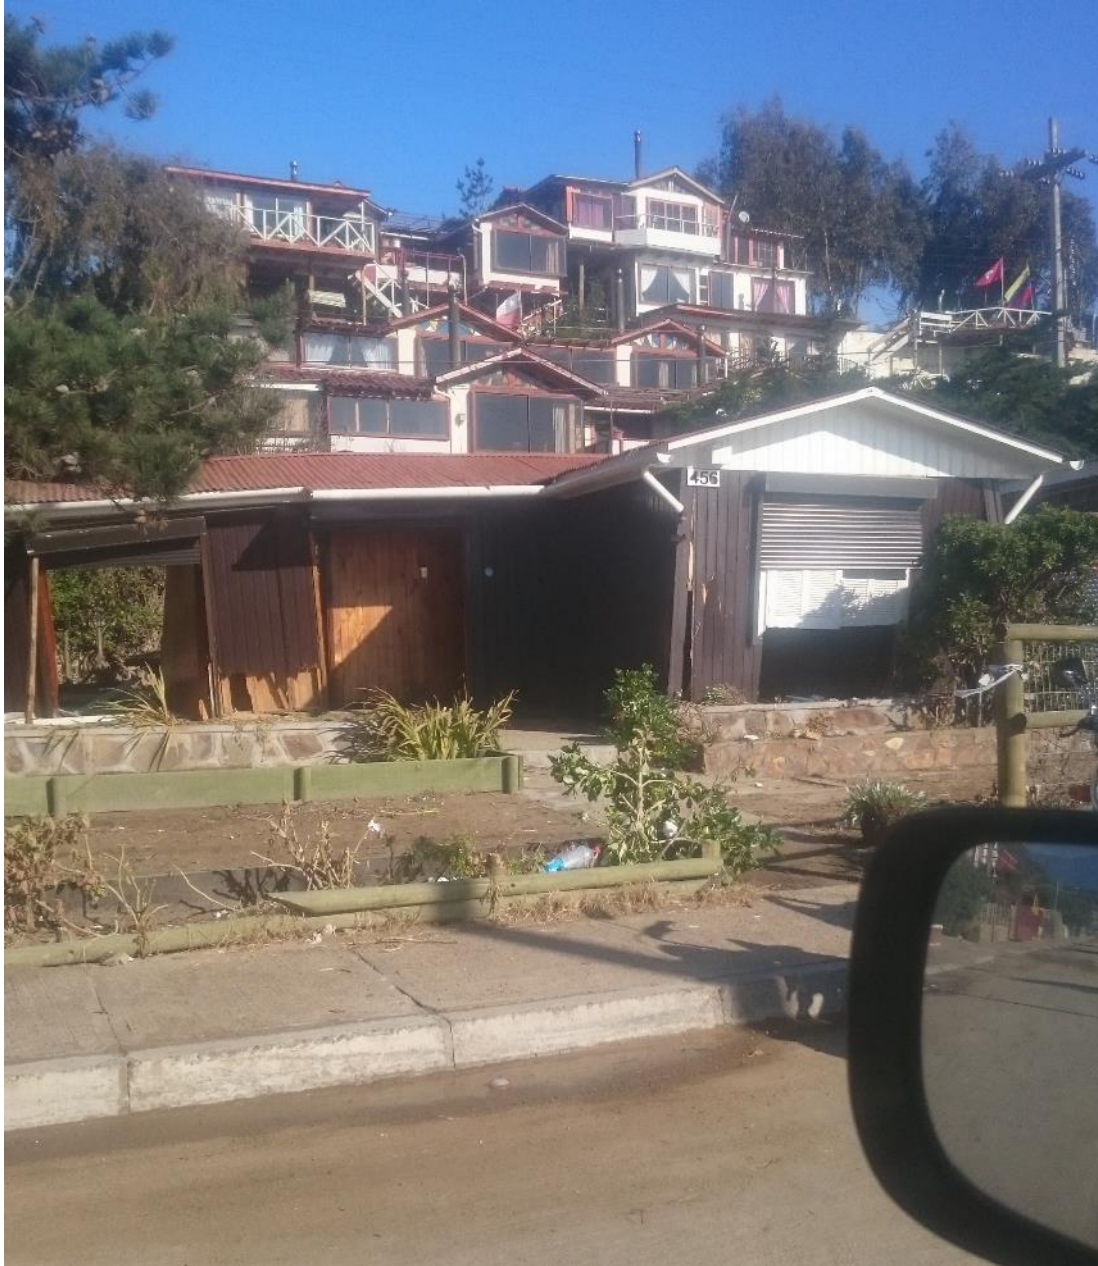
Figure 6.14. Field photograph looking east of a house at street level along the Costanera Av. in Los Vilos that was destroyed by the tsunami waves. Note that the house is tilted, and the backyard of the house is visible where the back wall was washed away. Many of the houses along this road were completely destroyed or greatly damaged by the waves. The beach here is just behind the photographer on the other side of the road (31.906212S; 71.500804W).
