Impacts on Geostuctures of the Michigan Dam Failures of May 19, 2020: Preliminary Observations

A preliminary report of the NSF-Sponsored Geotechnical Extreme Event Reconnaissance Association

Report GEER-067

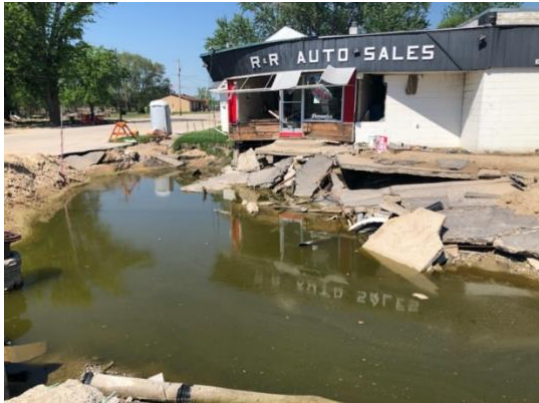
a. West Saginaw Road and West Center Street, Sanford (43.67334, -84.38350, NE)

- The impacts on structures were in some cases severe (Figures 3 and 4) due to scour and erosion. These included the complete loss of multiple properties in Sanford, and severe damage to bridges, approach embankments and utilities.

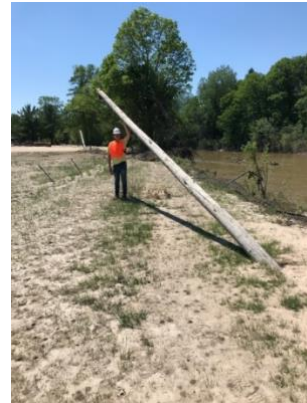
- Significant impacts on utilities were observed, particularly displacement of overhead power lines and telecommunications poles.
- No failures of retaining structures were observed other than at bridge abutments.

b. Telecom pole directly upstream of West Saginaw Road Bridge (43.67629, -84.38509)

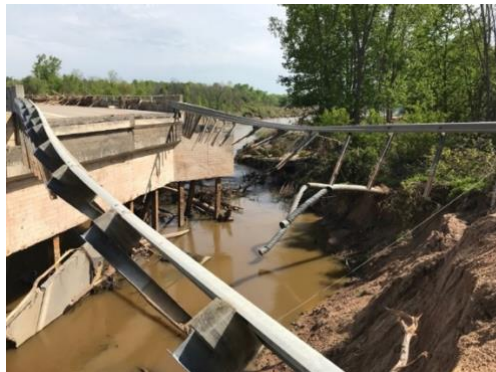
- For bridges, abutments were a common point of failure. There was some evidence that buried utilities through earthen structures had acted as initiation points for failures.

c. M-30 Road Bridge South Abutment, Edenville (43.80547, -84.38611)

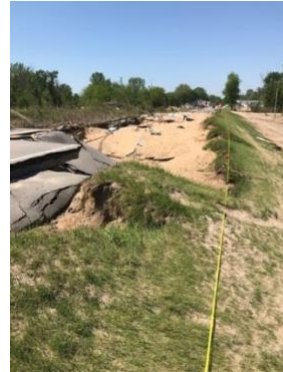
d. West Saginaw Road Bridge Approach Embankment, Sanford (43.67462, -84.38653)
