Geotechnical Extreme Events Reconnaissance

July 22, 2014

The 22 March 2014 Oso Landslide, Snohomish County, Washington

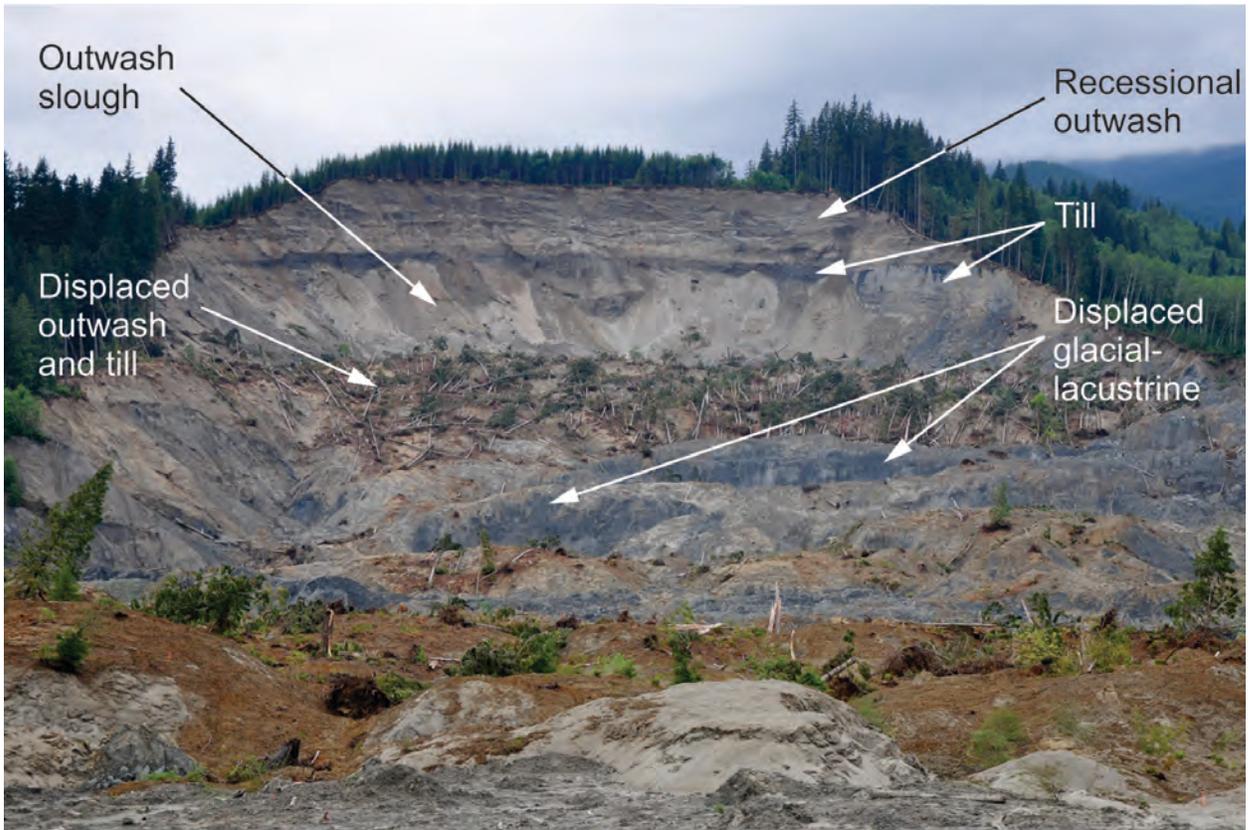
The stratigraphy of the landslide site is disrupted below the elevation of the “ancient headscarp” apparent on the 2003 hillshade image (Figure 2.2.2). But the undisturbed section now exposed in the 2014 landslide headscarp (Figure 2.2.3), together with exposures on the landslide lateral margins, indicates that the site geology consists of deposits that are typical of the sequence found throughout the Puget Lowland. [Note that “headscarp” in this report would be called “main scarp” by Cruden and Varnes (1996).]

Figure 2.2.3 View of Oso Landslide and geologic exposures in scarps.
Camera position: 48.27690°N, -121.83967°W; view direction: 327°.

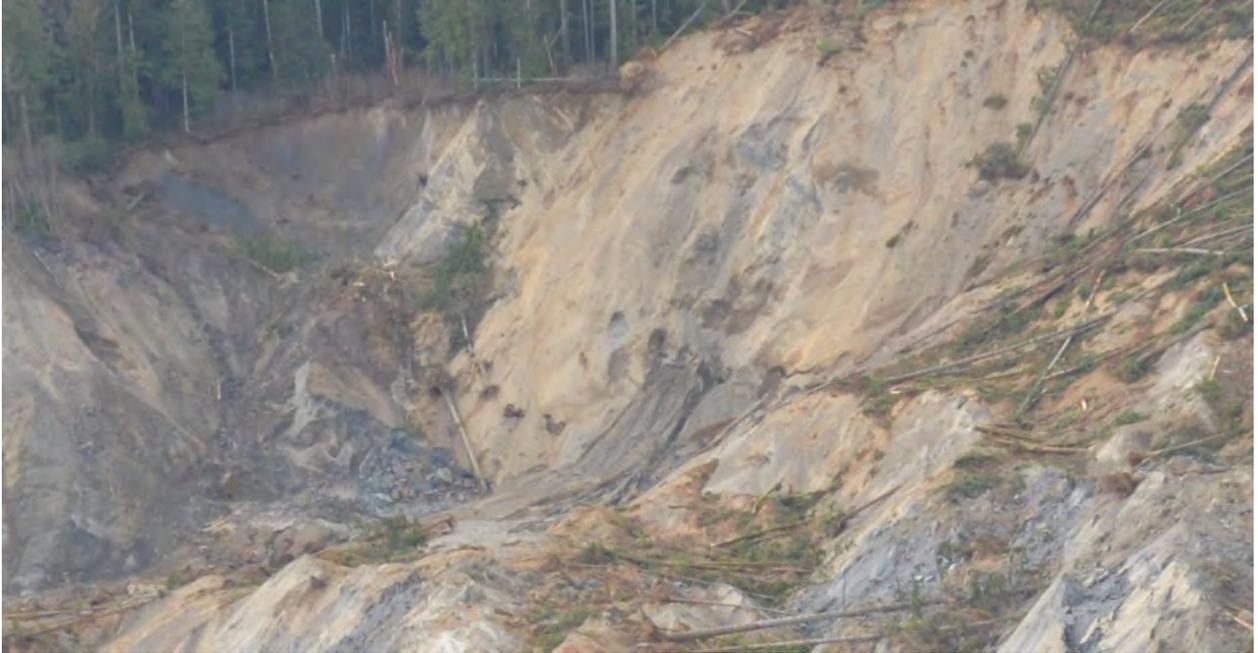
Figure 5.2.2. Seeps along western (right) margin of the landslide. Photo credit Eric Jensen, King County Sheriff Department, photo date 3/24/2014.

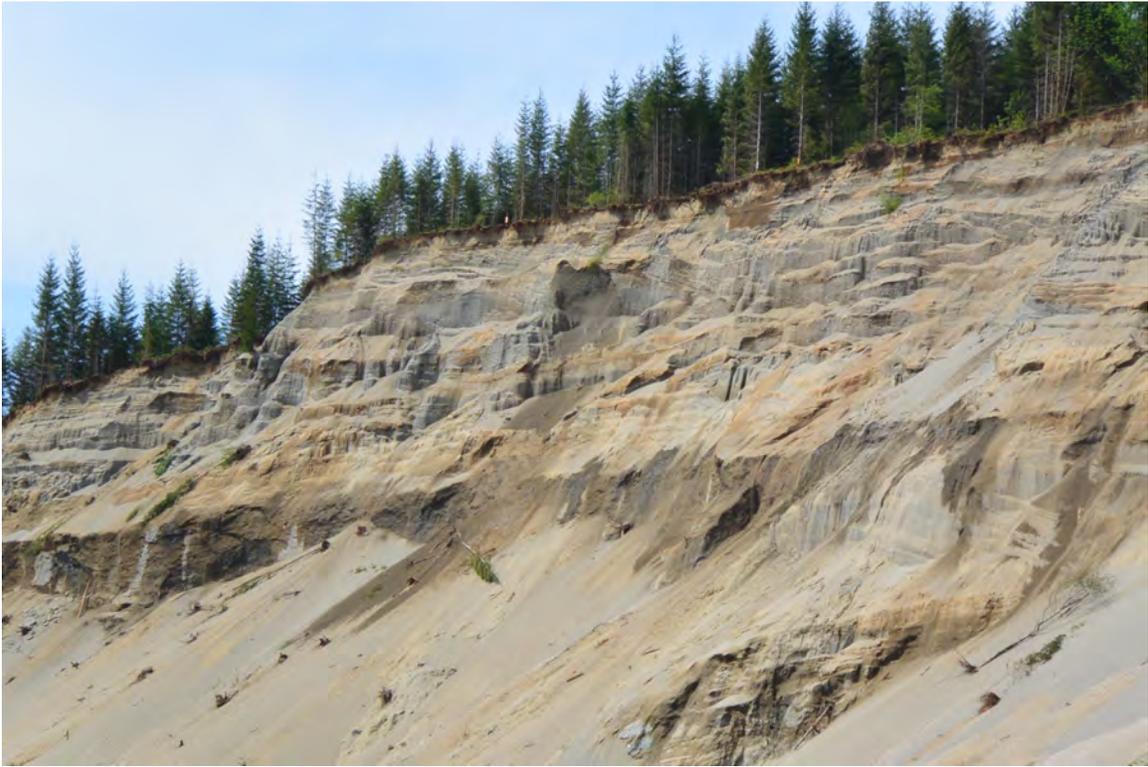
Figure 5.2.4 Photograph of Zone A1, recessional outwash and gray glacial till exposed in landslide headscarp.

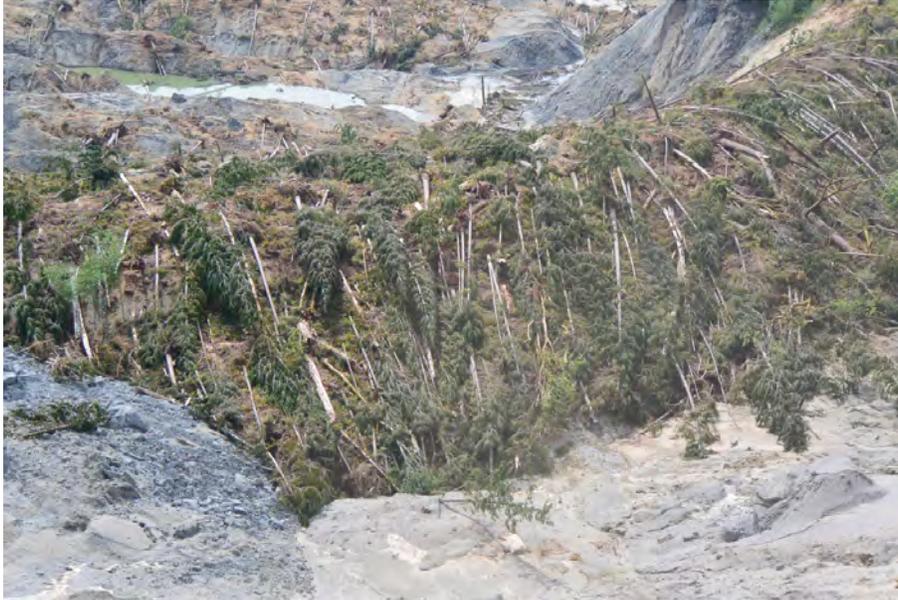
Figure 5.2.5a: Photograph of Zone A2 as seen from top of landslide headscarp; view to south. Note uniform back-rotation of trees and onlap of gray till fragments of Zone A4 from scarp-face failure at left.

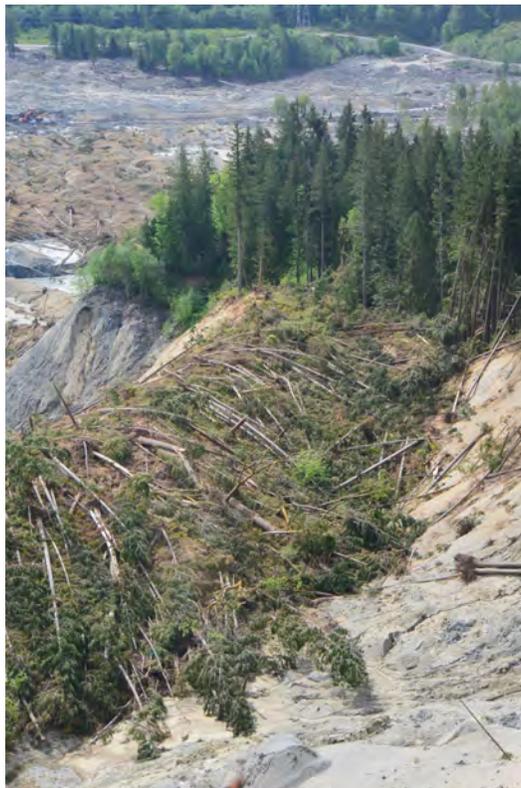
Figure 5.2.5b: Photograph of Zone A2 as seen from top of landslide headscarp; view to southwest. Note the topographic depression between Zone A2 (covered by downed trees) and Zone A1 (base of headscarp at right).

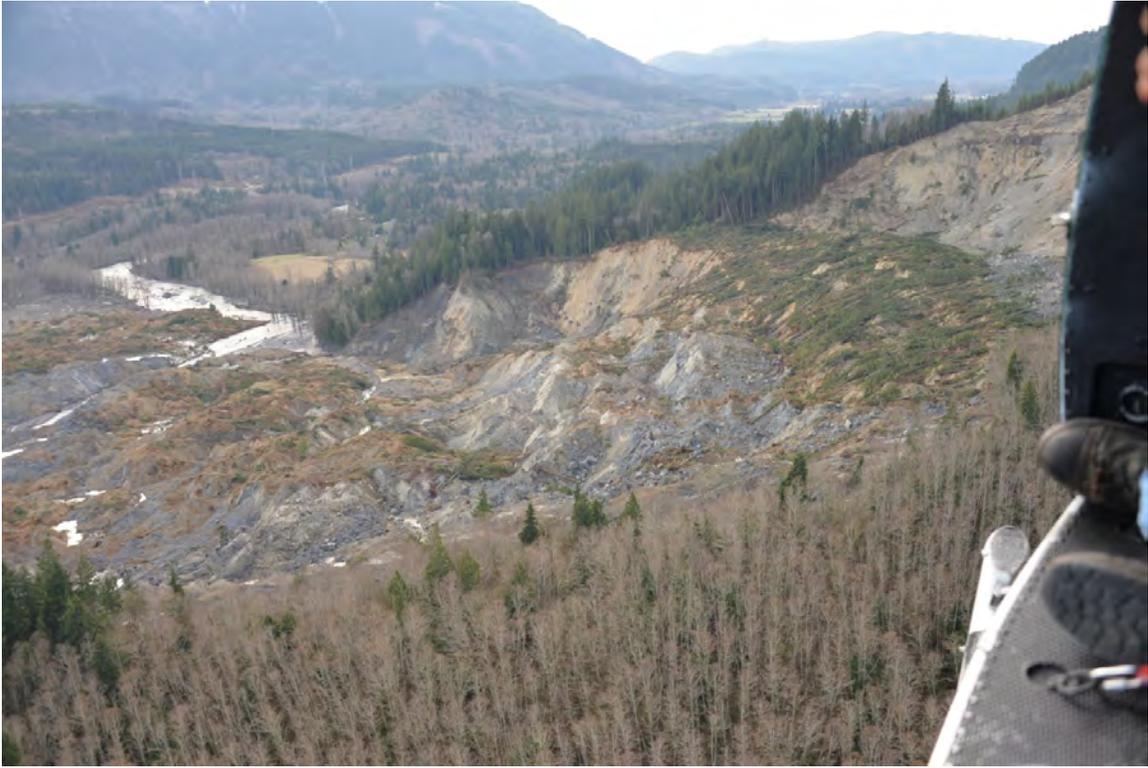
Figure 5.2.8 Rotational block field of Zone B seen from the air looking west. Photo credit Eric Jensen, King County Sheriff Department, photo date 3/24/2014.

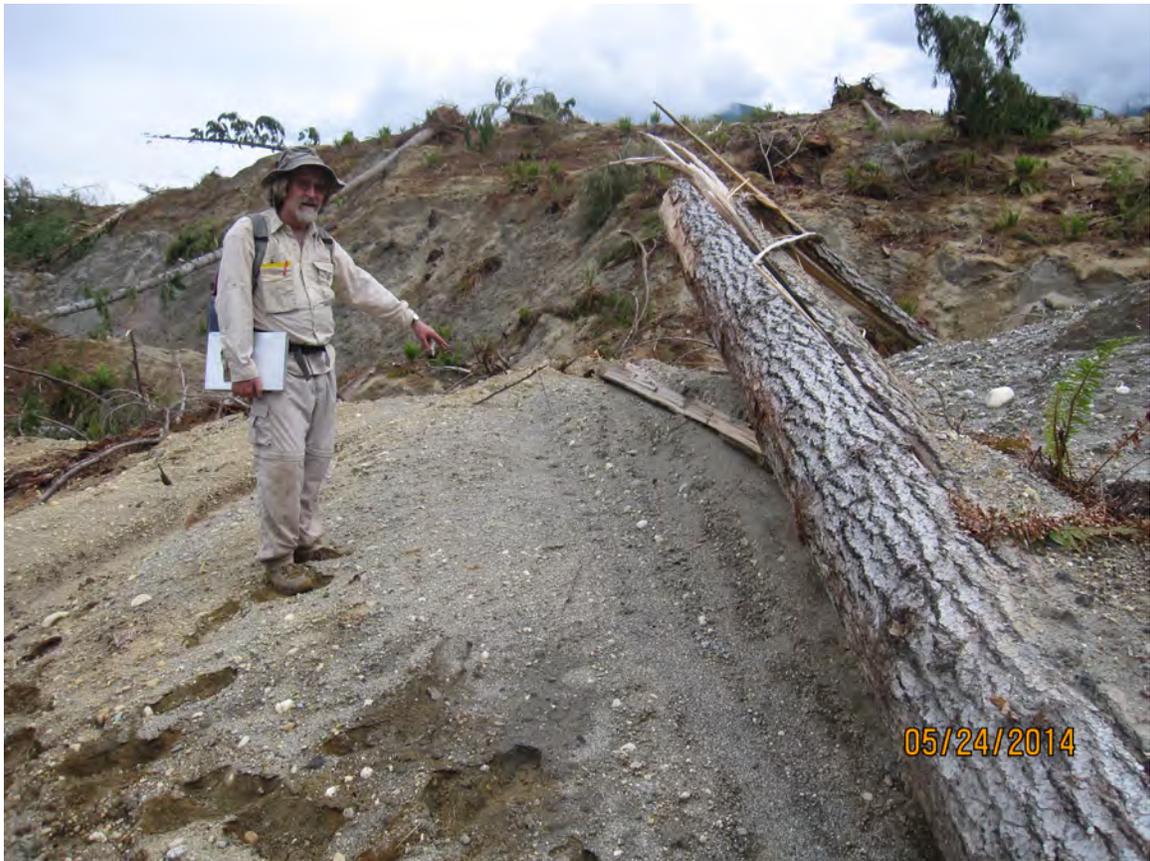
Figure 5.2.10c. pair of track-like impressions in the loose sand indicate that the log impacted violently and bounced before coming to rest. Photo taken by GEER on May 24, 2014. Camera position: 48.281458°N, 121.848316°W, view south.

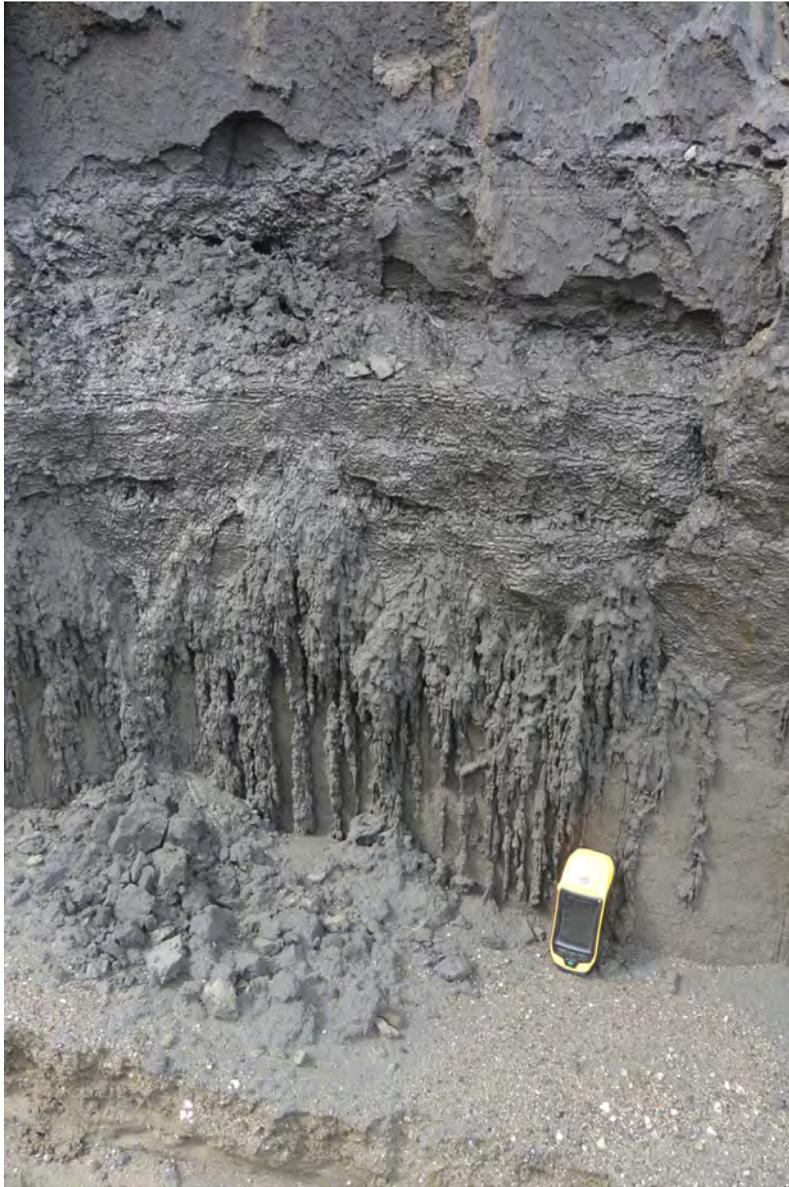
Figure 5.2.11: Lacustrine sediment exposed in western lateral margin in Zone B. Note flow structures running down from seeps in the outcrop face.

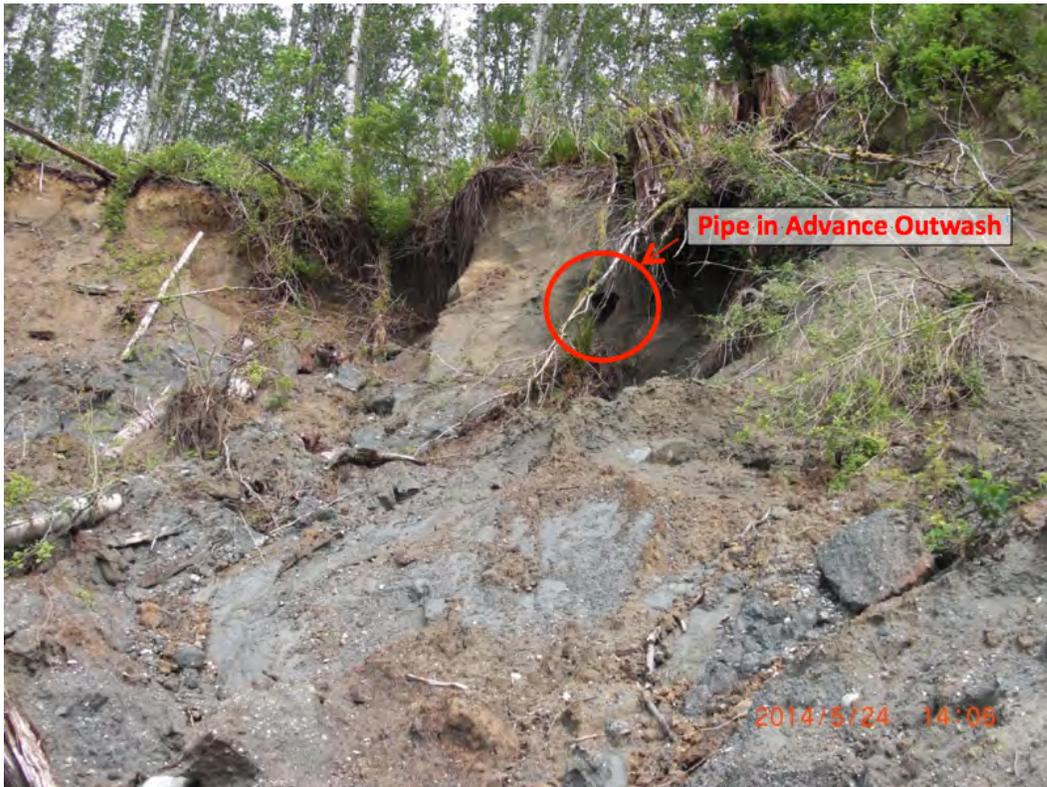
Figure 5.2.14 Seepage and piping near interface between Advance Outwash sand overlying Glacial Lacustrine clay. Location: N 48°17.124' W 121°50.827'; view looking east.

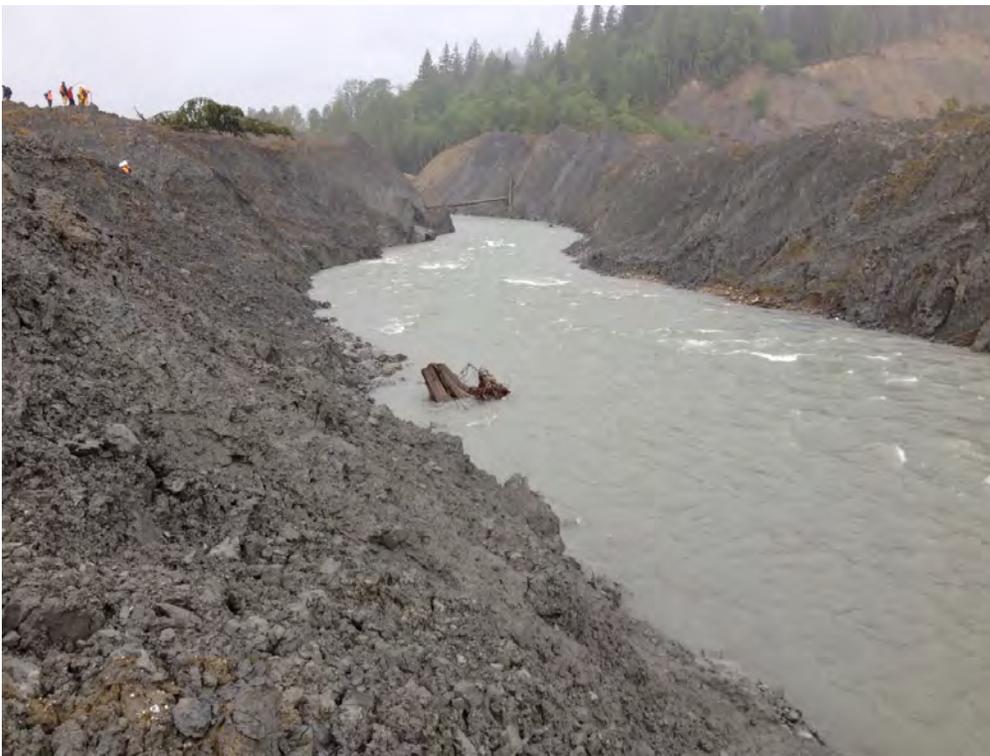
Figure 5.2.17. View west at loose and sloughing channel slopes in glacial lacustrine deposits within the landslide in Zone D. Camera position: 48.28026, -121.84339.

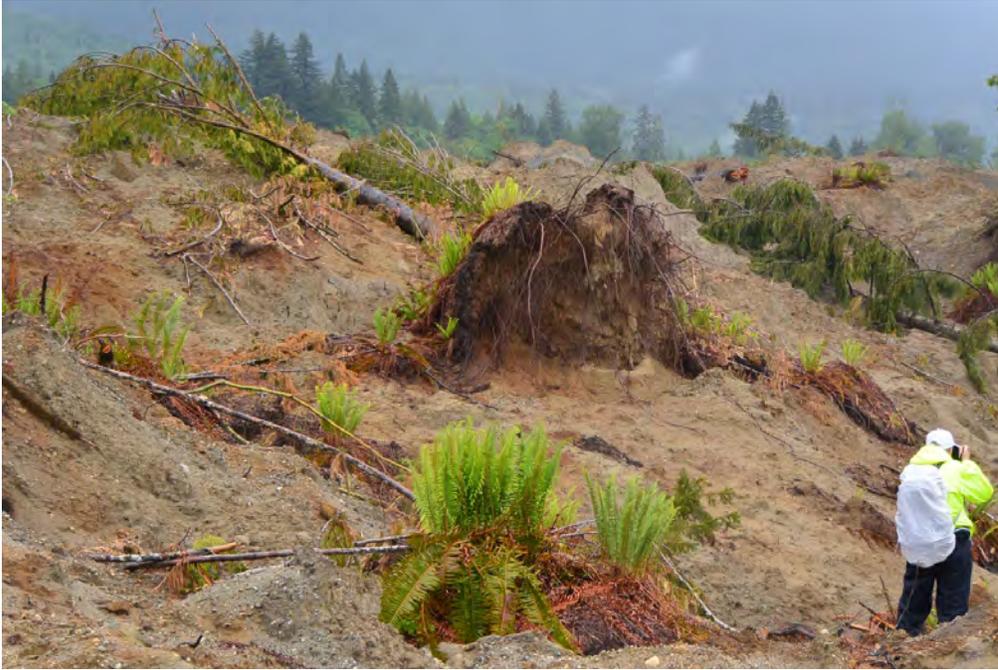
Figure 5.2.18 Preserved areas of intact forest floor in Zone E.

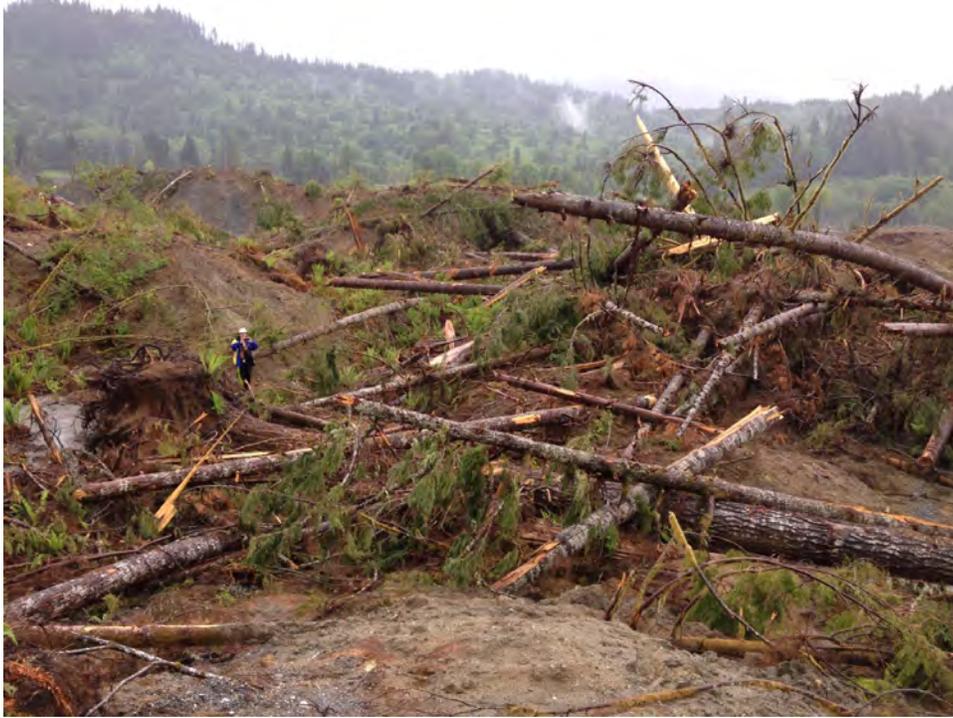
Figure 5.2.20 Tumbled and broken trees in the impact zone between Stage 1 and Stage 2. Camera position: 48.27897, -121.84609.

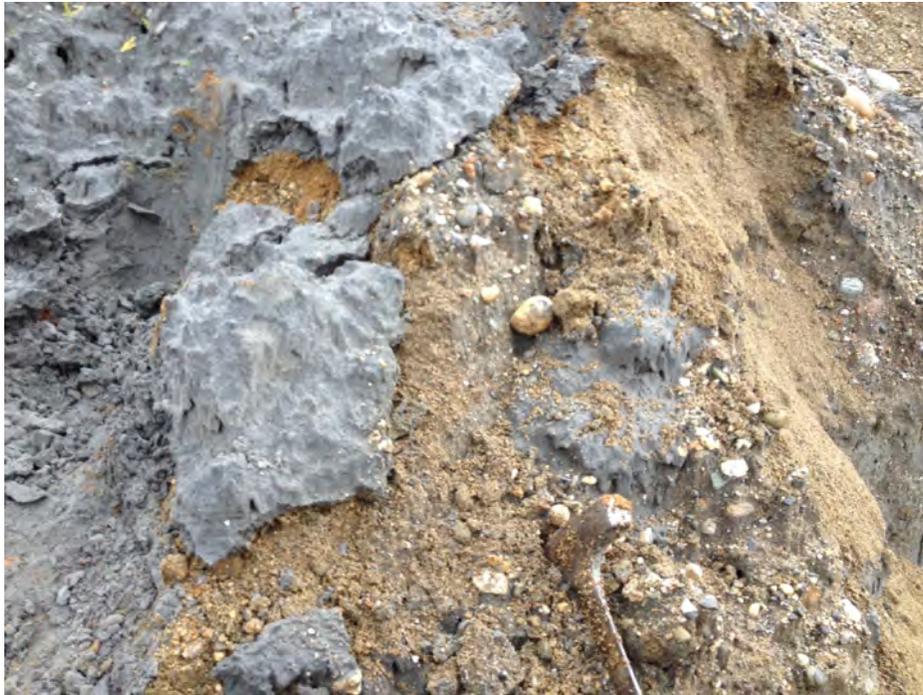
Figure 5.2.21 Typical gray veneer that appears to be a splash deposit. Head of rock hammer in bottom center for scale. Camera position: 48.27903, -121.84611.

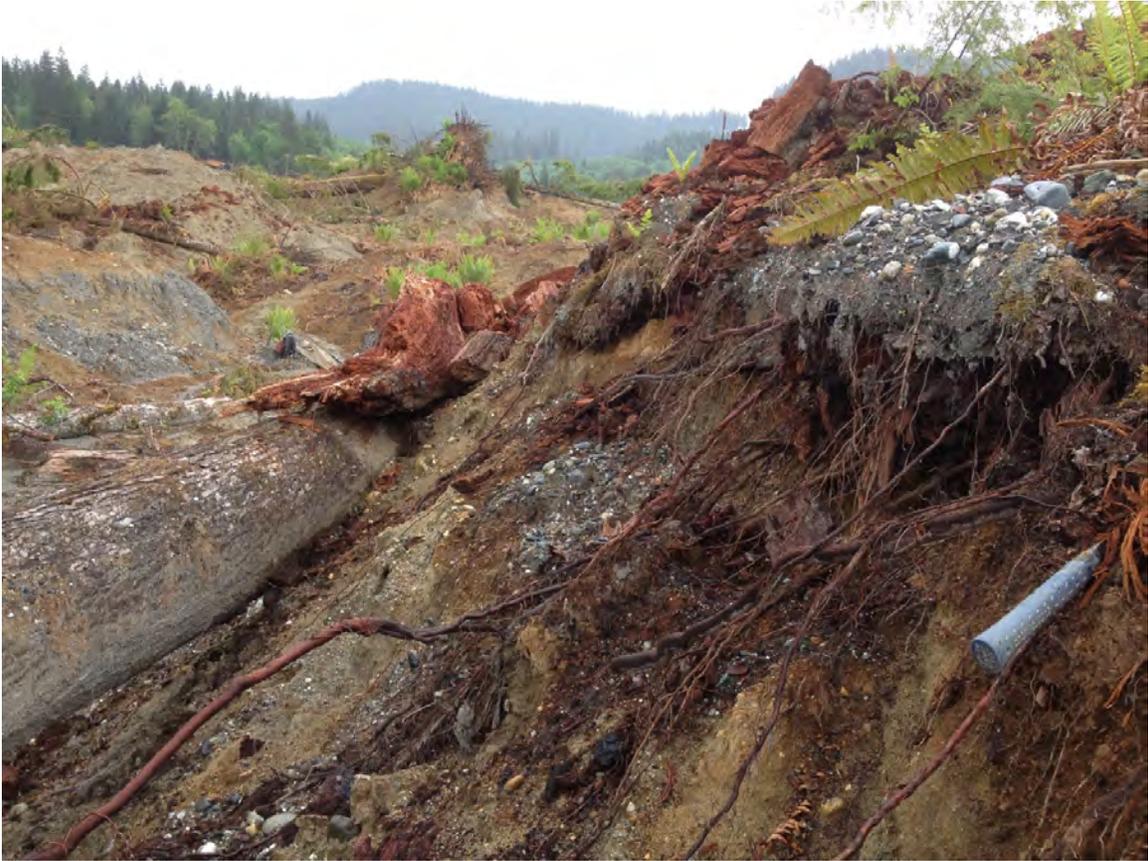
Figure 5.2.22 Gravelly and sandy silt veneer. Visible here on a remnant of the forest floor in the foreground, on a fallen tree towards the left of the photo, and coating the sandy bank of the basin in the background. This veneer-ringed basin appears to open only to the south, indicating flow to the north and thus a splash-back or flow reversal in the debris flow runout zone (i.e., from Zone F). Camera position: 48.27735, -121.84674, view south.

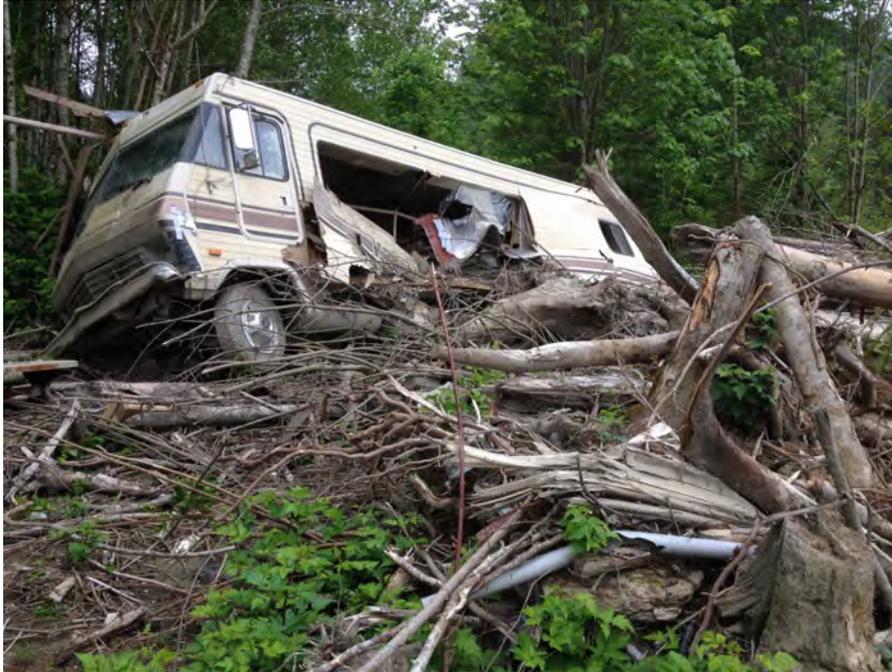
Figure 5.2.28 Recreational vehicle (RV) at the distal edge of the flow. Image shows damage to its side by a root-wad that is still present beside the vehicle. There is little evidence of earth debris: the RV was pushed and damaged by woody debris, as if carried by a flood. Camera position: 48.27528, -121.84160.

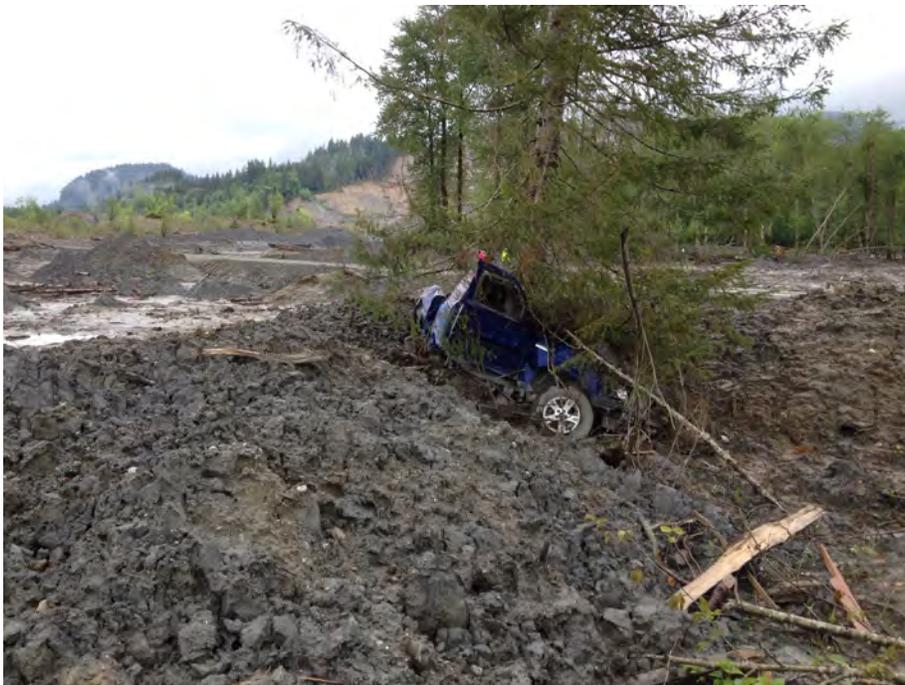
Figure 5.2.29 Vehicle wrapped around tree as if pushed from the southwest. The landslide source area is to the northwest and is visible in the background. Camera position: 48.27871, -121.83420.

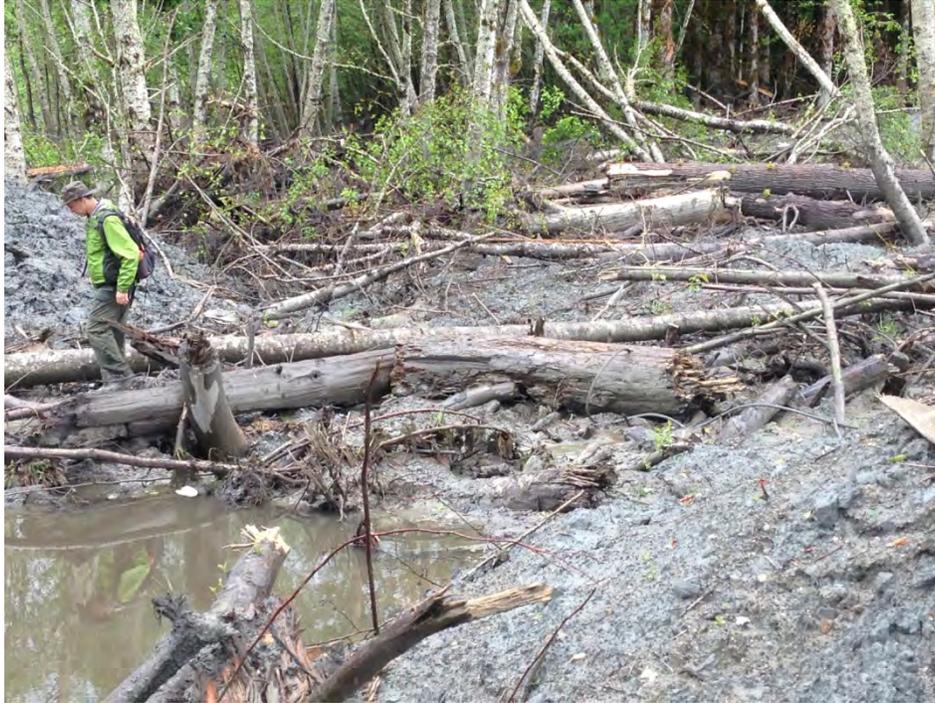
Figure 5.2.30 Log that formed part of the log revetment constructed after the 2006 landslide and found in distal portion of Zone F (note steel cables). Photo taken on May 23, 2014; Camera position: 48.27912°N, 121.83592°W, view toward the northeast.

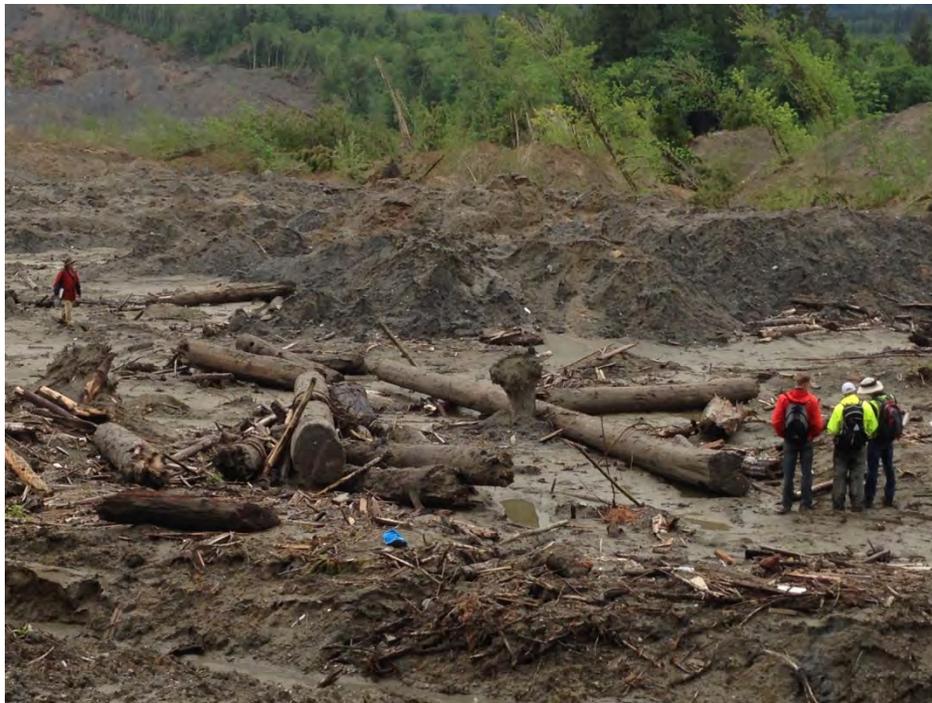
Figure 5.2.31 Revetment logs with metal identification tags and drilled holes with steel cables being examined by GEER team members on May 23, 2014. Camera location: 48.27737°N, 121.83876°W, view toward the north from SR530.

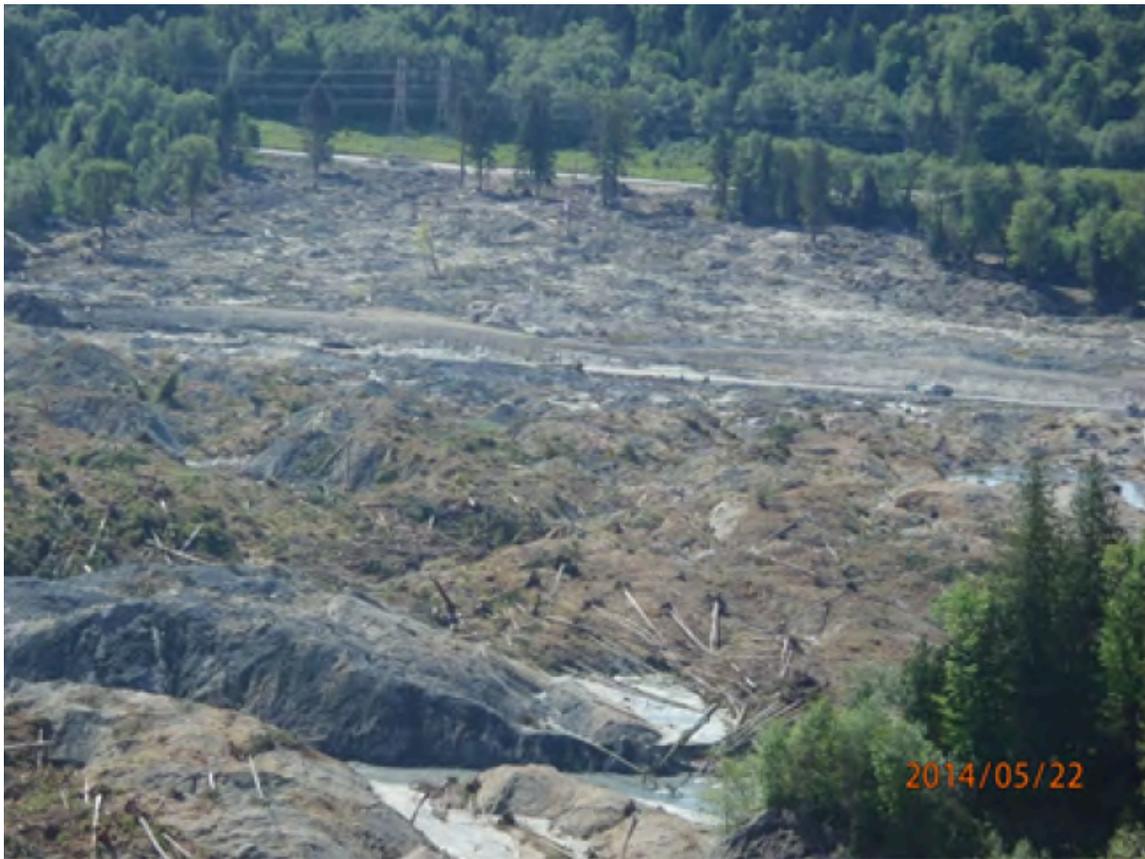
Figure 6.2.1 View of the distal zones of the deposit from the headscarp showing excavation of Highway SR 530 in the approximate center of the photograph. The highway is an approximate boundary between the distal zone where very little of the original ground surface is preserved and trailing part of Stage 1 where remnants of the forest floor have been rafted into position. View from the headscarp.
