Geotechnical Reconnaissance of the January 7, 2020 M6.4 Southwest Puerto Rico Earthquake and Associated Seismic Sequence

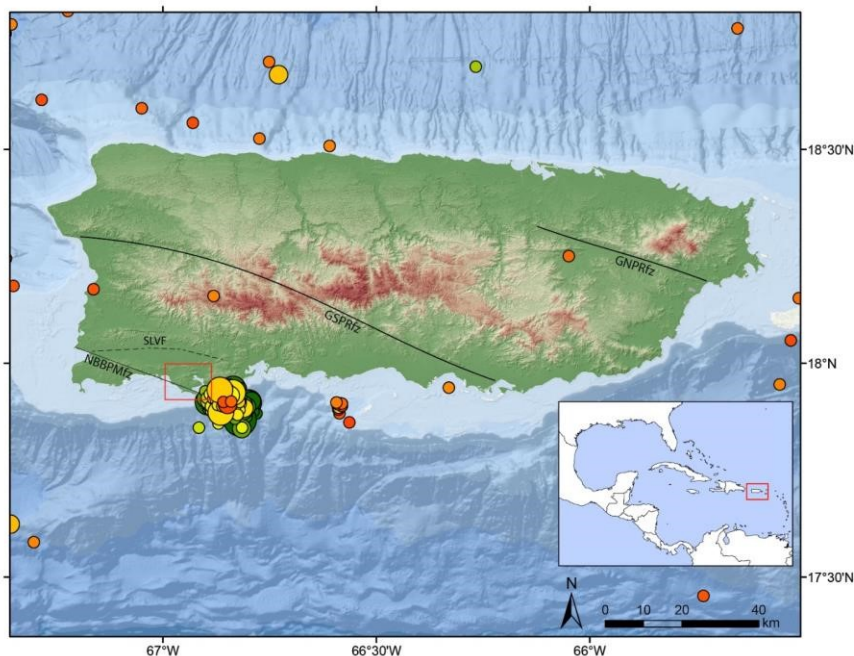
Figure 1: Shaded relief map of the island of PR. The location of the events in the seismic sequence are shown. Size corresponds to magnitude. Red events are 28December-2019 or earlier and colors fade to yellow and green into January-2020. Modified from López et al. (2020a). GNPRfz= Great Northern Puerto Rico fault zone. GSPRfz=Great Southern Puerto Rico fault zone. SLVF=South Lajas Valley fault. NVVPMfz=North Boquerón

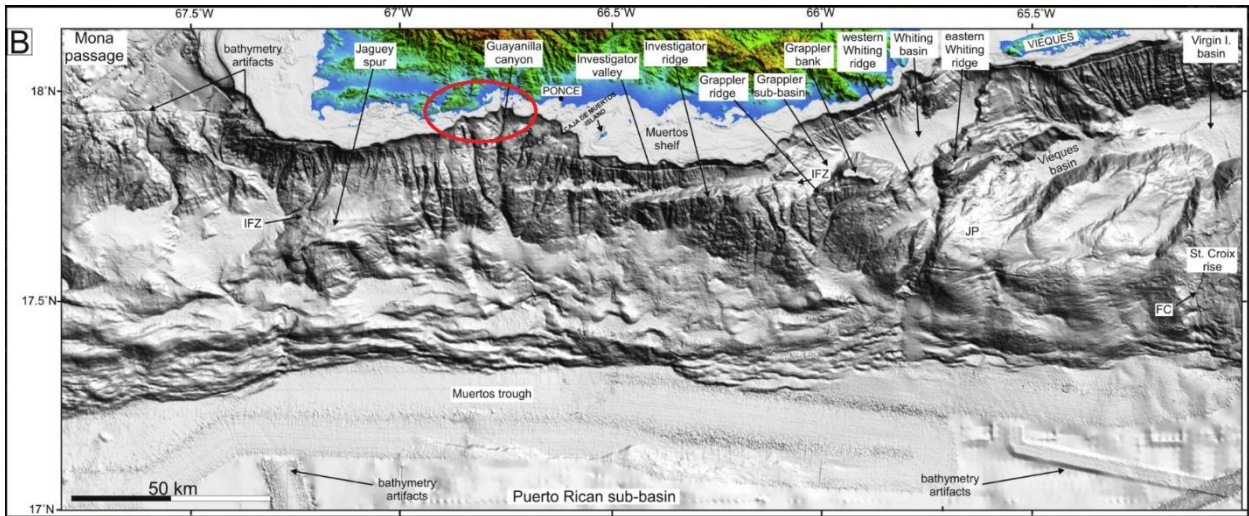
Figure 3: Bathymetry of the sea floor to the south of Puerto Rico. Modified from Granja Bruña et al., 2015. Red circle represents the epicentral area for the 2020 earthquake swarm.

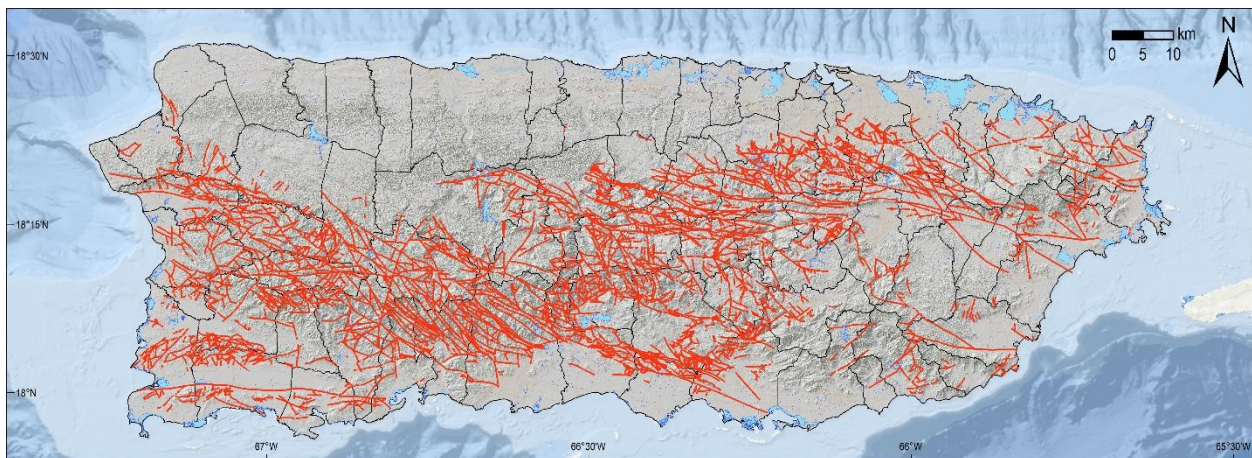
Figure 4: Mapped faults in Puerto Rico. Data from USGS.

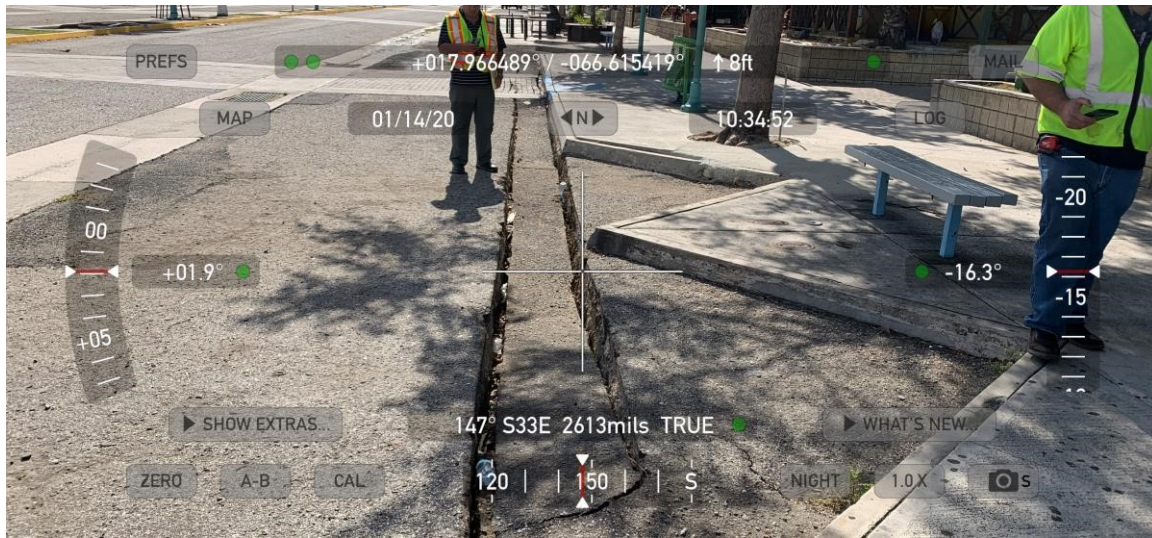
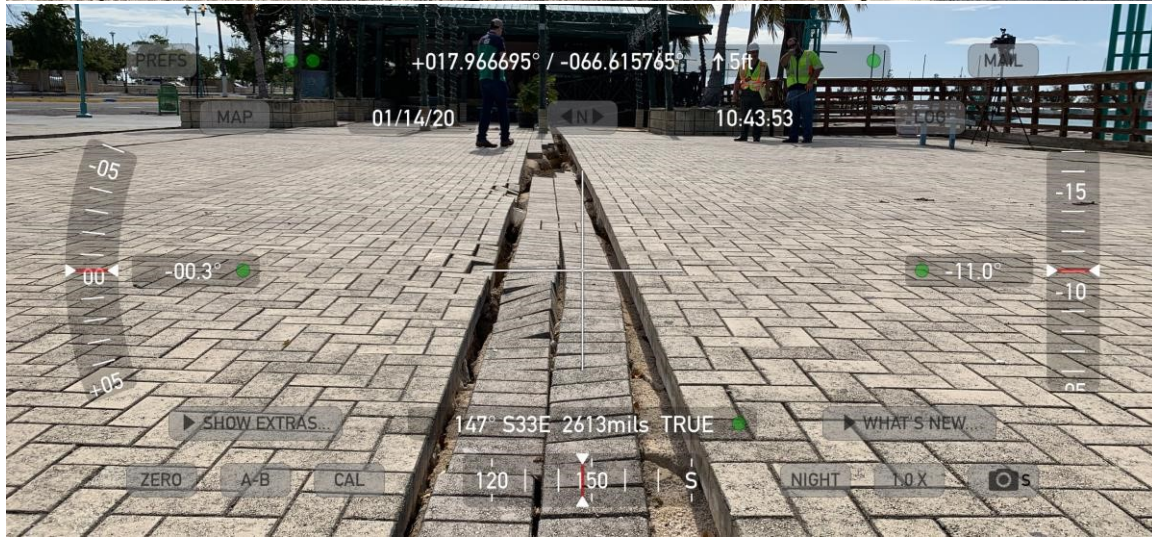
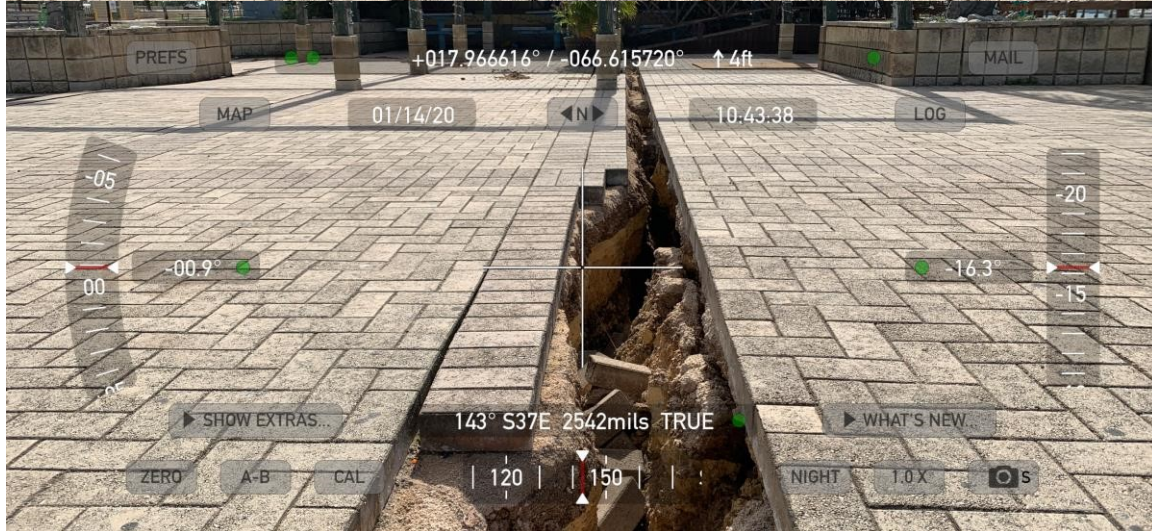
Figure 14. Sequence of the observed ground cracks due to potential lateral spreading at *Paseo Tablado - La Guancha*. Ground cracks follow the path of a petroleum pipeline.

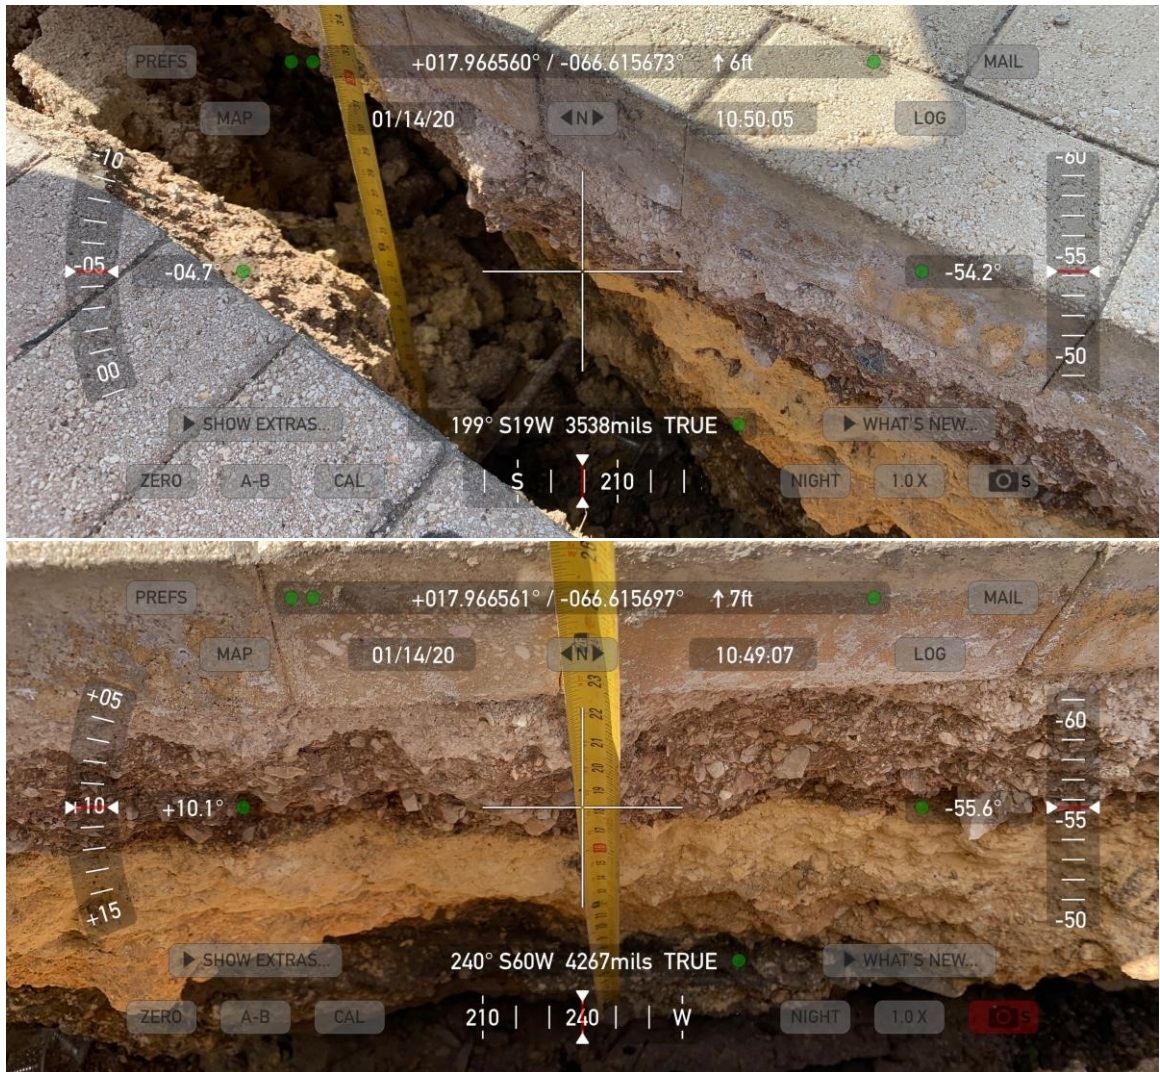
Figure 15. Typical soil profile at the site.

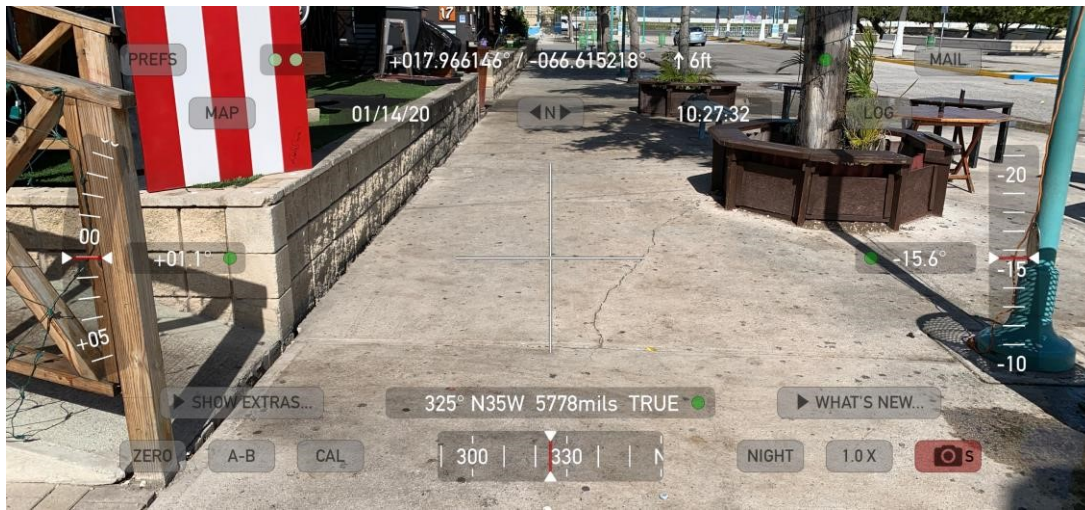
Figure 16. Ground cracks and separation of the boardwalk structure and sidewalk slab.

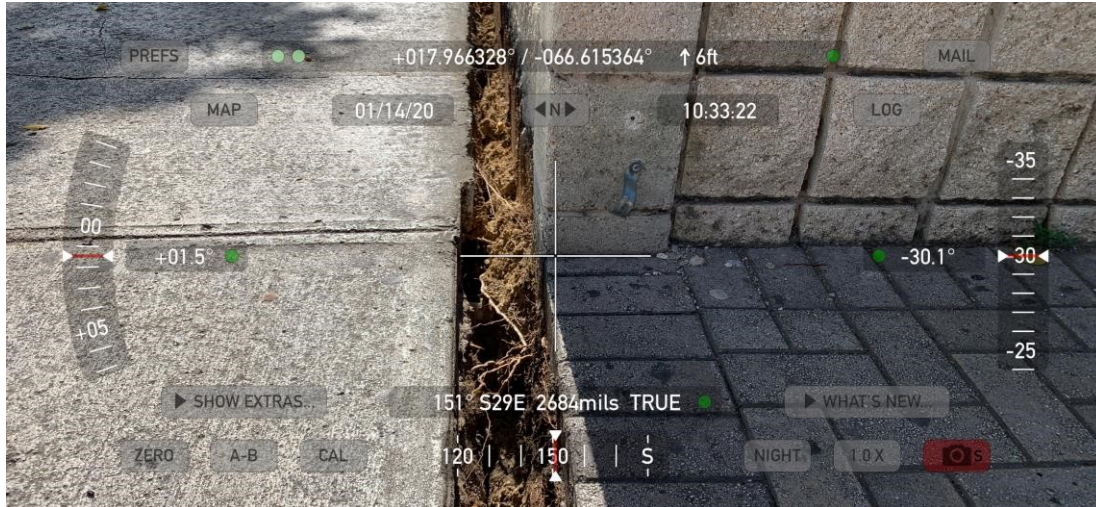
Figure 17. Separation of the sidewalk slab and the boardwalk structure.

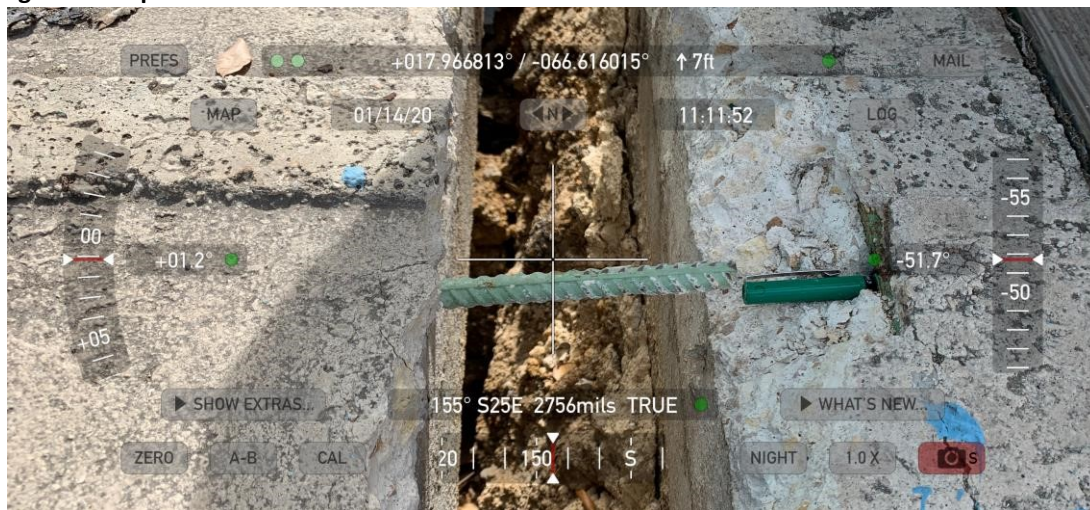
Figure 18. Exposed rebar at the joint of the concrete-wood structure.

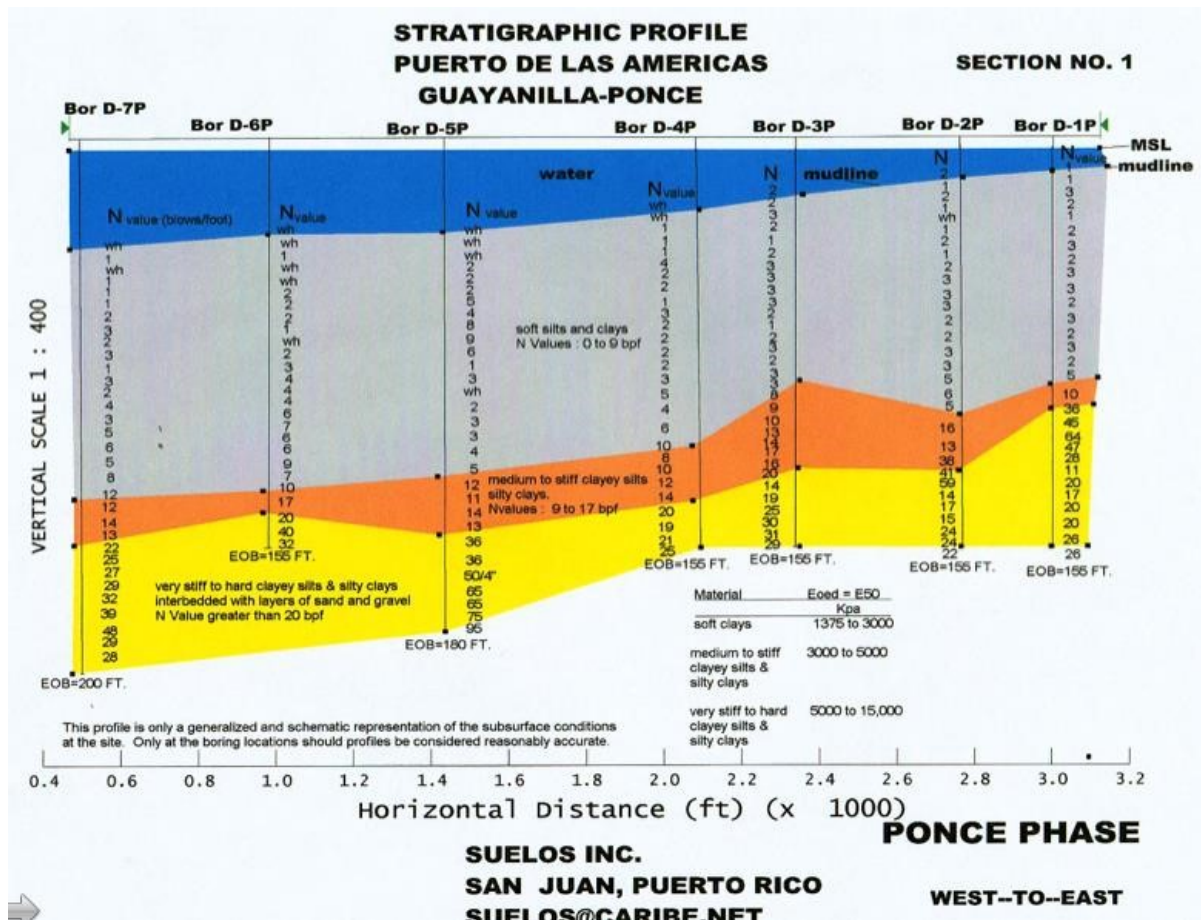
Figure 19. Typical soil profile at the Las Americas Port. Courtesy of Suelos Inc.

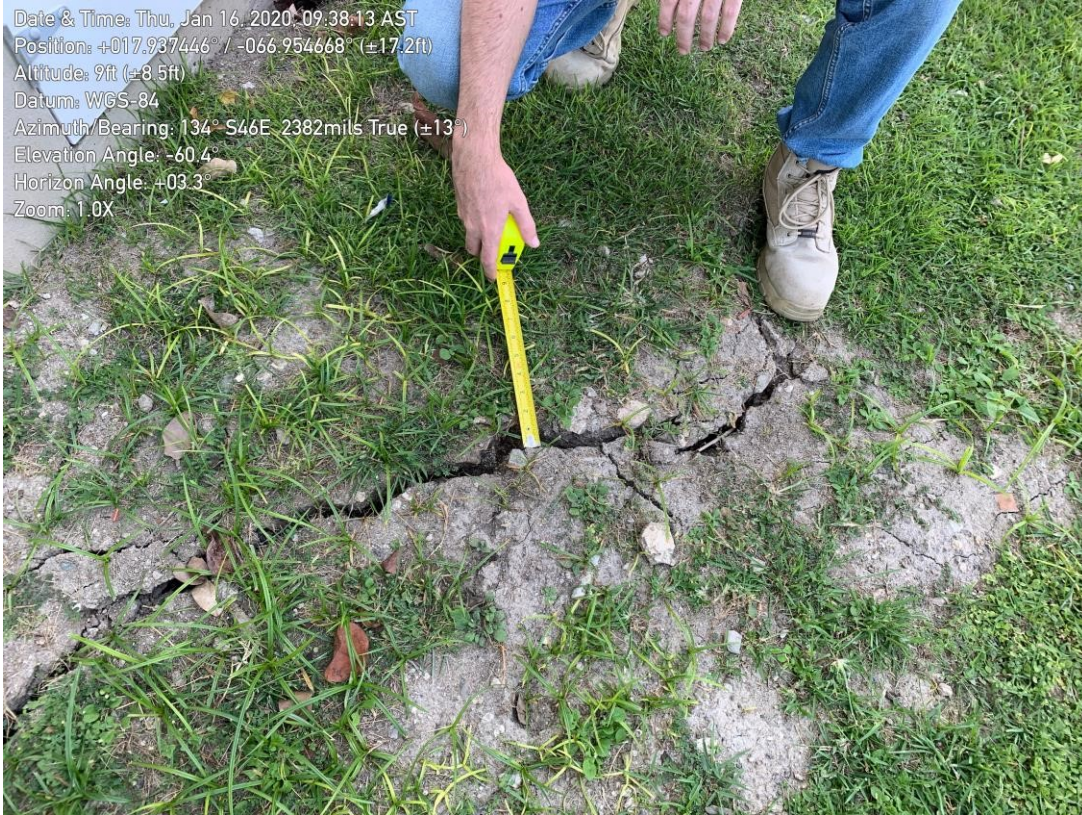
Figure 20. Cracks due to ground settlement at the site. Cracks like this were observed all around the perimeter of the structure.

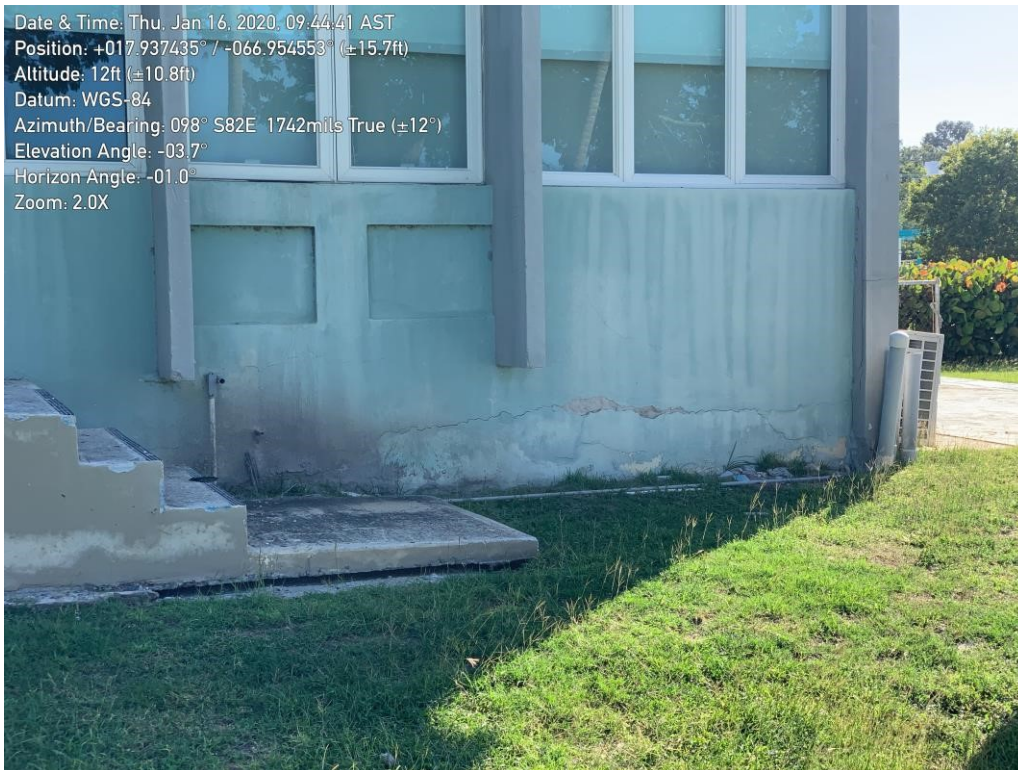
Figure 21. Separation between ground surface and staircase in the back of the building due to ground settlement

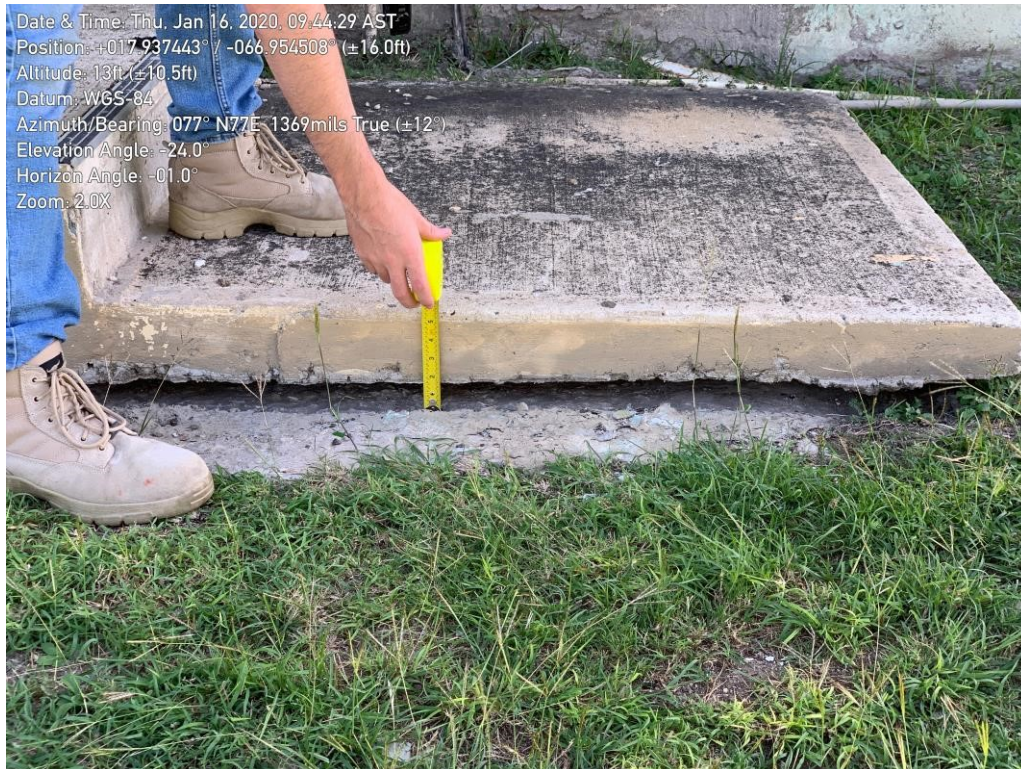
Figure 22. Detail of the separation shown in the previous figure. A gap of approximately 2 inches can be observed.

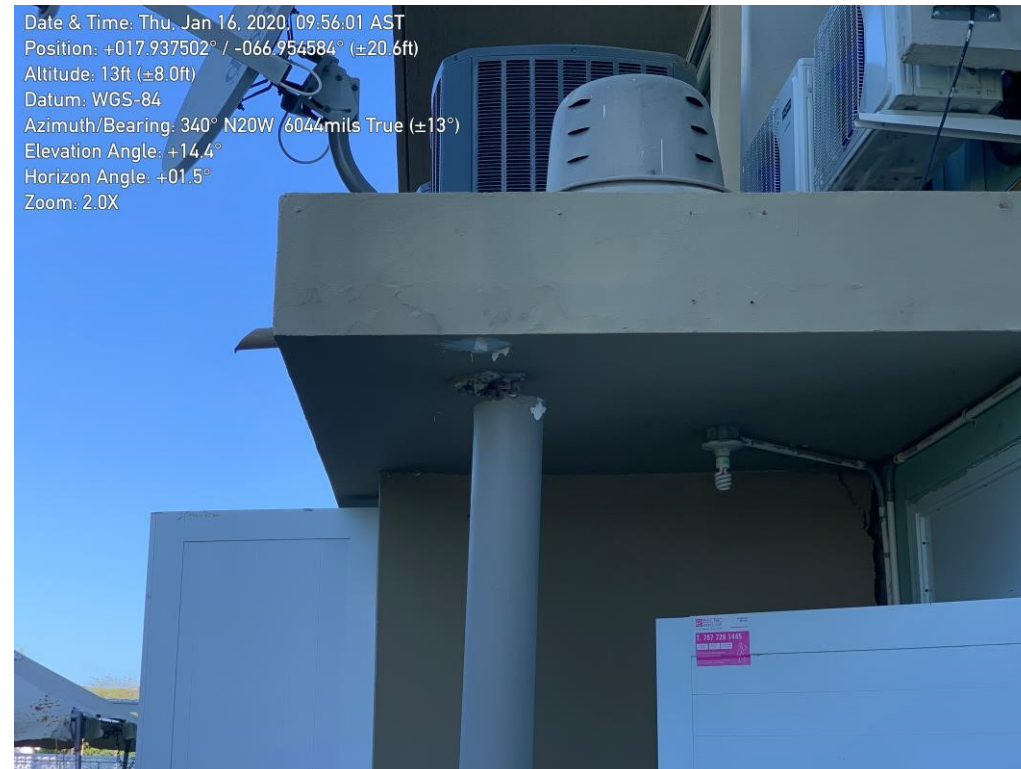
Figure 23. Displacement between a column and the main structure.

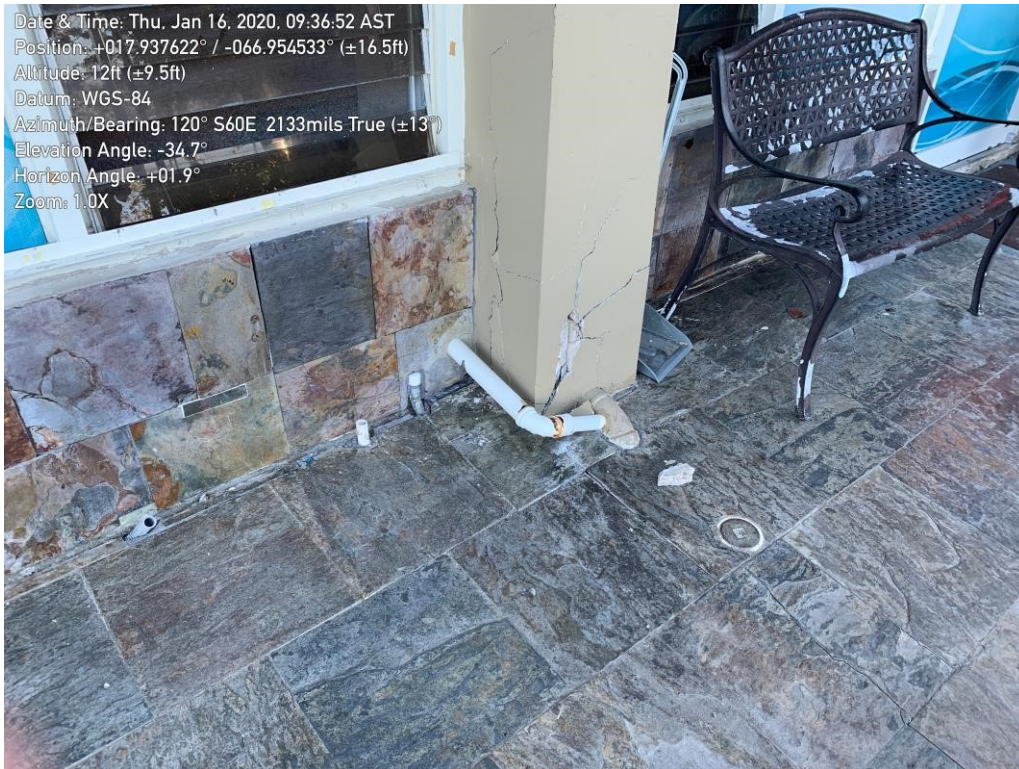
Figure 26. Cracks in column and broken PVC pipe due to ground settlement.

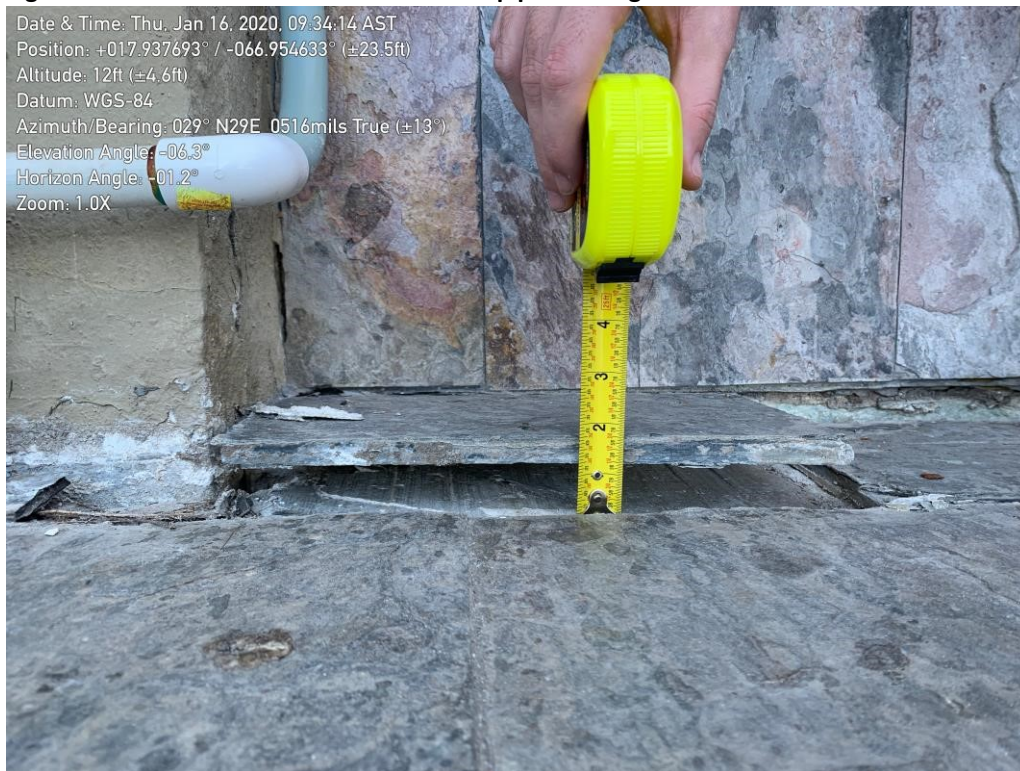
Figure 27. Hanging tile due to ground settlement. Gap in between the floor slab and the wall of approximately 1.5 inches.

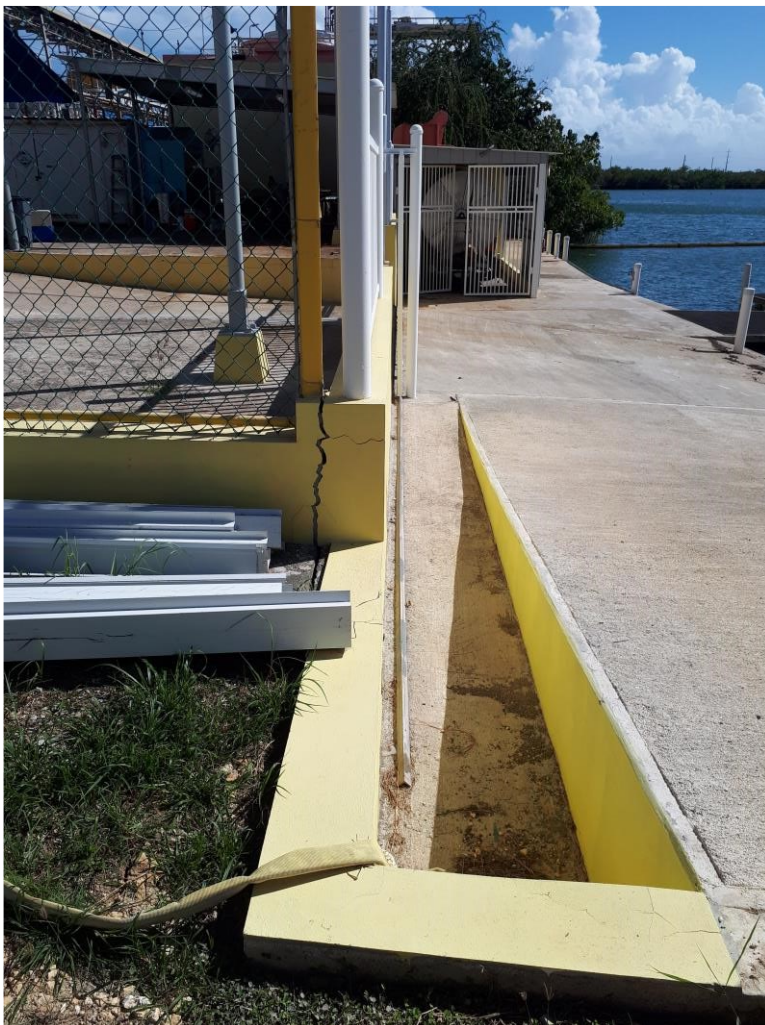
Figure 28. View looking south towards the Costa Sur facility boat dock. Vertical fracture in wall is an expression of seaward lateral spreading (18.002N, 66.754W).

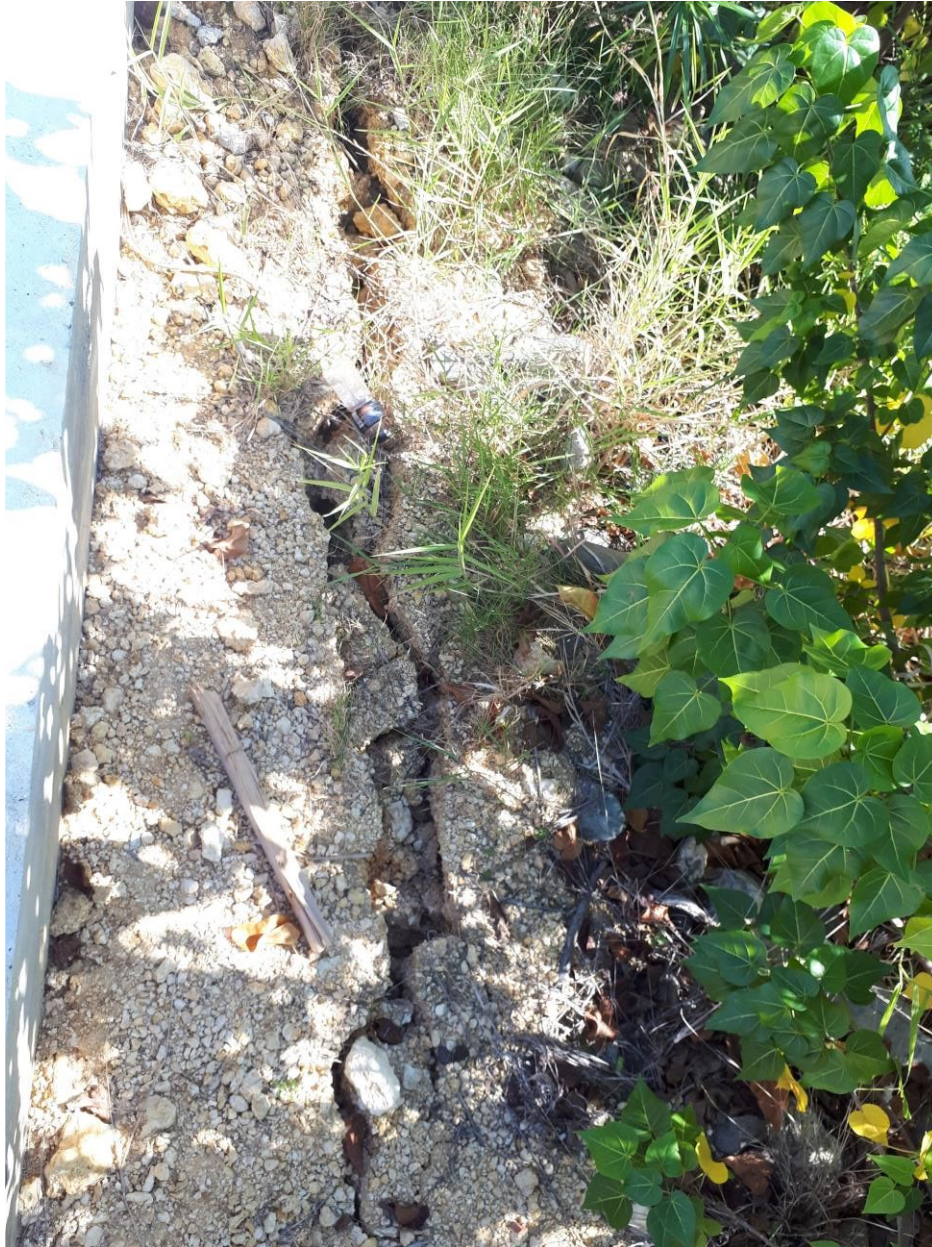
Figure 29. Looking down and generally to the south. The sea is immediately to the right. Unconsolidated soil (desiccated crust) material shows lateral spreading (18.002N, 66.754W).

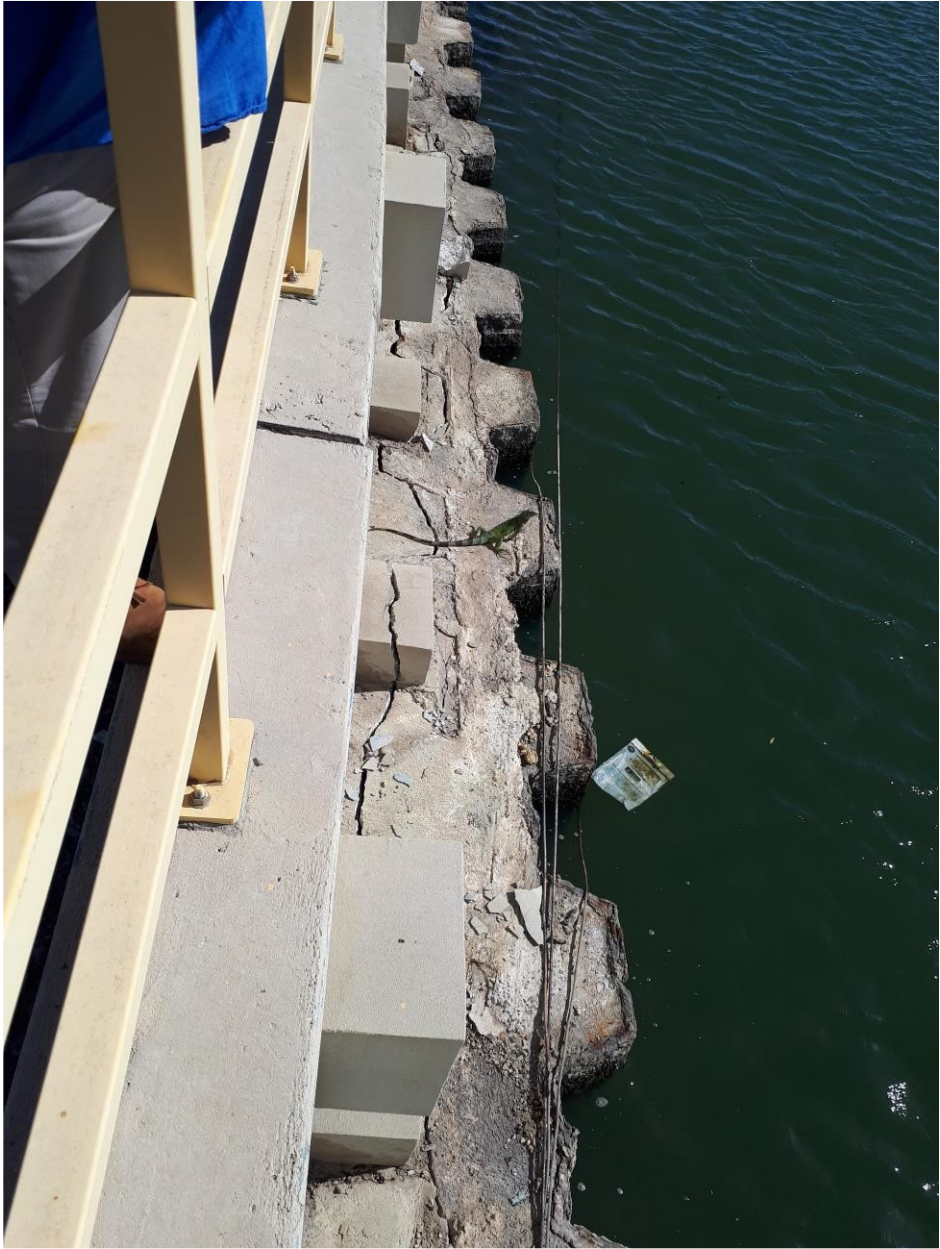
Figure 30: Looking south. The wall of the Costa Sur facility's cooling water outflow channel suffered fractures parallel to the water line. Adolescent iguana for scale (18.002N, 66.754W).

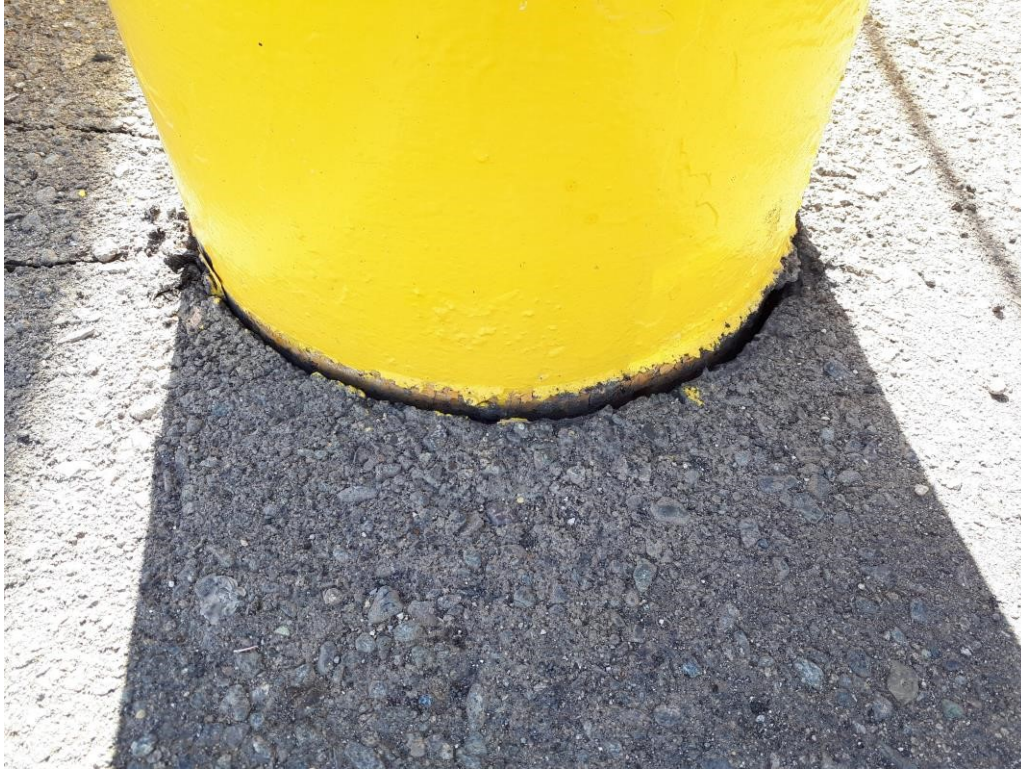
Figure 31. Looking southwest. One of the columns near the waterline. Pavement has detached and settled, as visible along paint line. At the Costa Sur facility (18.002N, 66.754W).

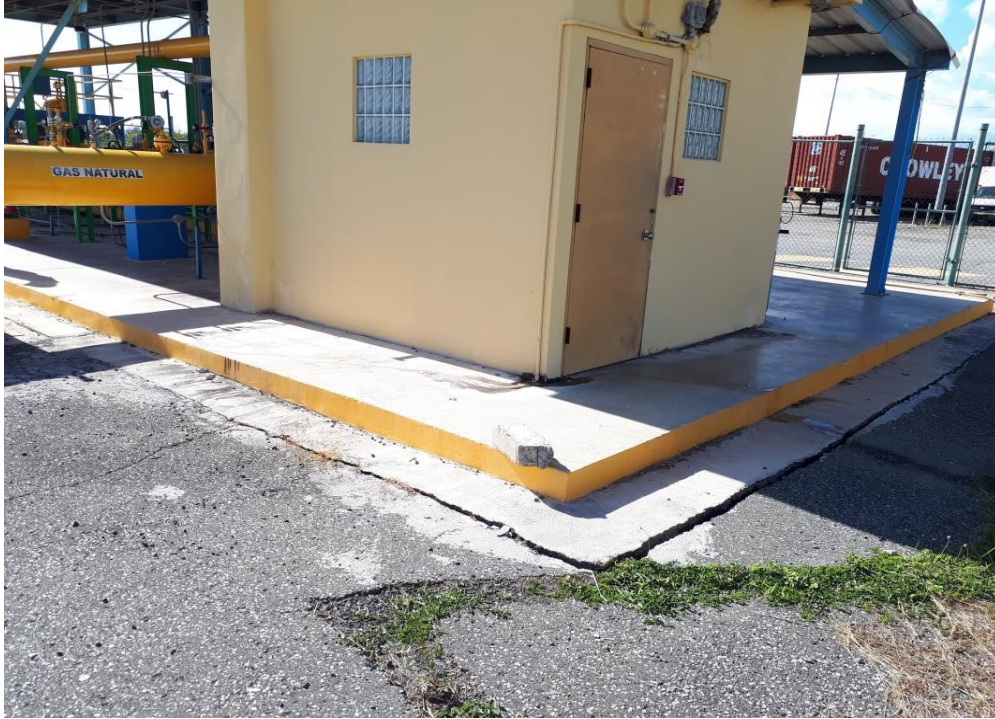
Figure 33. Settlement around the foundation of a small building near the natural gas pipeline at the Costa Sur facility (18.002N, 66.754W).

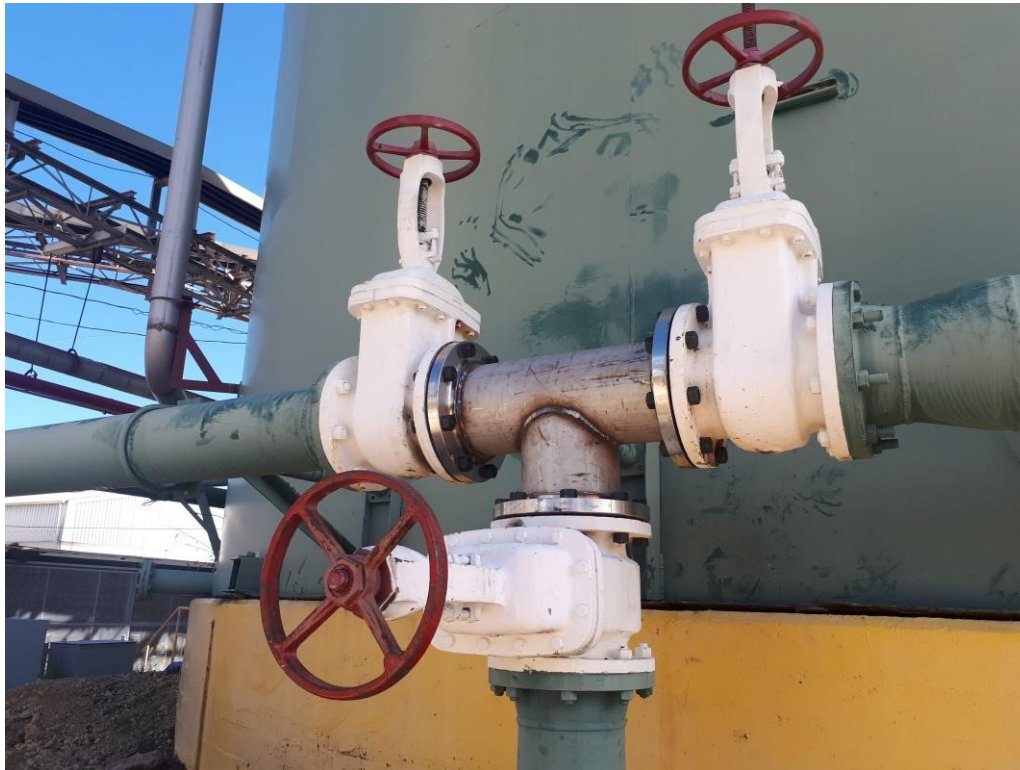
Figure 34. At one of the two water tanks immediately adjacent to the plant the center pipe piece (seen here without paint) was damaged and resulted in water discharge around the base of the tank. At Costa Sur facility (18.002N, 66.754W).

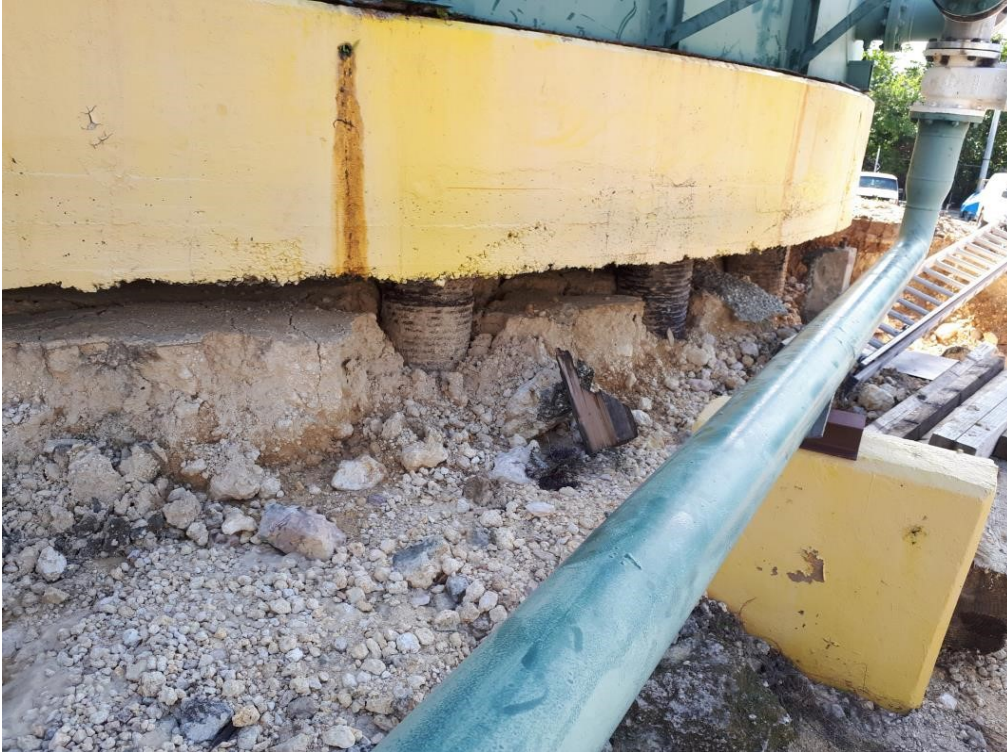
Figure 35. Scour of earthen material between pile cap and corrugated piles. New replacement section (pipe) seen in upper right of photograph (without paint). Scour was mainly on the north side of the structure (18.002N, 66.754W).

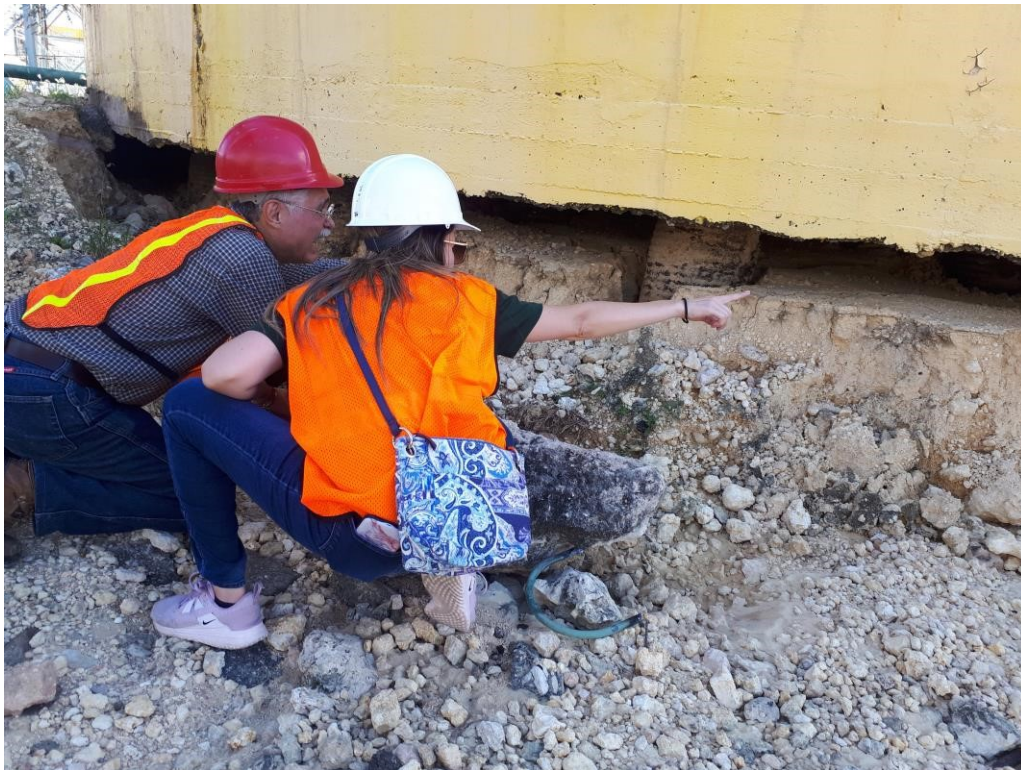
Figure 36: Members of the GEER team study the foundation scour site. Pile tilting seems to have occurred during pile driving (18.002N, 66.754W).

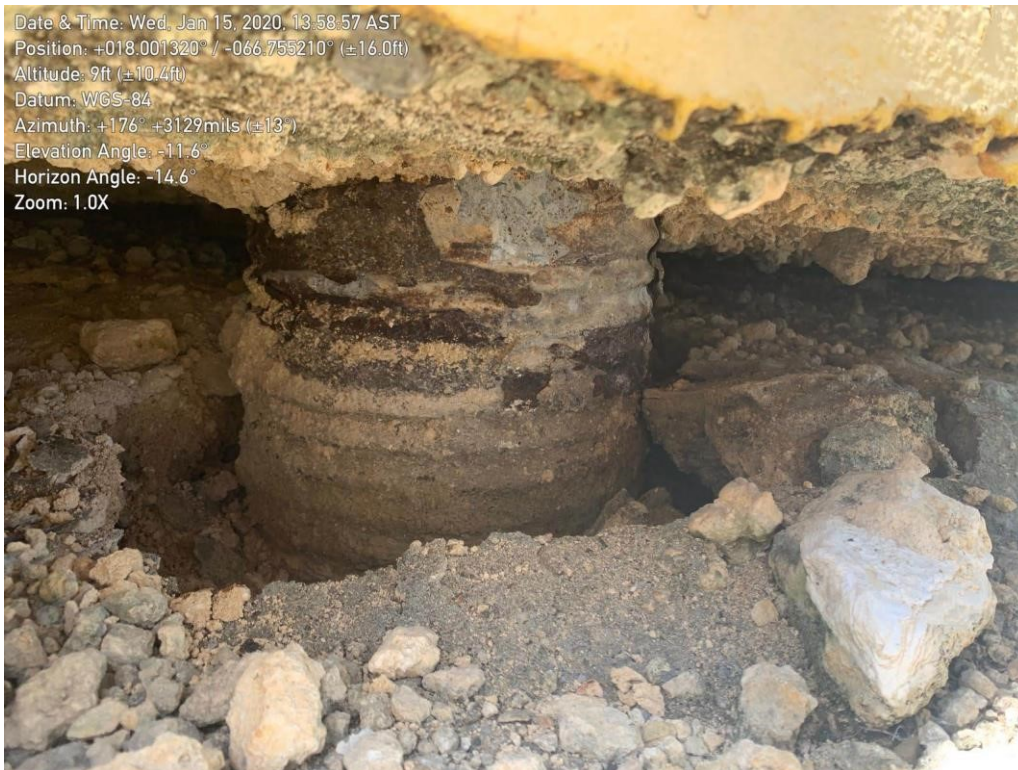
Figure 37: Close view of one of the piles showing some corrosion at the scour site. At the Costa Sur facility.

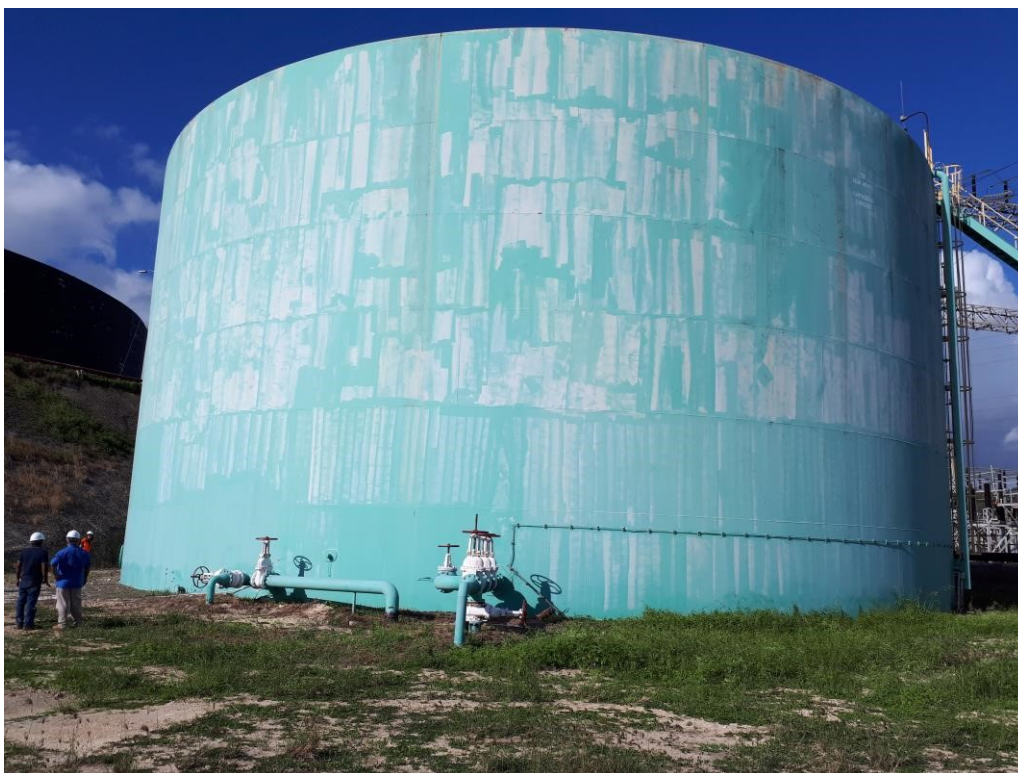
Figure 38: Larger water tank located across the highway just north of the main Costa Sur facility. Humans on the left for scale. View is to the north (18.002N, 66.754W).

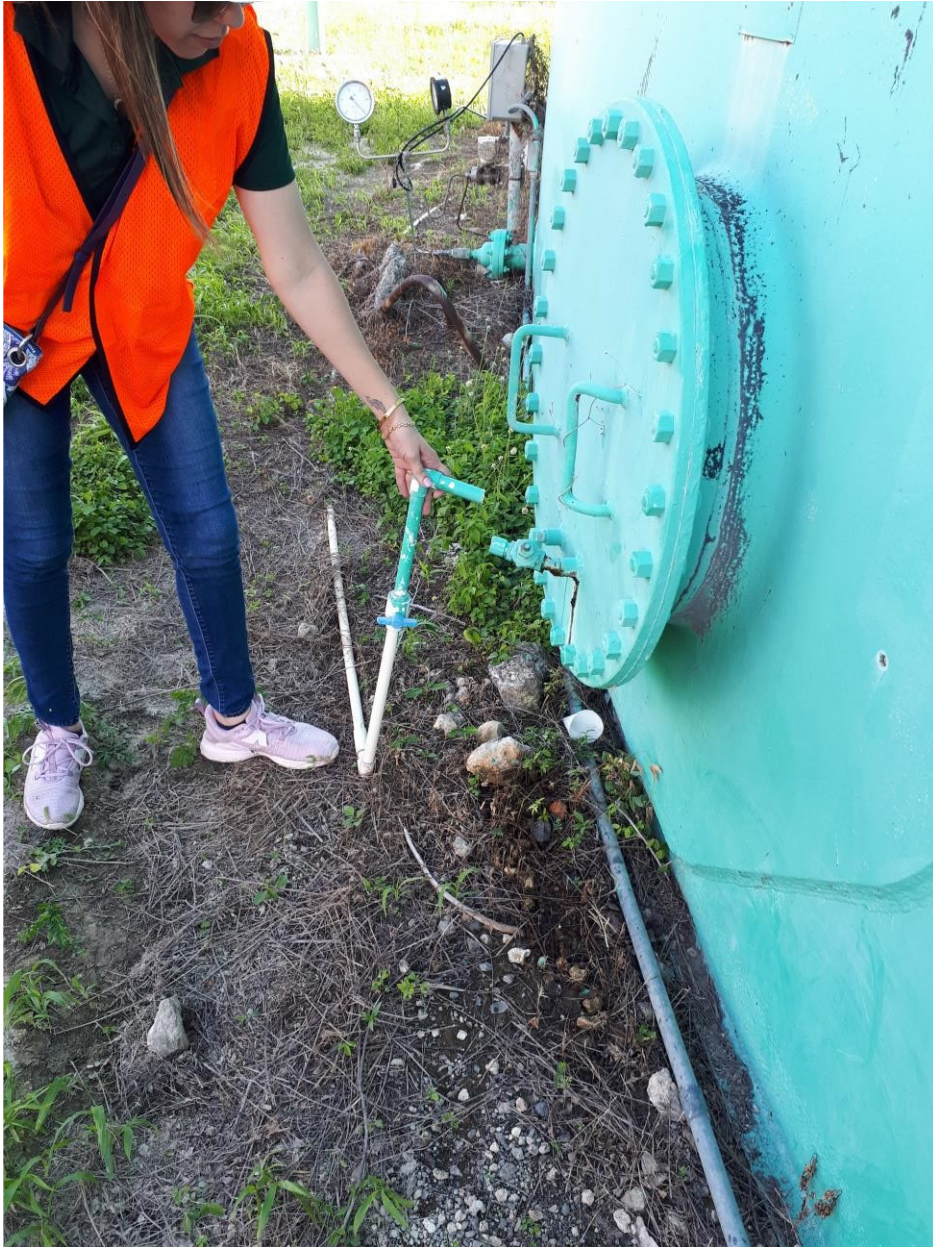
Figure 39: On the eastern base of the tank seen in previous figure, a severed PVC pipe displays a few inches of offset, suggesting minor settling of the structure (18.002N, 66.754W).
