Geotechnical Reconnaissance of the January 7, 2020 M6.4 Southwest Puerto Rico Earthquake and Associated Seismic Sequence

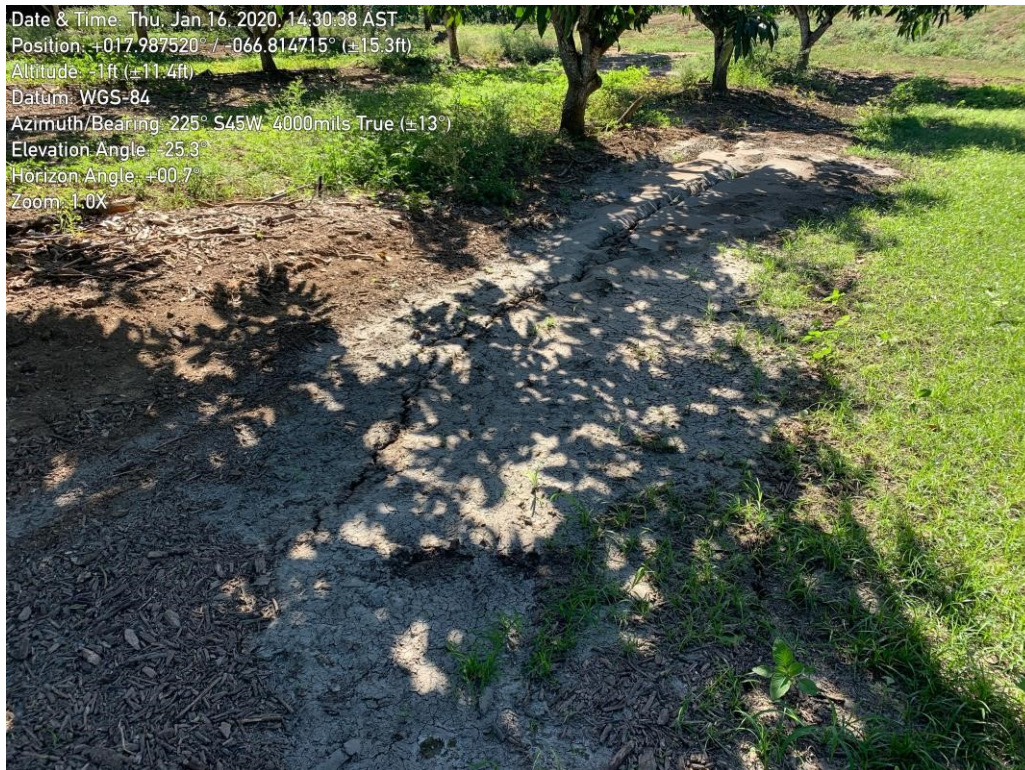
Figure 40. Typical ground cracks with sand ejecta at the mango fields in Tropical Fruit farms.

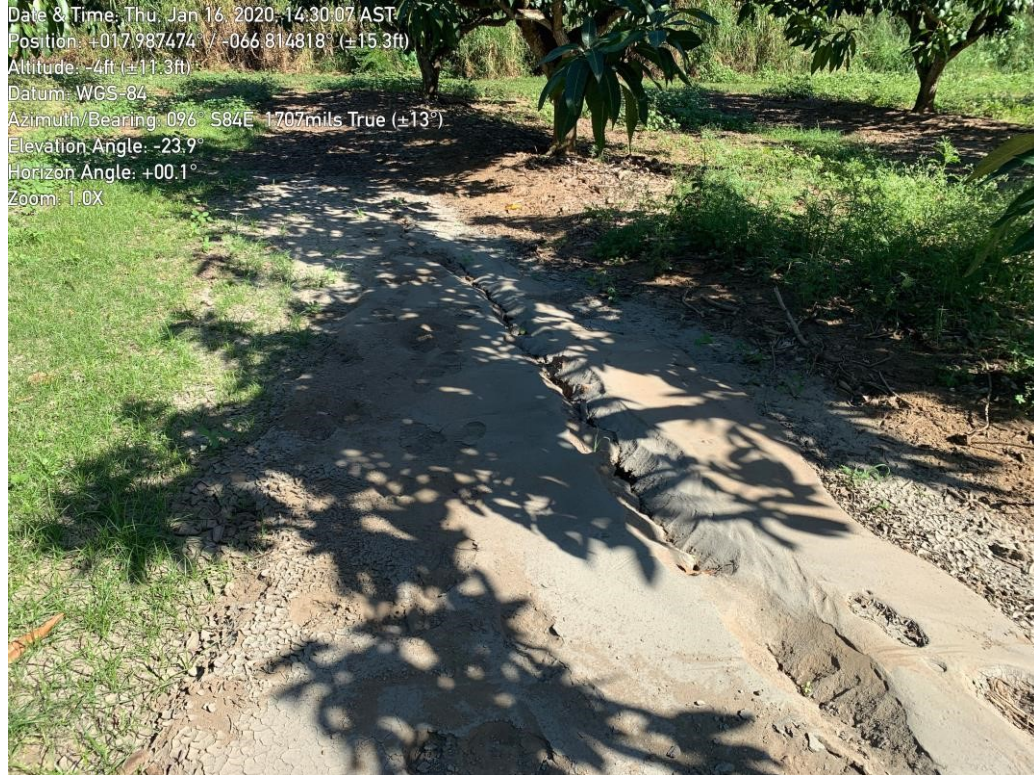
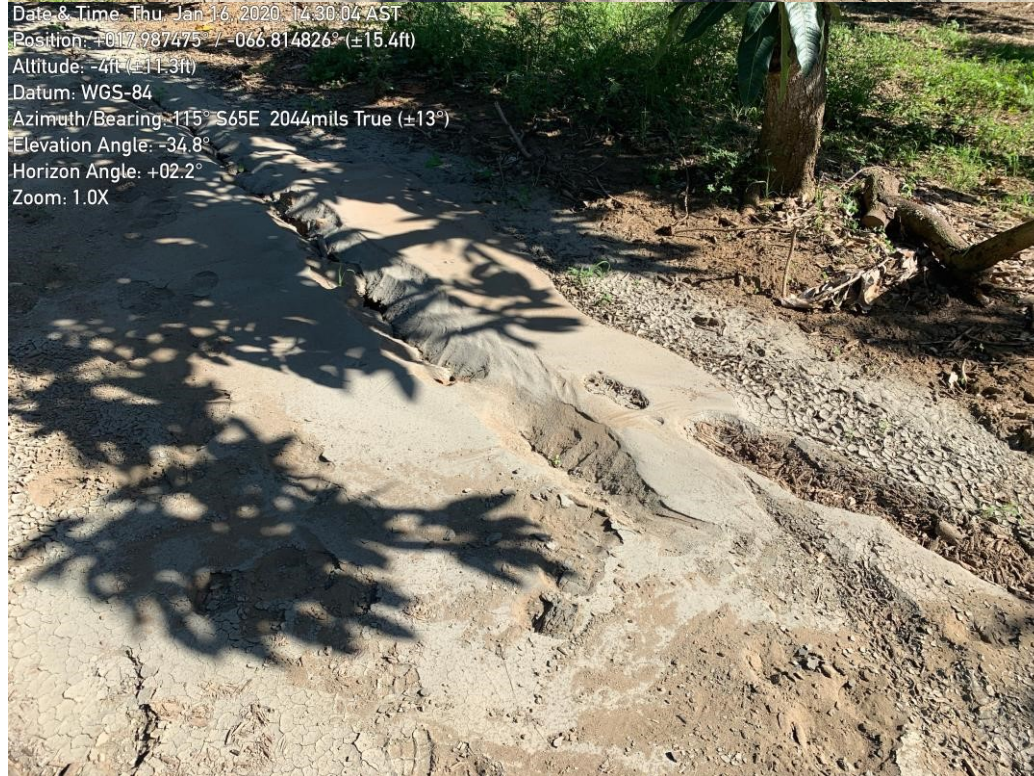
Figure 41. Ground cracks showing enormous amounts of sand ejecta at the mango fields in Tropical Fruit Farm.

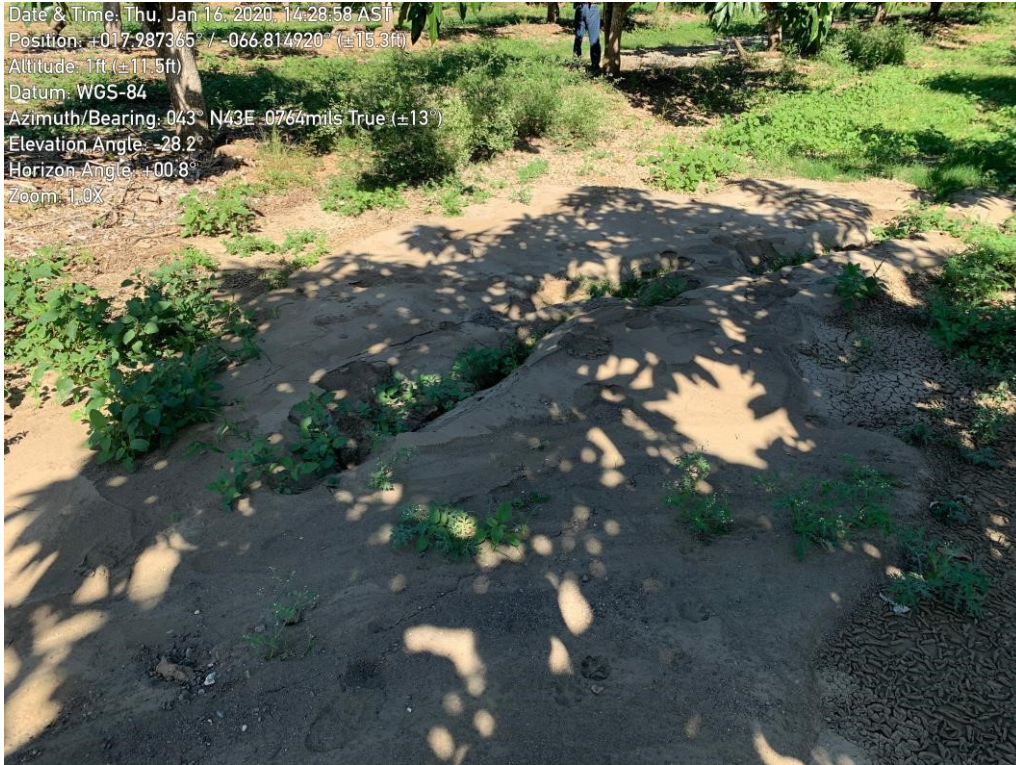
Figure 42. Series of sand boils and sand ejecta in the mango fields at Tropical Fruit Farm.

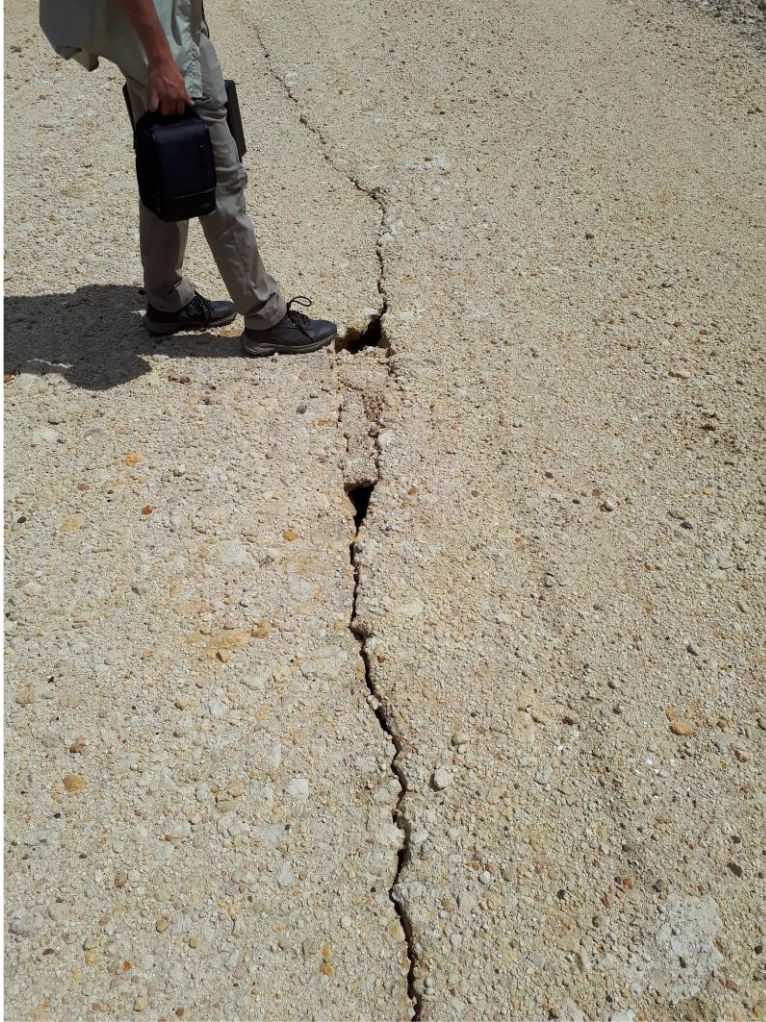
Figure 44: Ground cracks in road fill material in a low lying area between the Tropical Fruit farm and nearby Punta Verraco (17.988N, 66.815W).

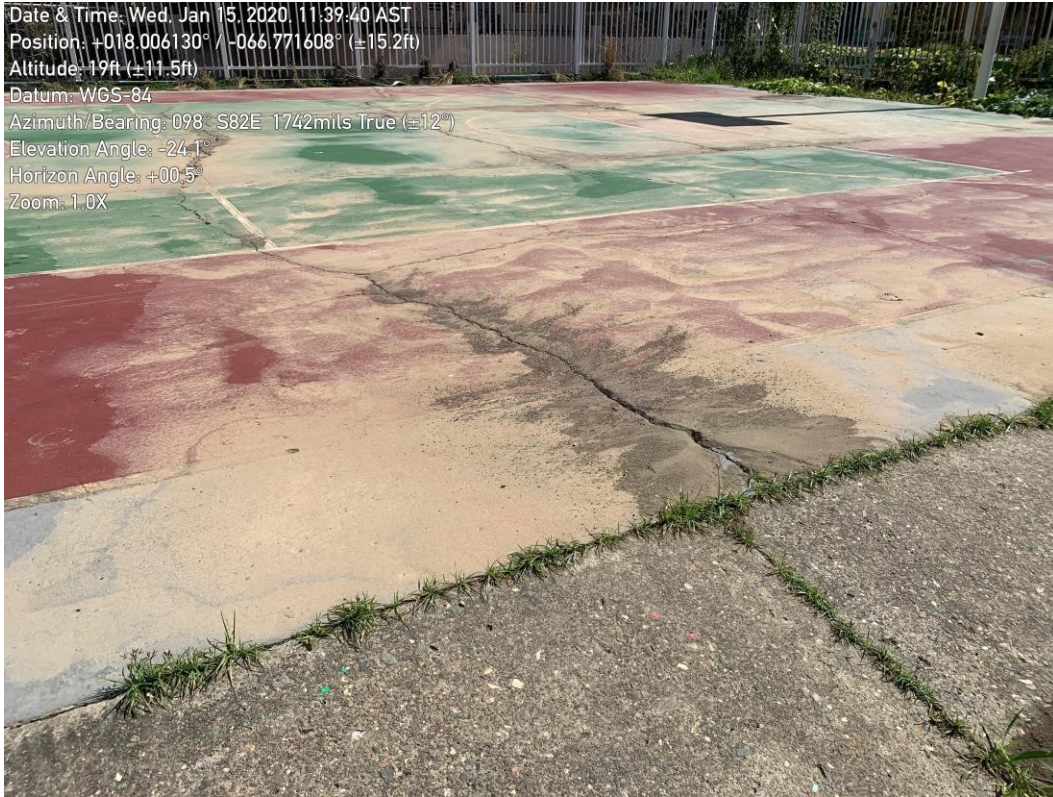
Figure 45. Ground cracks and sand ejecta at the community basketball court. Sand at this site was a silty sand. This crack ran through the whole width of the basketball court.

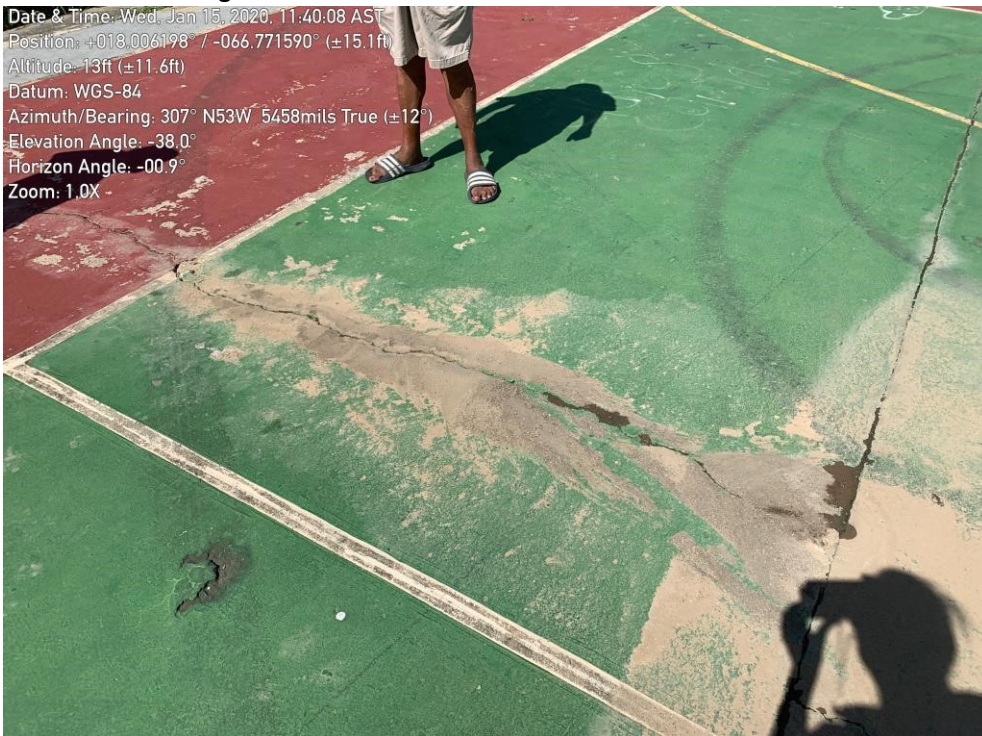
Figure 46. More ground cracks and sand ejecta at the community basketball court.

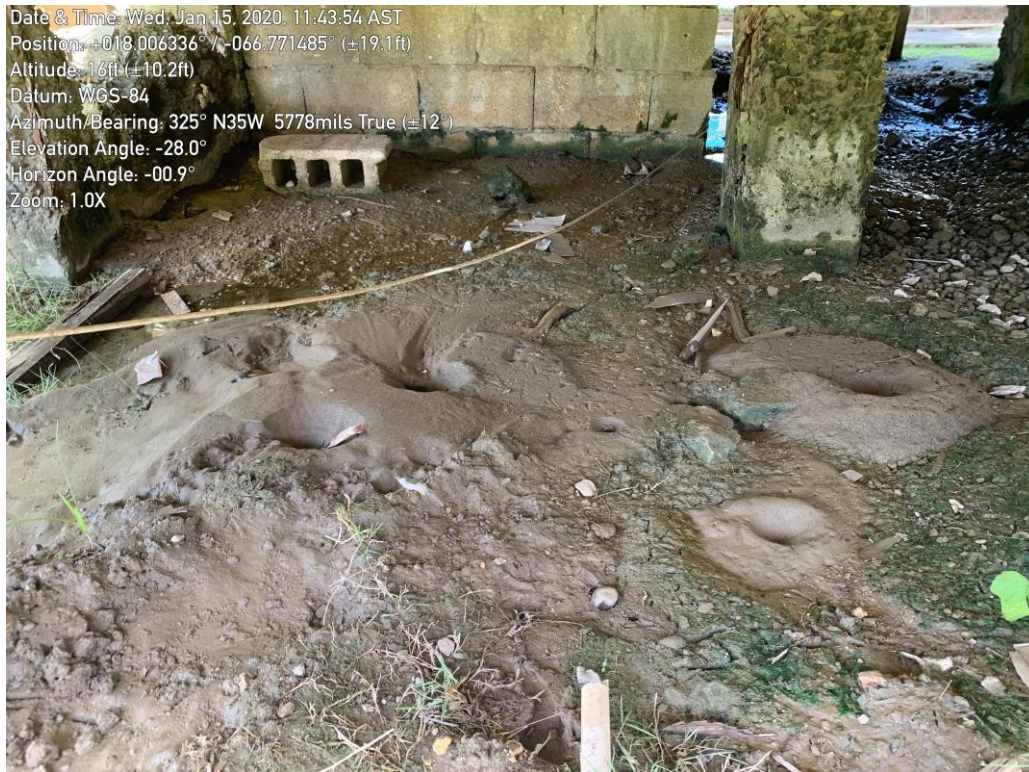
Figure 47. Sand boils in the crawl space of a private residence. This was seen all through the crawl space of the residence and in the backyards of multiple houses.

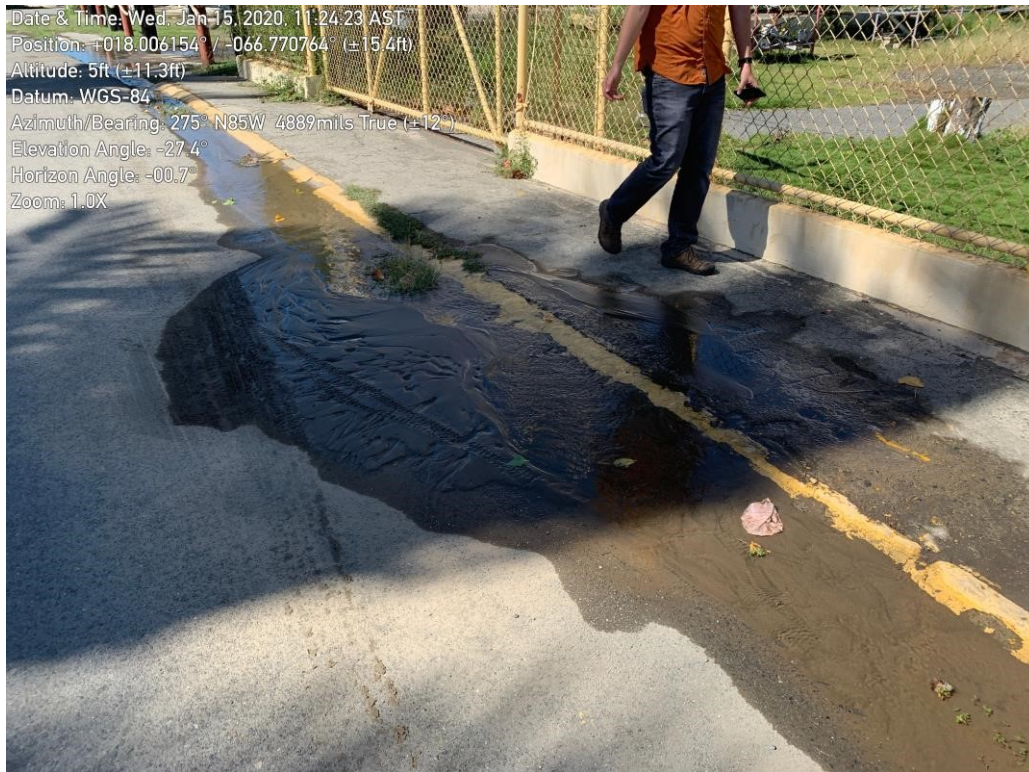
Figure 49. Broken water pipe and sand ejecta.

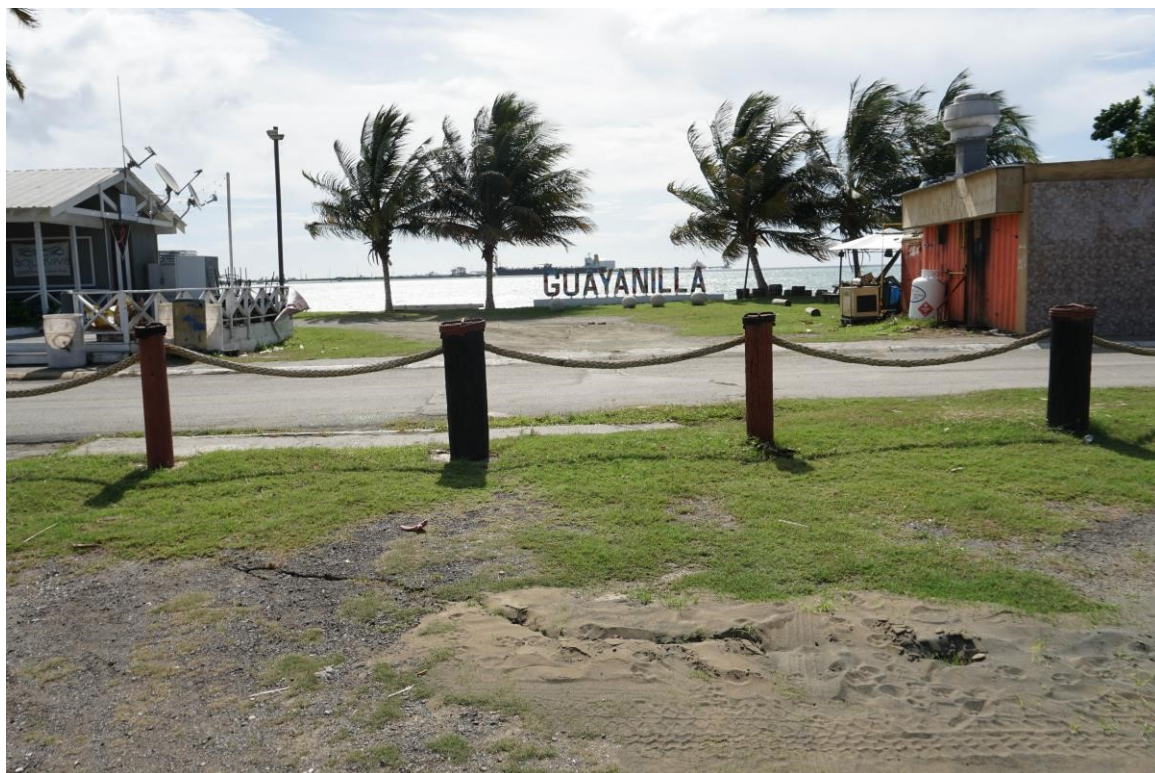
Figure 50: Liquefaction blow in the parking lot of a restaurant in “El Triangulo” neighborhood. Same as Figure 48. Photo by colleague Kate Allstadt (18.006N, 66.771W).

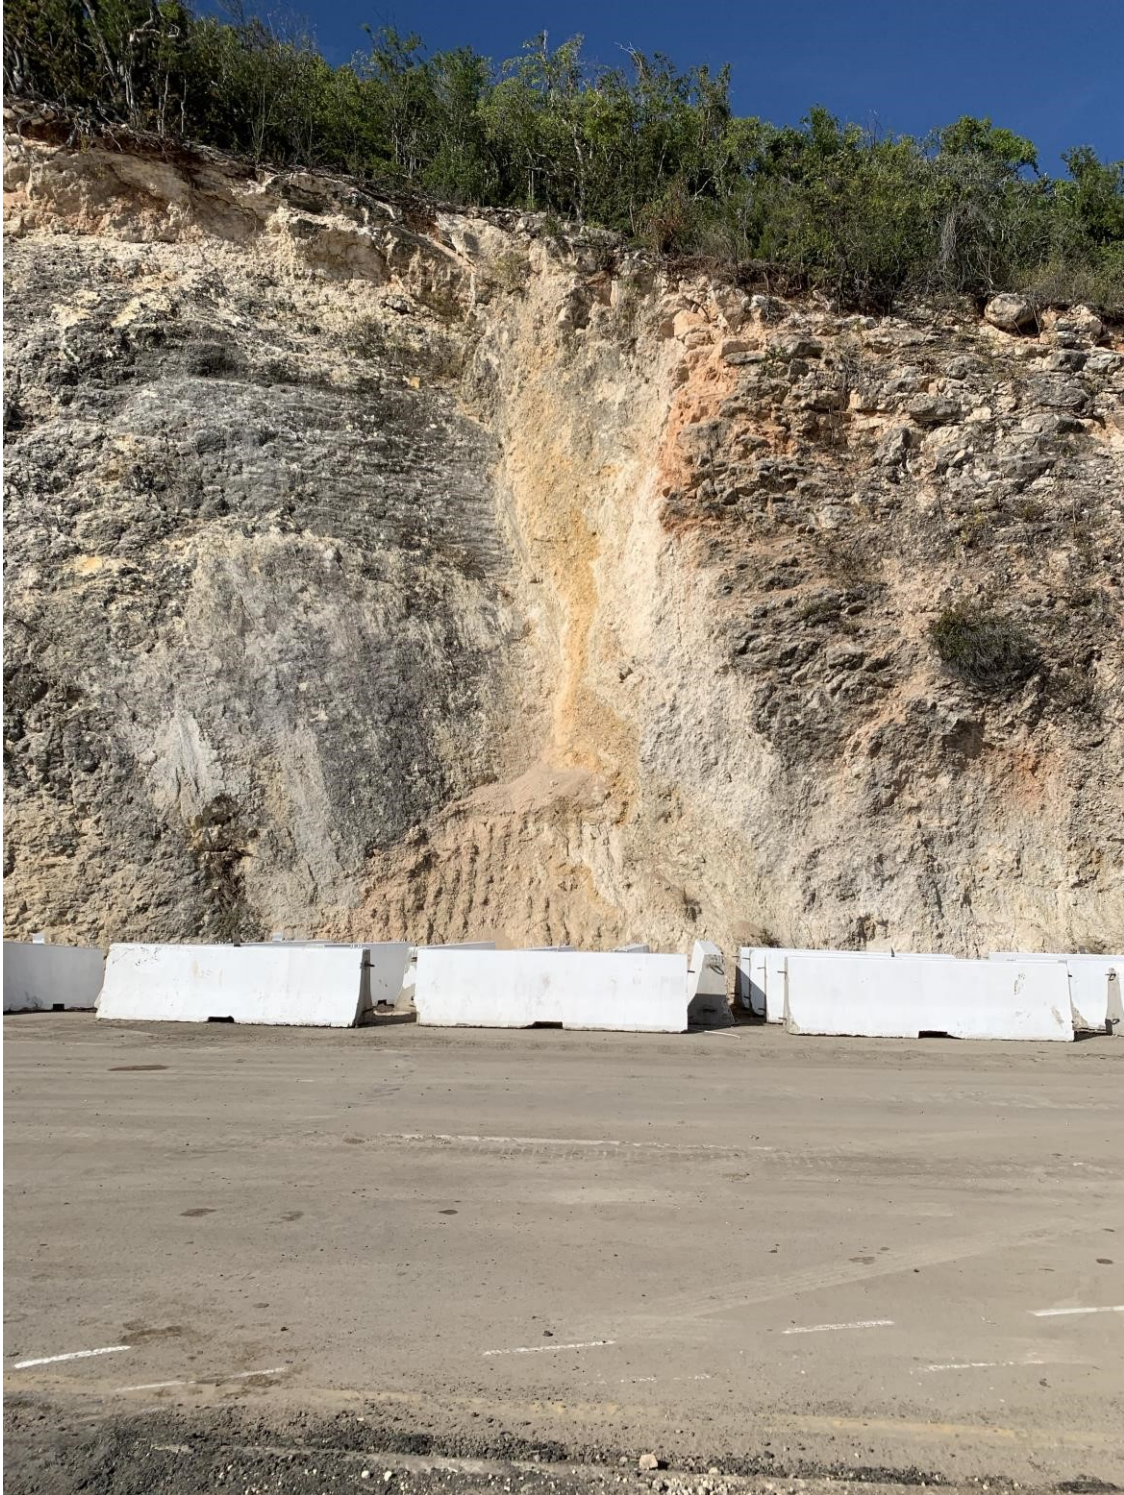
Figure 51: Part of the cut slope failure along the PR-2 landslide. The site suffered continuous failures during aftershocks and the 4 lanes of the roadway were shifted seaward.

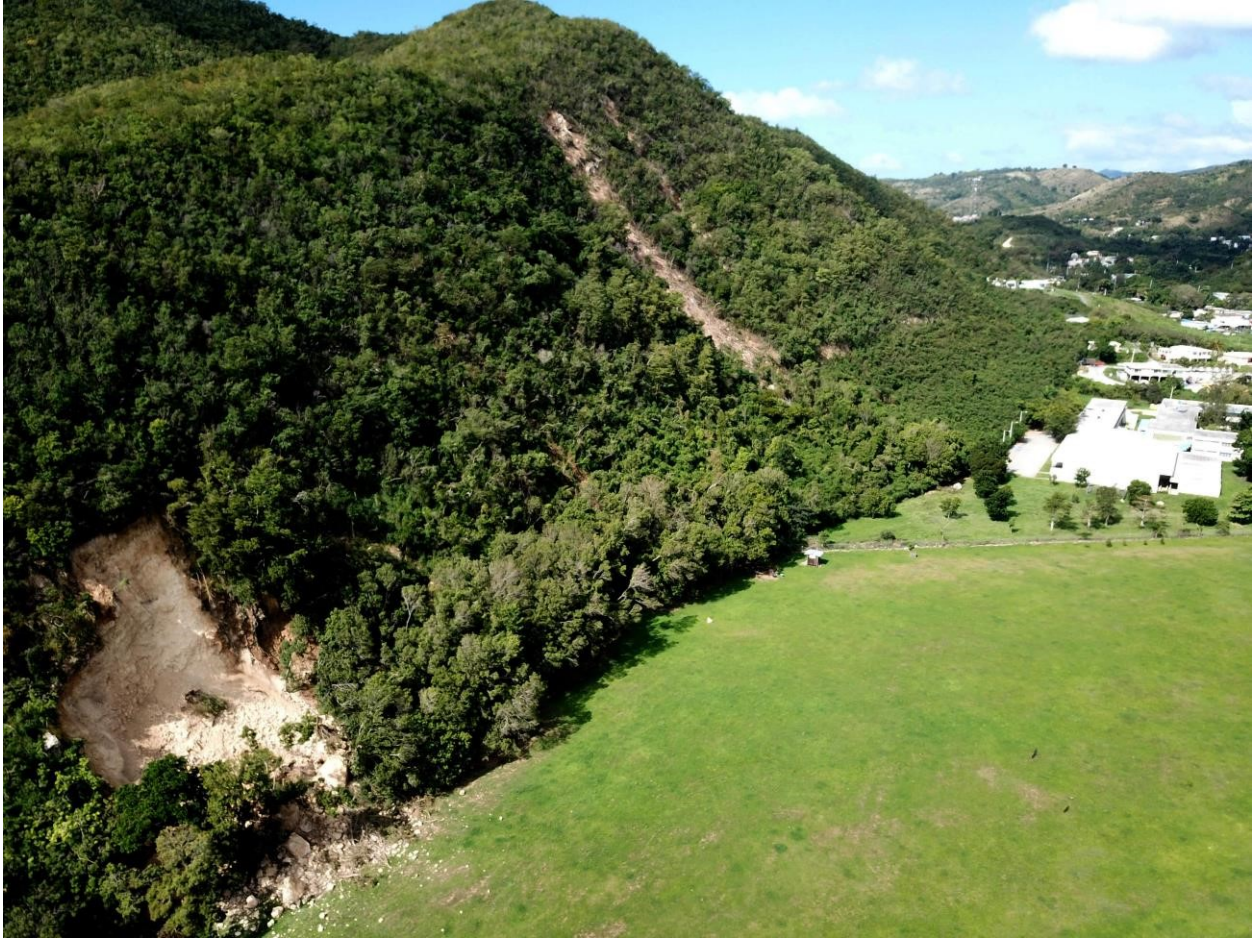
Figure 52: Slump in the foreground and twin rock falls in the center of the photo. Location along PR-127 in Guayanilla. White building at the right center of photograph is the Escuela Secundaria Asunción Rodríguez de Sala. Photograph is modified from López et al., 2020b.

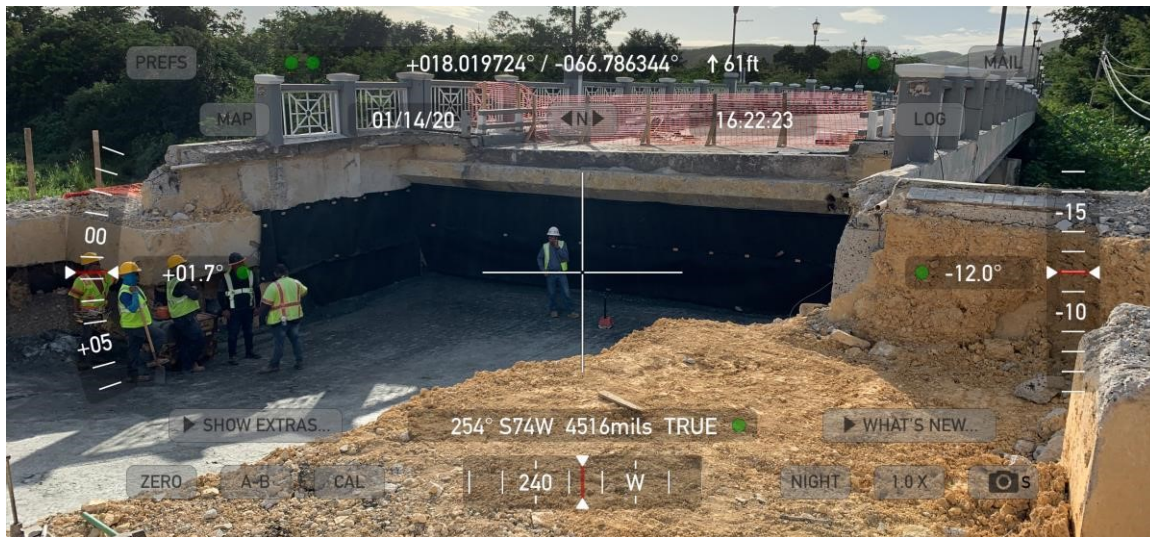
Figure 56. PR-127 bridge over Rio Guayanilla showing the east abutment already demolished.

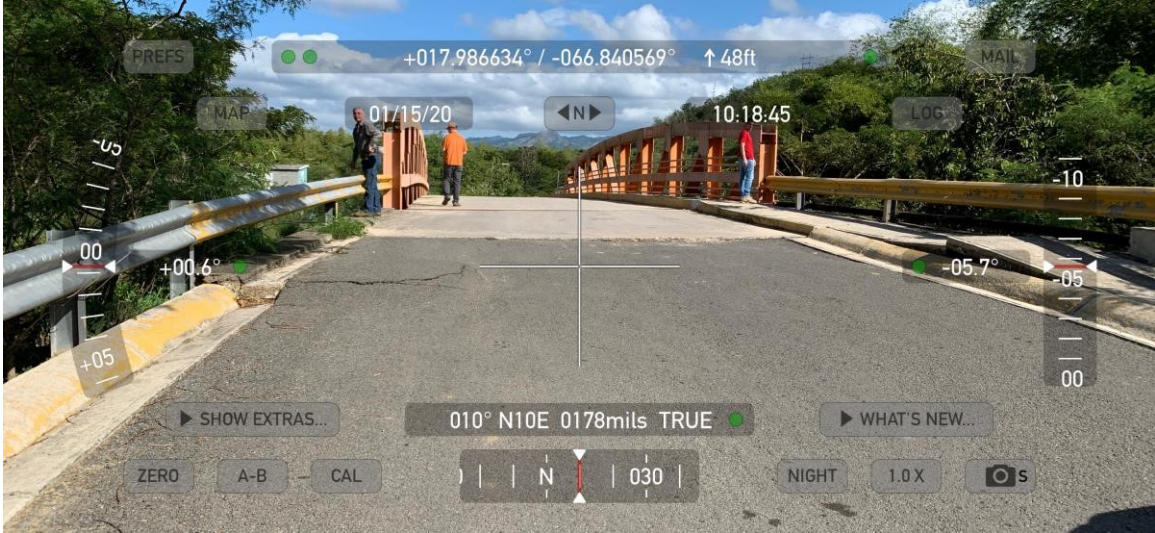
Figure 57. PR-335R bridge over the Rio Yauco south abutment showing damage near the joint between flexible and rigid pavement. Also, the sidewalk shows major displacement.

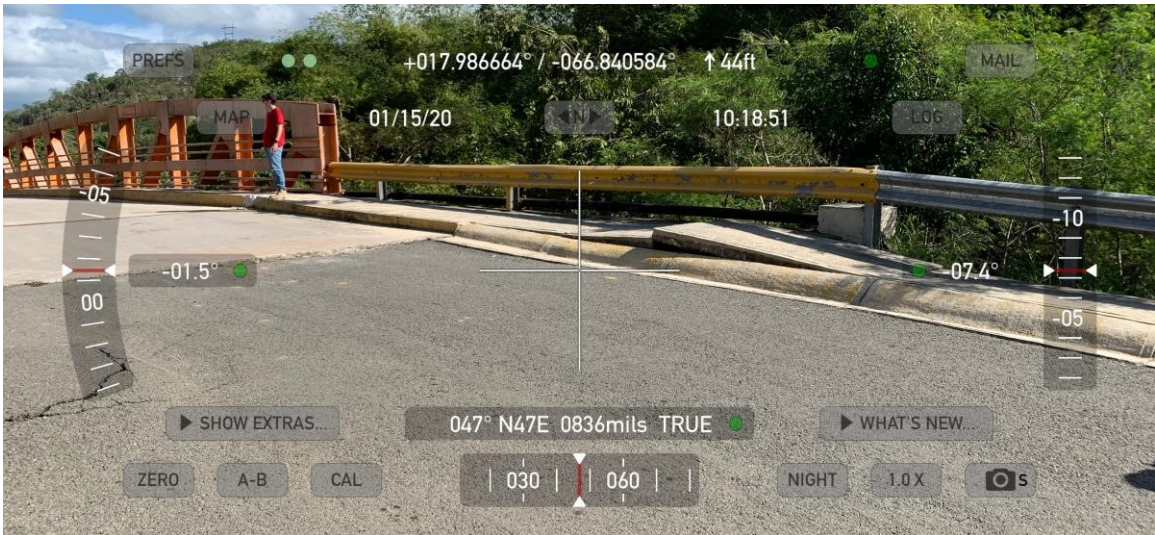
Figure 58. Side view of the sidewalk displacement.

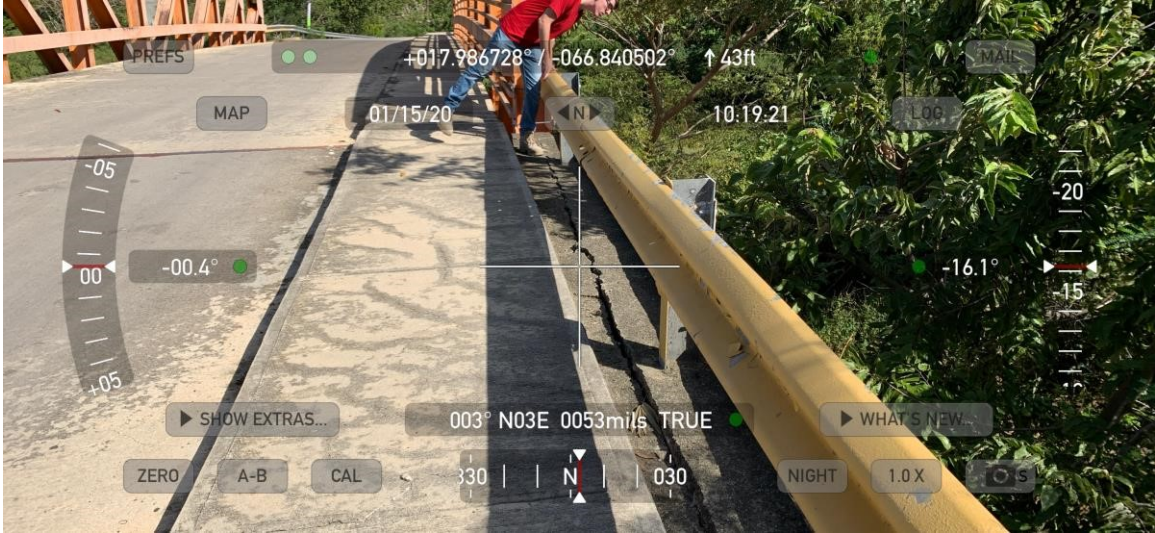
Figure 59. Ground cracks parallel to the lanes in the PR-335R bridge. These ground cracks ran almost throughout the whole bridge span.

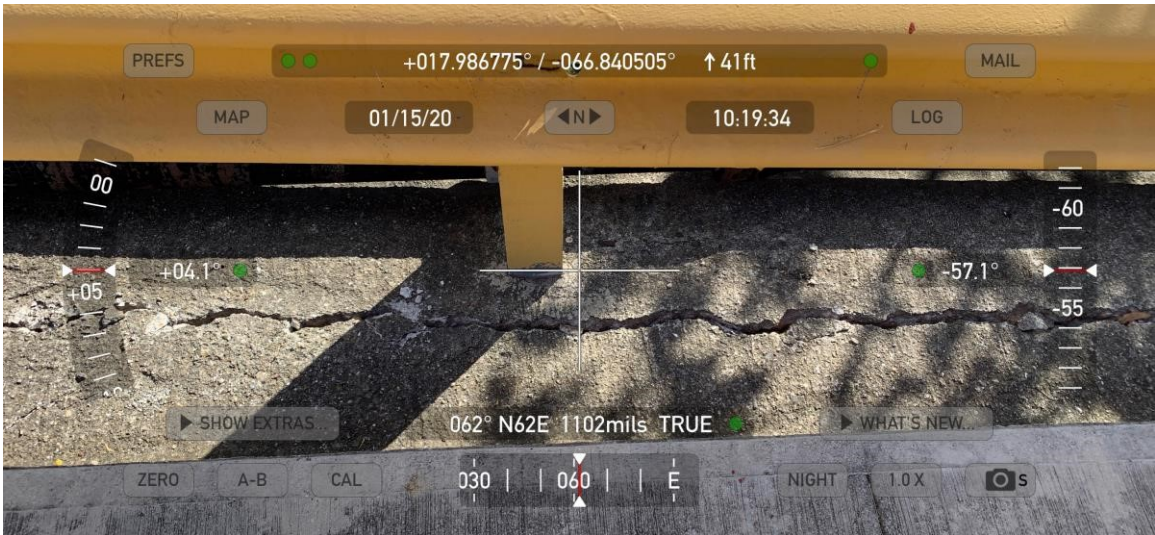
Figure 60. Detail of the ground cracks show in the previous figure.

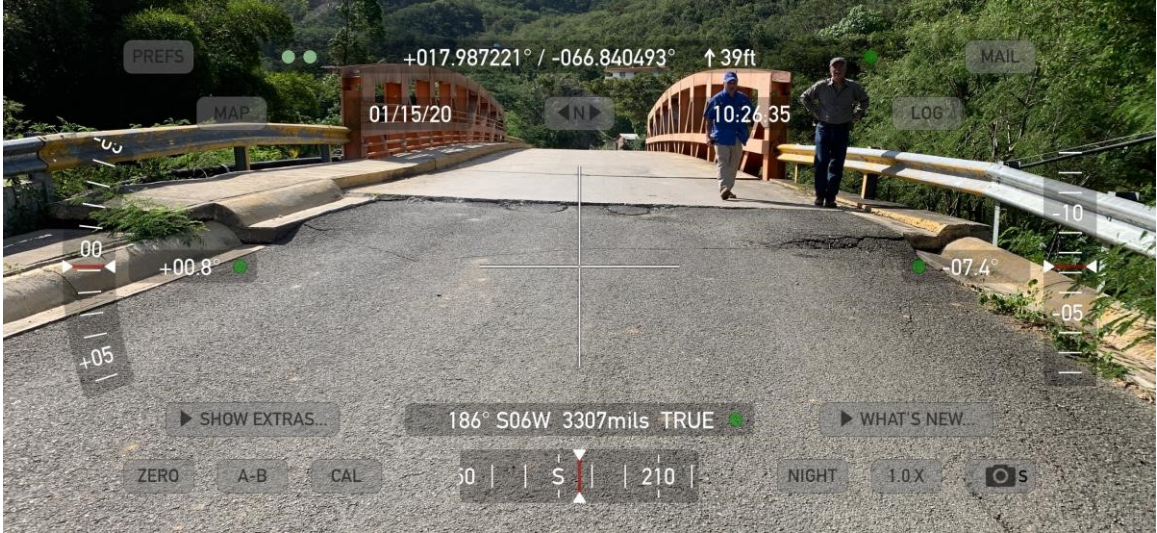
Figure 61. PR-335R bridge over the Rio Yauco north abutment showing ground settlement near the joint between flexible and rigid pavement. This settlement lead to a complete break of the sidewalk.

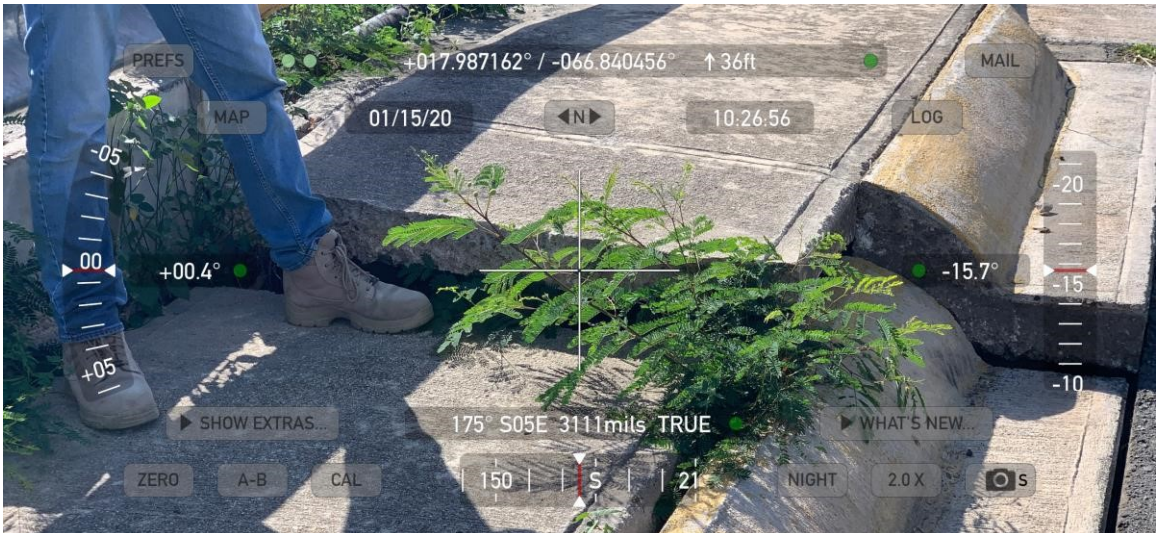
Figure 62. Detail of the sidewalk damage in the north abutment of PR-335R bridge over the Rio Yauco.

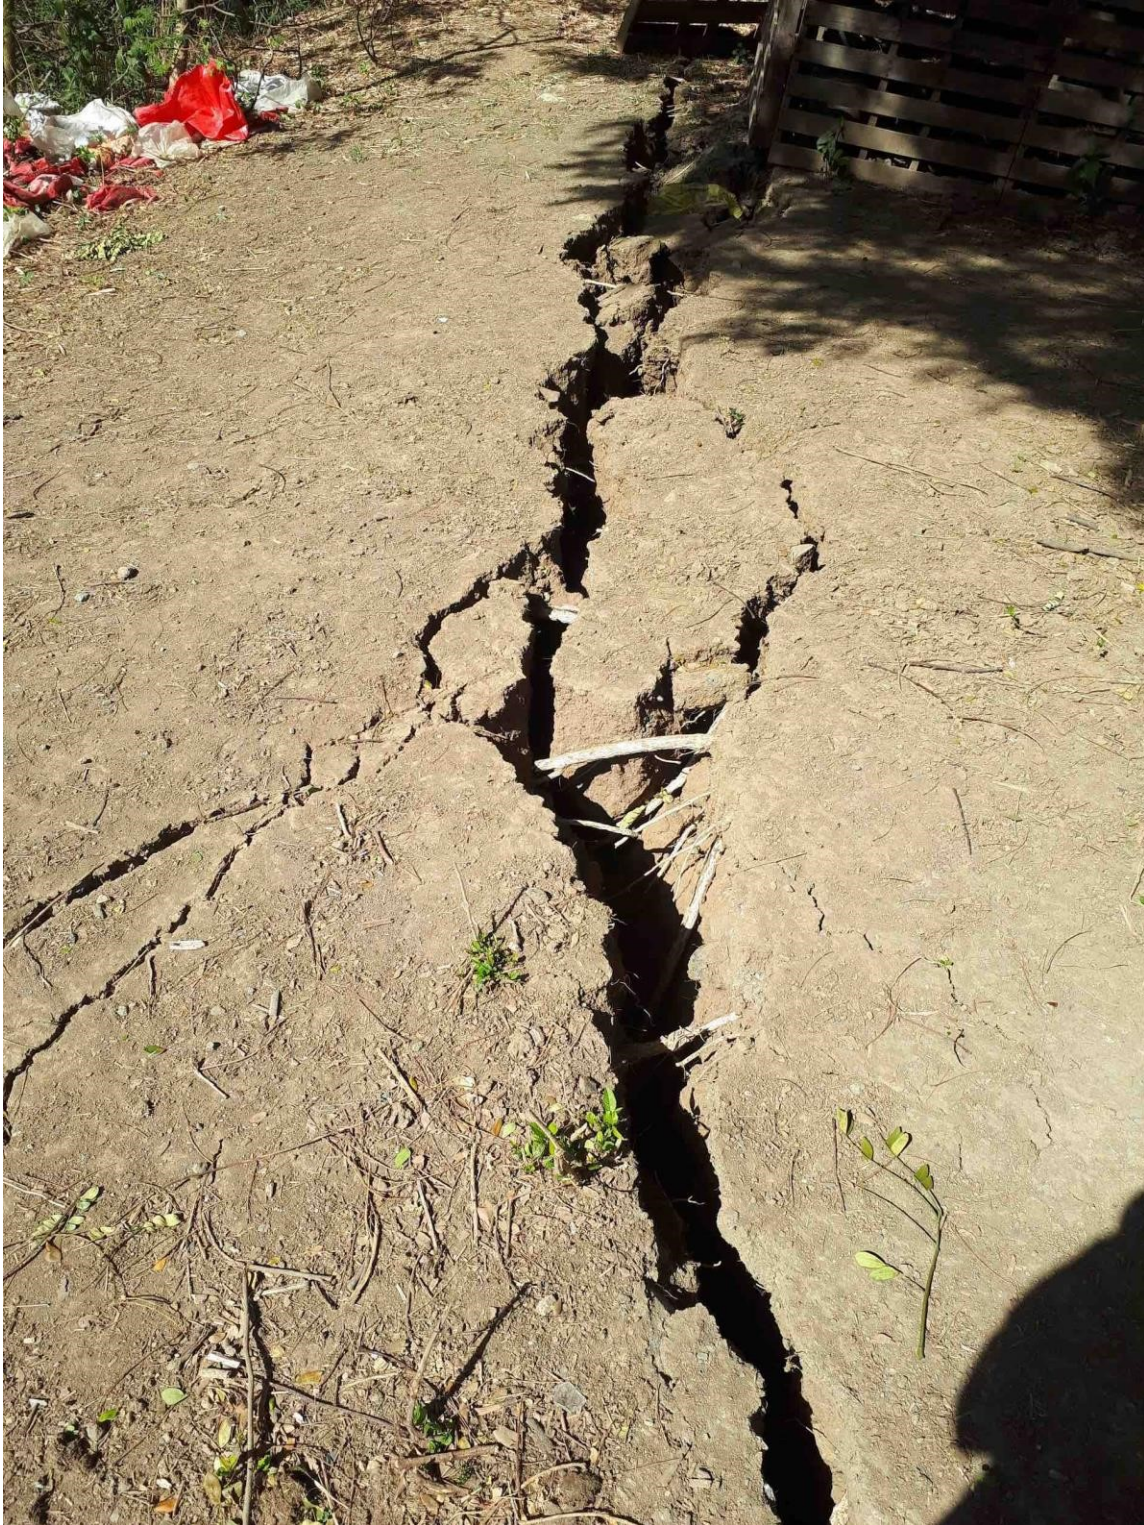
Figure 63: Lateral spreading at the same PR-335R bridge site as previous photo. The Rio Yauco is just a few meters to the right of the field of view (17.987162N, 66.840456W).

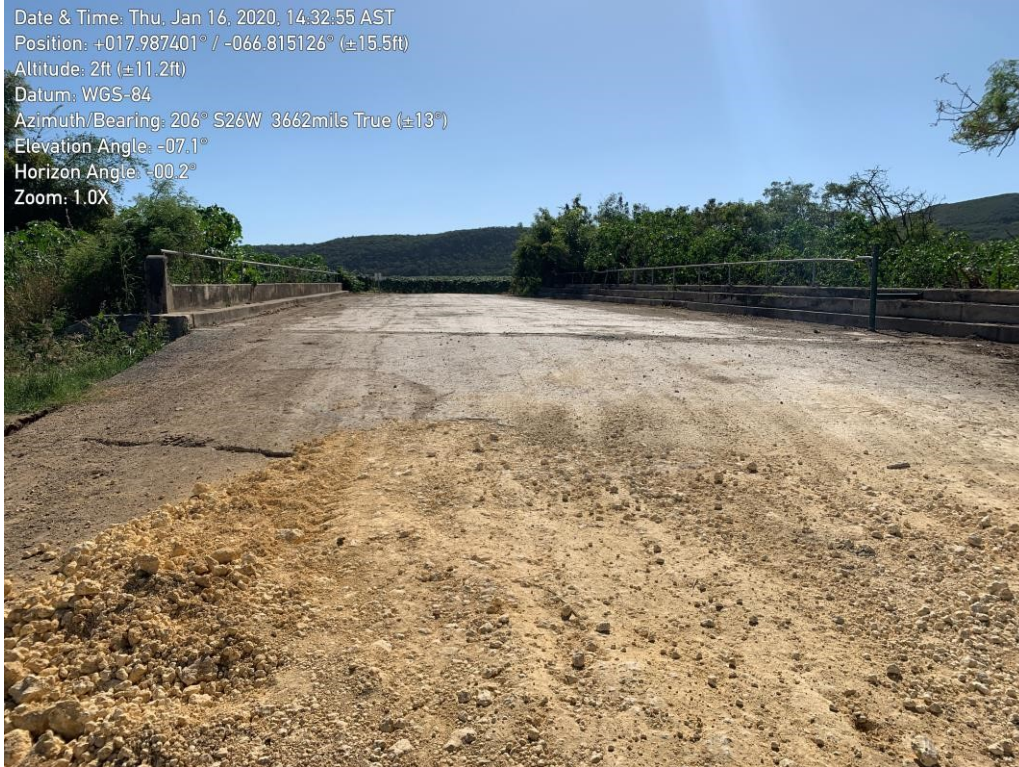
Figure 64. Settlement and ground cracks due to lateral spreading in the mango fields bridge in Tropical Fruit farm that gives access to Playa Ventana.

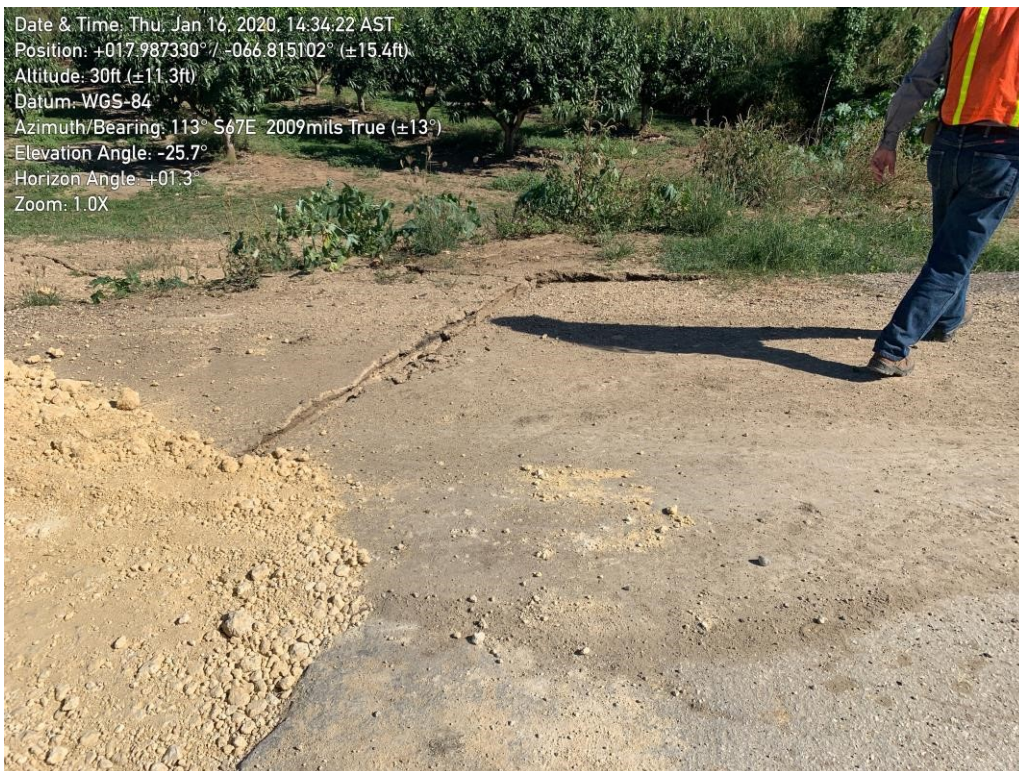
Figure 65. Ground settlement in the bridge north abutment also seen in Figure 64.

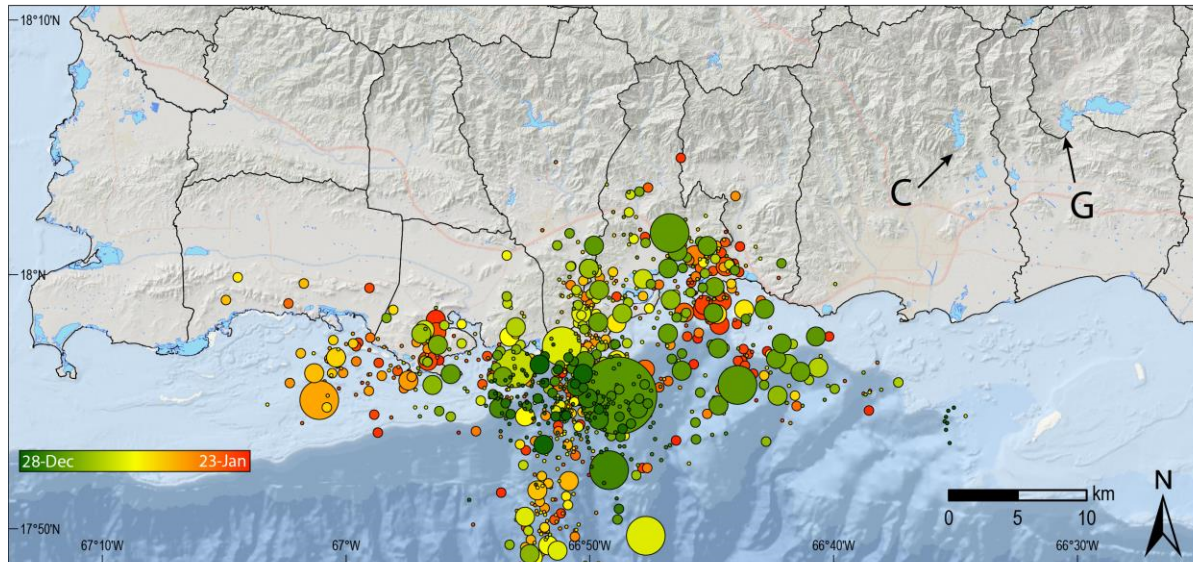
Figure 67: Map of the seismic sequence events and the location of Lago Cerrillos (C) and Lago Guayabal (G), to the northeast of the epicentral area.

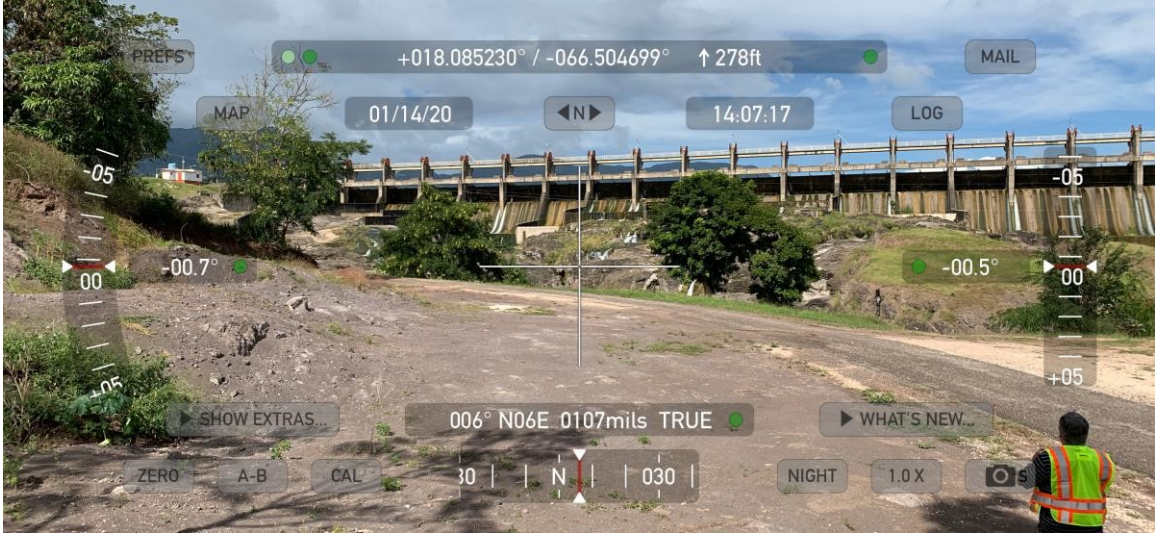
Figure 68. Downstream area at Guayabal dam. No damage was reported.

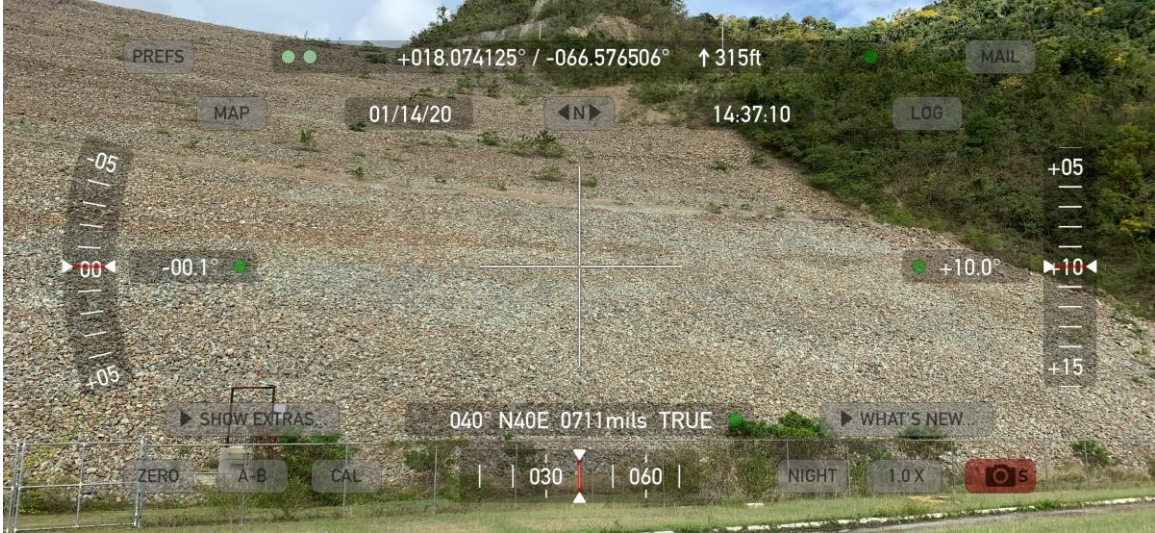
Figure 69. Downstream area at Cerrillos dam. No damage was reported.

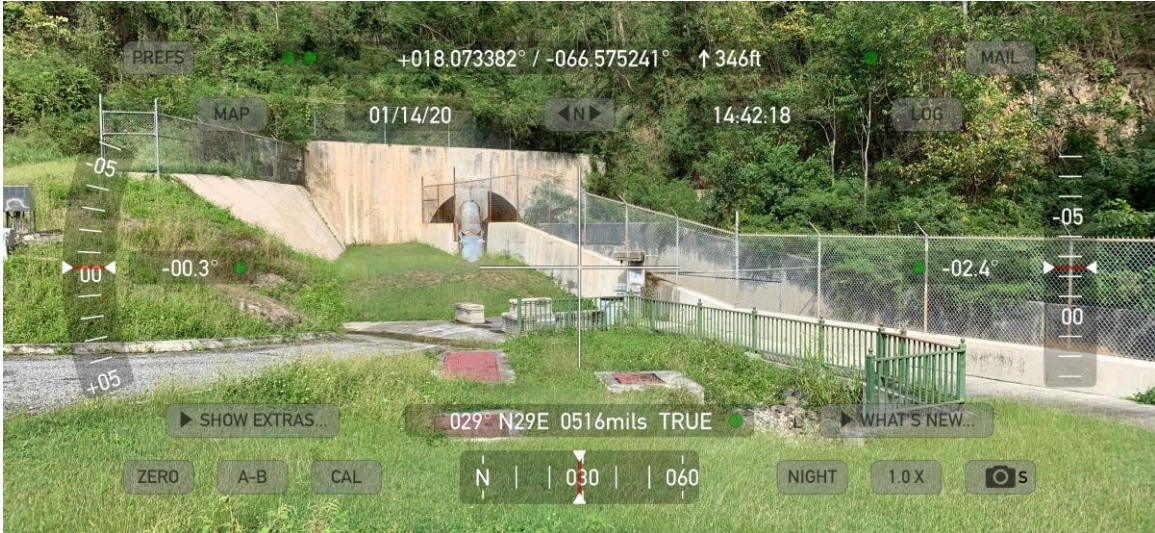
Figure 70. Discharge tunnel area at Cerrillos dam. No damage was reported.
