# **Reconnaissance of the New Orleans Hurricane and Storm Damage Risk Reduction System after Hurricane Gustav**

R. Lee Wooten, P.E., Robert B. Gilbert, Ph.D., P.E., William F. Marcuson, III, Ph.D., P.E.,  
Leslie F. Harder, Jr., Ph.D., P.E., G.E., and Peter G. Nicholson, Ph.D., P.E.

Geoengineering Extreme Events Reconnaissance (GEER) Association.

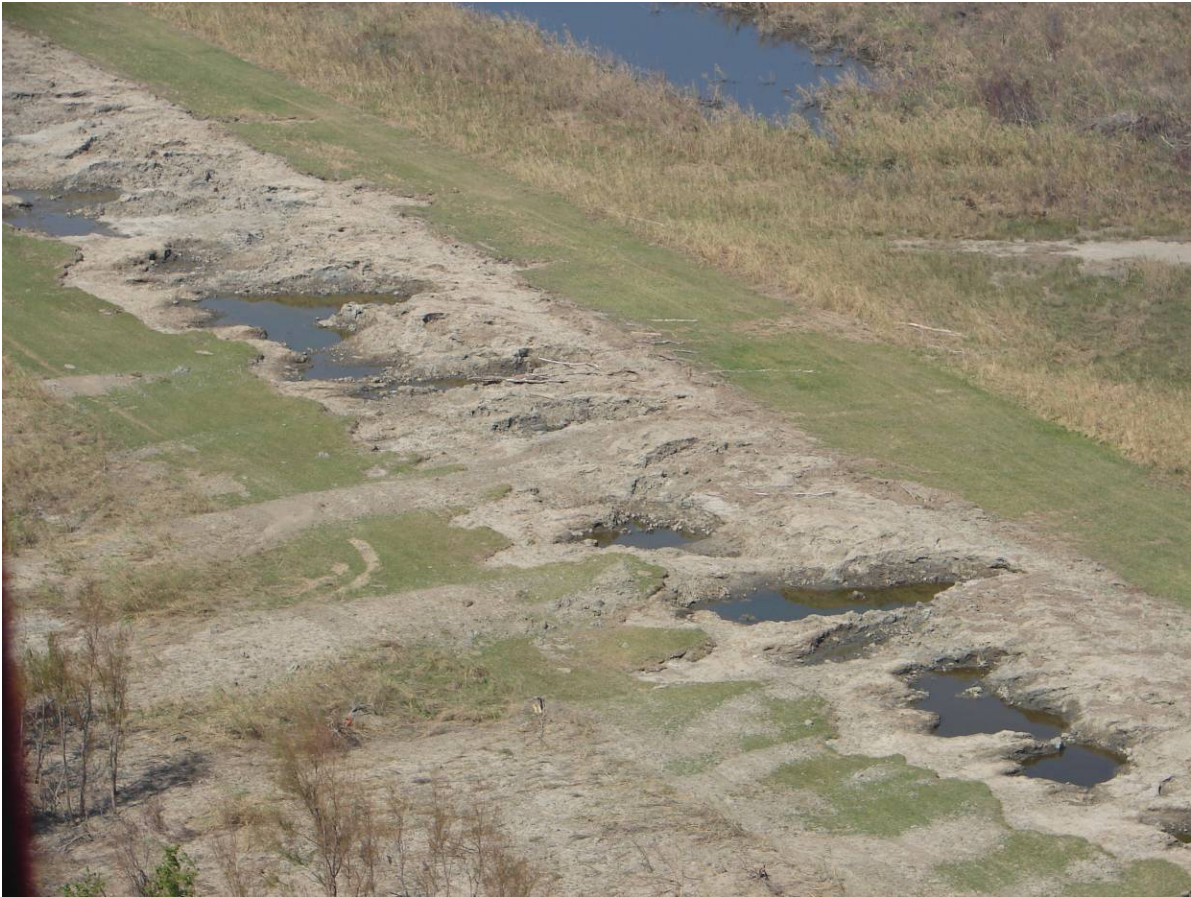
Figure 2.2.1-1 shows a section of the MRGO frontage levee and the typical extent of the erosion damage caused by the Katrina overtopping.

Fig. 2.2.1-1 Post-Katrina MRGO Frontage Levee, October 14, 2005. (L. Harder)

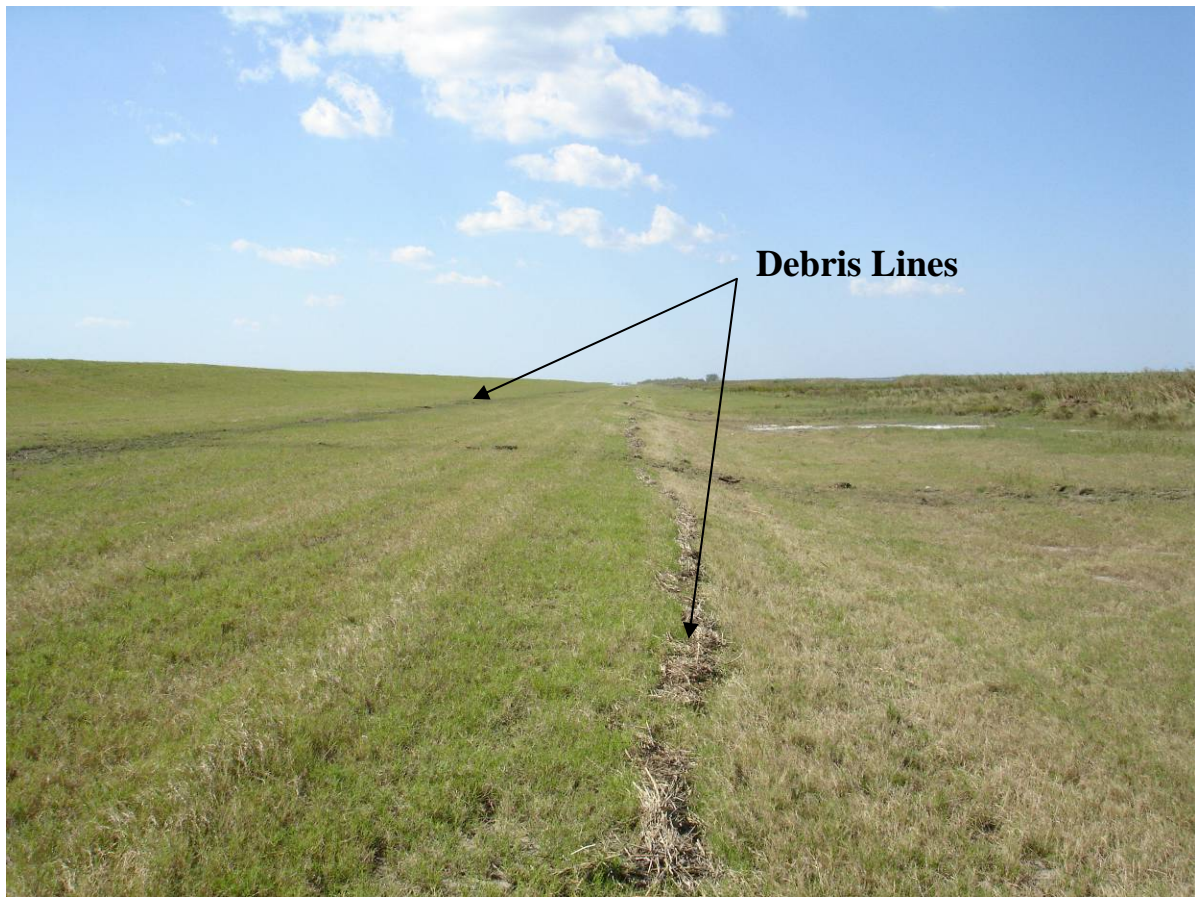
We observed no signs of either erosion or overtopping of the MRGO frontage levee during our visit. Based on the limited debris lines along the levee, the high water levels during Gustav were well below the crest of these rebuilt and elevated earthen embankments. The wave and current actions of Gustav also appeared to have caused no erosion on the earth embankments. Figures 2.2.1-2 and 2.2.1-3 show two typical views of the MRGO frontage levee embankment.

Fig. 2.2.1-2 MRGO Frontage Levee, flood side, looking northwest. Upper debris line, believed to be due to Gustav, was cleared prior to our visit, probably as part of the ongoing efforts to maintain the protective grass cover. The lower debris line may represent the high water level during Ike. (L. Wooten)

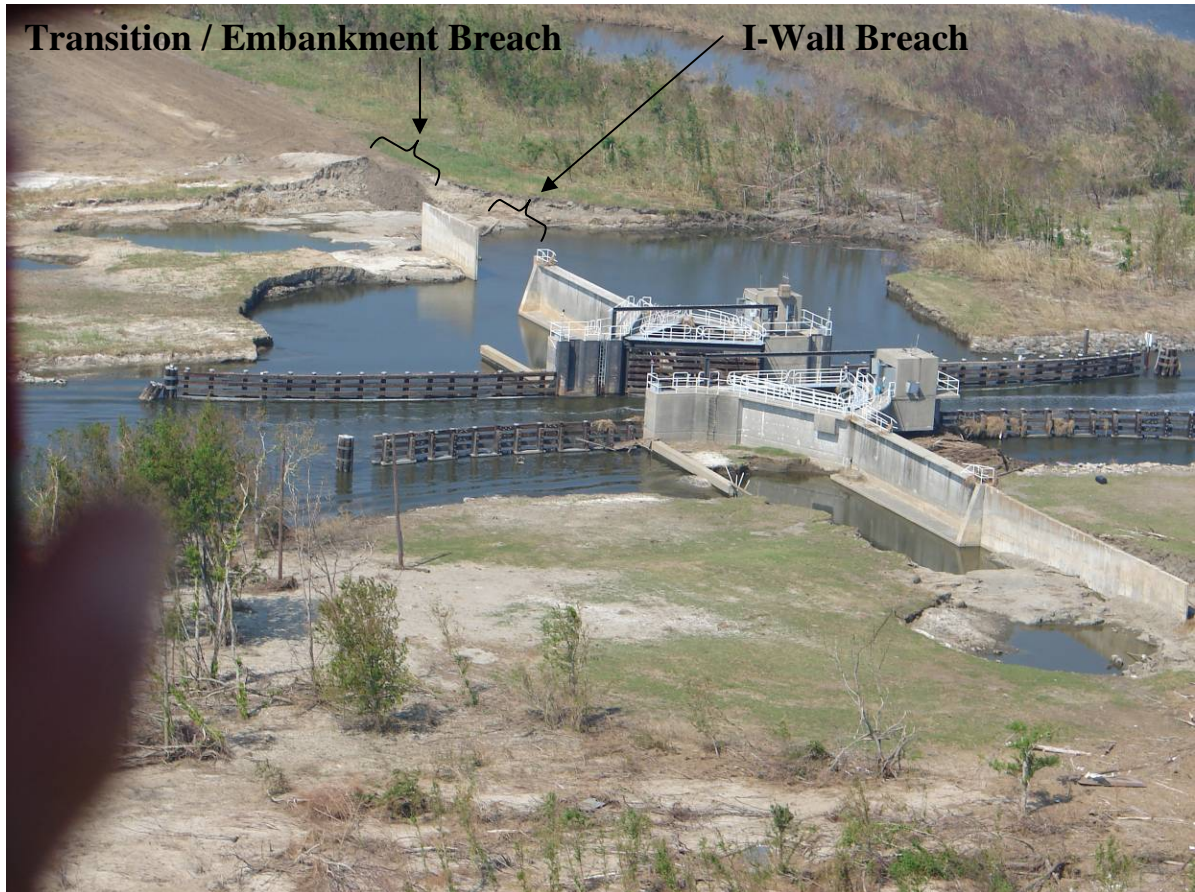
Fig. 2.2.2-1 Bayou Dupree gate, October 14, 2005 (L. Harder)

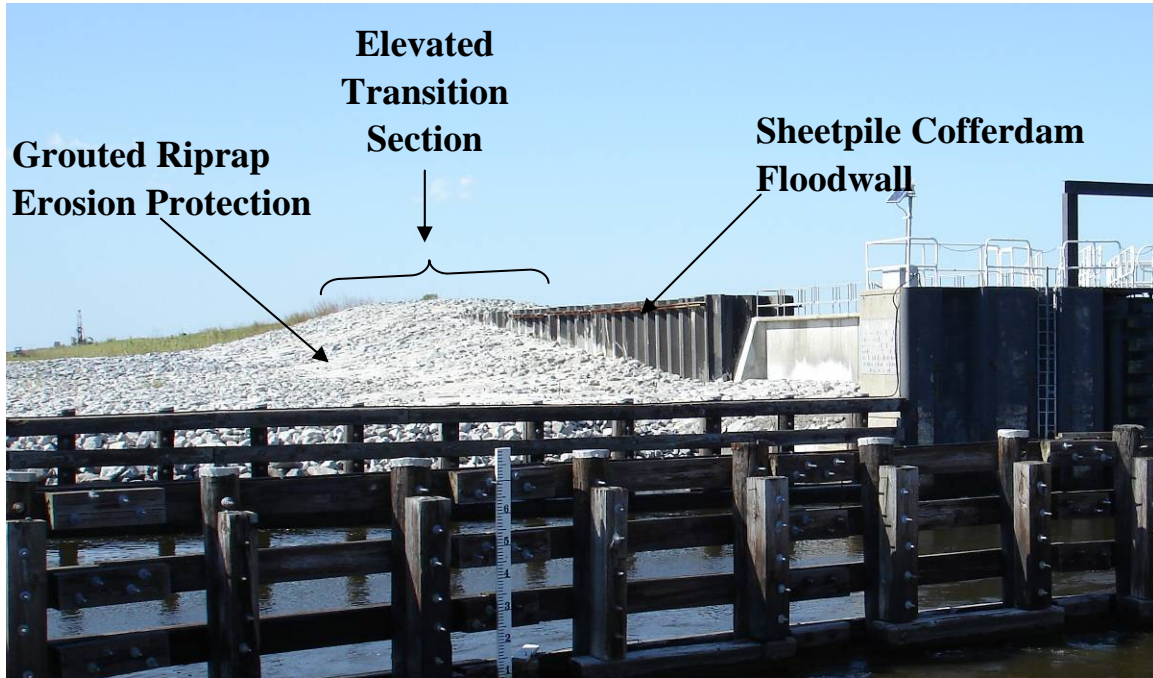
Fig. 2.2.2-2 Bayou Dupree Gate, October 2008, northwest flank, protected side, looking north (L. Wooten)

Figure 2.2.2-2 shows the improvements constructed by the USACE to the same section of gate. The concrete sheetpile I-wall has been replaced with a steel sheetpile cofferdam section, and the transition to the earthen levee has been elevated and covered with grouted riprap. The use of grouted riprap to harden vulnerable areas around the gate has been extensive as illustrated in Fig. 2.2.2-3. UngROUTED riprap has also been placed as erosion protection at the toe areas of grouted riprap.

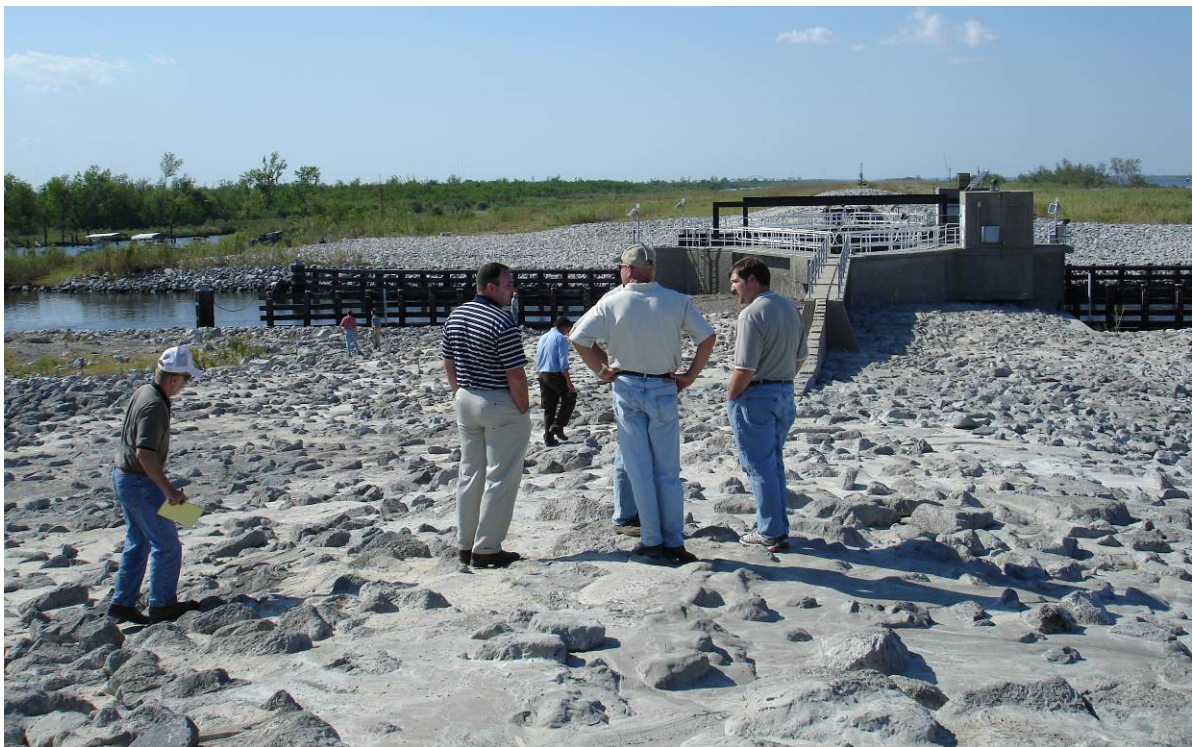
Fig. 2.2.2-3 Bayou Dupree Gate, October 2008, southeast flank, crest, looking northwest (L. Wooten)

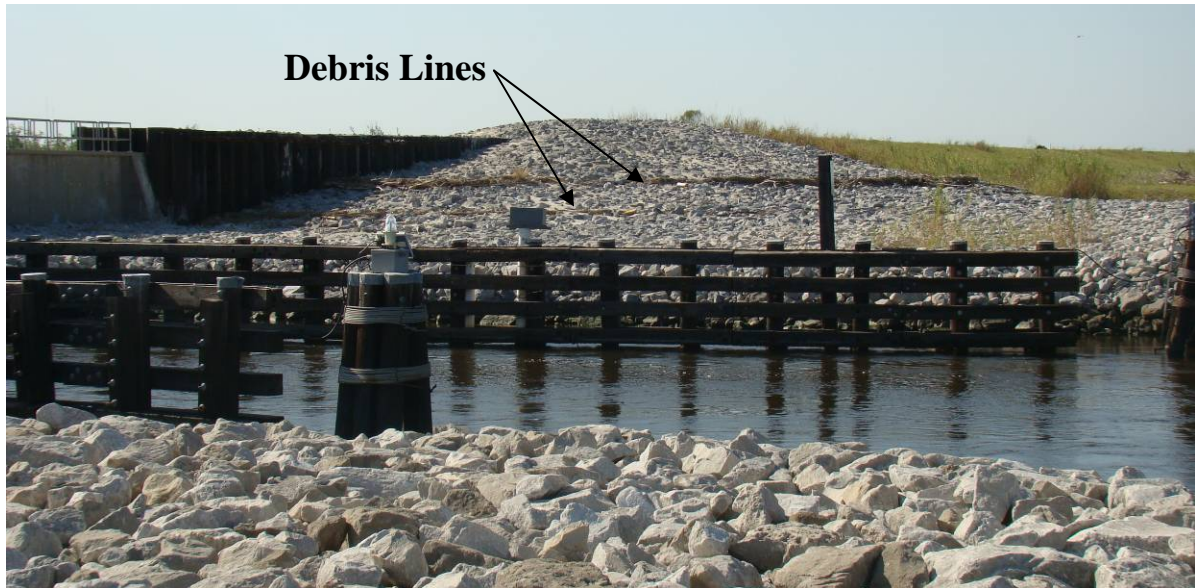
We observed no signs of erosion or damage from Gustav's high water and waves at or near the gate. The limited debris line on the northwest flank appeared to indicate that the highest waters from Gustav were several feet below the crest of any of the gate structure elements (see Fig. 2.2.2-4).

Fig.2.2.2-4 Bayou Dupree Gate, October 2008, northwest flank, MRGO side, looking east. The lower debris line may represent the high water level during Ike. (L. Harder)

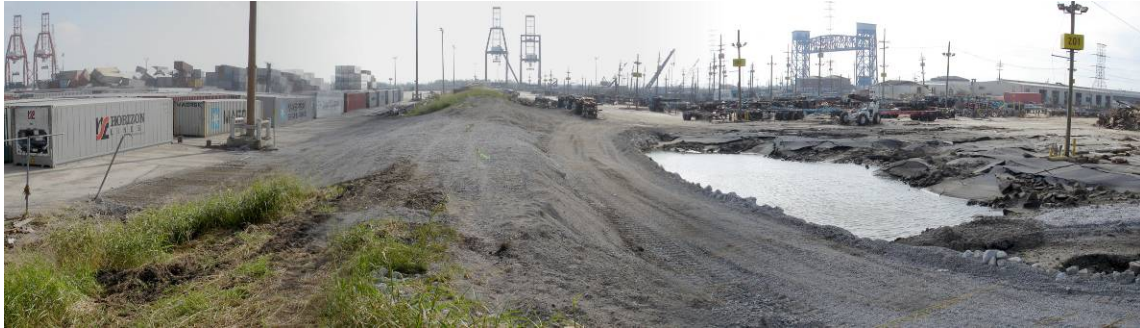
Fig. 2.4.1-2 IHNC West levee Katrina breach site, October 2005 (Breach had been temporarily repaired. Note scour hole.) (L. Wooten)

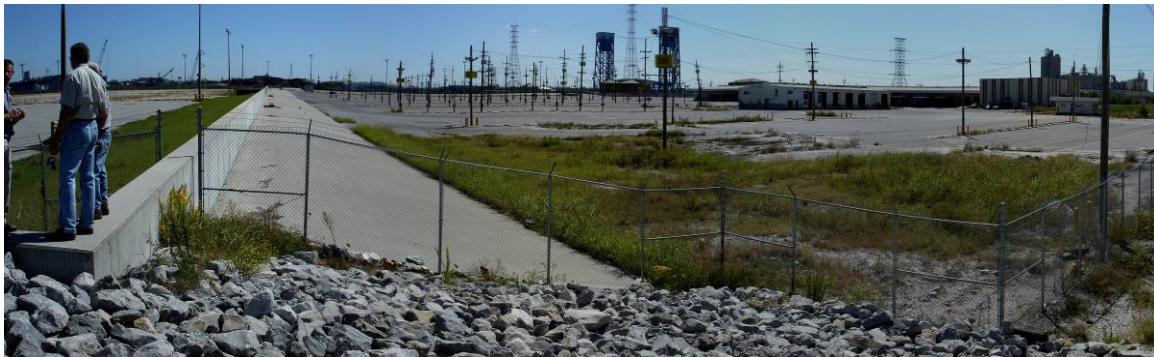
Fig. 2.4.1-3 IHNC West new floodwall at location of breach shown in Fig. 2.4.1-2, October 2008 (L. Wooten)

Repairs and improvements of these failed and distressed sections included raising and buttressing embankment sections, armoring of embankment-concrete floodwall transitions, replacement of I walls with L-walls (due to space constraints), and buttressing of pre-existing I-wall sections to reduce the stick-up height (the height of wall above finished grade). Figures 2.4.1-2 and 3 show the post-Katrina (October 2005) and post-Gustav (October 2008) conditions at the location of the earth levee breach. Figures 2.4.1-4 and 5 show the post-Katrina and post-Gustav conditions at the railroad gate transition breach location. Figures 2.4.1-6 and 7 show the post-Katrina and post-Gustav conditions at the I-wall breach location.

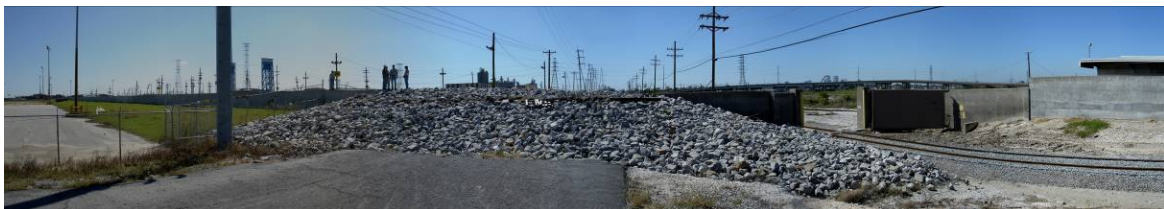
Fig. 2.4.1-5 IHNC West repaired breach at railroad gate transition, October 2008 (L. Wooten)

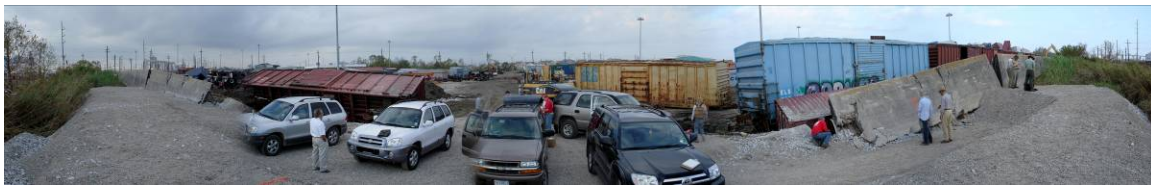
Fig. 2.4.1-6 IHNC West I-wall Katrina breach site, October 2005 (L. Wooten)

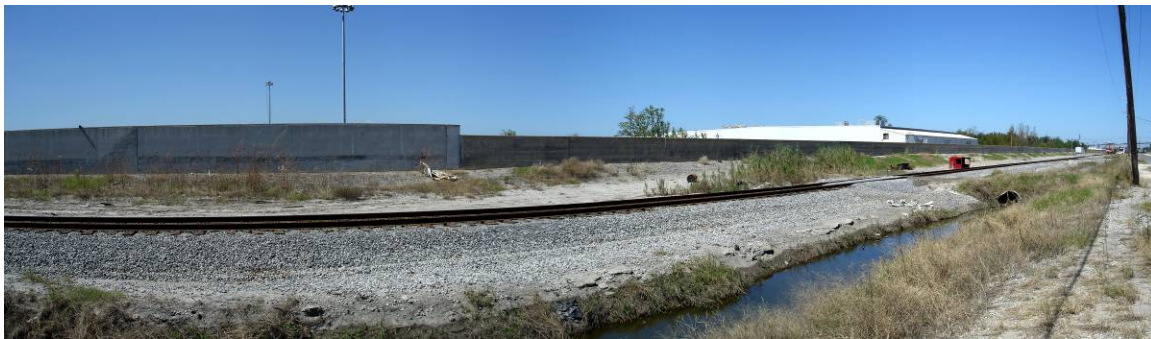
Fig. 2.4.1-7 New L-wall – old I-wall transition near location of Katrina I-wall breach on IHNC West (L. Wooten)

L-walls were used to replace damaged I-walls instead of T-walls because the L-walls provided suitable stability and because railroad rights of way restricted space for construction.

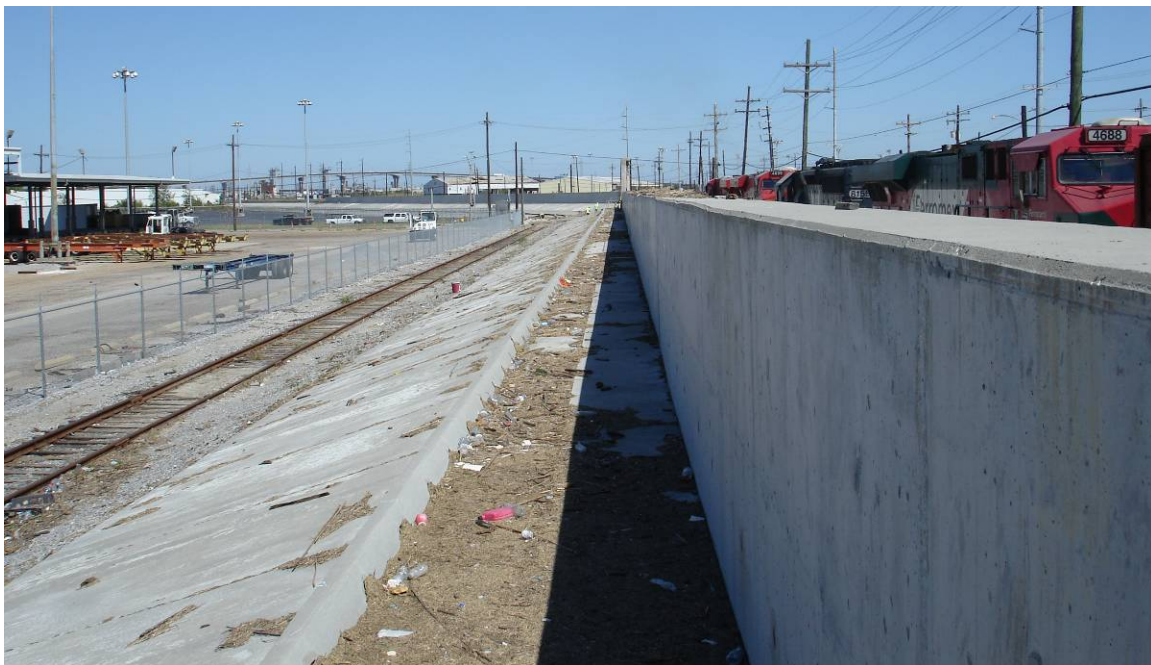
The repairs and improvements of these sections of the hurricane protection appeared to have performed well in light of clear evidence of wave overtopping. Figure 2.4.1-8 shows the debris left by overtopping waves on the protected side of one section of new L-wall along the IHNC West.

Fig. 2.4.1-8 Protected side of new L-wall along IHNC West. Note debris left by overtopping on floodwall and slope protection. October 2008 (L. Wooten)

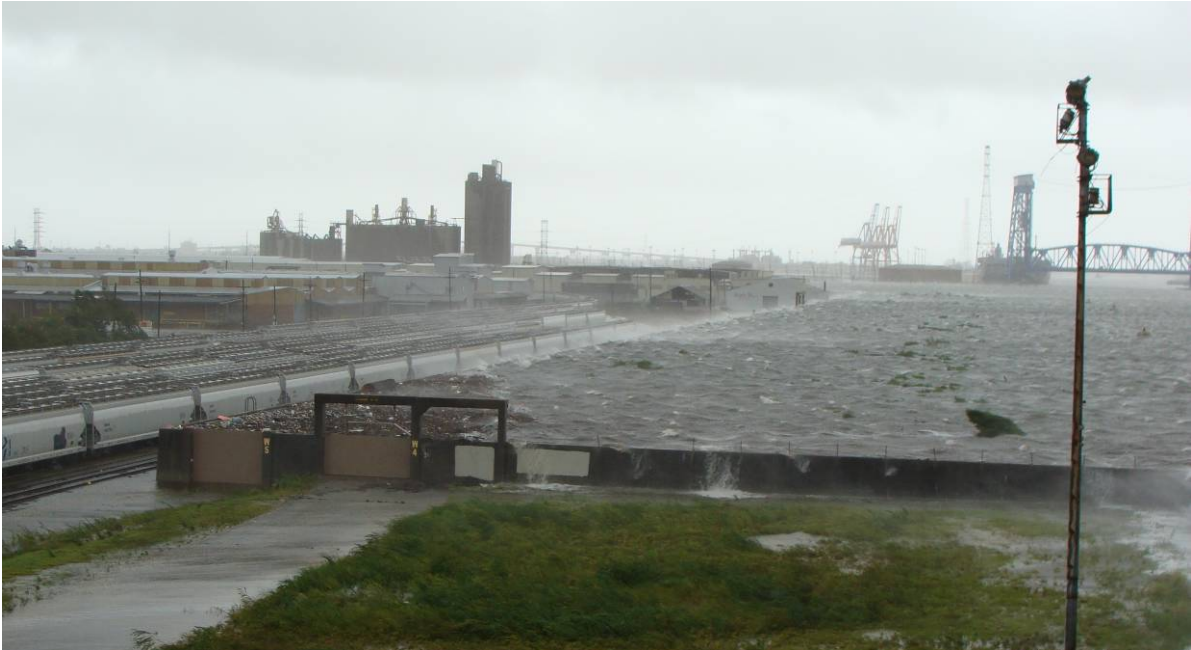
Fig. 2.4.2-2. Photograph from Sept. 1, 2008 of Gustav storm surge. Photograph taken from Claiborne Ave. Bridge looking north. The waves are overtopping the T-wall. (USACE)

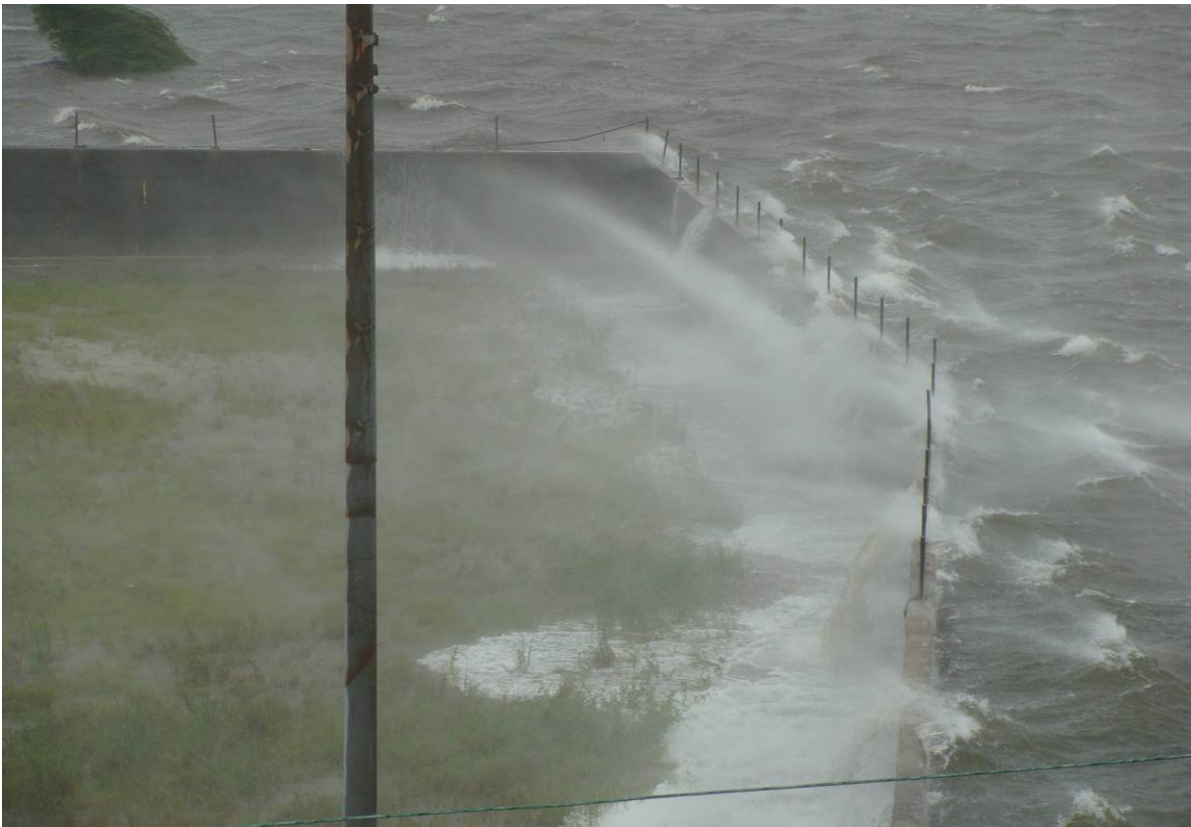
Fig. 2.4.2-3. Photograph from Sept. 1, 2008 of Gustav storm surge. Photograph taken from Claiborne Ave. Bridge looking north at T-wall southeast of floodwall shown in Fig. 2.4.2-2. (USACE)

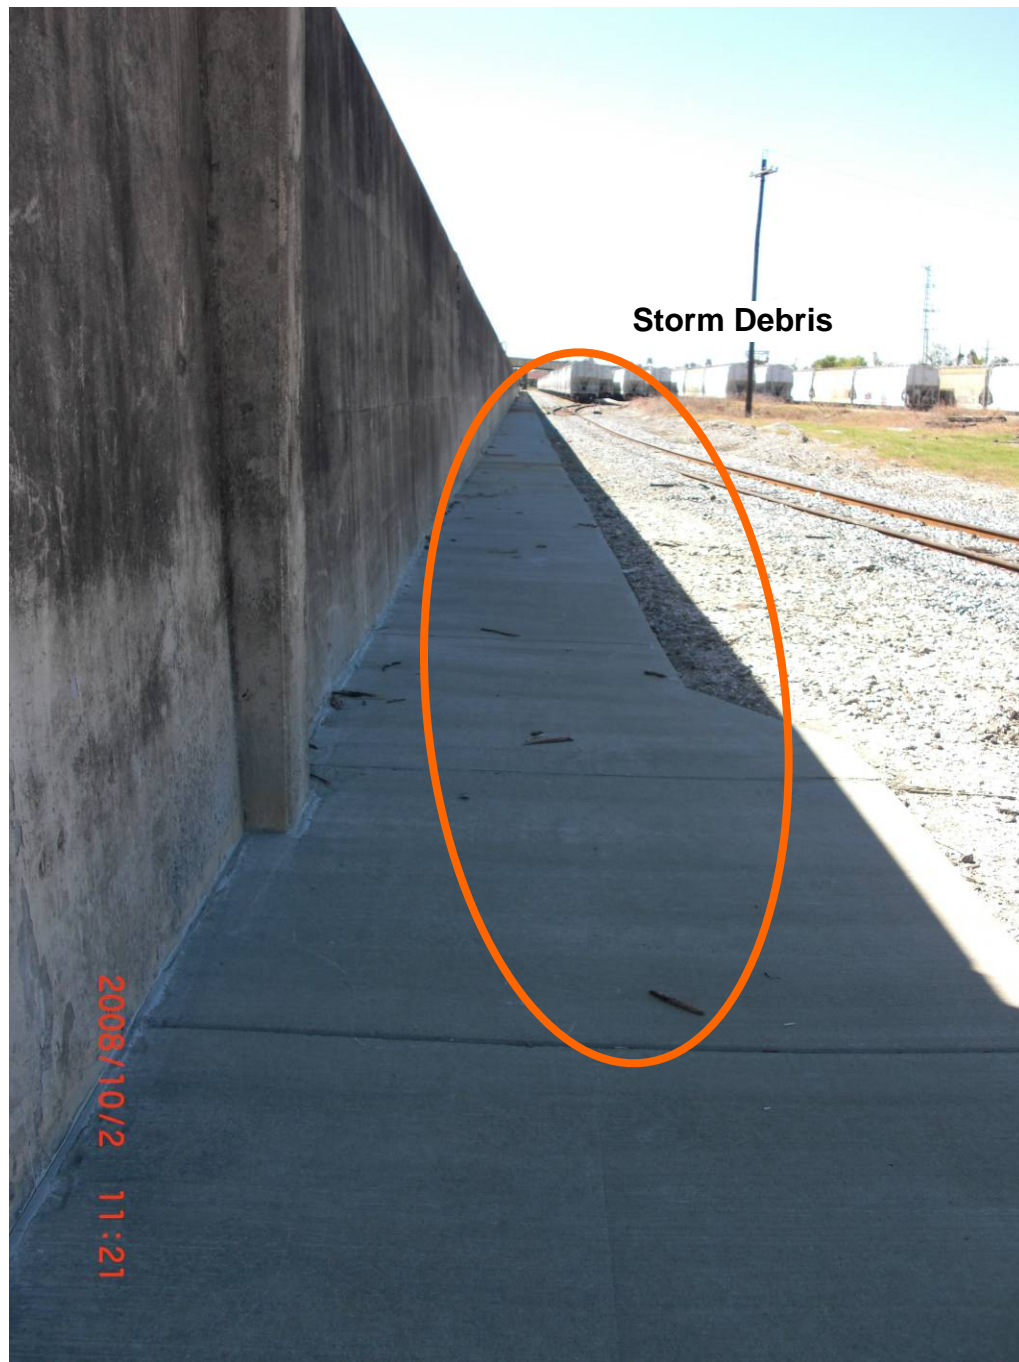
Fig. 2.4.2-4 Photograph from Oct. 2, 2008 of IHNC west side T-wall (same section as shown during Gustav in Fig. 2.4.2-2). Picture taken looking south on the protected side (IHNC is to the left and Claiborne Ave. Bridge is in the background). Waves overtopped this wall based both on the photos during Gustav (Fig. 2.4.2-2) and the debris still there on Oct. 2, 2008 (see above). The concrete splash apron was added here after Katrina to protect from erosion. After Gustav, there was evidence of minor erosion in the ballast of the railroad tracks to the right, but no evidence of distress to the wall itself or to the splash apron. (R. Gilbert)

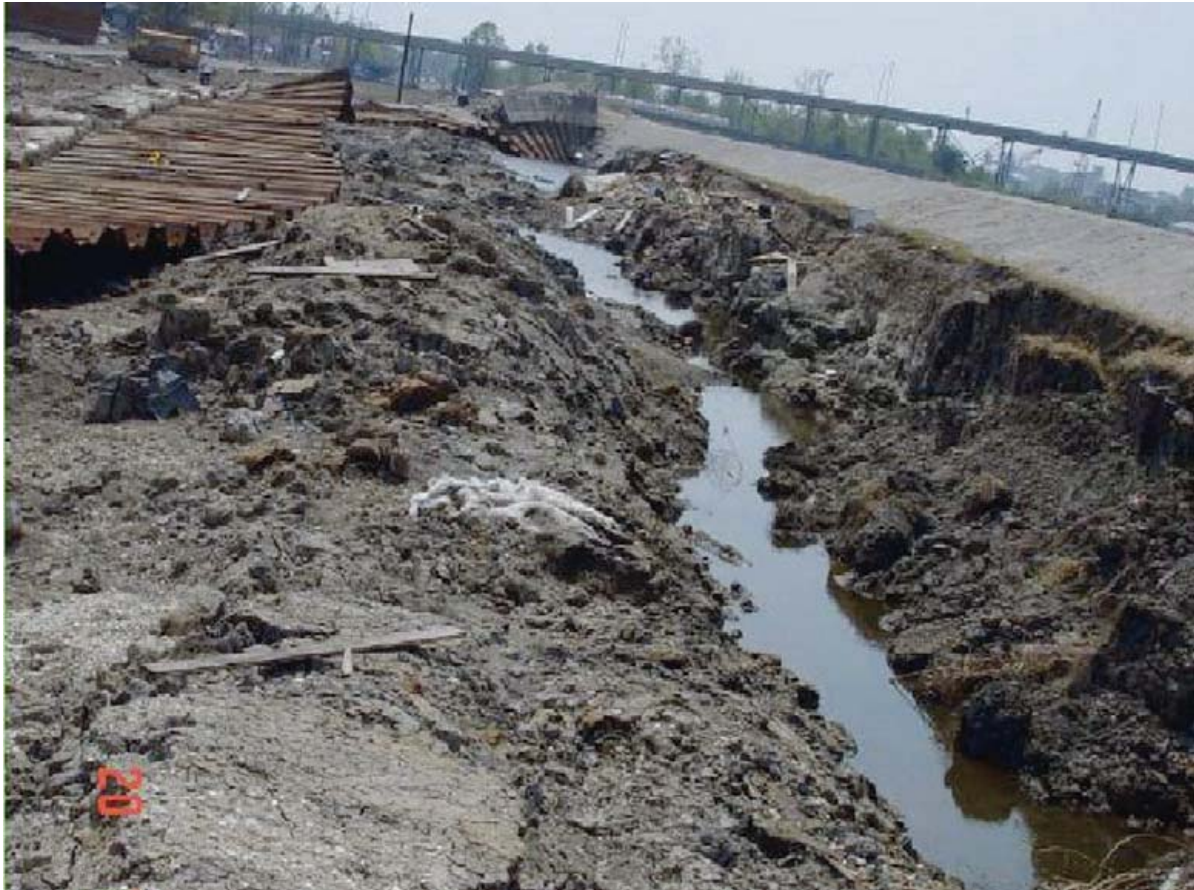
Two breaches occurred during Hurricane Katrina on a stretch of I-wall between Claiborne and Florida Avenues on the east side of the IHNC (Figs. 2.4.3-1 to 2.4.3-4). These breaches led to flooding of the Lower 9<sup>th</sup> Ward during Katrina. The suspected cause of the southern-most breach was loss of soil support due to overtopping erosion on the protected side of the I-wall (Fig. 2.4.3-2 and Fig. 2.4.3-3), while the suspected cause of the northern-most breach was a stability failure before the surge level reached the top of the wall (Fig. 2.4.3-4). This entire stretch of I-wall, even the section between the two breaches that survived Katrina, was replaced with a T-wall (Figs. 2.4.3-5 and 2.4.3-6). The I-wall section south of Claiborne Avenue that did not breach in Katrina was left in place but was reinforced with a larger earthen berm and a buttressing structural concrete splash apron to strengthen the section, reduce the wall height, and provide overtopping scour protection.

Fig. 2.4.3-2 Photograph from 2005 of southern-most breach that occurred in the I-wall on the east side of the IHNC during Katrina. Photograph is looking south, with the IHNC on the right and the Lower 9<sup>th</sup> Ward of the left. The breach was 850 feet long and located about 100 yards north of the Claiborne Avenue Bridge (seen in background). The suspected cause of this breach was erosion of the toe on the protected side due to water pouring over the top of the wall when the surge level exceeded the top of the wall. ("Performance Evaluation of the New Orleans and Southeast Louisiana Hurricane Protection System, Volume V: The Performance - Levees and Floodwalls," Final Report of the Interagency Performance Evaluation Task Force, June 2007)

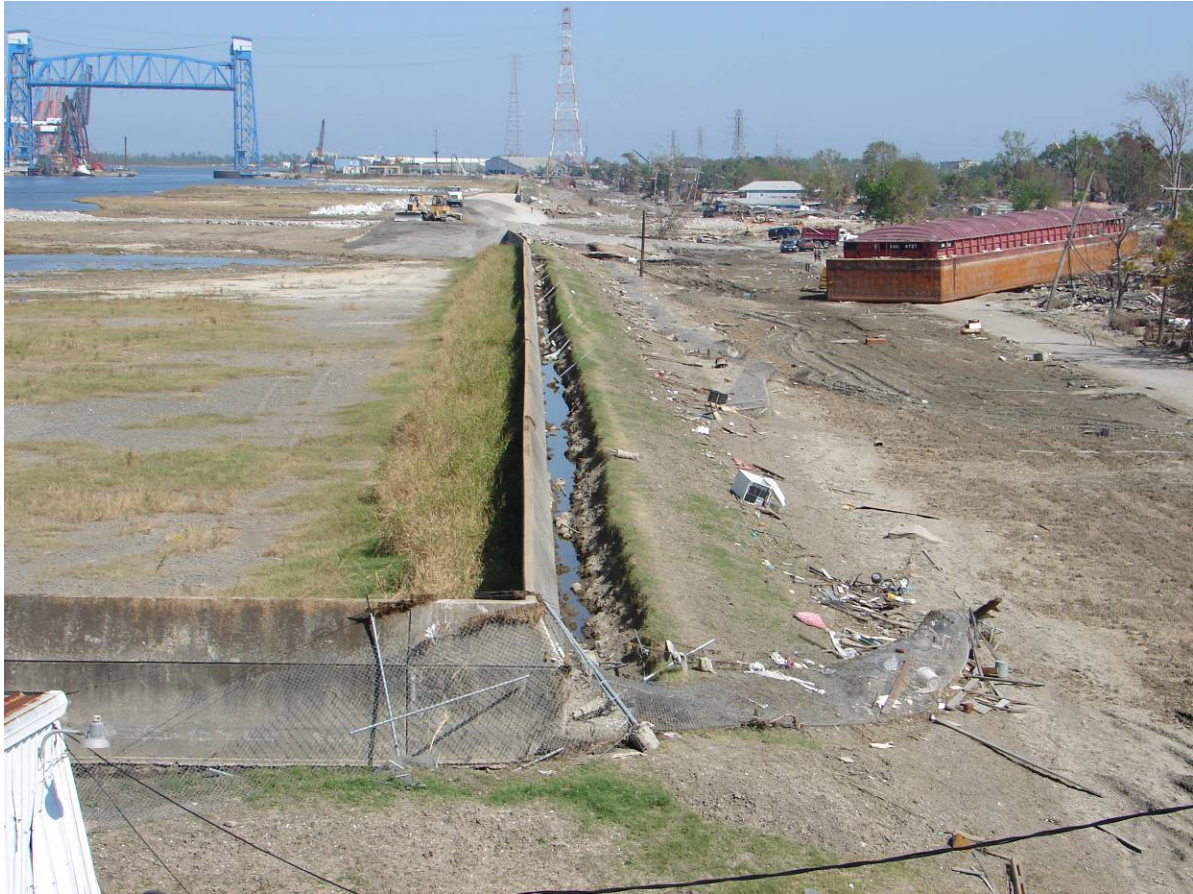
Fig. 2.4.3-3 Photograph from 2005 of southern-most breach and the scour behind the adjacent I-wall on east side of IHNC during Katrina. Photograph is looking north, from the Claiborne Avenue Bridge. (L. Harder)

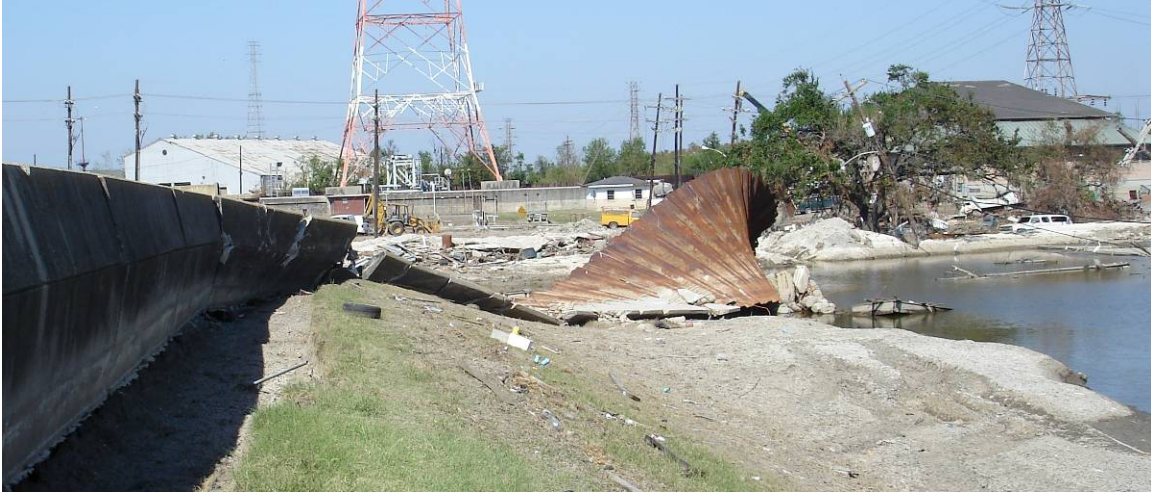
Fig. 2.4.3-4 Photograph from 2005 of northern-most breach that occurred in the I-wall on east side of the IHNC during Katrina. Photograph is looking north, with the IHNC on the left and the Lower 9<sup>th</sup> Ward of the right. The breach was 250 feet long and located just south of Florida Avenue. The suspected cause of this breach was a stability failure when the surge level was near the top of the water. (L. Wooten)

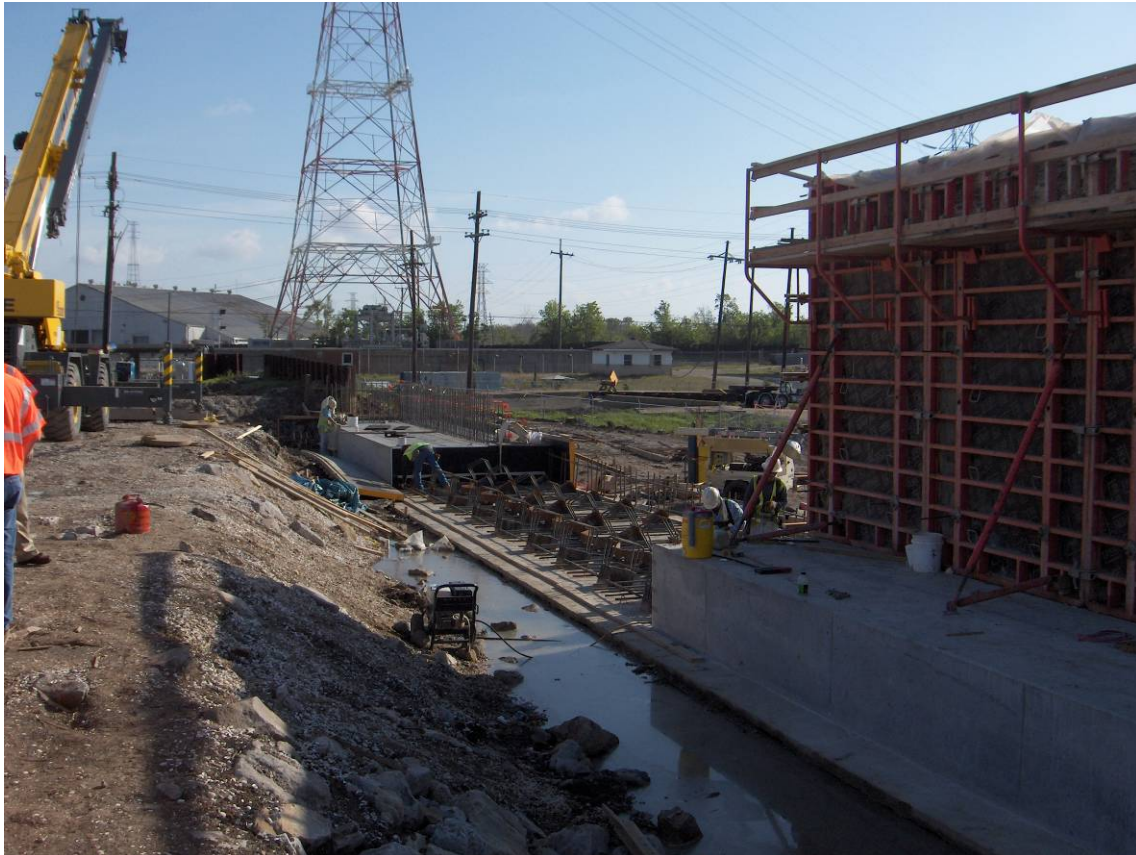
Fig. 2.4.3-5 Photograph from 2006 of T-wall being constructed to replace the I-wall that breached in two locations on the east side of the IHNC during Katrina. Photograph taken looking north at about the same location as the northern-most breach near Florida Ave. (see Fig. 2.4.3-4). (ASCE External Review Panel, May 2006)

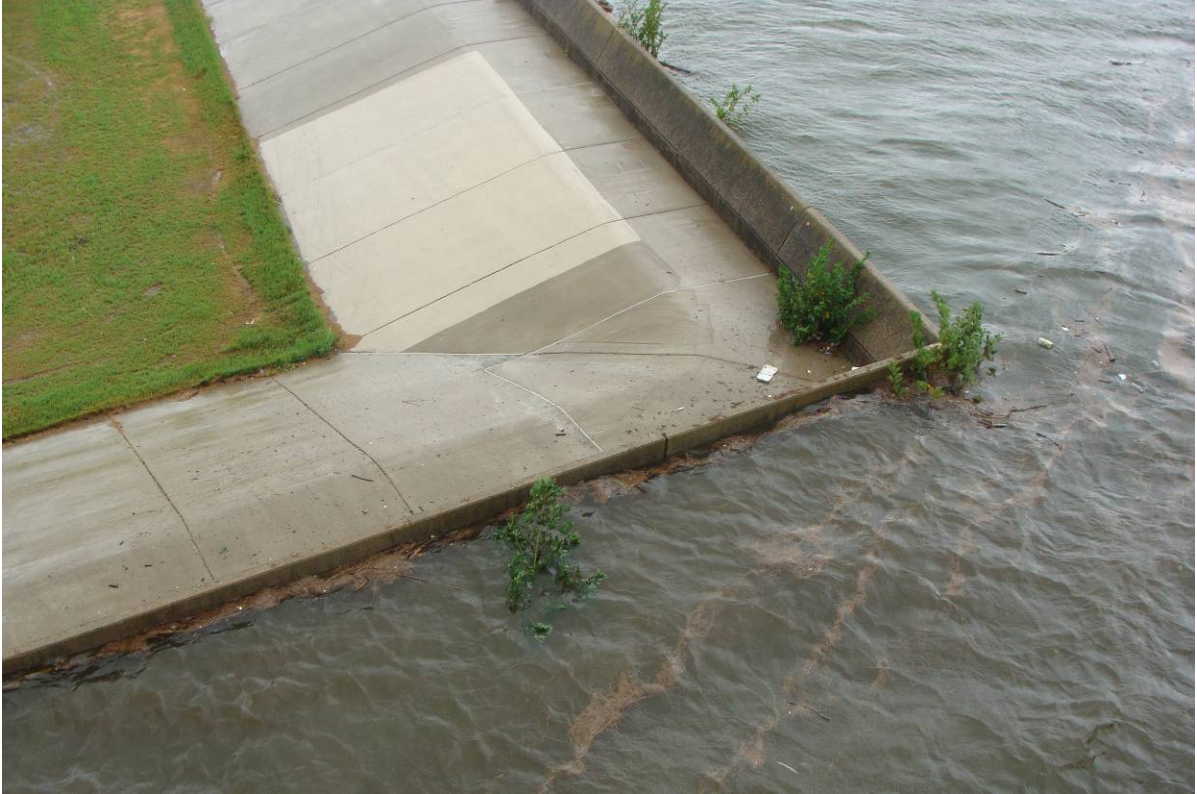
Fig. 2.4.3-7 Photograph from Sept. 1, 2008 of Gustav storm surge. Photograph taken just south of Claiborne Avenue, looking south, south-west. The storm surge is within about 1 foot of the top of the wall. The wall at this location is an I-wall that was overtopped but did not breach during Katrina. The protected side of the wall has been built up to improve stability and covered with a concrete to protect against erosion. The I-wall stick-up on the protected side is just under 4 feet, while that on the canal side is just under 6 feet. (USACE)

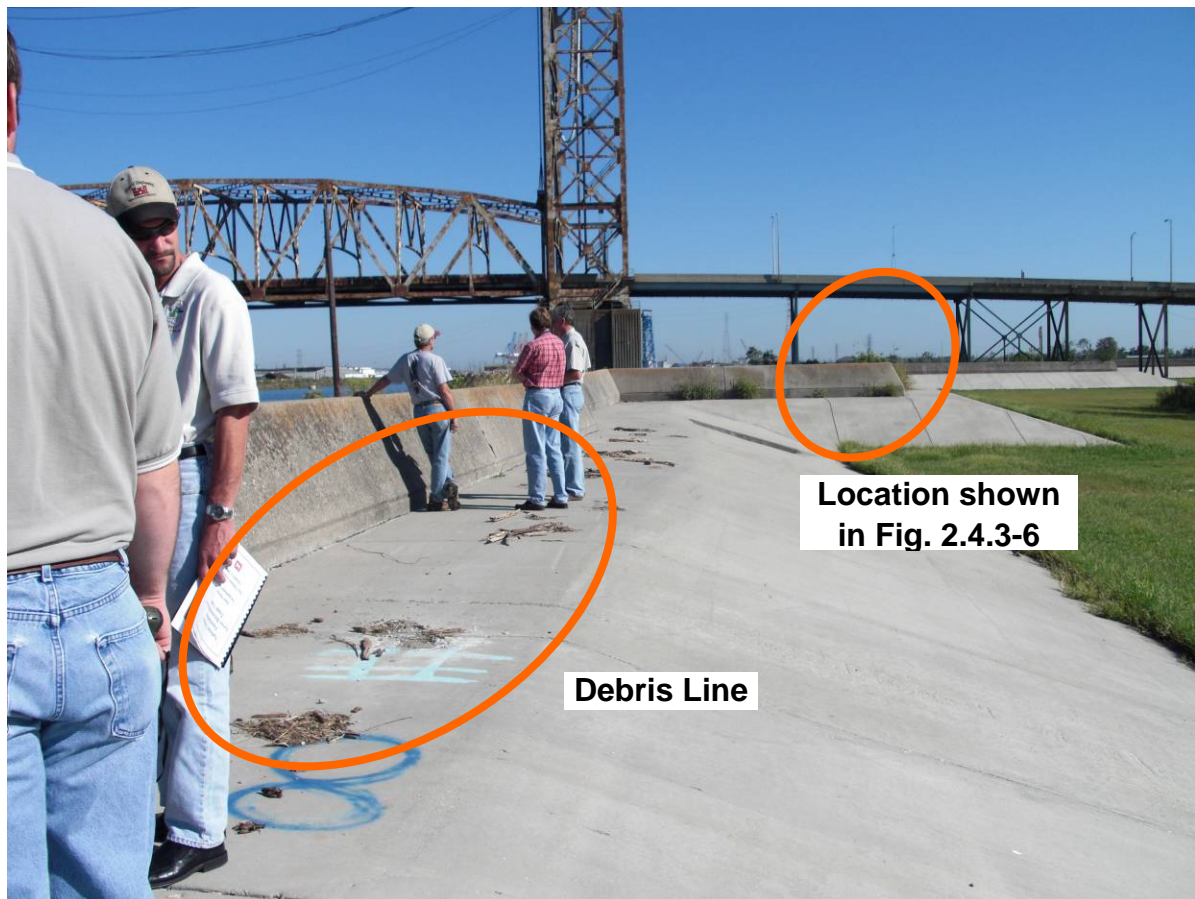
Fig. 2.4.3-8 Photograph from Oct. 2, 2008 of I-wall shown during Gustav above in Fig. 2.4.3-6. Photograph taken looking north on protected side (IHNC is to the left and Lower 9<sup>th</sup> Ward to the right); location shown in Fig. 2.4.3-7 is circled. This wall was loaded with the surge within about 1 foot of the top of the wall (Fig. 2.4.3-7), and apparently had waves that overtopped it based on the debris line (circled in photo). After Gustav, there were no noticeable signs of distress here, including movement of the wall due to the surge load or erosion at the toe due to waves overtopping the wall. (R. Gilbert)

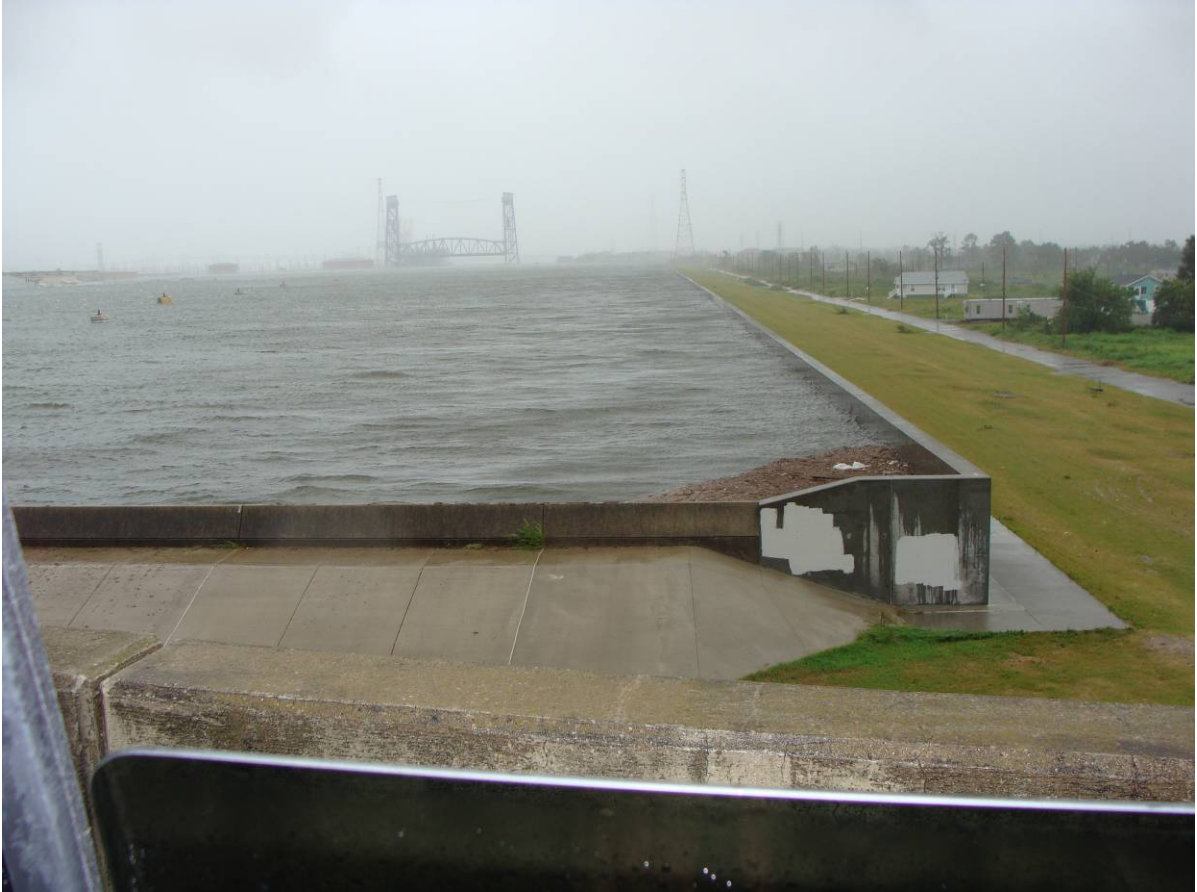
The peak still water level was several feet below the top of the new T-wall section (Fig. 2.4.3-9). After Gustav, there were no noticeable signs of distress at either the transition between the old I-wall and the new T-wall (Fig. 2.4.3-10) or along the new stretch of T-wall (Fig. 2.4.3-11). Also, there was no visible evidence of underseepage on the protected side. However, a water main leak on the protected side just south of the Florida Avenue Bridge was causing water to pond on the ground surface, making it difficult to see any evidence of underseepage.

Fig. 2.4.3-9 Picture from Sept. 1, 2008 of Gustav storm surge. Picture taken from the Claiborne Avenue Bridge, looking north toward Florida Ave Bridge (seen in background) from perspective similar to Fig. 2.4.3-3. This location is where the old I-wall section shown in Figs. 2.4.3-7 and 2.4.3-8 transitions to the new T-wall section shown being constructed in Figs. 2.4.3-5 and 6. The storm surge is close to the top of the I-wall and several feet below the top of the T-wall. (USACE)

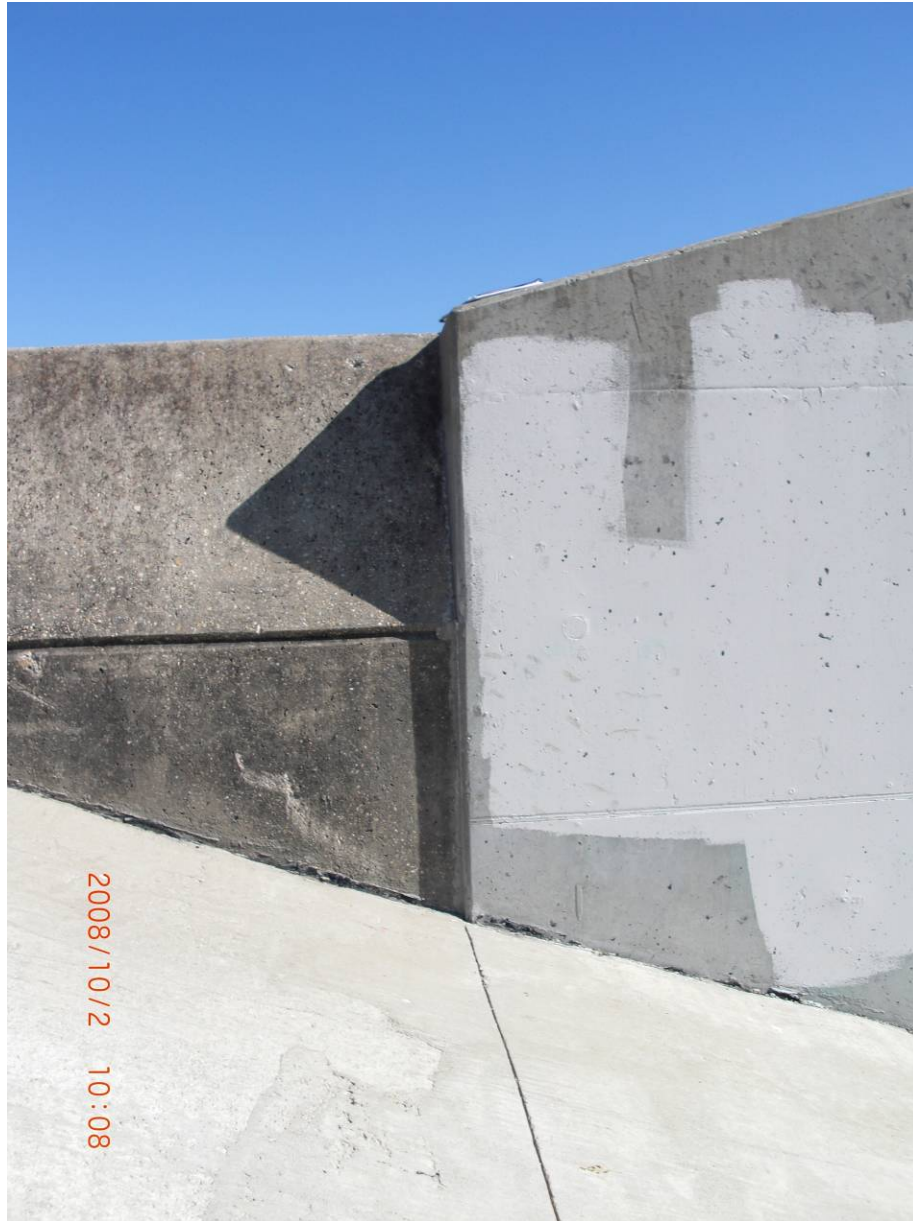
Fig. 2.4.3-10 Photograph from Oct. 2, 2008 of transition between old I-wall and new T-wall (shown in Fig. 2.4.3-3 post-Katrina and Fig. 2.4.3-9 during Gustav). Picture taken looking north from the protected side (same orientation as Fig. 2.4.3-3 and Fig. 2.4.3-9). After Gustav, there were no noticeable signs of distress at this transition. (R. Gilbert)
