# **Reconnaissance of the New Orleans Hurricane and Storm Damage Risk Reduction System after Hurricane Gustav**

R. Lee Wooten, P.E., Robert B. Gilbert, Ph.D., P.E., William F. Marcuson, III, Ph.D., P.E.,  
Leslie F. Harder, Jr., Ph.D., P.E., G.E., and Peter G. Nicholson, Ph.D., P.E.

Geoengineering Extreme Events Reconnaissance (GEER) Association.

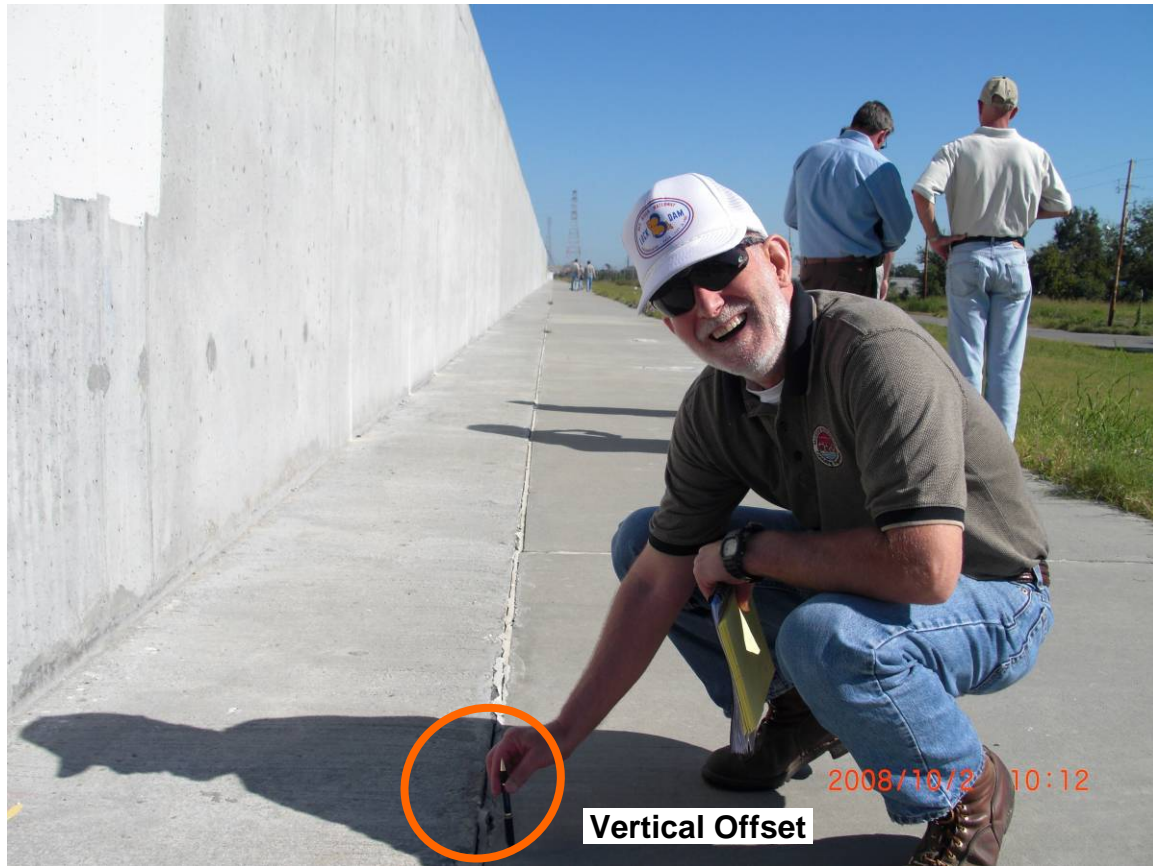
Fig. 2.4.3-11 Photograph from Oct. 2, 2008 of new T-wall section between Claiborne and Florida Avenues (shown in Fig. 2.4.3-9 during Gustav). After Gustav, there were no noticeable signs of distress in this wall. One potentially interesting feature here is the approximately 1-inch-deep vertical offset between the pile-supported base of the wall (to the left of the caulked joint) down to the concrete slab-on-grade splash apron (to the right of the caulked joint). If this splash apron was cast to be flush with the base of the wall, then this offset is possibly an indication of differential settlement between the pile-supported wall and the surrounding ground. If it is settlement, the rate is approximately 1 inch over two years, or 0.5 inches per year, and is likely occurring in the upper 70-feet of the profile (because the piles tip is approximately 70 feet below the ground surface – see Fig. 2.4.3-6). (R. Gilbert)

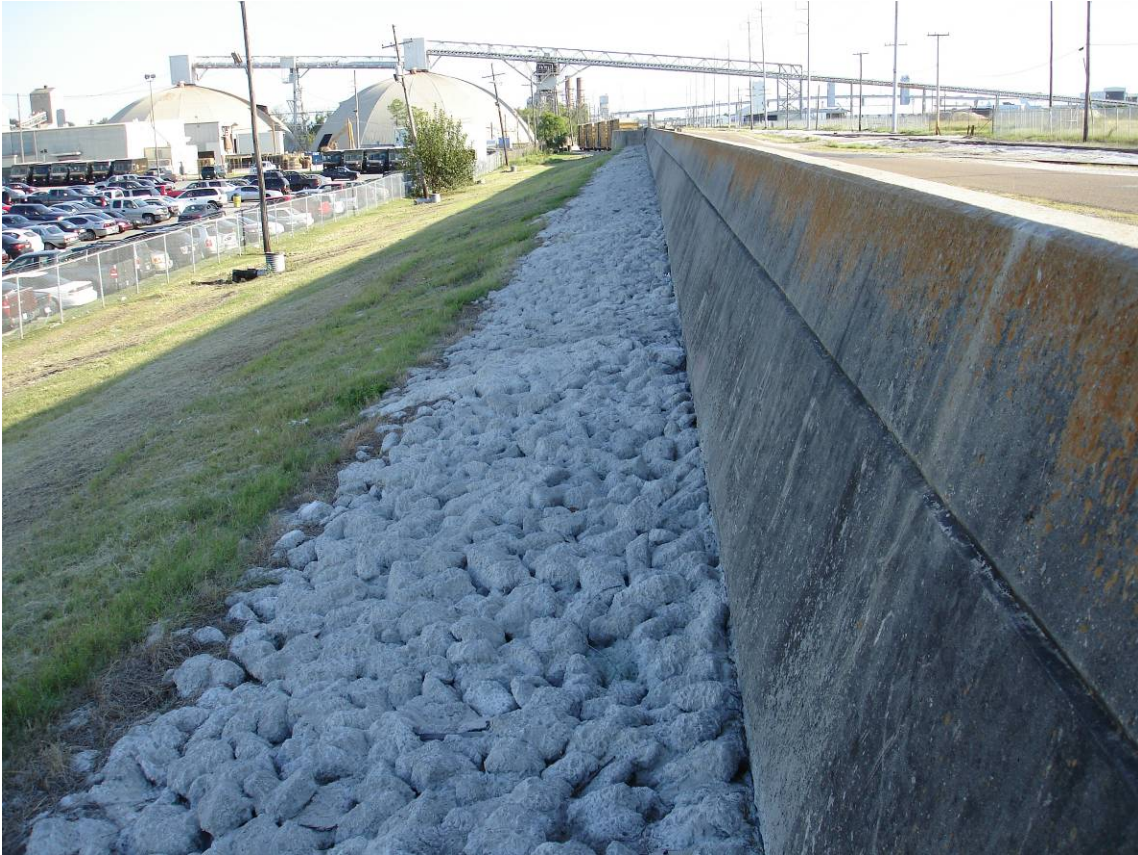
Fig. 2.4.4-1 IHNC Floodwall near East Morrison Road. Note splash apron (center) and relief wells (left). (L. Wooten)

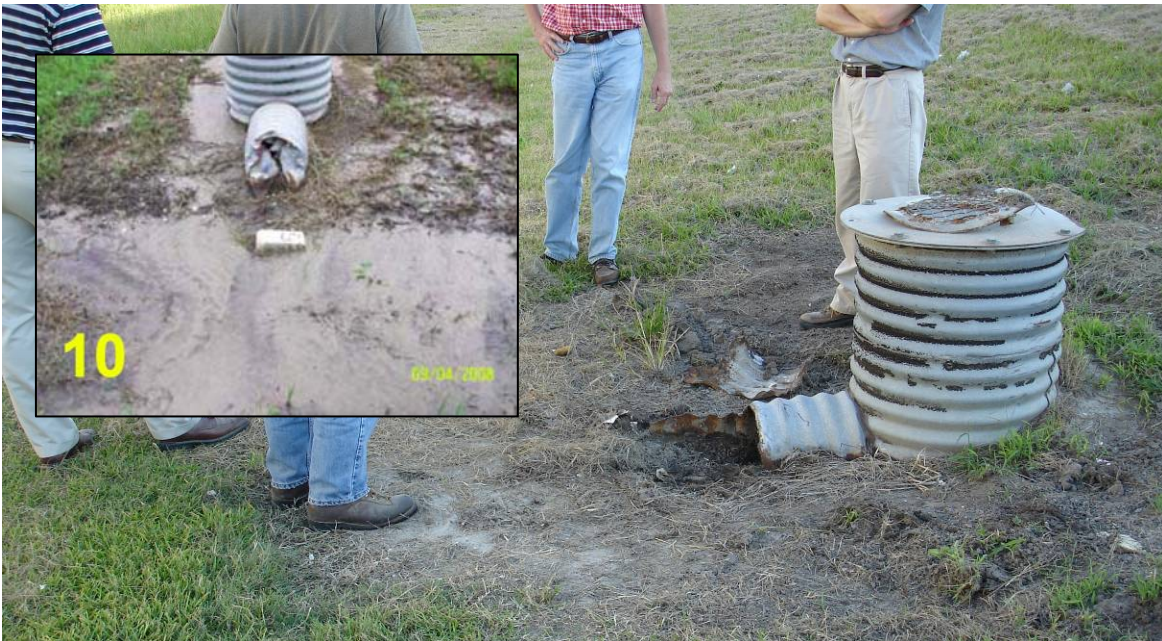
Fig. 2.4.4-2 Relief Well Cover, October 2008 with inset taken from USACE Hurricane Gustav Damage Assessment Team SITREP 05 Sep 08 (L. Wooten)

We observed no signs of damage to the HSDRRS near East Morrison Road due to Gustav. The corrugated metal protective casings over the relief well outlets were in various states of deterioration. We did not see evidence of extensive sand migration out of the wells, although our observations were more than a month after Gustav, and we did not inspect all wells. The inset photo to Fig. 2.4.4-2 was taken from the USACE SITREP dated September 5, 2008 which shows a damaged outlet casing and sand that appears to have discharged from the well.

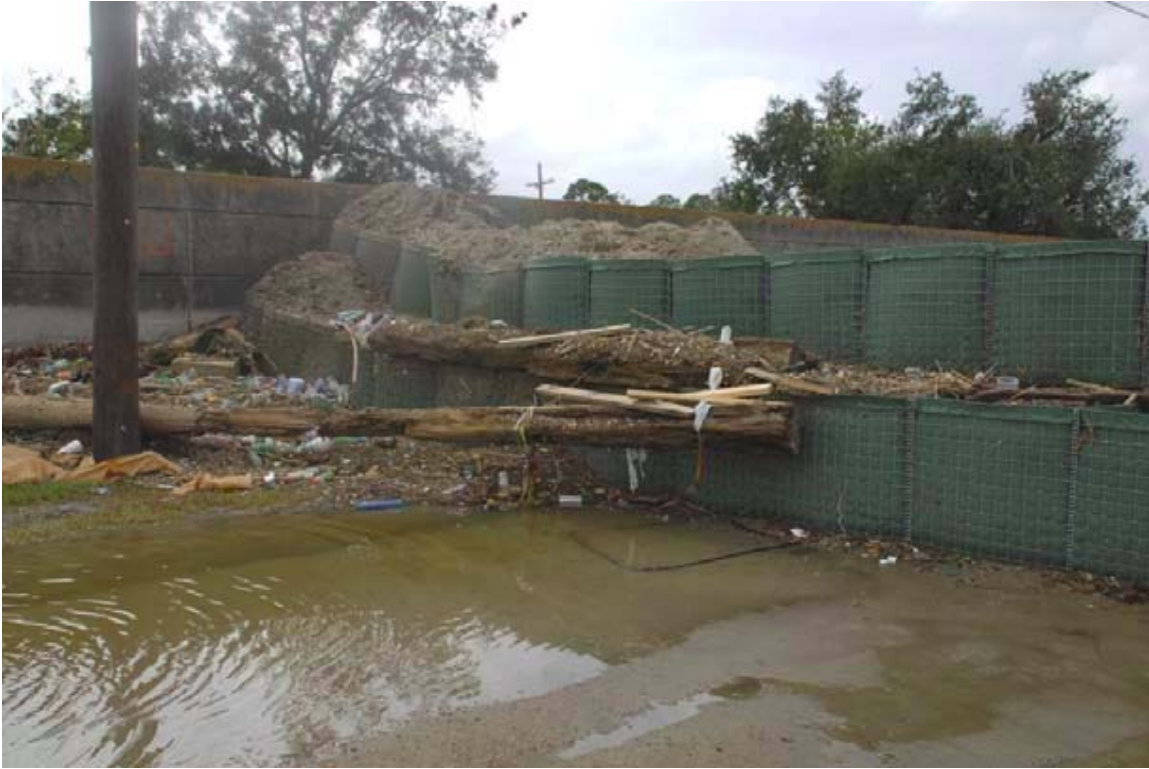
Fig. 2.4.5-2. Post-Gustav Photograph of End of Temporary Bin Wall at Tie-in to I-Wall  
([http://www.mvn.usace.army.mil/HPS/Status%20Report%20Newsletters/Sept\\_9\\_2008.pdf](http://www.mvn.usace.army.mil/HPS/Status%20Report%20Newsletters/Sept_9_2008.pdf))

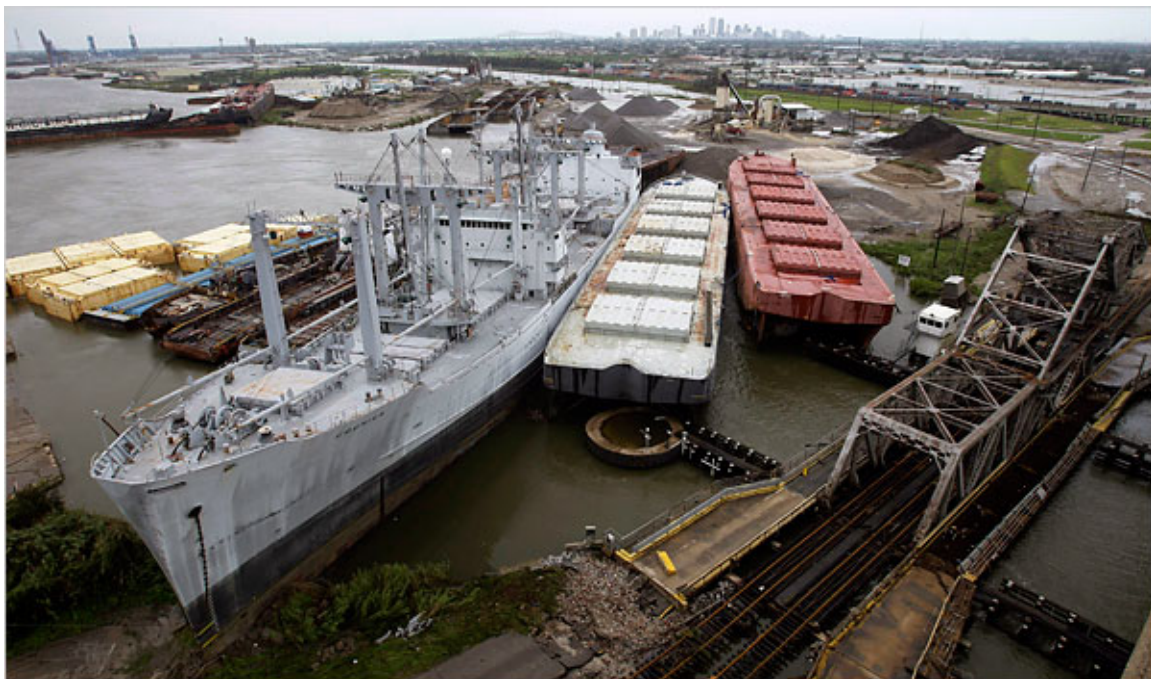
- Preparation for a hurricane requires timely action by all responsible parties. Delays by the railroad, salvage yards, boat and barge operators, operators of facilities on the flood side of the HSDRRS in clearing potential hazards could put the HSDRRS at risk.

Fig. 2.4.6-2. Ships and barges pushed against railroad bridge after Gustav, September 1, 2008 (Eric Gay, Associated Press)

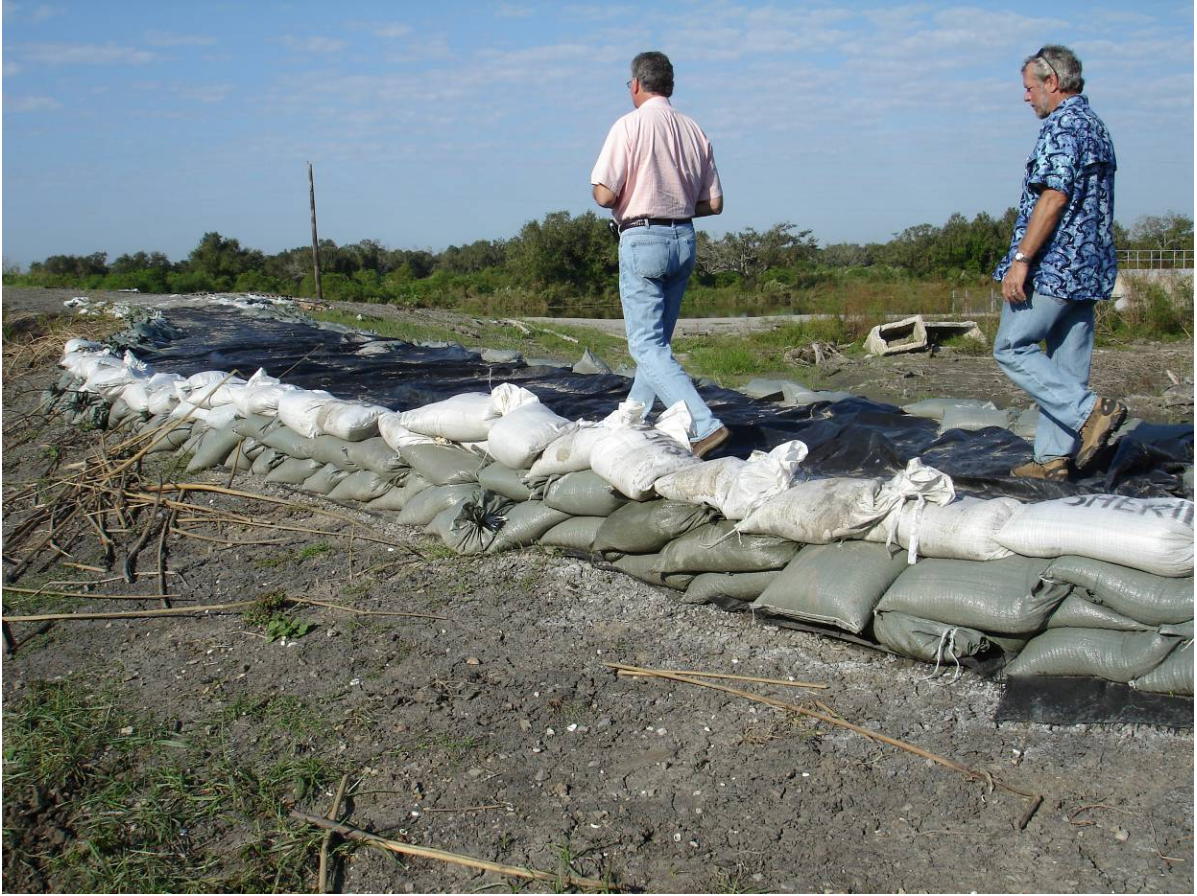
Fig. 2.6-3. Plaquemines Parish Back Levee sand bags and geotextile crest cover (L. Wooten)

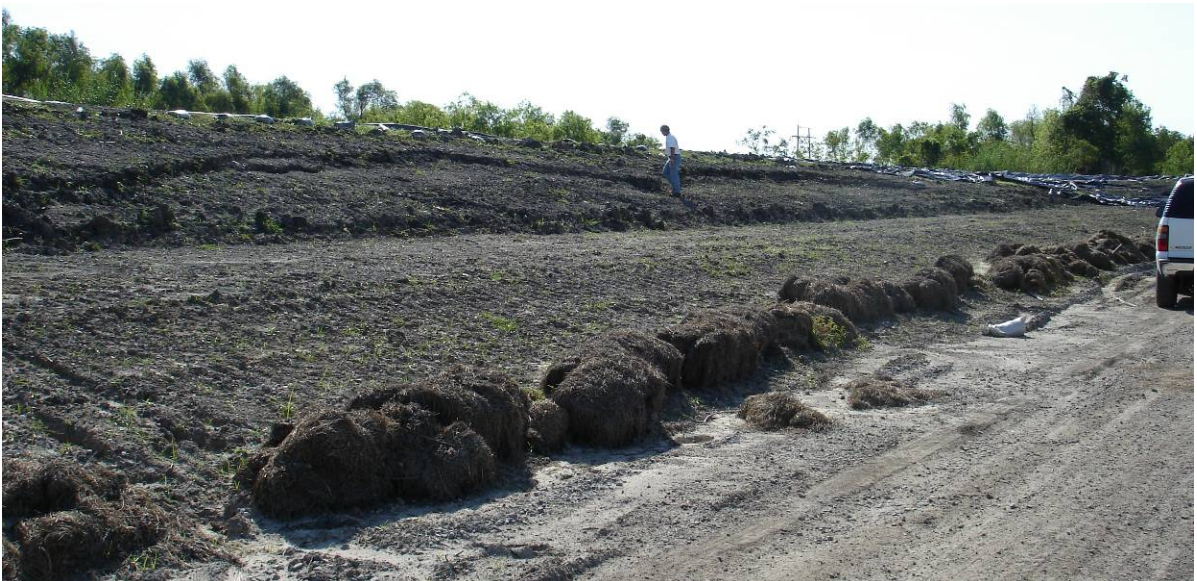
Plaquemines Parish Back Levee Performance - The non-federal back levee in Plaquemines Parish was overtopped by Gustav flood levels and was in danger of failure at the location of a shallow slide on the protected side slope. Desiccation cracks on the levee may have contributed to the slide by allowing overtopping water pressures into critical zones.

Fig. 2.6-4. Protected side slope of Plaquemines Parish back levee and slide (L. Wooten)

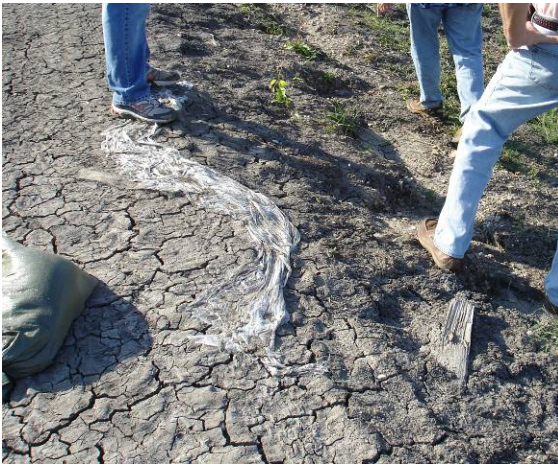
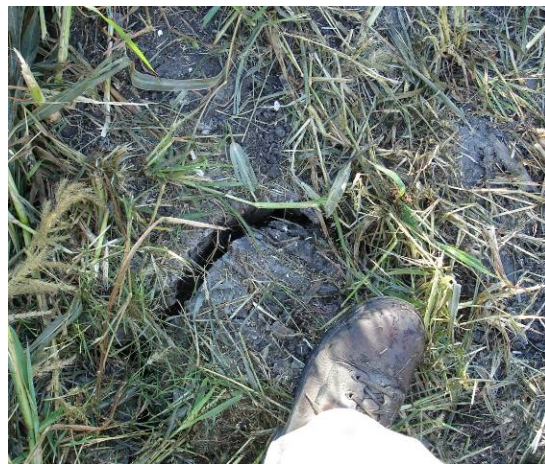
- The erosion resistance of non-federal local clay levees in Plaquemines Parish (not part of the HSDRRS) during overtopping was noted during Katrina. The clay back levees in Plaquemines Parish resisted erosion during Gustav, but may have demonstrated a potential vulnerability due to desiccation cracks. Improved placement control of water content and compaction, revised material requirements relative to plasticity and organic content, or landscaping measures such as establishment of dense vegetation may be required to prevent desiccation.

Figs. 2.6-6 and 2.6-7. Desiccation cracks on Plaquemines Parish back levee (L. Wooten)

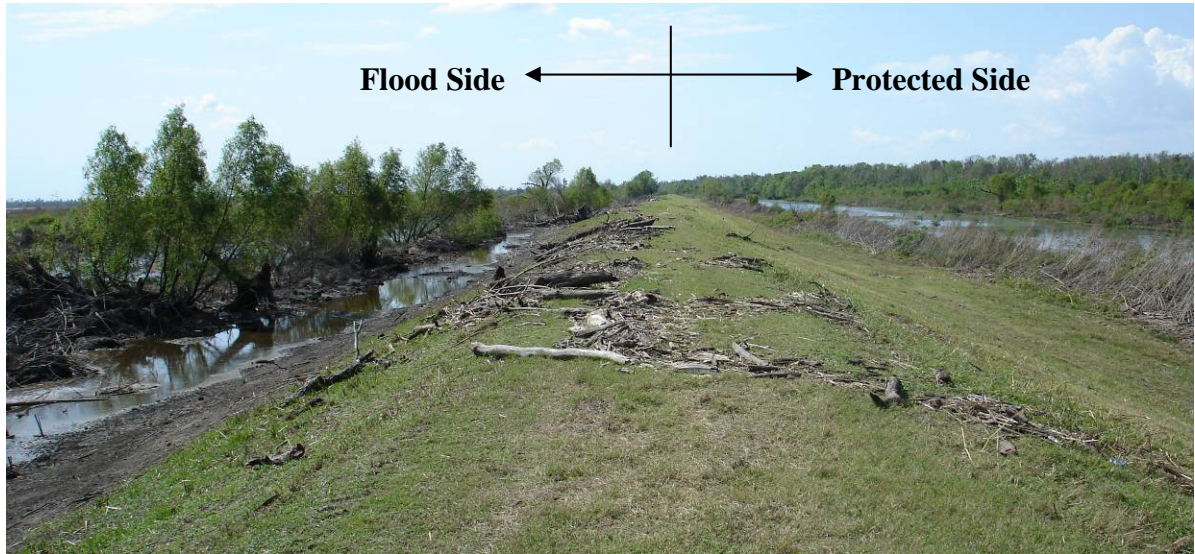
Fig. 2.6-8. Debris left by hurricane surge and waves on Plaquemines Parish back levee (L. Wooten)
