**GEOTECHNICAL EFFECTS OF  
INTENSE PRECIPITATION ON AUGUST 9, 2013, ON  
SLOPES ABOVE MANITOU SPRINGS, COLORADO,  
THAT WERE BURNED IN THE  
2012 WALDO CANYON FIRE**

Geotechnical Extreme Events Reconnaissance (GEER) Association  
Reconnaissance Dates: August 16 to 18, 2013

Jeffrey Keaton, AMEC Americas (Team Leader)  
Scott Anderson, Federal Highway Administration  
Paul Santi, Colorado School of Mines  
Shideh Dashti, University of Colorado, Boulder

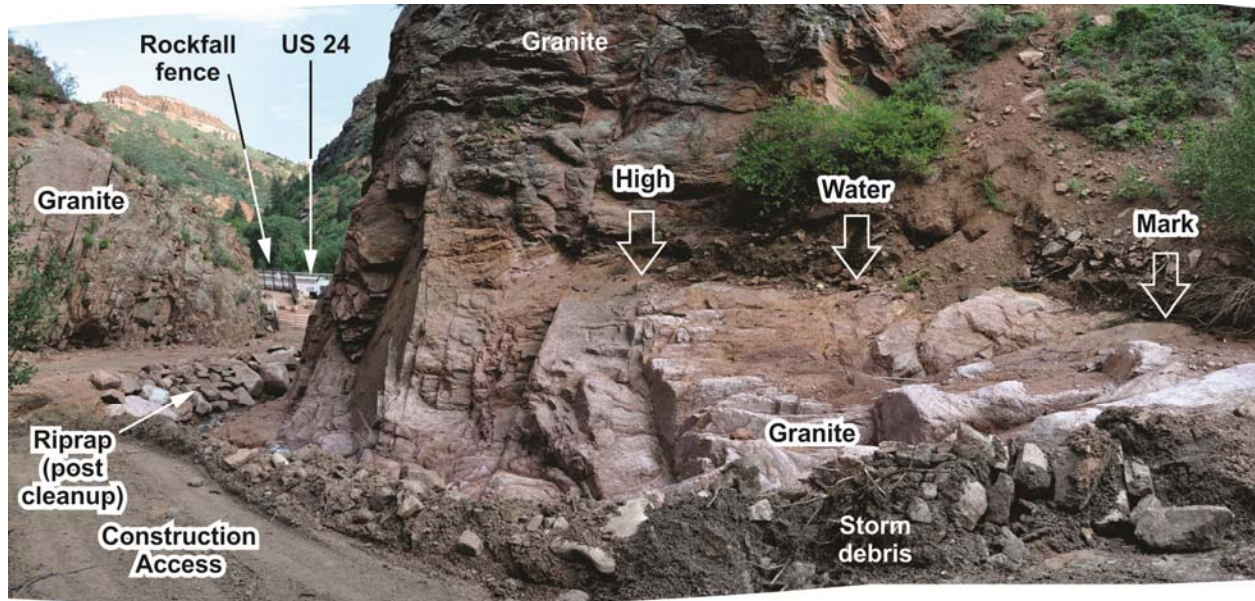
Figure 3.2.3. Lower stretch of Waldo Canyon showing rock-bed channel and high-water mark of August 9, 2013, flood. US 24 and the rockfall fence also are visible. Location is in Narrow area in Figure 3.2.2; 38.8771° N, -104.9331° W, elevation 6796 ft; view azimuth is 155° (SE).

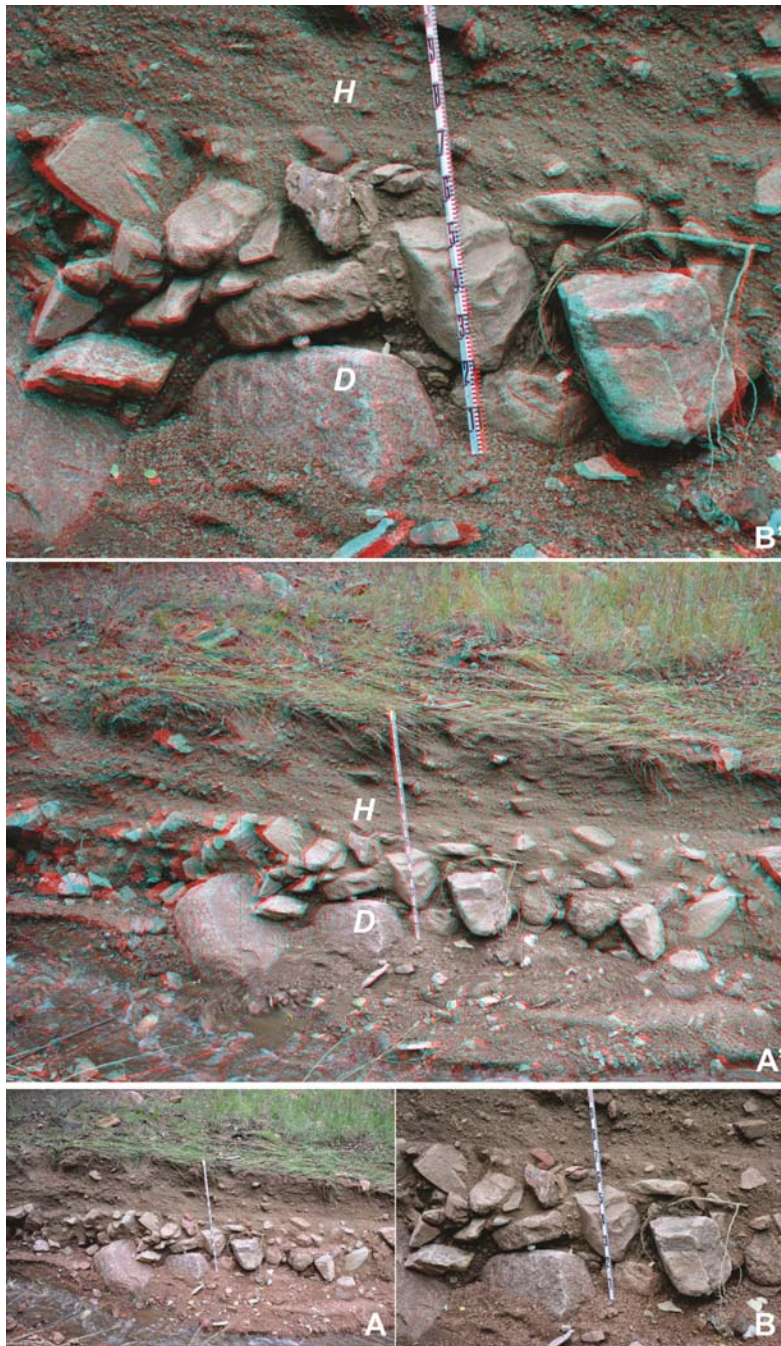
Figure 3.2.4. Pre-August 9, 2013, debris flow (D) and hyperconcentrated sediment flow (H) deposits exposed in channel of Waldo Canyon. A and B are photographs; A' and B' are red-cyan anaglyphs made with StereoPhotoMaker v. 4.41. Ruler numbers are decimeters. Location is a short distance above Narrow area in Figure 3.2.2; 38.8778° N, -104.9337° W, elevation 6846 ft.

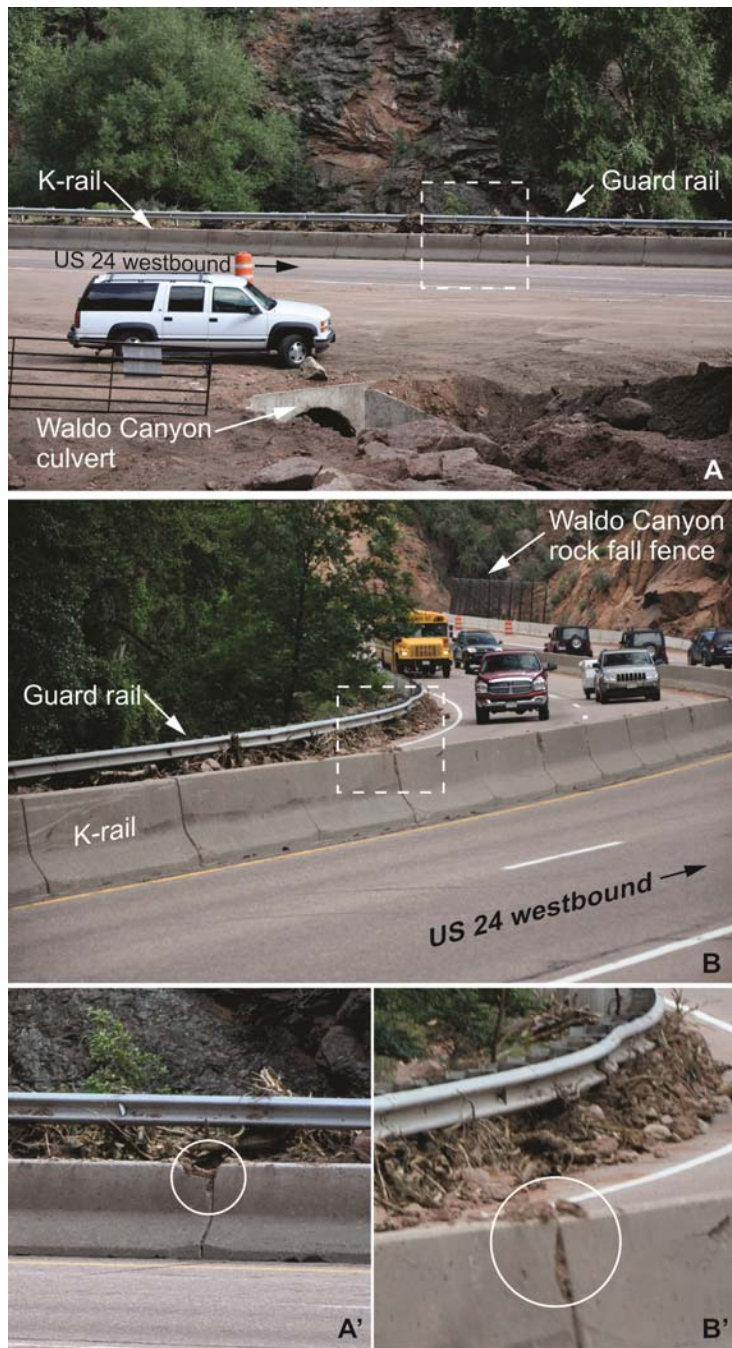
Figure 3.2.6. Rock and woody debris on K-rail and under guard rail on eastbound US 24. A. view from mouth of Waldo Canyon (38.877° N, -104.932° W); B. view from wide shoulder on westbound US 24 (38.8754° N, -104.9292° W). A' and B' are inset photos for A and B, respectively; soil on K-rails marked by open white circles.

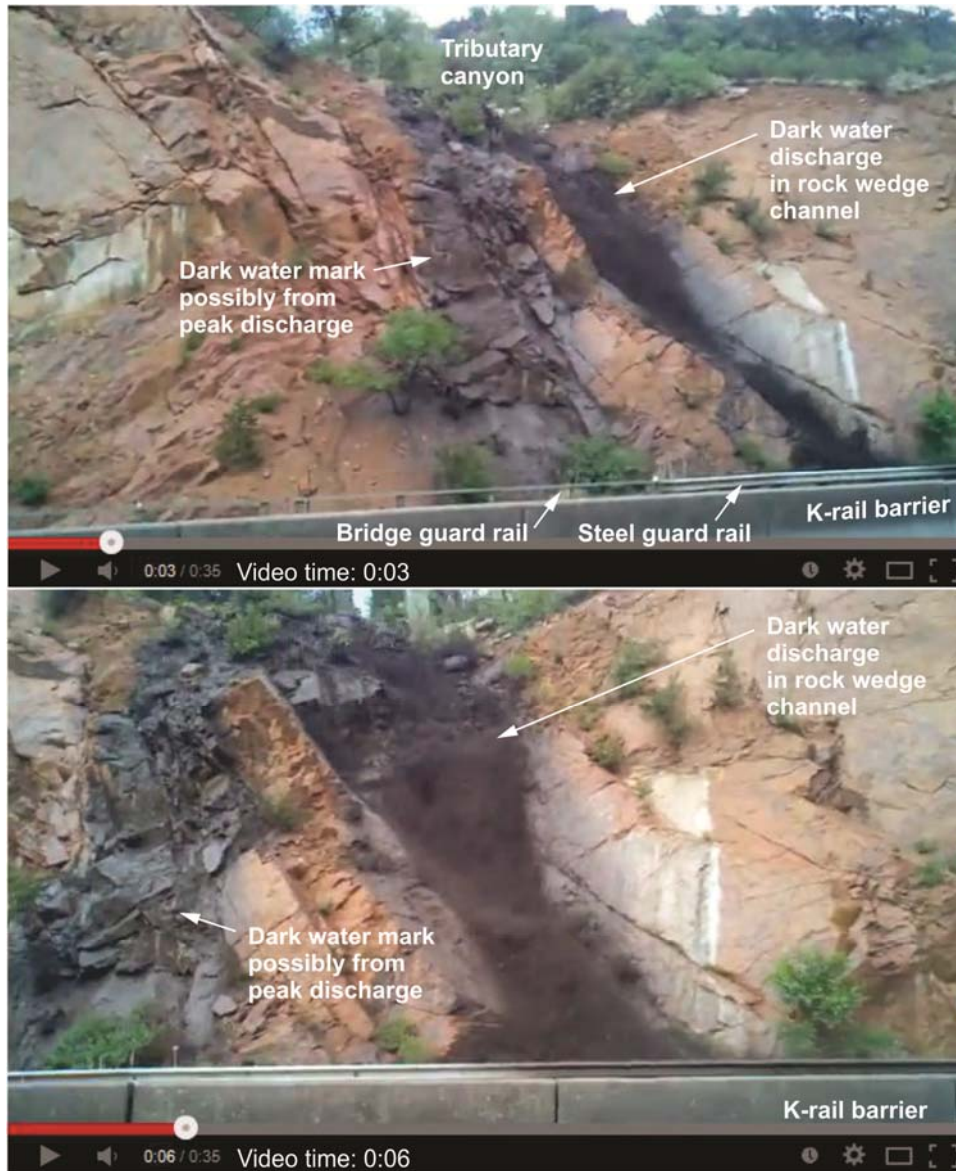
Figure 3.2.14. Screenshots from YouTube video by MMaksimow at two times during its 0:35 duration. Upper (video time 0:03): dark water discharge over cut slope on westbound US 24 shoulder just southeast of overpass on Manitou Avenue where it becomes the westbound on-ramp; view toward the northeast over K-rail barrier from eastbound lanes of US 24 showing the transition from steel guard rail to bridge guard rail. Lower (video time 0:06): same view as upper screenshot with rock wedge more clearly visible.

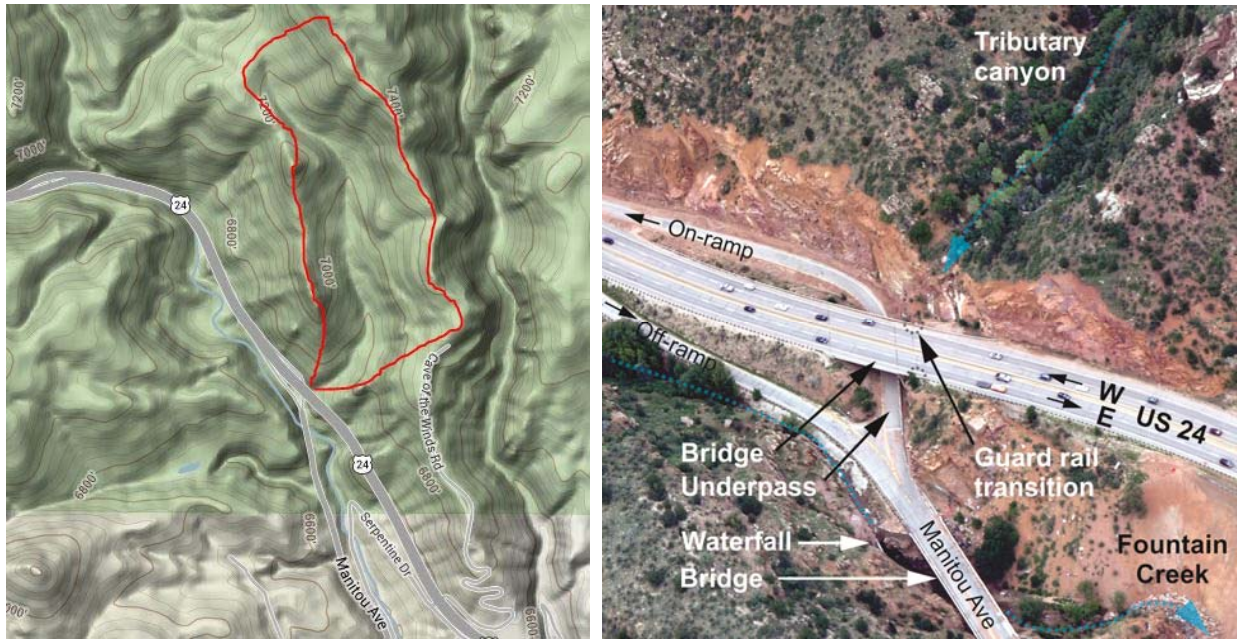
Figure 3.2.15. Tributary canyon draining onto cut slope on US 24 westbound shoulder at bridge abutment with dark water flood discharge captured in YouTube video by MMaksimow (Figure 3.2.14. Left: shaded relief topographic map from Google Maps with drainage basin outlined. Right: aerial oblique photograph taken August 17, 2013, showing details of the US 24 overpass of Manitou Avenue.

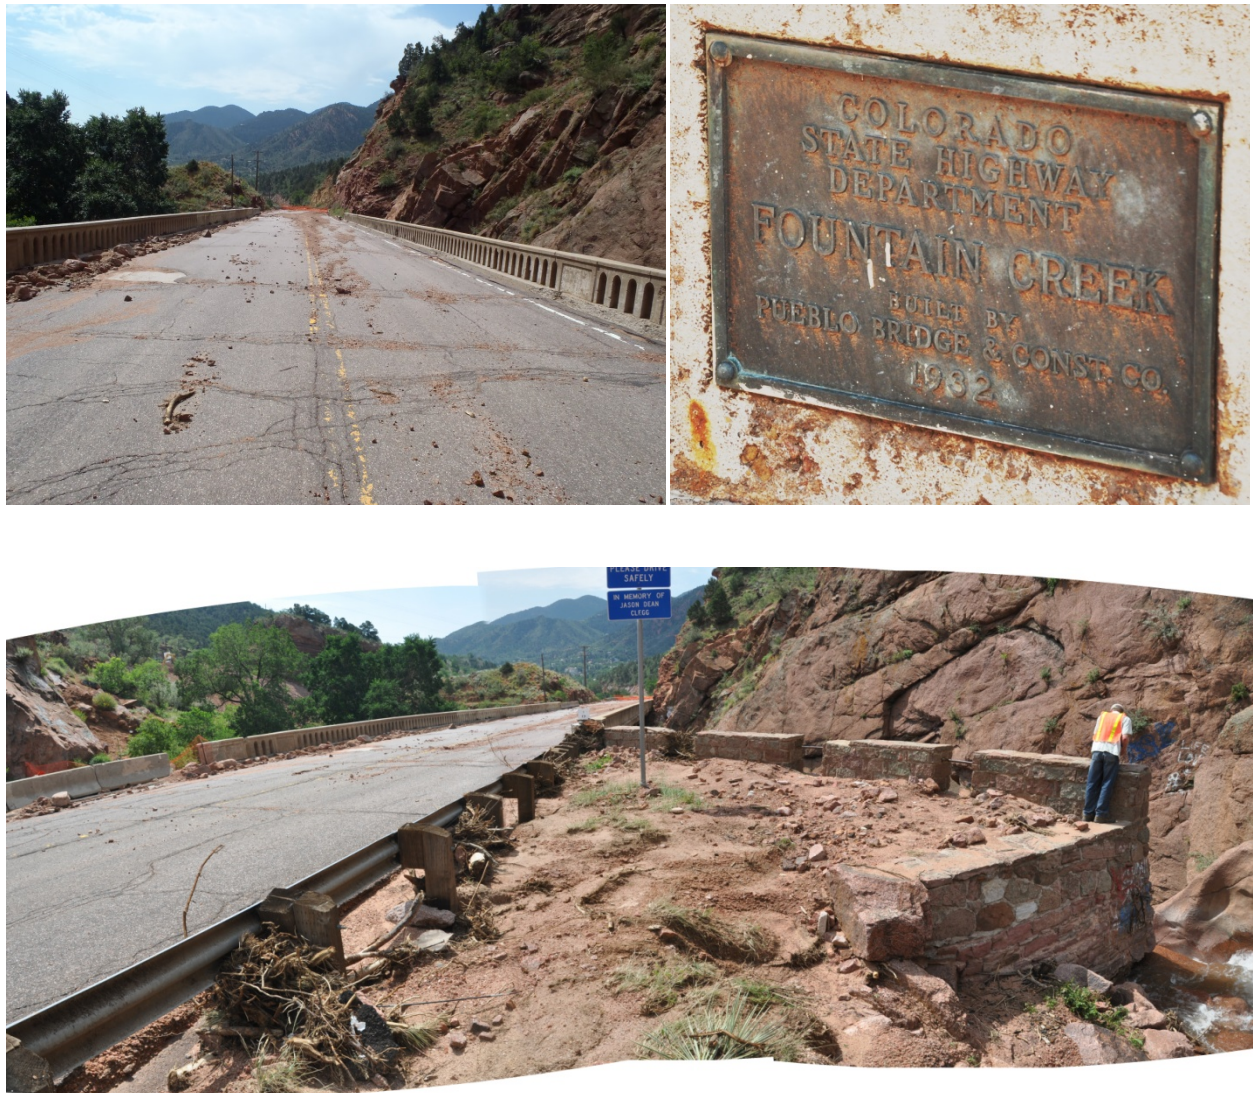
Figure 3.2.17. Fountain Creek Bridge on Manitou Avenue (old US 24). Top left: looking downslope to the south-southeast, towards Manitou Springs; storm debris visible on bridge, particularly against the left (east) guard rail. Top right: State of Colorado Highway Department plaque on Fountain Creek Bridge from 1932. Bottom: mosaic photo of Fountain Creek Bridge from west side of guard rail north of north abutment; Fountain Creek at the waterfall is visible in the lower right corner of the mosaic photo at the base of the rock wall below the man. Camera position for top left photo: +38.8702°N, -104.9258° W, approximate elevation 6589.

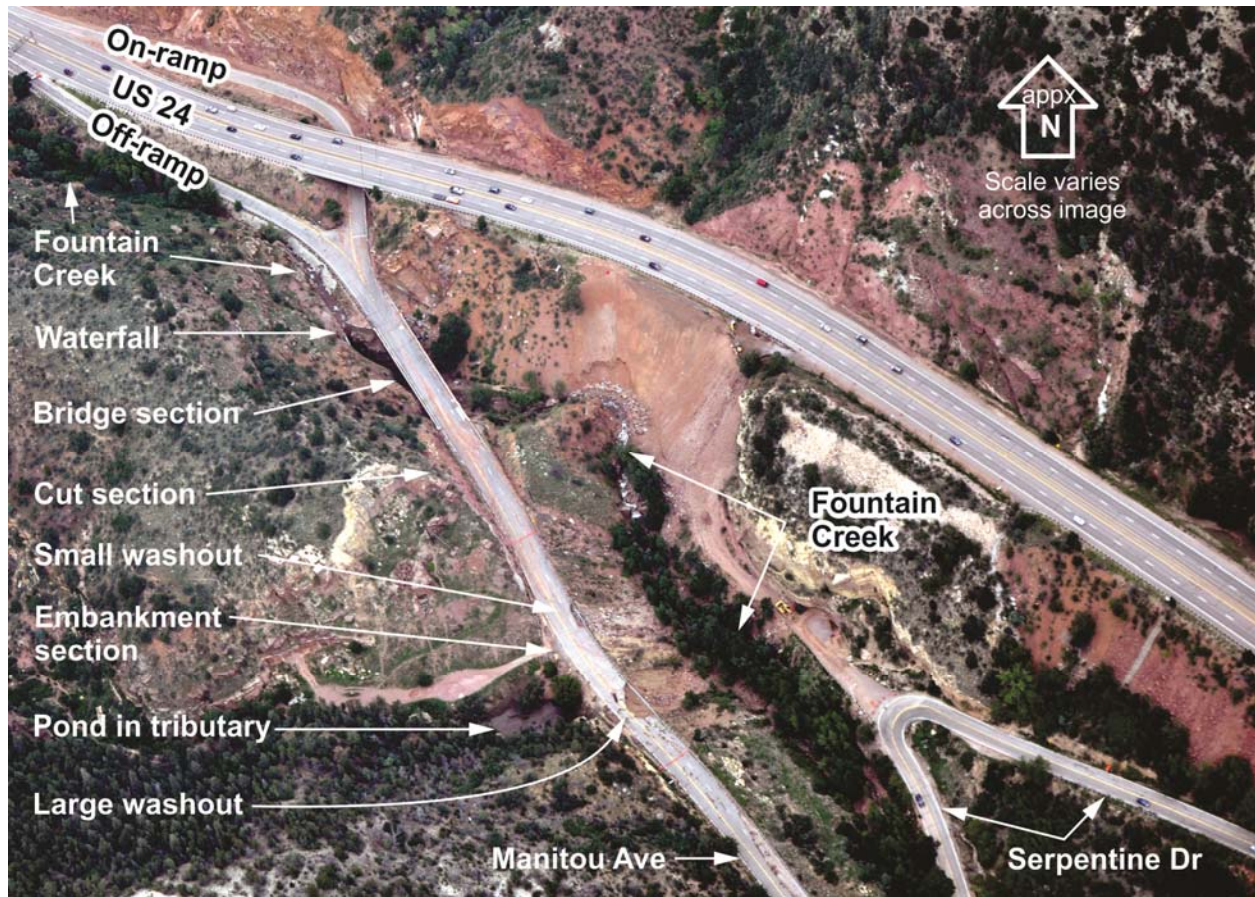
Figure 3.2.18. Aerial oblique photo of Manitou Avenue showing selected features, including two washout areas. Aerial oblique photograph taken August 17, 2013, as part of the GEER reconnaissance.

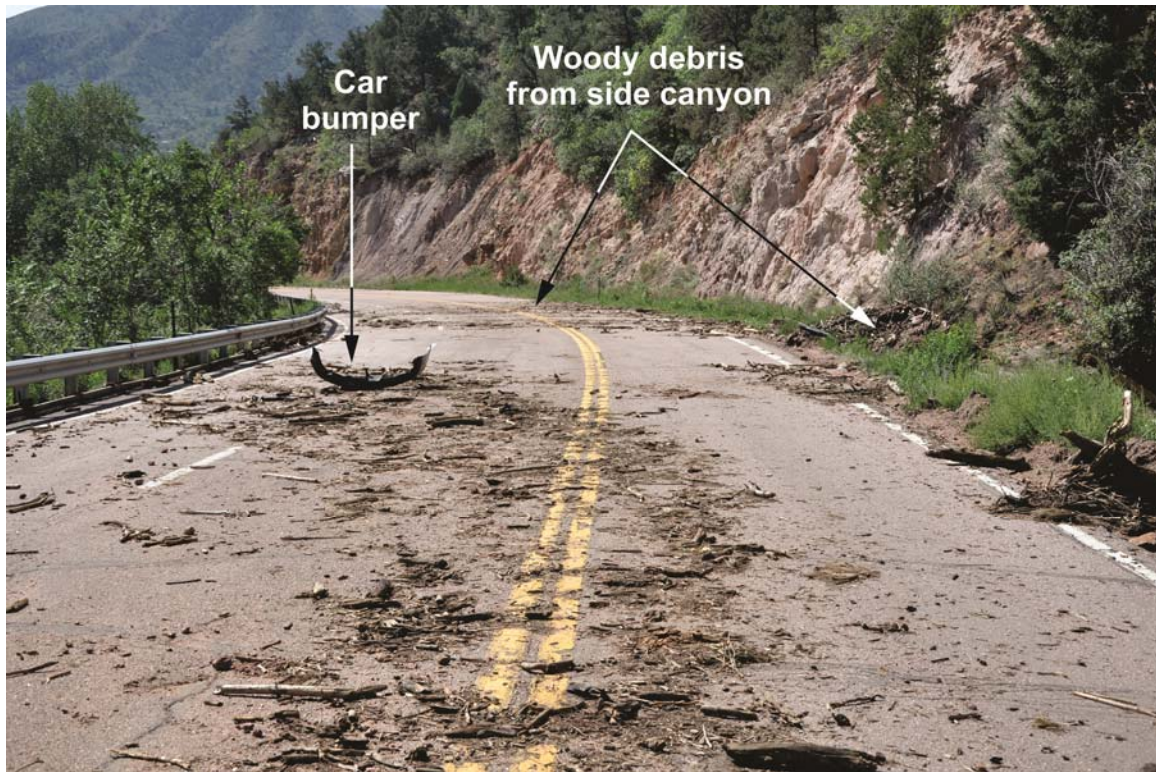
Figure 3.2.22. Manitou Avenue below large washout with woody debris but not much sediment. Woody debris from side canyon is also visible. Car bumper is a distinctive feature visible in top right photo in Figure 3.2.20. View south-southeast from 38.8667° N, -104.9245° W, approximate elevation 6486 ft.

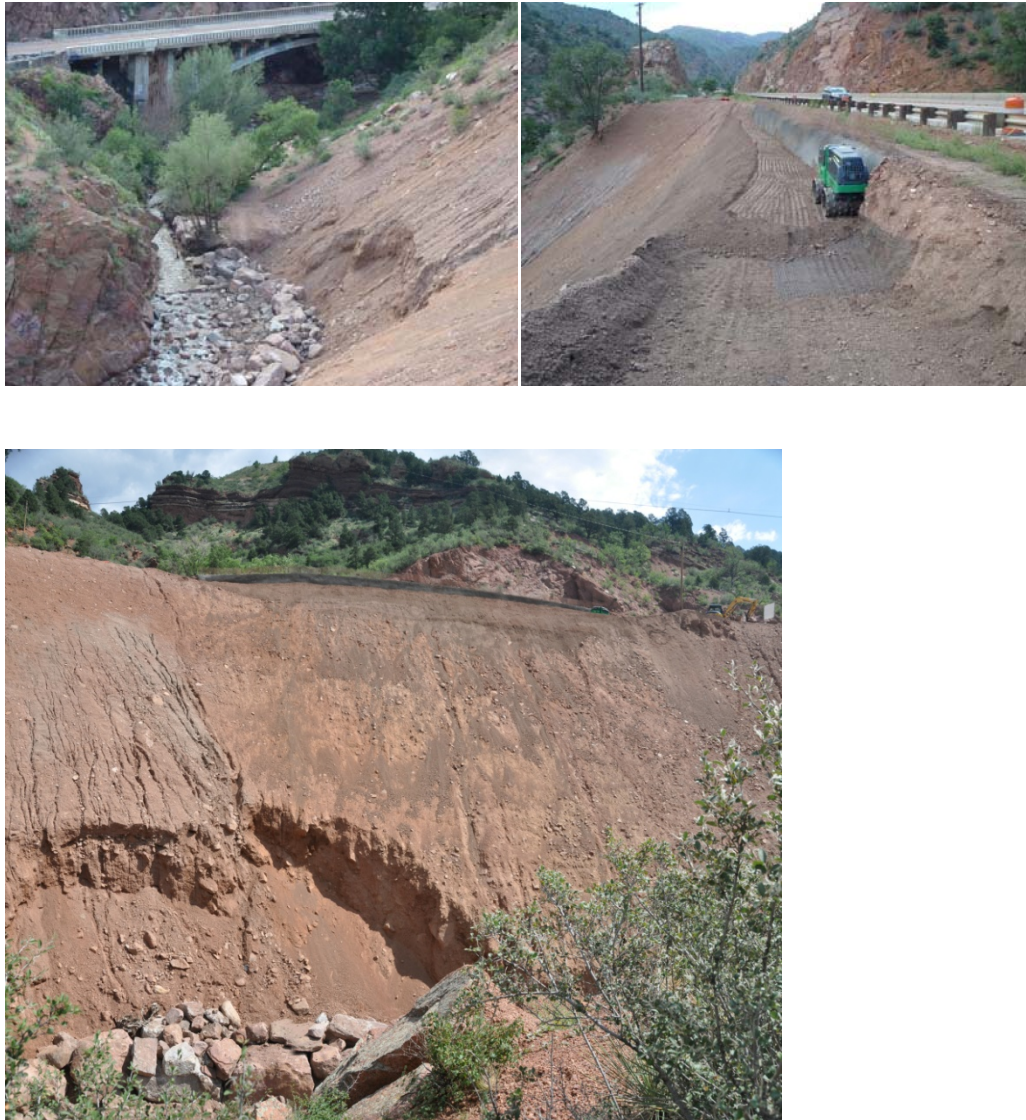
Figure 3.2.23. Riprap and rilling on eastbound US 24 embankment, and Geogrid reinforcement with shotcrete and chain-link facing at crest of embankment. Top left: view to the northwest from  $+38.8695^{\circ}$  N,  $-104.9245^{\circ}$  W, approximate elevation 6583 feet; Fountain Creek Bridge that carried flood and debris from Waldo Canyon is in the background. Top right: view to the north from  $+38.8695^{\circ}$  N,  $-104.9245^{\circ}$  W, approximate elevation 6583 feet. Bottom: view to the east from  $38.8695^{\circ}$  N,  $-104.9250^{\circ}$  W, approximate elevation 6564 feet; the small green soil compactor visible in the top right photo also is visible in the bottom photo.

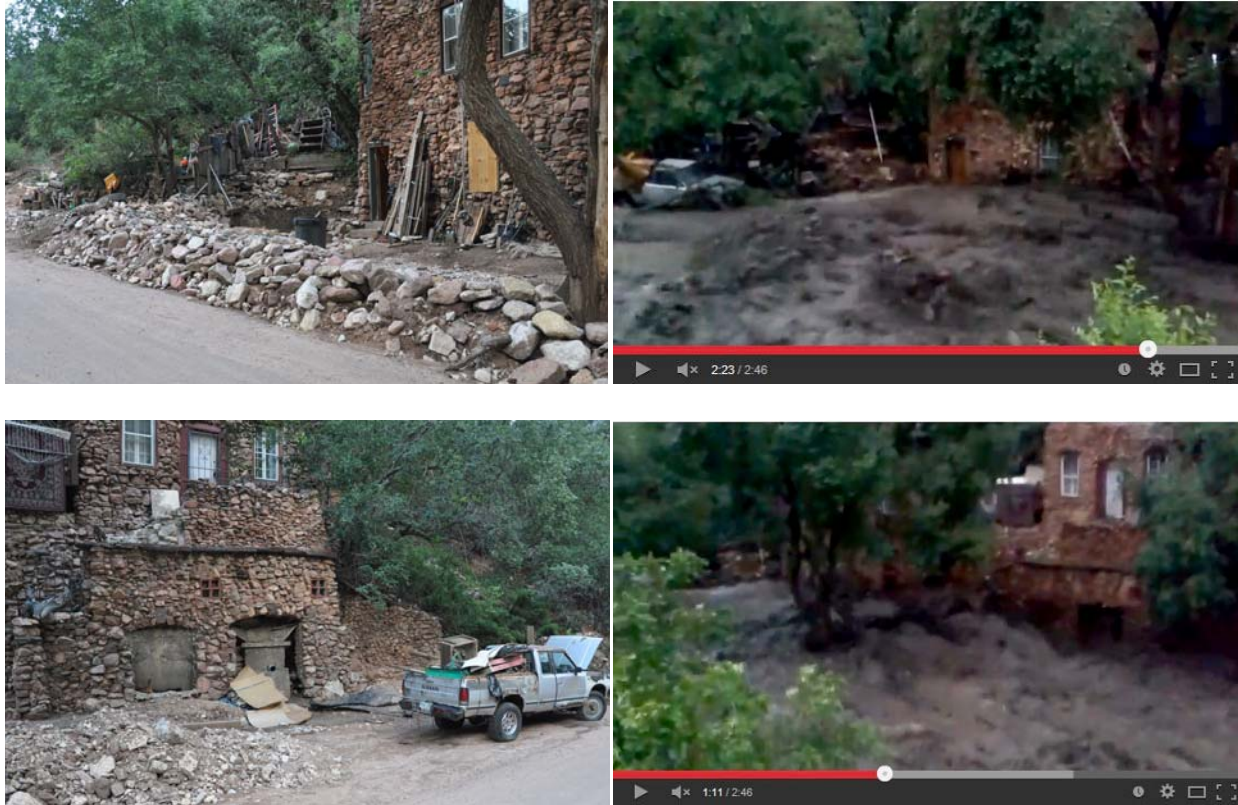
Figure 3.3.6. Stone-and-mortar residence in Williams Canyon north of US 24. Top left and bottom left: photos of residence taken on August 16, 2013. Top right and bottom right: screenshots of YouTube video by Dave McCrary taken on August 9, 2013; Video 1 in Figure 3.3.1. Flood flow is partway up the wall of the residence. Top: door and boarded window in left photo correspond to door and window with white trim in right photo; flow appears to be below the middle of the window. Bottom: distinctive white-trimmed windows and white door above horizontal dark line in left photo are visible in right photo; flow appears to be about the level of the boarded doors in the left photo. Camera location:  $+38.8641^{\circ}\text{N}$ ,  $-104.9173^{\circ}\text{W}$ , elevation 6472 ft.

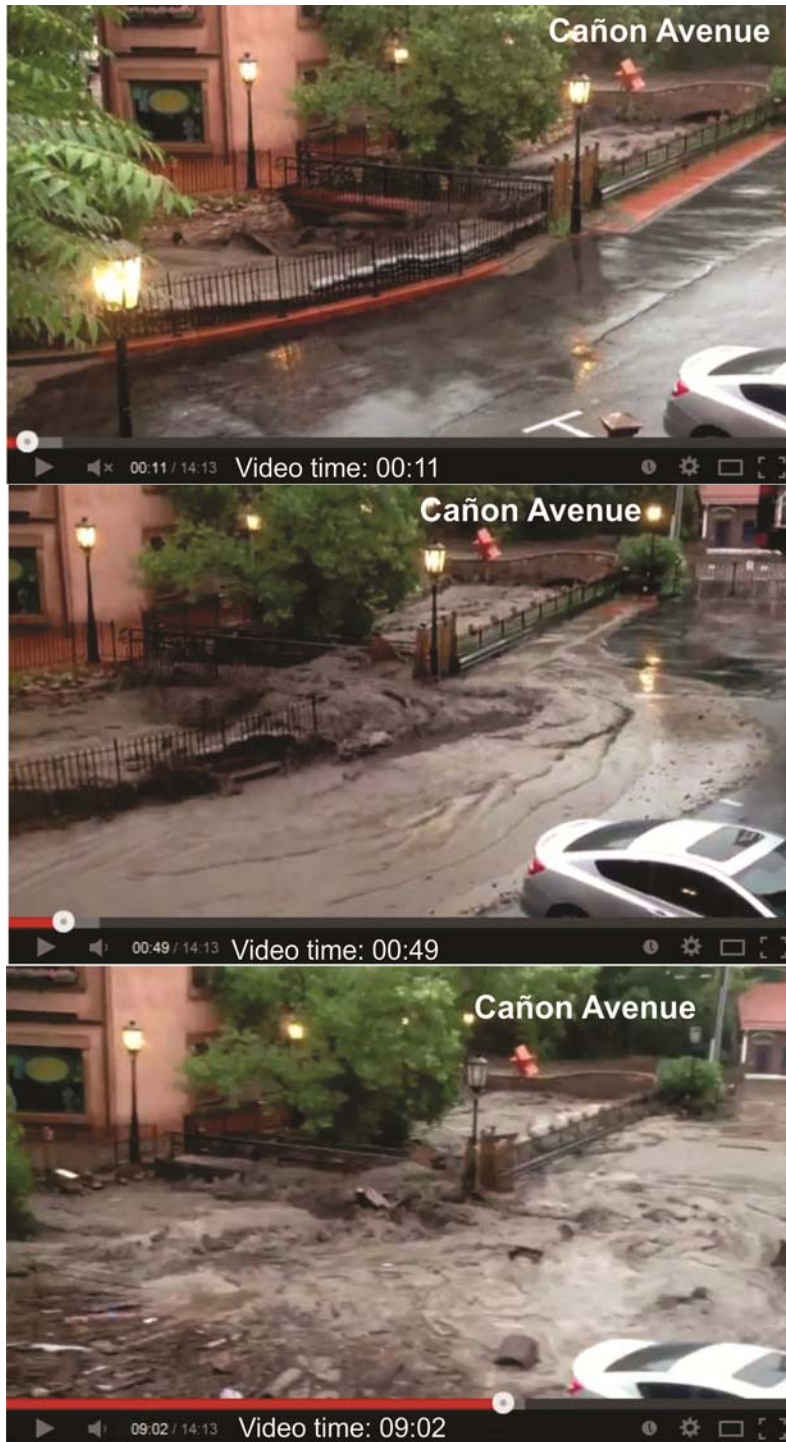
Figure 3.3.17. Flooding in Fountain Creek just west of Cañon Avenue. Three screenshots of YouTube video by Apeakrunner taken on August 9, 2013, at video times 00:11, 00:49, and 09:02; Video 5 in Figure 3.1.1. Camera location: 38.8583° N, -104.9170° W, elevation 6345 ft.

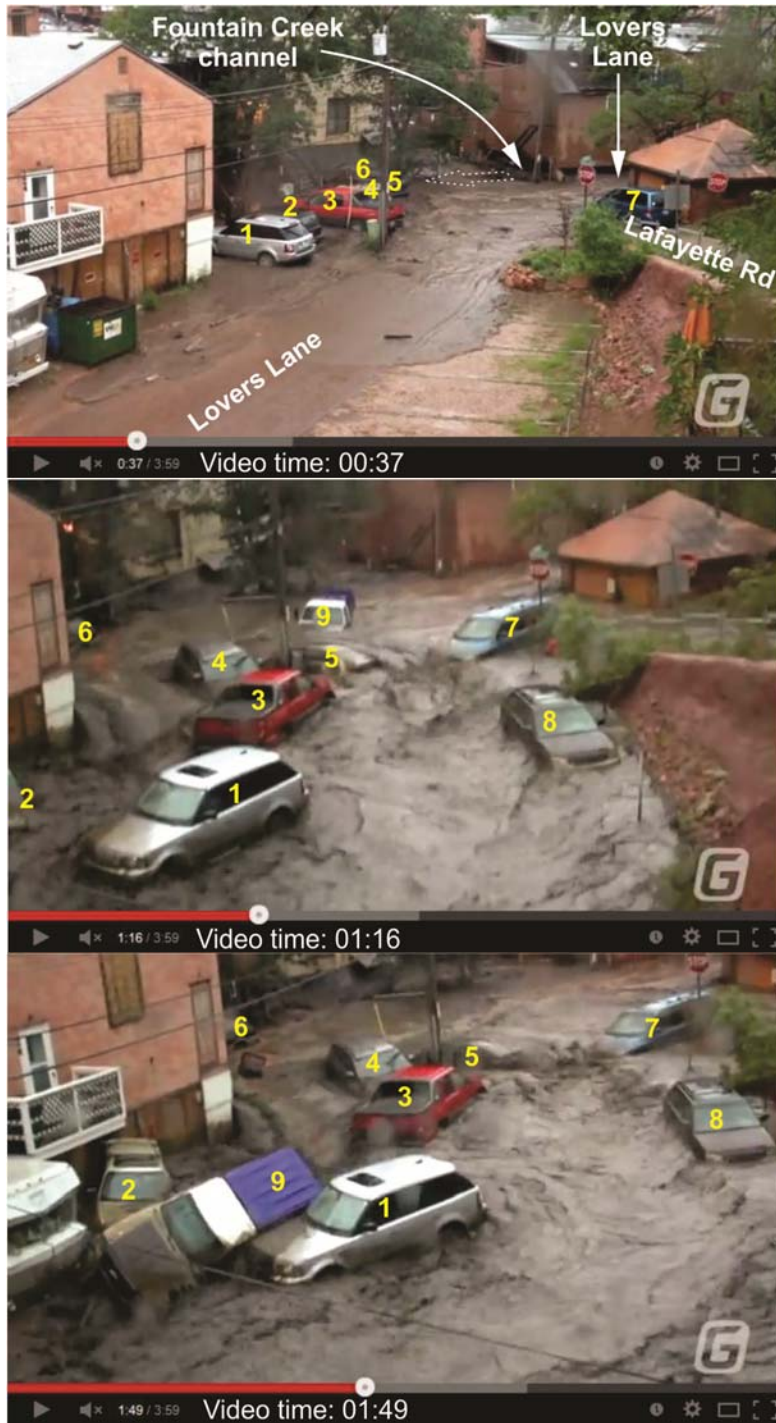
Figure 3.3.18. Flooding in Fountain Creek at intersection of Lovers Lane and Lafayette Road.

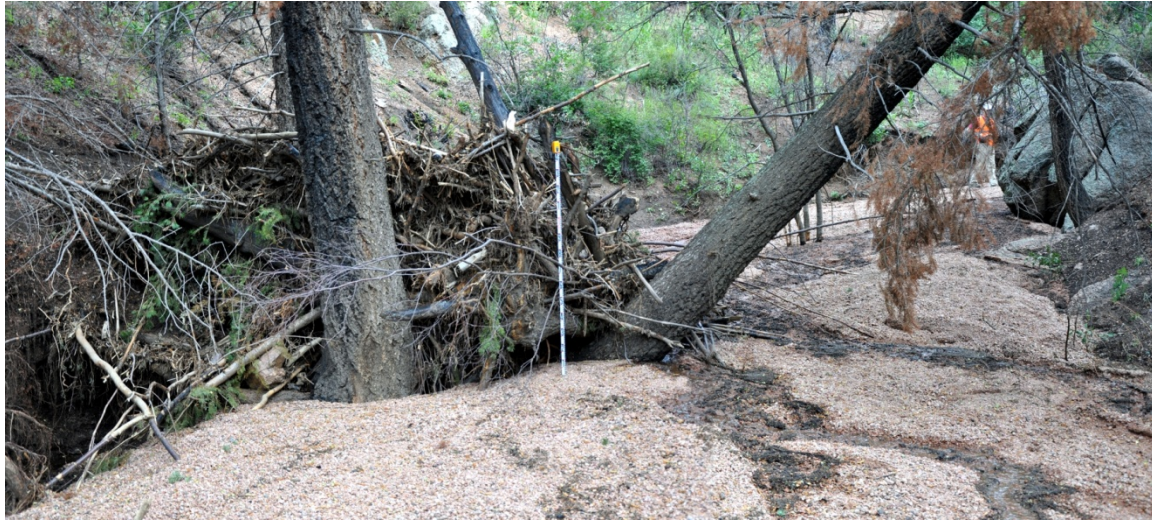
Figure 3.4.3. Woody debris trapped on the upstream side of a tree in Unnamed Creek 1. View looking north-northeast; ruler is 1.5 m long. Trickle of water to the right of the leaning tree trunk was infiltrating into the clean, coarse sand and gravel that had been deposited by the August 9, 2013, flood. Camera location is 38.8909° N, -104.9584° W, approximate elevation 7259 ft.

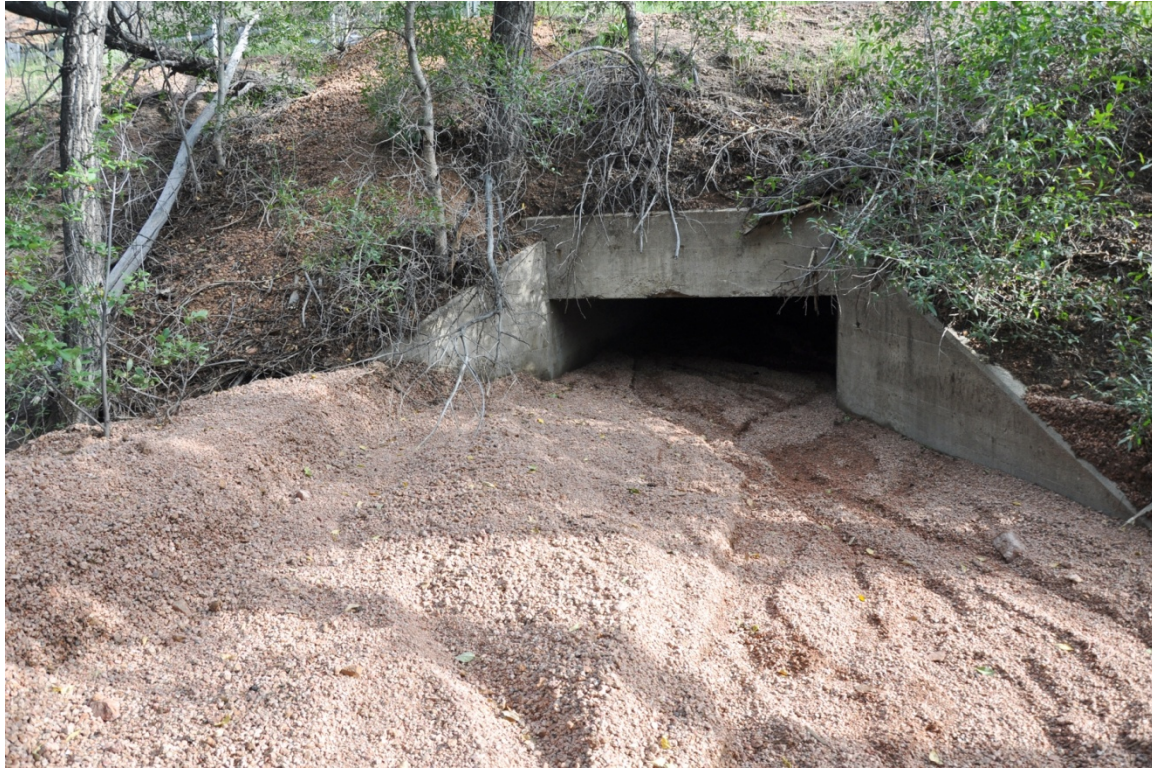
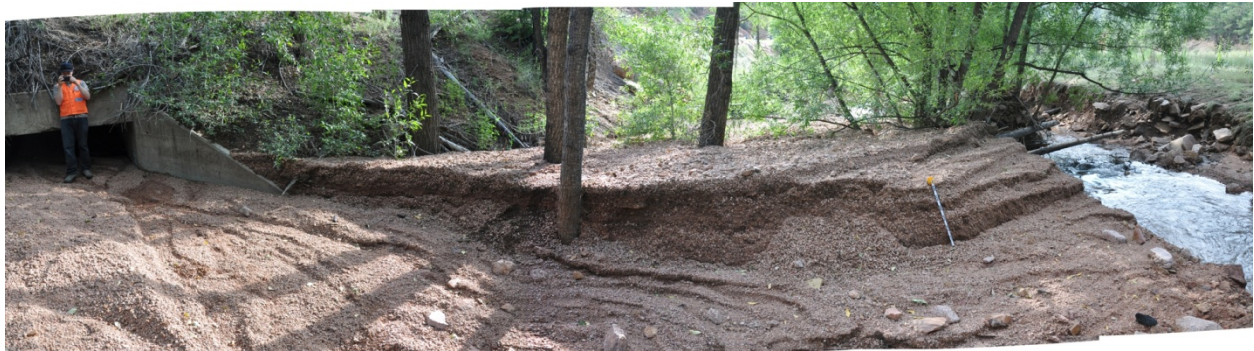
Figure 3.4.4. Unnamed Creek 1 culvert outlet on US 24 median at Fountain Creek. Top: view to north at culvert outlet at base of westbound US 24 embankment. Bottom: panoramic view to southeast at culvert outlet and sand and gravel deposit adjacent to north side of Fountain Creek; ruler is 0.7 m long. Both views from 38.8898° N, -104.9587° W, approximate elevation 7187 ft.

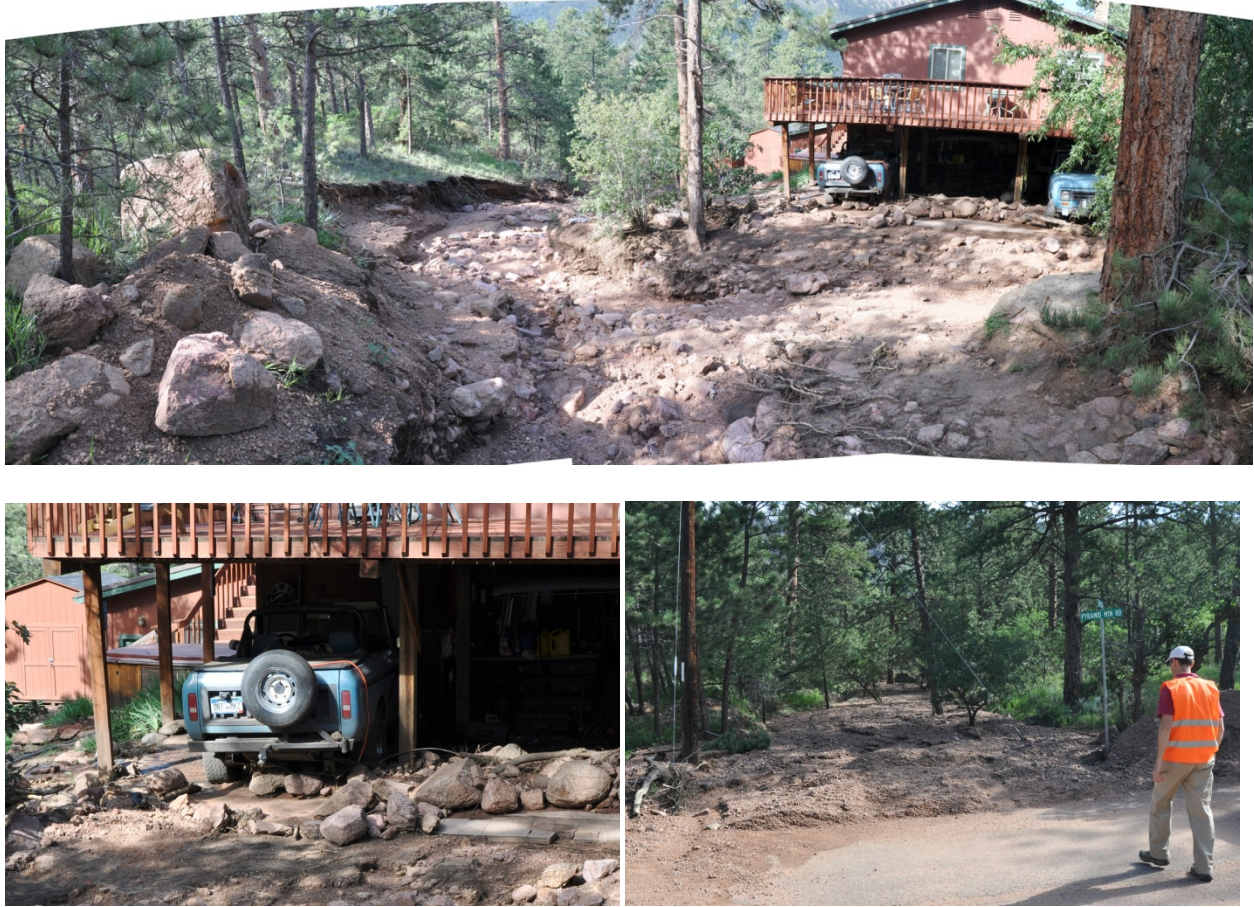
Figure 3.4.11. Flood effects near the apex of the alluvial fan at Cascade. Top: panoramic view looking southwest at Unnamed Creek 3 from Pyramid Mountain Road. Bottom left: detail of carport area in top photo showing boulders on the concrete slab. Bottom right: view looking northeast up Unnamed Creek 3 from Pyramid Mountain Road; absence of boulders is conspicuous. Views from 38.8996° N, -104.9635° W, approximate elevation 7599 ft.

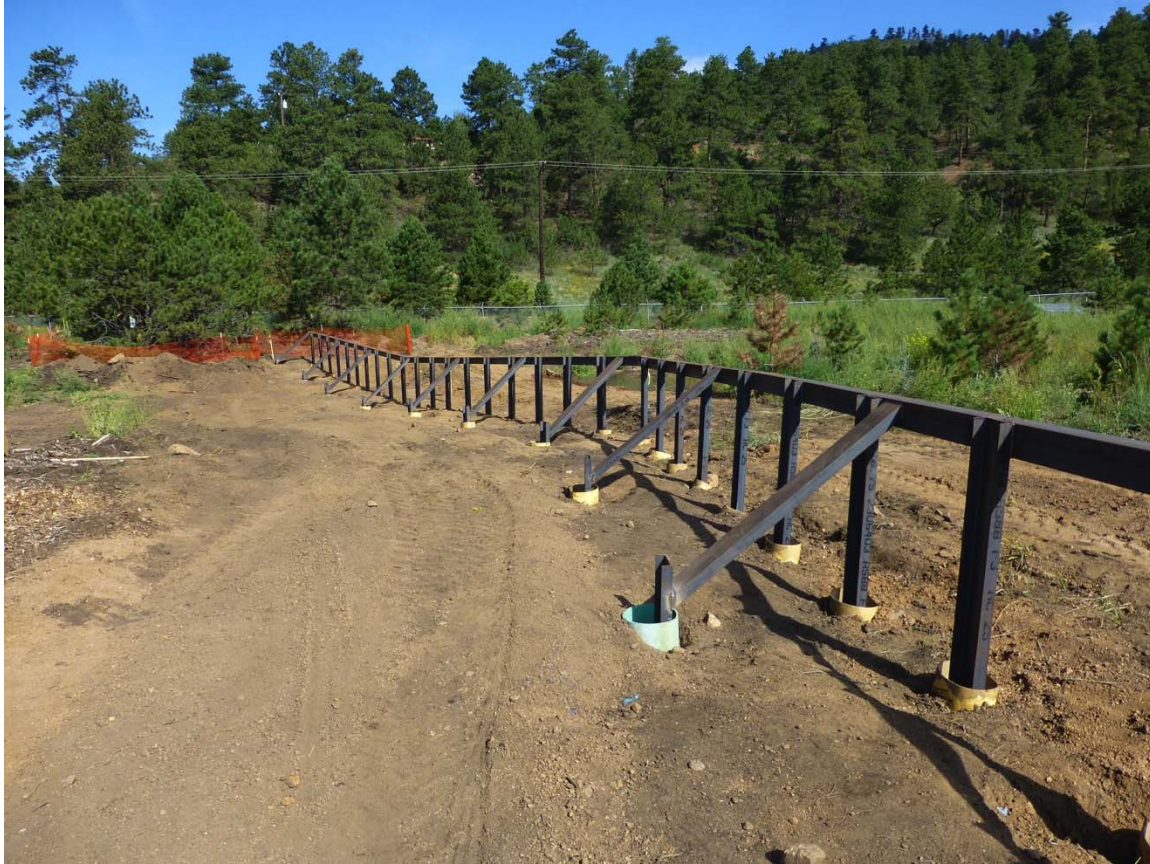
Figure 3.4.17. Debris rack under construction in the mouth of Wellington Gulch south of Wellington Road. Note Sonotubes for grouting of foundation footings, the diagonal support braces, and the welded joints. The rack is oriented perpendicular to the flow direction. View looking north from 38.918603° N, -104.983124° W, approximate elevation 7611 ft.

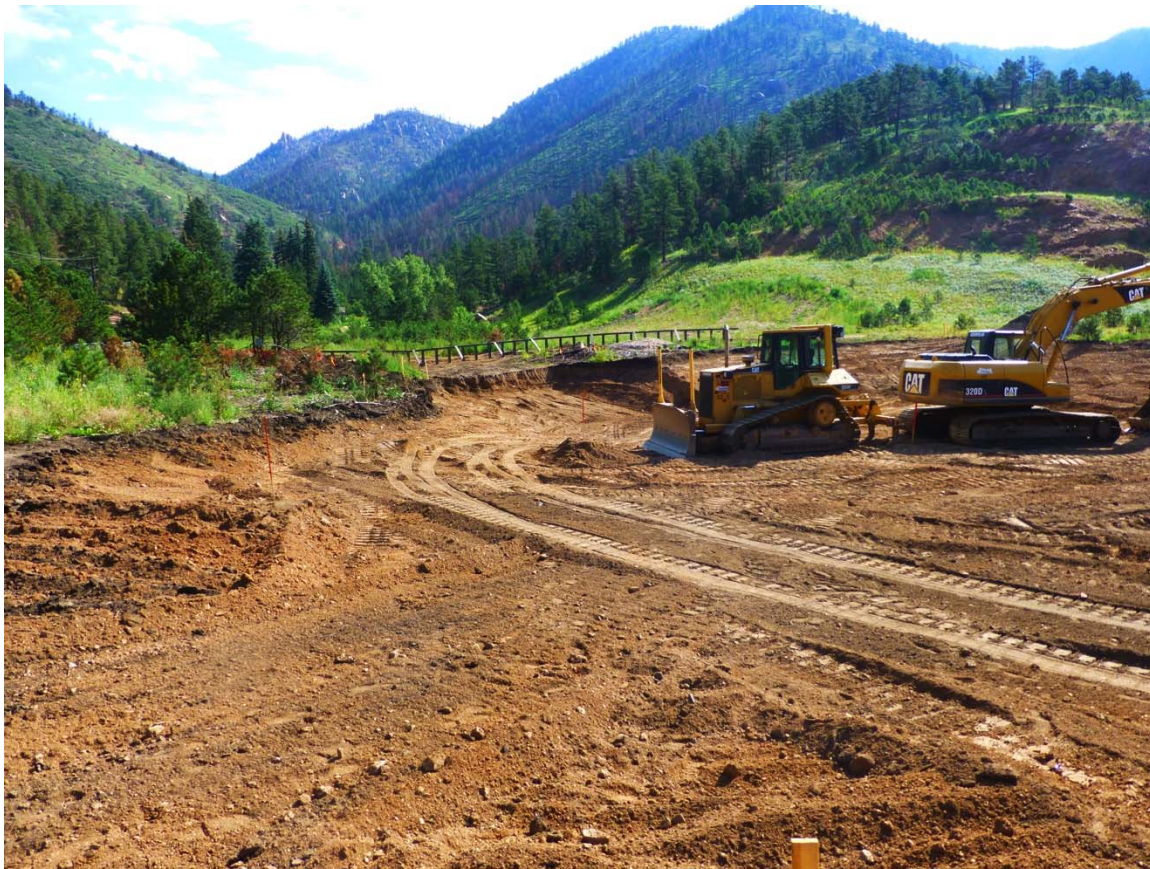
Figure 3.4.18. Sediment basin excavation downstream of debris rack. This basin is not intended as a large capacity storage area, but more as a stilling basin to allow debris and larger particles to drop out in a controlled manner without clogging the drainage culvert inlet. View toward east from 38.9185° N, -104.9840° W, approximate elevation 7597 ft.

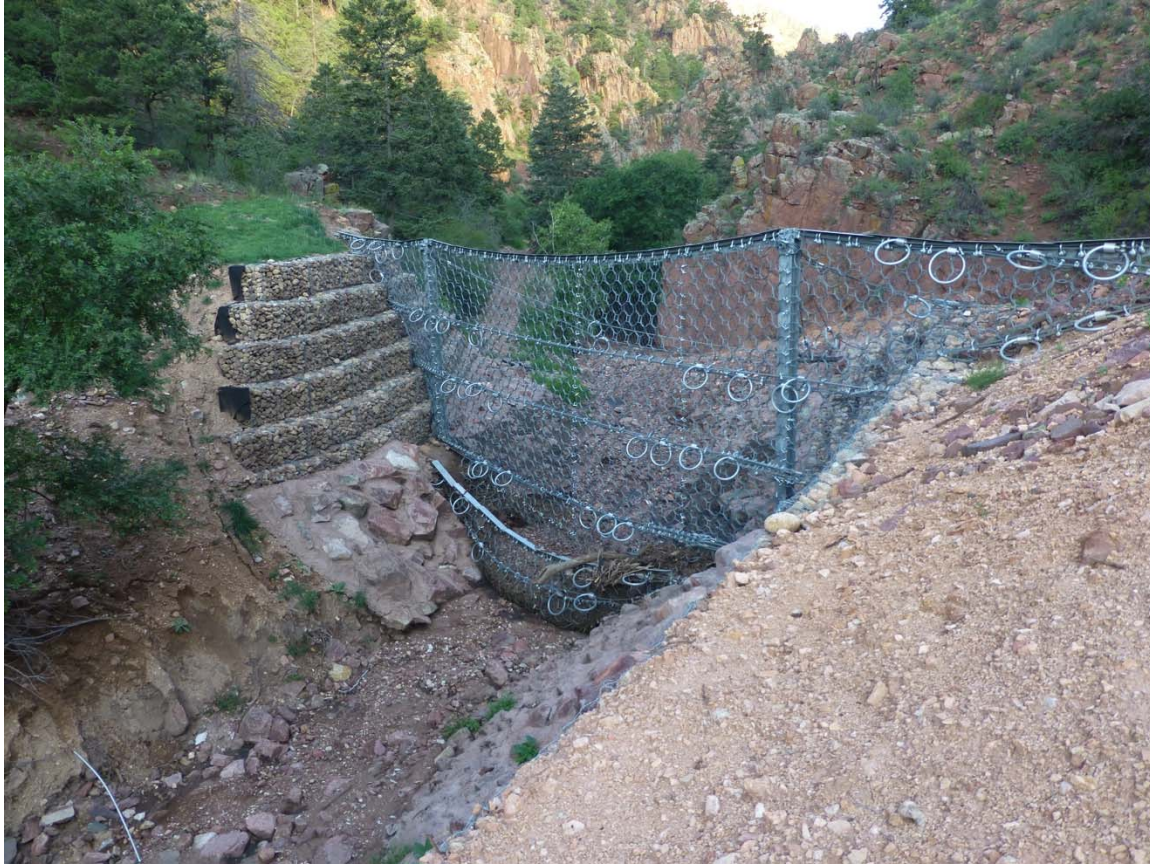
Figure 3.4.20. Ring-net debris fence constructed in the mouth of Queens Canyon above the Glen Eyrie Castle and conference center. View to the west from 38.8937° N, -104.8872° W, approximate elevation 6571 ft. Note gabion walls and grouted riprap protecting the abutments and channel from erosion, the use of two separate fences in the design, and the accumulation of a small amount of mostly gravelly sediment and logs in the lower fence. Prominent circles are loops on cables that are friction brakes to convert mechanical energy into heat and minimize damage to the fence while stopping debris.
