Preliminary Report on Engineering and Geological Effects of the July 2019 Ridgecrest Earthquake Sequence

A report of the NSF-Sponsored Geotechnical Extreme Event Reconnaissance Association

Report GEER-064

July 19 2019

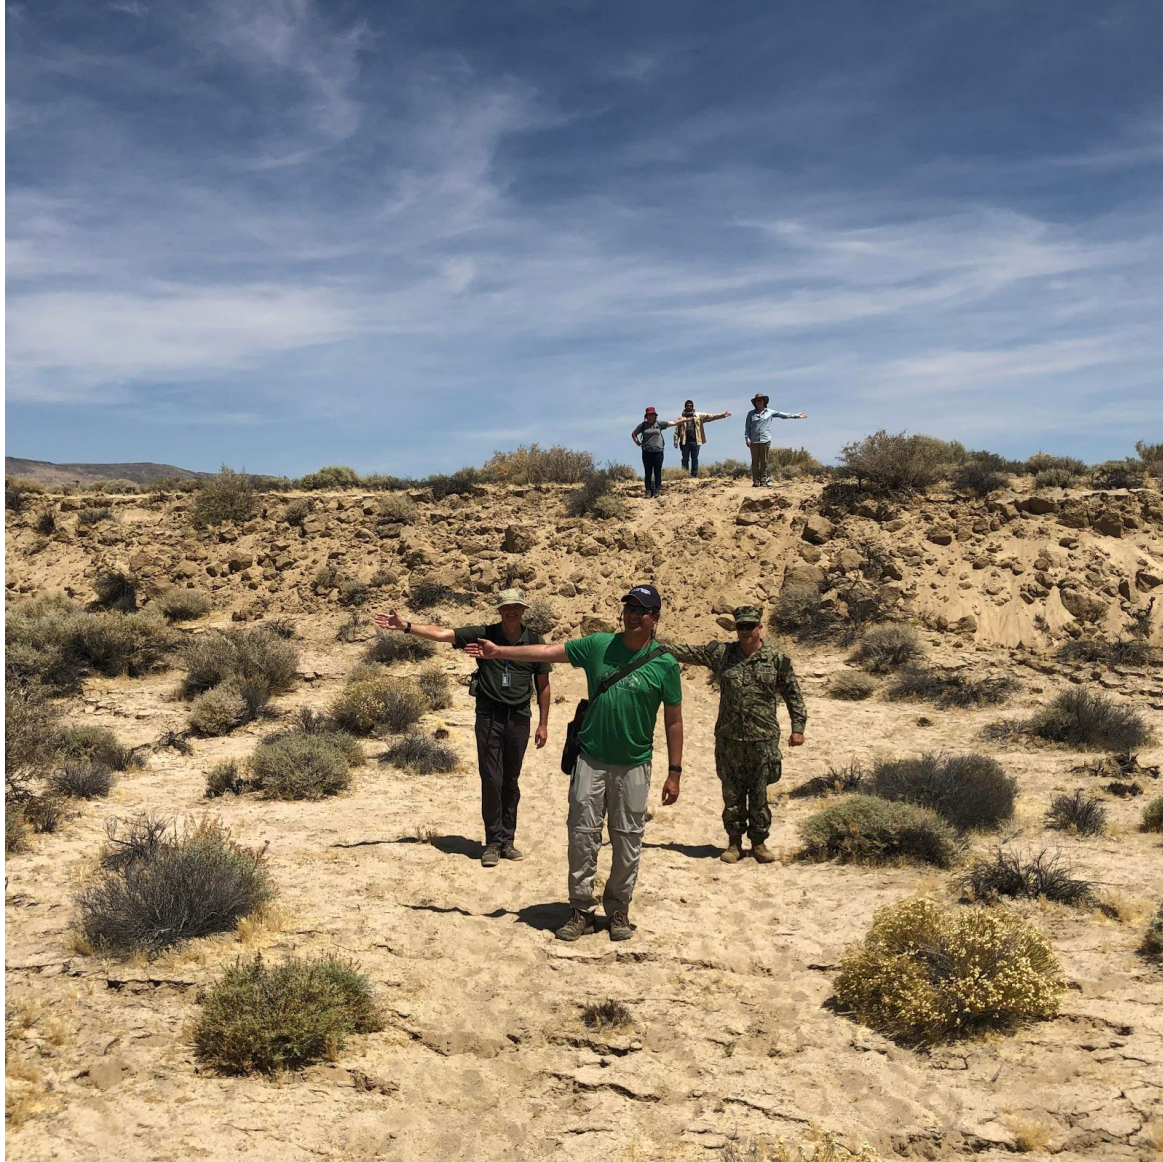
Figure 5. All six people are standing on a surface that was flat prior to the **M7.1** earthquake, and here the fault rupture offset the ground surface vertically by over two meters, forming a fault scarp. The lateral offset of about 3 to 4 m shifted a dirt road set of tracks to the right (see Fig. 9 for additional details at this site). On each of the sides of the fault, three people are marking the same three features that have been offset; the center line of the road and each of the tire tracks. All are pointing to indicate the tectonic sense of right-lateral fault motion. (Credit; Photo by John Foster, US Navy; public domain).

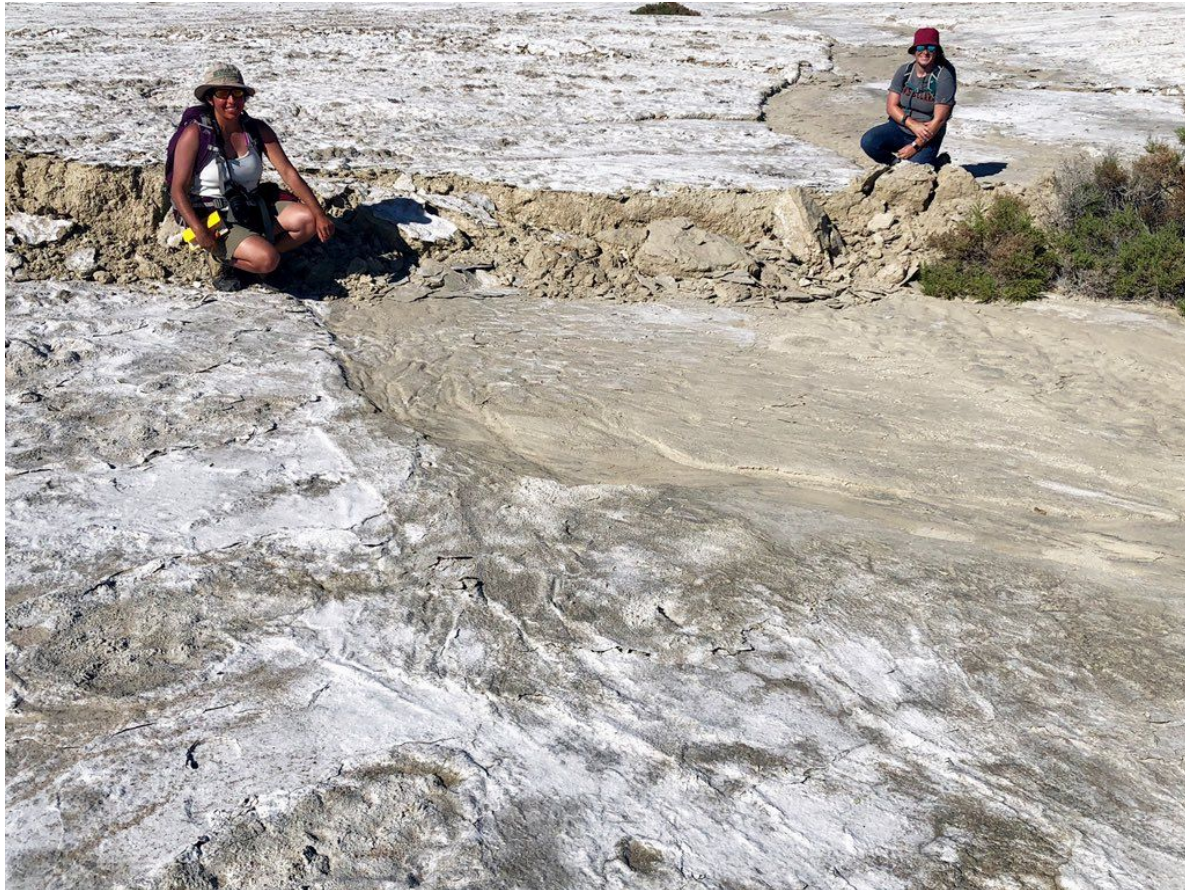
Within the NW edge of the China Lake playa, 0.6 km to the SE of CGS FID 585 we encounter offsets of 3.75 ± 0.2 m (USGS FID 975). Further along by 0.7 km, we encounter 4.2 ± 0.05 m offset (USGS FID 875), which is the maximum observed slip (Figure 6).

Figure 6. A 4.20 m right-lateral offset is measured by Belle Philobosian (USGS) and Kelly Blake (NAWSCL Geothermal Program Office) on the dry lake bed (playa) surface of China Lake. The channel margin sharply demarcates the salt-crusted white surface of the pre-incisional dry lake bed surface from the fresh fine-grained deposits in the wide flat channel thalweg. This sharply defined feature provides a reference line that allows measuring this displacement vector with unusually small errors of approx. ± 5 cm. This is considered the maximum offset measurement obtained as of this writing (Credit: photo by Brian Olson, CGS).

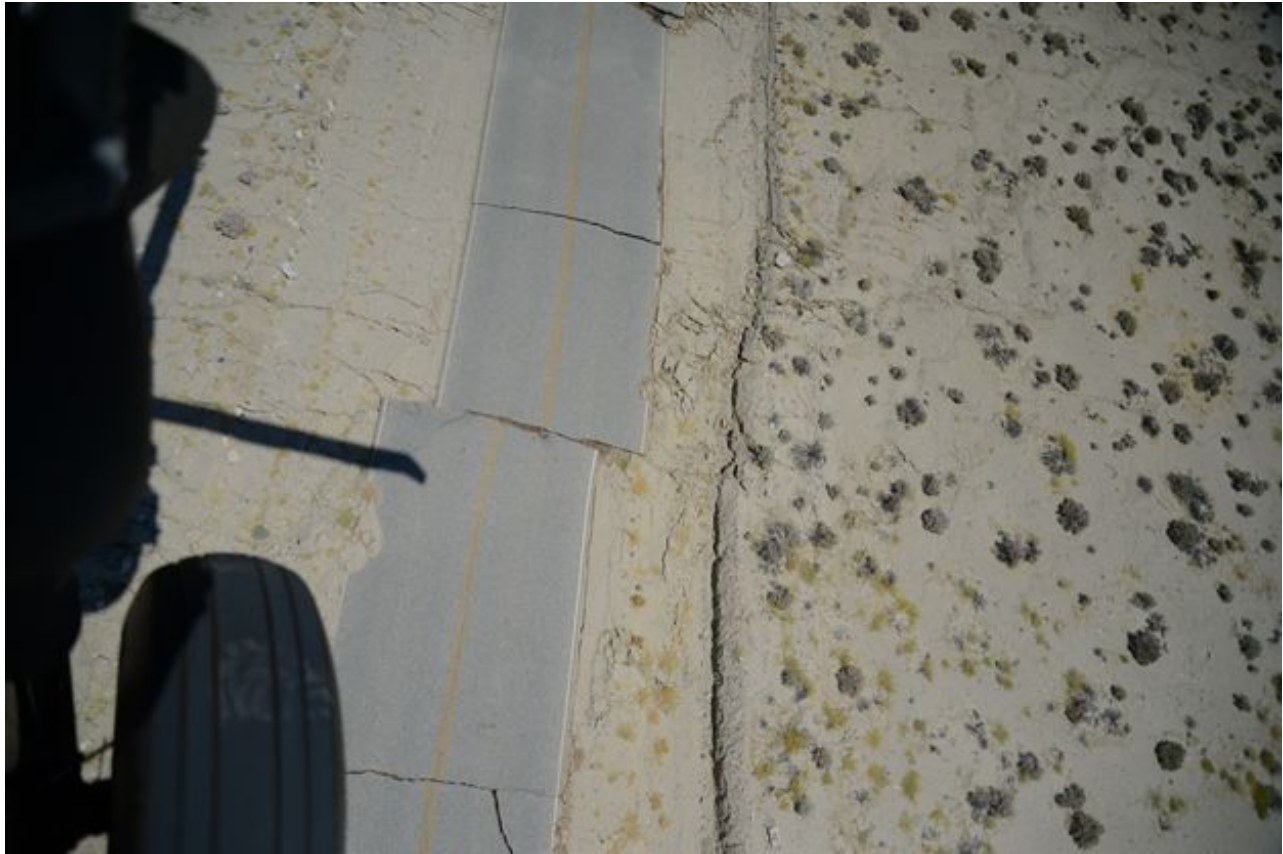
Figure 7. Helicopter Overflight Viewing Access Road Fault Offset. The CGS and USGS, along with National Guard and Navy personnel, view road damage showing 2.5 \pm 0.2 meters of right-lateral motion along the primary rupture associated with the magnitude 7.1 event. This offset access road was broken by the mainshock fault rupture about 600 m southeast of the China Lake playa (Credit: Ken Hudnut, USGS. Public domain)

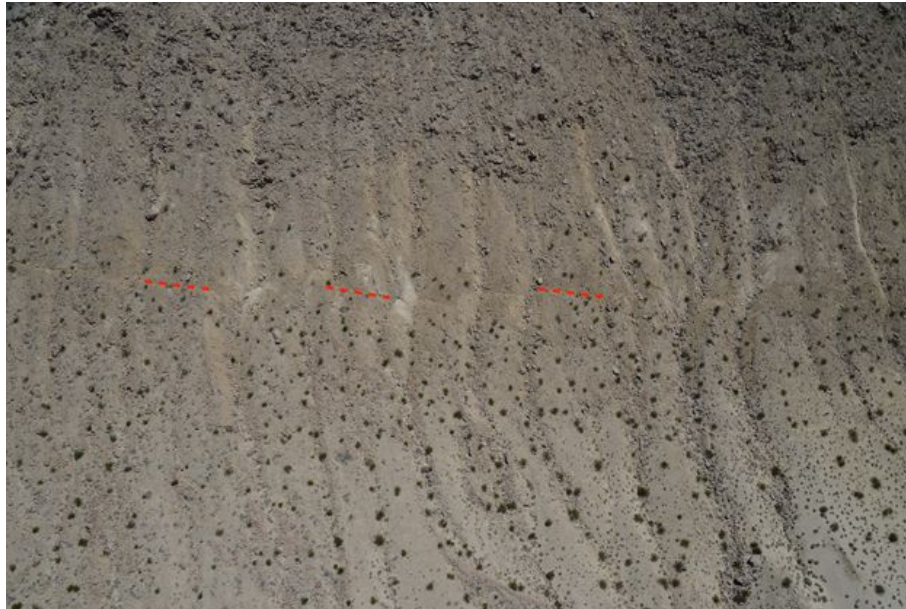
3.9 km along a SW-facing hillside that is characterized by multiple sub-parallel drainages that we refer to as “offset gullies” (Figure 8). A hillside bench was formed along this same NW-to-SE oriented ridge, down to CGS FID 1053 to 1051. At this offset channel locality, Janis Hernandez (CGS) made a set of detailed observations on July 8 2019. She found offsets of less than one meter.

Figure 8. A series of nearly parallel and sharply incised small drainage gullies occur along a NW-SE oriented ridge line that lies from 1 km to 3 km southeast of the offset access road shown in Fig. 7. The roughly twenty such gullies shown in this photo are referred to as the “offset gullies”. The short dashed red line segments indicate the location of the mainshock fault surface rupture, which forms a bench as the fault cuts across this hillside, nearly perpendicular to these gullies. With high-resolution topography from the air photos already collected, and potentially from the airborne lidar in the future, geologists expect to be able to precisely measure fault slip variation along this section of the fault. Slip is known to diminish from approx. 1.8 m at the abandoned railroad tracks down to less than one meter at the SE end of the ridge where these gullies were found. So, it is expected that these gullies will afford a way to quantify the reduction in slip from NW to SE along this 2 km long section of the fault.

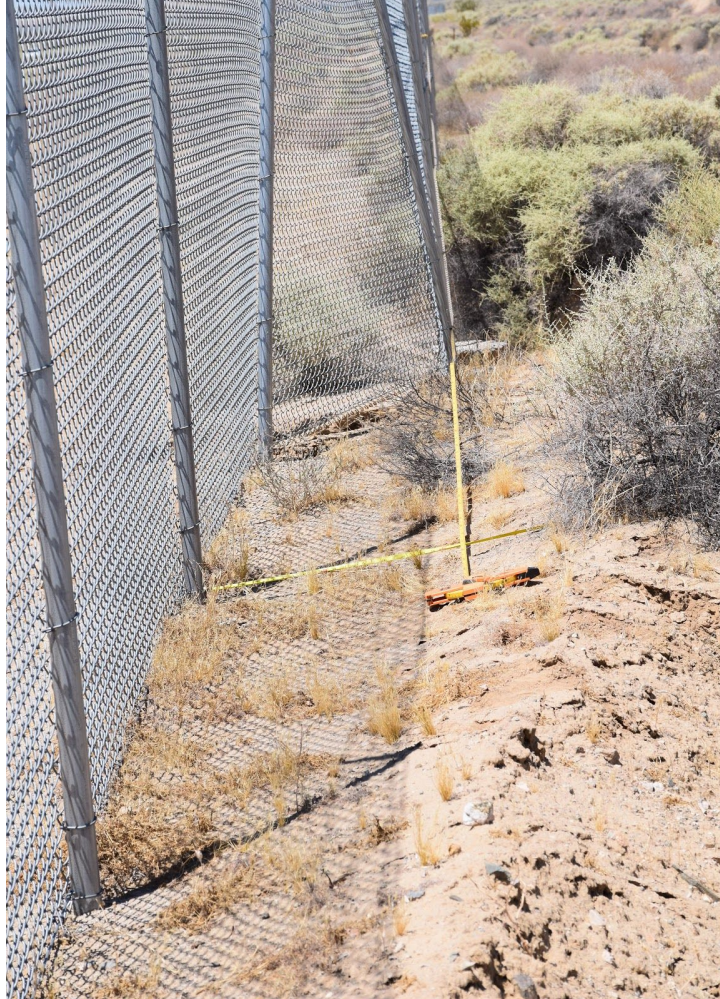
Figure 9. Offset fence line at southern Salt Wells Valley, just north of highway 178. The fence offset is 70 ± 5 cm right-lateral sense. (photo by Jason R. Patton, CGS; Lat./Long. 35.6495, -117.4828)

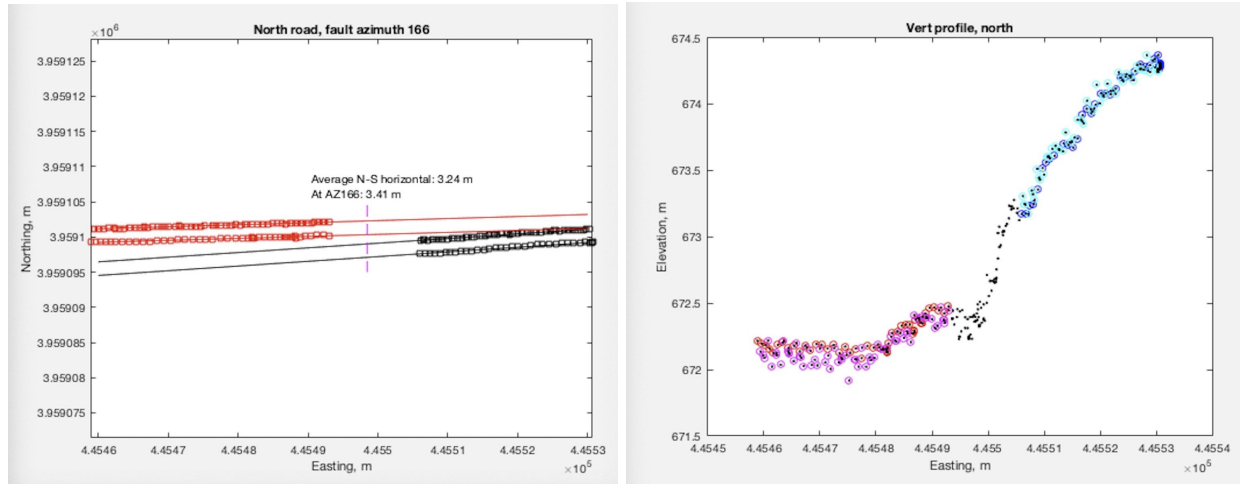
Figure 10. a & b. A handheld high-accuracy GPS unit was used to measure points along the dirt road that is shown in Fig. 5. The dirt road tire tracks extending out in either direction from the fault offset were measured to within a few cm's accuracy at hundreds of points. These lines were then used to estimate the fault offset more accurately than could be done using conventional methods such as with a tape measure and straight-edge rulers (as in Fig. 3). In this location, extensive cracking was seen across a width that extended more than 350 m to the west of the scarp, and over 150 m east of the scarp, for a total width of more than 500 m at this location. The dirt road azimuth was estimated by GPS to be 166 degrees, and the fault rupture trace was projected so as to estimate that fault offset was 3.4 m right-lateral in the plane of the fault (panel a). Over two meters of vertical separation was also quantified by GPS at this location (panel b).

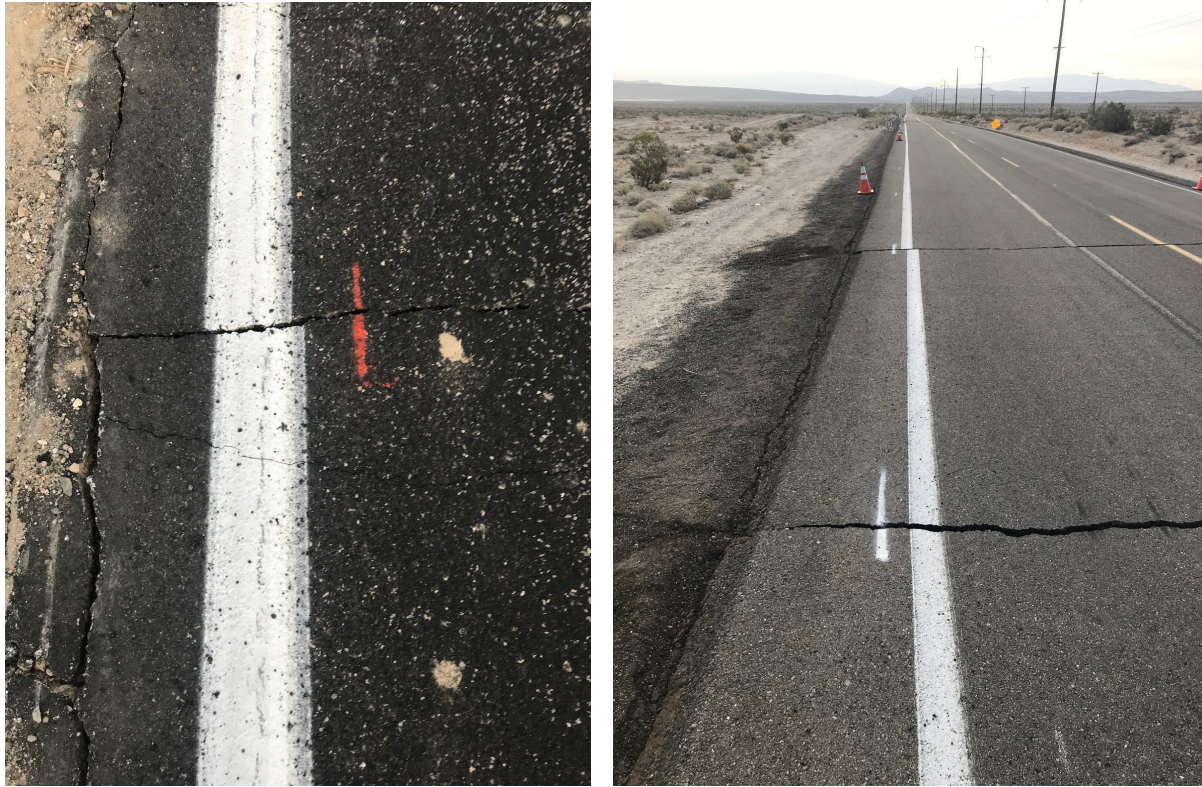
Post-mainshock afterslip monitoring has been undertaken using different methods. At Highway 178, lines were painted across ruptures in the asphalt surface to enable checking of subsequent slip (Figure 11). These lines were painted onto the pavement shortly after the **M6.4** and **M7.1** mainshocks; no afterslip was observed through July 8 2019. GPS monitoring in the region is ongoing. Satellite based monitoring of afterslip is occurring more broadly along the fault, with some evidence of afterslip having been encountered in China Lake.

Figure 11. Pavement of Highway 178 offset by **M6.4** event fault rupture (shown by white lines) and short painted lines used to monitor afterslip. Locations: Left 35.649, -117.4824 (red line), Right 35.6441, -117.537 (white line). Photo credits: Ben Brooks, USGS

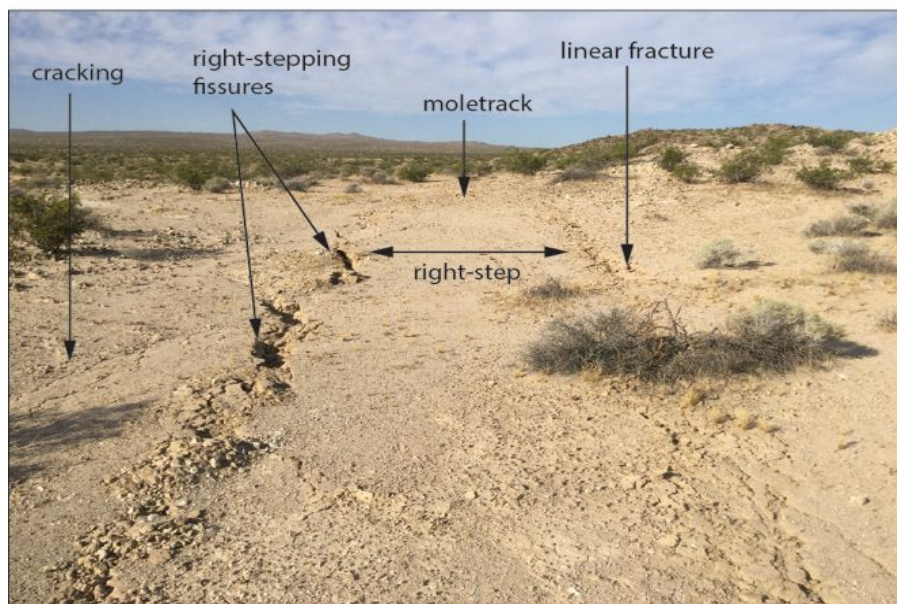
Figure 12. Typical right-stepping and overlapping surface cracks generated by the **M6.4** rupture southwest of Highway 178. View to southwest. (Lat./Long. 35.6413, -117.5391). Photo credit: Rich Koehler.

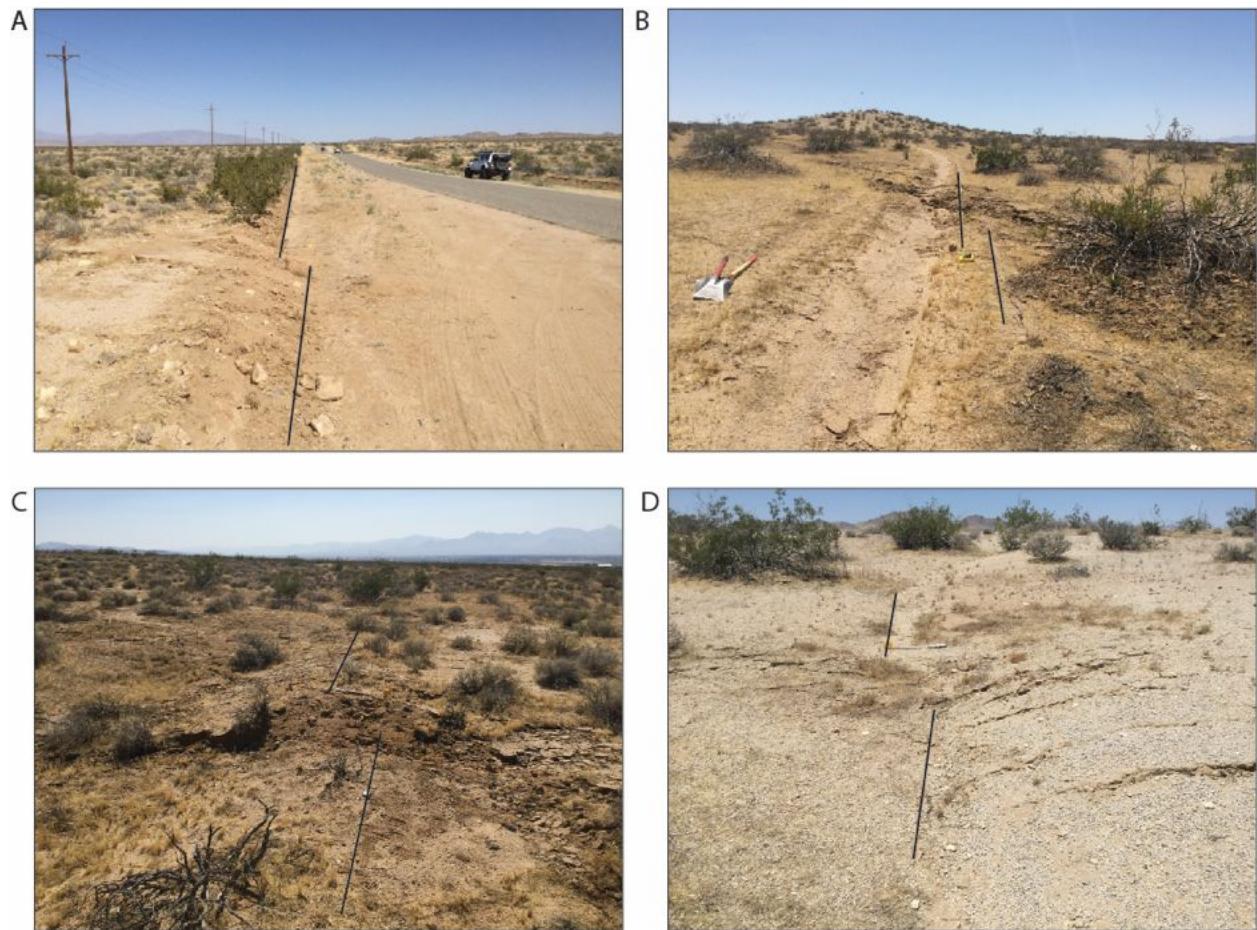
Figure 13. Observed left-lateral offsets along the **M6.4** rupture (black lines) including (A) 60 cm displacement of Randsburg Wash road, view east (Lat./Long. 35.6178, -117.5734), (B) 37 cm displacement of a motorcycle track along a dirt road, view west (Lat./Long. 35.6312, -117.5563), (C) 60 cm displacement of the crest of an erosional swale, view northwest (Lat./Long. 35.6155, -117.5758), and (D) 45 m displacement of a wash gully, view northwest (Lat./Long. 35.6336, -117.5522). Photo credit: Rich Koehler.

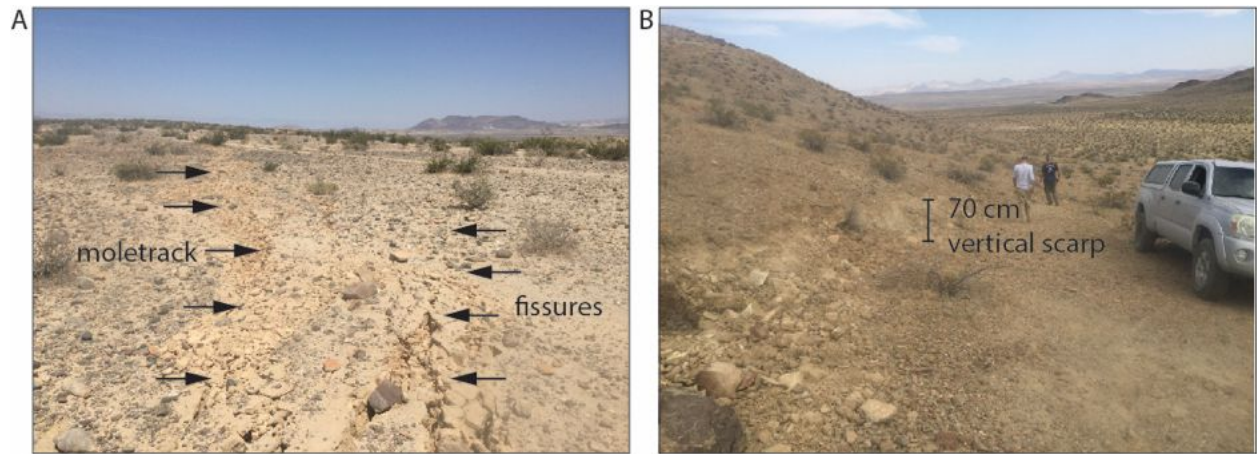
The **M7.1** rupture extends 8 miles (~13 km) southeast from Highway 178, across the crest of the Spangler Hills to the Searles Lake basin. Within the Spangler Hills, the rupture is expressed as left-stepping en echelon surface fractures and fissures separated by small moletracks where it cuts across bedrock surfaces with thin lacustrine and soil cover, and remnant tufa deposits from paleo lake Searles (Figure 14). In this area, fissures are typically <10 cm wide and deep, however the largest fissures are up to 30 cm wide and deep. Moletrack scarps are typically 10-15 cm high, ~1 m wide, and characterized by cracked blocks of duricrust soil. A number of gullies are offset by the rupture up to ~1 m within the Spangler Hills. Distributed cracking occurs over a width of at least 100 m. Southeast of the crest of the Spangler Hills the rupture is characterized by down-to-the-southwest vertical scarps up to 70 cm high and right lateral

offsets of colluvial boulder rubble swales from 70 cm to up to 1 m where it extends across saddles and southwest facing bedrock/colluvial slopes (Figure 14).

Figure 14. (A) Left-stepping fissures and moletracks (Lat./Long. 35.6380, -117.4546), and (B) vertical scarp (Lat./Long. 35.6217, -117.4277) within the Spangler Hills. Photo credit: Rich Koehler

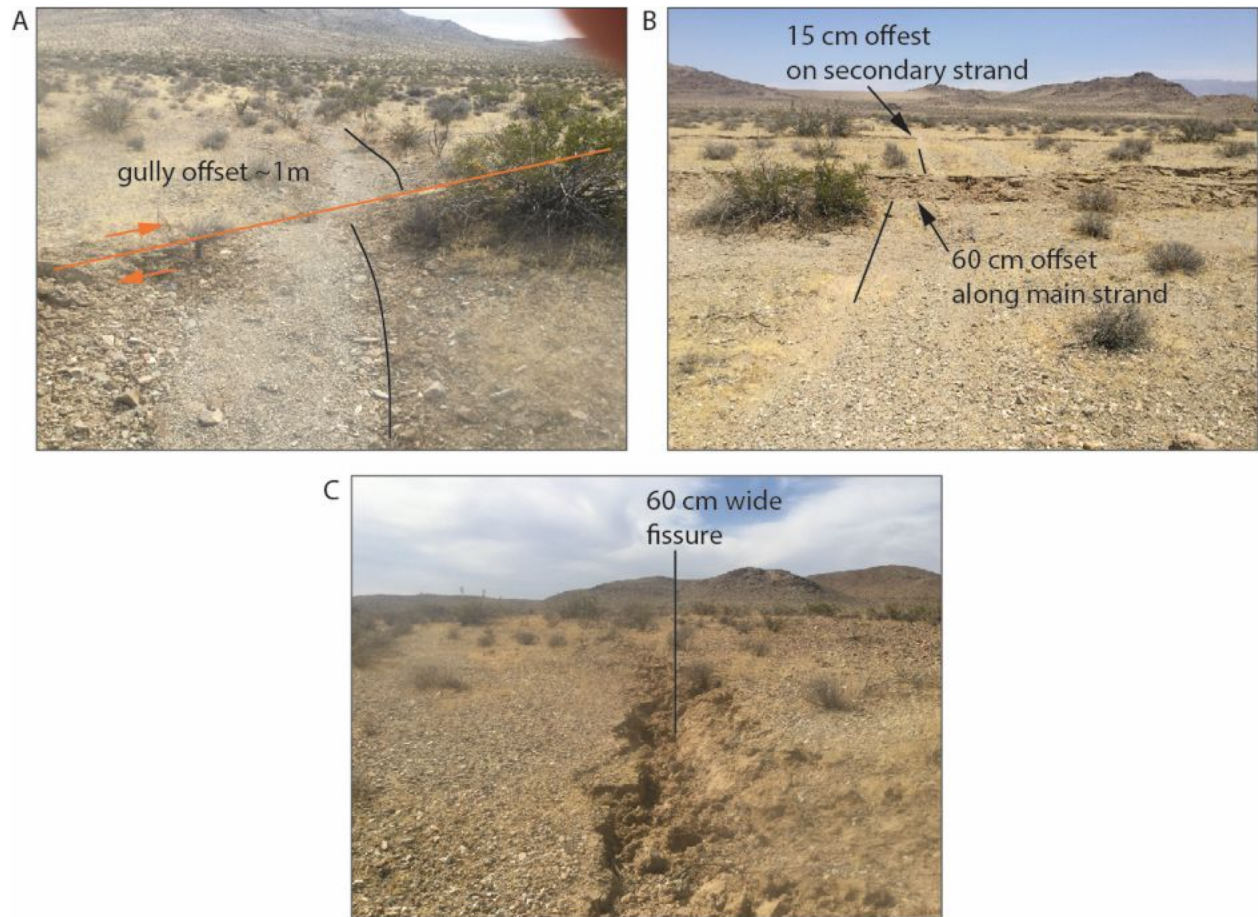
Figure 15. Photographs of the rupture where it cuts an alluvial fan on the southeast flank of the Spangler Hills including (A) ~1 m right-lateral offset of a gully (Lat./Long. 35.6172, -117.4236), (B) right-laterally offset dirt road, 60 cm across main strand and 15 cm across parallel subsidiary strand (Lat./Long. 35.6022, -117.4069), and (C) a large fissure (Lat./Long. 35.6171, -117.4227). Photo credit: Rich Koehler.

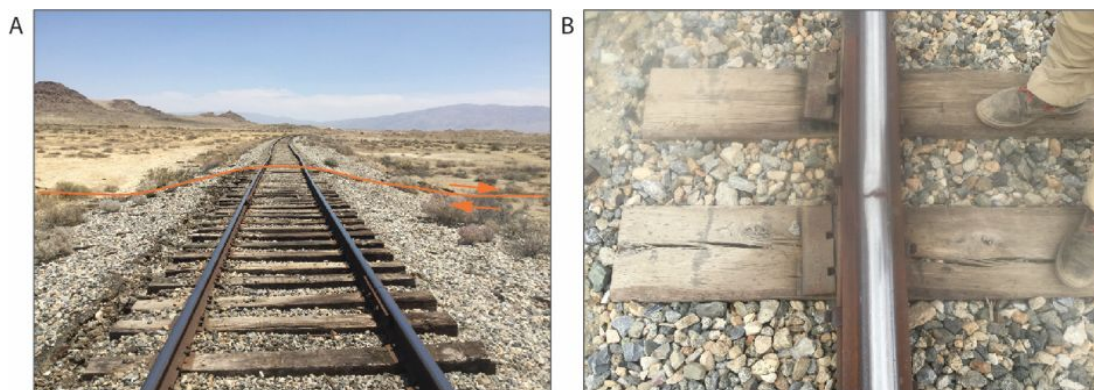
Figure 16. (A) Right-laterally offset rail bed and bent tracks along the main rupture trace (Lat./Long. 35.5944, -117.4004) and (B) kinked tracks and jostled rail spikes along a secondary trace (Lat./Long. 35.5872, -117.4141). Photo credit: Rich Koehler.

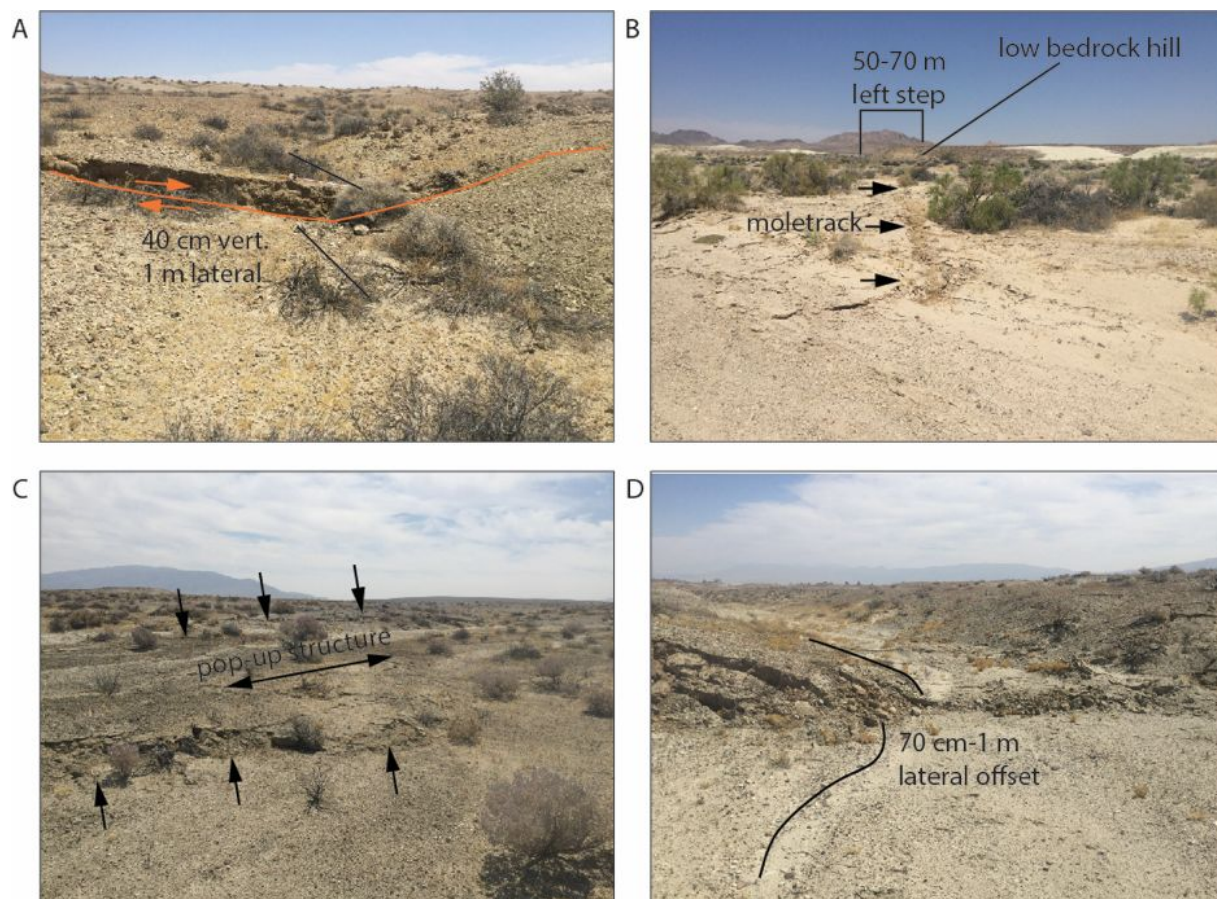
Figure 17. Photographs of the M7.1 rupture south of the Trona railway. (A) 1 m right lateral and 40 cm vertical displacement of small drainage, view northeast (Lat./Long. 35.5917, -117.3978), (B) moletrack projecting northwest into 50-70 m wide stepover in rupture trace (Lat./Long. 35.5869, -117.3903), (C) left stepping scarps in active wash connected by pop-up structure, view west (Lat./Long. 35.5856, -117.3889), and (D) right-laterally displaced channel margin (70 cm-1 m), floor of active wash displaced vertically up on NE about 30 cm, view NE (Lat./Long. 35.5826, -117.3845). Photo credit Rich Koehler.

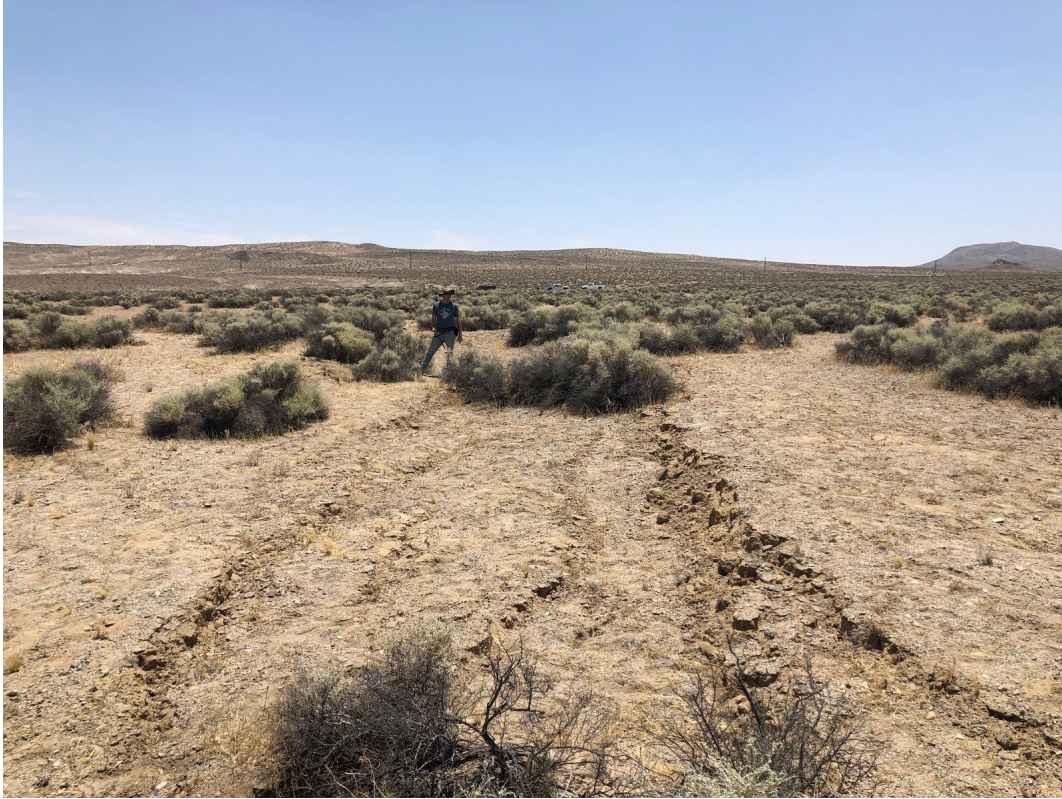
Figure 20. Fault rupture from the **M7.1** event south of Highway 178 showing a 3 m band of concentrated deformation (35.6483, -117.4813). Photo credit Christine Goulet.

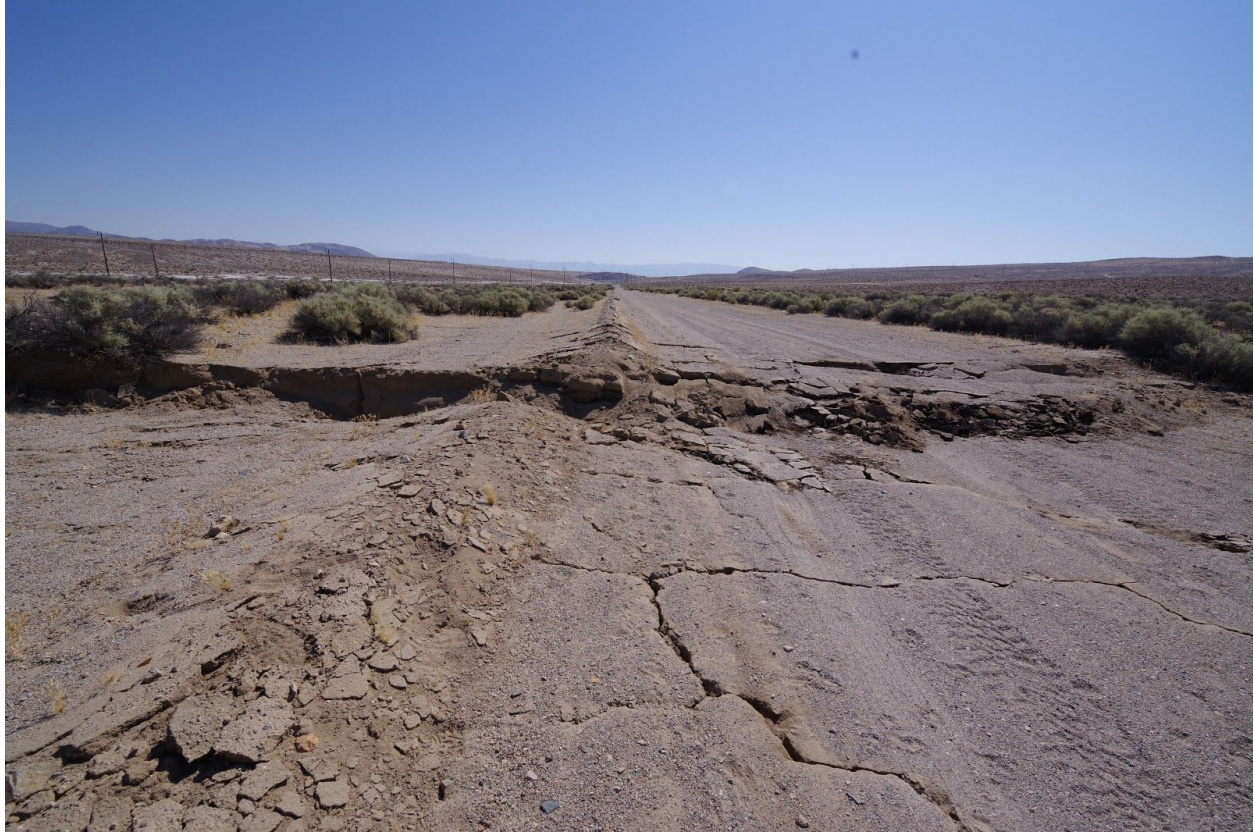
Figure 22. Fault rupture from the **M7.1** event showing at a road crossing south of Highway 178 (35.6468, -117.4800). Photo credit Scott Brandenburg.

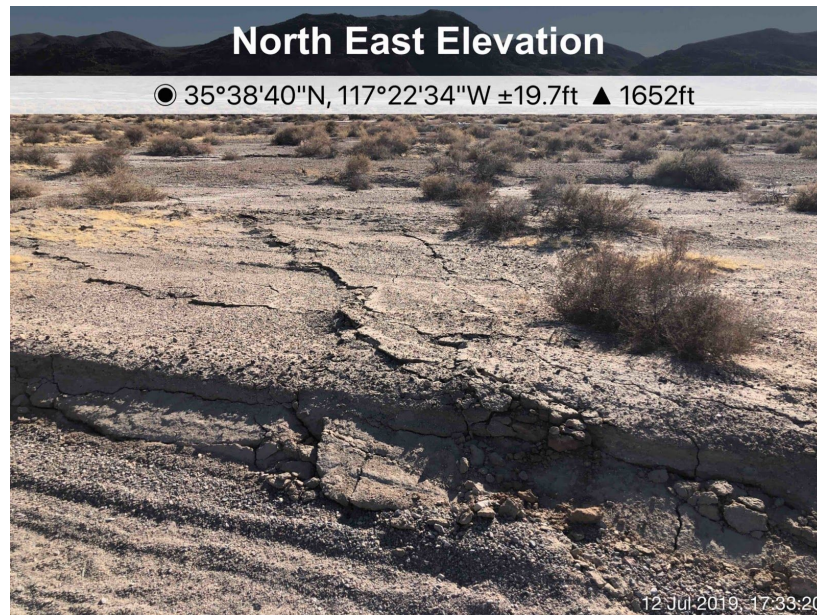
Figure 25. Example of cracks observed along Pinnacles Road. This specific picture was taken at zone 3 and shows where the cracks cut the Pinnacles Road.

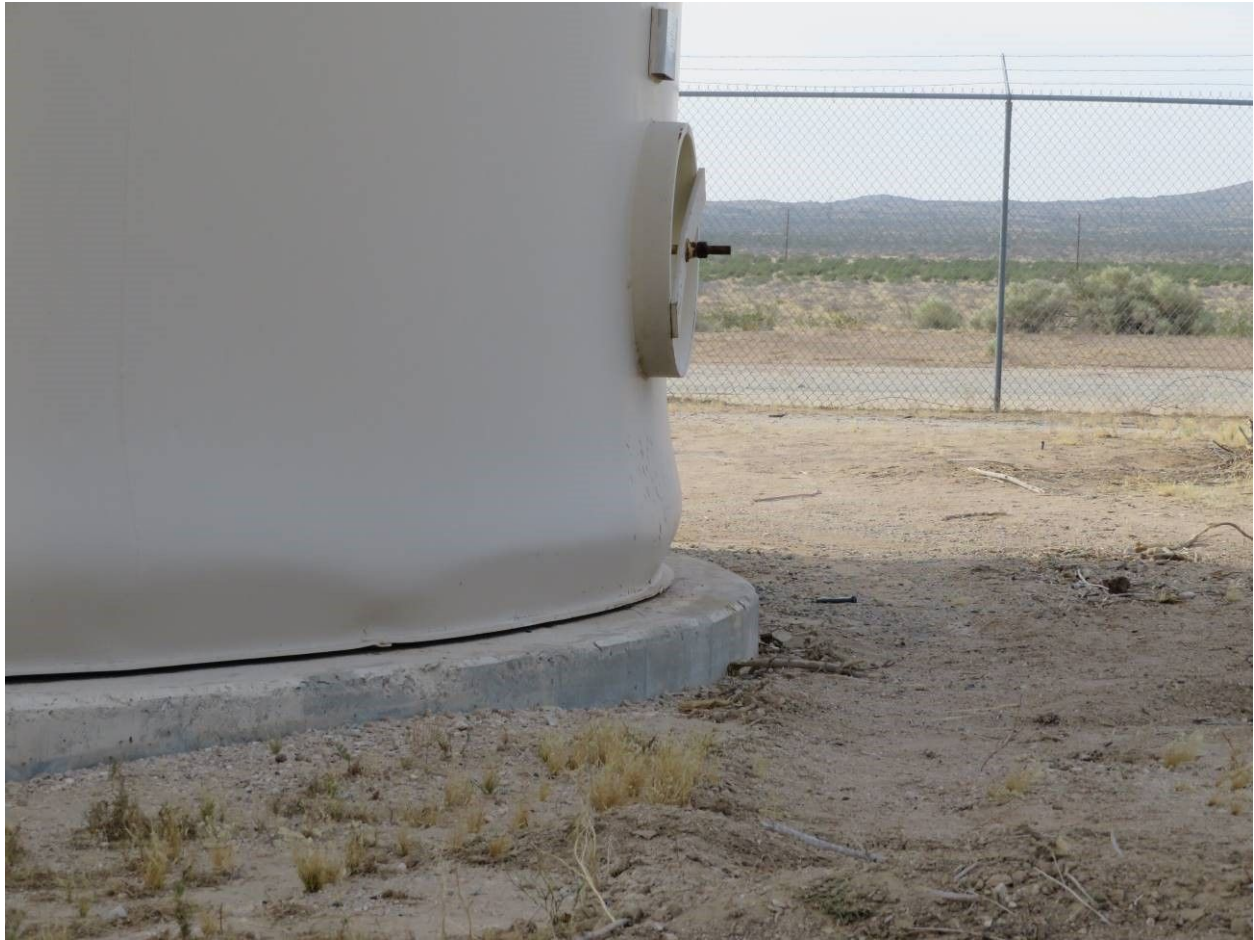
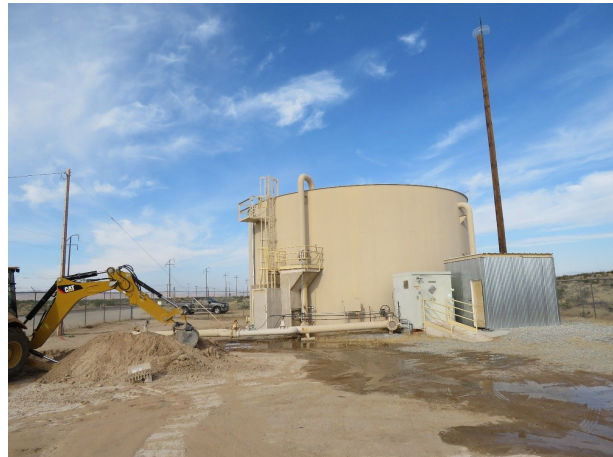
Figure 26. Hilltop Tank elephant foot buckle, pipe repair and continued leaking (35.6260, -117.5916).

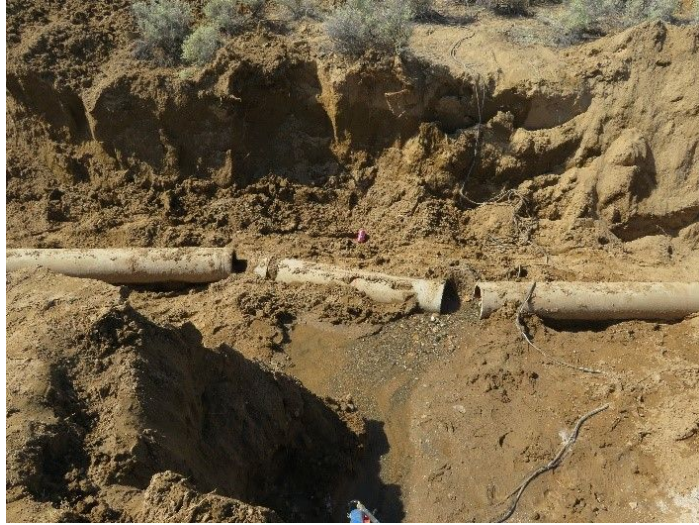
Figure 28. Offset of buried concrete segmented pipeline crossing the M7.1 surface fault rupture. (35.6492, -117.4822).

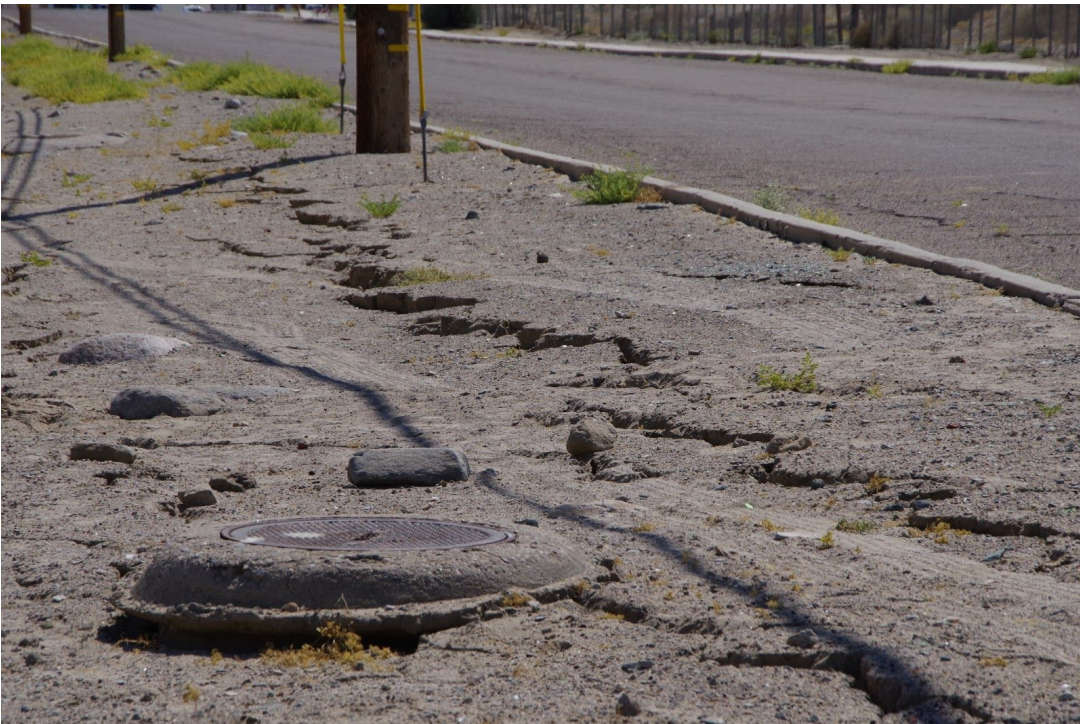
Figure 32. Ground cracks due to liquefaction-induced lateral spreading in Trona. Photo by Scott Brandenburg, (35.7626, -117.3731).

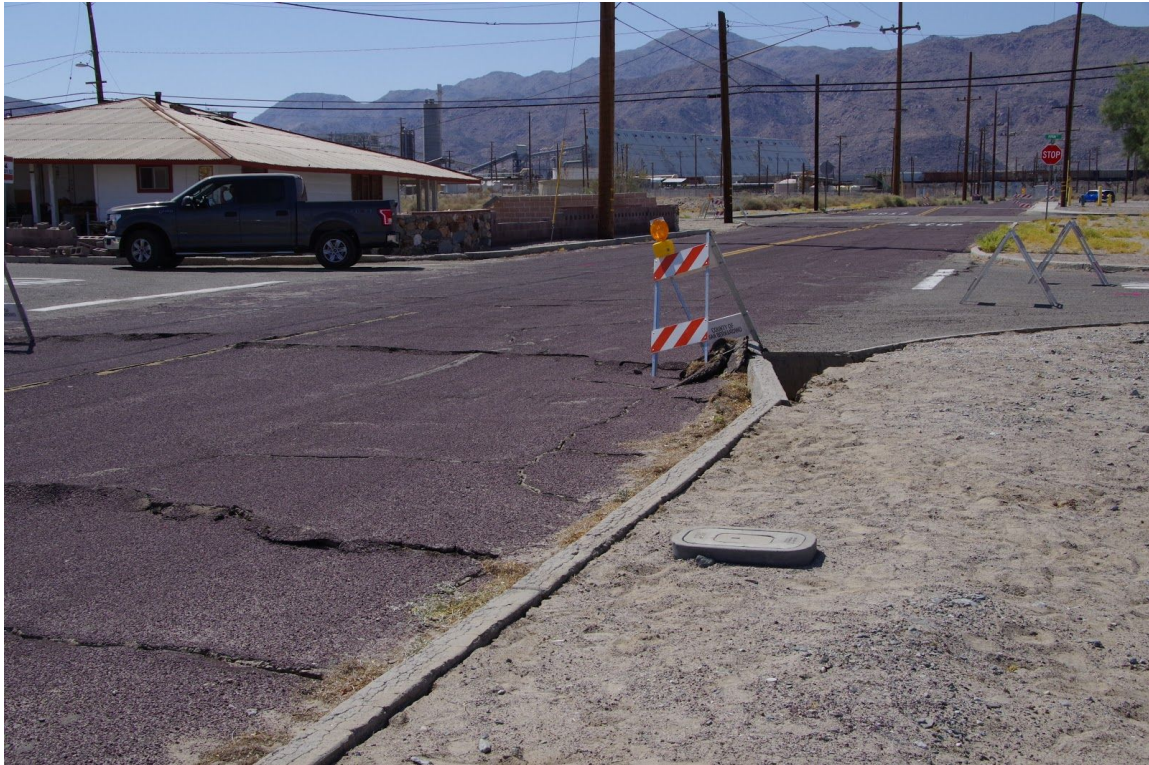
Figure 33. Ground compression, including buckled curb, due to liquefaction-induced lateral spreading in Trona. Photo by Scott Brandenburg, (35.7623, -117.3725).

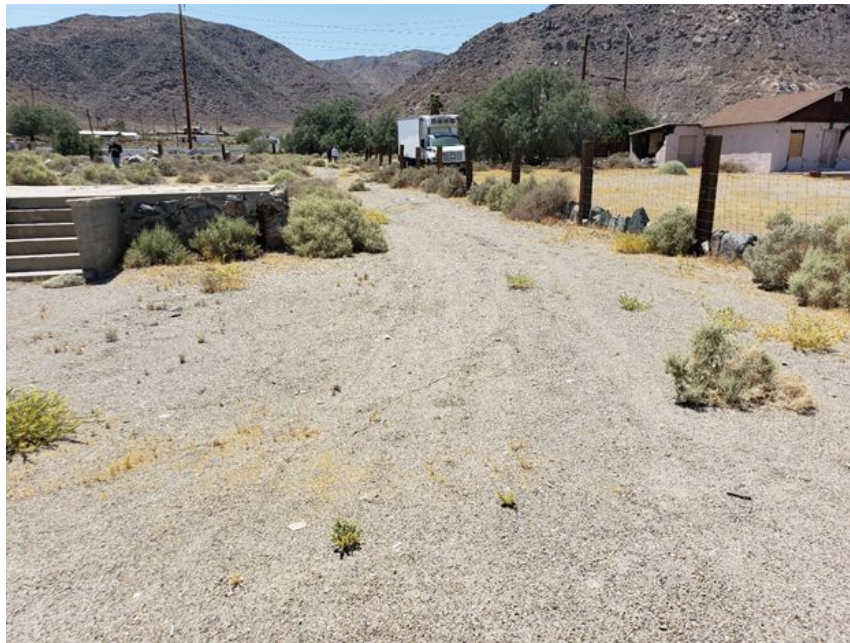
Figure 41. Example of liquefaction-induced lateral spreading ground cracking in vicinity of Structure A1 (at right of photograph). (35.7454, -117.3963)

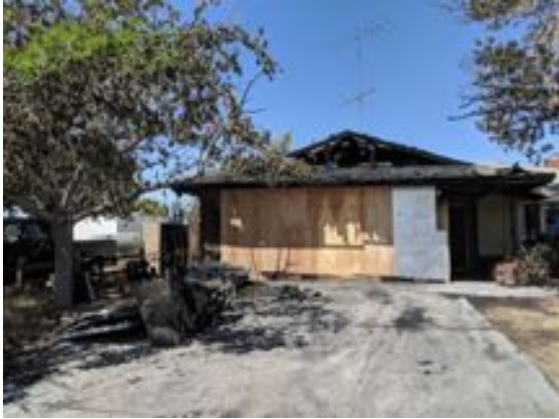
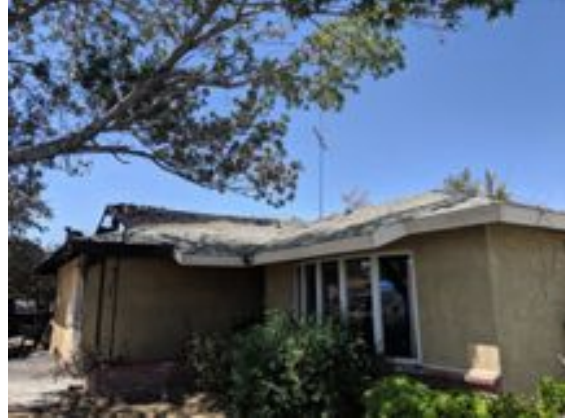
Figure 43. Damaged wood-frame house due to gas leak fire in Ridgecrest (35.6202, -117.6612) Photo credit: Farzin Zareian

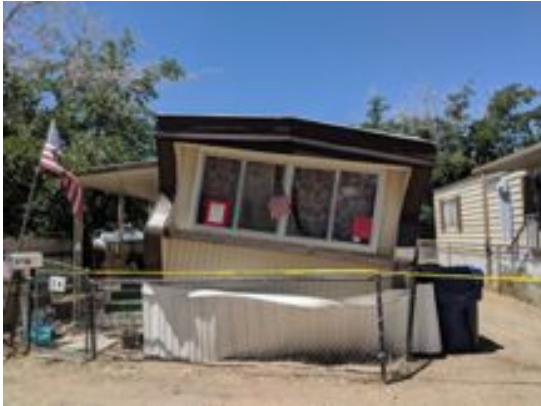
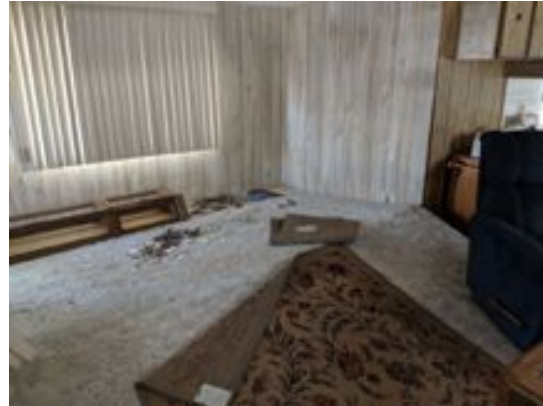
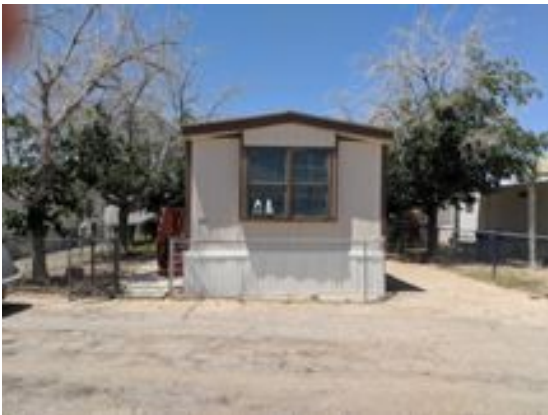
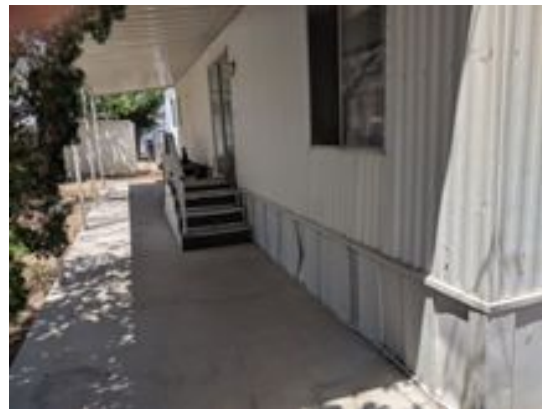
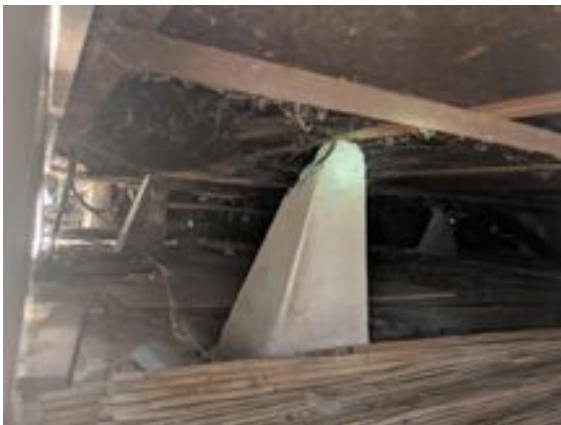
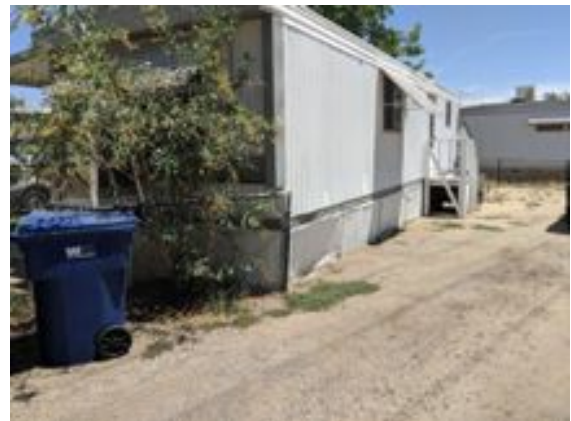
Figure 44. Damaged mobile homes in Ridgecrest after M6.4 event (35.6444, -117.6733) Photo credit: Farzin Zareian
