Preliminary Report on Engineering and Geological Effects of the July 2019 Ridgecrest Earthquake Sequence

A report of the NSF-Sponsored Geotechnical Extreme Event Reconnaissance Association

Report GEER-064

July 19 2019

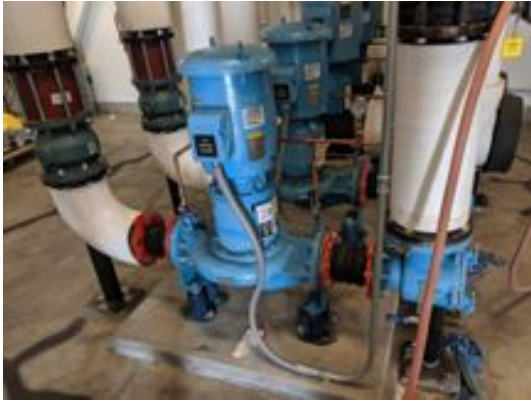
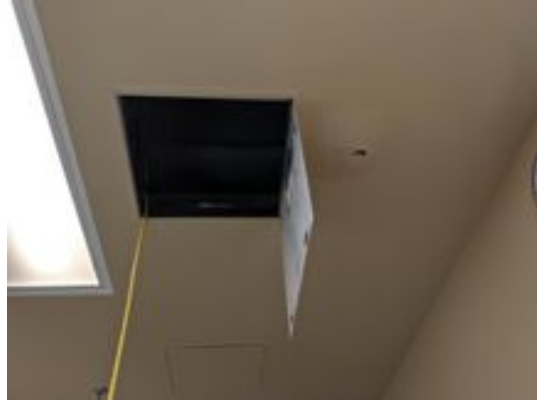
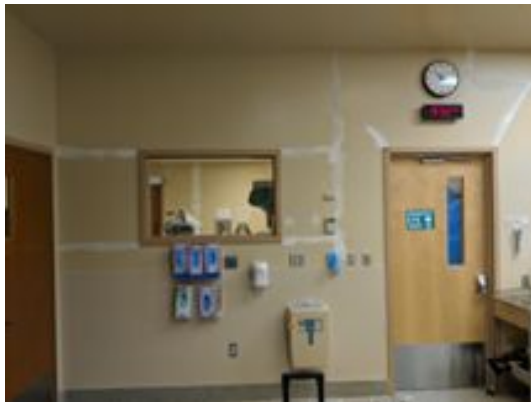
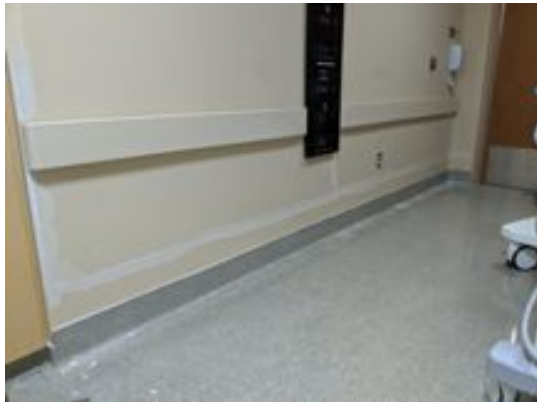
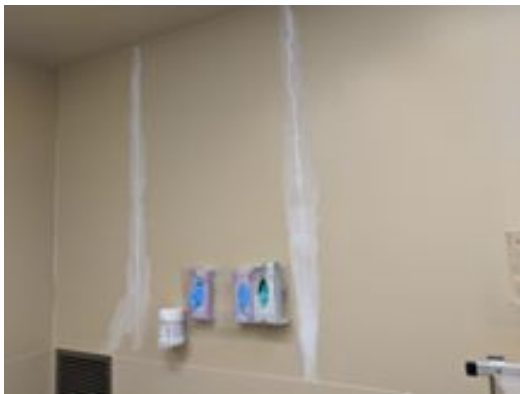
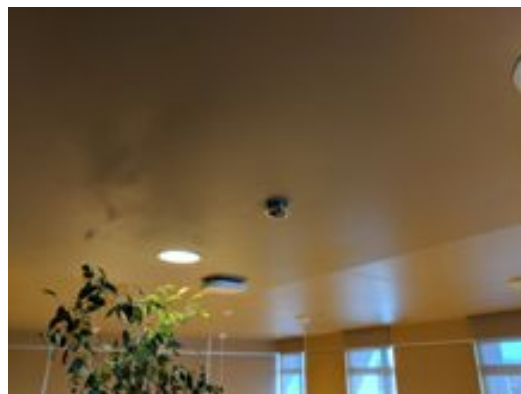
Figure 46. Damages to Ridgecrest Regional Hospital after the **M6.4** event (35.6410, -117.6707) Photo credit: Farzin Zareian

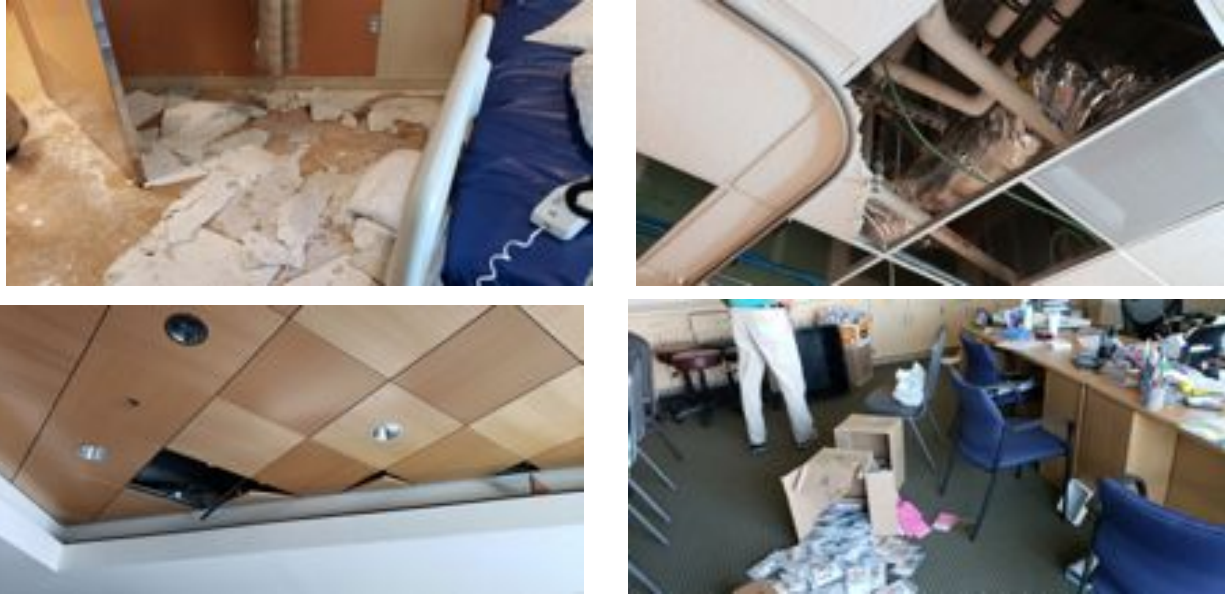
Figure 47. Damages to Ridgecrest Regional Hospital after the M7.1 event (35.6410, -117.6707) Photo credit: Jawad Fayaz

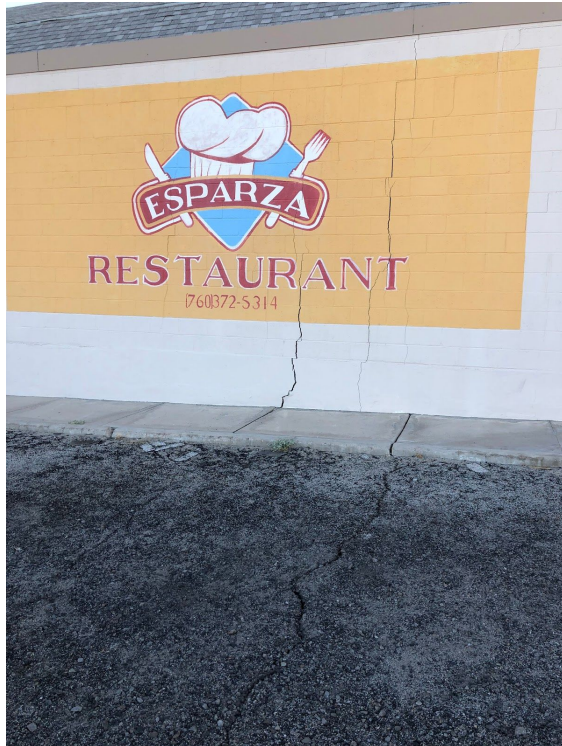
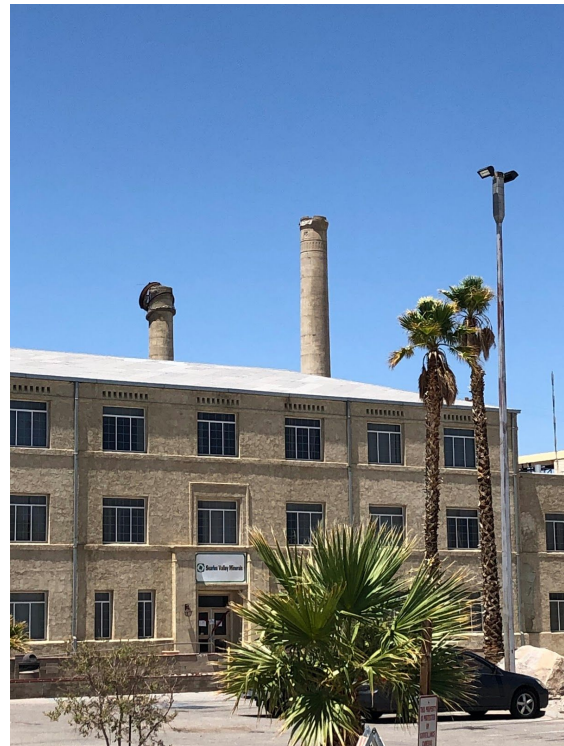
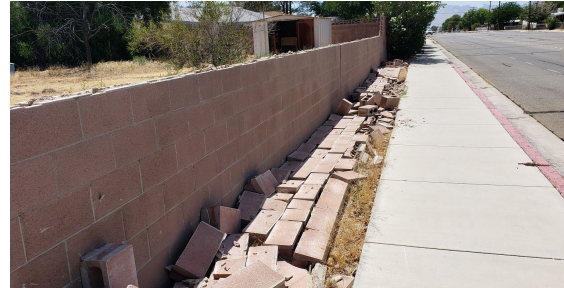
Figure 48. Damages to Masonry components after the M7.1 event (a: 35.7595, -117.7357, b: 35.7592, -117.3766, c: 35.7595, -117.7357, d: 35.6444, -117.6720) Photo credit: Christine Goulet and Jawad Fayaz
