GEOTECHNICAL ENGINEERING RECONNAISSANCE OF THE 19 SEPTEMBER 2017 Mw 7.1 PUEBLA-MEXICO CITY EARTHQUAKE

Report No. GEER-055A

16 October, 2017

Geotechnical Engineering Reconnaissance of the 19 September 2017 M_w 7.1 Puebla-Mexico City Earthquake: Version 1.0

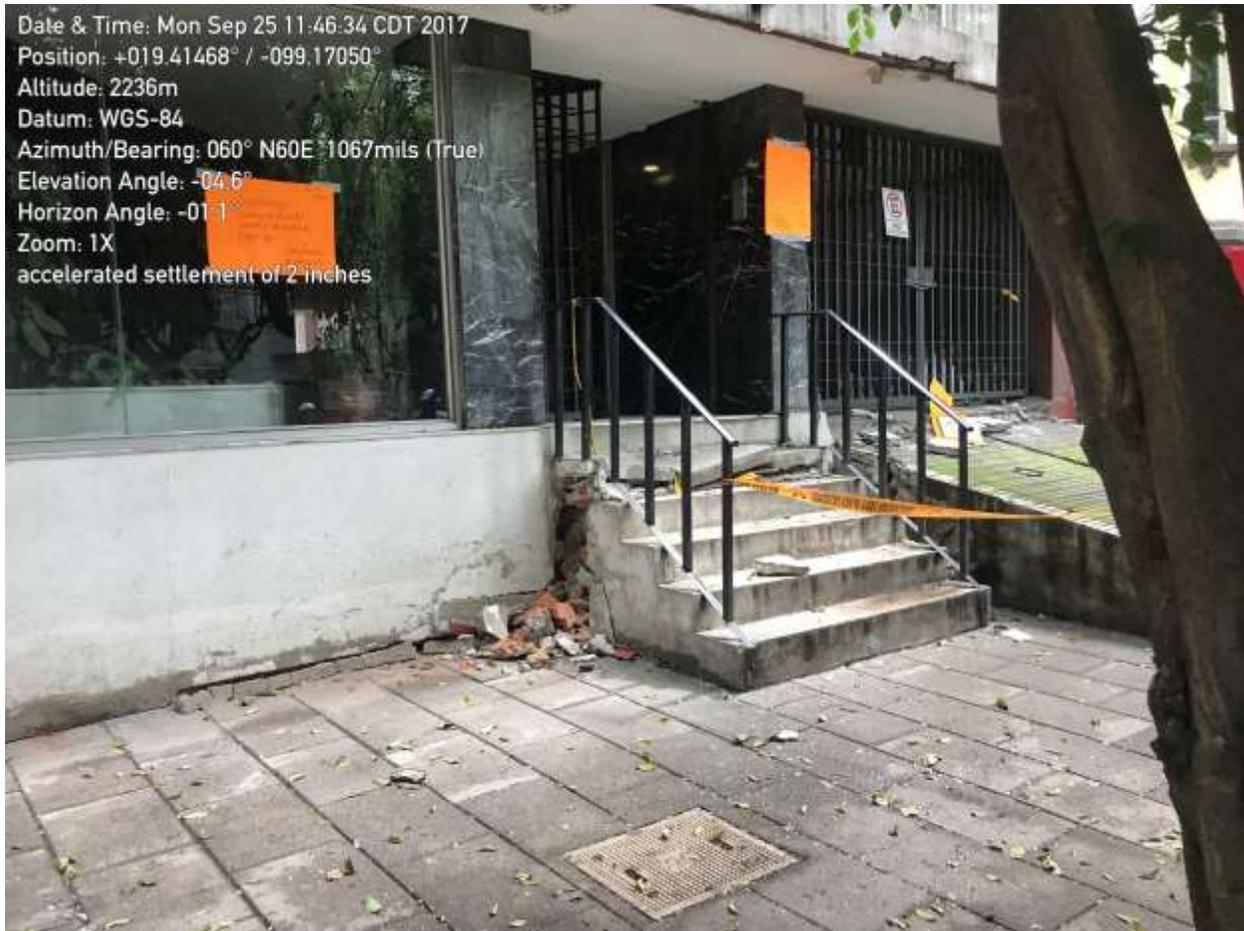
Figure 19. An end-bearing pile structure built in 1966 that experienced approximately 3 cm of settlement in the soil surrounding the structure; otherwise, the structural components of the building were generally undamaged. Note that the building entrance used to be level with the sidewalk, but is now 1.25 meters above the sidewalk elevation, due primarily to pre-event settlement (GPS: 19.4146, -99.1705)

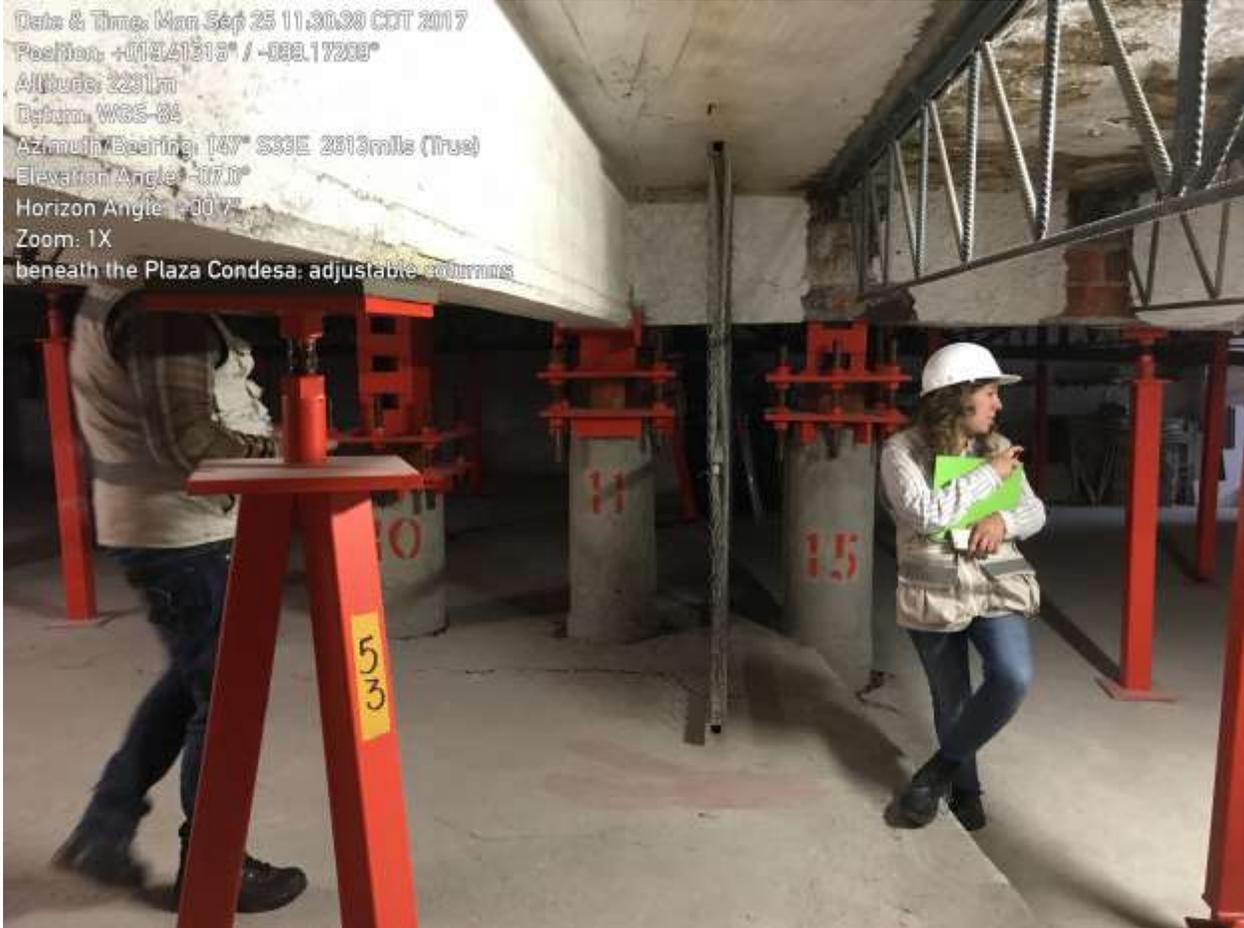
Figure 20. End-bearing control piles supporting the La Plaza Condesa building (19.4132, -99.1721)

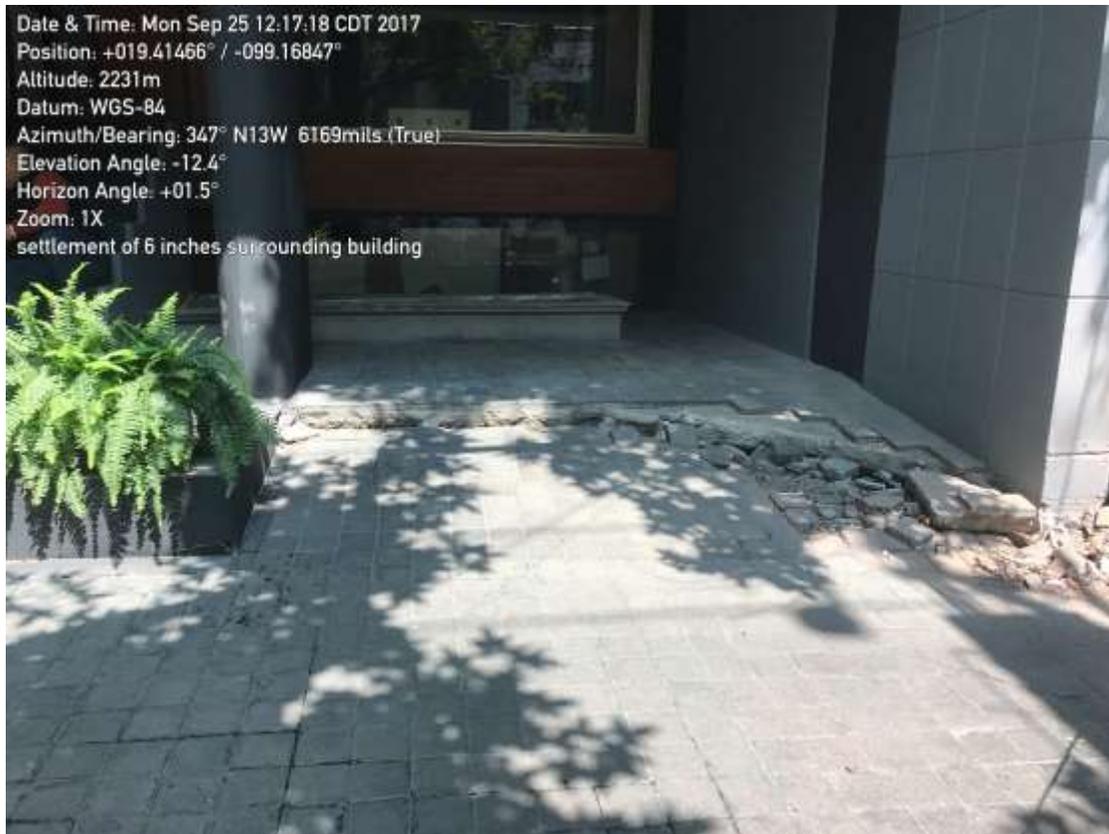
Figure 21. Settlement of approximately 15 cm in the soil surrounding an end-bearing pile-supported structure (19.4146, -99.1684)

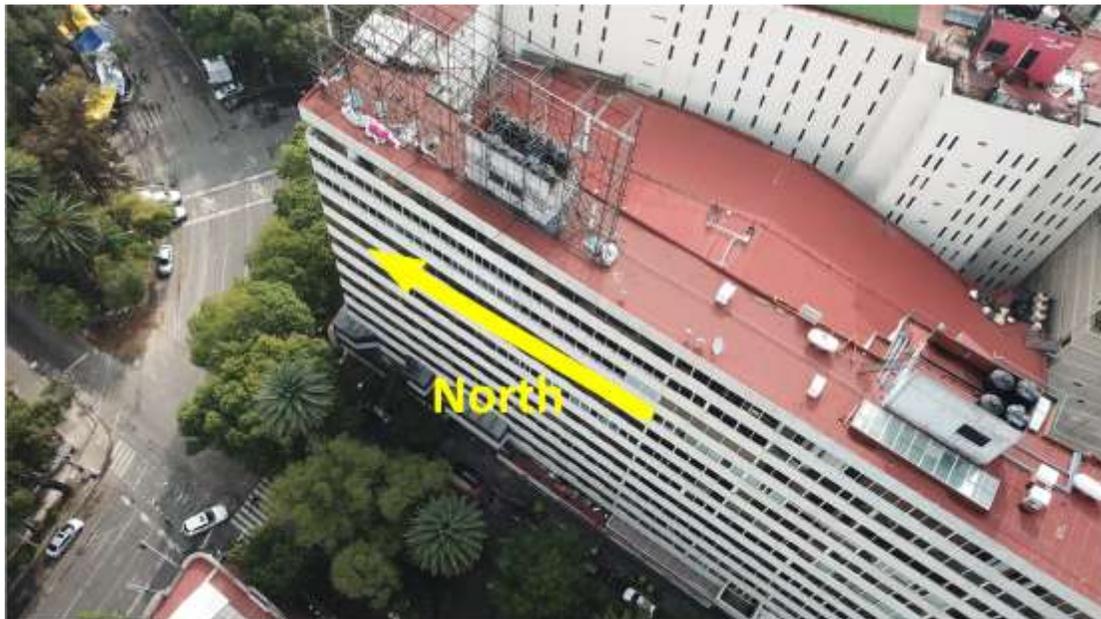
Figure 22. The 12-story La Condesa building (19.4129, -99.1722), which was tilting approximately 1 degree to the north

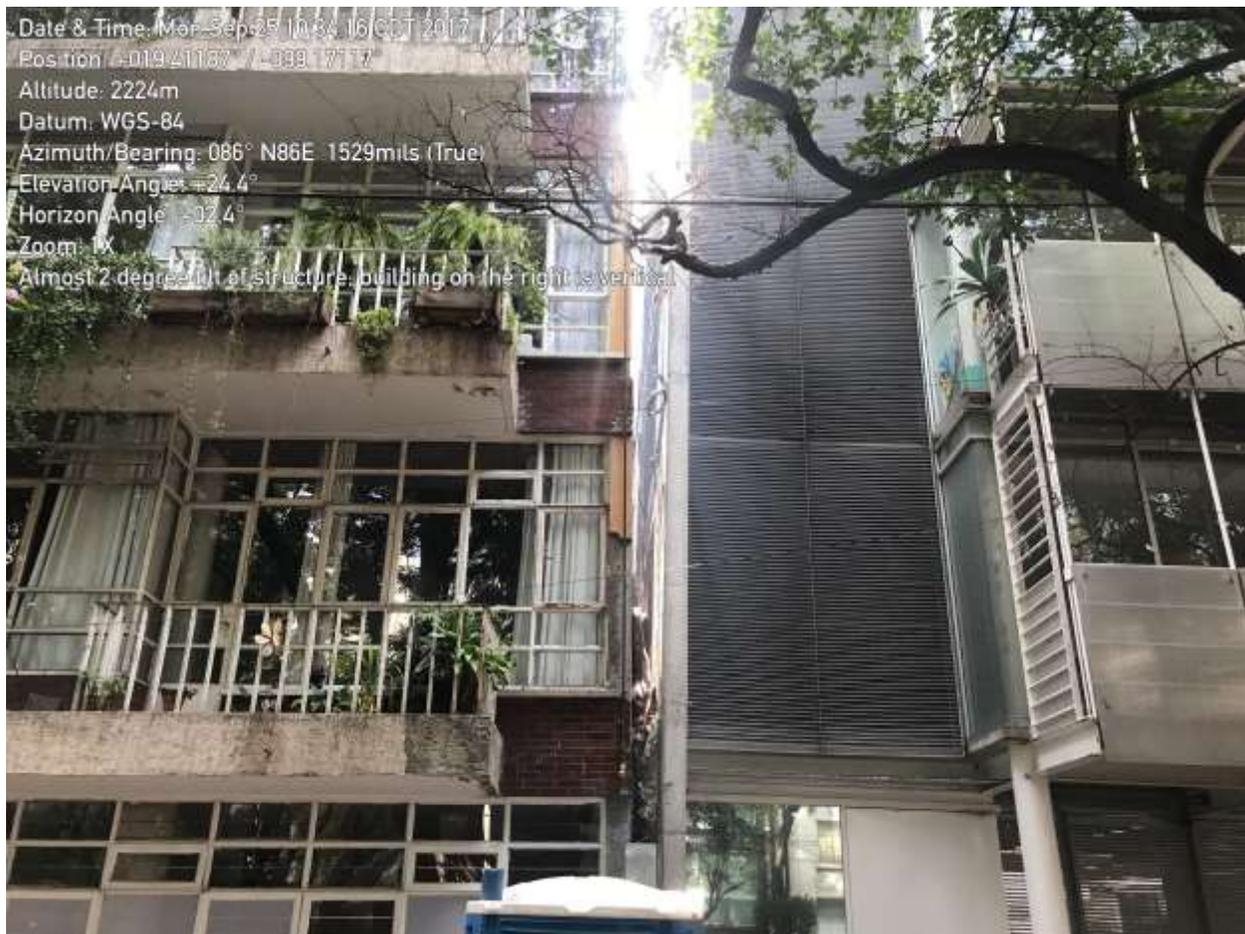
Many structures founded on friction piles with mat foundations did not perform well in the earthquake. While little to no differential settlement between the structure and the surrounding soil was generally apparent because the structure tended to settle over time with the surrounding ground, there were observed cases of permanent structural tilt following the earthquake, as shown in Figure 23. This damage likely occurred as the rocking structure with its corresponding friction piles weakened the underlying lacustrine clays sufficiently to induce cyclic softening and reduced shear strengths beneath the structure and along the friction piles. As a result, piles on one side of the building were uplifted, and the mat foundation on the opposite side of the structure caused shear-induced deformation and bearing capacity failure in the underlying clay. While it is certainly possible that many of the damage that affected areas of Mexico City were caused by structural deformations following the 1985 and 2017 earthquakes, many of the tilted buildings that the UNAM-GEER advance team inspected in La Condesa showed no signs of structural distress (e.g., cracking, exposed rebar, spalling, etc.). The advance team did not address whether the observed damage was due to the 1985 or 2017 earthquakes; however, future efforts should do so to refine the observations that were gathered.

Figure 23. Permanent tilt of approximately 2 degrees in the friction pile-supported structure on the left; the structure on the right is vertical (19.4118, -99.1711)

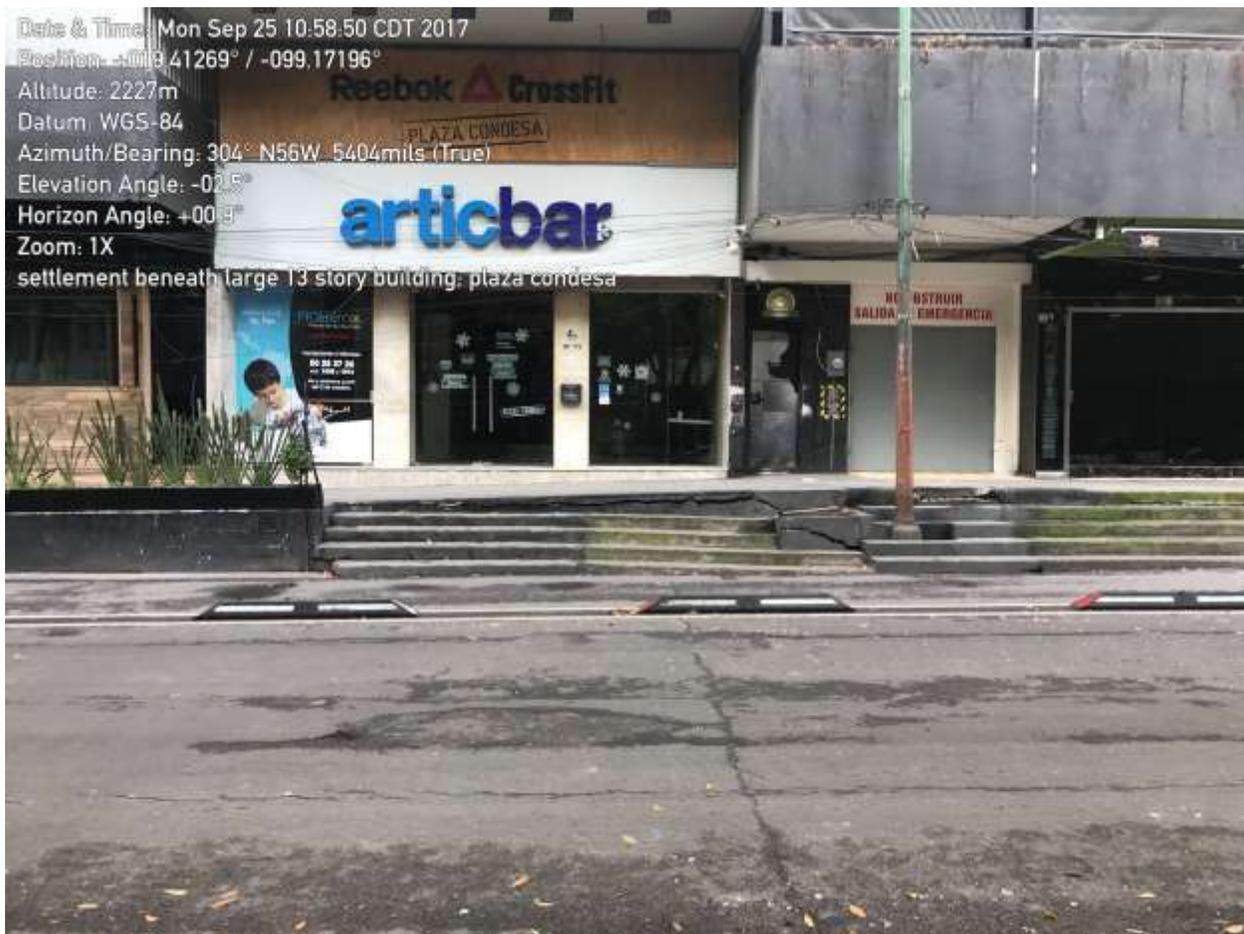
The advance team reconnaissance revealed few incidences of co-seismic ground deformation, most likely due to highly plastic lacustrine clays that are abundant in Mexico City. This observation does not include slope instabilities and landslides, which will be summarized in Section 7 below. As described in Section 3 above, the UNAM-GEER observed several occurrence of settlements on the order of 1 to 15 cm in the lacustrine clays of Mexico City. These settlements became apparent when the soil surrounding end-bearing pile-supported structures settled relative to the fixed structure, as demonstrated in Figure 24.

Figure 24. Settlement of the ground surrounding a pile-supported structure in La Condesa (19.4126, -99.1719)

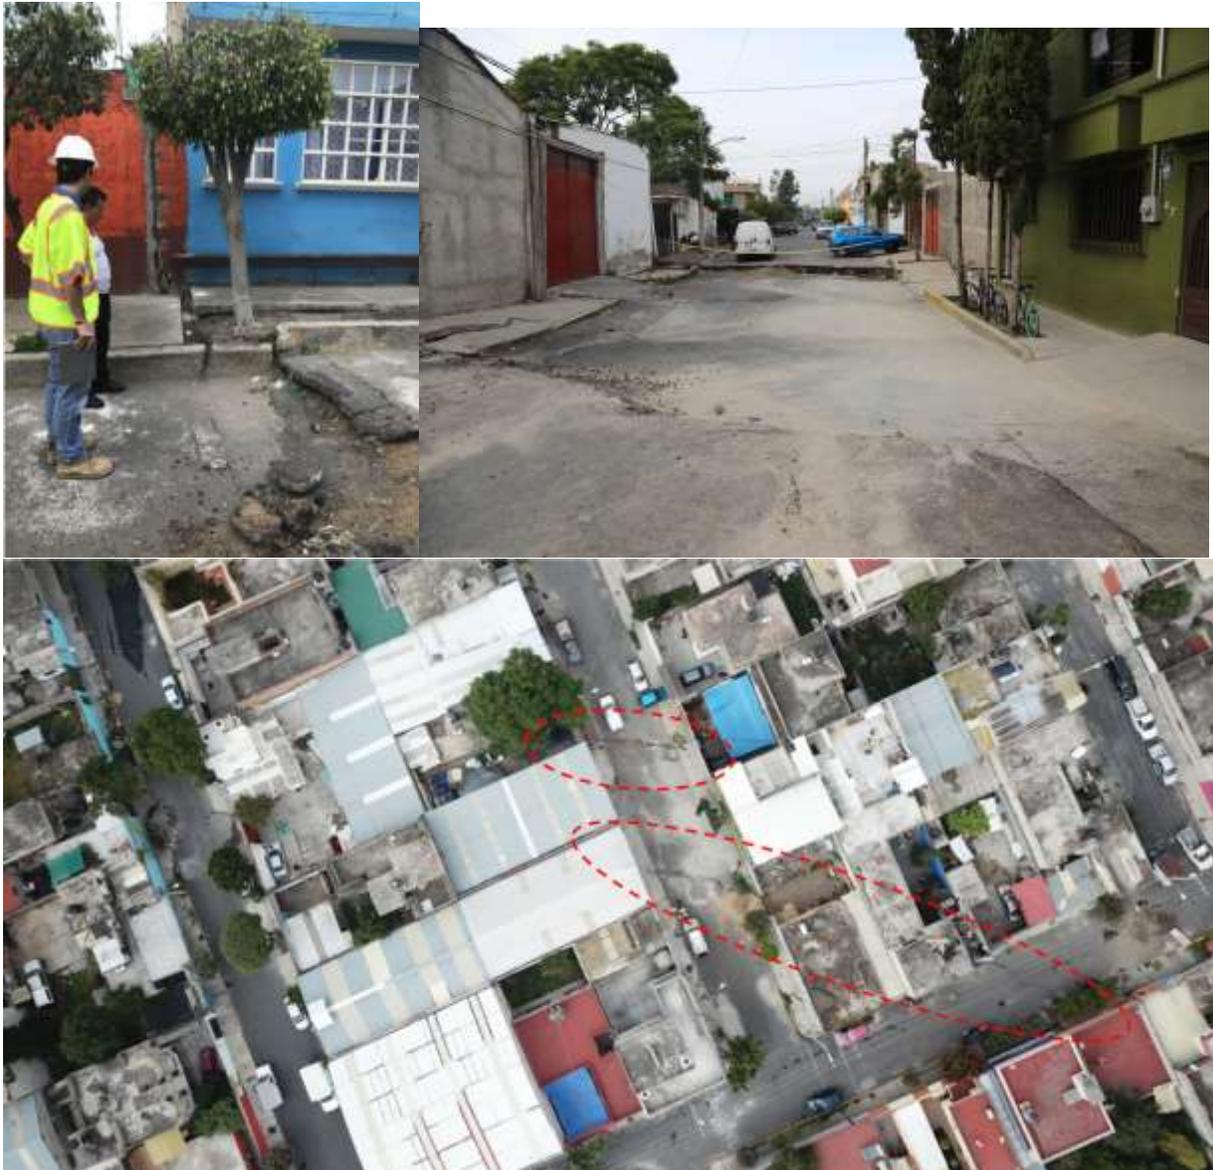
Extensive ground deformation was observed by the UNAM-GEER team in the vicinity of Colonia del Mar, Tlahuac, near the southern rim of Mexico City. A series of cracks and trench-like depressions were observed throughout the neighborhood that rendered settlements as large as 50 cm, with widths ranging from 15 meters to 25 meters across. These bands of settlement extended over several city blocks, passing beneath structures and causing damage to several pipelines. Figure 25 shows a band of settlement passing

beneath residences, causing many of the structures to tilt. The UNAM-GEER team originally postulated that these bands of settlement may have been caused by buried alluvial stream deposits with varying thickness that may have settled or moved laterally during the earthquake. However, subsequent investigation by team members revealed that numerous cracks from settlement-induced subsidence had been previously mapped throughout that portion of the city (CENEPRED, 2017). The mapped location of the cracks (Figure 26) corresponded well with our observed cracks in Colonia del Mar. While it is clear that the earthquake likely initiated additional settlement and lateral displacement along existing cracks, preliminary assessment suggests that new cracks may have developed. This assessment is currently being refined, and new findings will be reported in Version 2 of this report.

Figure 25. Images of ground cracking from subsidence in Colonia del Mar at: (top) 19.2839, -99.0571, and (bottom) 19.2846, -99.0578

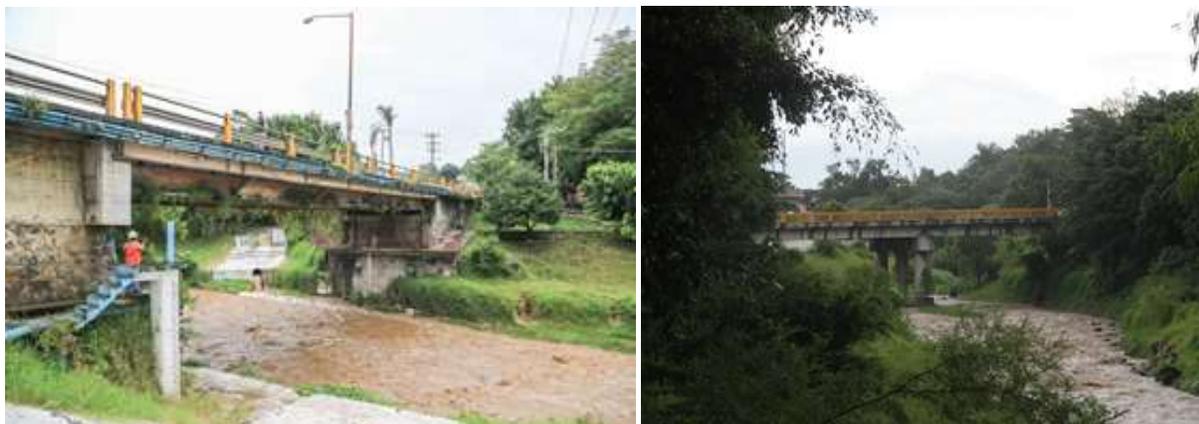
Figure 28. Two bridges in Cuautla, assessed on September 27th 2017, no visible sign of damage across both structures, left: Carlos Pacheco Bridge (18.8091, -98.9490), right: Solidaridad Bridge (18.8106, -98.9473).

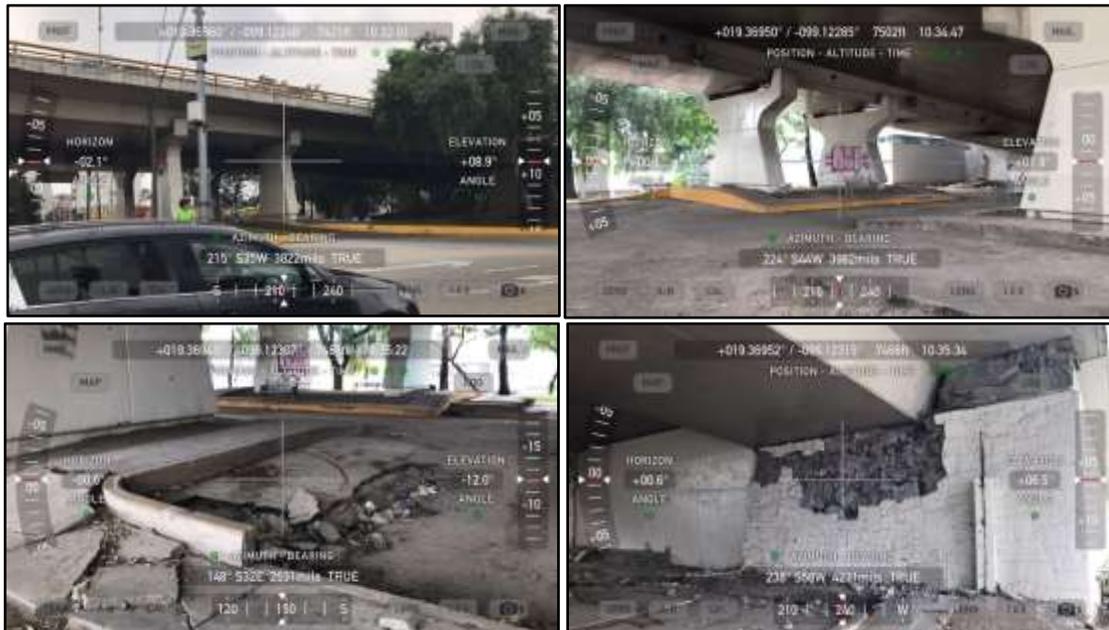
Other bridges like the Metro Viaduct (see Appendix) were damaged but did not collapse due to the light shaking. Collaborator Prof. Miranda of Stanford shared some photos of the Circuito Interior Avenida Rio Churubusco (19.3696, -99.12248) in Mexico City. These parallel box girder viaducts on pier walls rocked during the earthquake (the pier walls were too stiff to bend) and a masonry abutment was damaged (Figure 30). More information regarding this and other bridge inspections conducted by the UNAM-GEER Main team will be included in Version 2.

Figure 30. Damage to the Circuito Interior Avenida Rio Churubusco (19.2913, -99.1105).

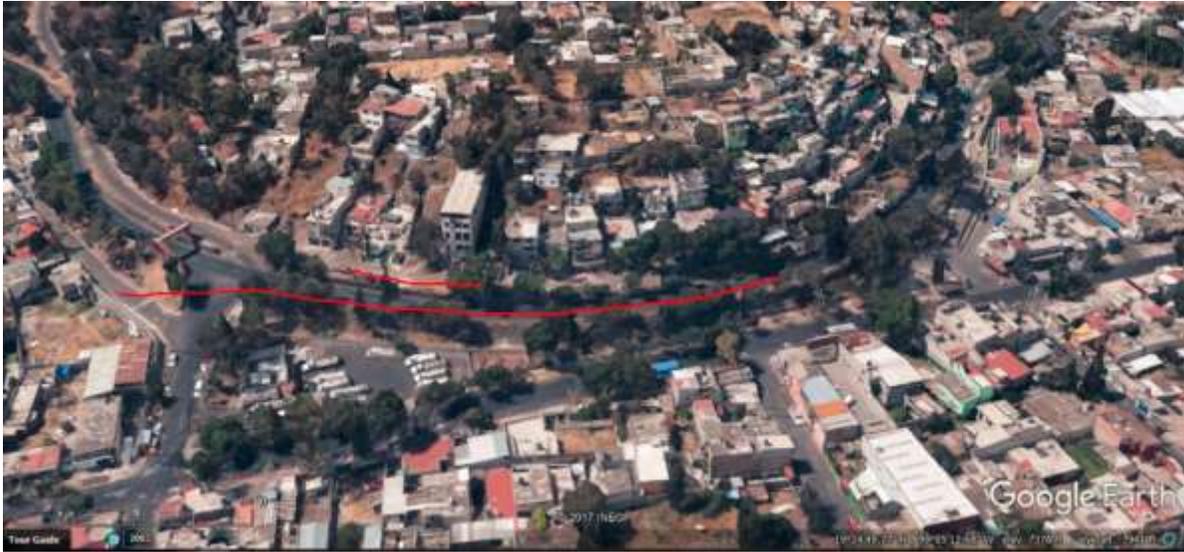
Relatively moderate slope stability problems were observed within the city boundaries of Mexico City. The UNAM-GEER advance team investigated one site located near Xochimilco and several more outside Mexico City. The Xochimilco slope instability (Figure 33) was of concern as ongoing deformation due to groundwater pumping and increasing ground earthquake-induced deformation indicated concurrent slide movement. The site is fully inhabited with residential construction. In addition, the district's water pumping station is located at the bottom of the slope.

Figure 33. Photo of unstable hill site Xochimilco, red lines indicated documented cracking

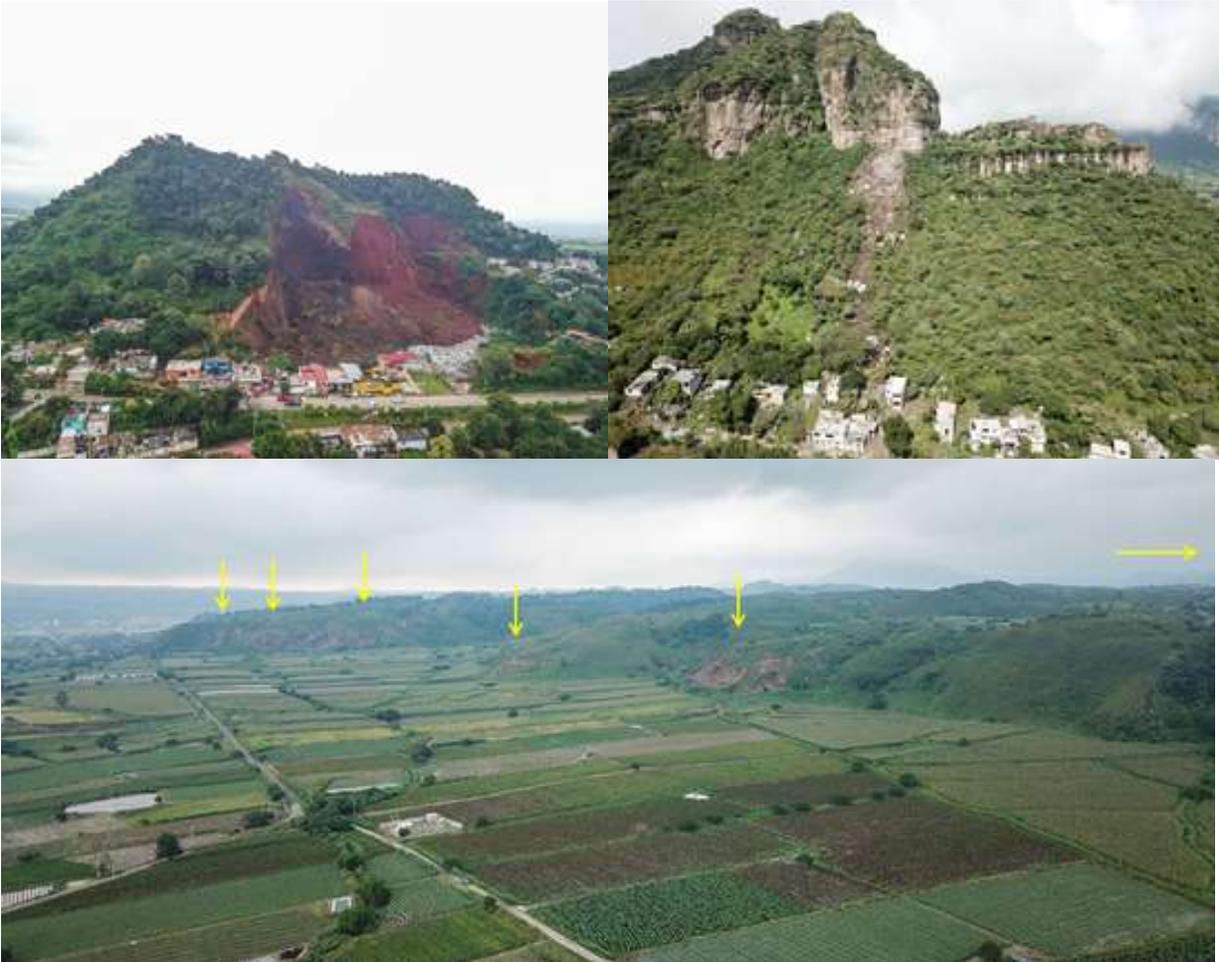
Figure 34. Totolapan debris slide in old quarry (top left; 18.9816, -98.9246), Tlayacapan debris (rock) flow (top right; 18.9486, -98.9837), and Atlatlahucan landslide region (18.9378, -98.8784)

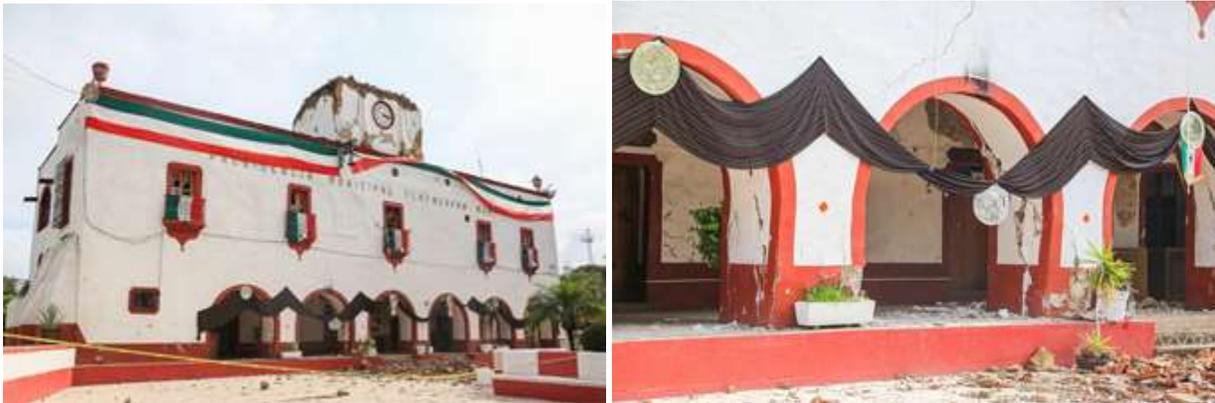
Figure 35. Severe damage at the historical municipality building in Tlayacapan, a 2 story unreinforced masonry building (18.9565, -98.9832)

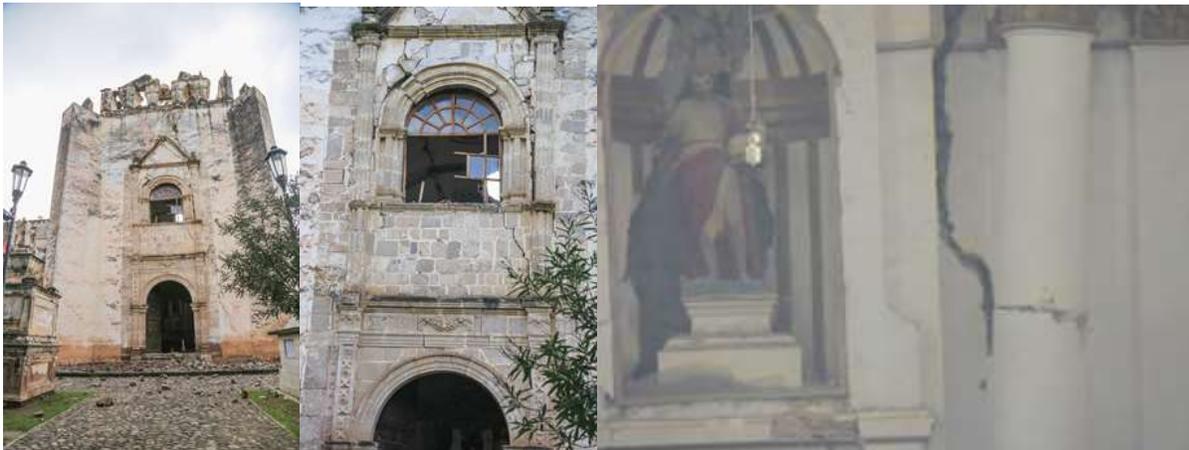
Figure 36. Damage at the historical Tlayacapan Church (complete closure) (18.9561, -98.9821)

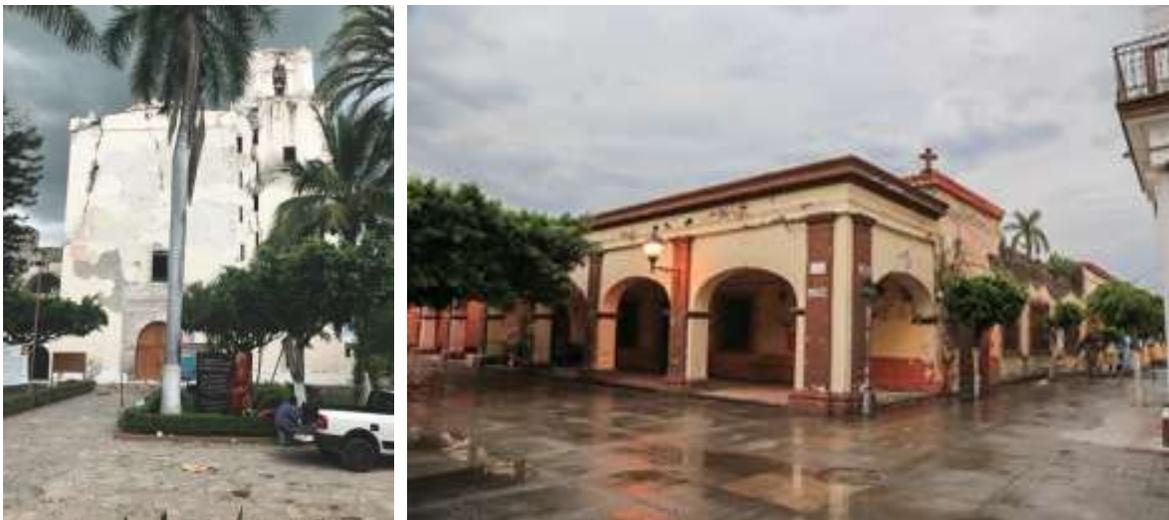
Figure 38. Left: Severe cracking of the Tlaquiltenango church (18.6296; -99.1607), Right: damage to municipality building and entire historic downtown district of Cuautla (18.8122, -98.9553)

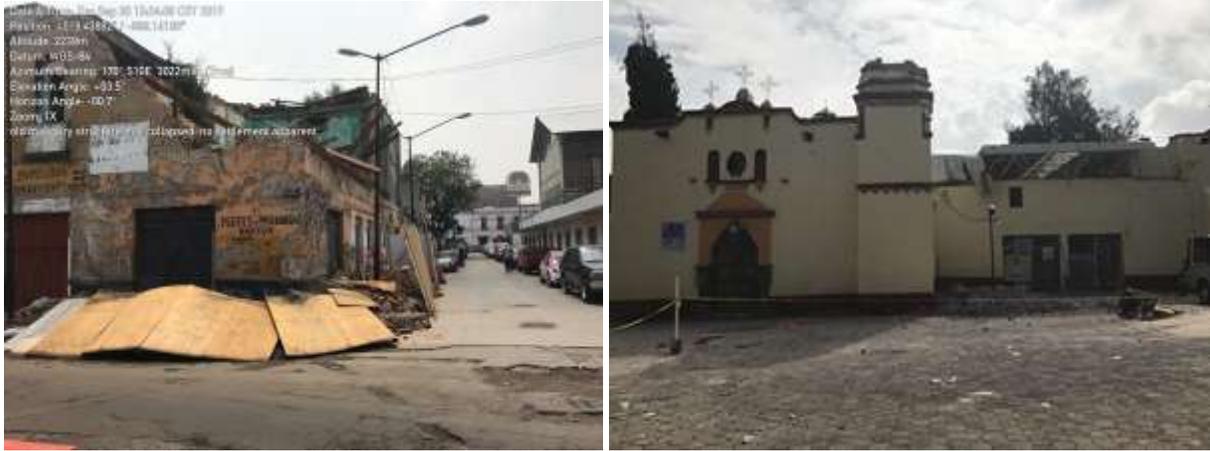
Figure 39. Unreinforced masonry structure that collapsed from the 2017 event in the historical district of Mexico City (19.4388, -99.1413), and San Gregorio Church with collapsed bell tower (19.2535, -99.0568)

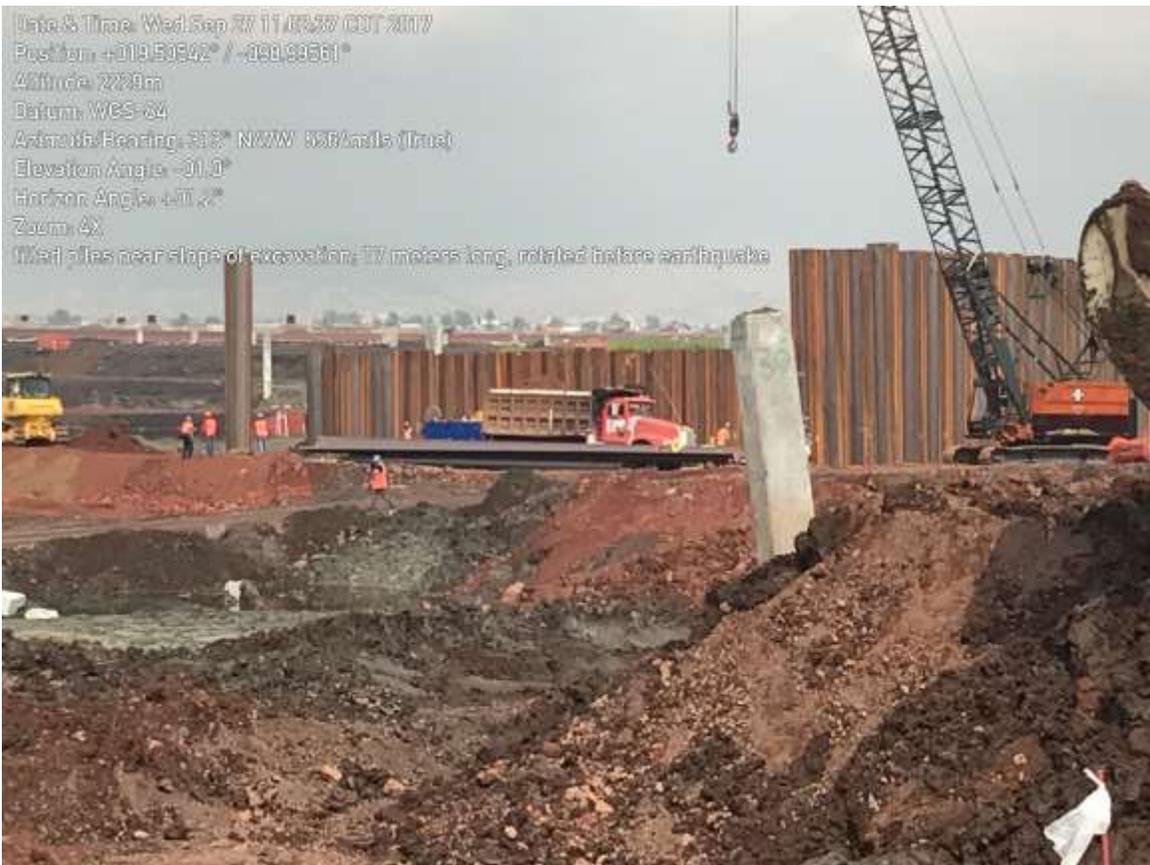
Figure 43. Tilted driven pile near the perimeter of the excavation for the NAICM terminal construction

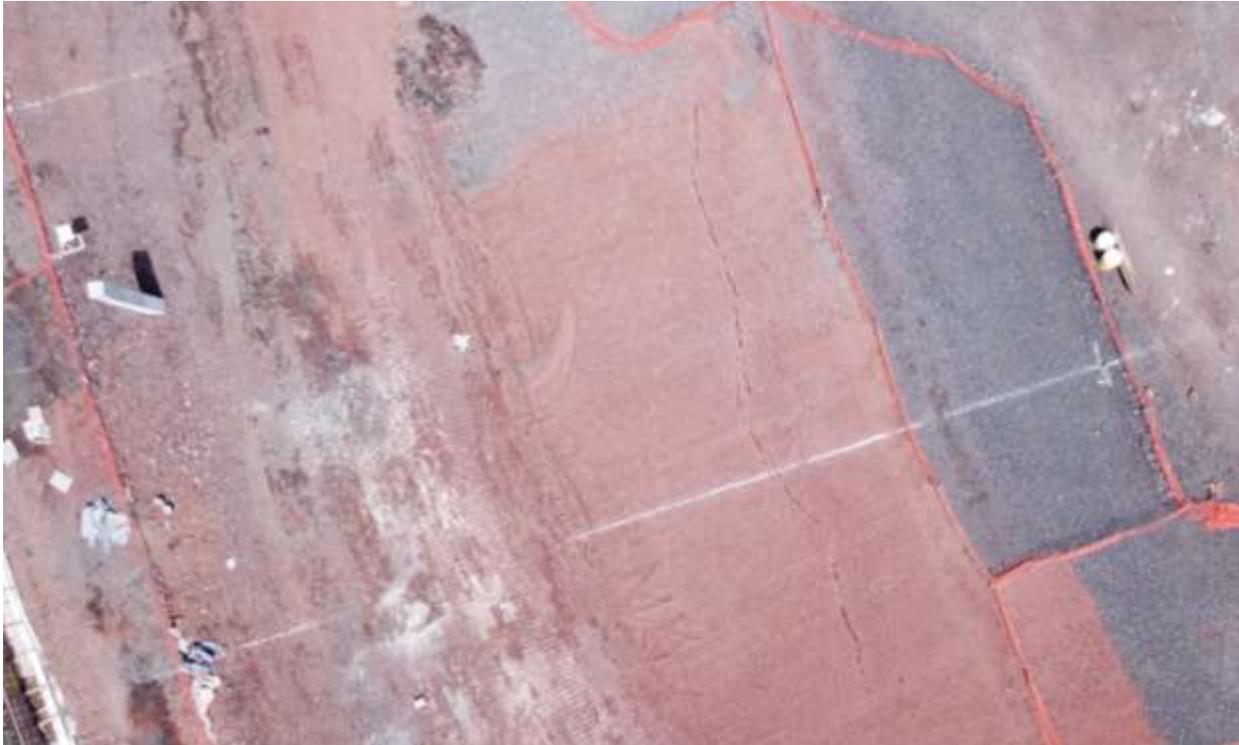
Figure 44. Tension crack observed in the NAICM excavation from a UAV flown at an altitude of 50 meters; driven pile is visible towards the left of the image (19.5050, -98.9957)

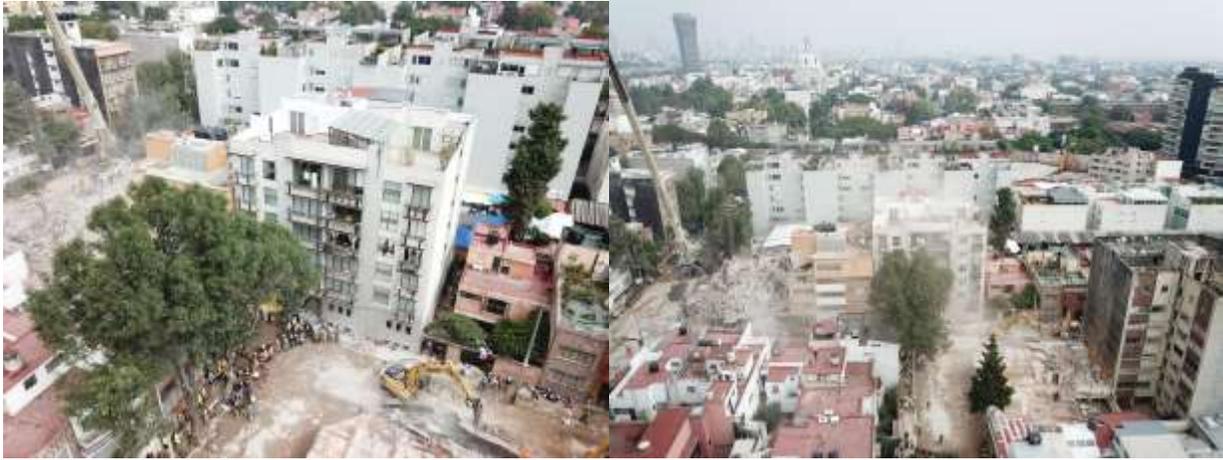
Figure A5. The Building across Escocia 4 (i.e., Escocia 14) also seemed to have collapsed, but was not listed as one of the damaged/collapsed buildings in the initial list (19.3877, -99.1637)

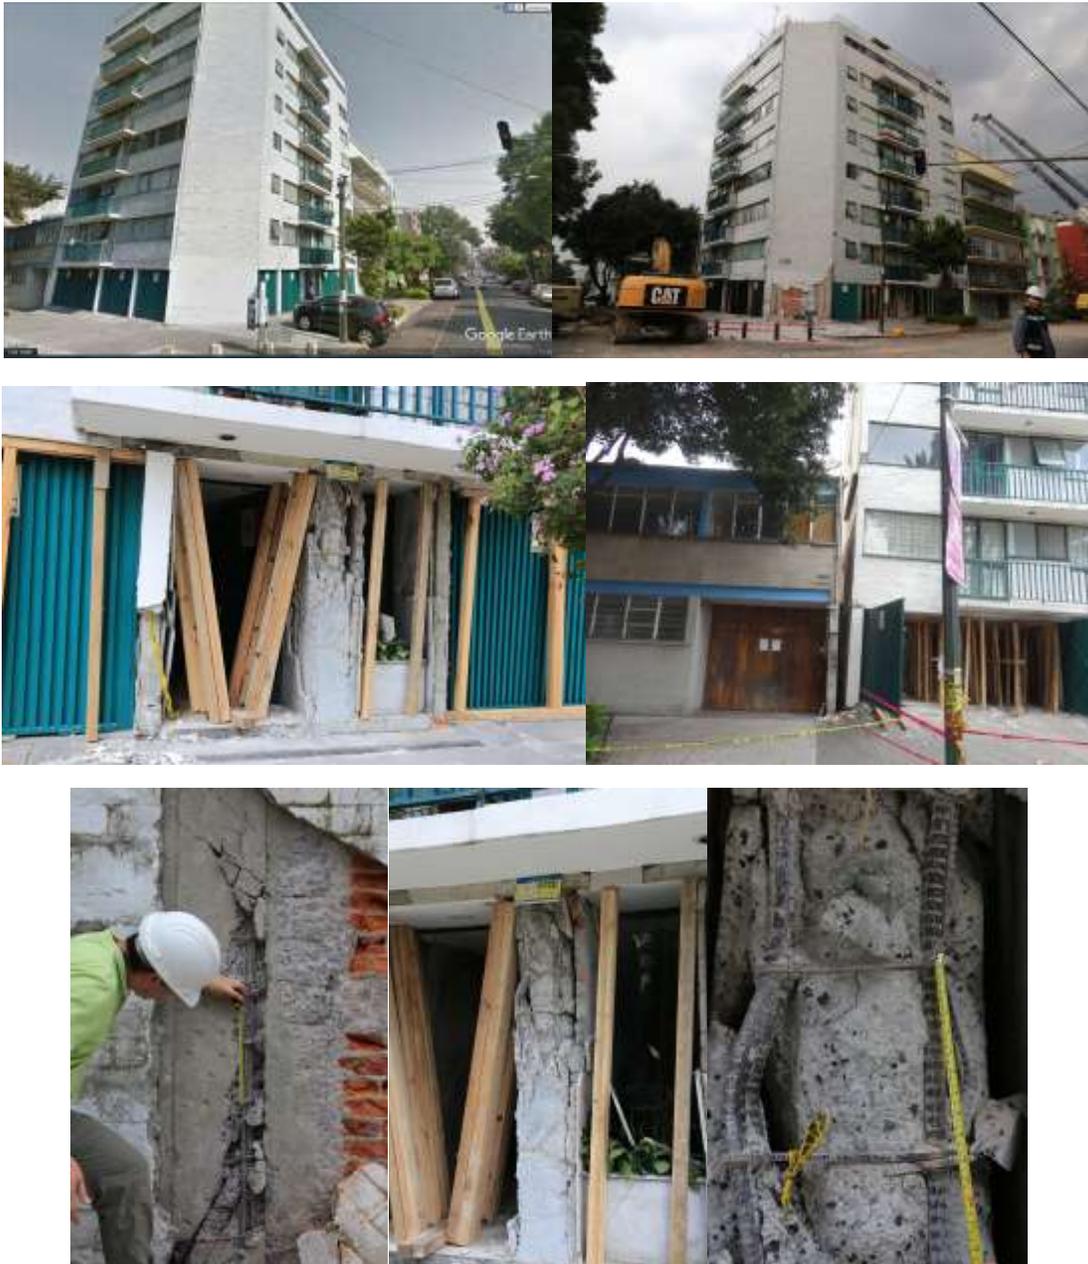
Figure A7. Top: Before and after shots of the corner building (19.3987, -99.1588), Middle and Bottom: Damage observed at the ground level

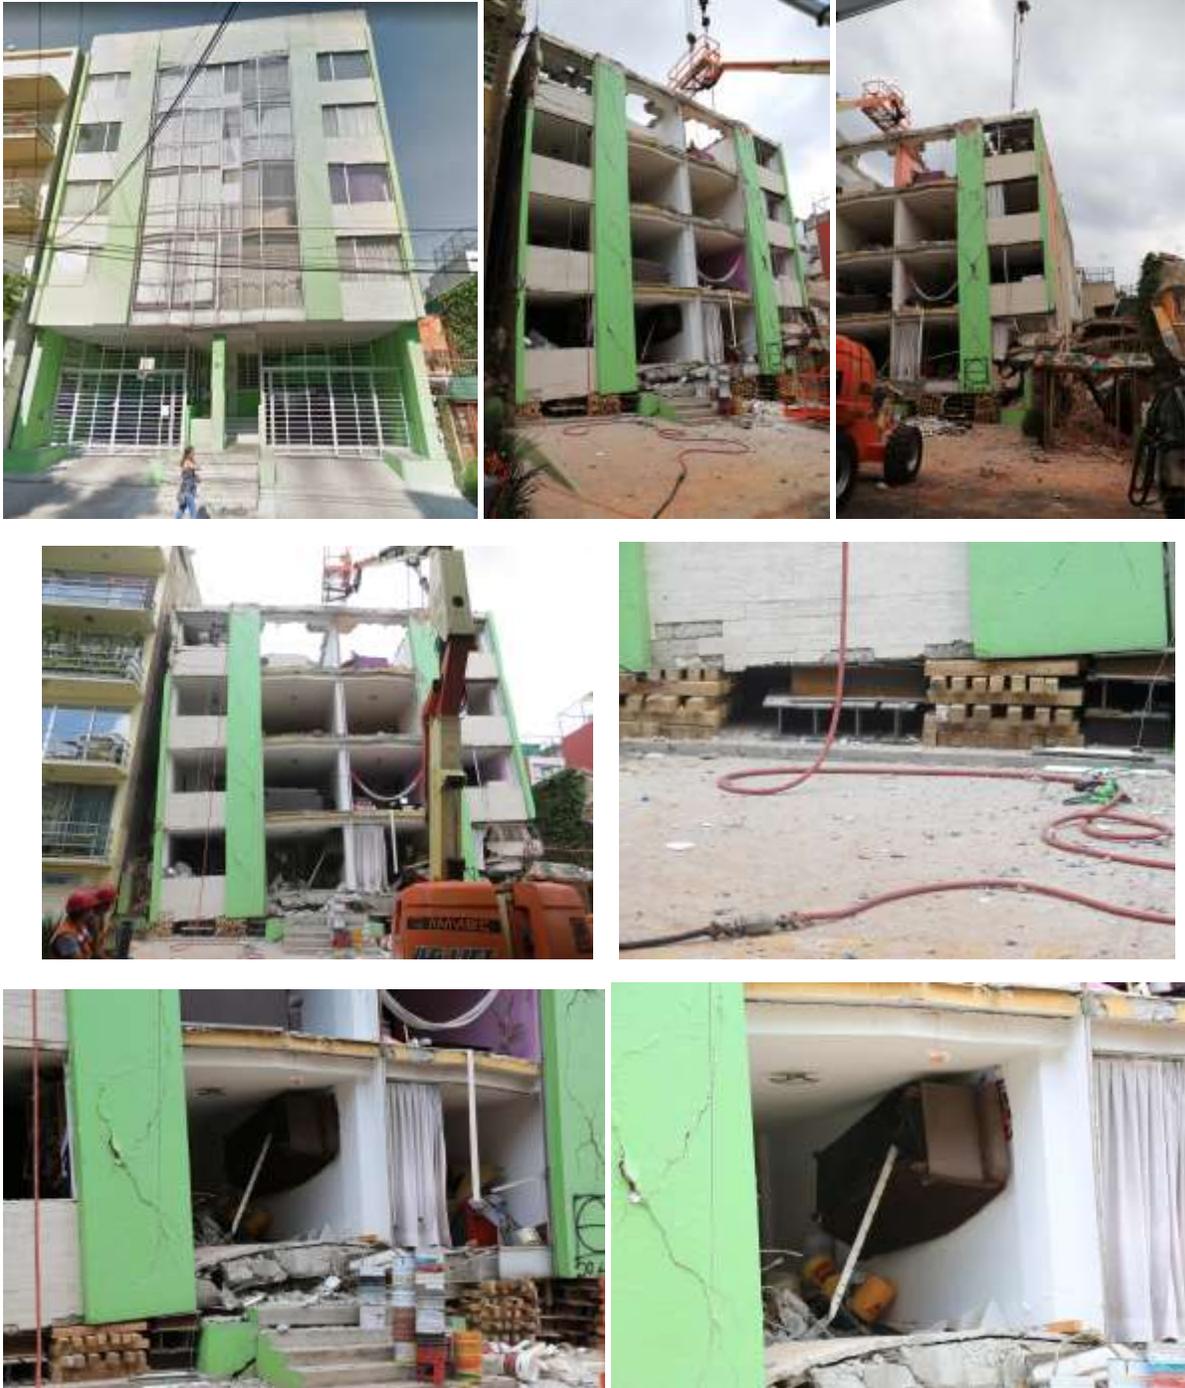
Figure A8. Enrique Rebsamen #241 photographs during site visit; top left: google pre-earthquake shot, remaining photos: frontal shots taken on site of damaged structure (19.3990, -99.1588)

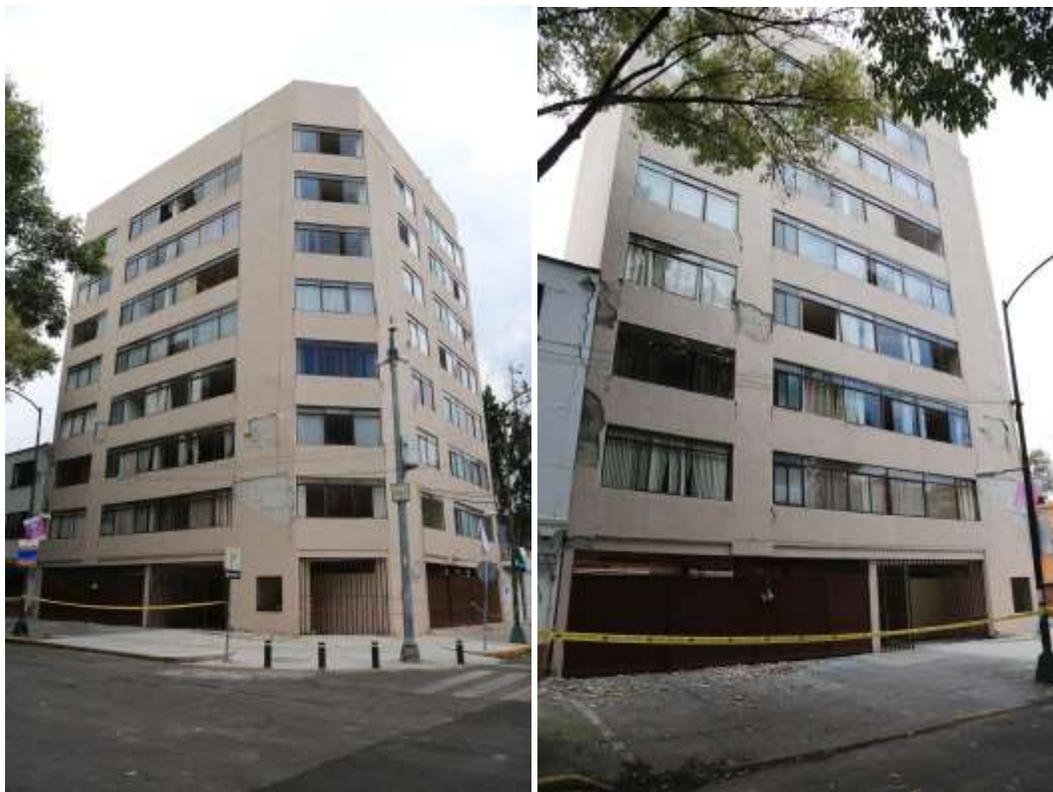
Figure A9. Moderate damage at 8 story residential structure (19.3986, -99.1581)

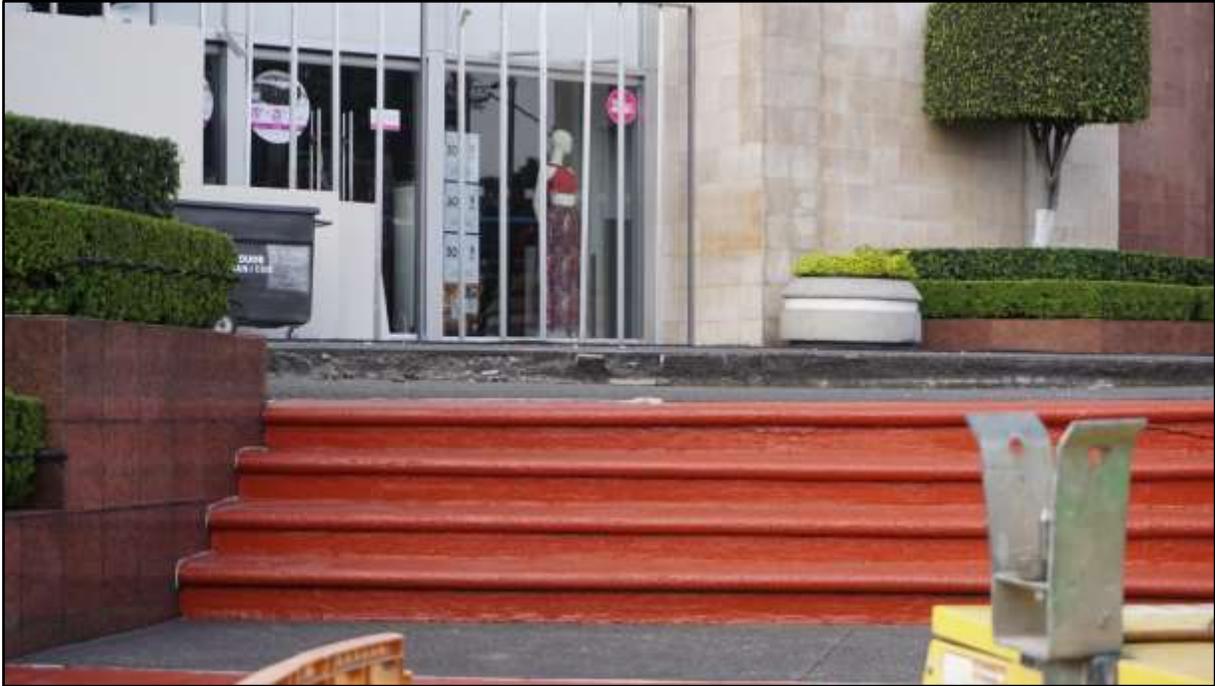
Figure A11. Stairway drop in front of Gallerias Coapa (19.3030, -99.1225)

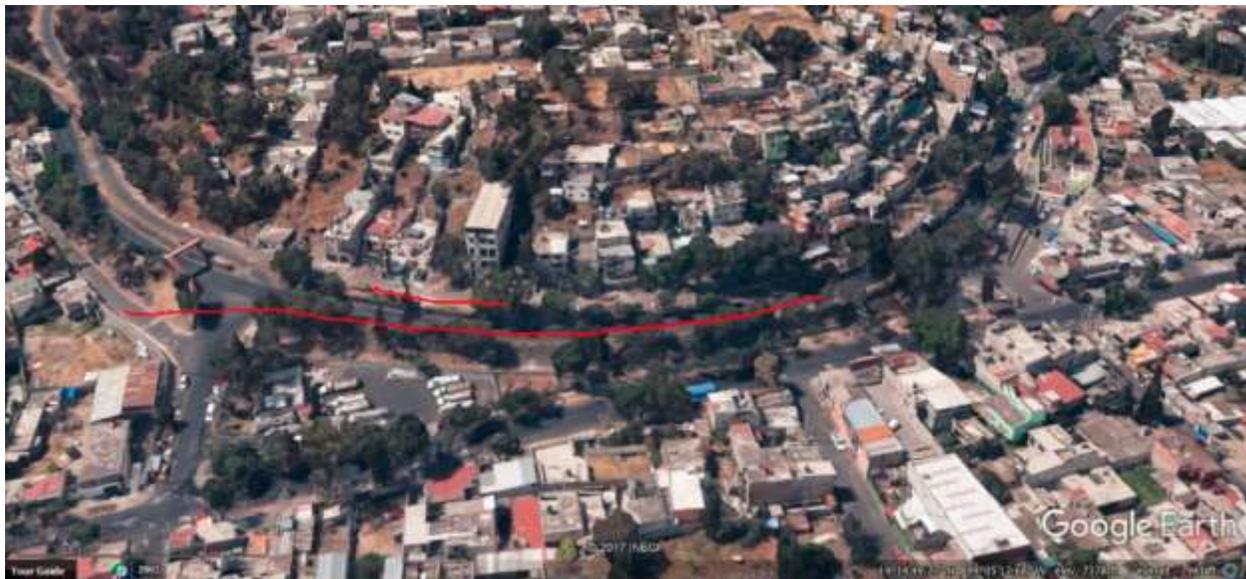
Figure A14. Aerial view of the slope instability with cracks marked along the road
