GEOTECHNICAL ENGINEERING RECONNAISSANCE OF THE 19 SEPTEMBER 2017 Mw 7.1 PUEBLA-MEXICO CITY EARTHQUAKE

Report No. GEER-055A

16 October, 2017

Geotechnical Engineering Reconnaissance of the 19 September 2017 M_w 7.1 Puebla-Mexico City Earthquake: Version 1.0

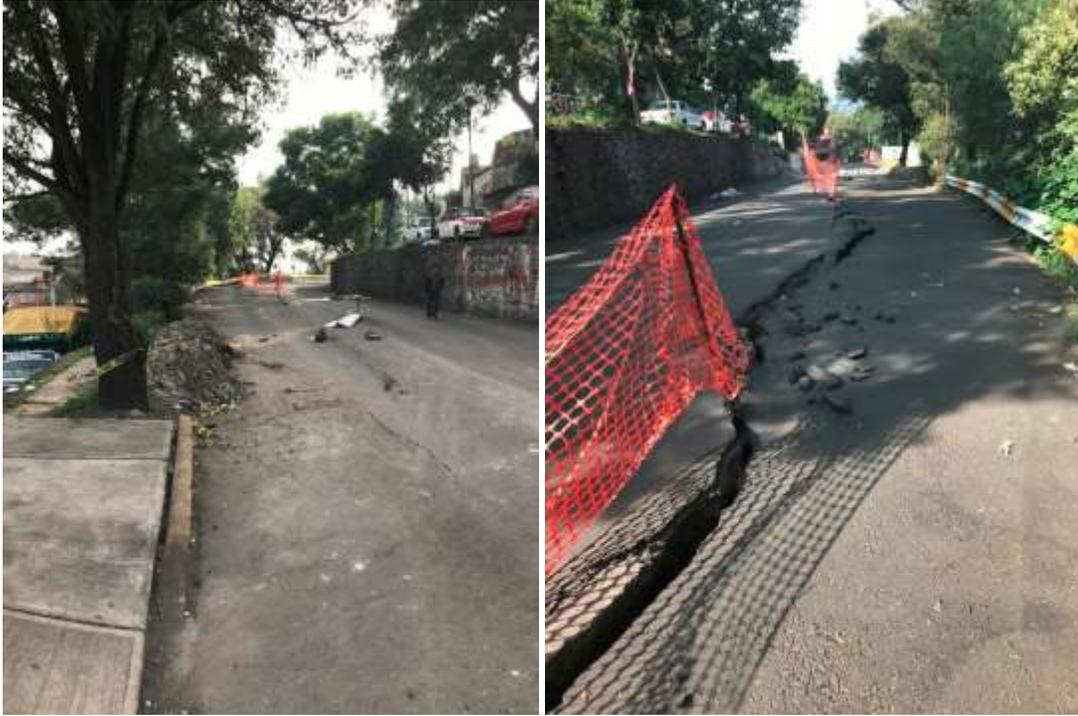
Figure A15. Surface cracks along lower step above market(left: 19.2469; -99.0895), (right: 19.2467; -99.0872)

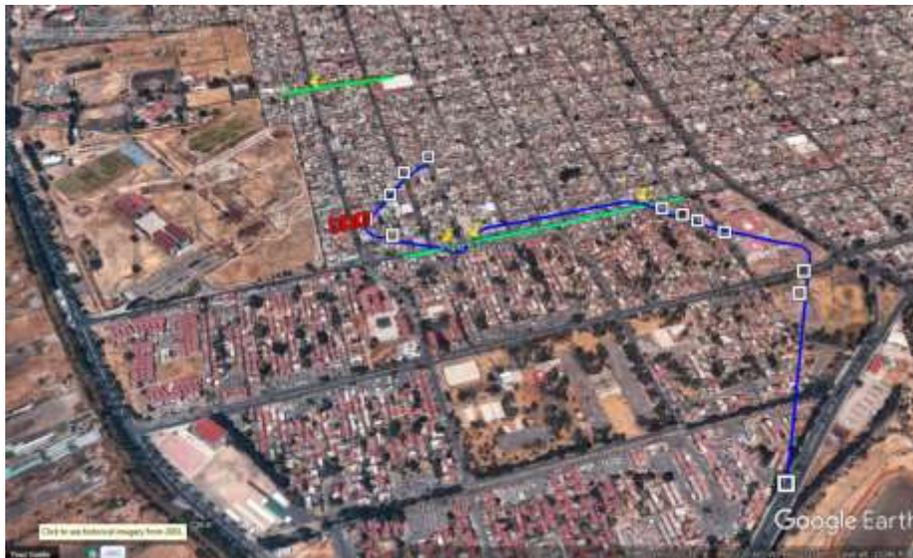
Figure A17. Aerial representation of damages in Colonia del Mar, showing pipeline breaks and ground depression bands (yellow pins indicate locations where pipelines broke; green lines indicate streets with pipeline breaks; white squares indicate ground depression bands, with the five located on the left side of the image being mapped from observations on foot, bottom right one observed while driving on the road, and remaining ones mapped from aerial photographs; blue line indicates interpreted extent of ground depression band; red squares showing other ground depression bands).

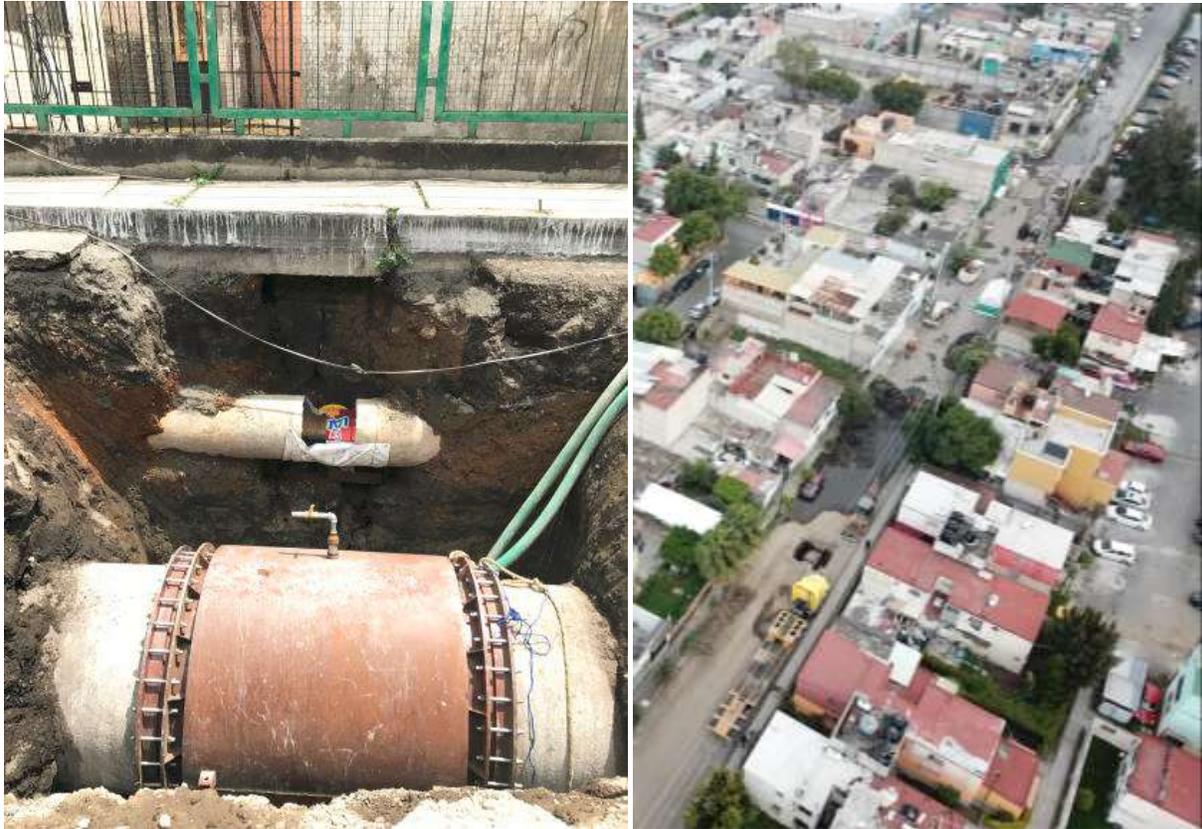
Figure A18. Damage in pipes due to ground settlement (19.28687; -99.0544)

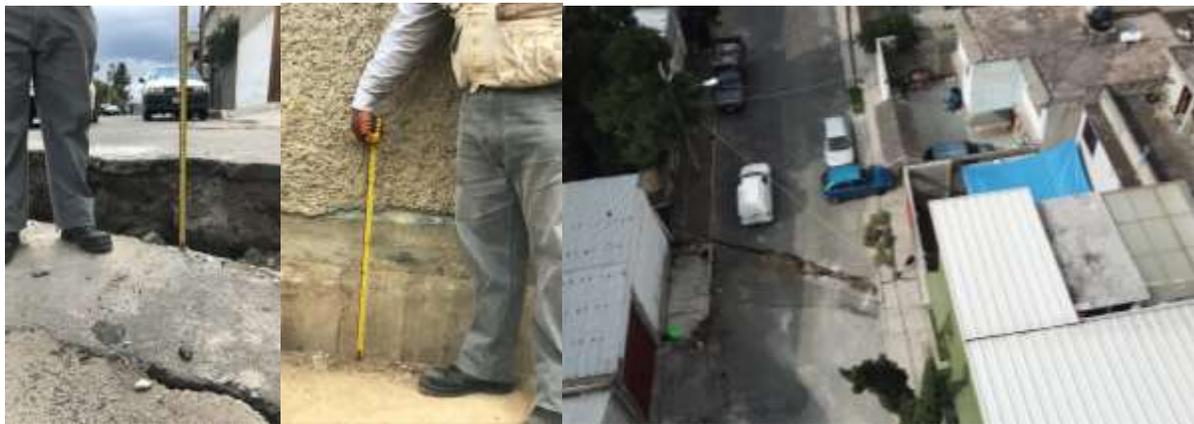
Figure A19. Settlement along ground depression band (left) (19.2868, -99.0604), sidewalk settlement close to damaged pipeline (19.2868, -99.0604), aerial shot of cracks on pavement.

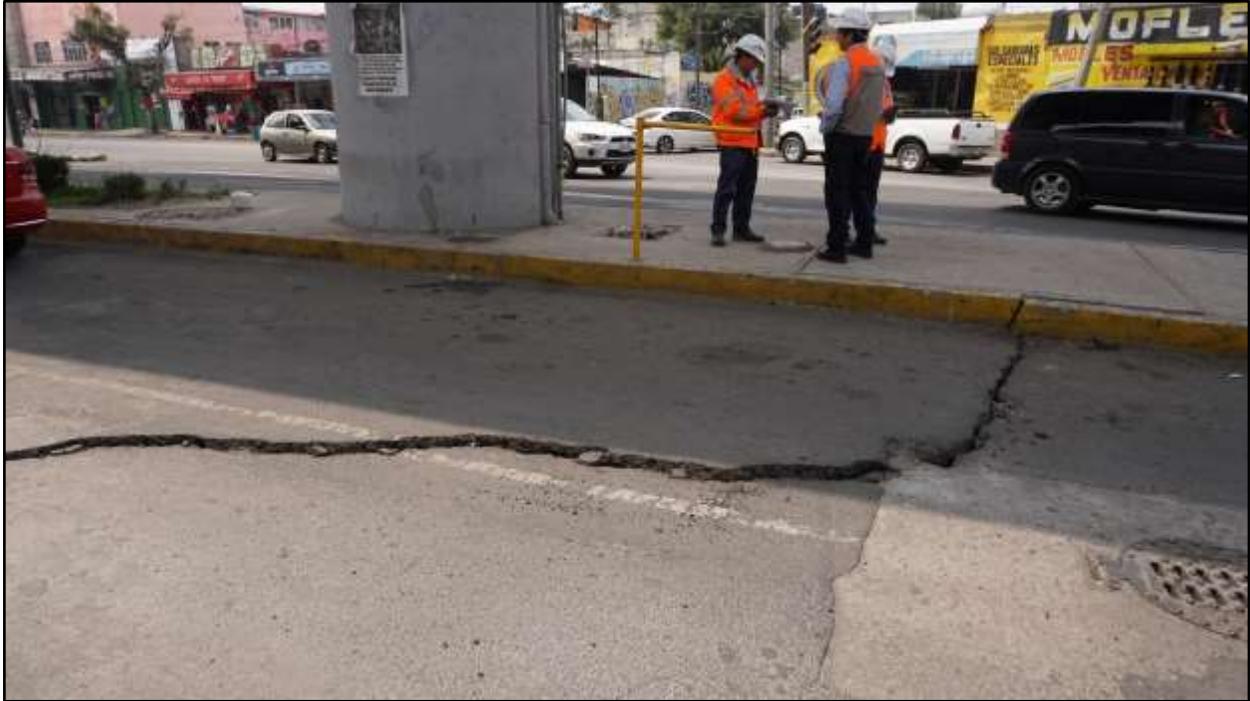
Figure A21. Roadway cracks as a result of column rocking during the earthquake (19.2982, -99.0339)

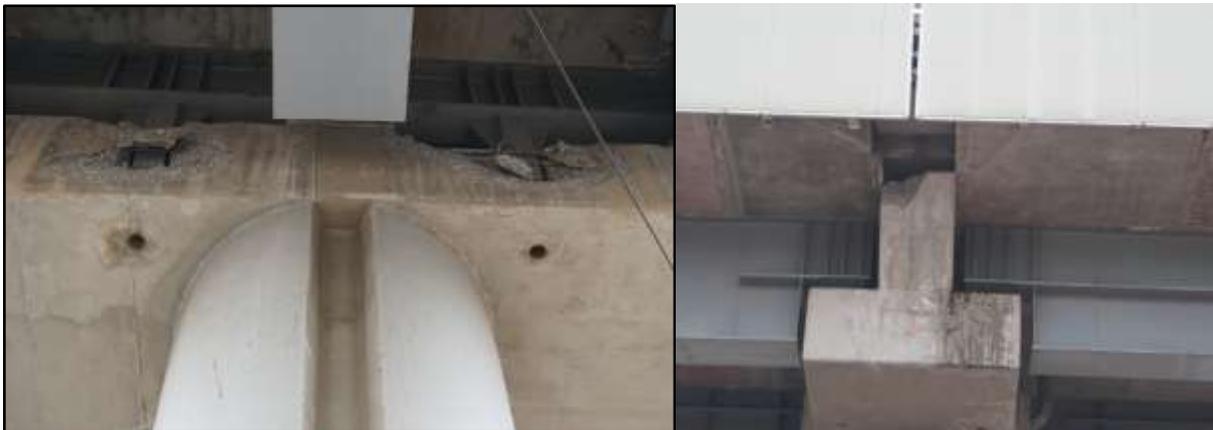
Figure A22. Damage to the bent cap due to shear plate movement during the earthquake (left) and spalling at expansion joints (right) (19.2982, -99.0339)

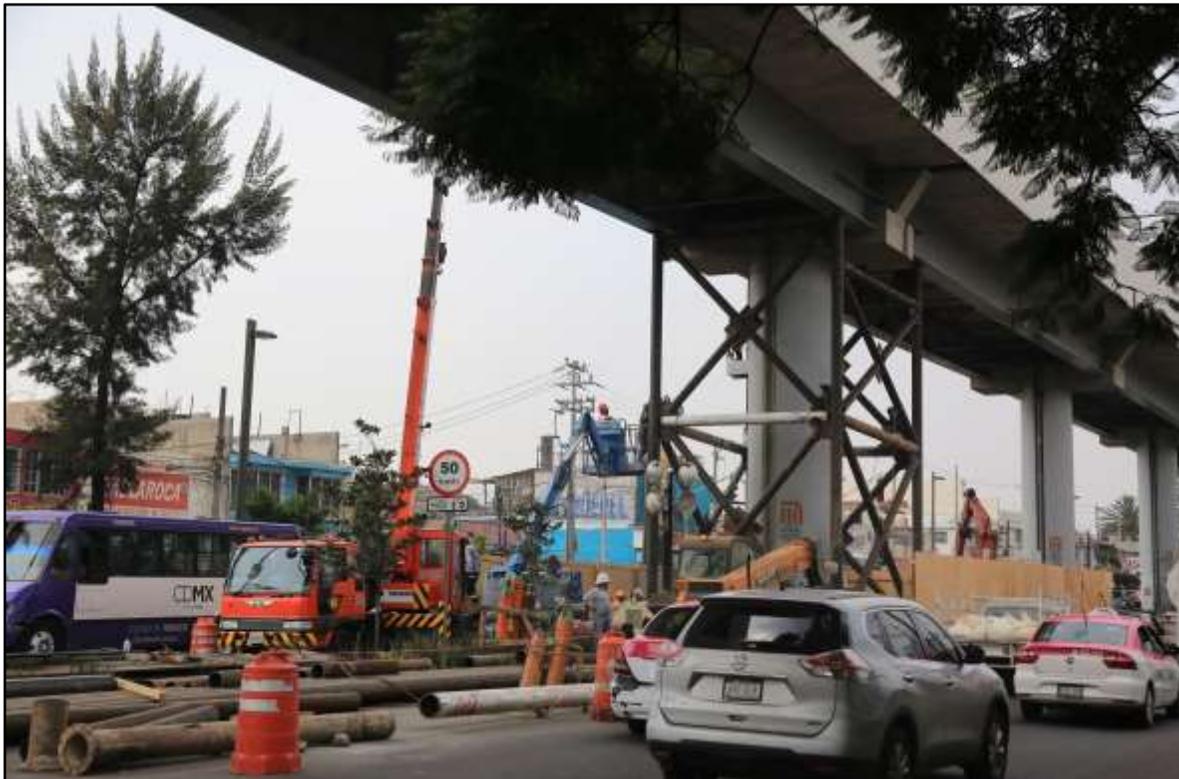
Figure A23. Cracks extending into the column core (shown on top) and superstructure shoring with tubular steel frame sections (shown on bottom). (19.3017, -99.0520).

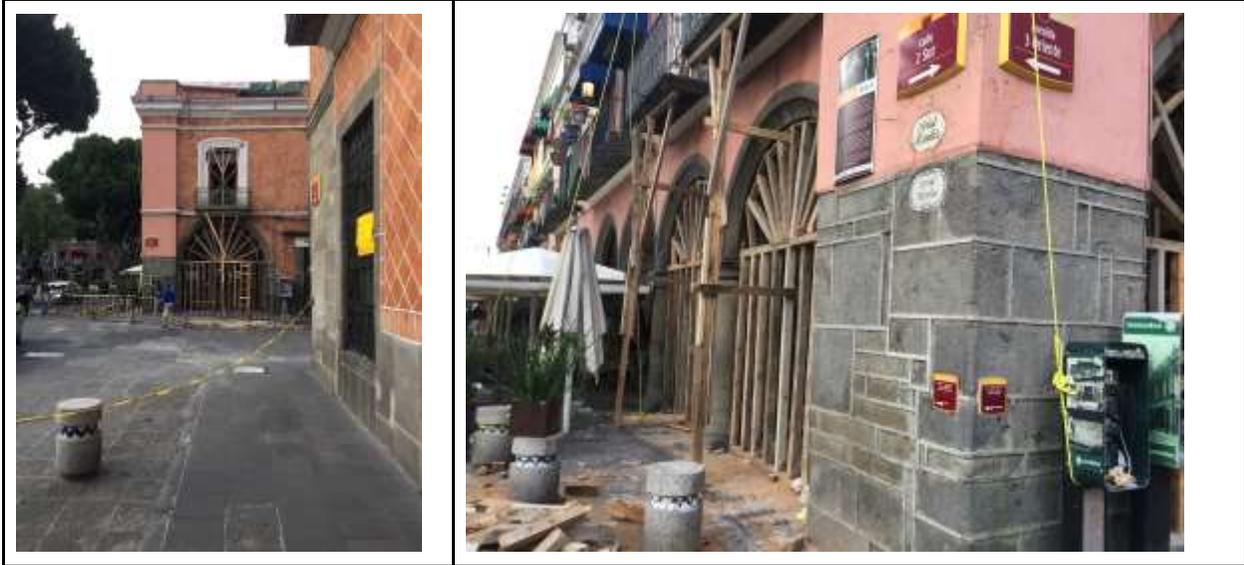
Figure A25. This restaurant (Portal Morales) has signboard covering its damaged roof and shoring supporting its windows, doors, and balconies, all suggesting severe damage (19.0429, -99.1975).

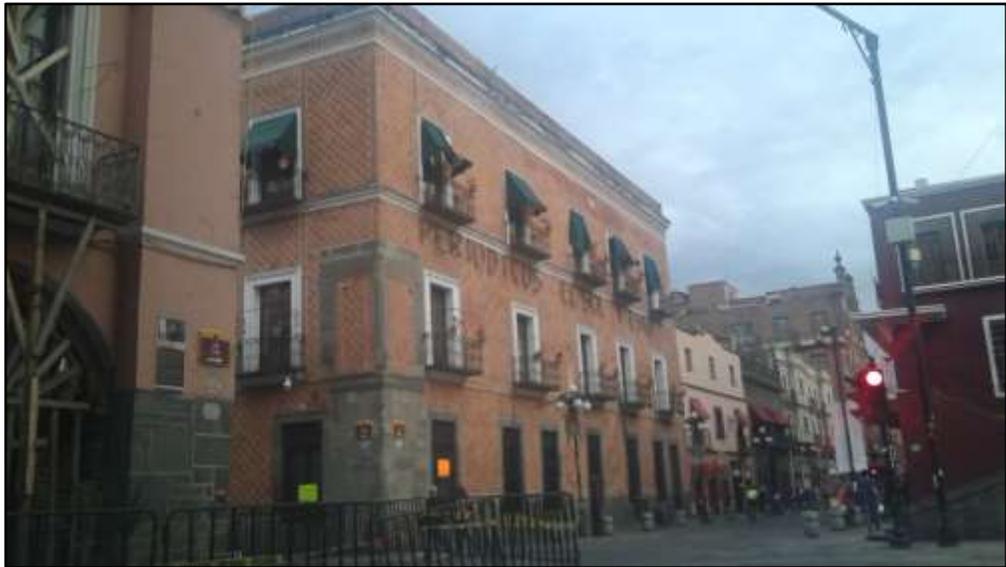
Figure A26. The building next door, the Periodicos El Sol (The Sun Newspaper) had yellow tape around the exterior and signs posted on the doors suggesting damage inside (19.0429, -99.1975).

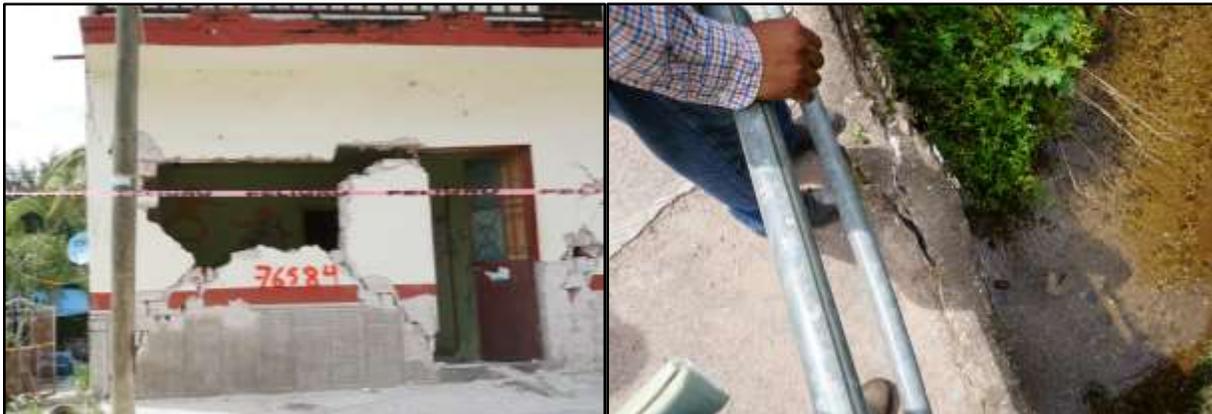
Figure A28. Building Damage (left) (18.2286, -98.7045) and damage observed at center pier of the bridge (right) (photo taken while standing on the bridge) (18.2335, -98.7040).

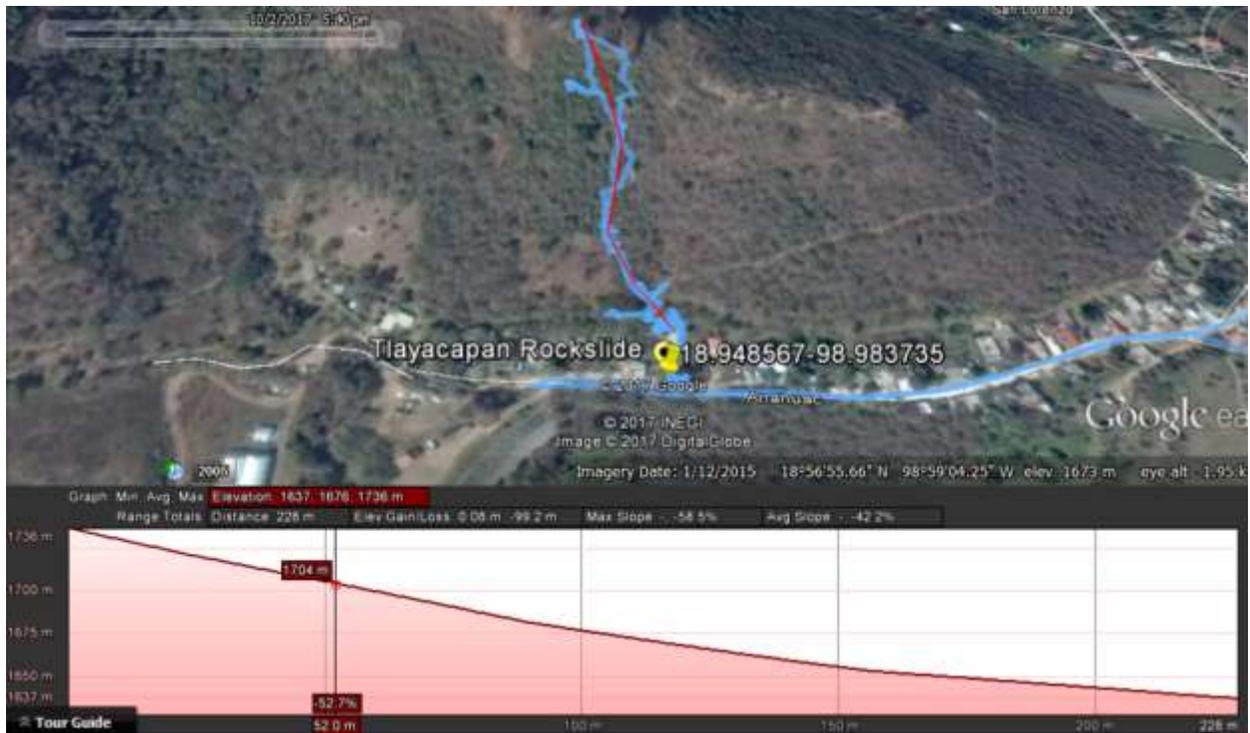
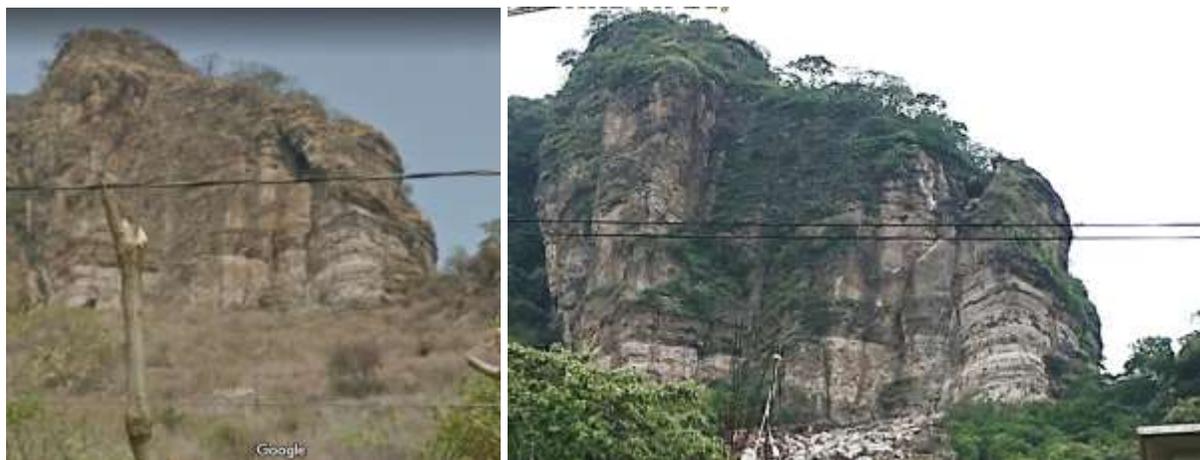
Figure A30. Top: Location and profile of rockfall slide, Left: 'Before" view from Google and Right: current view after earthquake (18.9486, -98.9837)

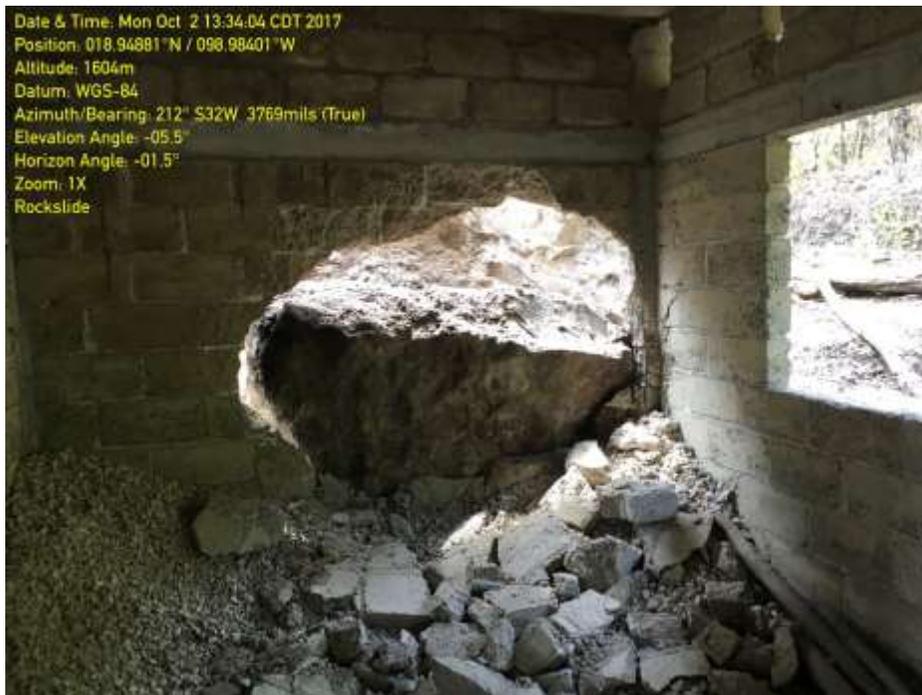
Figure A32. Damage to a resident under construction by massive boulder ($\sim 9 \text{ m}^3$) from rockfall (18.9488, -98.9840)

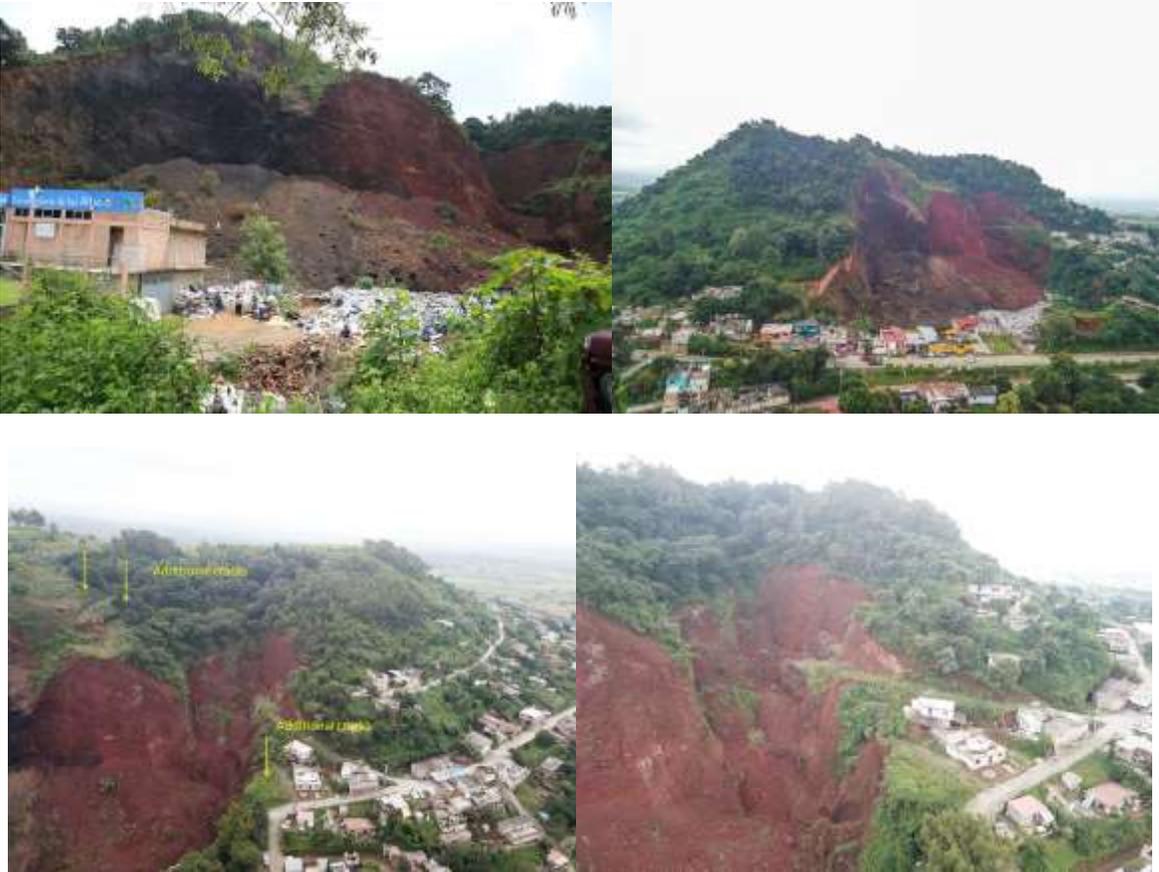
Figure A34. Photographs showing slope failure after the earthquake (18.9816, -98.9246)

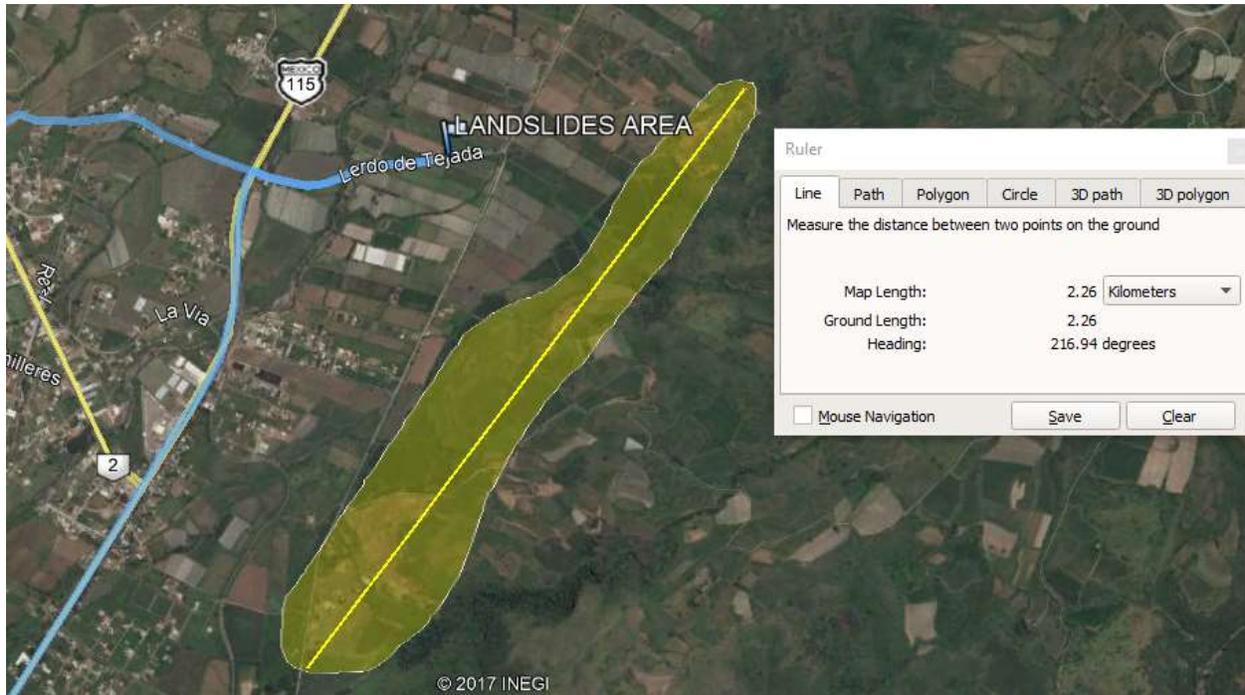
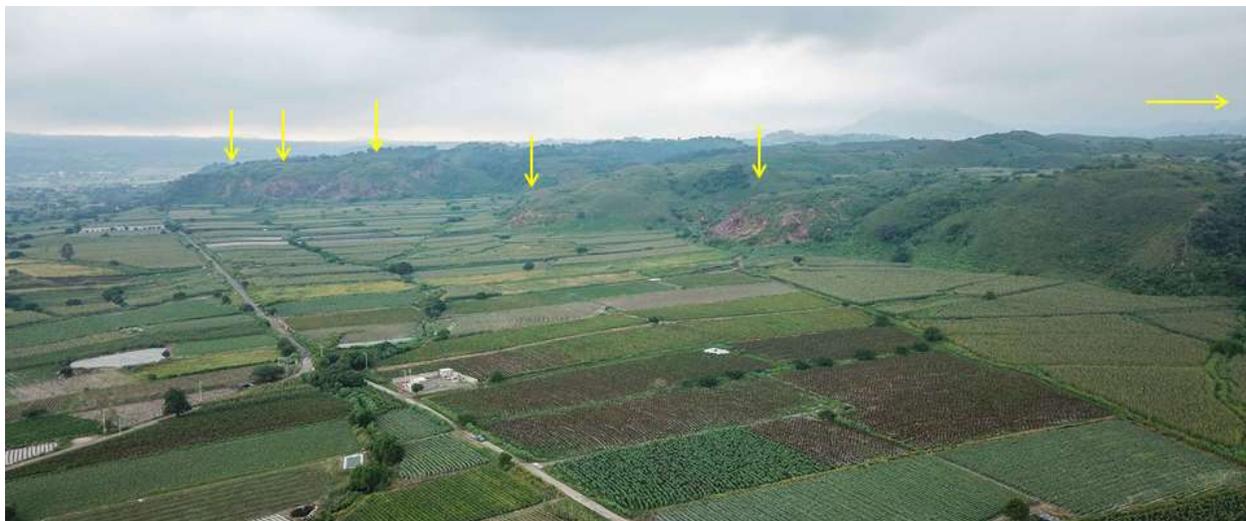
Figure A35. Extent of the observed Atlatlahucan landslides, but it is possible that the slides continue beyond our observation (18.9409, -98.8709)

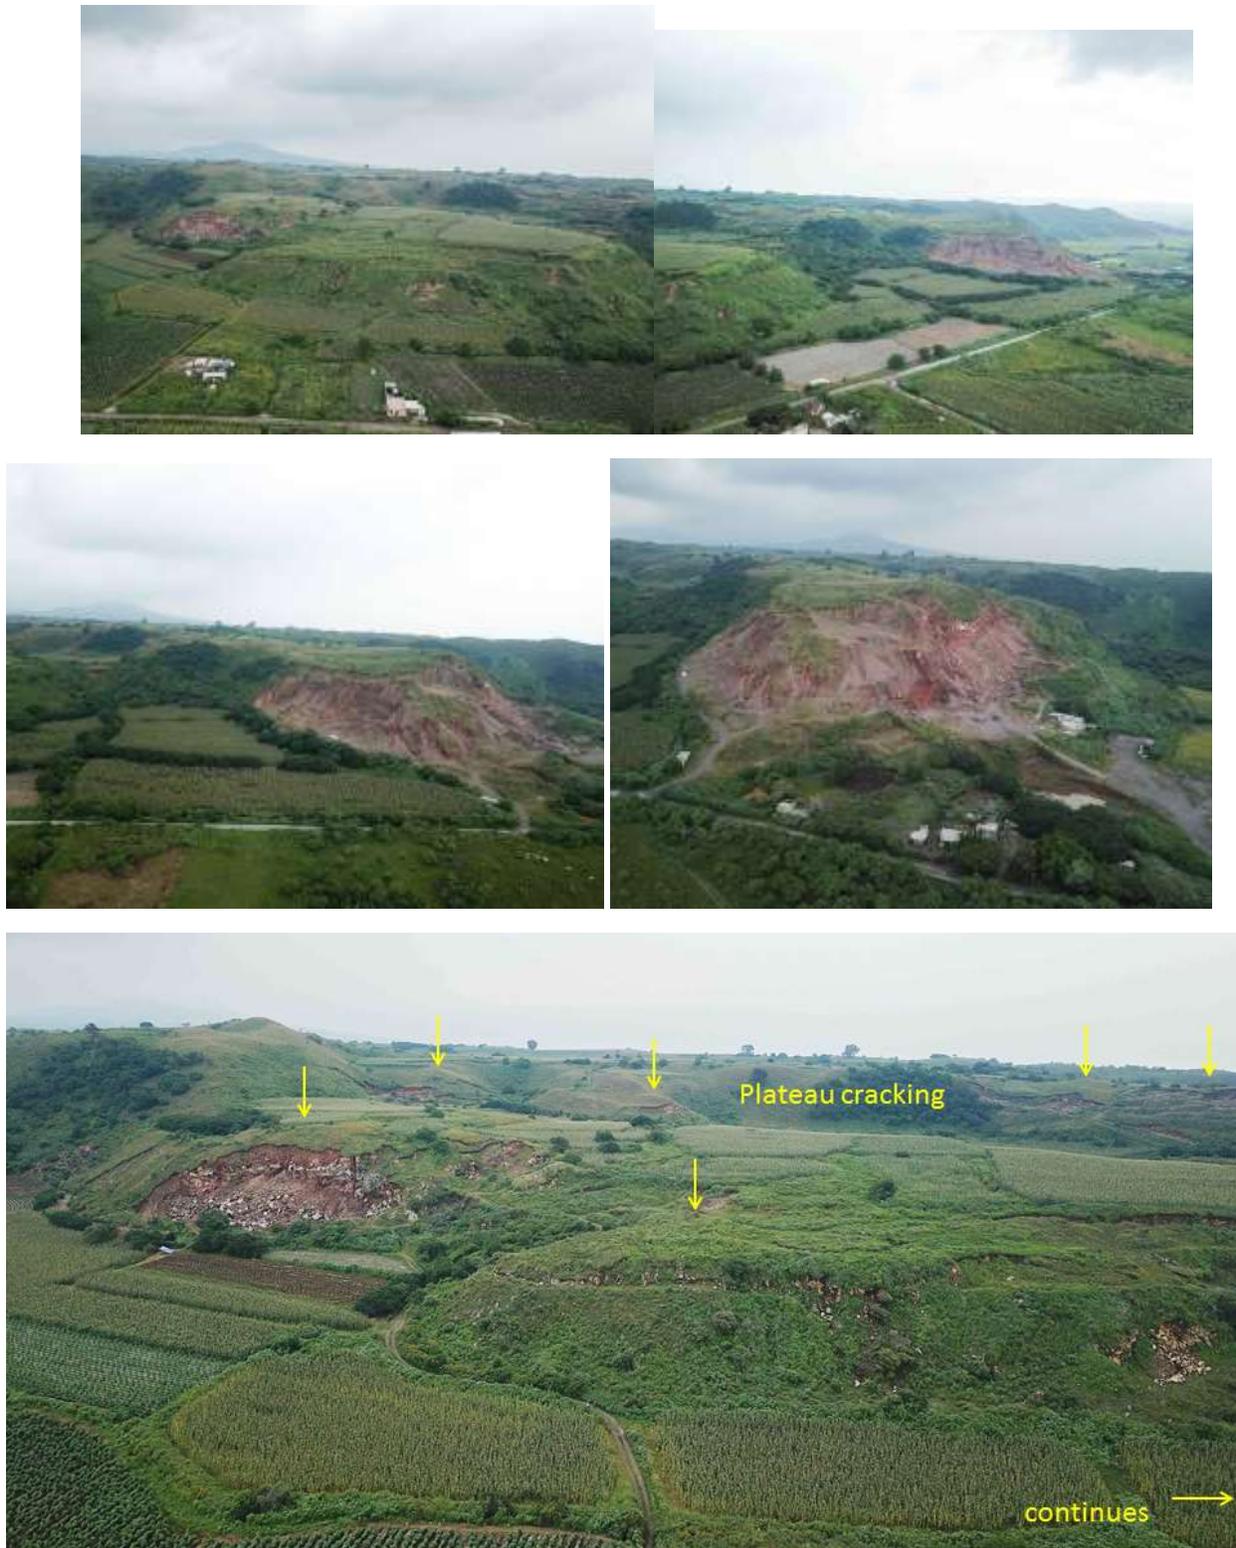
Figure A36. Aerial UAV images of several of the Atlahuacan landslide and cracking on top of the plateau (18.9409, -98.8709)

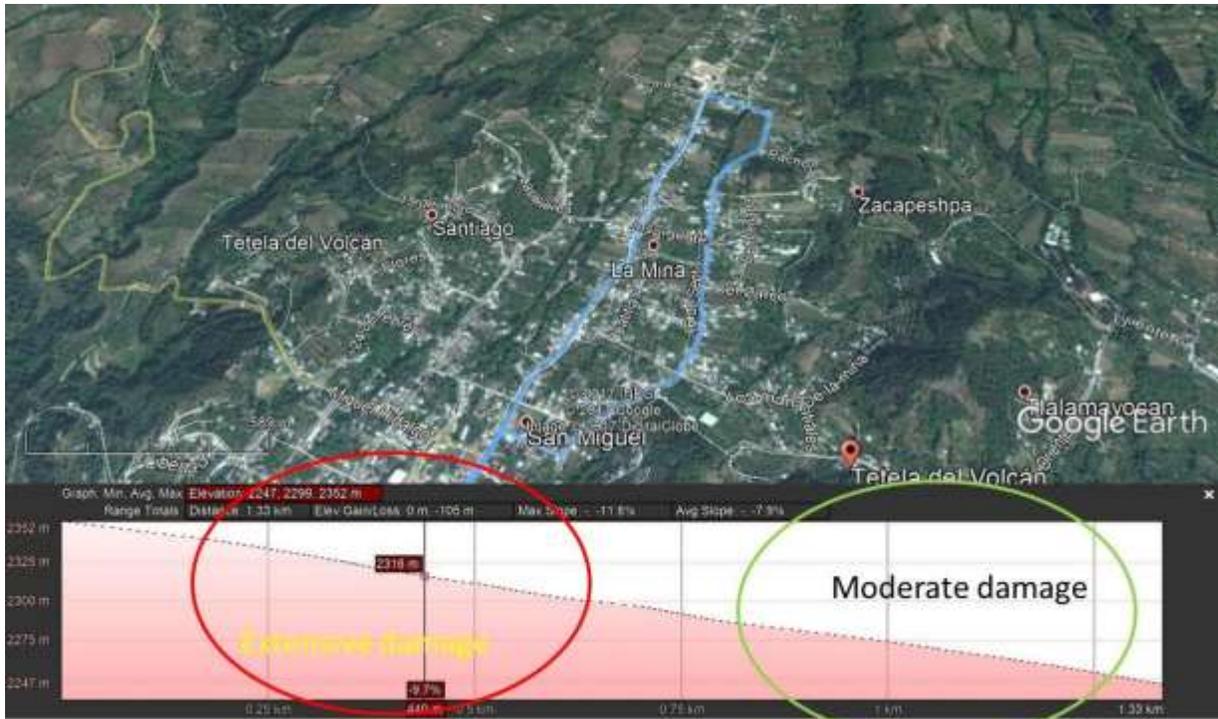
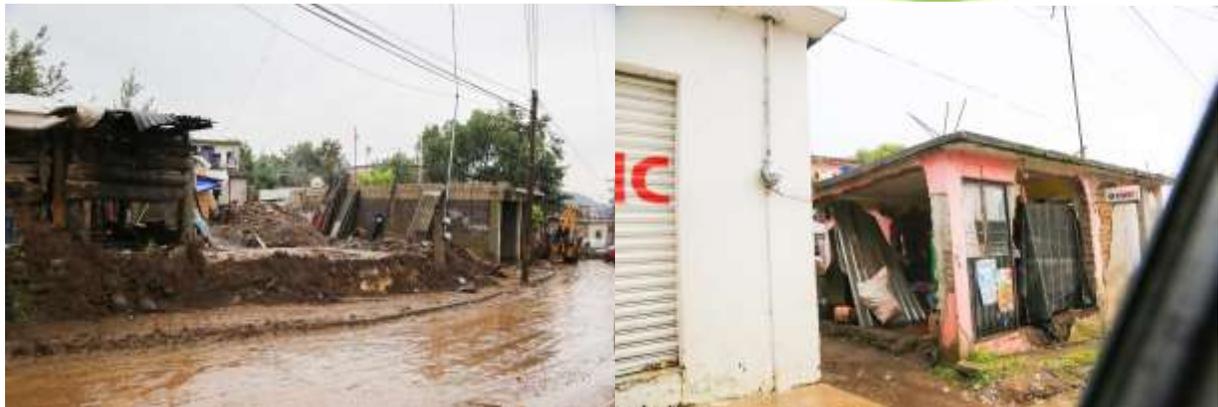
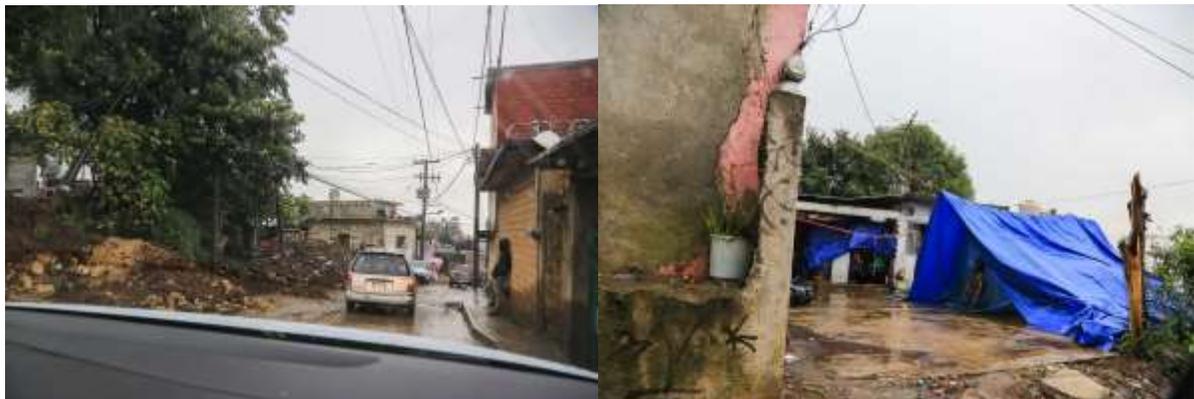
Figure A37. City map (top), structural damage and collapse to residential buildings (middle and bottom; 18.8949, -98.7279)

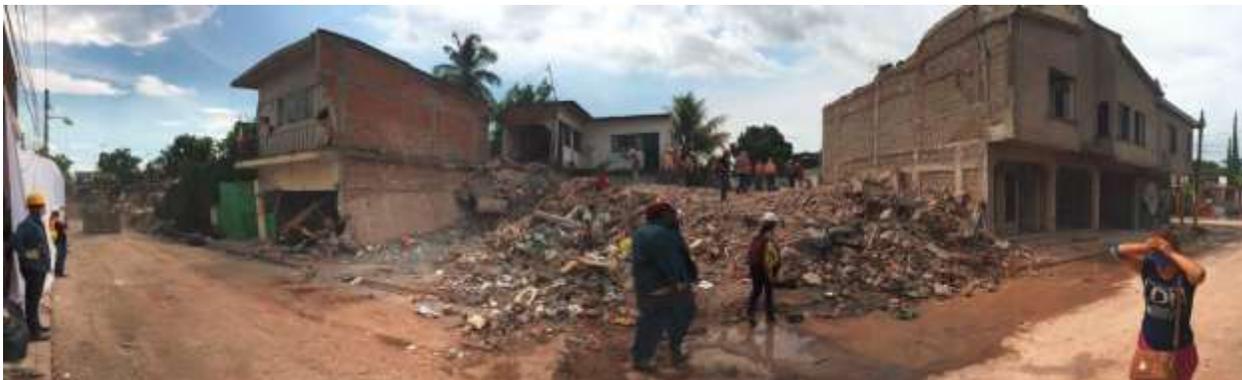
Figure A40. Group of partially collapsed and undamaged buildings in Jojutla (18.6176; -99.1775)

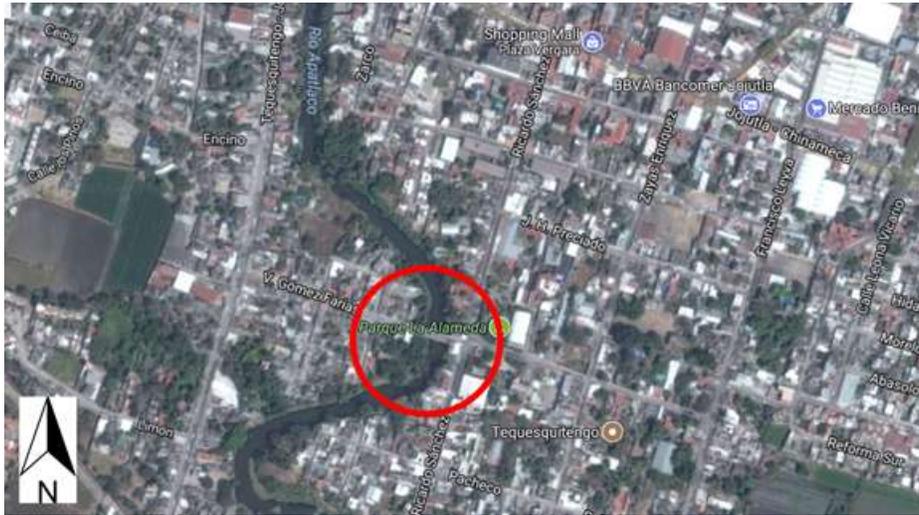
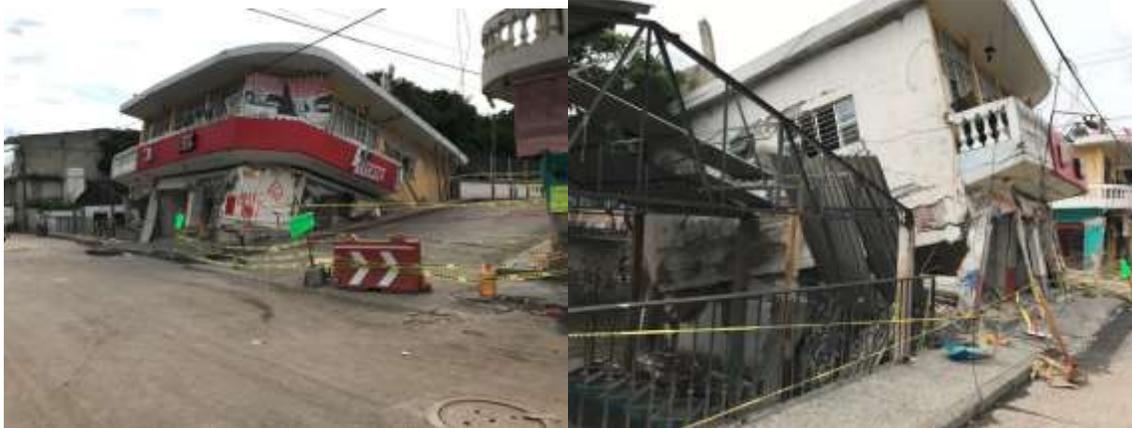
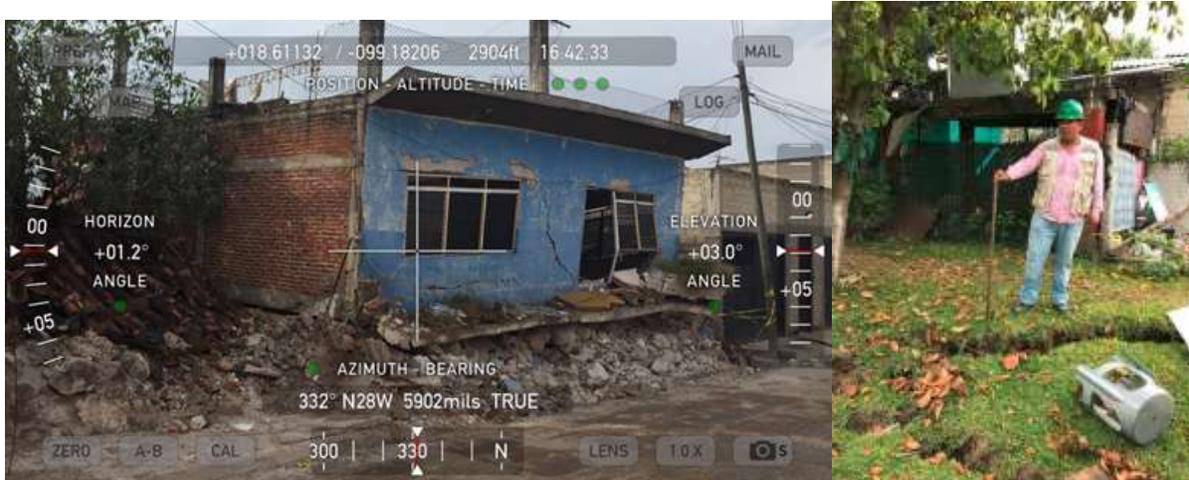
Figure A43. Map of Jojutla with heavily affected area by Rio Apatlaco highlighted in red (top), partially collapsed buildings close to Rio Apatlaco (middle, 18.6123, -99.1817), structure with failed first story and second story fallen on top (bottom left, 18.6113, -99.1821), and Apatlaco River bank failure and affected structures.

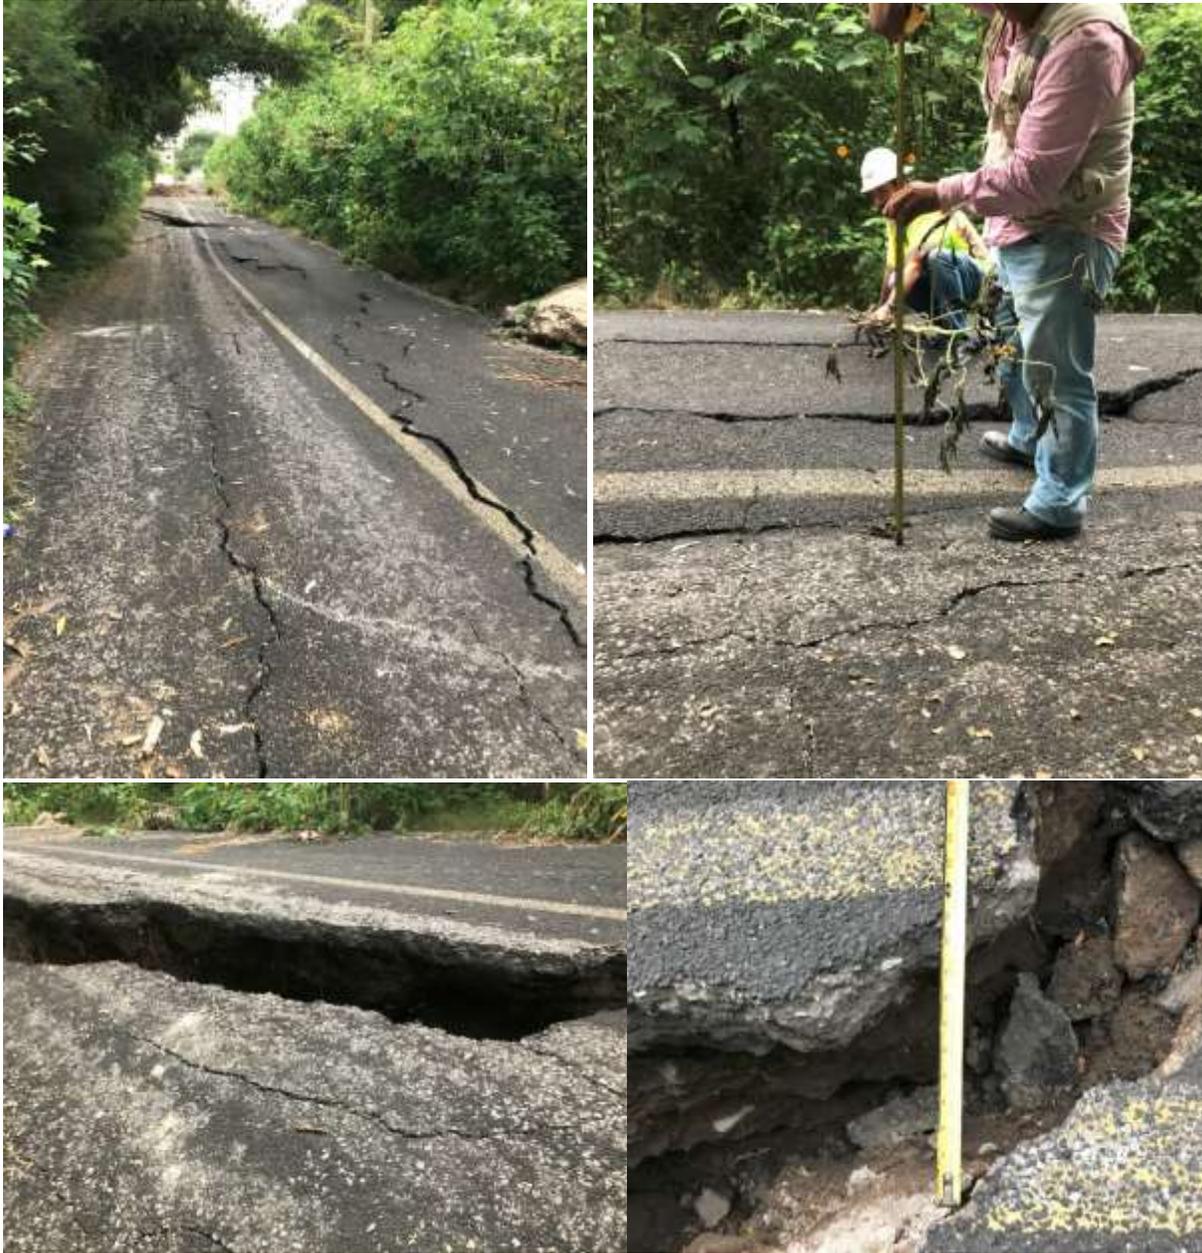
Figure A44. Cracks along pavement on Lake Tequesquitengo (top left), vertical displacement of road (top right), (c) and (d) large cracks opened on pavement (bottom, 18.8313, -99.2538).
