GEOTECHNICAL ENGINEERING RECONNAISSANCE OF THE 2022 CHIHSHANG EARTHQUAKE SEQUENCE

Version 1.0; April 2024

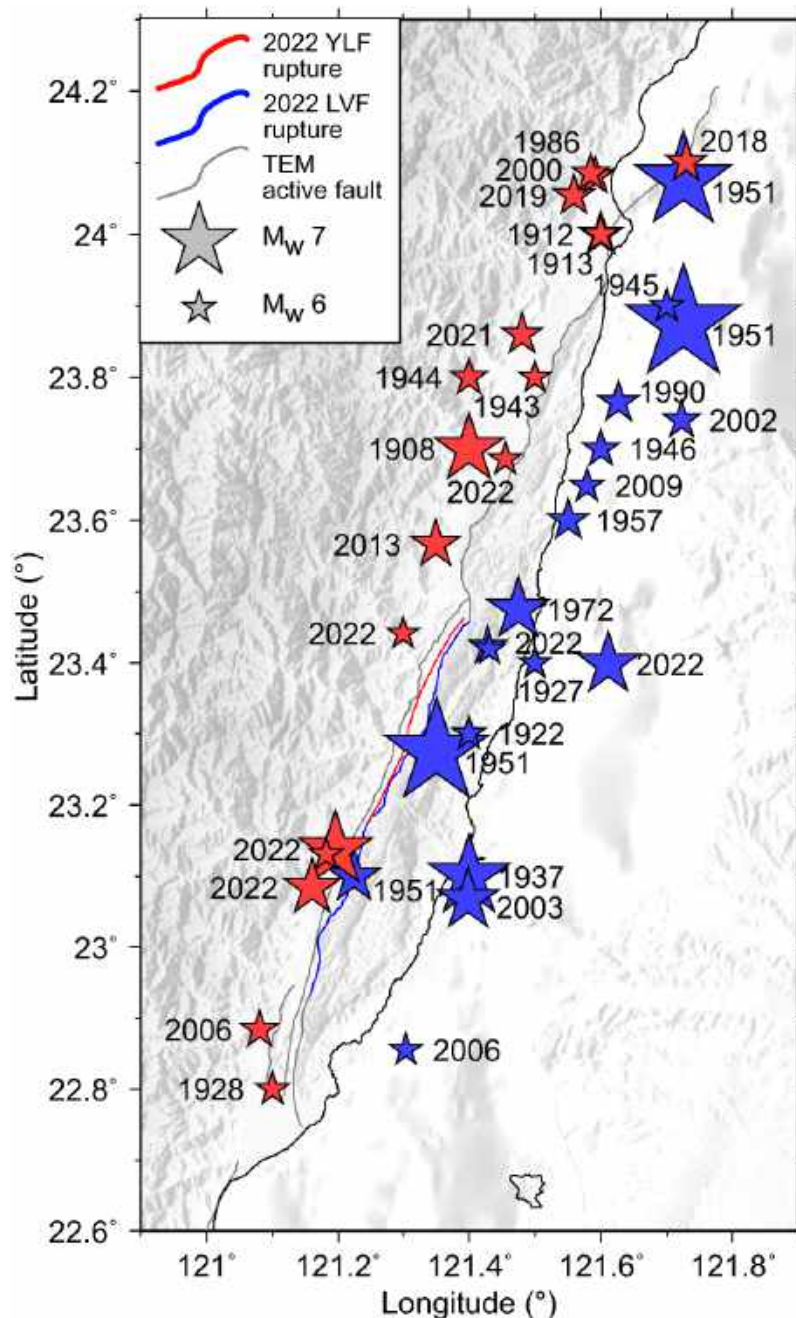
Figure 1.1 Spatial distribution of historical earthquakes since 1900 with $M > 6$ and depth < 30 km. Red and blue stars mark earthquakes attributed to the CRF and LVF, respectively. Red and blue lines are the 2022 surface ruptures along the Yuli fault and the LVF. Gray lines represent other active faults in the Taiwan Earthquake Model (modified from Tang et al, 2023).

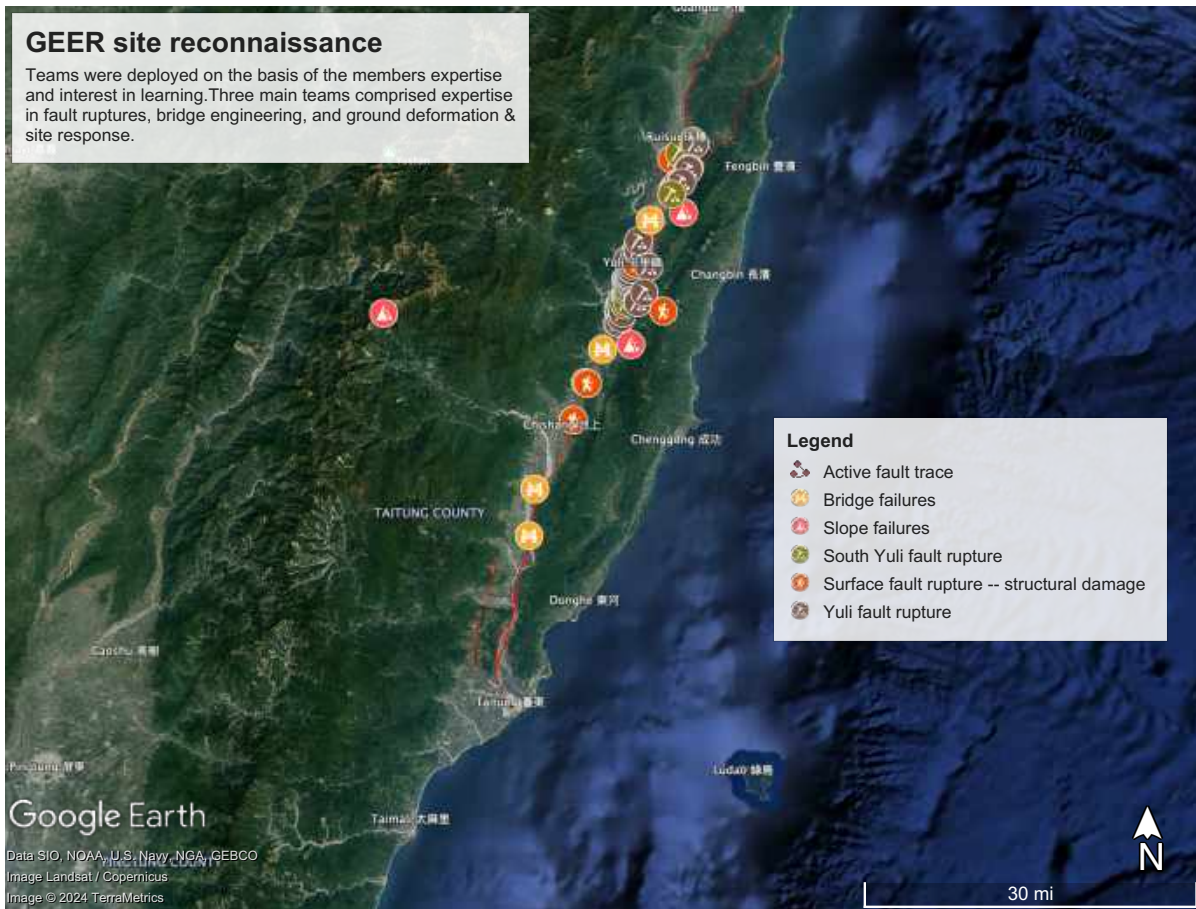
Figure 1.2 Bird's eye view of the GEER mission, categorized by class of failures that we focused on.

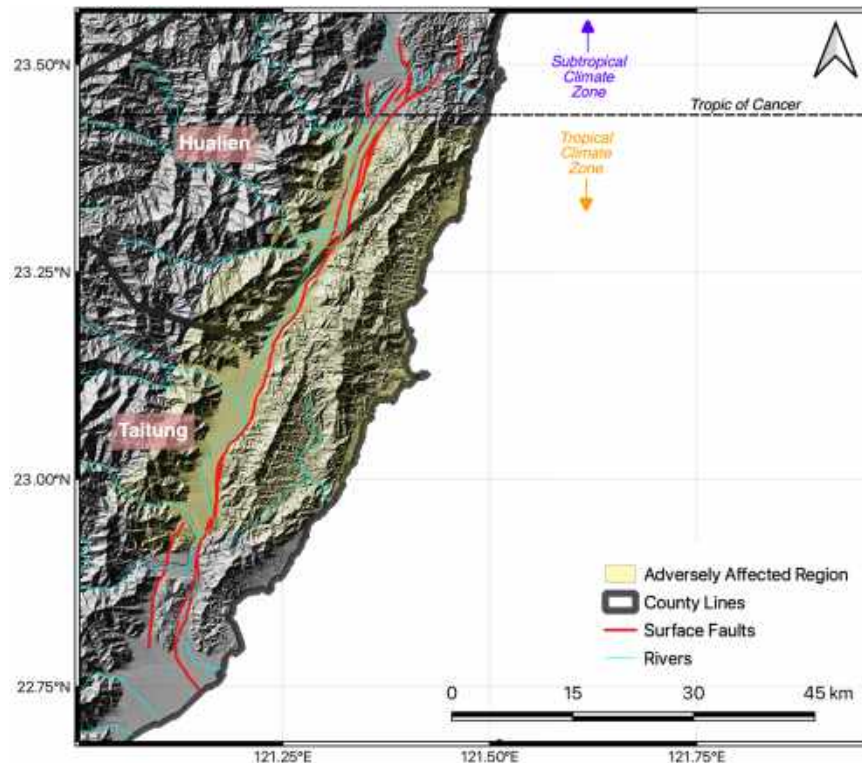
Figure 2.1 Summary map of region adversely affected by the **M6.9** and **M6.5** earthquakes, the counties, and known fault locations.

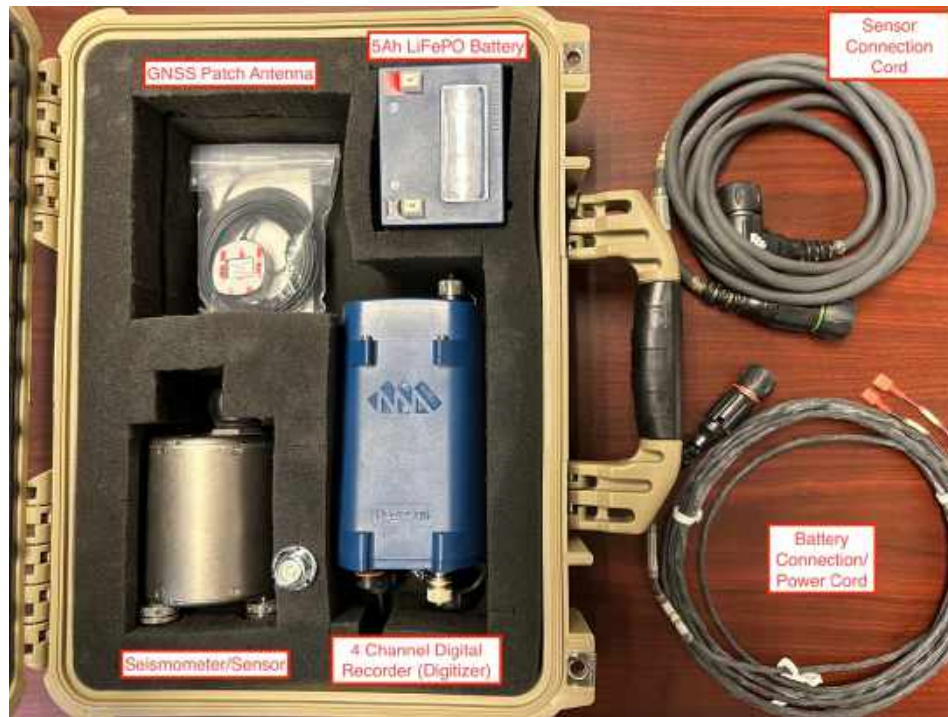
Figure 2.2. Necessary components/equipment for the operation of one seismometer

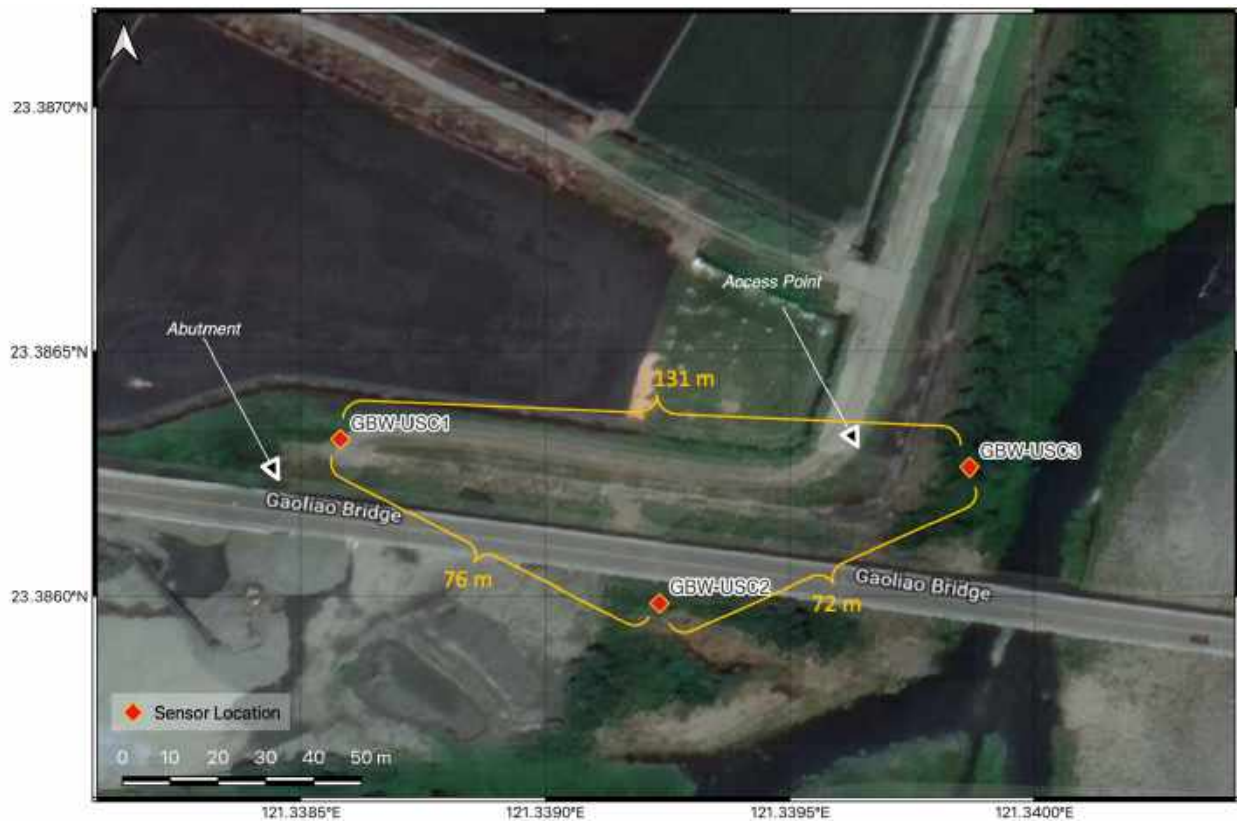
Figure 2.5. Layout of the temporary seismometer deployment at the western end of Gaoliao bridge. Shows the configuration of the semi-triangular array, highlighting the distances between the sensors, the location of the access point, the abutment, and the bridge.

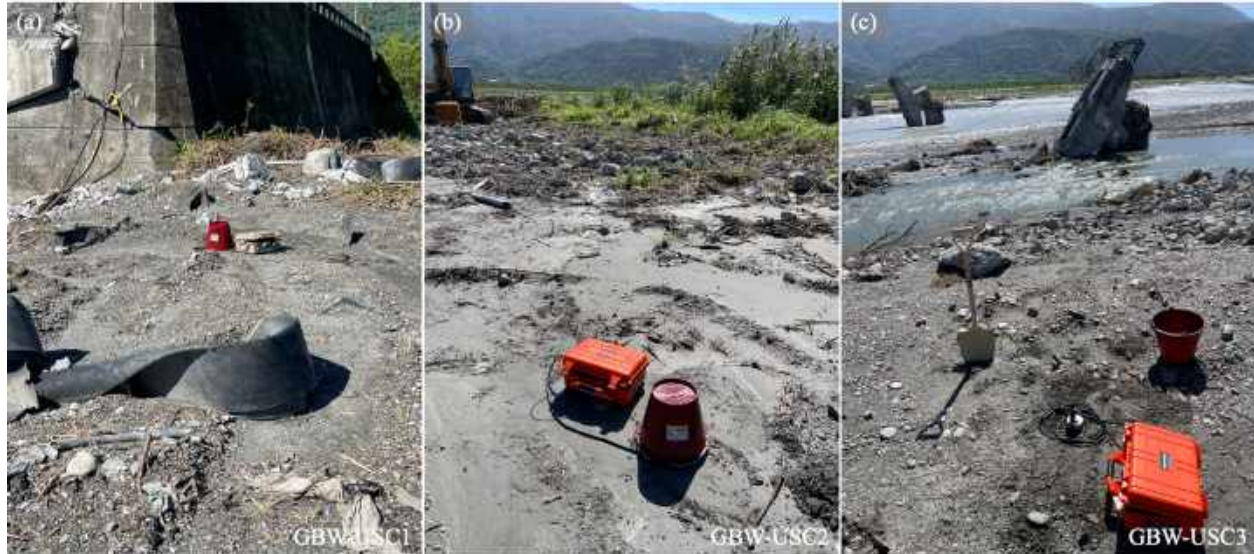
Figure 2.6. Photo of sensor setup at Gaoliao bridge (Western end). (a) GBW-USC1; (b) GBW-USC2; (c) GBW-USC3.

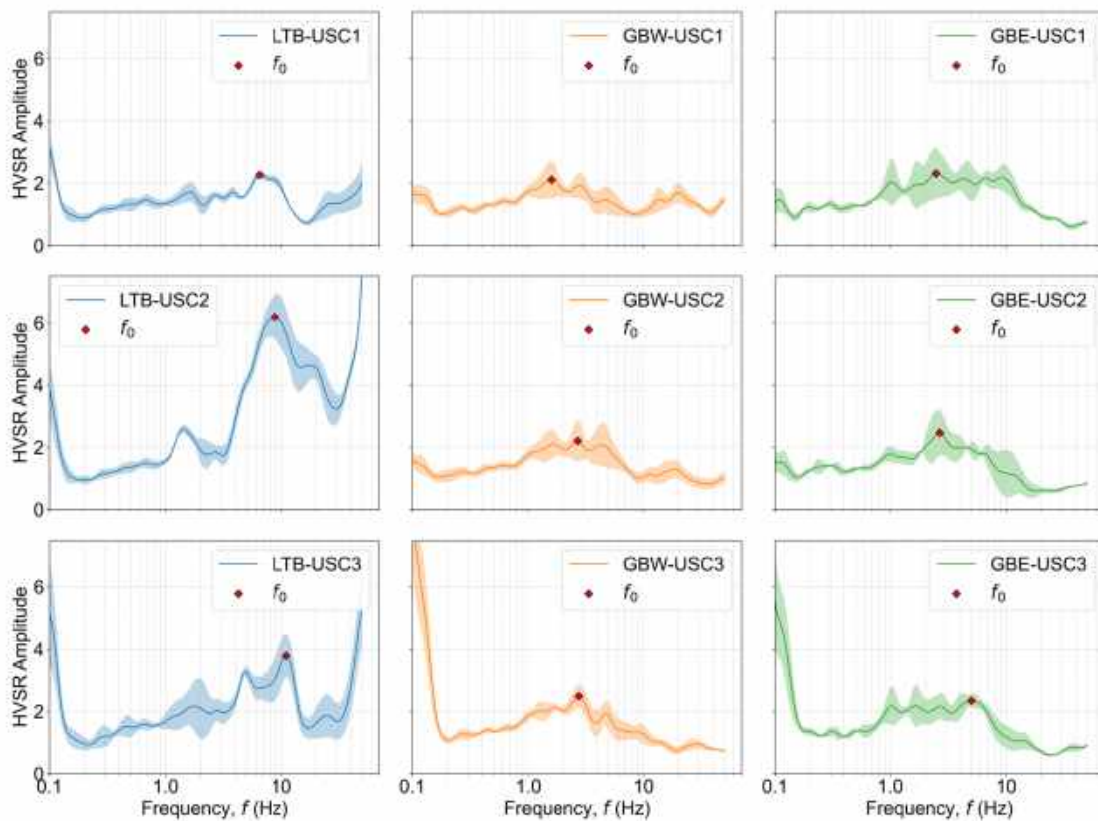
Figure 2.9. Plot of mean mHVSr curves derived from the recorded ambient vibrations at the bridge locations. The shaded regions around the mean curve (solid lines) represent ± 1 standard deviation. The red diamond indicates the estimated fundamental site frequency taken as the maximum amplitude peak within the range of 0.2 – 30 Hz.

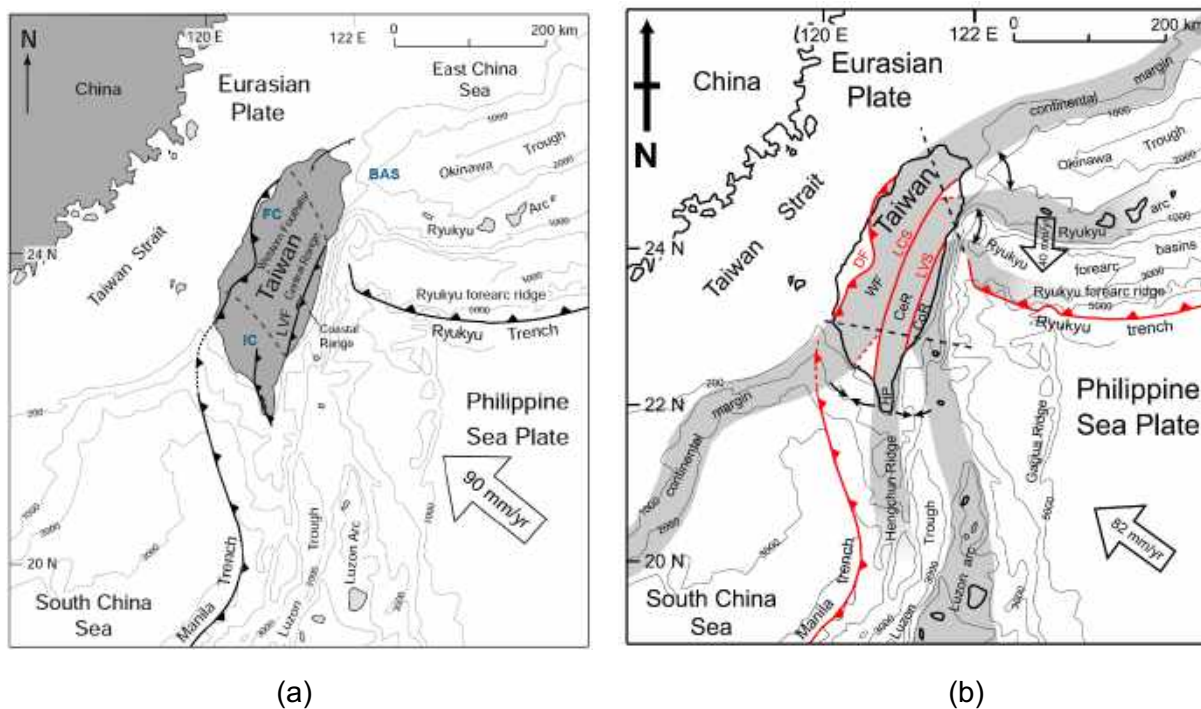
Figure 3.1 Tectonic map of Taiwan (a) modified and (b) directly from Shyu et al. (2005).

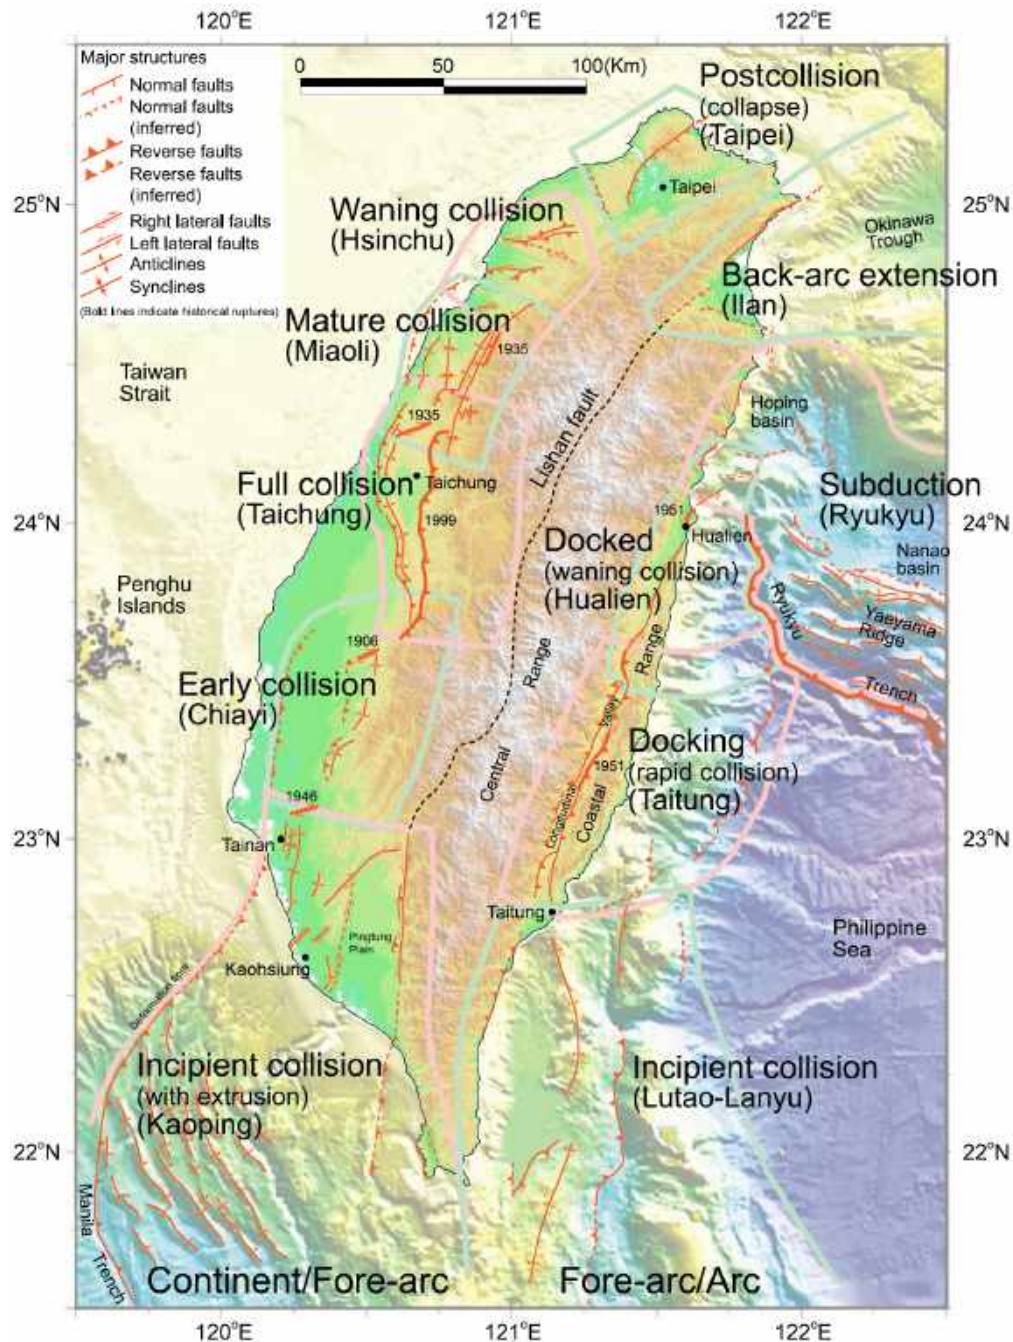
Figure 3.2 Taiwan fault structures, from Shyu et al. (2005).

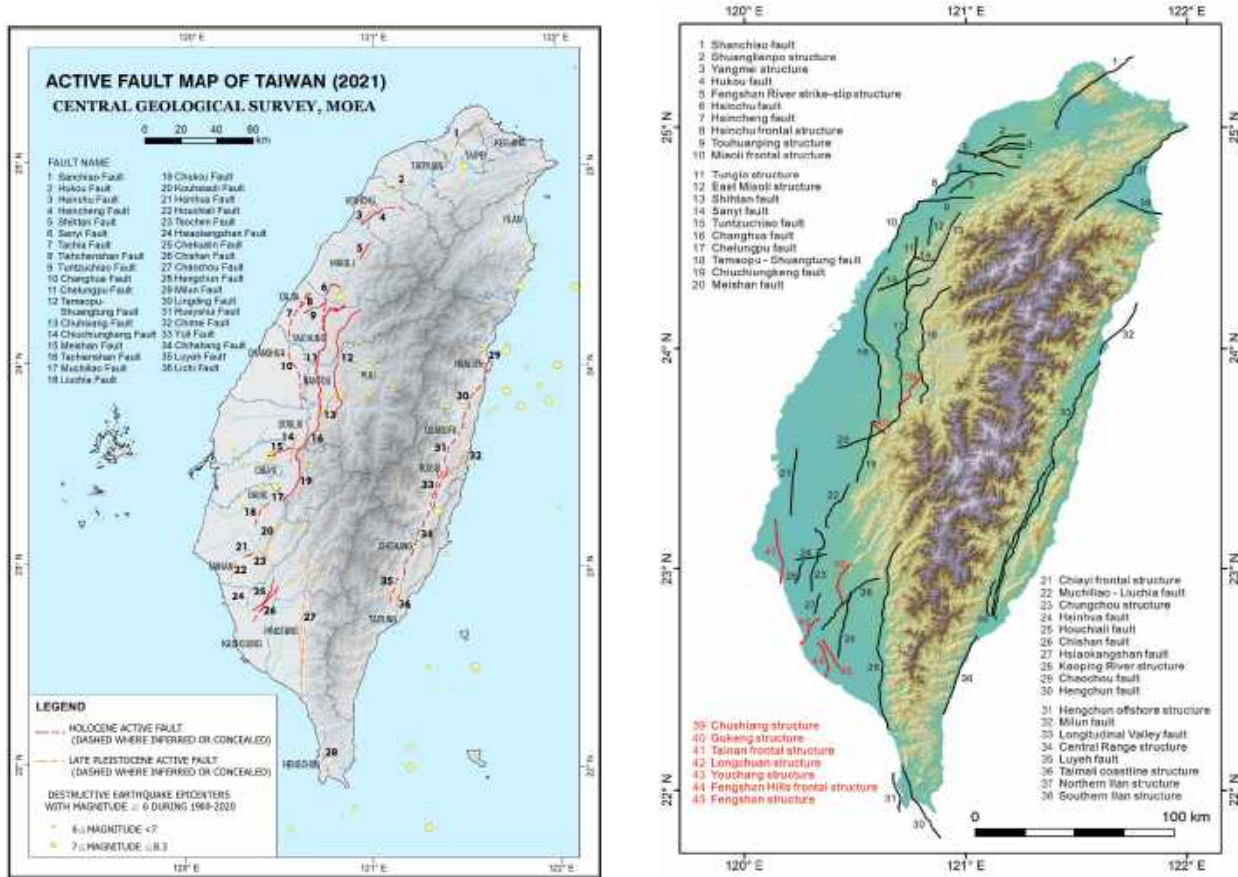
Figure 3.3 Active fault maps of Taiwan.

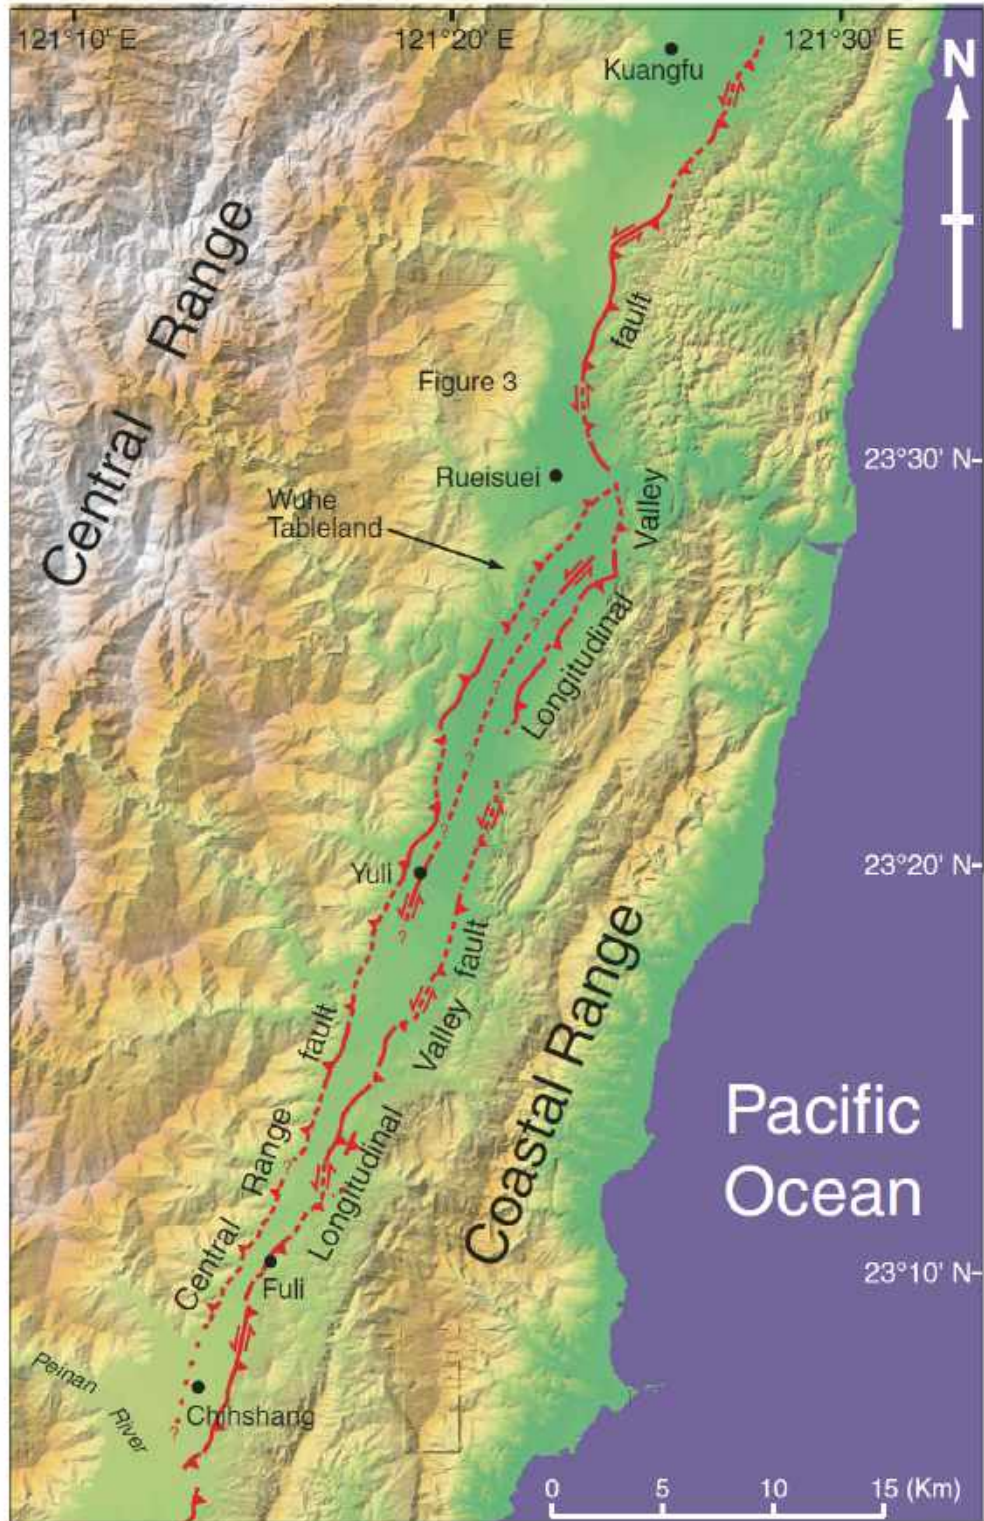
Figure 3.4 Tectonic map of Taiwan's Coastal Range (adapted from Shyu et al, 2006).

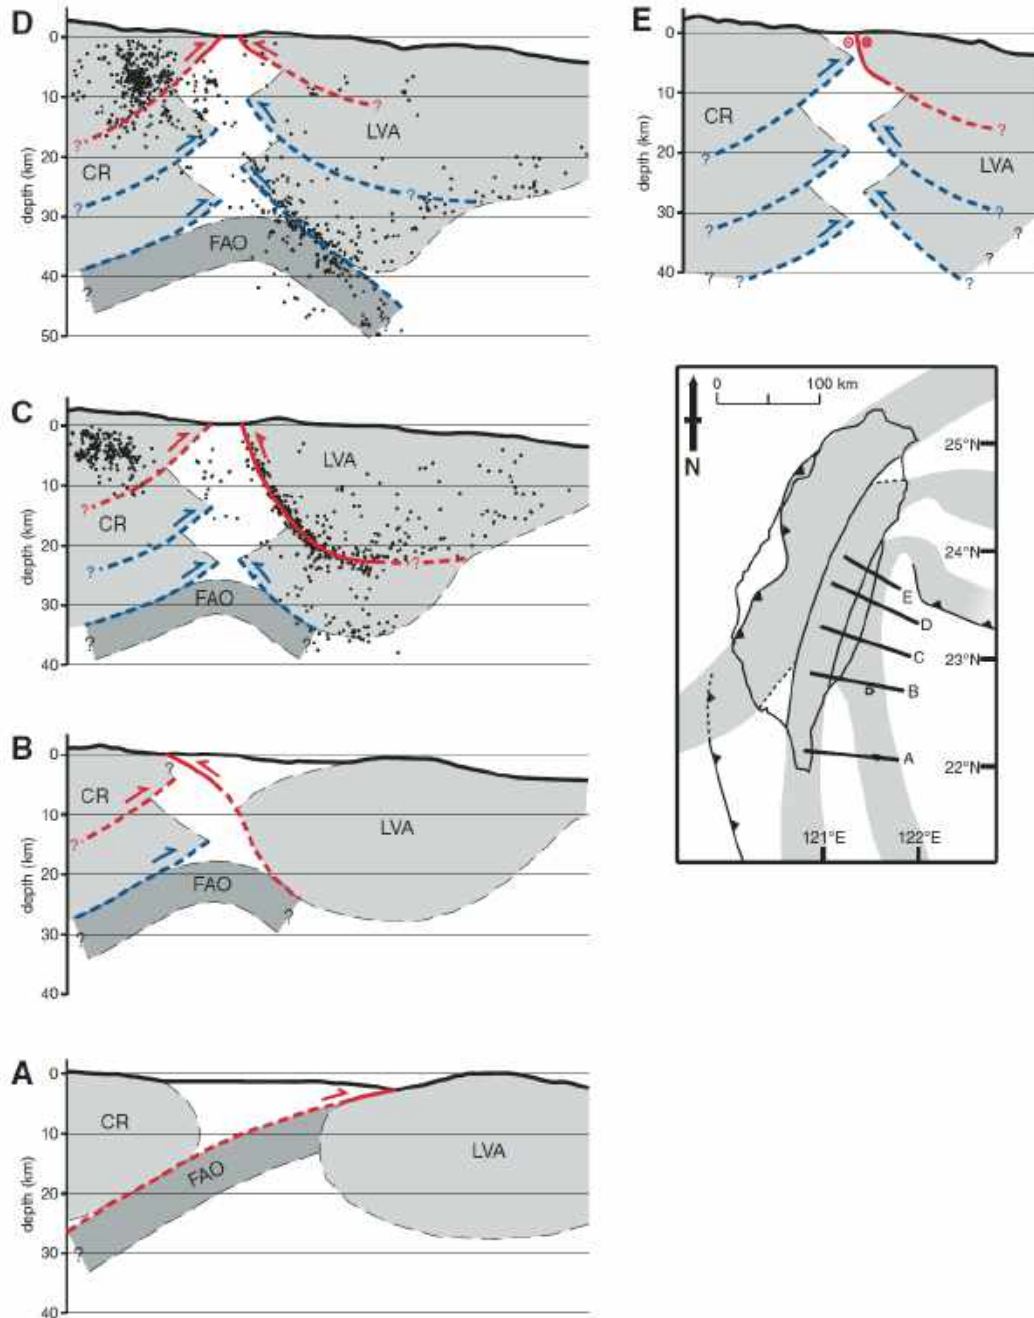
Figure 3.5 Schematic crustal cross-sections depicting the Shyu et al (2006) hypothesis of the “Christmas tree” model for the evolution of the Longitudinal Valley suture. Each section is drawn using current topography and observations along the lines specified on the index map, with no vertical exaggeration. Red indicates the youngest and currently active faults in each time frame, and blue indicates older faults, which may still be active. Faults are dashed where inferred. Relocated earthquake hypocenters in Figures C and D are adapted from Kuochen et al. (2004)

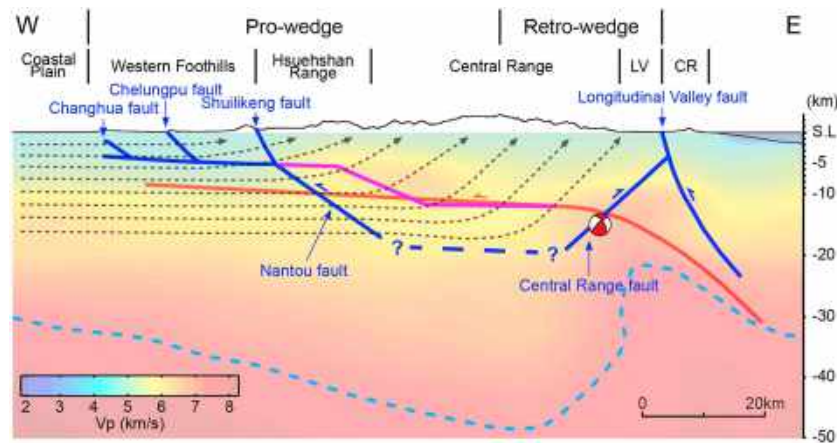
Figure 3.6 Cross section of Taiwan orogenic wedge from Chuang et al (2014). Blue lines are major faults after Chuang et al. (2013). Focal mechanism shows the Rueisuei earthquake. P wave velocity tomography image is from Kuo-Chen et al. (2012). Dashed blue line indicates iso-surface of 7.5 km/s P wave velocity. CR: Coastal Range; LV: Longitudinal Valley.

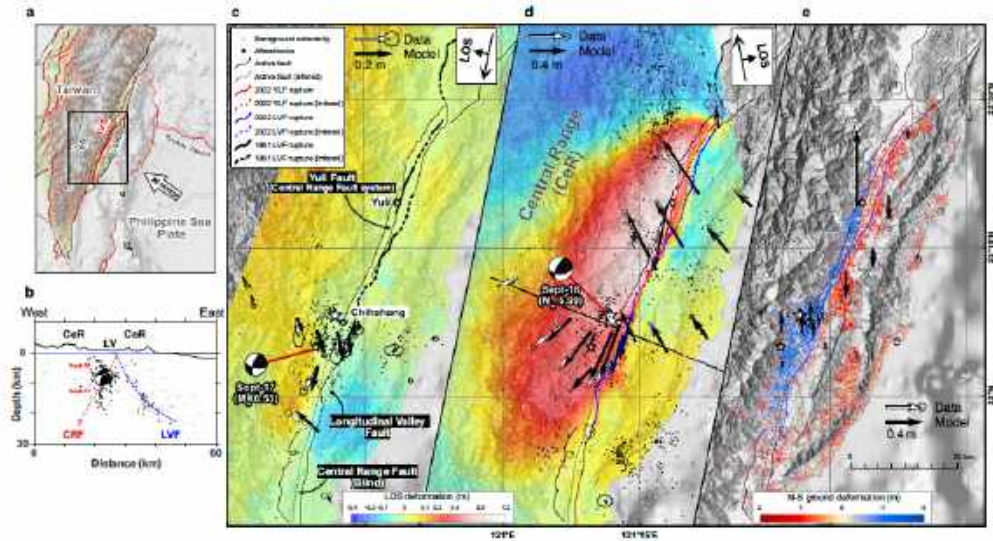
The consequence of the unique rupture mechanism from south to north manifested in strong evidence of forward directivity effects, with strong associated pulse-like velocity motions; as well as single-sided velocity pulses normal to the direction of rupture propagation that resulted from the accommodation of the tectonic slip of the complex normal-reverse rupture communication. Typical pulse like motions extracted by NAR Laboratories are shown in Figure 3.7 below for the **M**6.9 mainshock and the **M**6.5 foreshock.

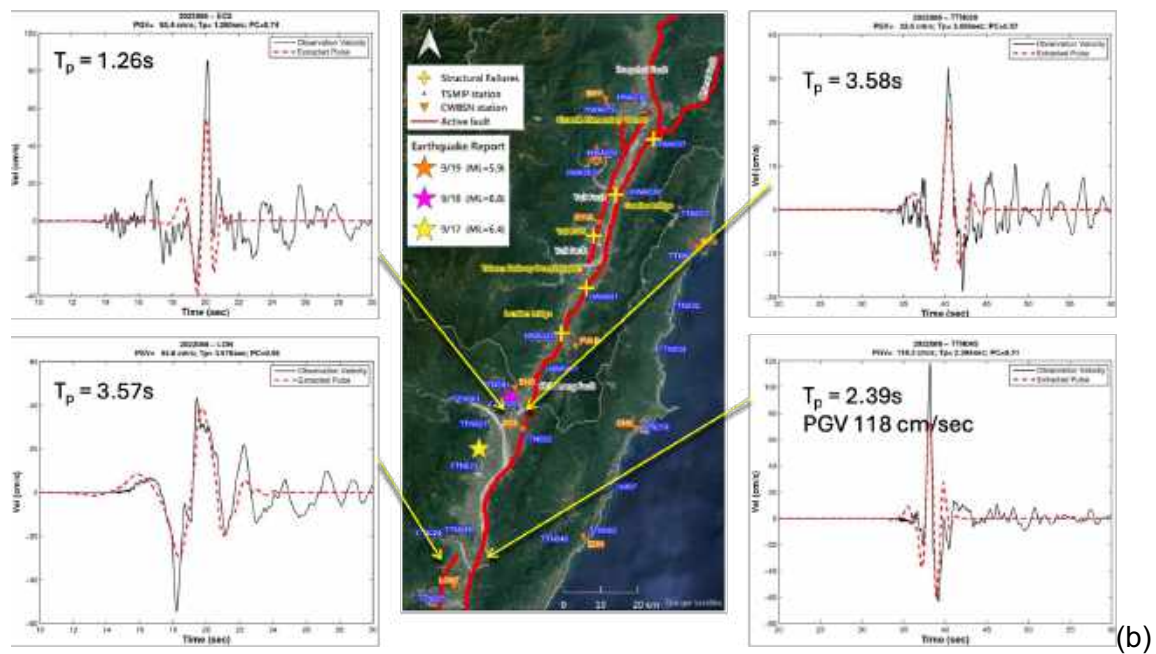
Figure 3.8. Pulse like motions extracted by NARLabs from the Chihshang mainshock (a) and the Guanshan foreshock (b); each ground motion time series depicts the extracted pulse-like motions, their period, and the peak ground velocity, where applicable.

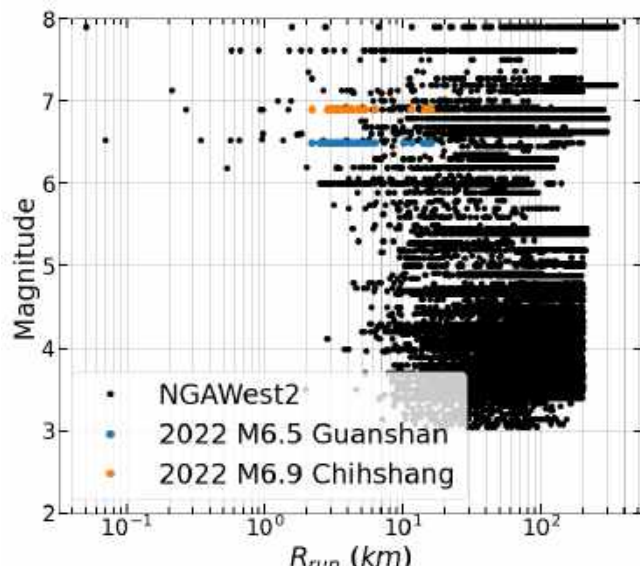
Figure 3.9 Distribution of magnitude-distance of the M6.5 Guanshan and M6.9 Chihshang events, plotted alongside the NGAWest2 database for reference.

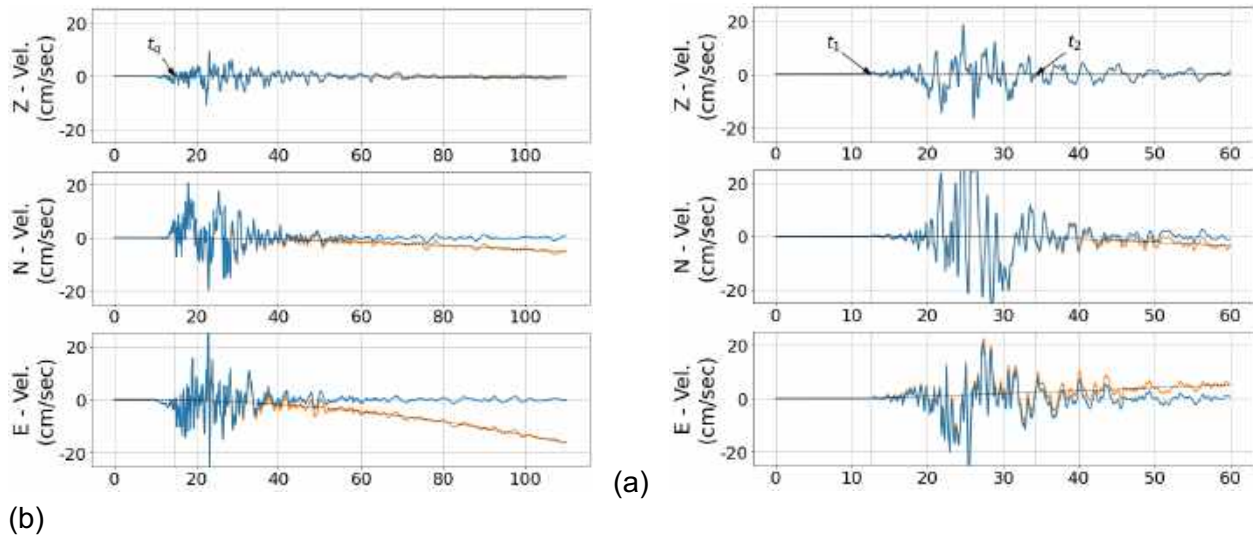
Figure 3.10 Instrument tilt correction simultaneously for all three components using the Boore (1999) quadratic baseline correction method (a) and the bilinear method (b).

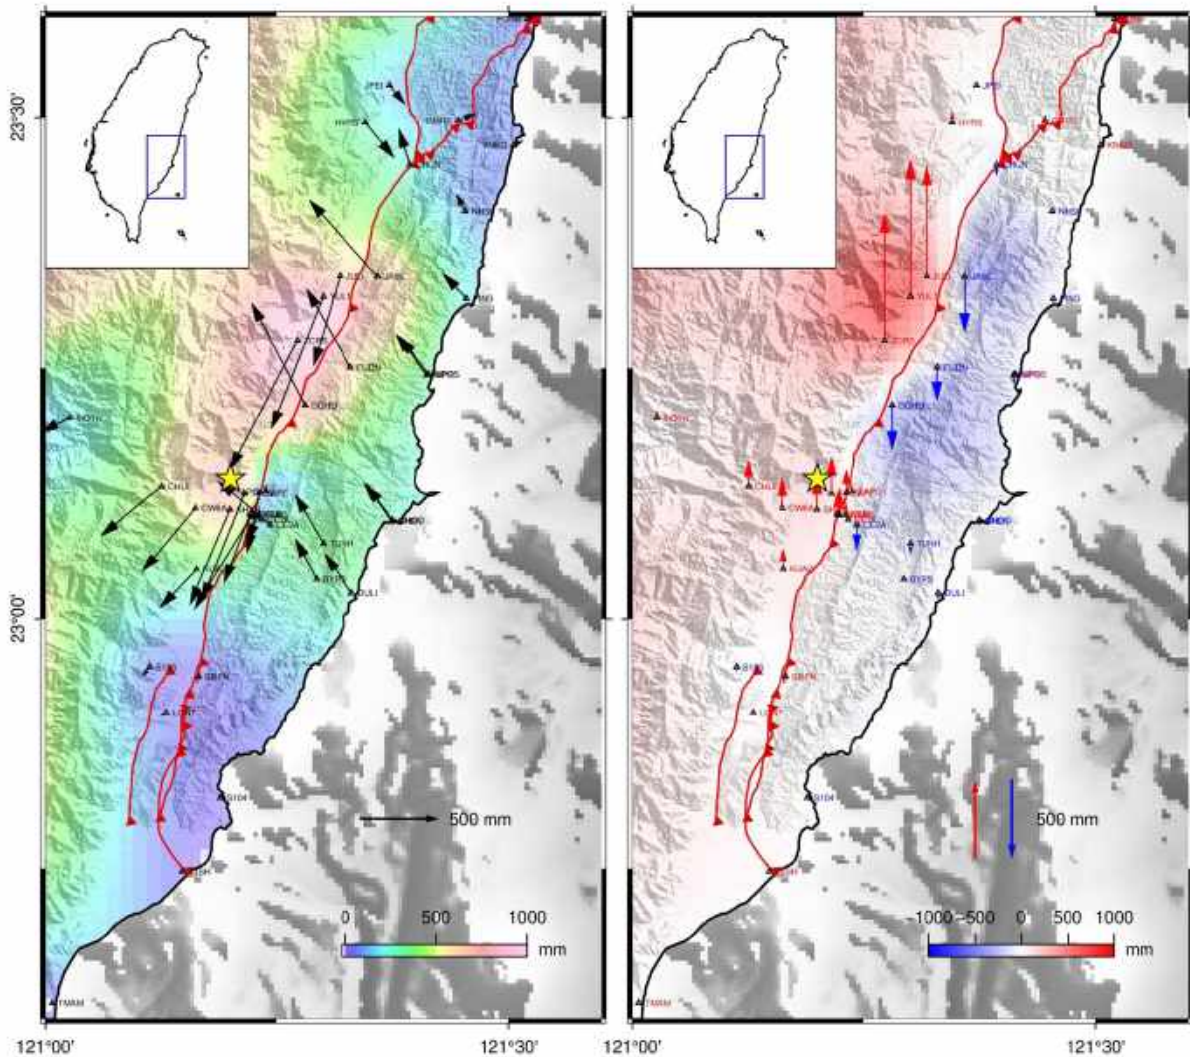
Figure 3.11 Horizontal and vertical permanent offset measured by the GNSS network in the vicinity of the $M_w6.9$ Chihshang earthquake epicenter. The maximum horizontal displacement was measured in the GPS station ZCRS south of Yuli town, with displacement of 1000 mm, while station DYES north of Yuli measured the largest uplift, 1100 mm (<https://tgm.earth.sinica.edu.tw>)

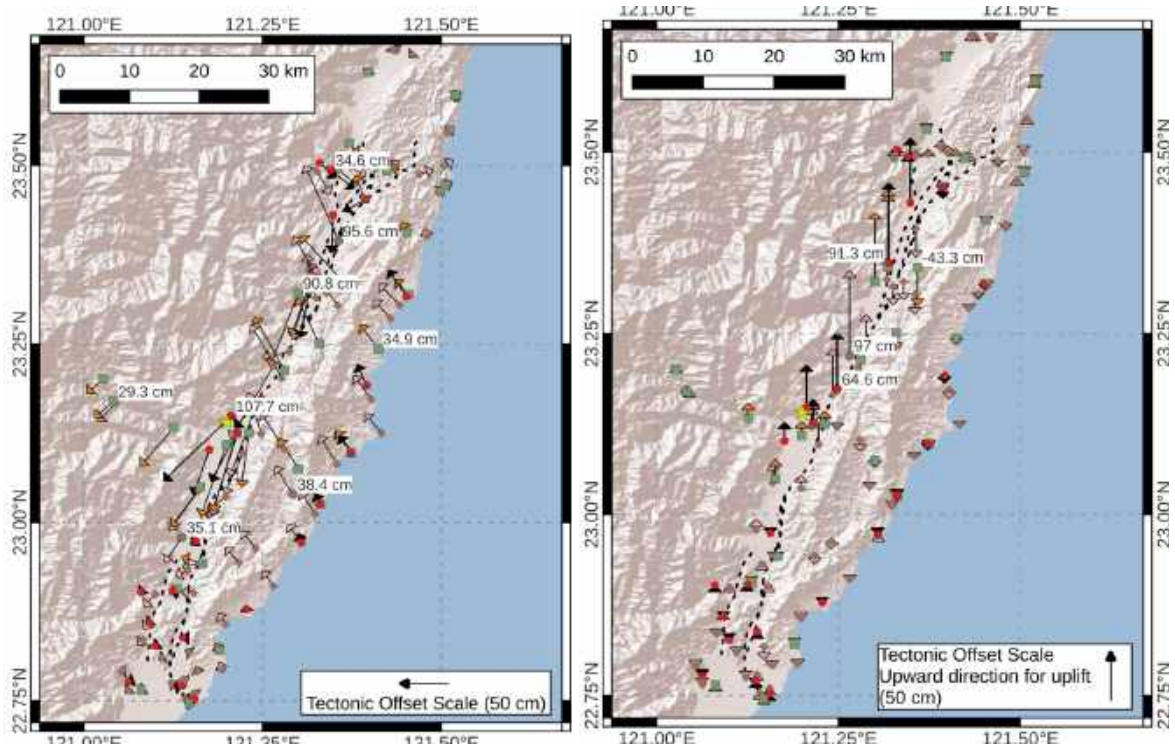
Figure 3.12 Comparison of tectonic offset estimated from the strong motion records by the GEER team (black arrows) and the GNSS stations (orange arrows). Recordings from the M_{6.9} Chihshang mainshock.

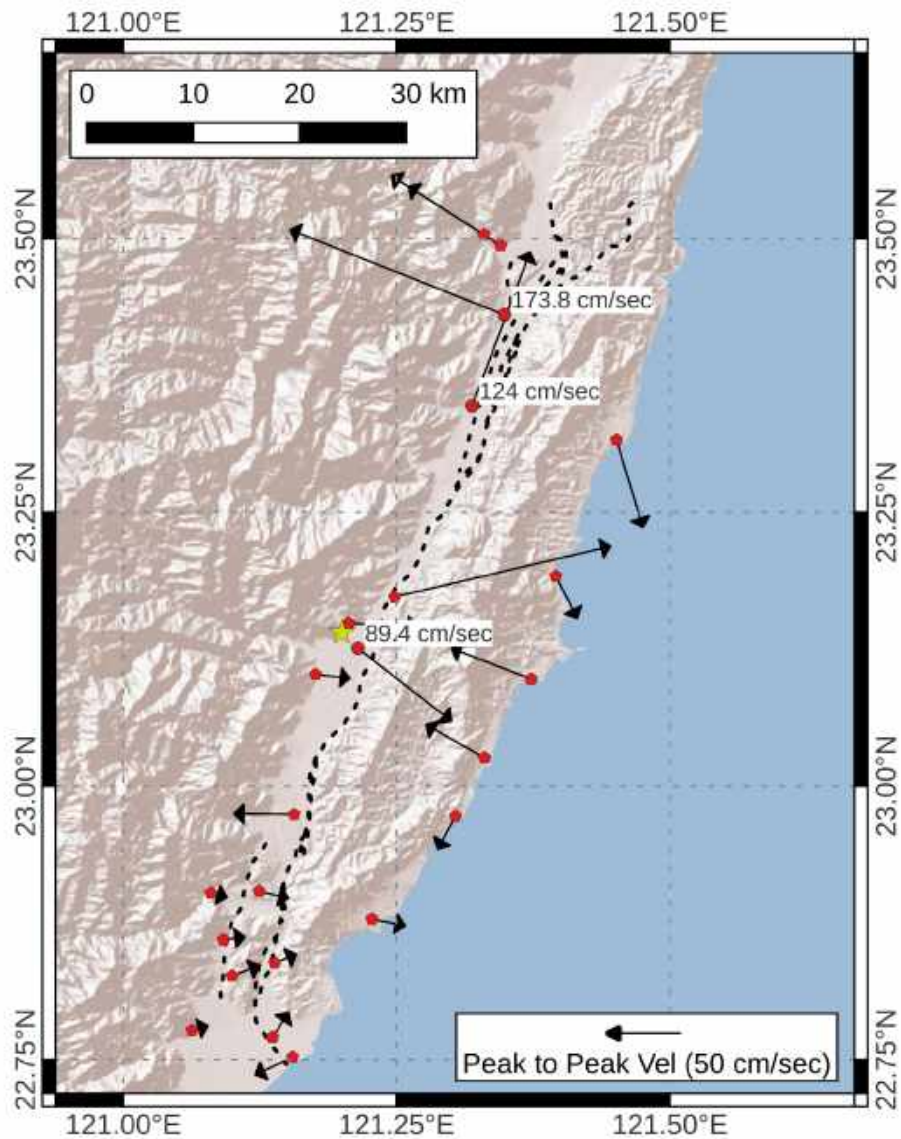
Figure 3.14 Peak-to-peak velocity vectors extracted from strong ground motion time series along the rupture (**M6.9 Chihshang mainshock**).

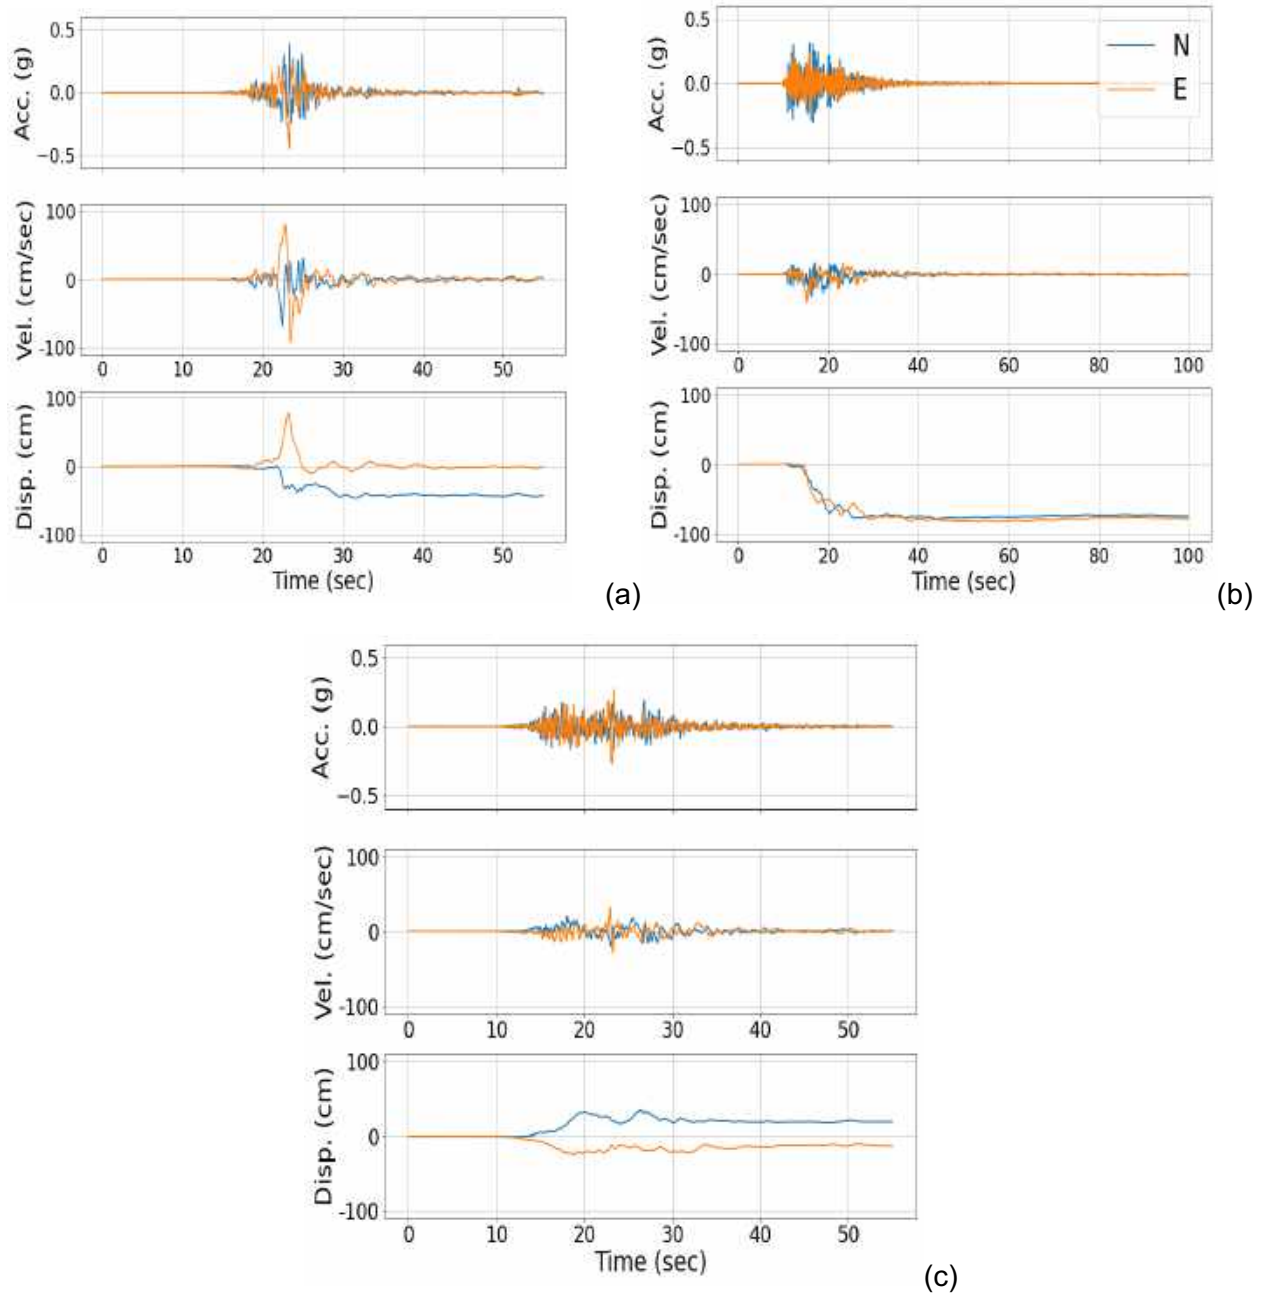
Figure 3.15 Examples of horizontal strong ground motions, processed by the modified Boore (1999, 2000) baseline correction to recover the tectonic offset. A second dataset that was not processed using the quadratic or bilinear baseline correction, was processed the NGA PEER processing protocols.

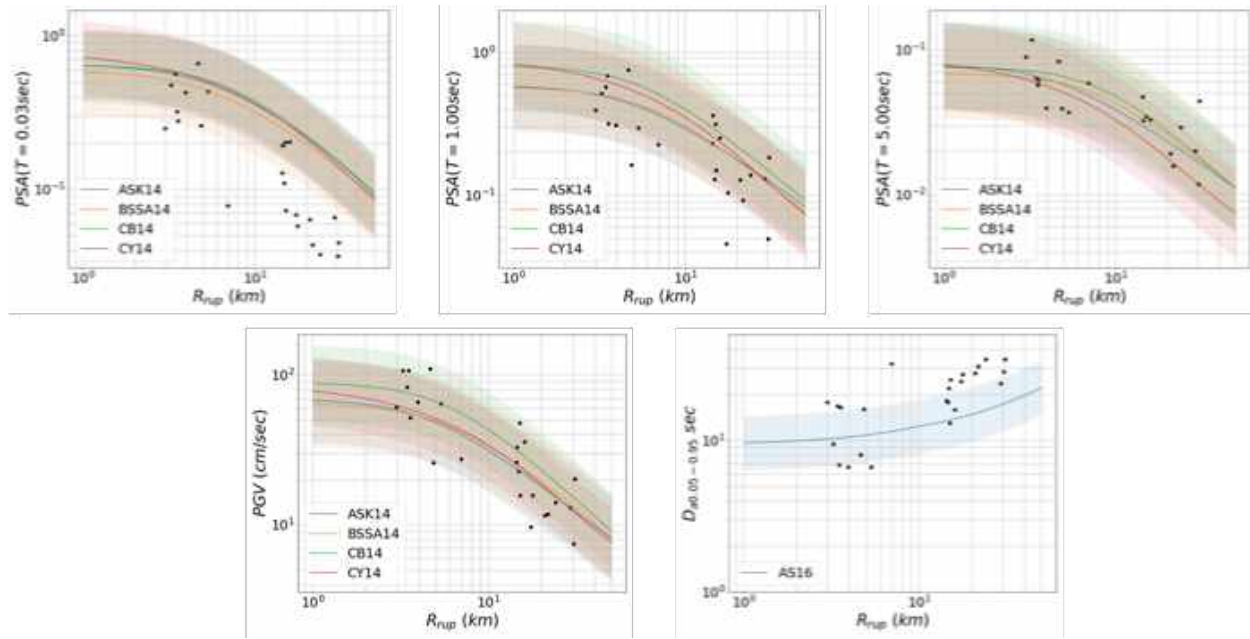
Figure 3.16 Ground motion scaling of the **M6.9** Chihshang strong ground motions.
