GEOTECHNICAL ENGINEERING RECONNAISSANCE OF THE 2022 CHIHSHANG EARTHQUAKE SEQUENCE

Version 1.0; April 2024

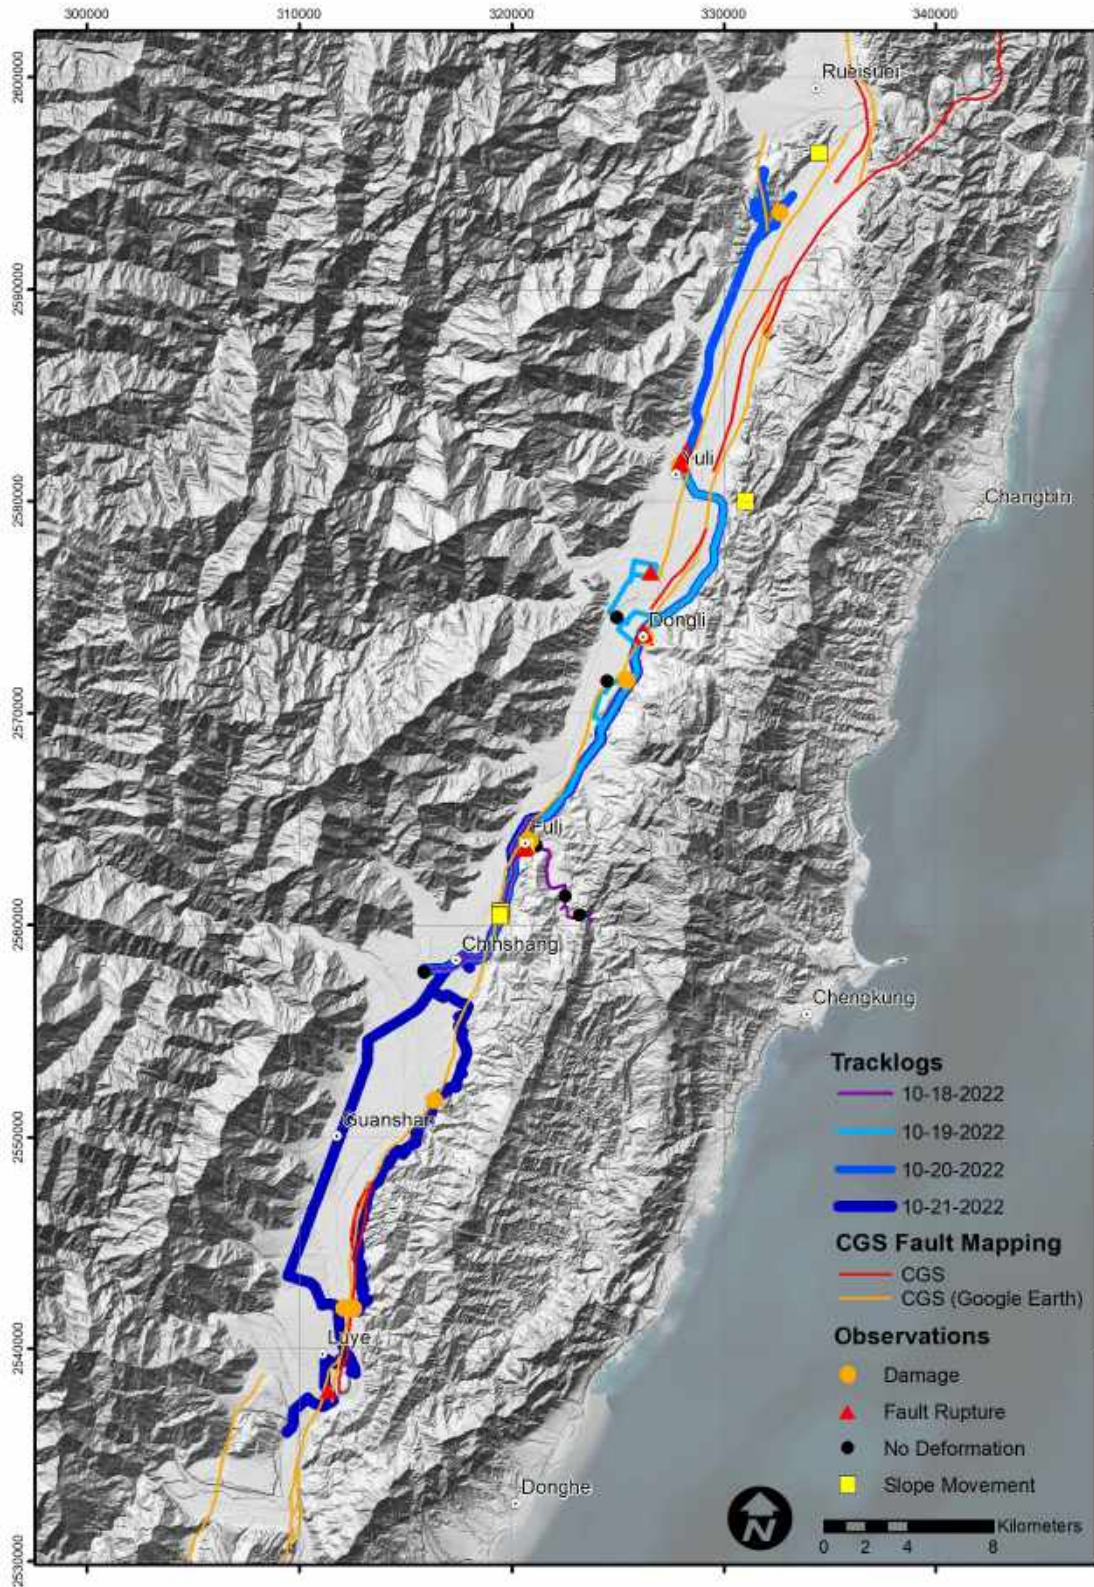
Figure 4.1: Tracklog and observation map from the surface fault rupture team.

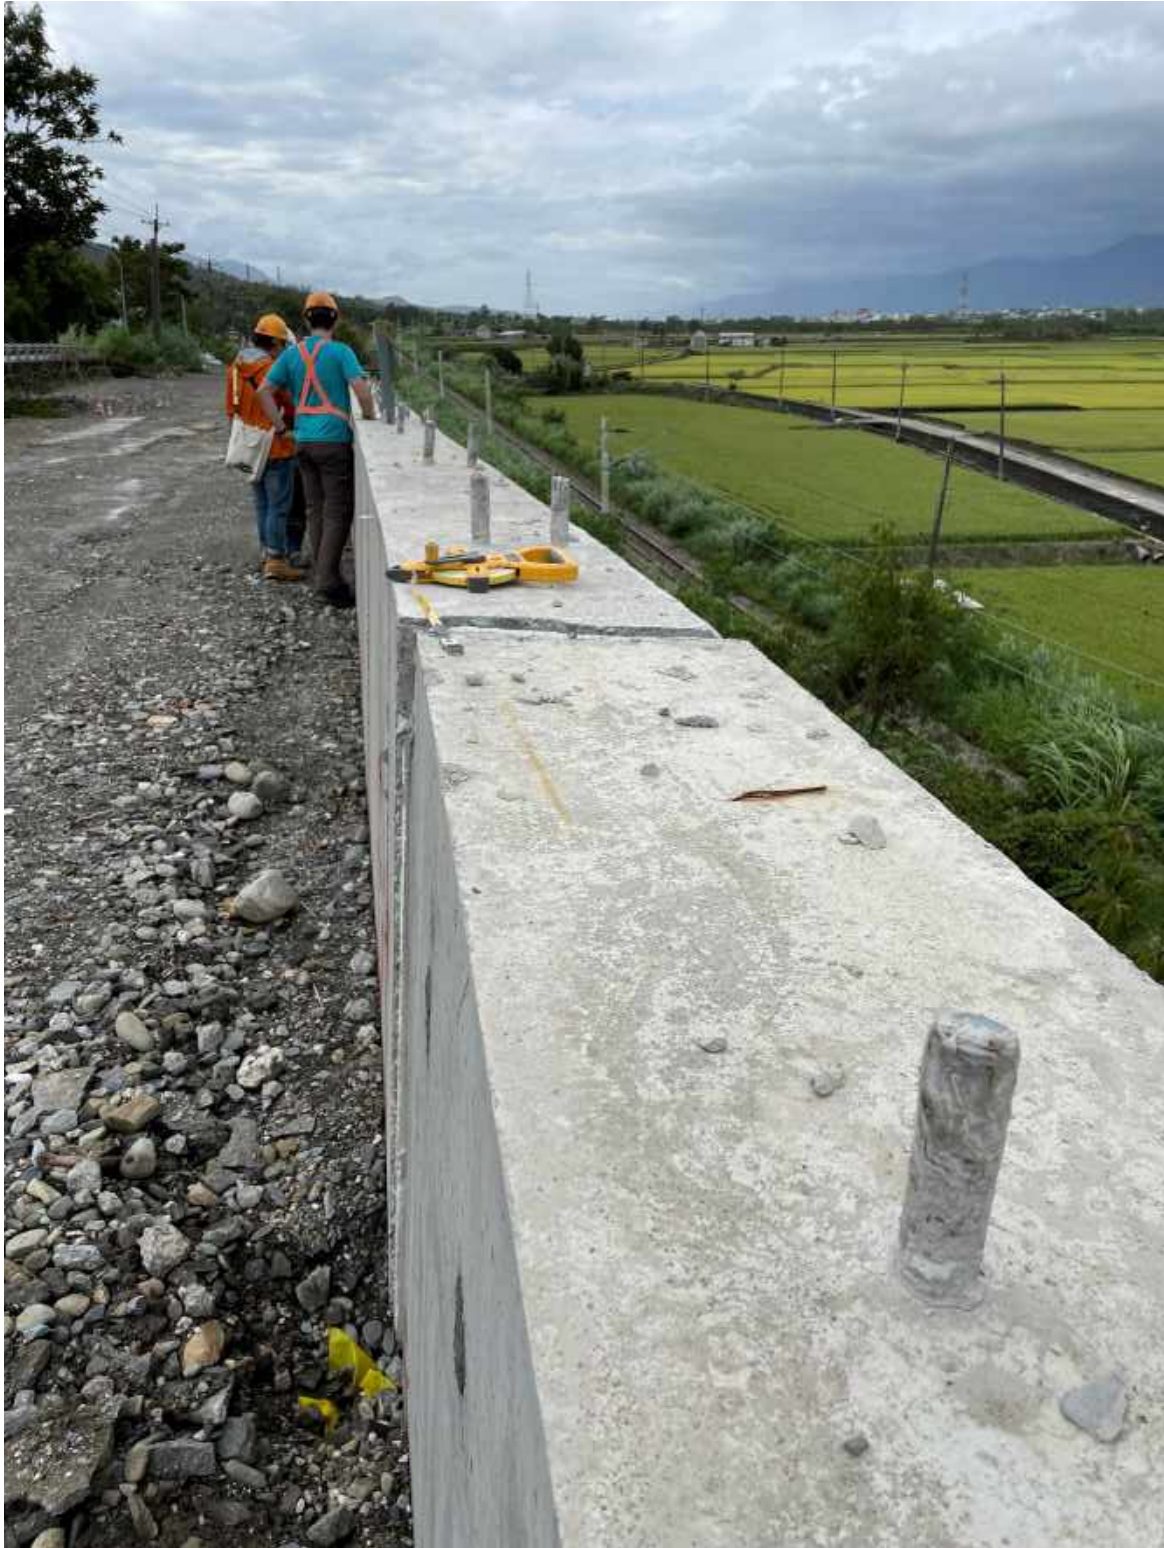
Figure 4.3: View looking south along retaining wall showing displacement of joint between 20-m wall sections. Backfill composed of river gravel, locally emplaced in lifts between geotextile. Lat: 23° 8' 43.47456", Lon: 121° 14' 13.727399".

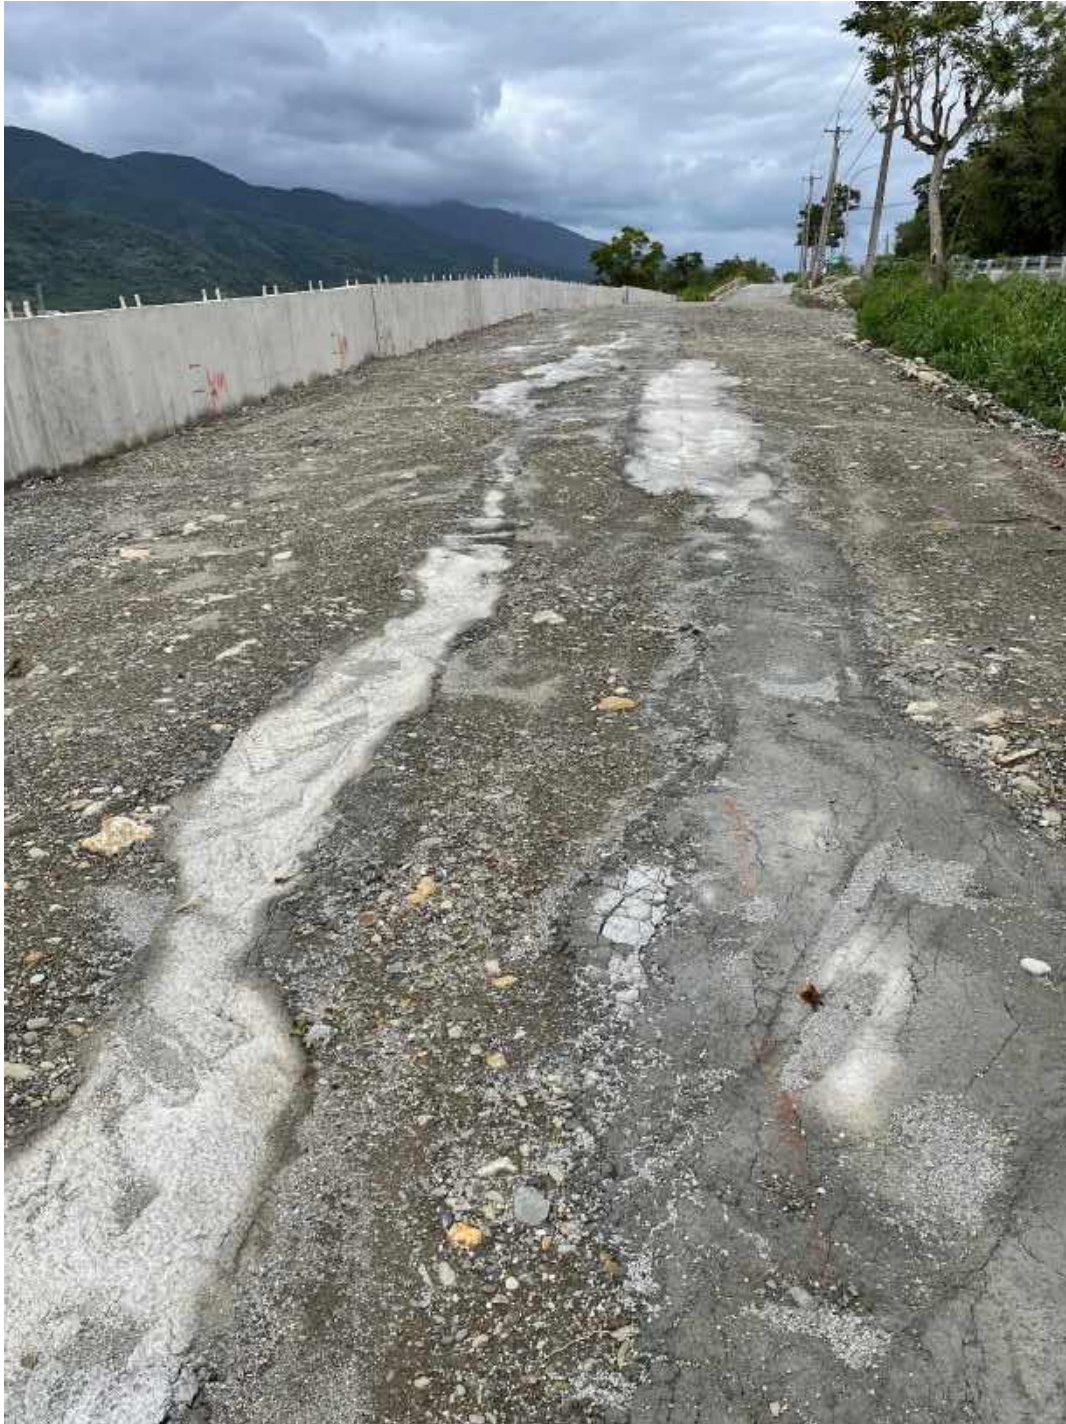
Figure 4.6: View looking north and ground cracking areas “repaired” with concrete. Failed retaining wall in upper left. Lat: 23° 8' 39.00048”, Lon: 121° 14' 12.52428”.

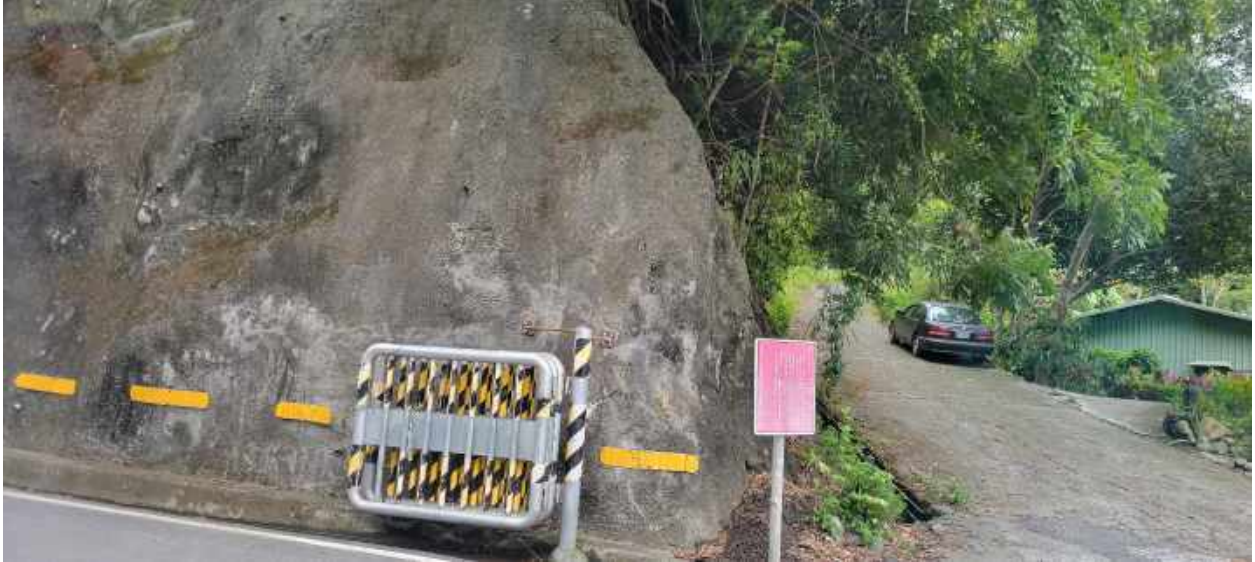
Figure 4.8: Roadside showing Tuluanshan volcanics.

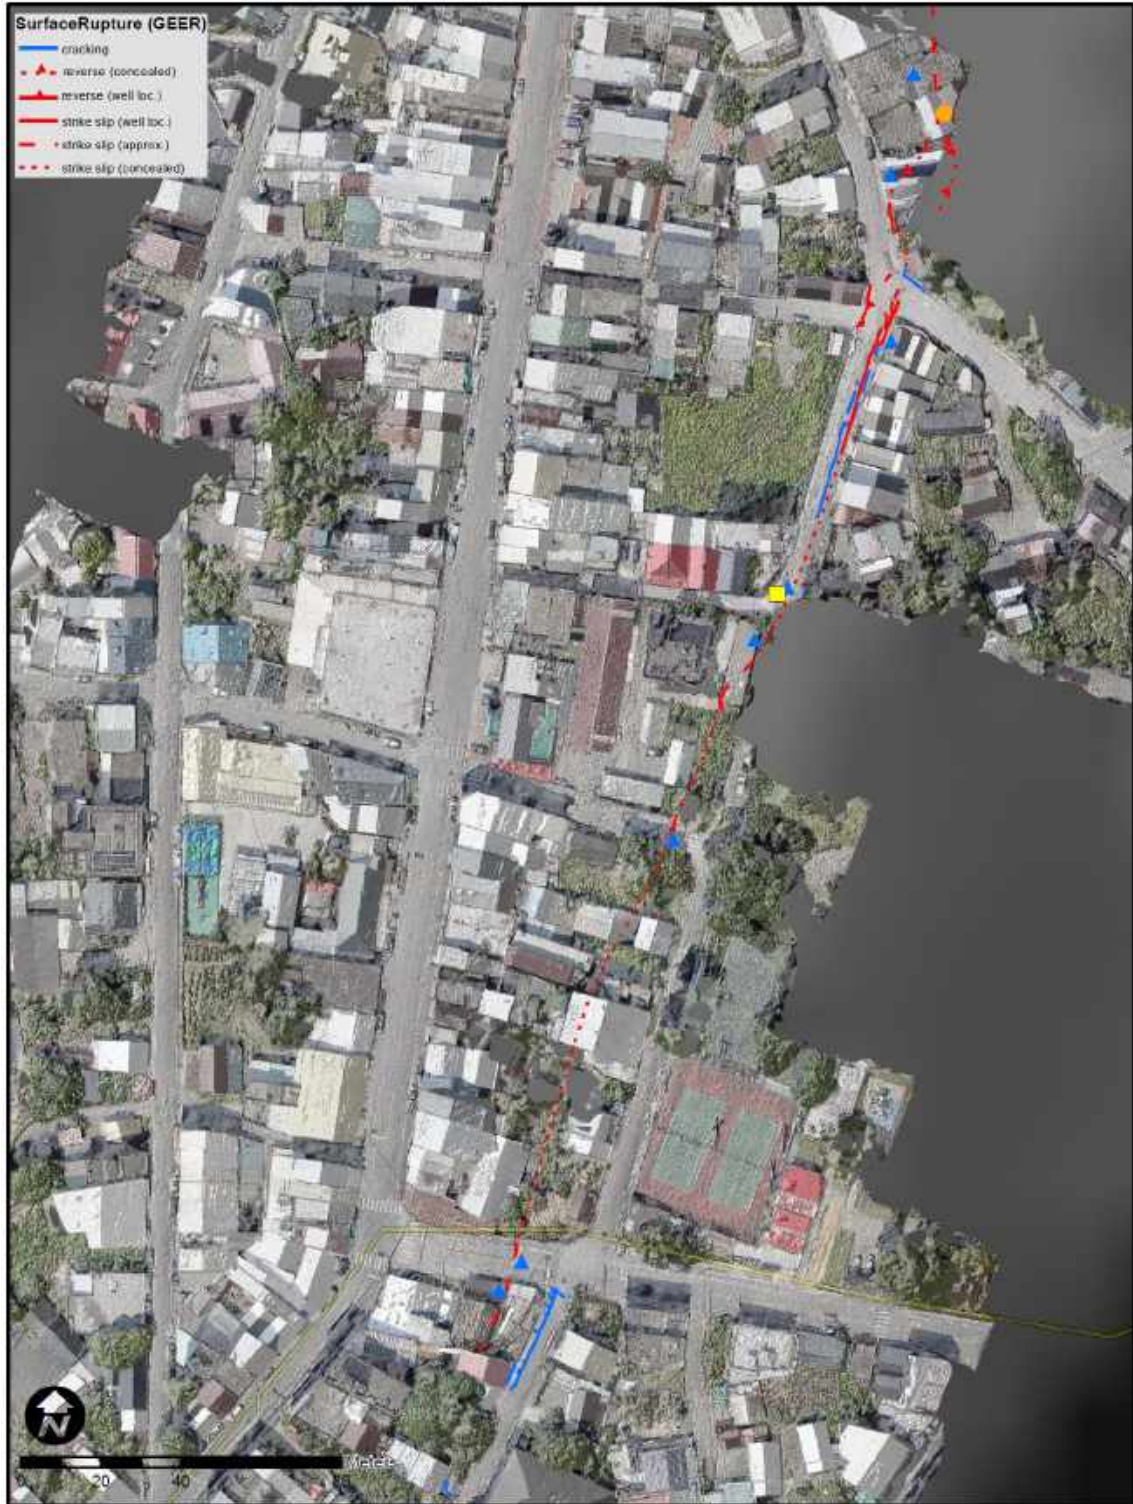
Figure 4.9: Rupture map in the town of Fuli.

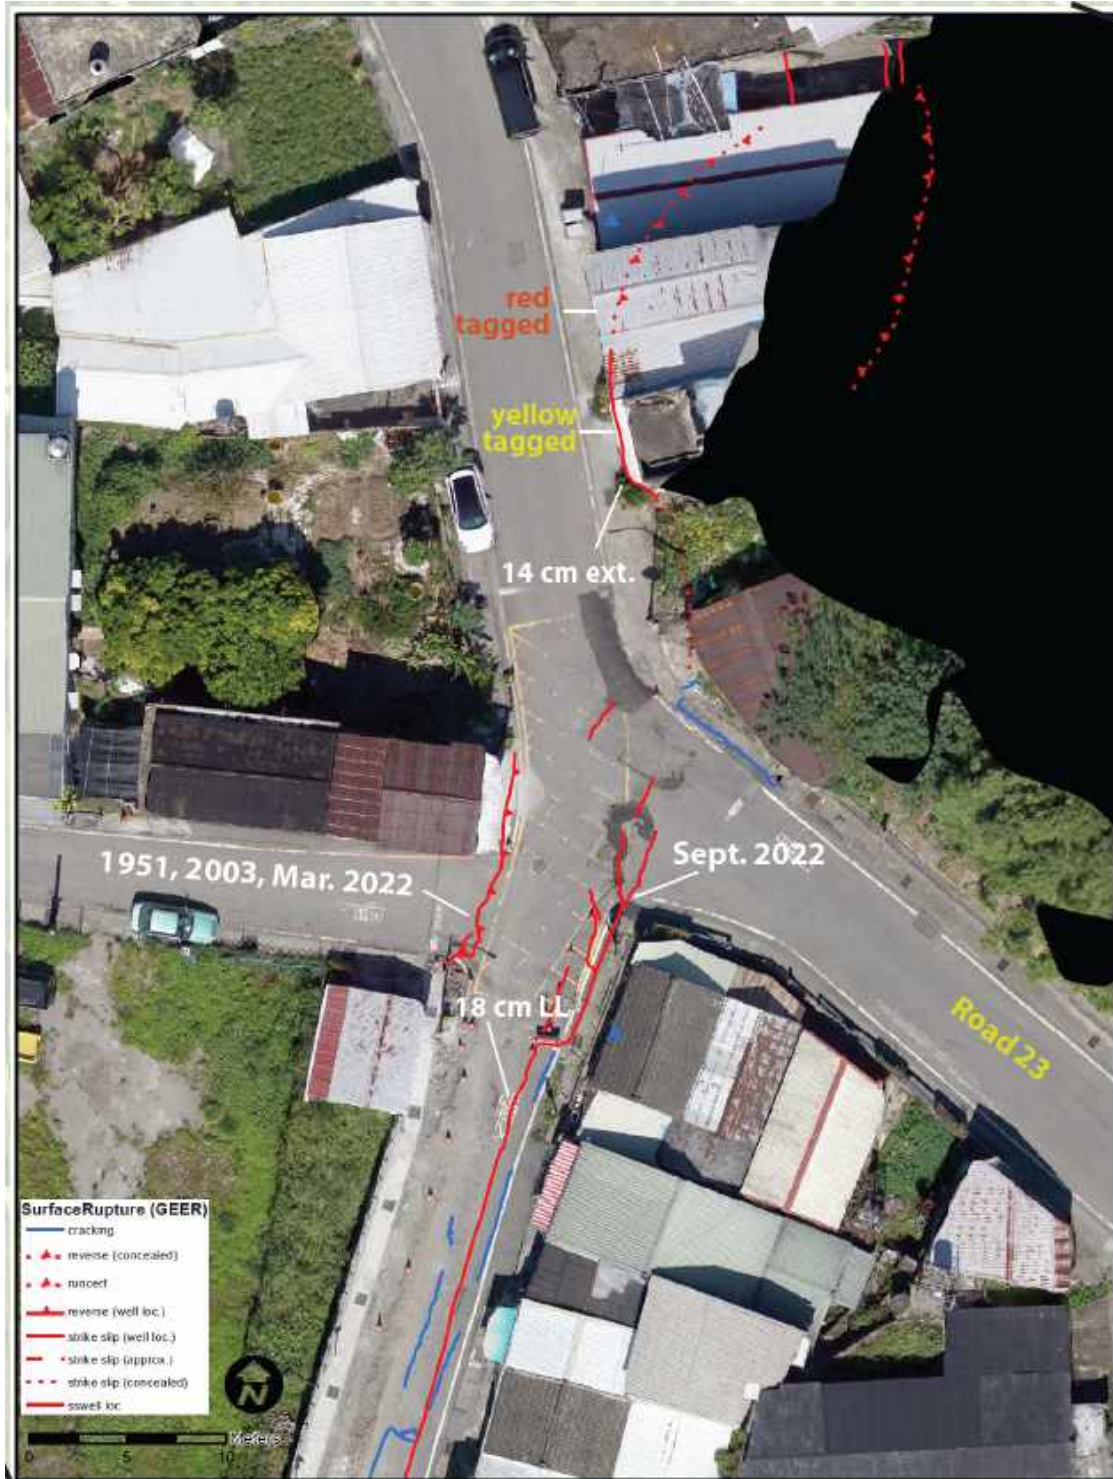
Figure 4.10: Detailed map of surface rupture at the Road 23 intersection in Fuli. Photos of structures north of the intersection are shown in figures below. Note position of September 2022 and prior surface ruptures at this location.

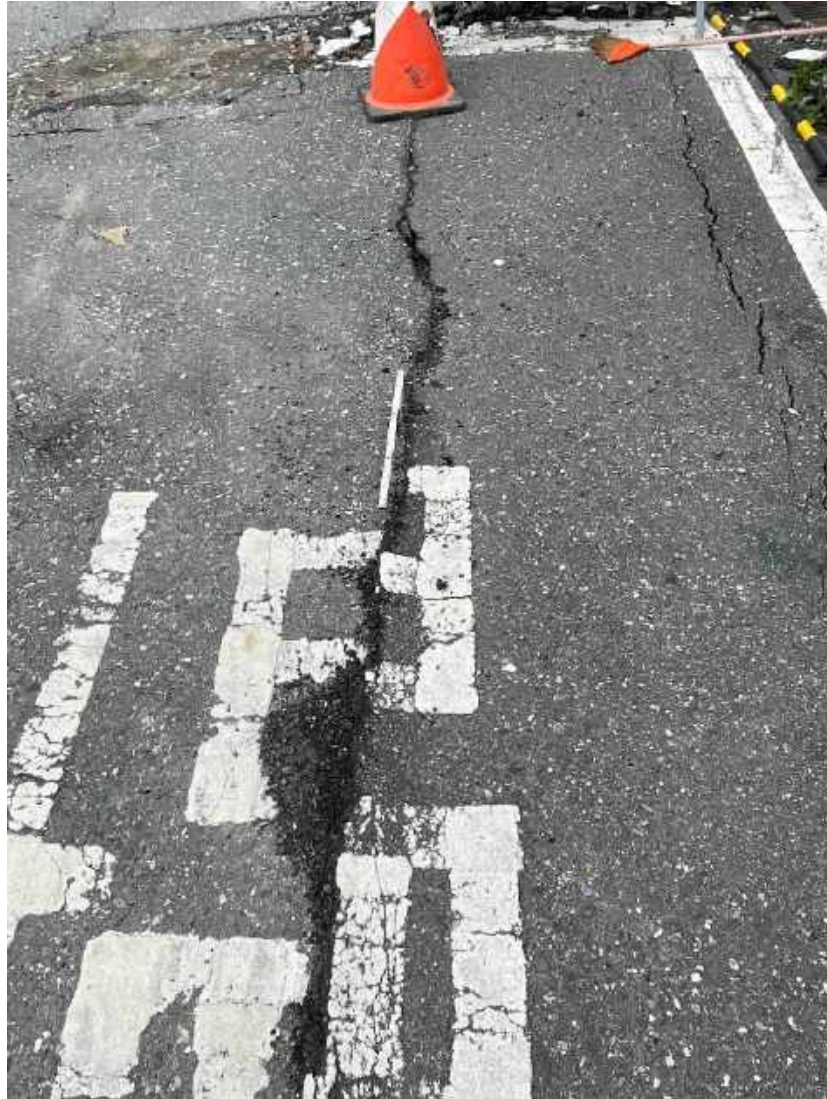
Figure 4.11: Surface rupture coincident with fault-parallel sewer line. Discrete LL offset is 18 cm. Lat: 23° 10' 24.693599", Lon: 121° 14' 54.185999"

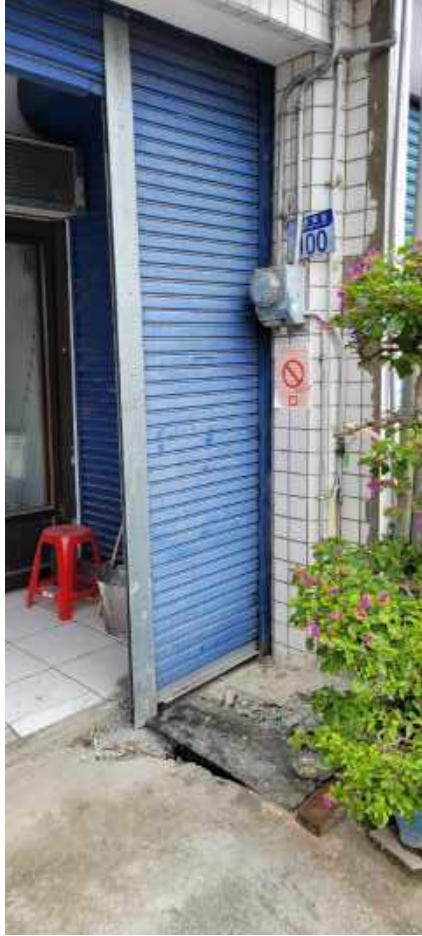
Figure 4.12: Fault rupture along a localized left (releasing) bend in the LVF. Rupture propagated around the foundation here but resulted in 14 cm of extension at the foundation corner. Lat: 23° 10' 25.973039", Lon: 121° 14' 54.221279"

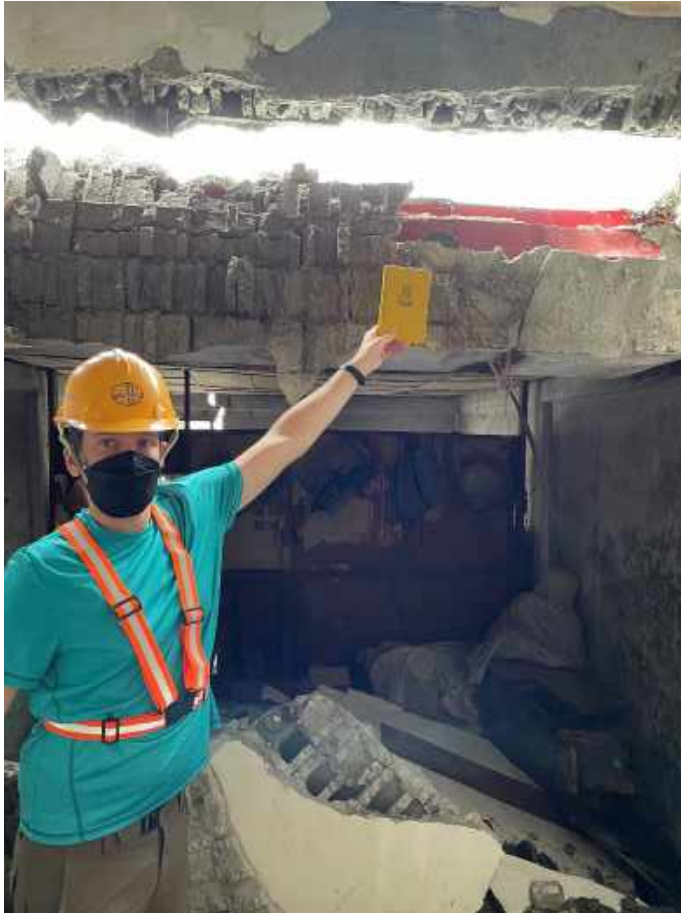
Figure 4.13: Fault rupture along a localized left (releasing) bend in the LVF. Fault rupture propagated along the edge of this foundation here, adjacent to the structure shown in Figure 4.12. Lat: 23° 10' 26.174639", Lon: 121° 14' 54.370679"

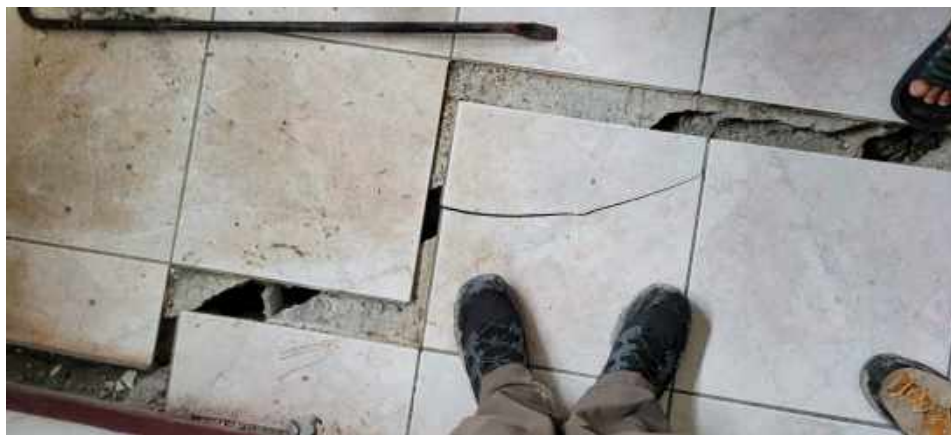
Figure 4.14: Partial collapse of URM structure along the LVF. Rupture propagated beneath the house. Lat: 23° 10' 26.201999", Lon: 121° 14' 54.605400"

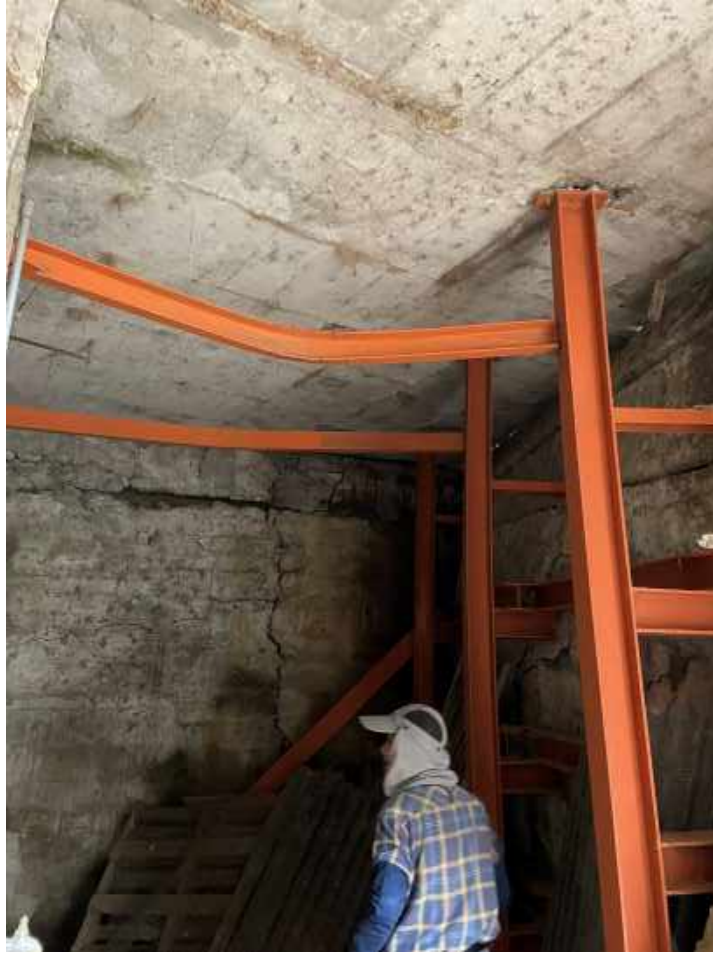
Figure 4.17: Deformation of braced concrete structure built into the LVF scarp. Deformation was largely coseismic based on owner's account. Lat: 23° 10' 27.884280", Lon: 121° 14' 54.895199"

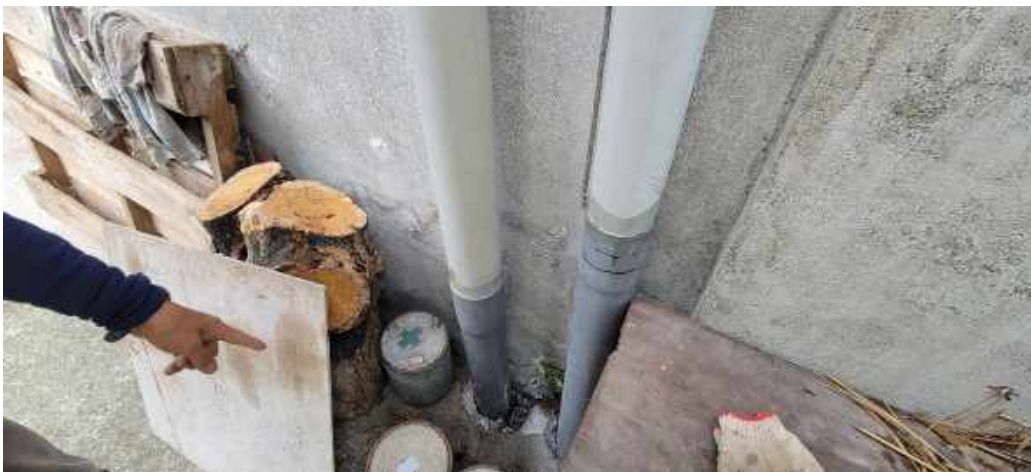
Figure 4.18 (a) Concrete damage due to relative foundation movement around water pipeline. Lat: 23° 10' 28.720199", Lon: 121° 14' 55.052159"

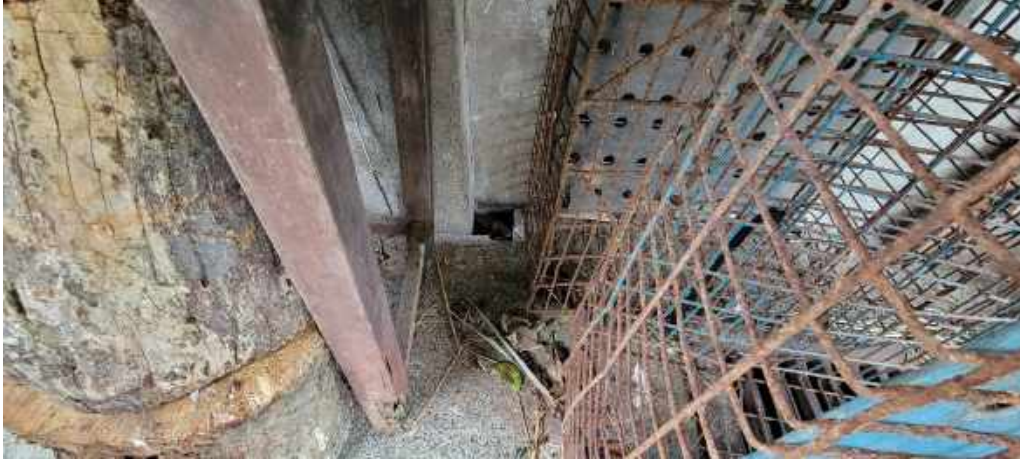
Figure 4.18 (b) Separation of concrete walls from foundation. Lat: 23° 10' 28.626959", Lon: 121° 14' 54.975479"

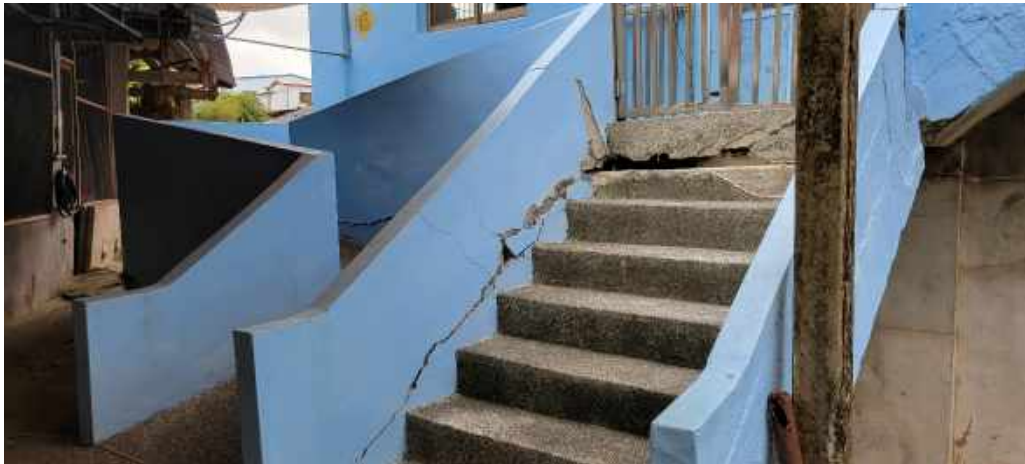
Figure 4.18 (c) Cracking in concrete stairs resulting from relative foundation displacement. Lat: 23° 10' 28.512480", Lon: 121° 14' 54.98628"

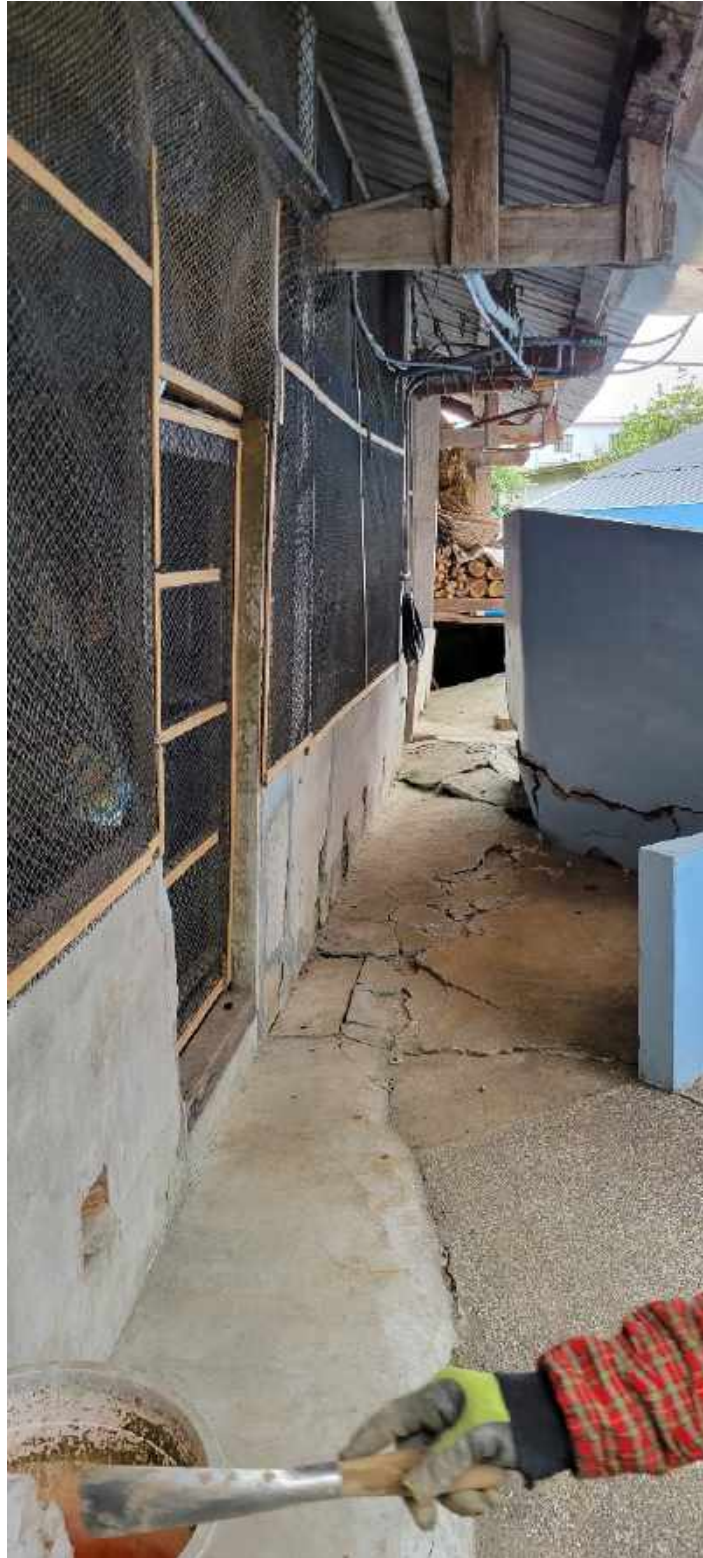
Figure 4.18 (d) Pavement buckling. Lat: 23° 10' 28.520039", Lon: 121° 14' 55.023719"

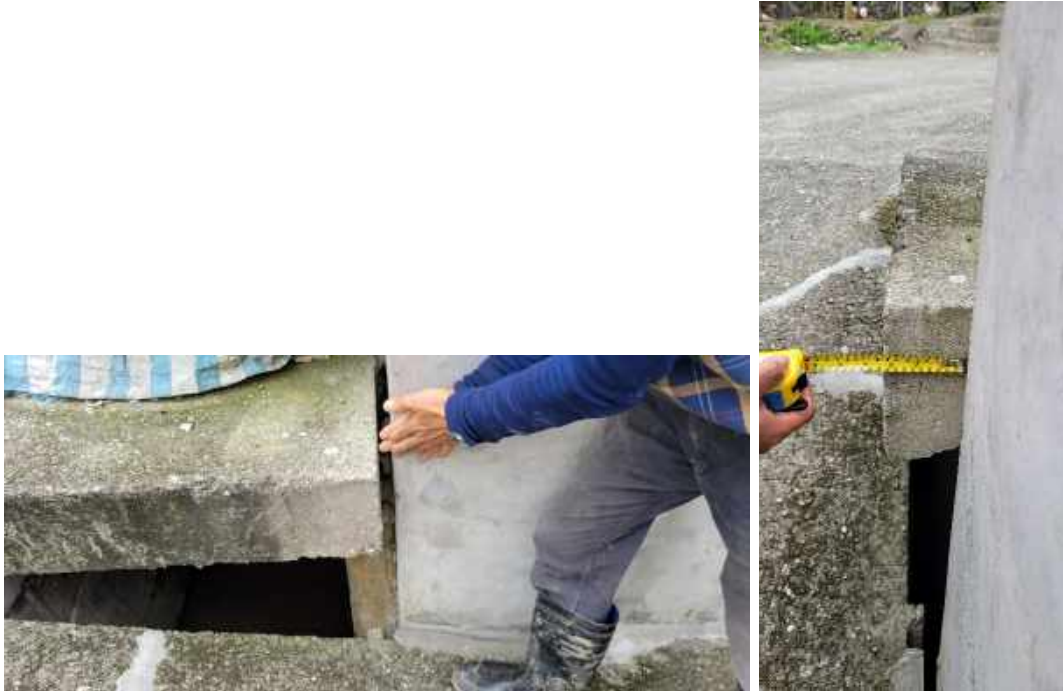
(e) Relative movement of foundation. Lat: 23° 10' 28.924320", Lon: 121° 14' 54.961080"

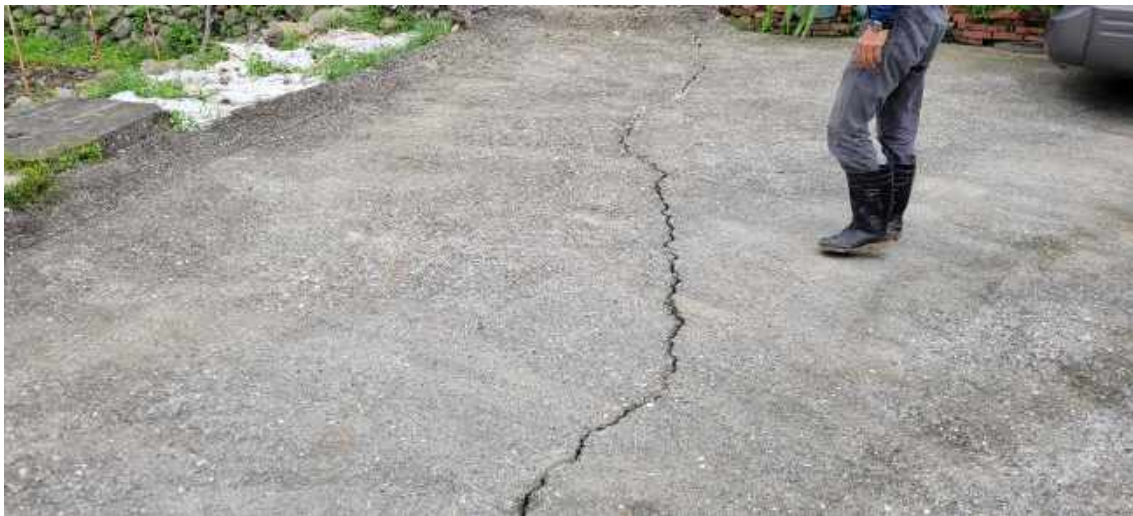
(a) Crack in pavement produced during mainshock. Lat: 23° 10' 28.945920", Lon: 121° 14' 54.936599"

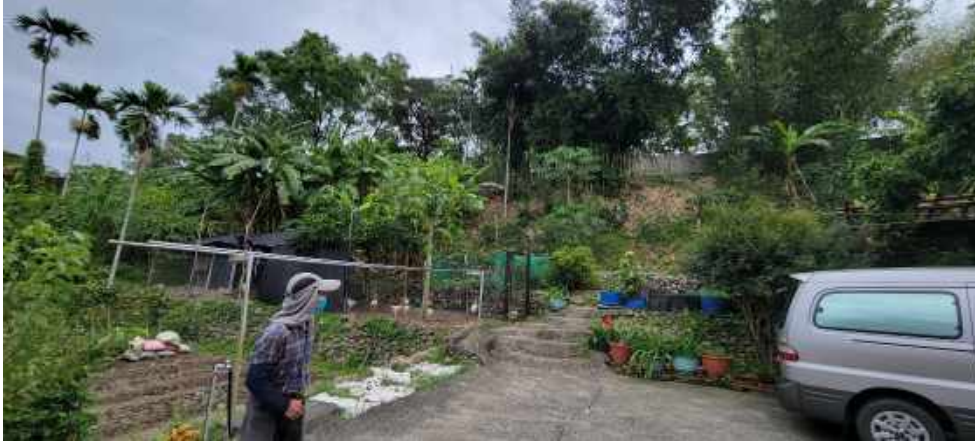
(b) View uphill following presumed trace of fault seen via cracks in pavement. Lat: 23° 10' 28.918199", Lon: 121° 14' 54.926159"

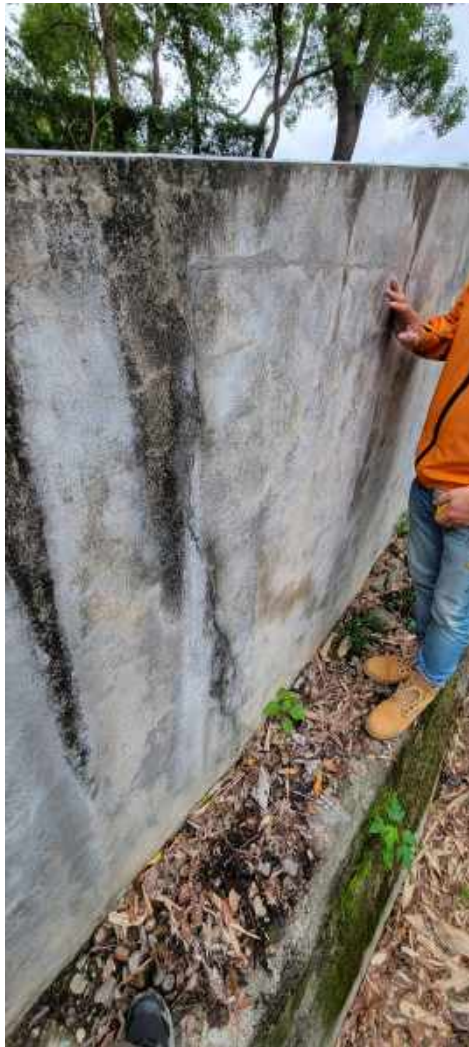
(c) Hairline fracture in concrete wall uphill from (b). Lat: 23° 10' 28.858440", Lon: 121° 14' 56.000759"

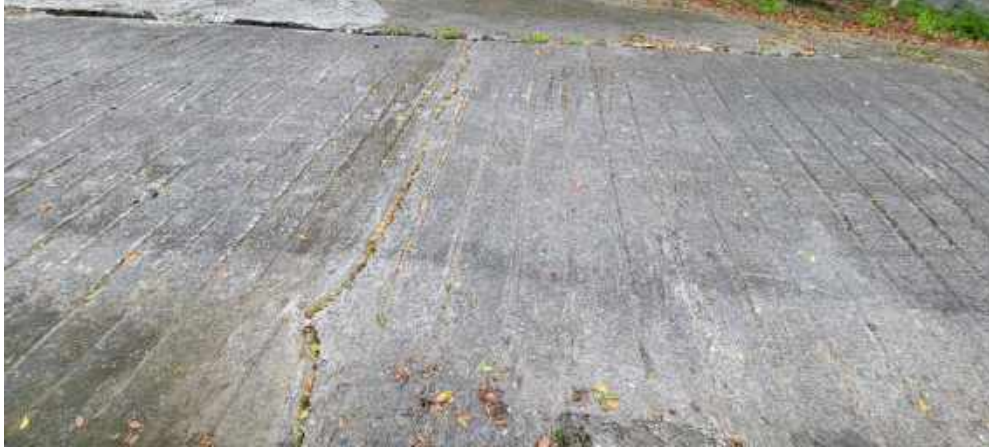
(d) Cracks in walkway between private property and Fuli Junior High School. Whether this crack was directly caused by the September 18 earthquake is uncertain. Lat: 23° 10' 28.848720", Lon: 121° 14' 56.038199"

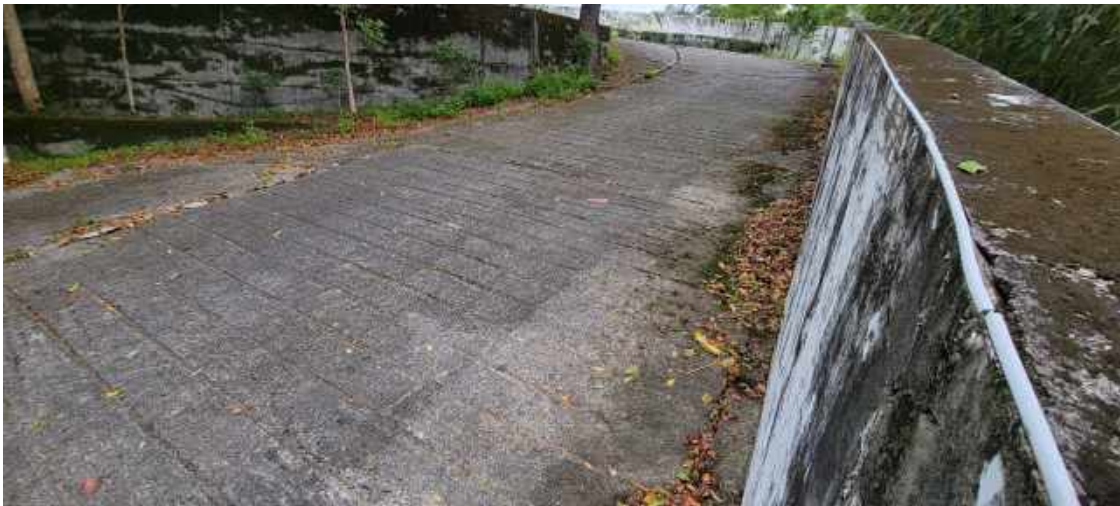
(e) View looking uphill from (d).

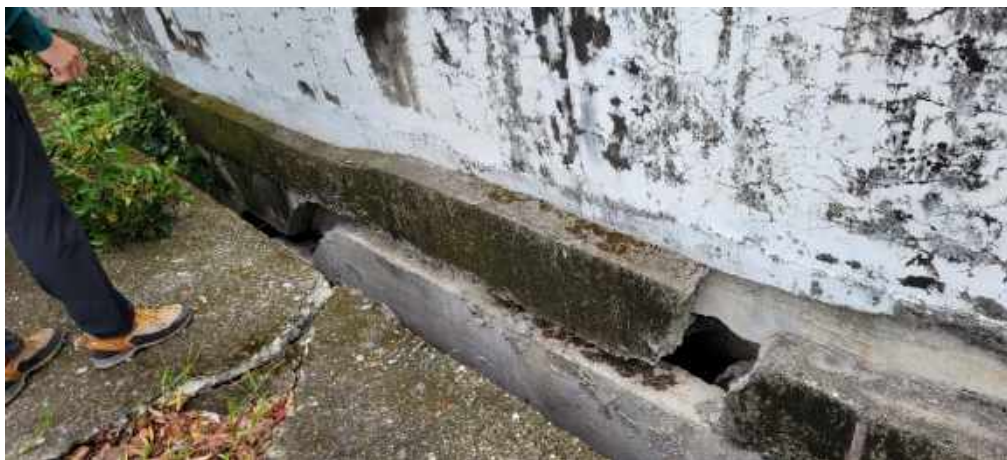
(f) Foundation offset with uncertain cause. Lat: 23° 10' 28.041599", Lon: 121° 14' 56.212440"

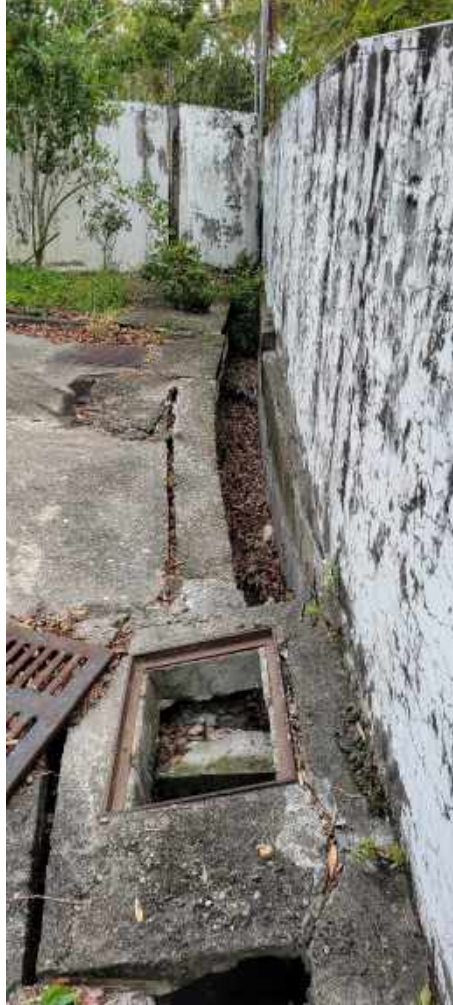
(g) Inward buckling of concrete wall. Uncertain as to whether this was a direct result of the September 18 earthquake. Lat: 23° 10' 28.223039", Lon: 121° 14' 56.014799"

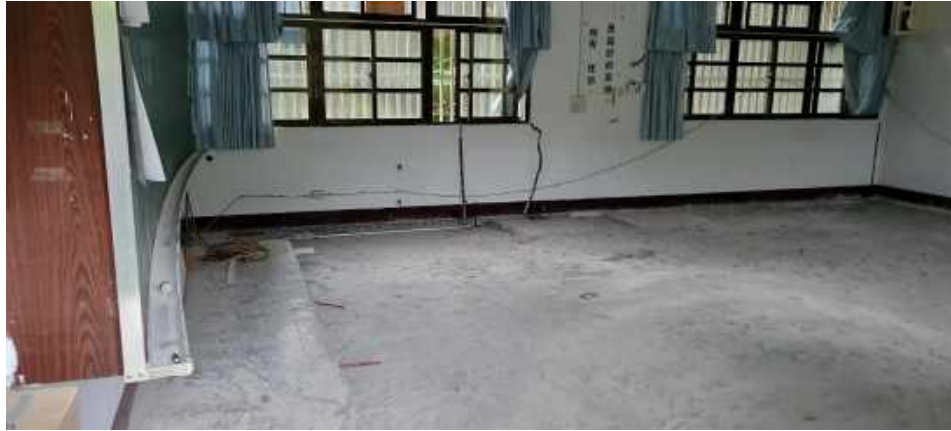
Figure 4.19 Possible continuation of fault rupture uphill from Figure 4.17 towards Fuli Junior High School.

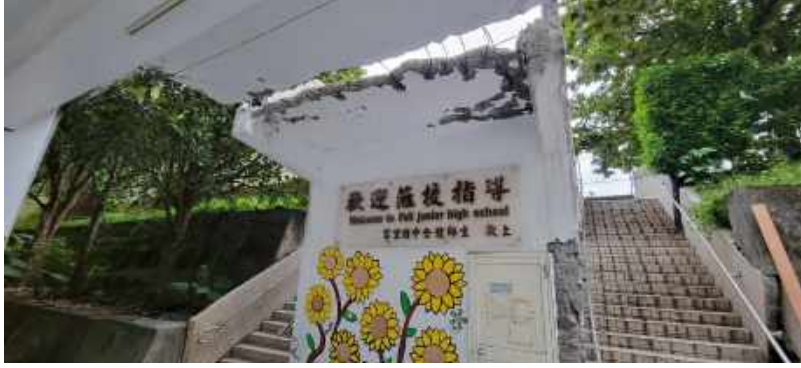
Figure 4.20: Diagonal cracks in walls of Fuli Junior High School classrooms presumed to have been caused by September 18 earthquake. Lat: 23° 10' 30.607680", Lon: 121° 14' 56.832000"

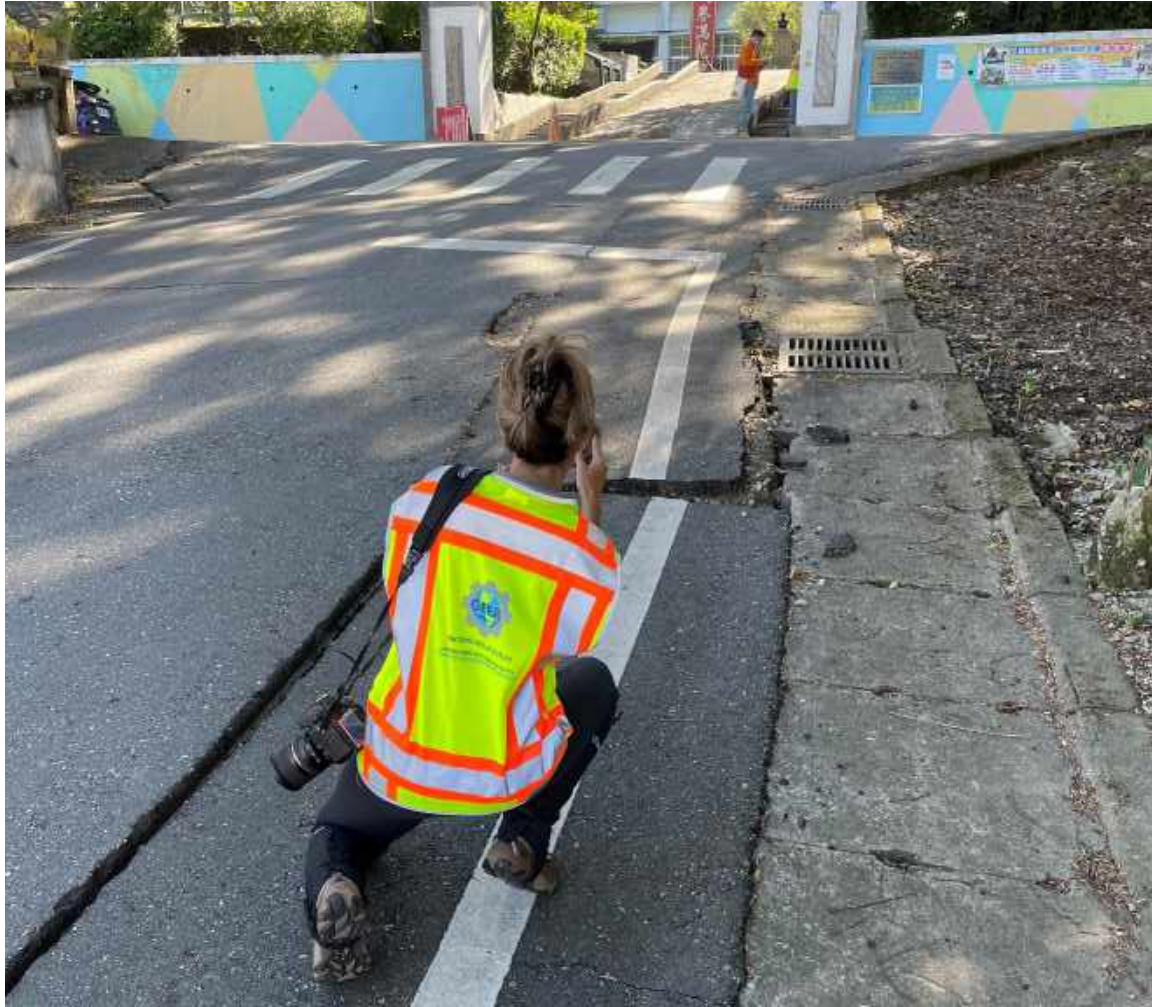
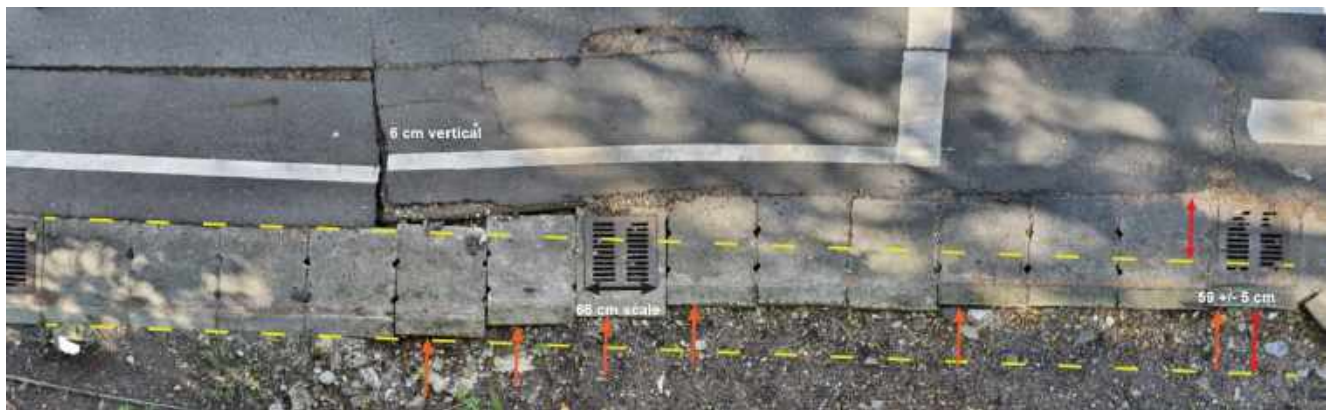
Figure 4.22: offset of sewer lateral in Fuli. The best estimate of total LL displacement is 59 cm, include possible pre-event creep and/or prior surface rupture on the LVF.
