GEOTECHNICAL ENGINEERING RECONNAISSANCE OF THE 2022 CHIHSHANG EARTHQUAKE SEQUENCE

Version 1.0; April 2024

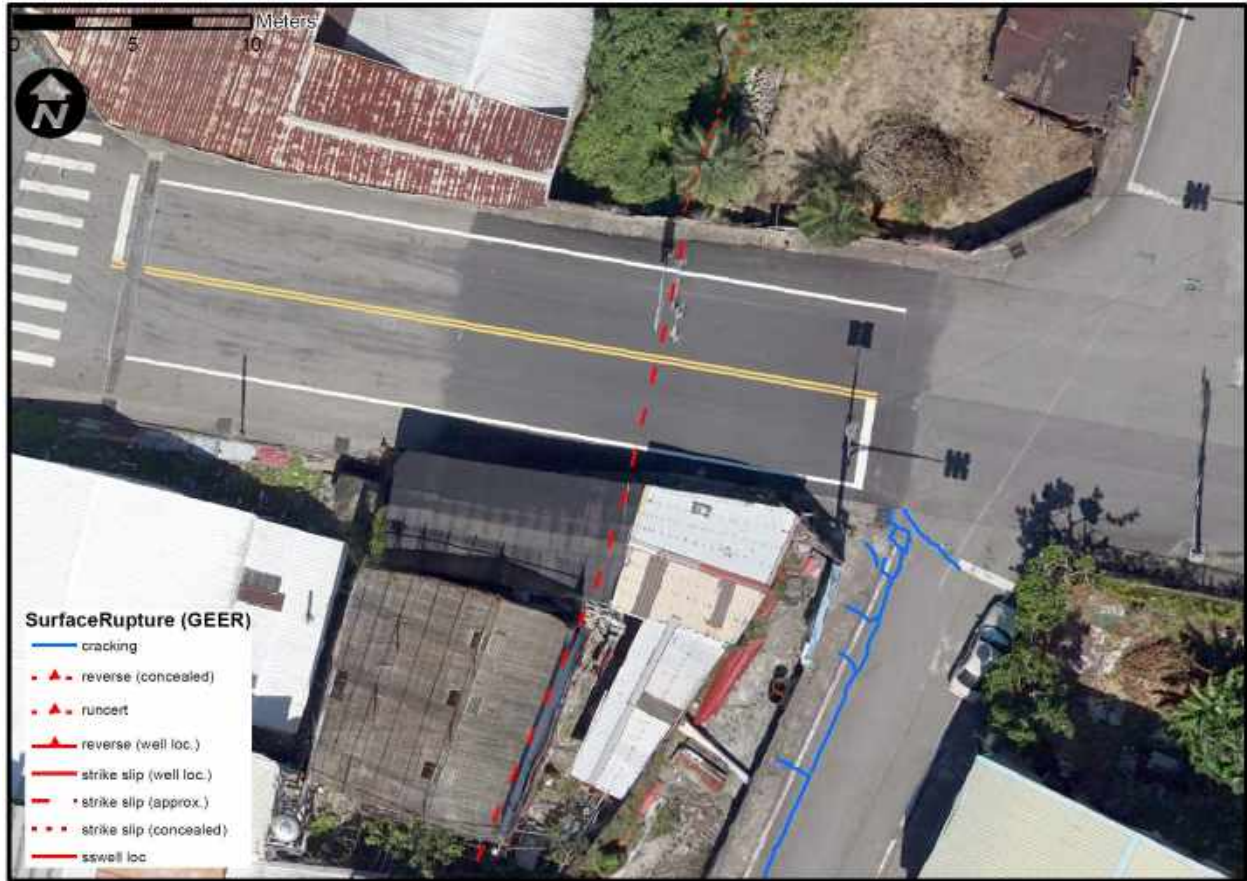
Figure 4.23: Map view of repaired intersection in Fuli. Sewer lateral and adjacent wall are sinistrally offset ~90 cm. Displacement may include pre-event creep and/or prior surface rupture on the LVF.

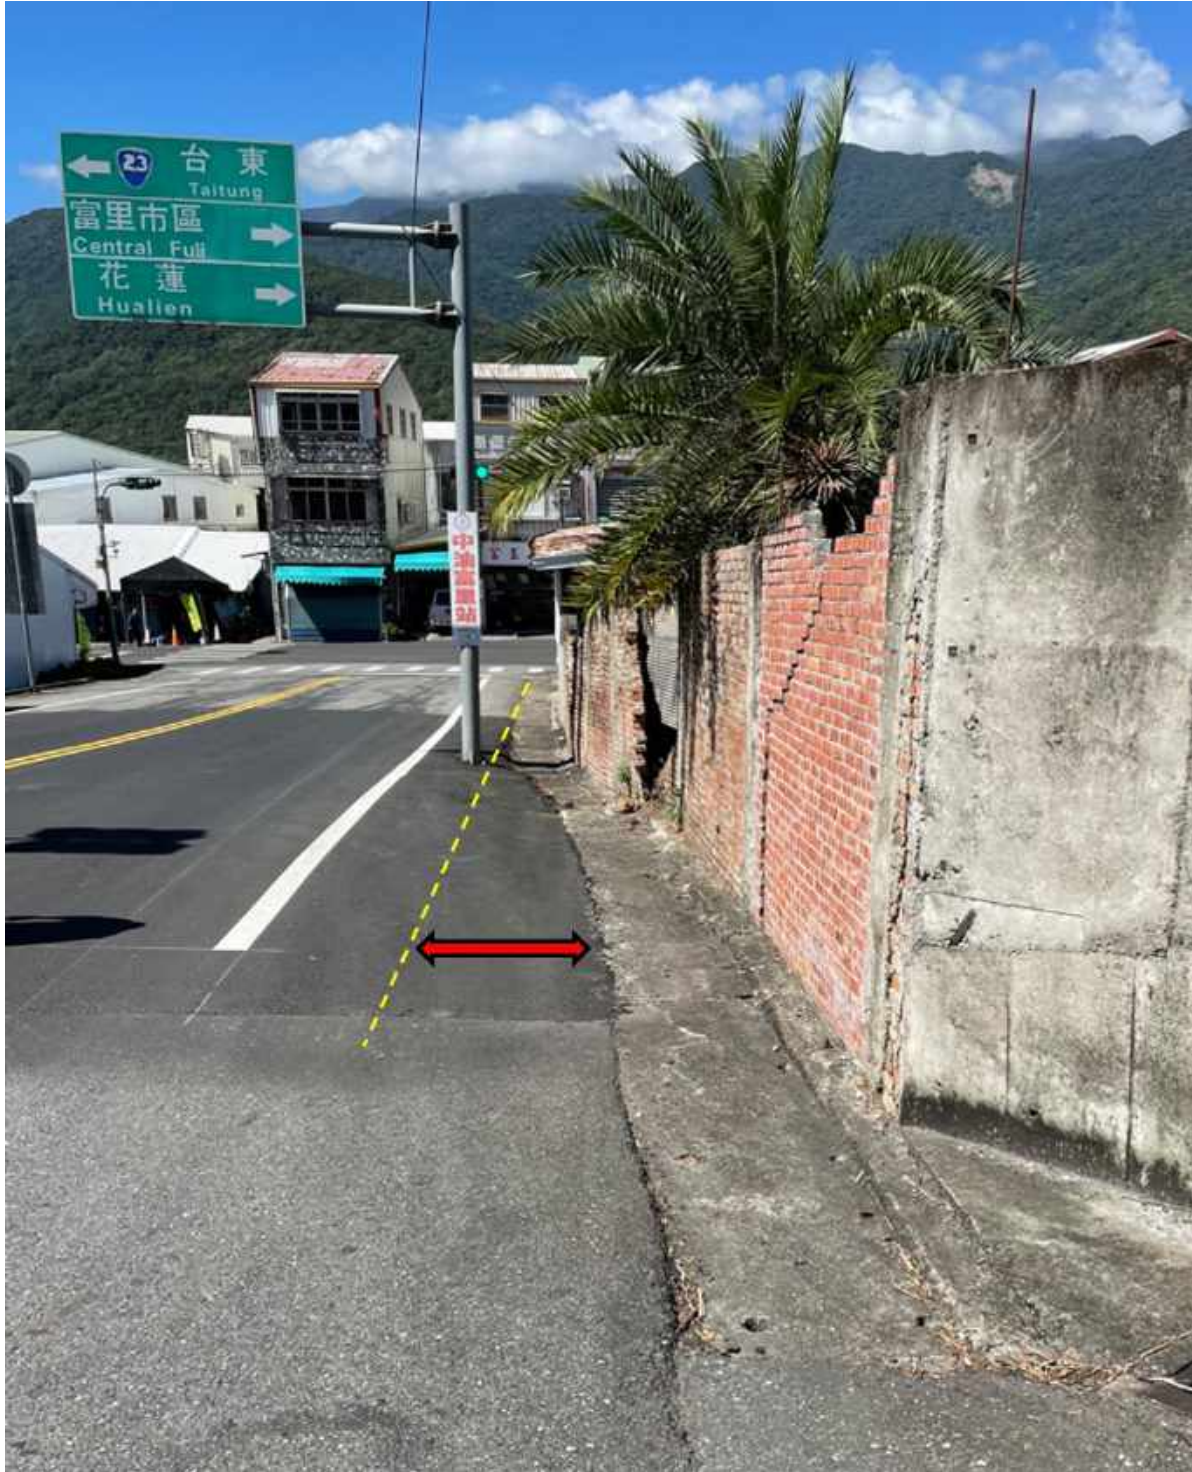
Figure 4.24: West-looking view of offset sewer lateral and brick wall. Total LL offset is ~90 cm, which may include creep and/or surface rupture on the LVF that occurred prior to the September earthquake.

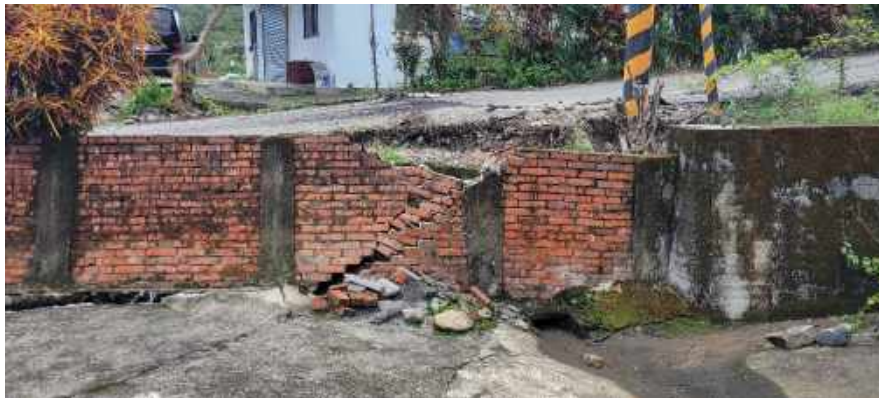
Figure 4.25: Views looking (a) uphill and (b) downhill along Dongning Street adjacent to properties exhibiting recent damage. Lat: 23° 14' 39.447239", Lon: 121° 17' 37.383720"

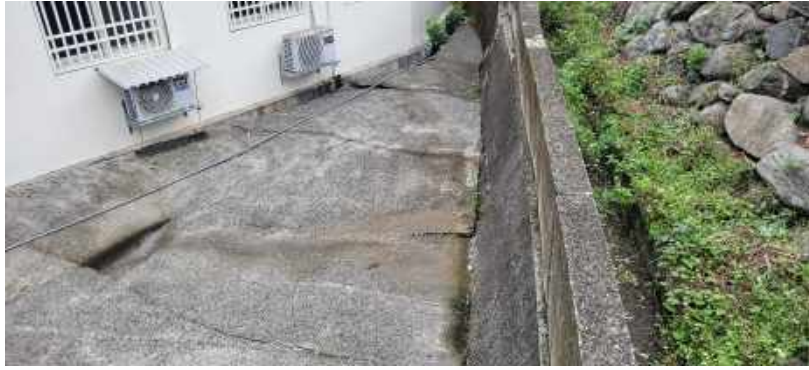
Figure 4.26: Damage associated with property on north side of Dongning Street. Lat: 23° 14' 39.136920", Lon: 121° 17' 38.056919"

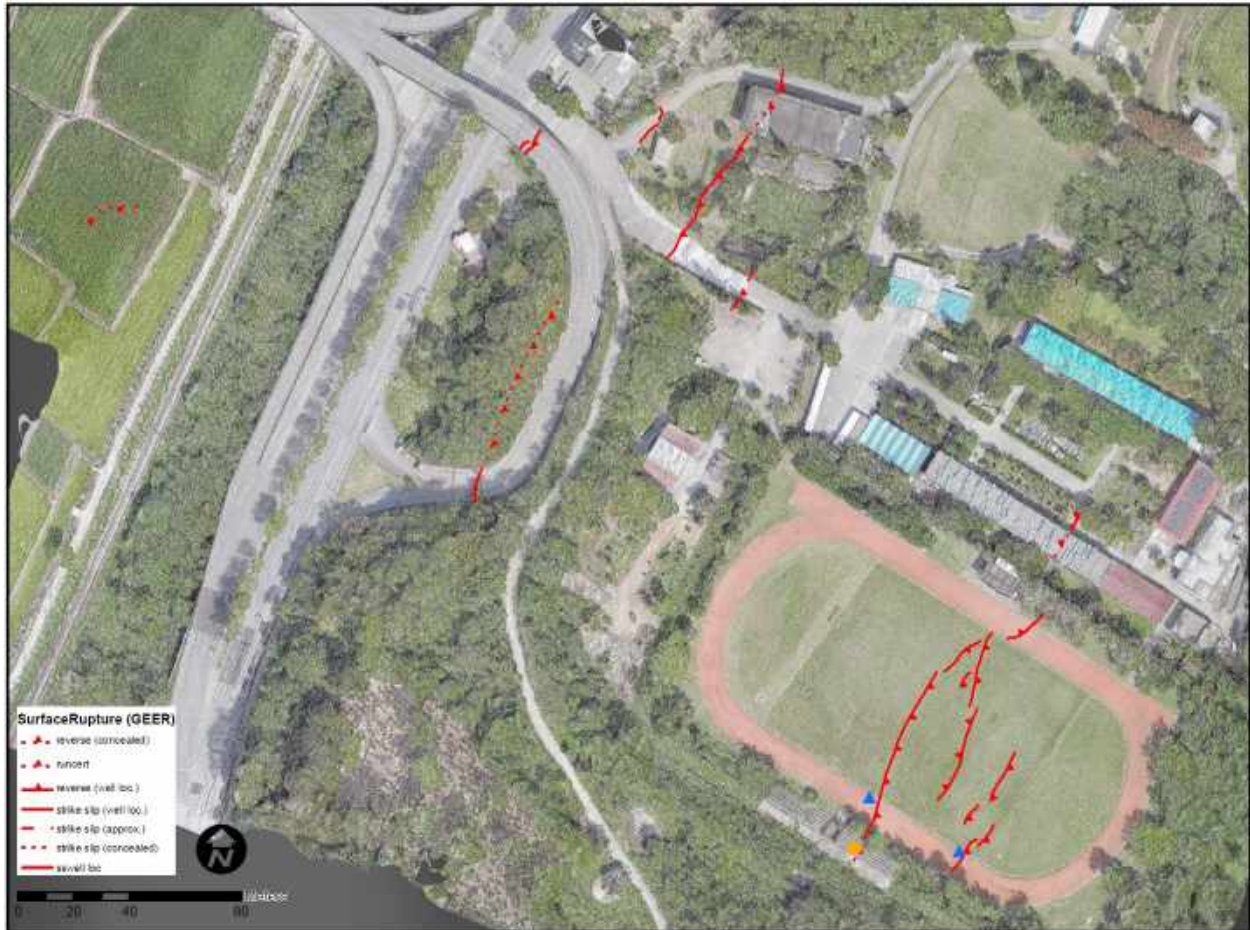
Figure 4.28: Surface Rupture Map at Dongli School

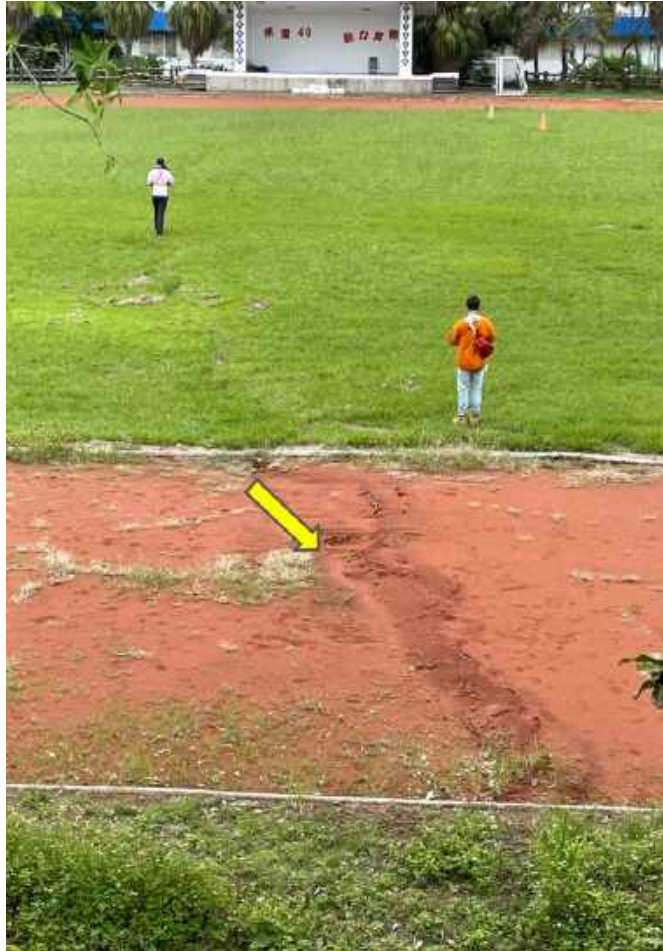
Figure 4.29: Reverse faults in the school athletic fault. Scarp height reaches a maximum of 13 across this strand, similar to others shown on the map above. Lat: $23^{\circ} 15' 44.124479''$, Lon: $121^{\circ} 18' 7.791120''$.

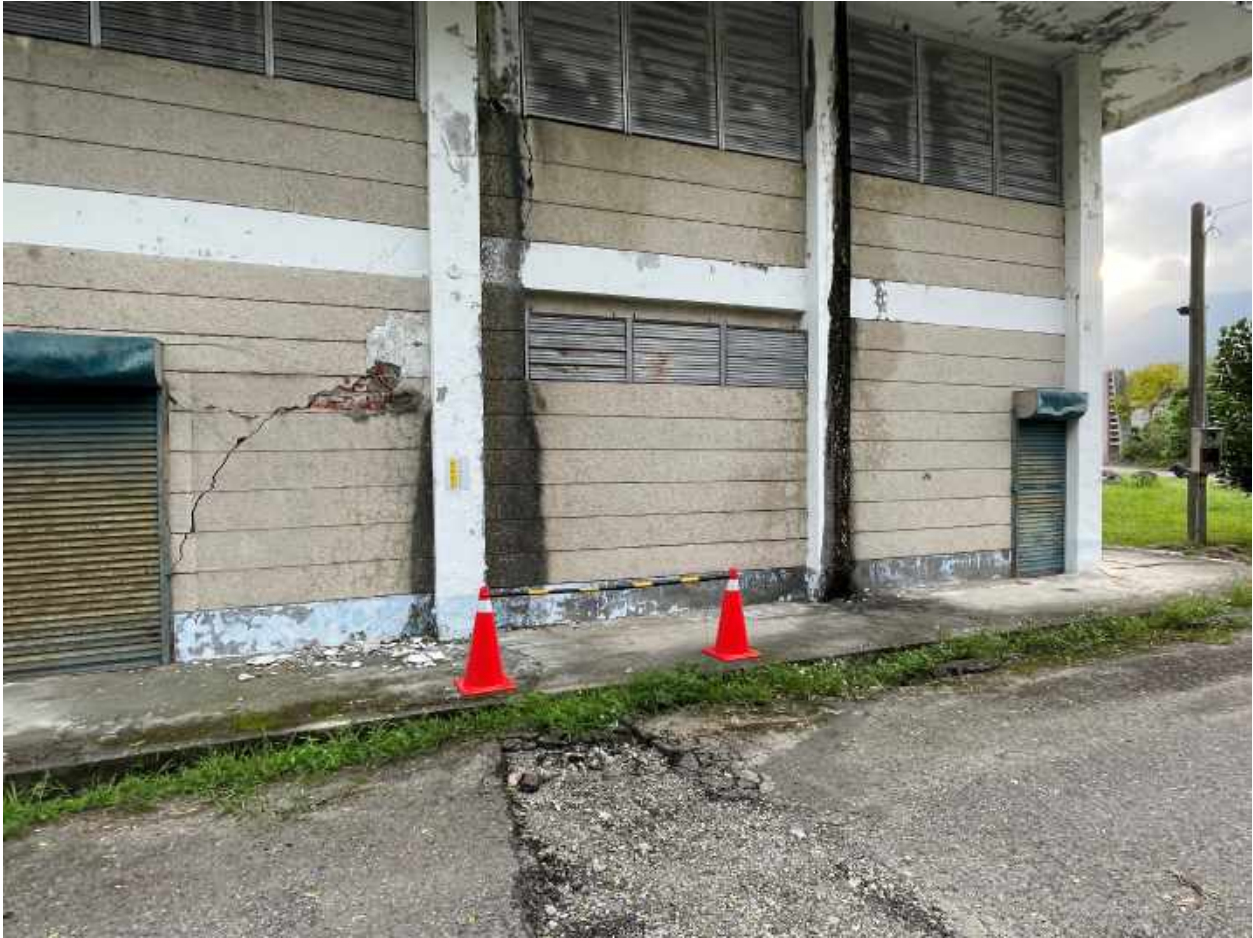
Figure 4.33: Damage to structure on the opposite side of the street from the retaining wall in the figure above. Cracking extends from the foundation to the roof, Lat: 23° 15' 46.403640", Lon: 121° 18' 9.362160"

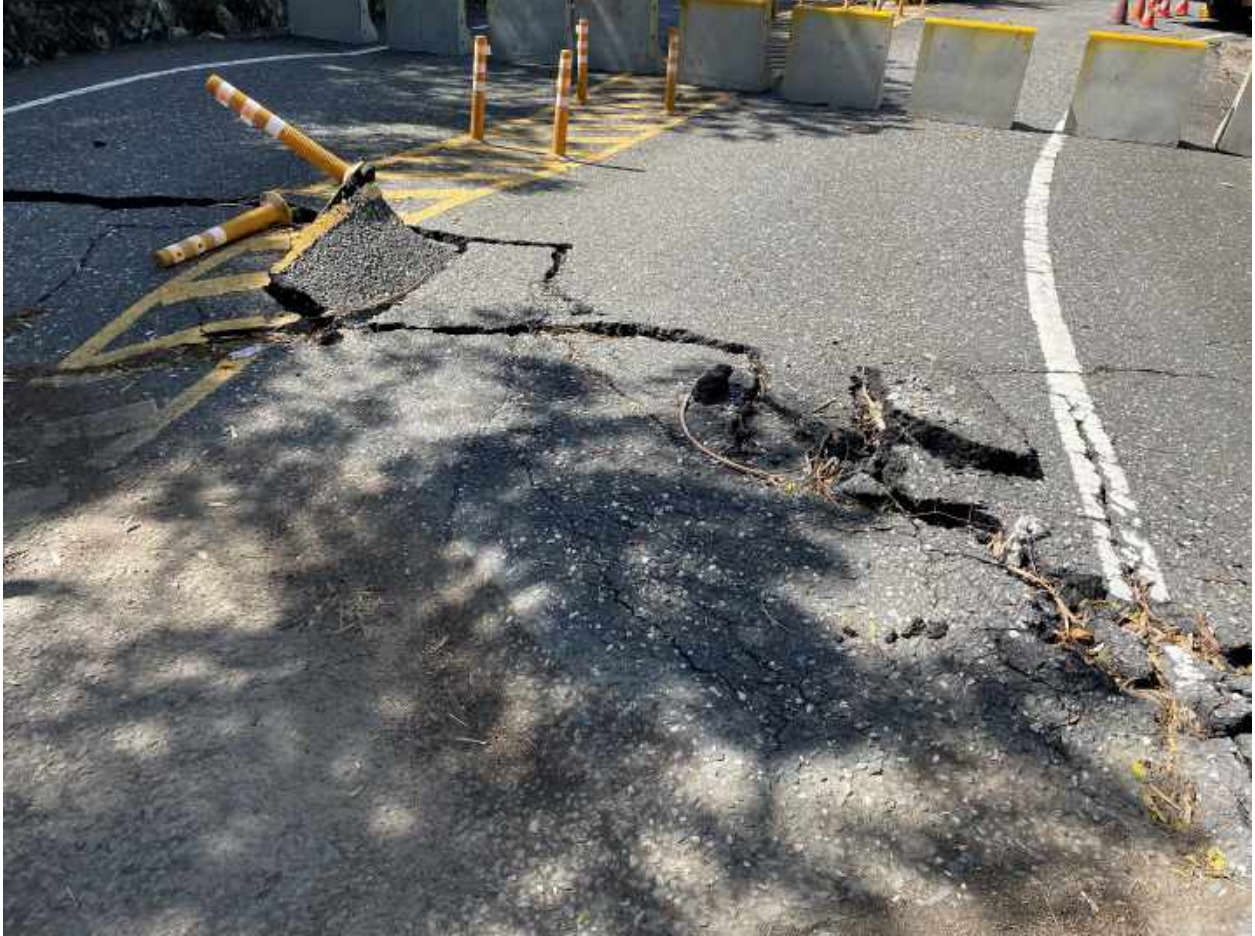
Figure 4.34: Surface rupture through the bridge approach near projected location of the LVF. Asphalt pavement buckled and locally detached. View looking southwest, Lat: 23° 15' 46.403640", Lon: 121° 18' 9.362160"

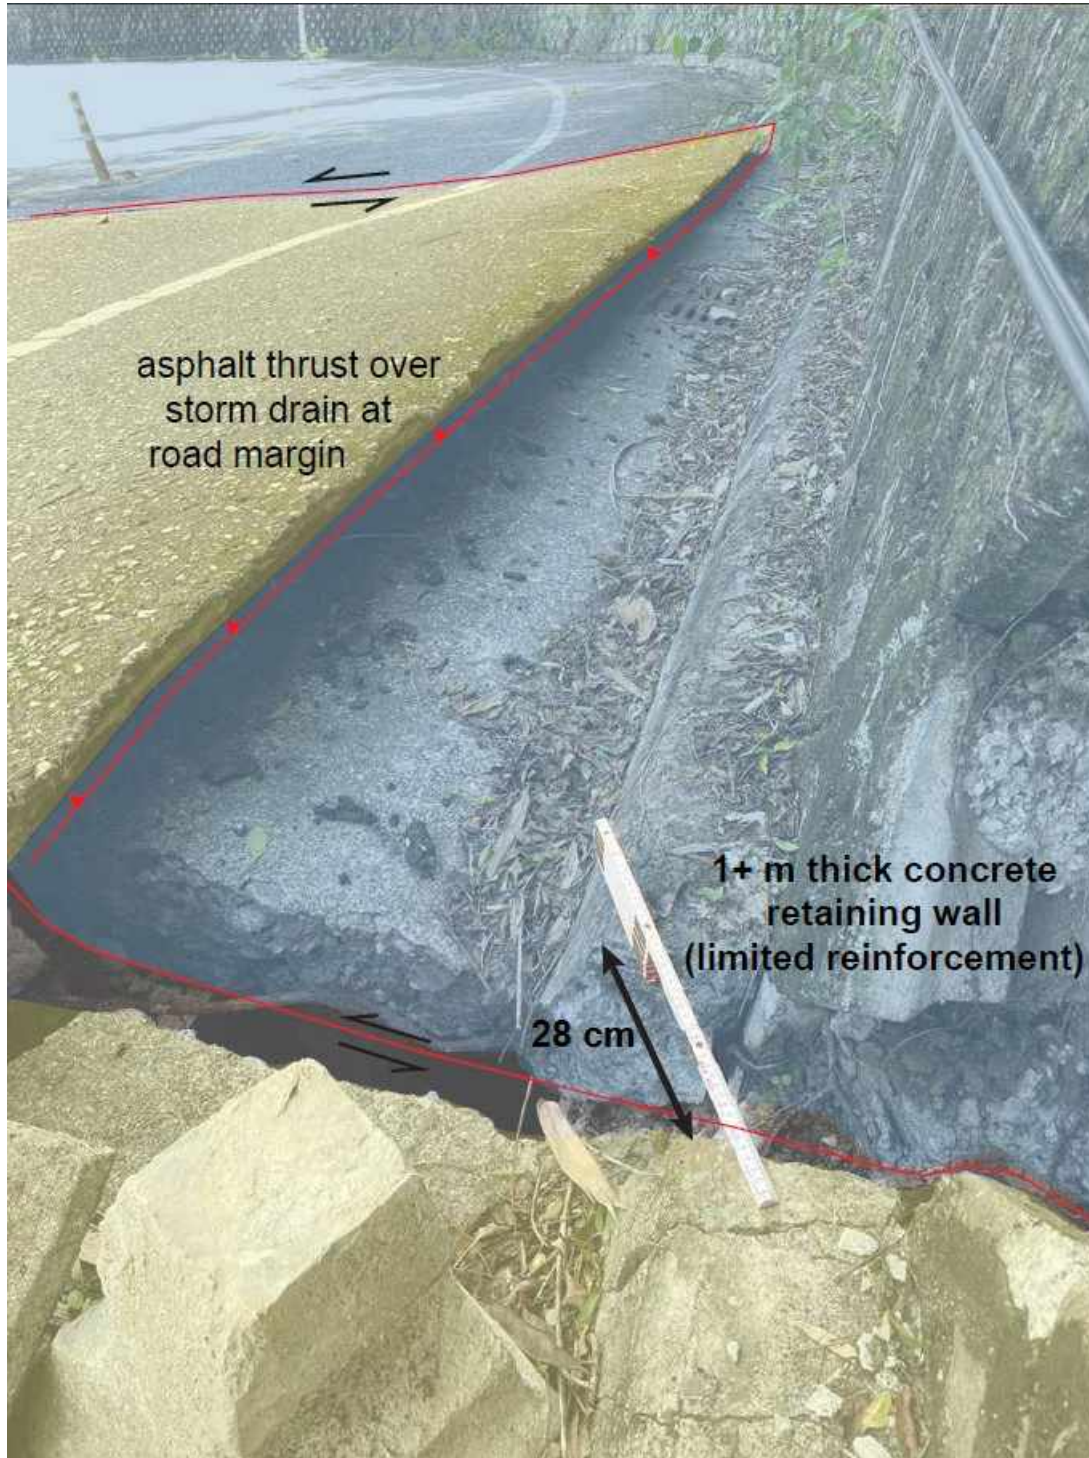
Figure 4.35: Annotated photo showing view of buckled pavement on bridge approach. Net horizontal displacement of the 1-m-thick concrete retaining wall (sparse reinforcement) was ~28 cm, Lat: 23° 15' 46.403640", Lon: 121° 18' 9.362160"

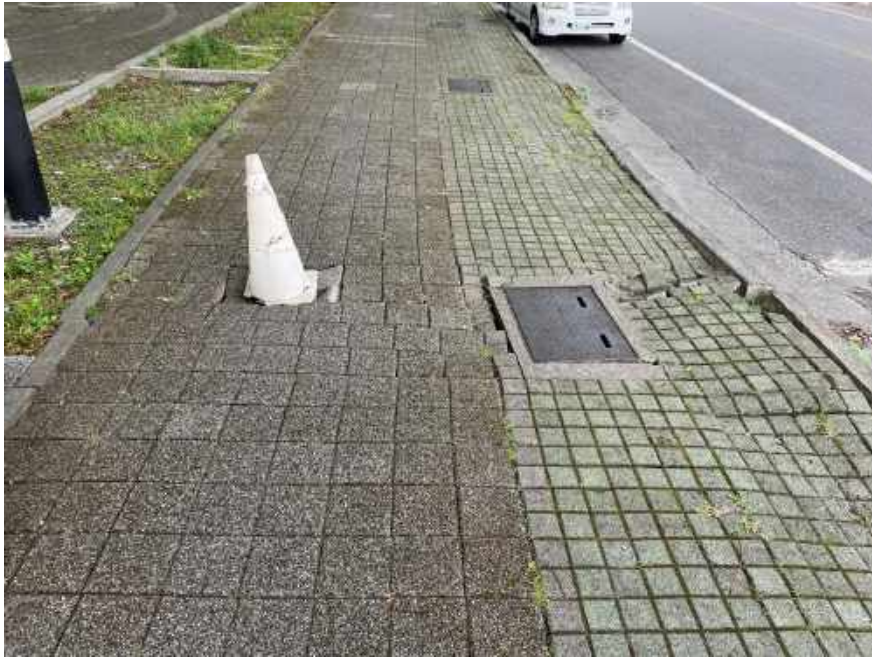
Figure 4.36: Minor (<10 cm) offset of storm drain across the Yuli fault. Location Roughly coincident with 1951 Rupture (Shyu et al., 2007). Lat: 23° 20' 10.720679", Lon: 121° 19' 1.702919"

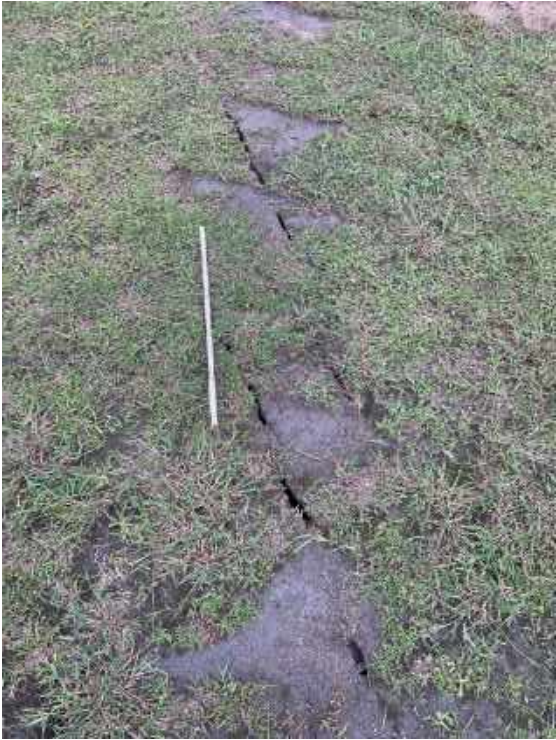
Figure 4.40: En-echelon tension cracks with apparent ejected sands at the Yuli High School athletic field. Lat: 23° 20' 31.165800", Lon: 121° 19' 11.031959"

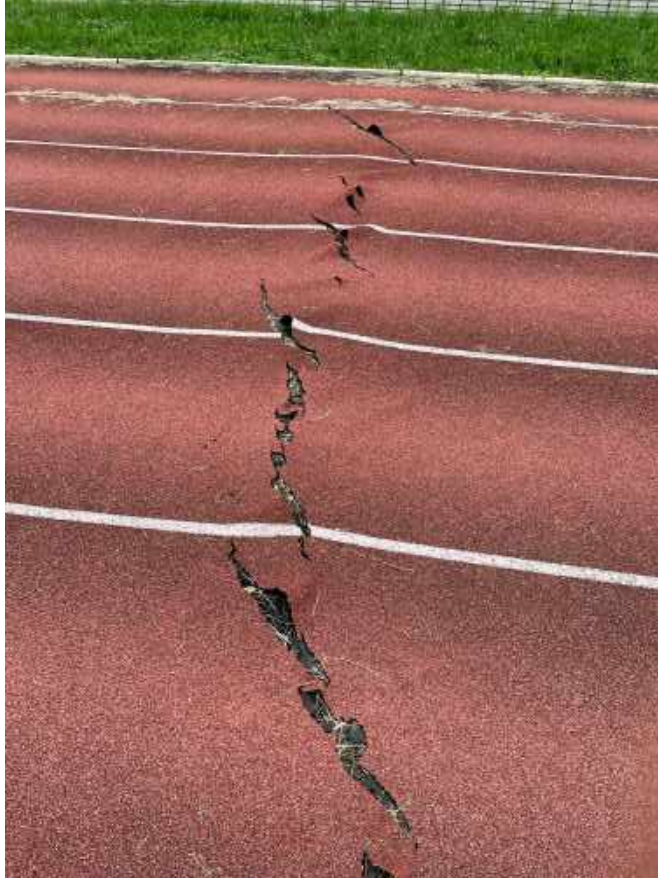
Figure 4.41: En-echelon tension cracks rupturing the track at the Yuli High School athletic field.
Lat: 23° 20' 31.715519", Lon: 121° 19' 11.219520"

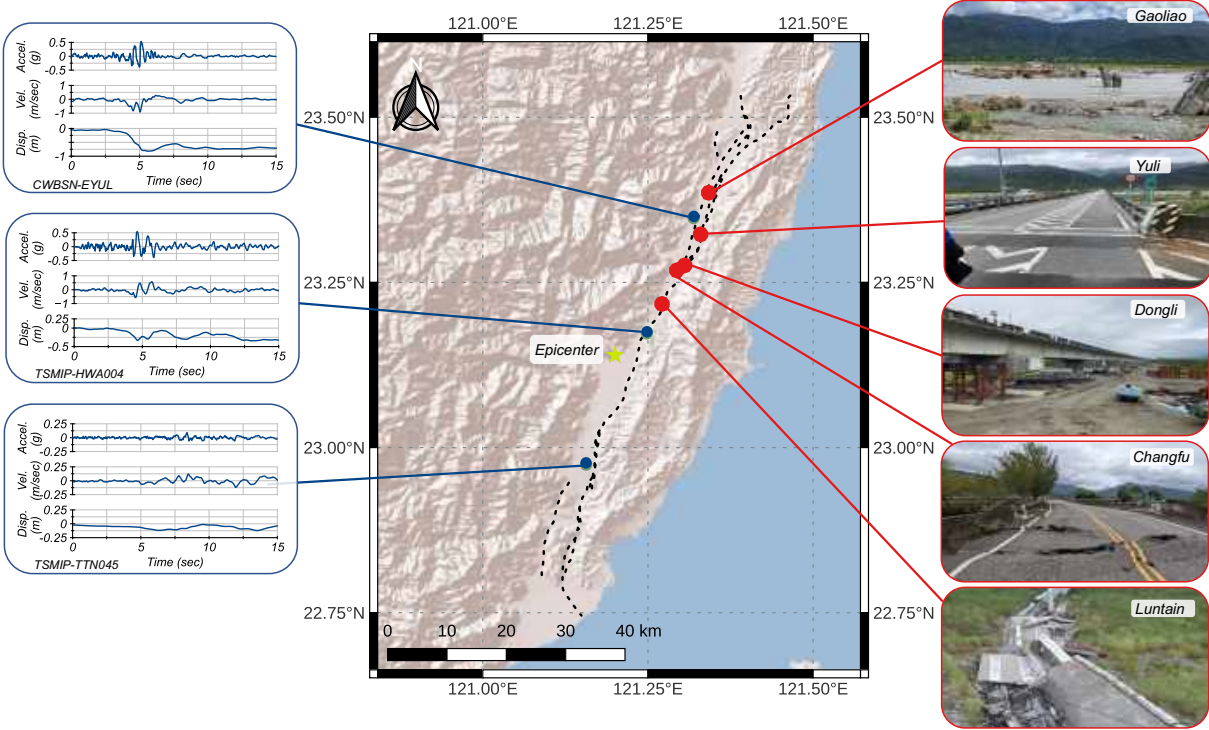
Figure 5.1. Locations of the five most heavily damaged bridges, the traces of the Longitudinal Valley Fault, the epicenter of the M6.9 earthquake, and select acceleration, velocity, and displacement time series from that event.

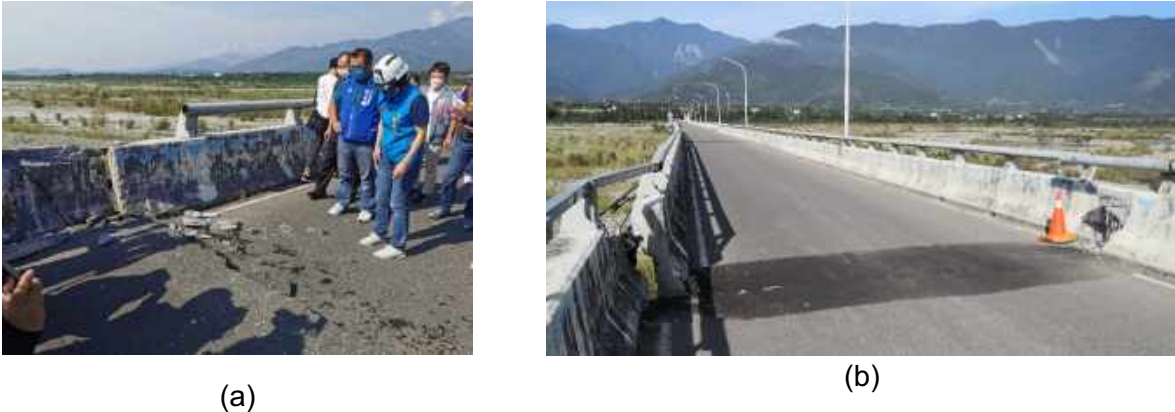
Figure 5.2. a) Damage between adjacent bridge spans buckling roadway, concrete barrier, and metal guardrail (United Daily News), looking south; b) repaired roadway and metal guardrail damage during GEER/NCREE visit looking northwest. (22.9748° 121.1702°)

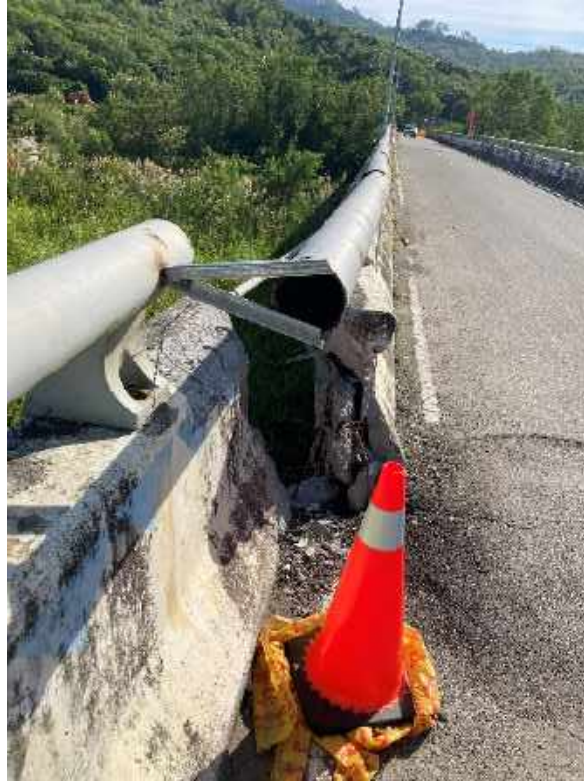
Figure 5.3. Lateral offset, looking towards the east abutment. (22.97484° 121.17017°)

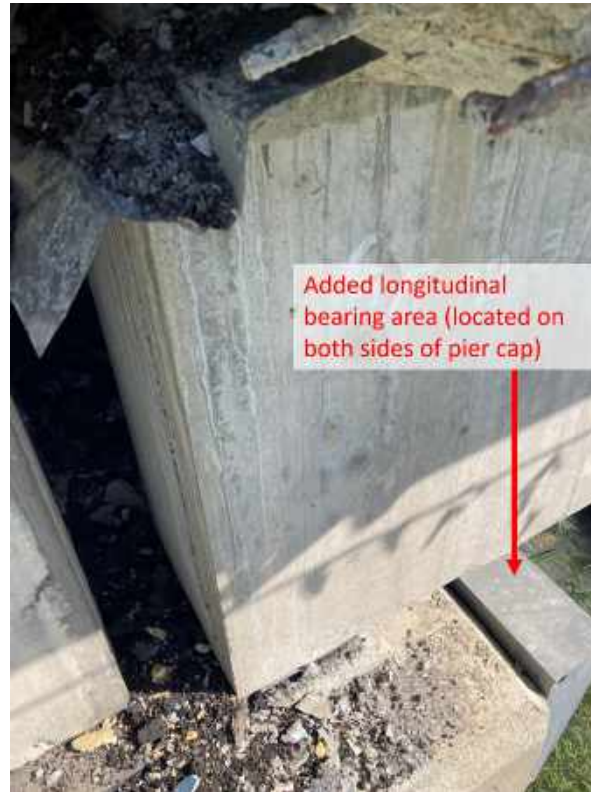
Figure 5.5. View of typical retrofit by adding additional bearing area to prevent longitudinal unseating (22.97479° 121.17059°)

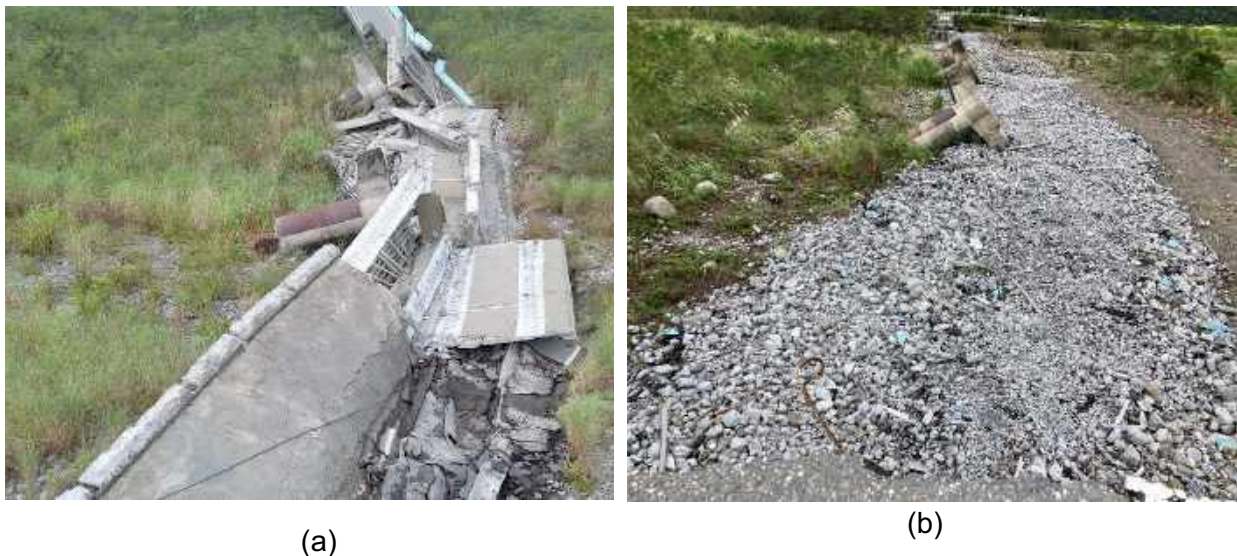
Figure 5.6. a) Failed spans and pier foundation supports at the Luntian Bridge (image curious of NCREE); b) view for concrete bridge piers after deck removal during GEER team visit in October 2022 (23.21726° 121.27172°)

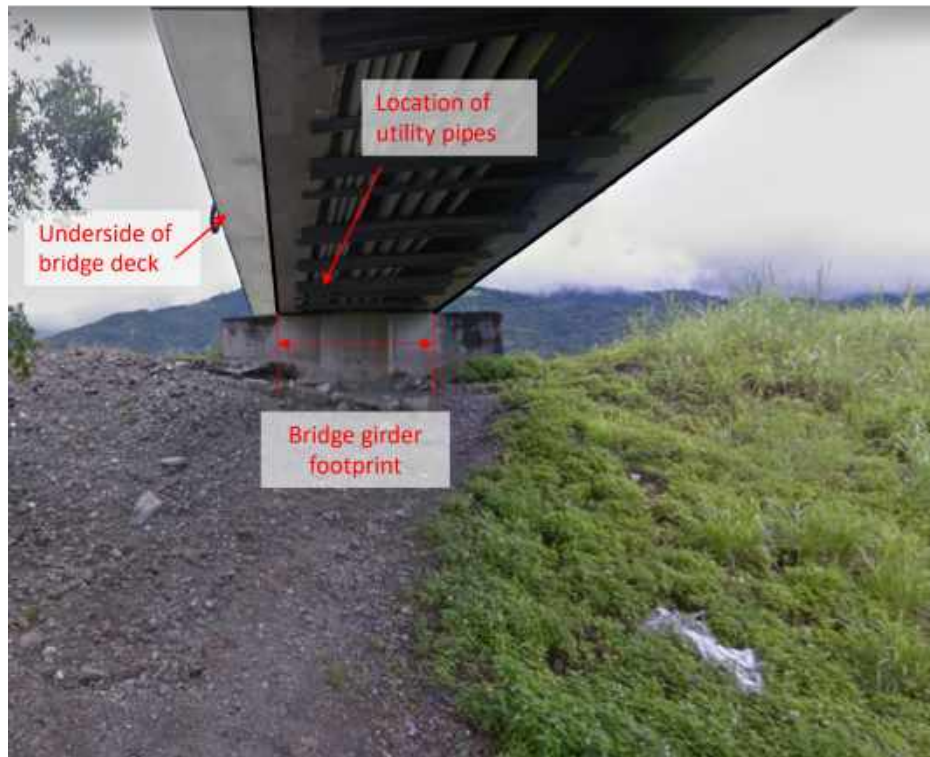
Figure 5.8. Looking west at the 2nd pier from the east abutment prior to the earthquake. Note the location of the utility pipes on the pier cap. Photo from Google Street View from 2012 (near 23.21457° 121.27268°)

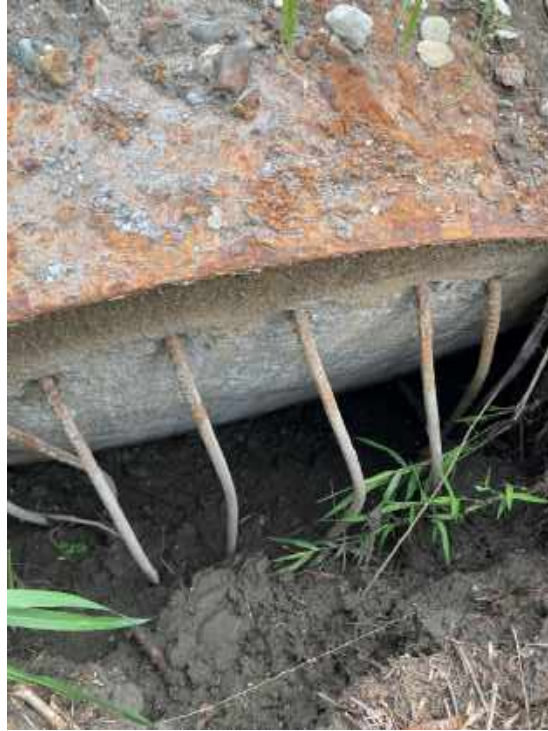
Figure 5.11. View from the bottom of one of the failed pier foundations. The longitudinal rebar yielded and relatively smooth base suggesting a cold joint (23.21753° 121.27116°)

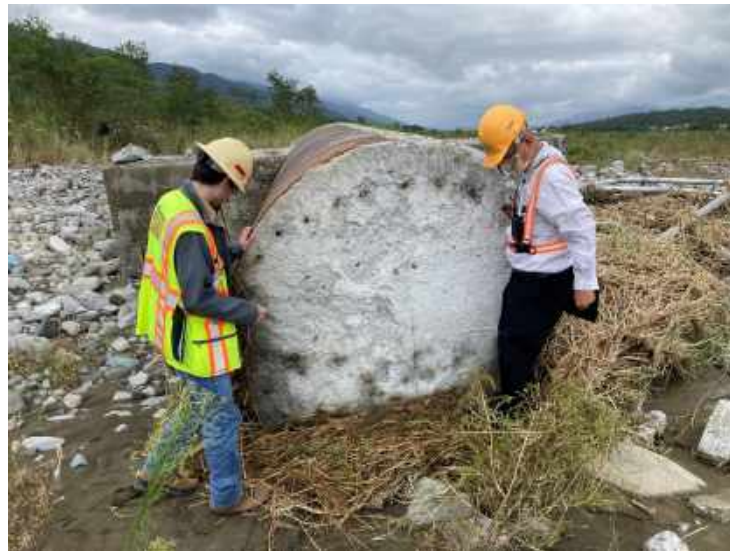
Figure 5.12. Typical view of one of the failed piers with irregular longitudinal rebar spacing. (23.21775° 121.27062°)

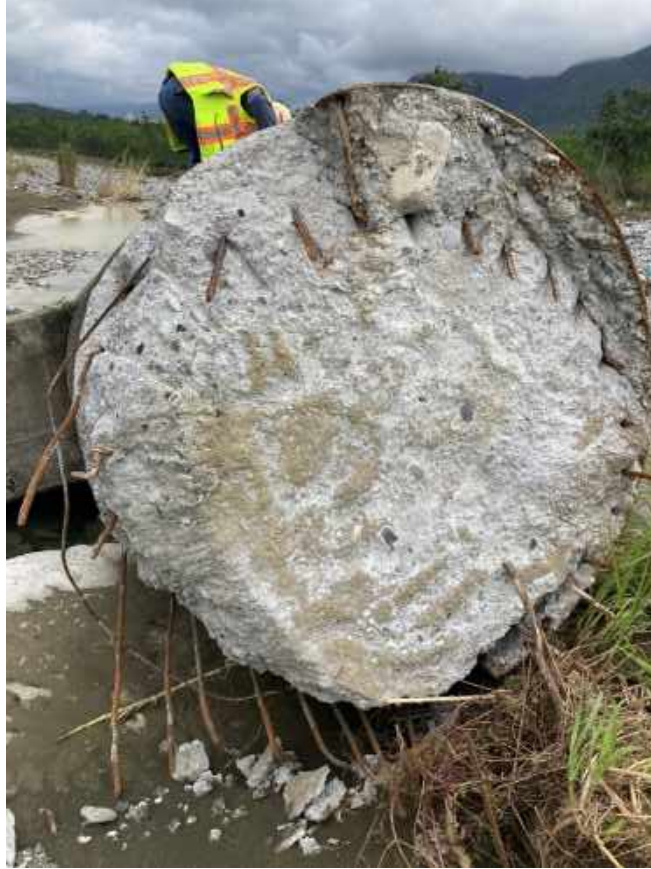
Figure 5.13. View of a failed pier with irregular longitudinal rebar spacing. Same pier as and concrete pad as Figure 5.14. (23.217653° 21.270928°)

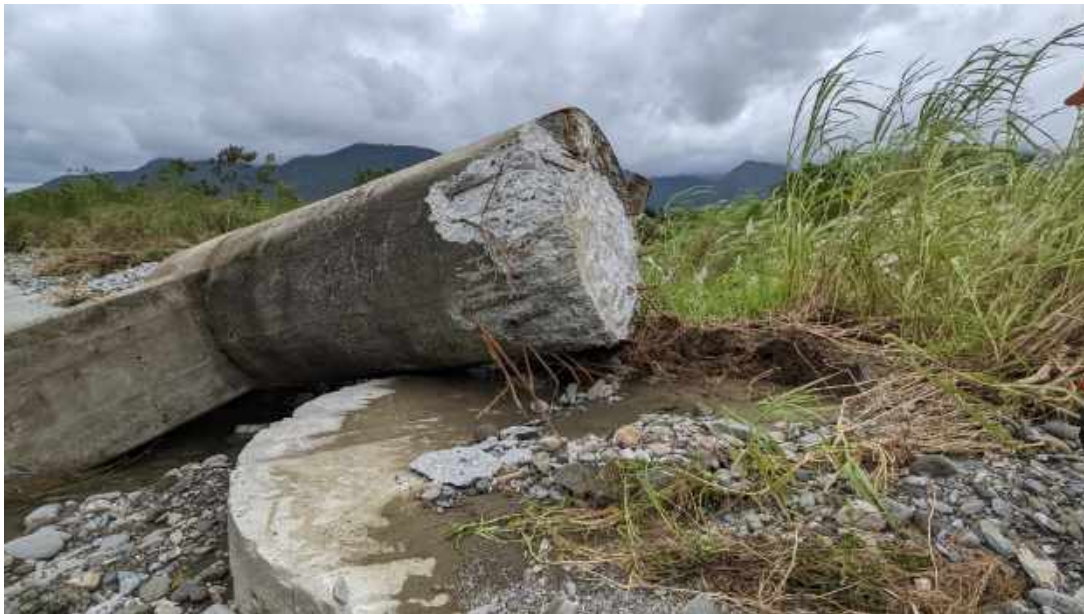
Figure 5.14. View of failed bridge pier and concrete pad. Note the yield longitudinal rebar connecting the pier to the concrete pad. (23.21771° 121.25425°)

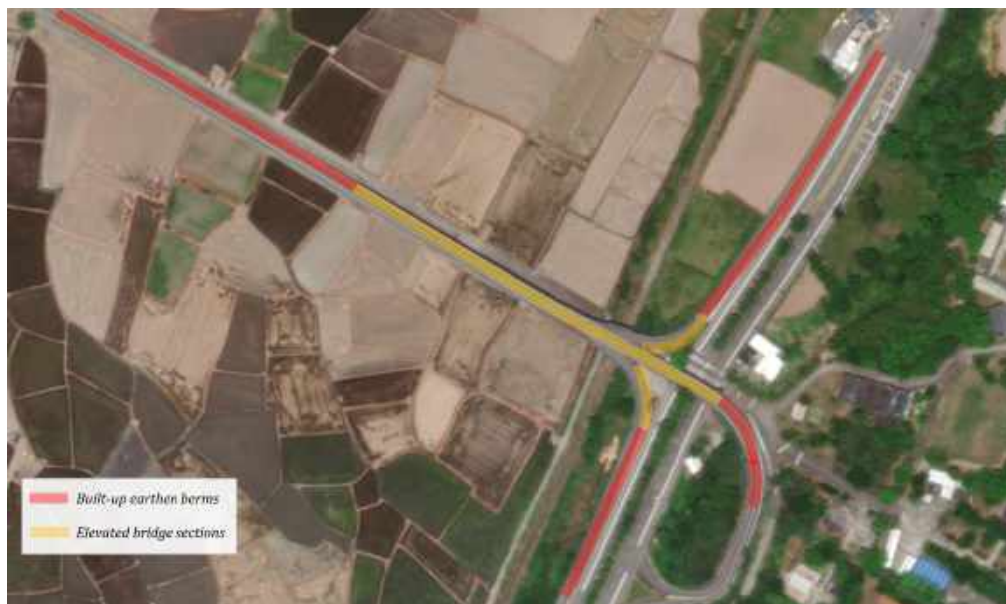
Figure 5.15. Google satellite view of the Changfu Bridge with the built-up earthen berms (red) and main-spans and approaches (yellow).

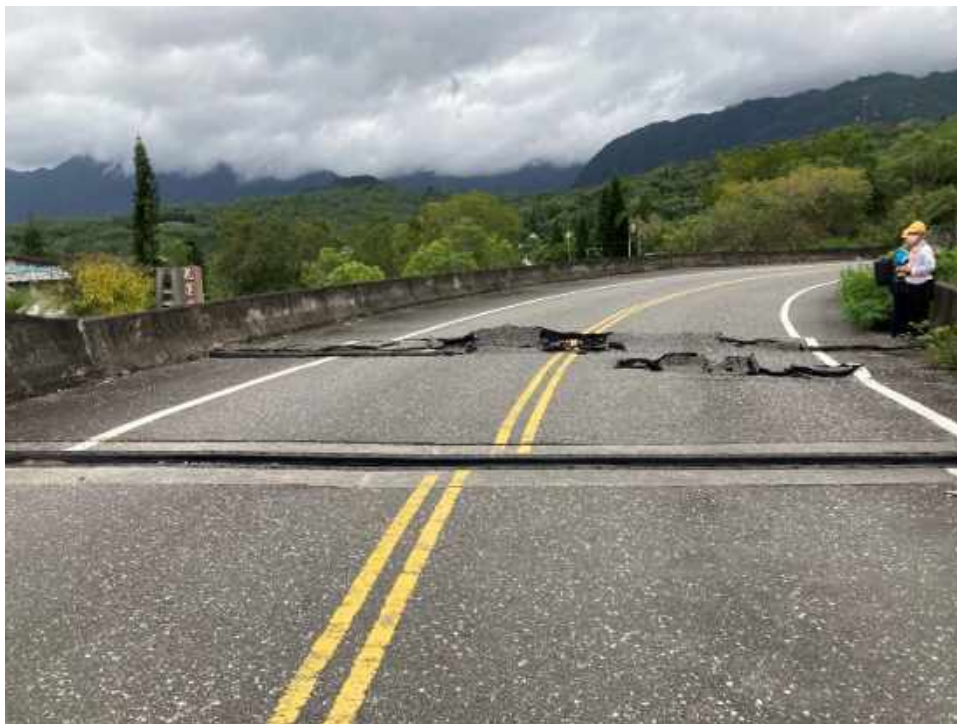
Figure 5.17. 41 cm lateral offset between bridge span and abutment. (Asphalt buckling due to surface fault rupture) (23.26452° 121.30089°)

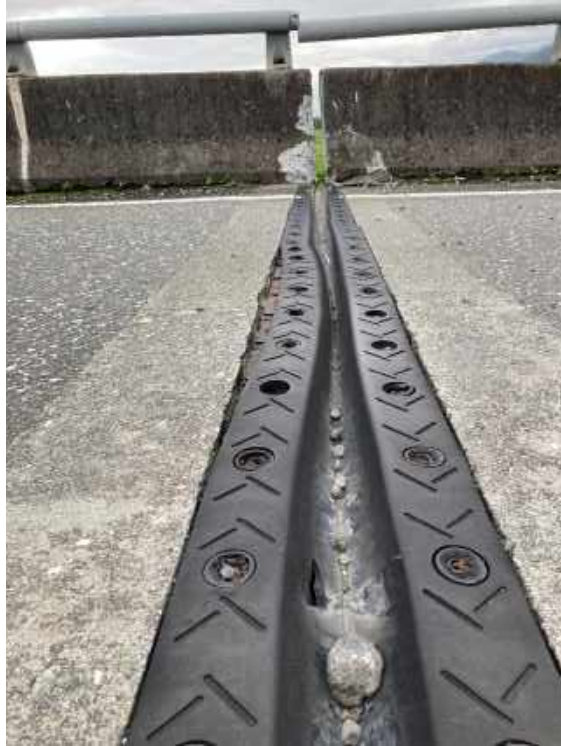
Figure 5.18. Damage to expansion joint, concrete and metal barriers (23.26557° 121.29901°)

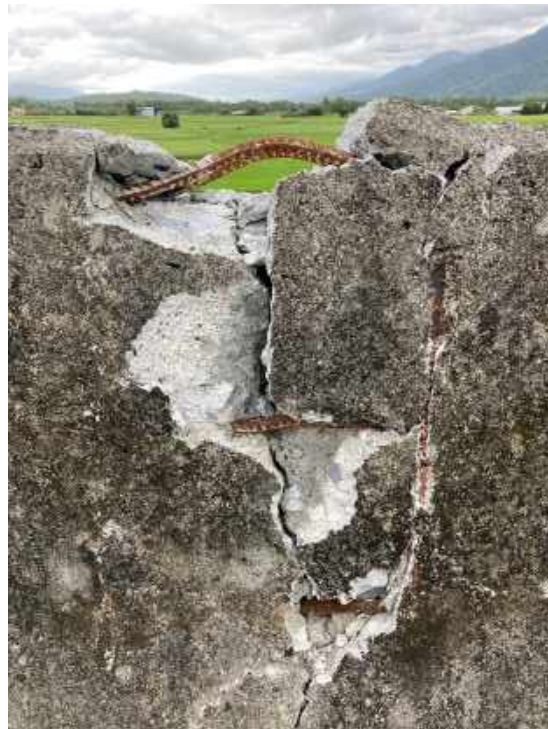
Figure 5.19. Compression buckling of concrete barrier steel reinforcement (23.26584° 121.29836°)

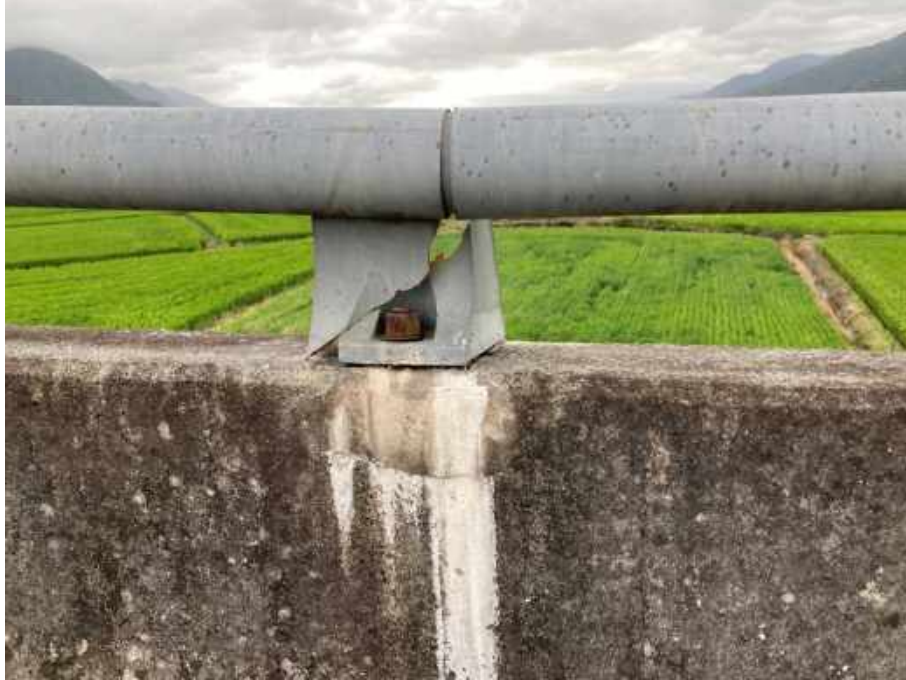
Figure 5.20. Shear failure in metal guardrail bracket caused by compressional loads. (The expansion joint preventing tensile loading) (23.26568° 121.29870°)

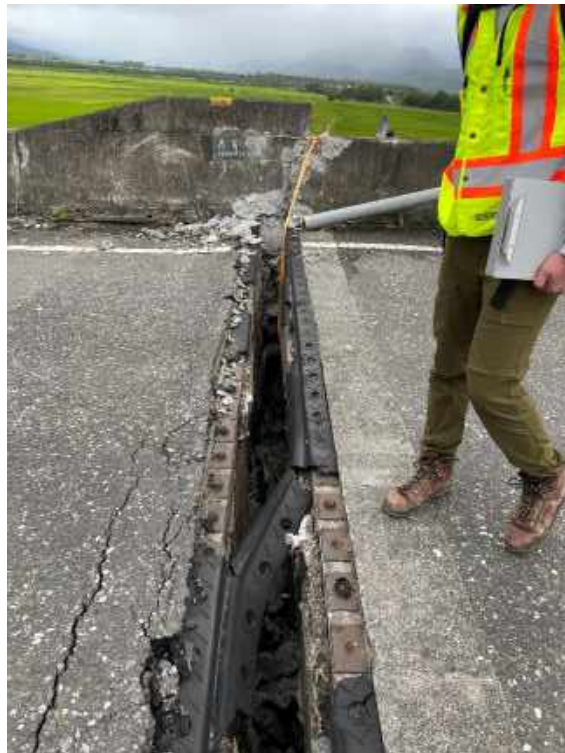
Figure 5.21. Extension of bridge joint at the west abutment. Gap approximately 25 cm. (23.26574° 121.29864°)

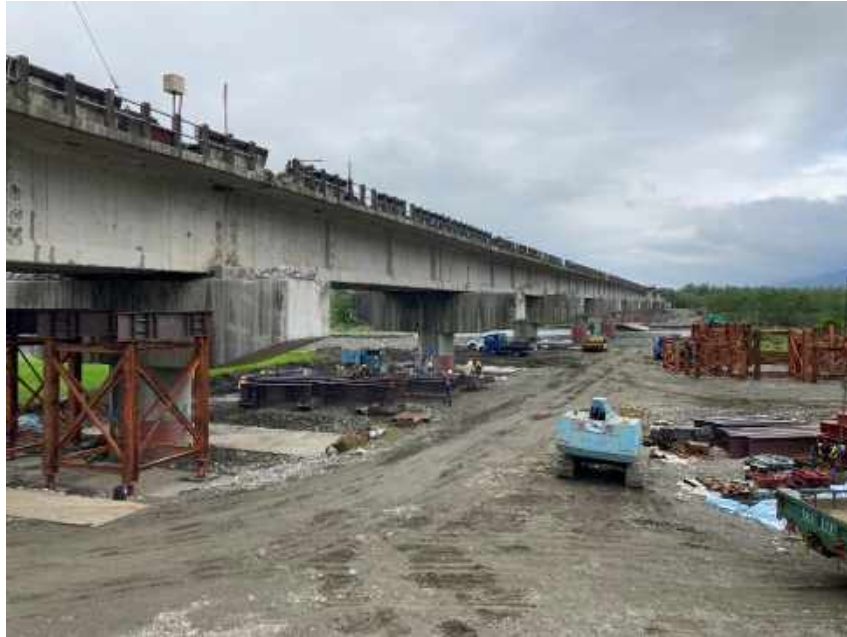
Figure 5.23. View of the Dongli Railroad Bridge during active repair operations. (23.27487° 121.30530°)

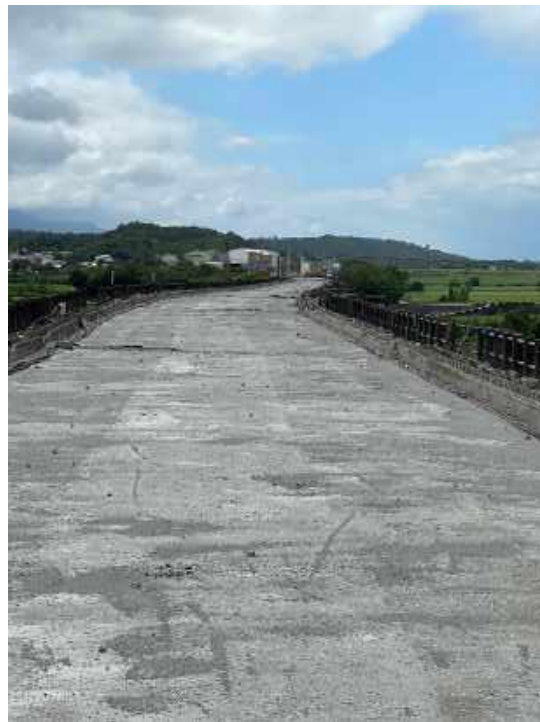
Figure 5.24. View from the bridge deck of the Dongli Railroad Bridge with the train rails removed. The twist in the deck was due to the lateral translation of the prestressed girders. (23.27829° 121.30669°)

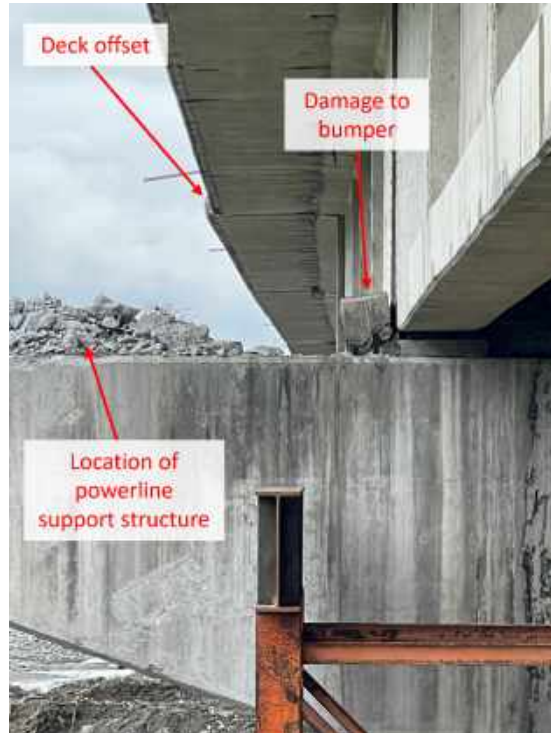
Figure 5.25. Typical damage to a concrete bumper shear key, offset of bridge deck, and location of concrete powerline support structure. (23.27481° 121.30502°)

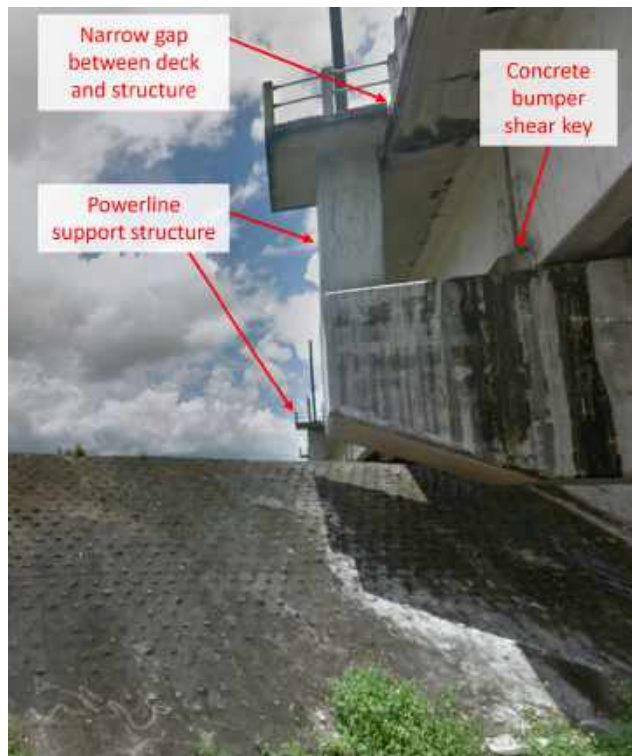
Figure 5.26. Google Street view from 2012 showing the intact powerline support structure and concrete bumper shear key (23.27468°, 121.30489°)
