GEOTECHNICAL ENGINEERING RECONNAISSANCE OF THE 2022 CHIHSHANG EARTHQUAKE SEQUENCE

Version 1.0; April 2024

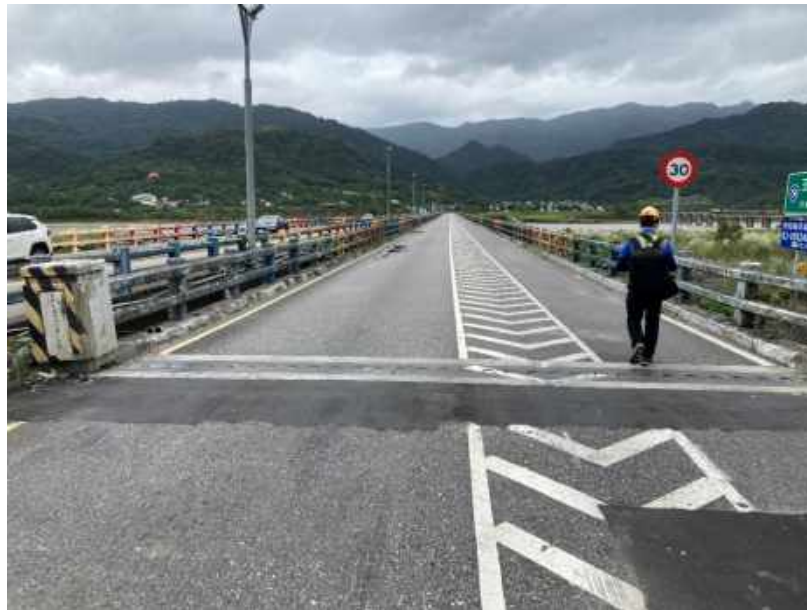
Figure 5.27. View from the west abutment of the south Yuli bridge. (23.32332° 121.32684°)

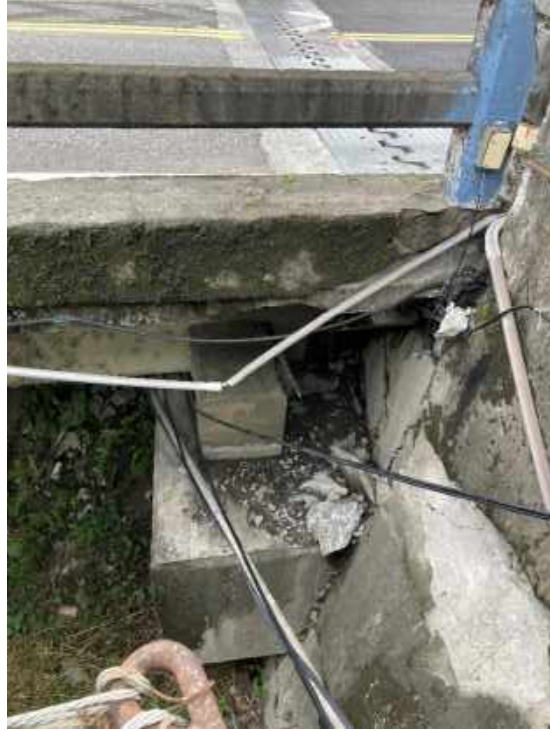
Figure 5.29. Damage to the North Yuli bridge east abutment and adjacent utility lines. (23.32233° 121.33240°)

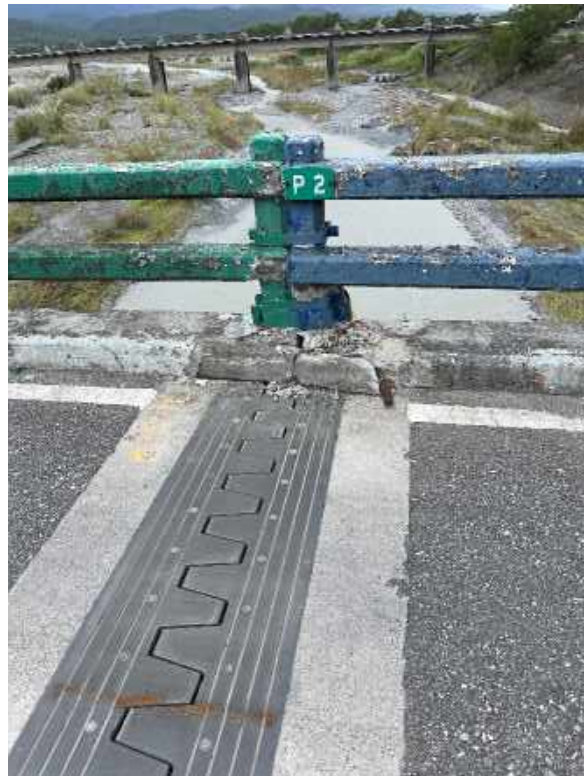
Figure 5.30. Typical damage in concrete railing at finger joints. (23.32317° 121.32758°)

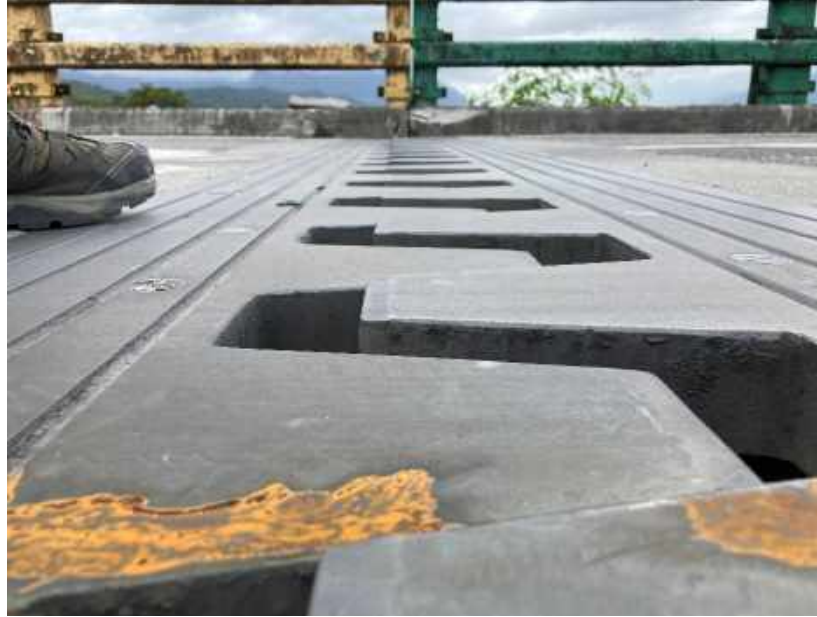
Figure 5.31. Typical differential movement at a Figure 5.joint. (23.32240°121.33194°)

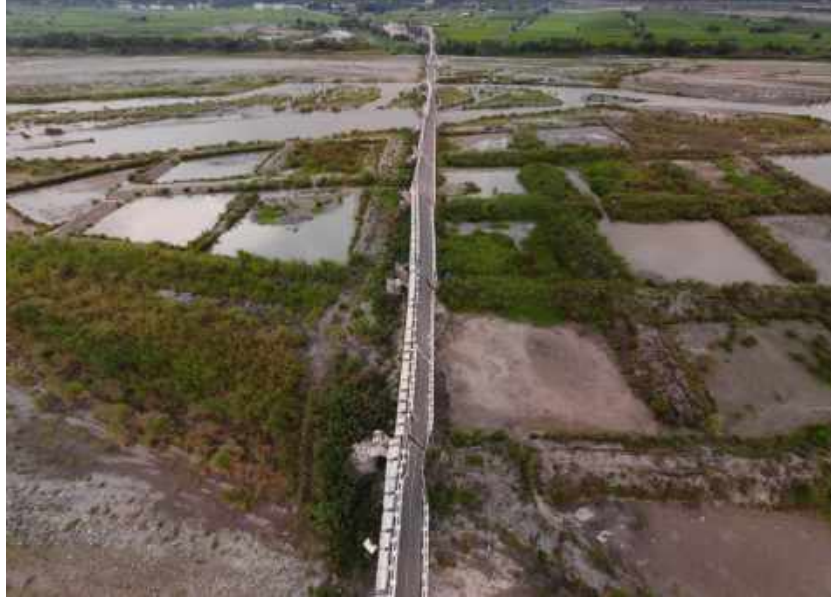
Figure 5.32. Failed spans of the Gaoliao bridge looking west (Image courteous of Zola Zhou, 23.38563° 121.34458°)

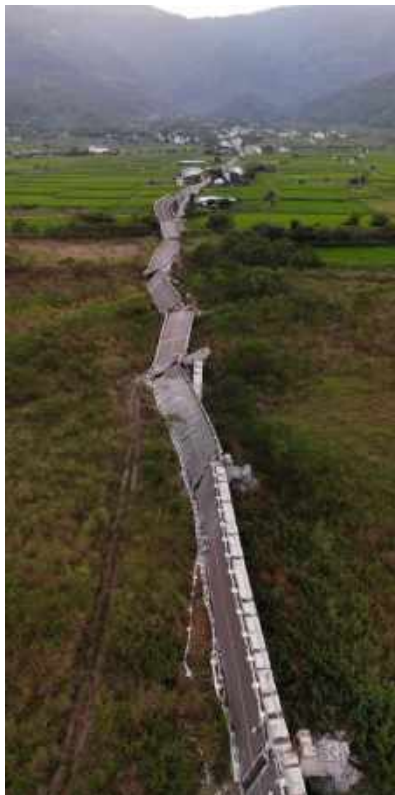
Figure 5.33. Failed spans of the Gaoliao bridge looking east (Image courteous of Zola Zhou, 23.38563° 121.34458°)

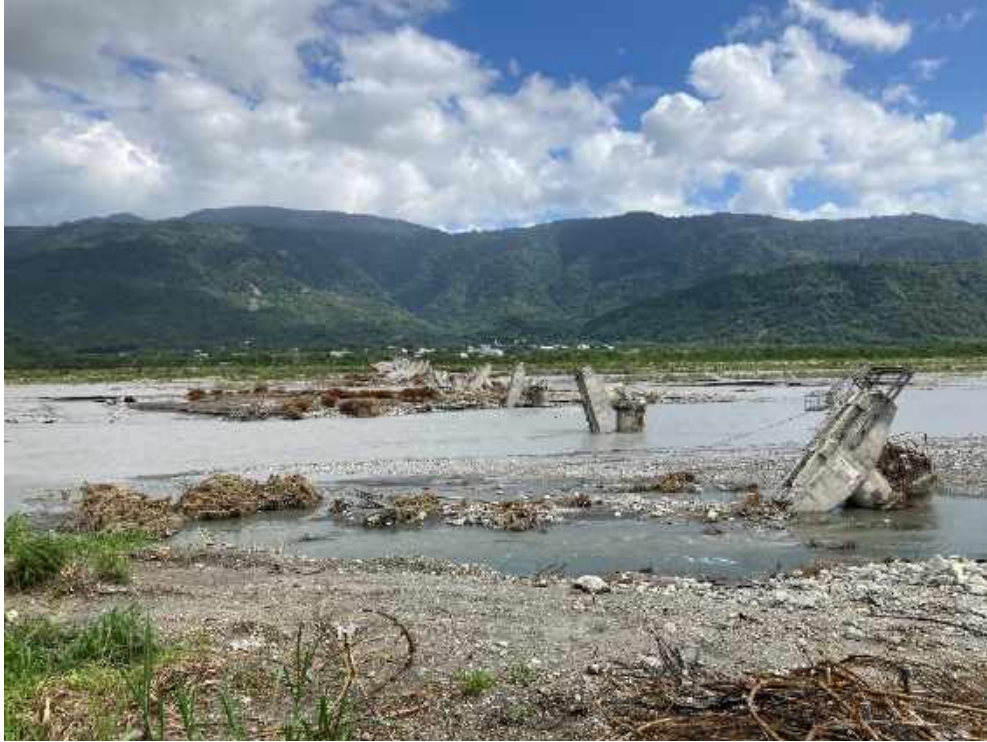
Figure 5.34. Looking towards the east abutment at the failed piers (23.38632° 121.33973°)

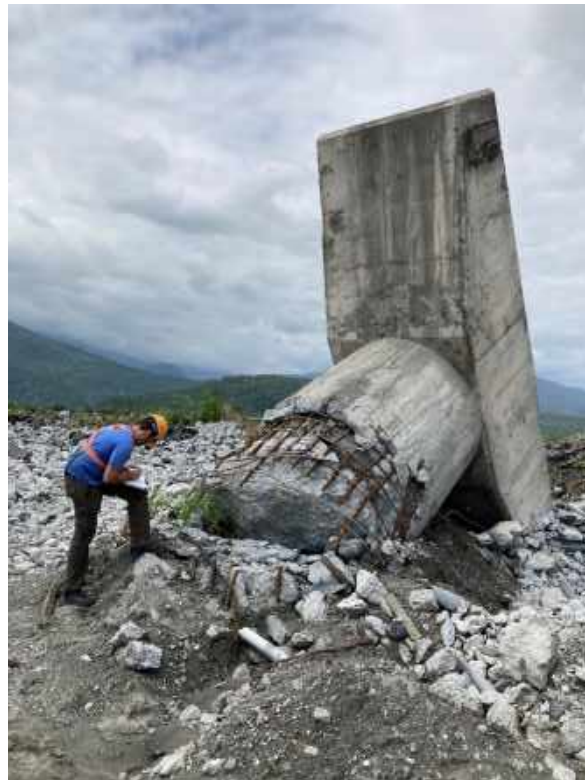
Figure 5.35. Typical view of the plastic hinges in the concrete piers (23.38630° 121.33930°)

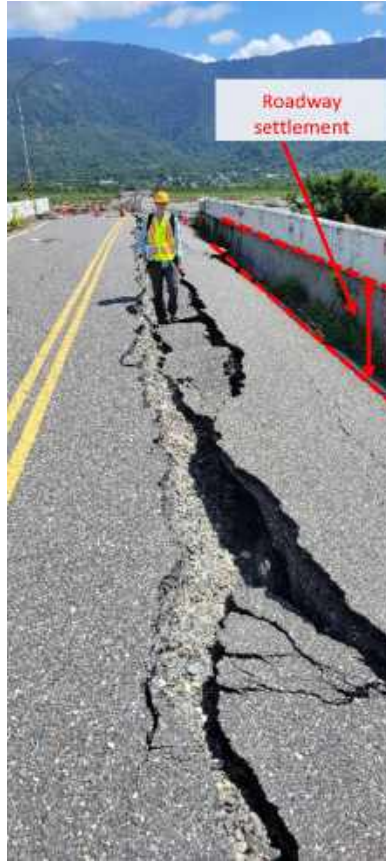
Figure 5.36. Roadway cracks and settlement in west abutment. Note (23.38625° 121.33806°)

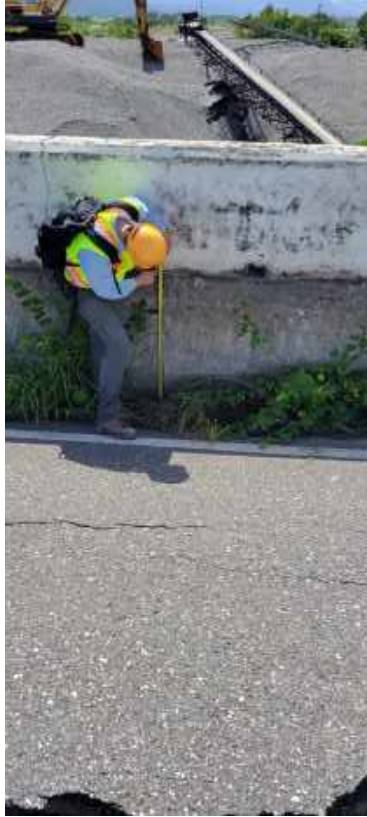
Figure 5.37. Roadway settlement at the south back-to-back concrete gravity wall in the west abutment (23.38629° 121.33811°)

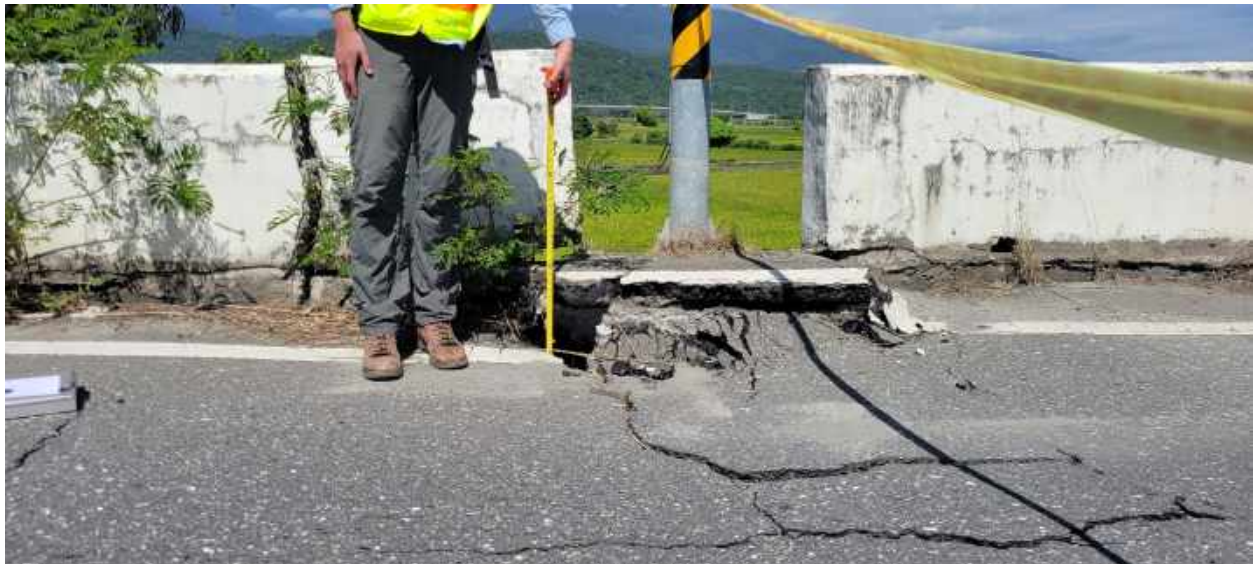
Figure 5.38. Settlement near the light post foundation in the east abutment (23.38617° 121.33741°)

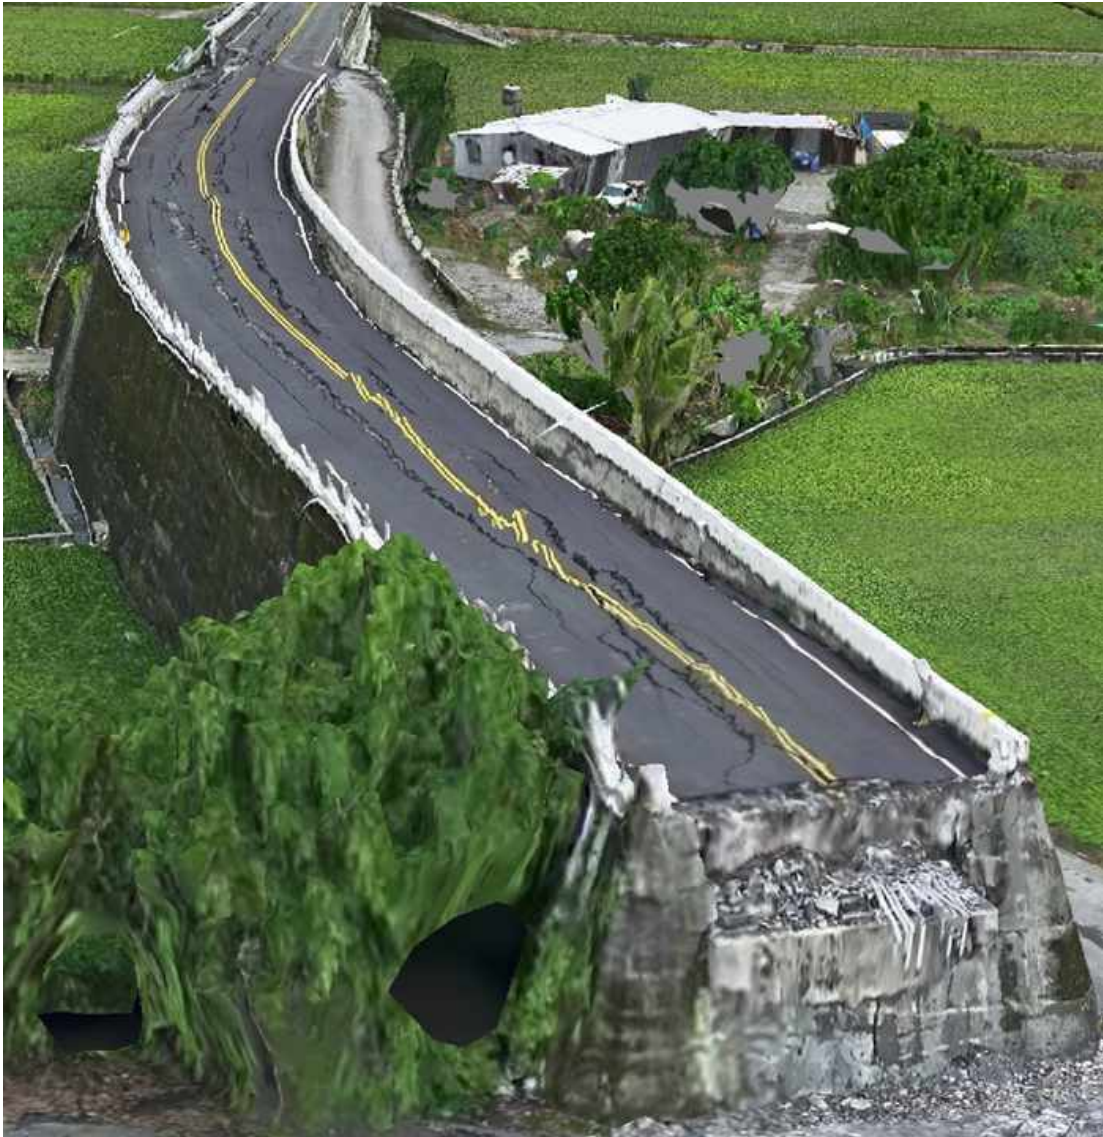
Figure 5.39. Drone view of the east abutment looking east (approx. 23.38522° 121.34690°)

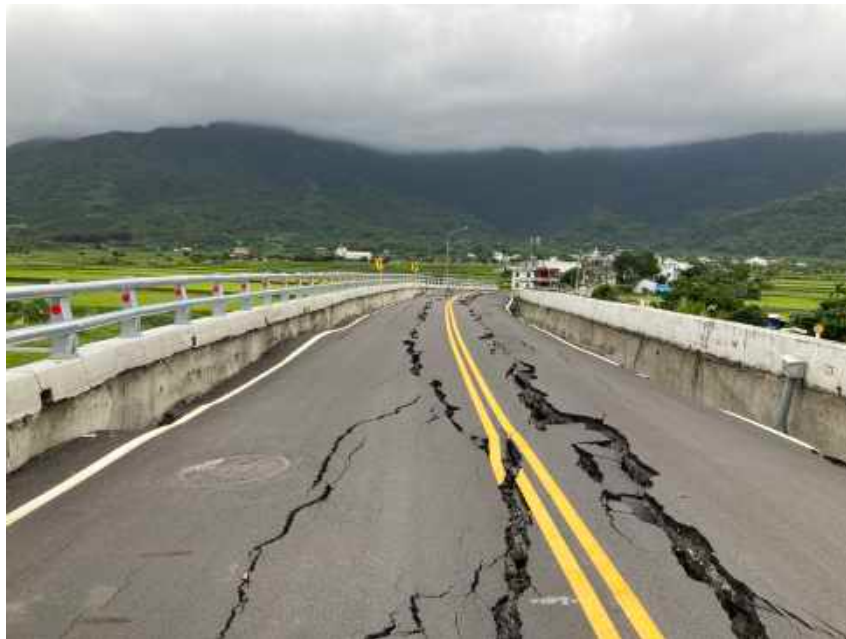
Figure 5.41. Roadway cracks and settlement in the east abutment looking east (23.38520° 121.34710°)

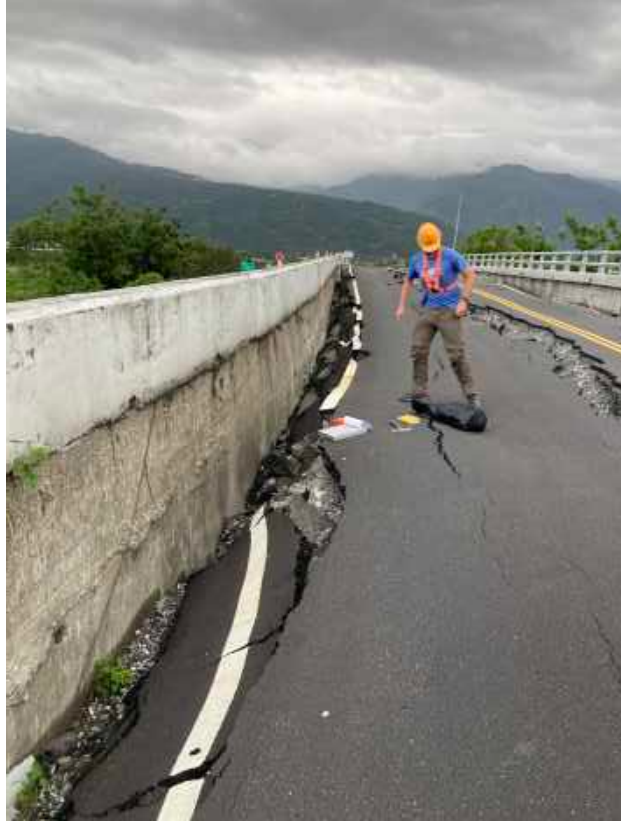
Figure 5.42. Roadway cracks and settlement in the east abutment looking west (23.38510°
121.34767°)

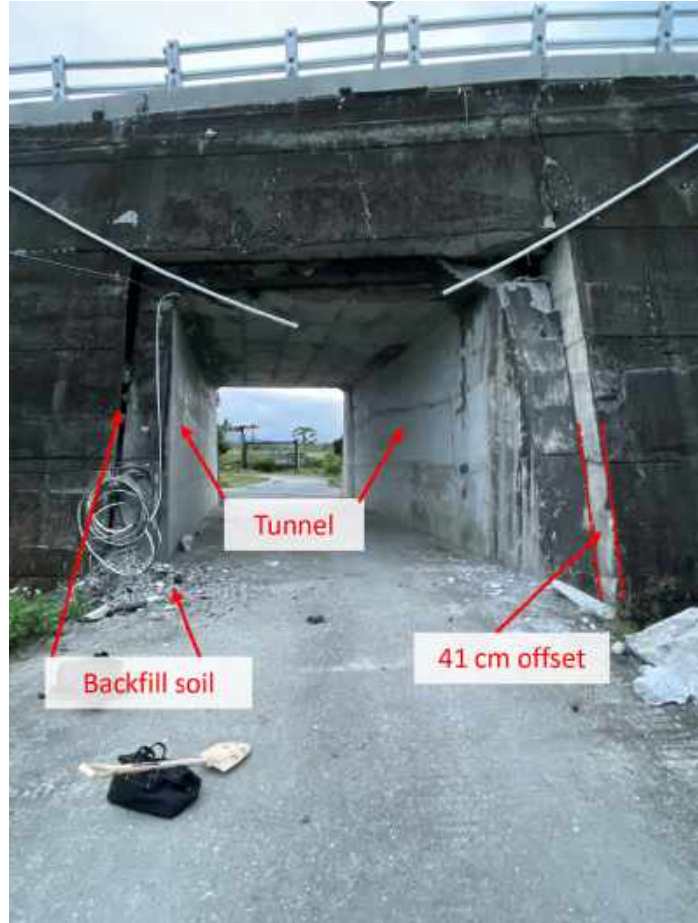
Figure 5.43. Tunnel beneath east bridge approach, 41 cm offset from gravity wall, and backfill soil that flowed from gap between the gravity wall and tunnel liner (23.38526° 121.34783°)
