**GEOTECHNICAL EXTREME EVENTS
RECONNAISSANCE (GEER) ASSOCIATION**

**EXECUTIVE SUMMARY OF **GEOTECHNICAL
RECONNAISSANCE** OF THE FEBRUARY 06, 2023,
KAHRAMANMARAŞ EARTHQUAKES, TÜRKİYE**

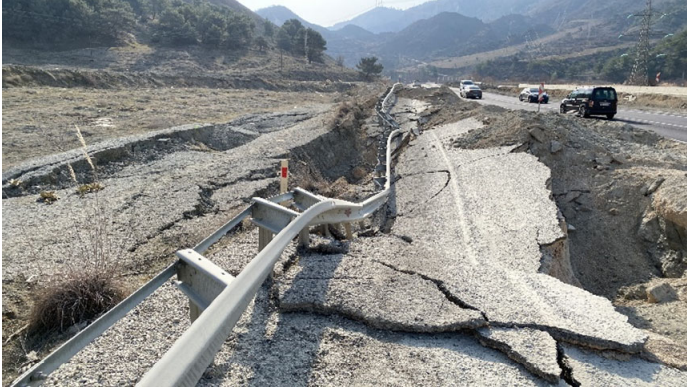
Figures 2a, b, c, d, e (clockwise from top left): **2a**, failed highway including lateral spreading (lat/long 37.86333/37.76715); **2b**, fissures on crest of Sultansuyu Dam (lat/long 38.31899/38.05171); **2c**, settled/tilted building on mat foundation resting on adjacent building (lat/long 37.78806/37.64898); **2d**, front view of building in photo 2c showing no structural damage (lat/long 37.78806/37.64898); **2e**, lateral spreading along lake shore in Golbasi (lat/long 37.79446/37.65331).
