Preliminary Report on the Principal Seismological and Engineering Aspects of the $M_w=6.5$ Achaia-Ilia (Greece) Earthquake on 8 June 2008

Report for Web Dissemination
Geotechnical Earthquake Engineering Reconnaissance
http://research.eerc.berkeley.edu/projects/GEER/Post_EQ_Reports.html

GEER Association Report No. GEER-013

June 2008

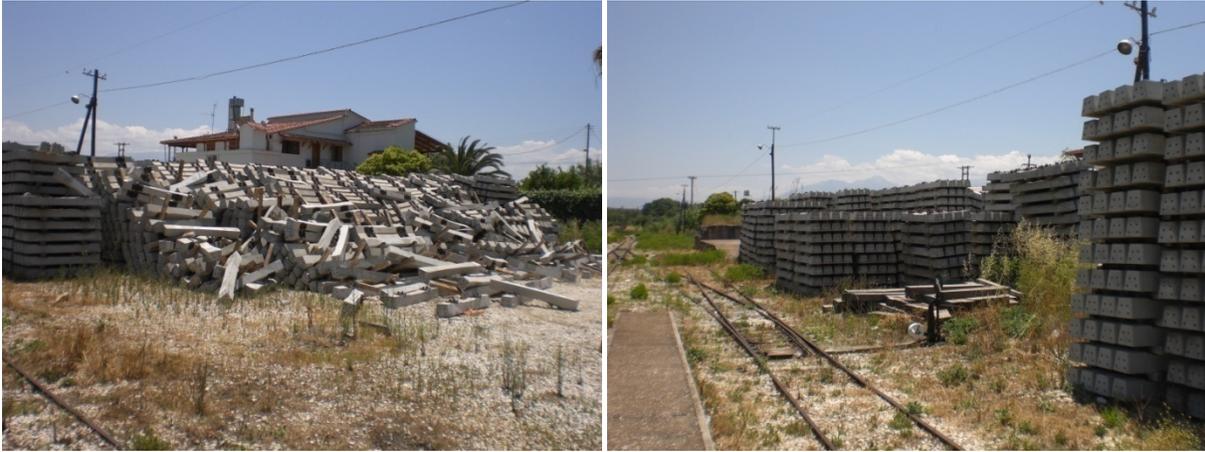
Figure 3.8. View of fallen railroad ties in fault normal direction (left) and lack of fall of ties at same location in fault parallel direction (right).

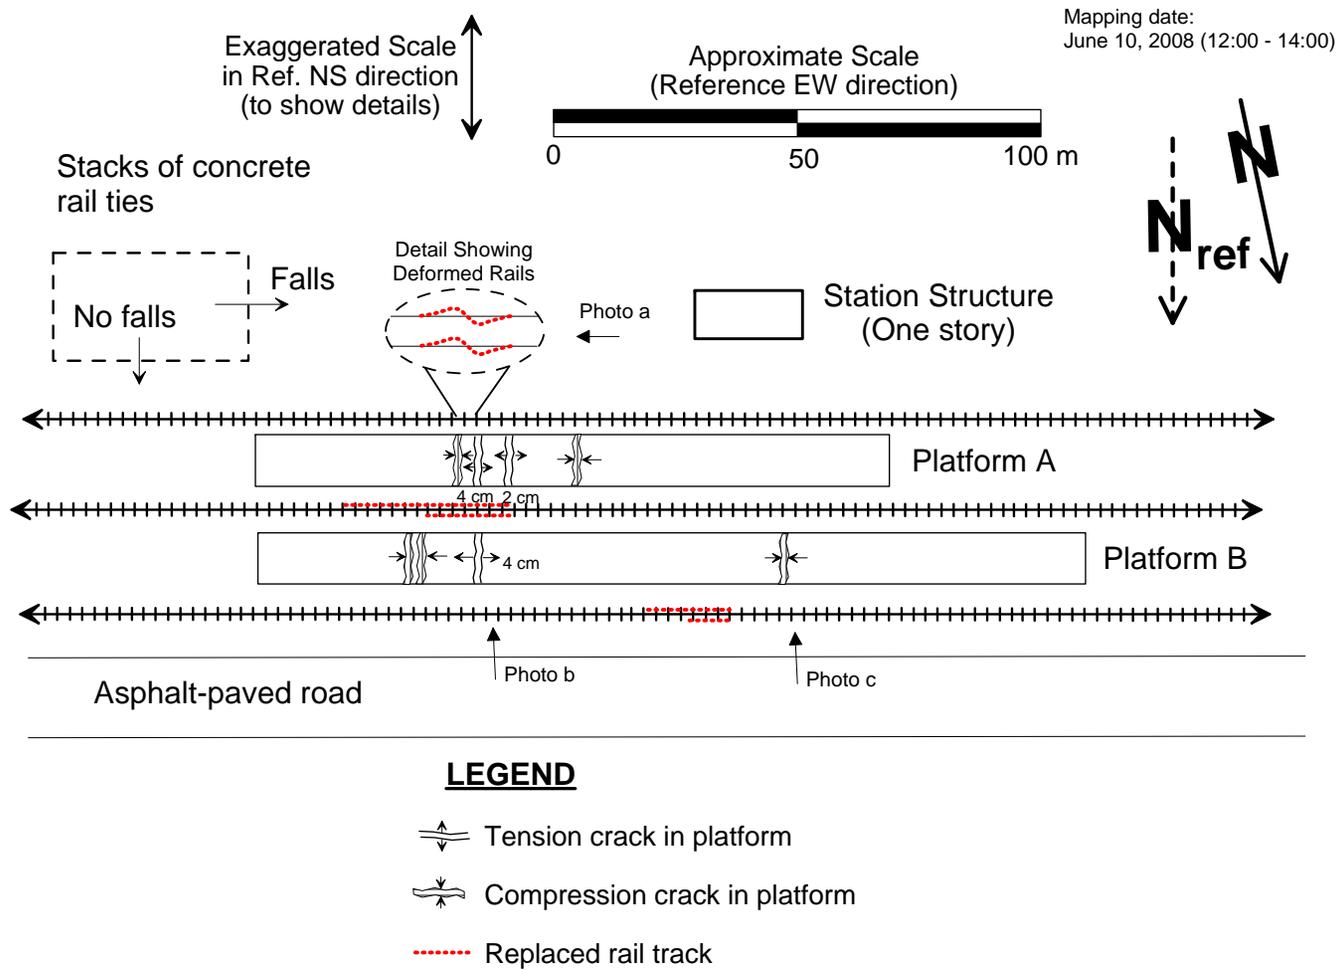
At the time of inspection, unrepaired damage remained on the south track, as shown in Figure 4.2 and 4.3. Damage to the two north tracks had been repaired immediately after the main shock, to keep train service open, but the removed sections of rail were available onsite for inspection. The damage to the south track consists of a buckling-type failure of the rail due to compression of the ground in the direction of the rail (Figure 4.3). No strike-slip displacement of sections of rail on opposite sides of the damaged section was apparent from visual inspection (Figure 4.3). Immediately north of the buckled rail, both compression and extension features were apparent in the concrete platforms, as shown in Figure 4.2. Note that the widths of extensional ground cracks were noted in the field, but it was not possible to measure displacements across compression features. Photographs of the distress in this area are shown in Figure 4.3-4.4.

The available data clearly indicate that ground failure occurred at the Kato Achaia train station. The cause of the ground failure is not clear, but the lack of any permanent lateral displacements across the ground failure features in the direction of fault strike does not support the presence of strike-slip surface rupture in this area. Soil failure phenomena or fault step-over deformations are other alternative mechanisms that could be investigated in future work.

Figure 4.2. Site plan of Kato Achaia train station showing major surface improvements and observed distress. Note exaggeration of scale in reference NS direction.

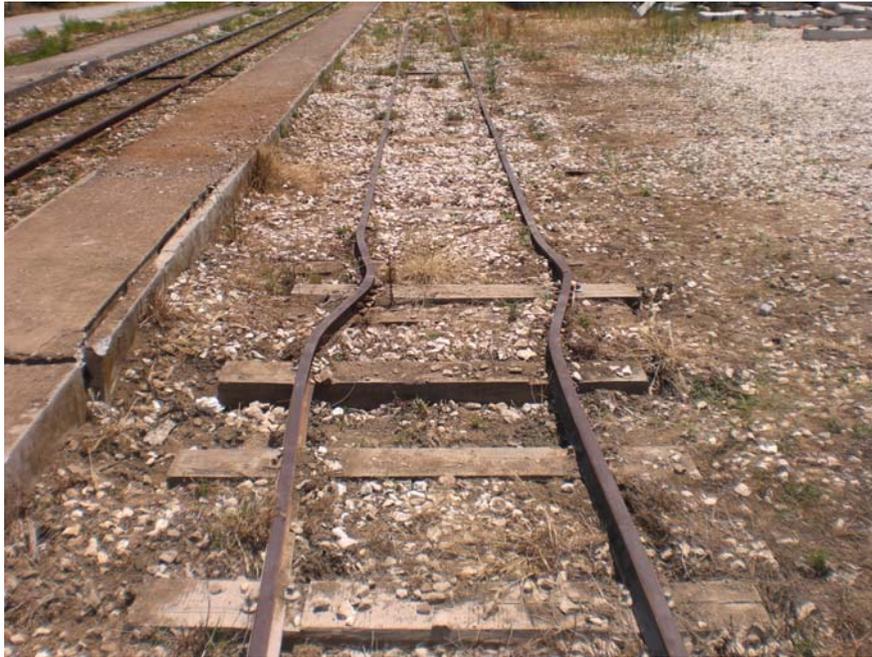
Figure 4.3. Photograph of buckled section of rail on south rail line. Note also distress in platform on left side of picture. Marked as Photo a in Figure 4.2.

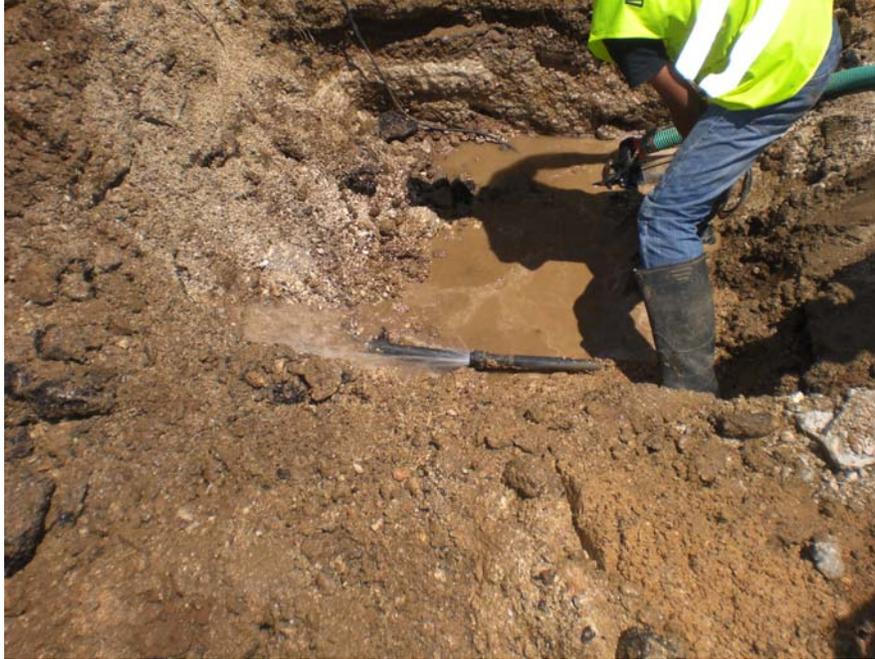
Figure 4.7. Photograph of leaking PVC water pipe on Apostolou Andreou Street south of train station site (N 38° 08.725', E 21° 33.691')

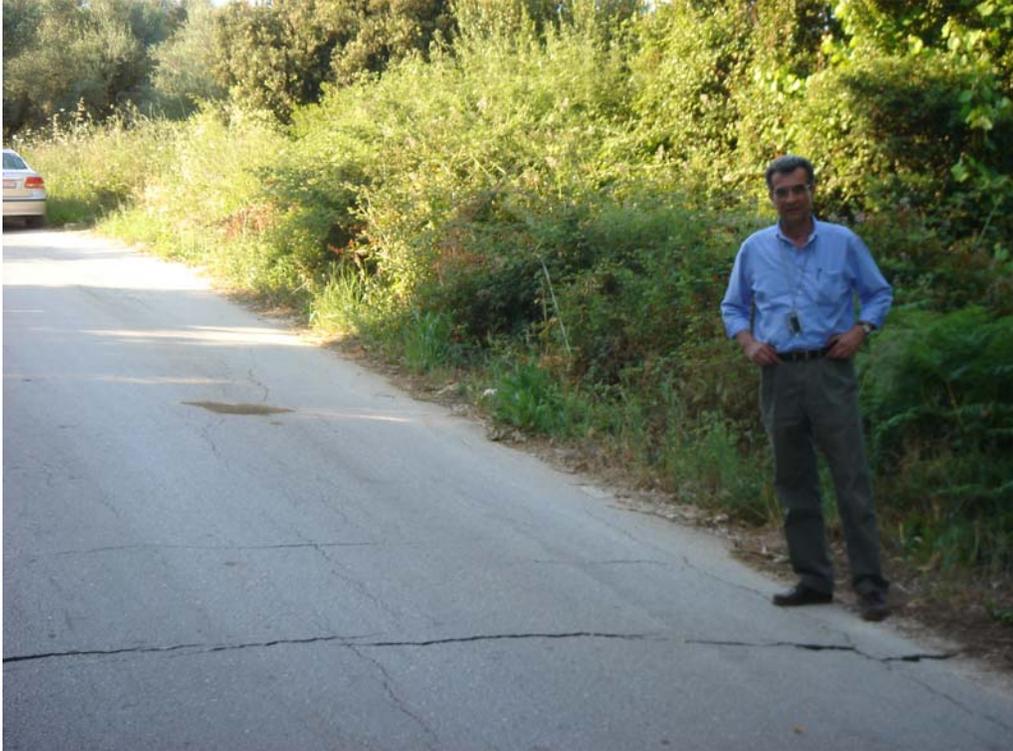
Figure 4.8. Fissures on road pavement between Peta and Mataraga

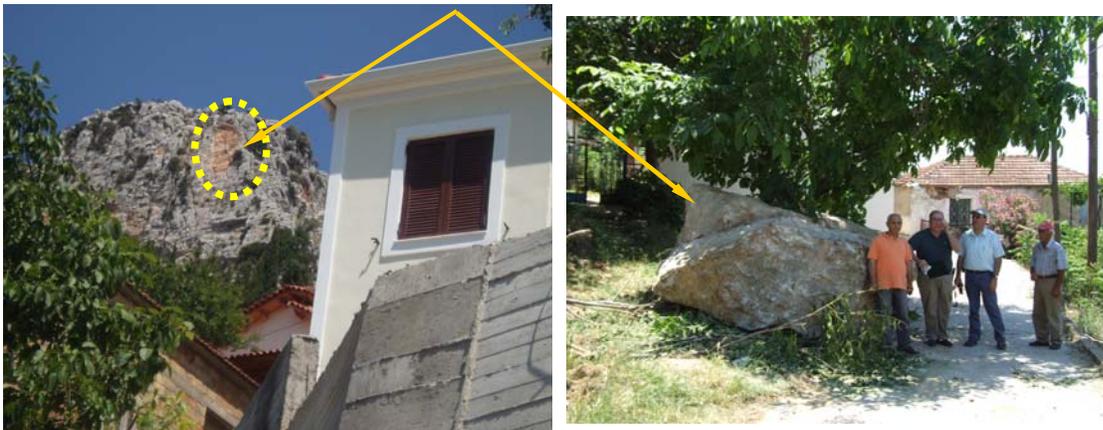
In both cases, rock toppling failures of limestones occurred during the earthquake as a result of the unfavorable combination of very steep slopes with the sub-vertical fractures and the inclined bedding. The volume of the rock blocks that toppled is crudely estimated between 1 and 7m³. In Figure 5.3, the location where a rock block was detached is shown on the left, whereas on the right is shown a detached rock block that rolled downslope and caused serious structural damage at a house in Santomeri village (fortunately with no casualties). The same features were observed in a less pronounced way at Portes village, as shown in Figure 5.4. Both villages have been declared by the Hellenic state, as “hazardous areas” due to rock detachment and toppling and therefore evacuation of the inhabitants was ordered.

Figure 5.3. Santomeri village: location of the detached rock block that toppled (left side) - the rock block itself (volume 6 to 7m³) that caused severe structural damage at one of the houses of the village (right side)

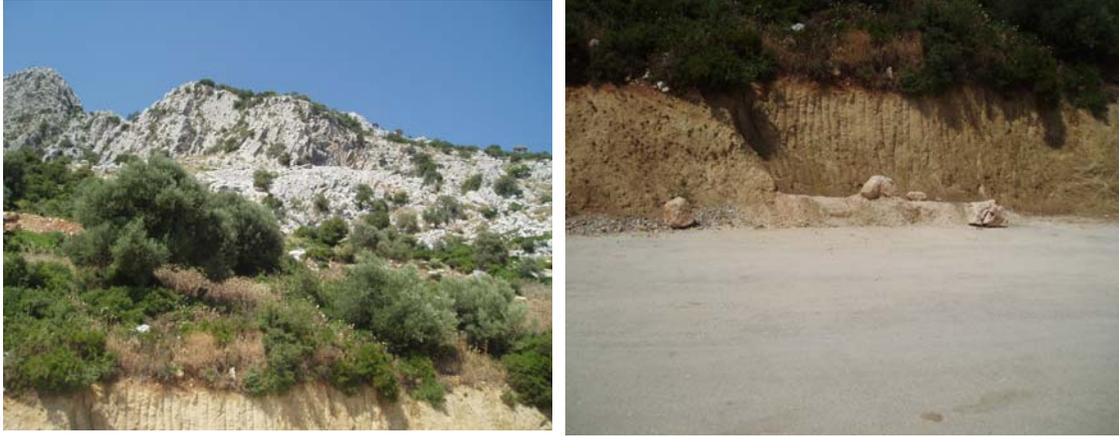
Figure 5.4. Portes village: general view of the limestones (left side) and rock blocks (<math><0.5\text{m}^3</math>) that toppled down to a flat area over the village (right side)

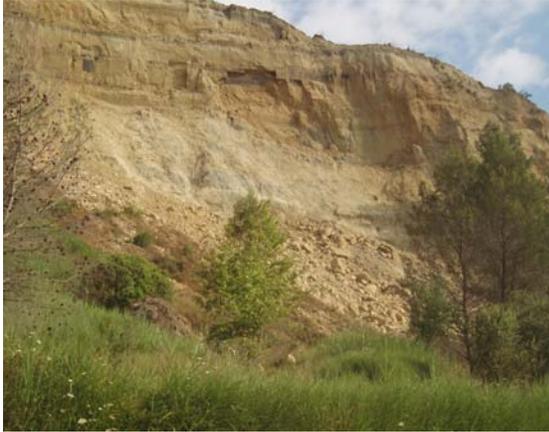
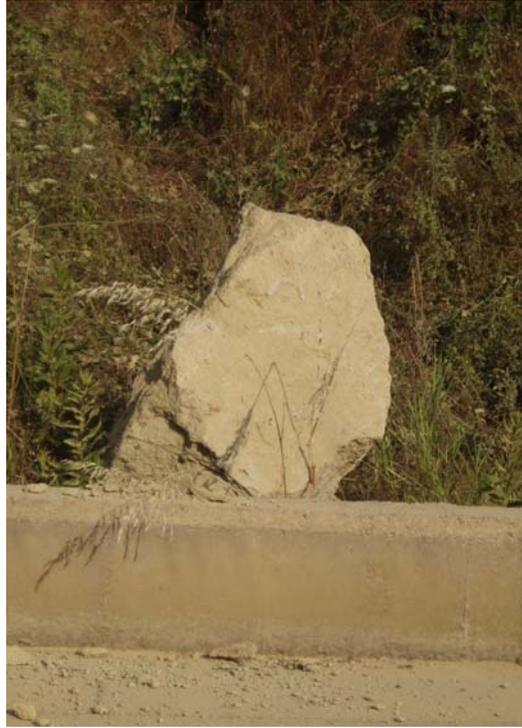
Figure 5.5. Landslide in marl and sandstone deposits along the road from Portes to Valmi village (direction N-S), in the near-field area. A general view is presented in the left part, where location of detached rock blocks are recognized as well as the scree deposits formed at the mild slope. Detachments were favored by subvertical joints parallel to the slope face. A detached rock block of estimated volume of 2m^3 , rolled down the hillslope and crossed the road (right part of the figure).

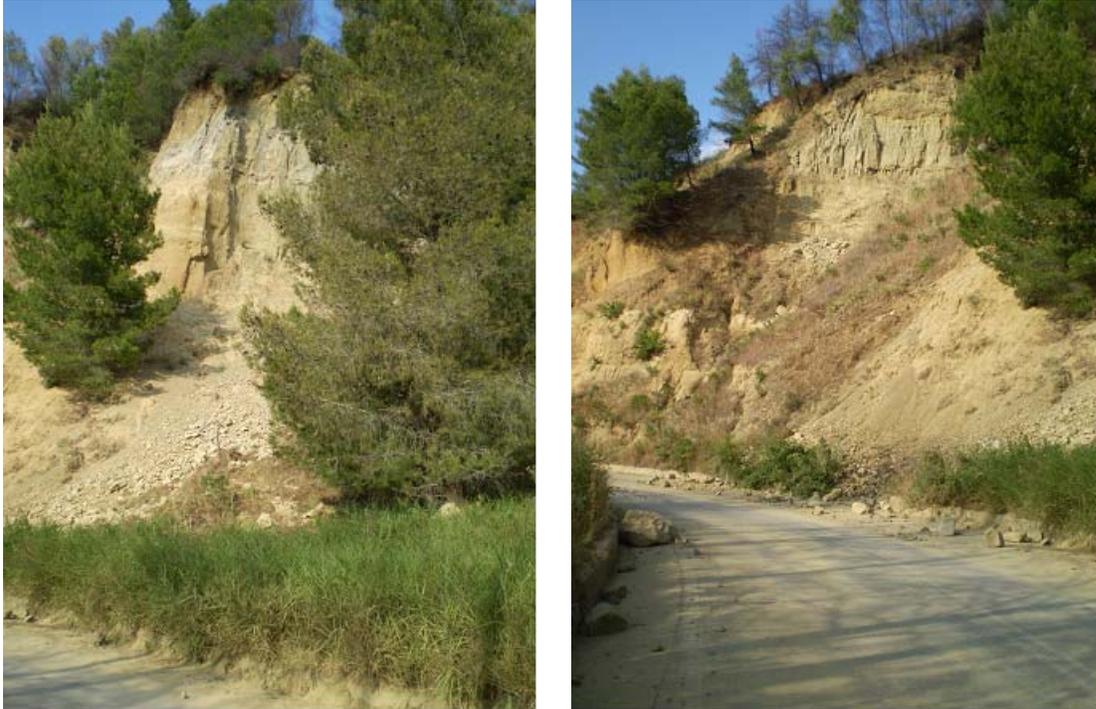
Figure 5.6. Toppling failures of upper relatively harder strata (marly sandstones) crossed by subvertical joints along the road from Portes to Valmi village (direction N-S). Close (left) and general (right)

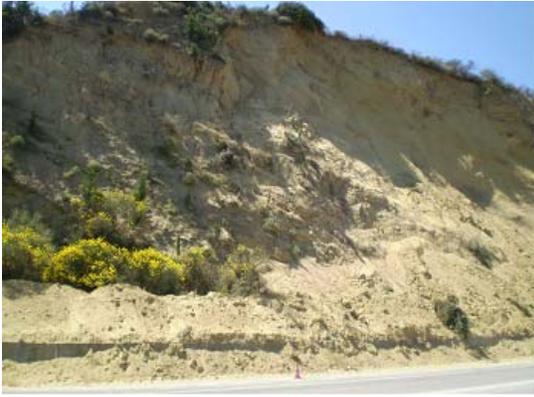
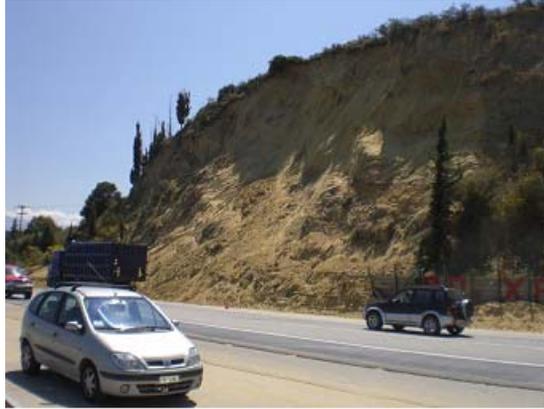
Figure 5.7. Sliding of marl strata along bedding planes and joints dipping towards the road. National road near Kato Ahaia. Westward and Eastward view.

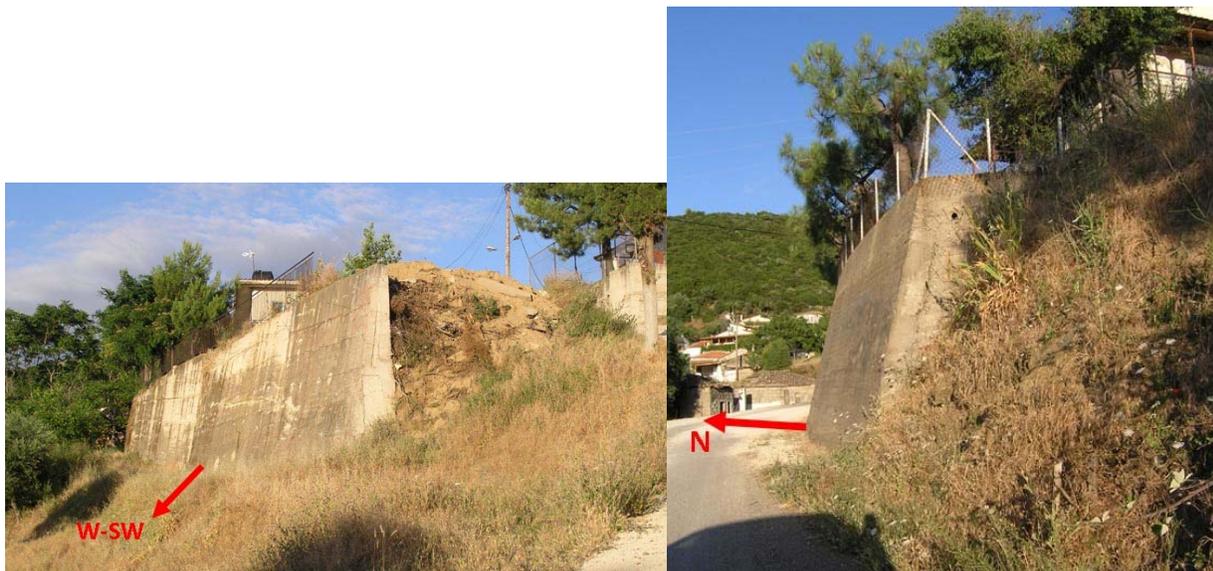
Figure 6.6. Cantilever type earth retaining walls (height \approx 4.5m) at Flokas village with no signs of distress (38°02.000'N, 21°38.000'E). Wall to left is approximately 4.5 m tall; to right wall height is approximately 3.5 m.

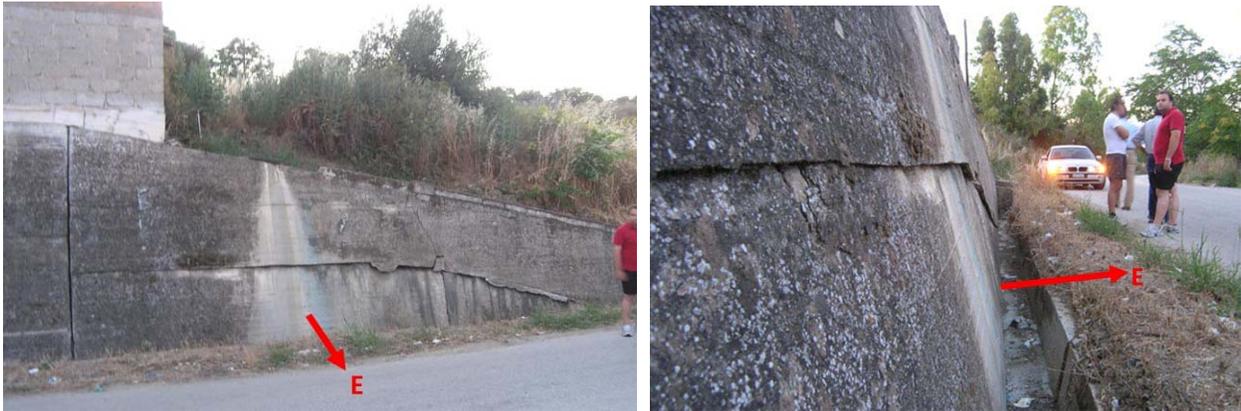
Figure 6.7. Gravity type earth retaining wall (height < 2.5m) at Agiovlasitika village ($38^{\circ}7.354'N$, $21^{\circ}33.821'E$), which was damaged from the June 8, 2008 earthquake.

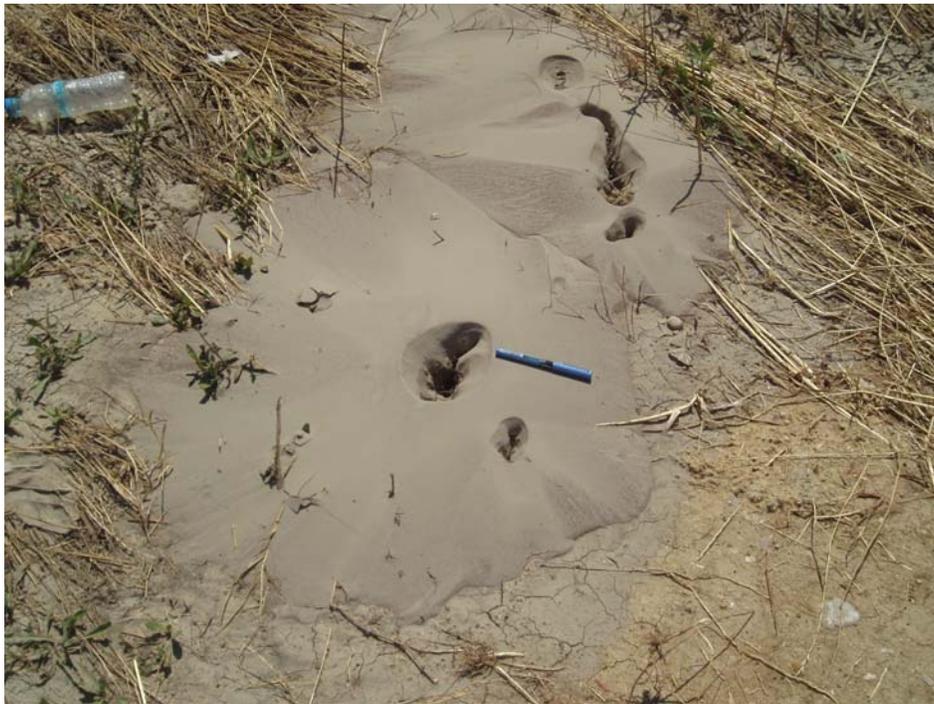
Figure 7.3. Boils with flows of grey coloured silty sand / sandy silt liquefied material

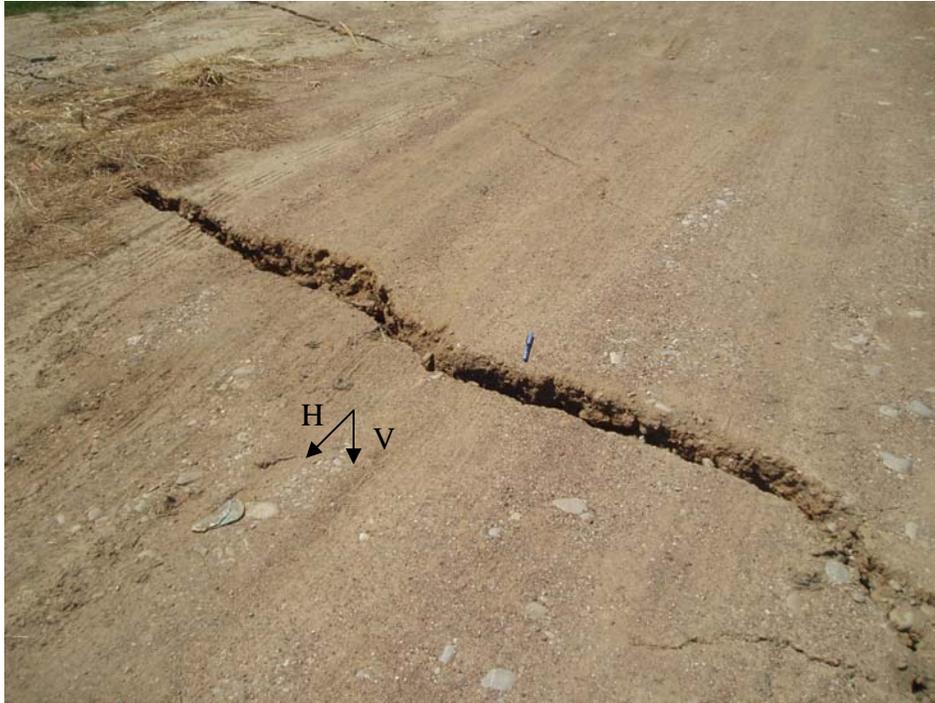
Figure 7.4. Crack attributed to lateral spreading effect (aperture $H \cong 4$ to 8cm, drop $V \cong 3$ to 6cm)

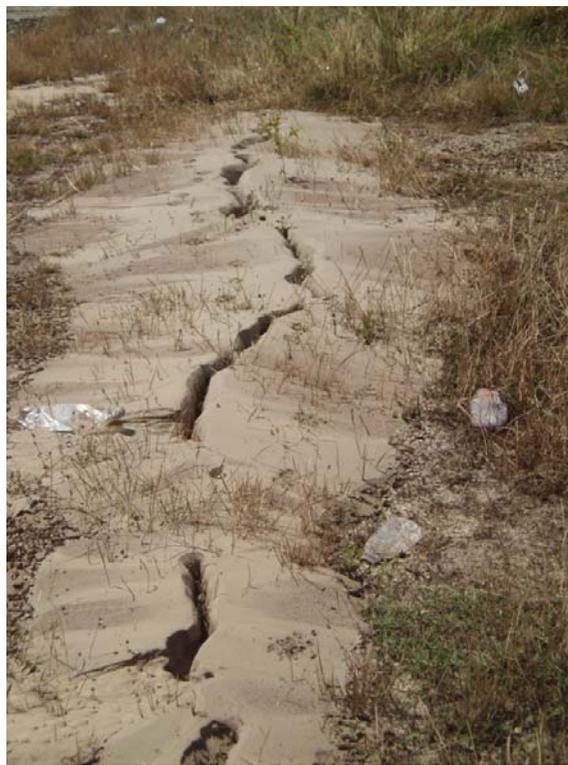
Figure 7.5. Cracks with flows of brownish, essentially sandy liquefied material

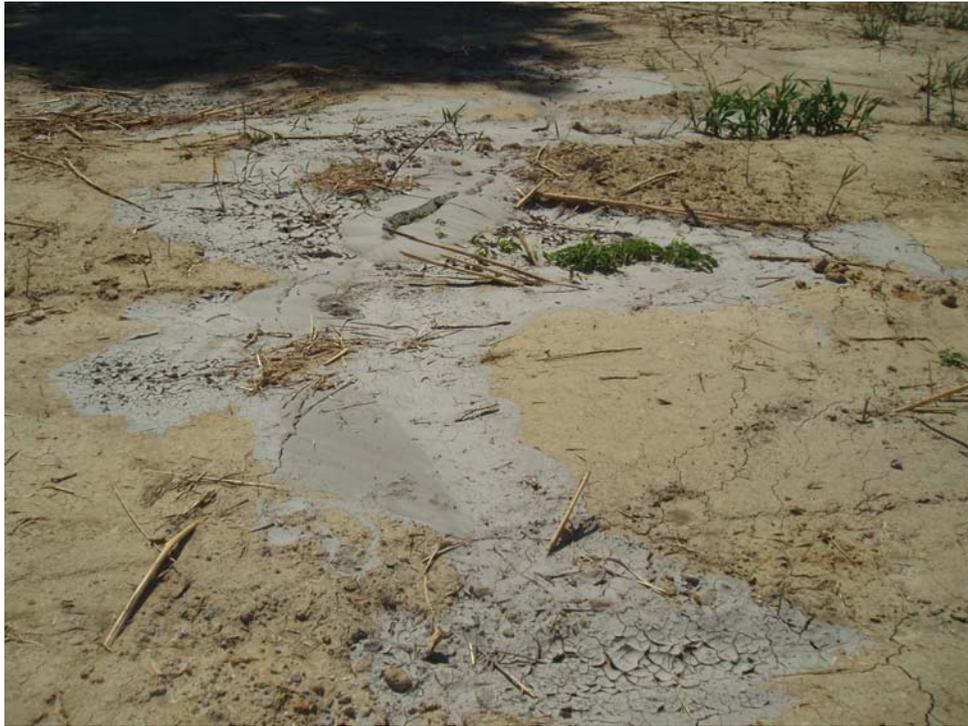
Figure 7.6. Cracks with flows of grey coloured silty sand / sandy silt liquefied material

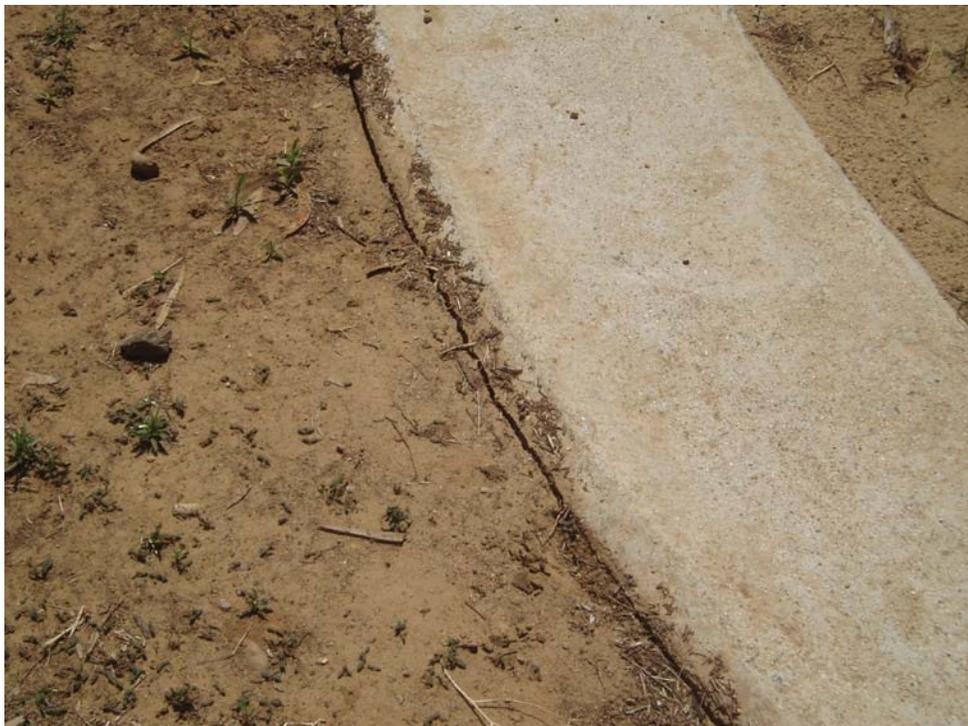
Figure 7.7. West part of Kato Achaia beach (minor cracks of maximum 1cm width)

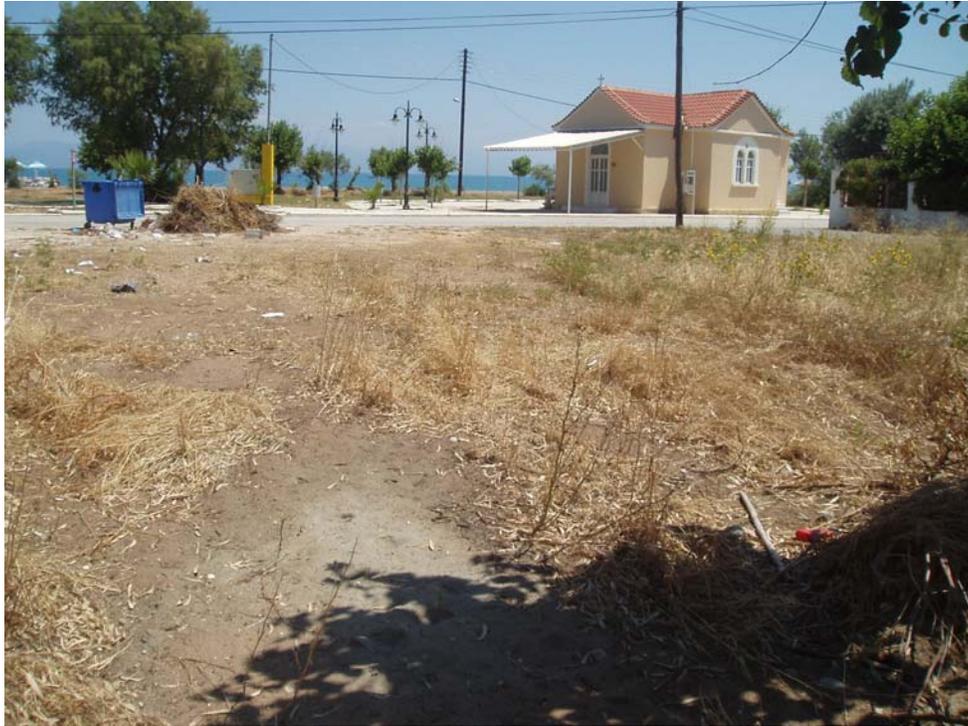
Figure 7.8. West part of Kato Achaia beach: sand boils of liquefied material

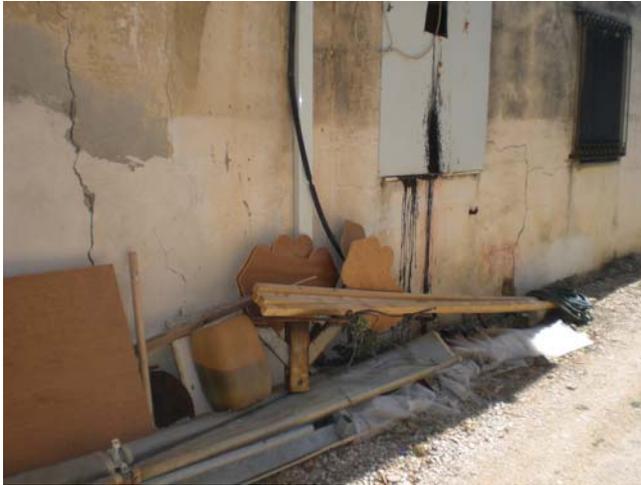
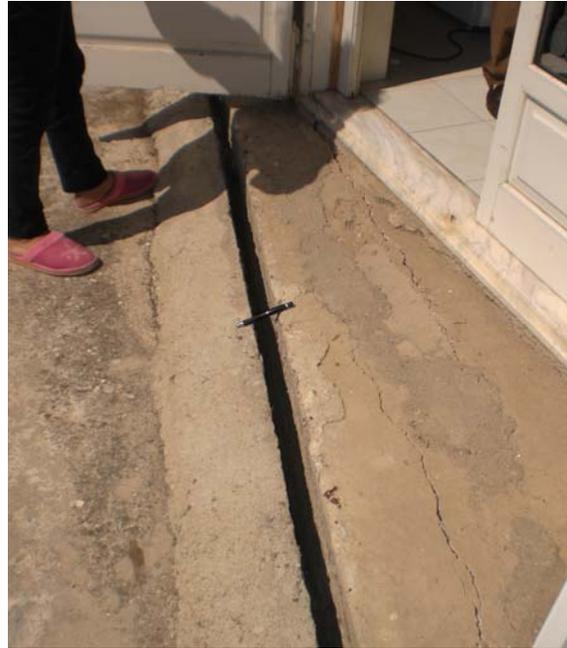
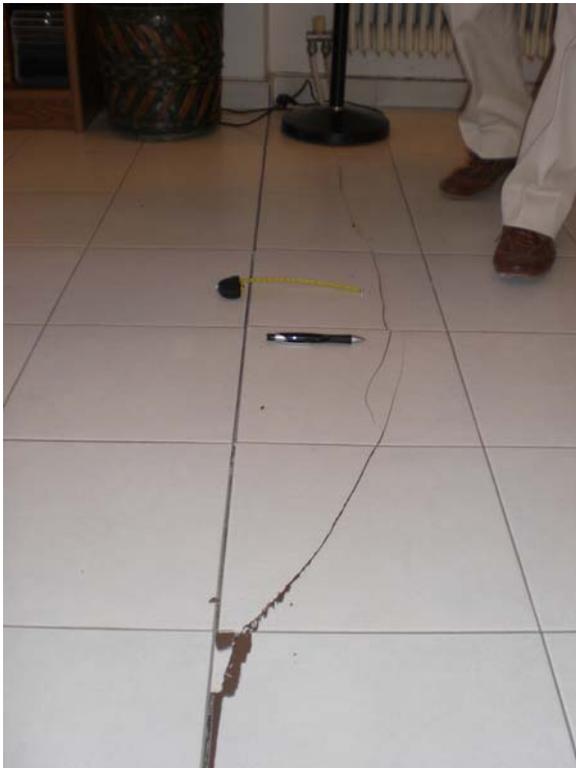
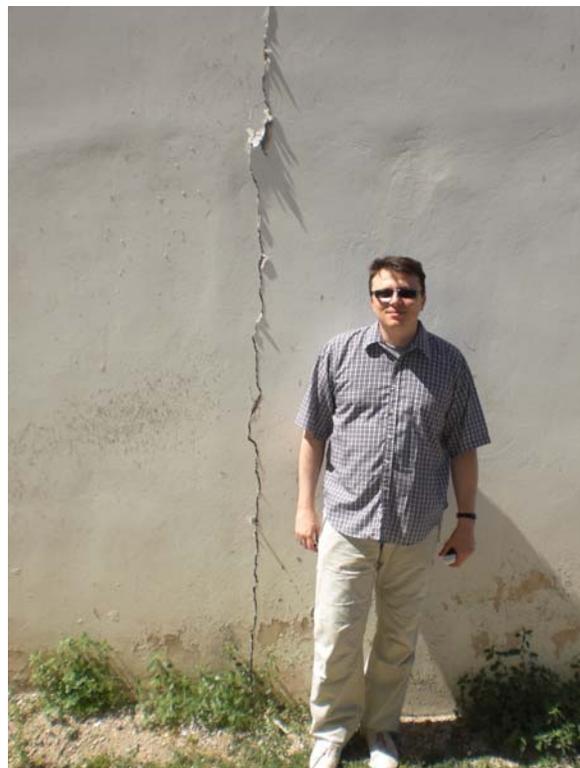
Figure 7.11. Photographs from site mapped in Figure 7.10. (a: top-left) wall cracking at two locations on west side of structure; (b: top-right) separation crack between foundation and surrounding ground at rear of structure; (c: bottom left) interior cracking of floor slab and tile with much smaller crack offsets than ground cracks at exterior; (d: bottom right) wall crack on east side of structure above floor slab crack from (c).

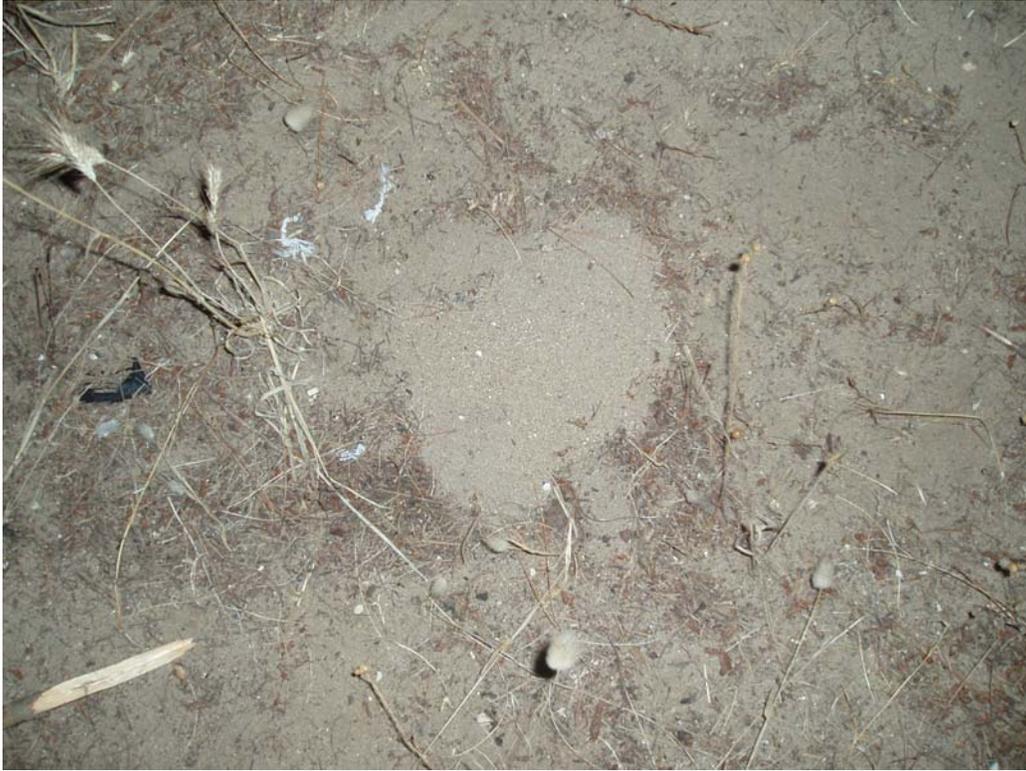
Figure 7.12. Detail of liquefied material (clean sand) at Manolada beach

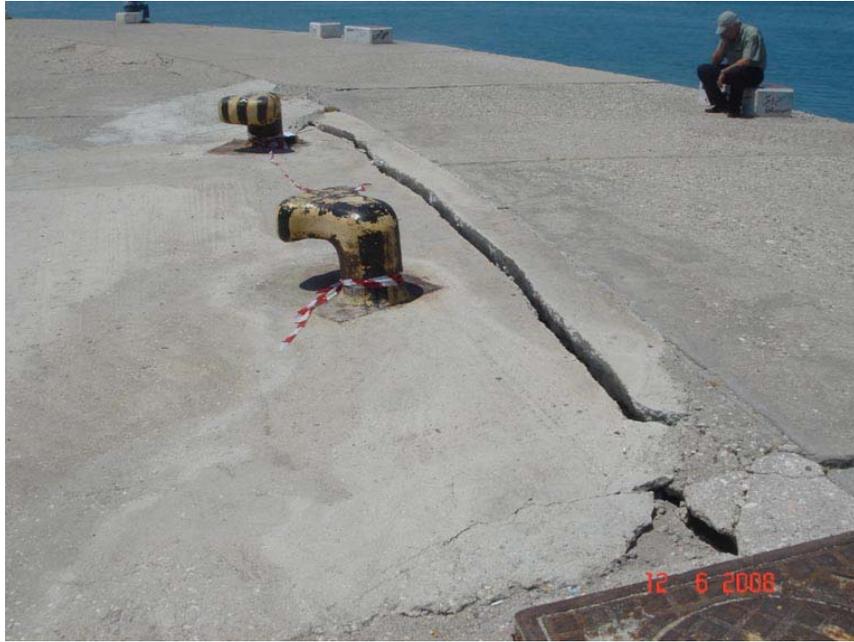
Figure 8.8. Subsided area near the end of the St. Nicolas mole.

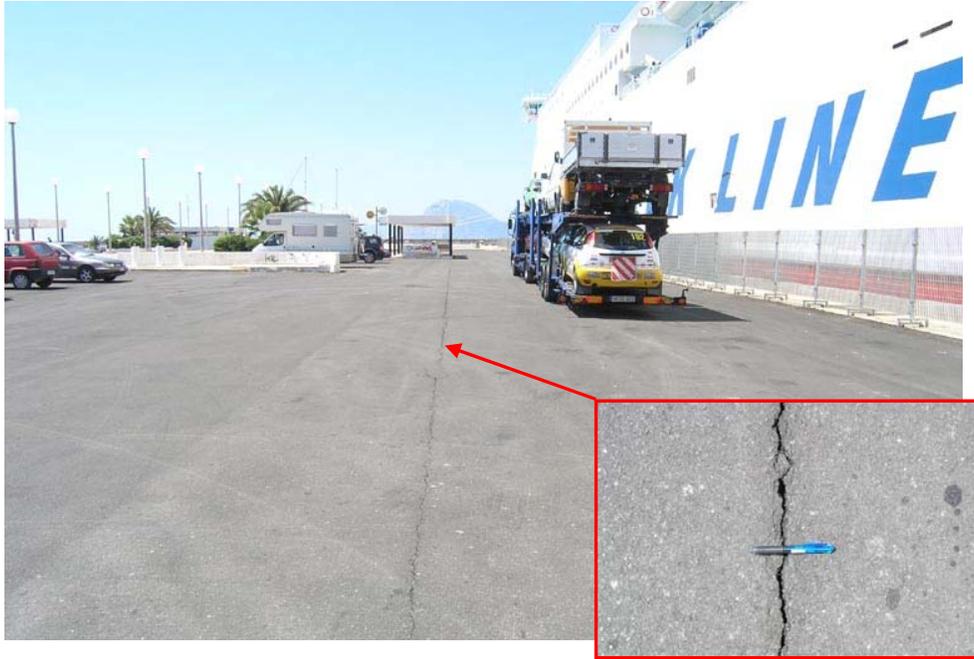
Figure 8.10. Longitudinal cracks at the surface of the mole with a maximum width of about 5mm.

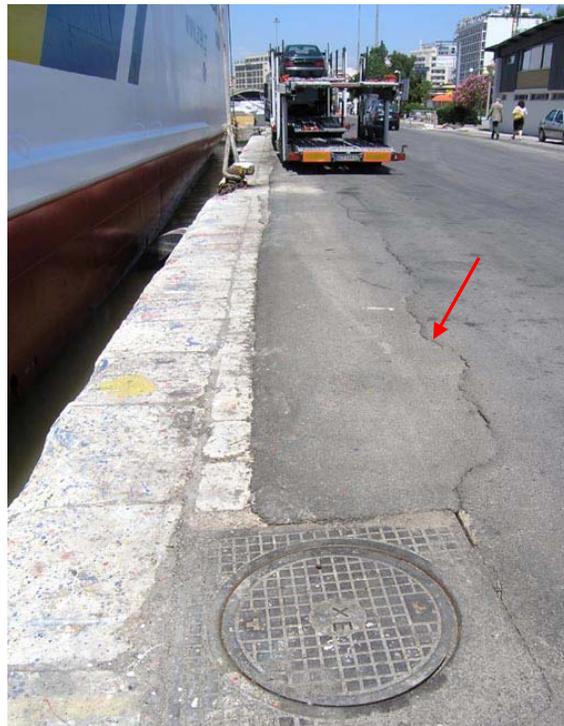
Figure 8.11. Cracks developed behind the quay wall at a small distance from the entrance of the St. Nicolas mole.

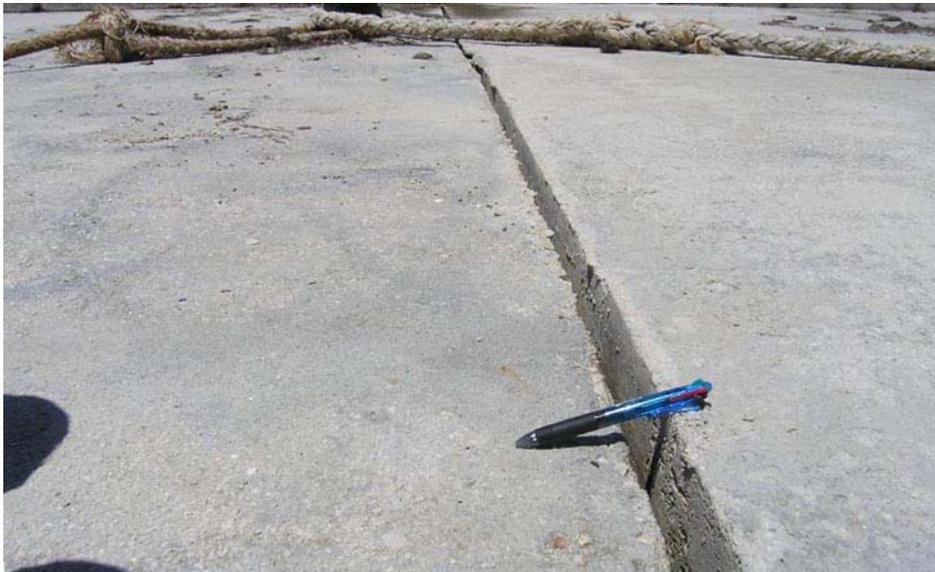
Figure 8.16. Differential settlement between two adjacent caissons of the breakwater.

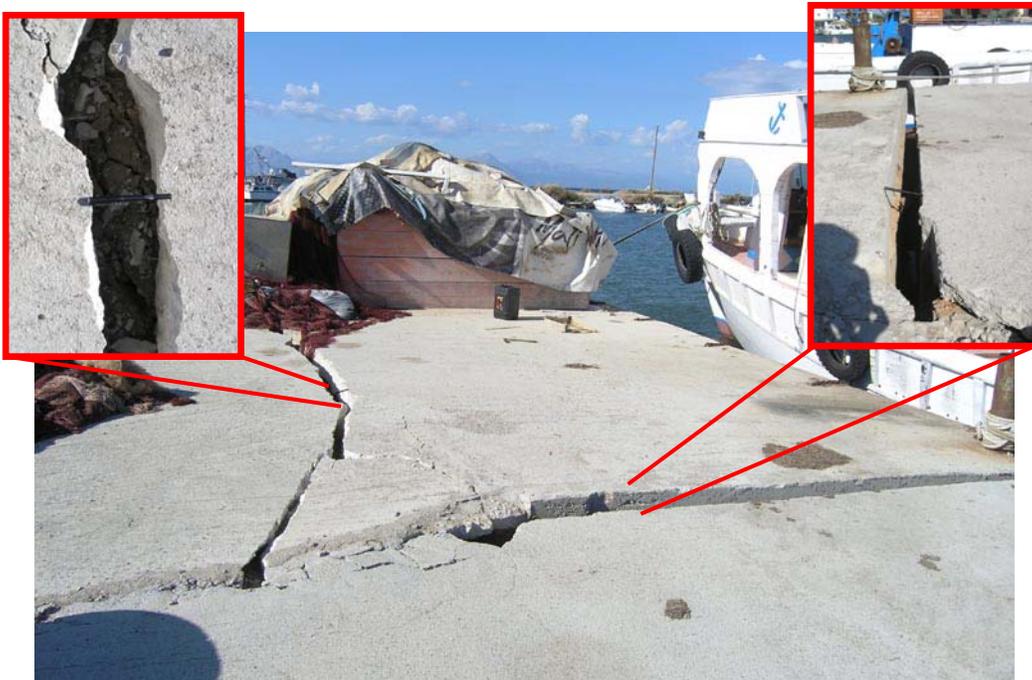
Figure 8.21. Development of excessive cracking and joint opening (width of about 10cm), in quay wall at Alykes fishing harbor.

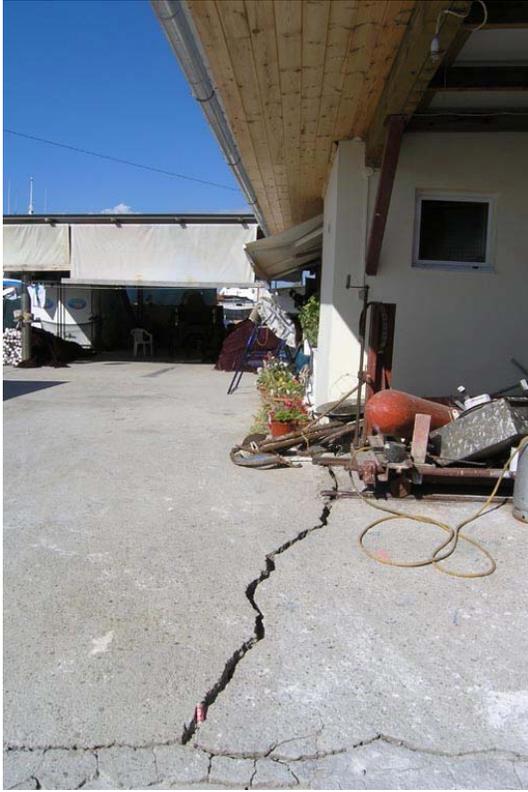
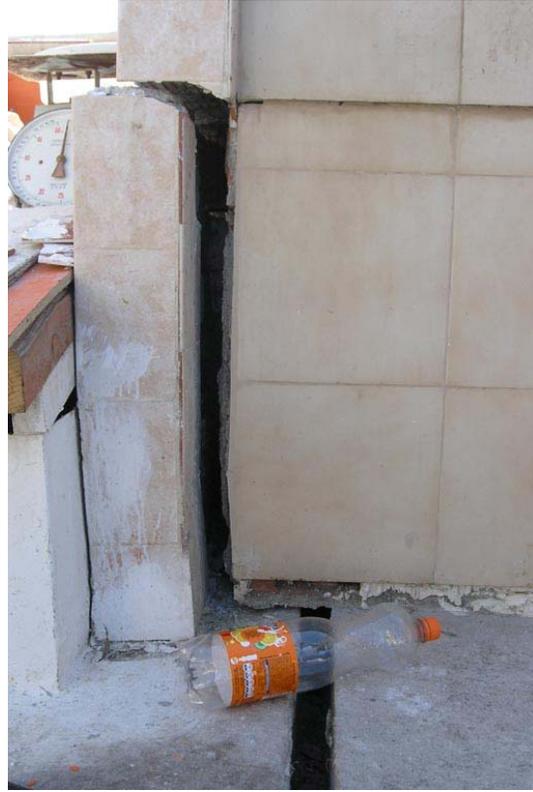
Figure 8.22. Development of separation crack between the foundation of a house and the surrounding ground (distance from the quay wall approximately 15m) in Alykes fishing harbor.

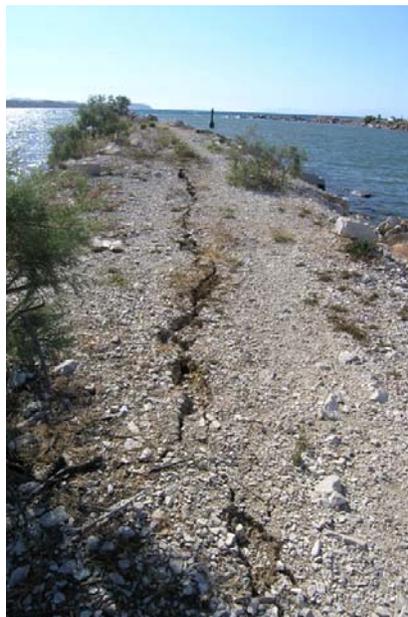
Figure 8.23. Development of surface cracking along the axis of a jetty at the Alykes fishing harbor.

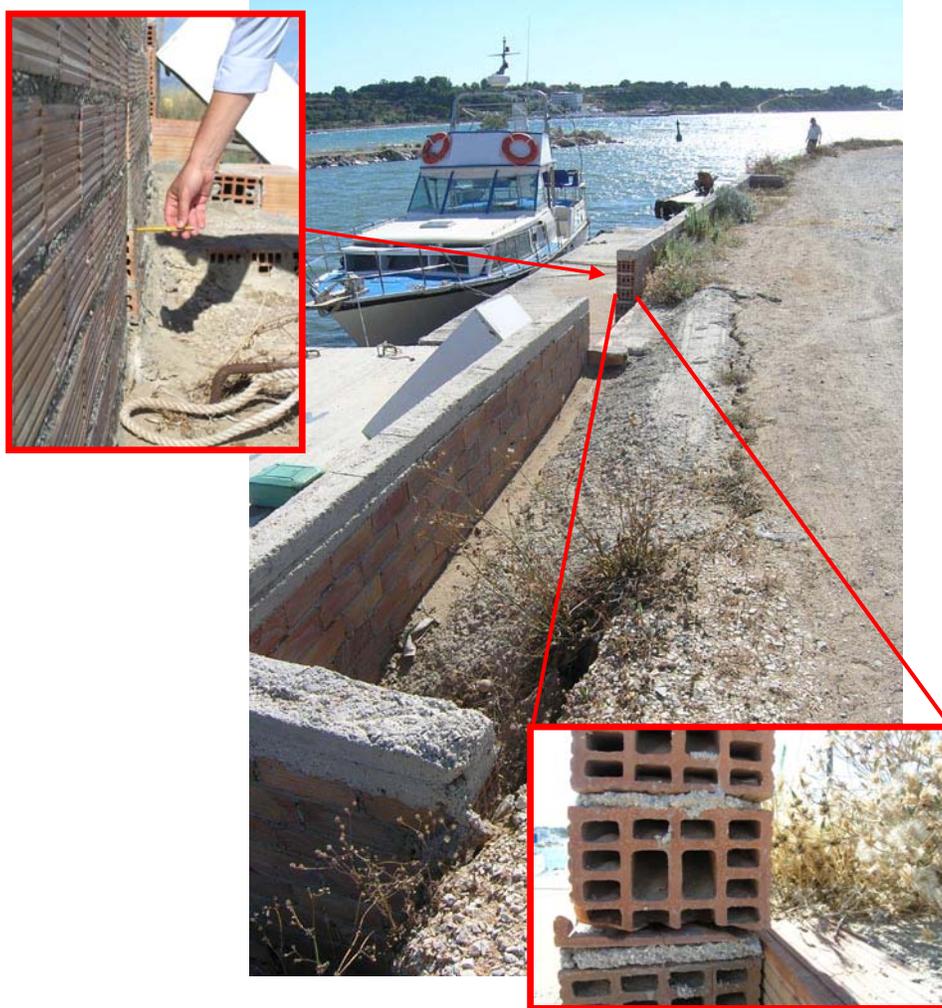
Figure 8.24. Breakage and horizontal displacement of a small retaining wall due to cracking (and related soil displacement) of a jetty at the Alykes fishing harbor.

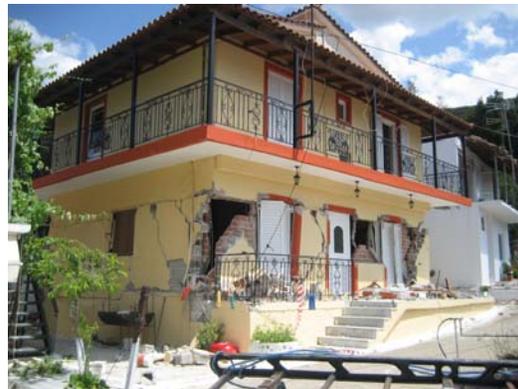
Figure 9.9. Valmi village. Severe cracks at a two-storey masonry building.

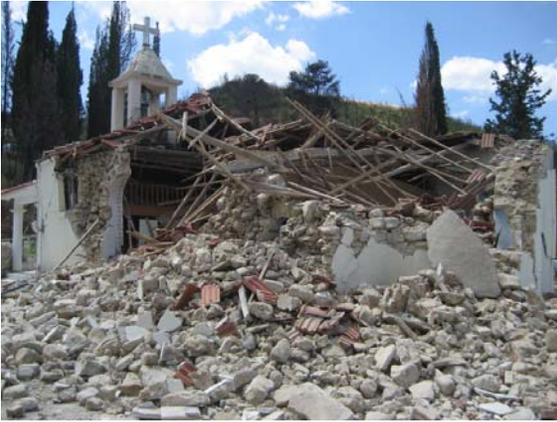
Figure 9.10. Valmi village. Total Collapse of a masonry Church building.

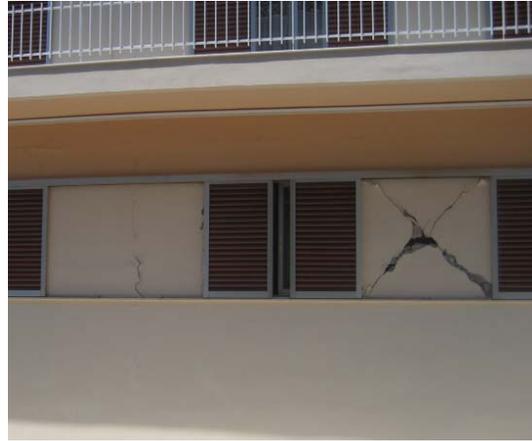
Figure 9.11. Amaliada town. Cracks at the infill masonry walls of r/c buildings.

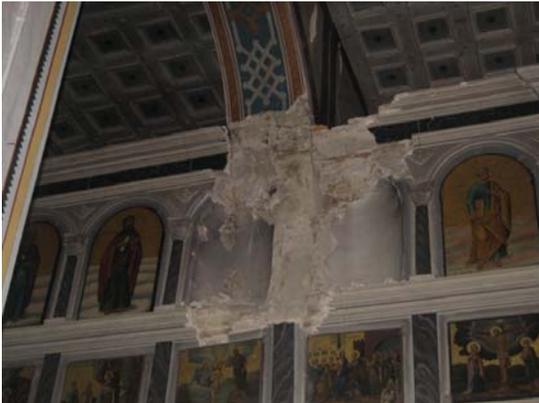
Figure 9.12. Amaliada village. Cracks at masonry arch of Agios Athanasios Church.

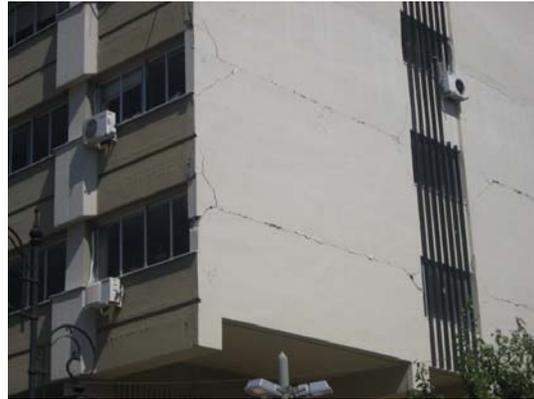
Figure 9.13. Pyrgos town. Infill wall cracks at the prefecture building.

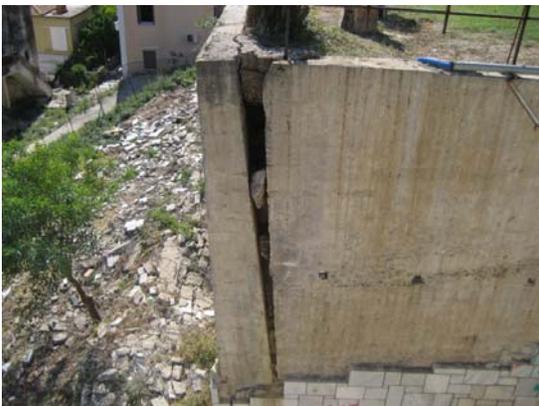
Figure 9.14. Pyrgos town. Horizontal displacement of R/C ground-supporting wall.

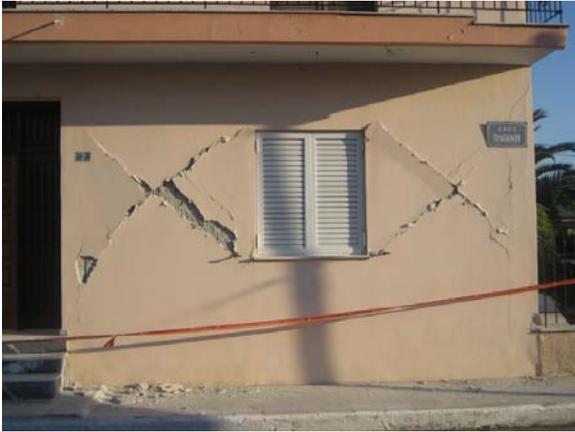
Figure 9.16. Andravida village. Cracks at the infill masonry walls in Stafidokampos area.

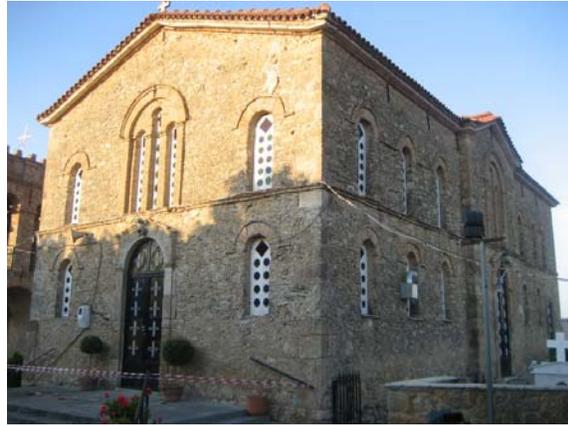
Figure 9.17. Andravida village. Cracks at upper area of a masonry church in the Strousi area.

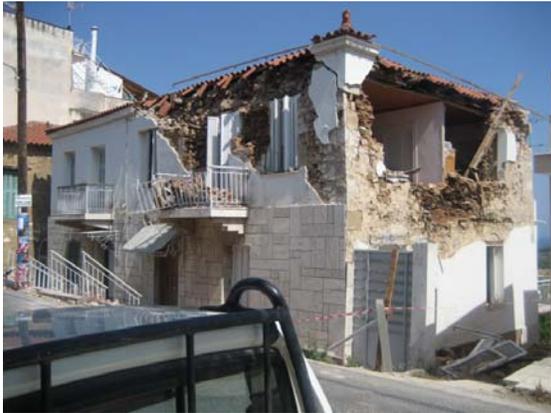
Figure 9.18. Kato-Achaia village. Partial collapse of masonry building.
