Preliminary Report on the Principal Seismological and Engineering Aspects of the $M_w=6.5$ Achaia-Ilia (Greece) Earthquake on 8 June 2008

Report for Web Dissemination
Geotechnical Earthquake Engineering Reconnaissance
http://research.eerc.berkeley.edu/projects/GEER/Post_EQ_Reports.html

GEER Association Report No. GEER-013

June 2008

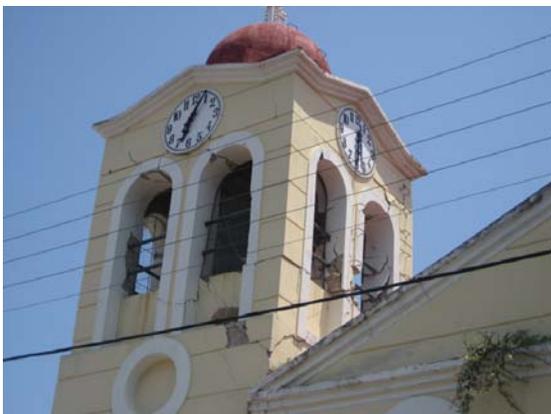
Figure 9.20. Vrachneika village. Cracks at the masonry bell tower of church.

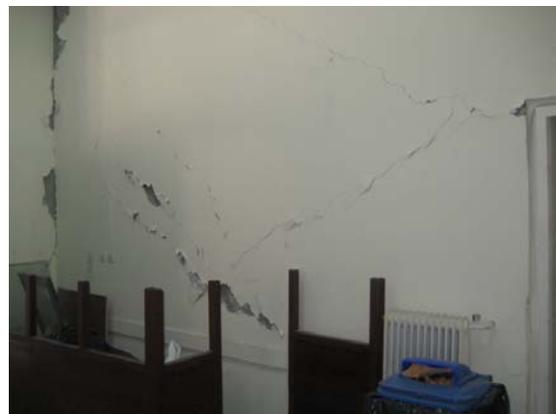
Figure 9.21. Patras town. Infill wall cracks at the Customs building in the port area.
