## 2. Geotechnical Aspects

### Liquefaction

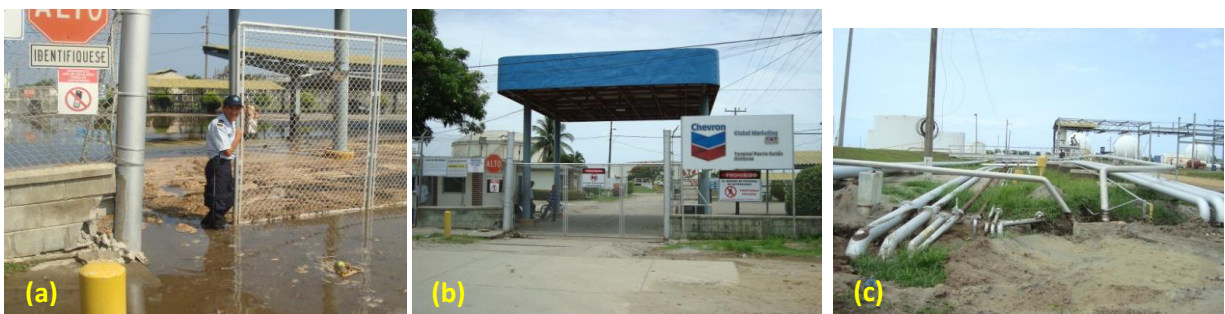
Of particular interest was the damage encountered at the Chevron Terminal in Puerto Cortés. This area was built on sandy fill. Liquefaction sand boils were wide spread throughout the terminal within tanks, pipe racks and small buildings (see Figure 3). Damage to tanks was not evident, except a pressurized vessel that settled more than 2 ft on one side tilting the entire tank, which was supported on shallow foundations (see Figure 4). Small structures supported on shallow foundations were damaged, such as the laboratory and office buildings (see Figure 5). Safety inspection requirements and repairs of tanks and pipeline systems will take more time.

Figure 3 – Chevron Terminal remains closed as of 06/28/2009.

- (a) Note inundation due to wide spread liquefaction [05/28/2009 N15.848287, W87.958041],
- (b) Same entrance location 3-weeks later [06/20/2009 12:40PM, N15.848287, W87.958041], and
- (c) Multiple pipeline deformation and breaks [06/20/2009 1:24PM, N15.849177, W87.959274]

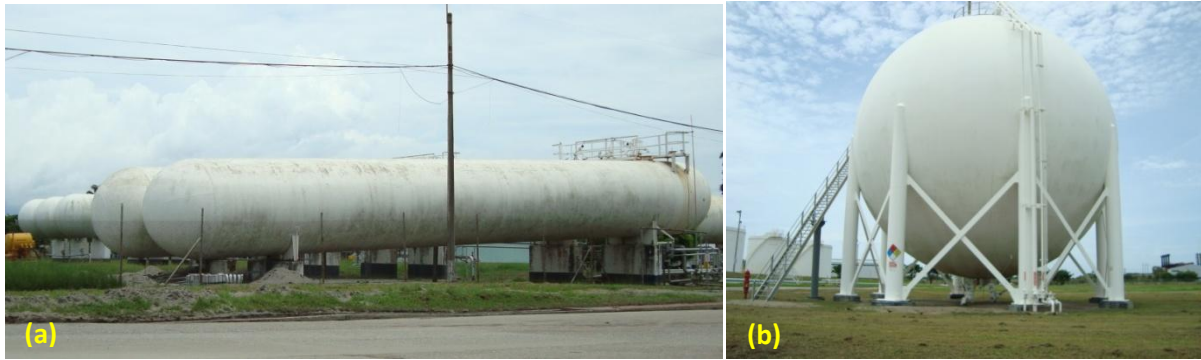
Figure 4 – (a) Tanks supported on shallow foundations sank and tilted, notice sand boil piled up next to foundation on left [6/20/2009, 1:12PM, 15.851061, -87.956882], and (b) those supported on piles performed well [06/20/2009, 1:16 PM, N15.851226, W87.958534].

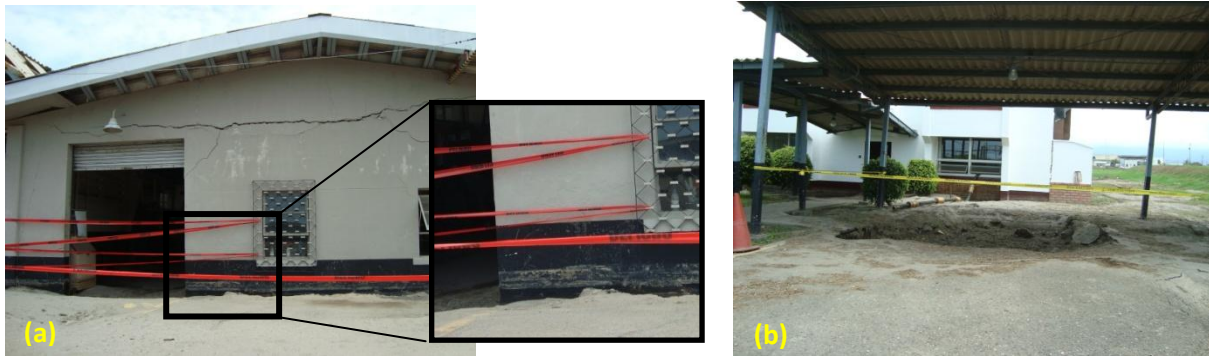
Figure 5 – (a) Buildings and small structures sank up to 3 ft and were flooded with liquefied sand [06/20/2009, 1:08 PM, N15.849851, W87.95793], and (b) vehicles sank into sand boils, see carport automobile was already extracted [06/20/2009, 1:25 PM, N15.848216, W87.958604].

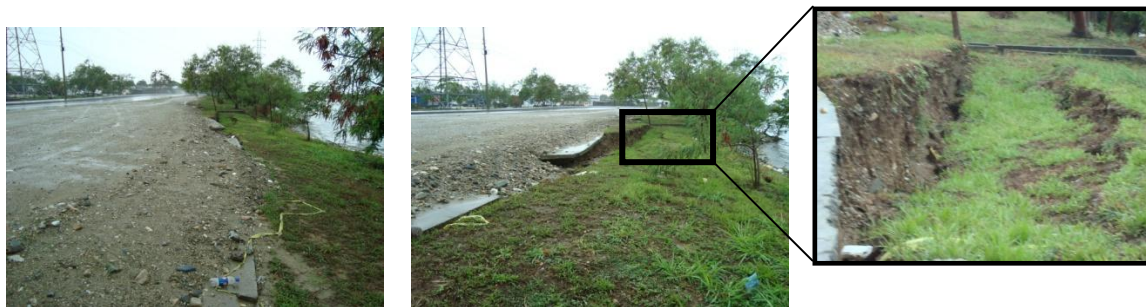
Other buildings and residences were damaged in the central zone of Puerto Cortés due to the wide spread liquefaction and ejected sand. Buildings tilted and became inundated, leaving much sand behind. The surface storm sewer system was clogged for weeks until the municipality and neighbors were able to excavate the drains. A recently build roadway embankment that contains a major utility on the south side of the city was seriously affected by lateral spreading. (Figure6)

Figure 6 – Temporary repair of roadway embankment, due to lateral spreading [06/20/2009, 1:25 PM, N15.848216, W87.958604].

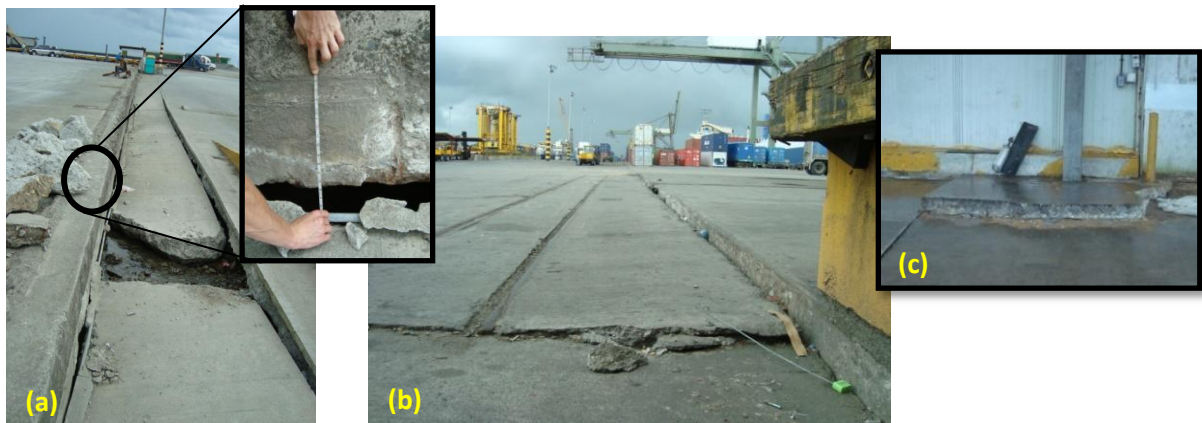
Earthquake damage at the most important port in Honduras was localized even though it remains in operation. Most of the damage was concerning movement of slabs and wharfs causing joints to move in the vertical and horizontal directions. In some cases the slabs collapsed due to the loss of subgrade support (Fig 7a and 7b). It was reported that some of the pile supported wharfs moved upwards by several inches. Some foundations appeared to have moved upward, but this differential movement is all relative to the surrounding ground subsidence, which needs to be confirmed by precision survey (Fig. 7c). Fuel tanks supported on concrete mats experienced large deformations due to widespread liquefaction and surface rupture of fill materials, see Figure 7(d).

(a) Up to 0.46m at the main dock [06/20/2009, 3:37PM, N15.843718, W87.951739],  
(b) 0.2m near port warehouses [06/20/2009, 3:49PM, N15.8424, W87.94941], and  
(c) Relative foundation displacement up to 0.15m [06/20/2009, 4:00PM, N15.841912, W87.941644].

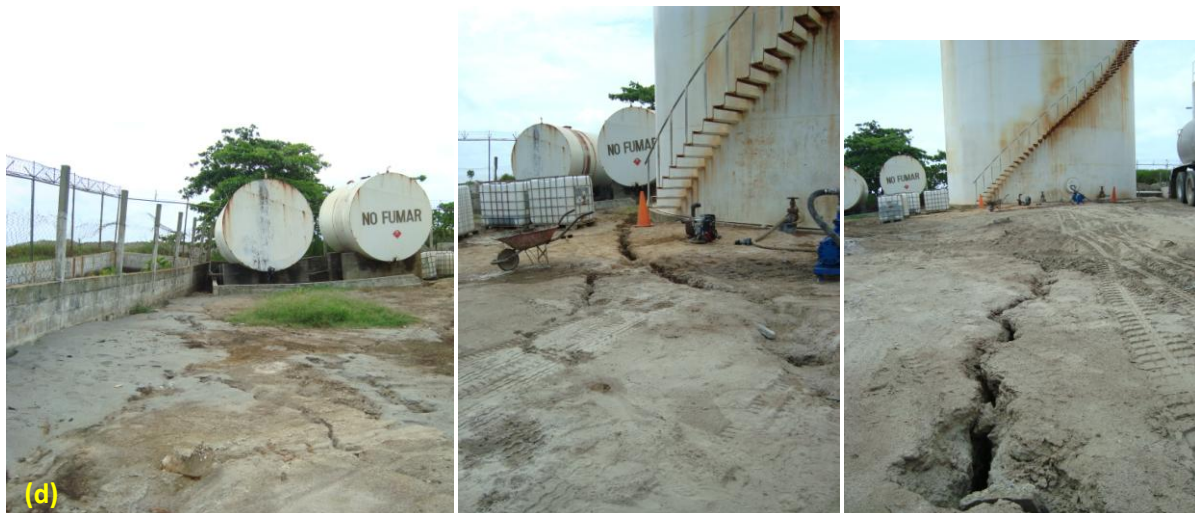
(d) Three view of fuel tanks and multiple ground fissures due to wide spread liquefaction  
[06/20/2009, 3:12PM, N15.846936, W87.963225]

Figure 7 – Liquefaction induced deformations at Puerto Cortés – Slabs on grade and Tanks.

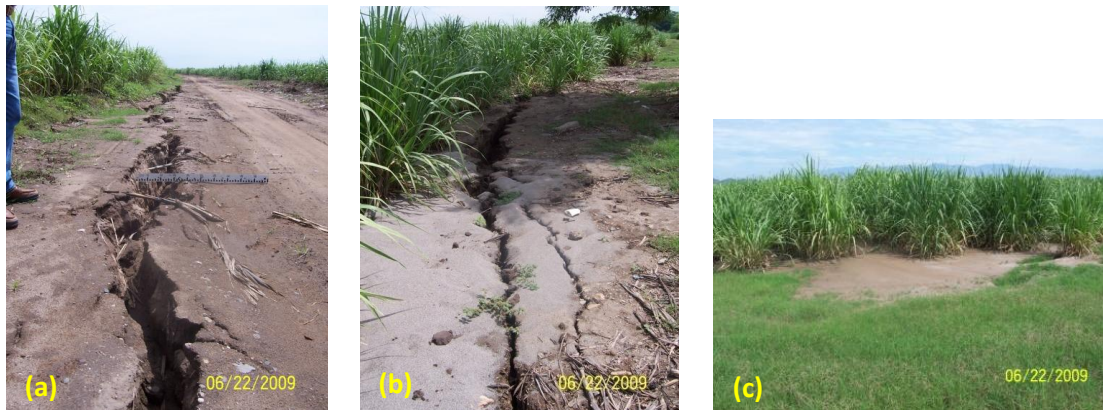
The valley of the Ulúa and Chamalecón rivers (Valle de Sula), runs north towards the Caribbean Sea. A system of levees protects the agricultural activities, urban and residential areas. A preliminary survey completed by the Comisión Ejecutiva Valle de Sula (CEVS) identified 58 km of levee damage due to the earthquake event. Lateral spreading was observed along the banks of the Ulúa River. On the edge of a sugar cane plantation, about 250 meters from the river edge, long fissures opened in the direction parallel to the river (Figure 8). The crack openings ranged from 10 to 50cm with a depth of about one meter. *Allochthonous sand ejecta* were present along the length of the fissures, and sand boils were scattered amongst the sugar cane plantations.

Figure 8 – (a) Longitudinal cracks along roadways [06/22/2009, 10:03AM, N15.368726, W87.861301], (b) with sand at surface [06/22/2009, 10:10AM, N15.369316, W87.860965], (c) sandboils within plantations [06/22/2009, 10:06AM, N15.368988, W87.861209].

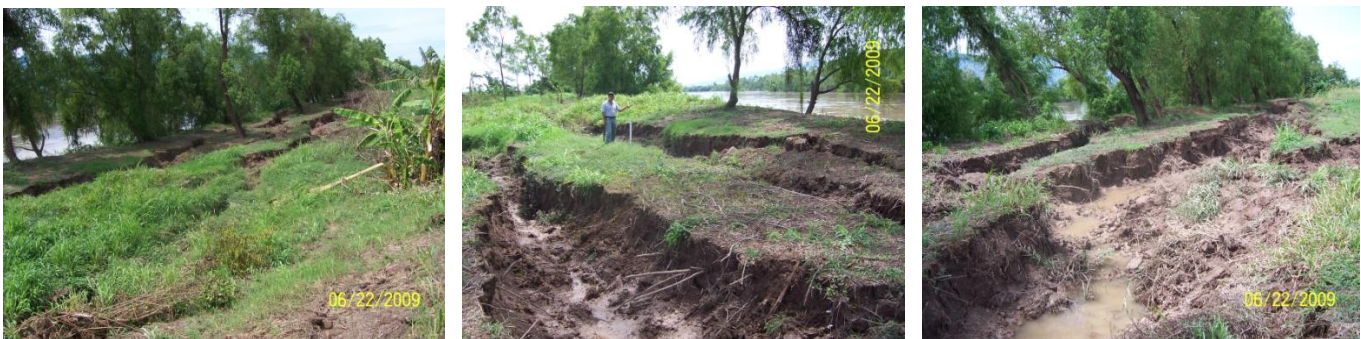
Near the edge of the Ulua River, on the unprotected zone of the levee system, extreme lateral spreading was evident. Gaping fissures up to 5 meters wide and two meters deep have indelibly altered the landscape (Figure 9). This will have serious consequences as the rainy season approaches and the levee system is not able to keep the flood water out of the protected zones (plantations and rural residences).

Figure 9 – Multiple views of severe lateral spreading between levees and river [06/22/2009, 10:25AM, N15.391266, W87.845191].
