3. Structural Aspects

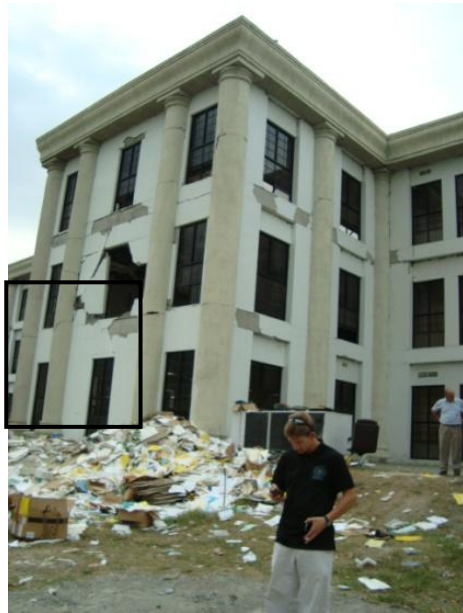
Infill walls, usually located between RC columns and beams, can suffer out-of-plane overturn due to inertial forces during an earthquake. Because infill walls are non-load-bearing elements, they tend to be thin and cannot rely on the additional shear strength that accompanies vertical compressive loads. If infill walls are not properly restrained in out-of-plane direction, walls can collapse during strong ground shaking, producing damages to inhabitants and properties. If walls on the façade of a structure collapse, the consequences could be deadly to pedestrians. Figure 11a shows a typical in-fill wall failure.

(a) Overall damage including out-of-plane failure of masonry infill wall [06/19/2009, 5:53PM, N15.472899, W88.018565].

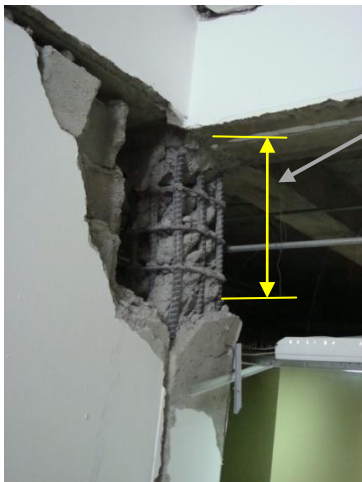
(b) Column failure at the infill wall frame interface [06/19/2009, 5:08PM, N15.473038, W88.018103]

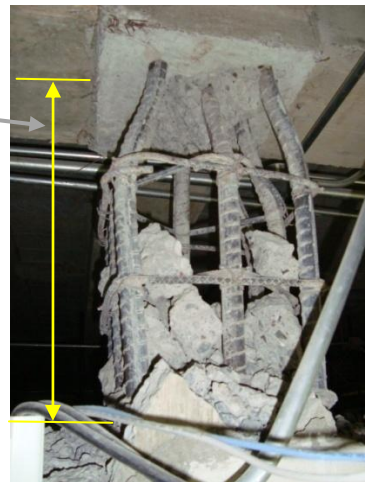
Inside the building and some locations, these frames were partially filled with masonry walls. This in turn causes the reduction in height of the column resulting in increased lateral shear during earthquakes. This is also called as short column effect. This failure mode, also called captive-column or captured-column, is very common in RC frames with infill walls. This failure happens when an infill wall is extended into a frame from the floor level up to another level to form a window, leaving a short free space in the top portion. The column in such a structure is partially restricted by the wall. This shortened column develops large shear force which may exceed the shear capacity of the column, resulting in failure. The problem is well known but is often ignored in practice. In some cases, the infill walls are separated from the column to allow flexure of columns. But insufficient gaps produced the same consequences. Figure 11b shows a reinforced column failed by shear. The column is constrained by masonry infill walls in perpendicular direction. Shear cracks were developed from masonry wall which led to shear failure of columns. Figure 11c shows the failure due to short column effect from a masonry infill wall. These columns had No. 3 ties spaced at 6 to 8 inches. This seems to be an inadequate detailing for seismic loading. The large spacing of lateral ties did not provide the required confinement to the core concrete.

(c) short column effect failure [06/19/2009, 5:31PM, N15.473346, W88.018592]

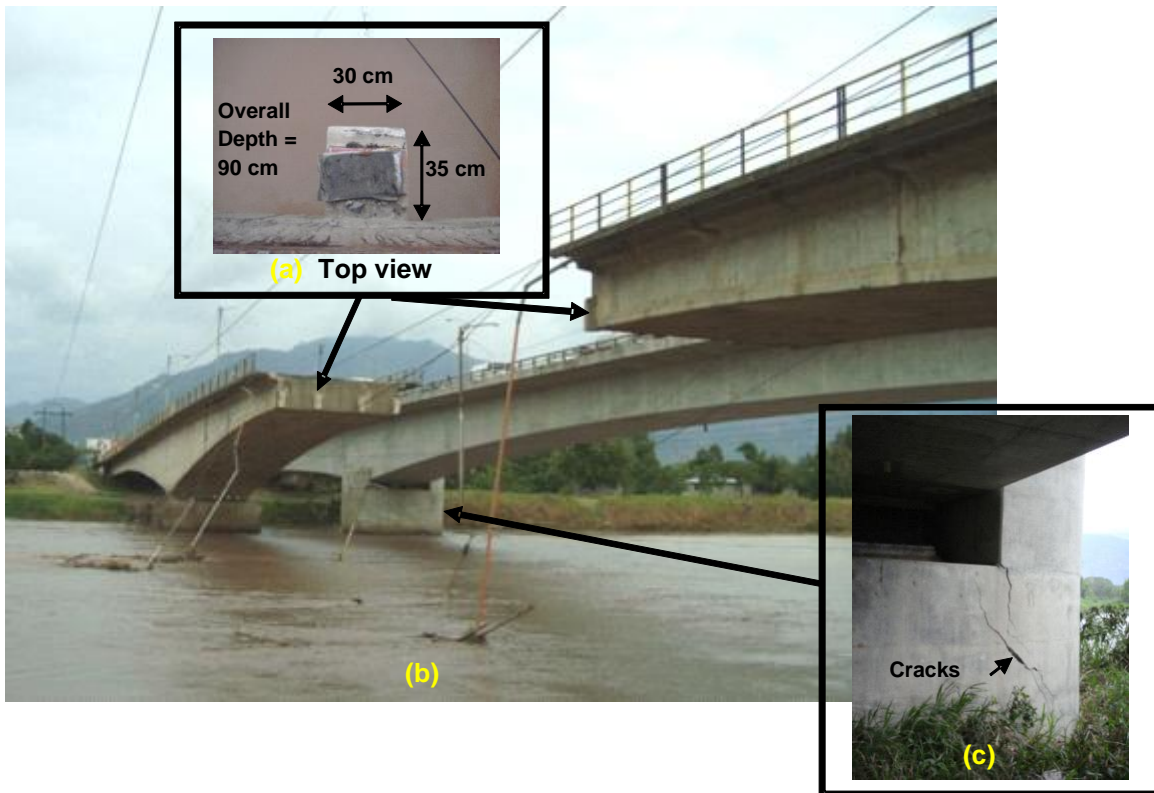
Figure 12 – La Democracia twin-bridge with middle span collapsed.

Two bridges suffered serious consequences by the seismic events of May 28th, 2009. The reinforced concrete 3-arch bridge, entitled “La Democracia”, crosses the Ulua River near the town of El Progreso. The bridge connects this town to the major city of San Pedro Sula in northern Honduras. The bridge that experience collapse of the middle span was built in 1965 by a team of French engineers. The structure consists of two middle supports with nearly symmetric monolithic arches, with the middle span complemented by a straight beam span. The total length of the bridge was 258 m. The middle span was 36 m. These middle components consist of four simply supported T-beams. All supports, including abutments, consist of steel plate bearings. Figure 12 shows the collapsed middle span and in the background the newer 2005 twin bridge built by the Japanese, which still is in service taking the traffic towards el Progreso. The bearings on the abutments moved more than 250 mm in the horizontal direction. This bridge had shear key only in the longitudinal direction to support the T-beams. This simply supported girder Type Bridge had inadequate seating and no provisions like lateral restraint to prevent unseating. The lack of redundancy in the simply supported beam also prevented formation of alternate load path which resulted in the fall of the beams and consequently the middle span.

- (a) Top view of shear key [06/19/2009, 6:45PM, N15.404139, W87.820174].
- (b) Overall view of the twin bridge [06/19/2009, 6:45PM, N15.40478, W87.819967], and
- (c) cracking due to lateral restraint in the new bridge [06/19/2009, 6:58PM, N15.40408, W87.820615].

In contrast, the new bridge, which consists of a single monolithic concrete arched structure, has neoprene elastomeric bearings and shear keys at the supports. The shear keys suffered diagonal cracks, evidence that they engaged in keeping the bridge on its bearings during the seismic event. A transverse crack on the bridge (western bank) was identified. Liquefaction sand boils and significant settlement of the banks and possible lateral spreading was evident on the river banks. In some locations cracks and settlement exceeding 250 mm was observed (See Figure 13).

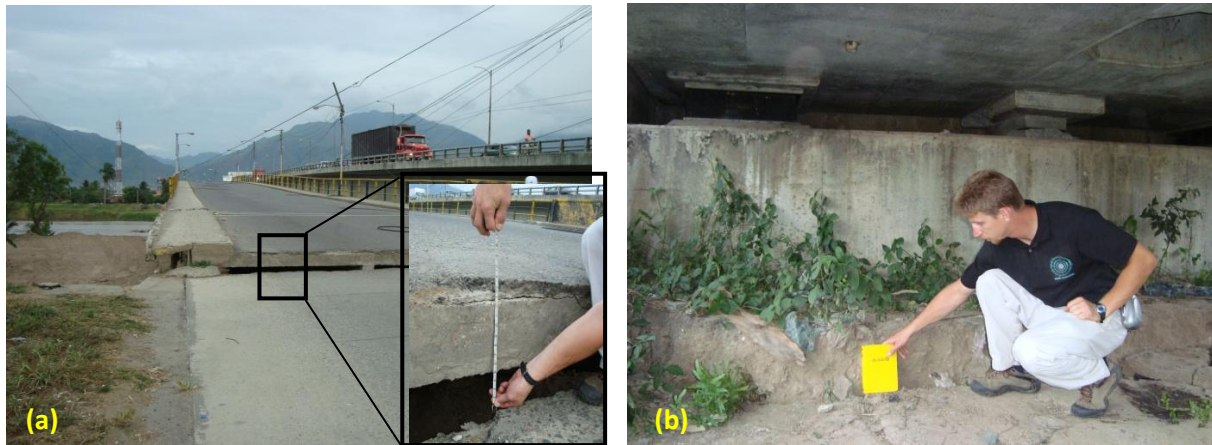
Figure 13 – Settlement of ground around abutments due to liquefaction
(a) Old bridge westbound [06/19/2009, 6:36PM, N15.404409, W87.821095], and
(b) New bridge, eastbound [06/19/2009, 6:52PM, N15.40422, W87.821021].

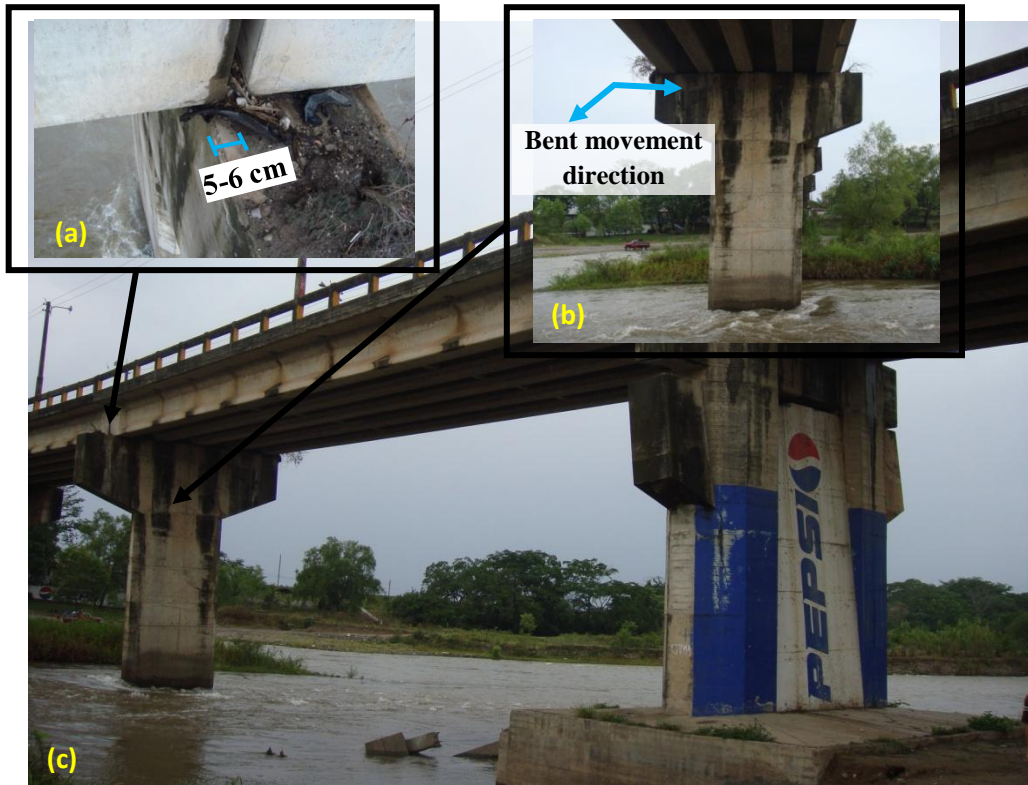
The other bridge that suffered damage during the seismic event was the bridge near Santa Rita over the Humuya River (Figure 14). The foundation support was already weakened due to scour, which historically has damaged the bridge and scour continues to aggravate the situation. The most common cause of bridge failure is structural instability and undermining caused by movement of column bent exaggerated by excessive scouring. Scour is the result of the erosive action of flowing water, excavating and carrying away material from the bed and banks of streams, and from around the piers and abutments of bridges.

This two-lane bridge consists of 8 spans of 5 simply supported reinforced concrete girders (1m x 0.6m x 30m) built in the 1970s. Two supports experienced significant movement and the third column bent was tilted and rotated causing settlement and a reduction in the bearing support of the girders. The fourth span had only about 5 to 6 cm of bearing on the third column bent as shown in Figure 14. The night of June 28th several spans collapsed as shown in Figure 15.

Figure 14 – Santa Rita Bridge over the Humuya River after the earthquake and before collapse

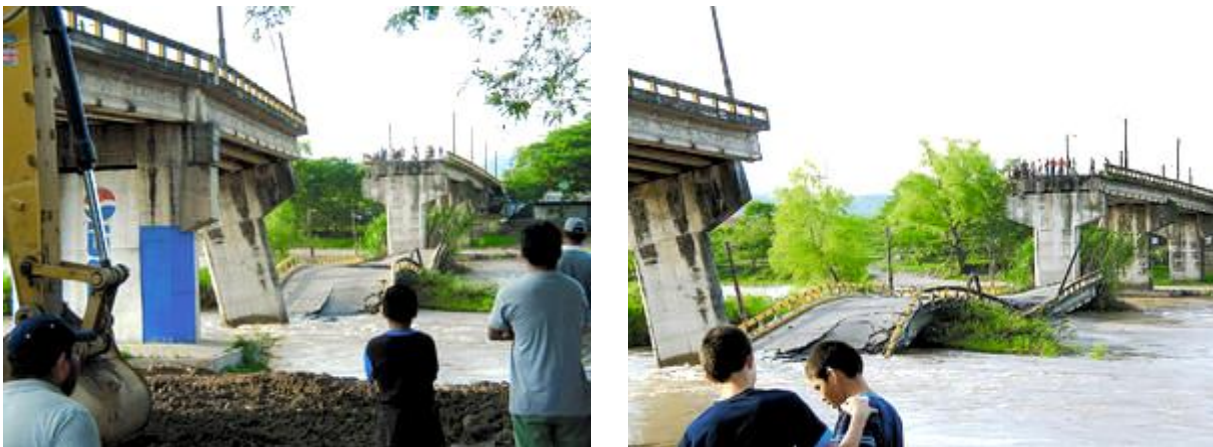
Figure 15 – Collapse of the 2 to 3 spans of the Sta. Rita Bridge over the Humuya River post-earthquake [06/28/2009, N15.191019, W87.892095] (source: LaPrensa.hn).

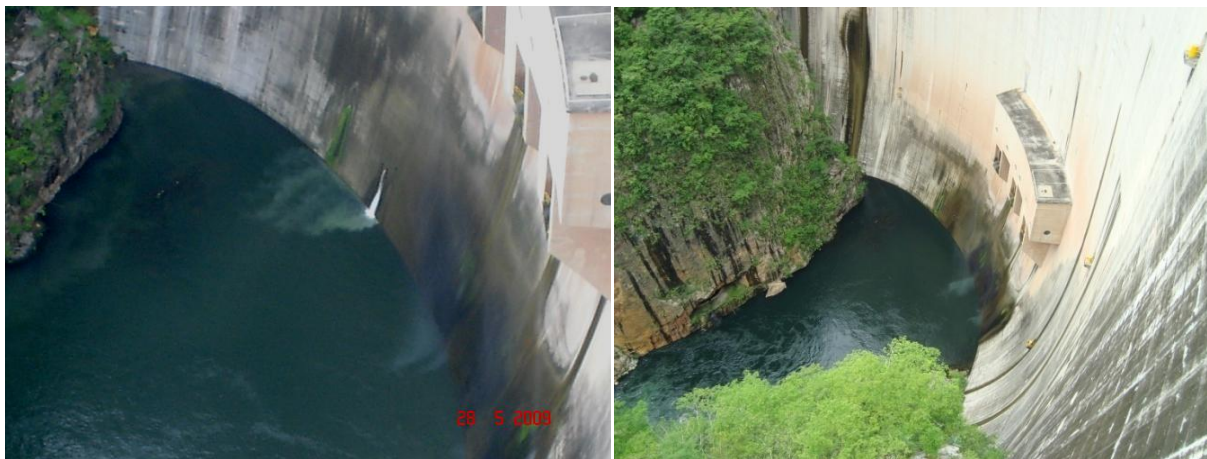
Figure 17 – (a) Turbid seepage at base of dam [05/28/2009, N15.03096, W87.747885], and (b) clear seepage at base of dam [06/21/2009, 11.55AM, 15.03096, -87.747885]
