GEOTECHNICAL RECONNAISSANCE AND INVESTIGATION OF IMPACTS FROM HURRICANE IAN

Geotechnical Extreme Events Reconnaissance
GEER Report - 080

Report Date: 9/21/2023

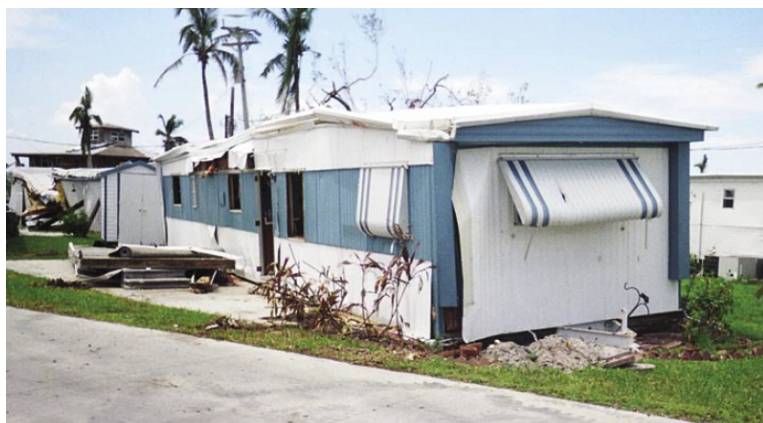
Figure 2.8: An older manufactured home that was uprooted off its base and damaged the building itself in Pine Island. Coordinates: 26.49995, -82.08538 (Ingargiola *et al.*, 2005)

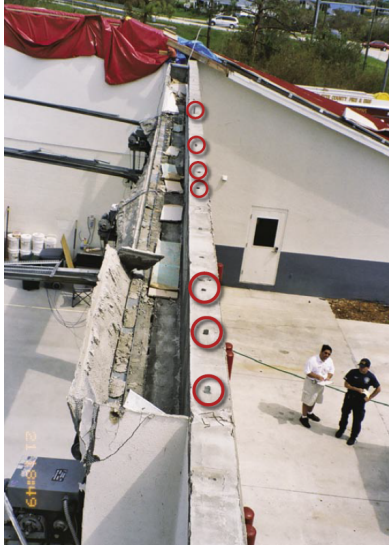
Figure 2.9: At Fire Station No. 12, the tie-beam storm anchor straps for the roof truss failed in Port Charlotte. Coordinates: 27.00927, -82.035509. (Ingargiola *et al.*, 2005)

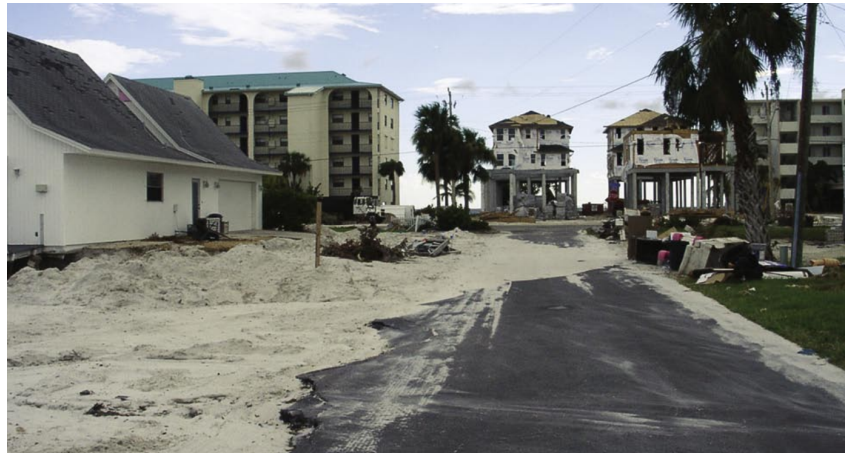
Figure 2.10: Scouring of the road and damage to the infrastructure in Fort Myers Beach. Coordinates: 26.45060, -81.95103

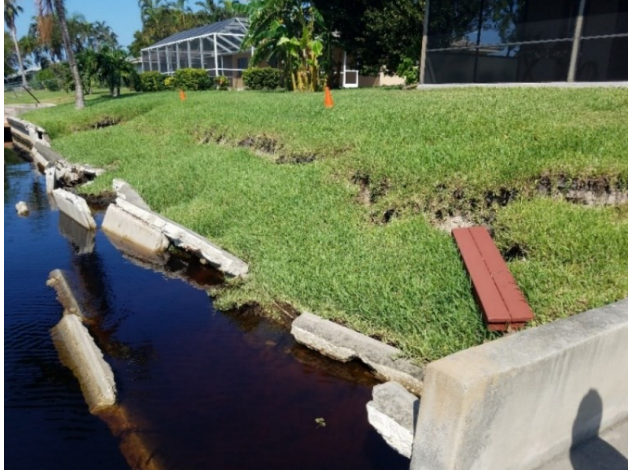
Figure 2.13: Seawall collapse at Cornwallis Parkway in Cape Coral. Coordinates: 26.595572, -81.930611 (Stark & Hudyma, 2017)

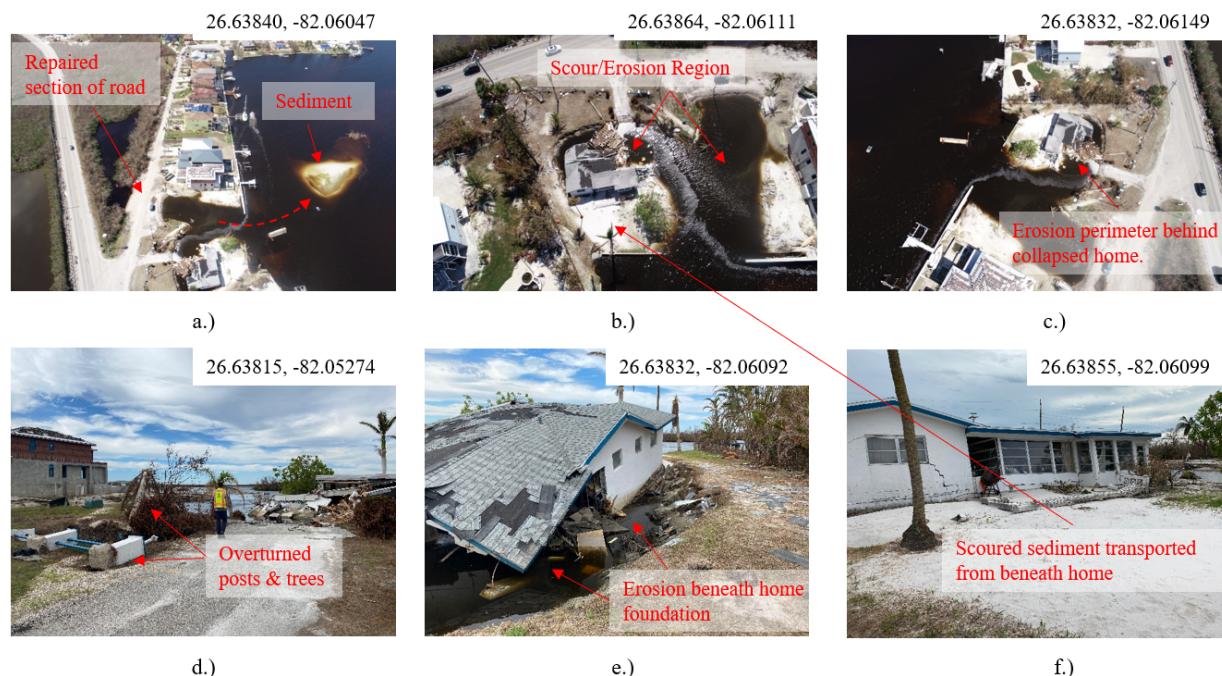
Figure 4.3: Damage and erosion near the intersection of Shoreview Drive and Pine Island Road in Matlacha: a.) drone image of repaired section of roadway and accumulation of sediment on shoal beyond failed retaining wall indicating likely direction of high water flow; b.) scour and erosion of lawn between new home under construction (right) and collapsed home (left); c.) erosion behind collapsed home; d.) overturned posts and trees potentially indicative of direction water flowed; e.) scour and erosion beneath foundation of collapsed home; f.) front of collapsed home and eroded sand sediment piped from beneath home to front lawn potentially indicating direction of water flow.

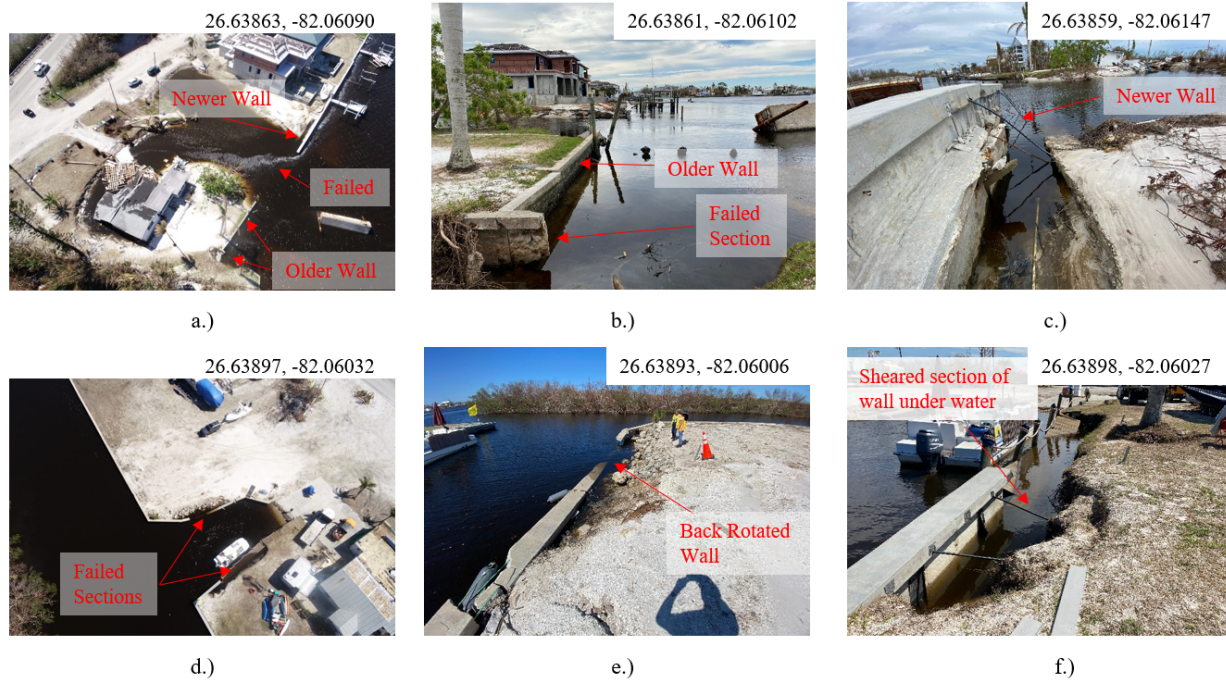
Figure 4.4: Damage to retaining walls near the intersection of Shoreview Drive and Pine Island Road in Matlacha Isles-Matlacha Shores: a.) drone image showing failed section of retaining wall believed to have occurred at the interface of older and newer section of the seawall; b.) older portion of sea wall; c.) newer section of sea wall; d.) drone image of failed retaining walls at a boat ramp; e.) back-rotated sea wall on one side of boat ramp; f.) sheared portion of a seawall underwater on other side of the boat ramp.

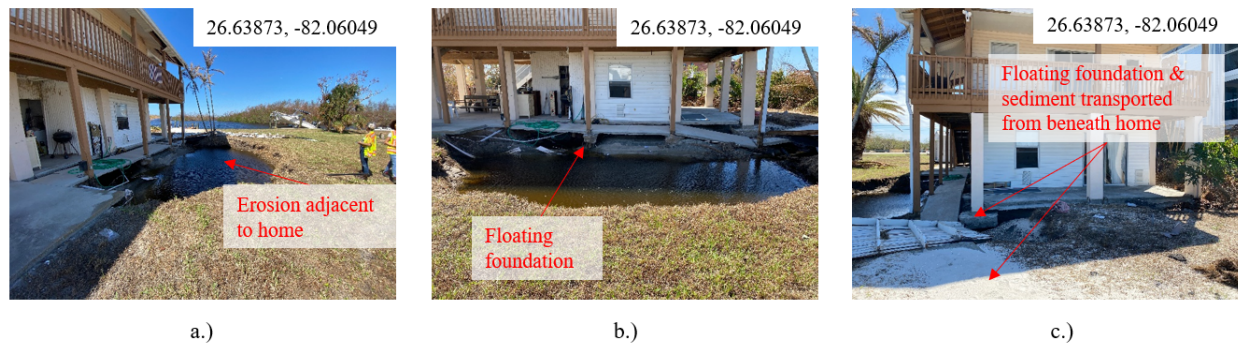
Figure 4.5: Erosion near home on Pine Island Road in Matlacha near intersection with Shoreview Drive: a.) erosion adjacent to residential home; b.) scour beneath concrete slab and unsupported deck column; c.) unsupported foundation and sediment transported to front lawn from beneath the home. Coordinates: 26.63818, -82.06133

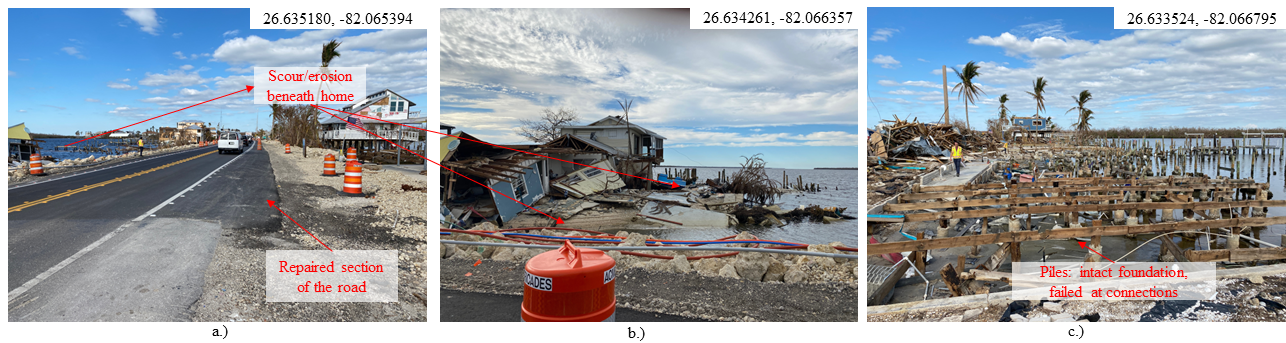
Figure 4.7: East entrance to Matlacha: a.) newly paved road connecting Matlacha and Pine Island; b.) erosion and scour underneath a house adjacent to the road on the upper east side of Matlacha; c.) lower left side of the east entrance of Matlacha where a significant number of houses slipped away due to failure at the piers connections.

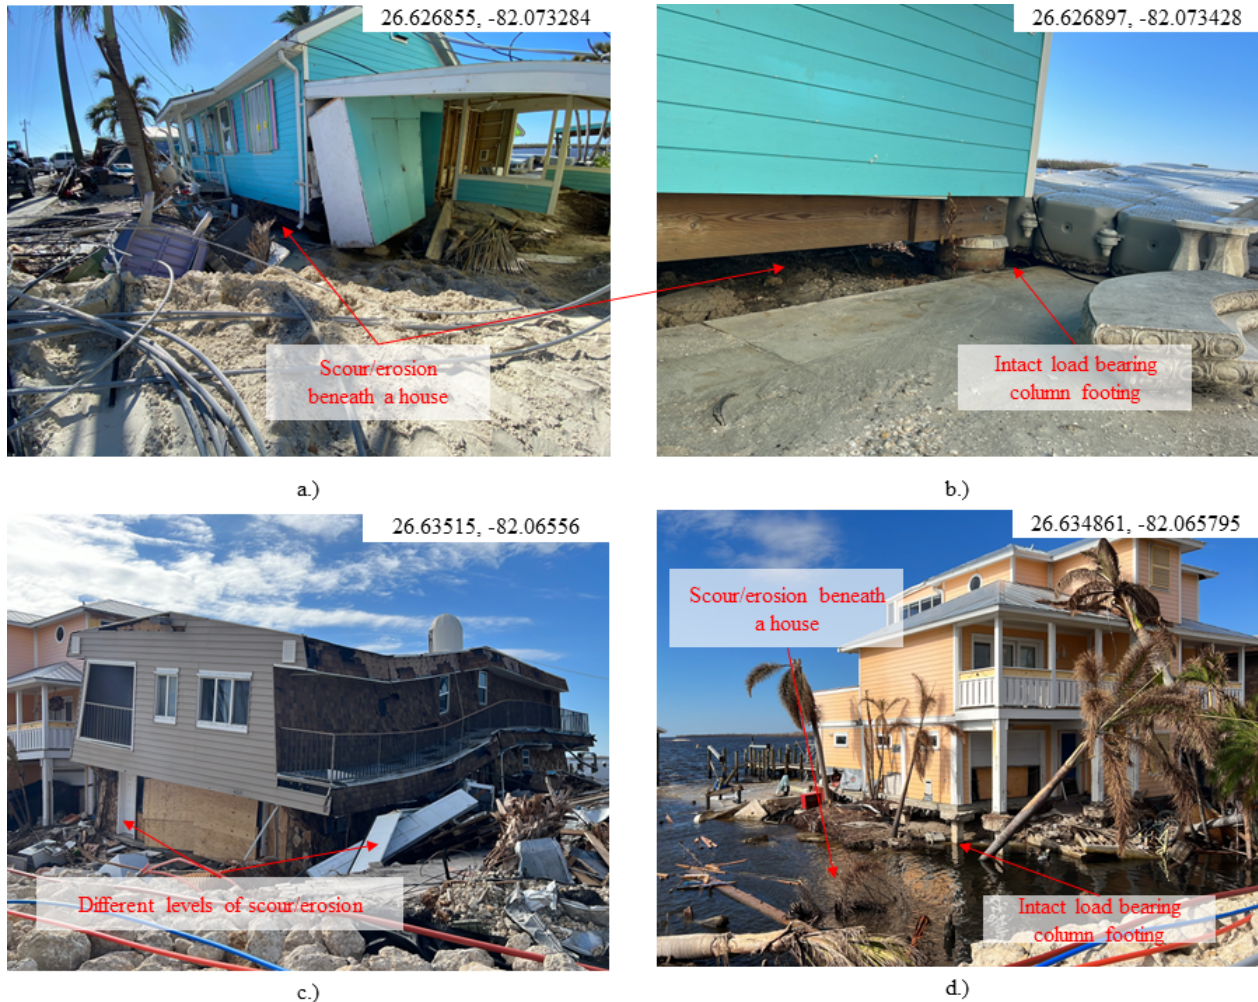
Figure 4.8: East entrance to Matlacha: a.) accumulation of sediment and debris and erosion and scour underneath the house; b.) load-bearing column without any damage to the footing during the scour and erosion process underneath the foundation at the back of the house; c.) different levels of erosion underneath the house's foundation resulting in a differential settlement; d.) the load-bearing columns remaining intact without any damage, despite a significant amount of scouring and erosion

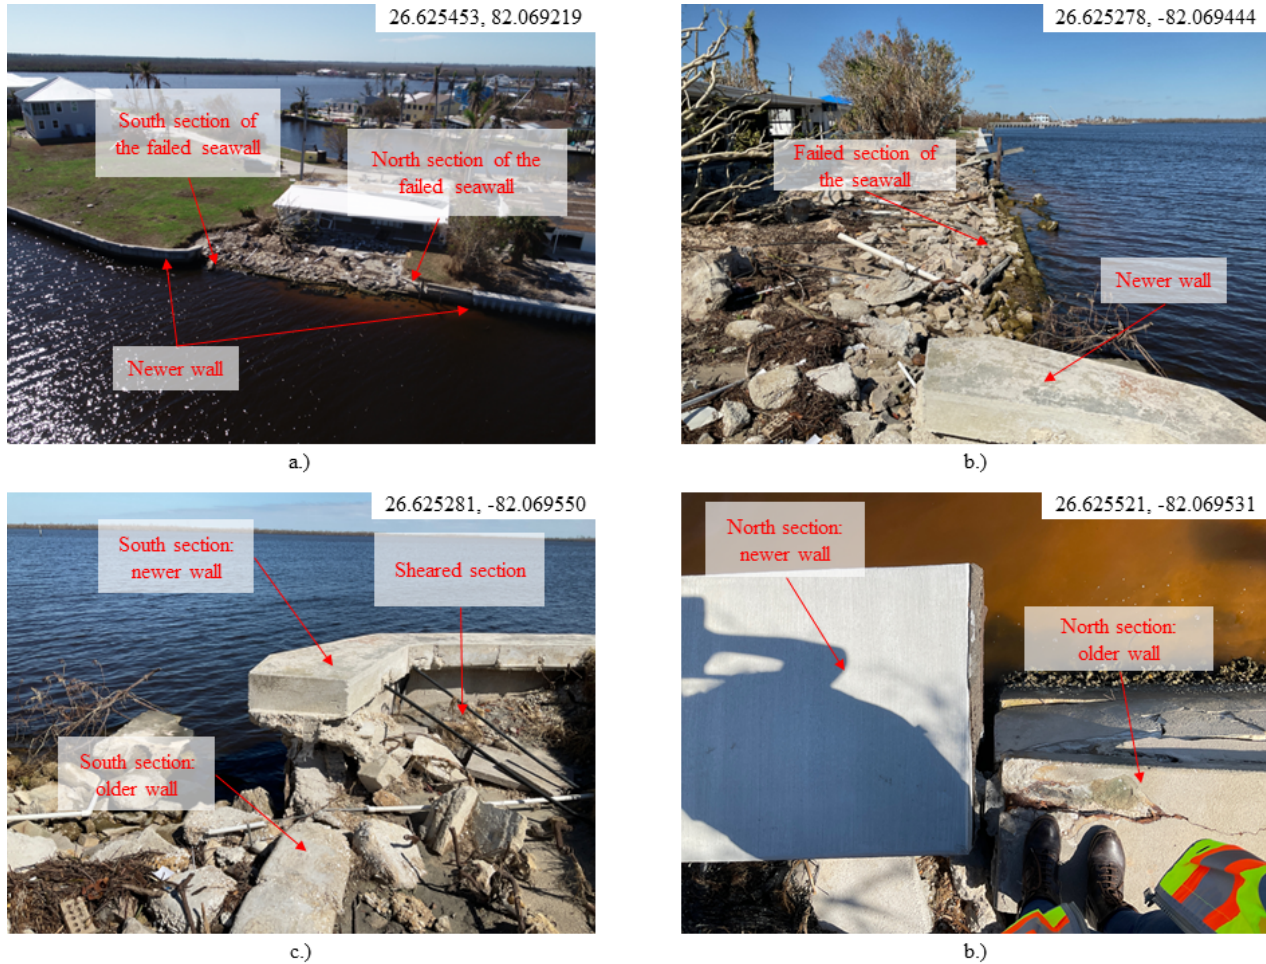
Figure 4.9: Damage to the seawall on the east of Matlacha Isles-Matlacha Avenue: a.) drone image depicting the newer installed seawall and the failed section of the old seawall believed to have failed at the intersection of the new and old one; b.) ground image showing the failed section of the seawall situated at the south of the river; c.) erosion behind the sheared section of the south seawall and breakage at the intersection of the old and new seawall; d.) plan view of the north section of the failed sea wall, depicting a stark contrast between the old failed seawall and the new one.

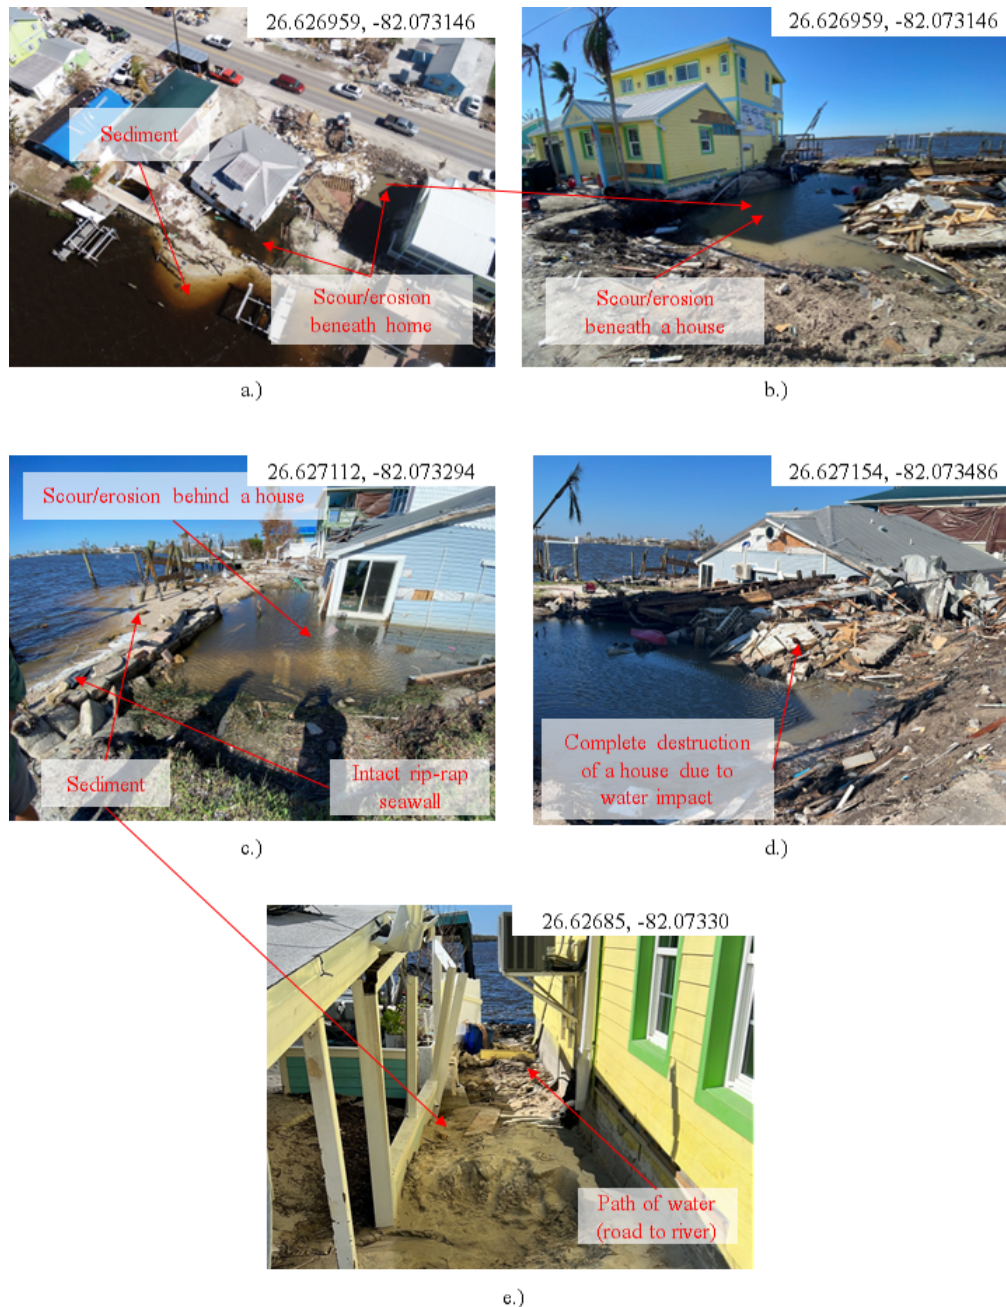
Figure 4.10: Severe damage and erosion to houses on Matlacha Isle, located on the left side of Pine Island Road: a.) drone image showing sediment accumulation, indicating the direction of high water flow with evidence of scouring and erosion beneath the foundation of two homes; b.) ground image depicting evidence of scouring and erosion beneath the foundation of the yellow house; c.) ground image of the back of the blue house reveals transportation of sediment, indicating the direction of water flow from behind the intact rip rap seawalls. The settlement of the house is also visible due to erosion and scouring beneath its foundation; d.) One house has been completely destroyed, with debris and water accumulation observed at the site; e.) accumulation of sediment suggesting water flow direction from Pine Island Road to the back of the houses, which is opposite to the predicted path.

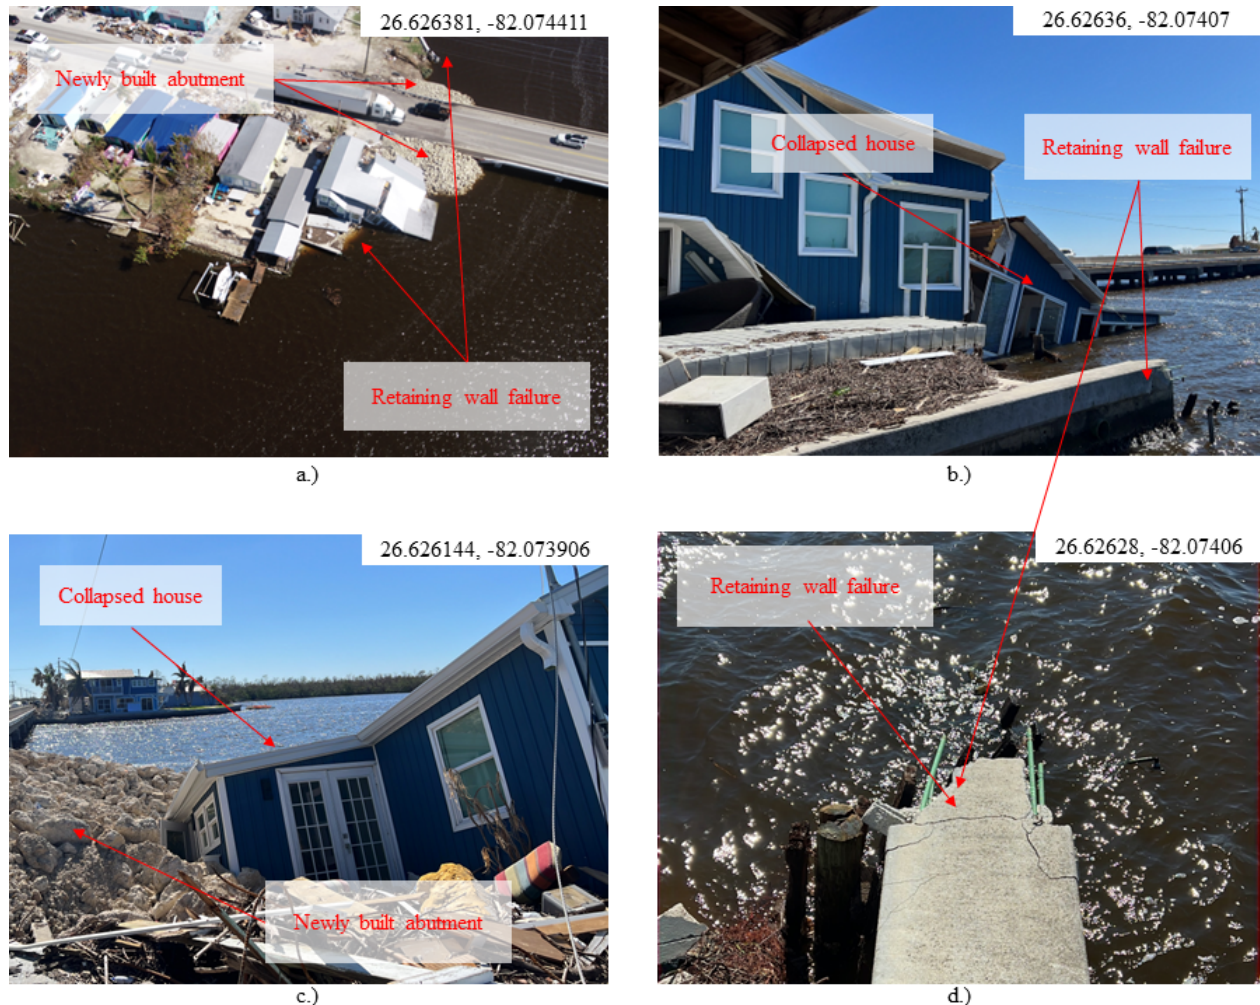
Figure 4.11: West entrance to Matlacha: a.) drone image of a severe retaining wall failure on both sides of the bridge along with the newly built abutment; b.) ground photo of the back of the house showing the remaining section of the retaining wall and the magnitude of collapse caused by the failure leading to half of the house sinking; c.) ground photo showing the road front of the house with the abutment built after the collapse; d.) Plan ground photo of where the retaining wall failed behind the house.

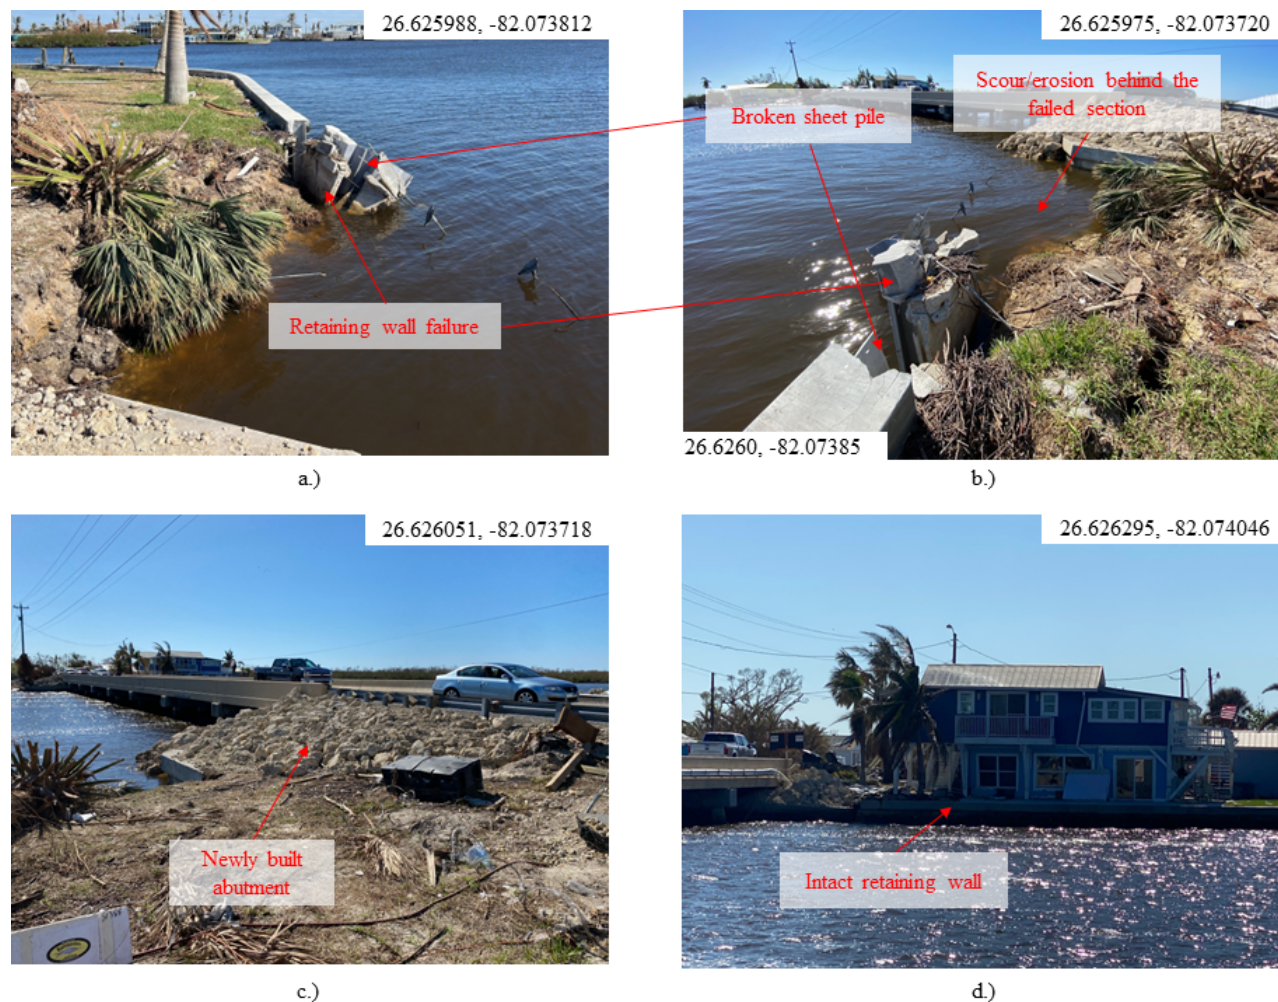
Figure 4.12: Ground photo of the upper side of the bridge: (a) remaining piece of the broken seawall showing breakage in the sheet pile's connection; (b) scour and erosion as a result of the failed seawall behind the failed section causing more damage to the wall and accelerating the deterioration; (c) ground photo of the newly built abutment for the bridge; (d) ground photo of the lower side of the bridge showing the intact seawalls that had no damage.

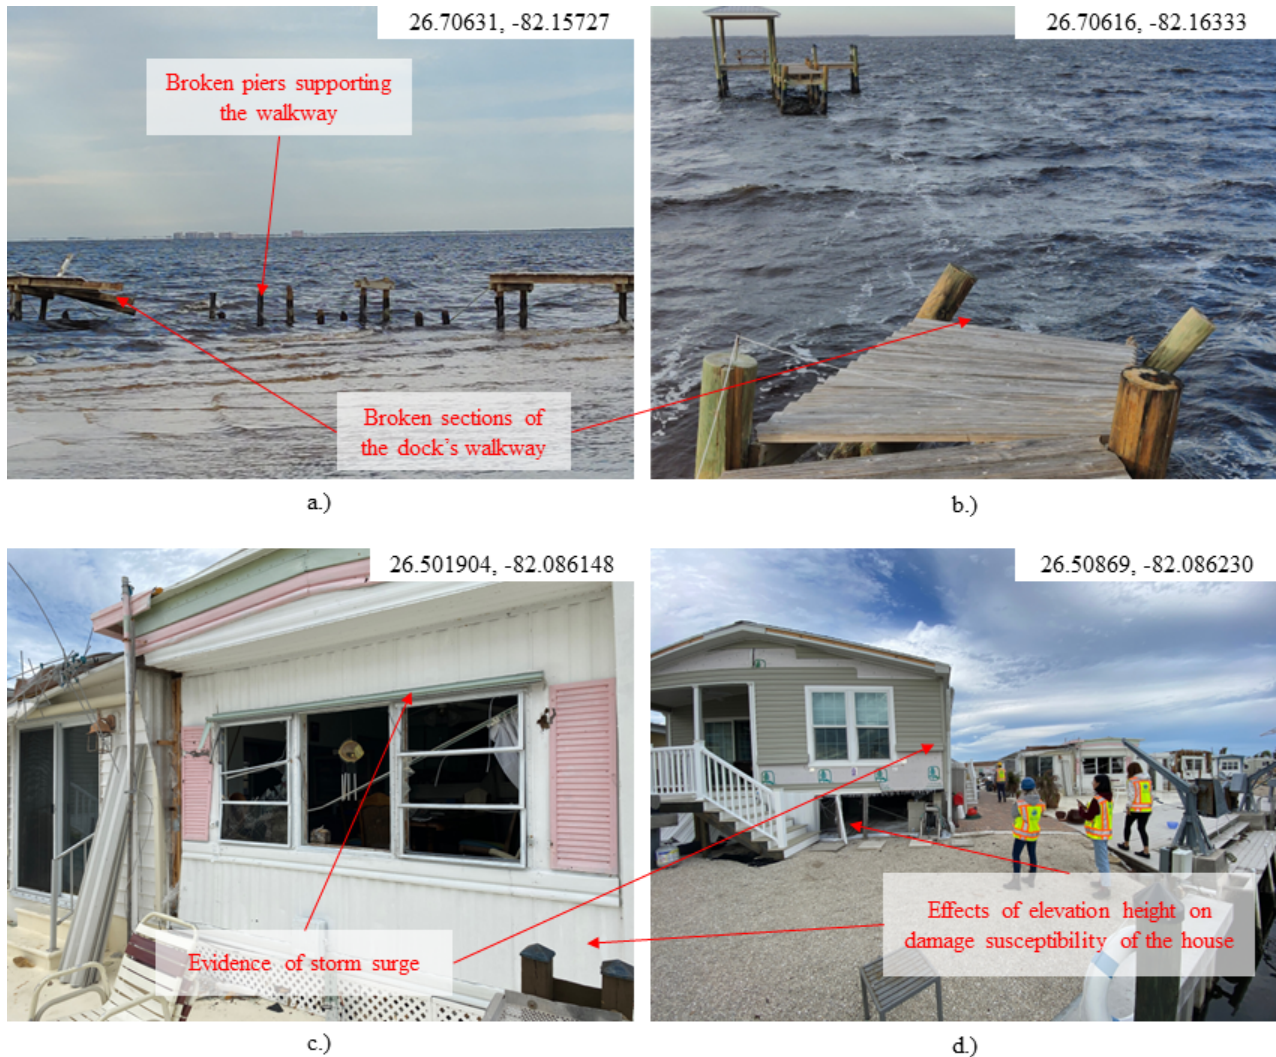
Figure 4.13: Ground photo of a broken dock in Bokeelia (top) and housing destruction in St. James city (bottom): (a) broken sections of the walkway is shown to be a cause of pillars breaking in half or being picked up at the base by the wave power; (b) closer look at the broken sections of the dock's walkway showing complete submergence of the supporting pillars; (c) evidence of storm surge in St. James City as damage was observed to go up to the top rim of the windows for houses that were on the same elevation; (d) for houses that were elevated higher, less damage was seen to be slightly above the lower rim of the windows approximately 6 feet high.

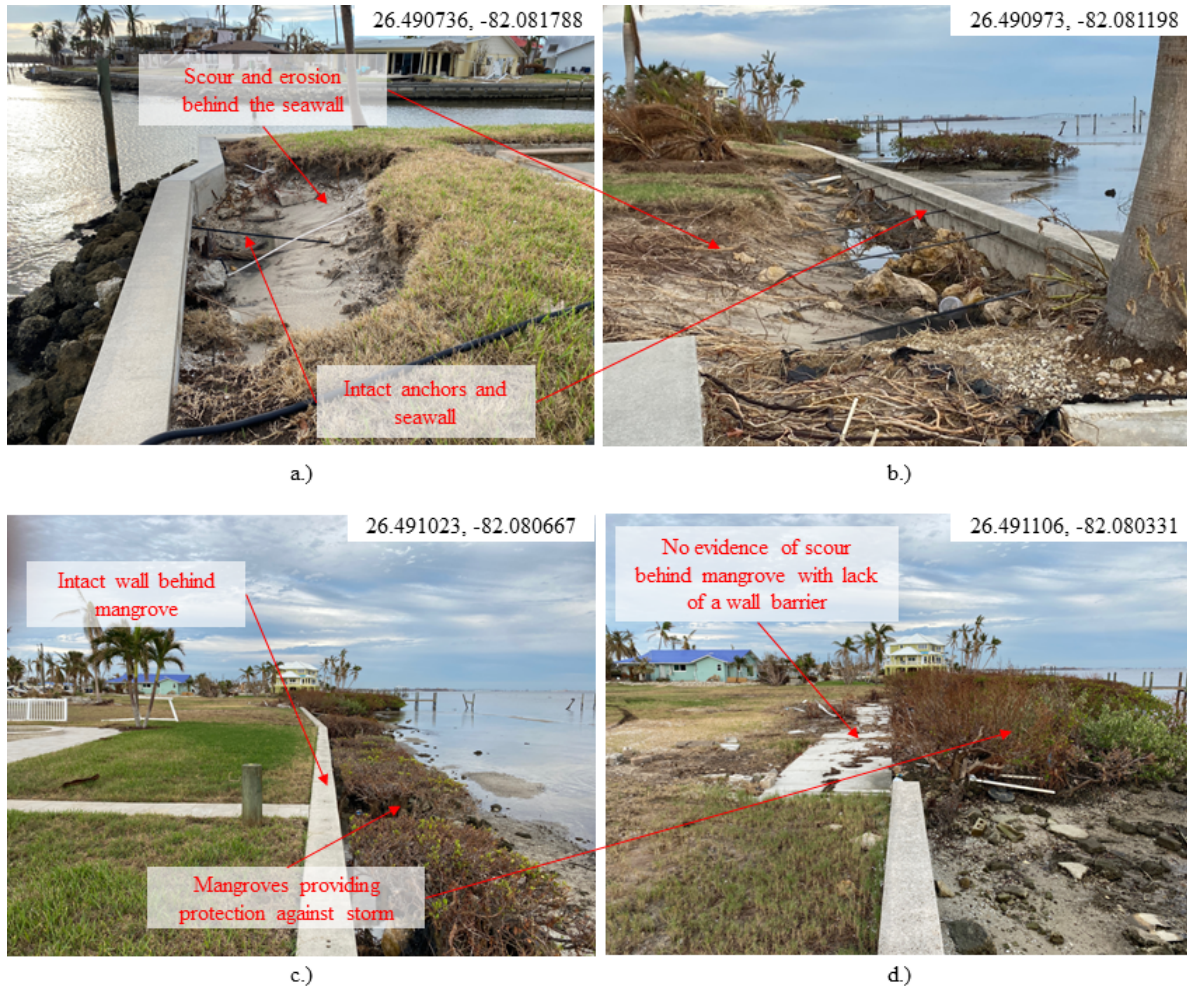
Figure 4.14: Ground photos St. James City: (a) scour behind the seawall noting that the seawall itself and the anchors are intact and no mangrove is present; (b) another instance of no mangrove being present and the seawall and anchors being intact with scour behind them; (c) no scour is present behind the seawall in lieu of protection from mangrove; (d) another example of mangrove protecting against scour where there is no sign of scour even where there is no seawall

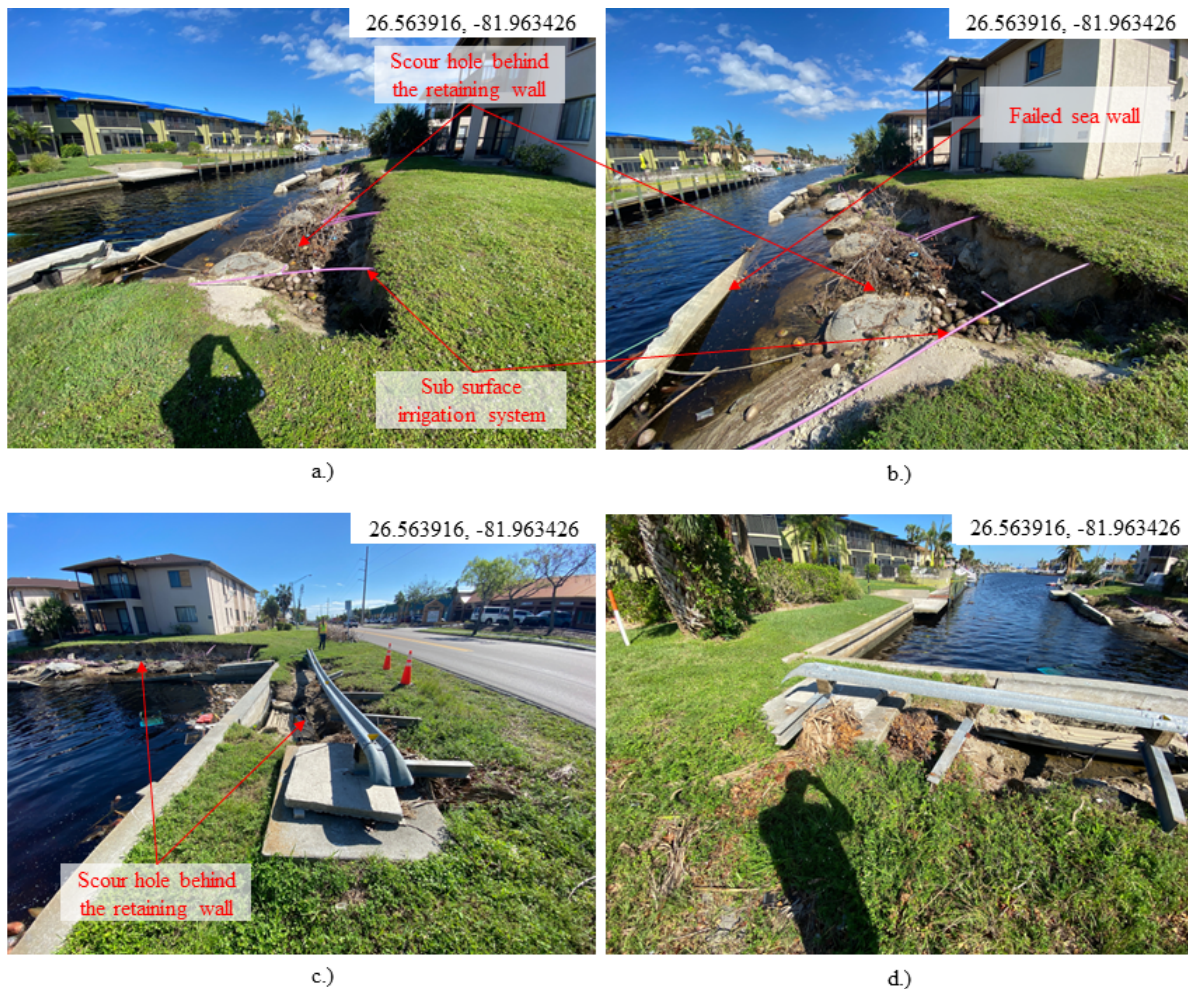
Figure 4.15: Ground photos of erosion-induced sinkholes at Cape Coral: (a) failed retaining wall on the side of the canal causing extreme ground depression and failed anchor rods with visible subsurface irrigation system; (b) a closer look at the same site; (c) top of the canal where much less soil erosion is present and the retaining wall has not failed; (d) behind the retaining wall at the top of the canal, showing some ground depression due to the erosion caused presumably by the drainage system

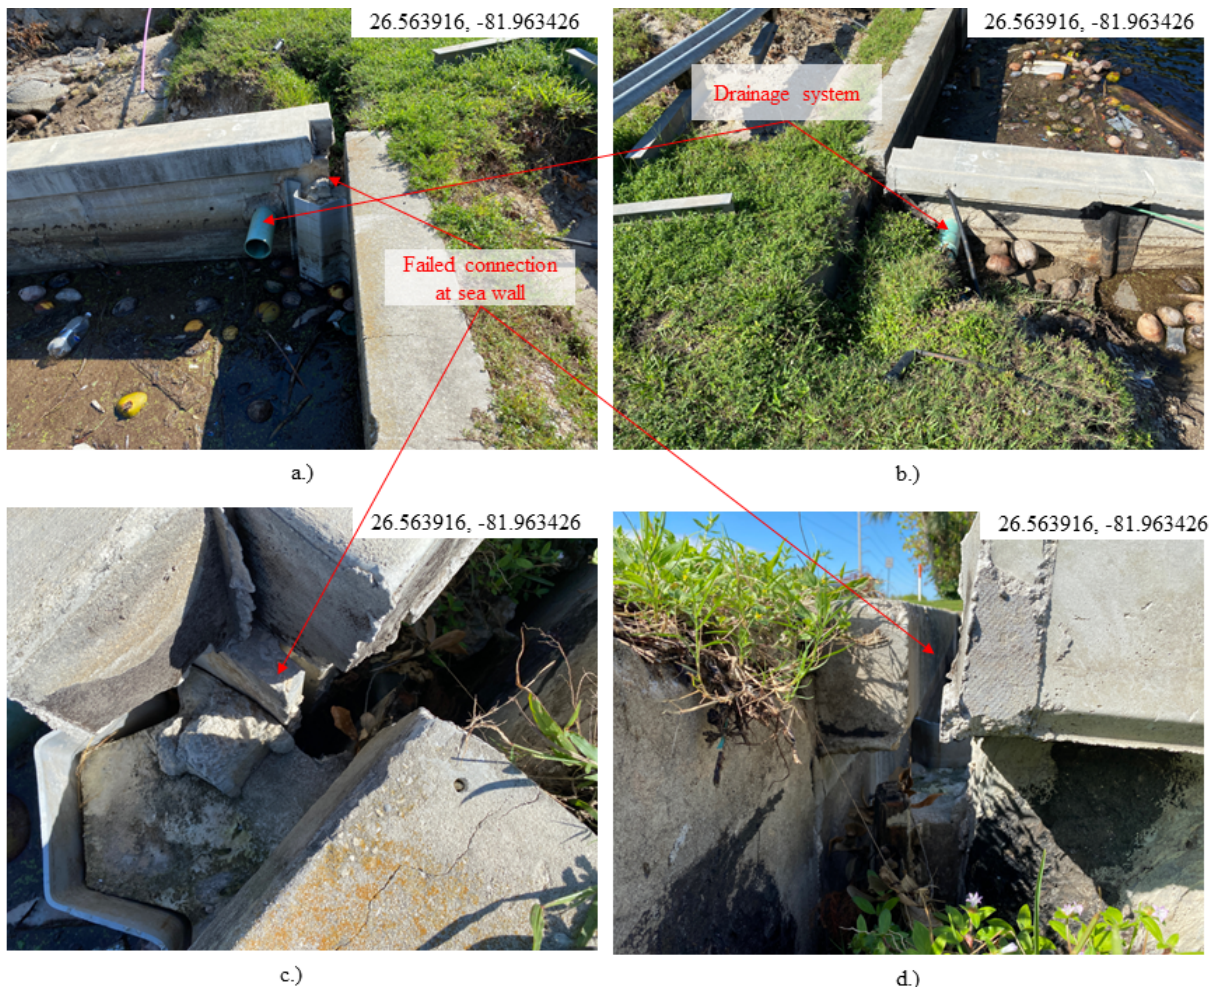
Figure 4.16: Ground photo of the erosion-induced sinkhole on the right side of the canal: (a) drainage pipe is visible and might have been the primary cause of the failure at this section (b) drainage pipe in the vicinity of the cavity created by erosion; (c) failure of the retaining wall as a result of the vacuum effect of the voids created in the soil; (d) back of the failed retaining wall showing the breakage and displacement

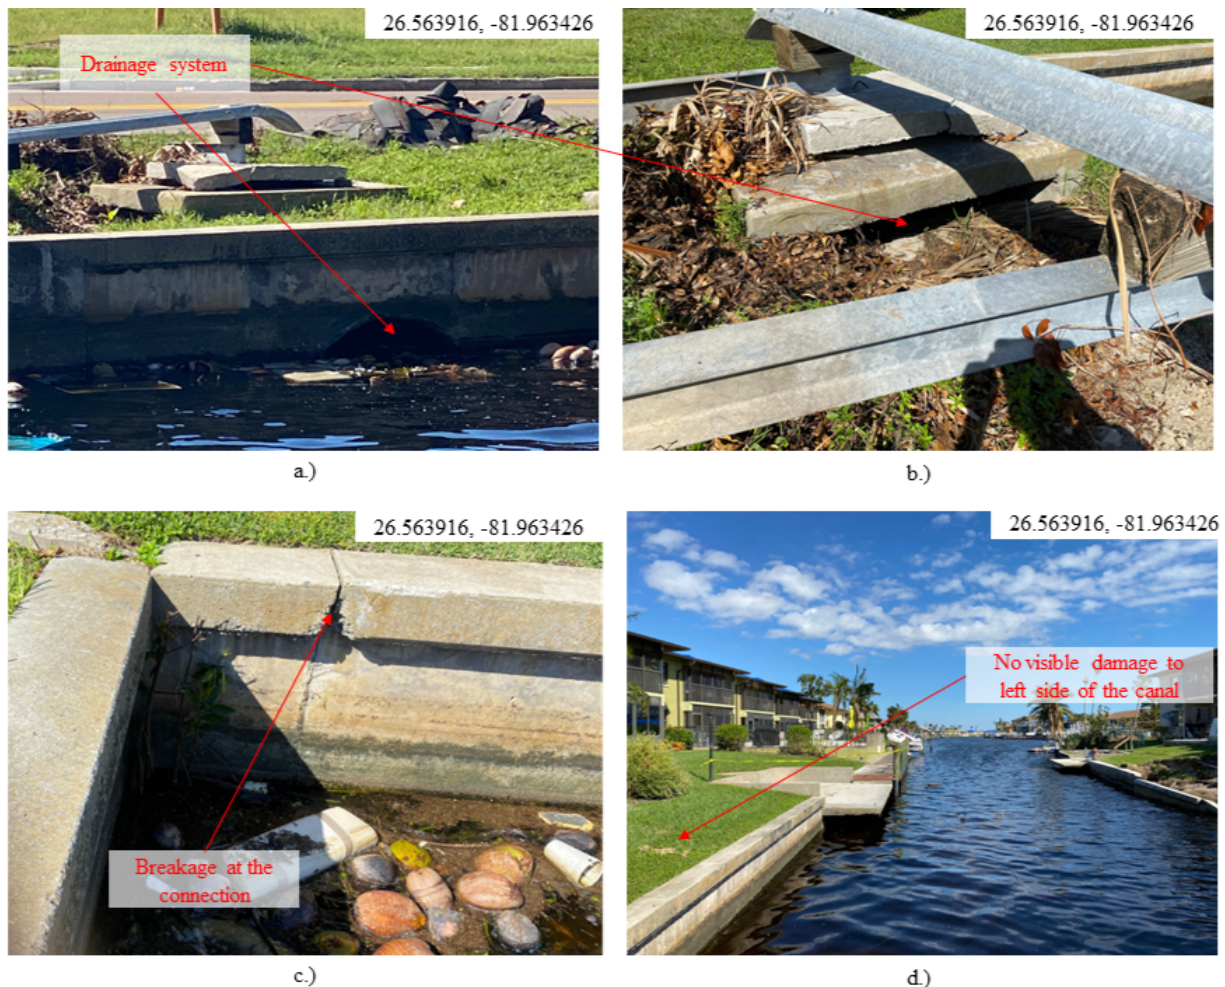
Figure 4.17: Ground photos of the top side of the canal (top) and left side of the canal (bottom): (a) drainage system at the top of the canal; (b) initial cavity created by the presence of the drainage; (c) small breakage due to compounding water pressure on the retaining wall and no sign of a drainage system present on the left side of the canal; (d) left side of the canal showing no sign of erosion

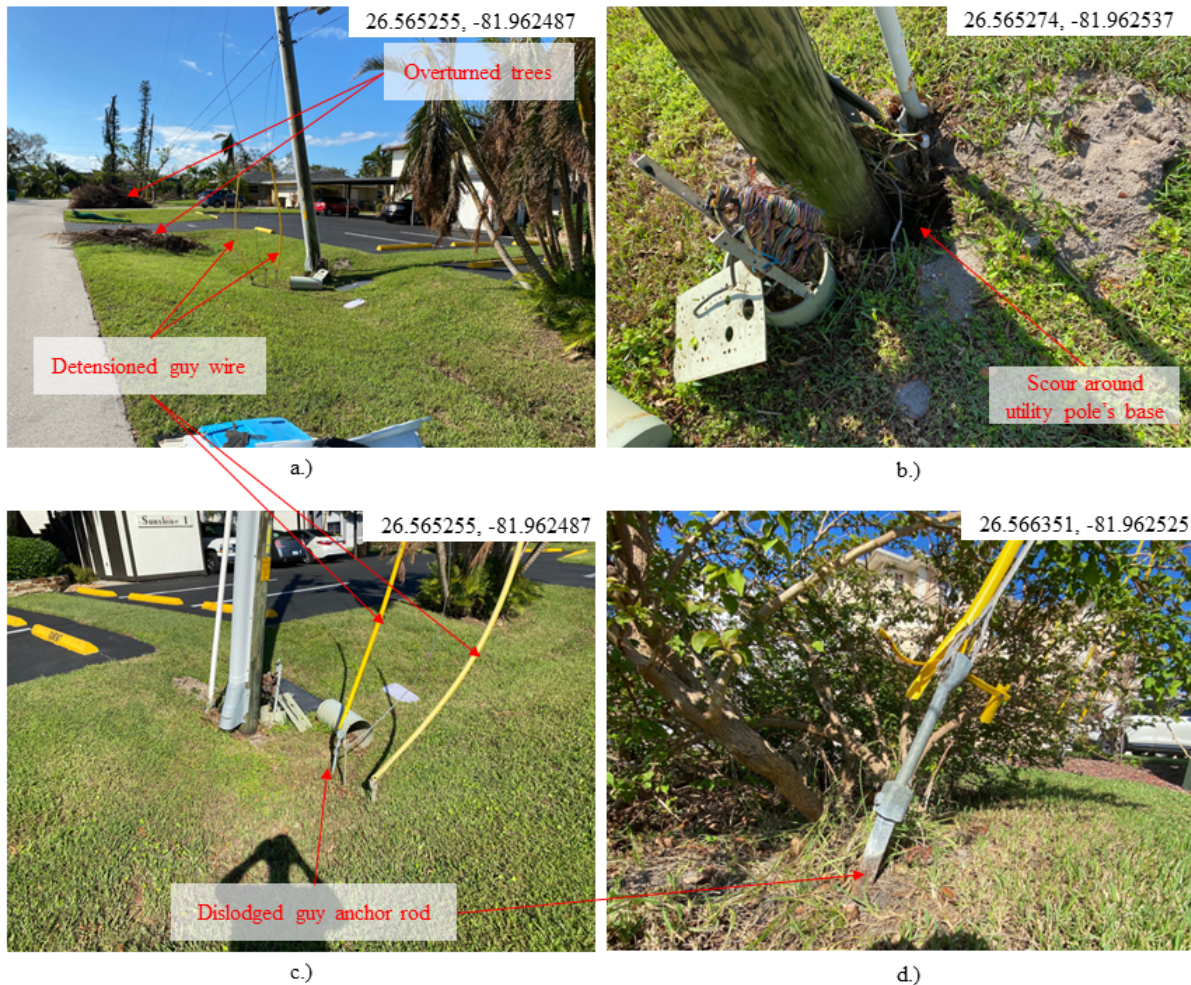
Figure 4.20: Bearing capacity and stability failure in Cape Coral: (a) overturned trees and detensioned guy wire anchor rod resulting in a stability failure of the utility pole; (b) erosion around the base of the pole; (c) closer look at the detensioned anchor rods; (d) anchor rod dislodged approximately eight inches from it's original location due to extreme force of the storm surge.

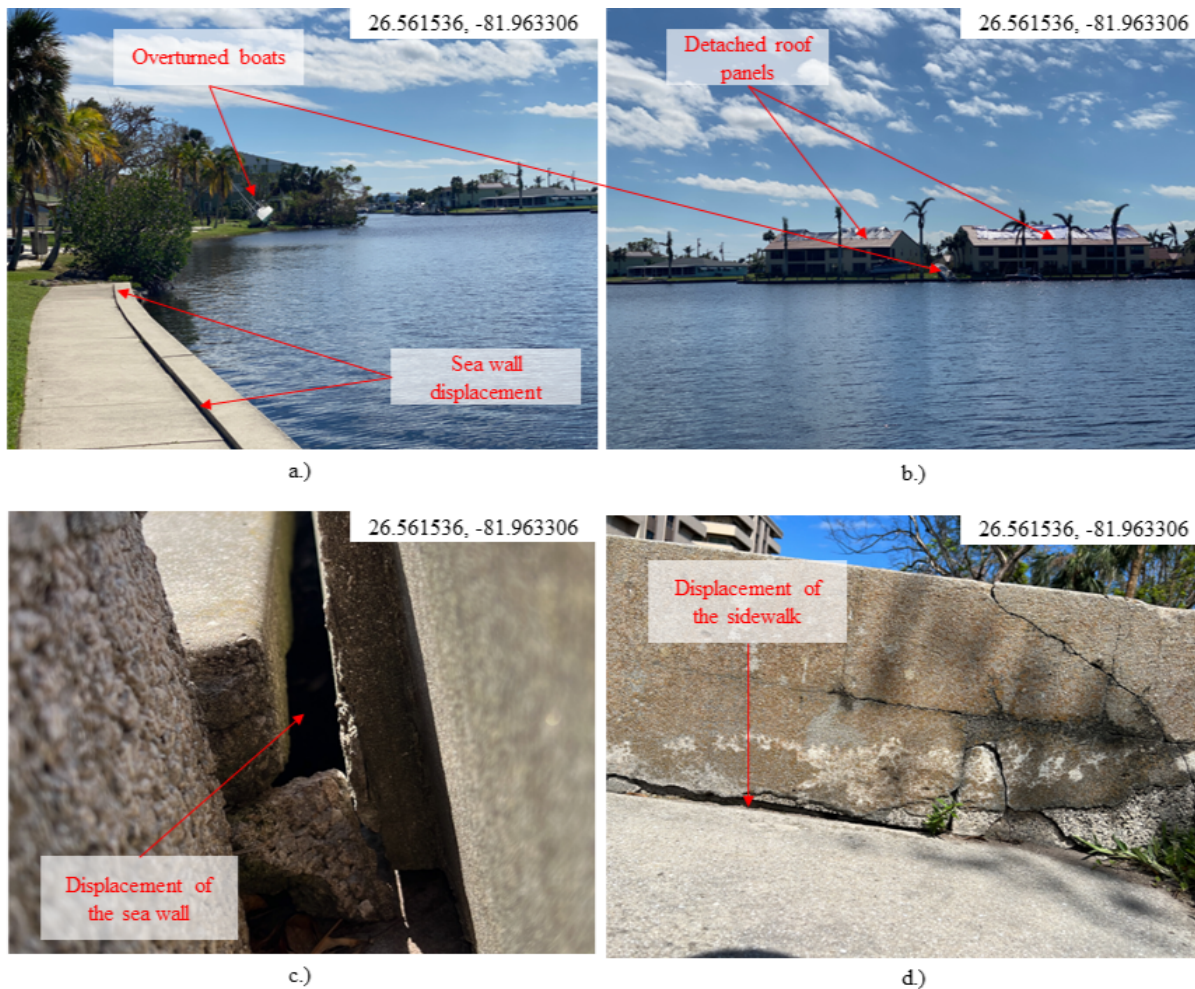
Figure 4.21: Ground images of Four Freedoms Park: (a) Overturned boats as a result of extreme water surges and wind power along with slight displacement of the sea wall along the side walk; (b) due to Hurricane Ian's powerful winds, roof panels came off as evidence of a structural failure; (c) closer look at the displacement of the sea wall; (d) the displacement also came from the base where there were stairs.

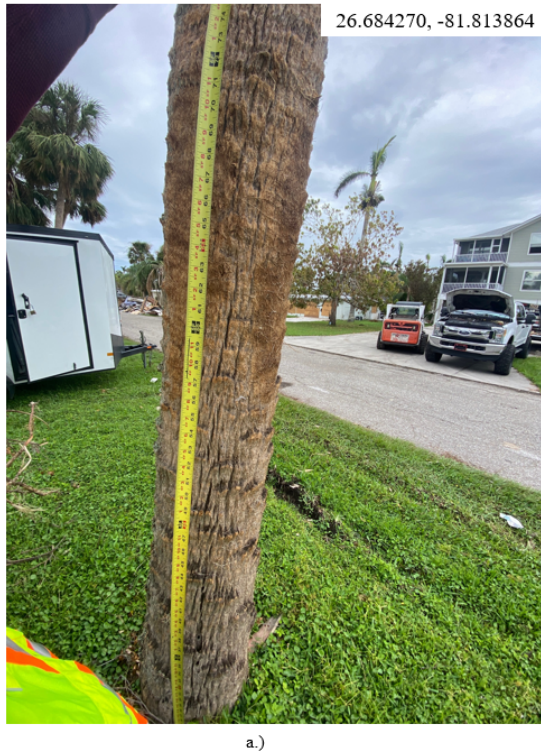
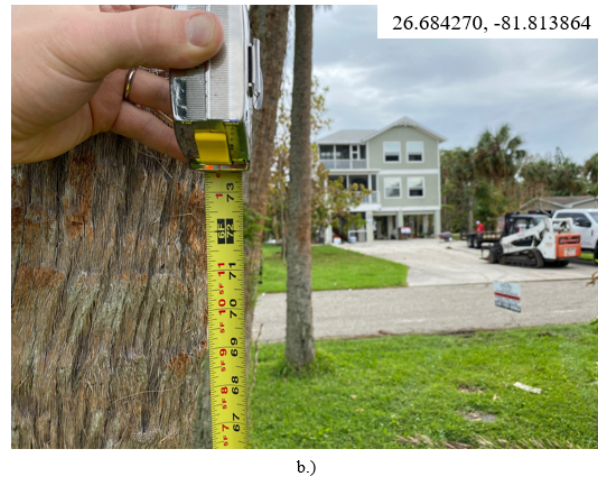
Figure 4.22: Evidence of the storm surge in Cape Coral: (a) debris marks on trees measuring at 72 inches (b) closer look at the debris marks

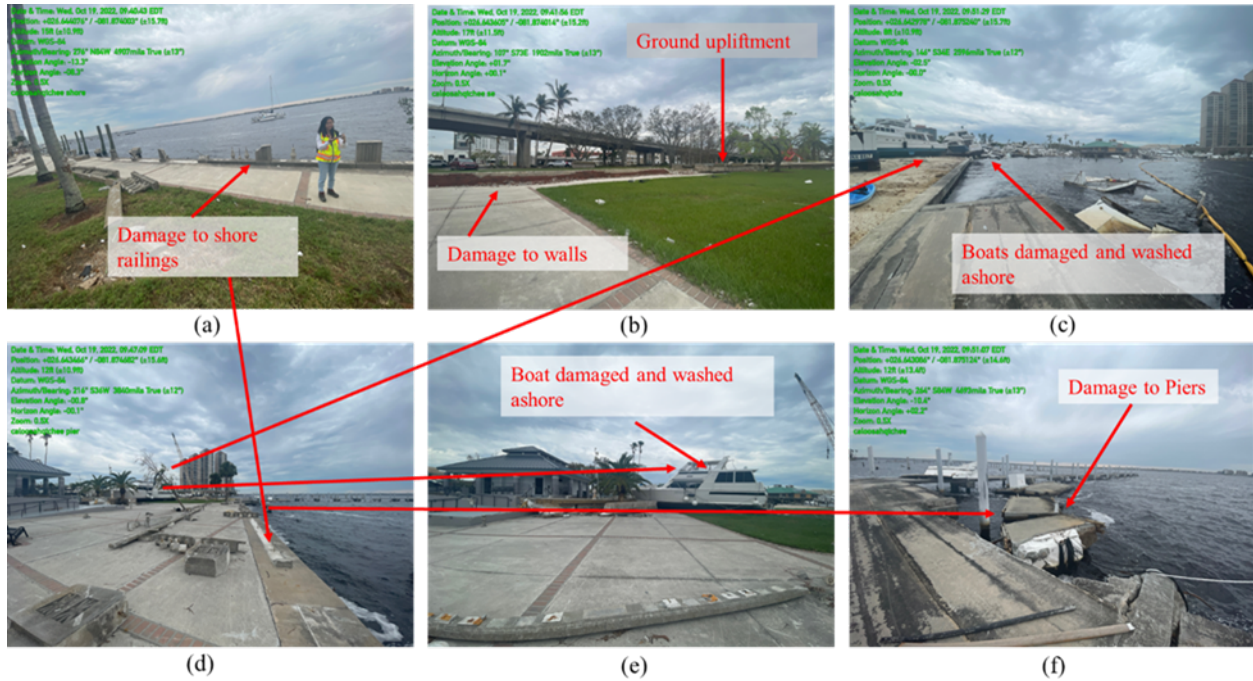
Figure 4.23: Surveying around Centennial Park, Downtown Fort Myers: (a) Damage to shore railings; (b) Ground upliftment and damage to walls near the Cleveland Avenue; (c) Damaged boats washed ashore due to the storm; (d) Damage to railings; (e) Boat damaged and washed ashore; (f) Damage to piers with severe damage to the foundation. Coordinates: 26.64375, -81.87416
