GEOTECHNICAL RECONNAISSANCE AND INVESTIGATION OF IMPACTS FROM HURRICANE IAN

Geotechnical Extreme Events Reconnaissance
GEER Report - 080

Report Date: 9/21/2023

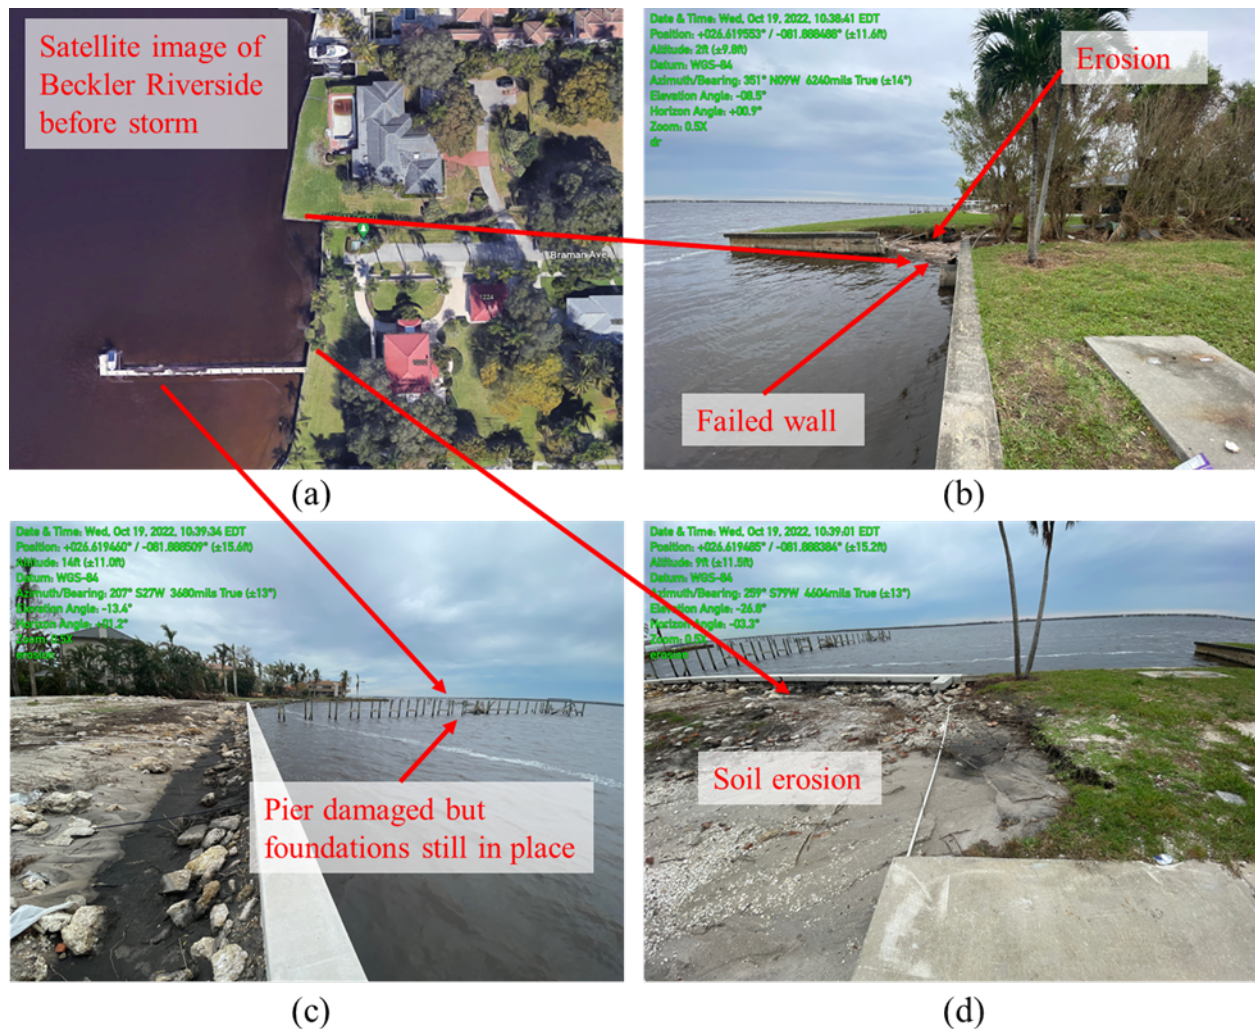
Figure 4.24: Surveying around Beckler Riverside along the bank of Caloosahatchee River: (a) Satellite image of the area before the Hurricane (b) Failing of wall and washing away of soils; (c) Pier completely washed away with foundations still intact ; (d) Soil erosion along the coast. Coordinates: 26.61952, -81.88840

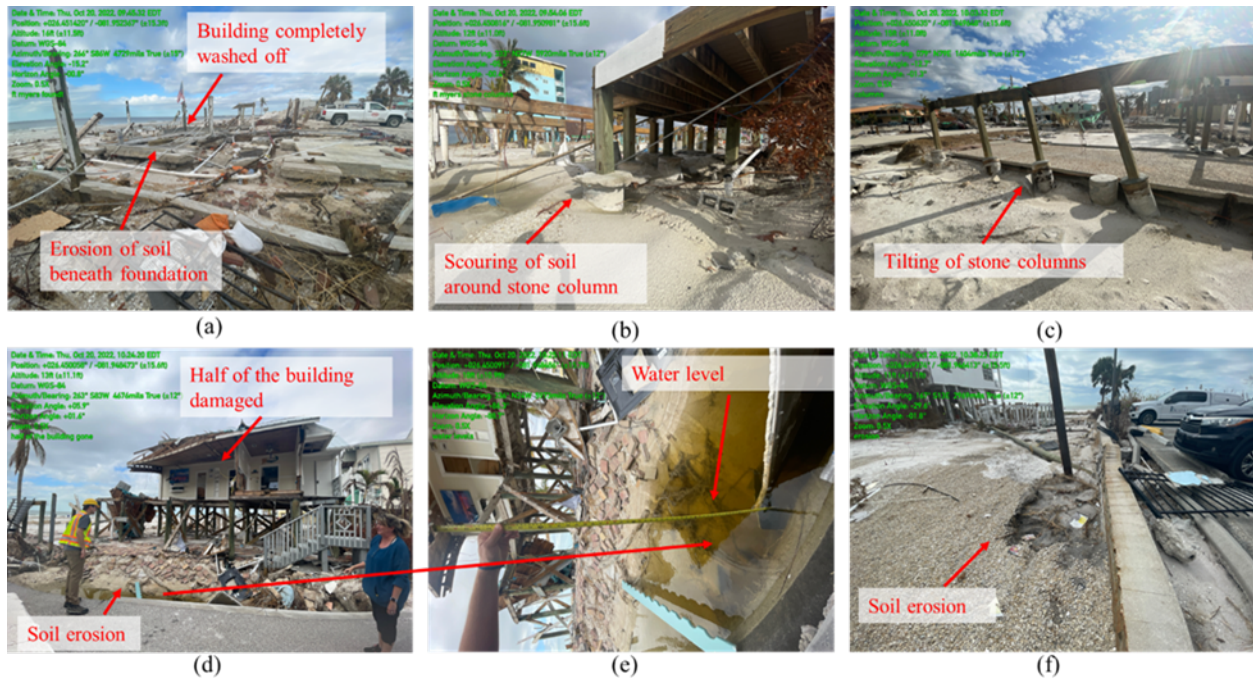
Figure 4.26: Surveying in Fort Myers Beach along the coast: (a) Buildings being completely washed off and soil erosion around the foundation (b) Scouring around the stone columns; (c) Tilting of stone columns and possible signs of erosion; (d) Damaged building and extreme soil erosion; (e) Survey of water levels near the building; (f) Soil erosion possibly causing tilting of pole. Coordinates: 26.44966, -81.94872

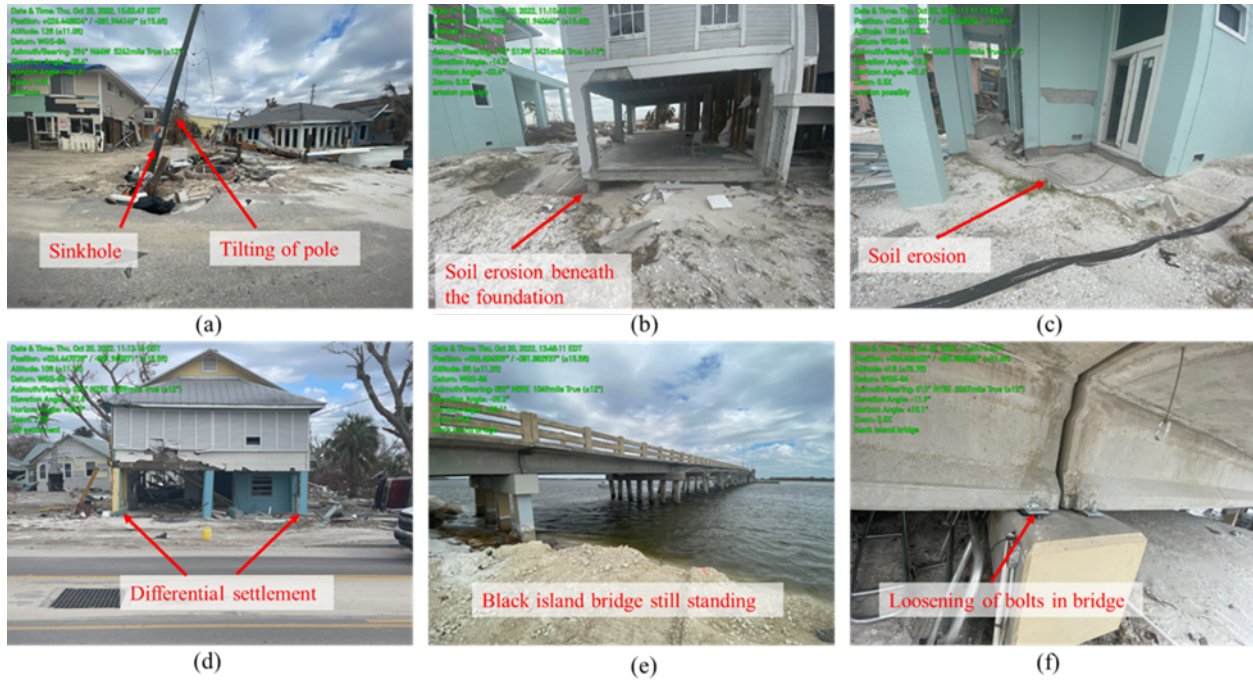
Figure 4.27: Surveying in Fort Myers Beach: (a) Formation of sinkholes and tilting of pole (b) Soil erosion beneath and around the foundation; (c) Soil erosion; (d) Differential settlement causing damage to the building; (e) Black Island bridge intact after the hurricane; (f) Loosening of bolts in the bridge. Coordinates: 26.45121, -81.95105

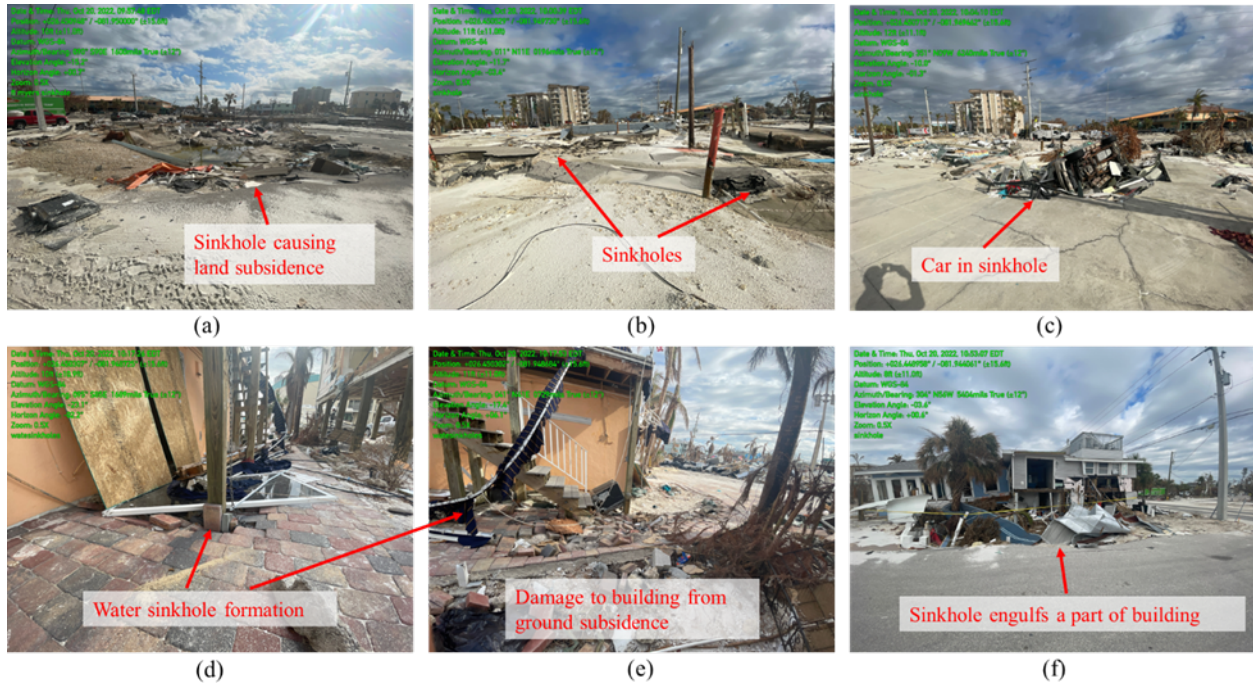
Figure 4.28: Surveying Fort Myers Beach: (a) formation of sinkholes resulting in land subsidising; (b) ground depressions as a result of cavity formation in the soil under the pavement; (c) sinkhole formation under a residential house causing cavity underneath the walk way and foundation of the house which in turn left the column's footing exposed; (e) structural damage to the building was observed which was due to the differential settlement caused by cavities formed; (f) extreme erosion and scour causing ground depression underneath the houses foundation, completely engulfing the middle of the house. Coordinates: 26.44742, -81.93963

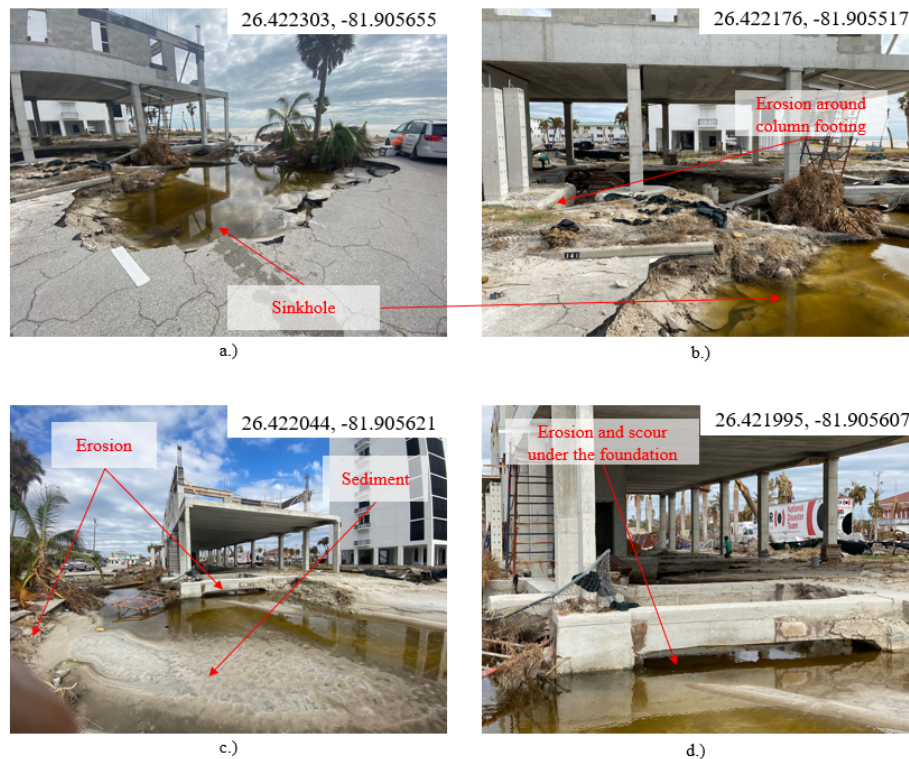
Figure 4.30: Ground images of failures observed in south east end of the Fort Myers Beach island, near Sunset Condominium: (a) Sinkholes caused by extreme scour and erosion resulting in the ground depression underneath the paved driveway and foundation of the skeleton of a new building; (b) extreme scour underneath the foundation of the building resulted in exposure of the footing of the load bearing column; (b) ground photo capturing the depth and size of the sinkhole formed by extreme erosion and scour. Notable, exposed load-bearing column footings reveal the building's vulnerability to water's path, evident from the transported sediment; (c) ground photo of the transported sediment depicting path of water; (d) erosion and scour underneath the shallow foundation of the building

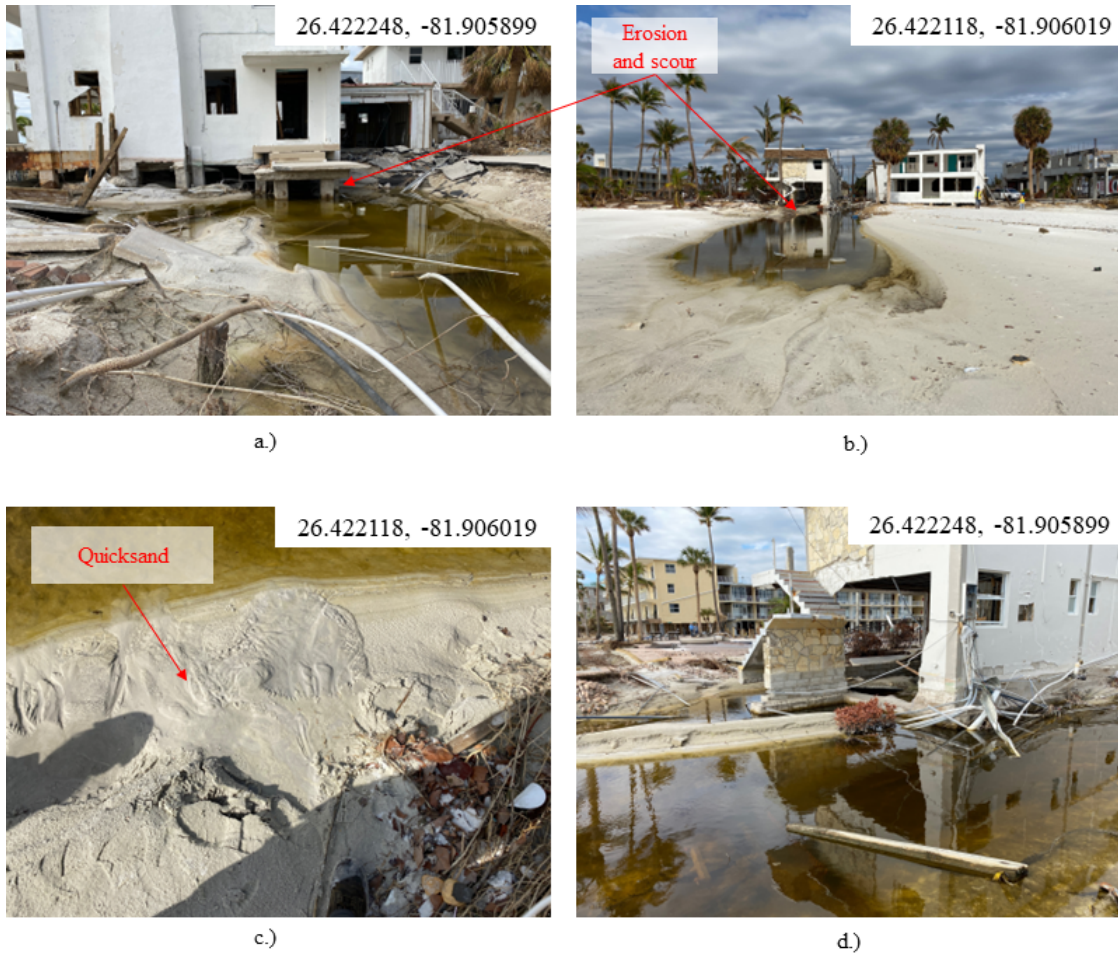
Figure 4.31: Ground images of failures observed in south east end of the Fort Myers Beach island, near Sunset Condominium: (a) erosion and scour underneath the buildings' foundation creating a ground depression filled with water and sediment transported by storm surge resembling a sinkhole; (b) path of water and sediment transported by storm surge depicting that the eroded areas were a result of a direct impact of the waves; (c) soil liquifaction or commonly known as quicksand was observed in the outer banks of the water path; (d) erosion and scour underneath the foundation of a house resulting in a ground depression engulfing the house and exposing the footings and foundation of the house

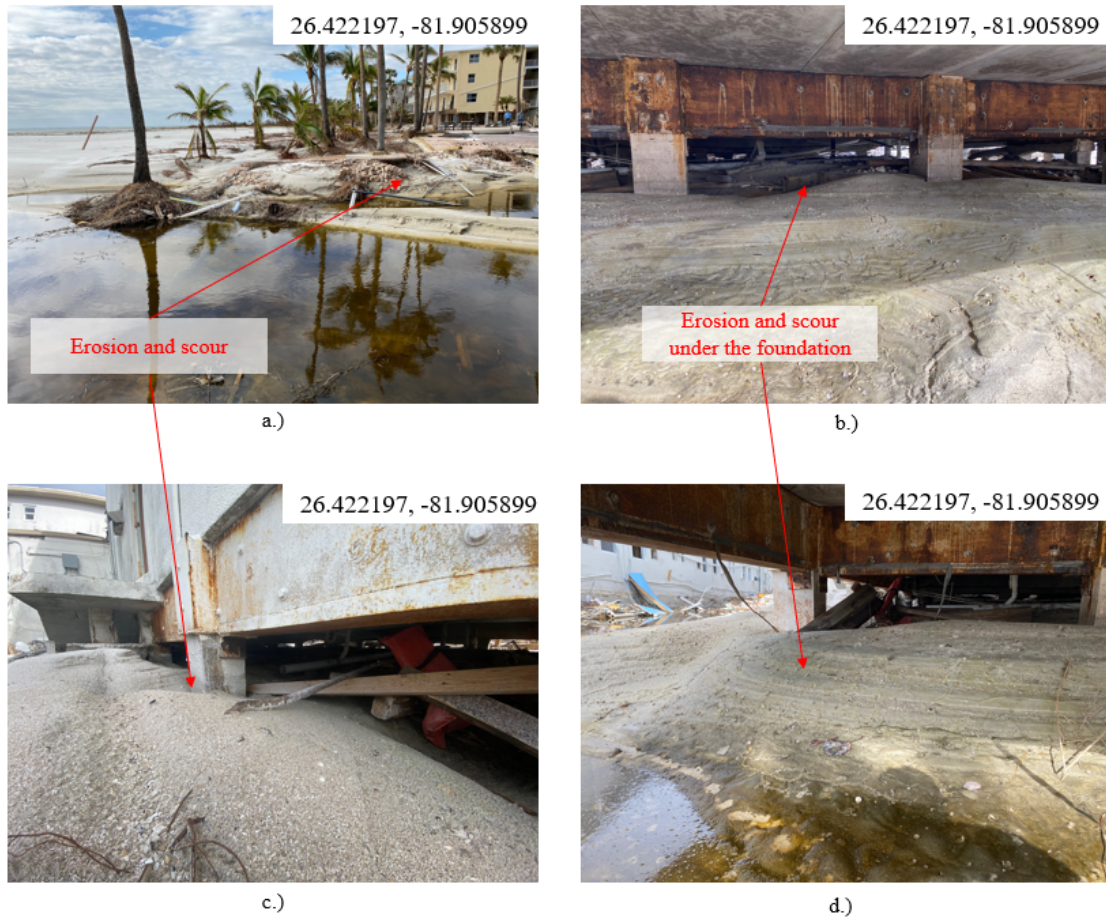
Figure 4.32: Ground images of failures observed in south east end of the Fort Myers Beach island, near Sunset Condominium: (a) erosion and scour underneath the foundation of the house; (b) closer look below the foundation showing extreme erosion and sediment transport; (c) exposed footing due to extreme erosion; (d) sediment transport below the foundation of the house

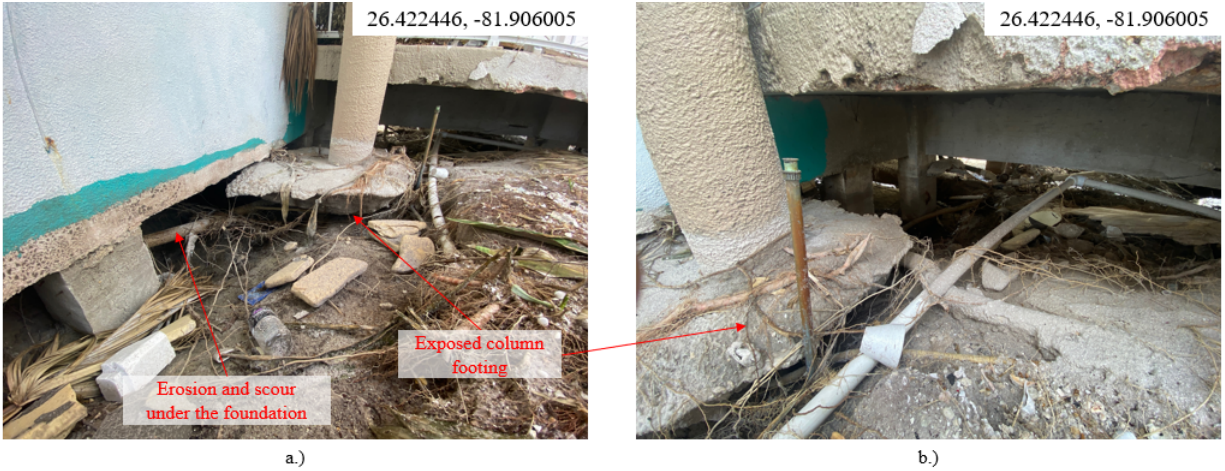
Figure 4.33: Ground images of failures observed in south east end of the Fort Myers Beach island, near Sunset Condominium: (a) Exposed footing of the stairways column and erosion below the foundation of the house; (b) closer look below the foundation showing the transported sediment and exposed footing

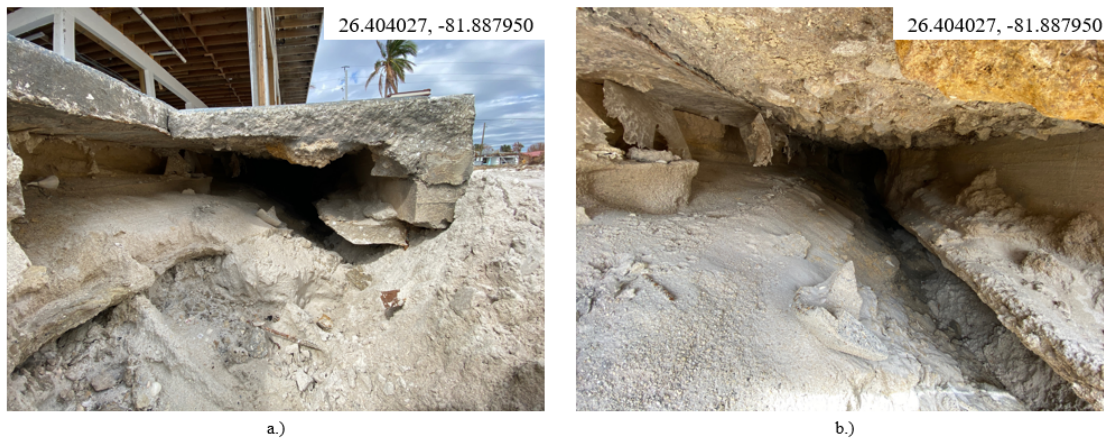
Figure 4.35: Ground photos of failures observed in south east end of the Fort Myers Beach island, at Carlos Point Condominium Associates: (a) ground photos of the erosion beneath the foundation depicting the scope of eroded area; (b) ground photo of the underneath the foundation depicting the exposed footing

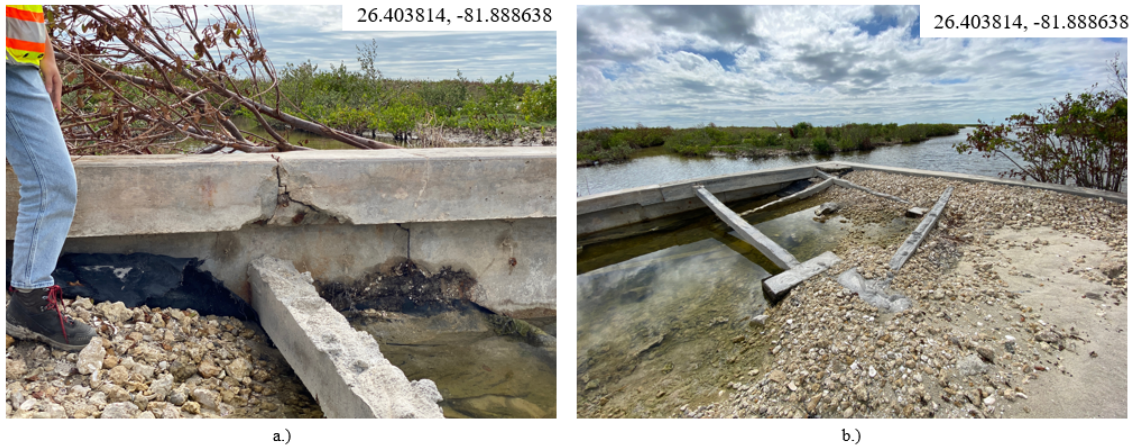
Figure 4.36: Southern end of the Fort Myers Beach: (a) ground photo depicting a broken anchor of a sea wall showing the tie-back used in the anchor system; (b) ground photo of the anchoring system showing cross beam tie backs and dead man weights

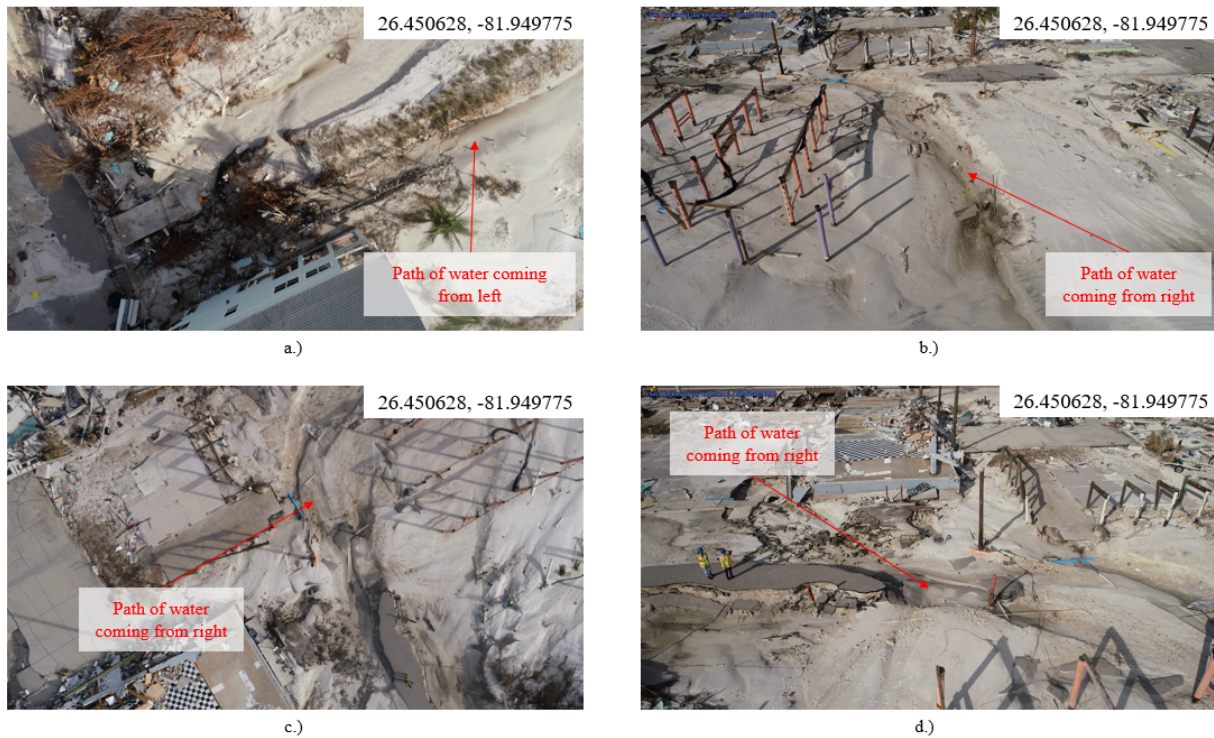
Figure 4.37: Drone images of failures observed in north west end of the Fort Myers Beach island: (a) image showing the path of water starting from the shoreline carrying a sizable amount of sediment from the left side of the building causing less damage in comparison to water coming from the right side in presence of mangroves; (b) water coming from the shoreline on the right side of the area of interest and hitting the first set of buildings, leaving only the piling of the houses behind; (c) the waves taking a turn to left and carrying the debris towards the next row of the buildings causing more damage; (d) path of water coming from the right side of the area of interest causing scour and erosion, joining with the water coming from the left side which in return caused more powerful storm surges resulting in damages in greater magnitude

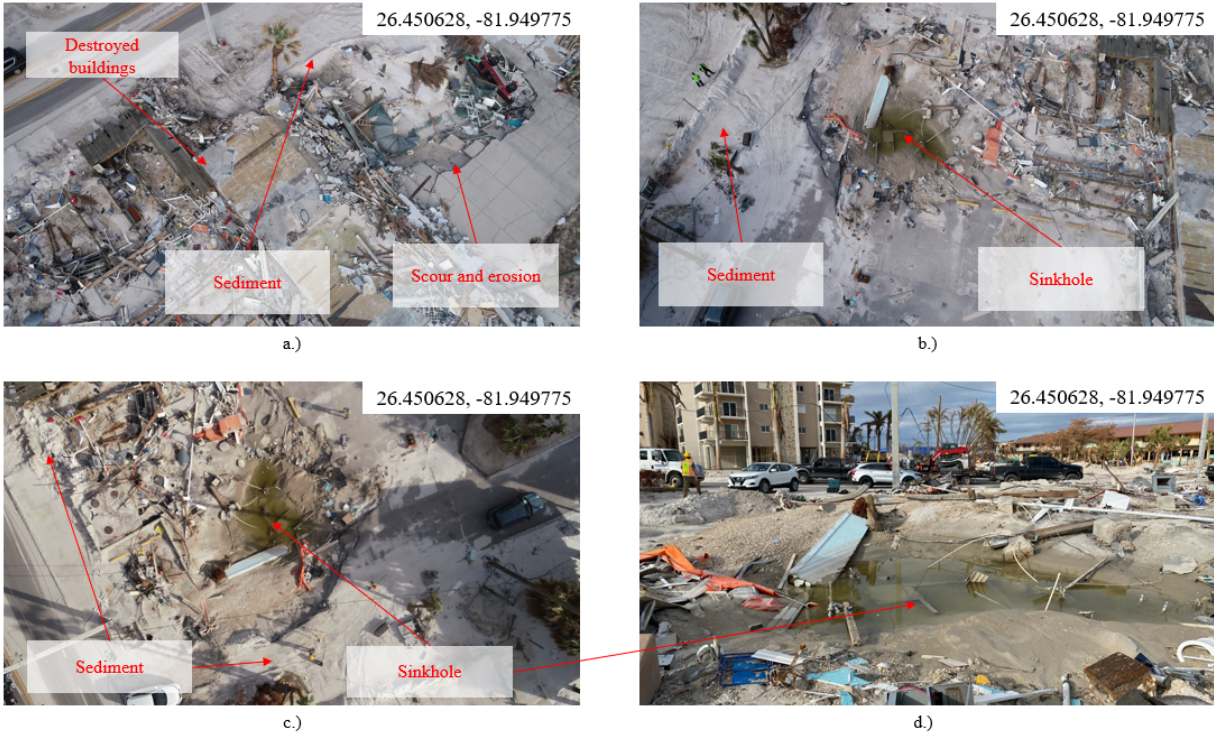
Figure 4.38: Drone images of failures observed in north west end of the Fort Myers Beach island: (a) image of the sediment transported and debris left from the buildings destroyed by storm surge. scour caused a ground depression near the driveway of the adjacent building; (b) sediment transported by the storm surge is shown and the sinkhole in place where a shop used to be; (c) ground depression filled with water and sediment resembling a sink hole where a shop used to be; (d) ground image of the sink hole presumably caused by erosion and scour resulted by powerful storm surges

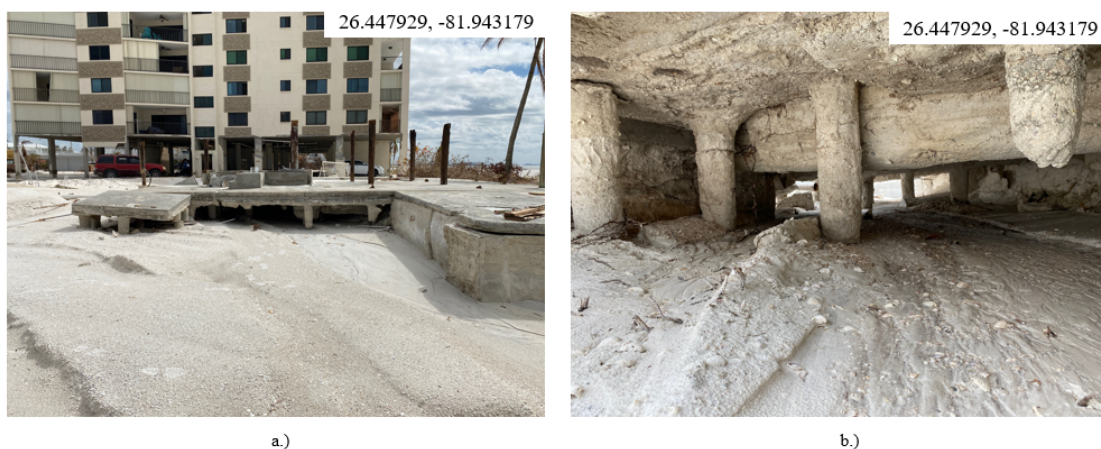
Figure 4.40: Ground photos of failures observed in north west end of the Fort Myers Beach island near Pelican Watch Condominium: (a) scour and erosion under the shallow foundation of a building; (b) Close up photo of damage to shallow foundation

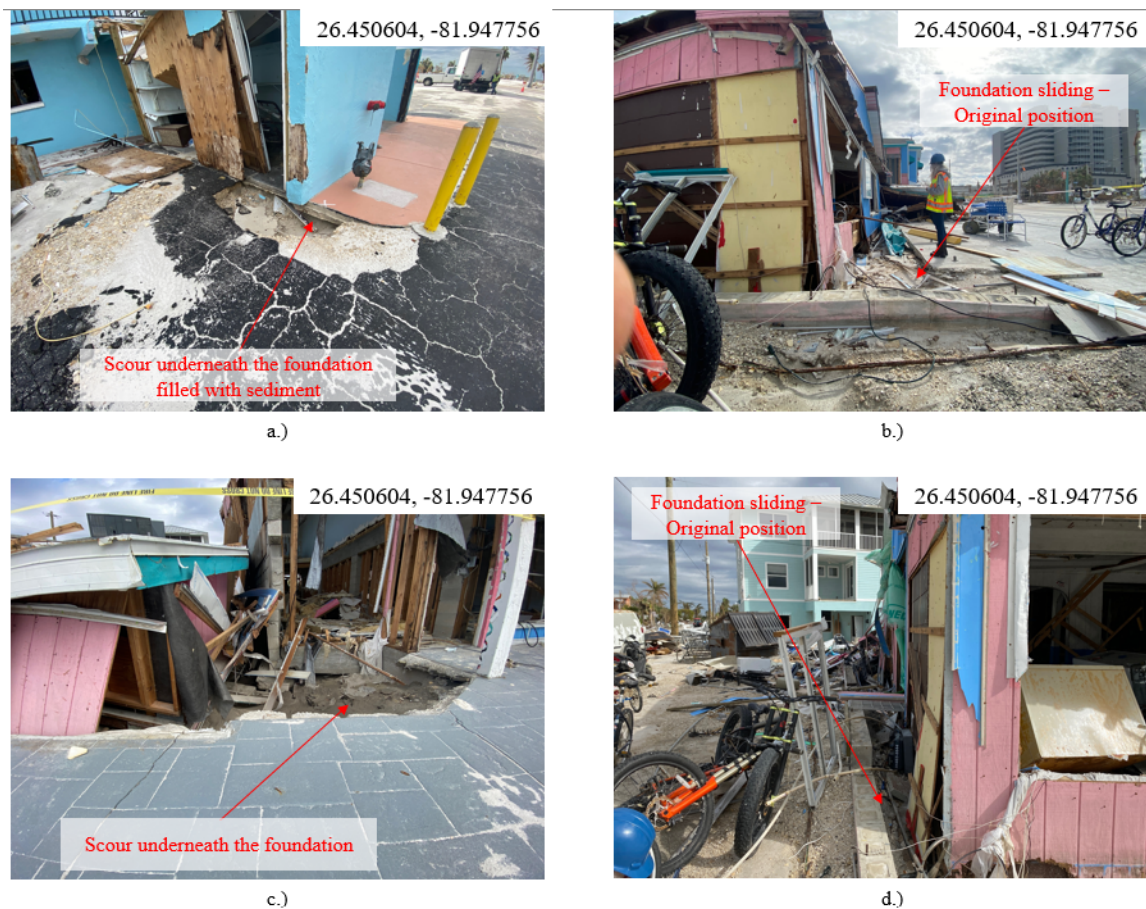
Figure 4.41: Ground photos of the failures adjacent to Estero Blvd in Fort Myers Beach: (a) photo of a shop building depicting erosion beneath the foundation; (b) sliding of the front of the building as a result of the scour and erosion behind the building, beneath the foundation; (c) scour underneath the foundation at the back of the building causing a cavity and engulfing the back of the building; (d) image showing the left side of the building sliding

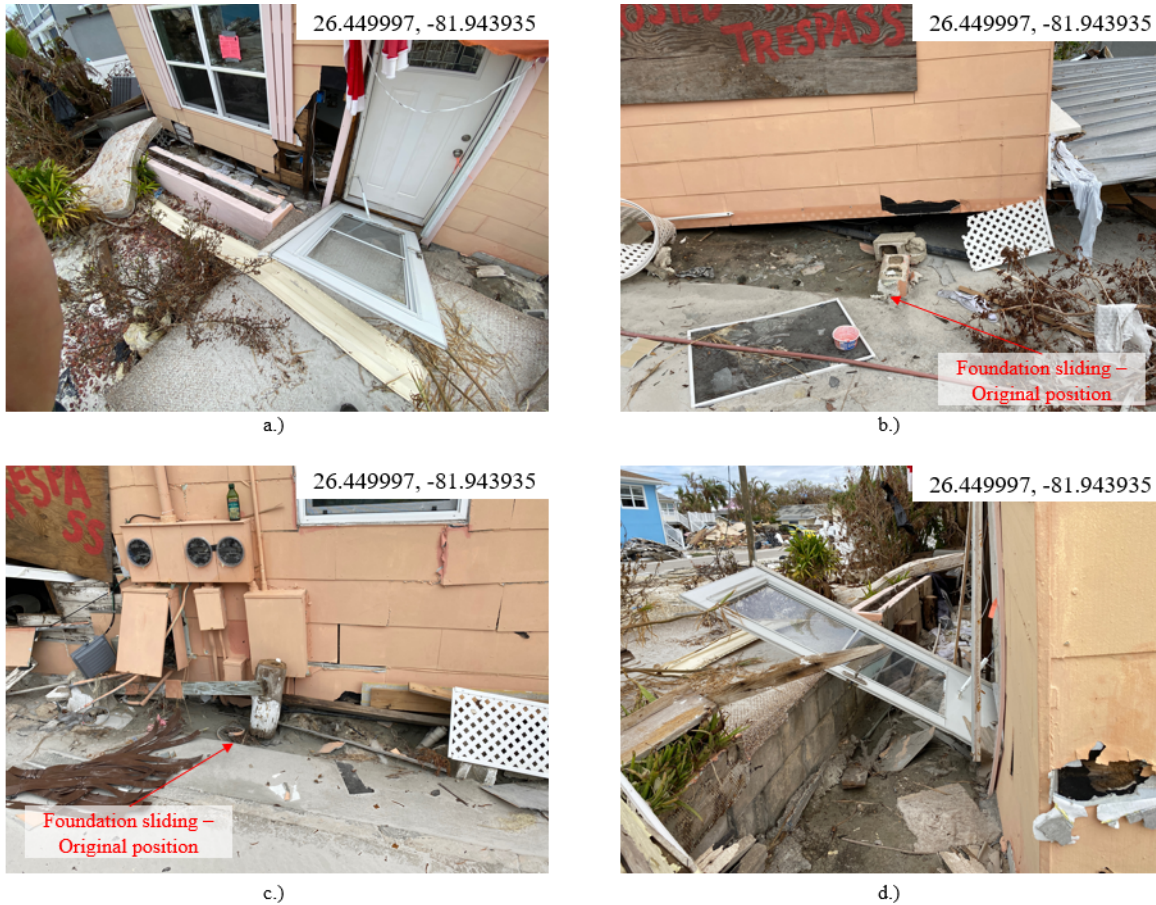
Figure 4.42: Ground photos of the failures adjacent to Estero Blvd in Fort Myers Beach: (a) front of the residential building showing that foundation has slid; (b) right side of the residential building showing that foundation has slid; (c) right side of the residential building showing that foundation has slid; (d) left side of the residential building showing that foundation has slid
