**GEOTECHNICAL EXTREME EVENTS RECONNAISSANCE (GEER) ASSOCIATION**

*Turning Disaster into Knowledge*

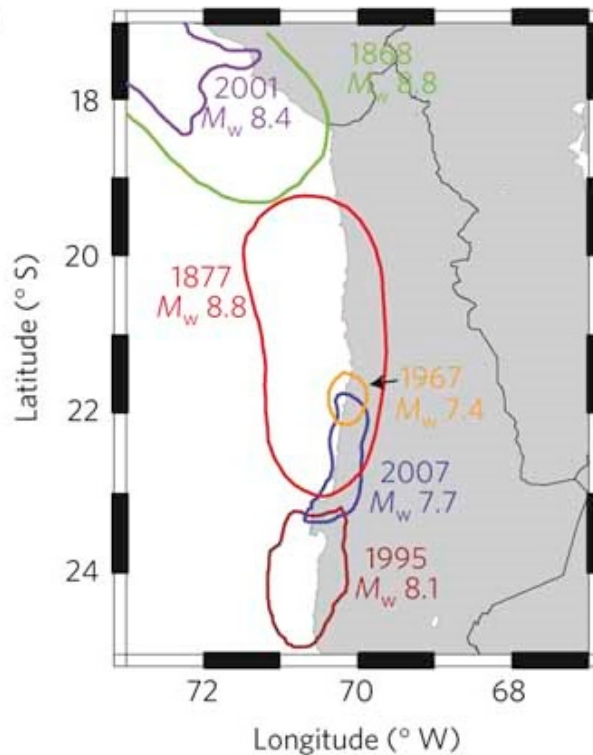
**Fig. 1.1. Northern Chile's seismic gap (Contreras et al., 2012)**

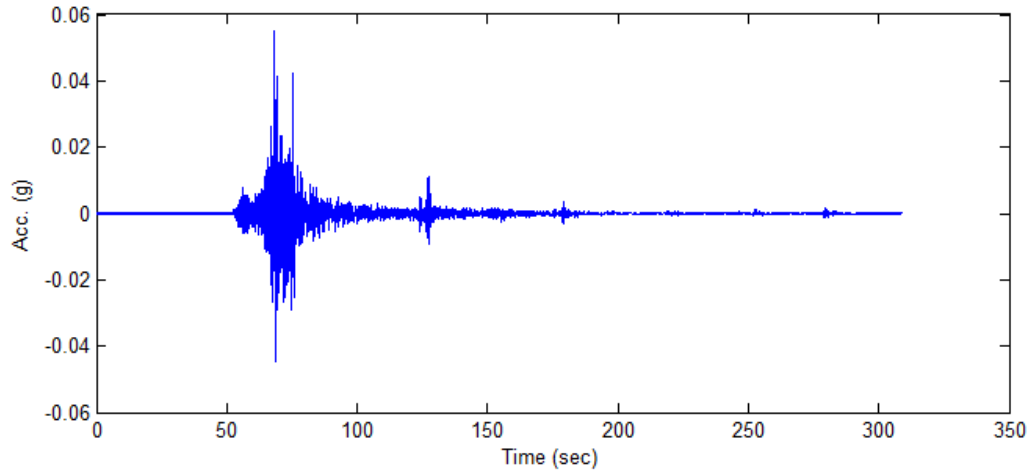
**Fig. 1.2.** Acceleration record of the main foreshock on March 16<sup>th</sup> 2014. North-south component of station TA01.

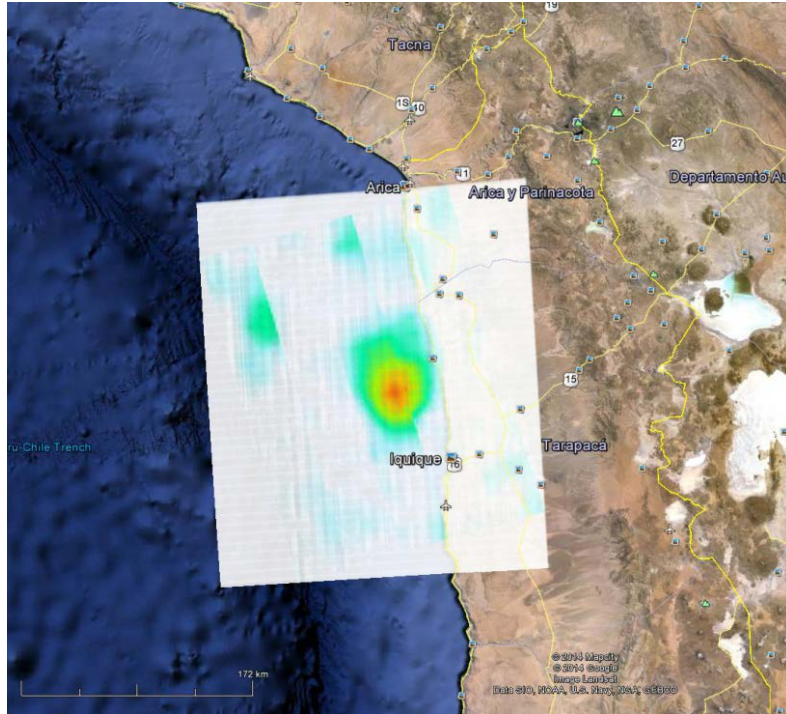
**Fig. 1.3. Finite fault solution of the main event according to the USGS (Hayes, 2014).**

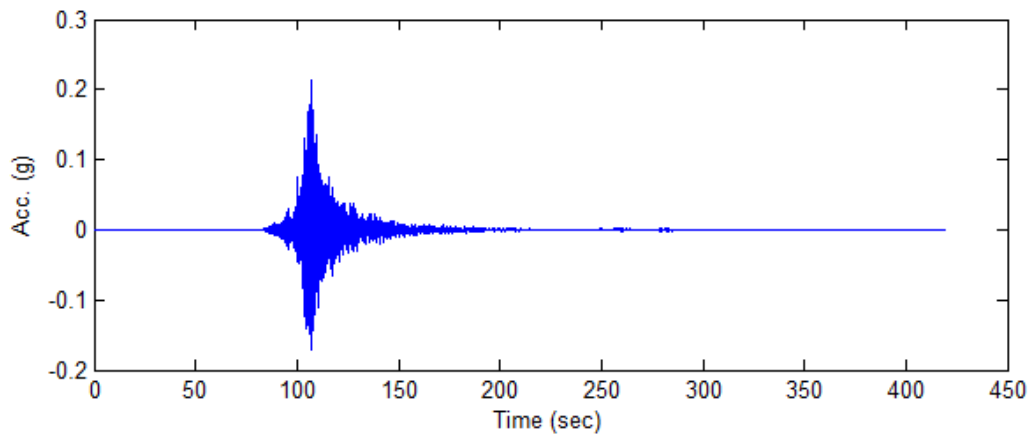
**Fig. 1.4. Aftershock ground motion for the NS component at PB11.**

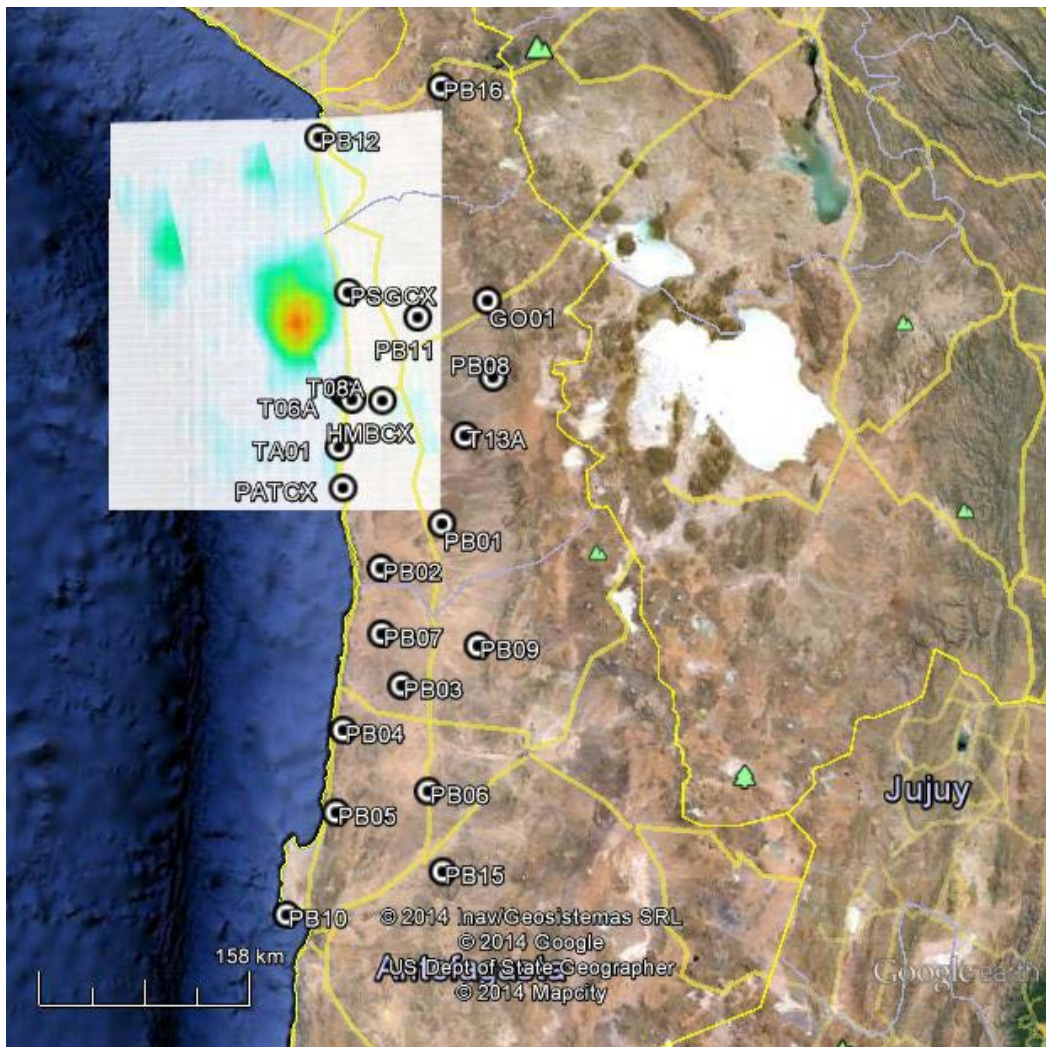
**Fig. 1.5. Ground motion station locations ranging from the north of Arica to Antofagasta.**

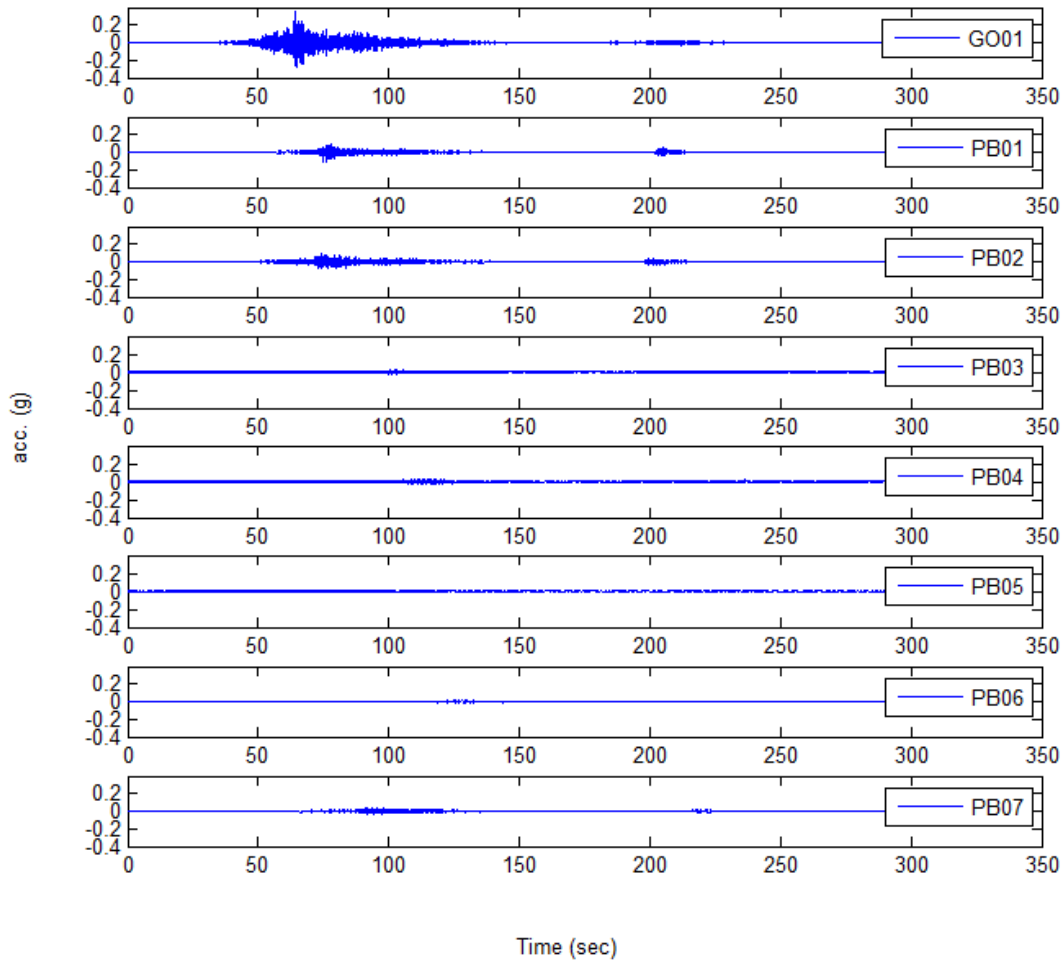
**Fig. 1.7. Recorded acceleration ground motions for the NS component of stations GO01 to PB07. Records available from [www.sismologia.cl](http://www.sismologia.cl) (under “informes”)**

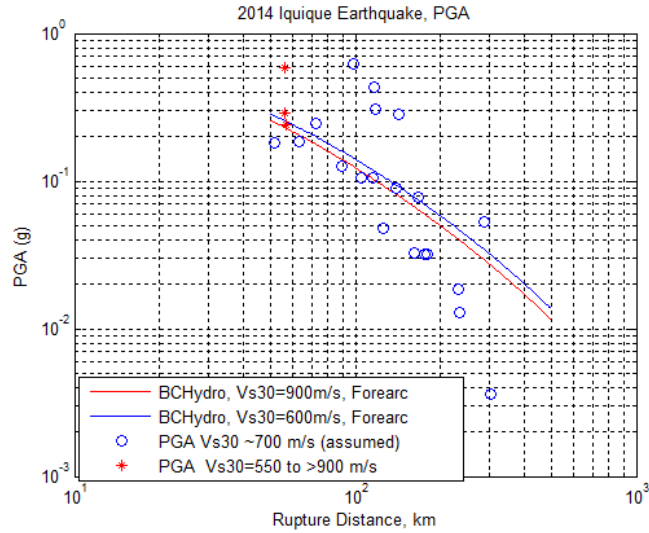
**Fig. 1.9. Observed versus predicted PGA values. Red icons correspond to ground motion stations in Iquique with good constraint on  $V_{s30}$ , while blue circles are ground motion stations mainly on the desert with hard soil conditions expected to have  $V_{s30}$  higher than 700 m/s.**

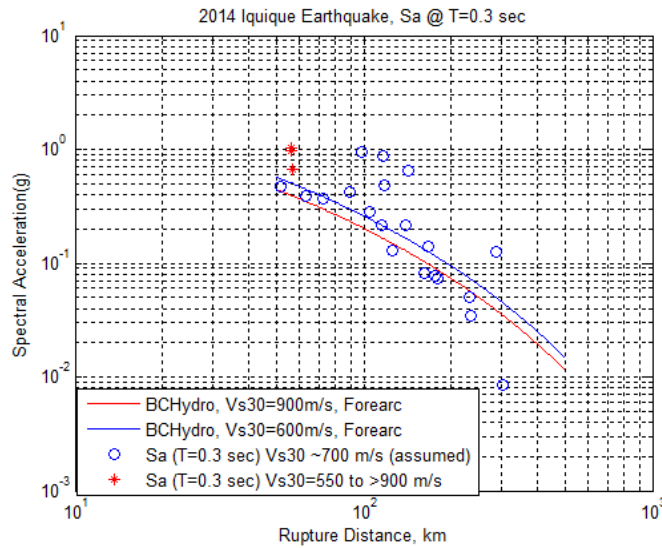
**Fig. 1.10. Observed versus predicted Sa values for a period of 0.3 seconds. Red icons are ground motion stations in Iquique with good constraint on  $V_{s30}$ , while blue circles are ground motion stations mainly on the desert with hard soil conditions expected to have  $V_{s30}$  higher than 700 m/s.**

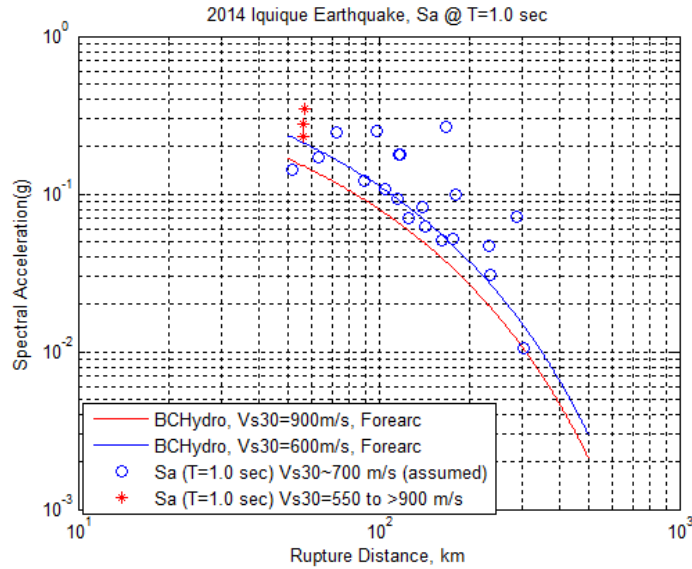
**Fig. 1.11.** Observed versus predicted Sa values for a period of 1.0 second. Red icons are ground motion stations in Iquique with good constraint on  $V_{s30}$ , while blue circles are ground motion stations mainly on the desert with hard soil conditions expected to have  $V_{s30}$  higher than 700 m/s.

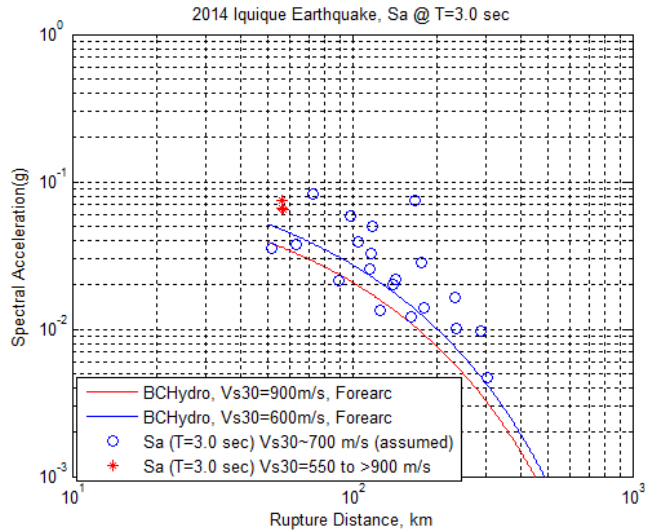
**Fig. 1.12.** Observed versus predicted Sa values for a period of 3.0 seconds. Red icons are ground motion stations in Iquique with good constraint on  $V_{s30}$ , while blue circles are ground motion stations mainly on the desert with hard soil conditions expected to have  $V_{s30}$  higher than 700 m/s.

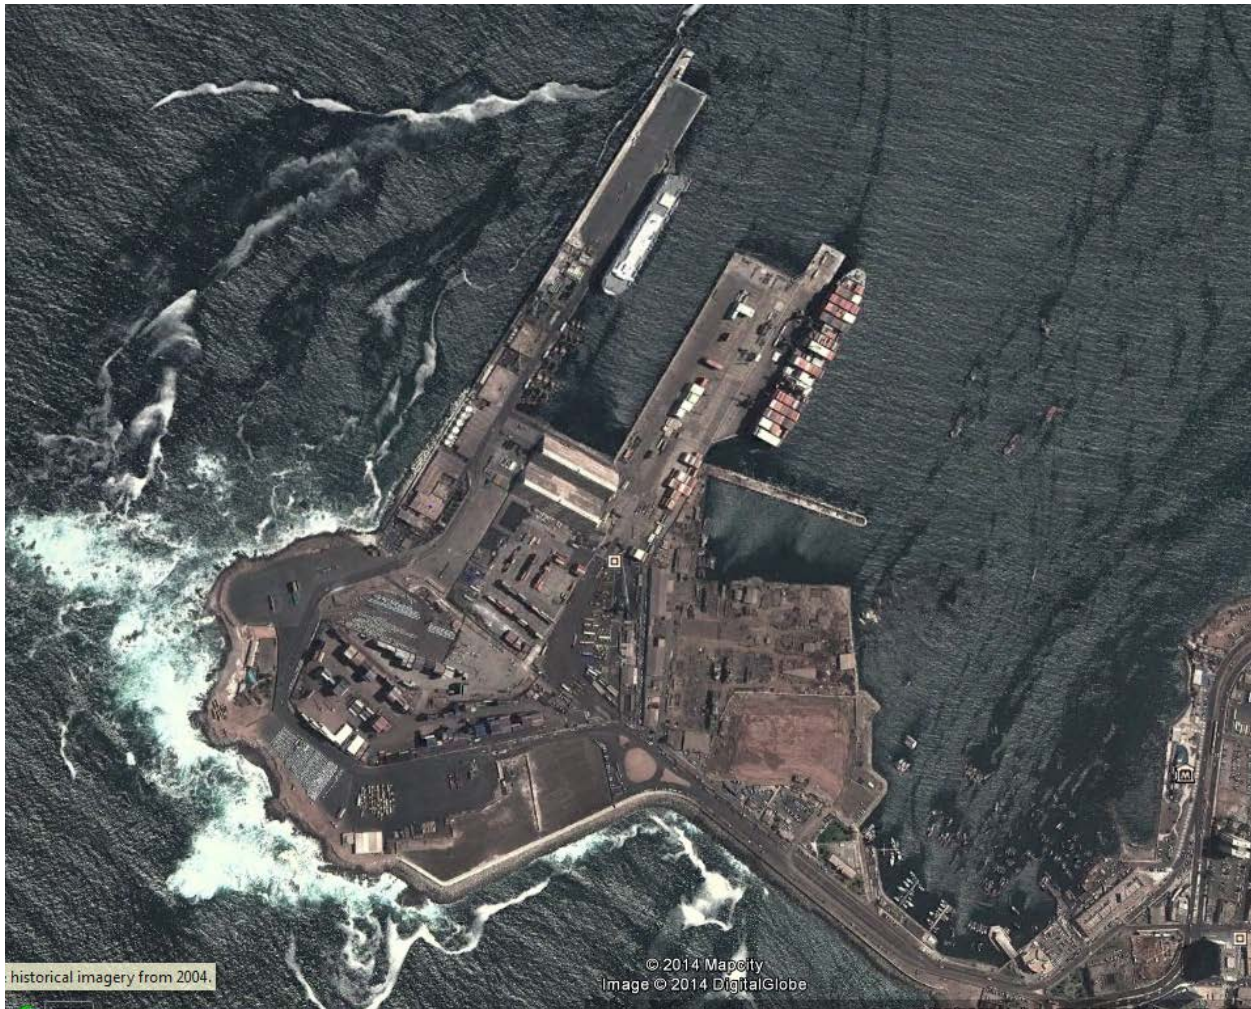
**Fig. 2.1. Google Earth image of the entire port of Iquique.**

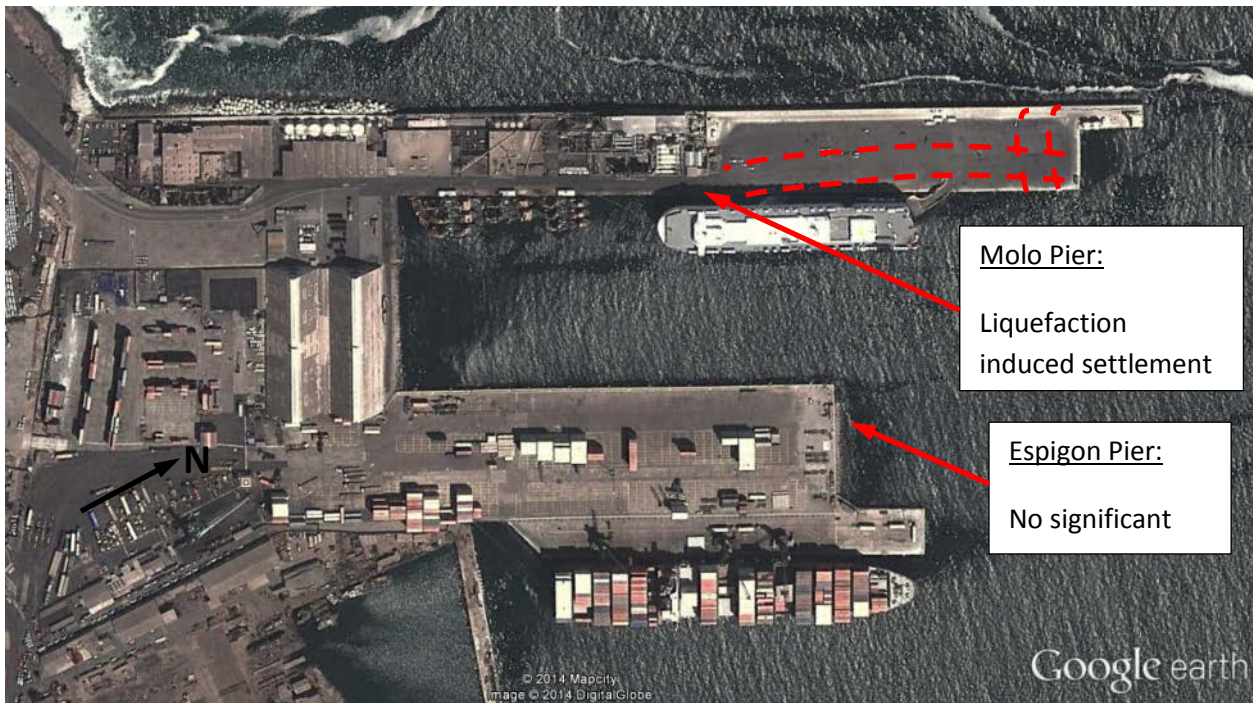
**Fig. 2.2** Google earth image focusing on the Molo and Espigon Piers. Liquefaction induced settlement and lateral spread was pervasive on the Molo pier but was not observed on the Espigon pier.

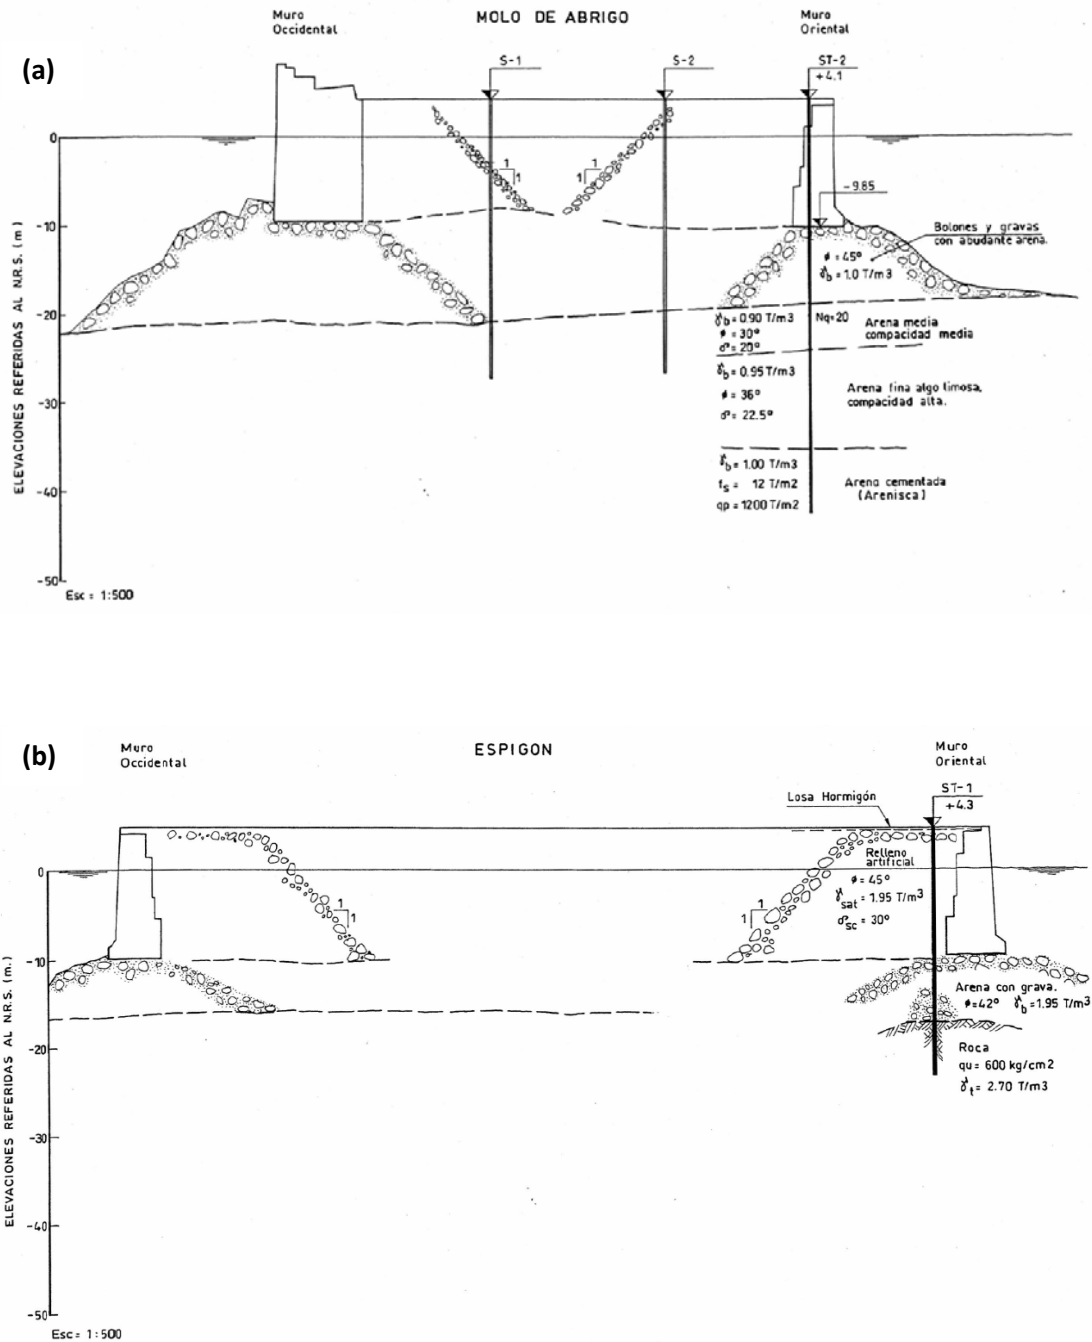
Fig. 2.3 Typical cross-section through (a) the Molo pier and (b) Espigon pier. Large concrete blocks are placed on top of piles of gravel and boulders around the perimeter of the pier and backfilled with gravel and sand within the interior of the pier.

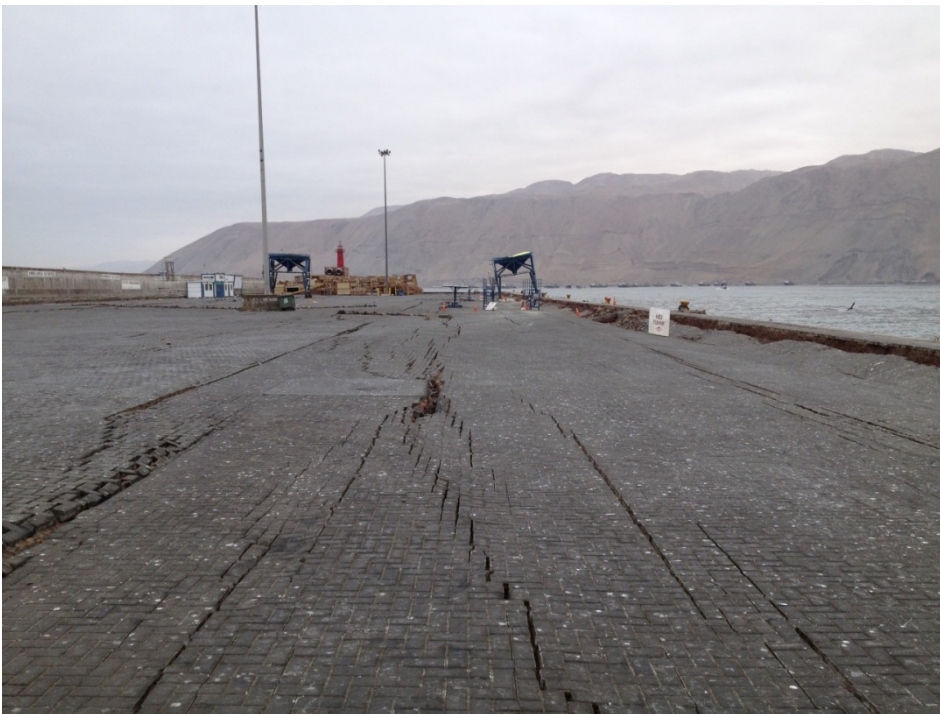
(-20.202206°, -70.158060°)

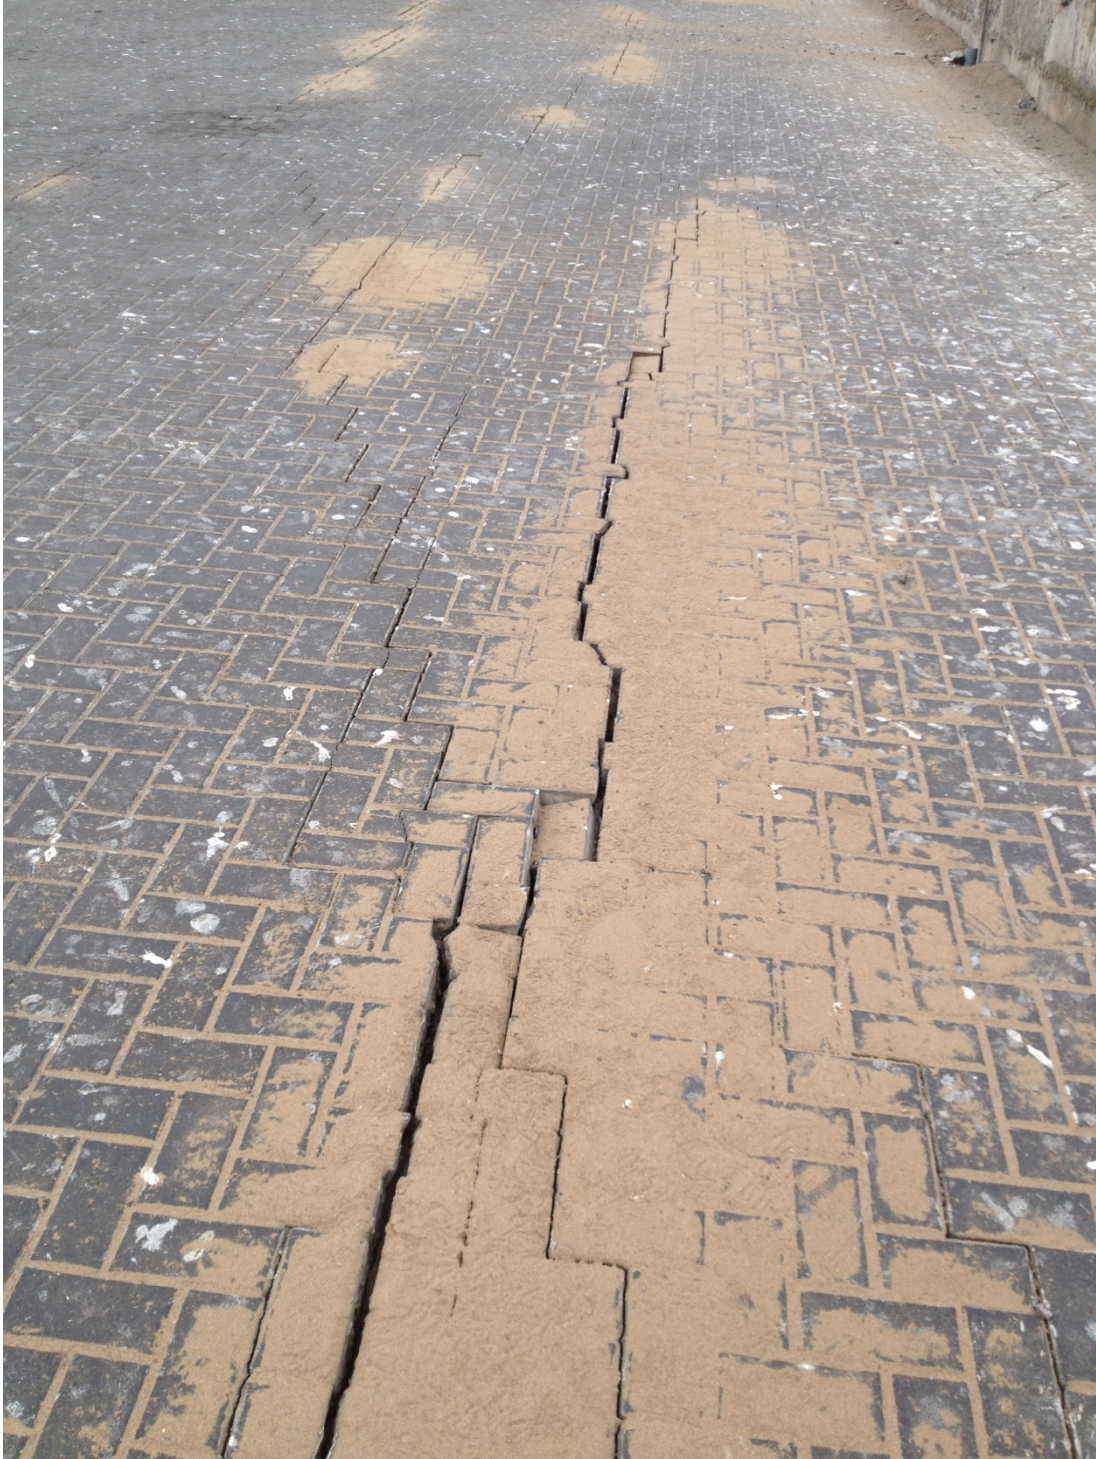
**Fig. 2.6 Photograph showing liquefaction ejecta (sand) which vented upward through brick pavement after formation of cracks from lateral spreading. (-20.202451°, -70.158441°)**

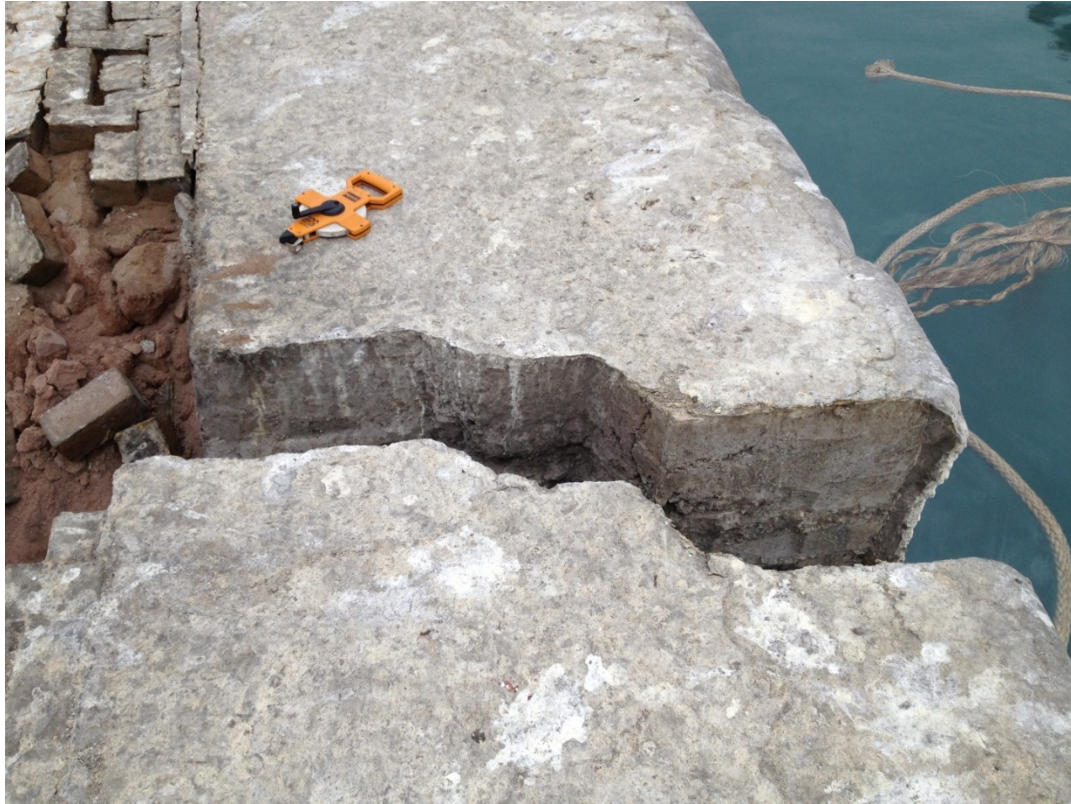
**Fig. 2.7 Longitudinal offset in the concrete block quay wall along the perimeter of the Molo pier.  
(-20.200806°, -70.157416°)**

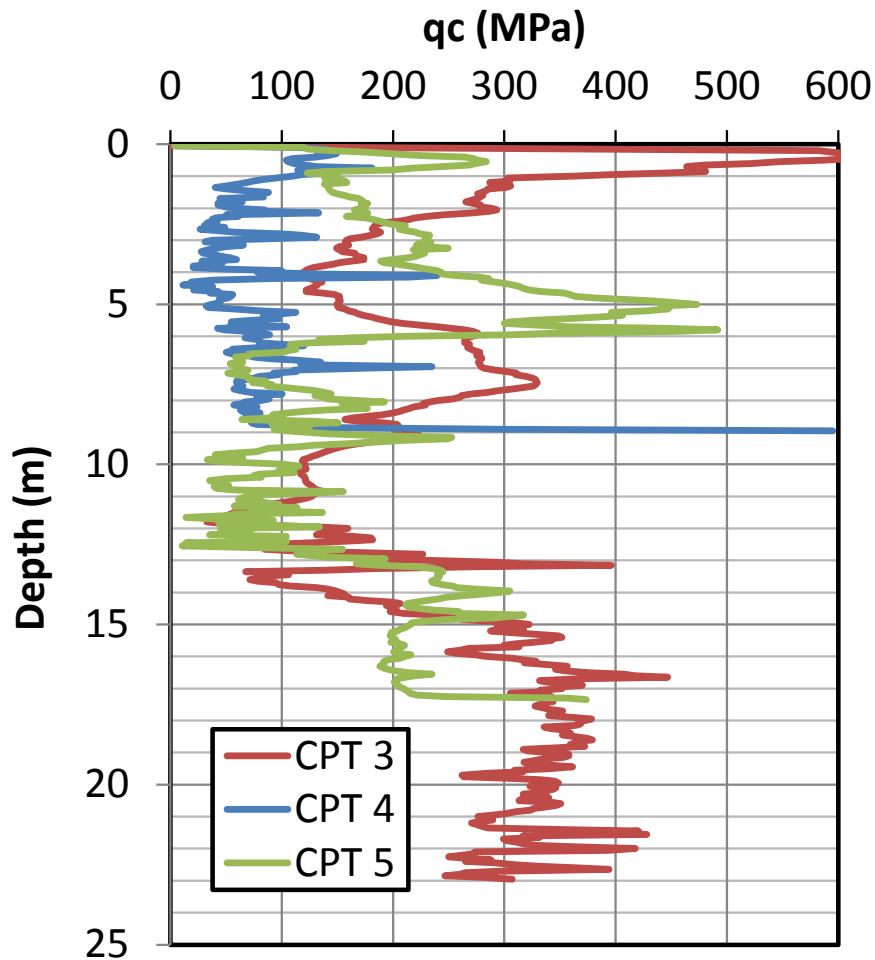
**Fig. 2.11 Profiles of cone tip resistance,  $q_c$ , for CPT3, CPT4 and CPT4 along a cross-section through the Molo Pier as shown in Fig. 2.9.**

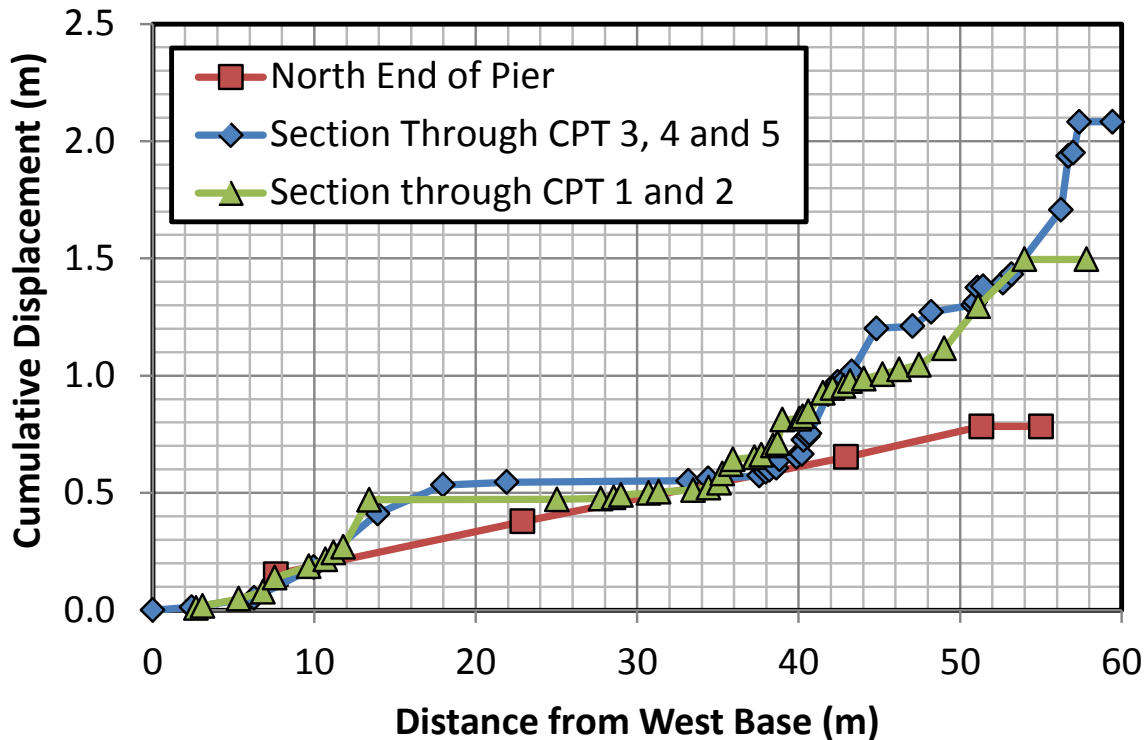
**Fig. 2.12 Cumulative lateral spread displacement vs. distance curves through three transverse sections through the Molo pier.**

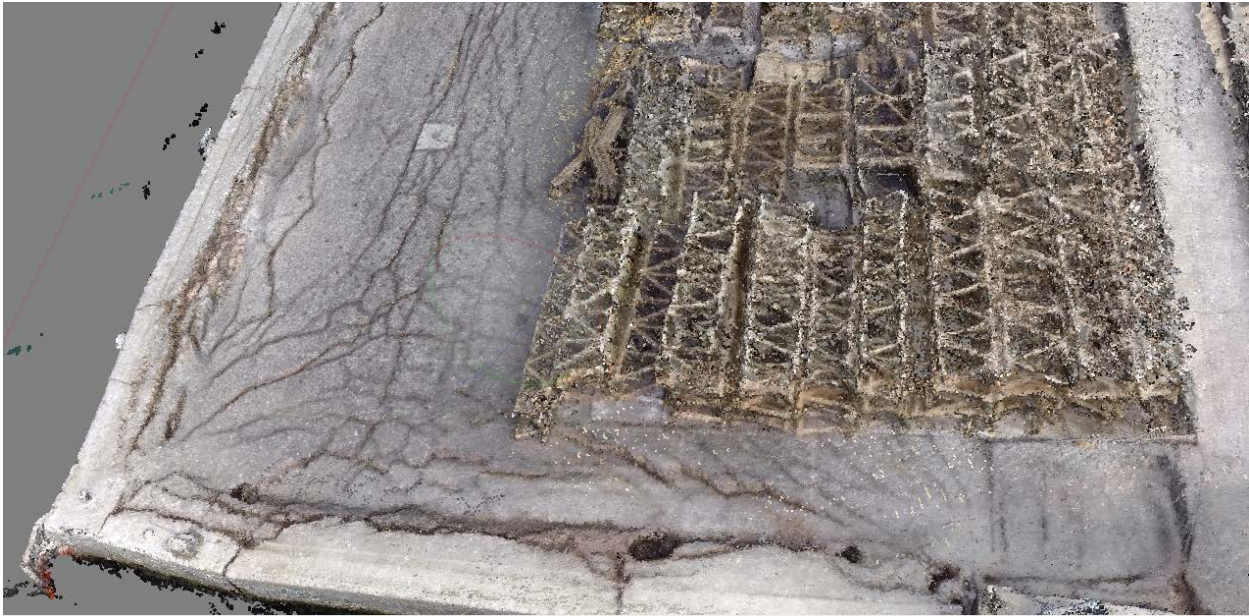
**Fig. 2.15 Screenshot of corner cracking and deformation from the dense point cloud**

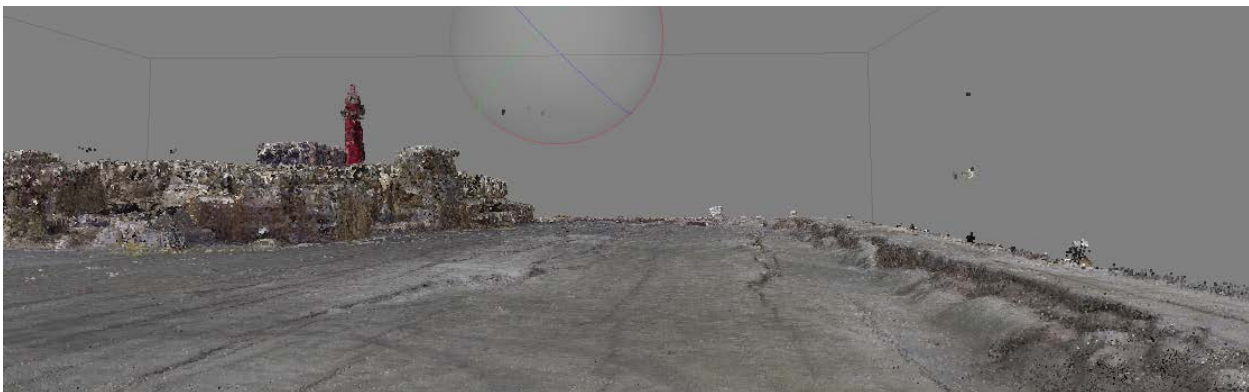
**Fig. 2.16 Screenshot of cracking and slumping at the pier surface from the dense point cloud**

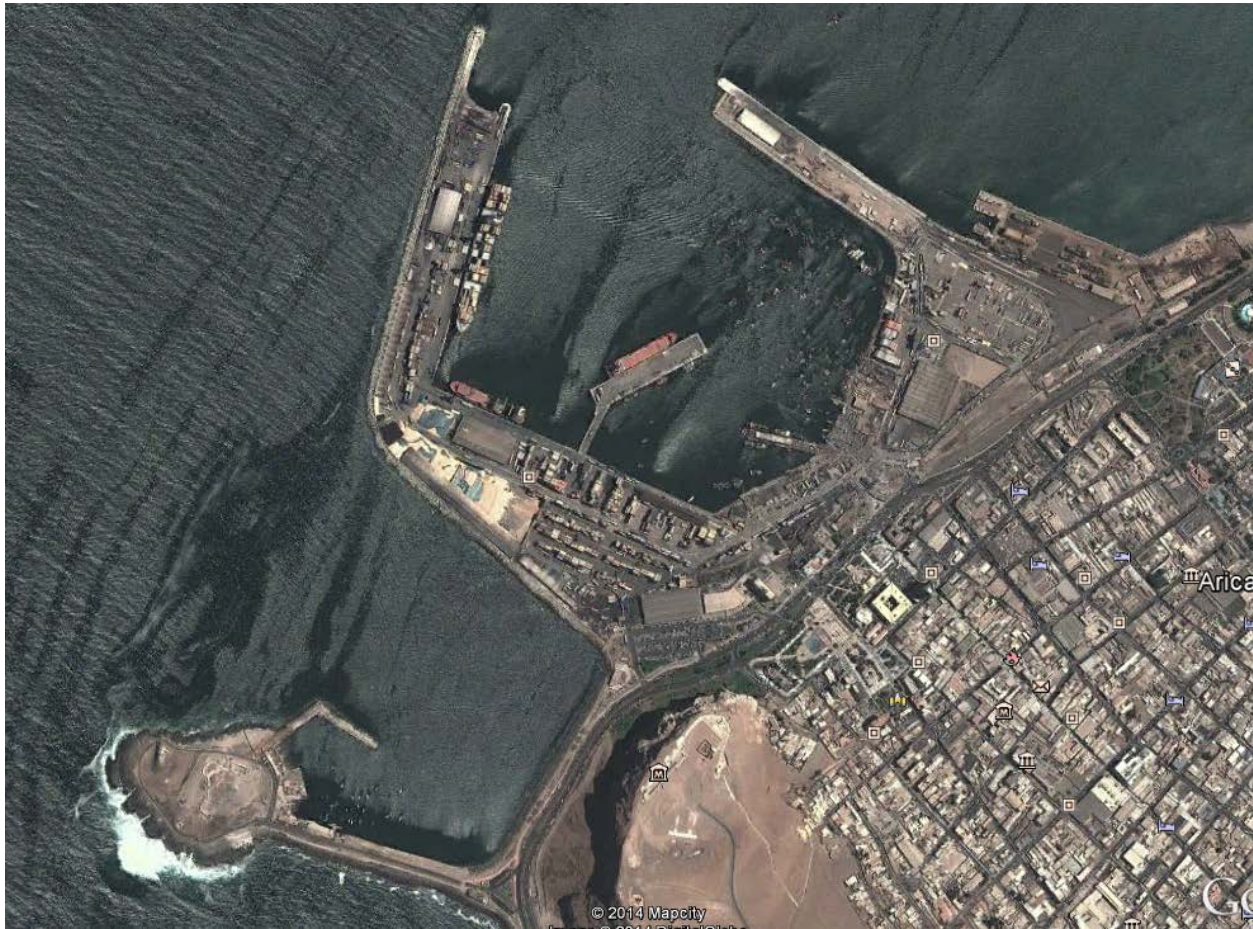
**Fig. 2.17** Google earth image of the port at Arica.

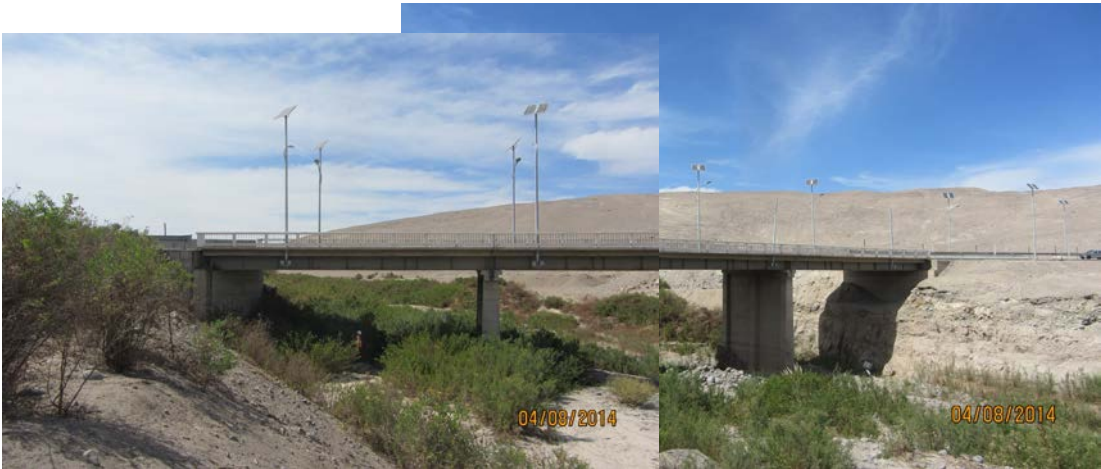
**Fig. 3.3. Photo of the Tiliviche bridge elevation (-19.551966°, -69.940921°).**

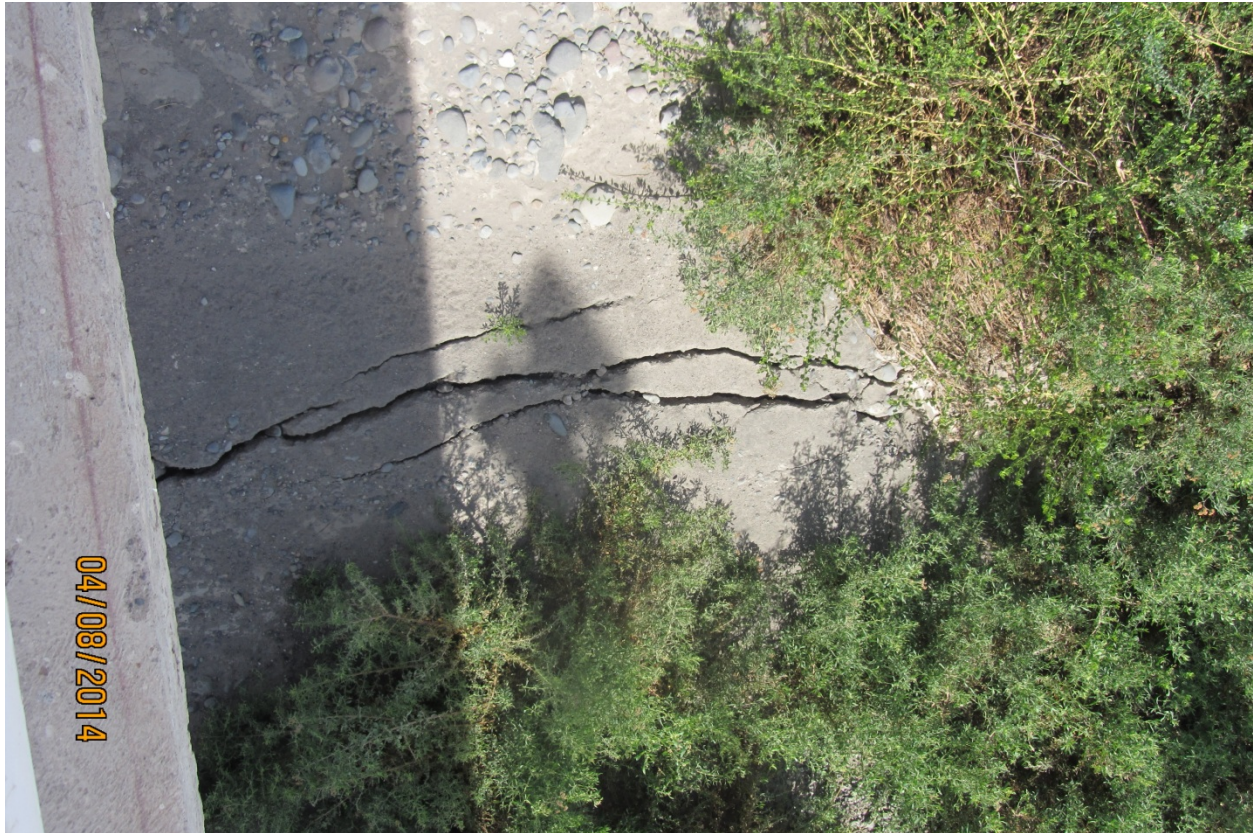
**Fig. 3.4** Photograph showing cracks paralleling the stream channel below the Tiliviche bridge (-19.551966°, -69.940921°).

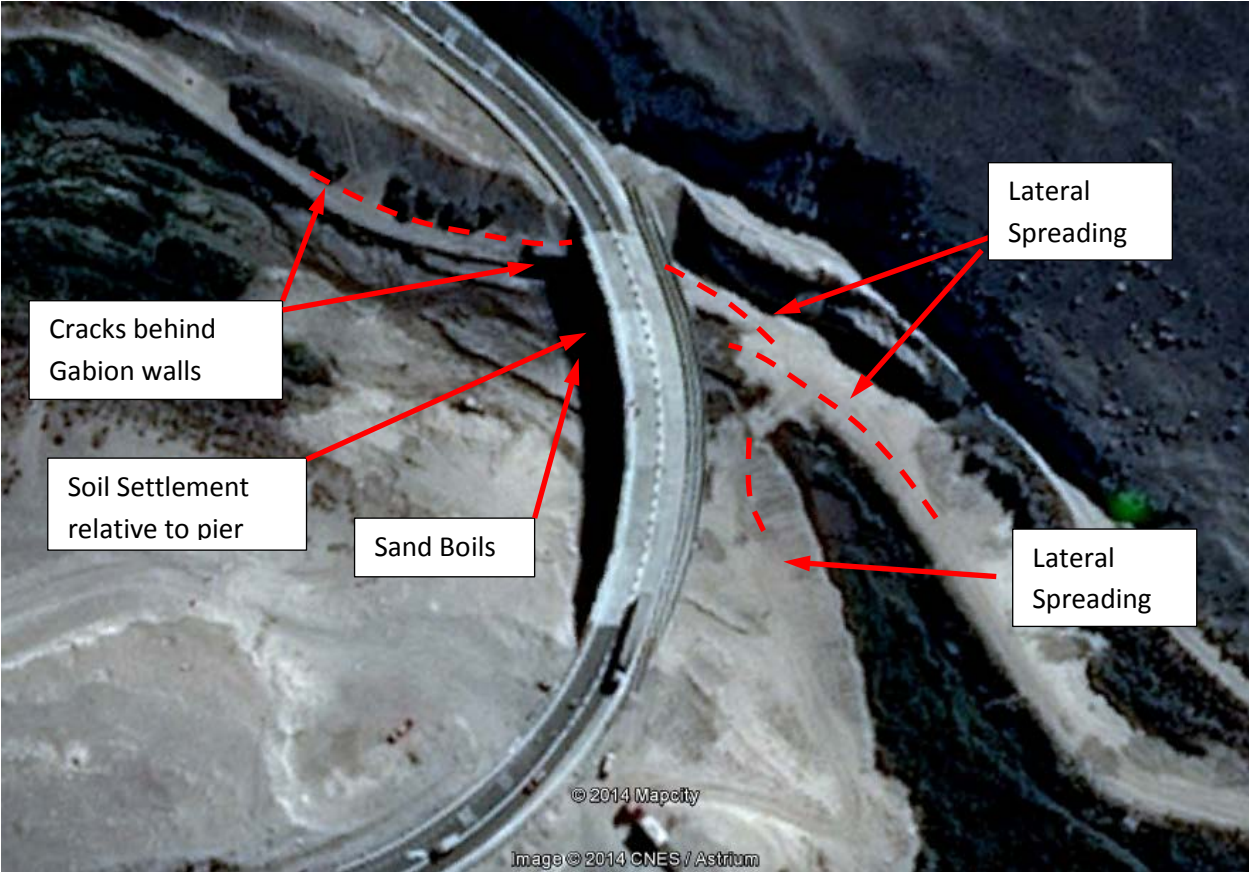
**Fig. 3.5 Google Earth image showing plan view of Tana Bridge (-19.454491°, -69.946831°).**

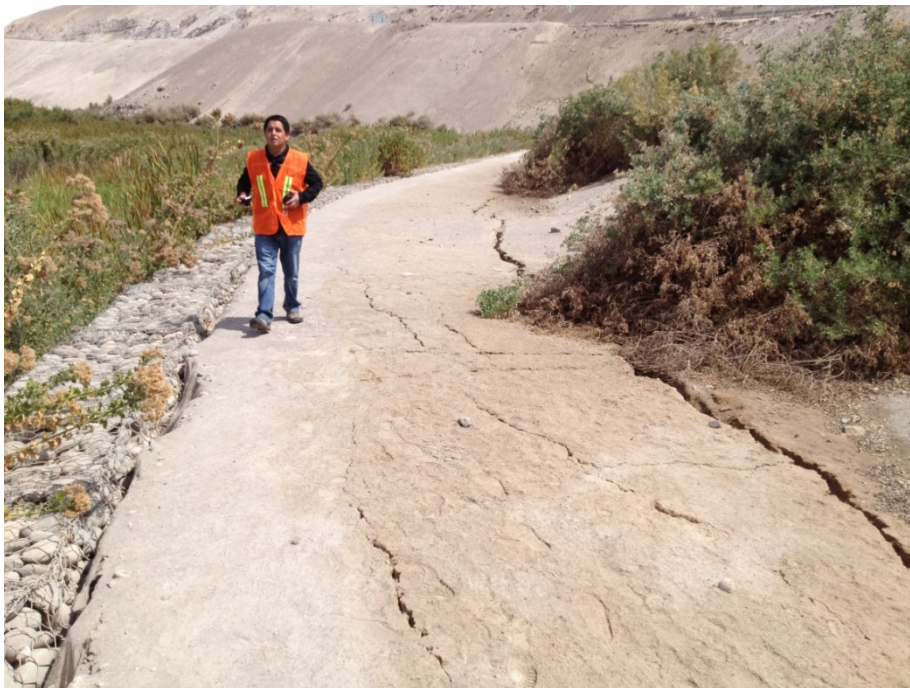
**Fig. 3.7 View of cracking behind gabion wall running parallel to the north abutment and river slope. Largest crack widths are approximately 20 to 40 mm. (19.454135°, -69.946804°)**

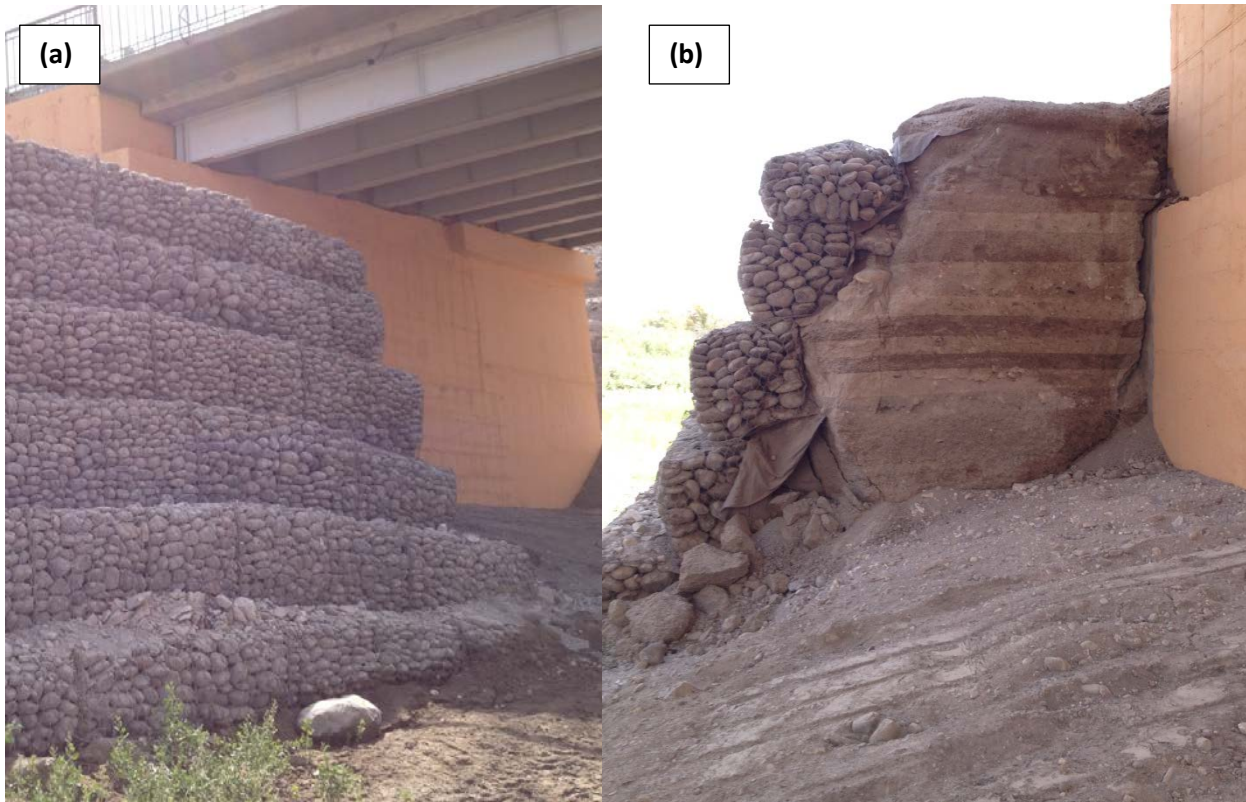
**Fig. 3.8 (a) Gabion wall adjacent to the north bridge abutment and (b) tension crack adjacent to abutment behind gabion wall. (19.454265°, -69.946496°)**

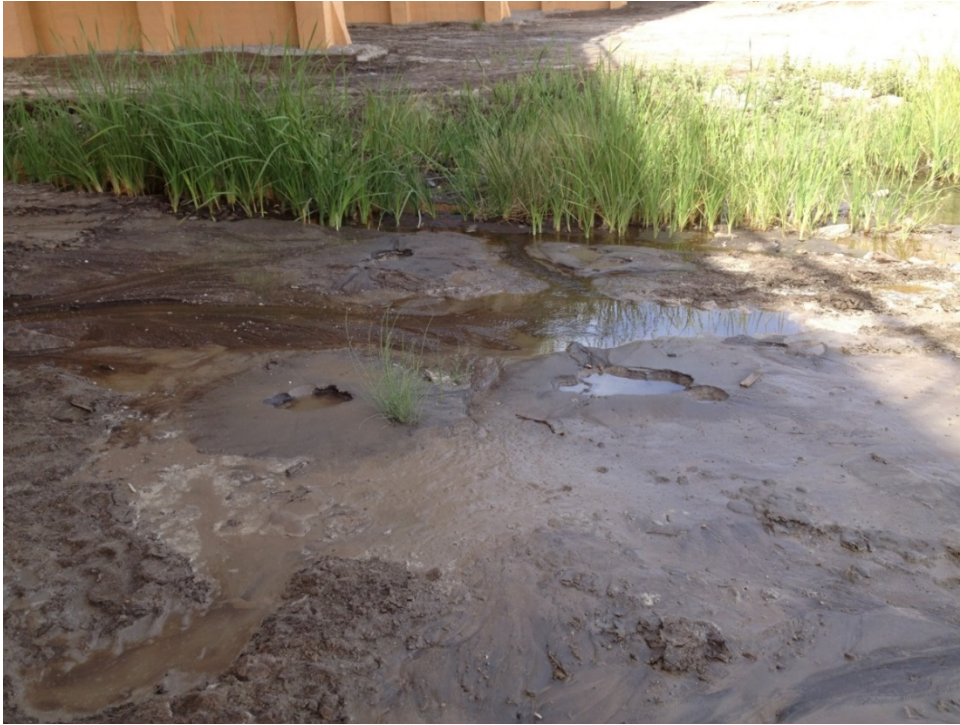
**Fig. 3.9** Photograph of sand boils adjacent to small stream flowing beneath the Tana bridge.  
(19.454245°, -69.946399°)
