**GEOTECHNICAL EXTREME EVENTS RECONNAISSANCE (GEER) ASSOCIATION**

*Turning Disaster into Knowledge*

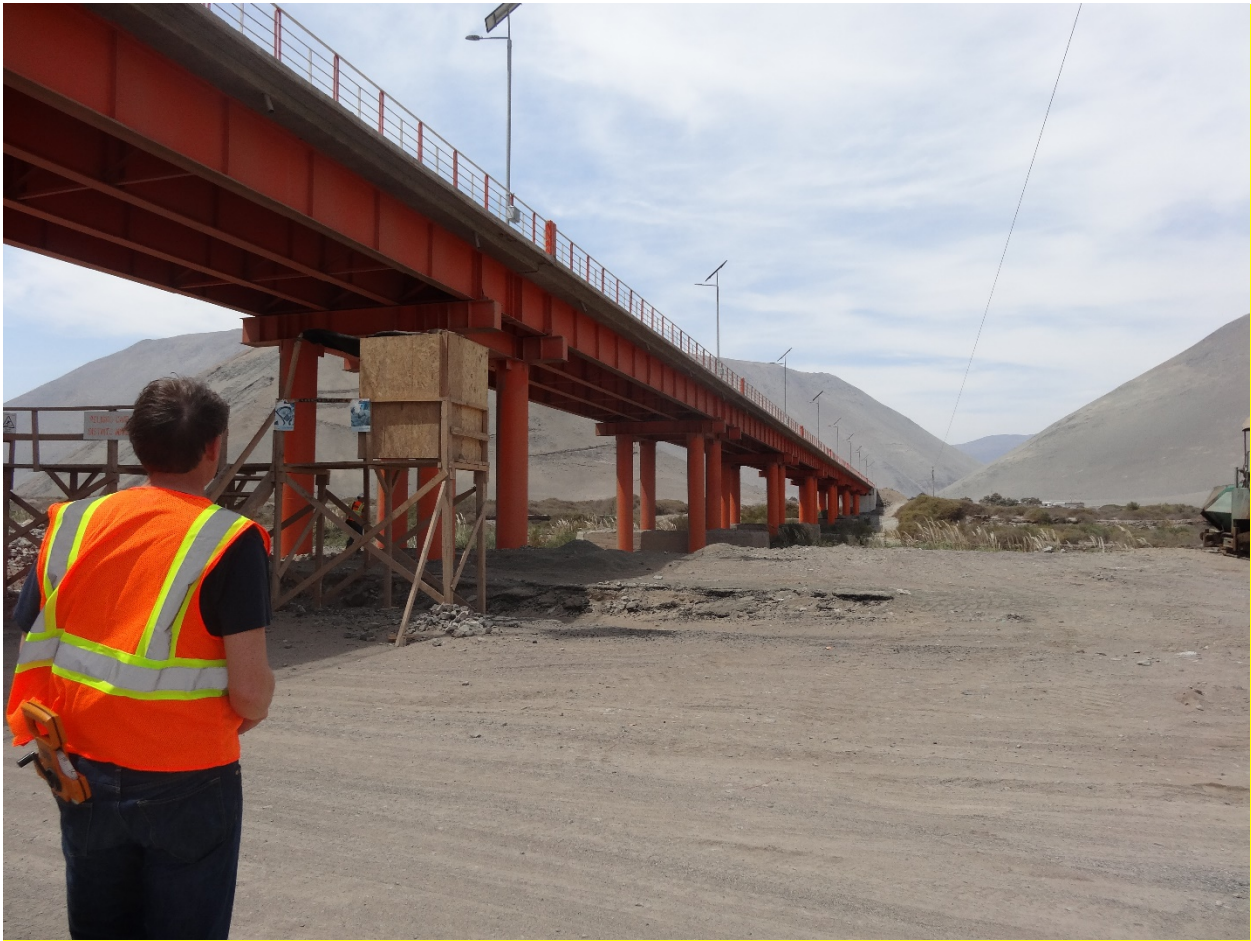
**Fig. 3.16 Photograph of the Camarones Bridge. (-19.157123°, -70.187611°)**

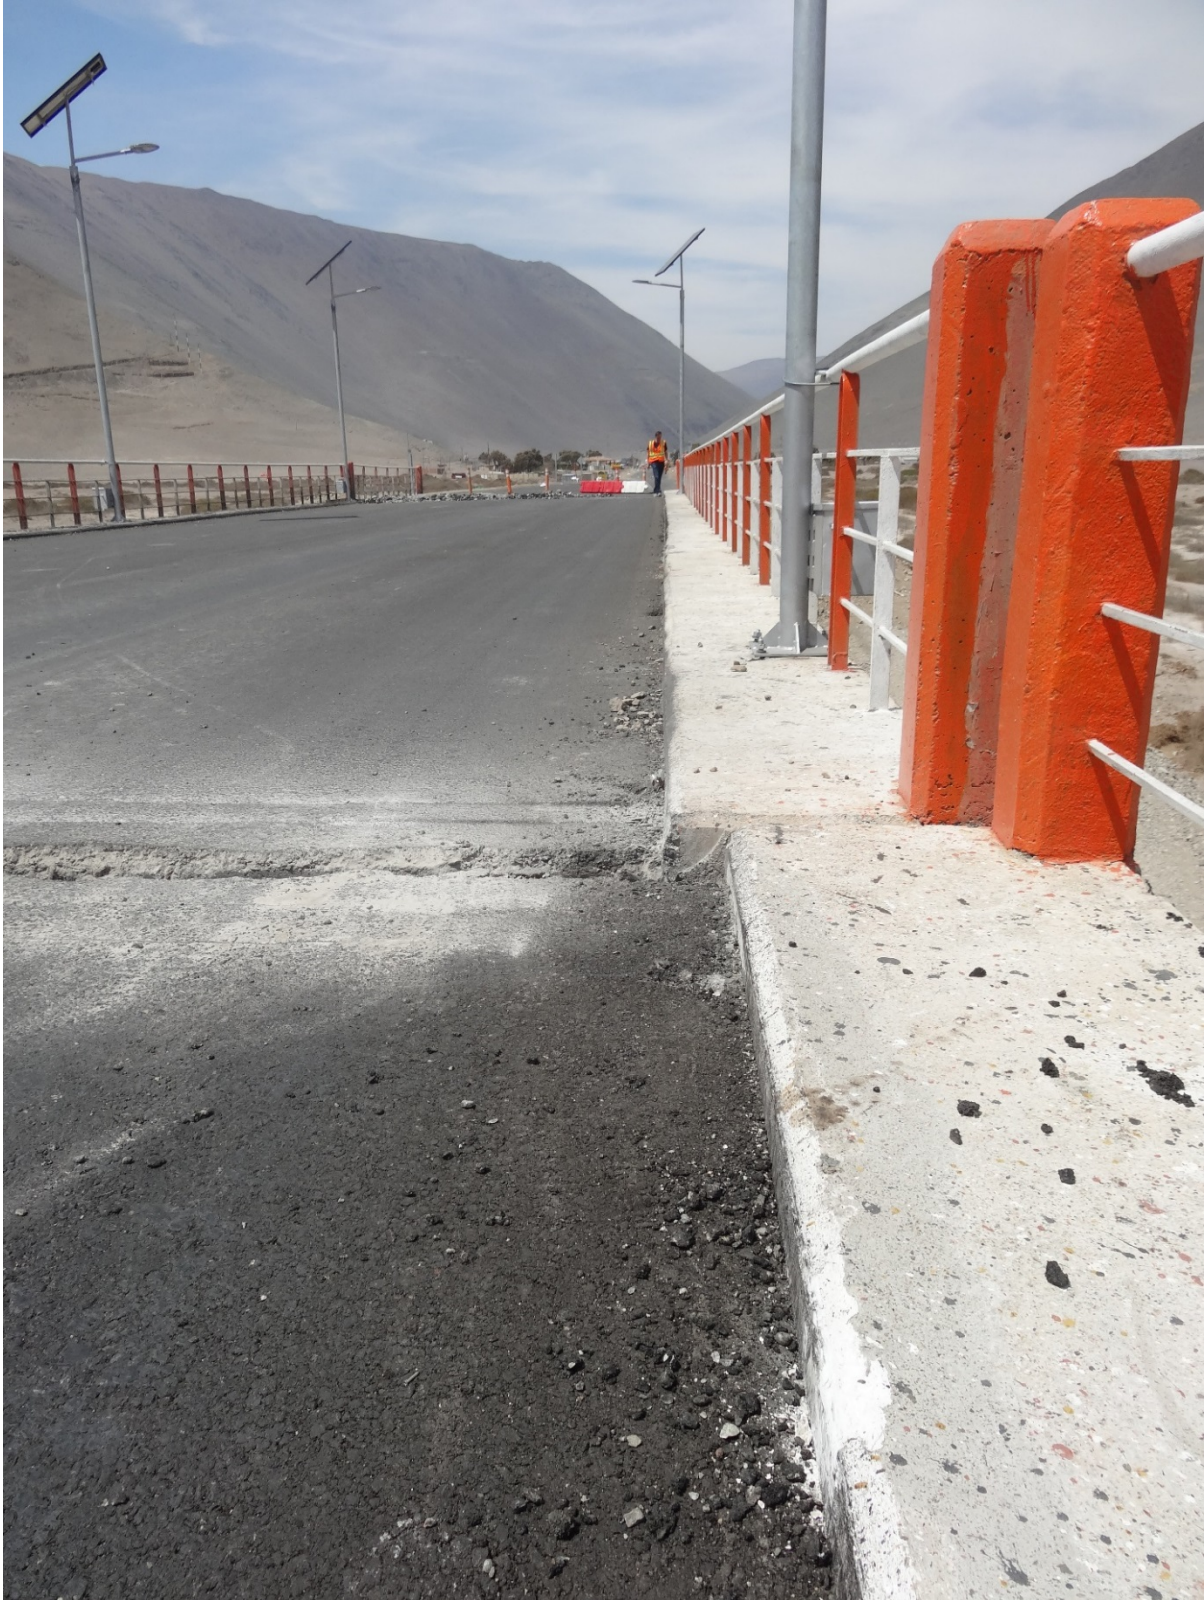
**Fig. 3.17 Photograph of lateral offset observed at the Camarones Bridge. (-19.007839°,-70.002497°)**

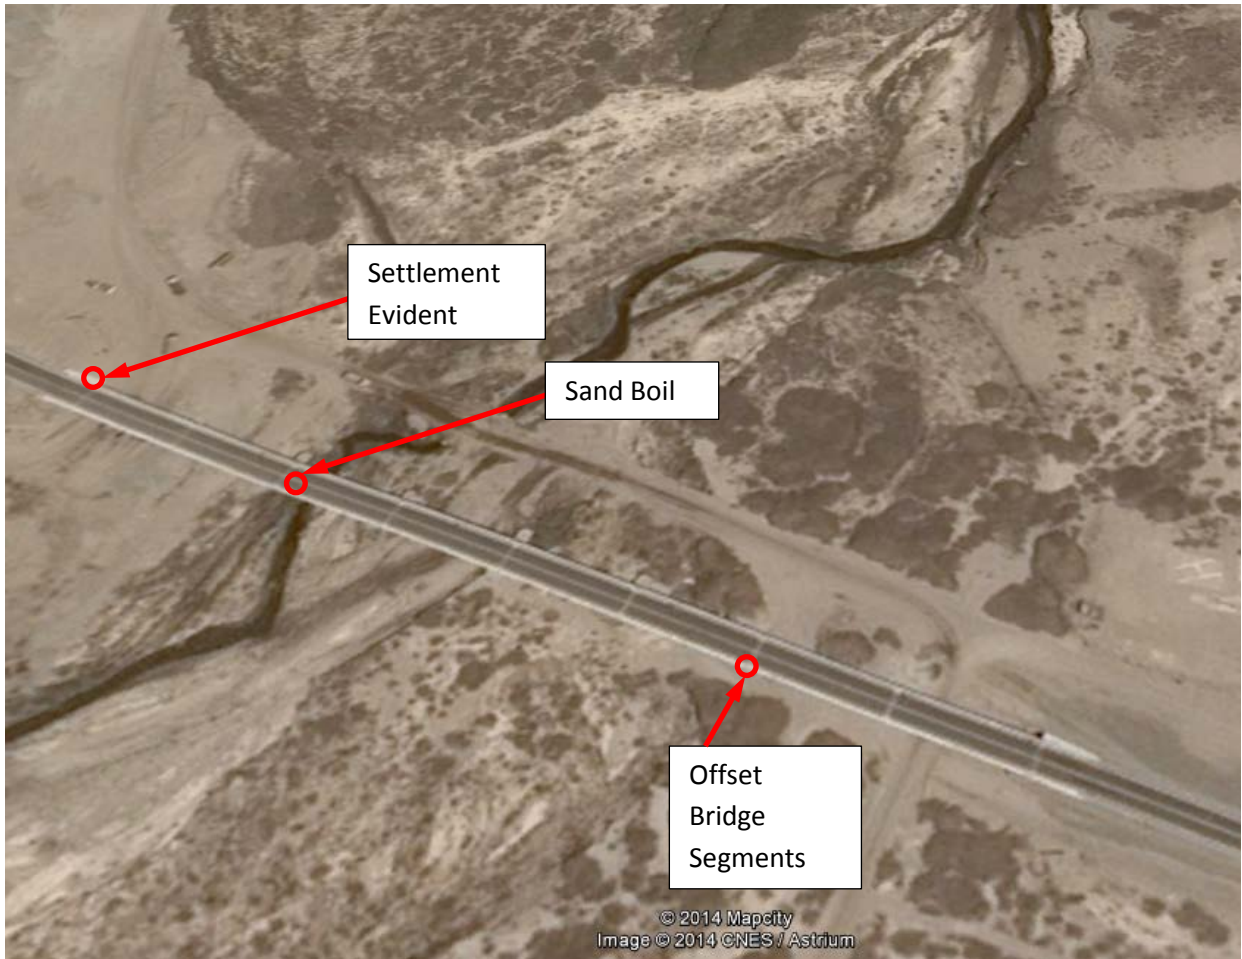
**Fig. 3.18** Google maps image of the Camarones Bridge composed of eight simply supported segments (-19.157493°, -70.186478°).

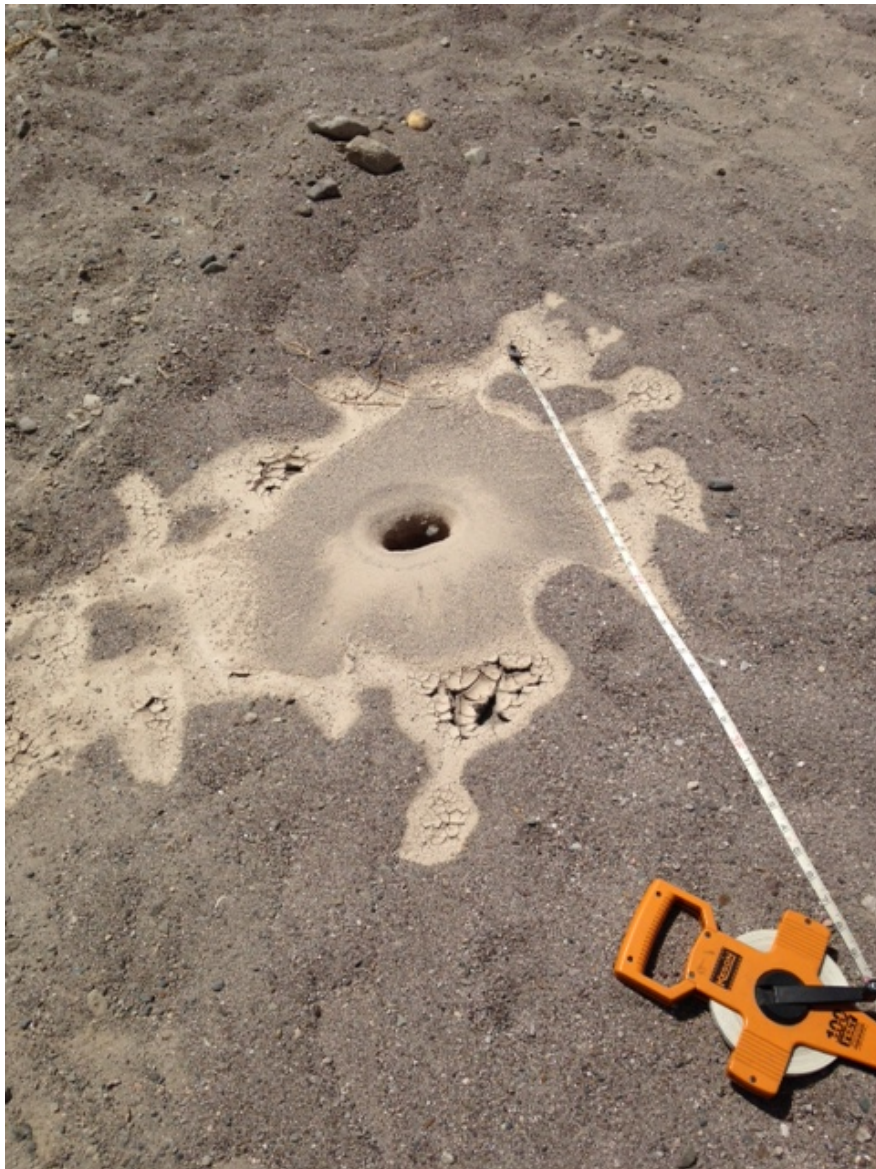
**Fig. 3.19** Sand boil observed at the Camarones Bridge (-19.157366°, -70.186806°).

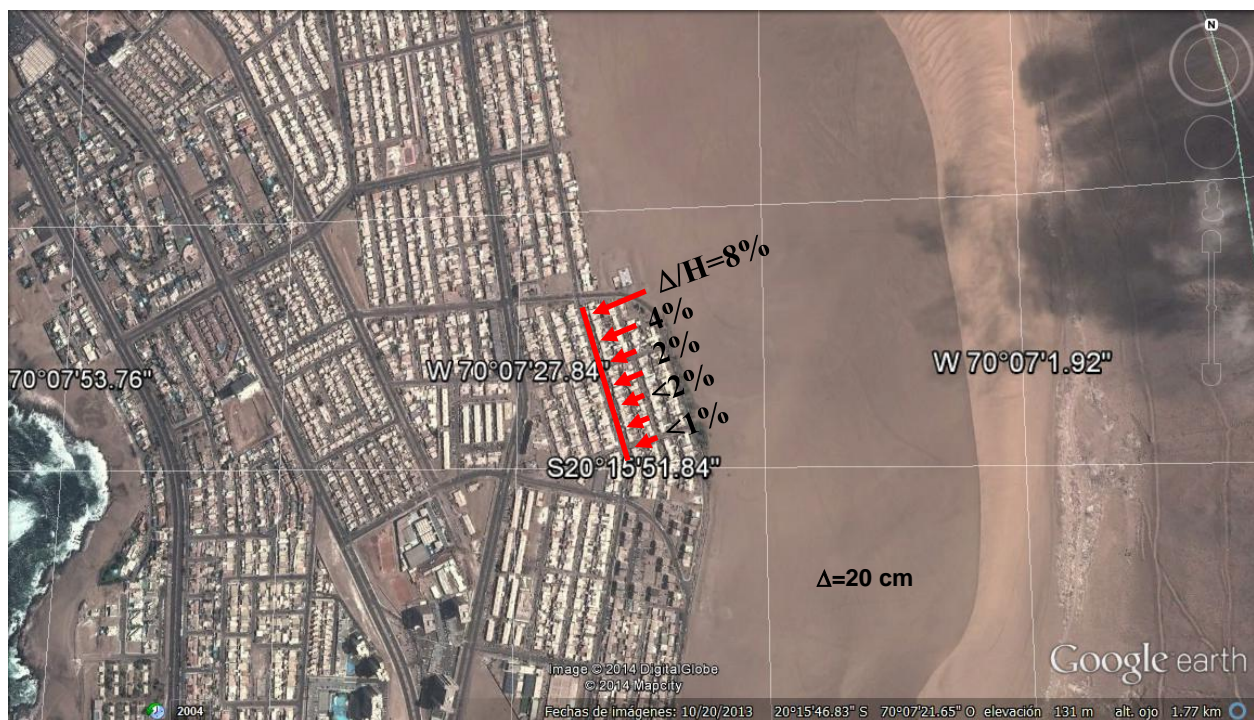
Fig. 4.1. Google earth photograph of the housing development of Cerro Dragón

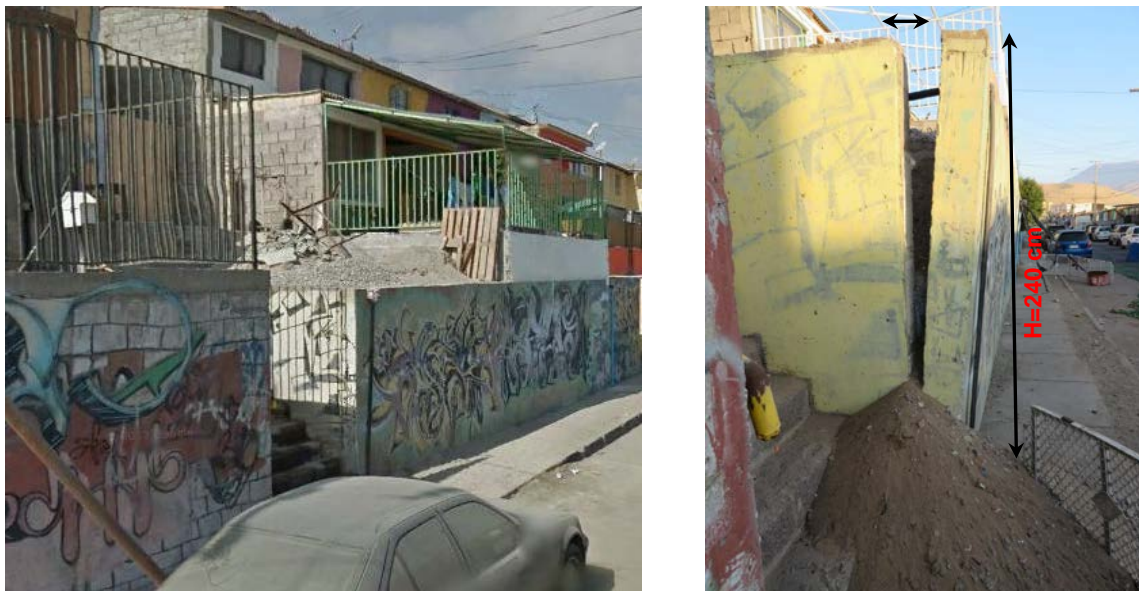
**Fig. 4.2. Retaining wall in Los Algarrobos Street  $20^\circ 15' 43''\text{S}$  -  $70^\circ 07' 24''\text{W}$ .  
Left: wall before the earthquake, source Google Street View.  
Right: wall displaced after the earthquake ( $\Delta/H=8\%$ )**

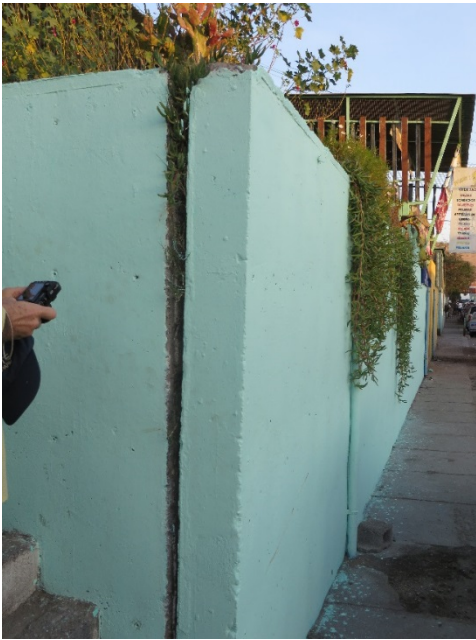
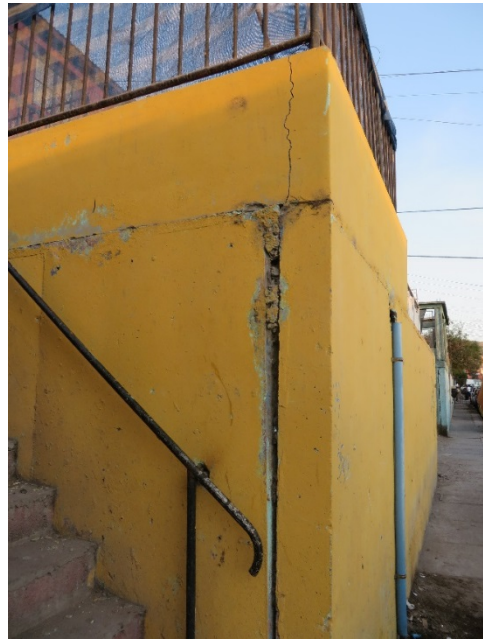
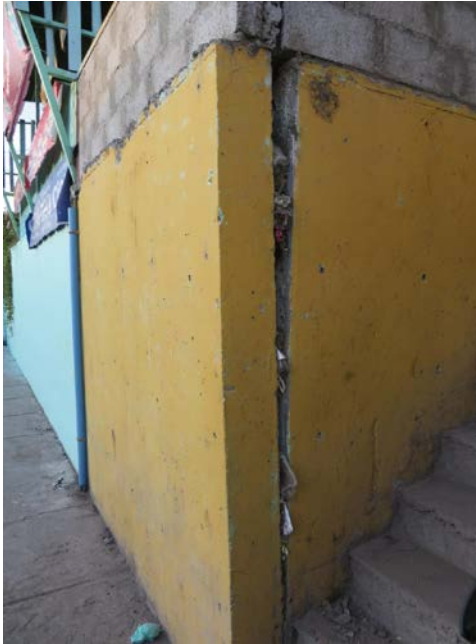
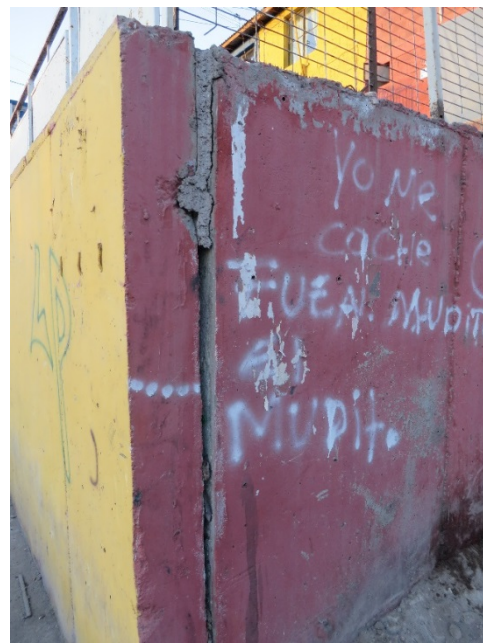
**Fig. 4.3. Retaining walls damaged in previous earthquakes. The gaps were filled with mortar, piping, and vegetation or in some cases left empty. (20°15'43"S - 70°07'24"W)**

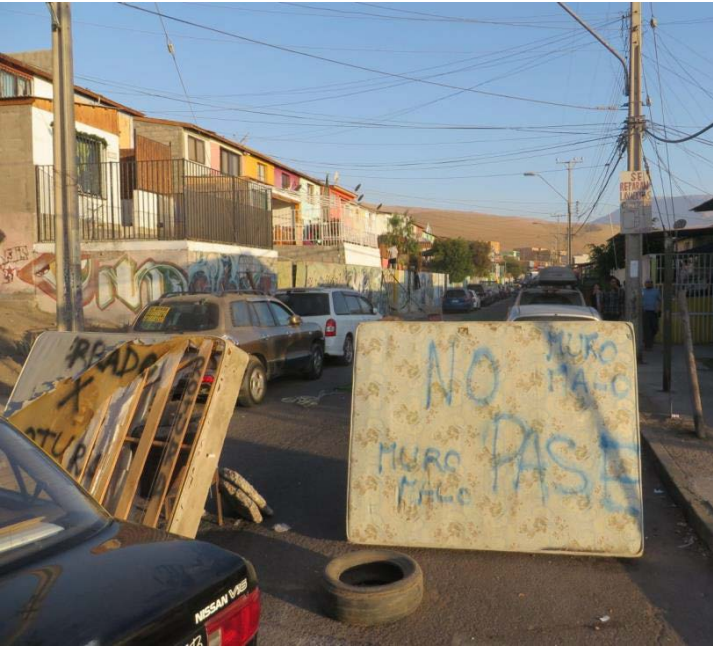
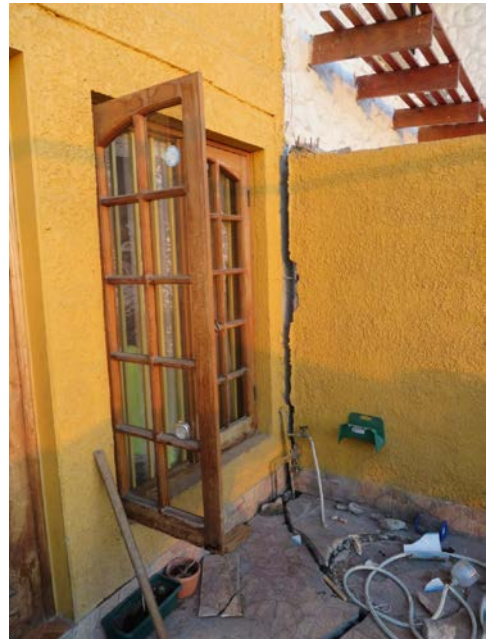
**Fig. 4.4. Left: Signs reading “closed due to failure” and “do not trespass, bad wall” in Los Algarrobos Street. Right: retaining wall displacement ( $\Delta/H=4\%$ ) induced large backfill displacements and structural damage to the houses. ( $20^{\circ}15'43''S$  -  $70^{\circ}07'24''W$ )**

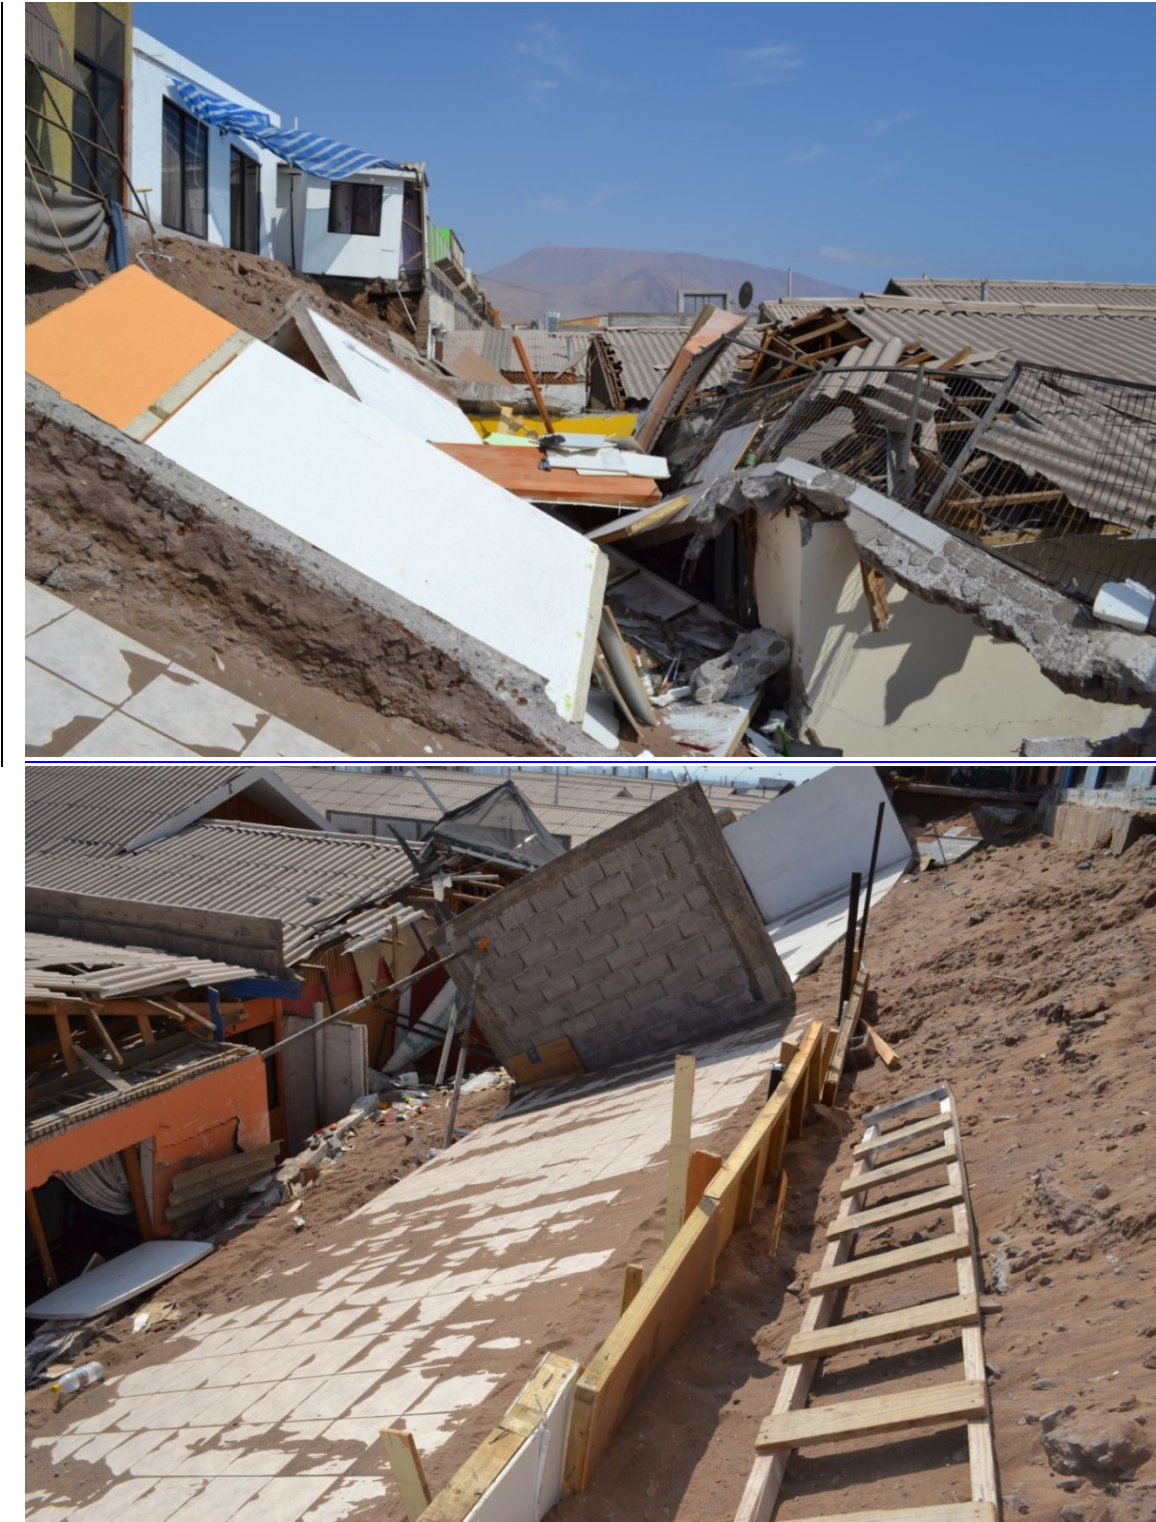
**Fig. 4.5 Failure of unreinforced non-engineered retaining walls. (-20.246503°, -70.129301°)**

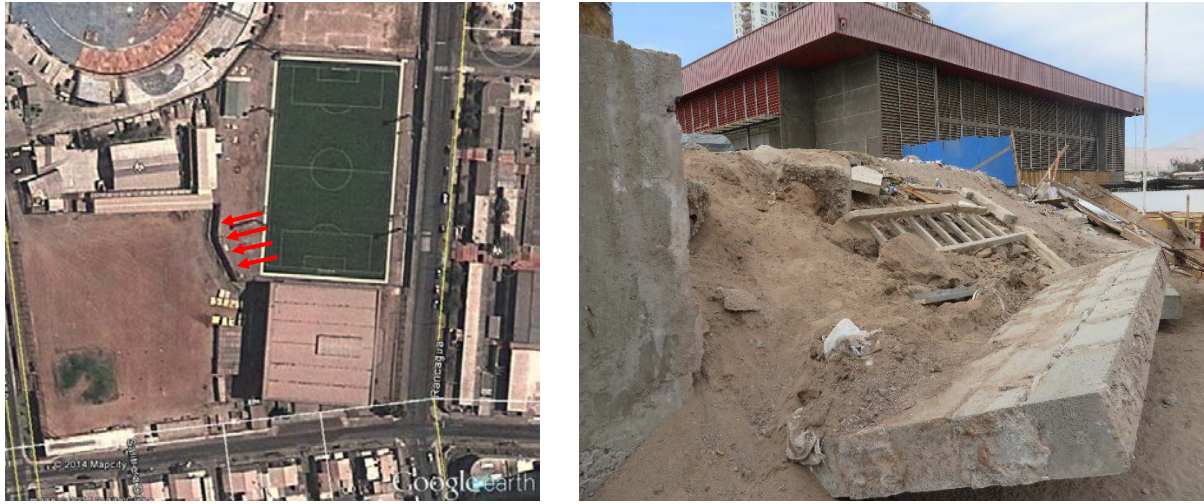
**Fig. 4.6. Left: Aerial view of retaining walls at the Municipal Stadium (-20.243611°, - 70.132222°). Right: overturning failure of masonry walls at the Municipal Stadium**

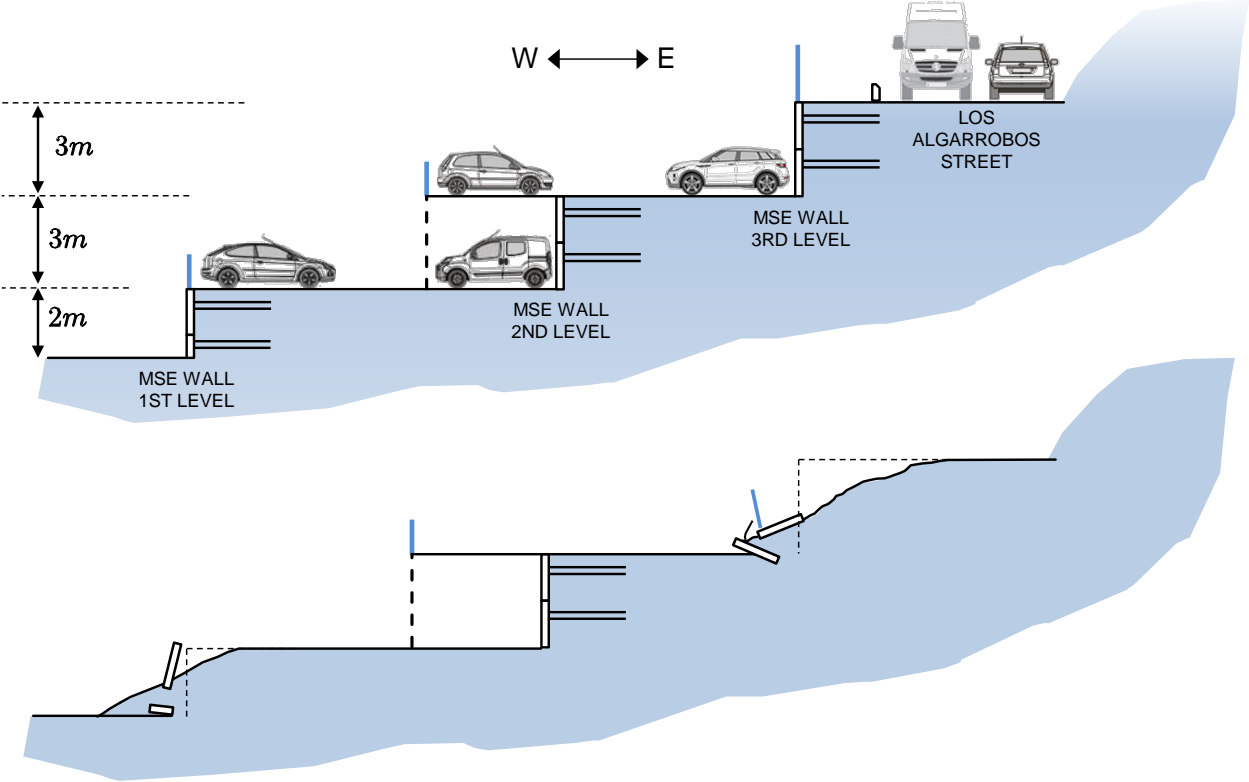
**Fig. 4.7 Top: schematic elevation of MSE retaining walls of the parking garage of “Condominio Horizontes”. Bottom: schematic view of the failure mode**

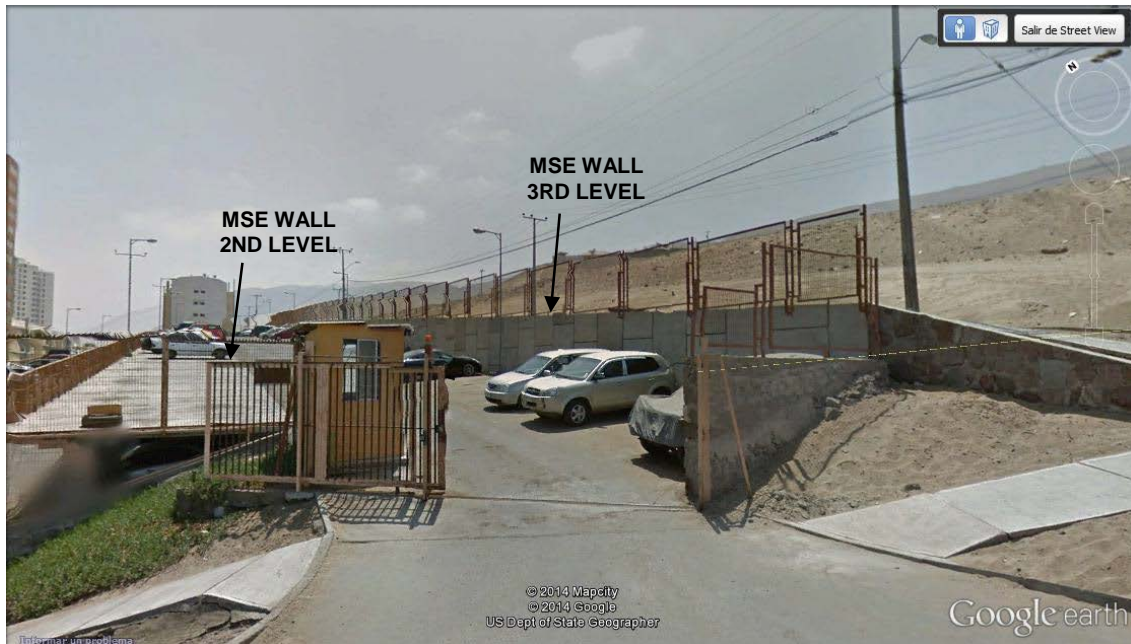
**Fig. 4.8** Photograph of retaining walls before the earthquake. Source: Google Street View (20.273889°, - 70.123889°)

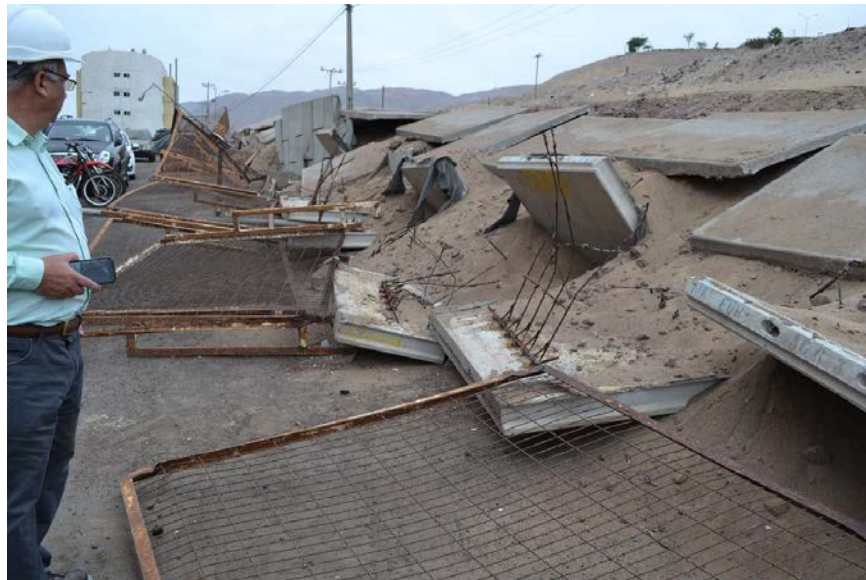
**Fig. 4.9.** Failure of retaining walls in the upper level and backfill displacements (20.273889°, - 70.123889°) (photograph courtesy of Ramon Verdugo)

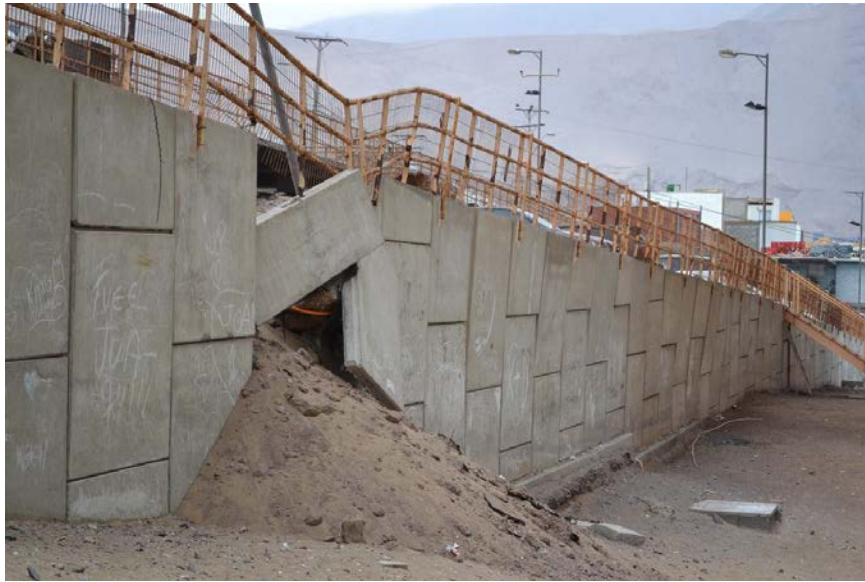
**Fig. 4.10. Localized failure in the 1<sup>st</sup> level and backfill flow (20.273889°, - 70.123889°) (photograph courtesy of Ramon Verdugo)**

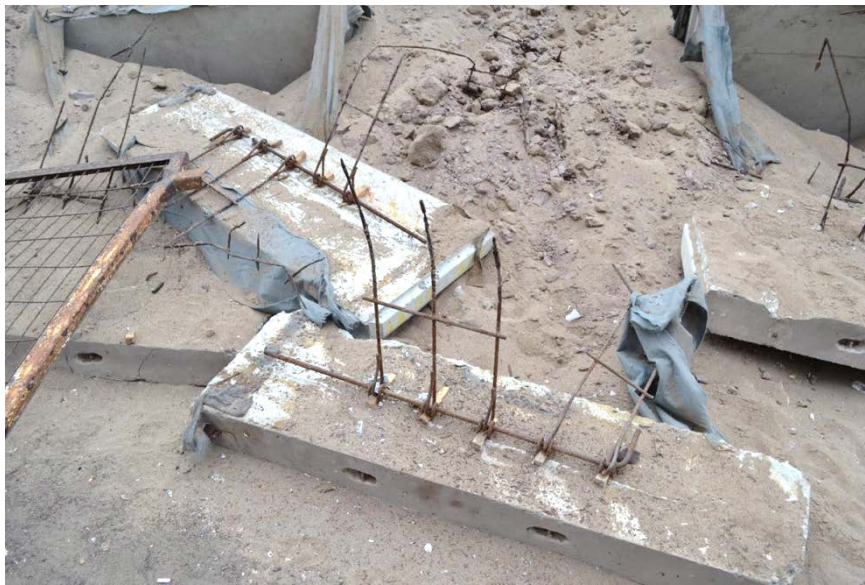
**Fig. 4.11. Advanced corrosion of the galvanized steel bars (20.273889°, - 70.123889°) (photograph courtesy of Ramon Verdugo)**

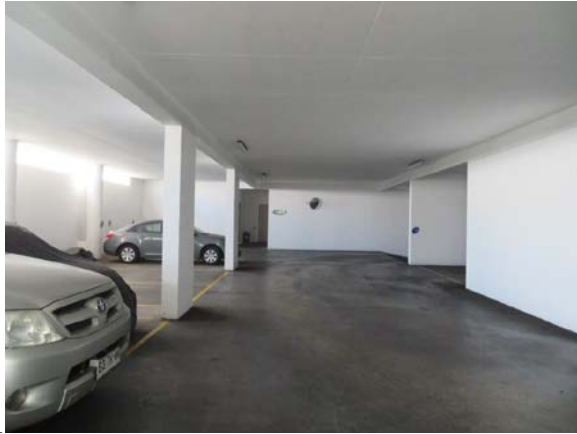
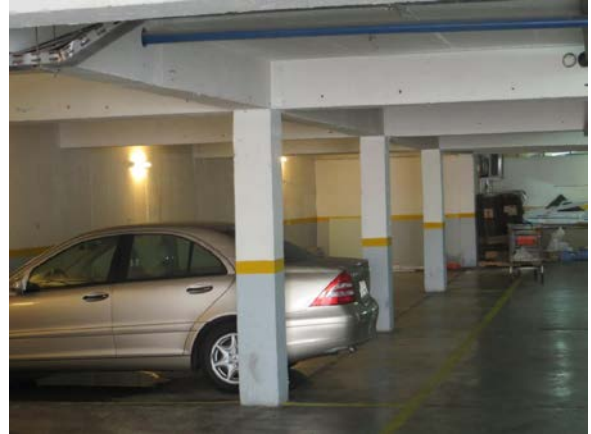
**Fig. 4.12. Undamaged basement walls of buildings ‘Punta Cavancha’ (Left) and ‘Hotel Terrado’ (Right)**

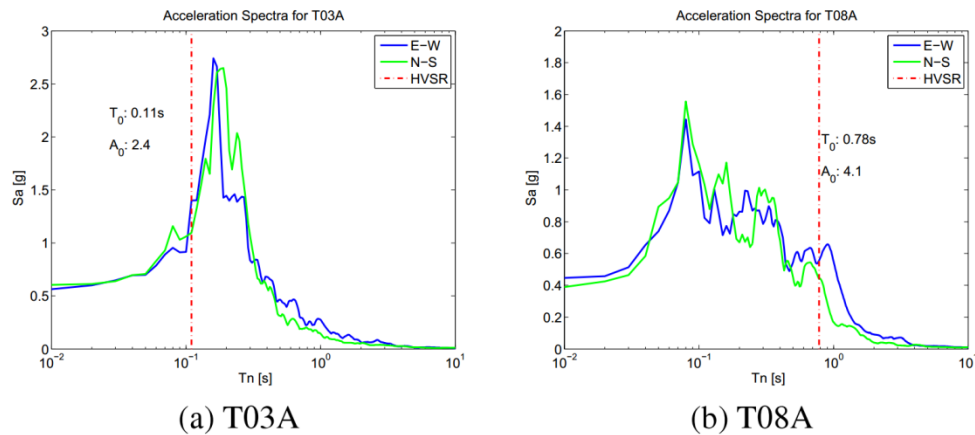
**Fig. 5.4. Acceleration spectra for stations T03A and T08A located on different soils. The red dotted line and text on the Figures represent the Nakamura's result for the closest site.**

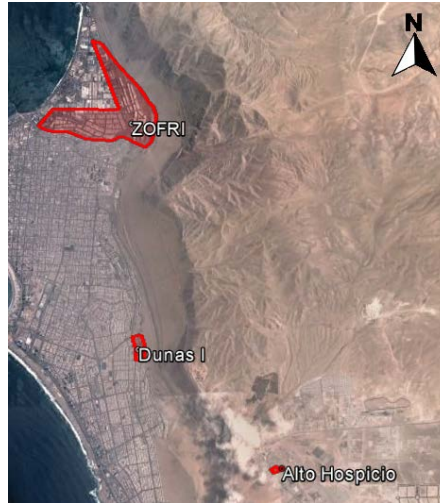
**Fig. 5.5. Location of cases of study**

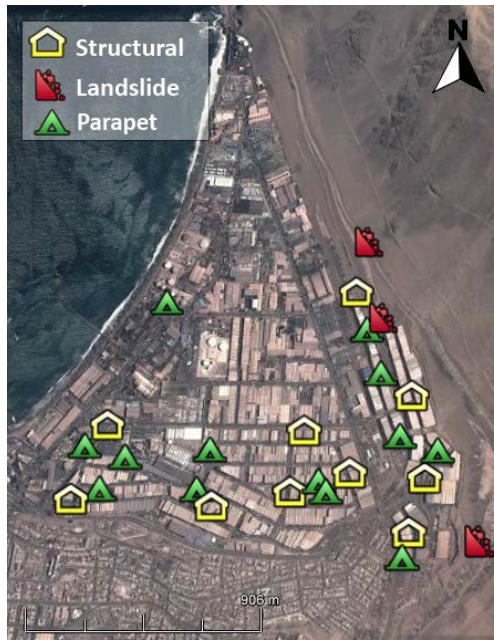
**Fig. 5.6. Observed damage in the ZOFRI zone**

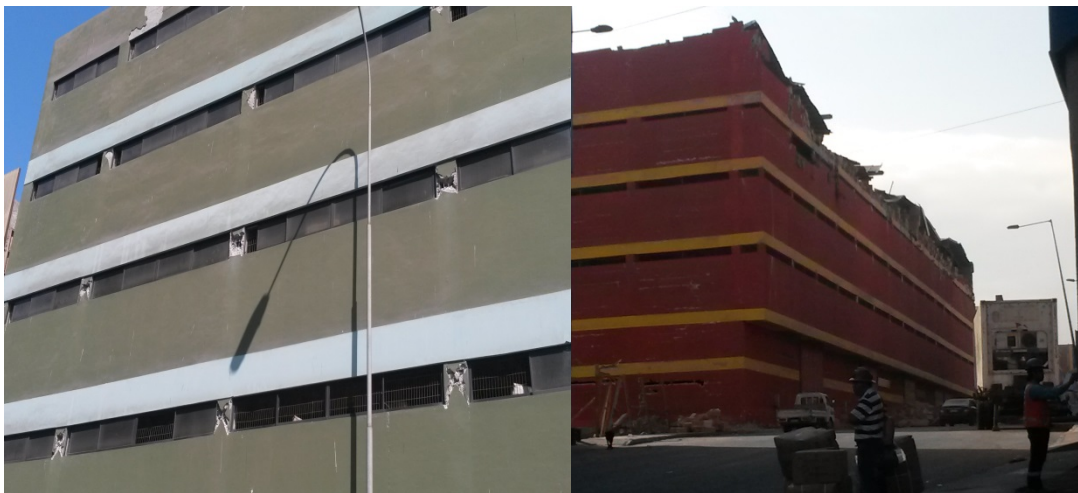
**Fig. 5.7 (left) Typical short column structural damage and (right) fallen roof parapets in the ZOFRI zone.**

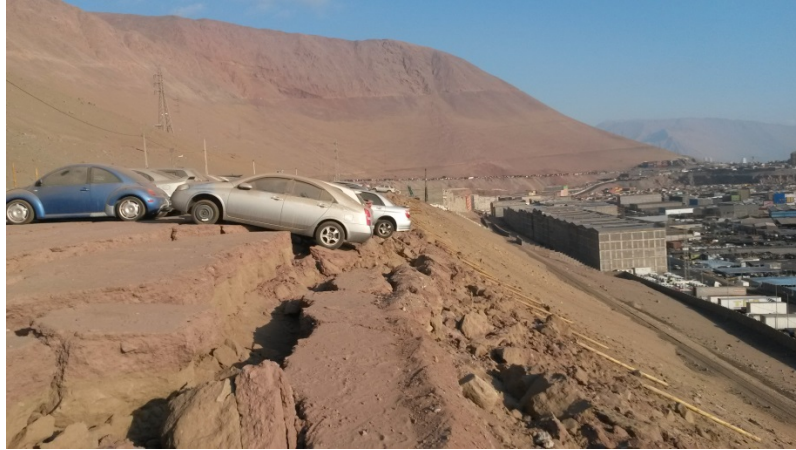
**Fig. 5.8. Observed landslides in the ZOFRI area (-20.200965°, -70.128995°)**

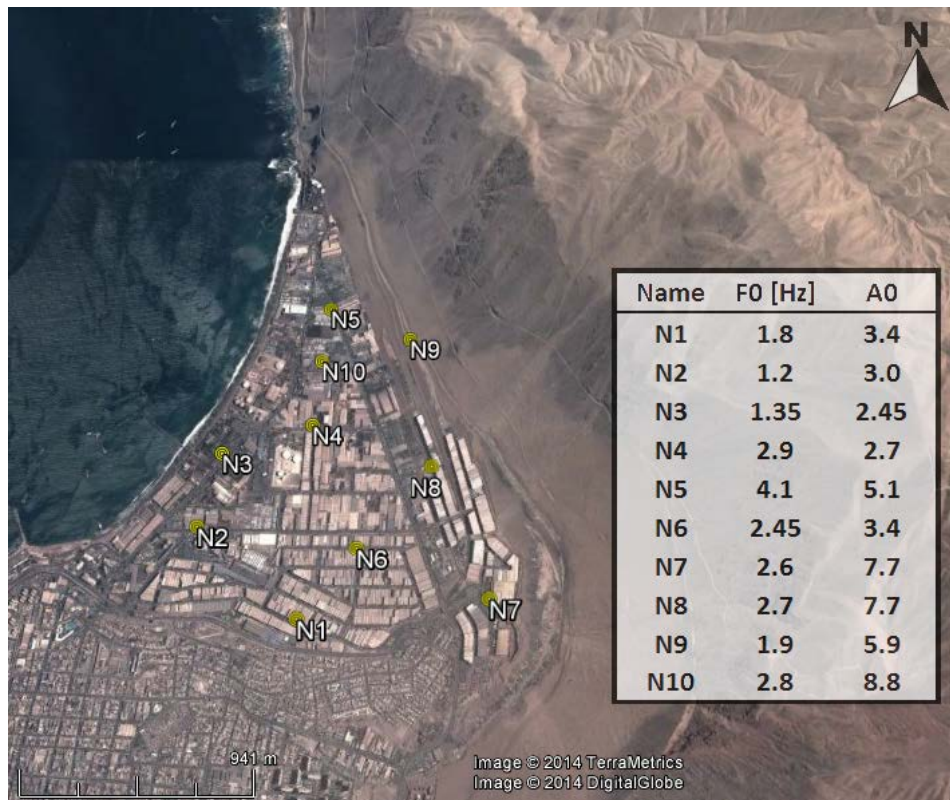
**Fig. 5.9 Typical Nakamura results in the ZOFRI area**

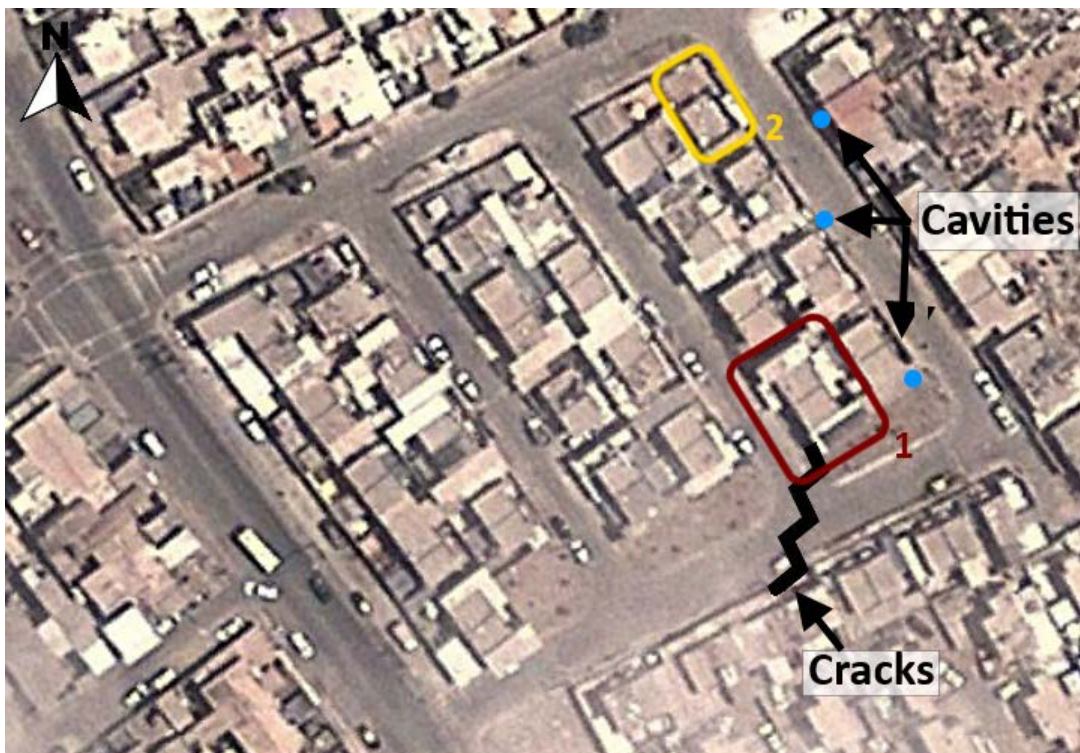
**Fig. 5.10** Cases of study in Alto Hospicio. The black line represents the seismic induced crack in the pavement, while blue dots are the places where cavities were found

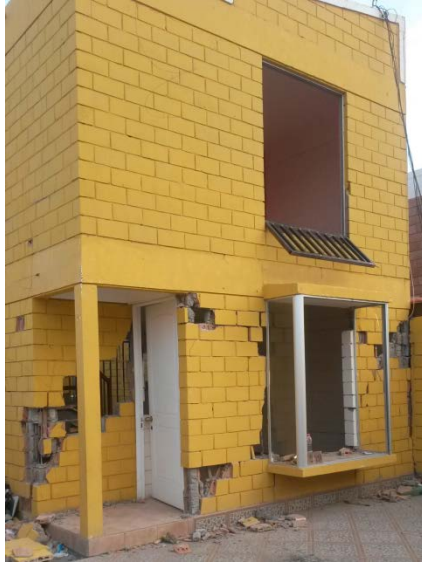
**Fig. 5.11. Observed damage for case 2 of Fig. 5.9.**

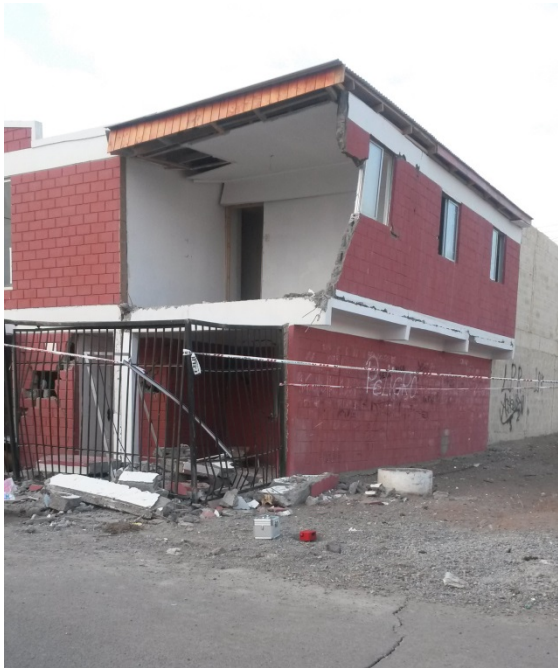
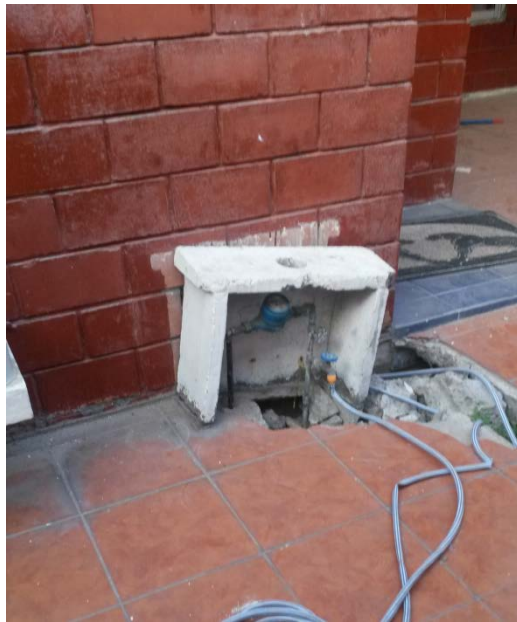
**Fig. 5.12. (left) Observed damage for case 1 in Fig. 5.9 and (right) cavities in Alto Hospicio**

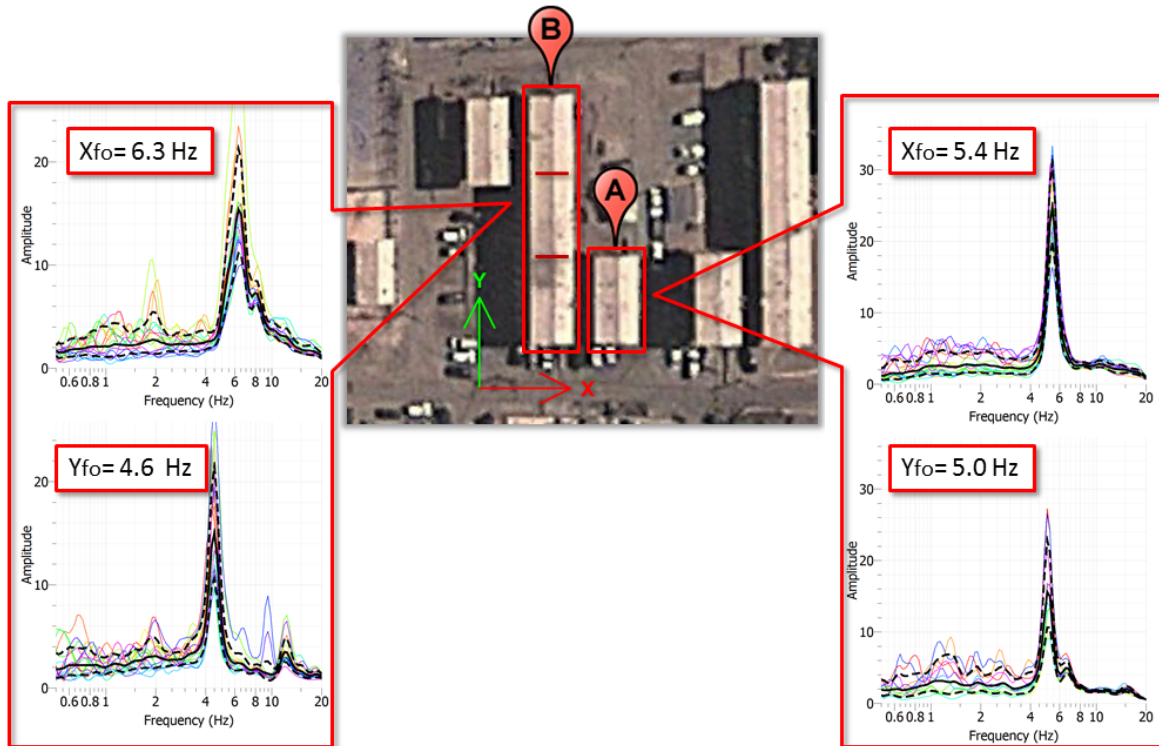
**Fig. 5.13. Estimation of fundamental frequencies of buildings type A and B.**

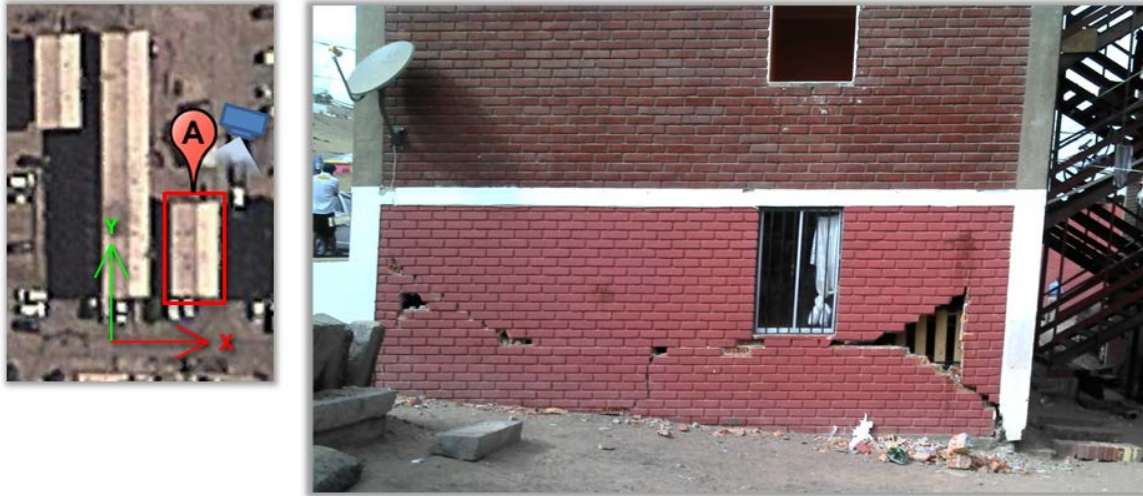
**Fig. 5.14. Observed damage in buildings type A**

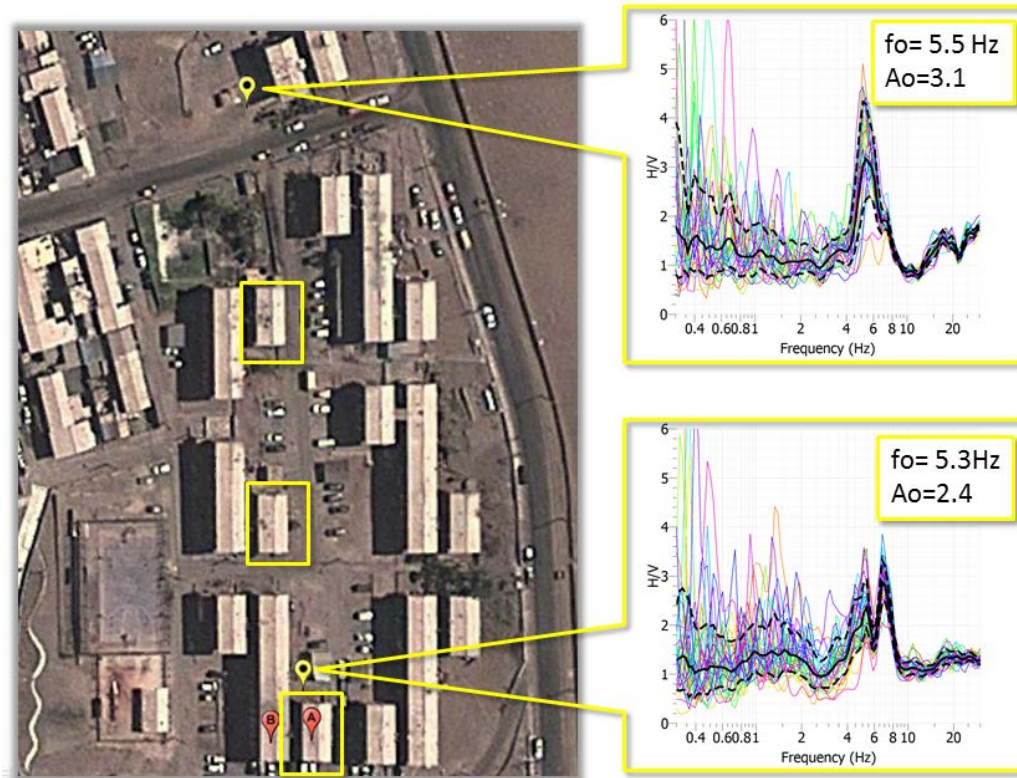
**Fig. 5.15. Predominant frequencies in Dunas I obtained by Nakamura's technique. The buildings marked in yellow are the ones who suffered most structural damage.**
