**GEOTECHNICAL EXTREME EVENTS RECONNAISSANCE (GEER) ASSOCIATION**

*Turning Disaster into Knowledge*

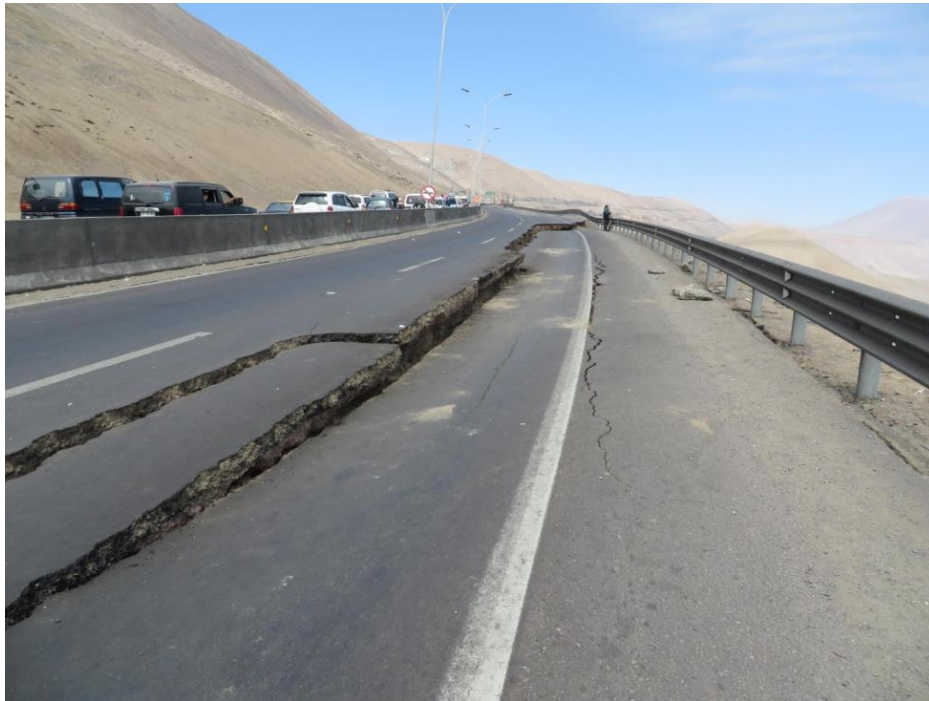
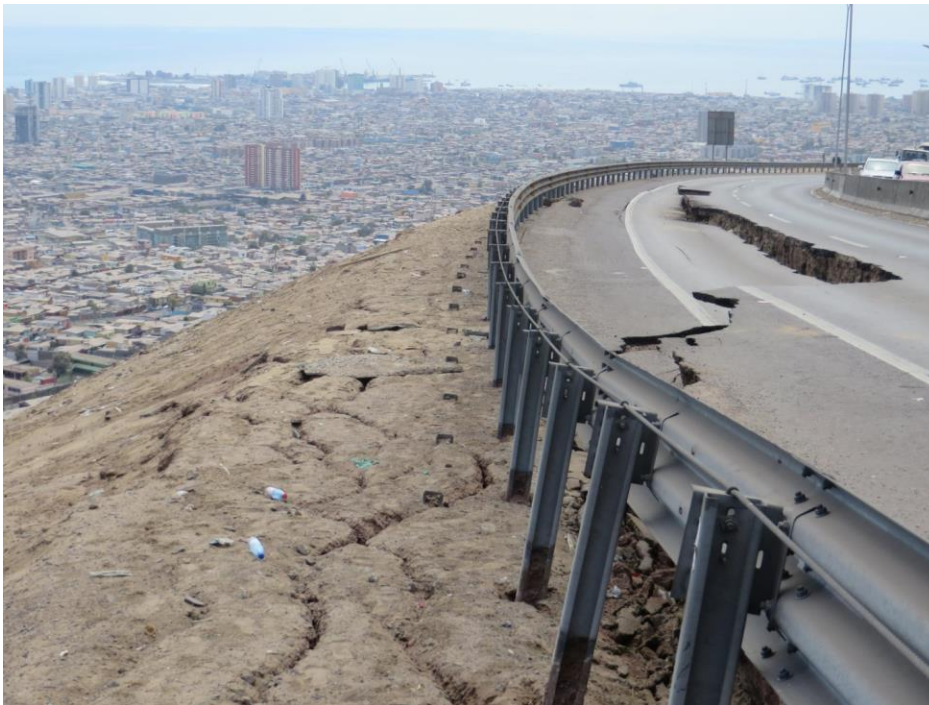
**Fig. 6.1 Deep seated slope failure on Route A-16 (-20.243028°, -70.124056°).**

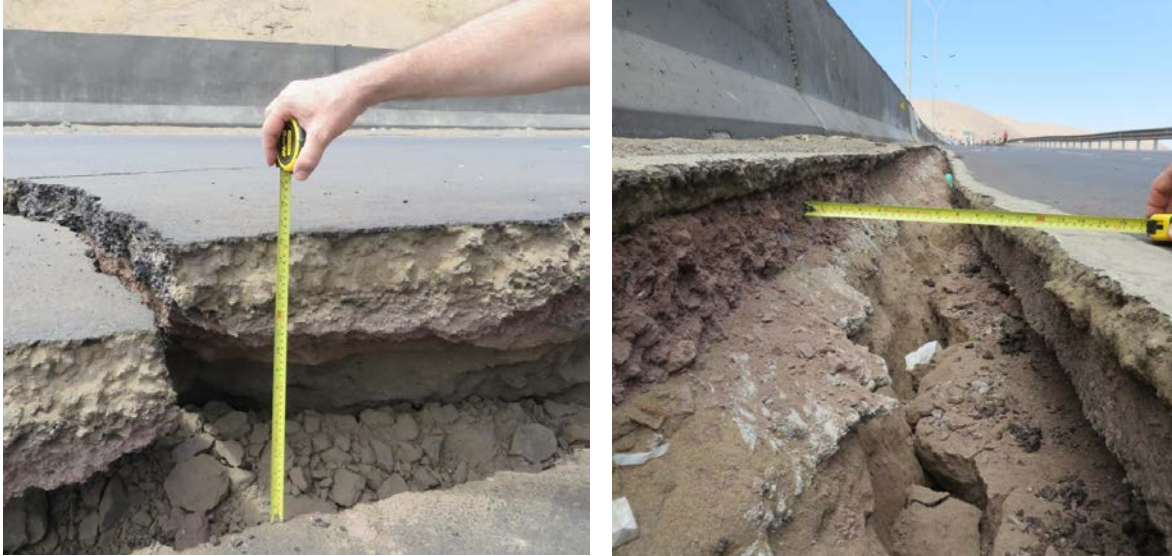
**Fig. 6.2 Measured displacements of 40 cm (vertical) and 30 cm (horizontal) on the slope displacement of Route A-16. (-20.243028°, -70.124056°).**

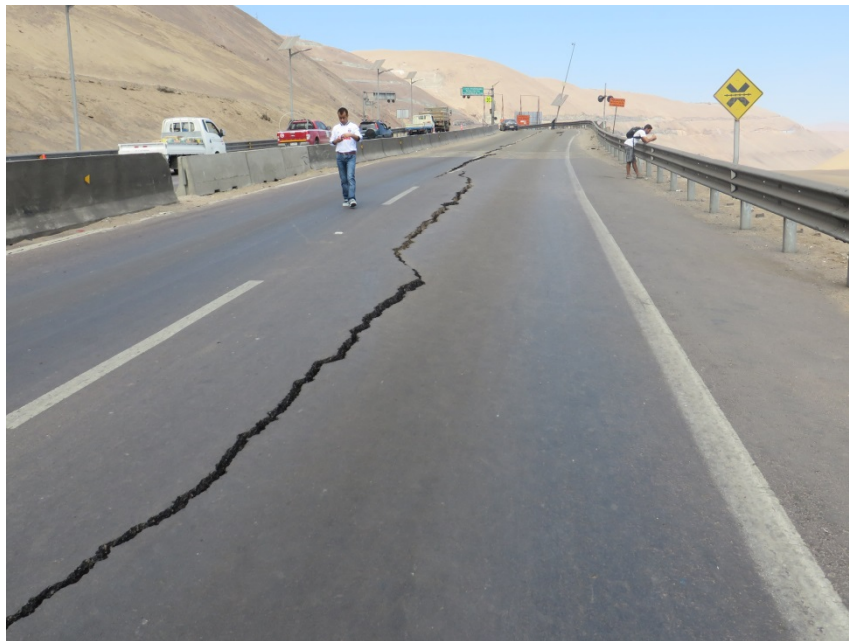
**Fig. 6.3 Minor slope displacements and surface cracks extending 300 m past the principal slope displacement on Route A-16. (- 20.243028°, -70124056°).**

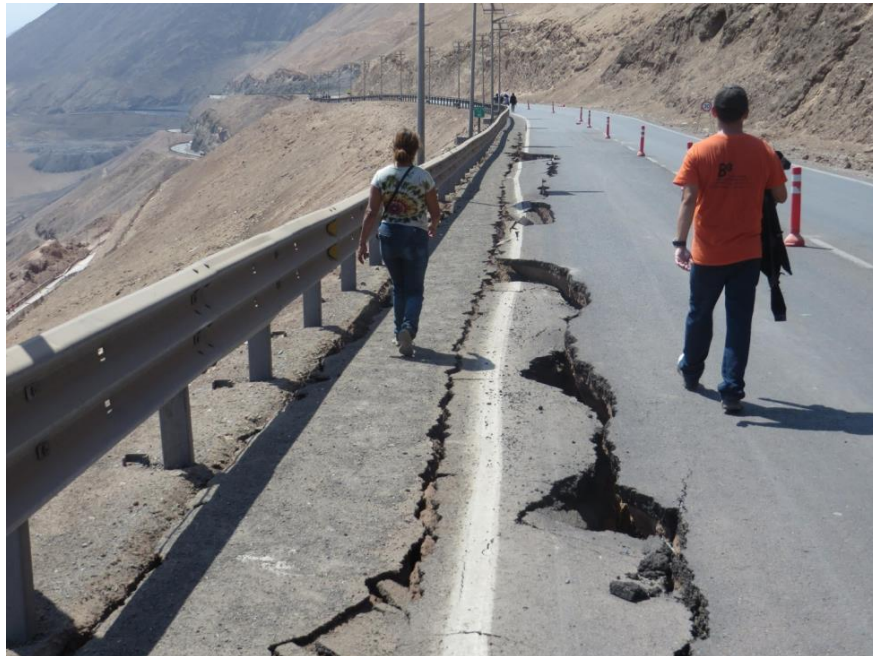
**Fig. 6.4 Shallow slope failure on Route A-16 (-20.270436°, -70.111544°)**

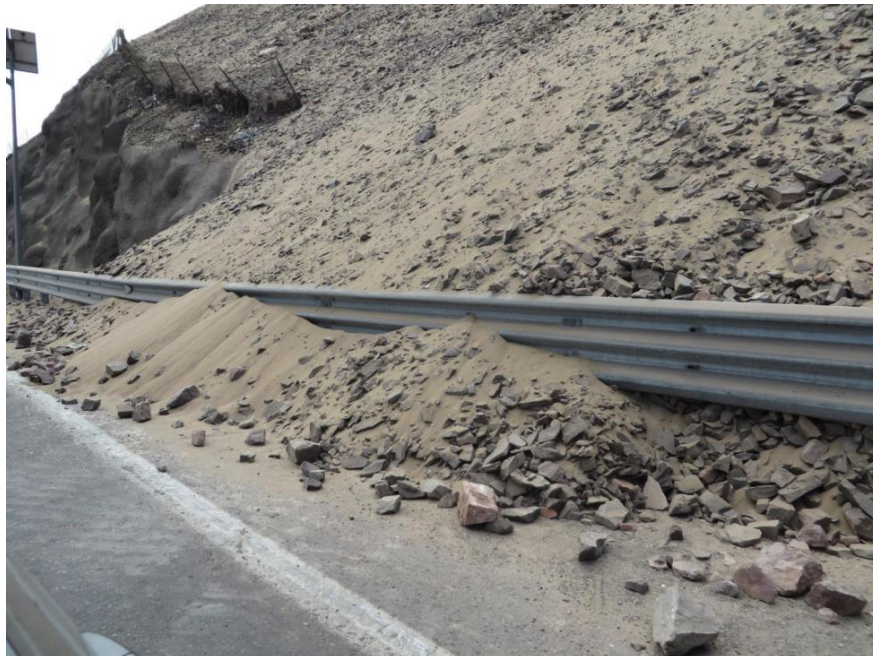
**Fig. 6.5 Raveling failure on non-stabilized slopes overtopping the guardrails in Route A-16. (-20.249944°, -70.117747°)**

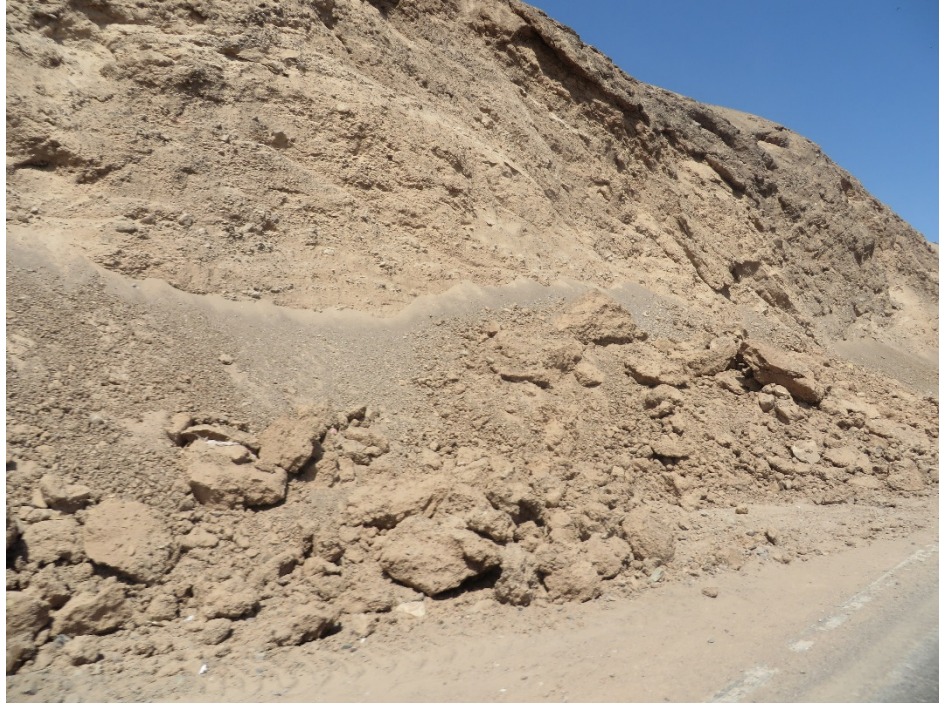
**Fig. 6.6. Disaggregated rock slides on Route A-16 (-20.264989°, -70.112106°)**

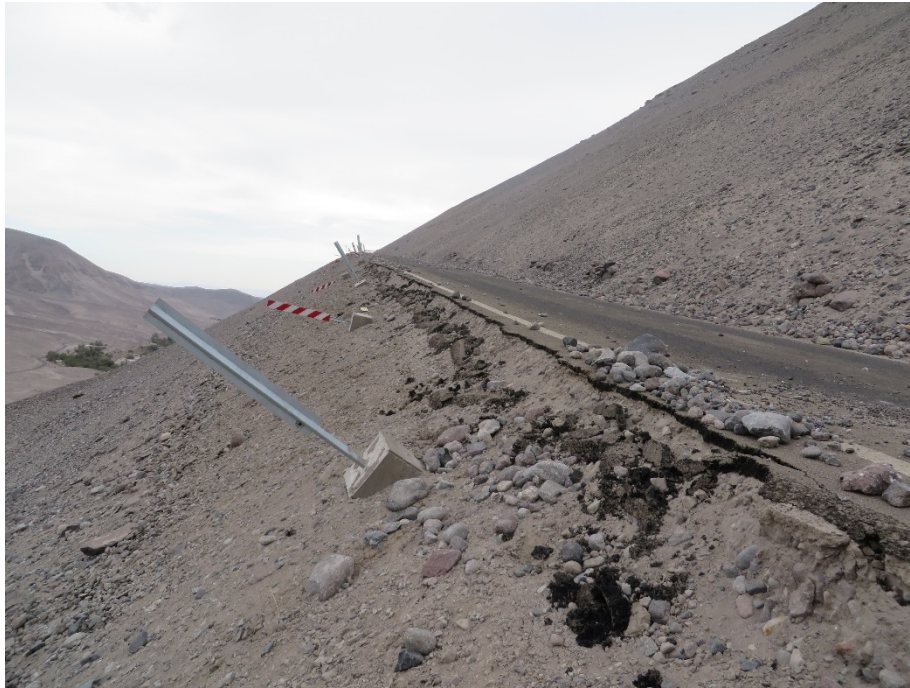
**Fig. 6.12** Damage on shoulders of Route A-555 induced by rock falls along unimpeded traffic.  
(-19.884222°, -69.468258°)
