Initial Geotechnical Observations of the August 17, 1999, Kocaeli Earthquake

**A report of the Turkey-US geotechnical earthquake engineering
reconnaissance team**

September 3, 1999

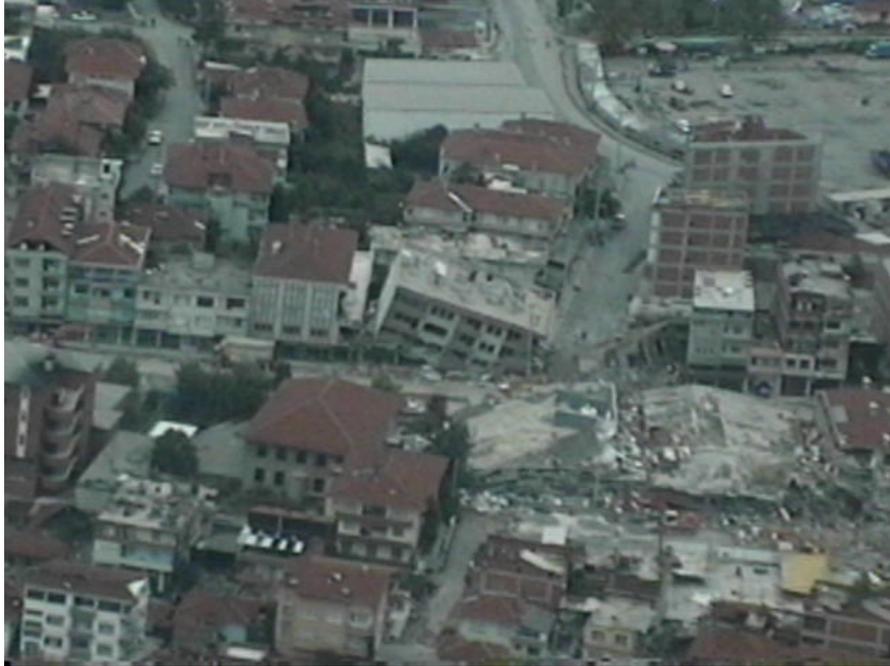
The collapse of buildings was widespread, but not uniform in Adapazari, possibly due to different soil conditions and inconsistent enforcement of building codes (N40°46.329', E30°24.328', 8/24/99, 15:47:42).

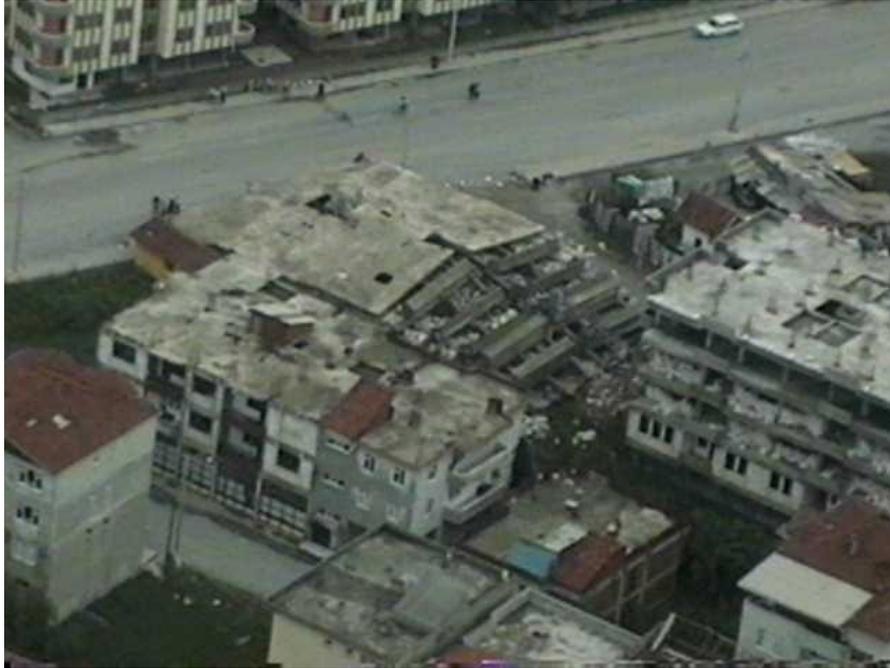
Lateral collapse of an apartment building in Adapazari. The rescue efforts were impeded by the collapsed concrete slabs that trapped many occupants (N40°46.329', E30°24.328', 8/24/99, 15:47:42).

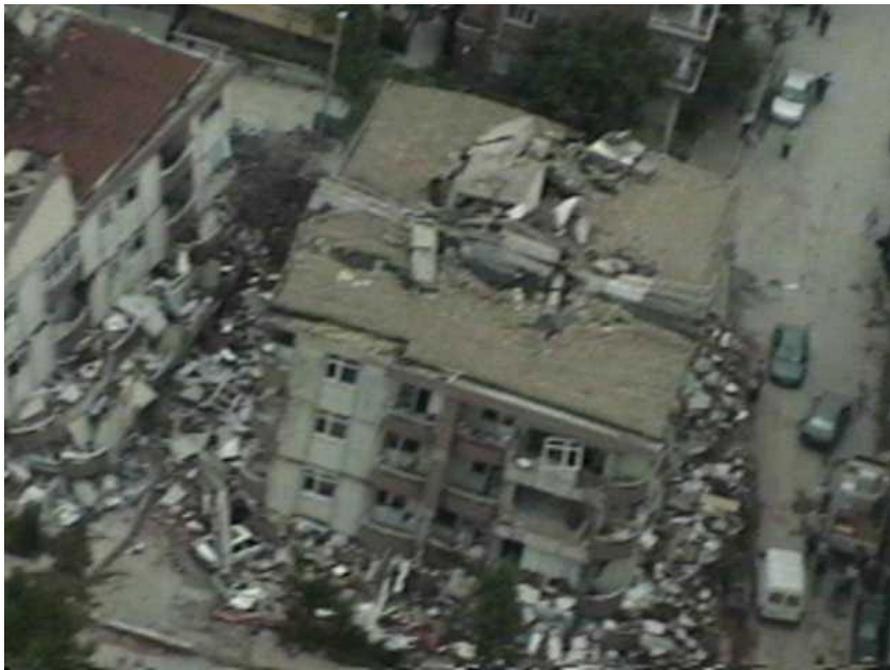
Many apartment buildings underwent failure of the lower floors (Adapazari, N40°46.329', E30°24.328', 8/24/99, 15:47:42).

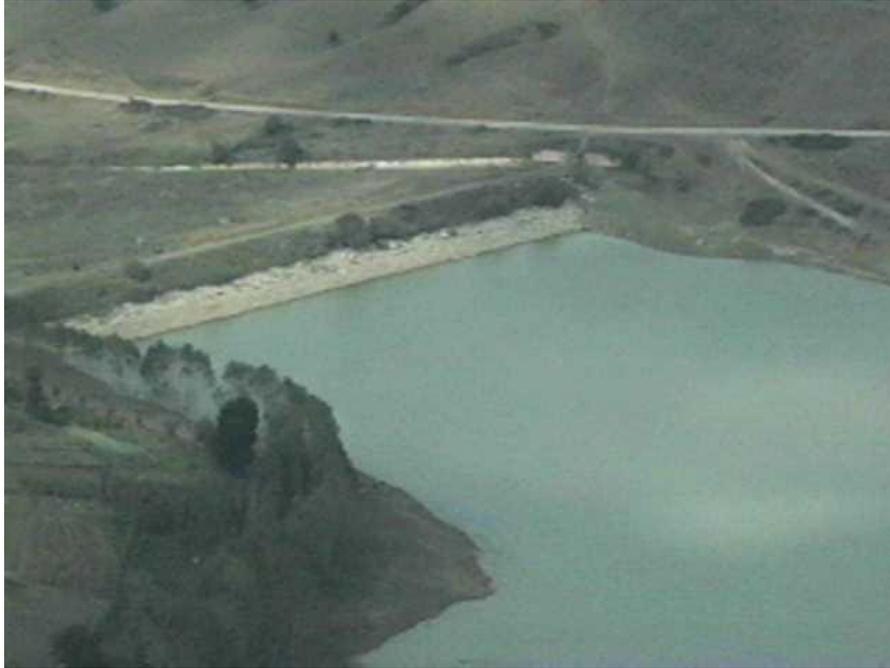
No visible signs of damage could be detected from the reconnaissance aircraft on the upstream face of this reservoir located to the north of Sapanca Lake between Izmit and Adapazari (N40°47.583', E30°15.295', 8/24/99, 16:17:56).

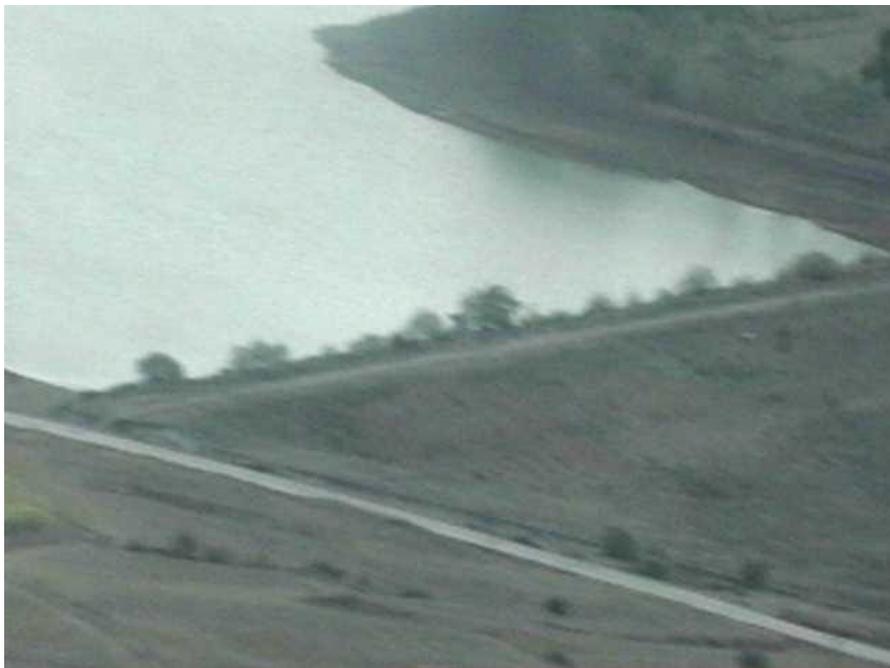
There were no signs of damage visible from the reconnaissance aircraft on the downstream face of this reservoir located between to the north of Sapanca Lake Izmit and Adapazari (N40°47.583', E30°15.295', 8/24/99, 16:17:56).

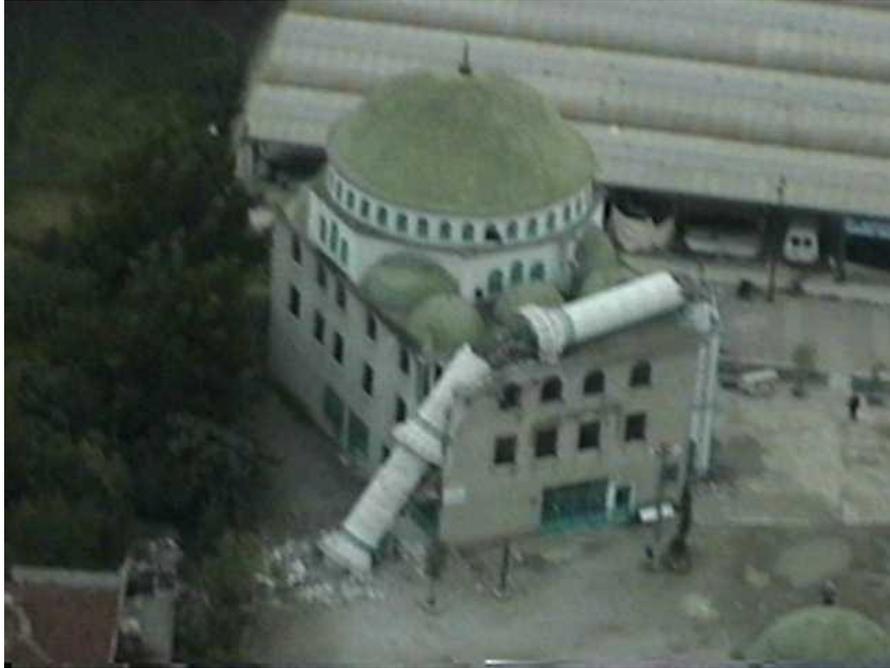
The minaret of the mosque tipped over and broke in the Arifiye area (N40°42.41', E30°22.808', 8/24/99, 16:26:18).

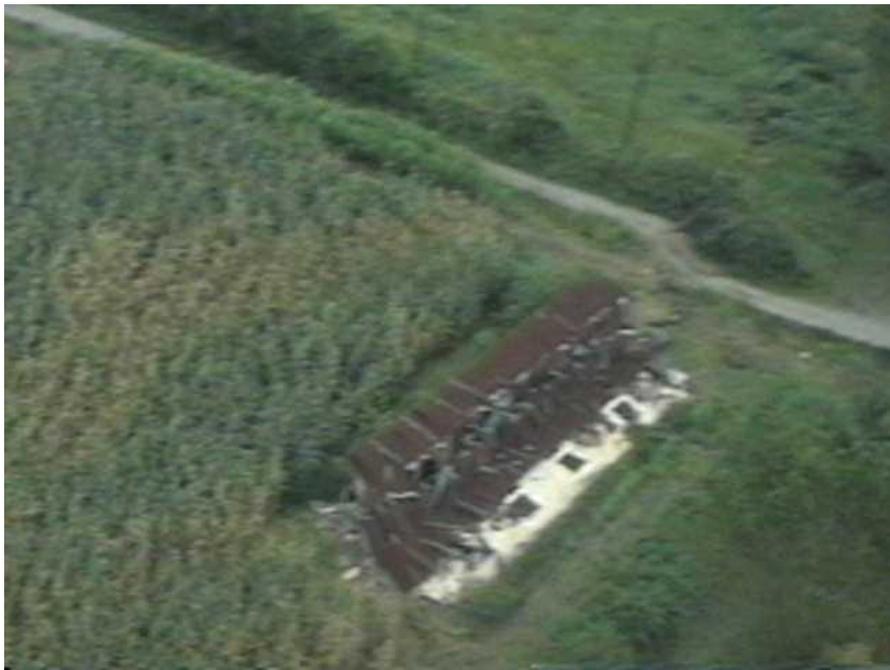
The fault surface rupture created an offset in the road and cut sharply through the center line of an elongated structure in the area of Arifiye (N40°42.41', E30°22.808', 8/24/99, 16:26:18).

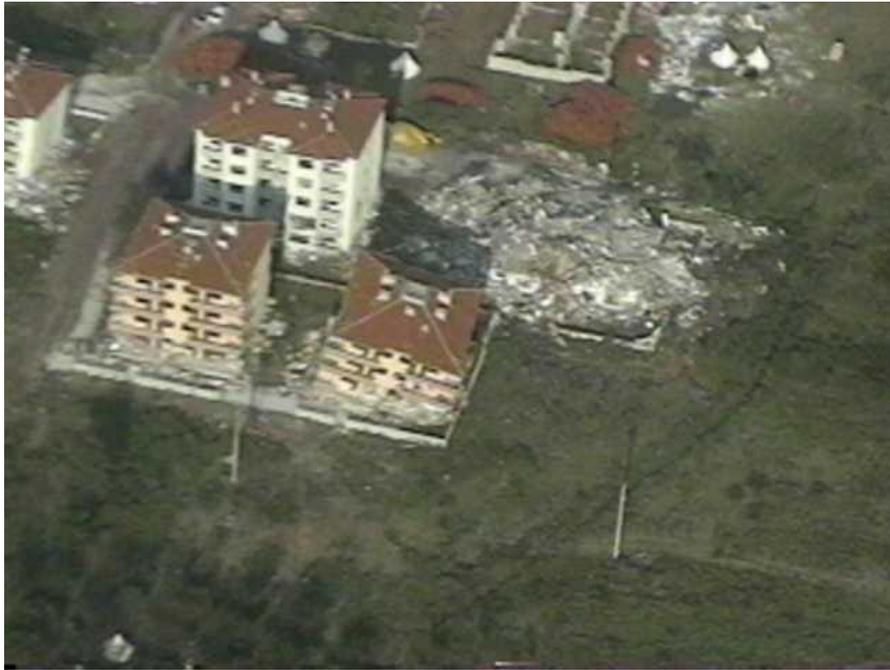
An apartment complex suffered heavy damage in Yalova (N40°47.357', E29°15.302', 8/24/99, 17:56:42).

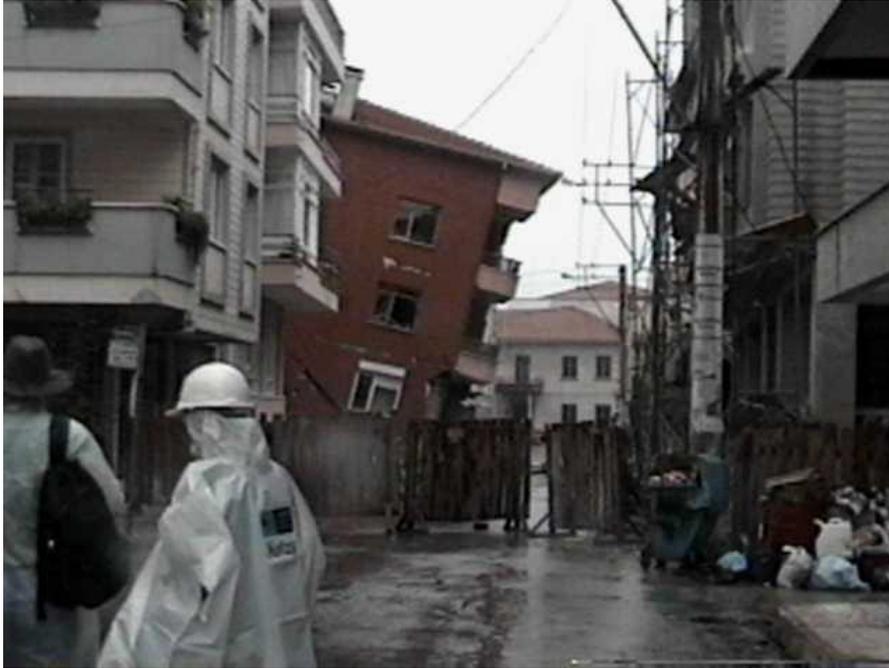
The reinforced concrete apartment building leaned sideways due to the unsymmetric failure of its first floor (N40°55.202', E29°21.011', 8/25/99, 11:38:40, poor GPS coverage).

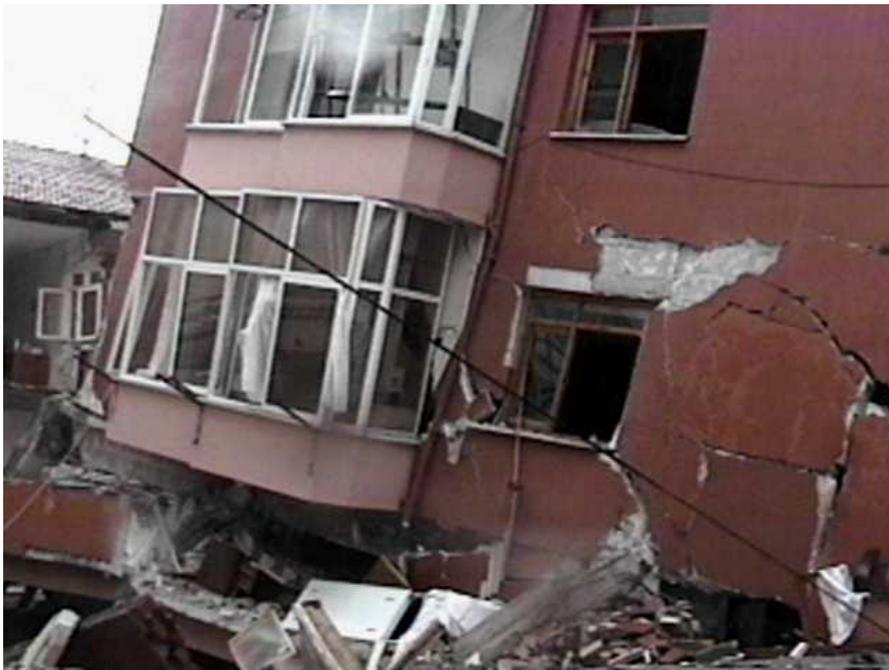
The bottom floors of the reinforced concrete building collapsed in Adapazari (N40°55.202', E29°21.011', 8/25/99, 11:38:40, poor GPS coverage).

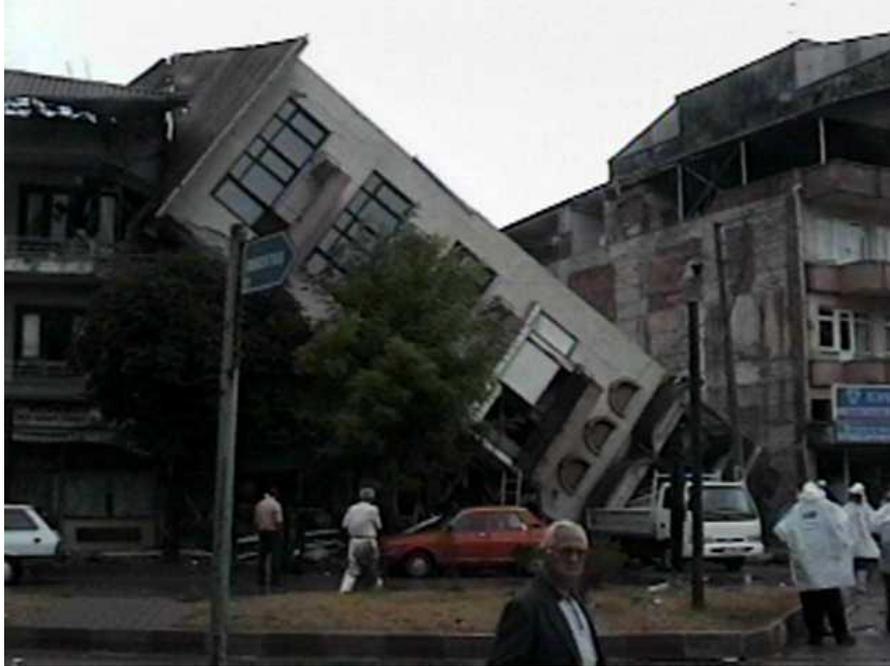
The foundation of this slender building in Adapazari failed and the building leaned onto its neighbor (N40°47.068', E30°23.976', 8/25/99, 12:36:00).

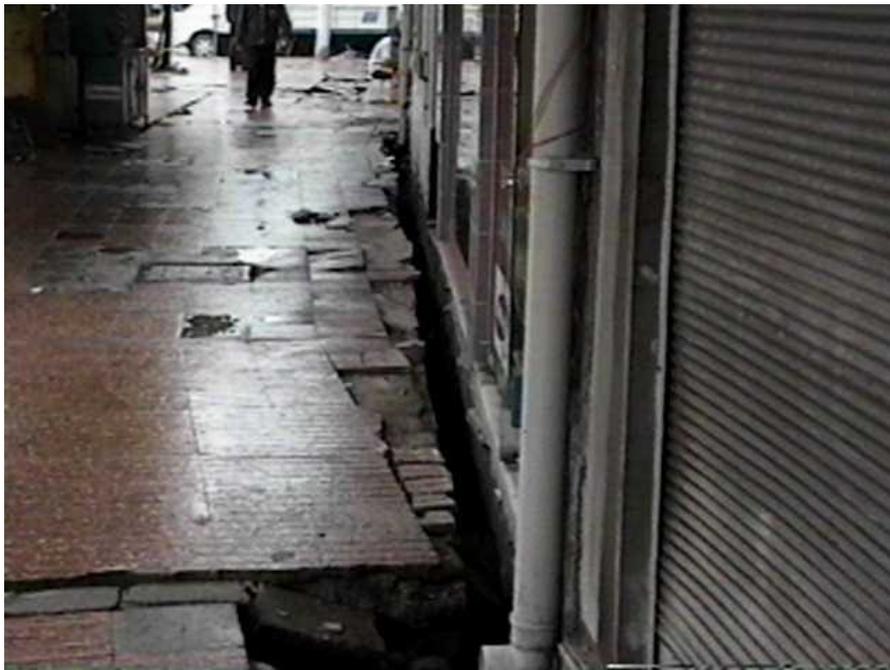
The building adjacent to the leaning building settled and shifted laterally, opening a gap between the sidewalk and the building (Adapazari) (N40°47.068', E30°23.976', 8/25/99, 12:36:00).

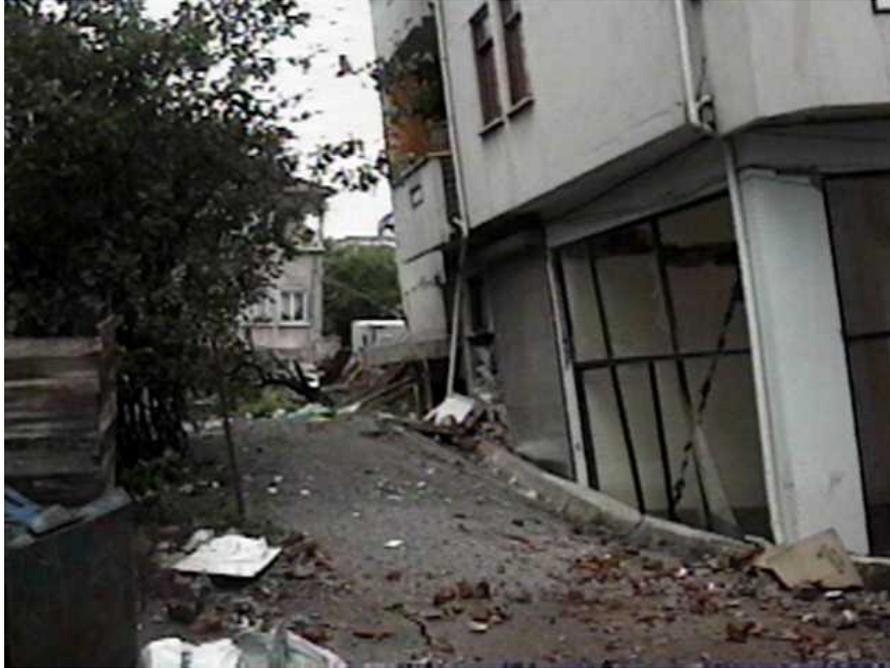
The foundation of the building failed and the building tilted in the east/west direction (Adapazari) (N40°46.862', E30°24.133', 8/25/99, 13:47:00).

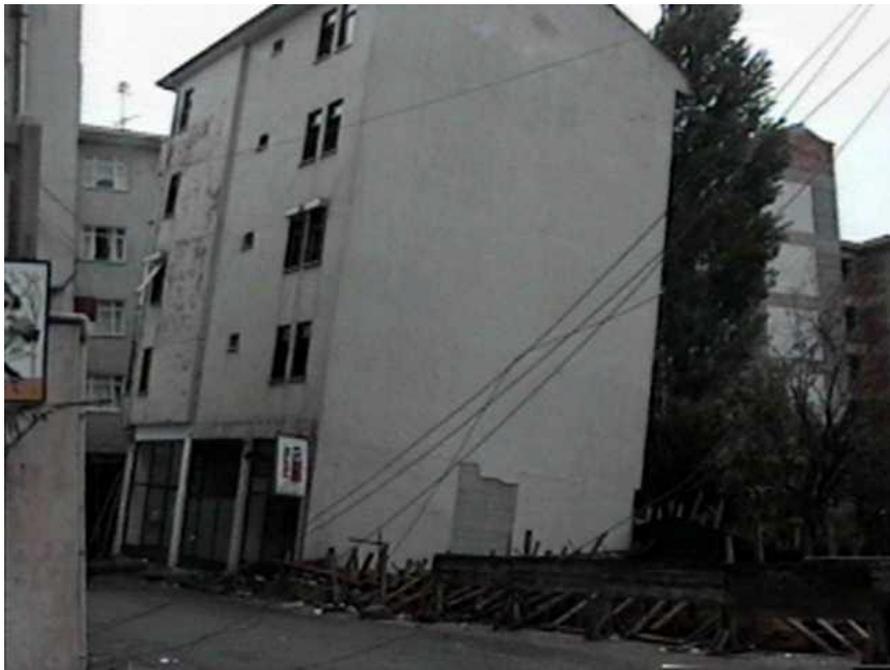
Another view of the building which underwent foundation failure (Adapazari) (N40°46.862', E30°24.133', 8/25/99, 13:47:00).

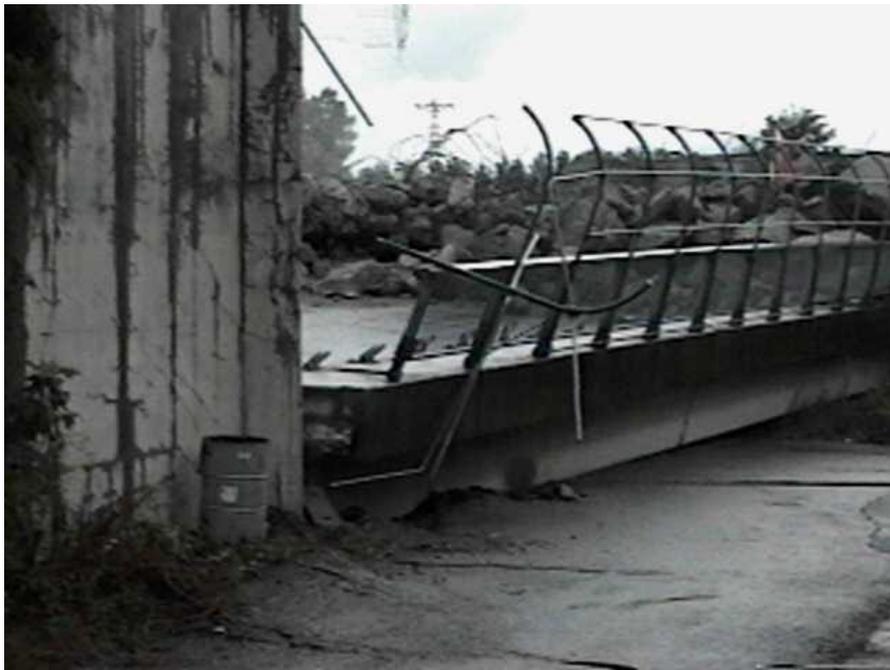
The deck of the bridge fell down on the ground as the fault surface ruptured beneath the bridge (South of Adapazari, $N40^{\circ}42.581'$, $E30^{\circ}21.495'$, 8/25/99, 15:40:56).

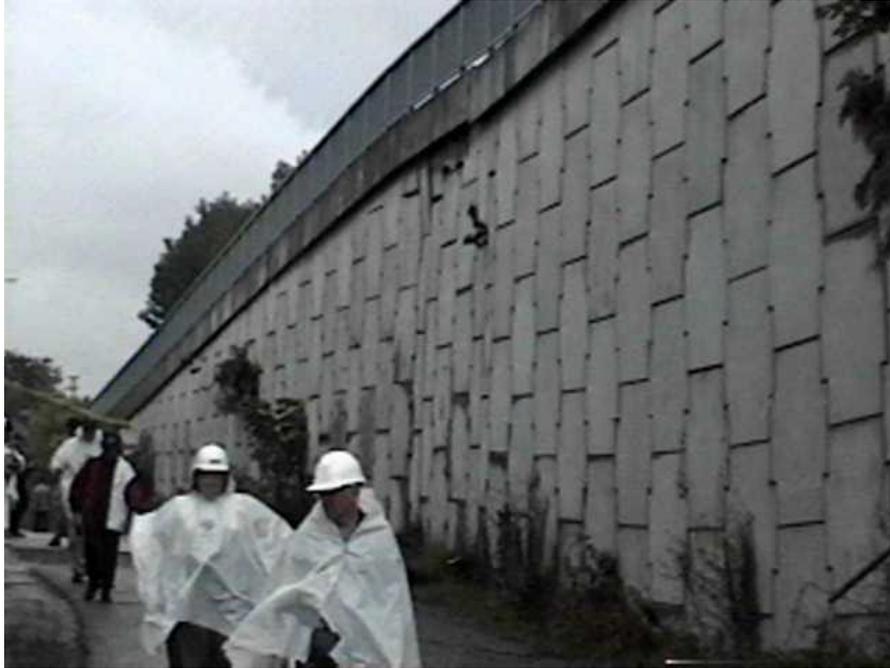
The overall performance of the mechanically stabilized earth abutment of the bridge was remarkable (South of Adapazari, N40°42.581', E30°21.495', 8/25/99, 15:40:56).

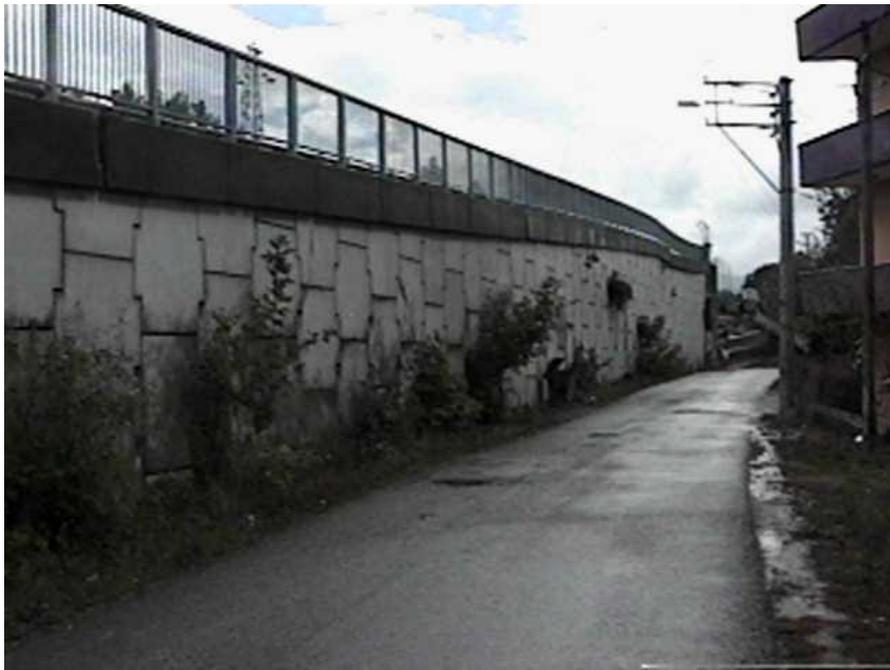
One side of the mechanically stabilized earth abutment showed very few signs of damage (South of Adapazari, N40°42.581', E30°21.495', 8/25/99, 15:40:56).

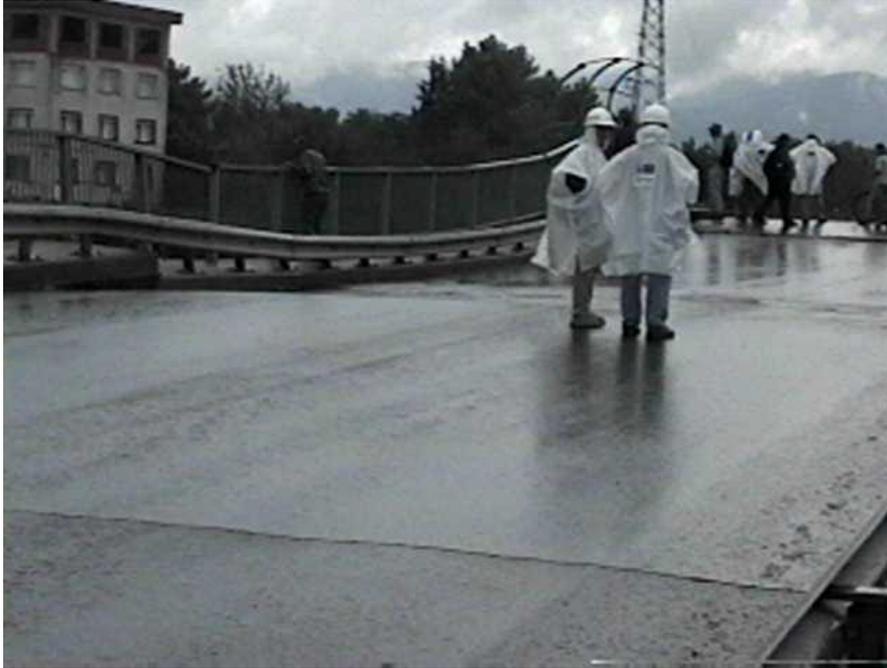
The road on top of the mechanically stabilized earth abutment sagged, possibly due to the failure of the reinforced concrete box culvert passing under it (South of Adapazari, $N40^{\circ}42.581'$, $E30^{\circ}21.495'$, 8/25/99, 15:40:56).

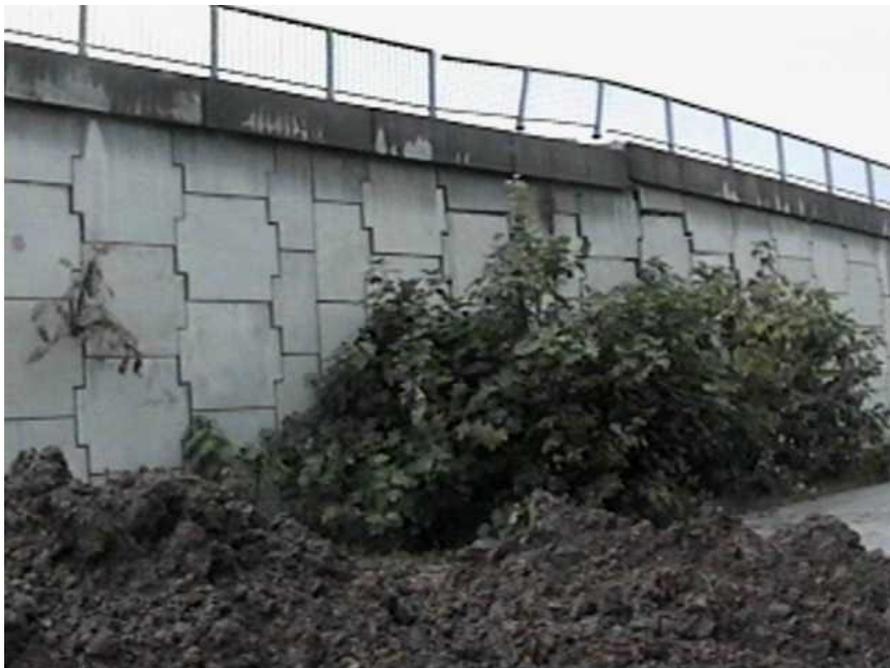
At the location where the road sagged, one side of the mechanically stabilized earth abutment displayed relative motion between face plates (South of Adapazari, ($N40^{\circ}42.581'$, $E30^{\circ}21.495'$, 8/25/99, 15:40:56).

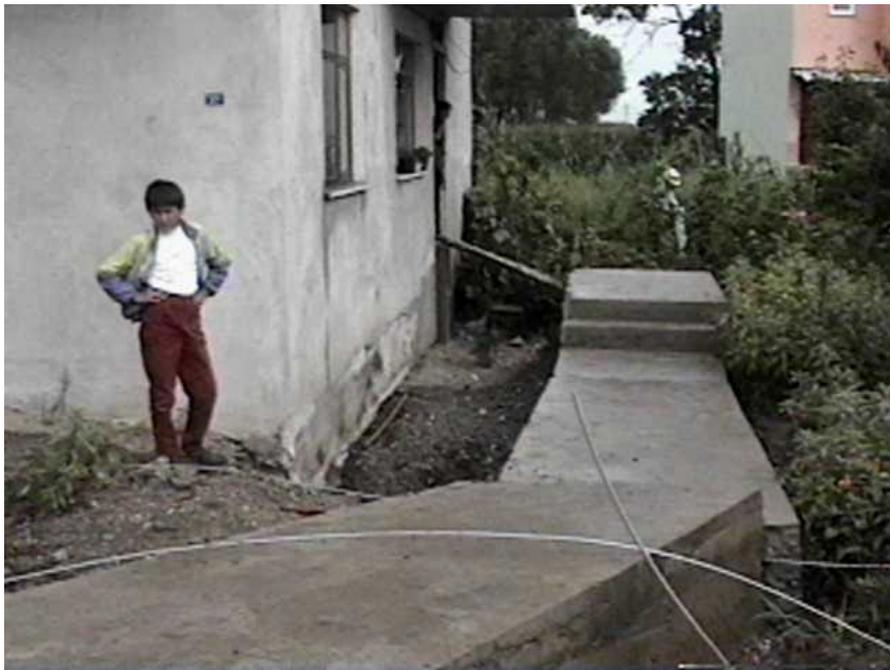
The concrete stair separated 1.5 m (58 in) from the house and moved 3.2 m (126 in) diagonally due to the fault surface rupture which went beneath the house. The house was only slightly damaged (south of Adapazari, N40°42.581', E30°21.495', 8/25/99, 15:40:56).

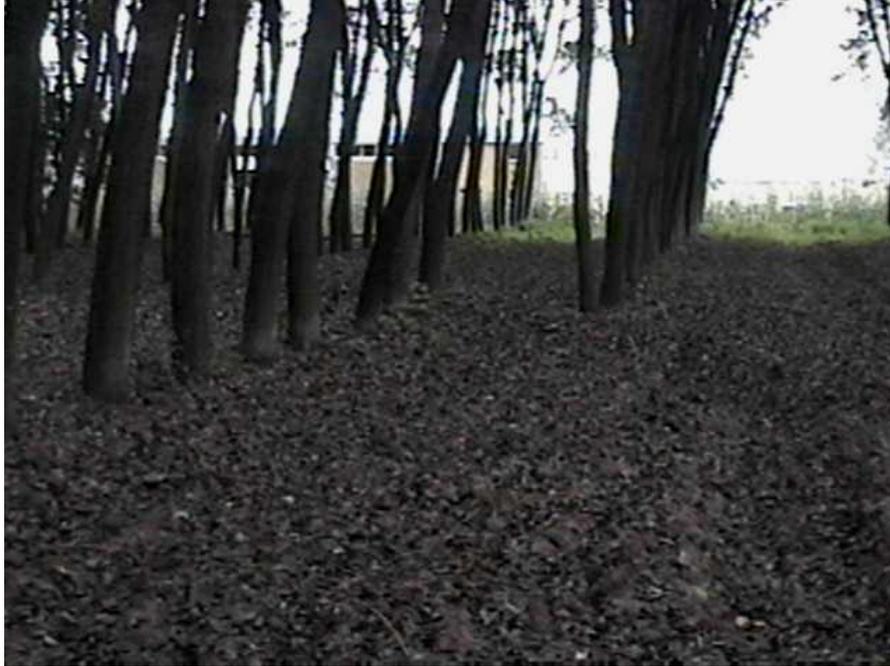
The fault surface rupture went through a group of trees, and displayed a clear offset in the tree rows (South of Adapazari, N40°42.581', E30°21.495', 8/24/99, 15:40:56).N40°42.581', E30°21.495', 8/25/99, 15:40:56).

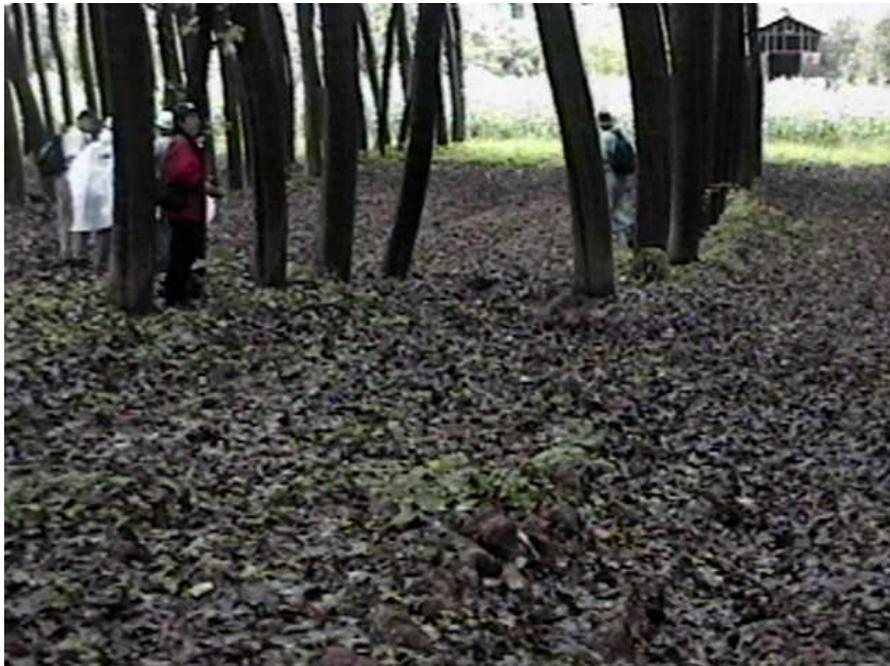
The fault surface rupture went through a group of trees, and displayed a clear offset in the tree rows (South of Adapazari, N40°42.581', E30°21.495', 8/25/99, 15:40:56).

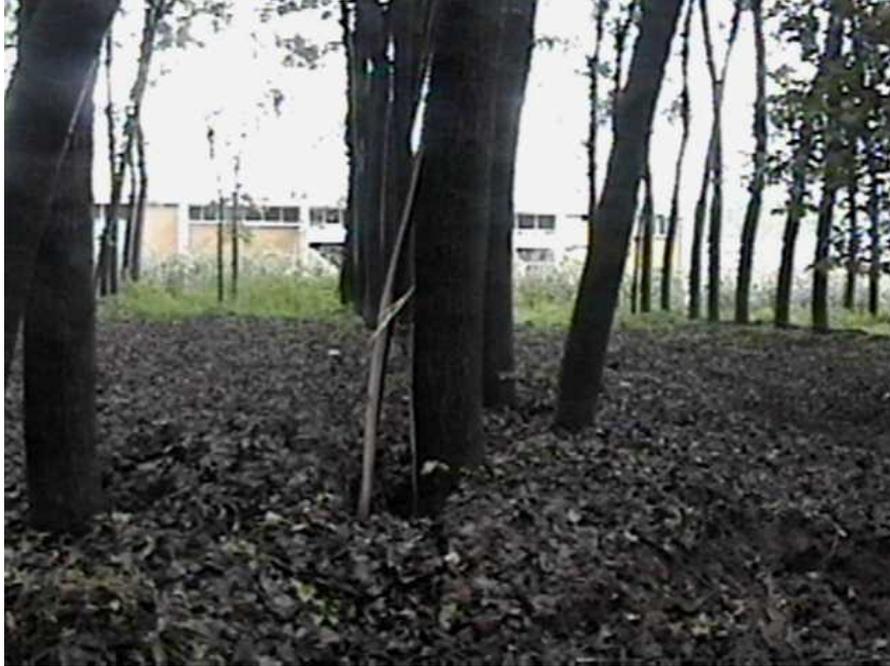
The fault surface rupture pulled apart the tree roots and split its trunk (South of Adapazari, N40°42.568', E30°21.612', 8/25/99, 16:21:10).

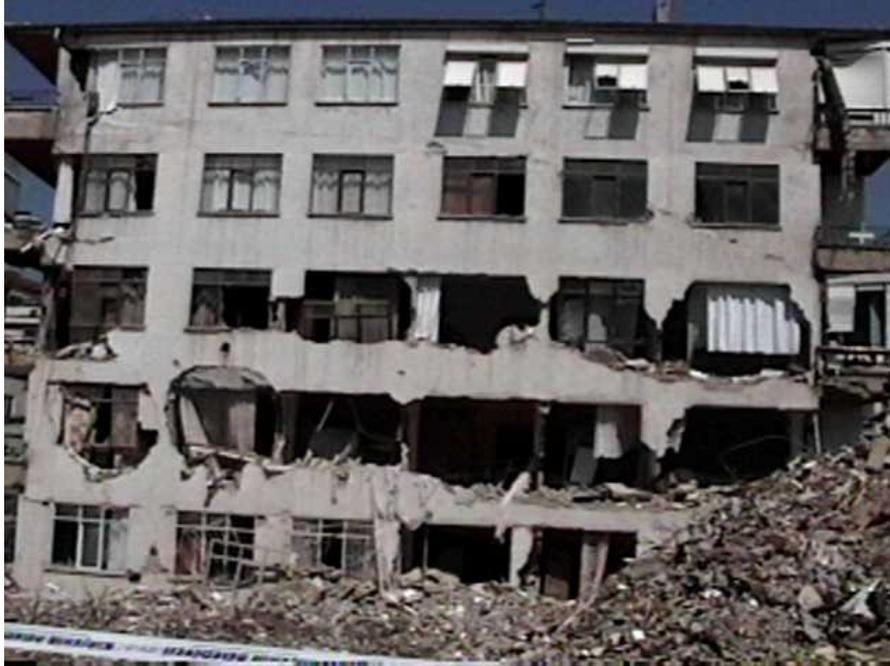
In Yalova, a summer resort along the southern coast of the Izmit bay, several apartment buildings collapsed, or were severely damaged (N40°38.822', E29°7.503', 8/26/99, 11:58:34)

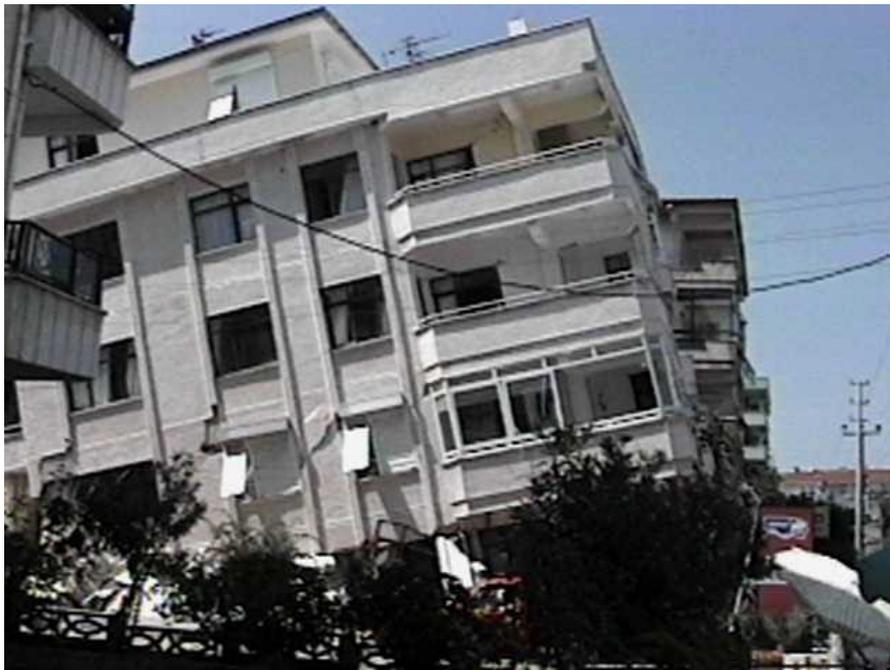
The bottom floors of this apartment building in Yalova failed (N40°38.845', E29°7.448', 8/26/99, 12:01:06).

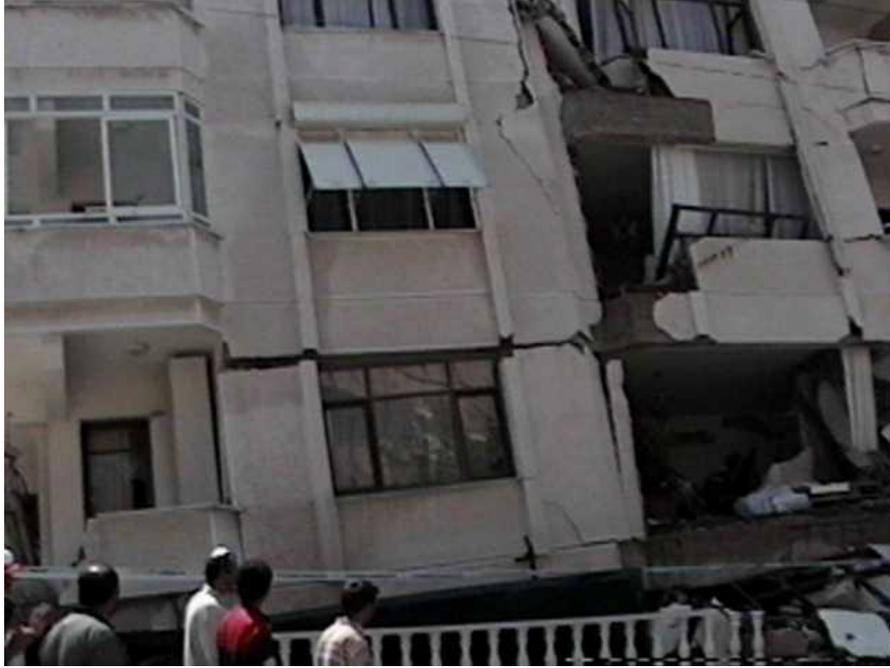
The apartment buildings in Yalova also underwent failure of their first floors (N40°38.845', E29°7.448', 8/26/99, 12:01:06).

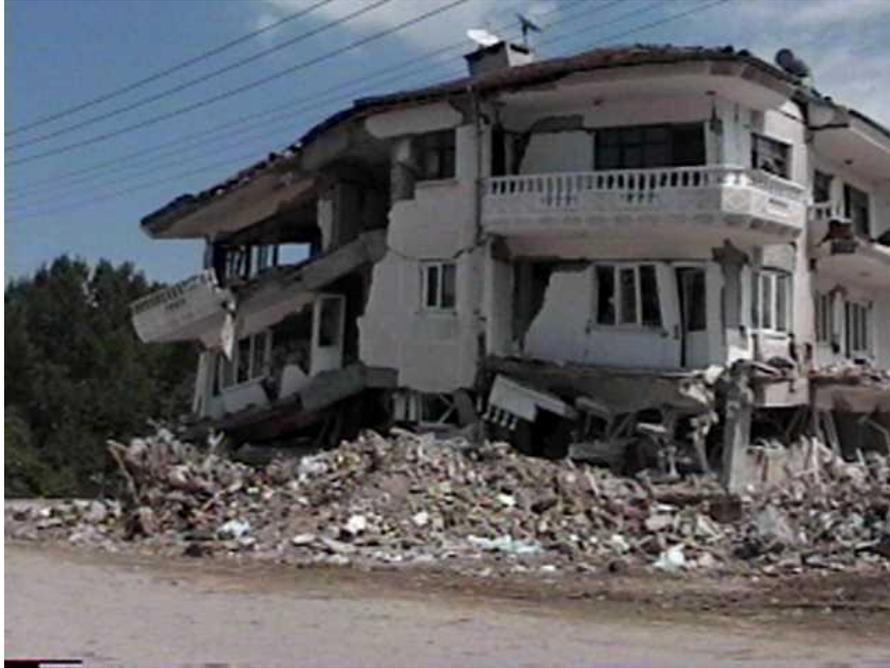
The first floors of this apartment building in Yalova collapsed ($N40^{\circ}39.08'$, $E29^{\circ}15.712'$, 8/26/99, 13:11:25).

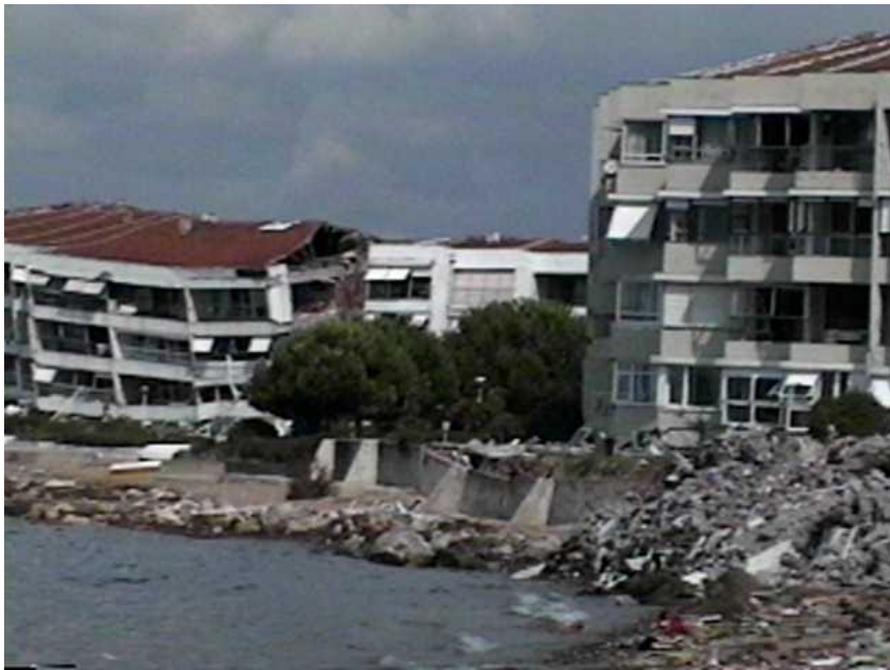
Along the shoreline in Yalova, many apartment buildings collapsed. The retaining wall in front of the apartment building on the right settled and shifted laterally due to the liquefaction of its foundation. However, there were no sign of lateral spread which could have damaged the building. ($N40^{\circ}40.913'$, $E29^{\circ}21.234'$, 8/26/99, 14:42:20).

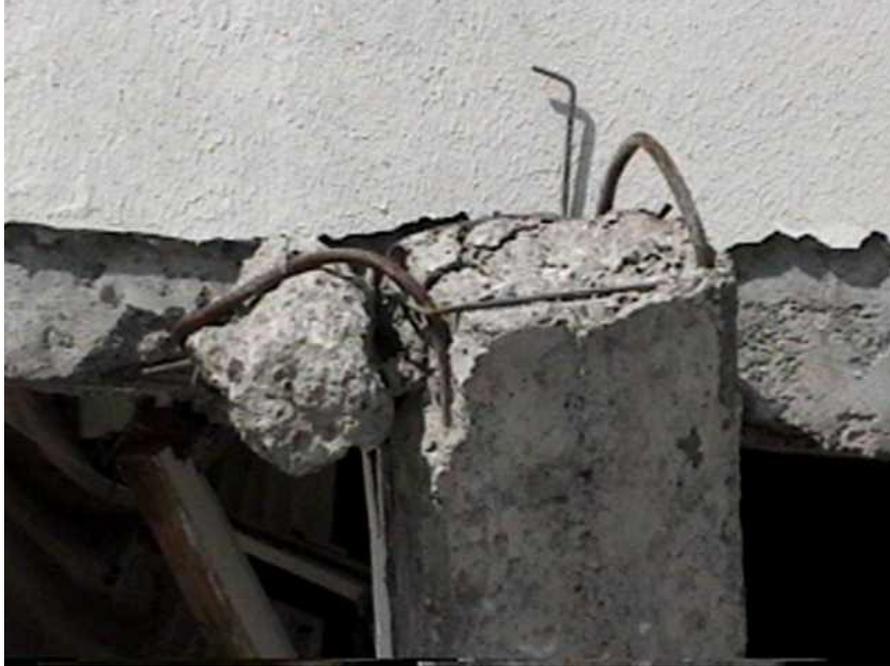
The steel rebars at the connection between the reinforced concrete columns and beams of some of the apartment buildings along the shoreline of Yalova were smooth and totally insufficient (N40°40.913', E29°21.234', 8/26/99, 14:42:20)

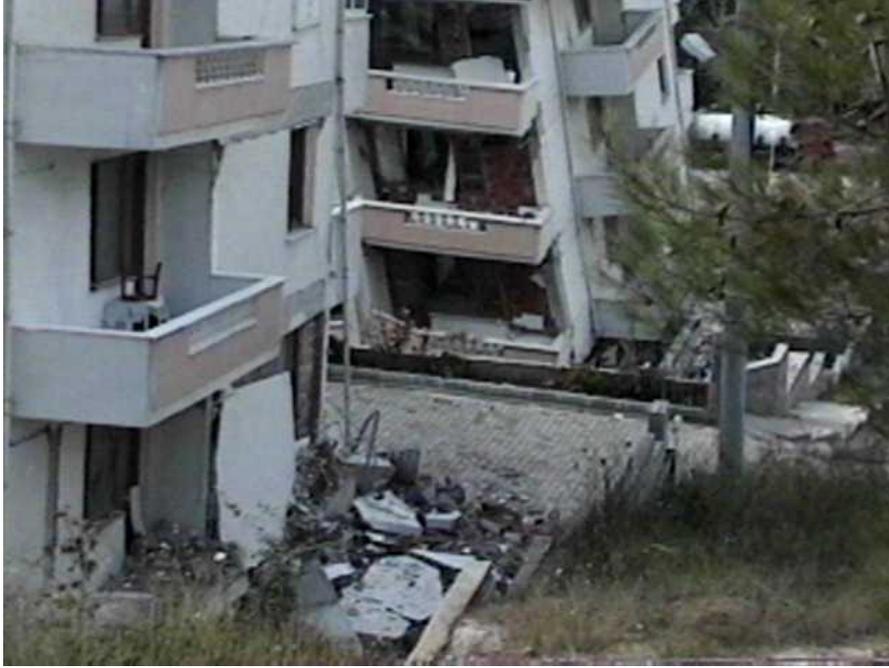
The first floors of the apartment buildings on the hillside east of Yalova were damaged or collapsed. There was no evidence of slope stability problems or ground failure (N40°41.274', E29°35.257', 8/26/99, 16:23:52).

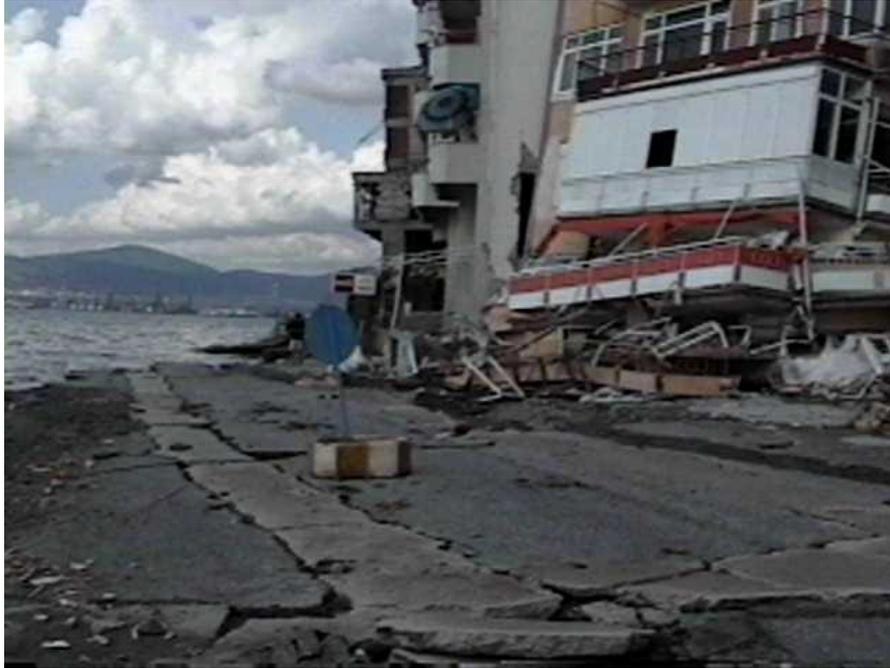
In Halidere, an apartment building collapsed., and the waterfront spread laterally toward the Marmara Sea (N40°42.961', E29°44.805', 8/26/99, 17:33:58).

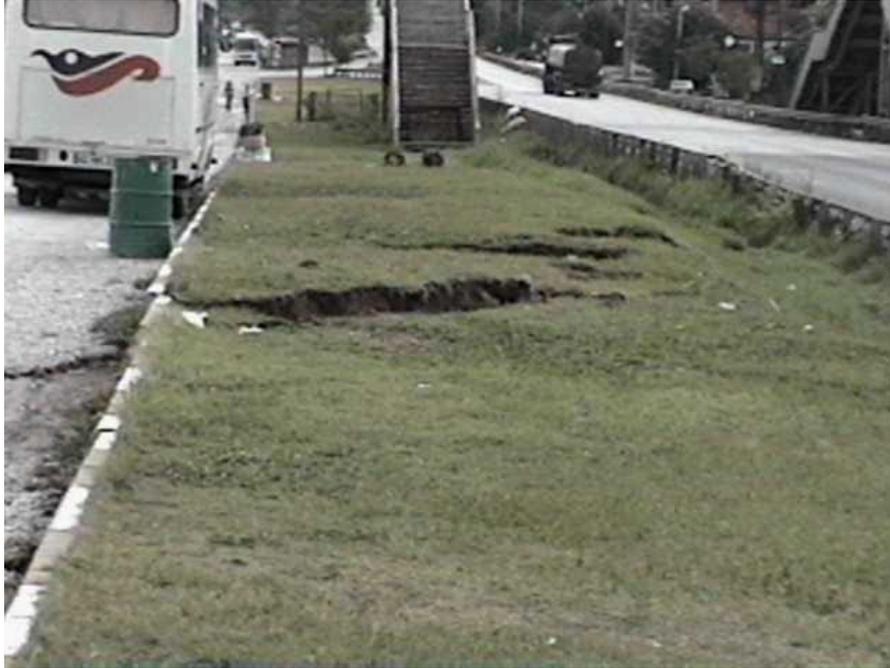
Ground cracks were noticeable from the highway north of Sapanca lake. These ground cracks were attributed to the reactivation of large existing landslides after the earthquake ($N40^{\circ}44.027'$, $E30^{\circ}13.275'$, 8/27/99, 11:24:52).

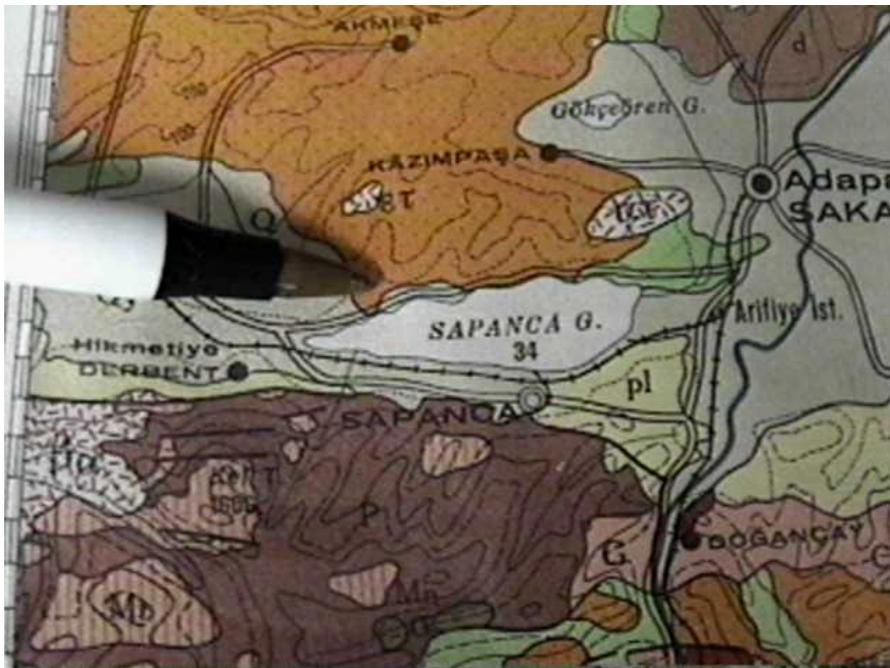
Assumed position of existing landslide north of Sapanca lake. The geological map represents a recent quaternary deposit which could be sliding toward Sapanca lake ($N40^{\circ}44.027'$, $E30^{\circ}13.275'$, 8/27/99, 11:24:52).

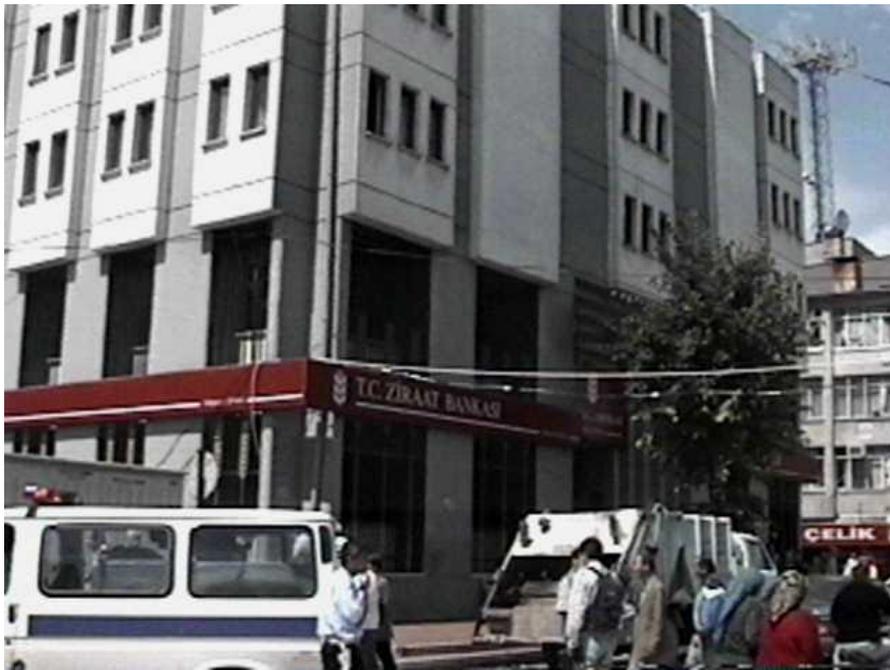
The Ziraat bank building in Adapazari is one of the few buildings founded on piles. There were no apparent signs of damage to this building (N40°46.6', E30°24.062', 8/27/99, 12:37:58).

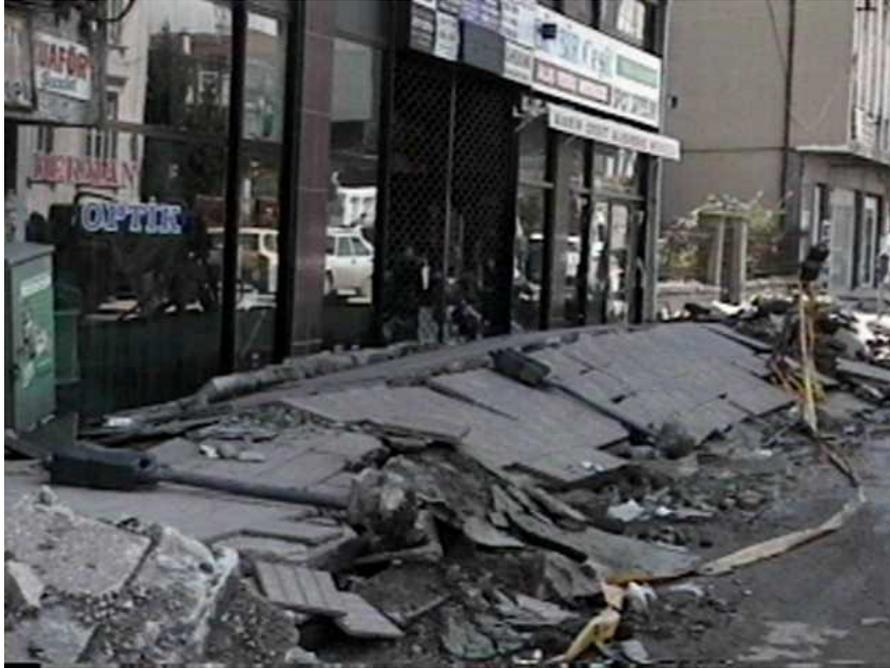
In Adapazari, the building settled and the sidewalk bulged and split longitudinally (N40°46.661', E30°24.163', 8/27/99, 12:46:27).
