Initial Geotechnical Observations of the August 17, 1999, Kocaeli Earthquake

**A report of the Turkey-US geotechnical earthquake engineering
reconnaissance team**

September 3, 1999

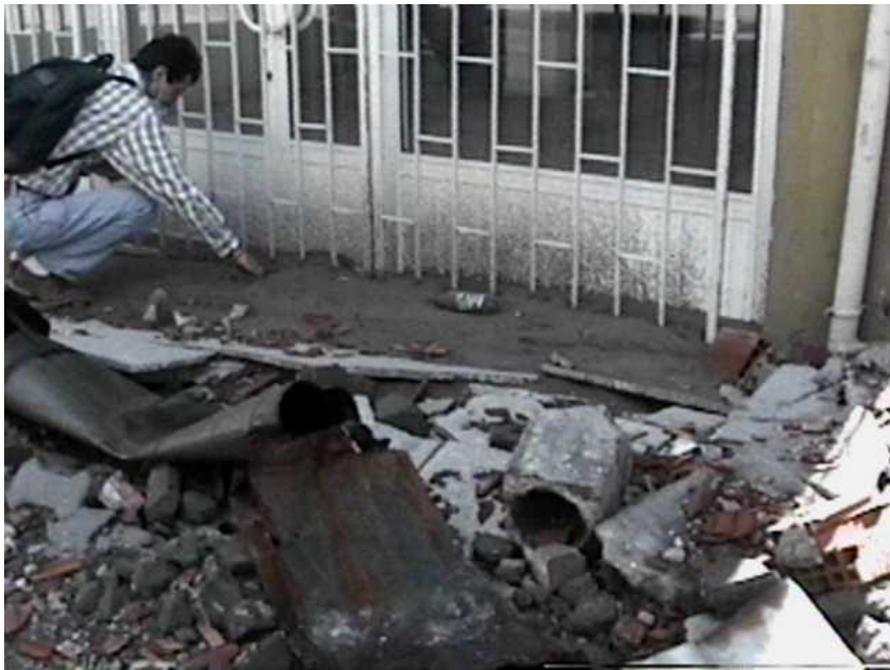
A deposit of ejected sand was observed in front of this building which settled into the ground. This was not systematically observed for all settled buildings (Adapazari, N40°46.612', E30°24.257', 8/27/99, 12:54:13).

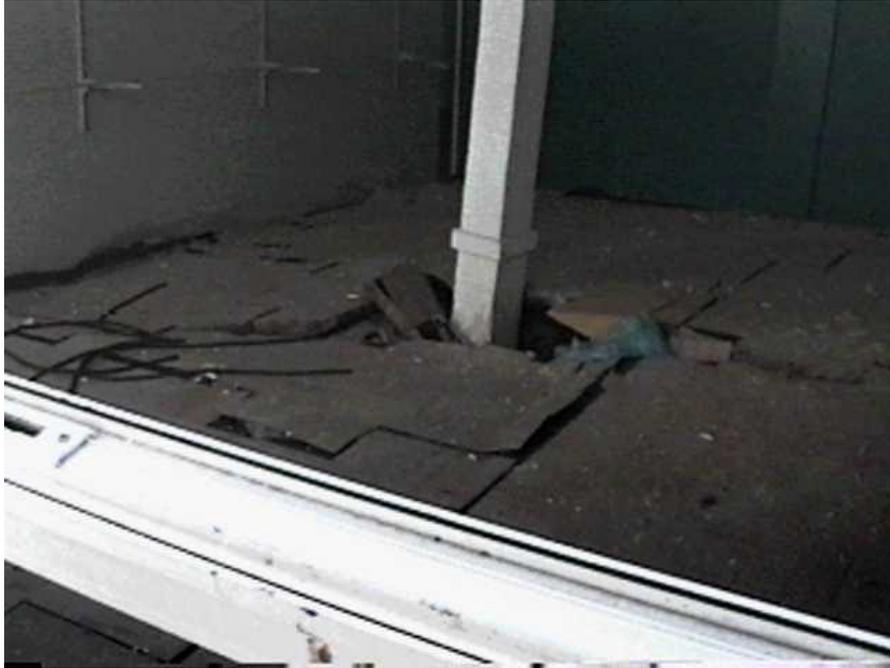
The column punched through the floor of the building which settled (Adapazari, N40°46.614', E30°24.287', 8/27/99, 13:02:07).

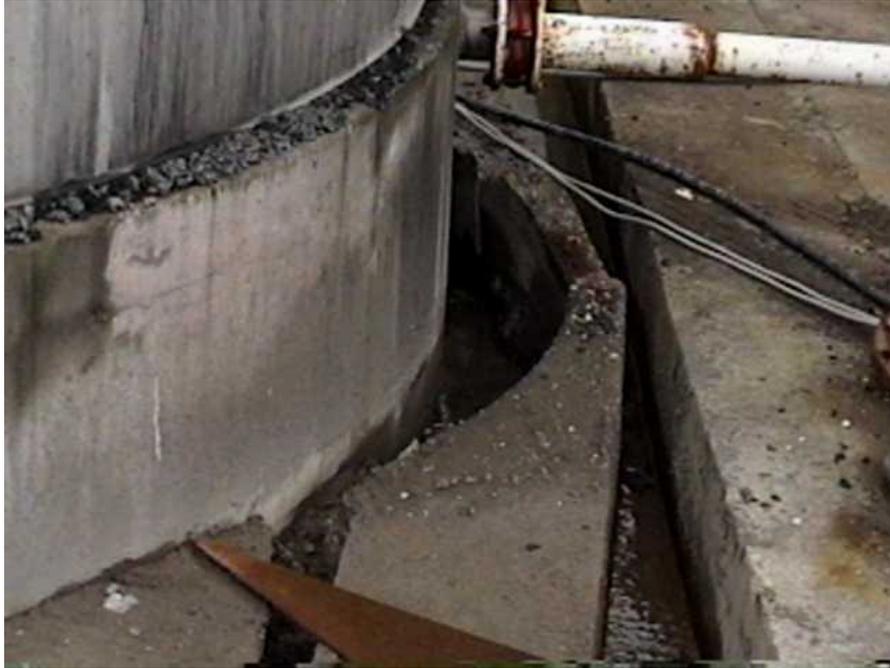
In a glue factory to the east of Golcuk, there was relative displacement and cracking between the foundation of the tank and the concrete slabs (N40°42.755', E29°53.139', 8/28/99, 12:07:23).

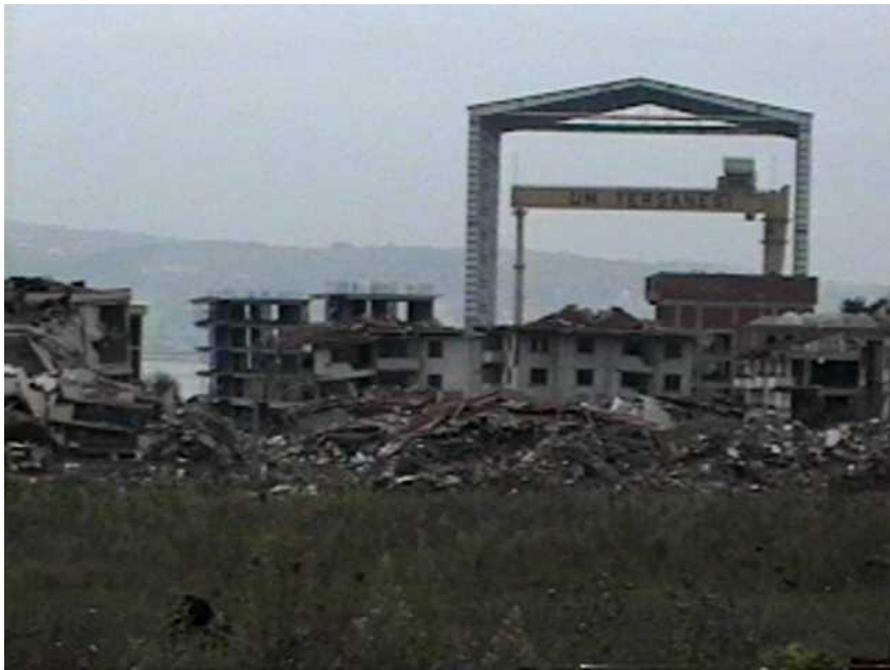
In Golcuk, the crane and steel frame of a construction site were standing apparently undamaged while many reinforced concrete buildings in the foreground had been destroyed by the earthquake (N40°42.385', E29°52.456', 8/28/99, 12:20:10).

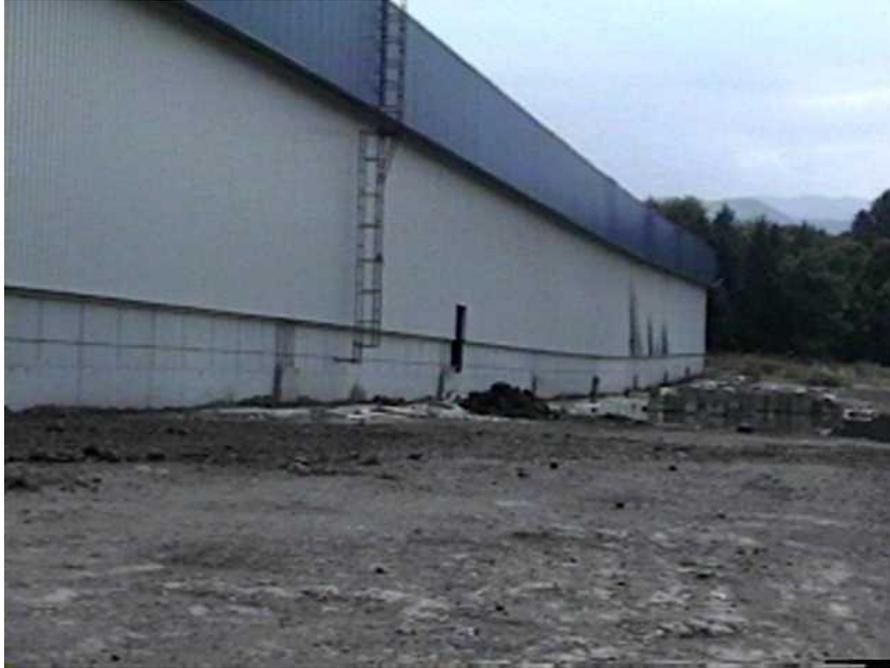
In Golcuk, the Ford plant was under construction. There was obvious evidence of ground rupture in the site. One side of the building subsided differentially, and the wall buckled (N40°42.947', E29°50.89', 8/28/99, 13:21:46).

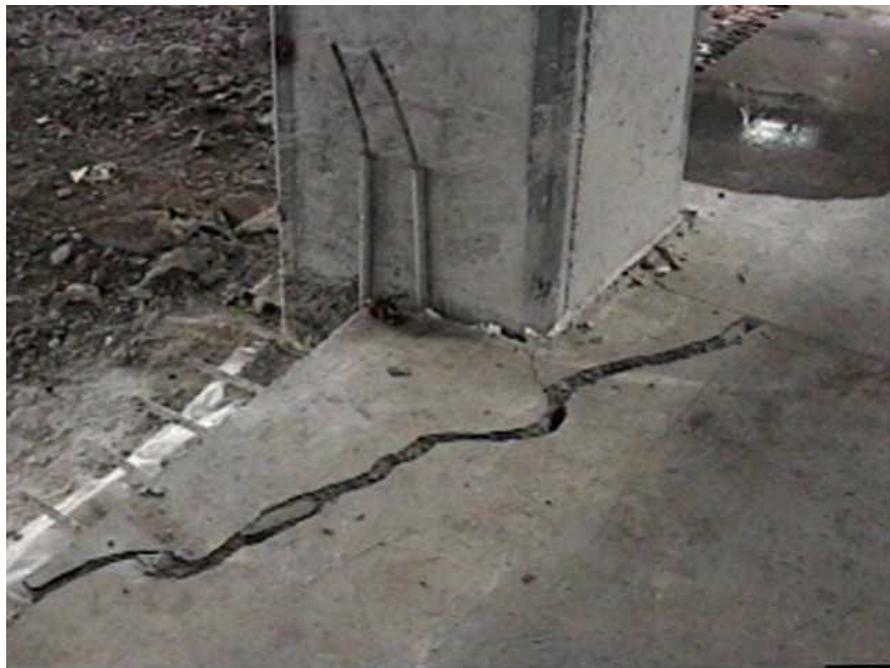
In the reinforced concrete slab inside the Ford plant in Golcuk, there were cracks caused by differential ground displacements (N40°42.947', E29°50.89', 8/28/99, 13:21:46).

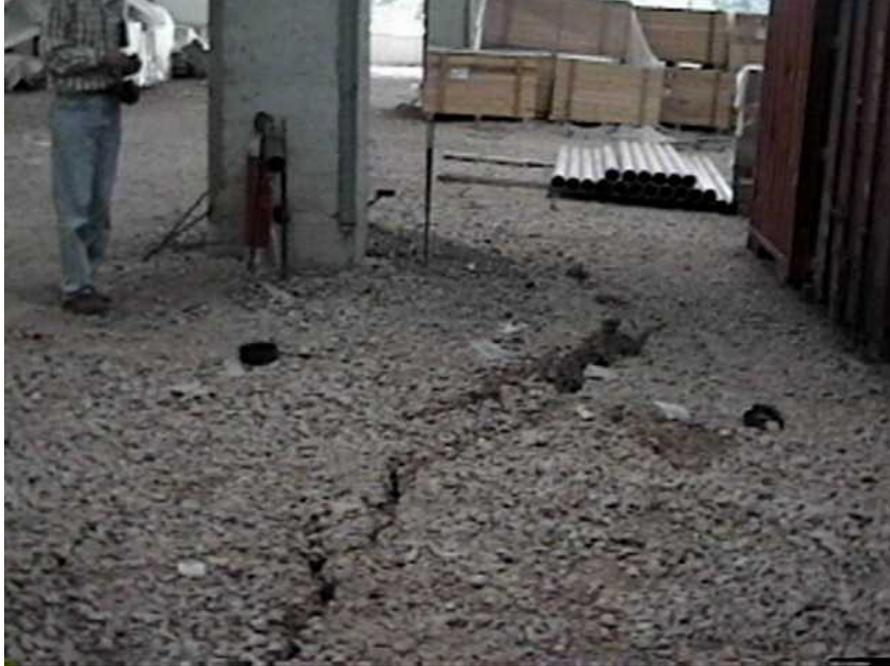
In the unpaved ground of the Ford plant in Golcuk, there were ground cracks (N40°42.947', E29°50.89', 8/28/99, 13:21:46).

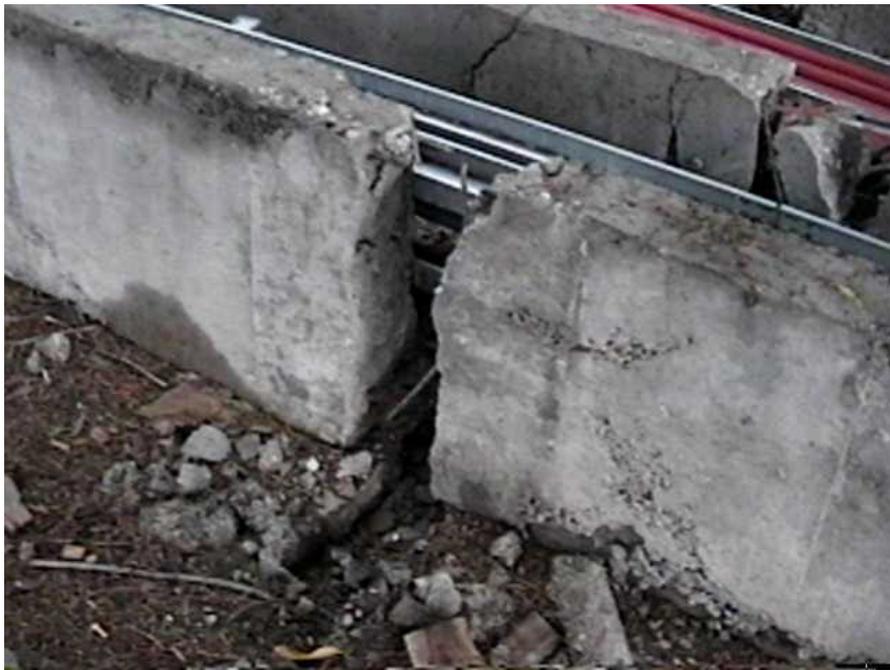
In the Ford plant in Golcuk, the U-shaped utilities corridor was subjected to tension and failed due to ground displacement (N40°42.818', E29°51.098', 8/28/99, 13:49:32).

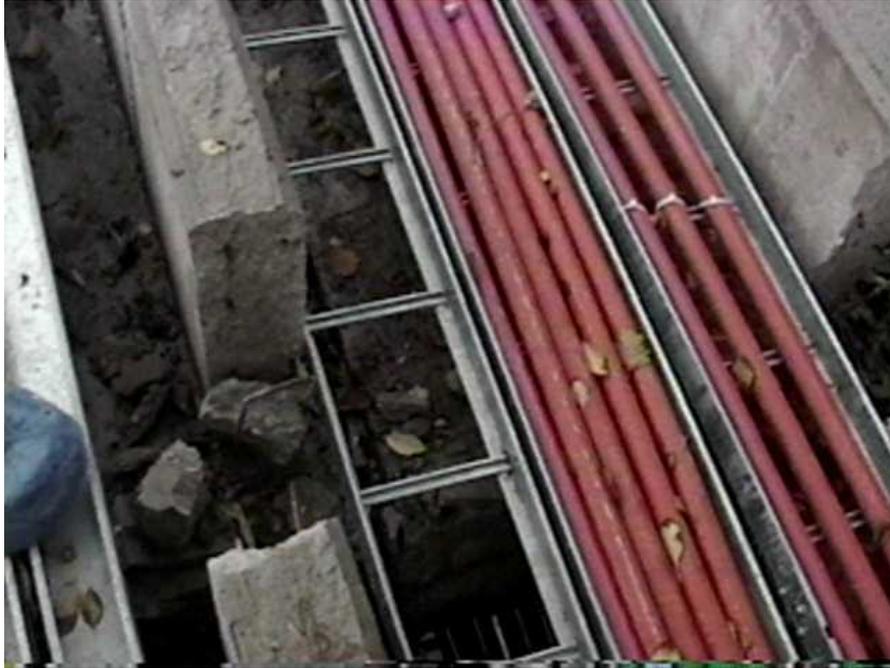
In the Ford plant of Golcuk, the utility corridor was broken and separated due to tensile strain (N40°42.818', E29°51.098', 8/28/99, 13:49:32).

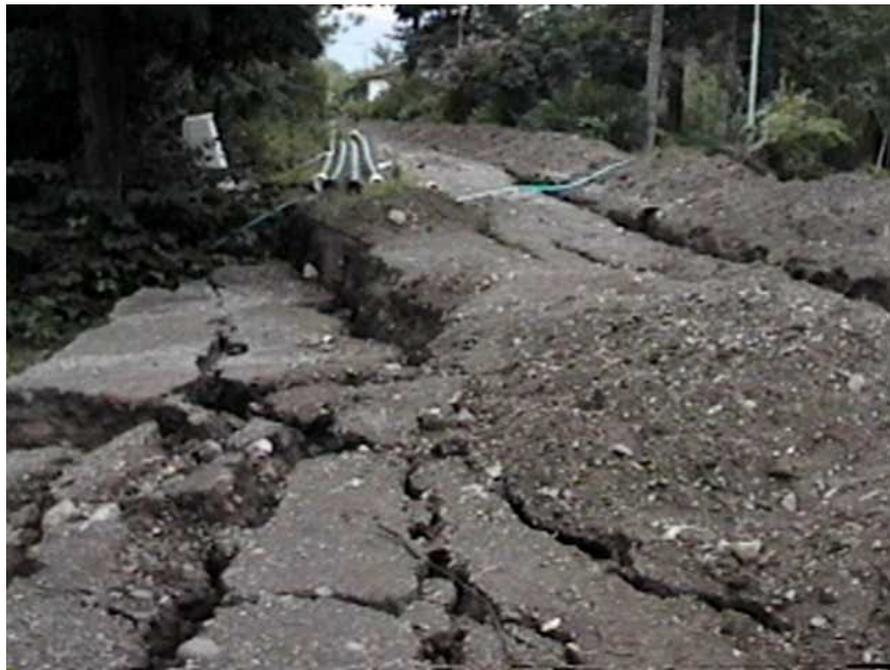
The ground spread laterally close to the ground rupture that went along the fence of the Ford plant in Golcuk (N40°42.818', E29°51.098', 8/28/99, 13:49:32).

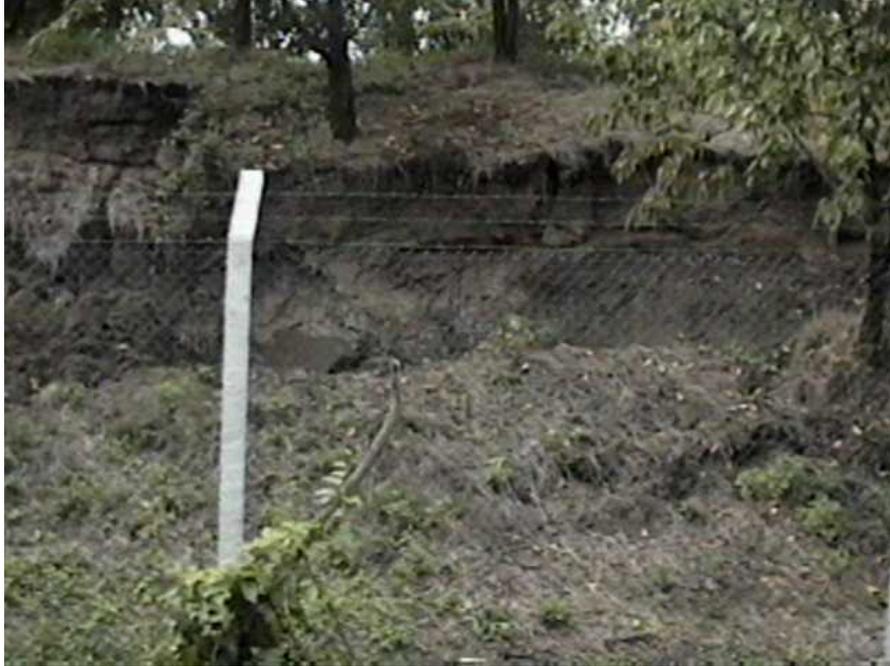
A ground rupture ran parallel to the fence of the Ford plant in Golcuk. In some areas the vertical offset exceeded two meters (N40°43.165', E29°50.596', 8/28/99, 15:42:14).

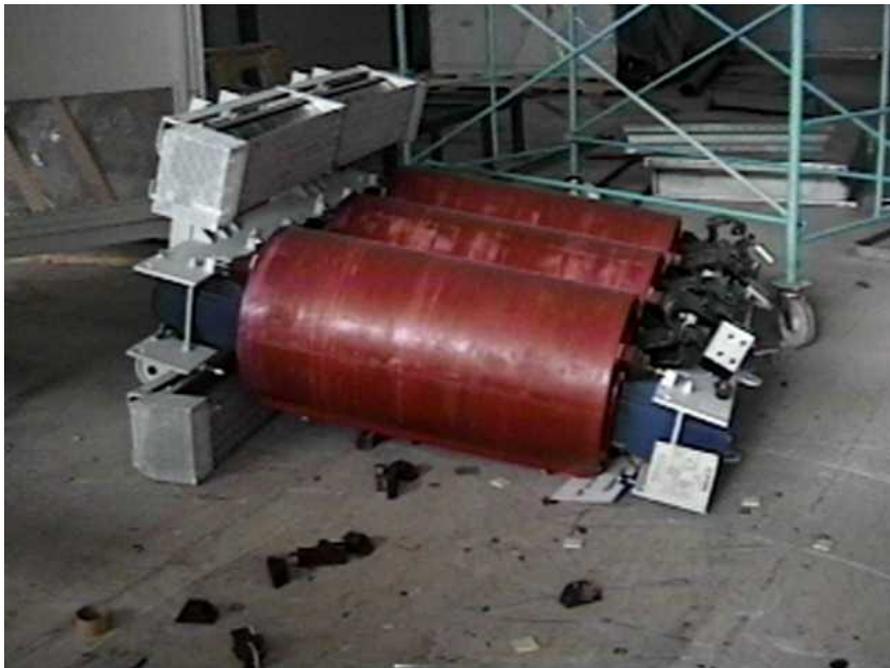
Located 80 m above the ground in the painting building of the Ford plant of Golcuk, the 5-ton transformer jumped out of its housing, and scraped the floor due to earthquake acceleration (N40°43.165', E29°50.596', 8/28/99, 15:42:14).

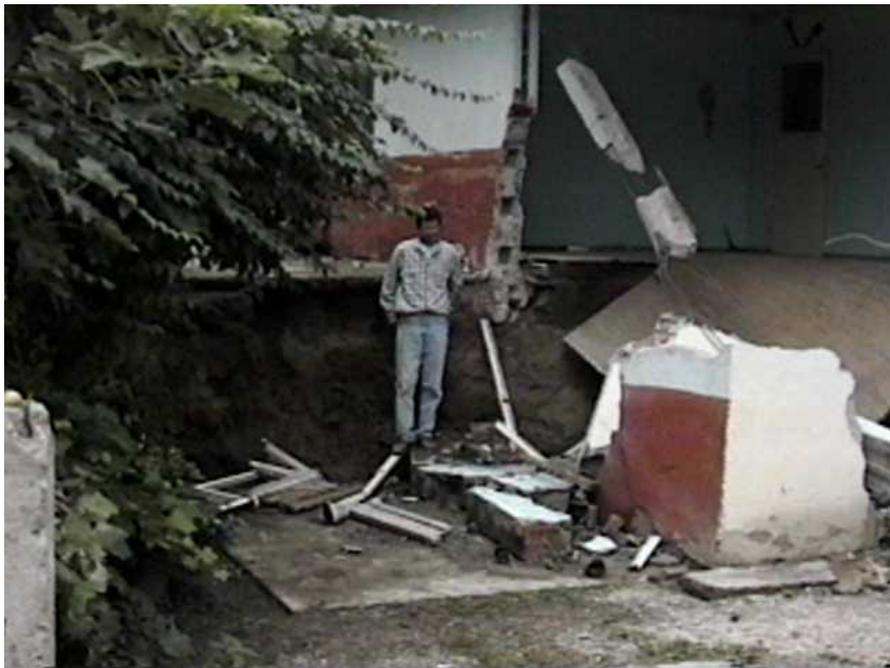
In Golcuk, the ground rupture passed beneath the corner of a house, and the corner of the house detached from the house (N40°43.178', E29°50.555', 8/28/99, 15:45:11).

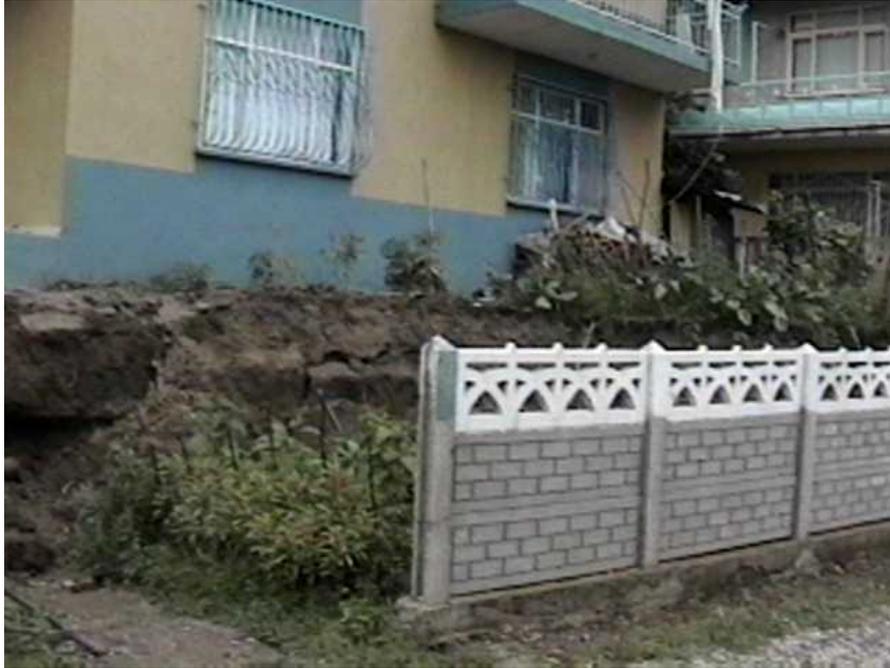
In Golcuk, the ground rupture passed very close to the house, causing almost no visible damage to the house. Some plants were still hanging to the soil close to the house (N40°43.178', E29°50.555', 8/28/99, 15:45:11).

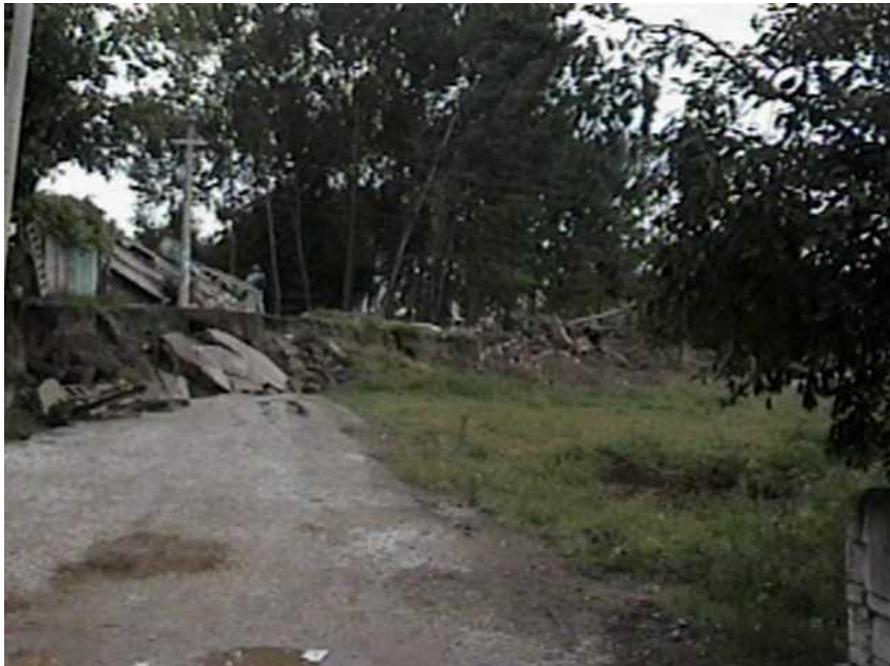
In Golcuk, the ground rupture crossed the road. The vertical offset was about 2 m (N40°43.132', E29°50.52', 8/28/99, 15:51:45).

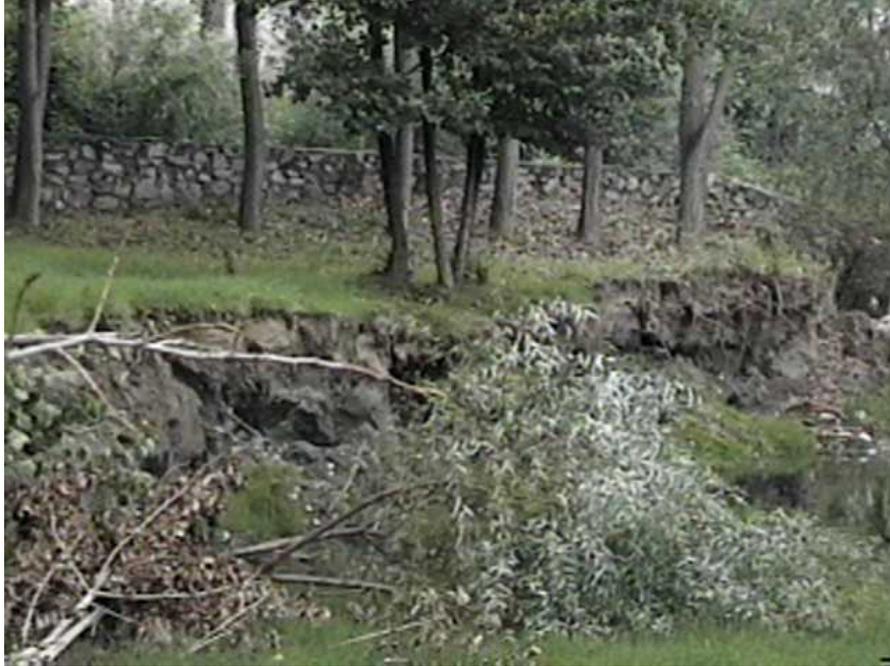
In Golcuk, the ground rupture passed close to a wall, intersected it, and sheared it. Most of the wall remained intact (N40°43.245', E29°50.477', 8/28/99, 16:01:42).

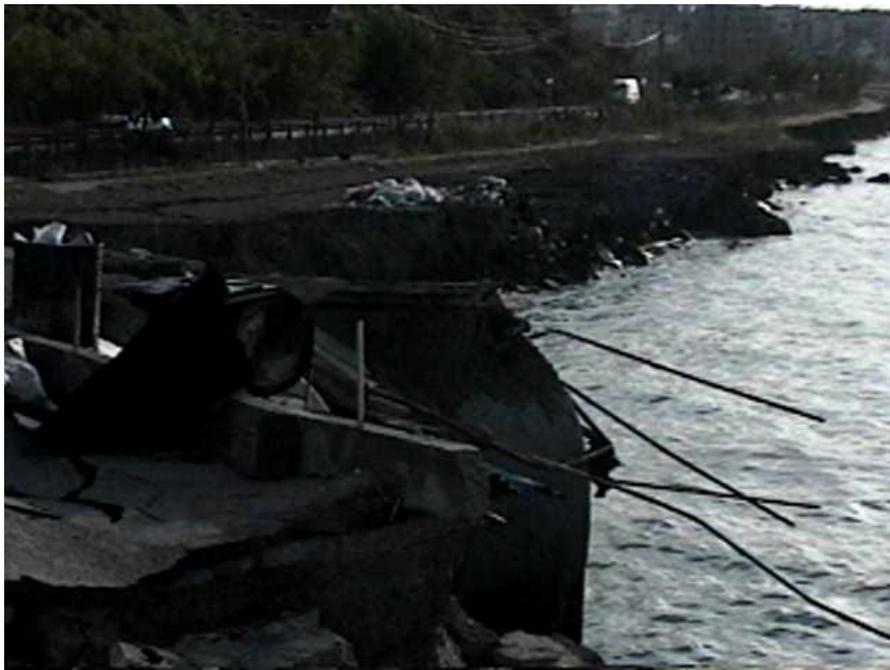
To the west of Golcuk, a piece of land slid into the sea. There were ground cracks parallel to the new shoreline (N40°43.074', E29°46.083', 8/28/99, 16:20:48).
