REPORT NO.
UCB/EERC-90/05
APRIL 1990

EARTHQUAKE ENGINEERING RESEARCH CENTER

PRELIMINARY REPORT ON THE PRINCIPAL GEOTECHNICAL ASPECTS OF THE OCTOBER 17, 1989 LOMA PRIETA EARTHQUAKE

R. B. Seed, S. E. Dickenson, M. F. Riemer, J. D. Bray,
N. Sitar, J. K. Mitchell, I. M. Idriss, R. E. Kayen
A. Kropp, L. F. Harder, Jr. and M. S. Power

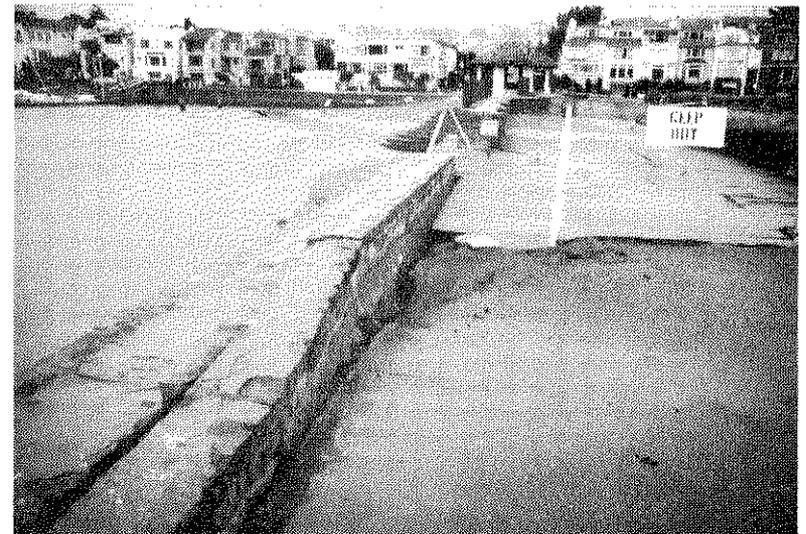
Fig. 3.5: Lateral Spreading, Settlement and Damage to the Seawall at the Marina Yacht Harbor, San Francisco

Figure 3.5 shows damage to the sea wall at the edge of the small yacht harbor at the north end of the District. This damage was the result of lateral spreading associated with liquefaction of the fill materials. Figure 3.6 illustrates conditions near the center of the Marina District (farther inland) immediately after the earthquake. In addition to the collapsed structure, this figure clearly shows buckling of the sidewalk at two locations. This buckling is not the result of settlement, but rather of lateral compression of the pavement due to lateral spreading associated with liquefaction of the underlying fill in this area. Similar evidence of lateral spreading, including extension and/or compression of pavements, occurred throughout much of the District.

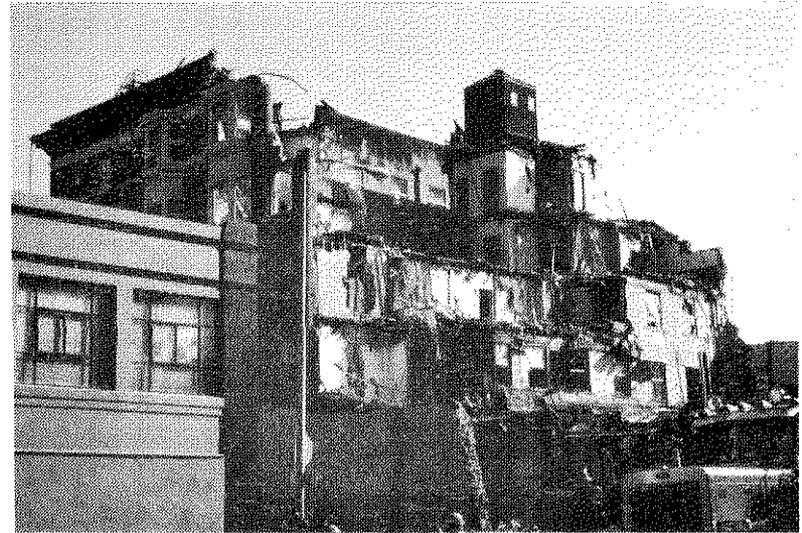
Fig. 3.17: Demolition of a Damaged Structure Near 6th and Howard Streets After the Loma Prieta Earthquake

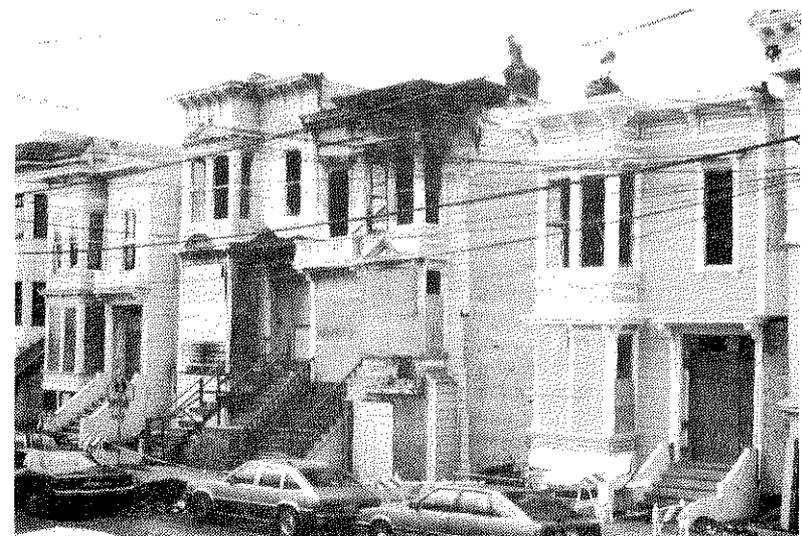
Fig. 3.23: Four Buildings on Shotwell near 18th Street Damaged by Liquefaction-Induced Foundation Displacements in the Loma Prieta Earthquake

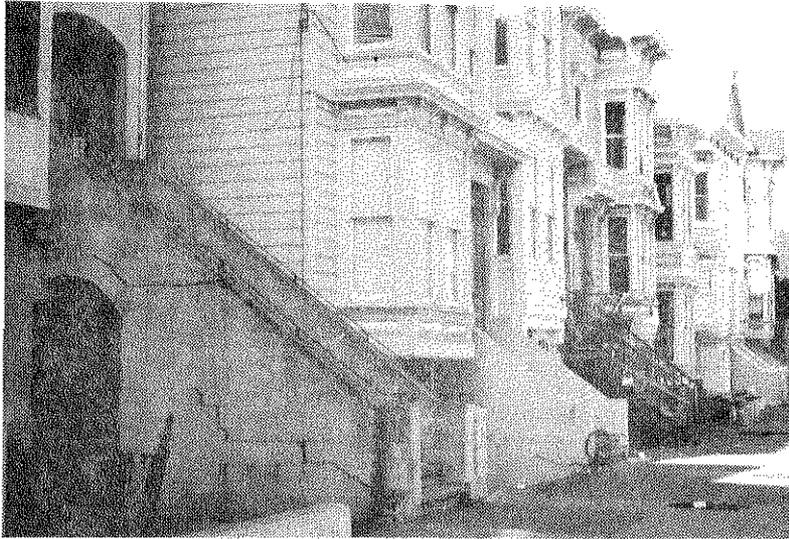
Fig. 3.24: Closer View of Structures from Fig. 3.23 Showing Settlements and Structural Cracking

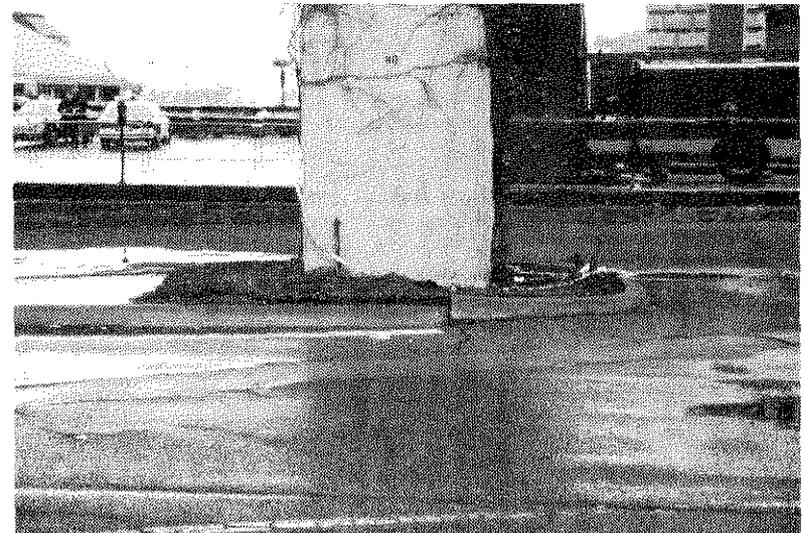
Fig. 3.32: Settlement Adjacent to Pile-Supported Bent of the Embarcadero Viaduct

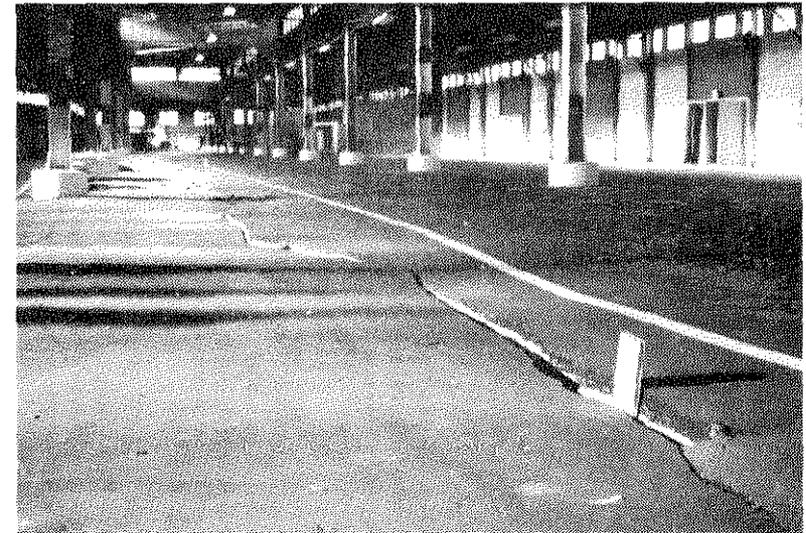
Fig. 3.34: Cracking Along Pier 45, within Warehouse, San Francisco Embarcadero Seafront

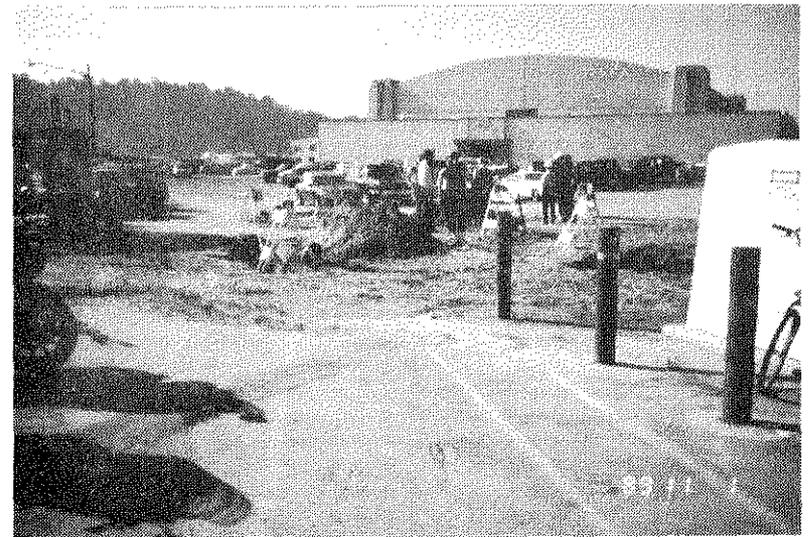
Fig. 3.44: Closer View of the Area in the Upper Right-Hand Corner of Figure 3.43

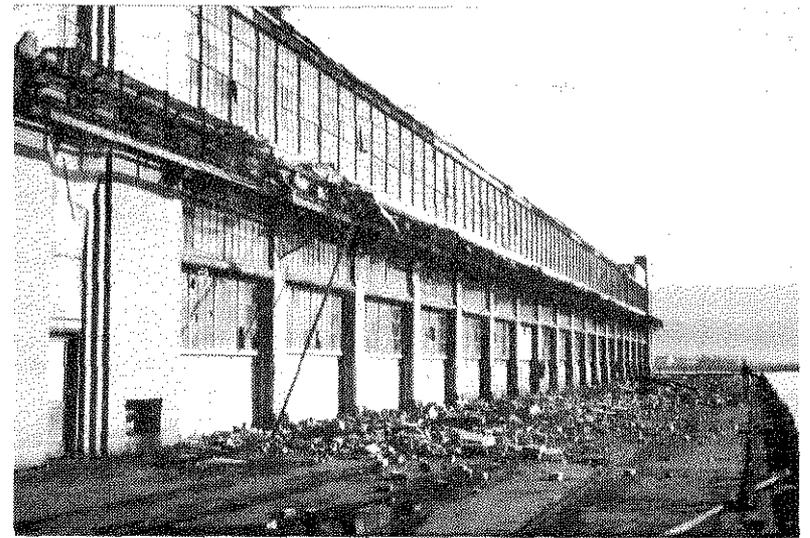
Fig. 3.49: Damage to Warehouse Structure at Richmond Inner Harbor

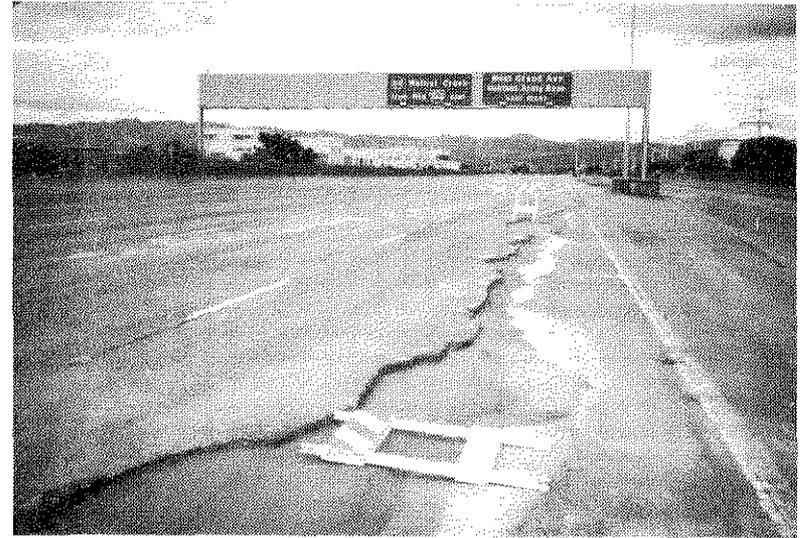
Fig. 3.51: Example of Pavement Fissure Due to Lateral Spreading and Settlement at the Bay Bridge Approach Fill

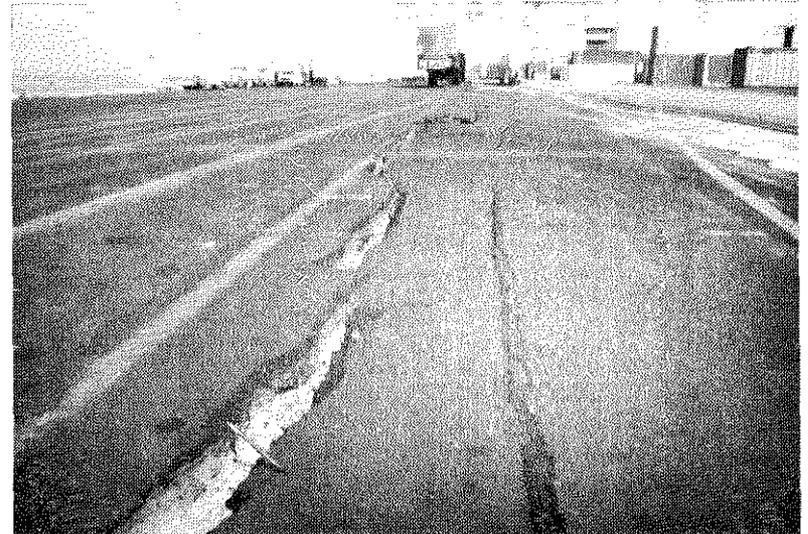
Fig. 3.55: Closeup View of Pavement Damage from Figure 3.54, Showing Open Fissures Exhibiting Both Vertical and Lateral Differential Movements

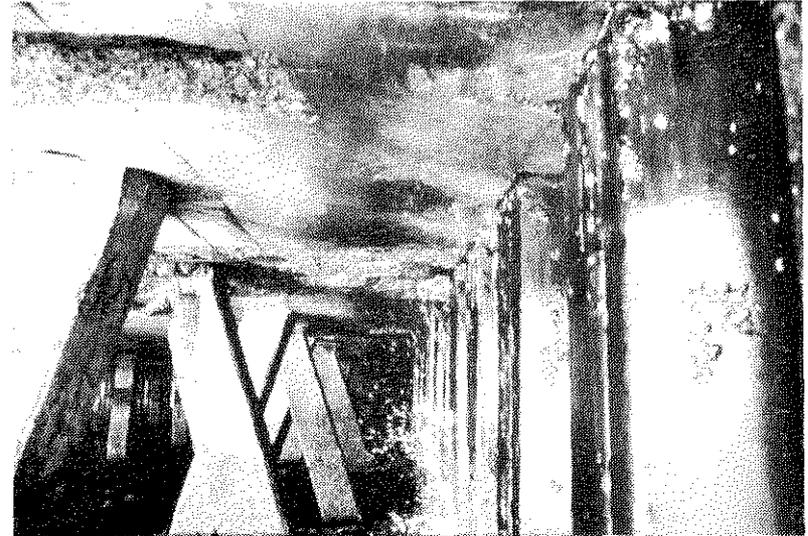
Fig. 3.57: Tensile Failures at Top of Battered Piles at the 7th Street Terminal [Photo courtesy of the U.S. Army Corps of Engineers, South Pacific Division]

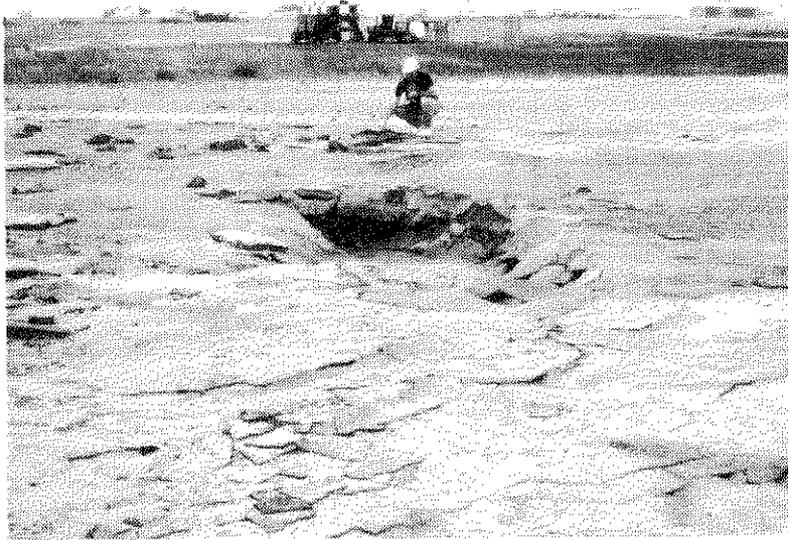
As shown in Figure 3.45, soil liquefaction occurred over large areas of Alameda Naval Air Station, immediately south of the Port of Oakland. Numerous sand boils, some of them very large, and significant settlements and lateral spreading occurred over a large area at the western end of the Station. The airfield runways that occur in this area were significantly damaged. Figure 3.59 shows a large sand boil (and sinkhole) adjacent to the intersection of the two runways, and Figure 3.60 shows damage to the runway shoulder pavement nearby. Both runways, and two taxiways, were significantly damaged and were rendered inoperational immediately after the earthquake. Damage to the pavements consisted of heaving and/or settlement, minor spreading, and resulting uneven surfaces as well as cracking and separation at joints. One large area at the runway intersection appeared to have heaved as much as four inches, and considerable cracking of the asphalt pavement slabs occurred in this area. Maximum crack and/or joint openings were on the order of four inches, though most were considerably narrower. Vertical offsets across joints and cracks ranged from zero to approximately two inches.

Fig. 3.59: Large Sand Boil and Sinkhole Adjacent to Runway at Alameda Naval Air Station

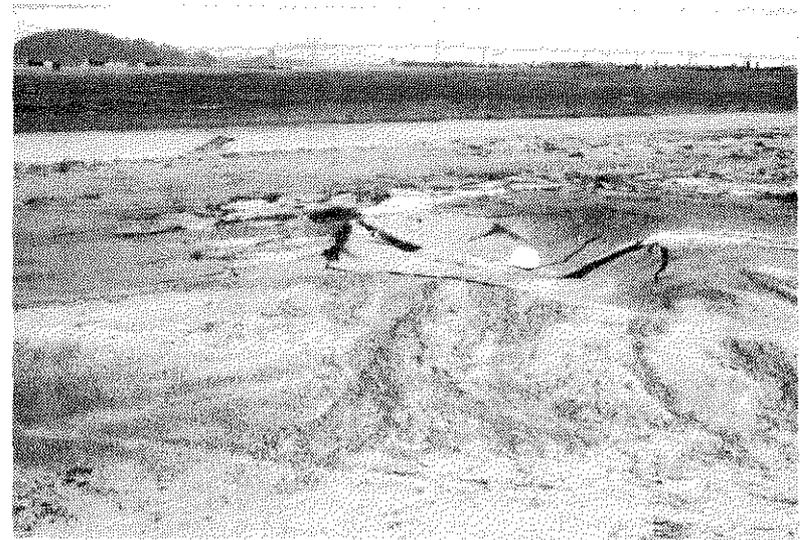
Fig. 3.60: Example of Damage to Taxiway Pavements; Alameda Naval Air Station

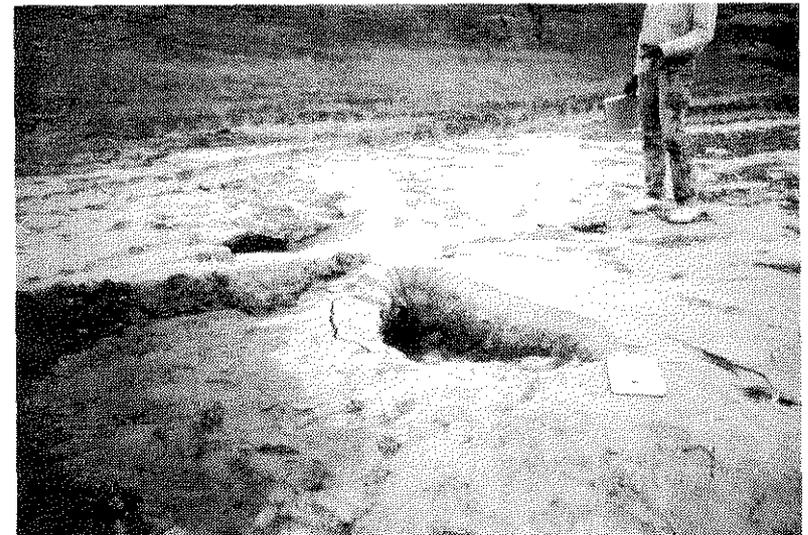
Fig. 3.62: Sand Boils on Undeveloped Land at the Northwest Corner of Bay Farm Island

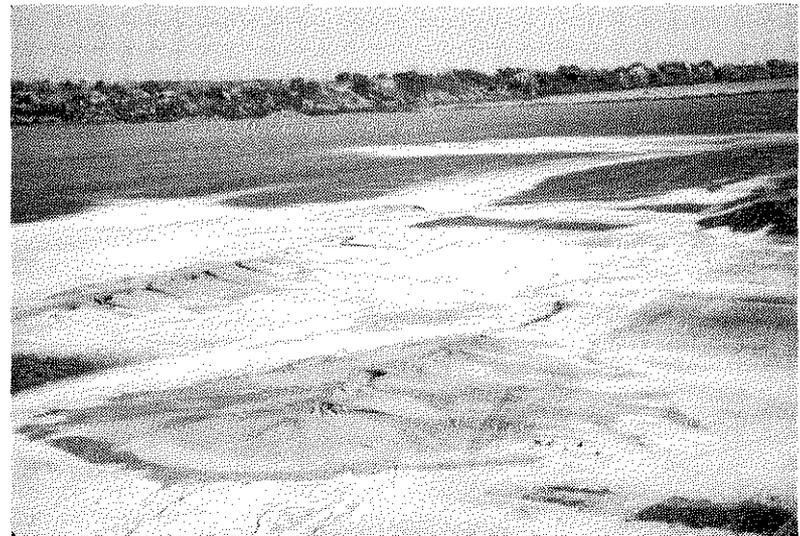
Fig. 3.65: Fissures and Exuded Boil Materials, Main Runway, Oakland International Airport

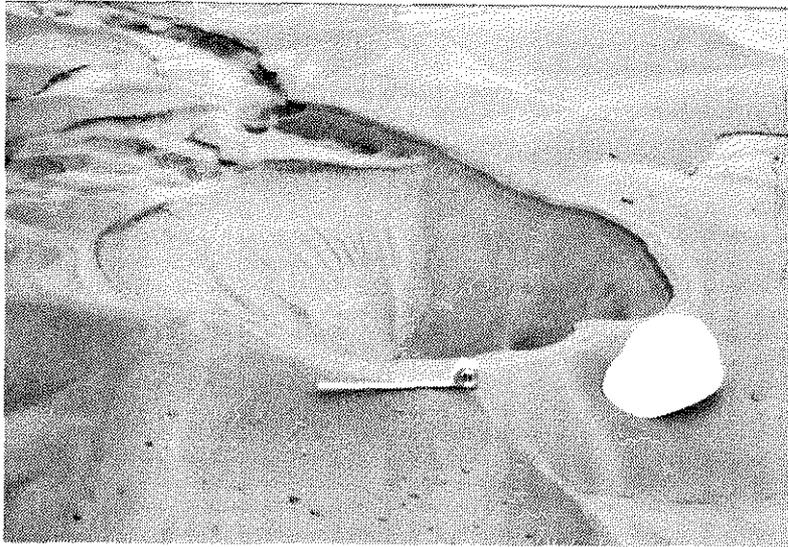
Fig. 3.66: Center of Large Sand Boil Near the North End of the Main Runway, Oakland International Airport

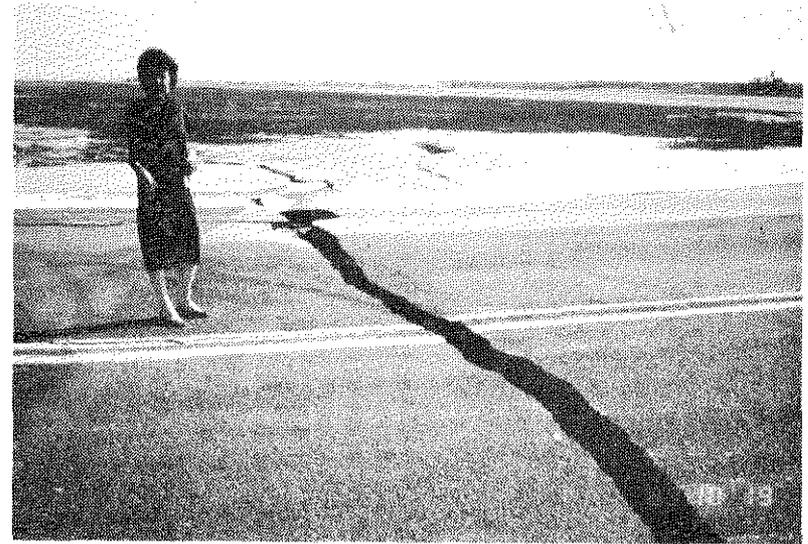
Fig. 3.67: Crack in the Pavement of the Taxiway Adjacent to the North End of the Main Runway, Oakland International Airport

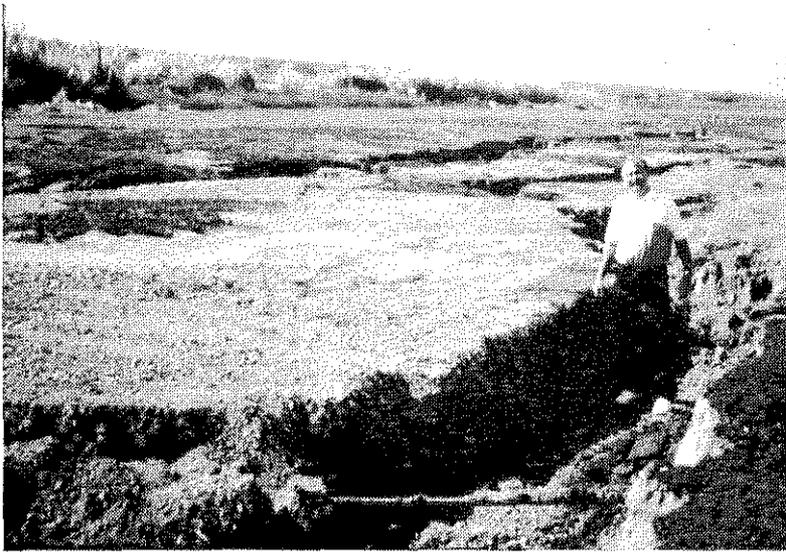
Fig. 3.70: Major Fissures, Grabens and Sand Boils Near the Northwest End of the Main Runway, Oakland International Airport [Photo courtesy of B. A. Vallerga]

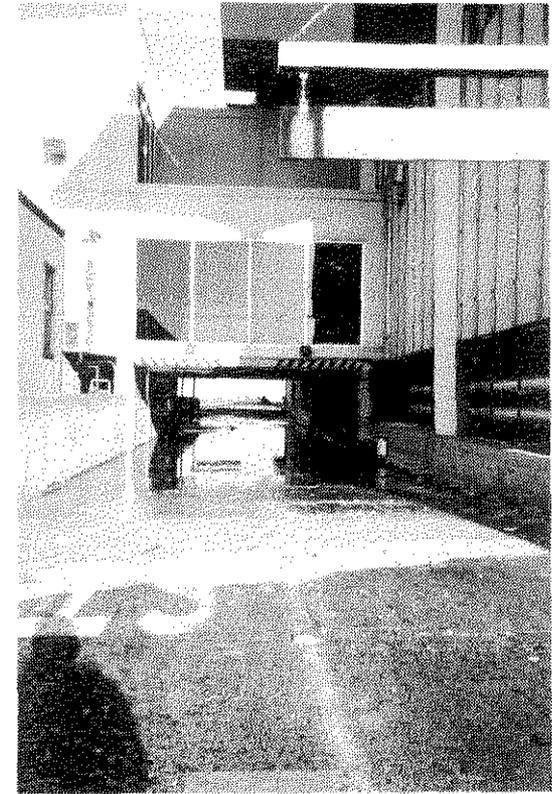
Fig. 3.72: Below-Grade Tramway Filled with Sand; Main Terminal Buildings, Oakland International Airport [Photo courtesy of B. A. Vallerga]

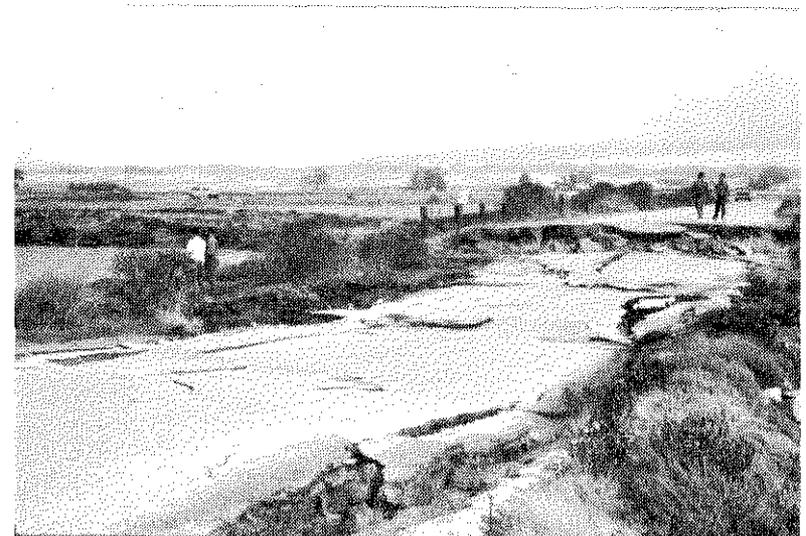
Fig. 3.84: Flow Failure of the Moss Landing Approach Road Embankment

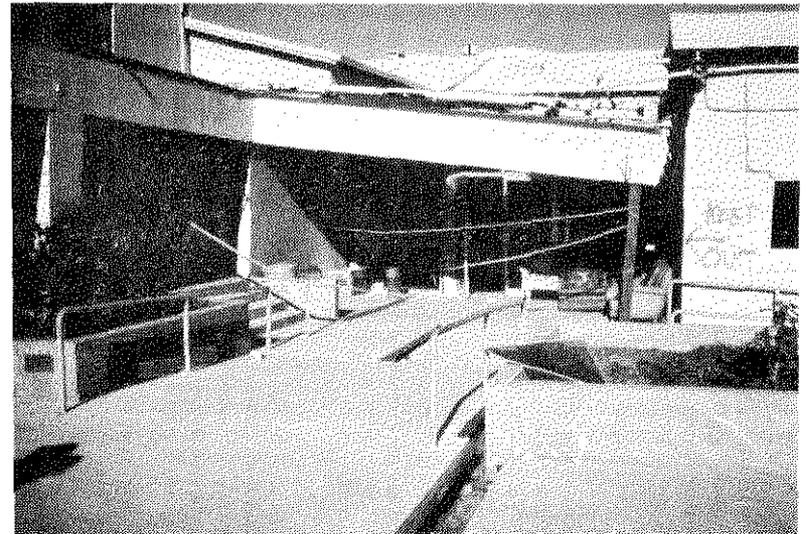
Fig. 3.86: Damage to the Moss Landing Marine Research Facility as a Result of Settlement and Lateral Spreading

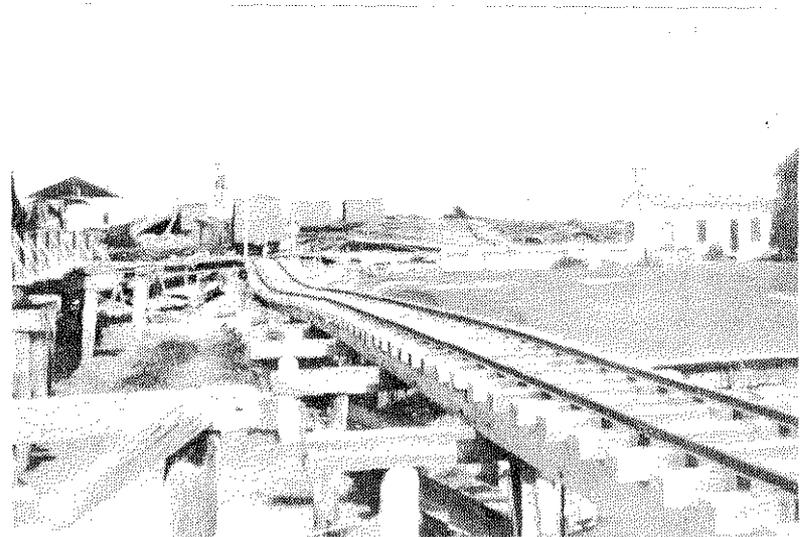
Fig. 3.88: Warehouse at Moss Landing Destroyed by Lateral Spreading in the 1906 San Francisco Earthquake [Lawson et al., 1908]

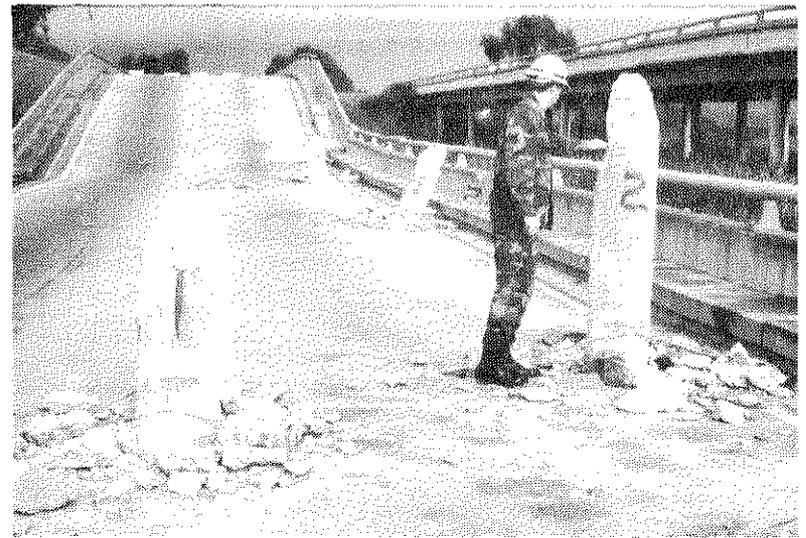
Fig. 3.90: Punching of Piles Through the Collapsed Roadway at the Struve Slough Crossing

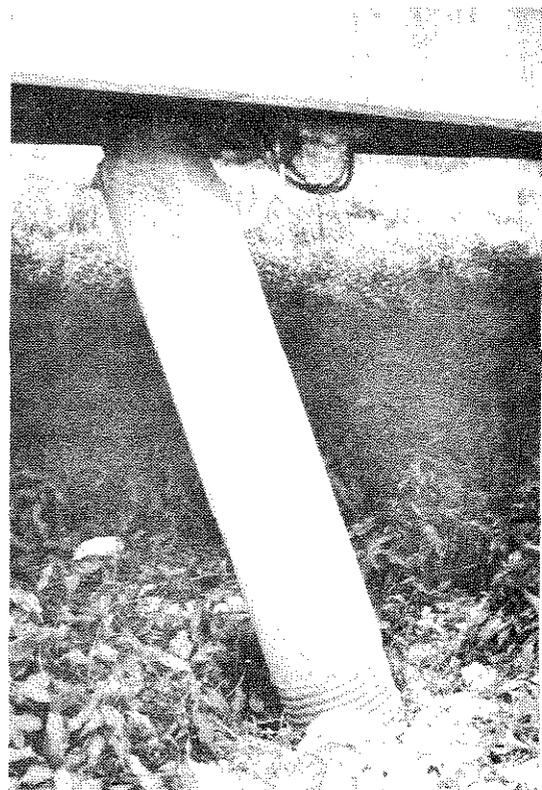
Fig. 3.92: Damage to Pile/Bridge Connection;
Struve Slough Crossing

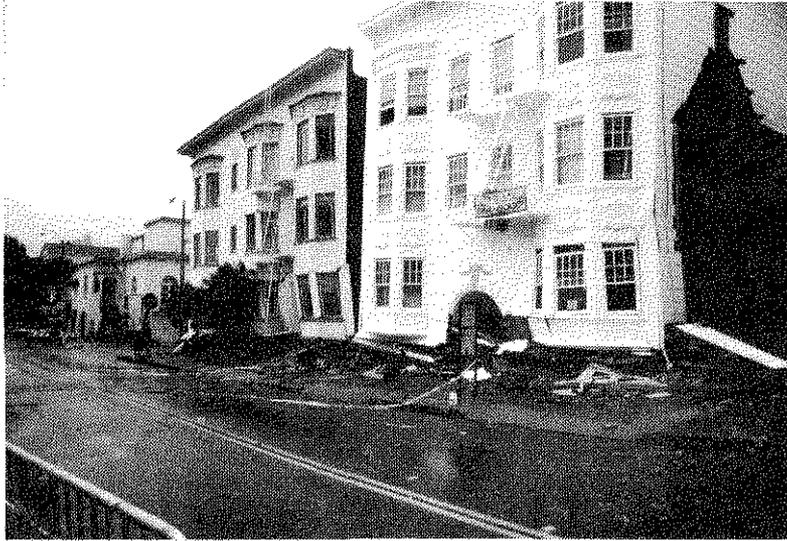
Fig. 4.11: Examples of Collapse of Two Structures in San Francisco's Marina District Due to "Soft" Ground Floors

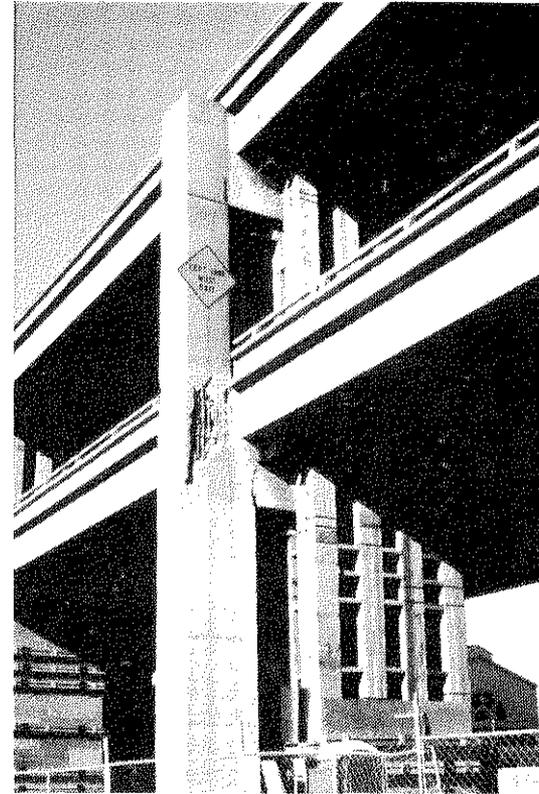
Fig. 4.13: Damage to the Embarcadero Highway Elevated Viaduct in San Francisco

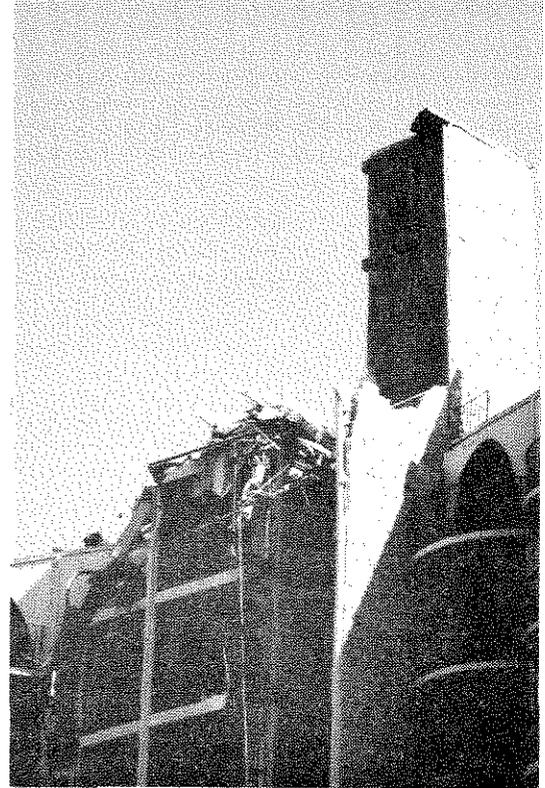
Fig. 4.15: Damaged Roof and Top of Elevator Tower, Amfax Hotel, Burlingam [Photo courtesy of Prof. S. A. Mahin]

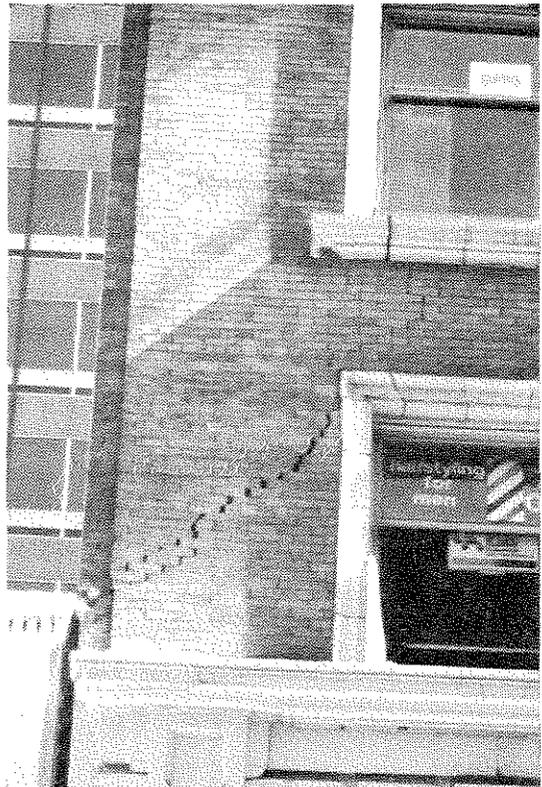
Fig. 4.19: Near Failure in Shear Due to Pounding Between Two Buildings on Franklin Near 21st Street, Oakland [Photo courtesy of Prof. S. A. Mahin]

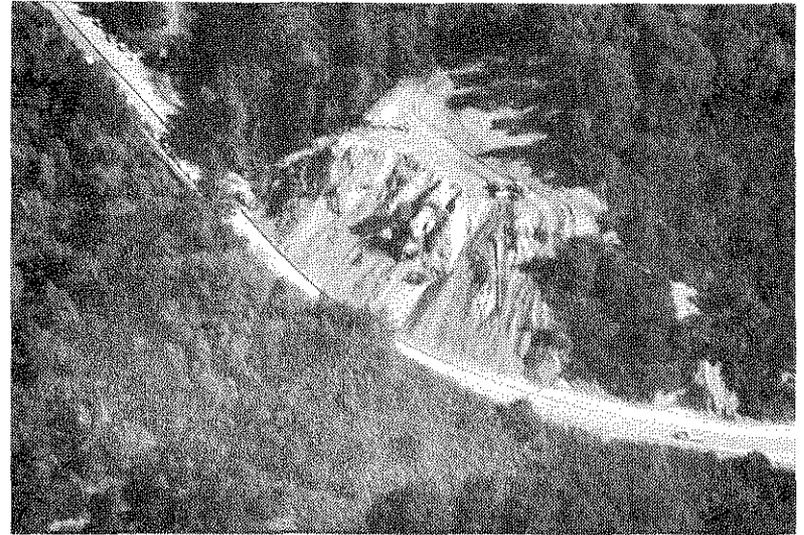
Fig. 5.3: Repair of Landslide on Highway 17 in the Santa Cruz Mountains

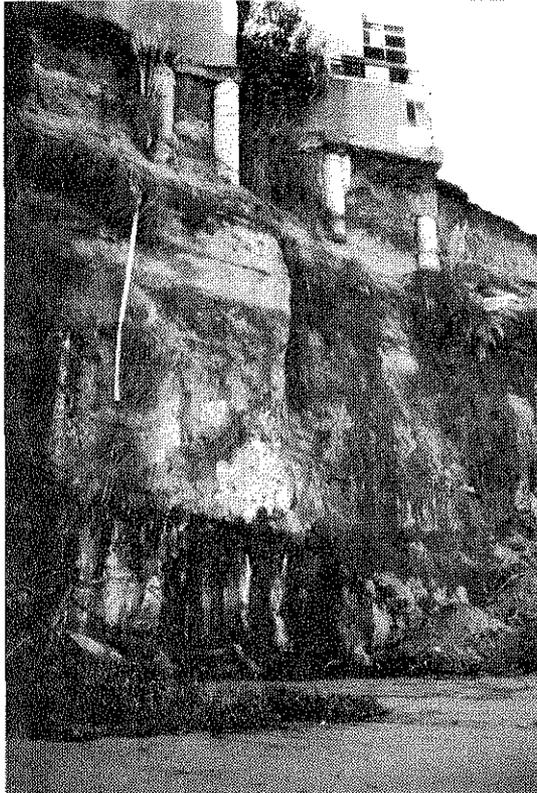
Fig. 5.6: Apartment Building Partially Undermined by a Small Coastal Bluff Failure Near Capitola

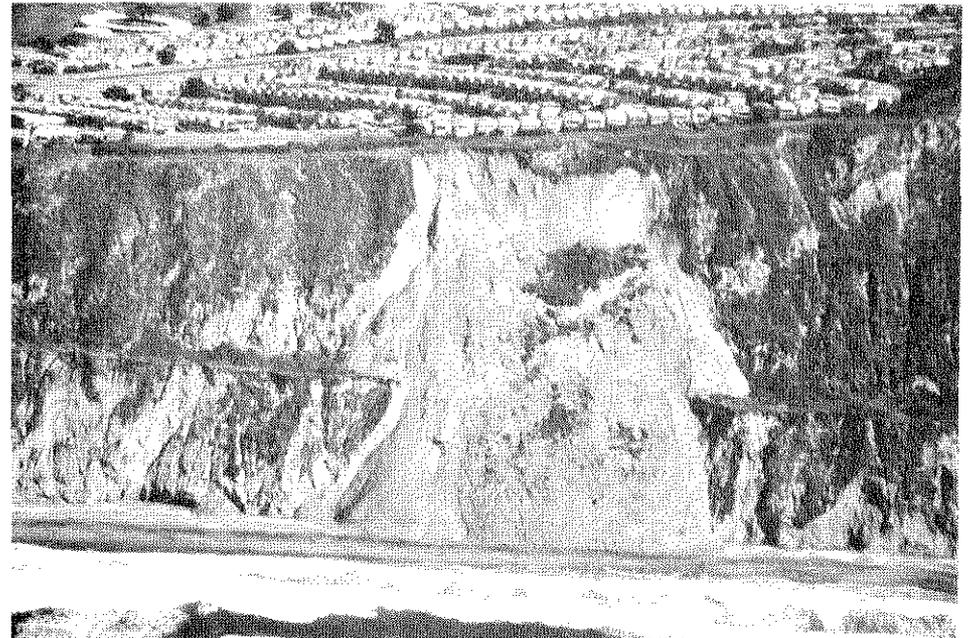
Fig. 5.8: Coastal Bluff Failure at Daly City

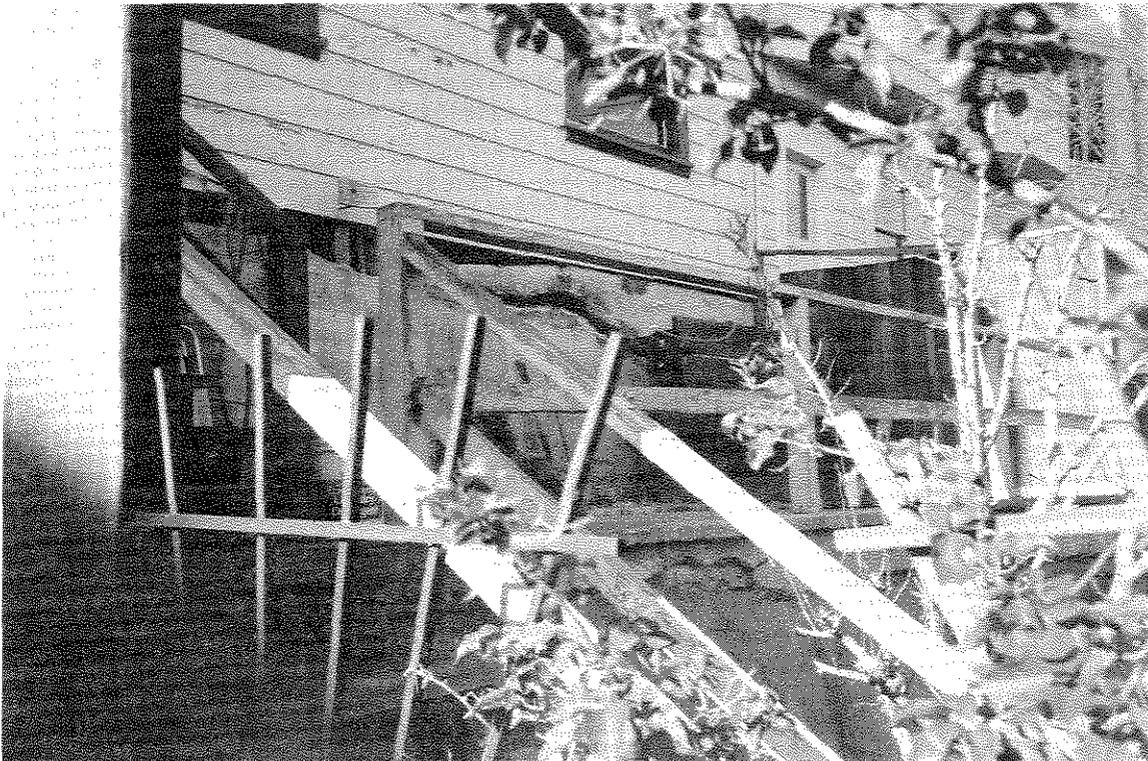
Fig. 5.10: Home With Foundation Sheared-Through by Eighth Avenue Slide

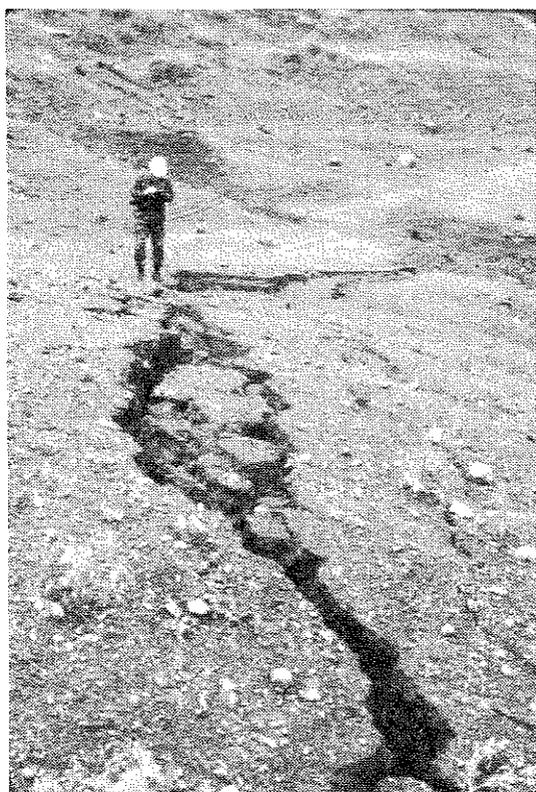
Fig. 6.4: Fissure in Right Abutment at Austrian Dam

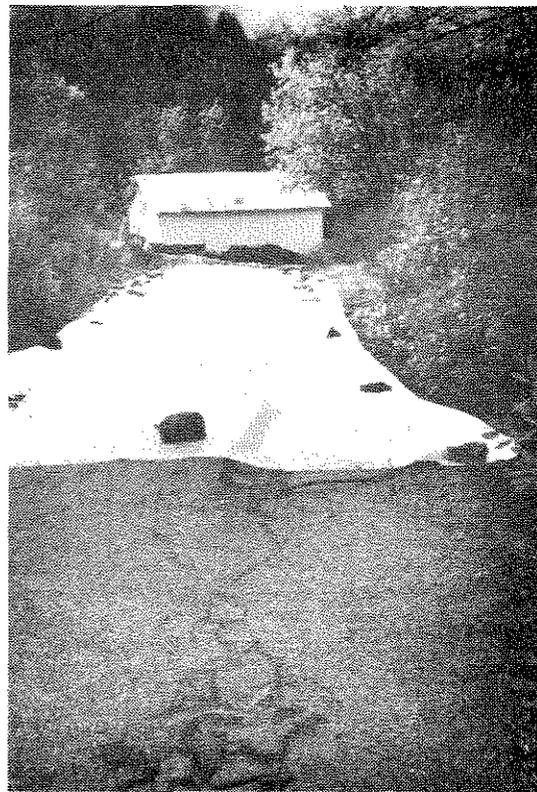
Fig. 6.7: Fissures near Left Abutment at Austrian Dam
