M 6.5 Earthquake Offshore Northern California January 9, 2010

Field Reconnaissance Summary

February 12, 2010

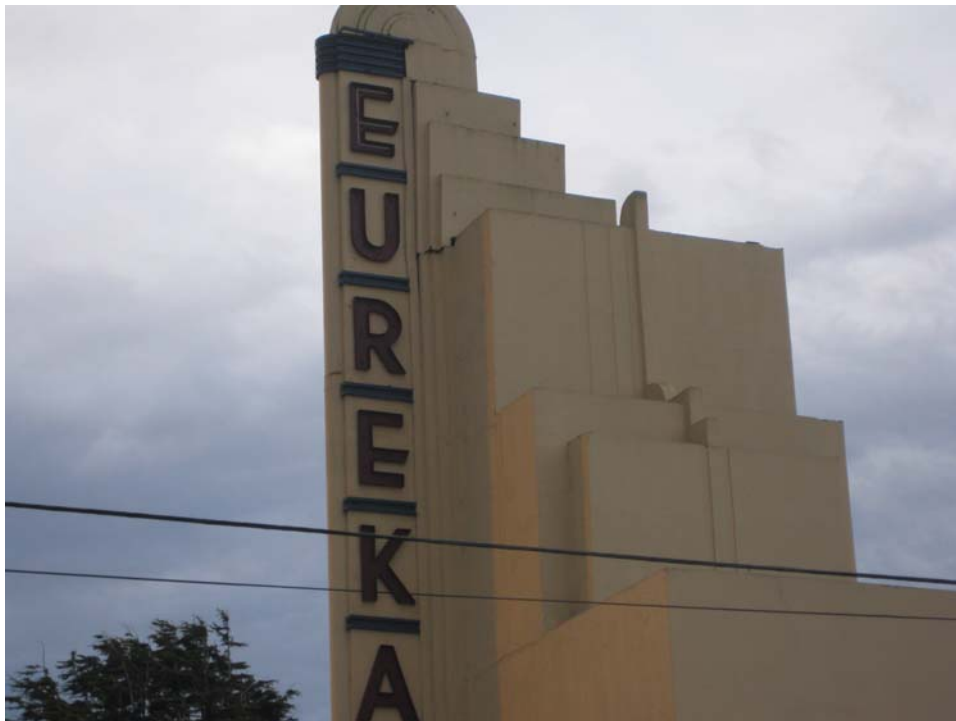
Structural damage to the Eureka Theater building at the corner of 6th and F Street in Eureka, California.

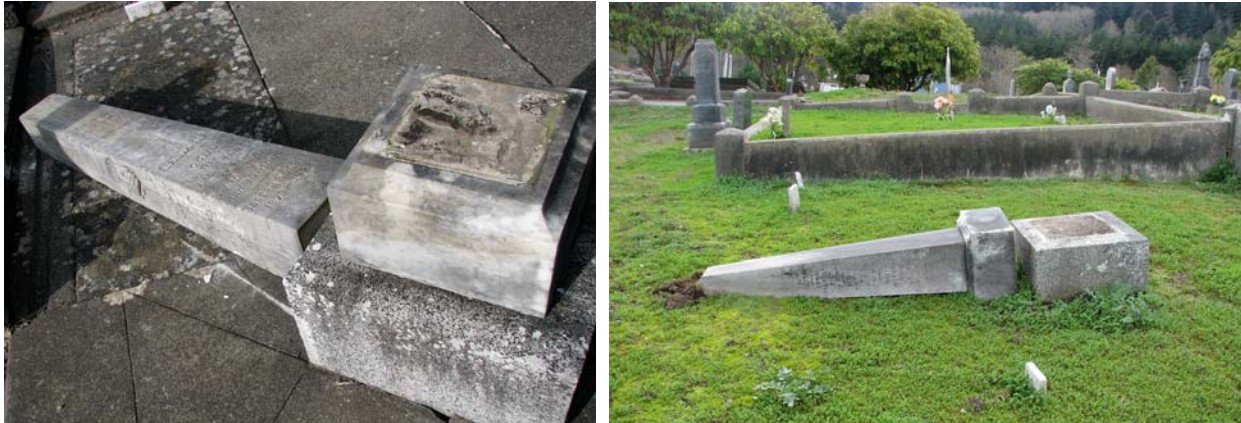
The maximum recorded shaking was observed in Ferndale (44%g) and at Eureka (33%g), which is sufficient to cause moderate damage. The instrumentally-computed “Shakemap” by the USGS shows a zone of strong shaking along the coast extending from the Eel River Valley to Eureka. About 20% of the vertical monuments at the Ferndale cemetery were toppled or displaced and preliminary analysis suggests an east-west alignment (Figure 4). Cemetery monuments in Eureka, Table Bluff and Loleta show similar, but smaller, amounts of displacement.

Figure 4 *Toppled monuments at the Ferndale Cemetery.*

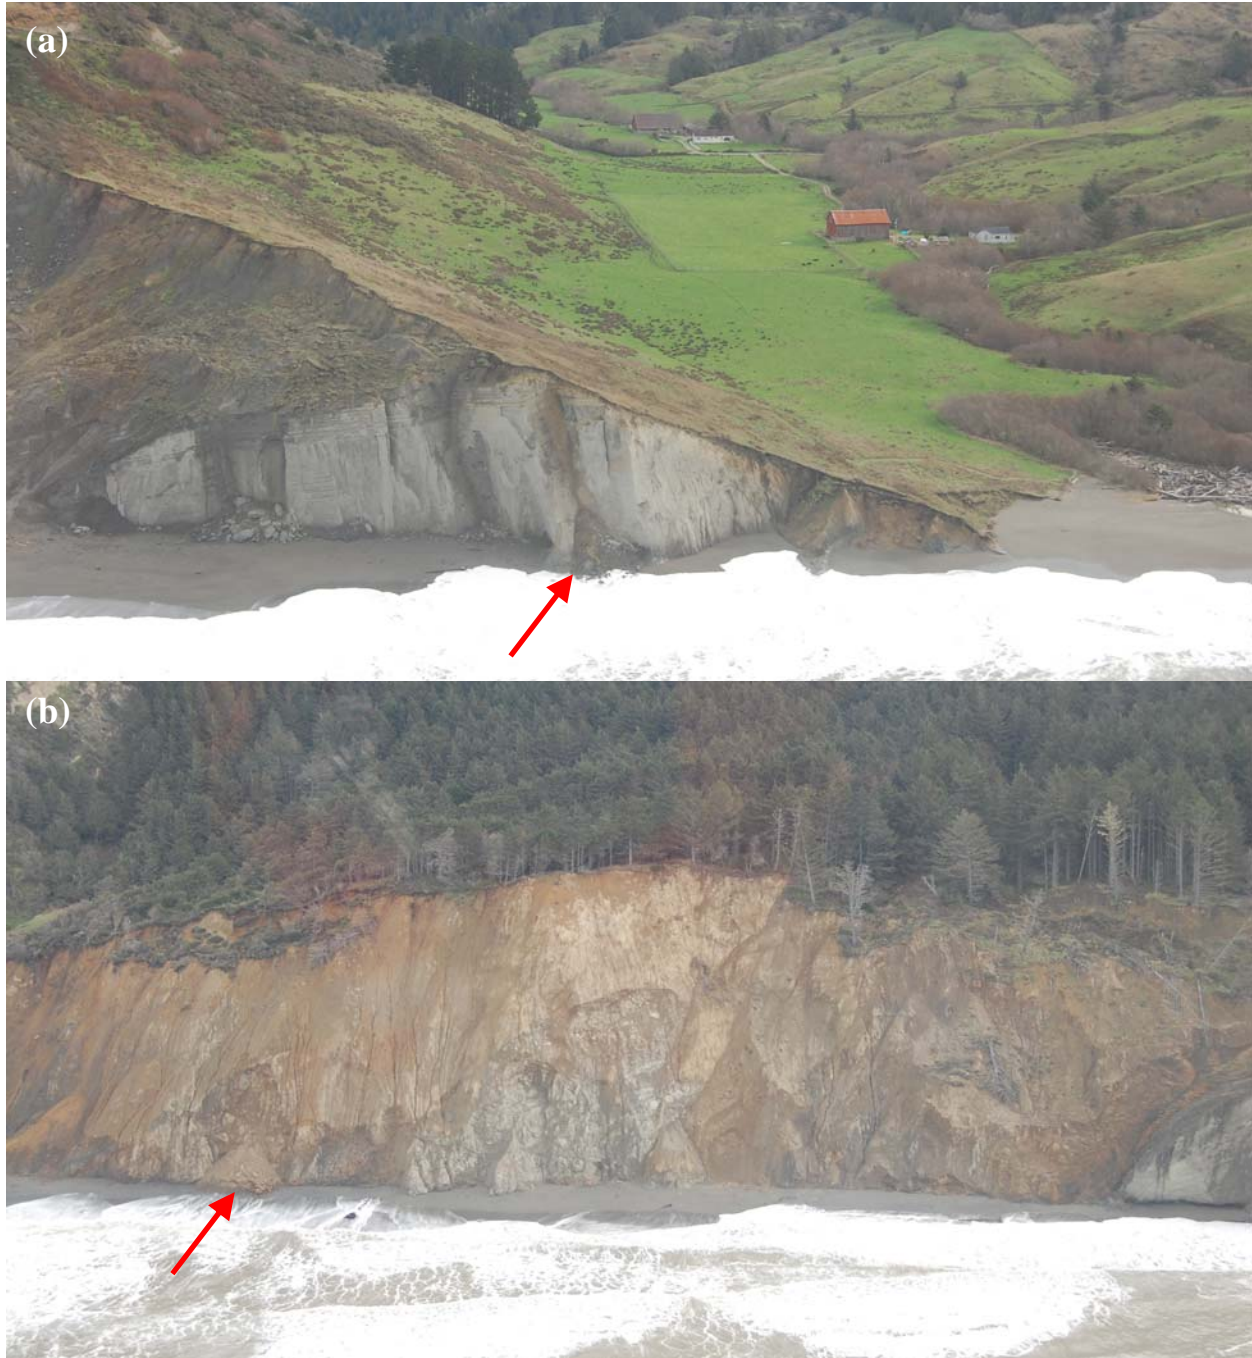
Figure 10 Typical coastal rock falls at 36 km epicentral distance. Arrows point to location of earthquake-induced rock fall in each case. (a) Rock fall from approximately 30 m tall cliff located at N40.559231°, W124.357405°, photo taken on 1/15/2010 at 10:49 a.m., (b) Rock fall from approximately 50 m tall cliff portion of existing larger deep-seated landslide located at N40.526835°, W124.374868°, photo taken on 1/15/2010 at 10:48 a.m.

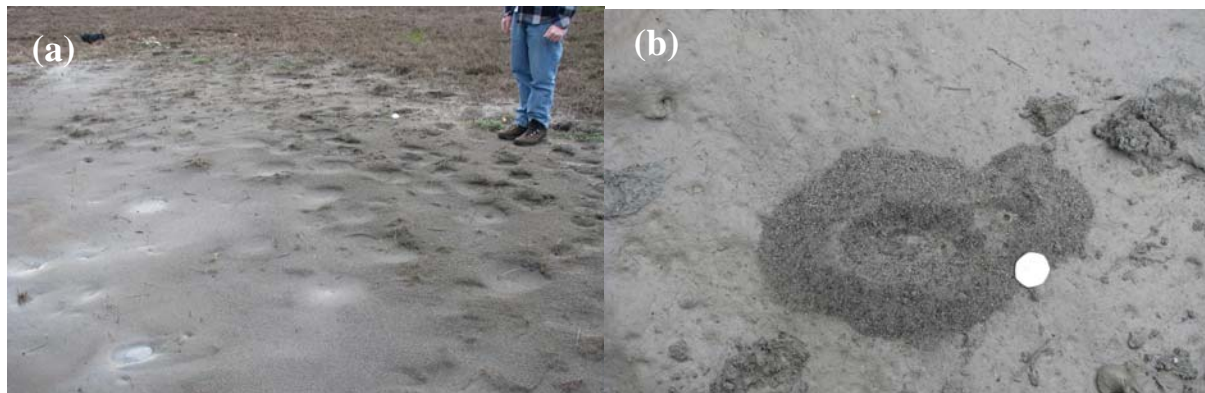
Liquefaction (sandboils) was observed on Centerville Beach and along the Eel River (Figure 11). The Centerville Beach features were subtle and had been overtopped by high tide washover. Small sandboils were better preserved on the banks of the Eel River and associated with spread failures ranging in length from less than a meter to 20 meters. Approximate locations of liquefaction features are presented in the “Observed Features” Google Earth file.

Figure 11 Liquefaction features: remains of sandboils at Centerville Beach (a) and sandboils along the Eel River (b).

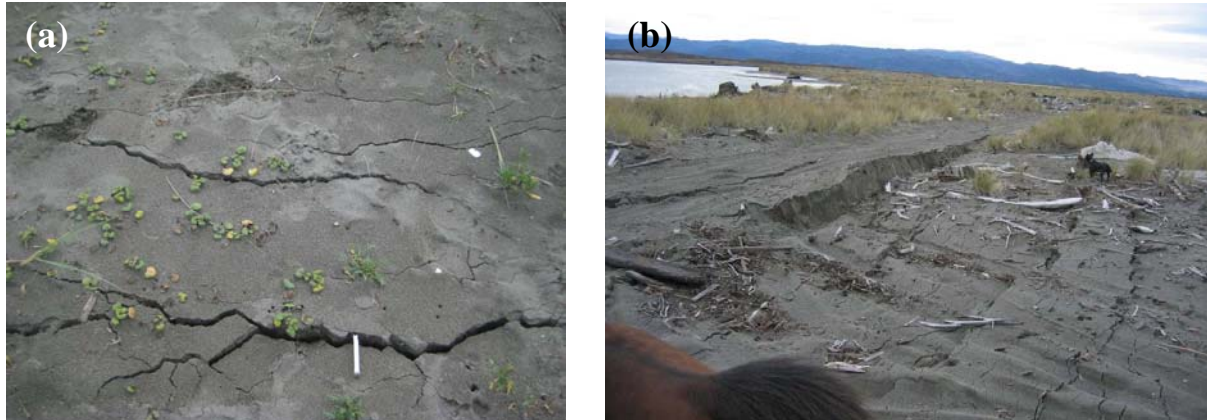
Lateral spread failures were observed at King Salmon and along the banks of the Eel River (Figure 12). The most well developed spread failures were located on the spit north of the mouth of the Eel River, where some features extended 10 meters or more with offsets up to 40 cm. Field reconnaissance for surface features was limited by weather constraints. There may have been features elsewhere but heavy rainfall on January 12 erased most traces. Approximate locations of ground cracking features are presented in the “Observed Features” Google Earth file.

Figure 12 Spread failures at King Salmon(a) and spread failures on spit north of Eel River mouth (b).

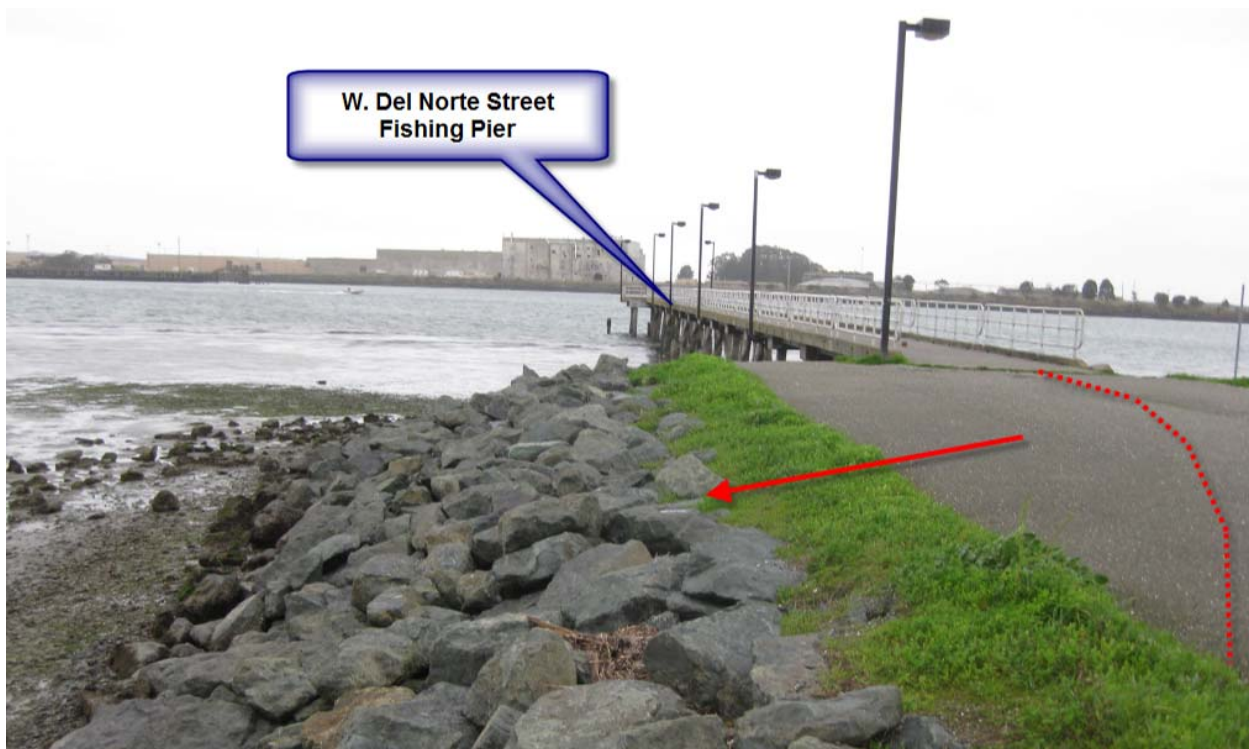
1. Minor differential ground displacements were observed at the interface of the pile-supported W. Del Norte Street Fishing Pier and approach embankment. Cracking was observed at the pier/embankment interface and a fracture line in the asphalt concrete pavement appeared to indicate the near-onset of a slope failure (Figure 13).

Figure 13 W. Del Norte Street Fishing Pier fractures in pavement indicated near-onset of slope failure (40.790688N; 124.187810W). Arrow indicates directly of movement of embankment and dashed line shows outline of cracking.

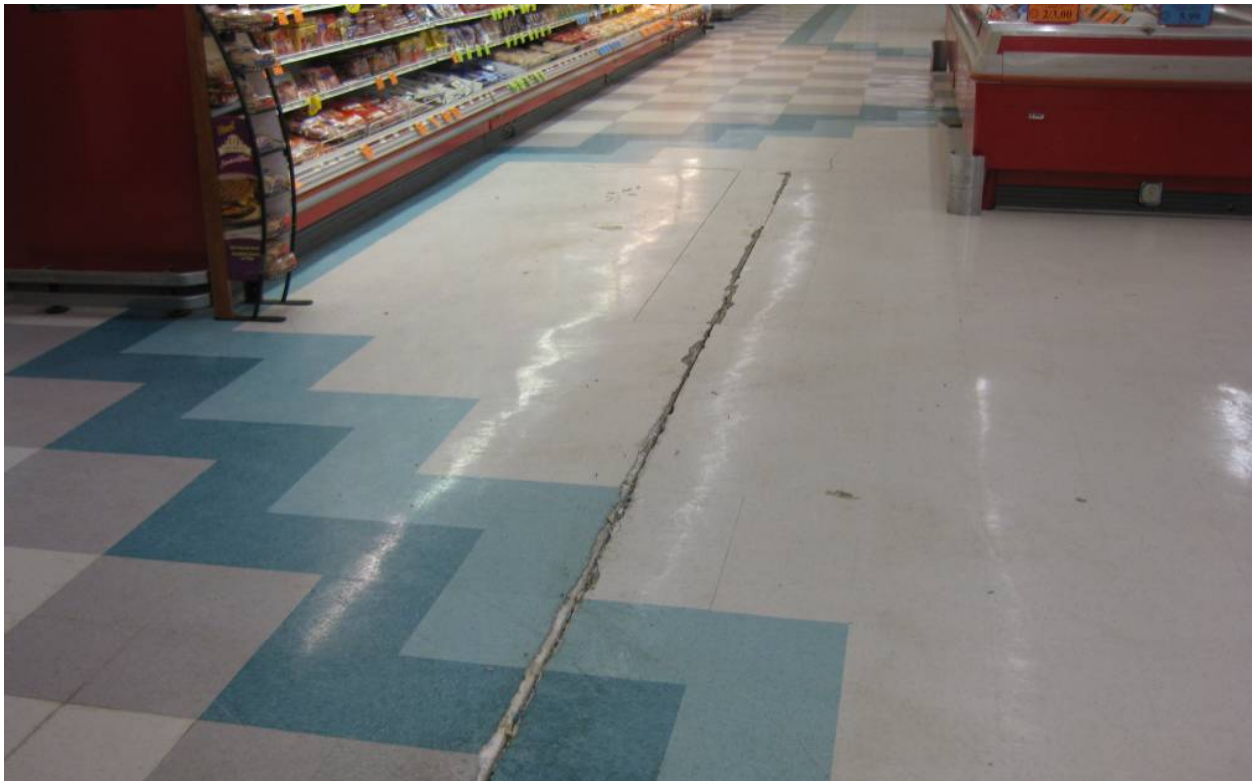
2. Fracturing and displacements (Figure 14) of the Ray's Food Place Market slab on grade concrete floors were observed, indicating differential settlement of foundation soils. No significant structural damage was observed to the exterior of the structure or any interior columns/beams. Some ceiling panels fell down and some shelves were knocked over. The structure was in operation at the time of the field observations.

Figure 14 Cracking of the slab on grade concrete slabs at cold joints indicating differential settlement of foundation soils at Ray's Food Place Market (40.776538N; 124.192284W).

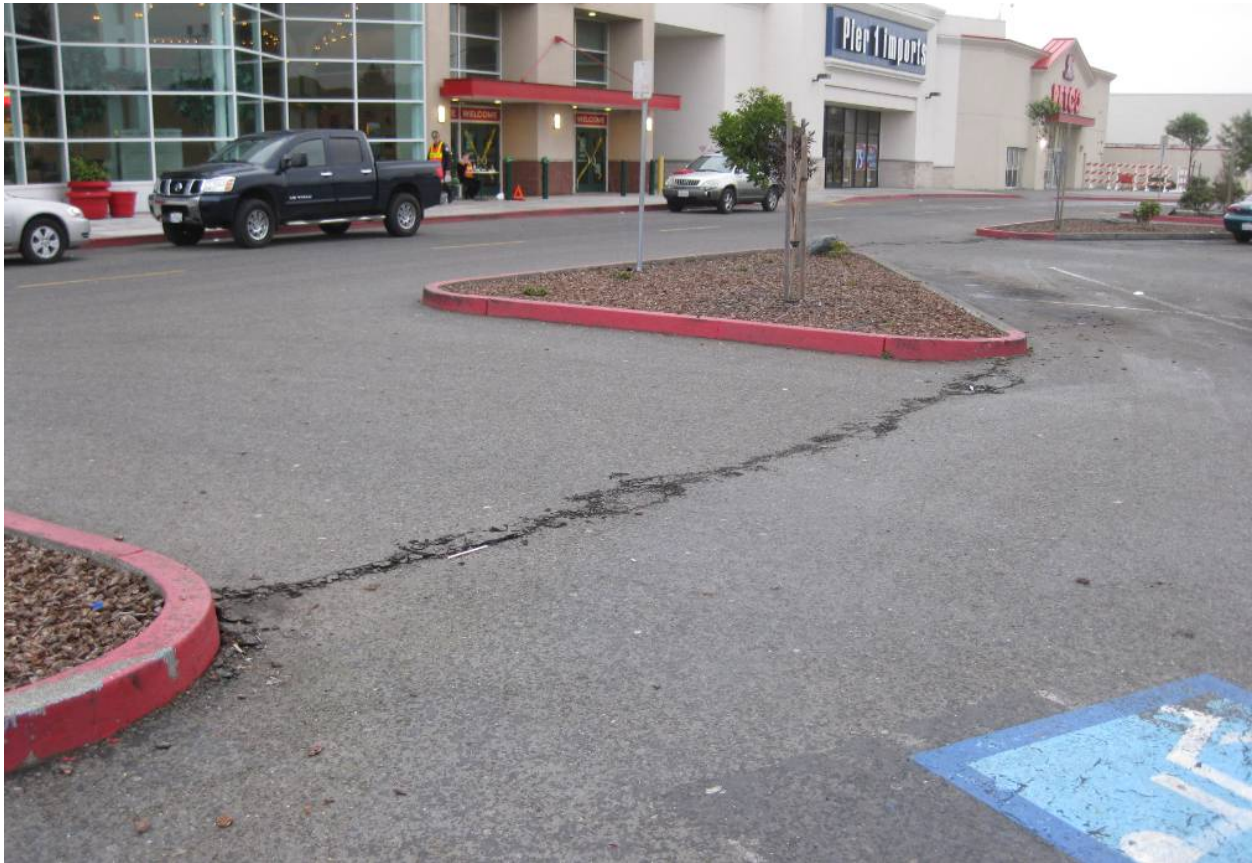
3. Ruptures in the asphalt concrete pavement at the Bayshore Mall (Figure 15).

Figure 15 Ruptures in the Bayshore Mall parking lot (40.778562N; 124.190219W).

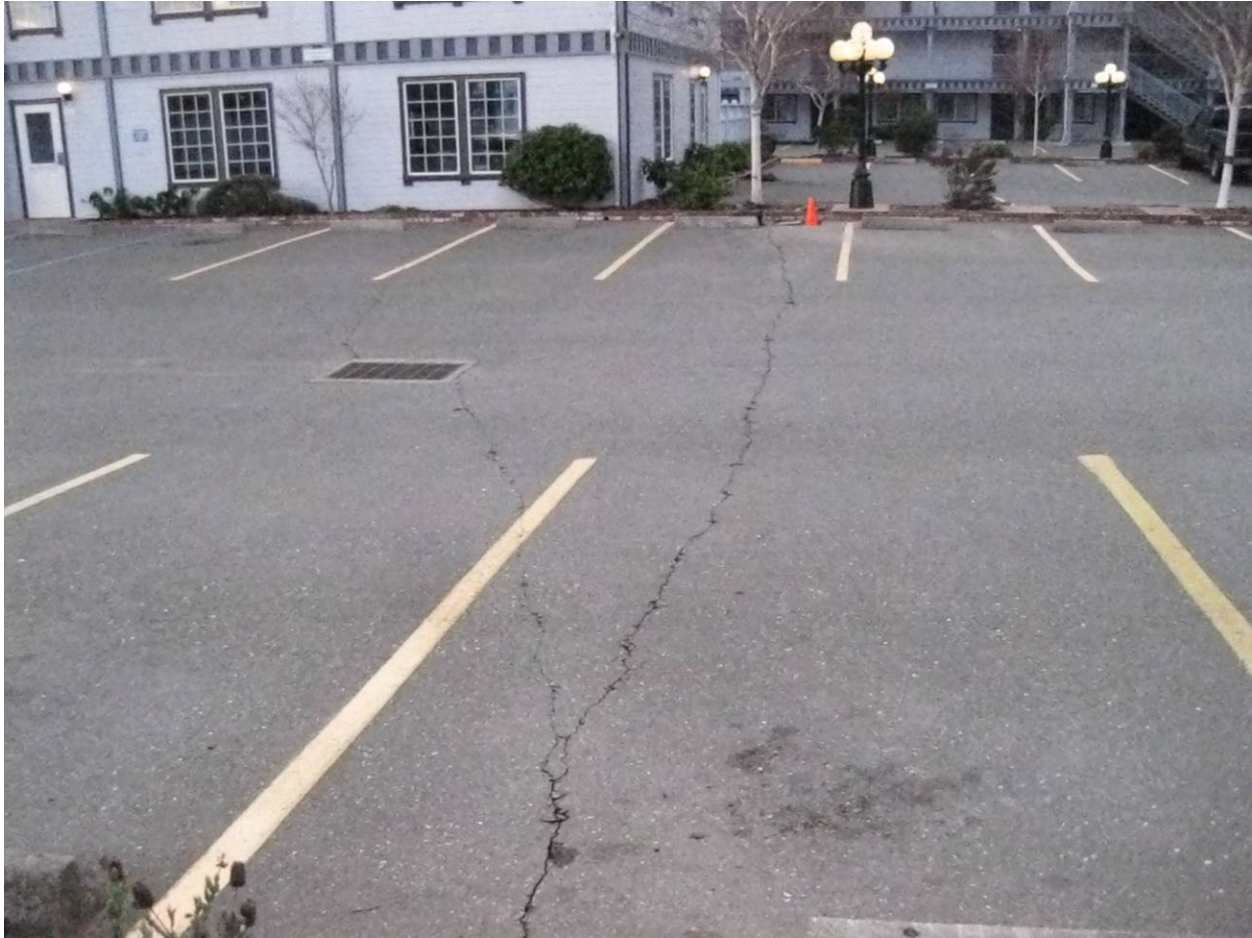
Figure 16 shows cracking in the AC pavement south of the Bayshore Mall and Ray's Food Place. These cracking features extend from Truesdale Street to Tomlinson Street (mostly parallel to Broadway Street/Highway 101).

Figure 16 Cracking in AC pavement in the parking lot at the Best Western, NW corner of Broadway Street and Truesdale Street (40.775312N; 124.1919019W).

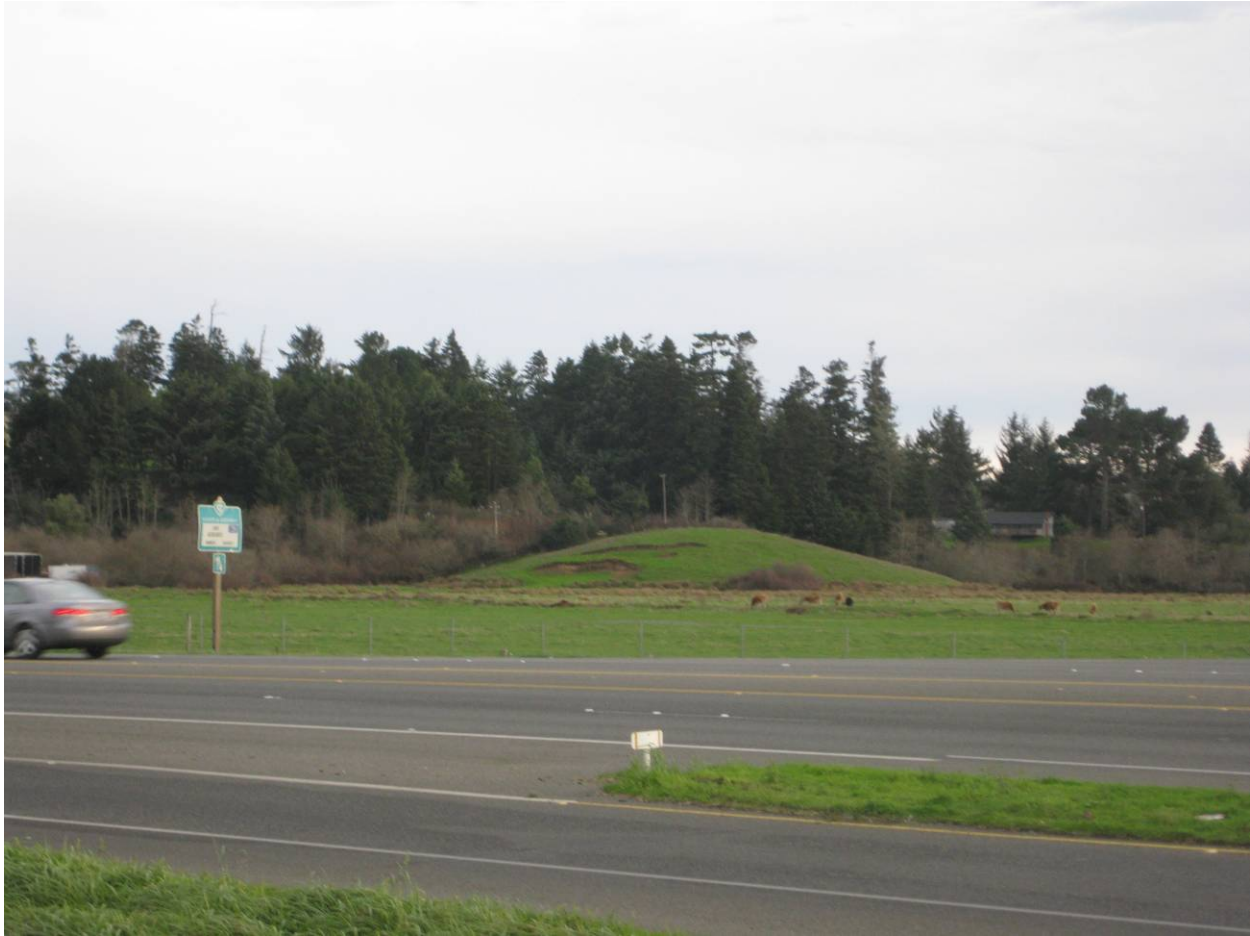
Figure 17 Landslide features on an earthen slope at the east of HWY 101, approximately 640 m north of Pound Road (40.763860N; 124.186335W). It was not possible to easily access the site, so it was not possible to ascertain potential for seismic induced movement.

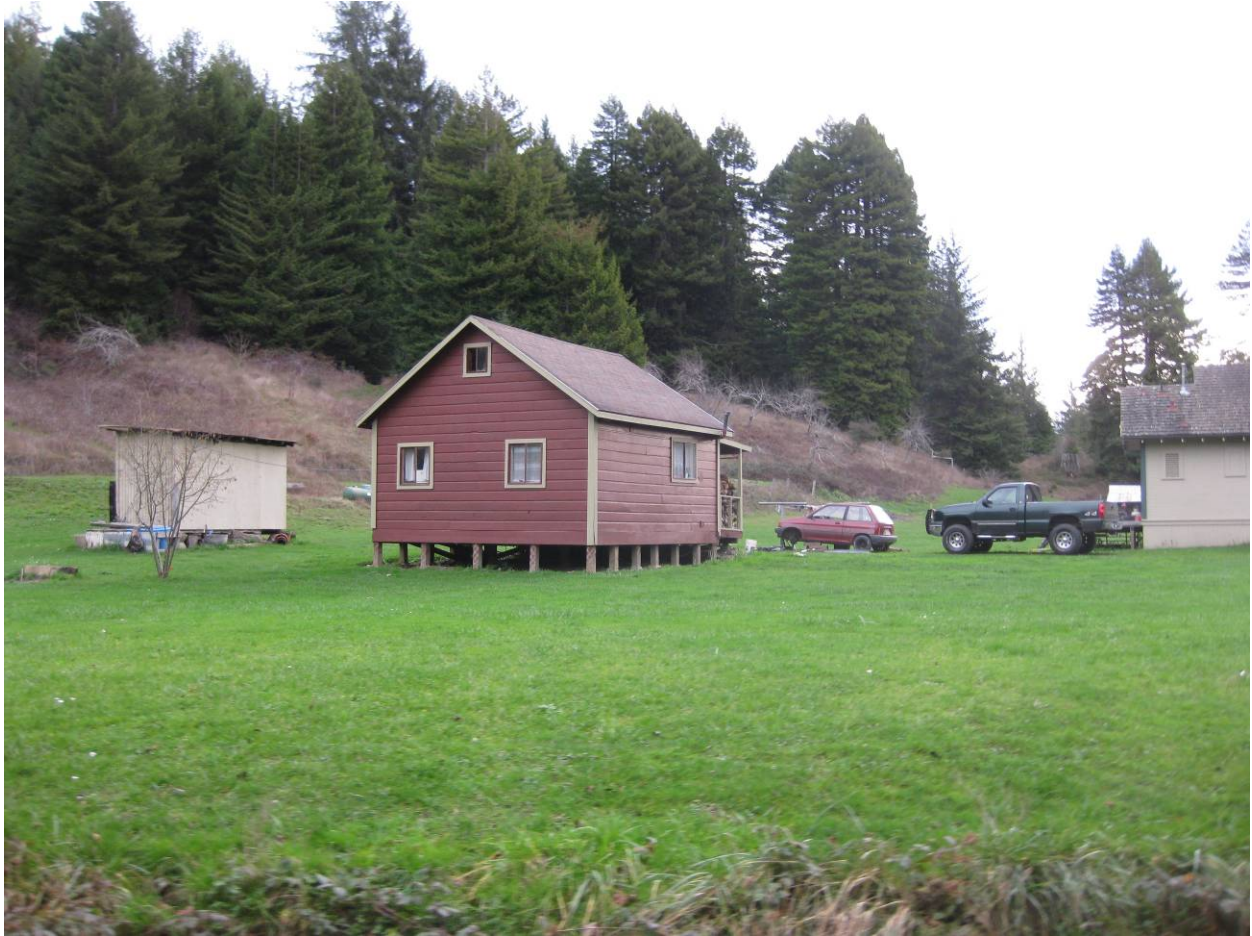
Figure 18 No apparent ground deformation was observed during my drive on Elk River Road (40.702672N; 124.146964W).

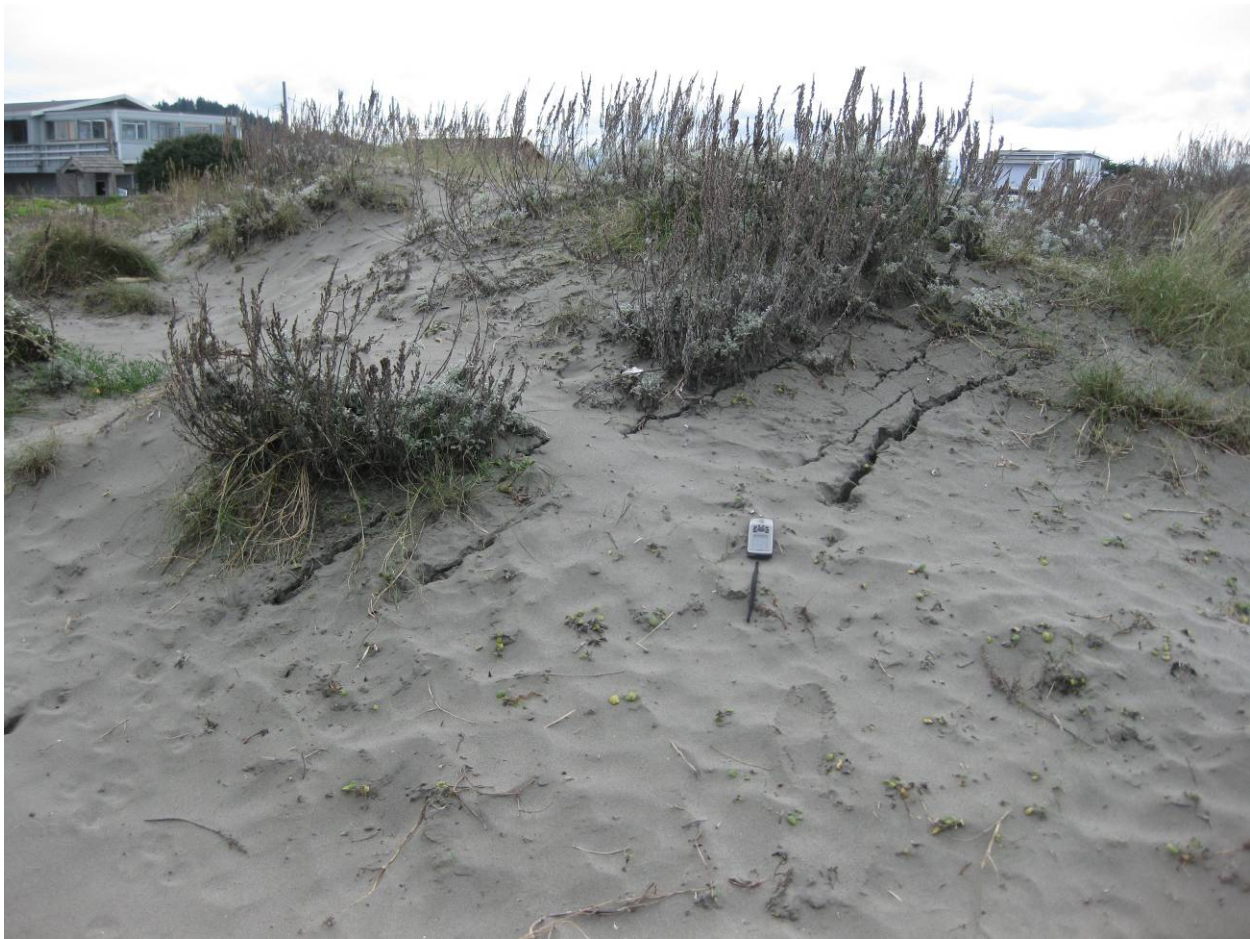
Figure 19 Ground cracking at the King Salmon region at Buhne Drive and King Salmon Avenue. Figure 20 shows the approximate extents of these ‘cracking’ features (40.741957N; 124.216385W).

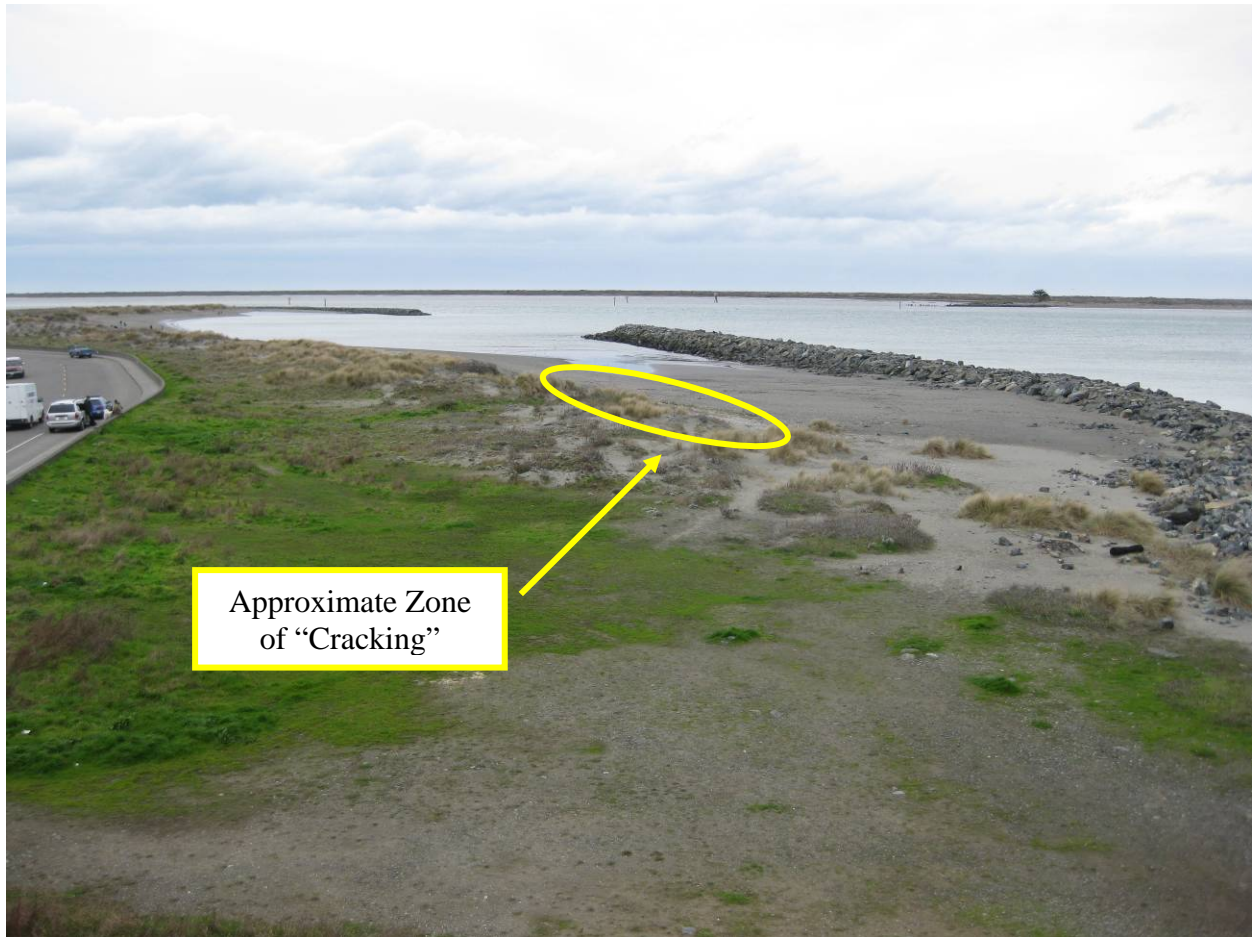
Figure 20 Approximate extents of the 'cracking features' shown in Figure 19.

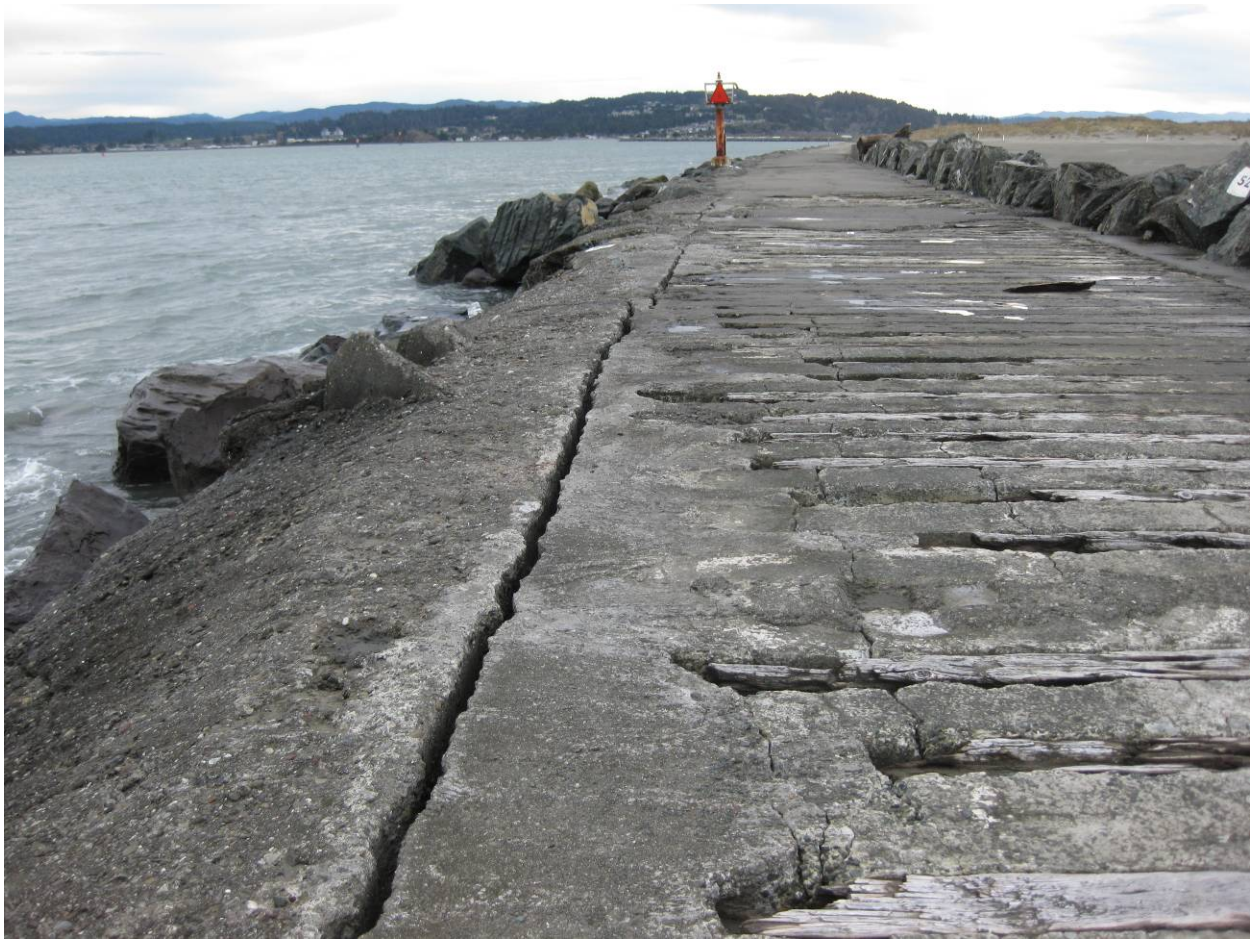
Figure 21 Deformations were observed in the Humboldt South Jetty. Some apparently fresh concrete spalling was observed; however, it was not apparent that this cracking was a caused by the Jan. 9 earthquake (40.75770N;124.234943W).

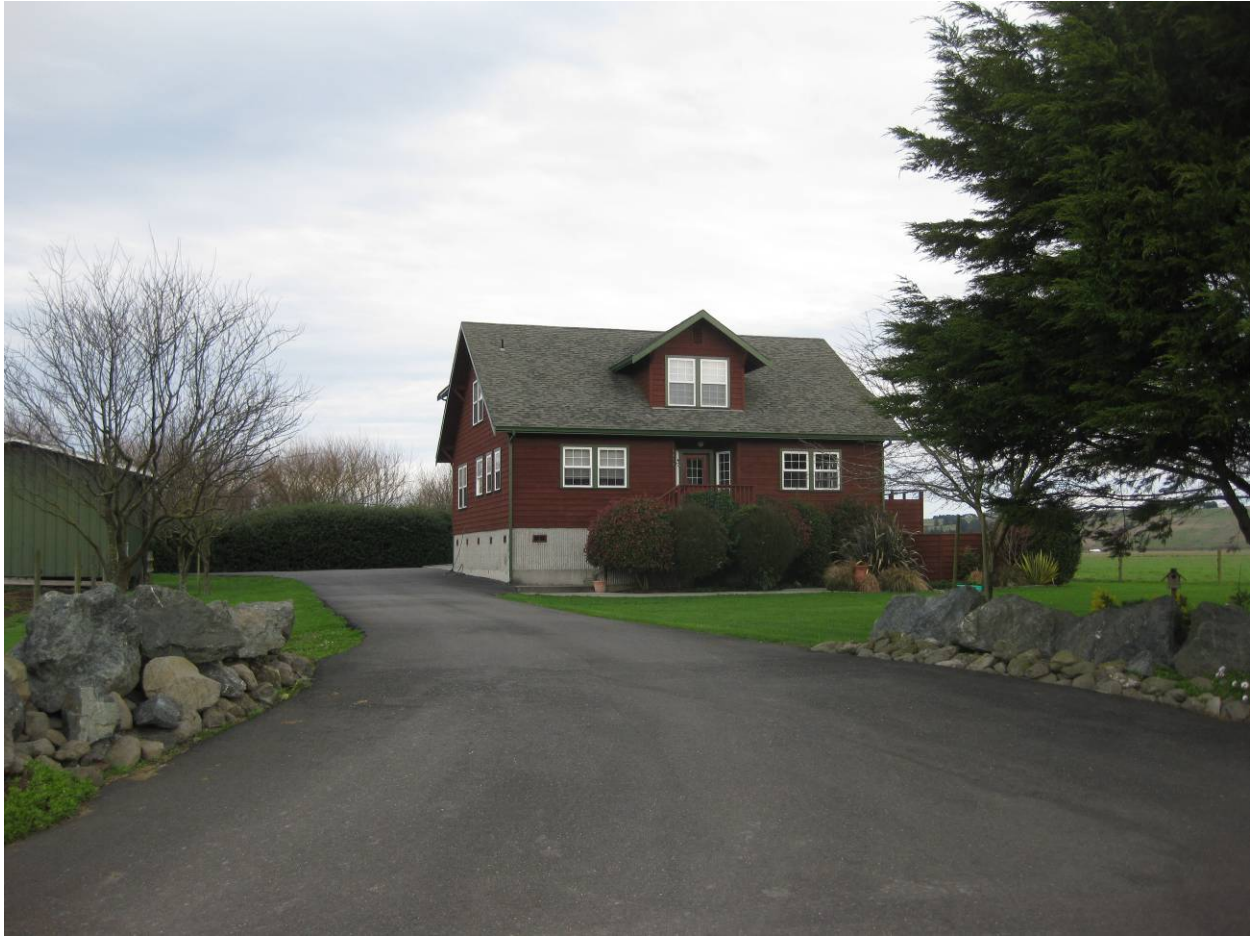
Figure 22 No significant structural damage and or ground features were observed in the Eel River valley along Cannibal Island Road (40.642967N; 124.262067W).

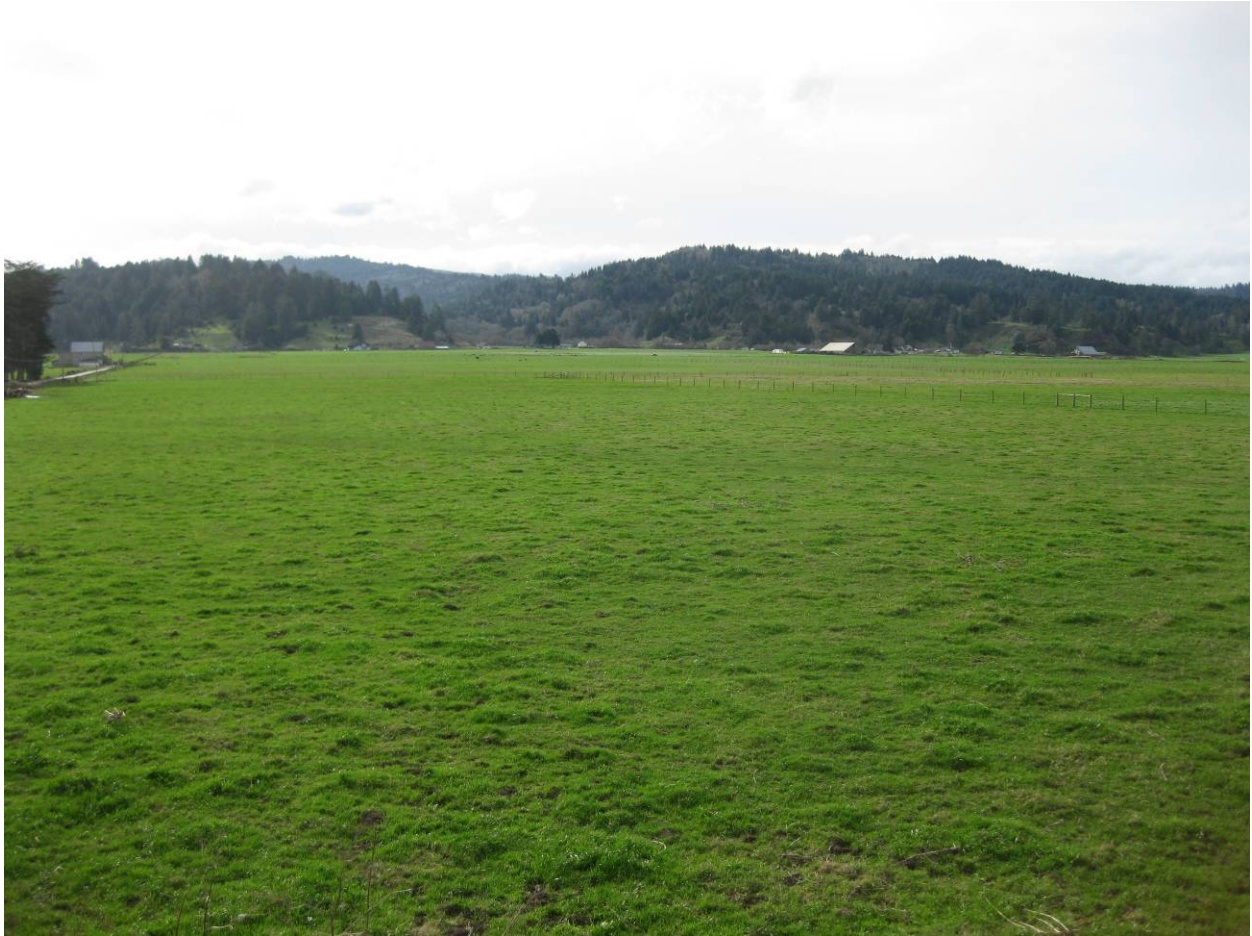
Figure 23 No significant features were observed in the southern portion of the Eel River valley (40.594551N; 124.274756W).

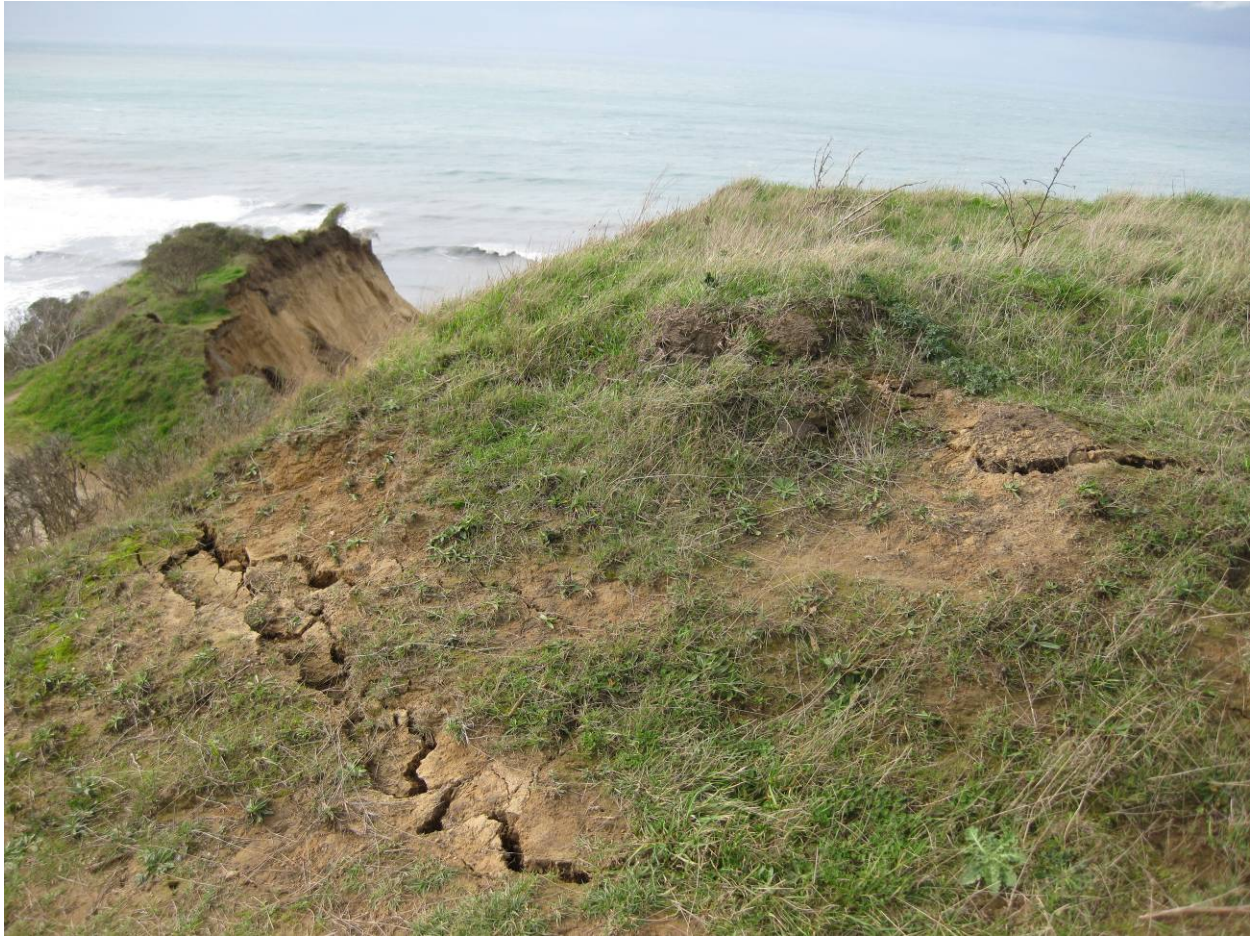
Figure 24 Some lateral displacement cracking was observed on the bluffs immediately south of Centerville Beach; however, this is an area of active bluff erosion (40.560943N; 124.353851W).

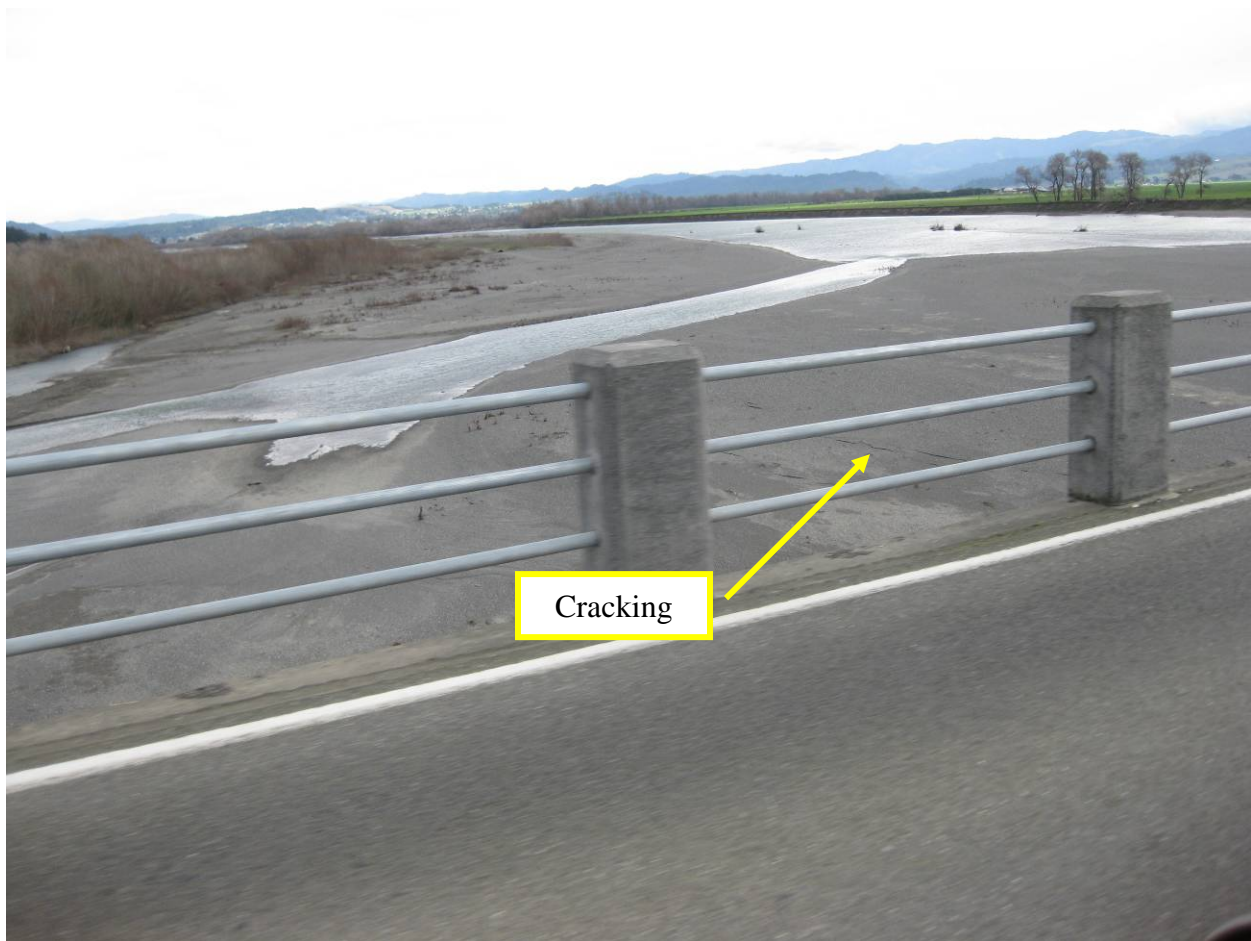
Figure 25 Ground cracking was observed in the Eel River channel near Fernbridge. This gravel bar was inaccessible by foot (channels on either side) and Fernbridge is a narrow two lane bridge without any pullouts, thus, additional information was not able to be collected at this location. (40.613716N; 124.202568W).

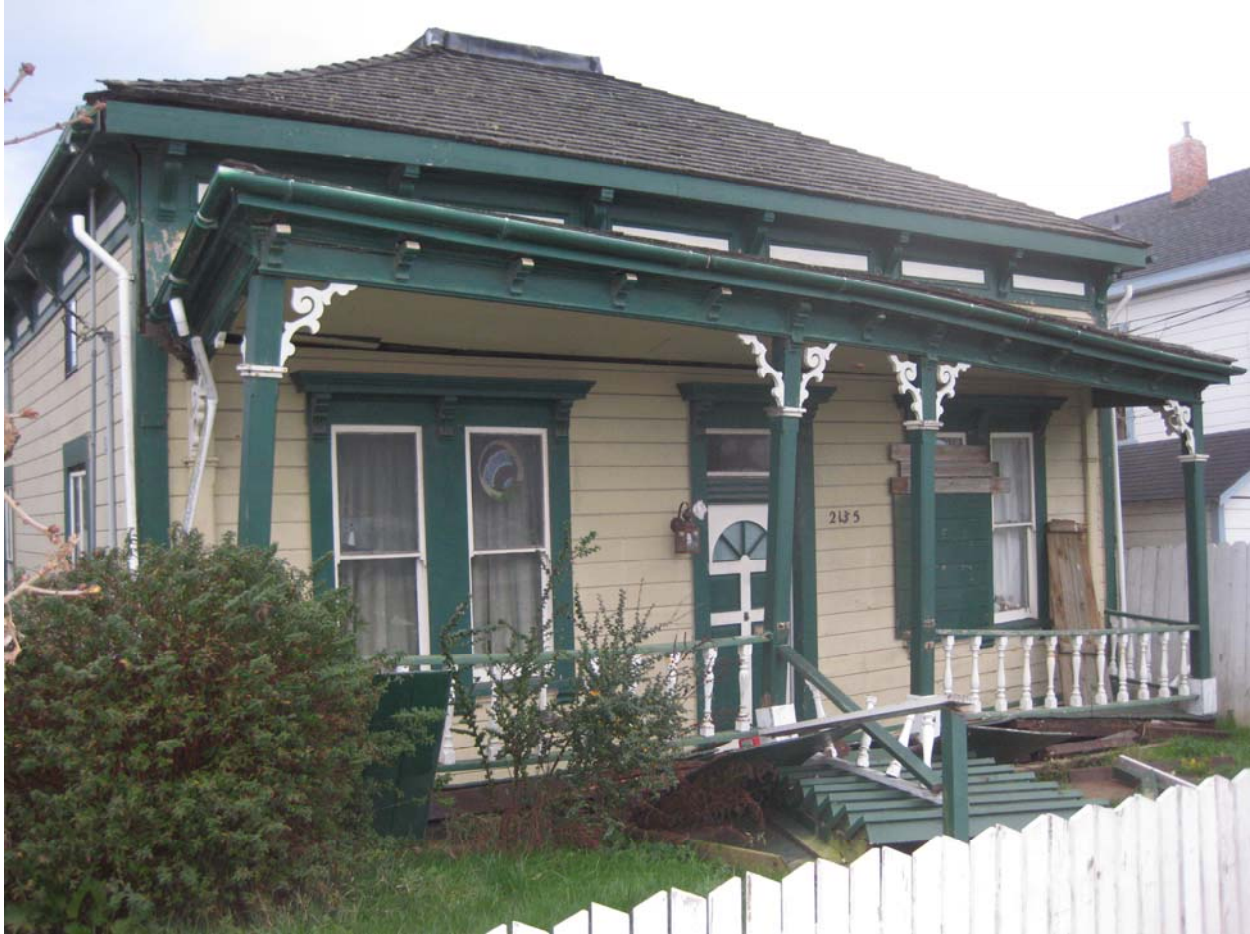
One reason I visited Eureka was to look at older wood building, especially ones supported on cripple walls. These are ones related to Plan Set A. There were many buildings of this type, ranging from old Victorians to perhaps 1970s-vintage houses. I was not able to find many seriously damaged buildings of this type, although at least one case (2135 California Street, Eureka, California) was documented (Figure 26).

Figure 26 This home was knocked from its foundation (2135 California Street, Eureka, California).

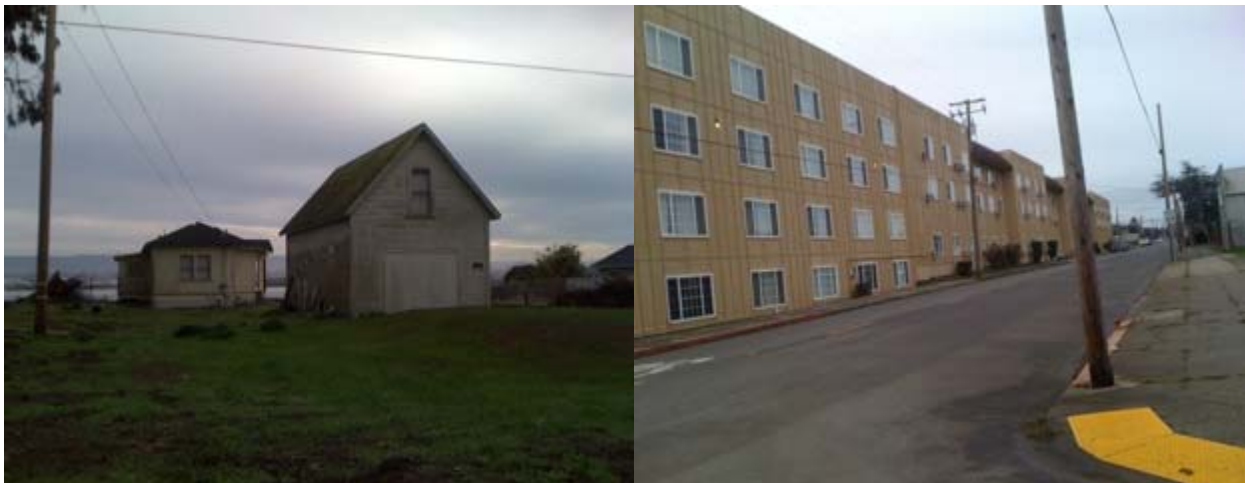
There are also more modern, multistory wood buildings. The two below (Figure 27) show extremes of wood buildings. Neither building appeared to be damaged from looking at their exteriors.

Figure 27 Many types of multistory wood buildings were undamaged.

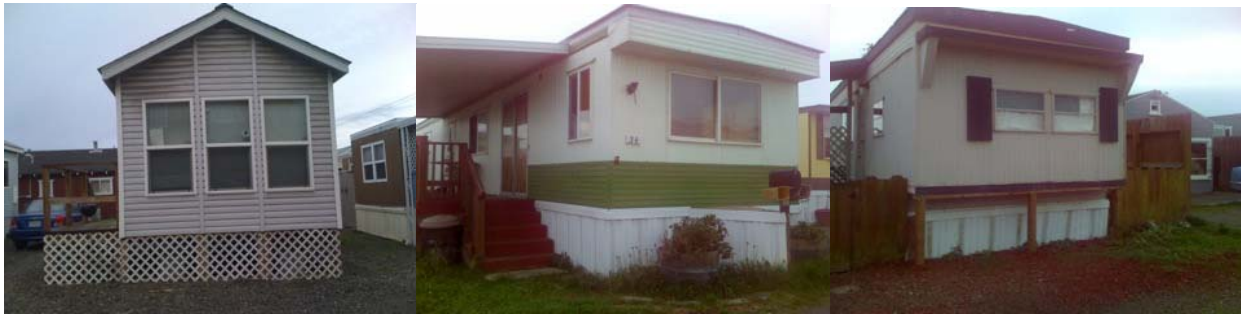
There are also lots of mobile homes. Many of these had no lateral bracing, and in most, it was difficult to see if there were lateral bracing, but my guess is that there was no lateral bracing due to the age of the mobile homes. I looked at four parks, two north, one in, and one south of Eureka. I was not able to see any damage that looked like it was caused by this earthquake. There is evidence of lateral movement at the base of some mobile homes (Figure 28), but it looked old. The vertical supports under the end of the mobile home on the far right appeared to predate the earthquake.

Figure 28 Evidence of lateral displacements on mobile homes in the Eureka area.
