M 6.5 Earthquake Offshore Northern California January 9, 2010

Field Reconnaissance Summary

February 12, 2010

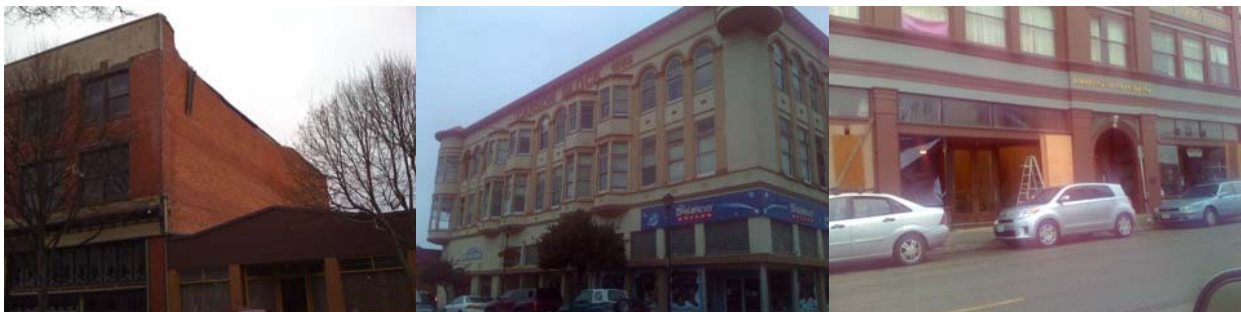
Eureka also has many URMs (Figure 29). These range from one story to three or four stories tall. Most of these buildings had little apparent exterior damage. I found two that had broken windows at front at the ground floor level. I was able to go into two three story URMs and there was lots of cracking of interior lath and plaster walls and ceilings, even though the exteriors did not look too damaged. There are two large URMs in Old Town that are cordoned off. One lost a parapet that fell into an adjacent building. The other seems to be leaning slightly into the street. I was told by neighbors (not necessarily a reliable source of information) that both had been given deferments for meeting the URM ordinance. I saw no classic examples of “X” cracking or similar structural damage in the masonry.

Figure 29 Damaged URMs in downtown Eureka.

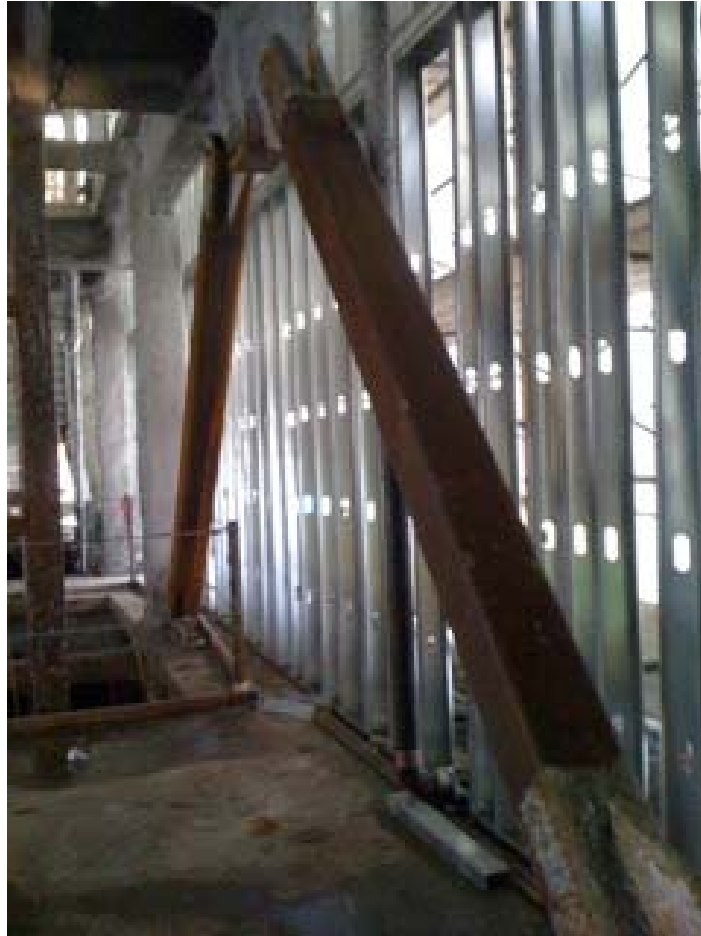
Figure 30 No evidence of damage to the new building (St. Joseph's Hospital) and the braces do not appear to have yielded or buckled

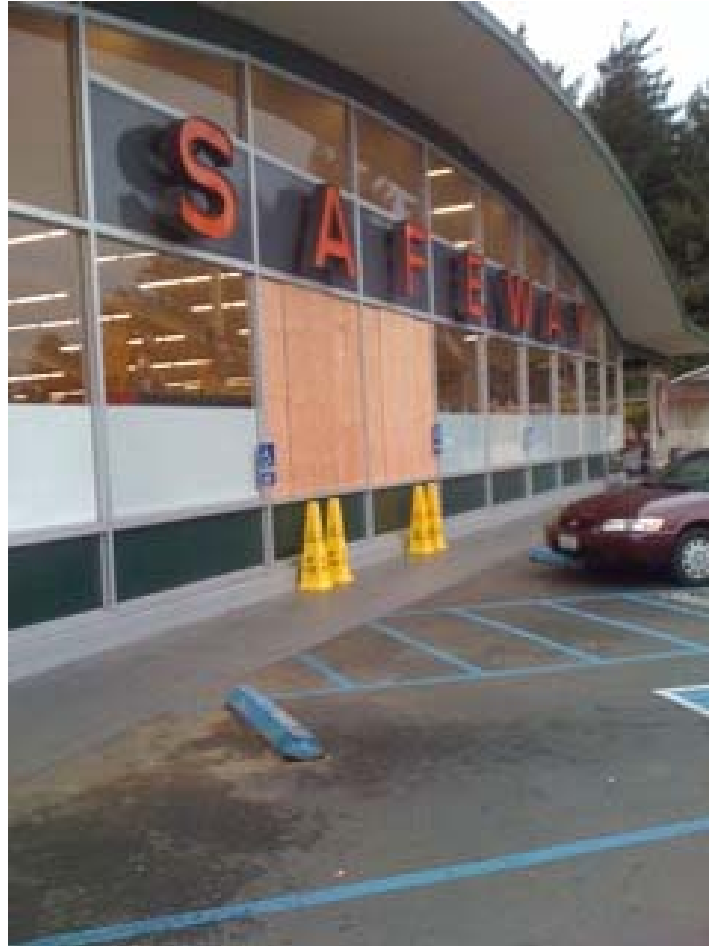
I looked at the residential and commercial construction near the hospital. The houses do not appear to have any damage, even ones on cripple walls. There is a shopping center a few blocks away (corner of Harris and Harrison Streets) that had a Safeway grocery store that had two broken windows (Figure 31).

Figure 31 A Safeway grocery store with two broken windows.

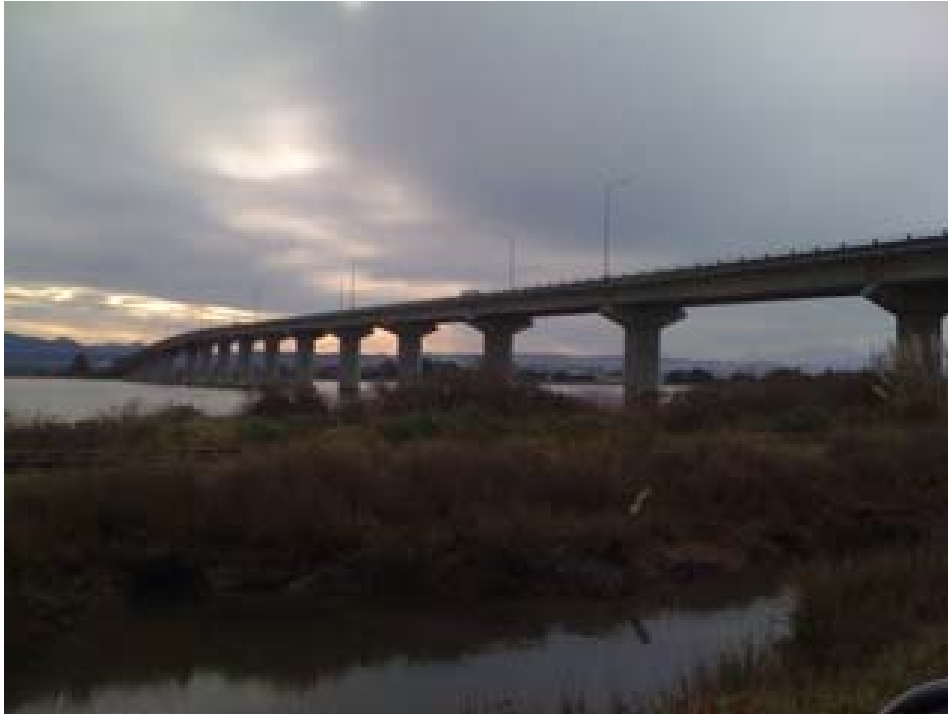
I also looked at several bridges (Samoa Bridges), in particular the Middle Channel Bridge studied by PEER, and the Eureka channel bridge, and outer harbor bridge (Figure 32). These have all been retrofitted, and two of them have instrumentation by CSMIP. Peak accelerations are about 26%g-28%g. There was no evidence of any damage, other than very minor working at the end expansion joints and some cracking in the end diaphragms, used to restrain the precast concrete I-girders.

Figure 32 There was no evidence of any damage to the Samoa Bridges, other than very minor working at the end expansion joints and some cracking in the end diaphragms, used to restrain the precast concrete I-girders.

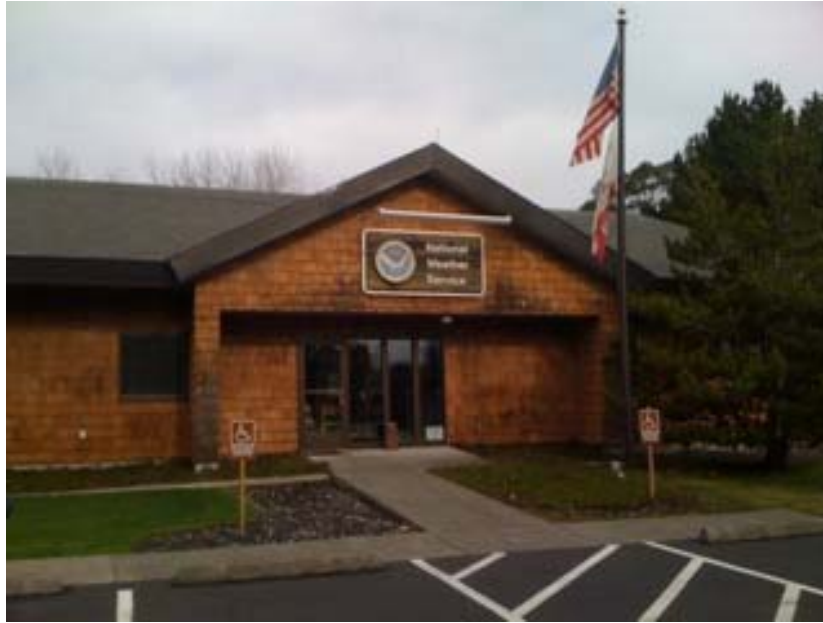
Figure 33 Wood-framed buildings on Woodley Island appeared to suffer no physical damage.

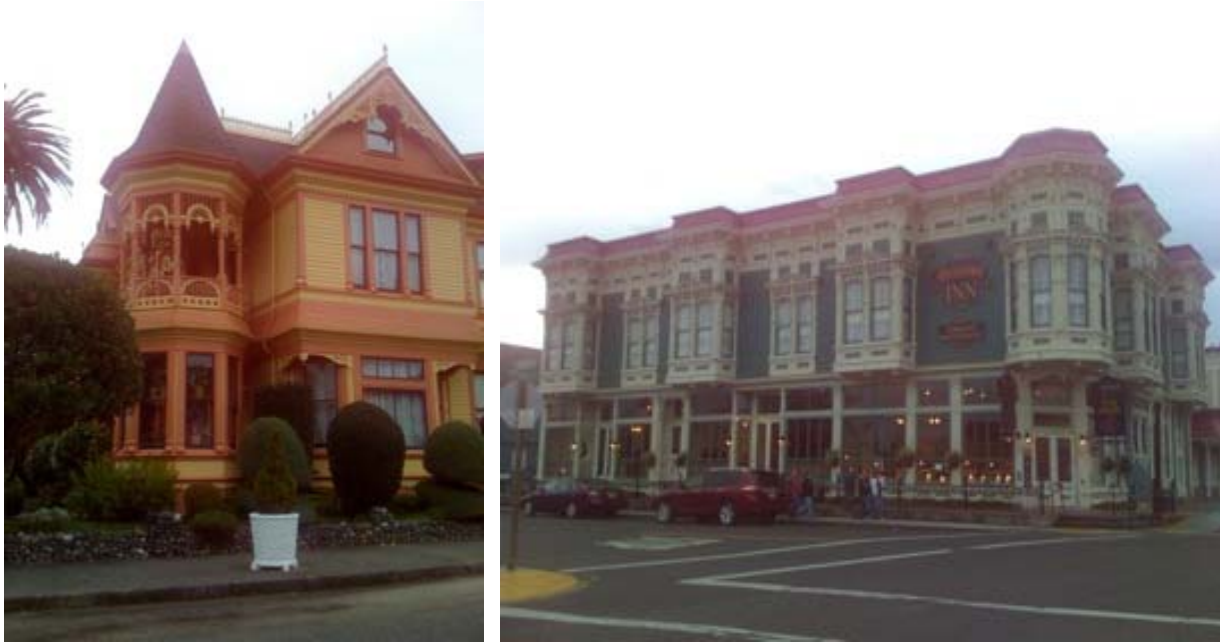
- Ferndale: There seemed to be a lot of nice Victorian houses and commercial buildings that appeared to have soft stories or cripple walls (Figure 34). No damage was seen. CSMIP indicates that ground accelerations as great as 44%g were experienced in this area. CSMIP had not released information on the fire station and bed and breakfast before I left the Bay Area, so I did not look at them specifically, but there was virtually no damage to structures in town.

Figure 34 There seemed to be a lot of nice Victorian houses and commercial buildings that appeared to have soft stories or cripple walls. No damage was seen.
