# M7.7 Myanmar Earthquake

March 28, 2025

## JOINT PRELIMINARY VIRTUAL RECONNAISSANCE REPORT (J-PVRR)

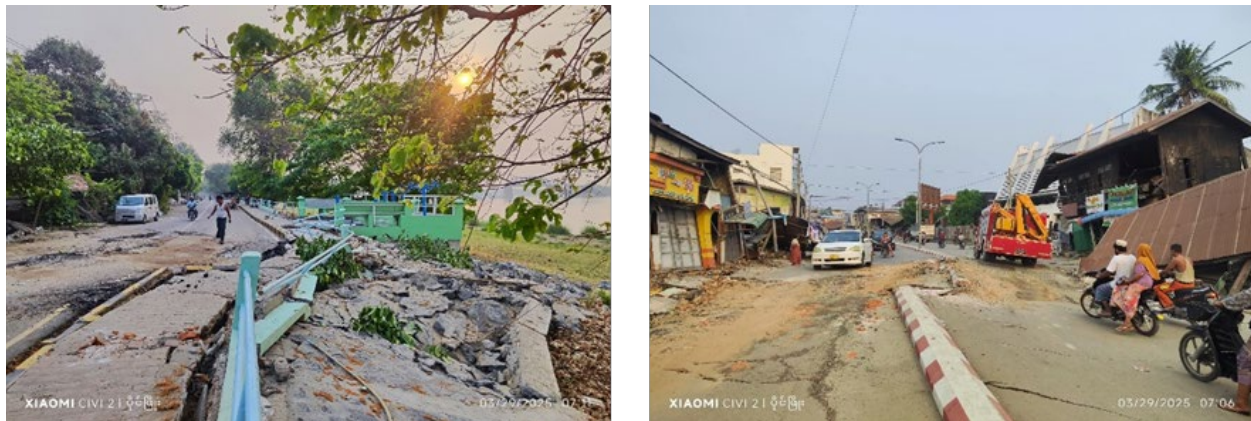
**Figure 2.15.** Roadways with offset of several feet (21°52'49.27"N, 95°59'5.57"E) (Source: [HMSon @heungburma on X](#)).

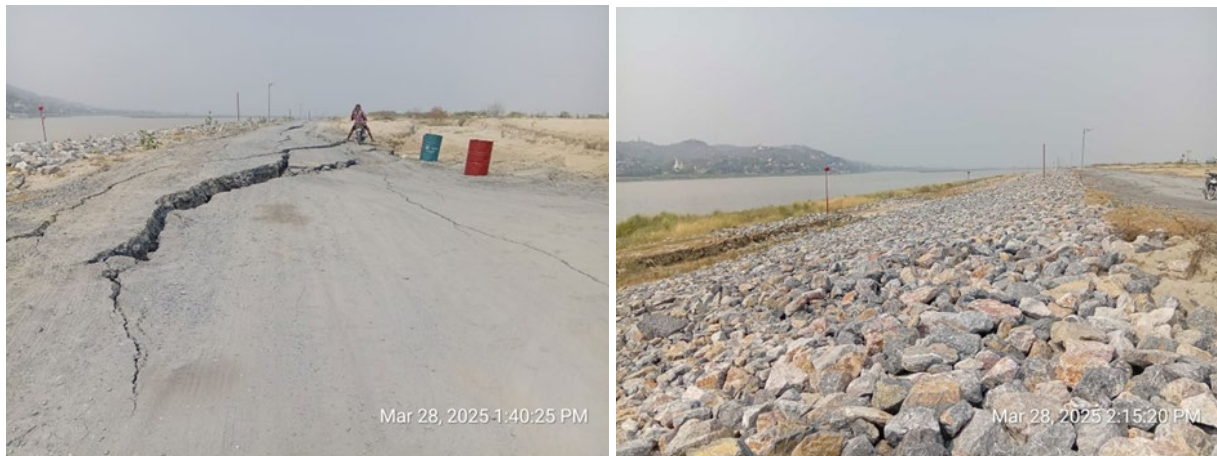
**Figure 4.3.2.** Evidence of lateral spreading along riverbank [Approximate location 21.9260, 96.0546]: fissures in the road at the crest of the slope (left) and extension cracking near the toe of slope (right) (Credit: ZoMung Thawng).

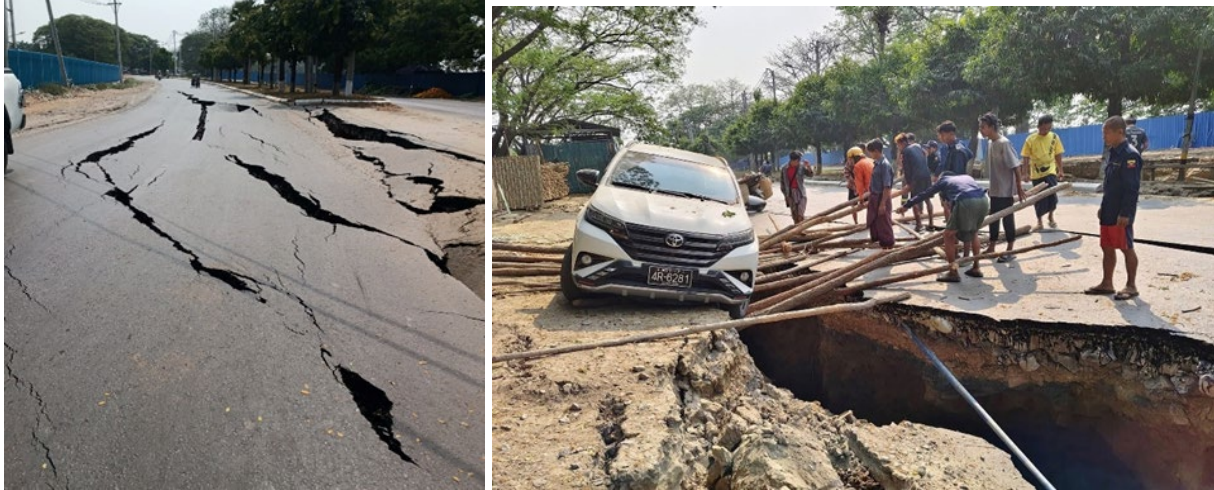
**Figure 4.3.3.** Extension in pavements along Myo Patt Road [Approximate Location 21.9260, 96.0546] (Credit: ZoMung Thawng).

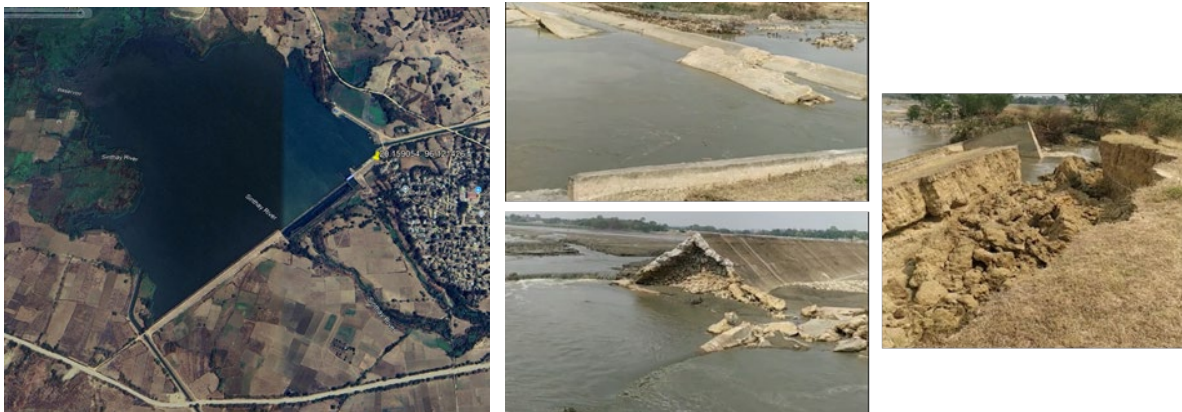
**Figure 4.5.1.** SinThe Dam aerial view (left) with images of post-earthquake damage. [Location 20.159054, 96.121426] (Sources: Google Earth (left) with still images extracted from video posted by [@heinwaisoe073](#) on TikTok).

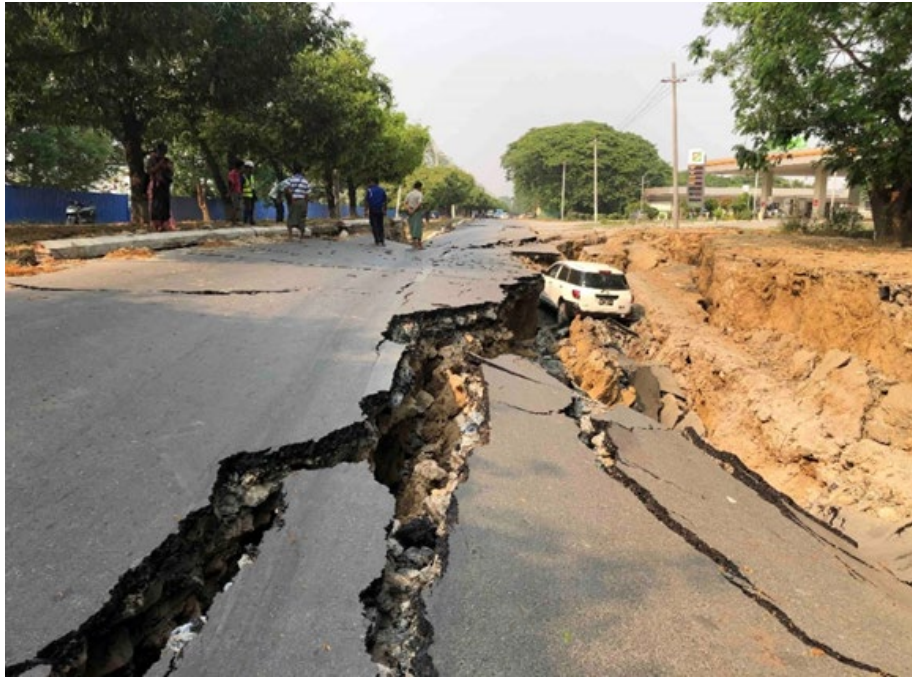
**Figure 4.6.2.** Severe ground deformation along Myo Patt Road next to Amarapura Urban Development Project site (Credit: ZoMung Thawng).

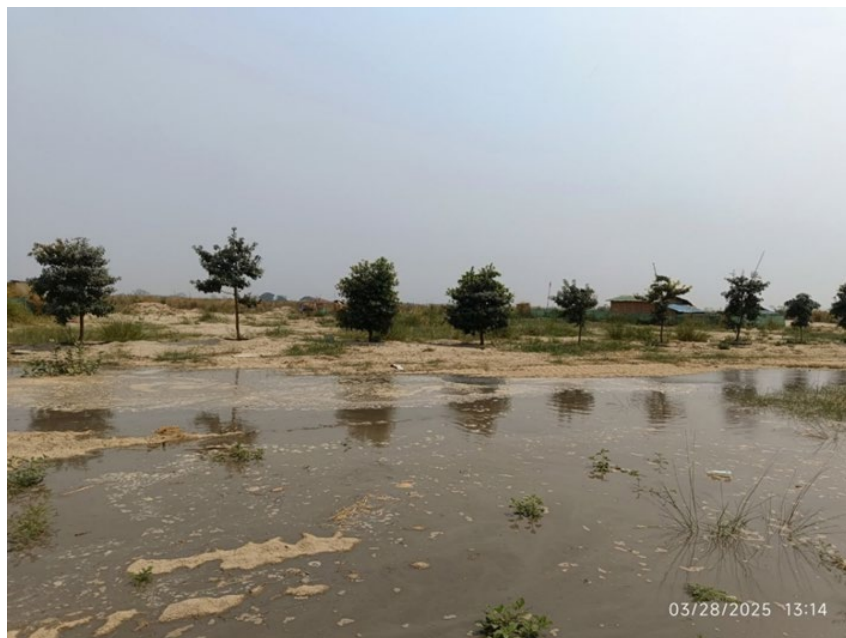
**Figure 4.6.3.** Liquefaction ejecta post-earthquake in area where ground improvement work for Amarapura Urban Development Project had not yet been completed (Credit: ZoMung Thawng).

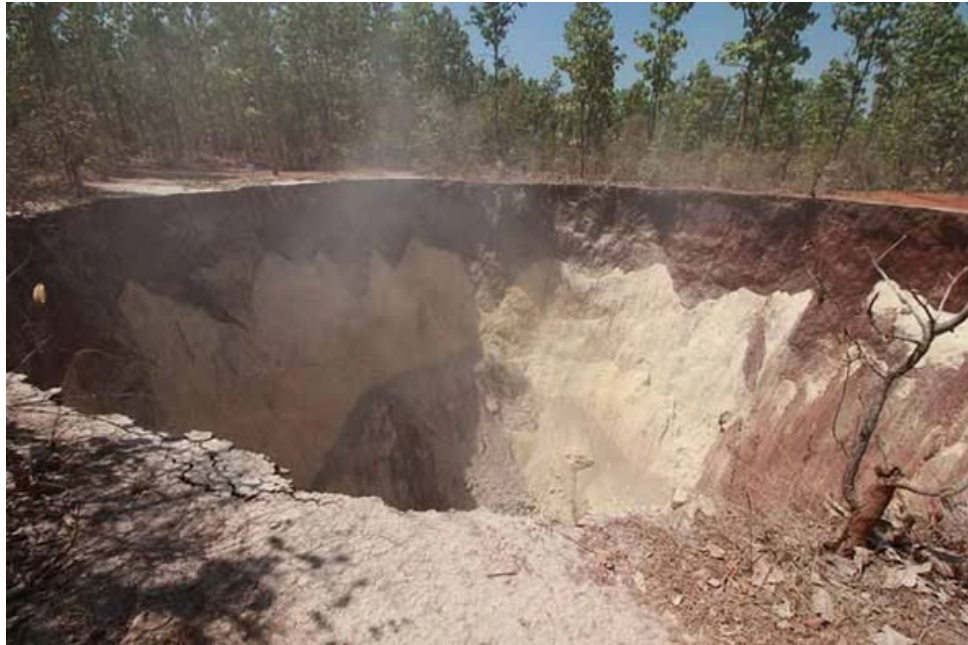
**Figure 4.7.1.** View of sinkhole located in Demoso Township in Loikaw District of Kayah State [Location 20.159054, 96.121426] (Source: [DVB TV Facebook](#)).

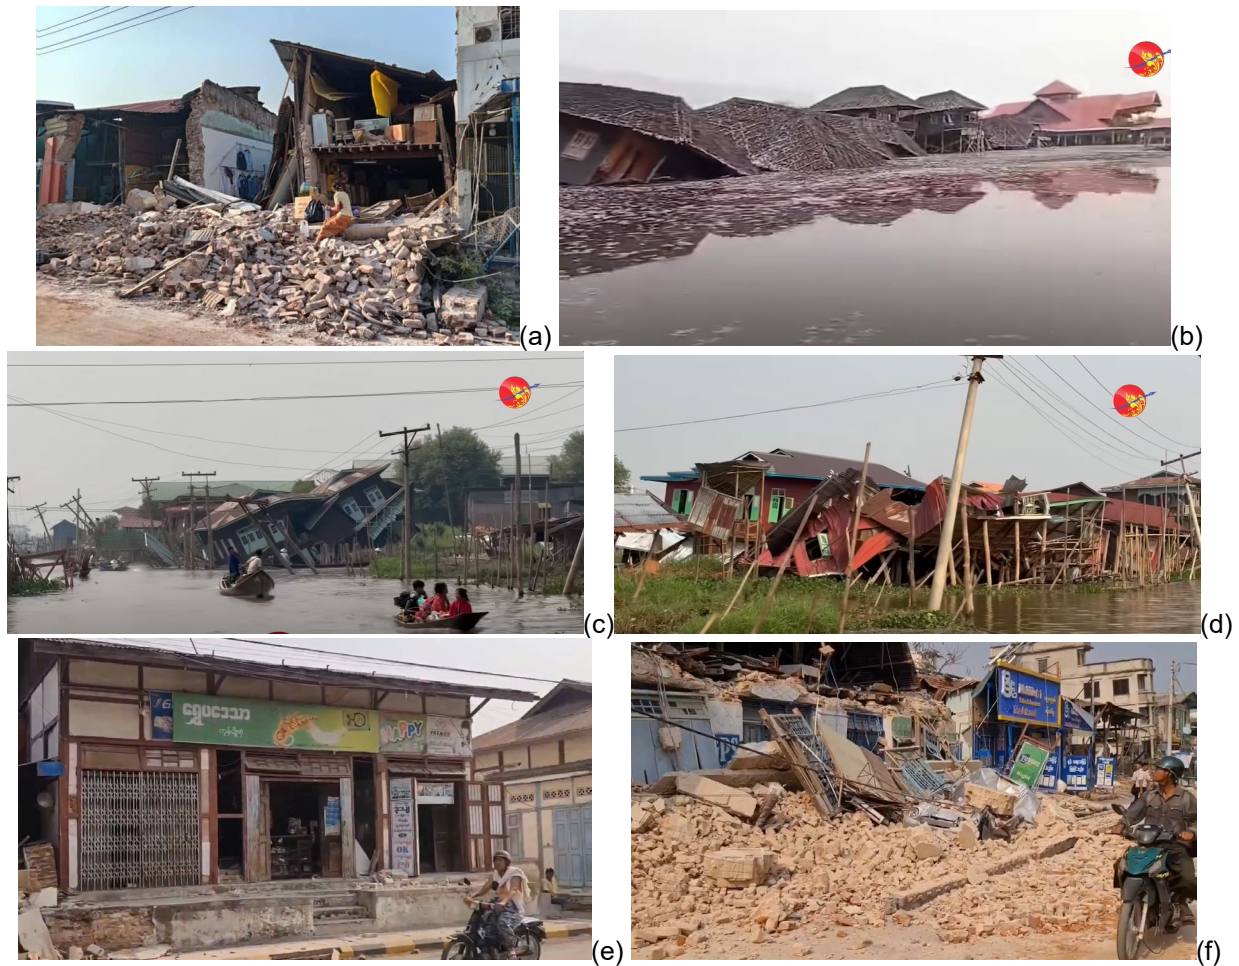
**Figure 5.1.1.** (a) Partial collapse of a brick-nogging single family house in Pyinmana Township, Nay Pyi Taw, due to the failure of masonry infilled wall (Source: [Pyinmana Update News Facebook](#)); (b-d) traditional buildings around Inle Lake in Nyaungshwe Township (Source: [The Irrawaddy News](#)); (e) timber and masonry traditional type commercial building in Sagaing city with limited visible damage (shedding of bricks from narrow piers by doorway) (Source: Screenshot of [@heungburma on X](#)); (f) partially collapsed brick masonry commercial building in Sagaing City (Source: Screenshot of [@heungburma on X](#)).

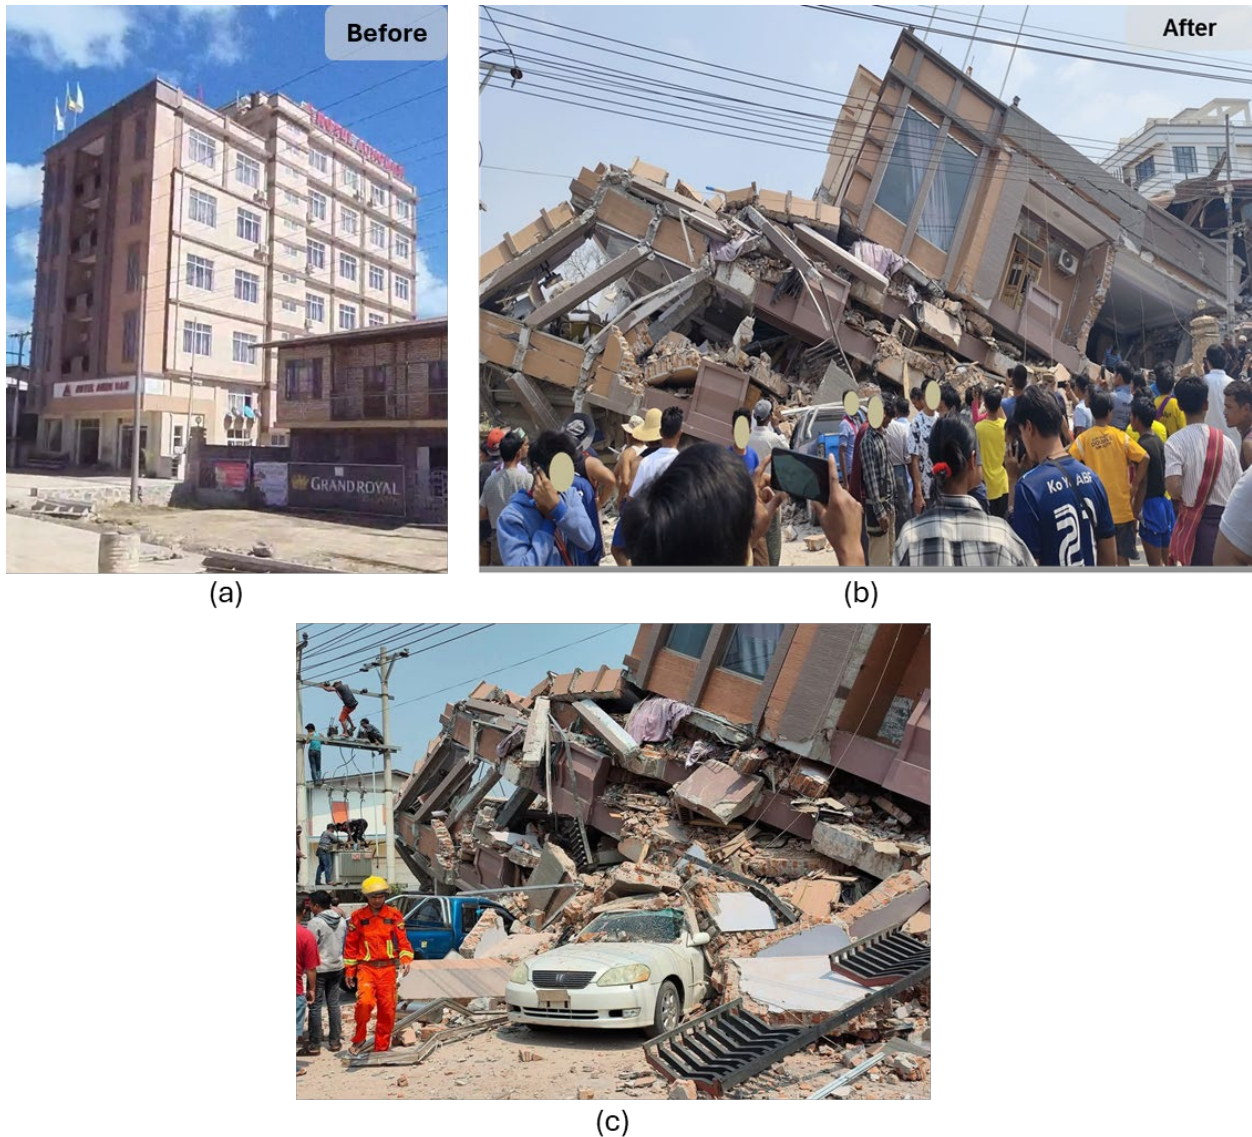
**Figure 5.1.4.** Hotel Aung Ban, Aungpan, Myanmar [Coordinates: 20.658, 96.632] (a) before and (b-c) after earthquake. (Sources: (a) [Google Maps](#); (b) [@IrrawaddyNews on X](#); (c) [www.ludunwayoo.com](#)).

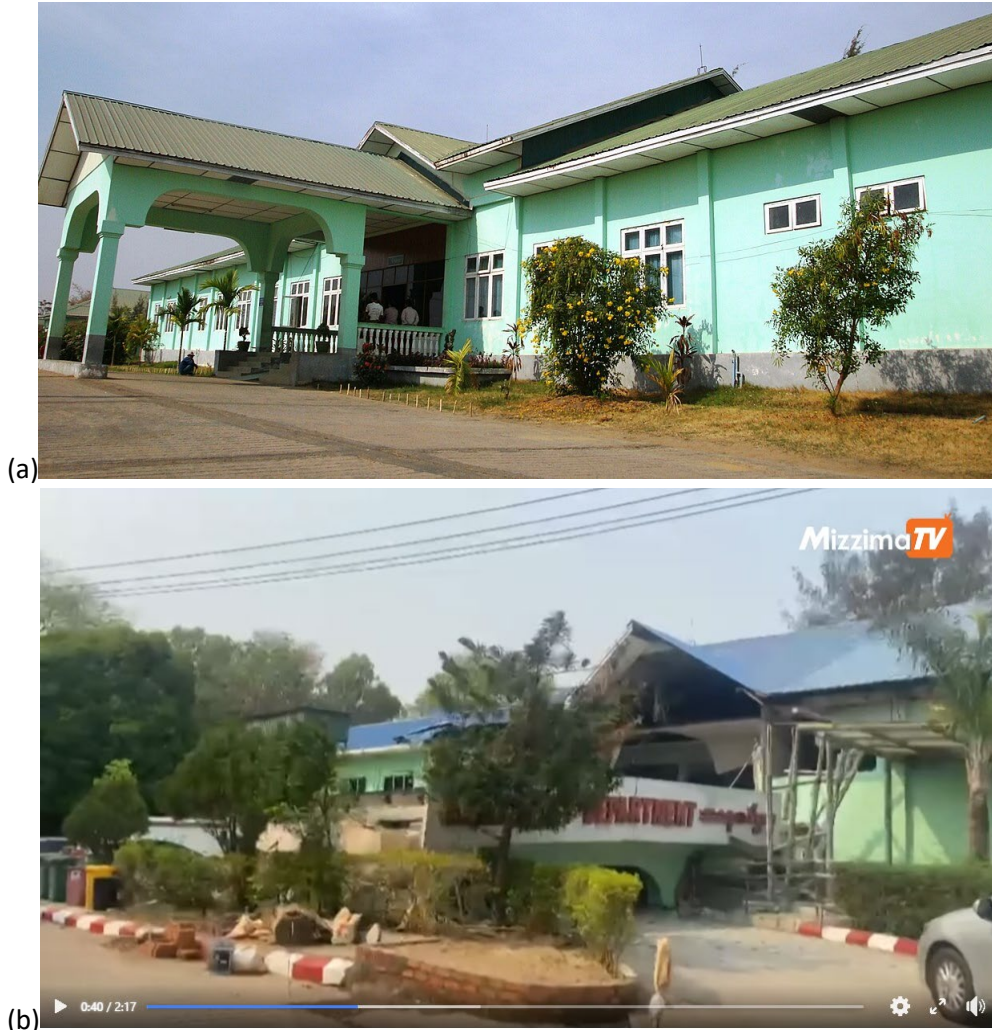
**Figure 5.2.2.** Nay Pyi Taw General Hospital: (a) back view of the building shows one of the typical reinforced concrete entrance canopies before the earthquake; (b) canopy collapsed at the Emergency Department (Sources: (a) [Wikimedia Commons](#), (b) [Mazzina Myanmar](#), 2025).

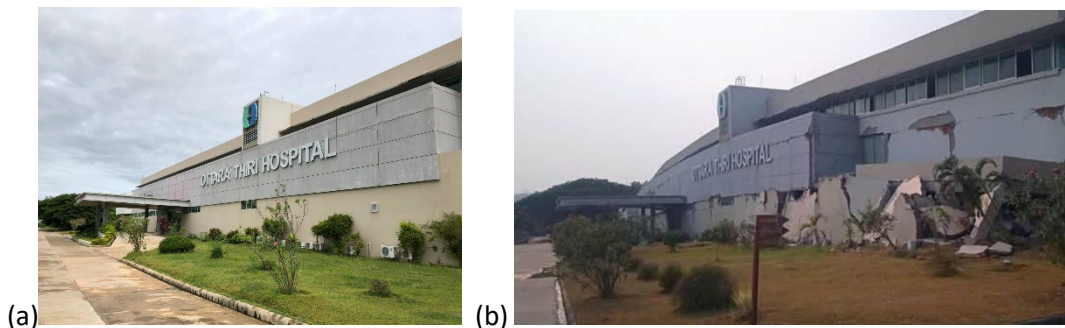
**Figure 5.2.3.** Before (a) and after (b) images of the entrance frame at Ottara Thiri Private Hospital, which suffered structural collapse due to column failure (Sources: (a) [Ottara Thiri Private Hospital Facebook Page](#); (b) [MMKM Chinese Language Center on Facebook](#)).

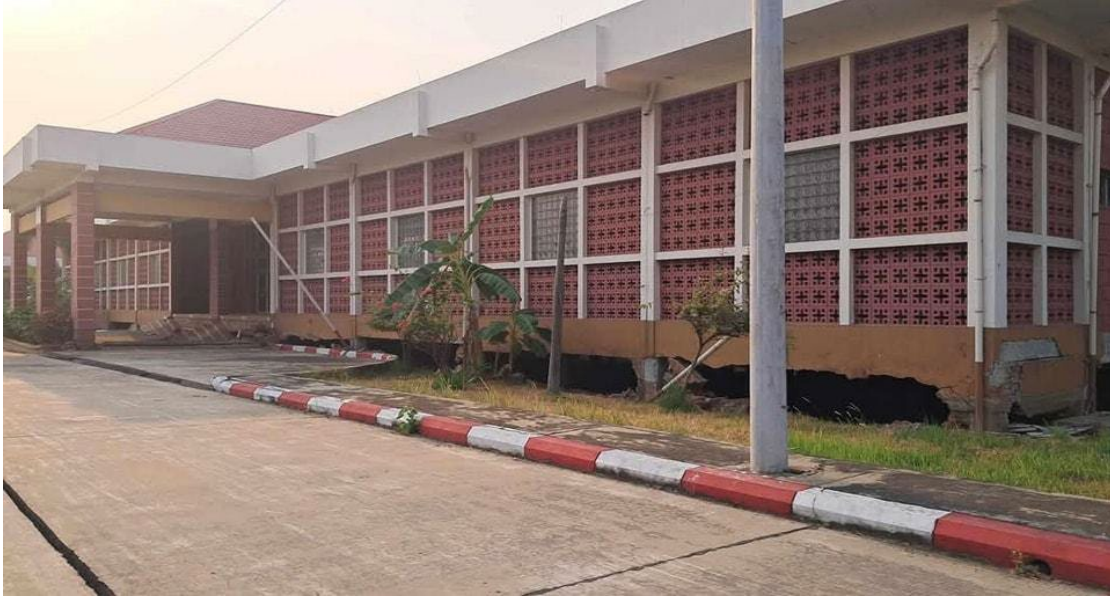
**Figure 5.2.4.** Wachat Jivitadana Sangha Hospital in Sagaing [Coordinates: 21.915215, 96.001606] was closed due to physical damage at the base of the structure (Source: [Than Lwin Khet News on Facebook](#)).

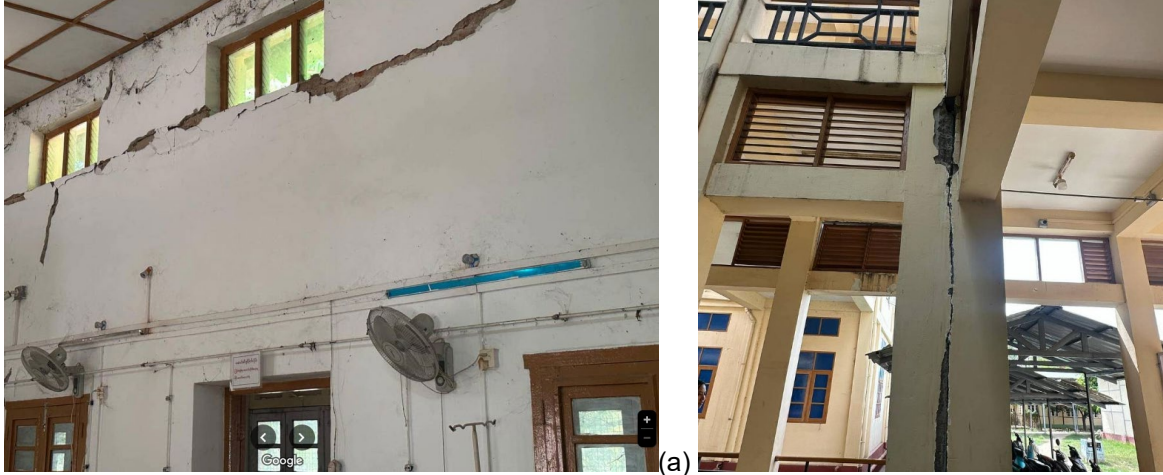
**Figure 5.2.5.** Evidence of physical damage in the interiors of a building at the Sagaing General Hospital: (a) non-structural damage in facade walls and (b) concrete cover detachment in reinforced concrete columns due to apparent pounding (Source: See Clearly via [GoogleMaps](#)).

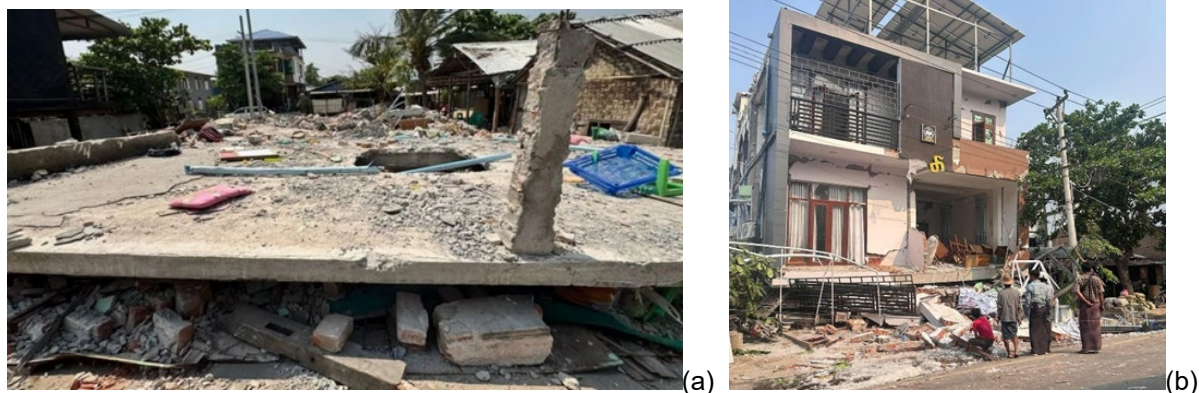
**Figure 5.3.1.** Collapsed reinforced concrete frames of private schools in Kyaukse (a) and Sagaing (b) (Source: Htet Naing Zaw, [BBC Burmese](#) (a); [BBC Burmese](#) (b)).

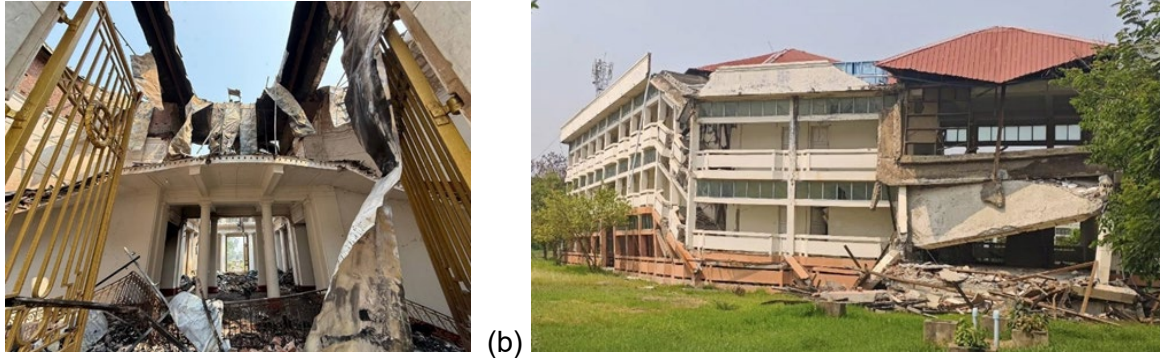
**Figure 5.3.2.** Earthquake and fire damage to Mandalay University (a) and collapsed ground story at Technological University Kyaukse (b) (Source: [Popular News Journal](#) (a); [student group via Facebook](#) (b)).

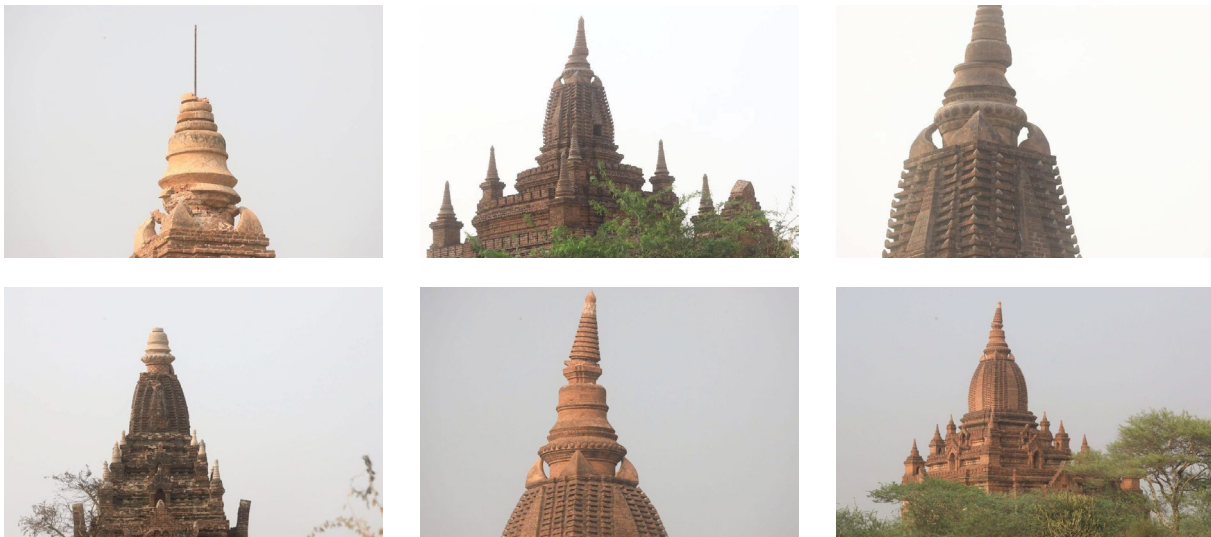
**Figure 5.4.1.** Examples of damage to the roof structures of the temples of the Bagan Ancient Cultural Heritage Zone (World Heritage Site) (Source: [Mizzima-Burma](#)).

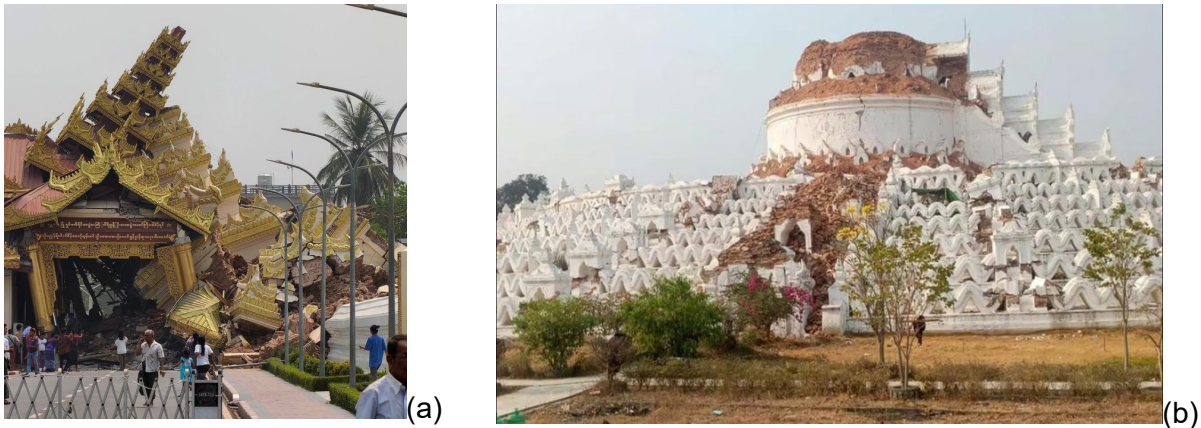
**Figure 5.4.2.** Damage to religious sites in Myanmar: (a) Mahamuni Pagoda (Source: [@SaadAbedine on X](#)); (b) collapse of the Myatheindan Pagoda (or Hsinbyume Pagoda) (Source: [Vietnam](#)).

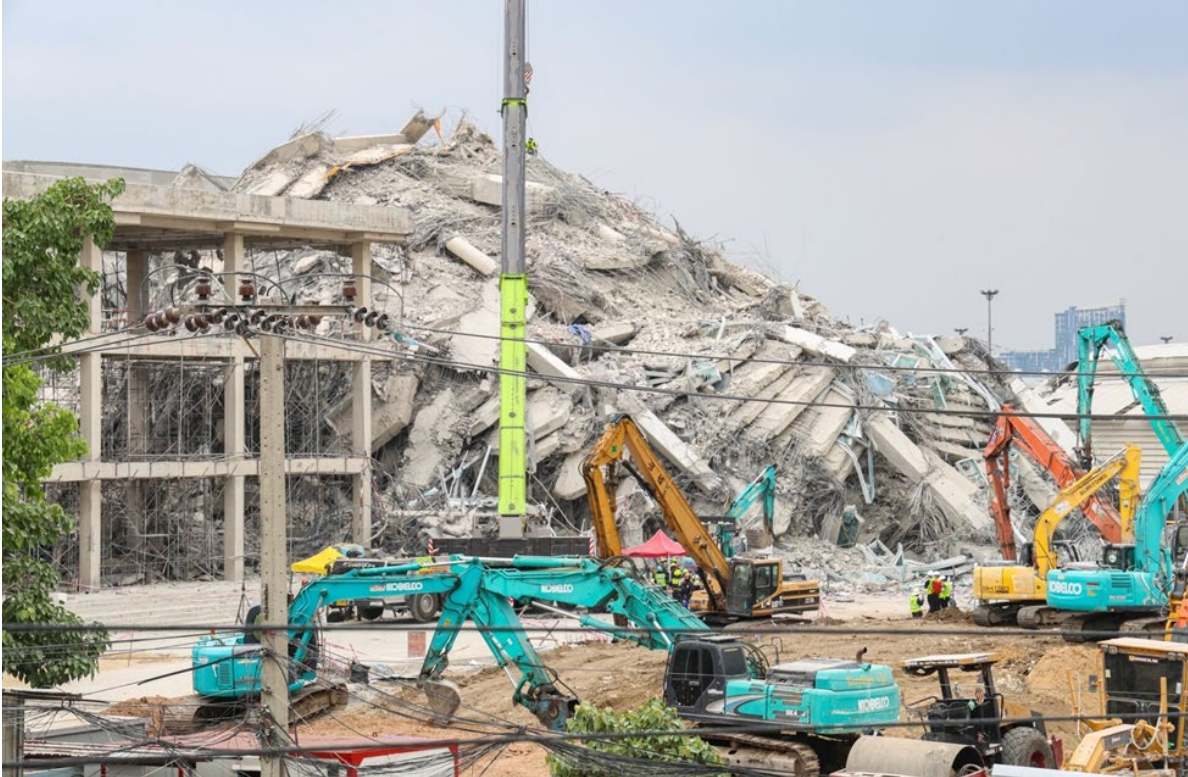
**Figure 5.5.1** The site of 30-story building collapse showing debris pile next to an undamaged ground plus two-story concrete frame building also under construction (Source: [Thai Post News](#)).

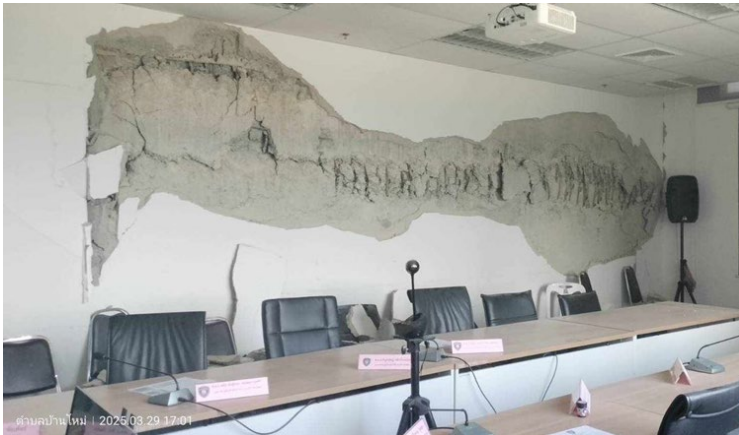
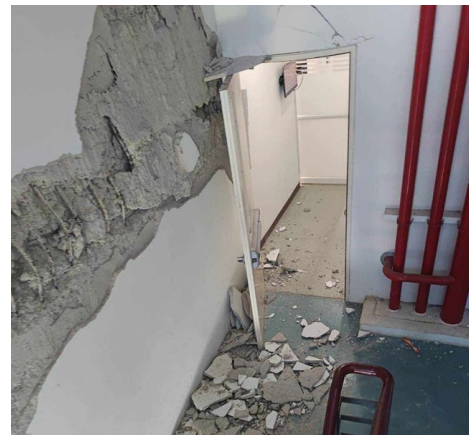
**Figure 5.5.2.** Shear wall compression and bar buckling failure (Source: [CSI LA Facebook post](#)).

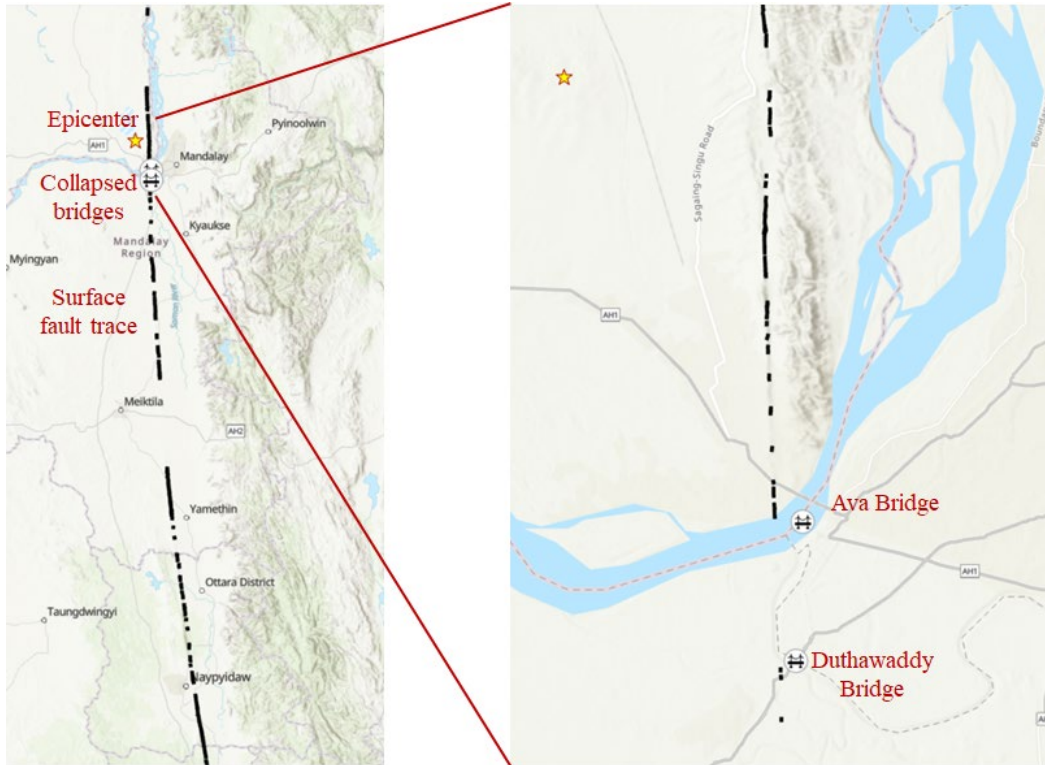
**Figure 6.2.1.** Collapsed bridges in epicentral region close to surface fault rupture (USGS 2025c).

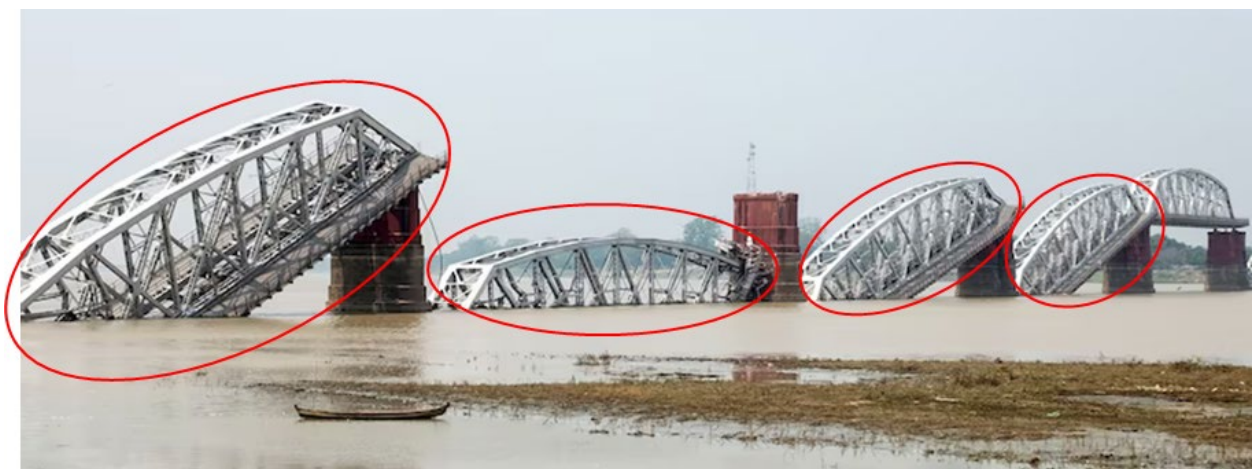
**Figure 6.2.2.** Unseated bridge decks of the Ava Bridge, noting undamaged piers and fully intact bridge deck sections (Deliso 2025).

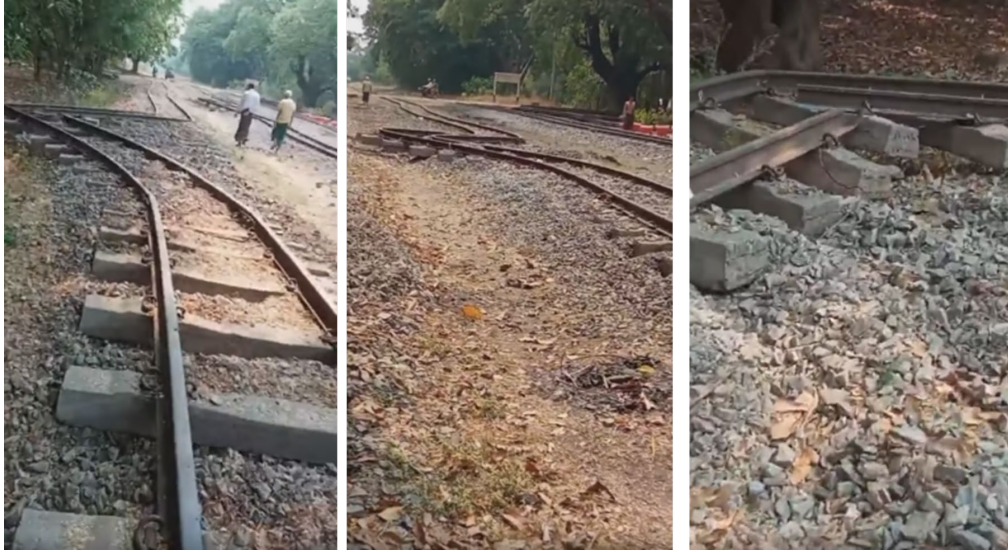
**Figure 6.2.5.** Track deformation at Thayetkon Railway Station (Source: [Facebook](#)).

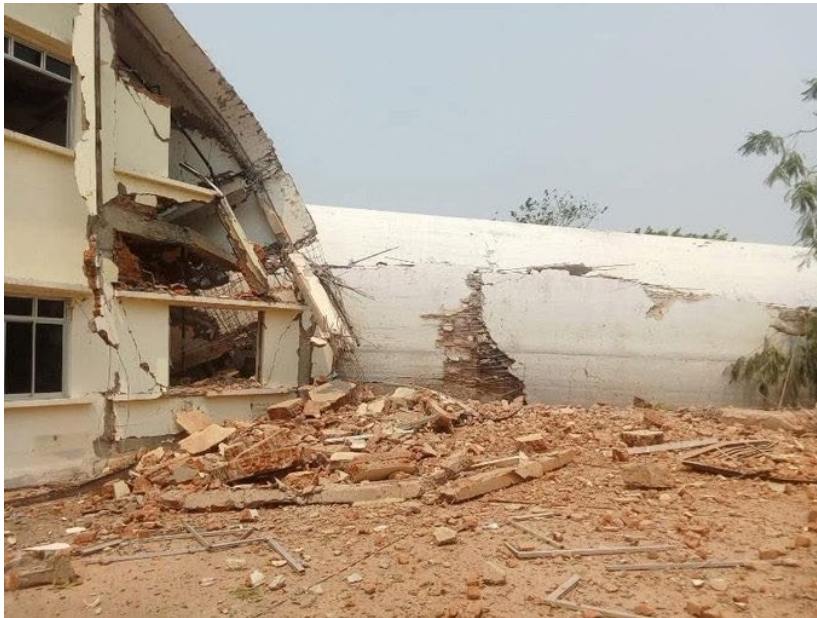
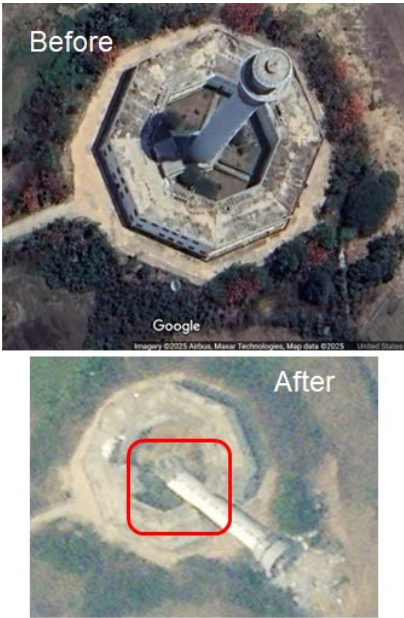
**Figure 6.2.7.** Collapsed airport control tower of the Nay Pyi Taw airport due to biaxial bending resulting from combined effect of horizontal ground motion components (Source: [@heungburma on X](#)), with aerial imagery of condition before and after earthquake (Sources: before, Airbus, Maxar Technologies; after, Maxar Technologies).
