10.0 SLOPE STABILITY AND LANDSLIDES

10.1. Rock Falls and Shallow Disaggregated Slides

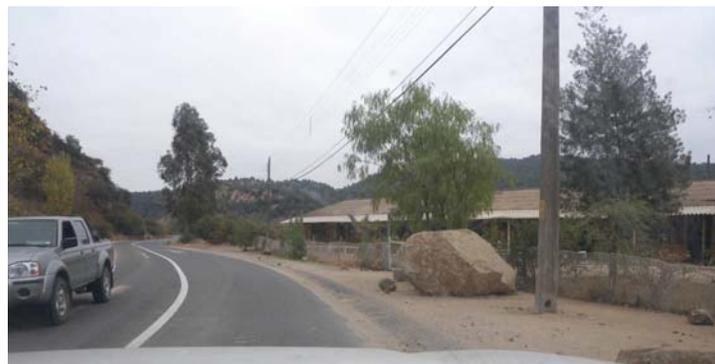
Rapel Dam (34.041445°S, 71.588856°W) - Figure 10.1 shows a rock fall from a road cut in granitic jointed rock mass on the main road approaching the Rapel Dam. Fortunately, there was no damage to the buildings, because the road acted as a buffer. Rock falls also occurred from steep unscaled slopes immediately below Rapel Dam on both abutments. While not causing any damage of consequence, the fallen rock did represent a removal nuisance (Figure 10.2). A shallow disaggregated slide in road cut in the weathered rock mass also covered a portion of the roadway along the immediate upstream section of the right abutment of the reservoir (Figure 10.3). This type of limited raveling failure is characteristic of failures observed sporadically throughout the region, as shown below.

Figure 10.1. Rock fall from a road cut at the approach to Rapel Dam (34.0365°S, 74.586983°W).

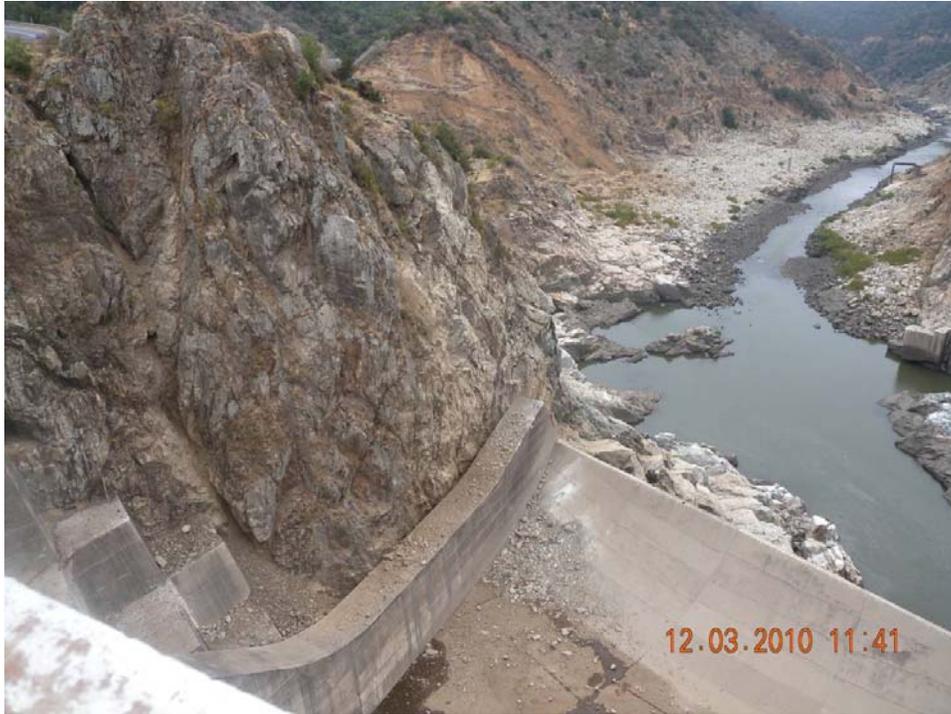
Figure 10.2. Rock fall from the downstream left abutment of Rapel Dam (34.04167°S, 71.59263°W).

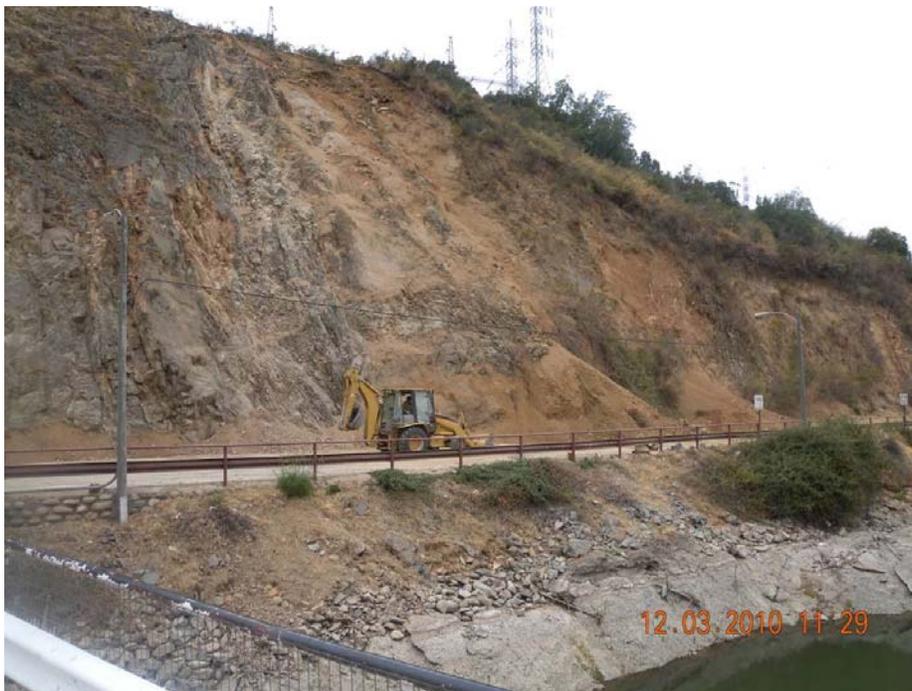
Figure 10.3. Shallow raveling failure of a road cut in weathered and heavily jointed granitic rock at Rapel Dam (34.0407421°S, 71.587153°W).

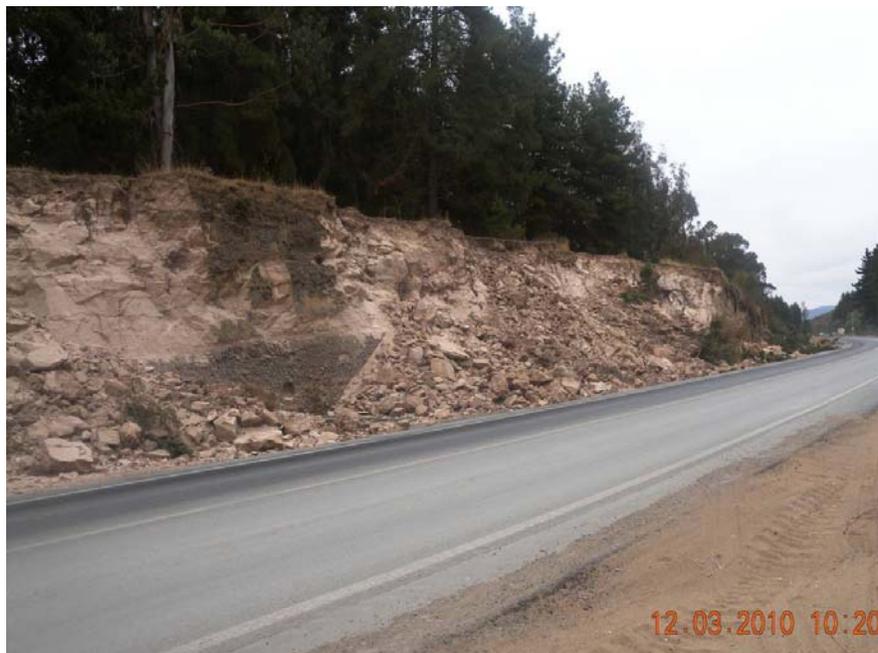
Figure 10.4. Road cut failure in jointed welded tuff north of El Manzano. The height of the cut is about 6 m (20 feet). Picture looking NE (34.144076°S, 71.38000°W).

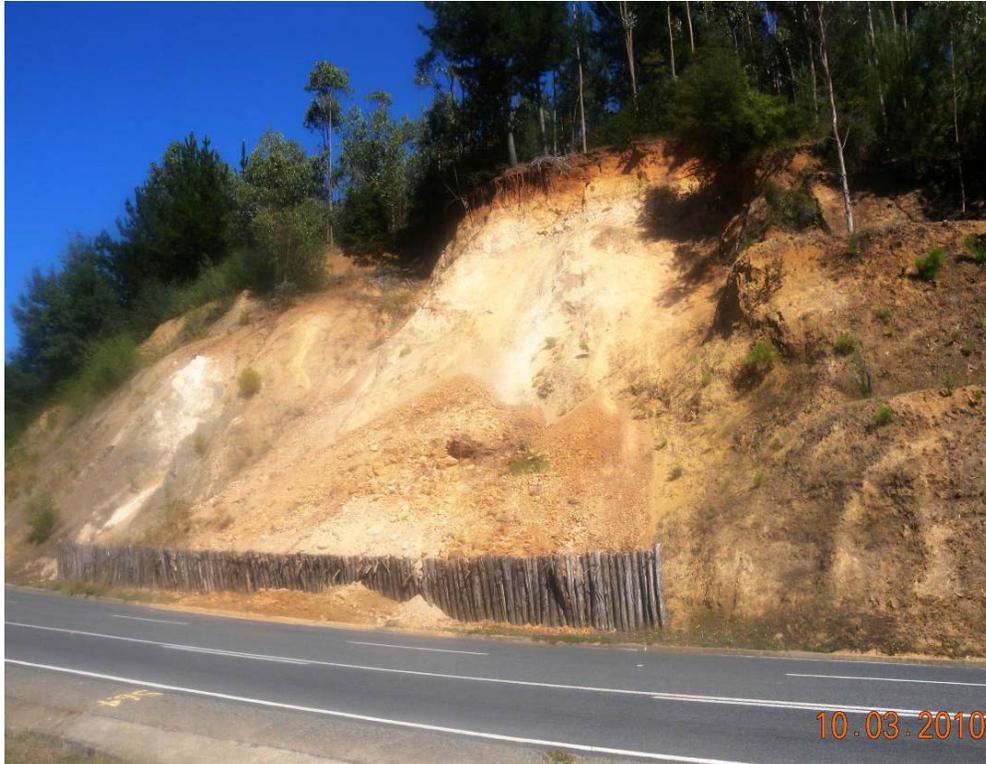
Figure 10.5. Shallow failure in a road cut in highly weathered bedrock (37.256493°S, 72.96018°W, looking SW).

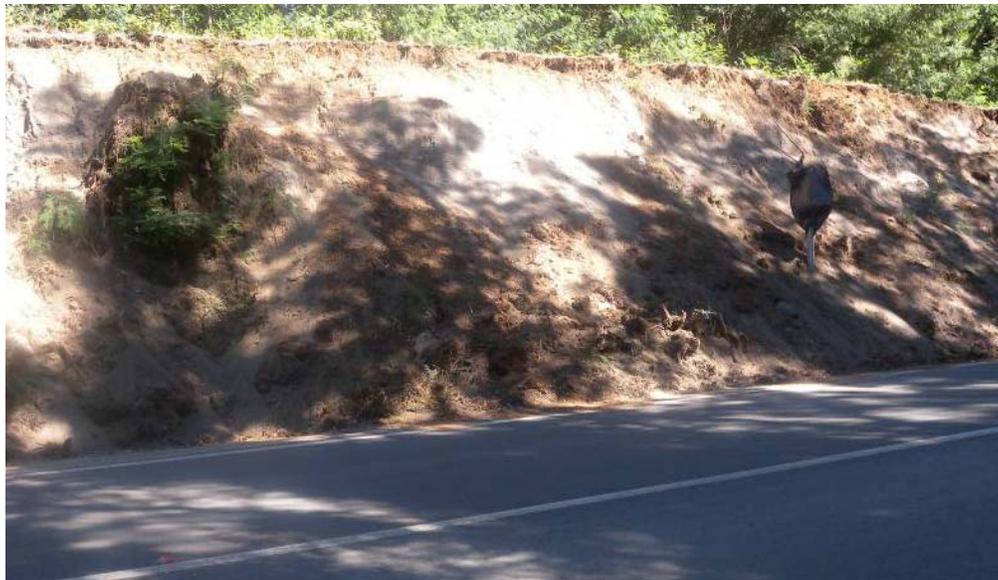
Figure 10.6. Sloughing of unconsolidated fluvial sand in a road cut North of Santa Juana (37.1111°S, 72.9876°W).

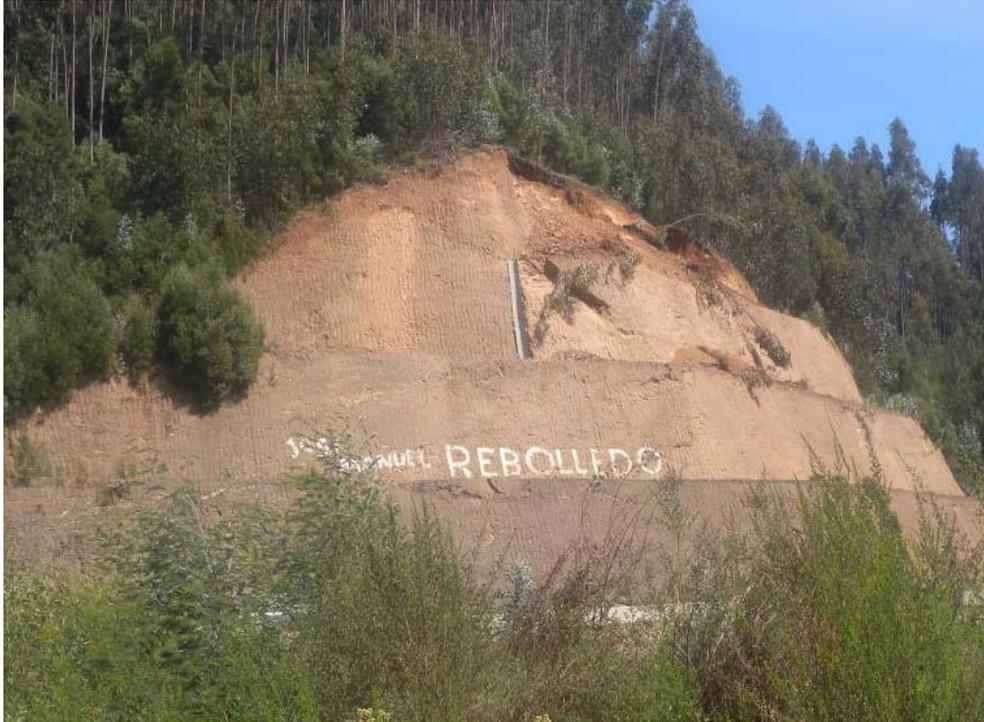
Figure 10.7. Bench failure along a daylighting joint in a road cut in deeply weathered rock south of Lota (37.1213°S, 73.1550°W).

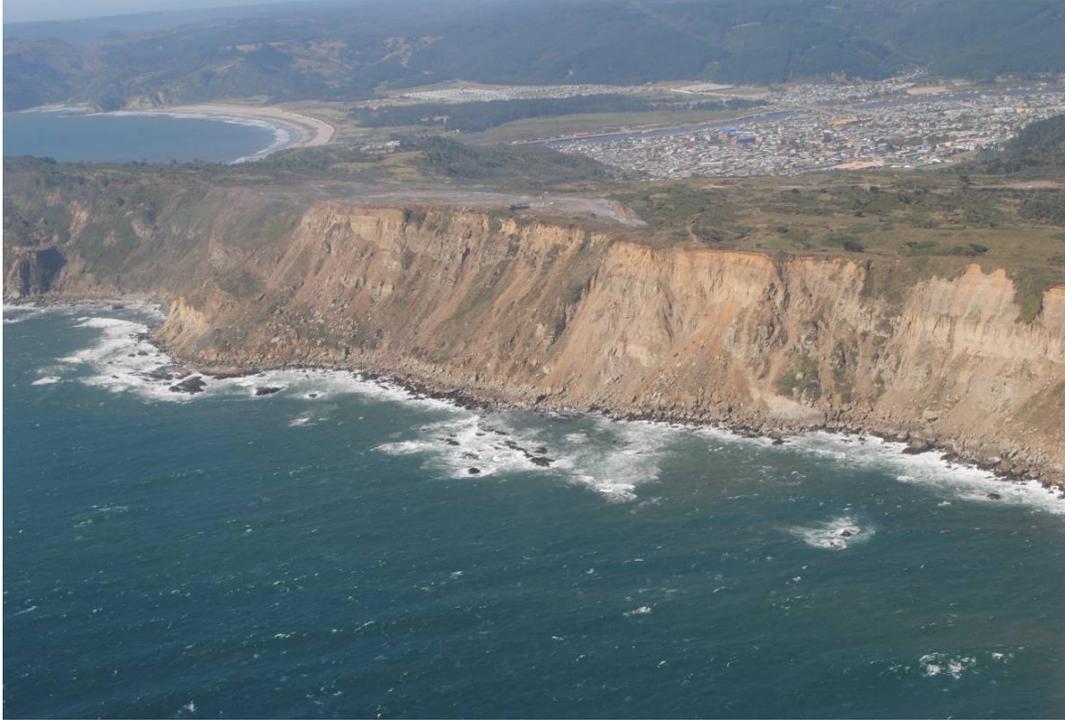
Figure 10.8. Shallow slides along bluffs southwest of Lebu (37.6°S , 73.674°W).

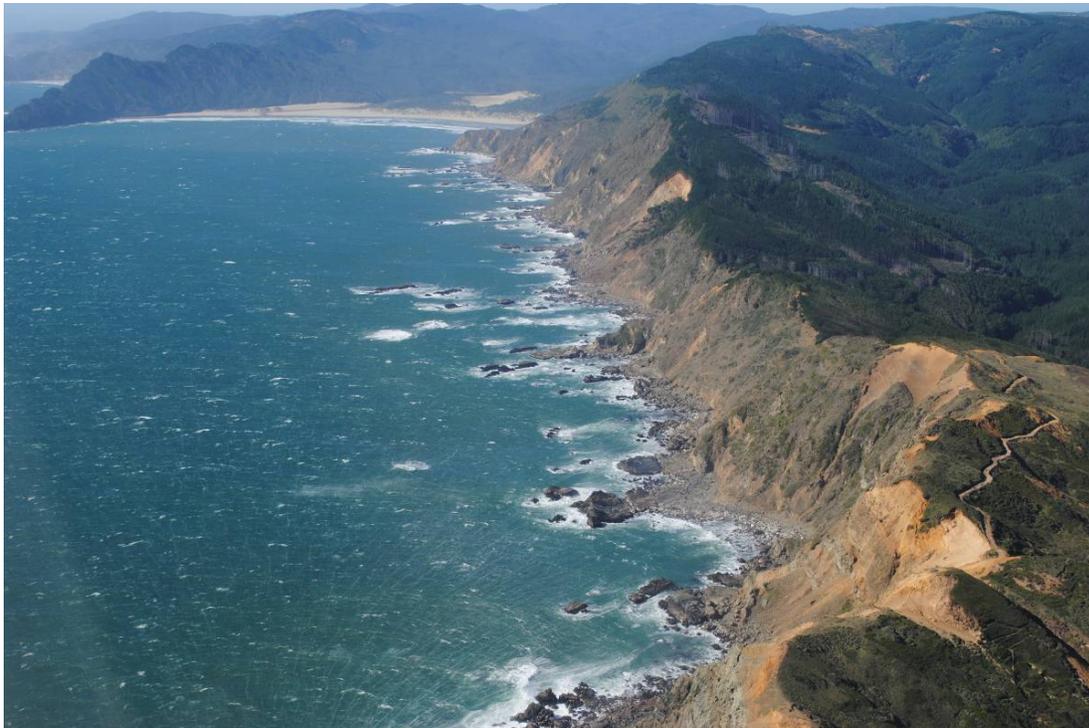
Figure 10.9. Bluffs north of Pta Carneros, southwest of Arauco, showing frequent but not pervasive sliding and raveling (37.326°S , 732674°W).

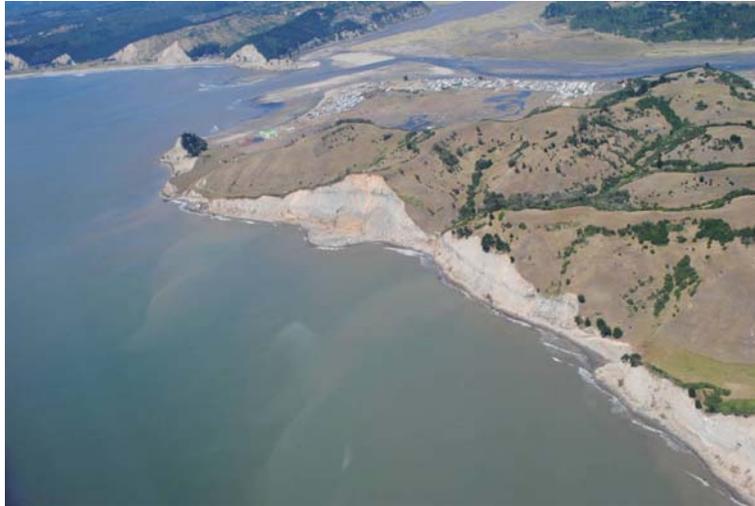
Figure 10.10. Aerial view of the coastal bluffs West of Arauco (37.2205°S, 73.443°W).

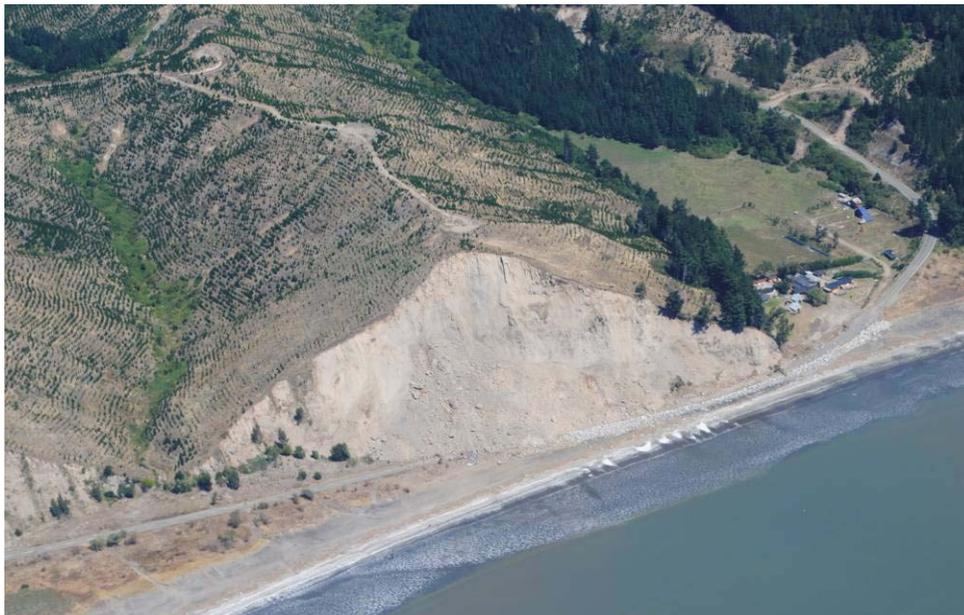
Figure 10.11. Shallow failure along a truncated ridge forcing road closure West of Arauco (37.2437°S, 73.413°W) .

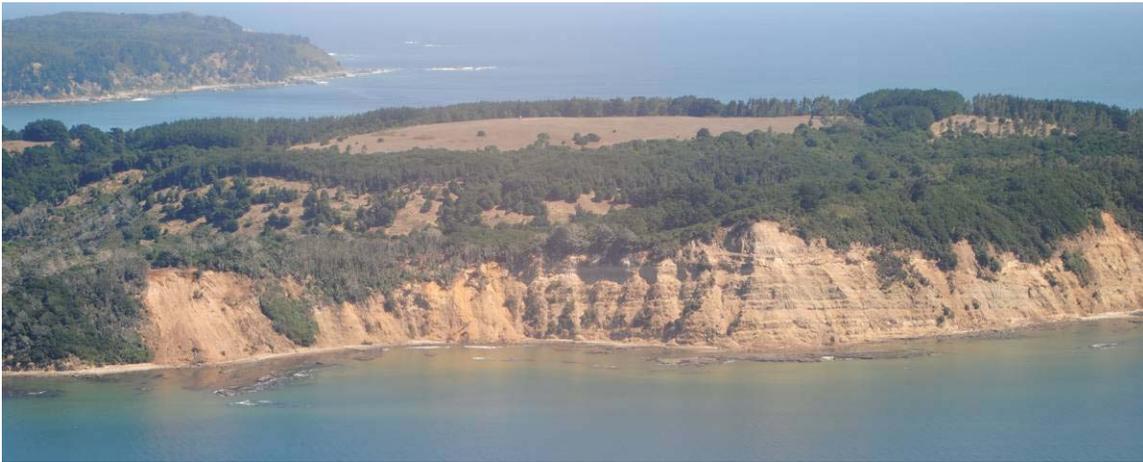
Figure 10.12. Shallow failures and raveling in Tertiary sedimentary rocks on Isla Quiriquina (36.627°S, 73.05°W).

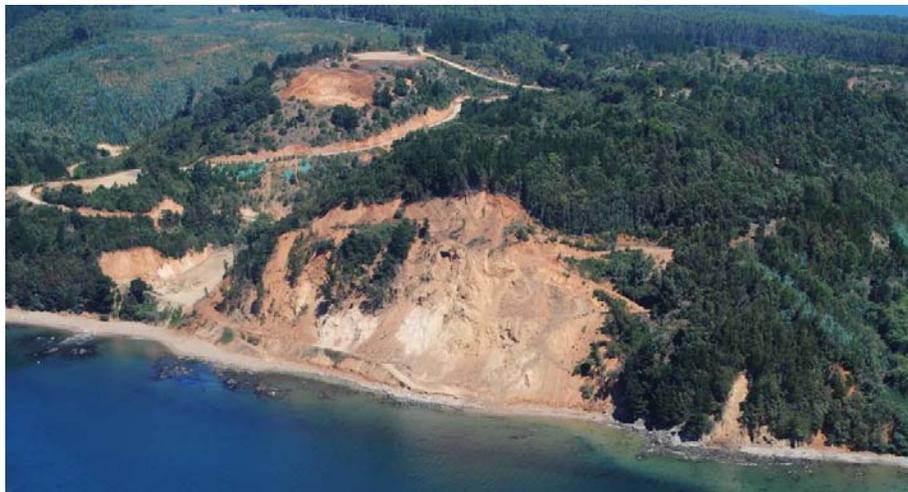
Figure 10.13. Disaggregated landslide complex, Punta Tumbes looking West (36.66°S, 73.098°W).

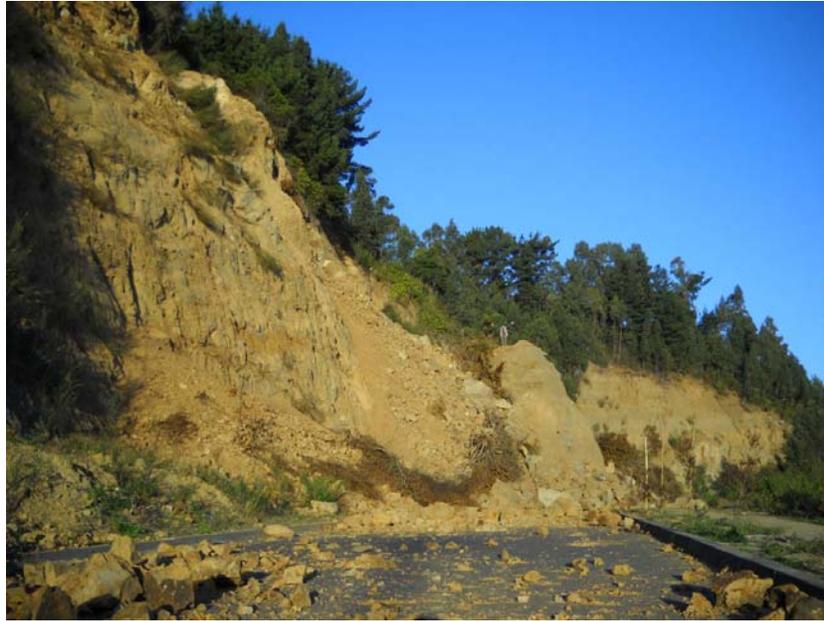
Figure 10.14. Landslide in a road cut in Cocholgue, north of Tome (36.595 S, 72.974 W). Photo and details courtesy of J.M. Lopez.

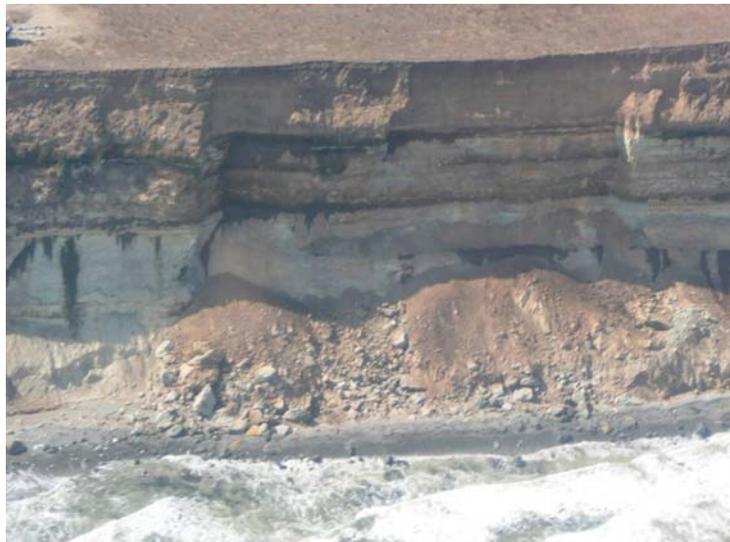
Navidad to San Antonio – Long stretches of the coastline north of Concepcion are fronted by bread beaches that are punctuated by occasional headlands with only occasional small slope failures. To the north of Navidad the coastline is defined by a relatively flat terrace capped by unconsolidated shallow marine and fluvial deposits. The terrace has an elevation of 80 to 100 m and drops abruptly to a narrow rocky beach. Numerous shallow failures by toppling and slumping of relatively thin slabs of bedrock and overlying sediments occurred in this region as illustrated in Figure 10.15.

Figure 10.15. Typical shallow failure of steep coastal bluffs, Reserva Nacional El Yali (33.841°S, 71.817°W) .

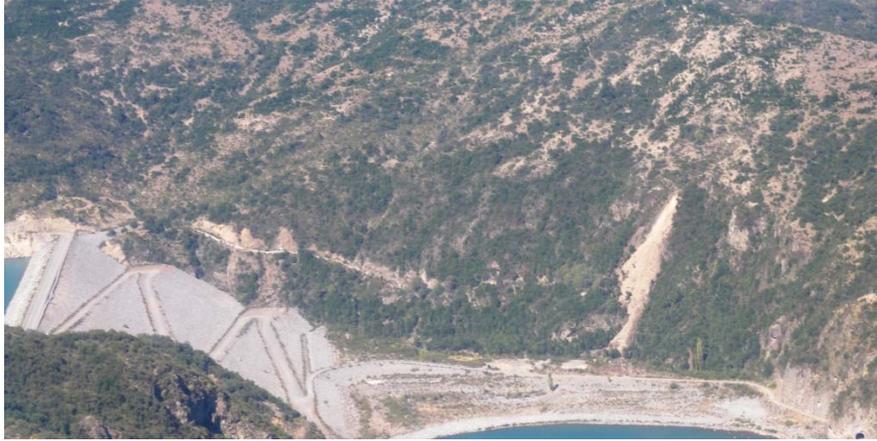
Interior Region – Widely scattered occasional disaggregated slides in natural slopes seemed to occur without any particular association with lithology or damage to nearby infrastructure as already shown at Rapel Dam. Figure 10.16 is an example of a typical small failure from a steep slope which occurred just below the Colbun Dam which suffered no damage.

Figure 10.16. Typical shallow disaggregated slide, Colbun Dam (35.668°S, 71.351°W) .

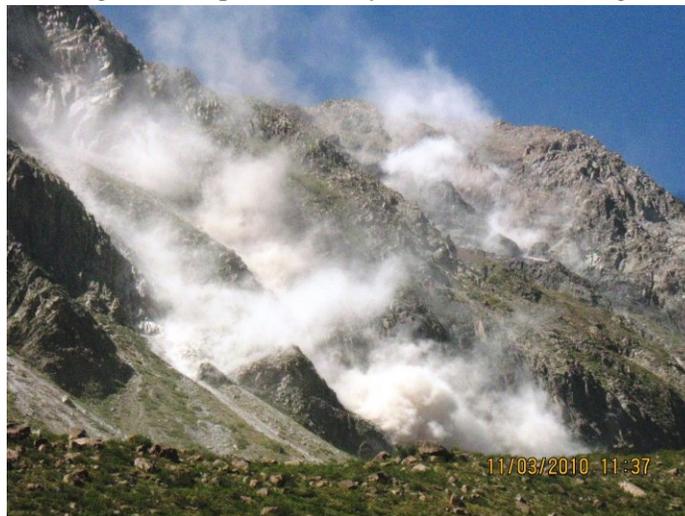
Given the paucity of sliding and rock falls in the main event, or at least lack of any significant damage due to them, it is interesting that rock falls and shallow raveling type failure was captured on camera in the foothills of the Andes during the M 6.9 event on March 11 (Figure 10.17). The site is east of San Fernando, in the direction of the Tiguiririca volcano, roughly 160 km east south east from the epicenter of the event, in steep terrain in highly fractured volcanic rock of the Coya-Machali Formation. Hence, rock falls presumably occurred in the main event but were not observed due to darkness and were apparently not considered significant enough to be reported as they did not cause damage of any consequence.

Figure 10.17. Rock falls and shallow debris slides following the M 6.9 event on March 11, 2010 (approx. 34.8°S, 70.5°W). Note, the time in the picture is 20 minutes off. Picture courtesy of Cristian Avila.

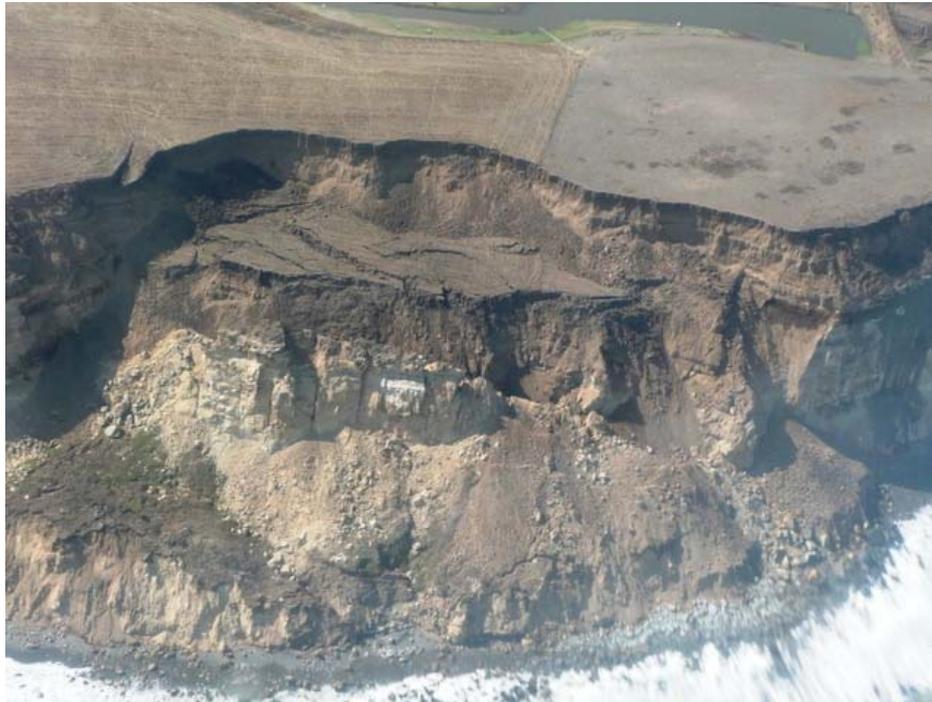
In general, deep-seated block or rotational slides were notable by their general absence. The one observed large failure, a deep-seated block slump, occurred in the coastal terrace in the El Yali National Park (Figure 10.18). The failure is clearly joint controlled, however, the exact reason for the size of this slump in an area otherwise characterized by relatively minor toppling or slumping (see Figure 10.15) is not readily apparent without further investigation.

Figure 10.18. Deep-seated bedrock slump in Tertiary sedimentary bedrock capped by marine terrace sediments (33.846°S, 71.821°W).

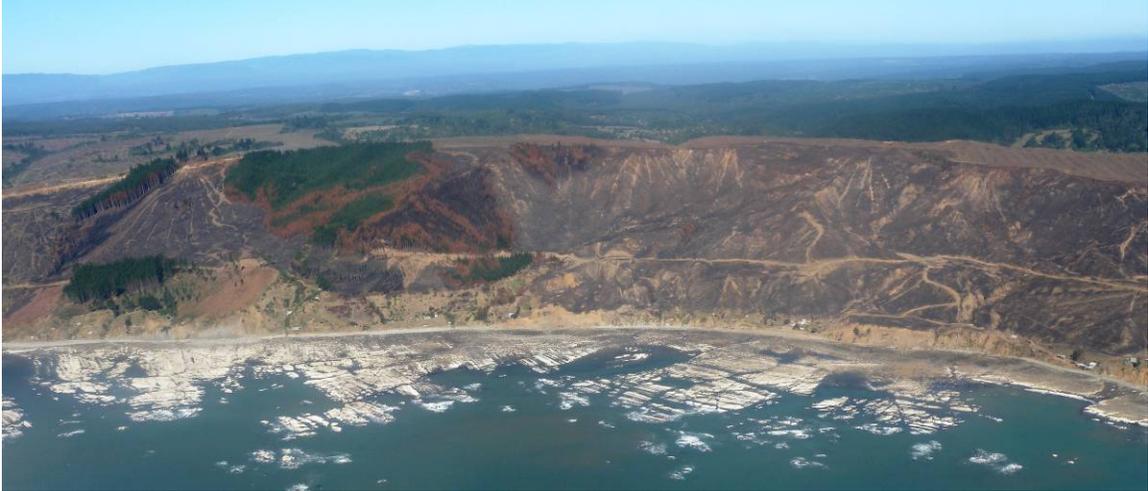
The general paucity of landsliding is best illustrated by the fact that even clearly identifiable areas of prior extensive landslide activity had little or no evidence of seismically triggered slides. For example, Figure 10.19 shows an old landslide complex along the coastal ridge just north of Lebu. The only evidence of sliding is seen at the lowermost portions of the slopes which form the back of the beach.

Figure 10.19. Old landslide complex north of Lebu showing no evidence of seismically-induced slope movement (37.561°S, 71.64°W).
