## 12.0 RETAINING STRUCTURES

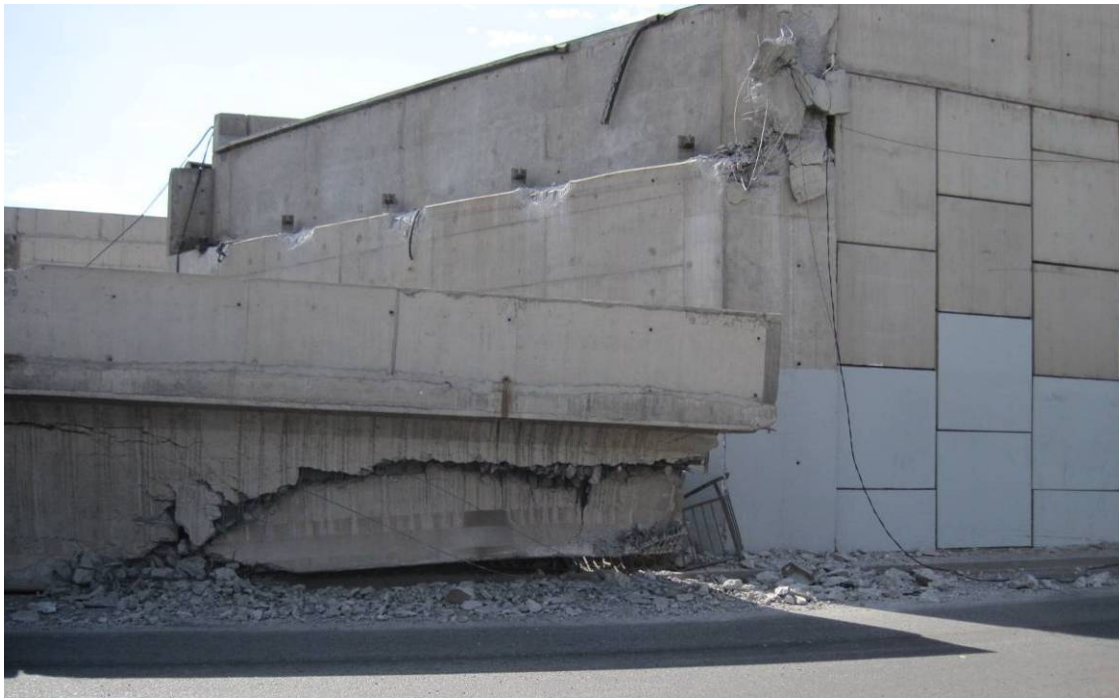
**Mechanically Stabilized Retaining Walls** – Mechanically stabilized earth embankment walls, specifically Reinforced Earth walls, have been used in Chile quite extensively for highway embankments, particularly for overpasses and bridge abutments. In the greater Santiago metropolitan area there are numerous underpasses, overpasses and sidehill fills retained with Reinforced Earth walls. Their performance was excellent even when bridges supported by the abutments failed by sliding off their seats as happened in a number of instances as shown in Figure 12.1. The same level of performance occurred along the major north-south freeway, Route 5. Figure 12.2 shows a Reinforced Earth abutment of a collapsed bridge across a rail line. In this case, the approach embankment to the North of this failed railroad overpass had a major failure as well (see Section 9.15), however, the abutments themselves showed no signs of appreciable deformation. In this case, the adjacent older bridge with multiple supports also performed very well and showed no evidence of damage.

Figure 12.1. Intersection of Americo Vespucio Norte and Independencia. Abutment of a collapsed bridge.  
(33°21'57.83"S, 70°41'17.71"W)

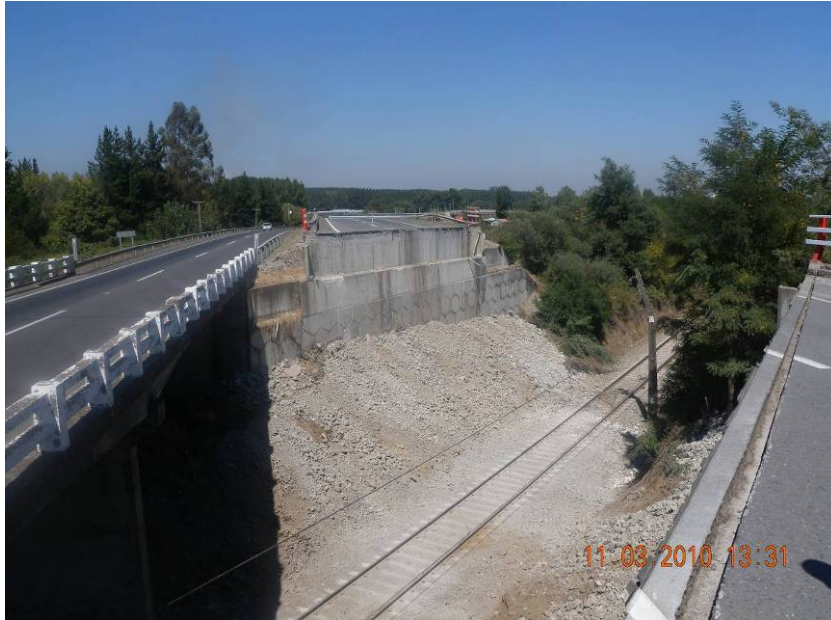
Figure 12.2. Reinforced Earth bridge abutments at a collapsed rail crossing on Route 5 north of Parral (36.0803°S, 71.788°W)

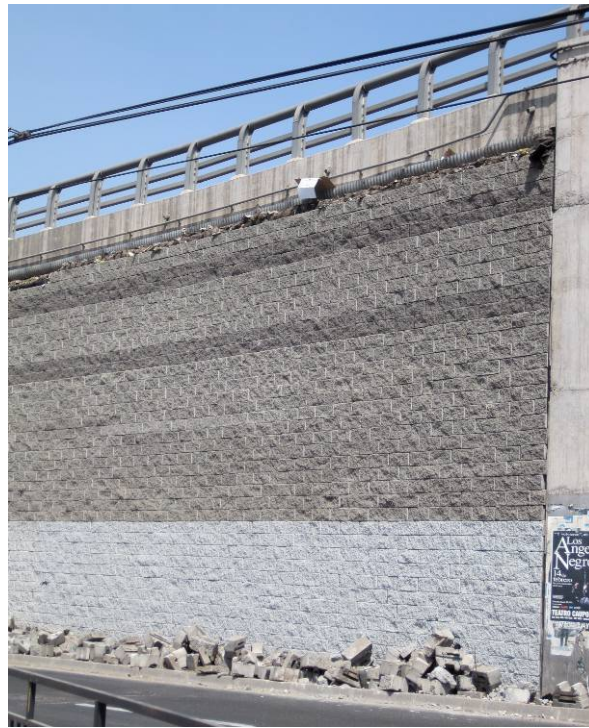
Similarly, block faced mechanically stabilized wall performed very well. Figure 12.3 shows a block faced mechanically stabilized bridge approach which lost the top most row of blocks but otherwise remained intact.

Figure 12.3. Block faced mechanically stabilized embankment, Intersection of Americo Vespucio Norte and Lo Echevers. (33°22'34.54"S, 70°44'52.83"W)

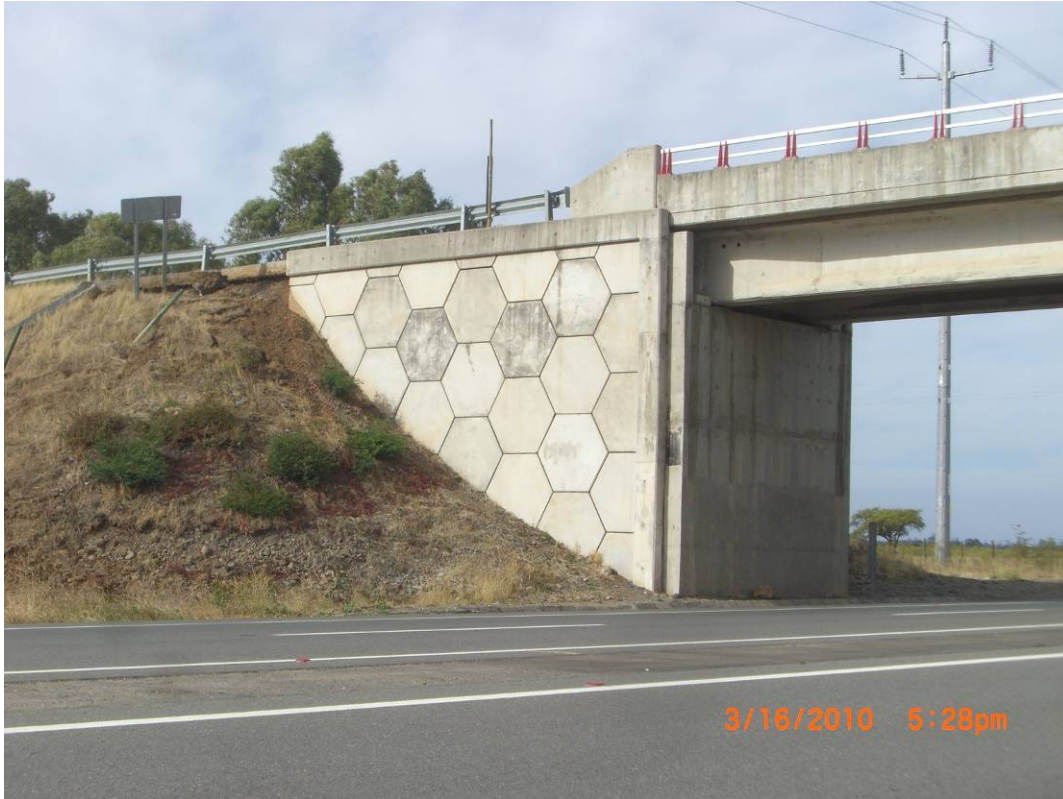
Figure 12.4 shows a photograph of yet another typical MSE retaining structure. This wall, located west of Chillan, was approximately 6 m high and exhibited no damage despite surficial slope instability in the adjacent approach fill slope.

Figure 12.4 Undamaged MSE wingwall on overpass structure over highway 152 west of Chillan despite sliding of adjacent fill slope (S36.6588, W72.2776).

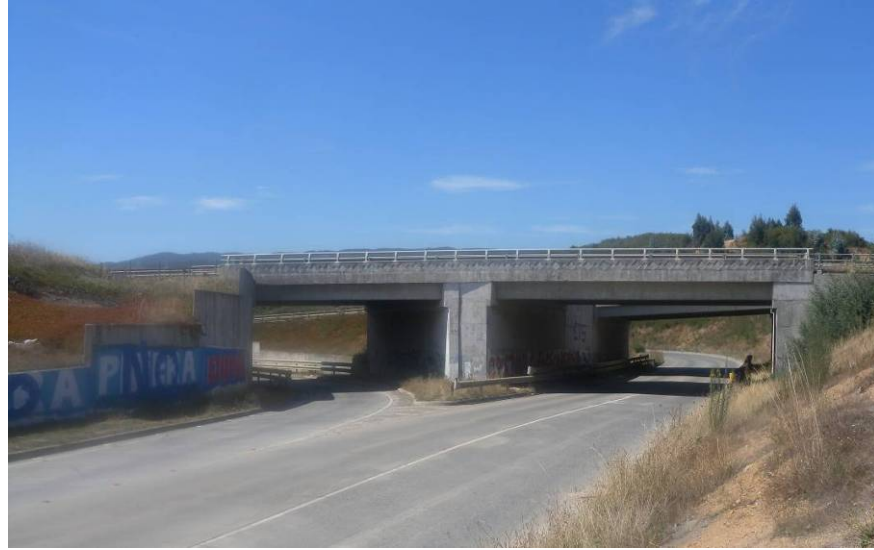
**Conventional, Concrete Gravity and Cantilever Structures** – Conventional concrete gravity and retaining structures similarly performed very well in many different settings. Figure 12.5 shows an overpass structure on the coastal highway just south of Coronel, about 140 km south of the epicenter in an area which experienced significant shaking. The structure experienced no distress and the bridge structures were fully functional after the event.

Figure 12.5. Multiple retaining structures for highway overpass structures south end of Coronel (37.0455°S, 73.1421°W)

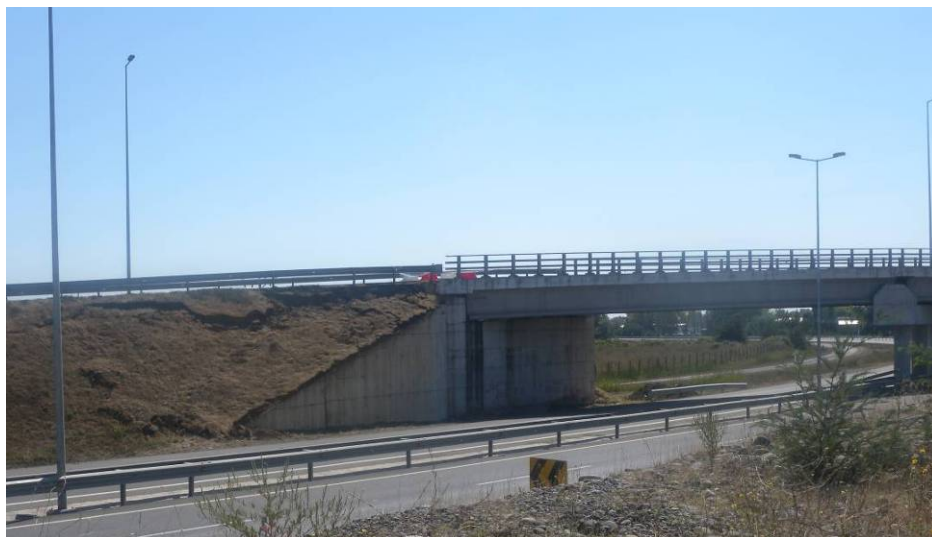
Most importantly, there were numerous bridge approach embankments that were shaken with sufficient intensity to experience surficial slumping, yet the abutment forming retaining walls performed very well and showed no evidence of damage. The bridge decks on the other hand were often offset and the concrete seats were spalled or completely fractured. Figure 12.5 shows one such bridge approach embankment and abutment wall on Route 5 north of Chillan. The bridge deck had temporary scaffolding supporting it at the other abutment as it was close to sliding off.

Figure 12.6. Surficial sloughing on a bridge approach embankment, with the abutment showing no evidence of damage, Route 5, north of Chillan.

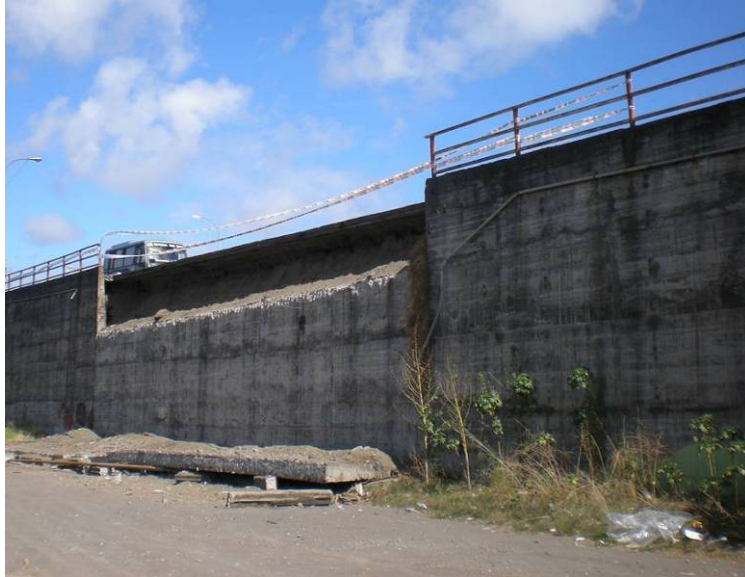
A rare failure of the uppermost section of a reinforced concrete retaining structure was observed in San Pedro, about 110 km south of the epicenter. The wall (Figure 12.7) was located within 3 km of the south approach to the Llacolen Bridge (the middle bridge across the River Bio Bio connecting Concepcion and San Pedro). The 16-inch thick wall was reinforced vertically with No. 3 or No. 4 bars on 12 inch centers (Figure 12.8). Failure occurred at the uppermost joint as the top wall toppled to the east apparently due to inertial forces. The granular backfill is clearly self supporting (Figure 12.9). Figures 12.9 and 12.10 show water seepage behind the intact portion of the wall and corrosion of the horizontal reinforcing along the joint.

Figure 12.7. Failed reinforced concrete retaining structure in San Pedro.

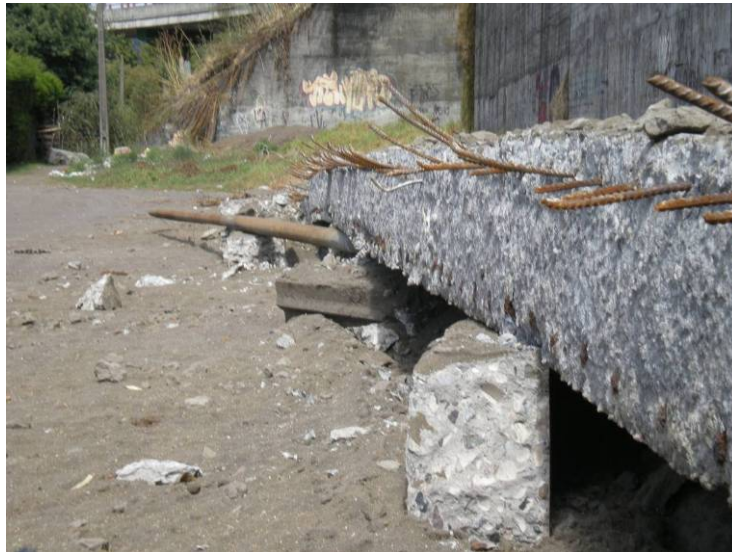
Figure 12.8. Toppled portion of 16-inch thick wall showing bent compression bars and snapped tension bars.

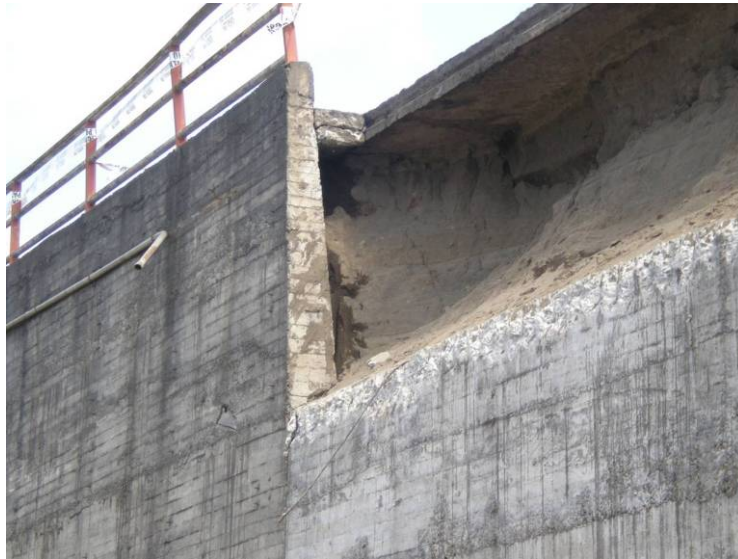
Figure 12.9. Granular fill soils and water seepage evident behind failed portion of wall.

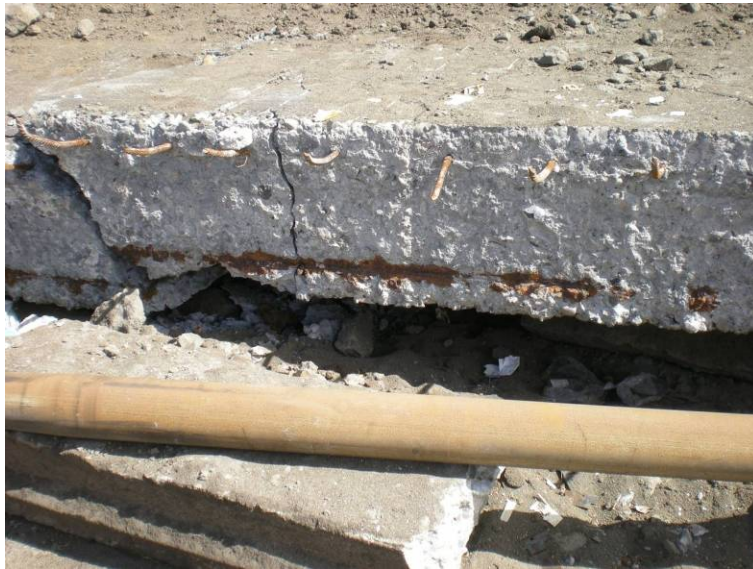
Figure 12.10. Corrosion of horizontal reinforcing steel where water entered the joint.

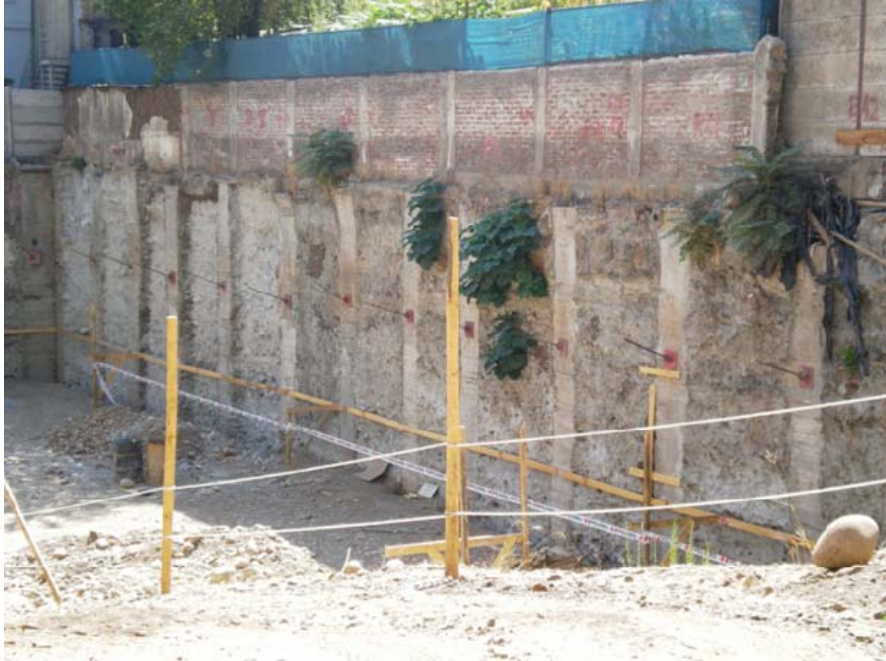
**Temporary Retaining Structures** – Temporary retaining structures were not widely observed; however, those observed performed well. Figure 12.11 shows a temporary shoring system in Santiago that appears to have been constructed some months before the earthquake given the vegetative growth on the wall face. The vertical members and single row of tieback anchors appeared undamaged while the exposed gravels between the vertical members did experience some raveling.

Figure 12.11. Undamaged temporary retaining structure in Santiago.
