5.0 SITE EFFECTS AND DAMAGE PATTERNS

5.1 The City of Santiago

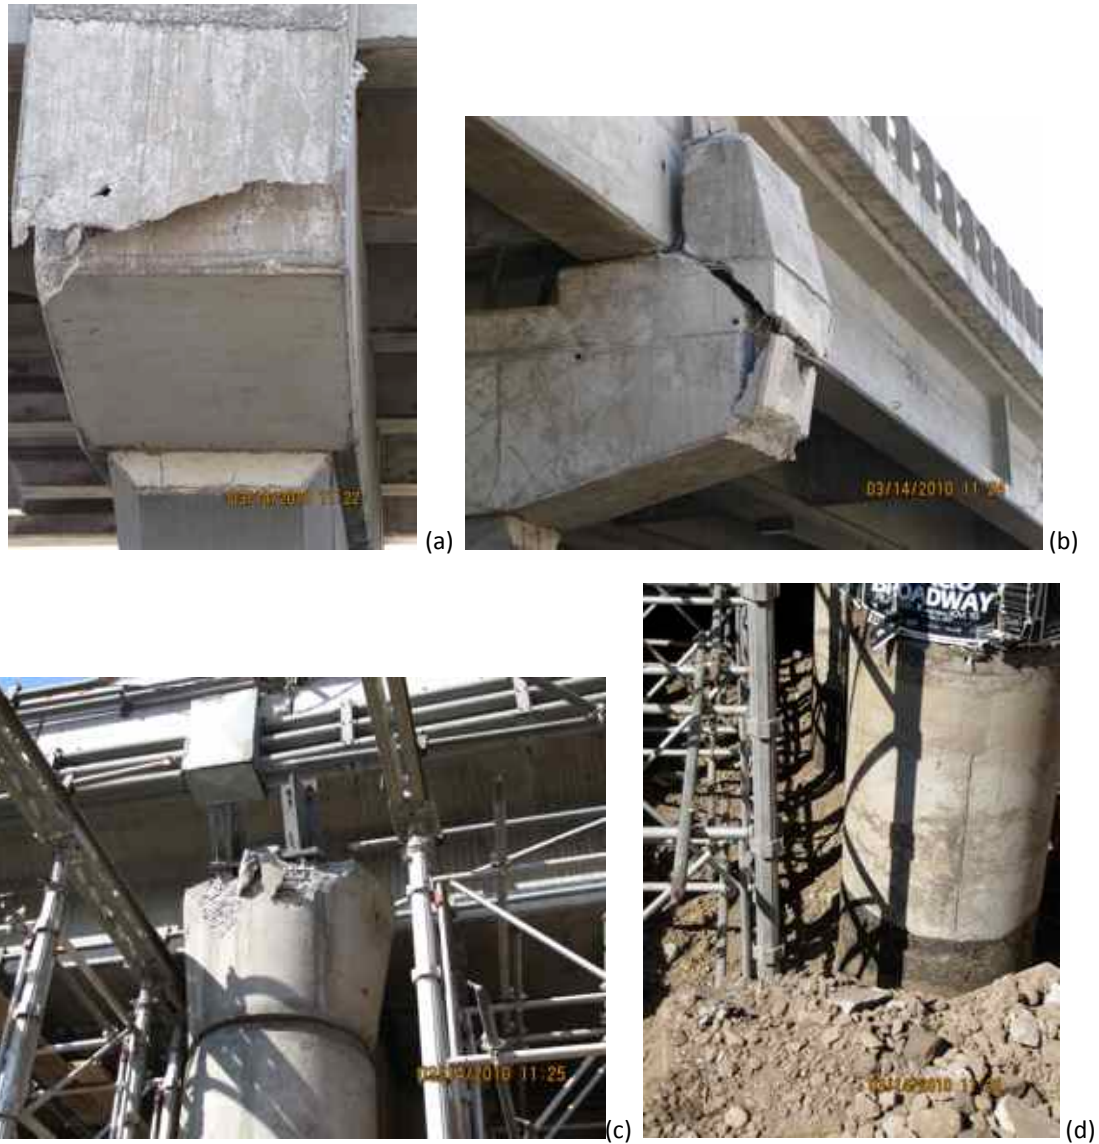
The bridge suffered repairable structural damage, characterized by shear key failure as shown in Figures 5.5a and 5.5b below. Longitudinal and transverse deck movement was also documented, leading to joint damage between the deck segments (Figure 5.5c). The two pile-diameter-deep excavation shown in Figure 5.5d, revealed no foundation failure. According to the local geology map, the soil profile at the site is clay and silty clay.

Figure 5.5. Paso San Martin (S33.3660° W70.6891°, 1122 hrs on 03/14/2010). Shear key failure and longitudinal, transverse deck displacement.

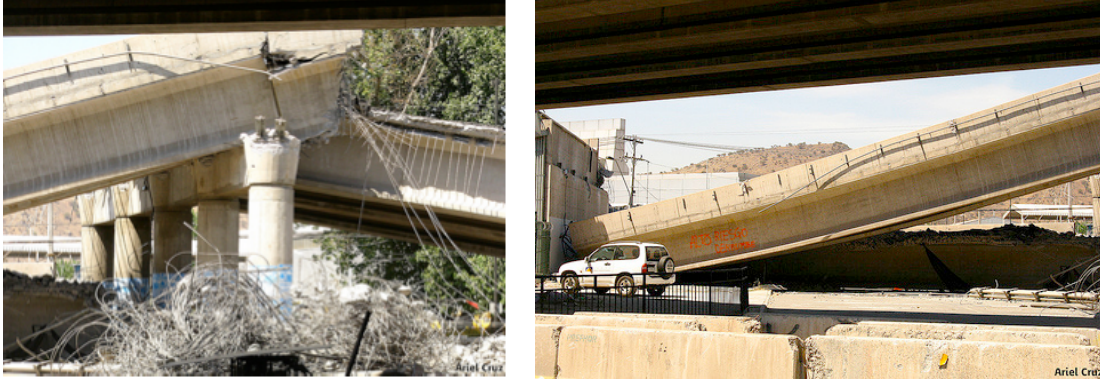
The bridge suffered collapse of the east direction deck of the highway (see Figure 5.6). According to the local geology map, the soil profile at the site is clayey/silty sand.

Figure 5.6. Paso Superior Lo Echevers (S33.3759° W70.7476°). Collapse of the eastbound deck of the Americo Vespucio Norte ring road (Source: http://www.flickr.com/photos/consulta_recorridos/).

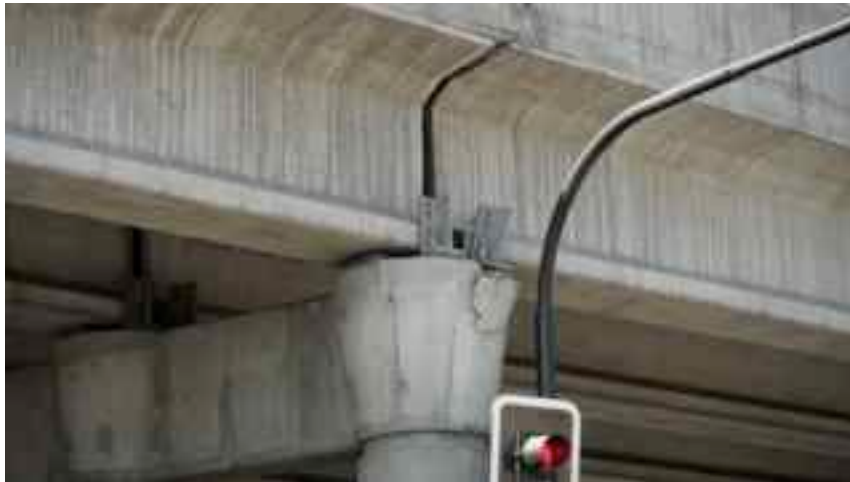
The bridge suffered minor damage, primarily shear key failure and subsequent displacement of the deck in the transverse direction (see Figure 5.7). According to the local geology map, the soil profile at the site is sandy silt.

Figure 5.7. Paso Lo Boza (S33.3865° W70.7601°). Minor structural damage of shear keys (Source: Dr. Roberto Leon, personal communication).

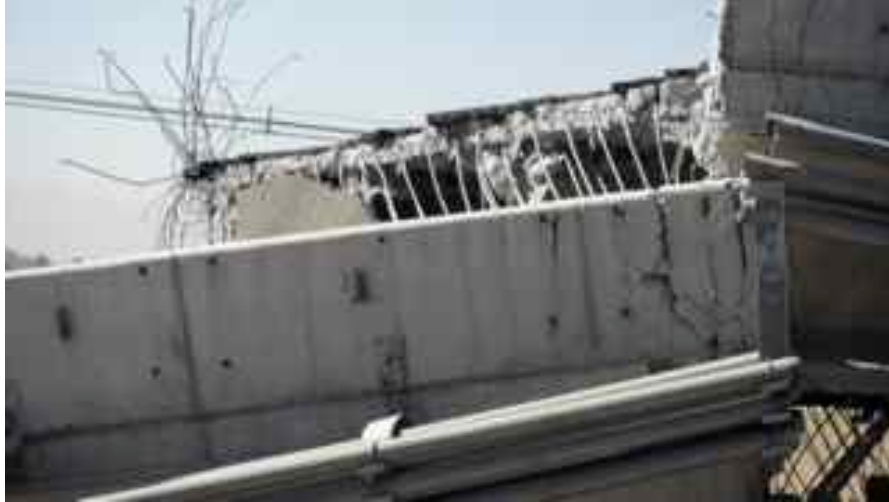
The bridge suffered collapse of the east direction deck of the highway (see Figure 5.8). According to the local geology map, the soil profile at the site is sandy silt.

Figure 5.8. Paso Miraflores (S33.3945° W70.7700°). Deck collapse detail (Source: Dr. Roberto Leon, personal communication).

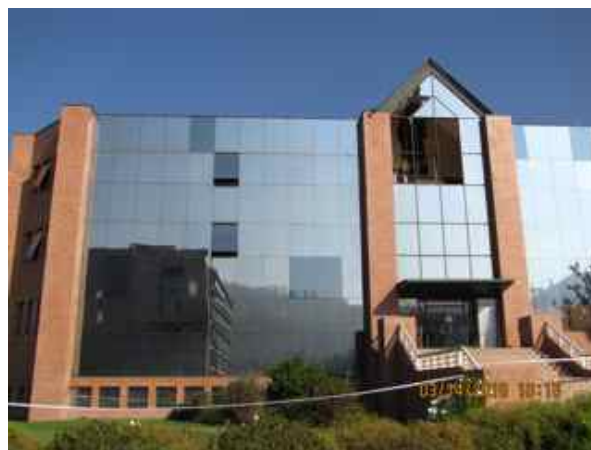
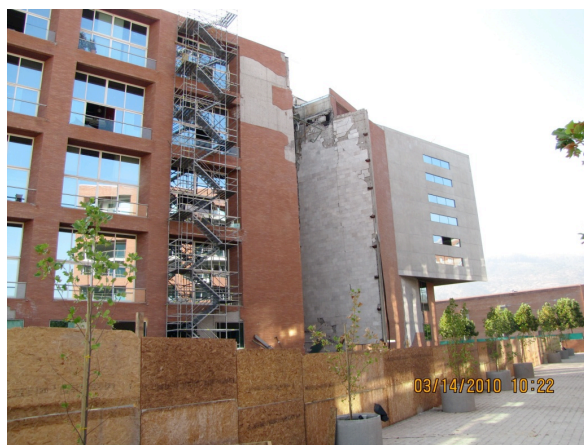
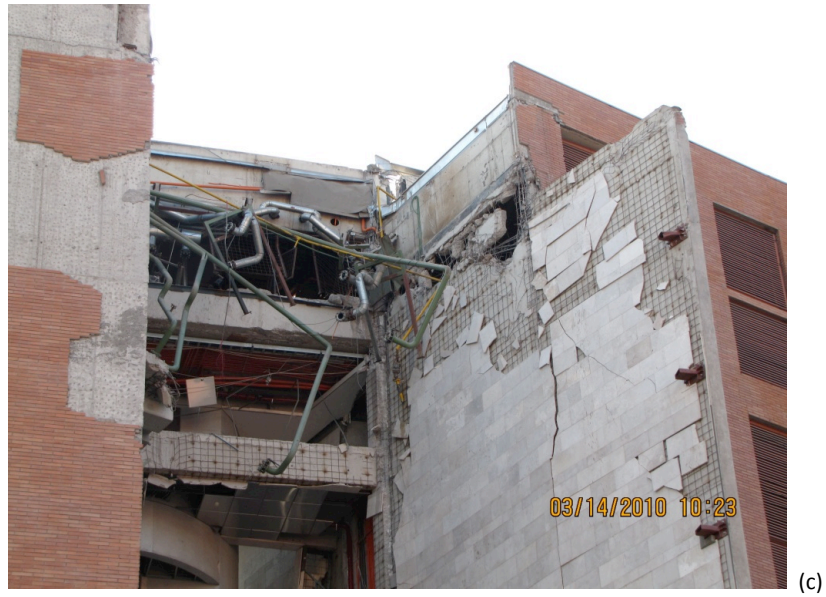
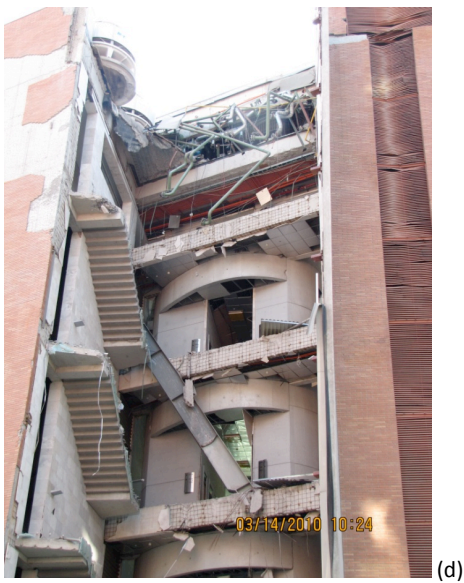
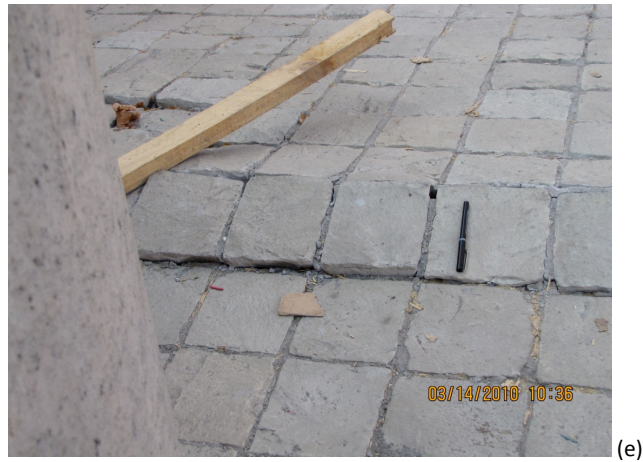
Figure 5.11. Site DA003 ($S33.387985^{\circ}$ $W70.618815^{\circ}$, 1015 hrs on 03/14/2010) 6-story commercial building. Damage of non-structural elements (glass windows, red brick façade) (Figures 11a,b) and emergency staircase (Figures 11c,d). Evidence of ground deformation (Figure 11e).

Overall, the business park was severely damaged, with 7 buildings that failed and were closed to the public. No total collapse was documented and no casualties were reported at the site, while the only evidence of soil deformation is shown in Figure 11e. The damaged structures ranged from a 5- to 12-stories, which to first approximation corresponds to 0.5-1.2 sec resonant periods (0.8-2 Hz).

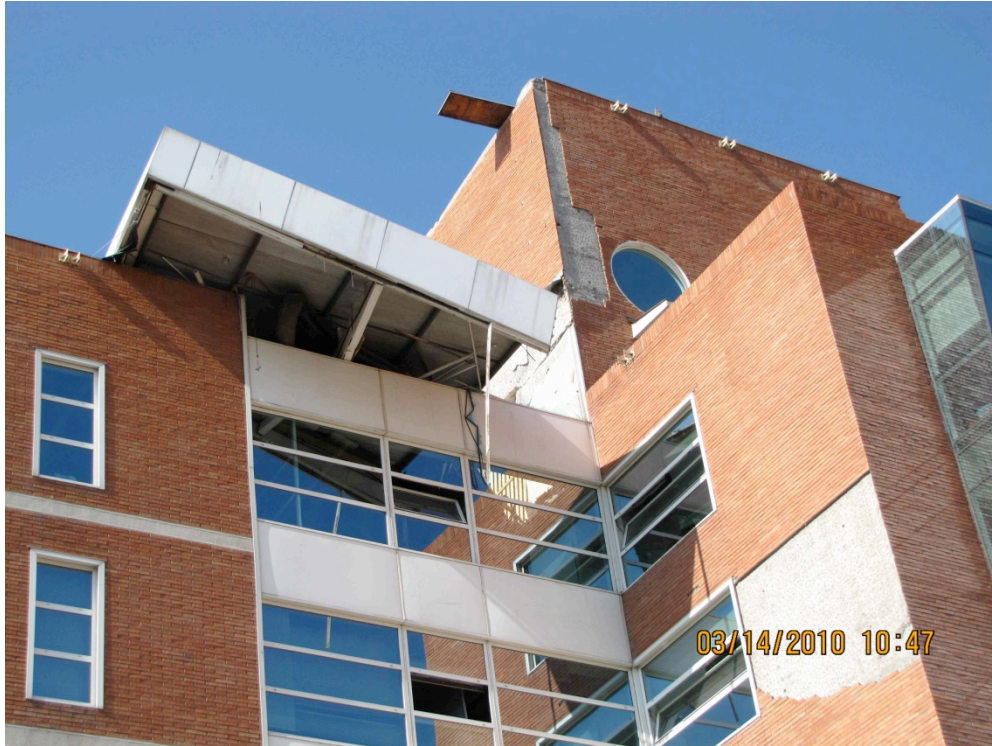
Figure 5.12. Site DA004 (S33.387652° W70.617122°, 1047 hrs on 03/14/2010) Identical 7-story buildings connected; damage was observed in only one of the two.

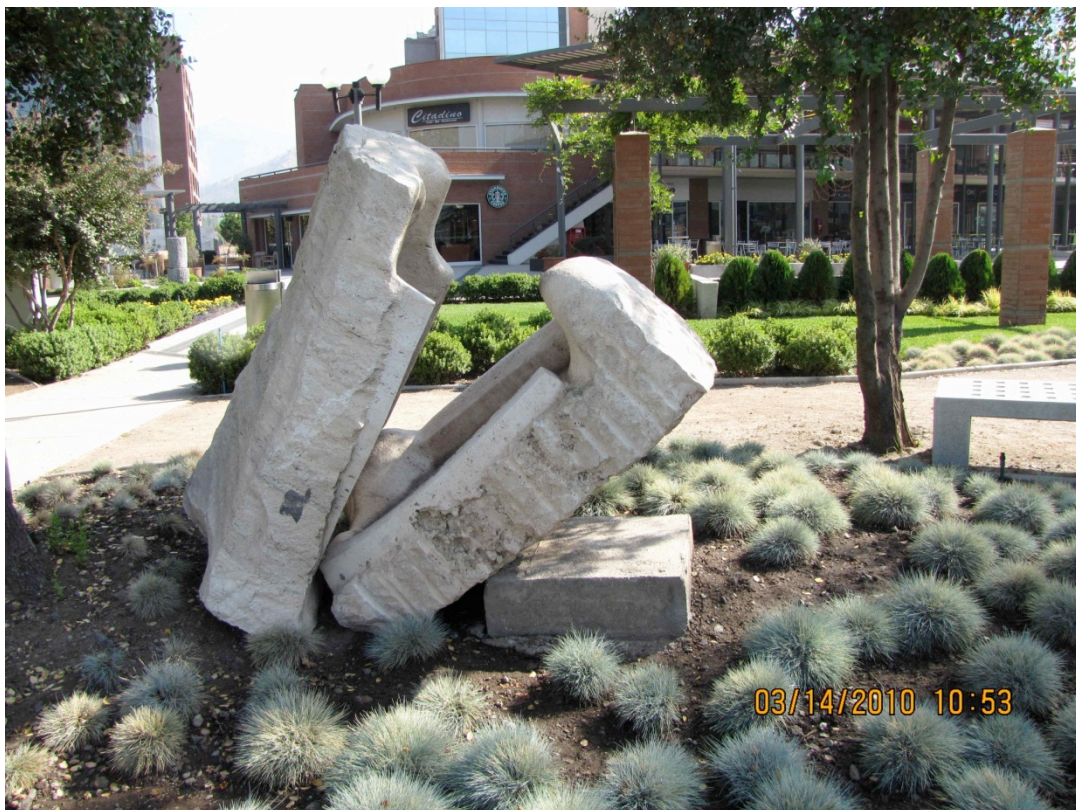
Figure 5.13. Site DA005 (S33.387652° W70.617123°, 1053 hrs on 03/14/2010) Overtopped art.

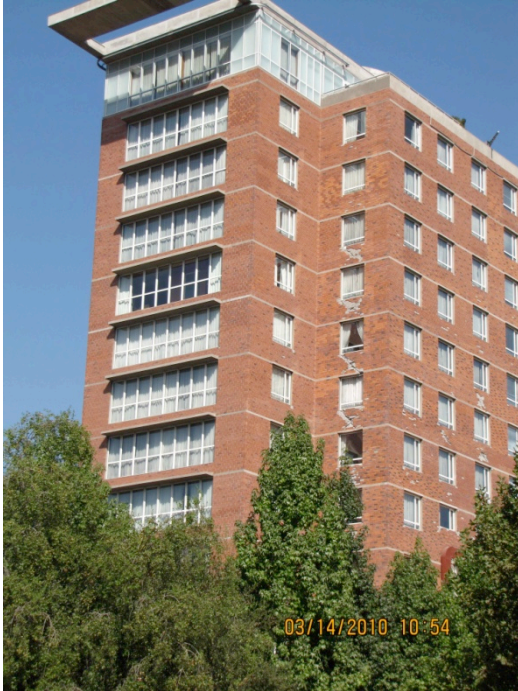
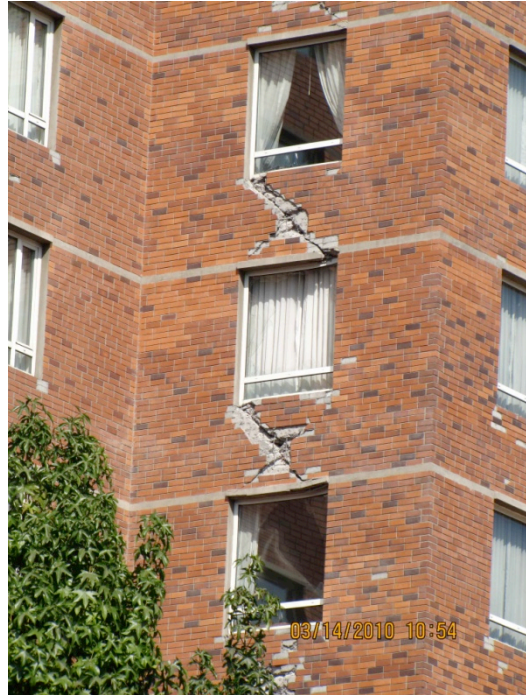
Figure 5.14. Site DA005 ($S33.387652^{\circ}$ $W70.617123^{\circ}$, 1054 hrs on 03/14/2010) 12-story building with severe structural damage.

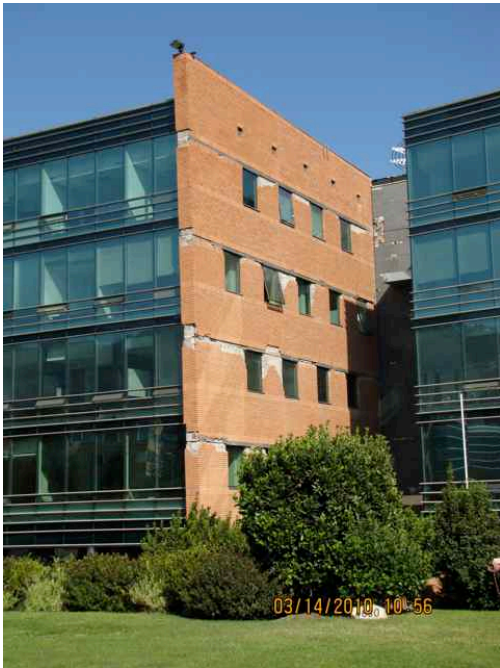
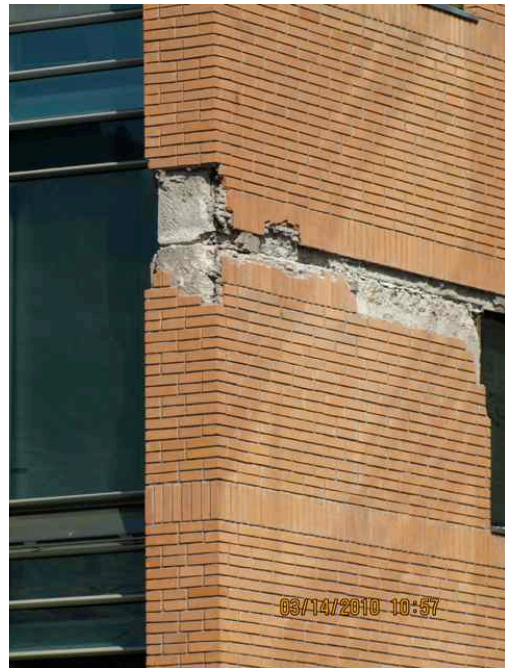
Figure 5.15. Site DA006 ($S33.389586^{\circ}$ $W70.618349^{\circ}$, 1056 hrs on 03/14/2010) 5-story building, structural damage.

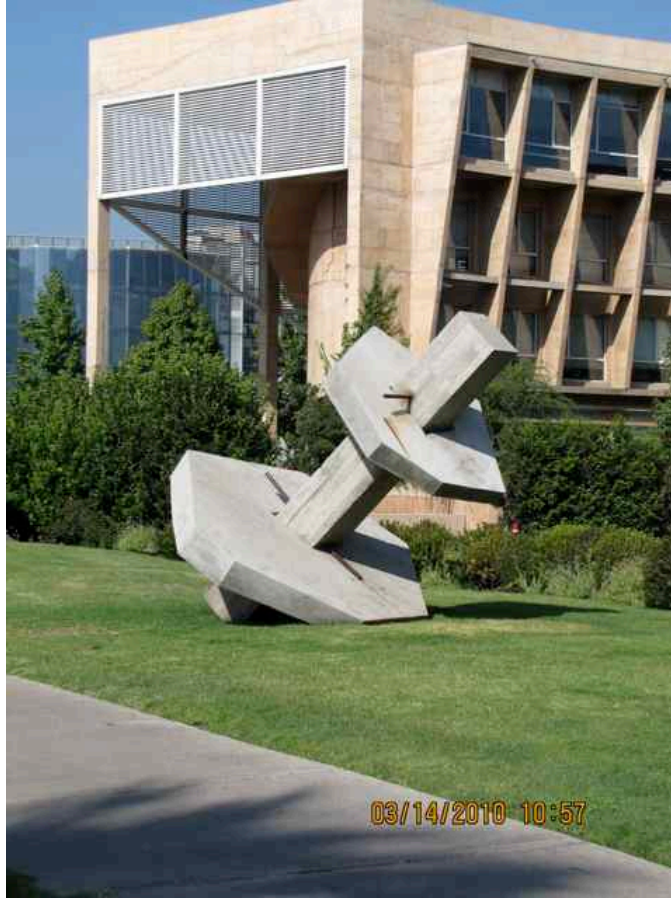
Figure 5.16. Site DA007 (S33.391163° W70.619502°, 1057 hrs on 03/14/2010) Minor external damage – non-structural. Overtopped art.

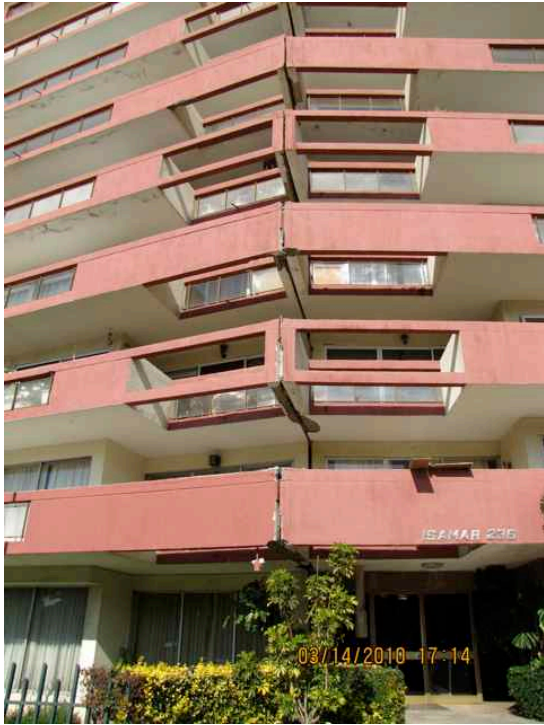
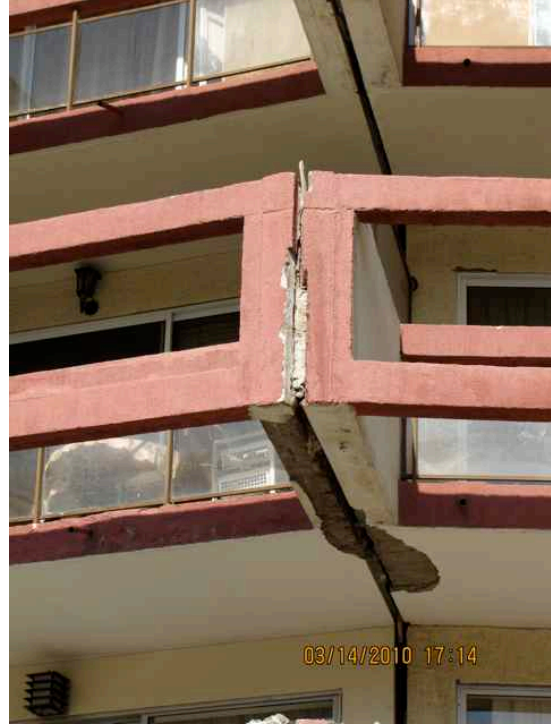
Figure 5.22 Site DA017 (S 33.018904° W 71.559206°, 1714 hrs on 03/14/2010) Damaged 9-story building.

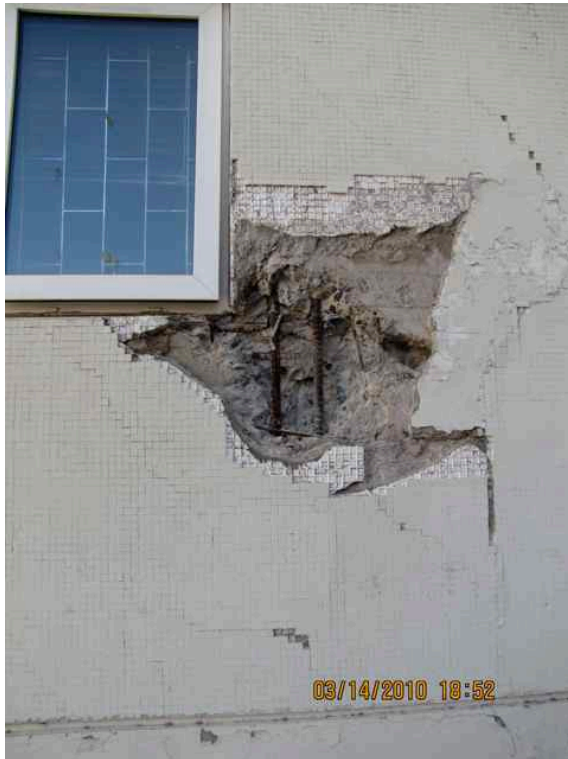
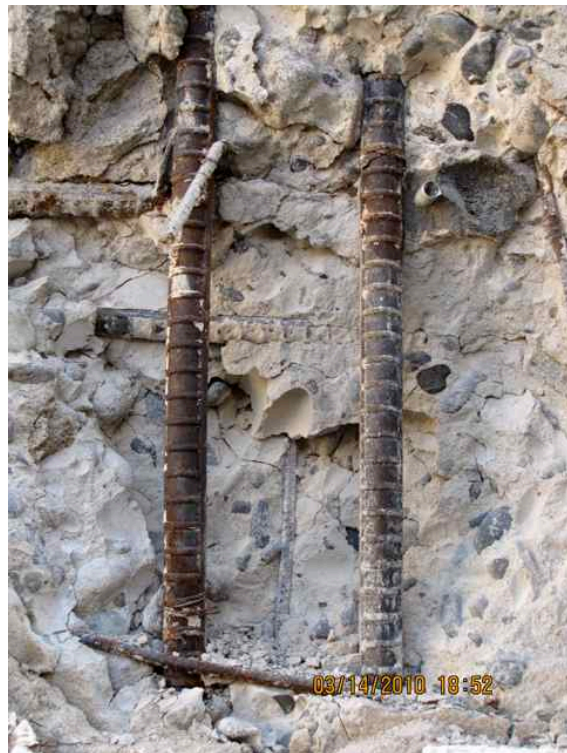
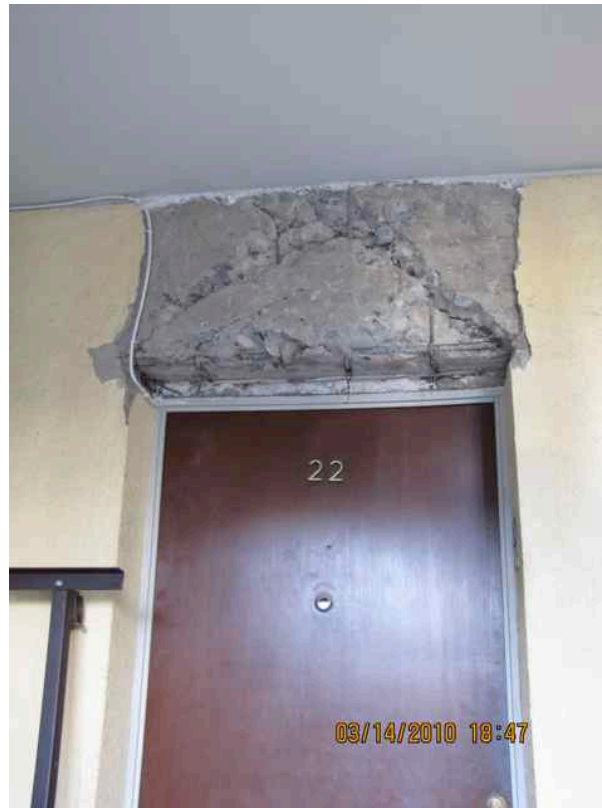
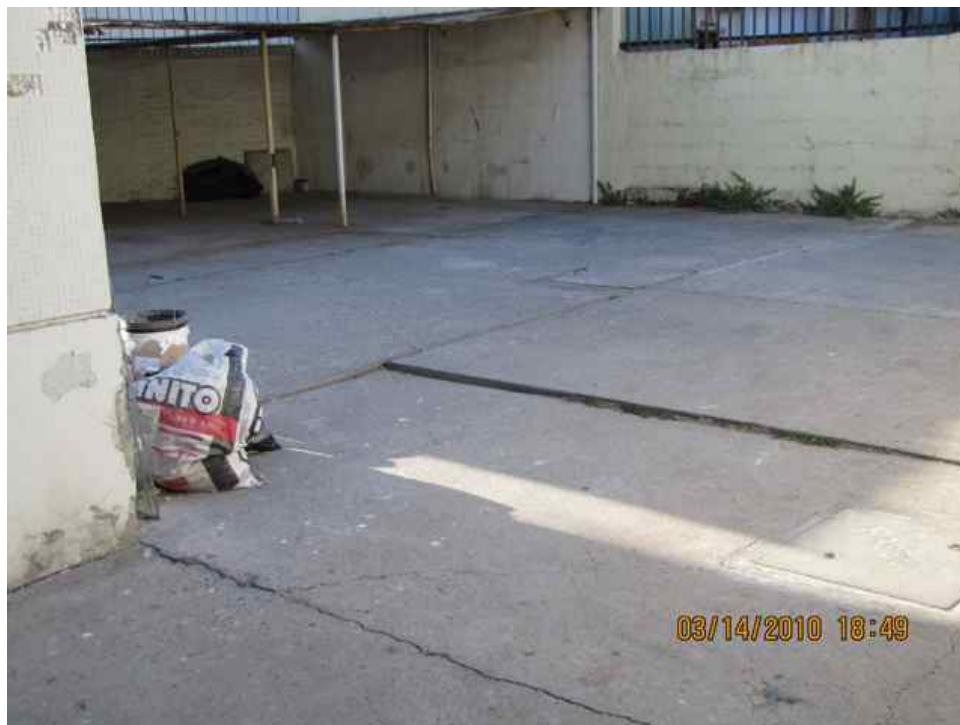
Figure 5.23. Site DA018 (S 33.017386° W 71.557107°, 18:48 hrs on 03/14/2010) Damaged 6-story building. Evidence of ground settlement.

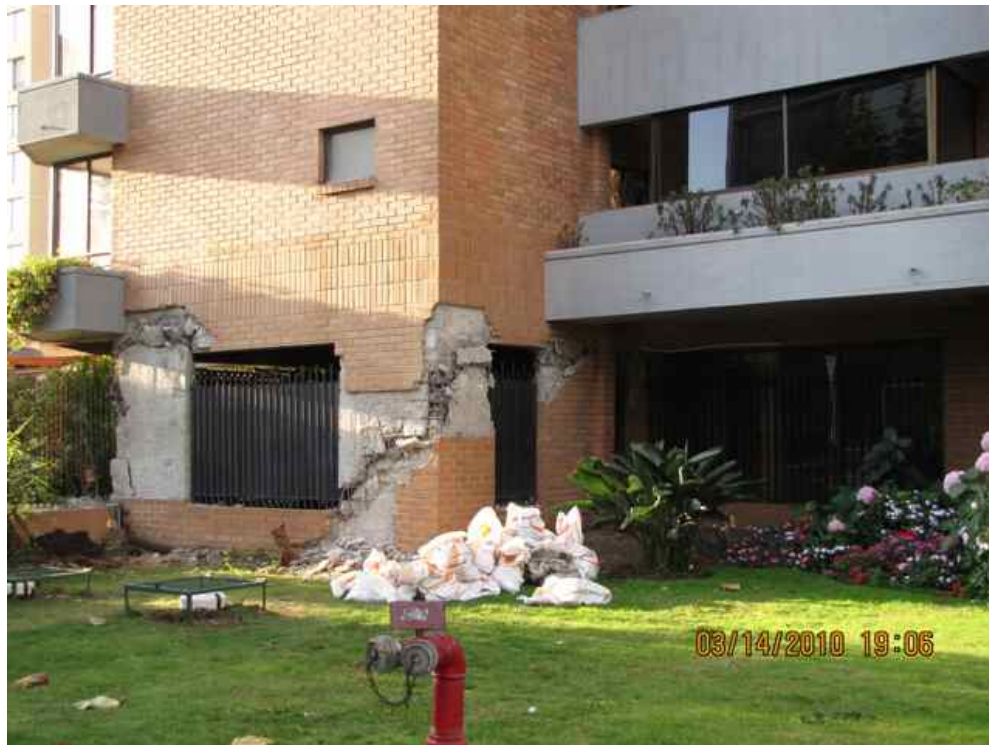
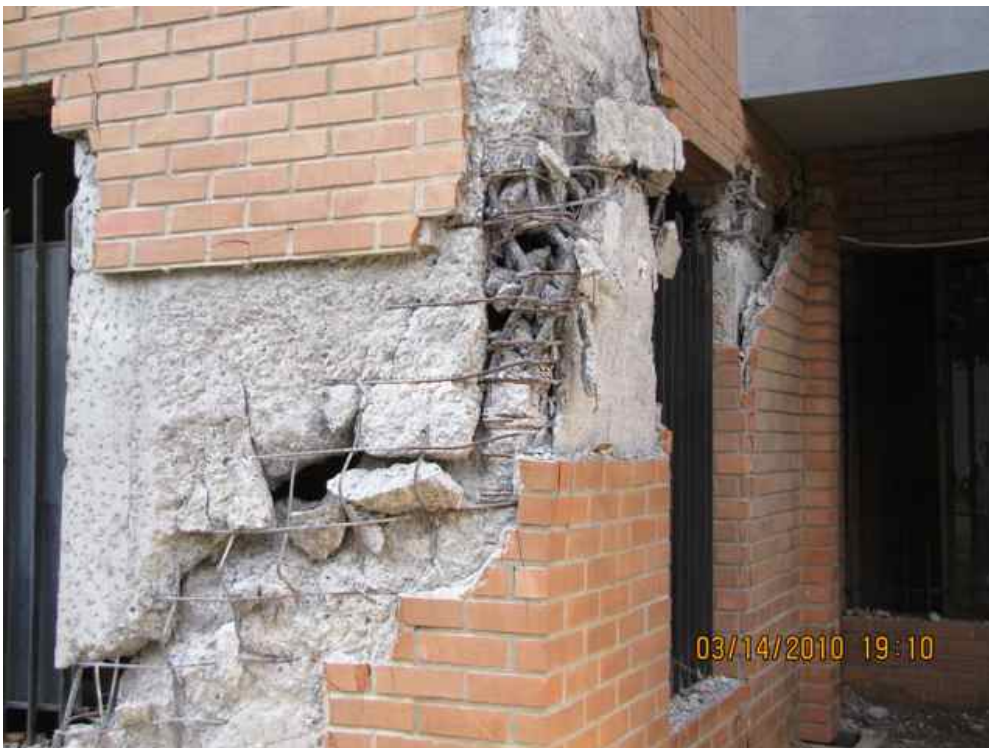
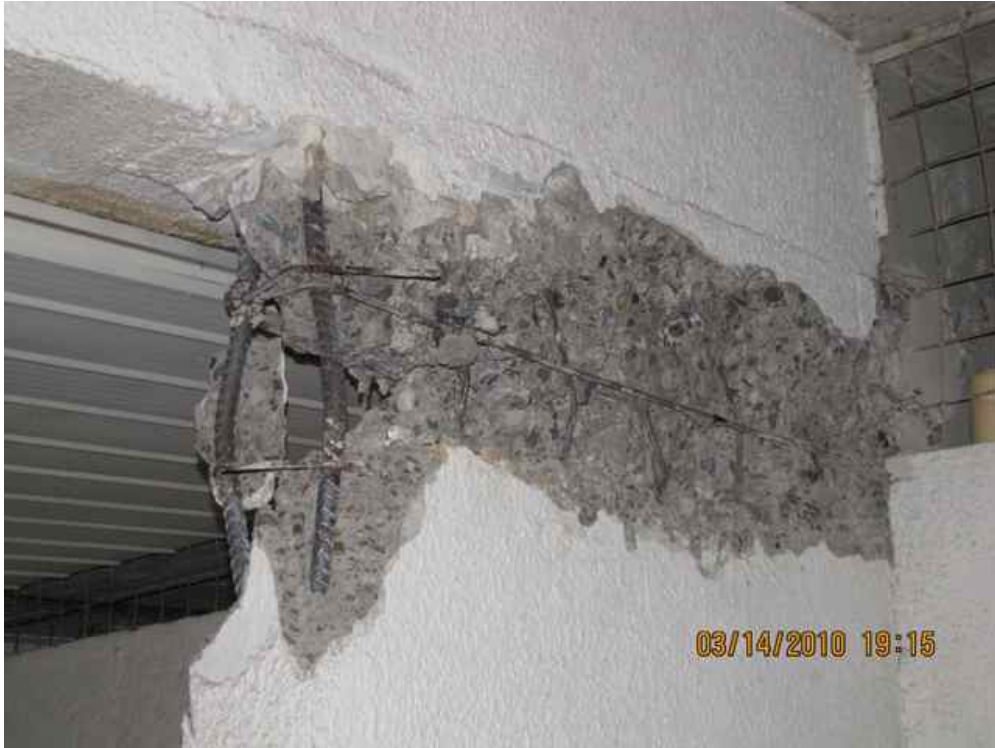
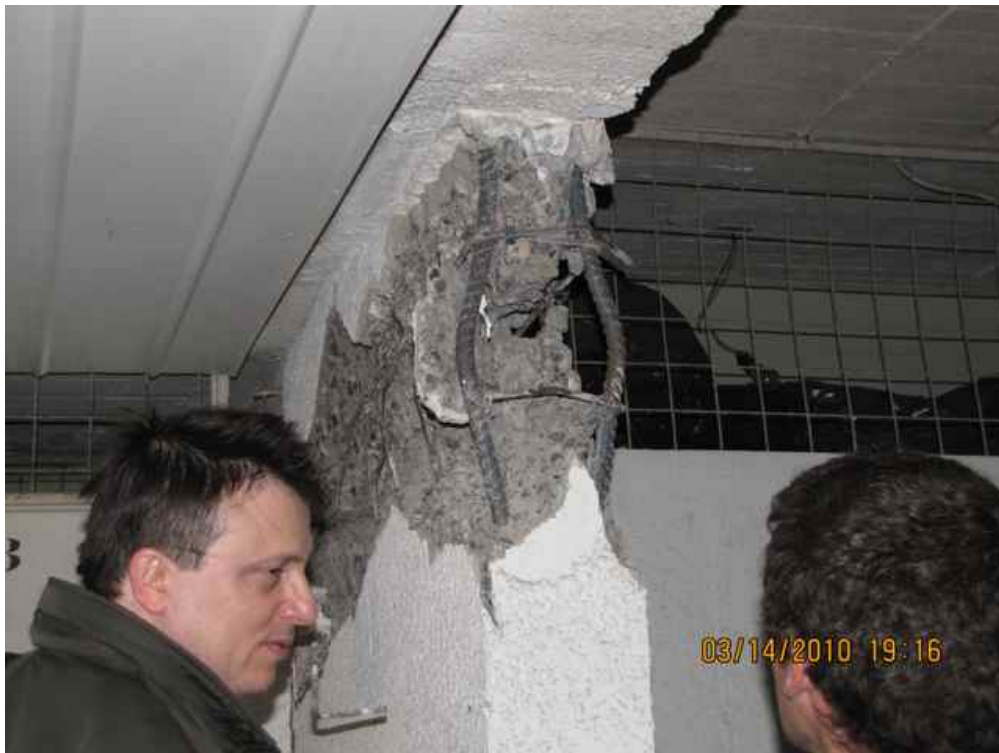
Figure 5.24. Site DA019 (S33.016045° W 71.551990°, 1916 hrs on 03/14/2010). Damaged 10-story building. Lack of confinement beam-column joints and low quality concrete.

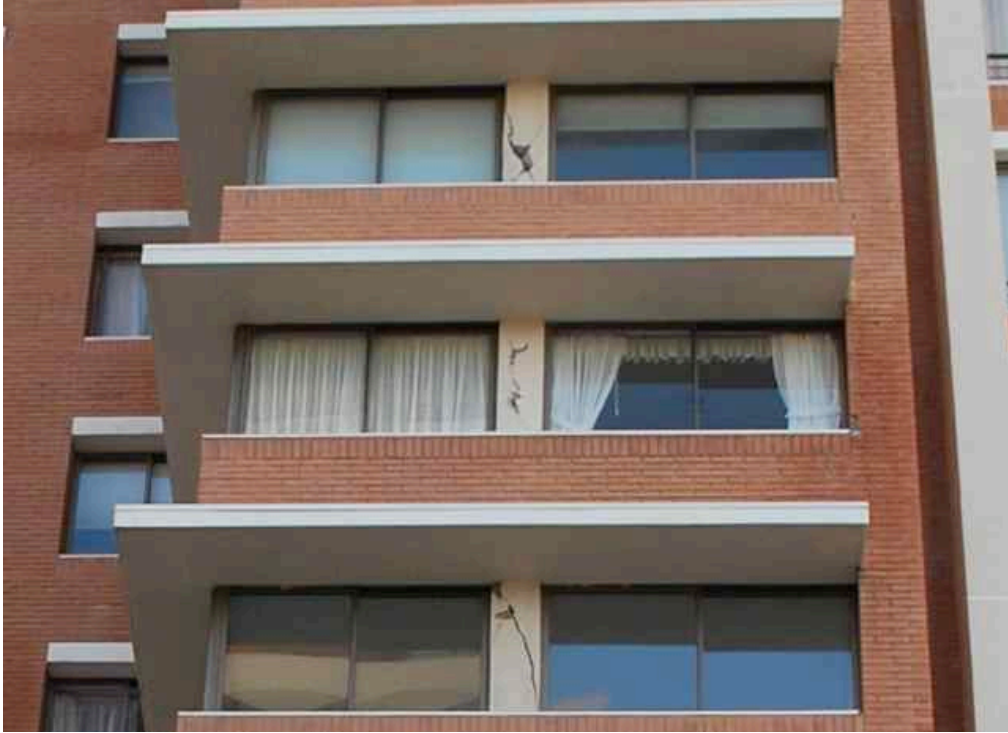
Figure 5.25. Site DA020 (S 33.018678° W 71.556288°, 1953 hrs on 03/14/2010). Diagonal cracks of columns in all the floors of 19-story building.

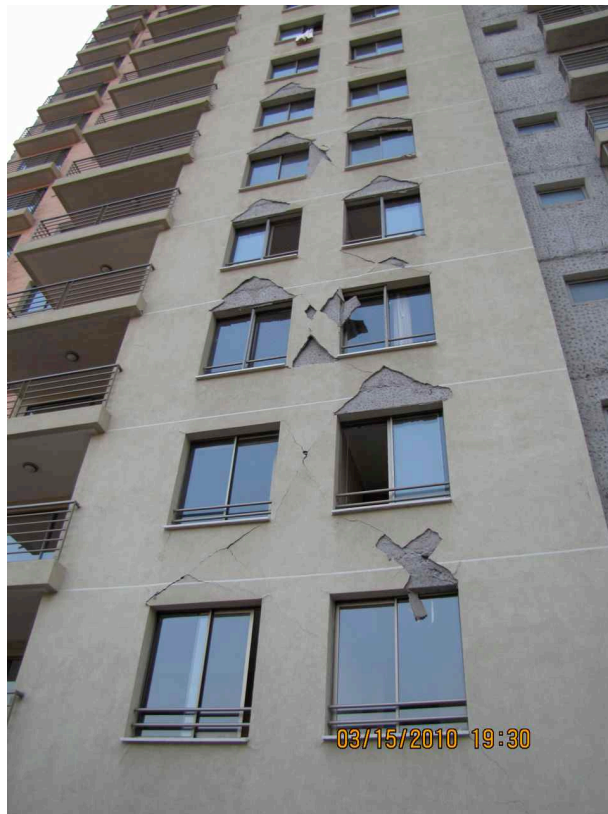
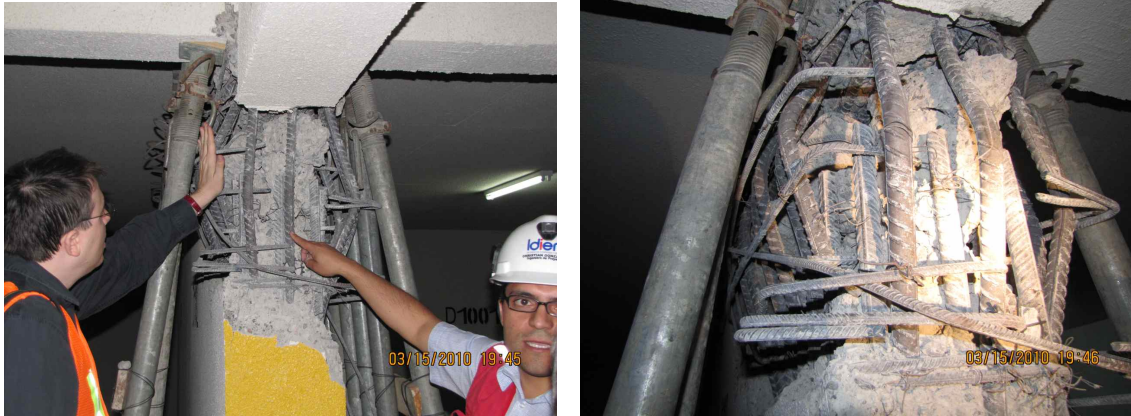
Figure 5.26. Site DA027 (S 33.020074° W 71.544055°, 1945 hrs on 03/15/2010). Heavily damaged 20-story building, lack of confinement at beam-column joints.

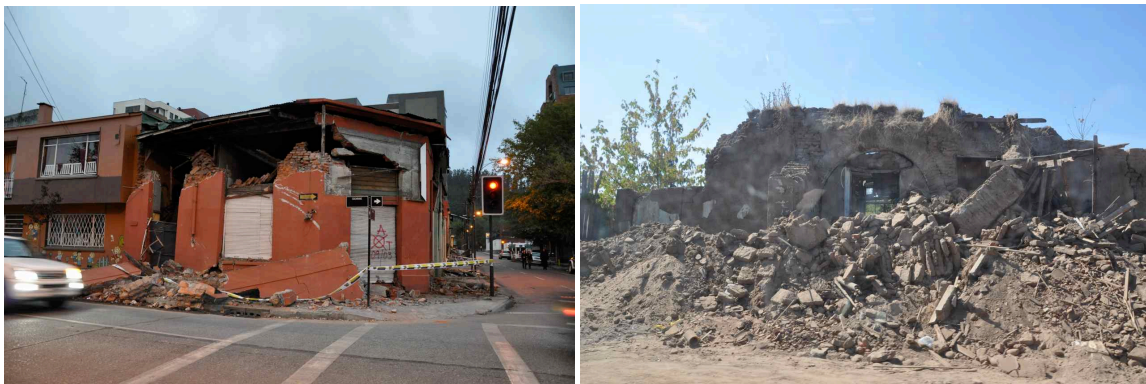
Figure 5.28. Adobe and unreinforced concrete damage concentrated adjacent to the Maule river across Talca (pictures shot from passenger seat while driving).

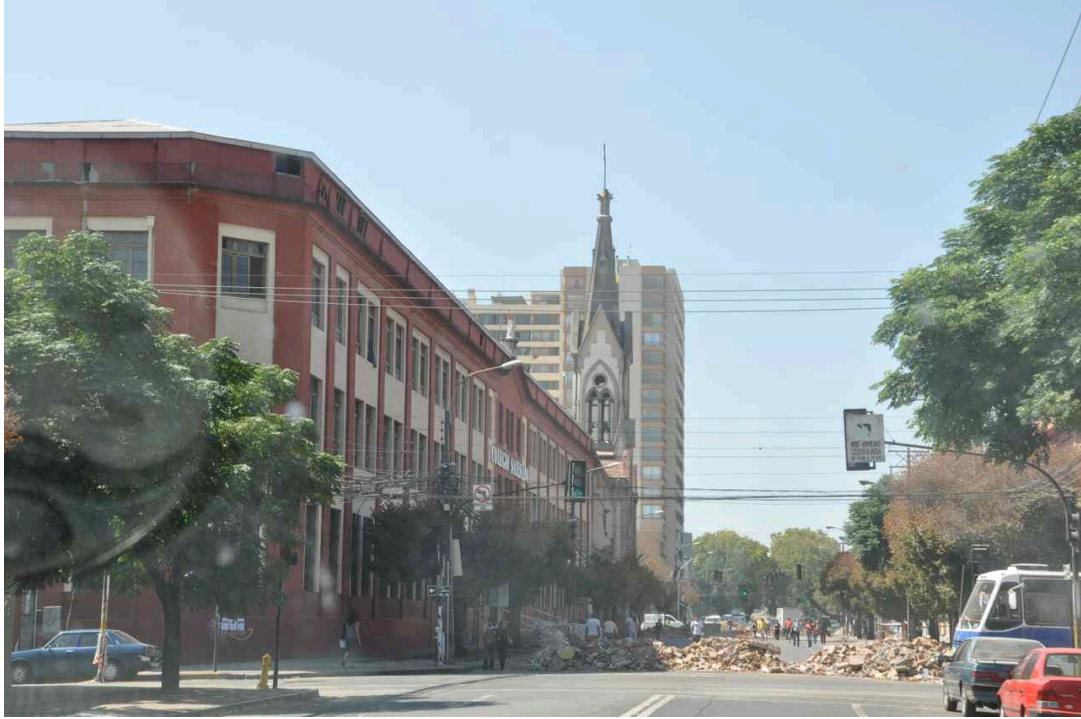
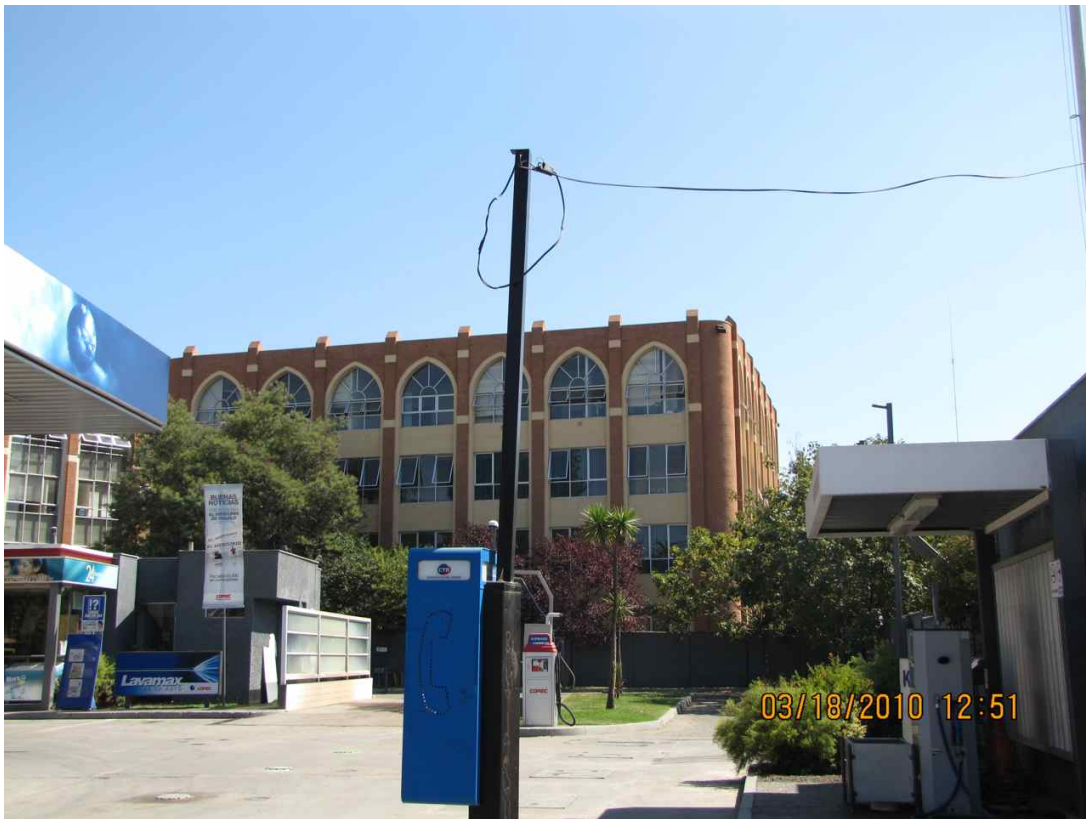
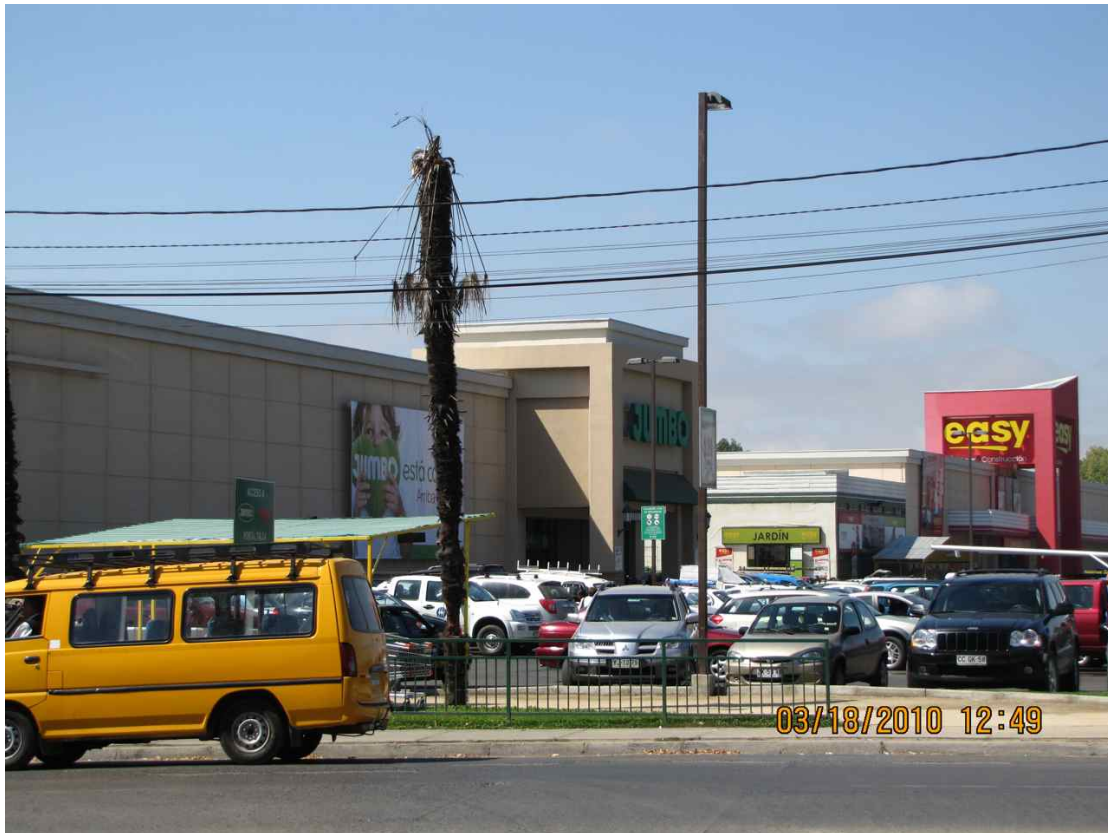
Figure 5.29. Modern (engineered) structures adjacent to the river that showed no or minor damage (S 35.437897° W 71.660151°, 1249 hrs on 03/18/2010).

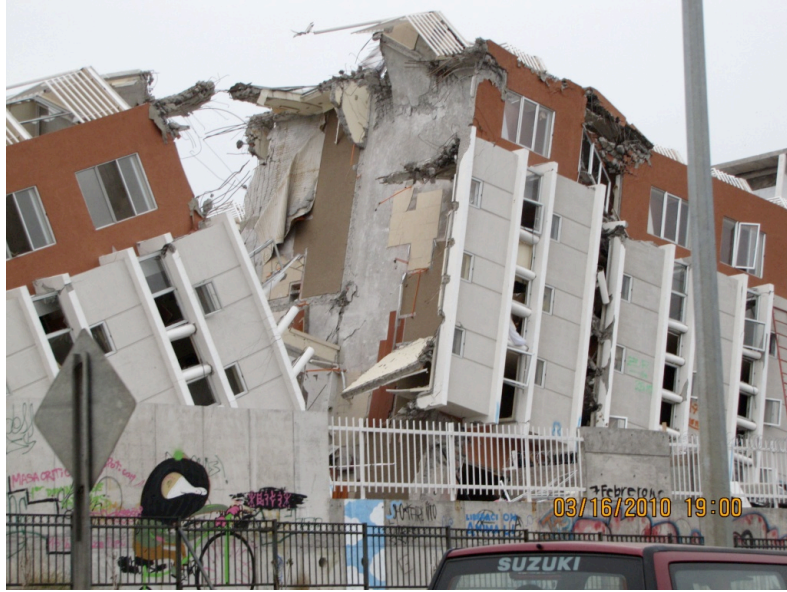
Two adjacent 20-story structures were inspected during reconnaissance close to the Llacolen bridge in downtown Concepción (see location in Figure 5.32), one fully collapsed during the 2010 event and the other suffered minor damage and is currently being repaired. The collapsed building was designed using Site Type II (Chilean design code) and the one that did not collapse using Site Type III, which implies different design spectra. While there is no evidence that the soil conditions are indeed different at the locations of the two structures (distance between approximately 20m), the difference in design spectra likely played an important role in the failure of the building. The locations of the two buildings are depicted in Figure 5.33 below.

Figure 5.34. Collapsed structure (S 36.828067° W73.061639°, 1900 hrs on 03/16/2010) designed using Soil Type II conditions.

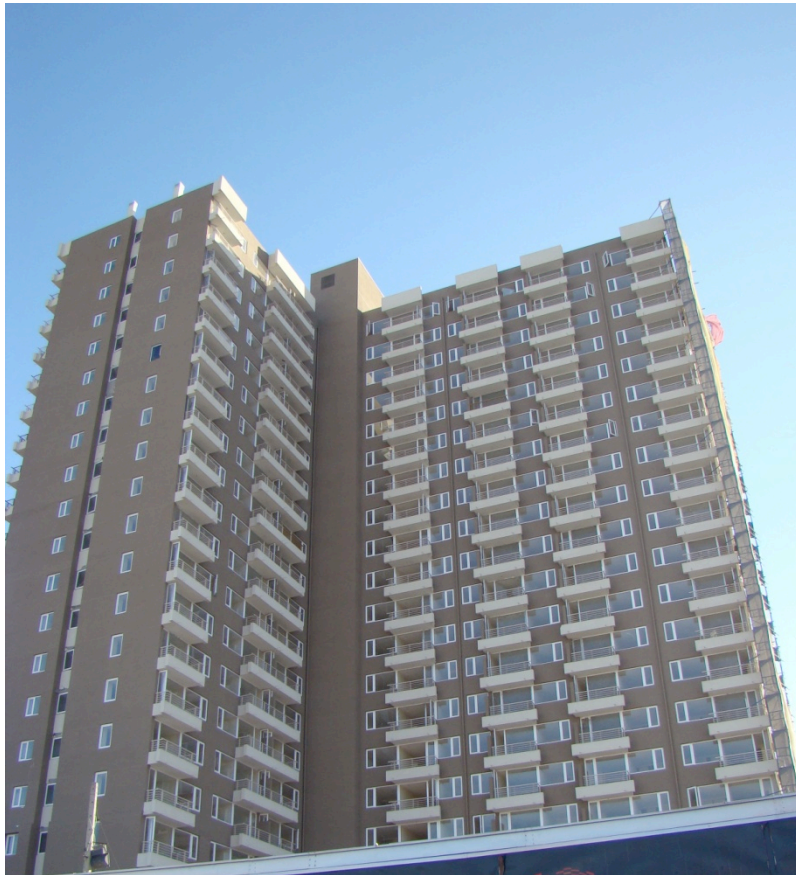
Figure 5.35. 20-story structure adjacent to collapsed (S 36.828083° W 73.060600°, 1910 hrs on 03/16/2010) designed using Soil Type III conditions, and suffering only minor damage.
