7.0 EFFECTS OF GROUND FAILURE ON BUILDINGS

7.1 General

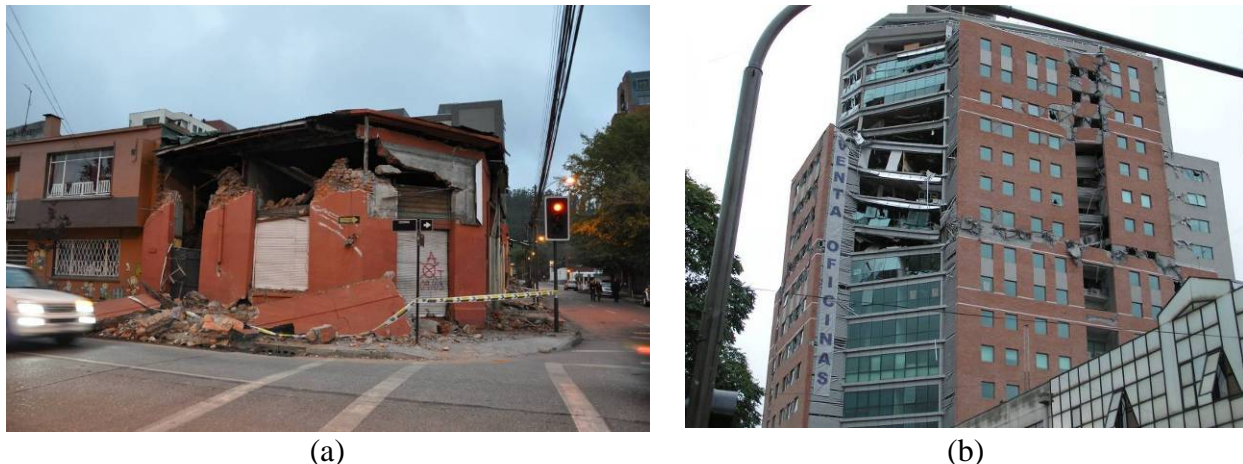
Figure 7.1. (a) Typical construction type and observed damage within the city of Talca ($S36.8323^\circ, W73.0554^\circ$; 1230 hrs on 3/18/2010) and (b) Significant structural damage, including partial collapse of a floor, of a modern high-rise building in downtown Concepción ($S36.8296^\circ W73.0550^\circ$; 2000 hrs on 03/17/2010).

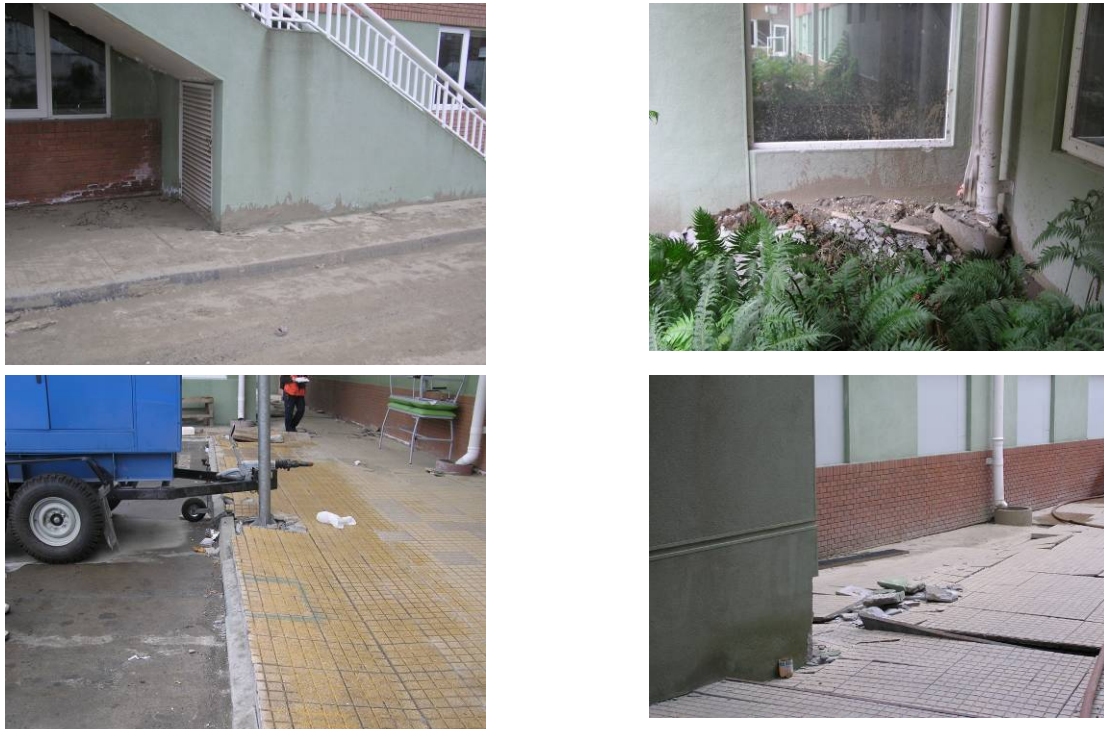
Clear evidence of soil liquefaction was observed throughout the hospital grounds adjacent to the structures. Sediment ejecta was observed along the west side of the hospital (Figure 7.7a), inside the two interior courtyards (Figure 7.7b), along the south side of the hospital (Figure 7.7c), within the walkway separating Wings 1B and 1F from Wing 2G (Figure 7.7d), and in other locations. Several samples of the ejecta were taken at this site, and grain size analysis and Atterberg limit testing is being performed and the results of this testing will be included in later versions of this report. The collected ejecta samples appeared to range from plastic silts to low plasticity silty sands.

Figure 7.7. Sediment ejecta observed around hospital wings; (a) ejecta observed along exterior staircase of Wing 1D (S37.47358°, W73.34890°), (b) ejecta observed along exterior of Wing 1C (S37.47342°, W73.34829°), (c) ejecta observed along south side of Wing 1D(S37.47375°, W73.34851°), and (d) ejecta observed along east side of Wing 2G (S37.47343°, W73.34788°).

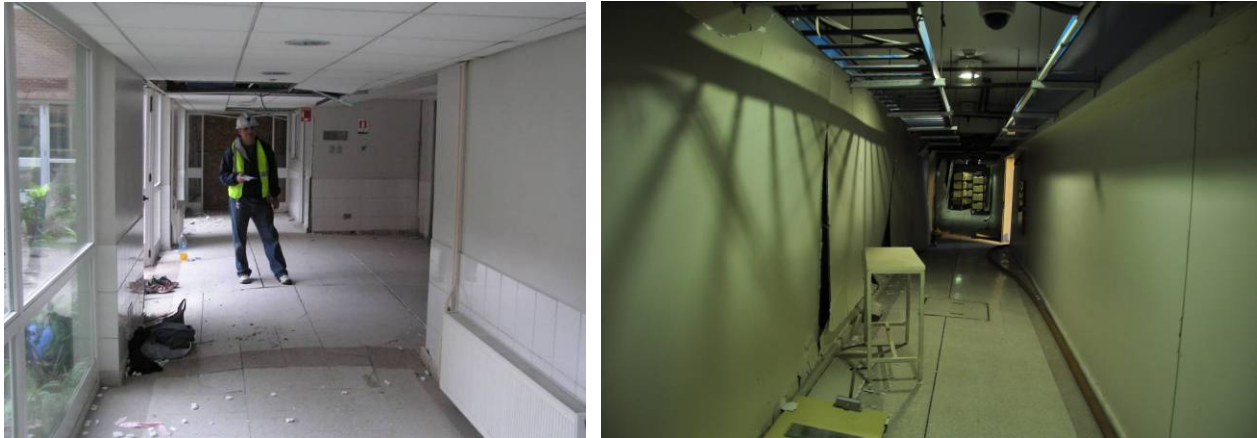
There was also evidence of internal distortion of these structures and their foundations. Bulging of the ground slab in front of the elevator shaft in Wing 1C is shown in Figure. 7.9a. The slab raised up about 19 cm relative the undeformed slab in the foreground of the picture. There was also evidence of floor bulging up or distorting in other wings of the hospital, such as the extensive warping of the slab-on-grade in Wing 1B as shown in Figure 7.9b.

Figure 7.9. Distortion of the slab-on-grade: (a) floor bulging in front of elevator shaft in Wing 1C (S37.47345°, W73.34835°), and (b) floor distortion in eastern hallway of Wing 1B (S37.4733°, W73.3478°).

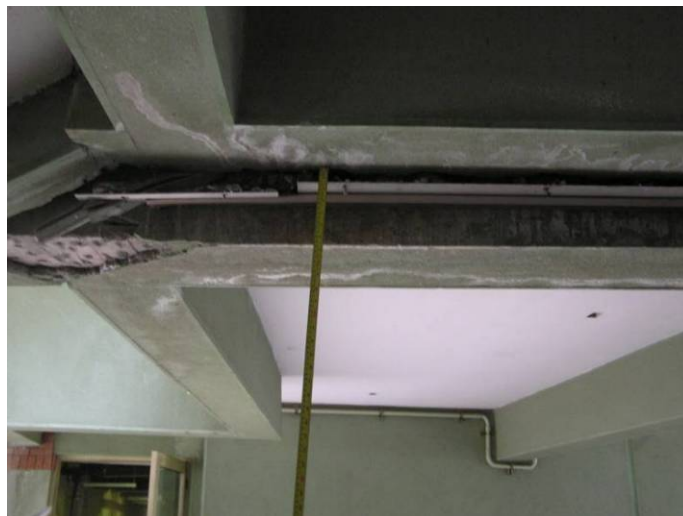
Relative movement between Wings 1B and 2G was apparent at the connection of these two wings as shown in Figure 7.10. At the northeast corner of the Wing 1B extension adjacent to the northwest corner of Wing 2G, Wing 1B displaced 4.5 cm downward and 4 cm southward relative to Wing 2G. The downward movement of Wing 1B relative to Wing 2G at the location of the photograph shown in Figure 7.10 was 14 cm. The measured relative offset between these two wings, however, was non-uniform, which suggested that Wing 1B tilted with respect to Wing 2G, which appeared not to tilt. The tilt of Wing 1B was reliably measured to be 1.5° with its top displacing to the south relative to its base. The southeast corner of Wing 1B displaced downward 8 cm relative to Wing 1F. The northwest corner of Wing 1B displaced downward 4 cm relative to Wing 1A. Wing 1B also displaced laterally to the south about 4 cm relative to Wing 2G.

Figure 7.10. Relative movement between Wing 1B (in the background) and Wing 2G (in the foreground) (S37.47335°, W73.34786°; 03/16/10).

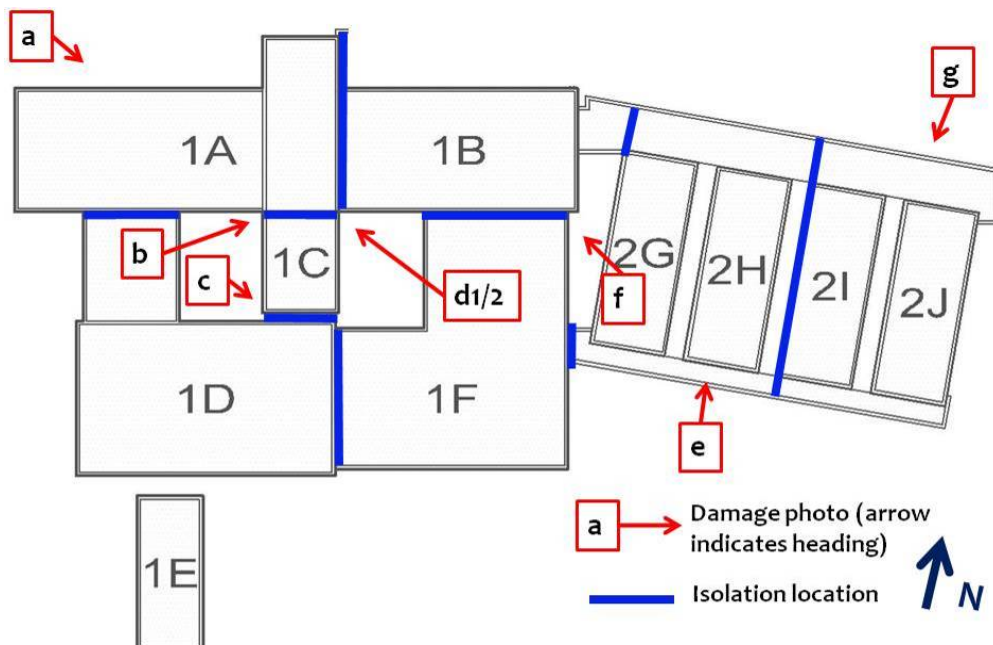
Structural and nonstructural damage was observed throughout the hospital; however, the extent of structural damage was minimal due to the isolation gap provided between the wings. The most pronounced damage was associated with closure of the seismic gap and resulting contact between wings, and in particular, Wing 1C and its neighboring structures (1A, 1B, and 1F). Select locations of shear wall damage were noted; however the extent of this was minimal. Figure 7.11 provides a map of the more pronounced structural damage observed, with photographic documentation associated with the map provided in Figure 7.12.

Figure 7.11. Damage map denoting select locations of observed perimeter damage; refer to Figure 7.12 for photographs and description of observation associated with letter annotations in this figure.

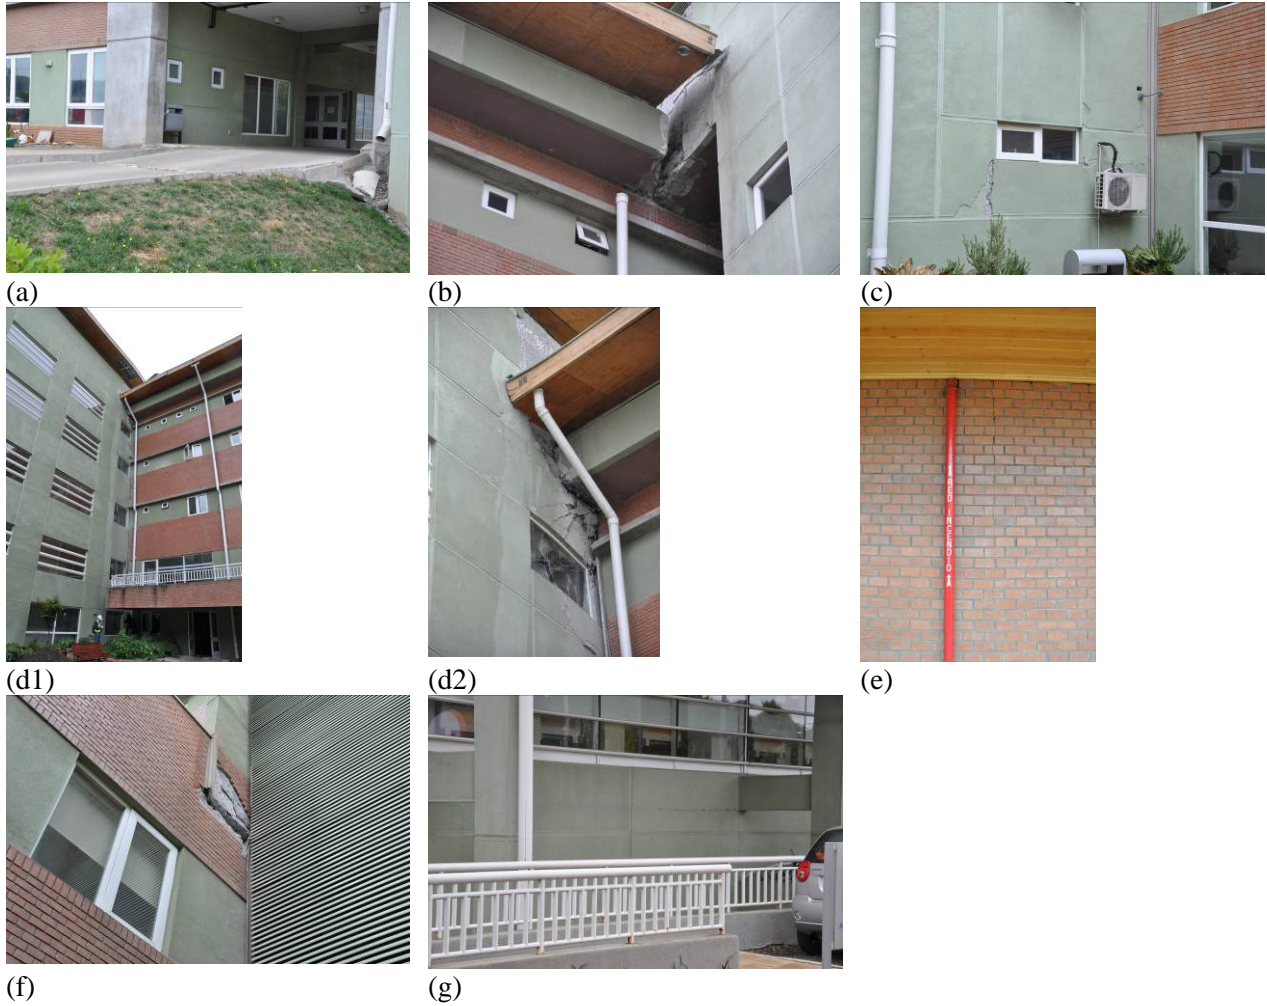
Figure 7.12 Most pronounced structural damage observations. (a) approach ramp to entrance bay at wing 1A (S37.473084°,W73.348712°), (b) pounding damage and resulting permanent gap developed between wings 1A-1C due to the easterly rocking of wing 1C (note the gap was measured by hospital staff as 37 cm after the main event on February 27, 2010) (S37.473376°, W73.348452°), (c) damage to shear wall of wing 1C due to contact with wing 1D (S37.473537°, W73.348488°), (d1) elevation view of the interface between wing 1B-1C and (d2) local view at the roof line of wing 1B observing the pounding between these two wings (S37.473406°,W73.348304°), (e) vertical cracks in masonry in-fill of wing 2H (S37.473713°, W73.347839°), (f) fallen masonry façade and spalling of structural wall of wing 1F due to impact with wing 1B (S37.473494°, W73.347948°), and (g) cracking damage at in-fill and structural shear wall interface at front of wing 2I-2J (S37.473528°, W73.347363°). Images taken at 1430, 1715, 1415, 1725, 1725, 1350, 1625, and 1645 hrs, respectively, on 3/16/2010.

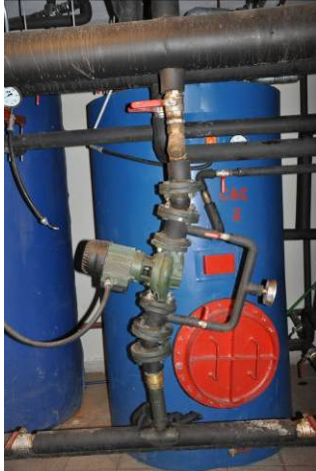
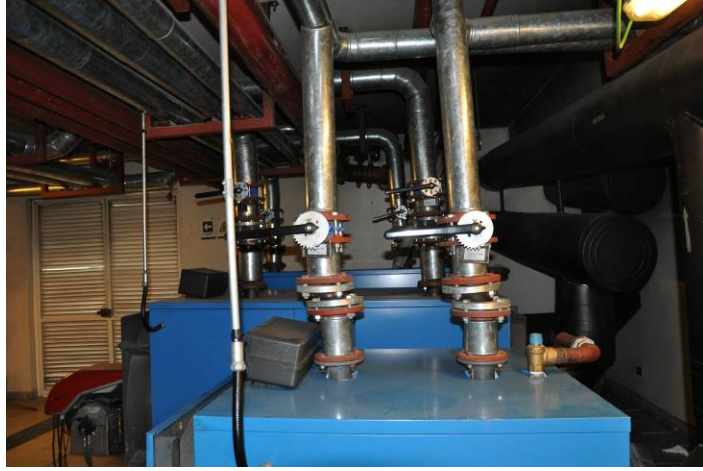
Figure 7.13. Generally good performance of building services equipment in the hospital building (note the blue tank in the background of the image of part (a) was unanchored and slide laterally, resulting in the lateral shift of the lower pipe run in the foreground). All connections were intact and operational for these service equipment. (images taken in wing 1F, approximately $S37.473577^\circ$, $W73.348042^\circ$; 1345 hrs on 3/16/2010).

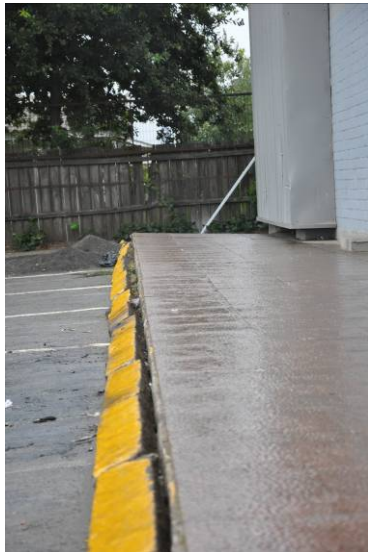
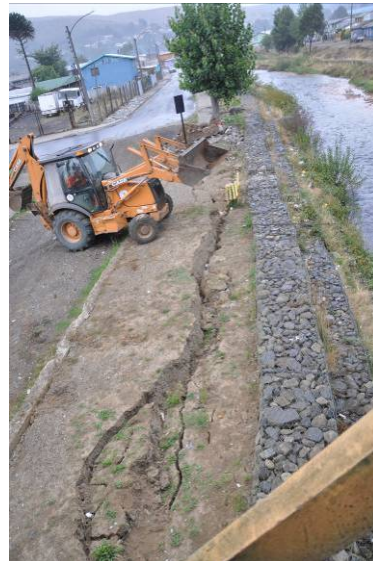
Slight evidence of liquefaction was observed to the north of the hospital in the parking lot area of a market (Figure 7.14a). Minor pavement distress and minor uplift of manholes in this area were observed. However, the pervasive liquefaction that was observed at the hospital was not observed here or at other locations in the city. Lastly, ground failure was observed near the river that is located south of the hospital (Figure 7.14b); however, the street that ran along the north side of the river showed no damage to its north, which indicates that the ground failure near the river was localized and did not extend to the hospital grounds.

Figure 7.14. (a) Curled sidewalk north across the street from the hospital ($S37.4727^\circ$, $W73.3477^\circ$) and (b) ground failure near the river south of the hospital ($S37.4742^\circ$, $W73.3471^\circ$; at 1930 and 1830 hrs, respectively, on 3/16/2010).

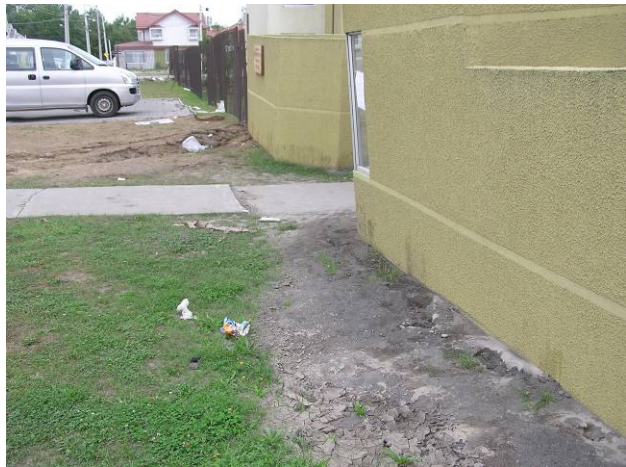
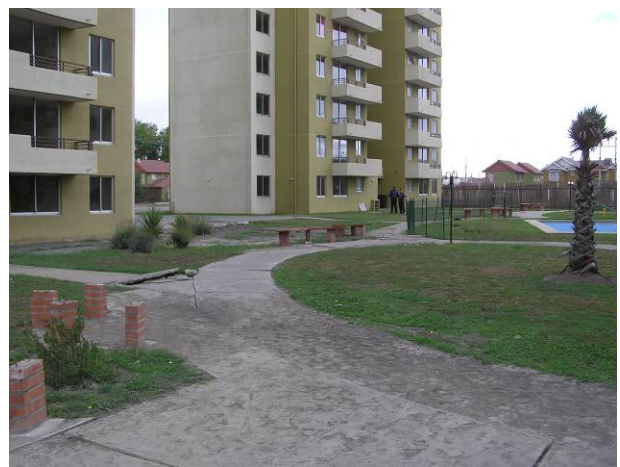
As shown in Figure 7.19, evidence of liquefaction of the gray sandy fill was present throughout the site. Sediment ejecta, ground cracking, ground settlement, and other evidence of liquefaction could be seen throughout the site. In the left photograph of Figure 7.19, sediment ejecta, ground settlement, ground cracks, and tilt of the guard room at the condominium entrance are seen. In the right photograph of Figure 7.19, similar evidence of liquefaction is seen inside the fenced area of the property.

Figure 7.19. Sediment ejecta, ground cracks, and other evidence of liquefaction of the sandy fill were found throughout the condominium site; however, street curbs around the property did not show evidence of liquefaction (S36.79107°, W73.08149°; 1300 hrs on 03/17/10).

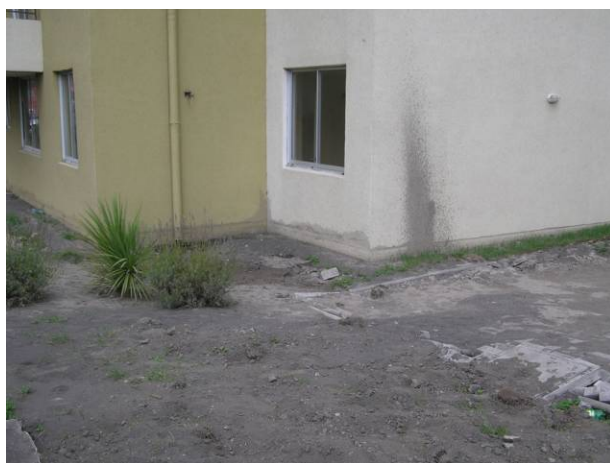
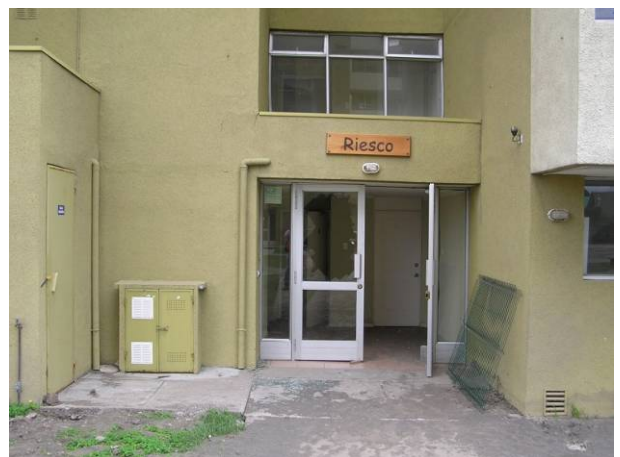
Clear evidence of sediment ejecta is seen in the left photograph of Figure 7.20. Large amounts of sand and water stains were observed in this area, which is at the northeast corner of the Riesco Building (i.e., the southwest existing building). The maximum vertical displacement of a building at this site was measured at this location. The base of the northeast corner of the northern extension of the Riesco Building displaced downward about 40 cm with respect of the ground adjacent to the Bulnes Building (i.e., the northwest existing building), which did not appear to undergo seismically induced permanent ground movement during the earthquake. The southern end of the Riesco Building, however, appeared to settle only 10 cm, and in this area, the ground surrounding the building actually settled an additional 9 to 14 cm more than the building's foundation. The top of the Riesco Building's northern end tilted 1° to the east and 1° to the north as a result of the differential ground movement across the building. The differential foundation movement produced tilting and warping of the interior on floor slab, which appeared to be on grade, and this produced damage of the living spaces as shown in Figure 7.21. A map depicting the measured foundation movement can be seen in Figure 7.22.

Figure 7.20. Riesco building that underwent most significant liquefaction-induced movement. Left photo shows evidence of large sediment ejecta at its northeast corner (S36.79077°, W73.08124°; 1330 hrs on 03/17/10). Right photo shows entrance to the building in the middle of its east facing side (S36.79089°, W73.08131°; 1310 hrs on 03/17/10).

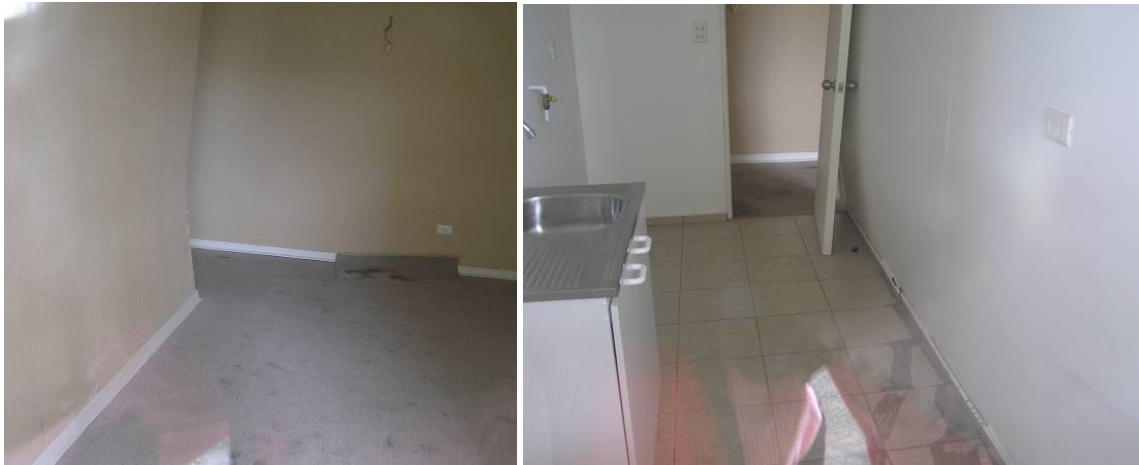
Figure 7.21. Evidence of interior damage to Riesco Building due to differential foundation movement (S36.79085°, W73.08128°; 1320 hrs on 03/17/10).

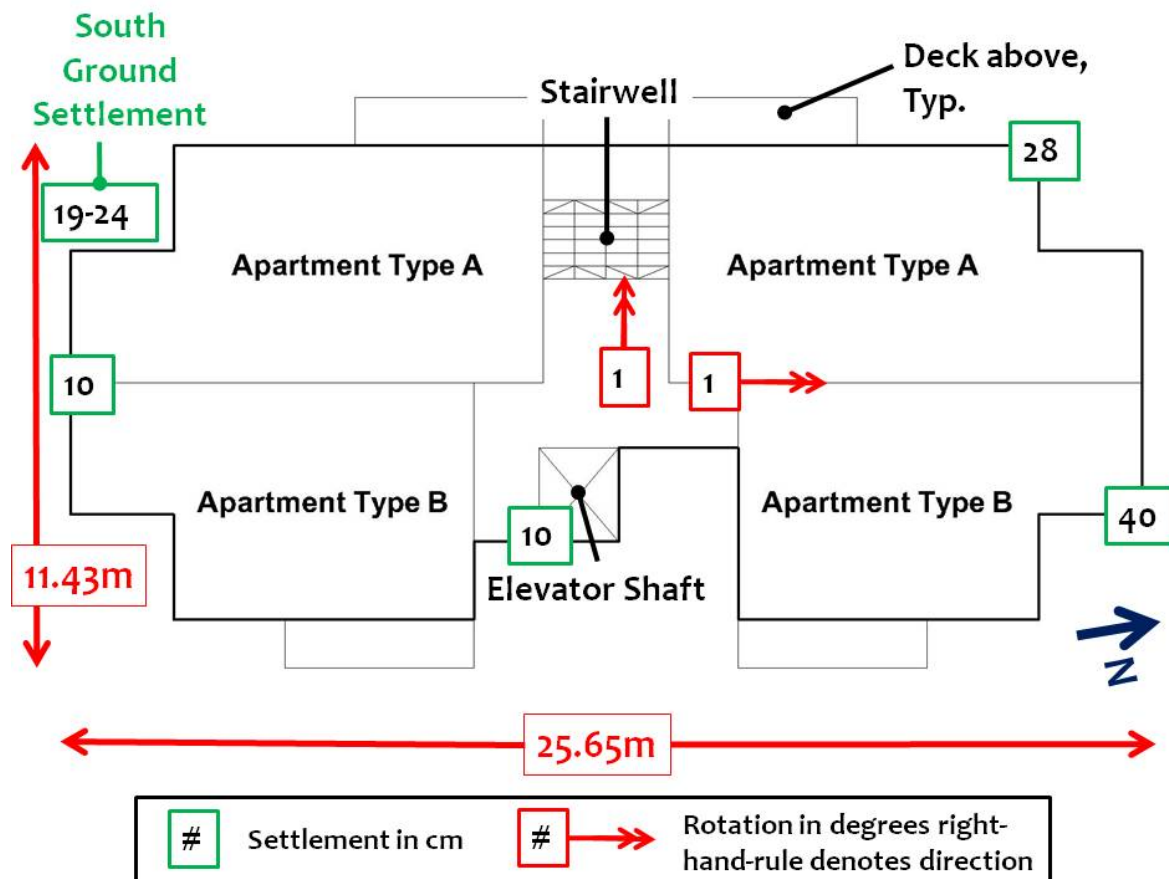
Figure 7.22. Schematic plan view of the Riesco building depicting measured movement of foundation. (note that rotation about the transverse axis of the building is believed to largely hinge about the shear wall-coupling beam interface as shown in Figure 7.23 (Bray, Hutchinson, Arduino, and Maureira).

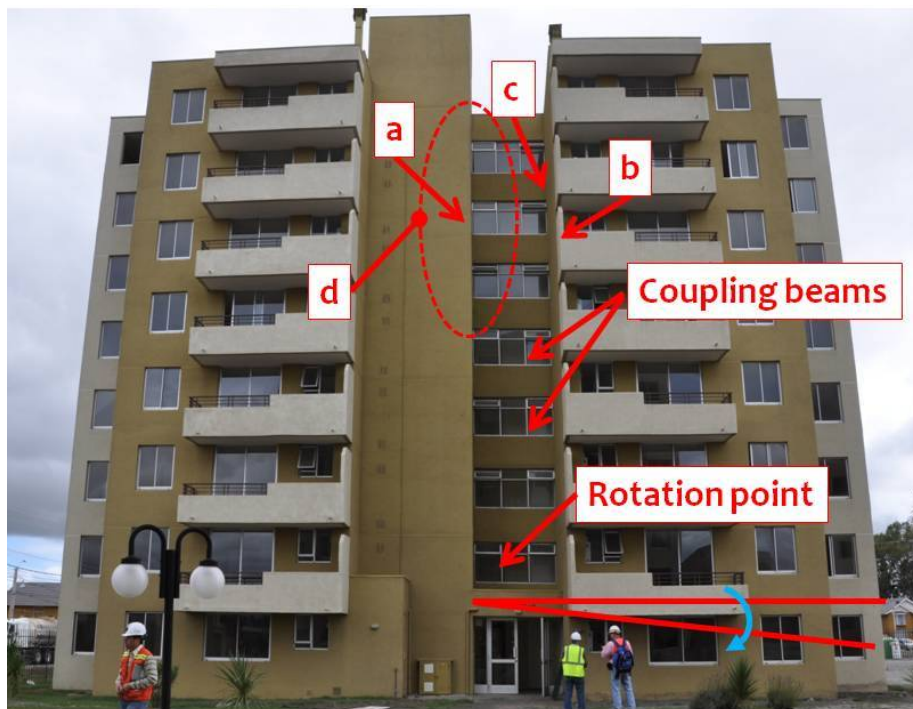
Structural damage to the Riesco building appeared to be largely a result of damage induced by differential settlement of its foundation. In particular, damage was precipitated by the significant liquefaction-induced settlement of the northern end of the building. As a result of the uneven foundation settlement and rotation about the transverse axis of the building of its northern half, excessive internal deformations were imposed on the coupling beams. All coupling beams up the height of the building were heavily loaded and observed shear failure at their interface with the full height shear wall at the elevator core (Figure 7.23 and 7.24). Shear walls in the transverse direction of the Riesco building appeared to be undamaged.

Figure 7.23. Elevation of the Riesco building depicting the movement characteristics (about transverse axis only) and resulting damage map – refer to Figure 7.24 for images of a-d (image taken at S36.790929°, W73.081296°; 1400 hrs on 3/17/2010).

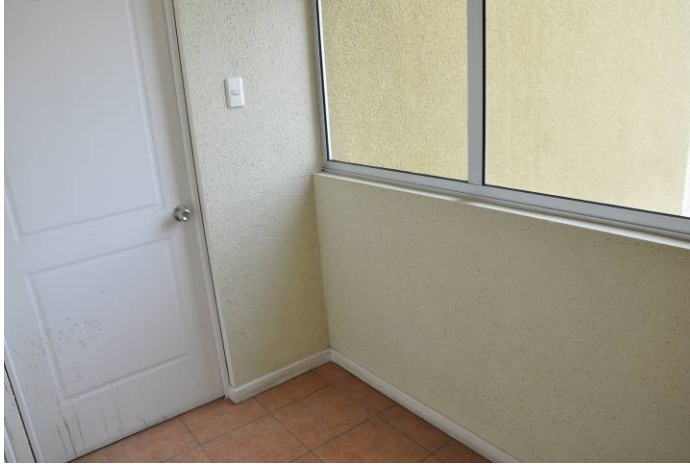
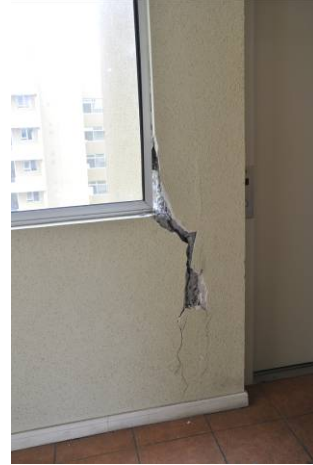
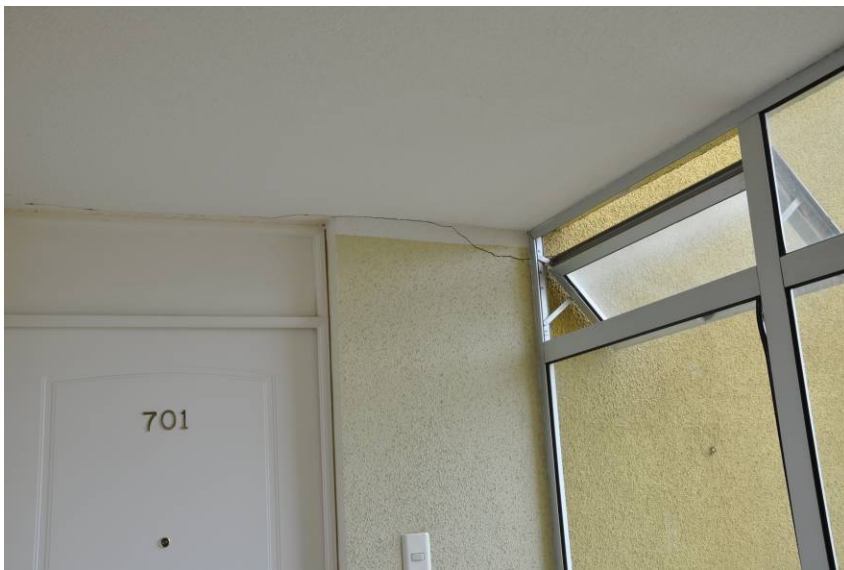
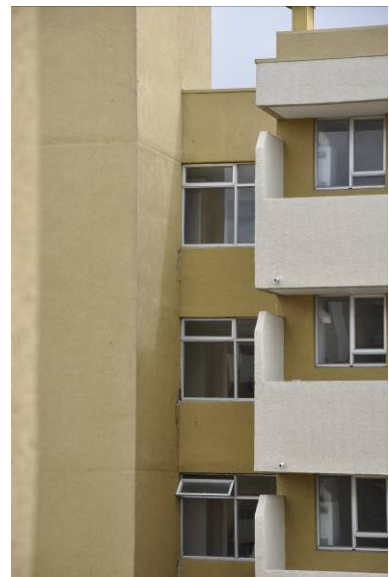
Figure 7.24 Observations at damage induced to the Riesco building due to liquefaction-induced movement of foundation. (a)-(c) at 7th floor of building; (a) left (north) end and (b) right (south end – at elevator shearwall interface), (c) ceiling-wall interface at end of coupling beam. Images taken at approximately S36.790867°, W73.081391°. (d) upper floor level coupling beam damage. Image taken at S36.791063°, W73.081043°. (images taken at 1430, 1430, 1430, and 1400 hrs, respectively on 3/17/2010).

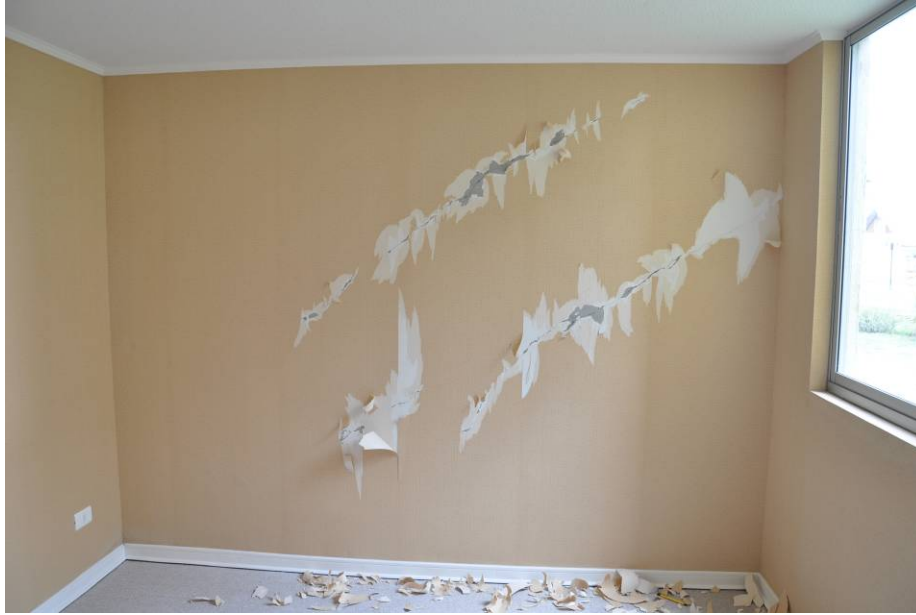
In contrast transverse shear walls in the other three buildings, which did not significantly rotate, suffered damage to the first floor structural shear walls in the form of large shear cracks (Figure 7.25). Nonstructural damage to these buildings included primarily cracked and fallen glass and partition wall damage buckling and cracking (e.g., see Figure 7.26).

Figure 7.25 Damage to ground floor shear walls of the Montt building (S36.790737°, W73.080901°; 1545 hrs on 3/17/2010)

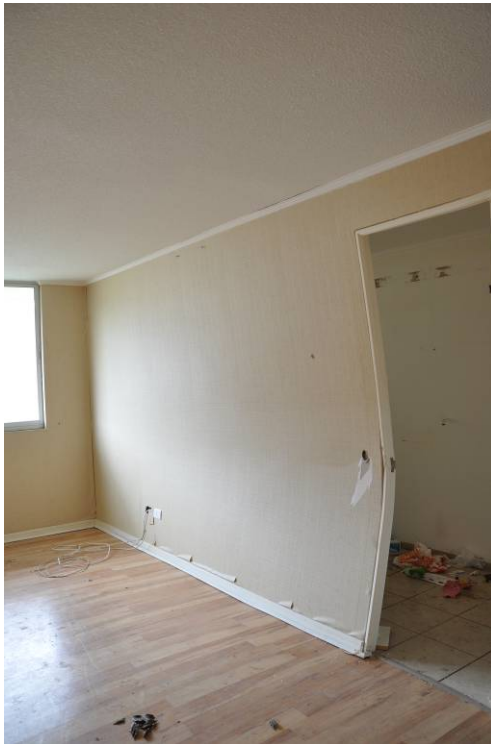
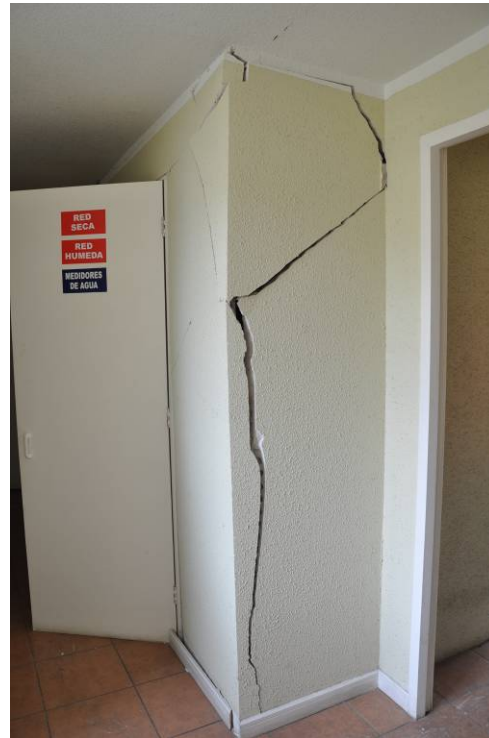
Figure 7.26. Typical nonstructural damage to nonstructural components in the buildings. Interior partition wall due to bulging of the ground slab (ground floor Errázuriz building, S36.791063°, W73.081043°; 1415 and 1430 hrs, respectively, on 3/17/2010)

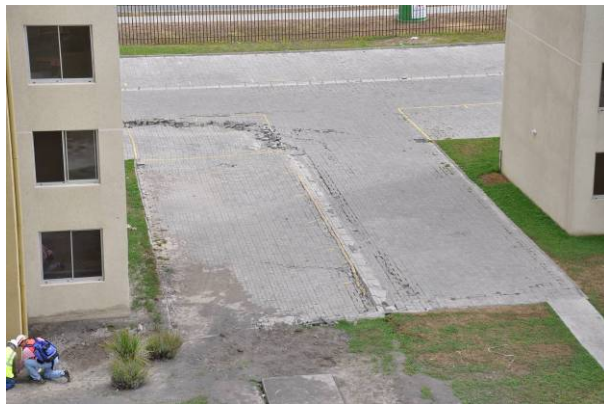
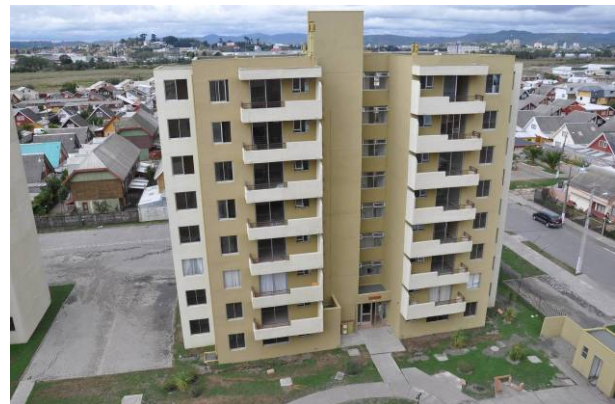
Figure 7.27. Ground settlement and ejecta pattern (a) between the Riesco and Bulnes building (taken from the Errázuriz building; S36.7909°, W73.0810°; 1400 hrs on 3/17/2010) and (b) surrounding the Errázuriz building (taken from the Riesco building; S36.7909°, W73.0814°; 1430 hrs on 3/17/2010).

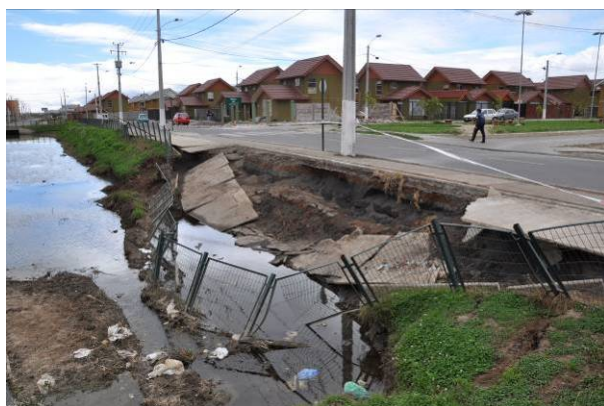
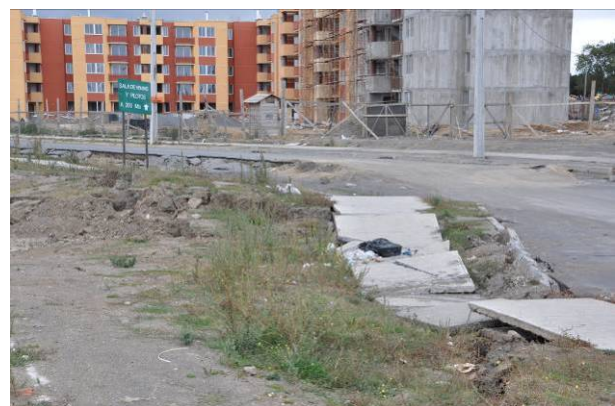
Figure 7.28. Neighboring ground failures at (a) sidewalk adjacent to a culvert about 120 m north of condominiums (S36.7898°, W73.0813°; 1300 hrs on 3/17/2010) and (b) roadside at 700m north of condominiums (S36.7847°, W73.0796°; 1630 hrs on 3/17/2010).

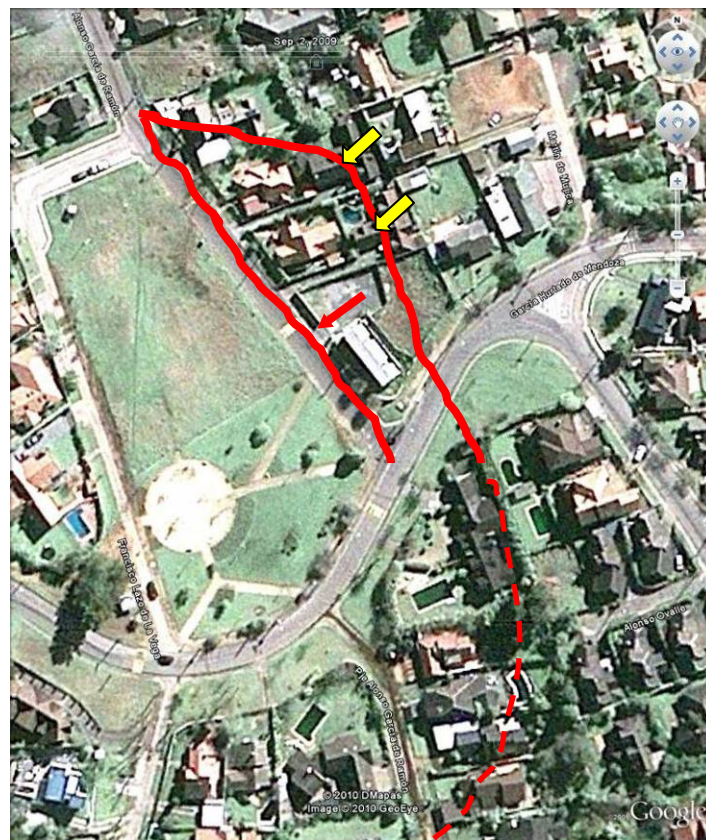
The slide appeared to be relatively shallow with its toe compressing ground directly along Alonso García de Ramón Road in a zone that was about 8 m wide, its head scarp causing a series of parallel extension cracks over a zone that was about 11 m wide, and its body between the toe and head scarp showing little evidence of internal ground distortion within it. Careful measurements across the head scarp extension zone at the location of the right photograph in Figure 7.32 showed that a zone that was 9.05 m wide initially (as evidenced by regular-sized pavement sections) extended about 1.7 m, so that it was now 10.73 m wide. At the toe of the slide, at the location of the person standing in the right photograph of Figure 7.30, the ground shortened about 1 m and pushed up about 1 m due to compression across a zone that was initially 8.5 m wide.

Figure 7.29. Affected area with approximate limits of the translational earth movement; the toe of the slide is along the eastern side of Alonso García de Ramón Road and the head scarp runs through the houses and the open field behind the rectangular apartment complex. ($S36.791841^\circ$, $W73.056996^\circ$). The yellow arrows denote the location of two severely damaged home which are shown in Figure 7.31.

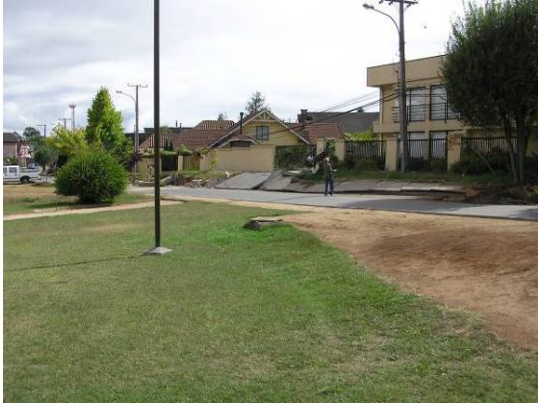
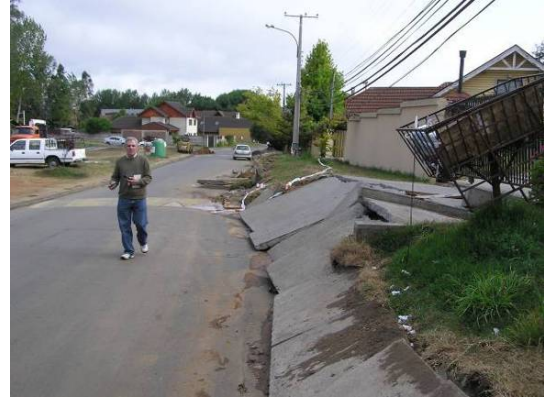
Figure 7.30. View to the north showing toe of slide in left photo, and view to the northwest of toe of slide along Alonso García de Ramón Road (right photo taken near its intersection with García Hurtado de Mendoza Road; S36.79146°, W73.05754°; 1200 hrs on 3/17/10).

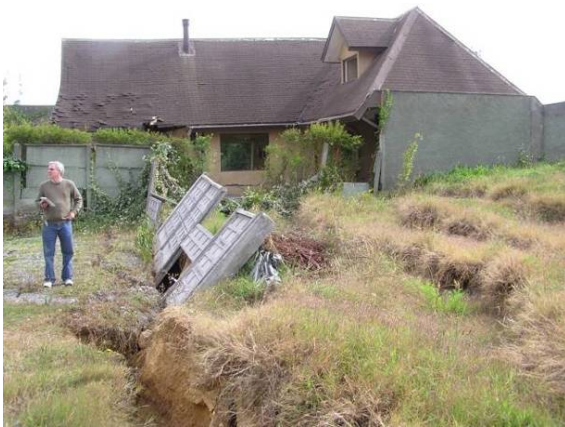
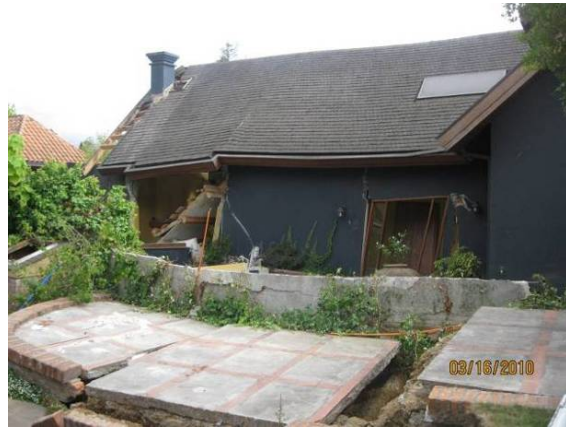
Figure 7.31. View of extension zone in open field behind apartment building (left photo(S36.79126°, W 73.05714°; 1120 hrs on 03/17/10), and view of damage to a home due to ground extension across its foundation (right photo, S36.79108°, W73.05728°; 1200 hrs on 3/17/2010).

The two homes identified in Figure 7.29 and shown in Figure 7.31 were the most heavily damaged structures in the area. Both of these structures were located across the head scarp of the landslide where the extension of the ground was most severe. Most damage to surrounding homes was cosmetic or limited to ground or hardscape dislocations, whereas these homes were severely damaged. Parents of the son residing in the home shown in Figure 7.34 informed the GEER team that the home was a total loss and will need to be demolished and reconstructed.

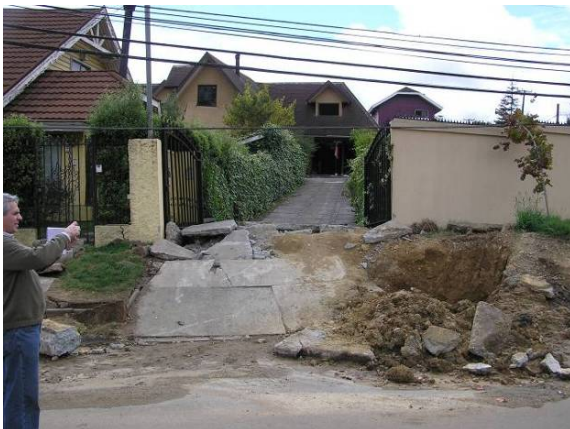
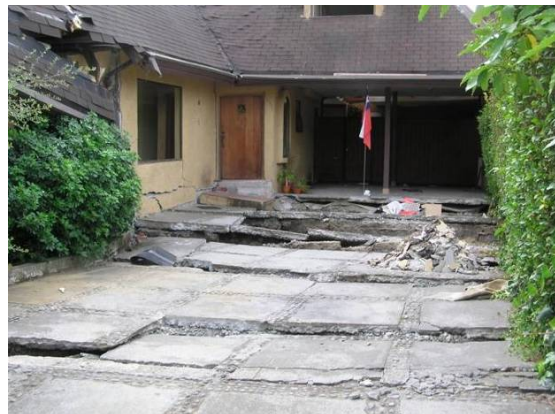
Figure 7.32. View of toe of translation slide in foreground of left photo (also note that the driveway behind the toe is not damaged(S 36.79134°, W 73.05762°; 1150 hrs on 03/17/10), and view of the head scarp of the translation slide at back of driveway in the right photo (S36.79126°, W73.05719°; 1130 hrs on 03/17/10).

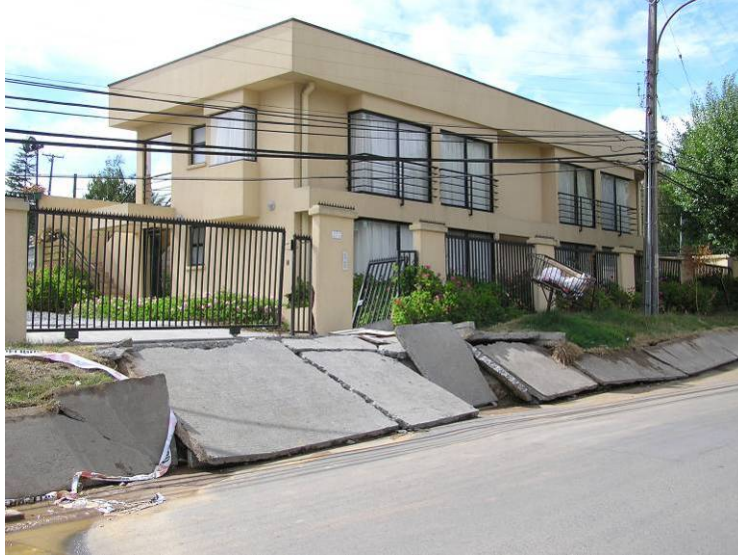
Figure 7.33. Apartment building underwent translation and tilt, but suffered no significant structural damage. (S 36.79167°, W 73.05721°; 1200 hrs on 03/17/10).

Interestingly, the 2-story apartment building shown in Figure 7.33, which is located near the intersection of Alonso García de Ramón and García Hurtado de Mendoza roads, showed no evidence of significant structural damage. Although the building translated to the southwest as a result of the translational earth movement, it did not appear to undergo internal distortion. However, its top tilted 1° to the northwest and 1° to the northeast, indicating that it had displaced and tilted in a rigid body manner.

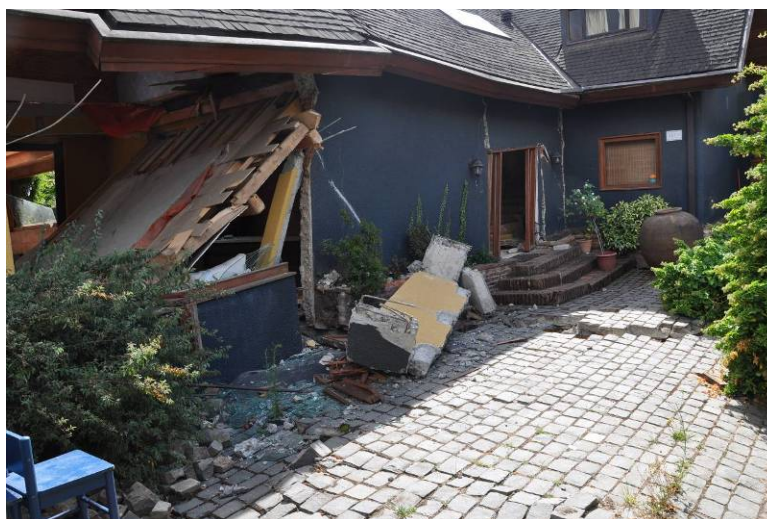
Figure 7.34. Single family residence severely damaged at backside of scarp (S36.79108°, W73.05728°; 1200 hrs on 3/17/2010).

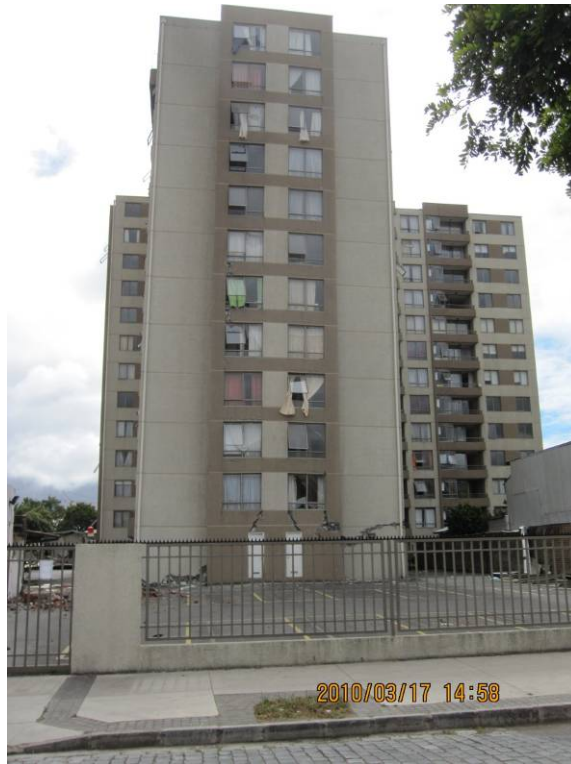
The EERI Reconnaissance Team observed damage of the south wing of a 13-story building located at 1343 Salas (S36.82044, W73.06164). The apartment building consisted of 2 rectangular wings in an offset T-shape (denoted as north and south wing in Figure 7.35). The north wings longitudinal axis runs approximately east-west, while the south wings longitudinal axis runs approximately north-south. The response of the two wings was extremely different. The north wing suffered only moderate damage, while the damage to the south wing was significant, including a residual tilt to the east of the entire wing. Residual tilt is believed to largely be attributed to cumulative structural damage. Failure was observed in the walls of the south wing, manifested as local shear as well as horizontal cracking (Figure 7.36).

Figure 7.36. Elevation view of 1343 Salas, looking north. North wing in is the background, while the south wing is in the foreground. Note shear and horizontal cracks in the wall on first floor of south wing. (S36.8205°, W73.0619°; 1458 hrs on 03/17/10).

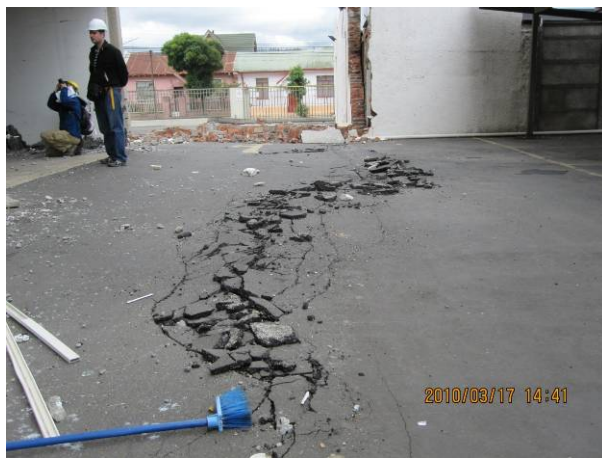
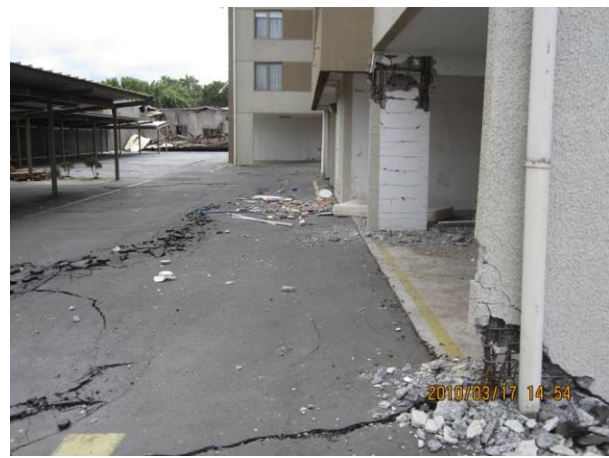
Although minor settlement was observed around both wings, pavement buckling was observed on the west, south, and east sides of the south wing (Figure 7.37), leading the EERI team to suspect that the south end foundation of the south wing underwent rocking during the shaking (Figures 7.37 and 7.38). The foundation below the north end (east-west running walls) of the south wing did not manifest pavement buckling. This may be due to restraint provided at the north end of the south wing foundation from the north wing. Minor pounding between the north and south wings was evident in the upper stories of the east side (Figure 7.39). It should be noted that the cracking pattern observed at the south end of the south wing was not pure shear as would be observed in well designed Chilean construction practice, but rather tension-type failure manifesting nearly horizontal crack patterns (Figure 7.37). For more information on the structural performance, refer to the EERI Reconnaissance Report.

Figure 7.37. Pavement buckling on the west side of the south wing (a) looking south and (b) looking north (note the utility settlement off to the left of the photograph and the diminishing intensity of damage to the structure, with greatest damage at south end – foreground of photograph) (S36.8205°, W73.0619°; 03/17/10).

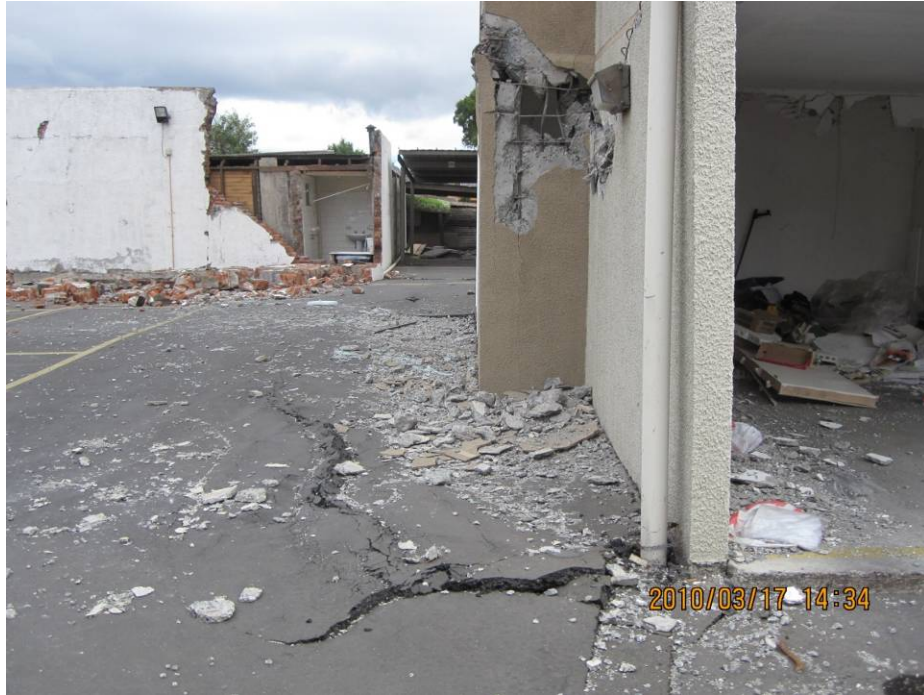
Figure 7.38. Pavement buckling on south side of south wing, view looking west (S36.8205°, W73.0619°; 03/17/10).

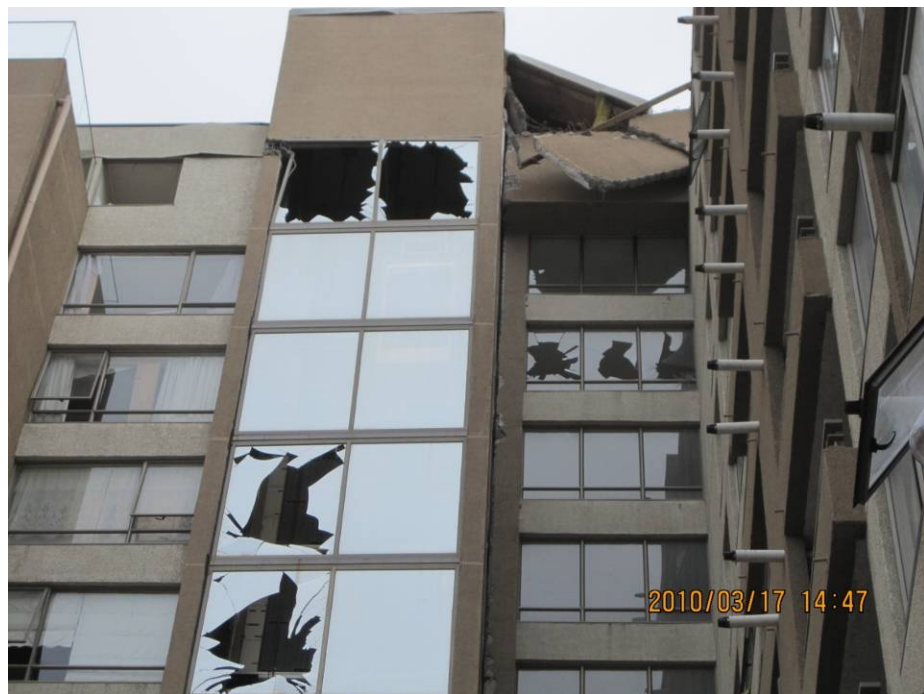
Figure 7.39. Interface between the north and south wings at the upper floors (north wing on right of photograph) showing evidence of minor pounding (view of east side, looking west) (S36.8205°, W73.0619°; 03/17/10).
