# A RECONNAISSANCE REPORT ON TYPHOON MORAKOT

September 21, 2009

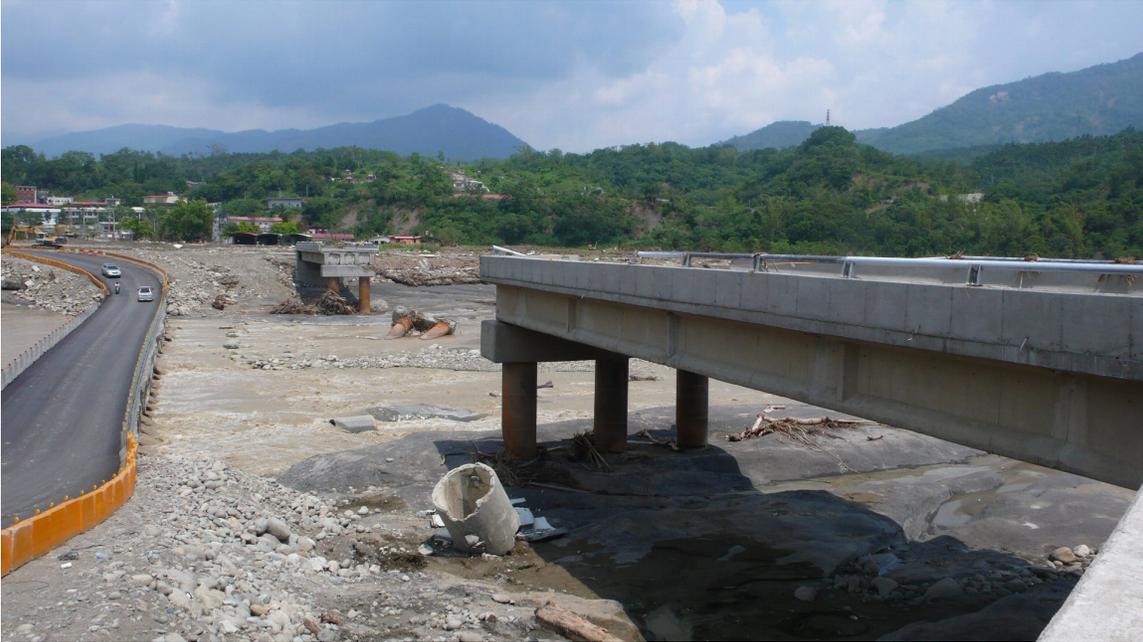
The Jia Xian Bridge was severely damaged by flooding (Photo 2-1-1) and a temporary access was built, as shown in Photo 2-1-2. Part of the bridge deck and piers (with steel pipe) disappeared. The retaining walls near the bridge abutment collapsed due to scouring (Photo 2-1-3).

Photo 2-1-1. Collapsed Jia Xian Bridge.

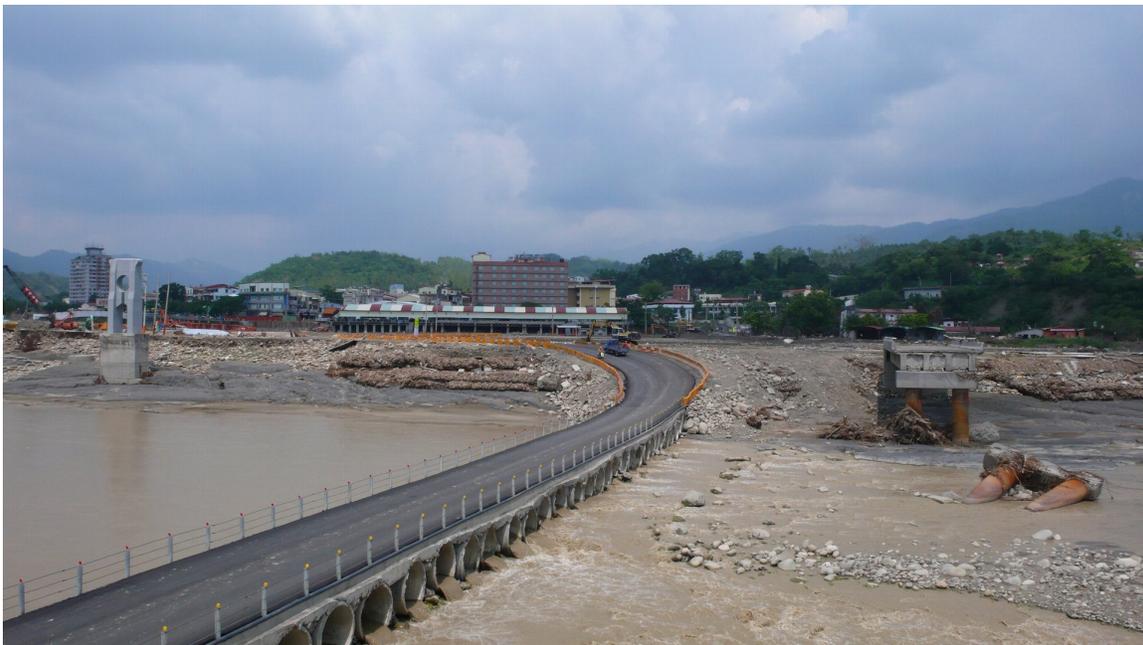
Photo 2-1-2. Temporary access bridge near Jia Xian Bridge.

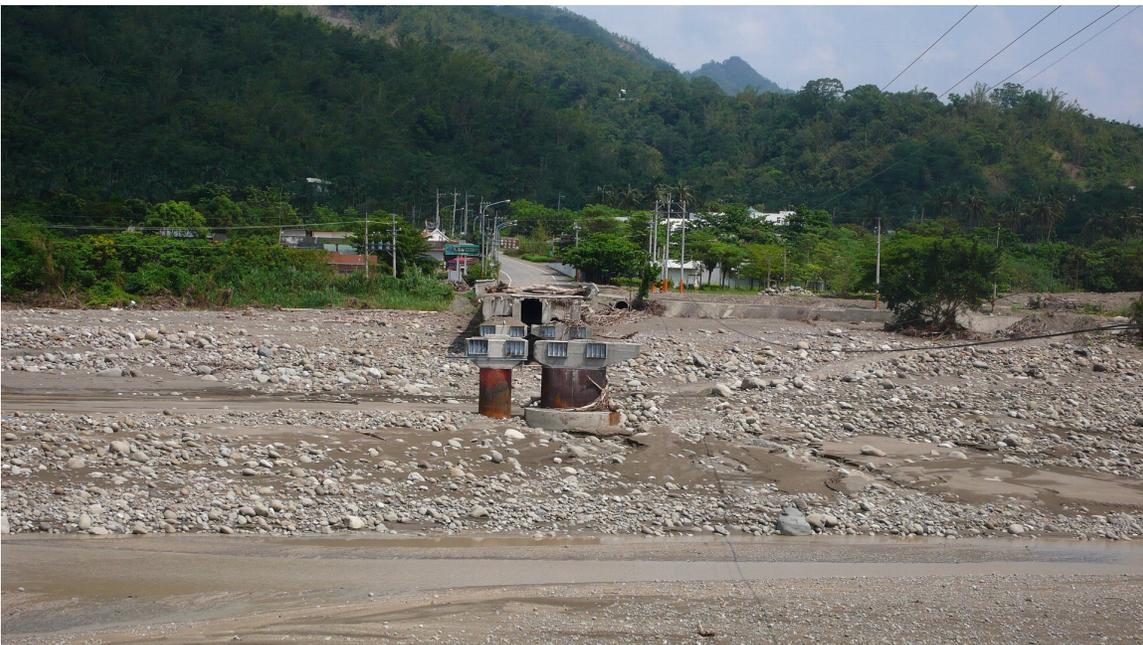
Side Bridge was also damaged by flooding. Almost the entire bridge deck disappeared, and part of the span was carried a distance down the river. Several piers disappeared, though the abutments remained. Timber debris piled at the site. The retaining walls near the bridge failed by scouring.

Photo 2-1-4. Part of the superstructure and pier foundation disappeared (Side Bridge).

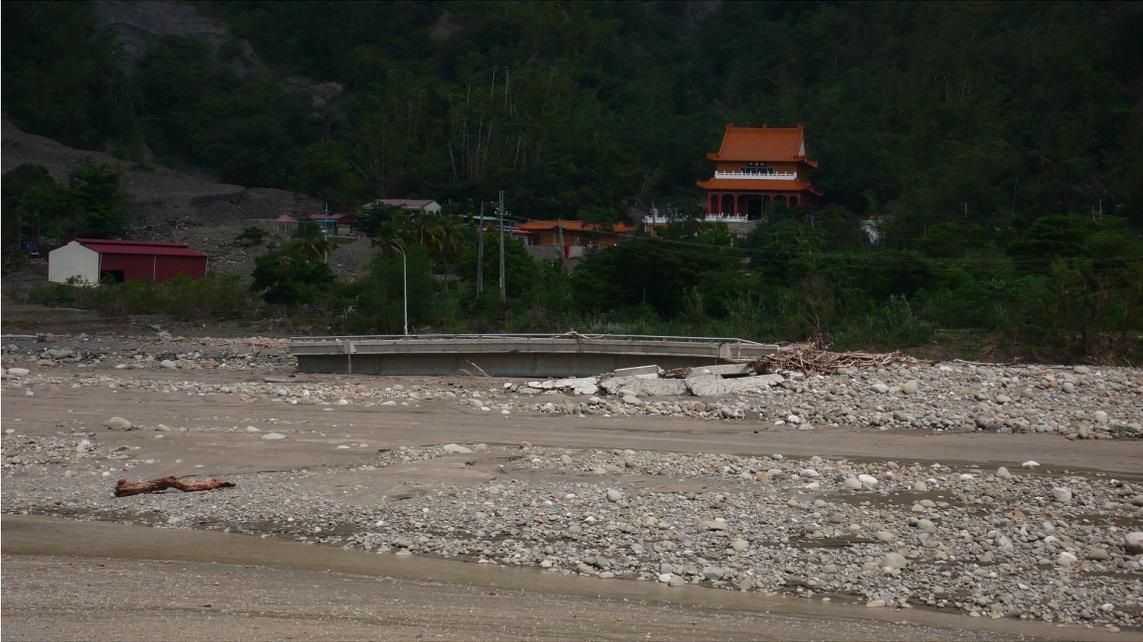
Photo 2-1-5. A span was washed downstream (Side Bridge)

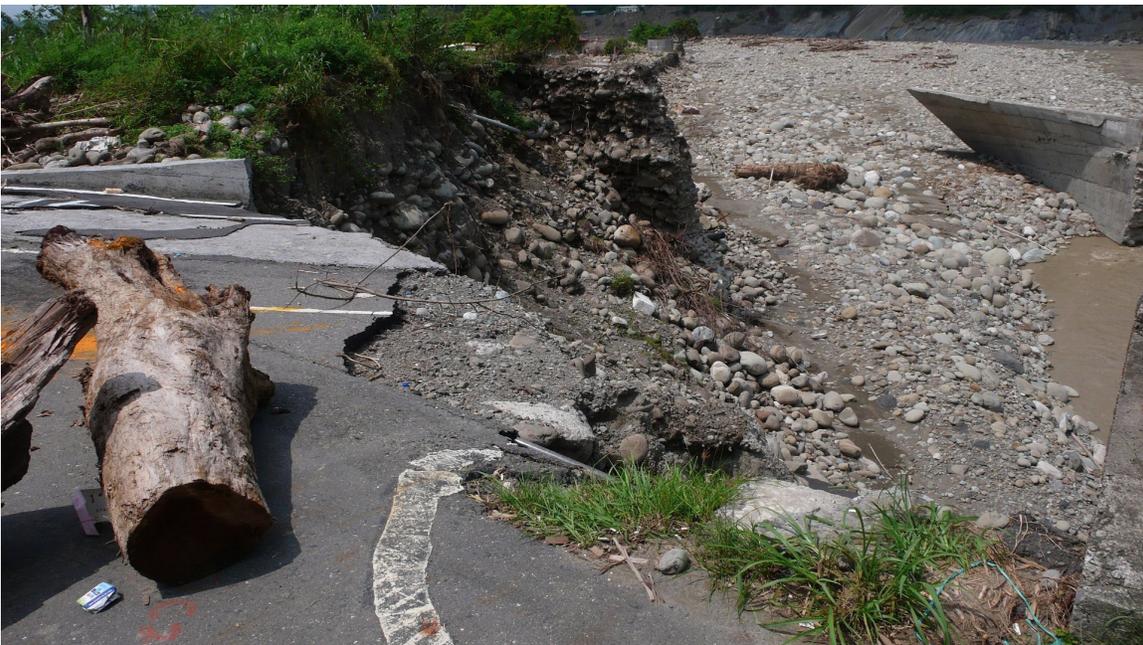
Photo 2-1-6. Scouring of the river bank and road. Note that part of a retaining wall stayed in the riverbed (Side Bridge).

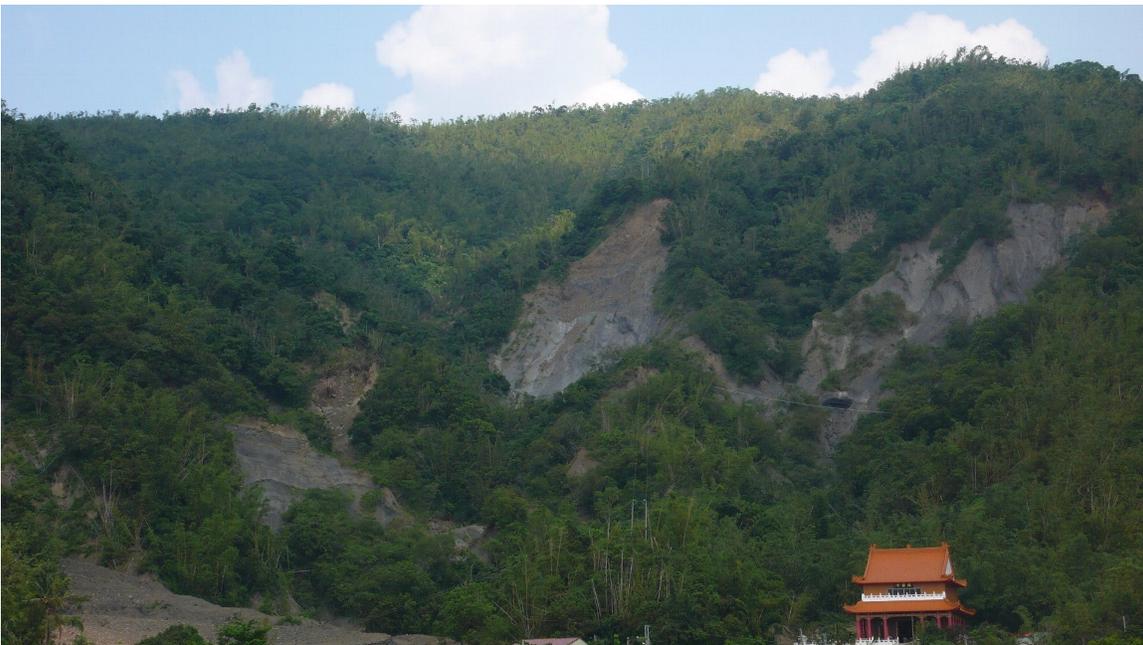
Photo 2-1-8. Landslides in the surrounding mountains.

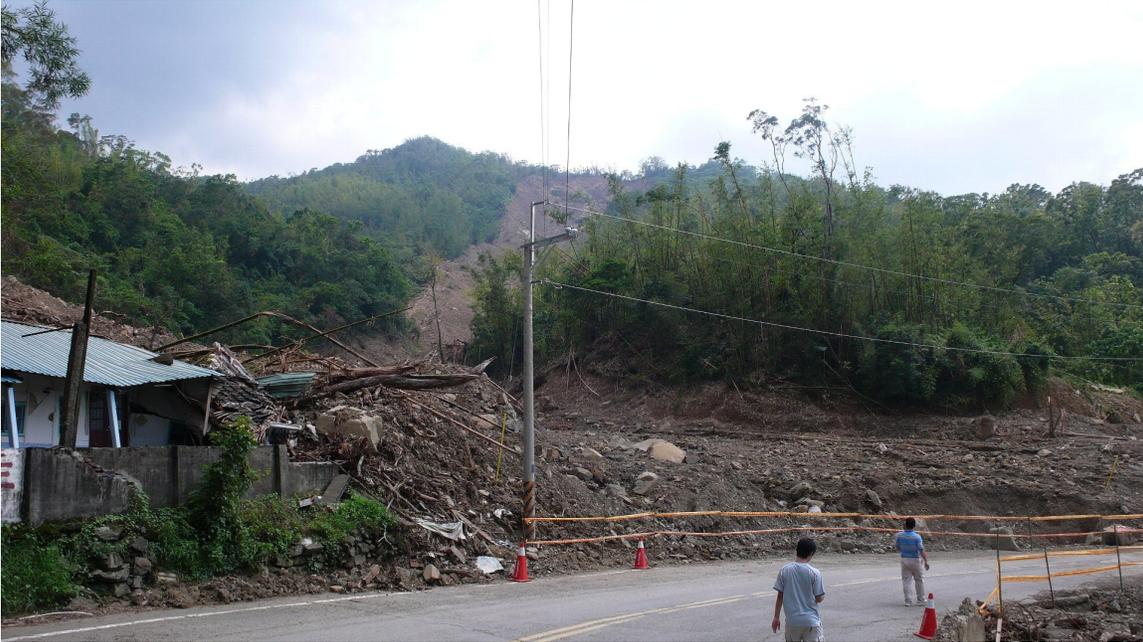
Along Wenhua Road (文化路), a debris flow inundated a residence and crossed over the road. Boulders of different sizes were observed (Photo 2-1-9).

Photo 2-1-9. Debris flow that originated from the mountain buried a home.

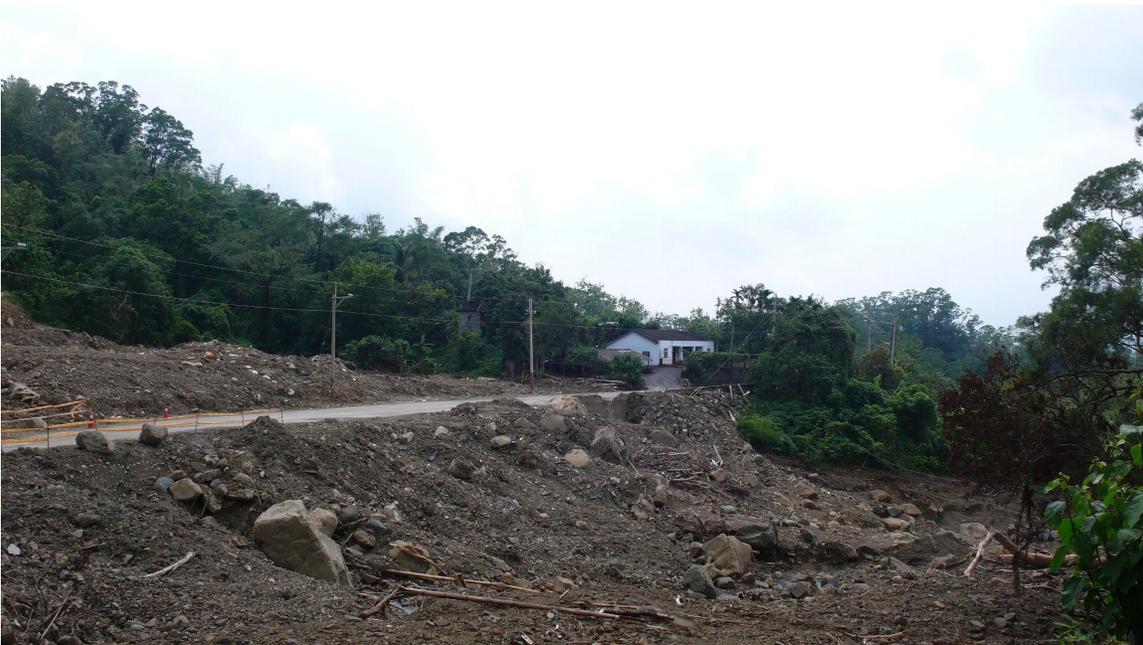
Photo 2-1-10. Overview of debris flow at the road (after cleaning up), leading to a stream on the right.

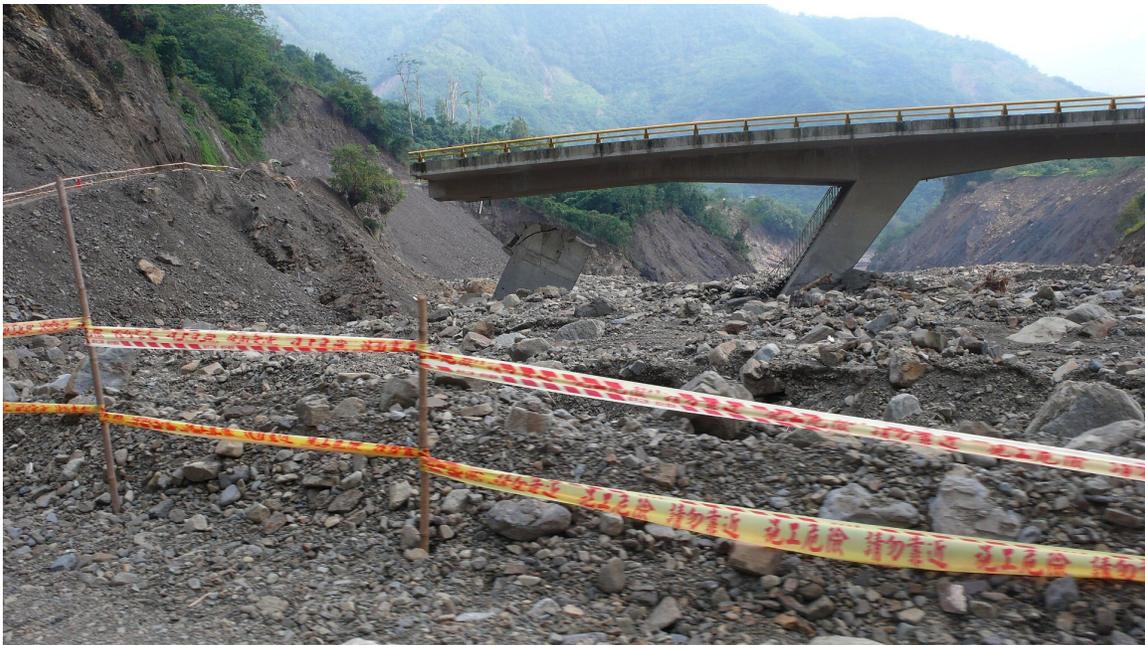
Not far from Taoyuan Village (桃源鄉) (2:43 pm; 23°08'24"N 120°43'47"E elev 558 m), a debris flow occurred. The abutment of a bridge failed, leading to the failure of the superstructure. See also the cover photo, which was taken from the end of the bridge.

Photo 2-2-1. Failure of the abutment and superstructure of a bridge.

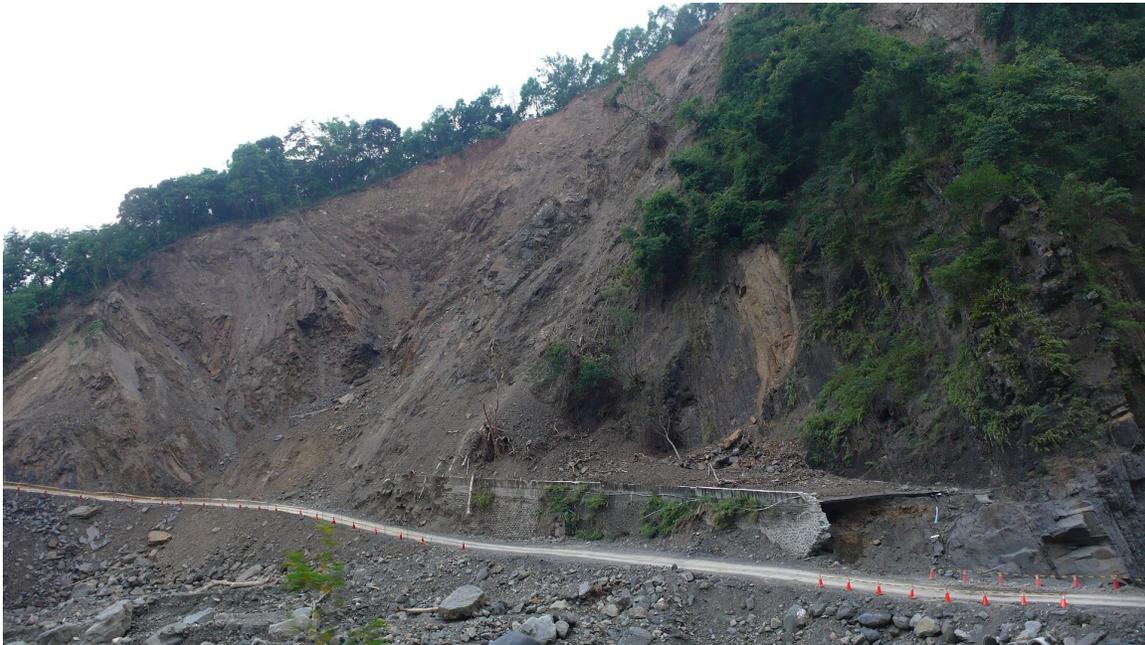
Photo 2-2-2. Significant slope failure on both sides of the road in Jia Xian Village.

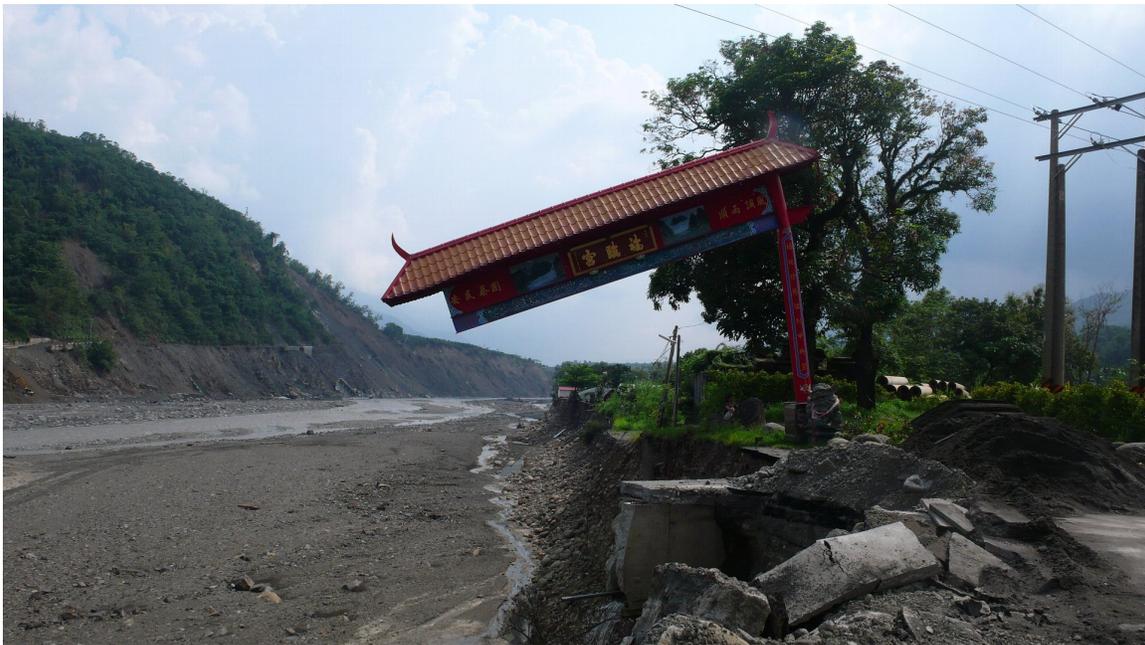
Baolai is an inland resort village, well known for its hot springs. At Baolai, significant scouring occurred along the banks of the river. Buildings were buried by debris or washed away by flooding. The gate of a temple was seen hanging on the bank after significant erosion [Photo 2-3-1; 23°06'39"N 120°42'17"E elev 399 m].

Photo 2-3-1. "Hanging Gate" of a temple [Location 1]

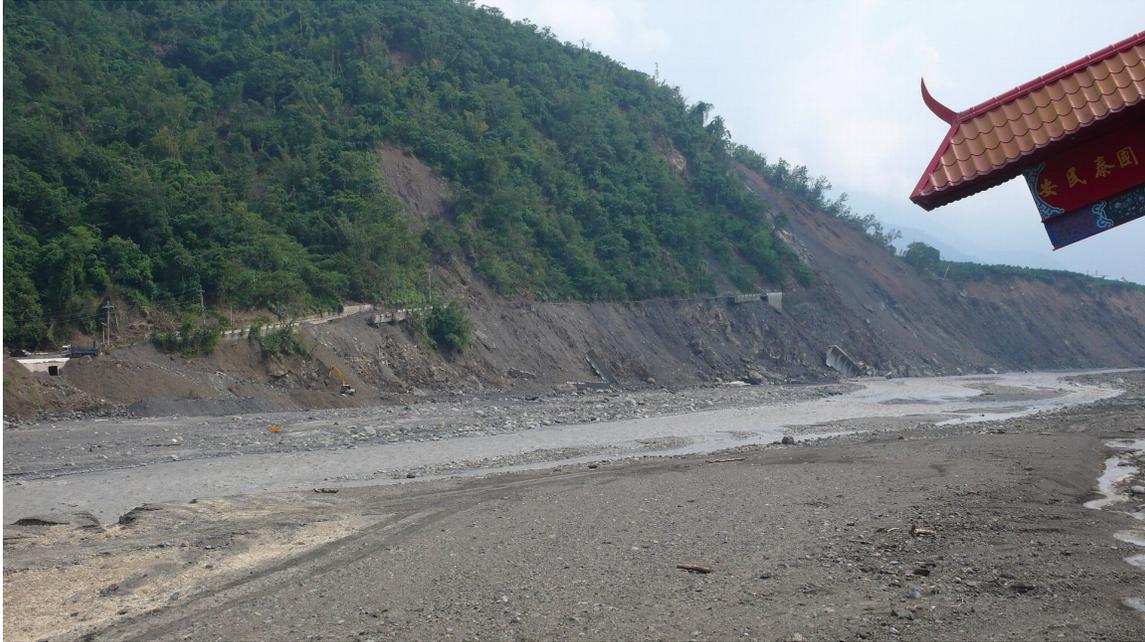
Photo 2-3-2. Large scale landslides along Shinbao Road [Location 2]

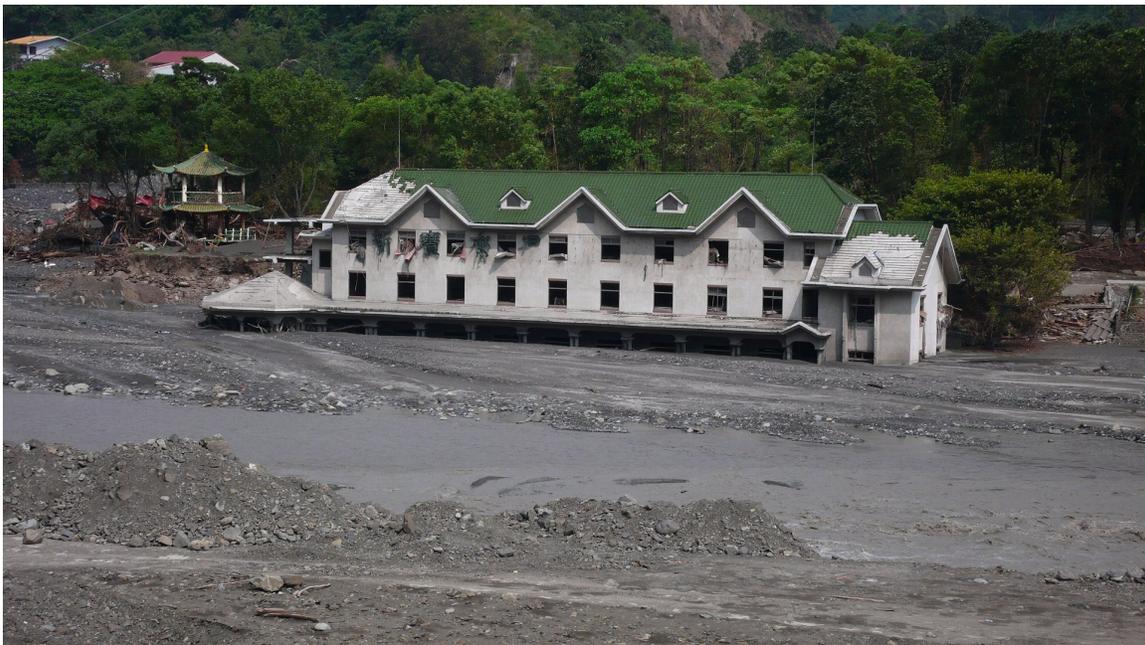
Photo 2-3-3. First floor of a hotel buried by debris [Location 3]

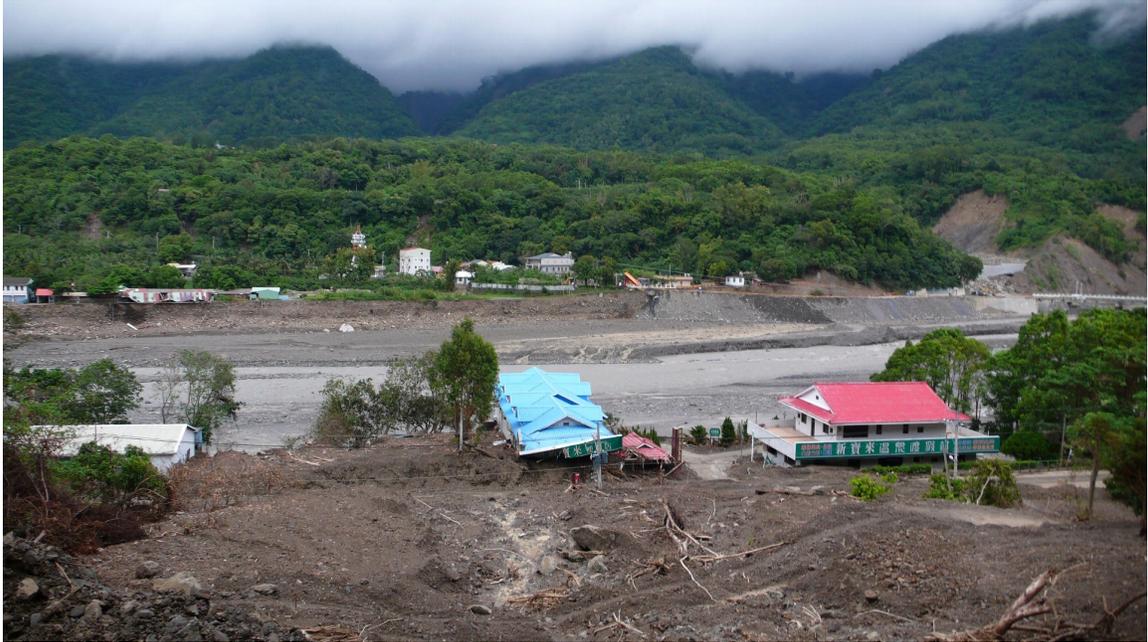
Photo 2-3-4. Buildings damaged by scouring and debris flow [Location 3]

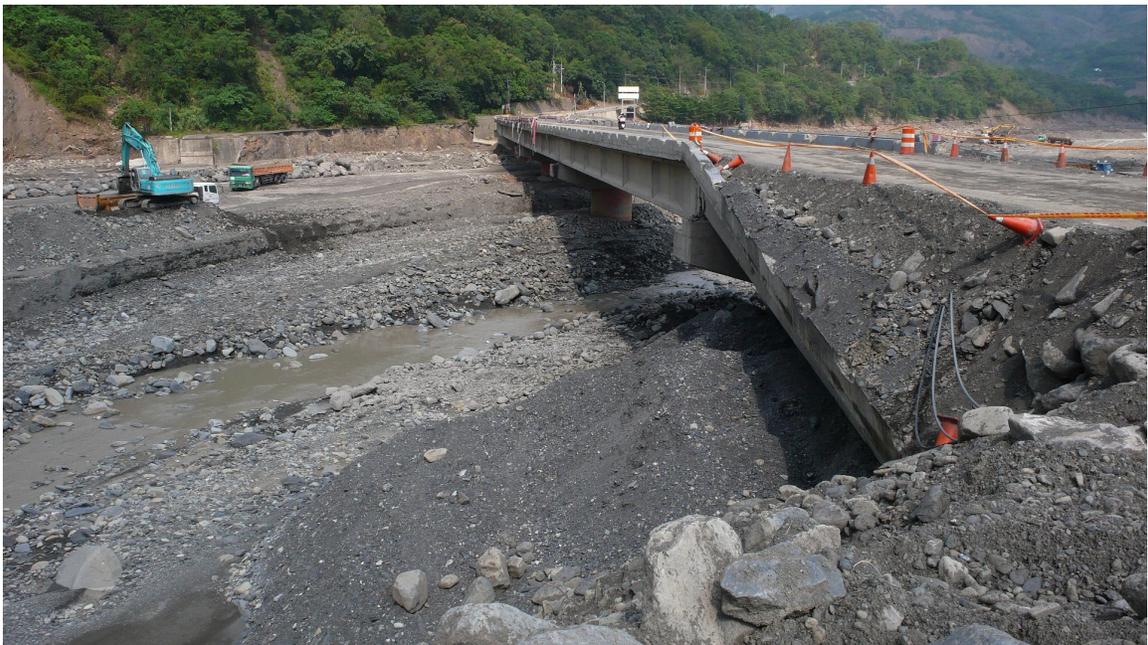
One of the abutments of Baolai Bridge #2 (L=174.4 m; 23°06'41"N 120°42'18"E elev 398 m) was damaged (Photo 2-3-5; ). The depth from Bridges #1 and #2 to the water was reduced from 10+ m to just a few meters due to debris deposition (Photo 2-3-6). A building located at the north end of the village, close to Bridge #2, was damaged by the debris (Photo 2-3-7; 23°06'40"N 120°42'12"E elev 399 m). Landslides were seen along the sides of the river, at the northern end of the map (Photo 2-3-8; 23°06'48"N 120°42'08"E).

Photo 2-3-5. Damaged abutment and deck of Bridge #2 .

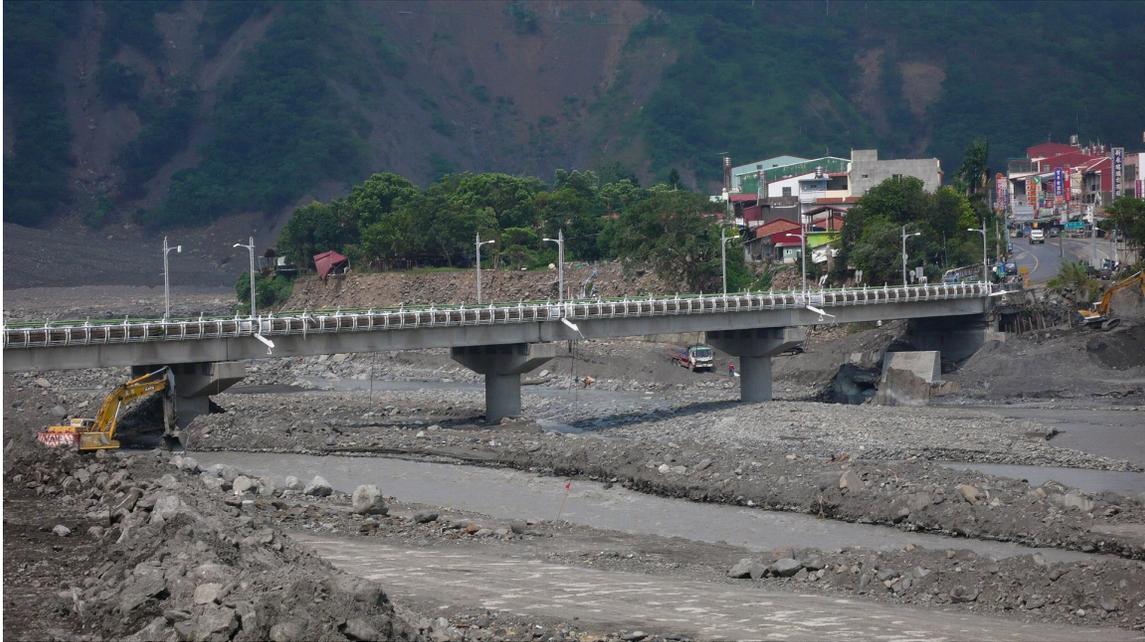
Photo 2-3-6. The vertical clearance of Bridge #2 was significantly reduced by debris deposition.

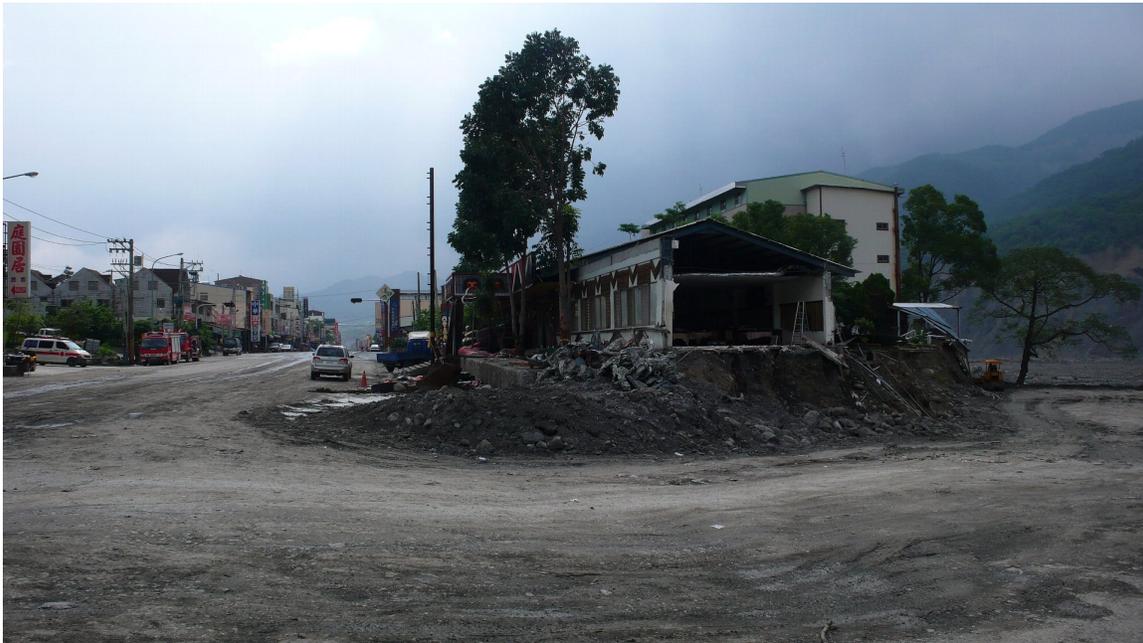
Photo 2-3-7. A building near Bridge #2 was damaged by the debris flow.

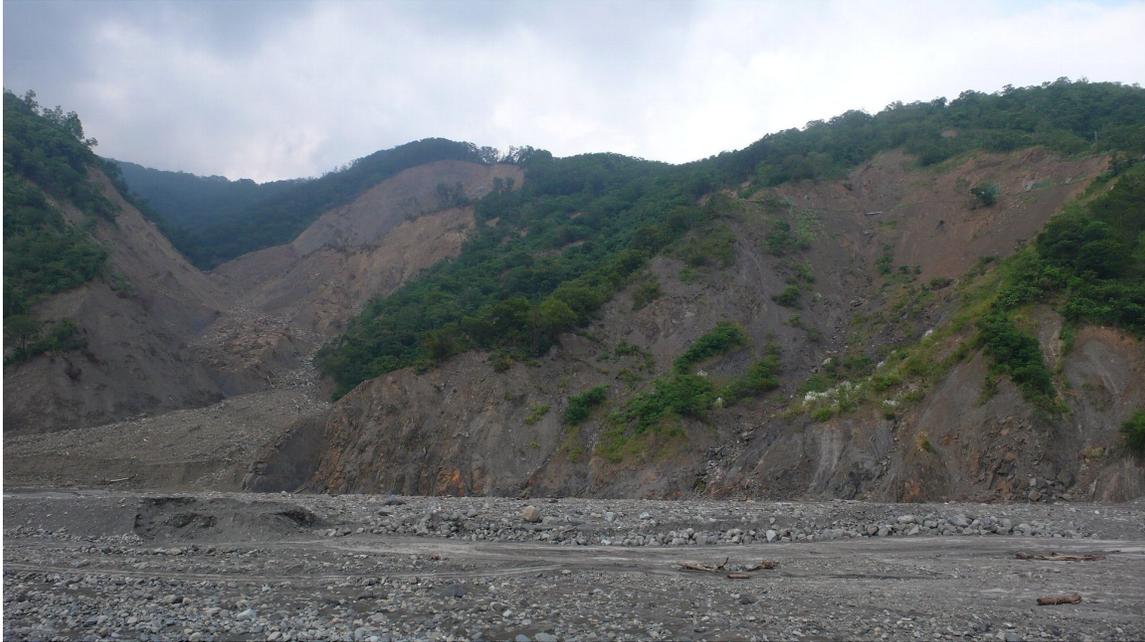
Photo 2-3-8. Large-scale slope failure near the river bank [Location 4]

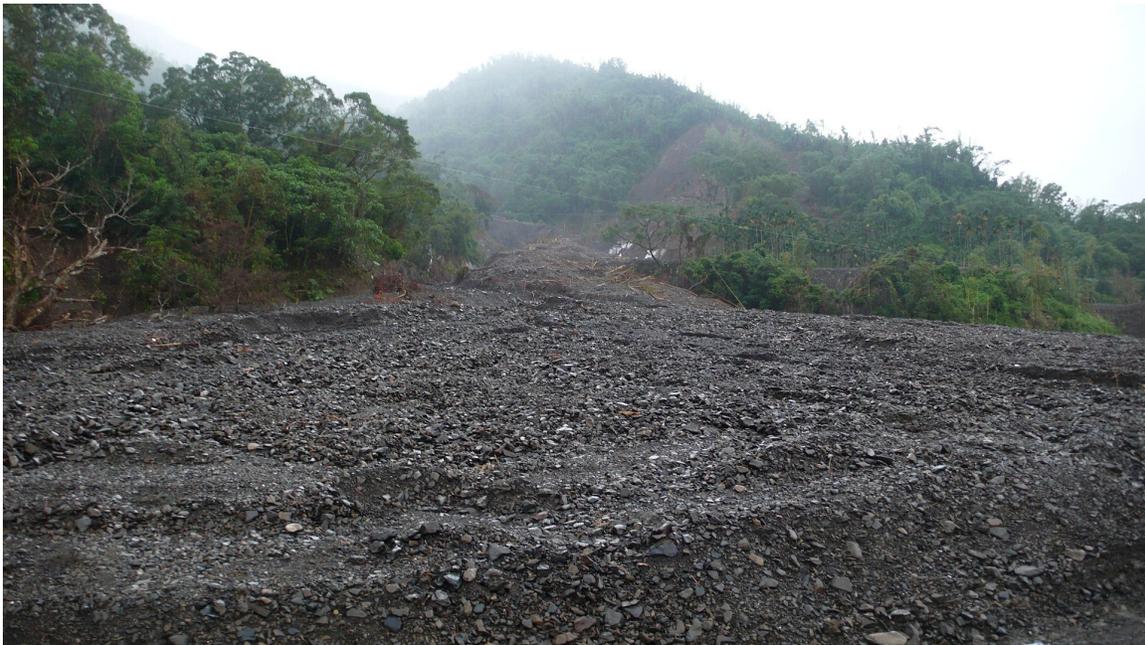
In the village of Shinkai, 32 persons were buried alive by a debris flow. The village was cut off for many days due to the damage of its bridge. Buildings were covered by material deposited from the debris flow. Several buildings were excavated, leaving behind ponds of water.

Photo 2-4-1. Debris flow at Shinkai Village.

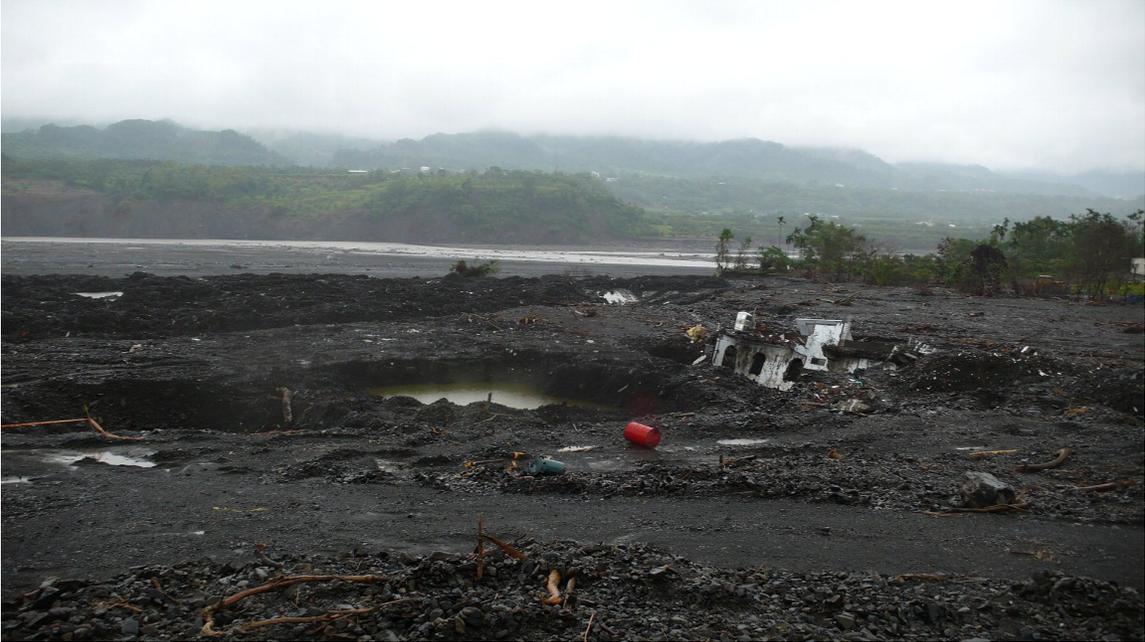
Photo 2-4-2. Excavation of buried buildings.

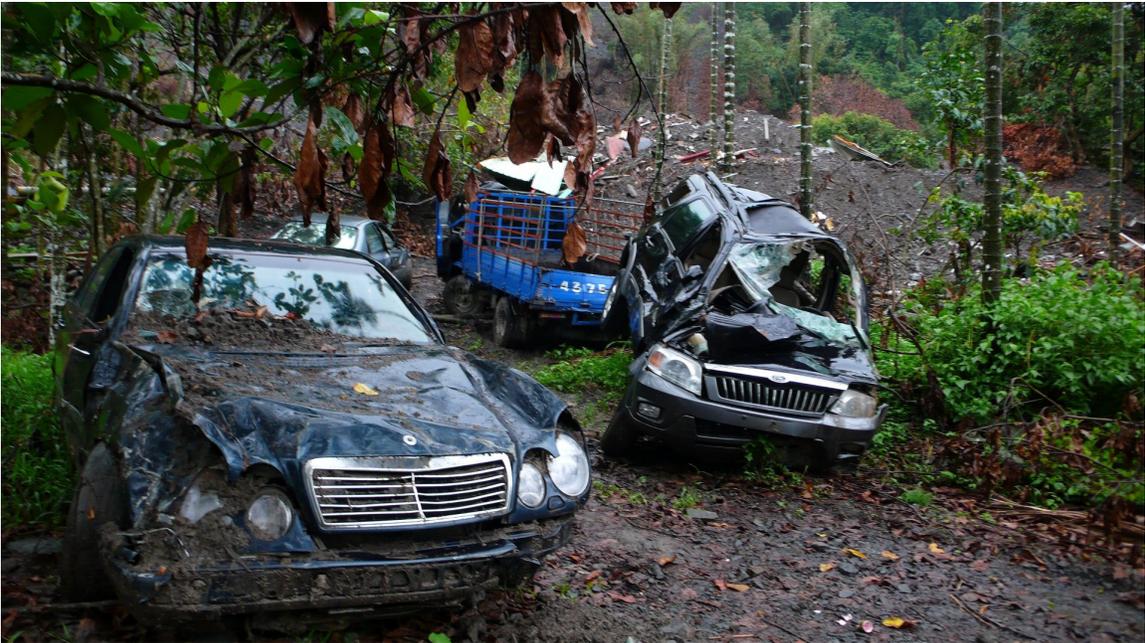
Photo 2-4-3. Car remains found near the village.

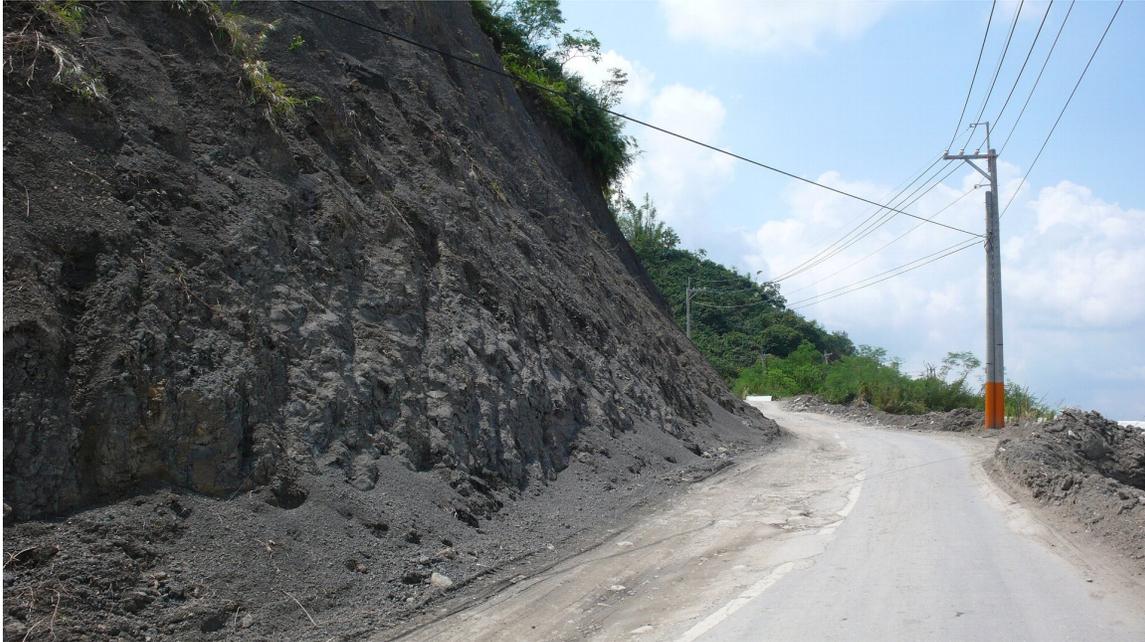
Photo 3-1-1. Typical landslide along Route 21. .

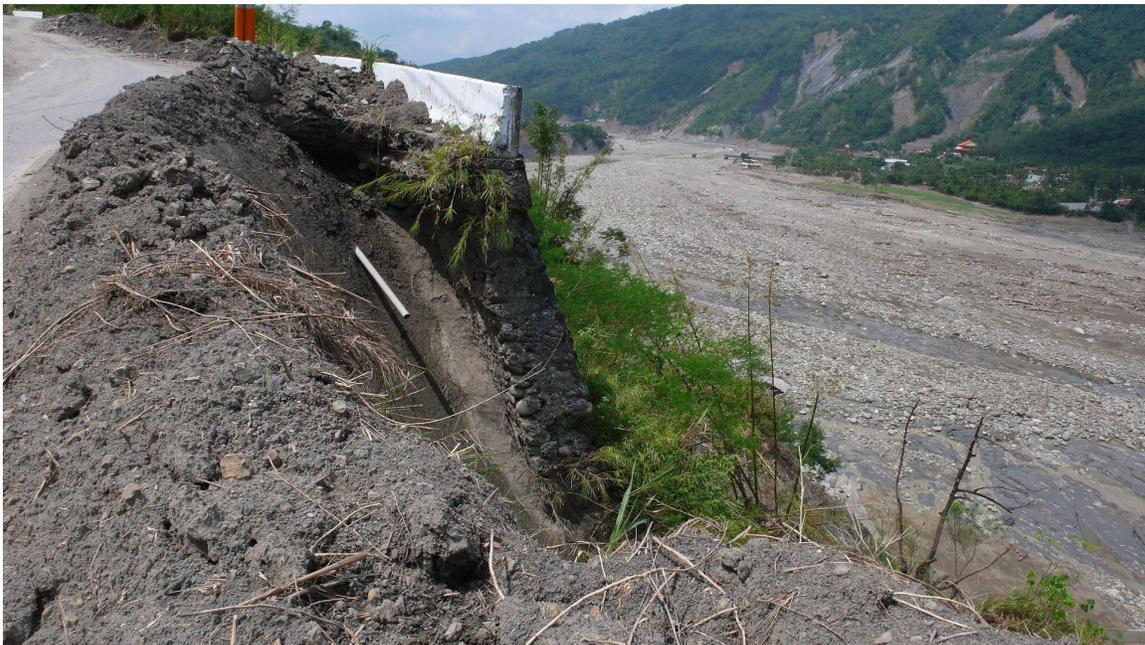
Photo 3-1-2. Typical case of retaining wall failure.

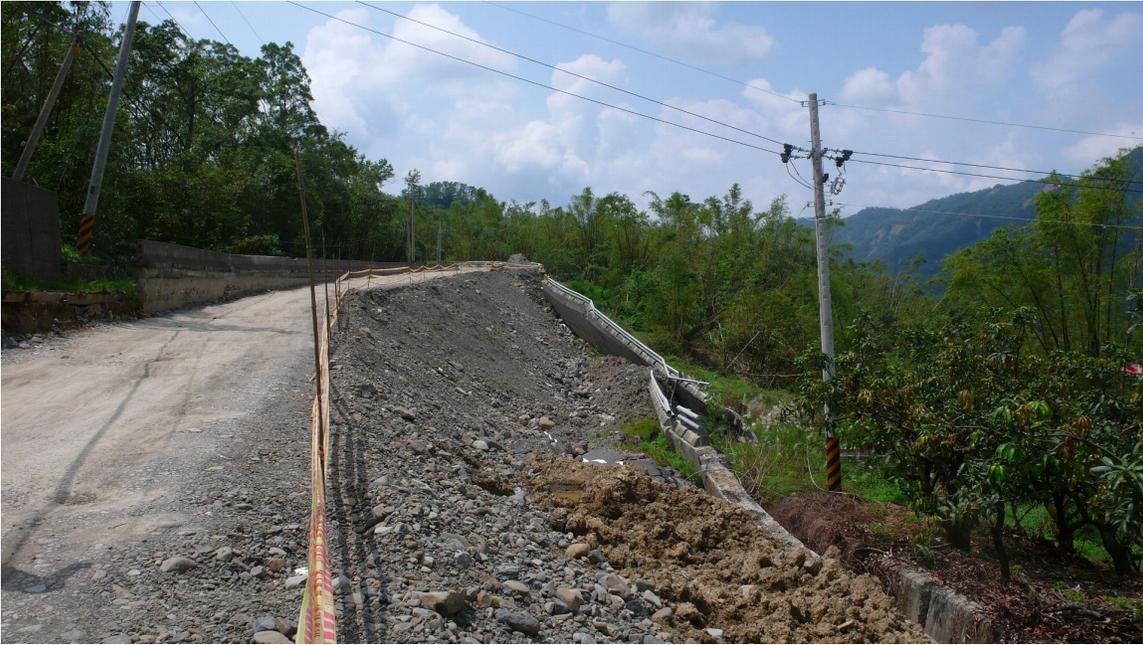
Photo 3-1-3. Typical case of retaining wall failure.

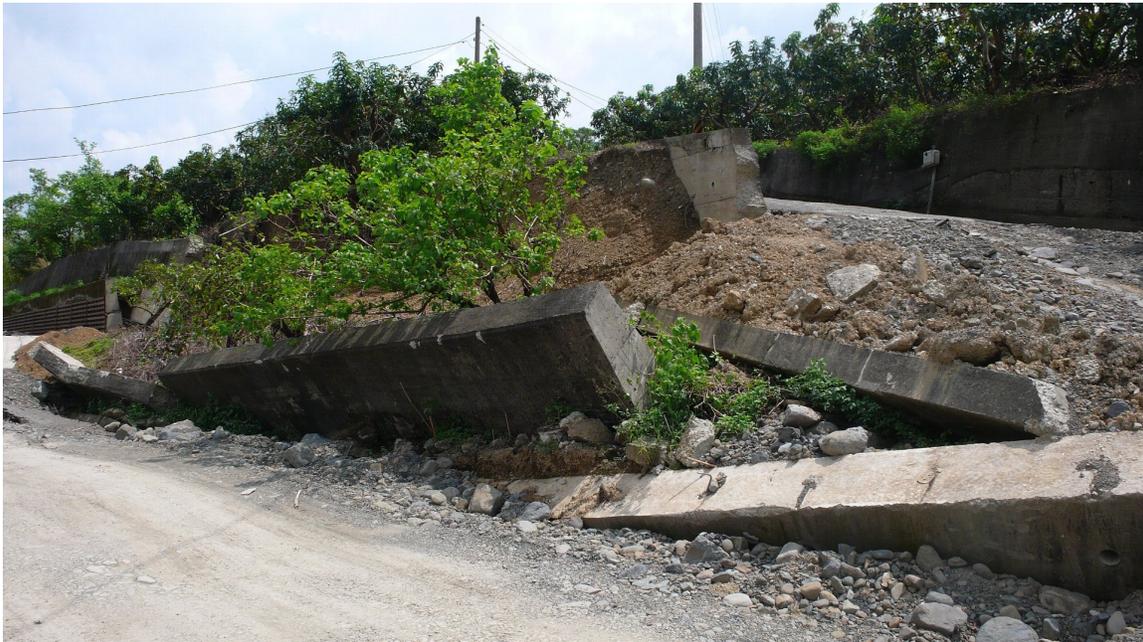
Photo 3-1-4. Typical case of retaining wall failure.

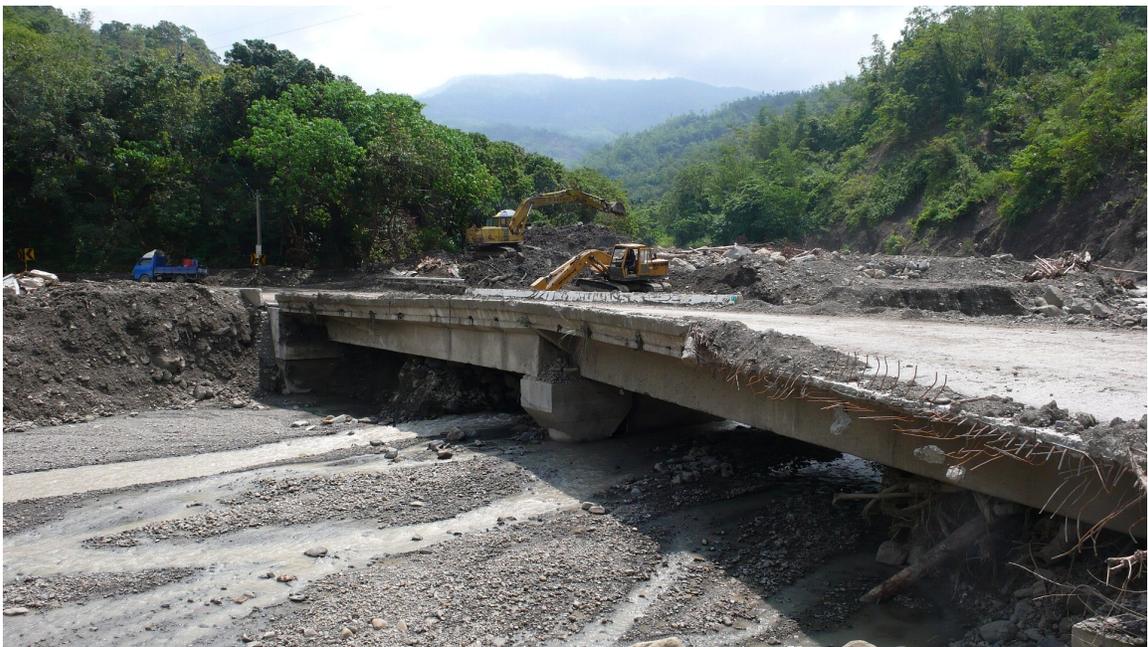
Along Route 21 at Sanmin Industry Road (三民產業道路) near Jia Xian, debris had blocked the road. Evidence of damage caused by debris flow included damage to the bridge superstructure and blockage of the river due to debris deposition.

Photo 3-2-1. Damage to the bridge and road by debris flow

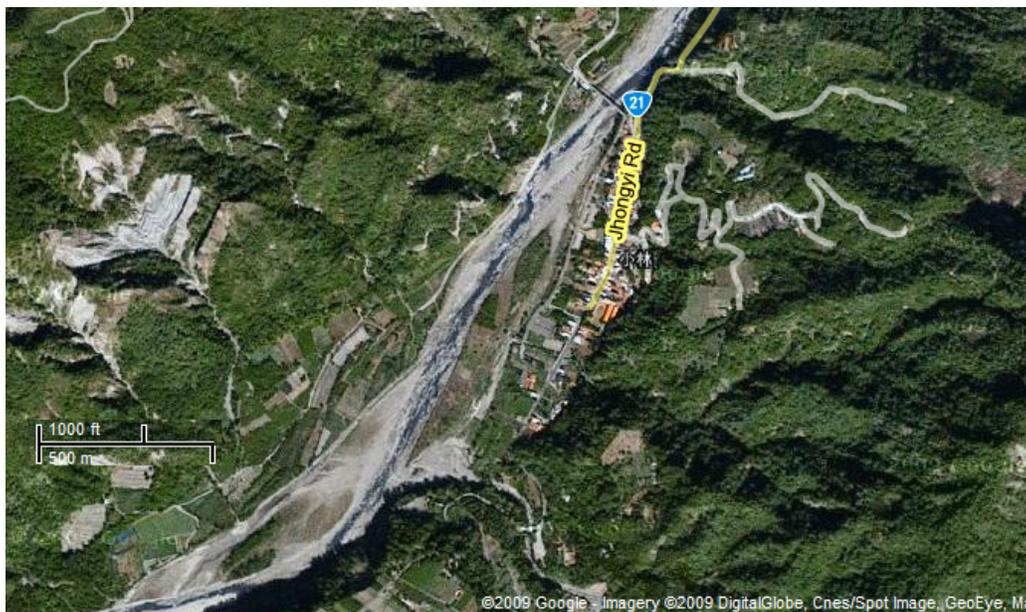
The reconnaissance along Route 21 ended at Hsiao Lin Village, where a bridge was damaged. More than 400 people were buried alive by debris flow. One debris flow originated from mountains to the left of the photo, while another debris flow occurred from the mountains on the opposite side of the river. The debris is estimated to be several meters deep, thus recovery of bodies has been abandoned.

Photo 3-3-2. Hsiao Lin Village was devastated by debris flow. Only two houses were left, as can be seen on the right side of the photo. More than 400 people were buried by the debris.

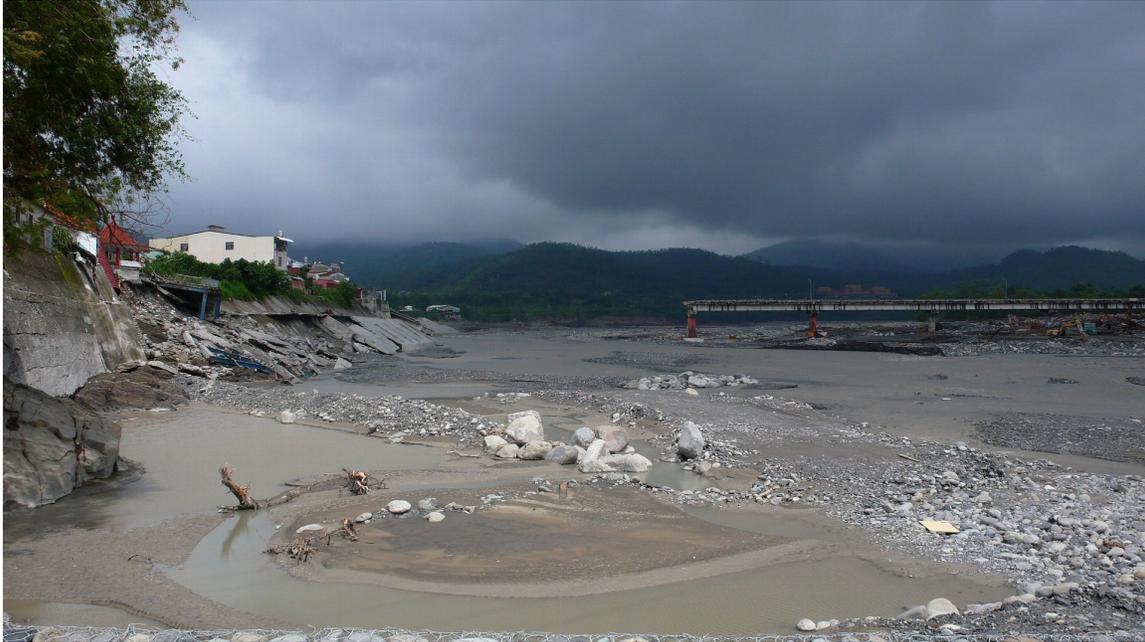
a) Liou Guei Bridge (Sept 6, 2009; 10:24am; 22°59'42"N 120°38'23"E elev 232 m), located along Route 27A, was seriously damaged by flooding. Timber debris was left on the bridge deck and in the river. The river banks were seriously eroded. At locations close to the bridge, some retaining walls collapsed.

Photo 4-1-1. Part of Liou Guei Bridge was destroyed.

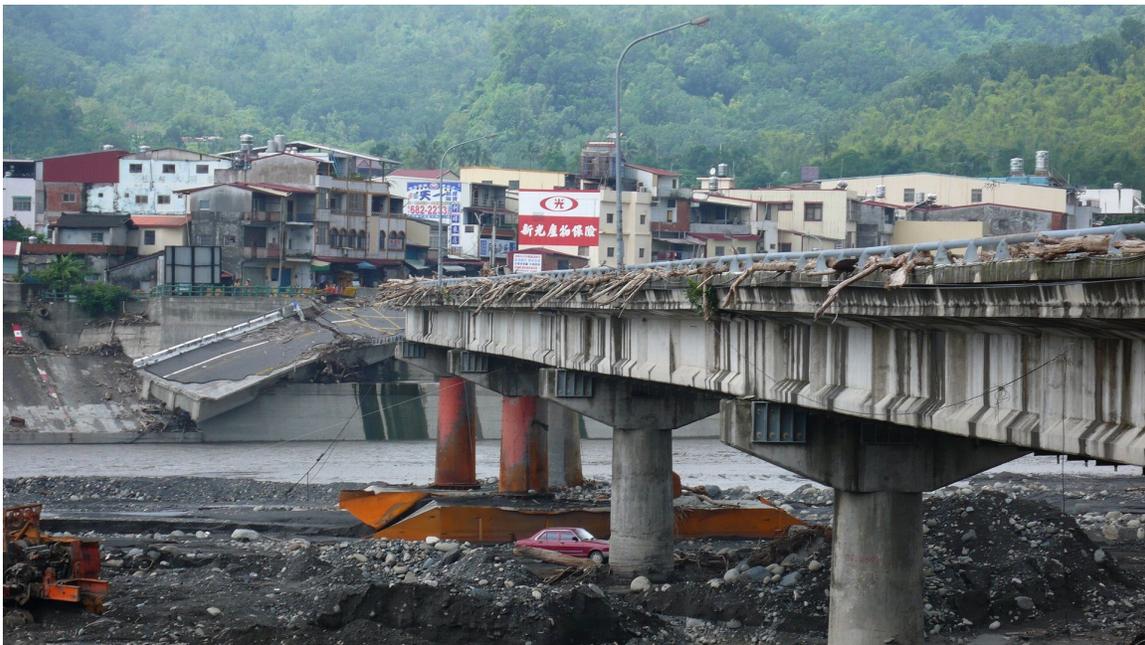
Photo 4-1-2. A closer view of Liou Guei Bridge.
