# A RECONNAISSANCE REPORT ON TYPHOON MORAKOT

September 21, 2009

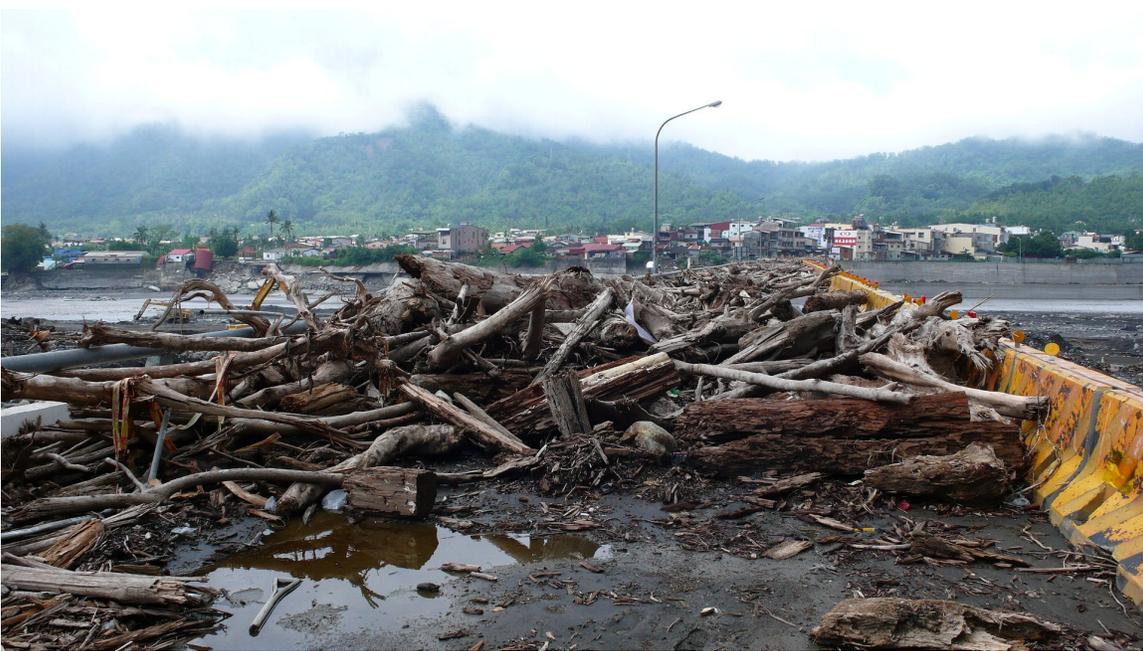
Photo 4-1-3. Timber debris and sediments piled up on the deck.

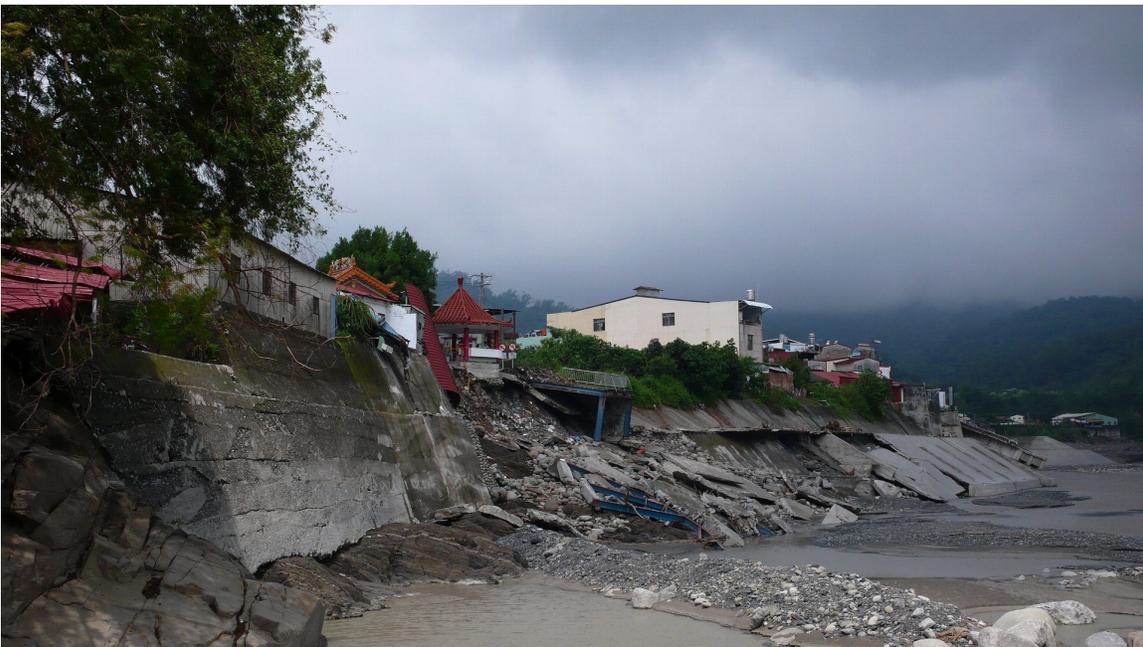
Photo 4-1-4. Collapse of retaining walls near the bridge.

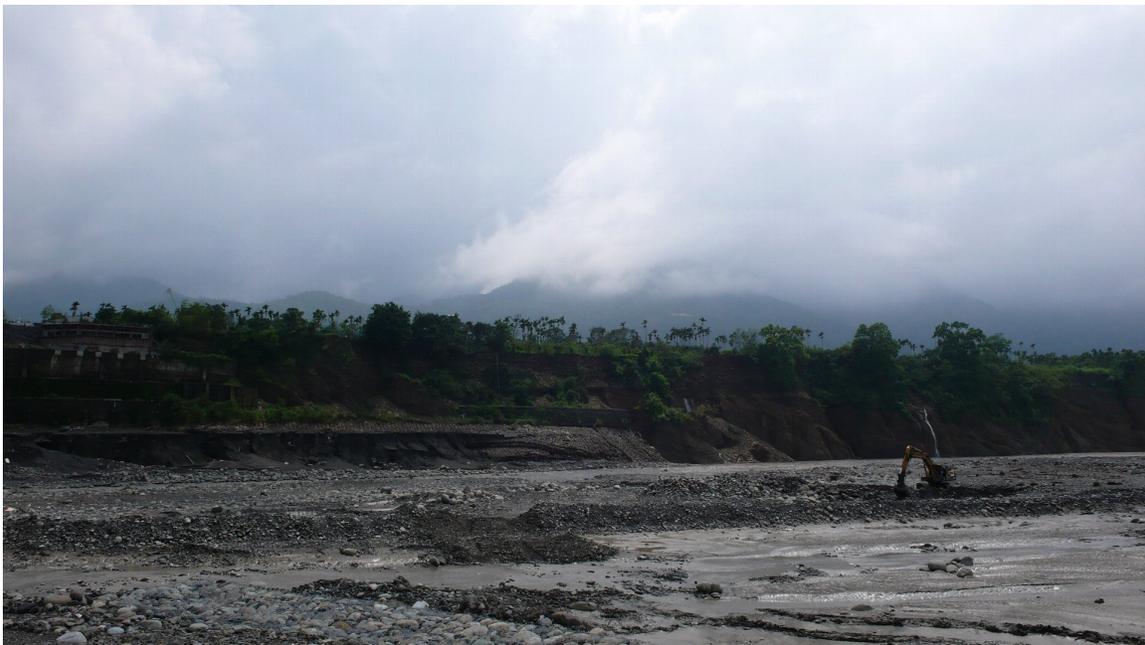
Photo 4-1-6. River banks were seriously eroded.

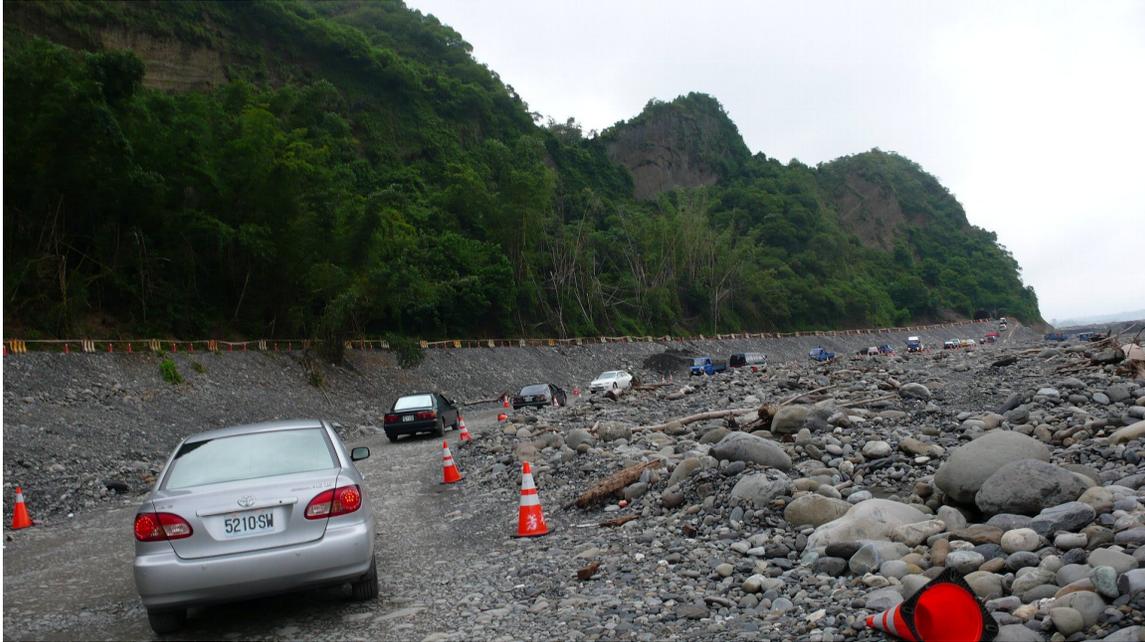
Photo 4-2-1. The primary road was damaged, thus part of the river bank was used as a temporary access road.

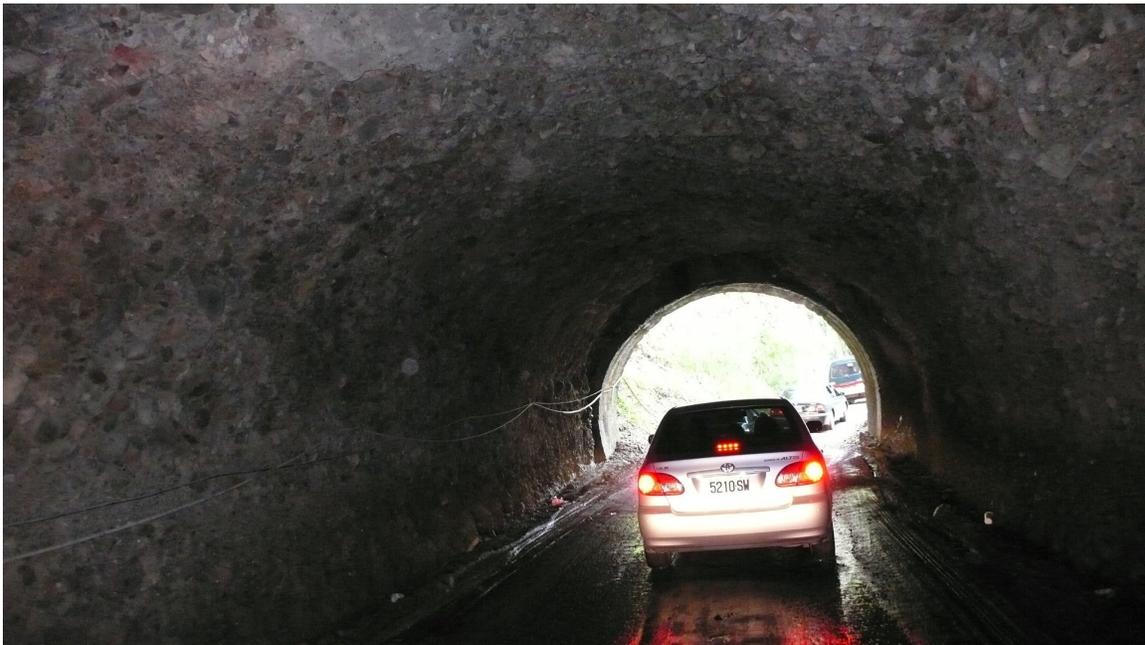
Photo 4-2-2. An old tunnel was reopened for traffic after the main road was damaged by scour.

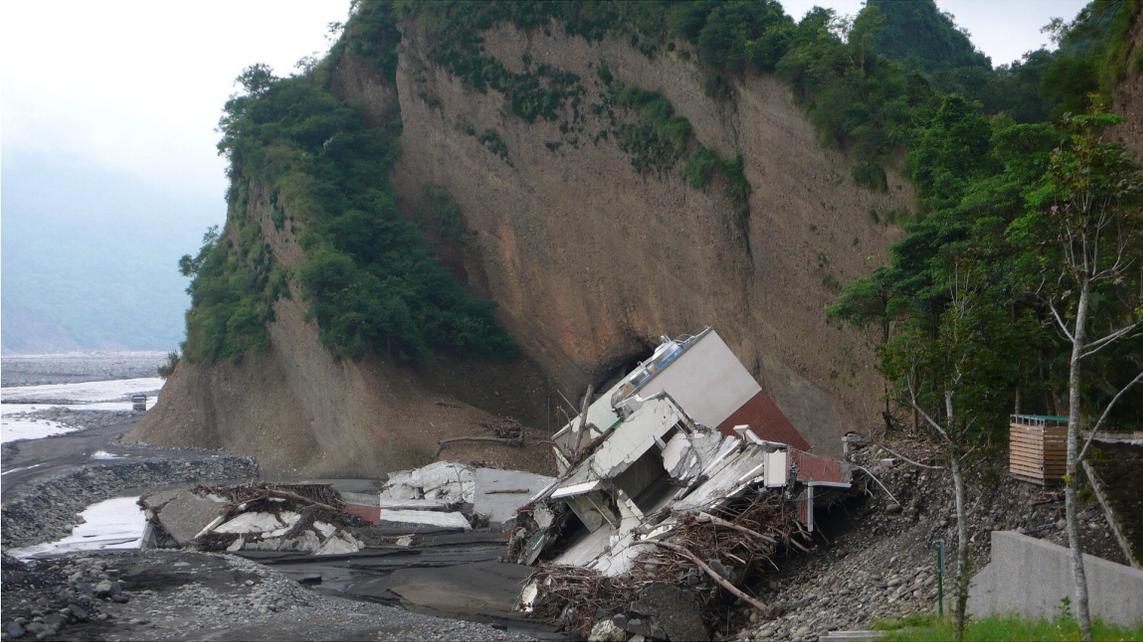
Photo 4-2-3. The Liou Guei Visitor Center collapsed because of scour.

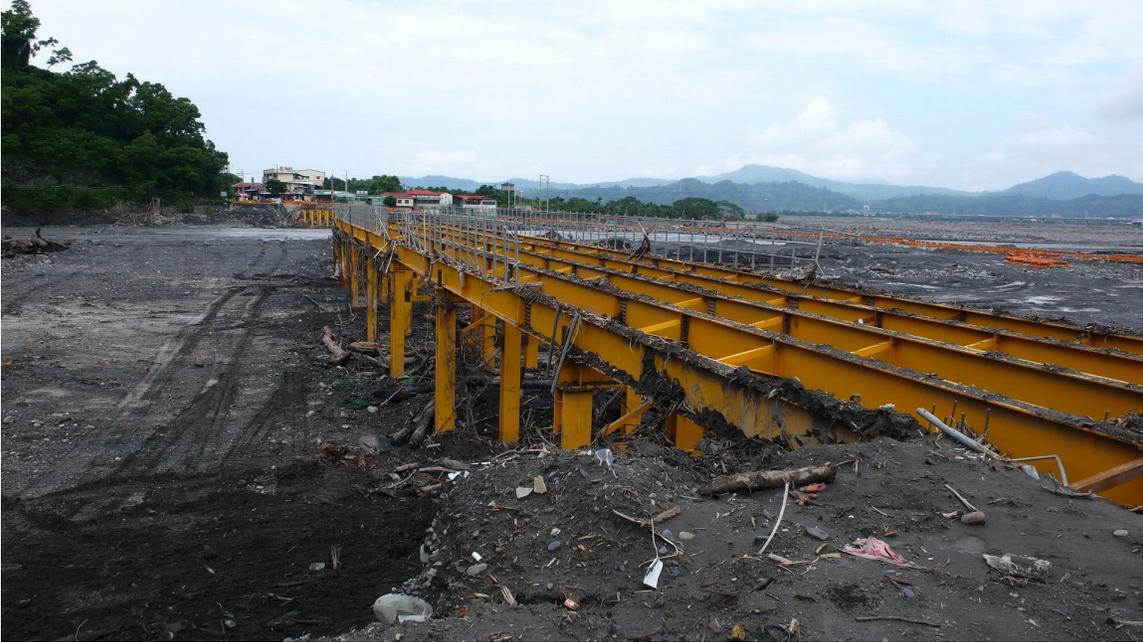
The old Dajin Bridge (大津橋) (Sept 6, 2009; 11:15 am; 22°52'47"N 120°38'51"E elev 146 m) was damaged by flooding. The deck disappeared entirely; only the steel members remained.

Photo 4-3-1. Dajin Bridge was damaged by flooding.

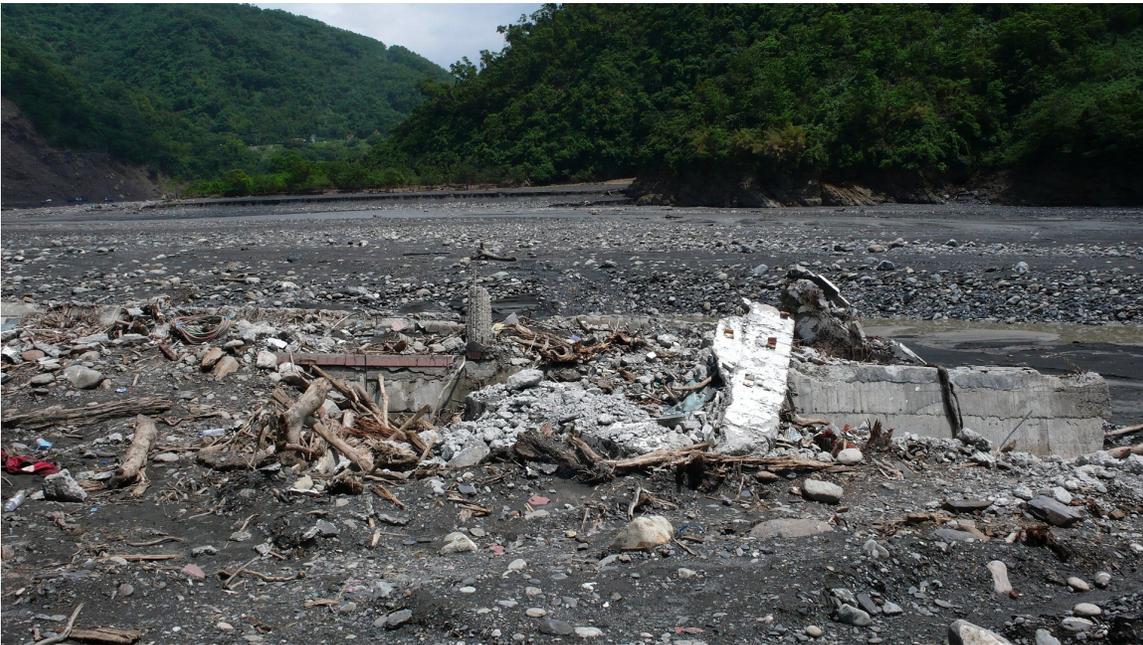
At the entrance to Mao Lin Village (茂林鄉), the riverbed was seriously eroded. The visitor center was washed away, leaving only debris.

Photo 4-3-3. Debris of Mao Lin Visitor Center.

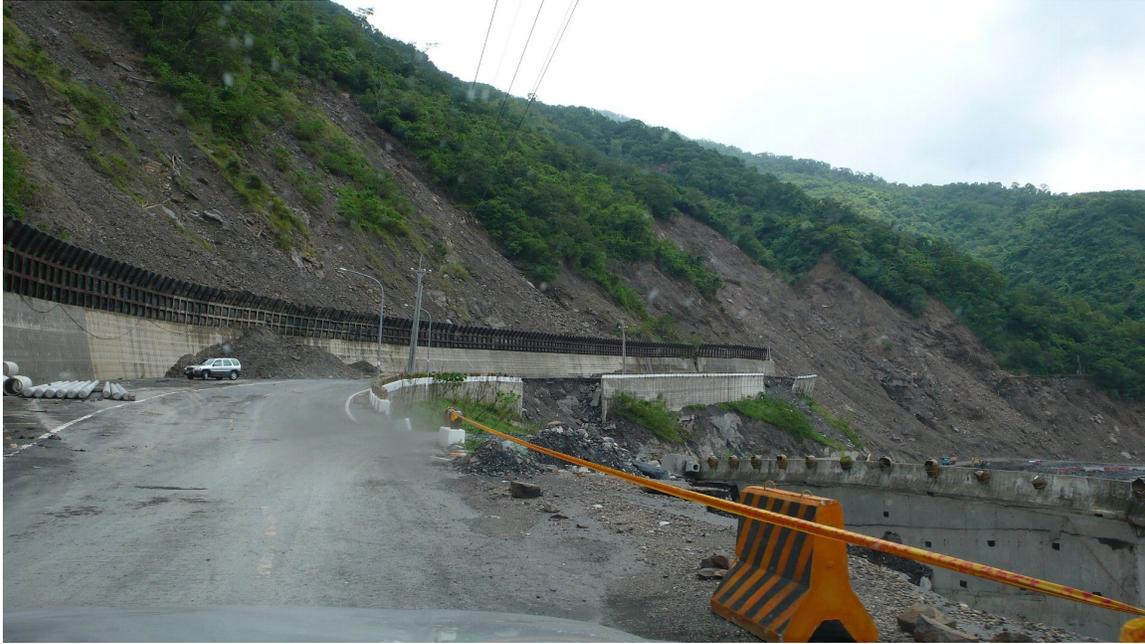
A section of retaining walls were observed (Sept 6, 2009; 11:19 am;  $22^{\circ}53'02''N$   $120^{\circ}39'08''E$  elev 169 m). The upper retaining wall was partially damaged; however, it was able to arrest some of the rock debris. This portion was a gravity retaining wall.

The lower cantilever wall, which retained the highway, was partially damaged. Portions of the wall tilted significantly. This wall ranged from 6 to 12 m tall.

Photo 4-3-4. Retaining wall on Route 132.

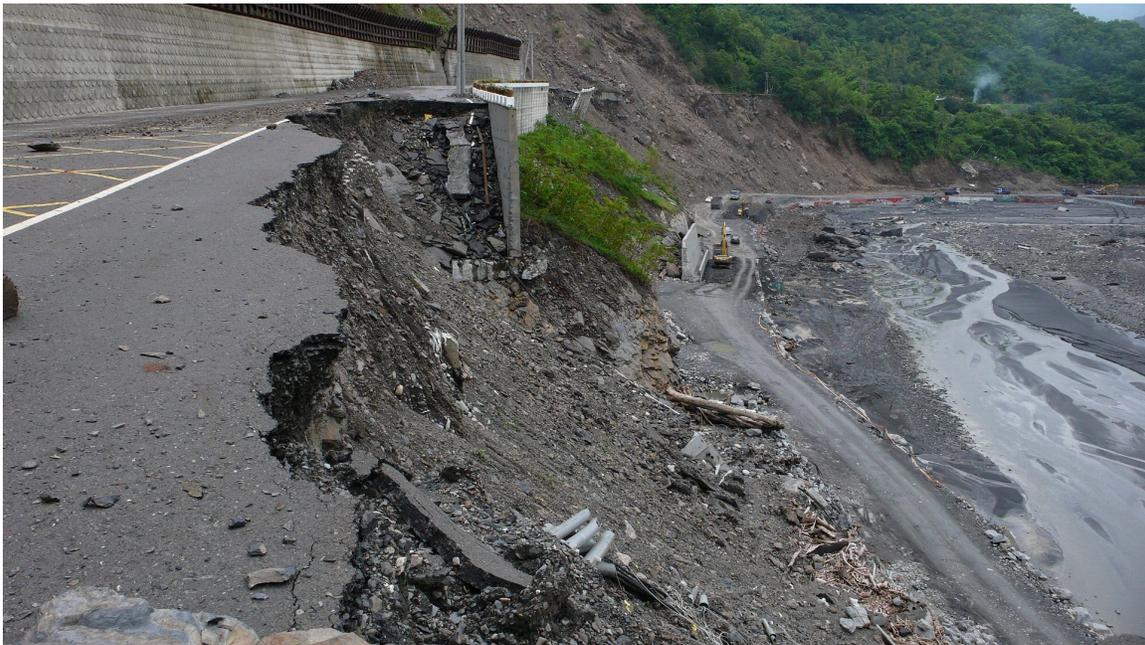
Beyond the retaining walls, the slope failed. This cut off Route 132, which provides access to Mao Lin Village.

Photo 4-3-5. A closer view of collapsed retaining walls. Temporary access road under construction down on the river bank

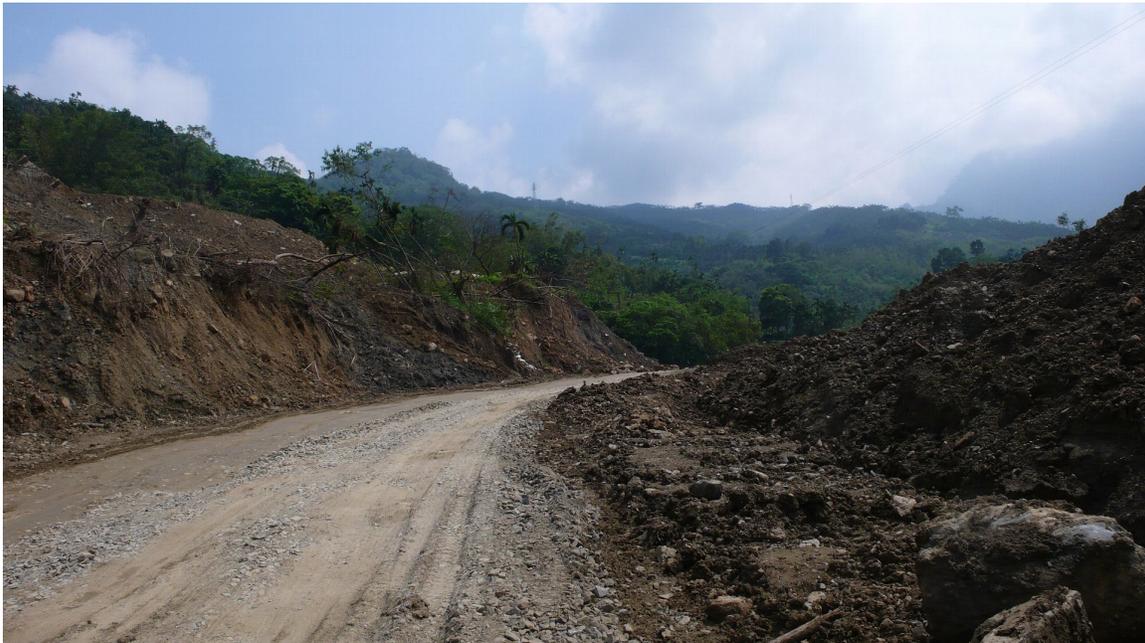
Photo 5-2-1. The road was buried by a debris flow which traveled from the top of a mountain down to a stream.

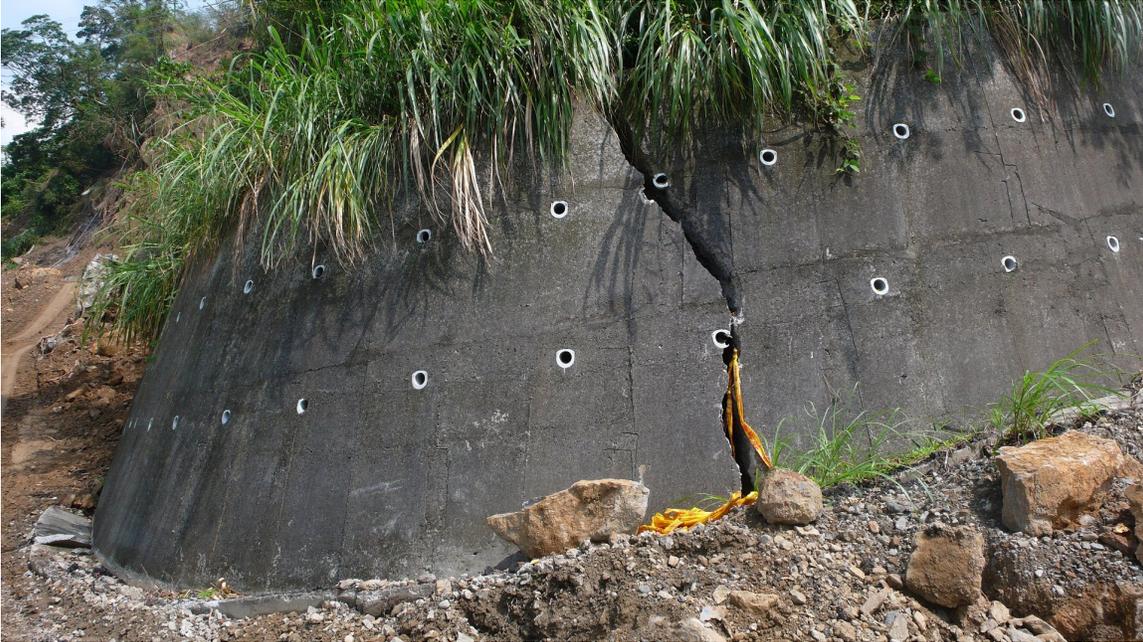
Photo 5-2-2. A retaining wall damaged by landslides.

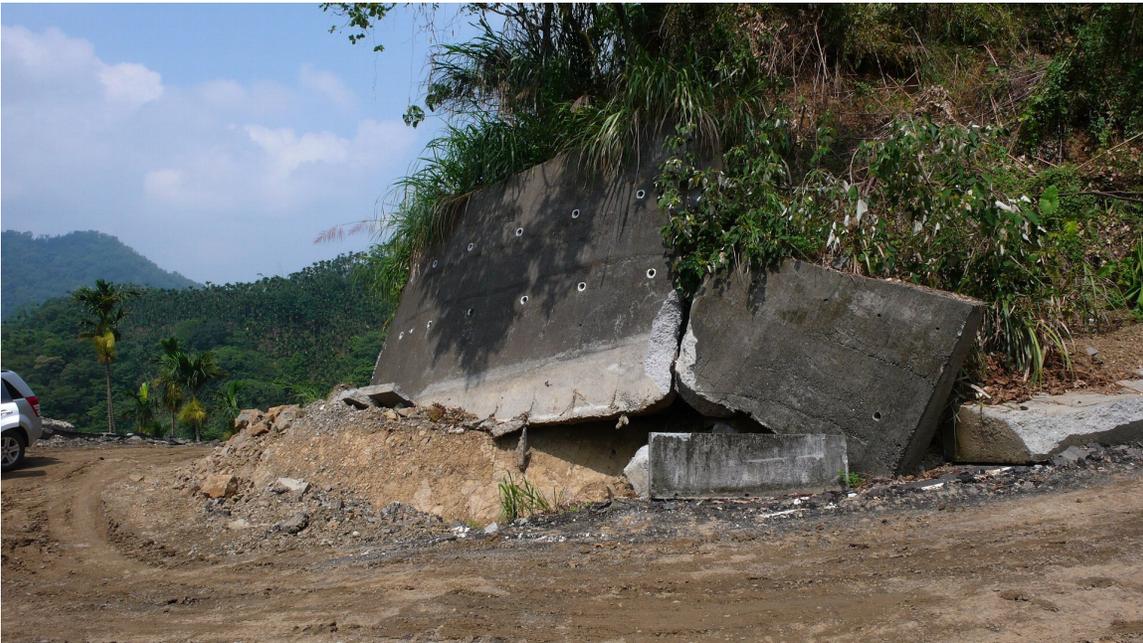
Photo 5-2-3. Another damaged retaining wall.

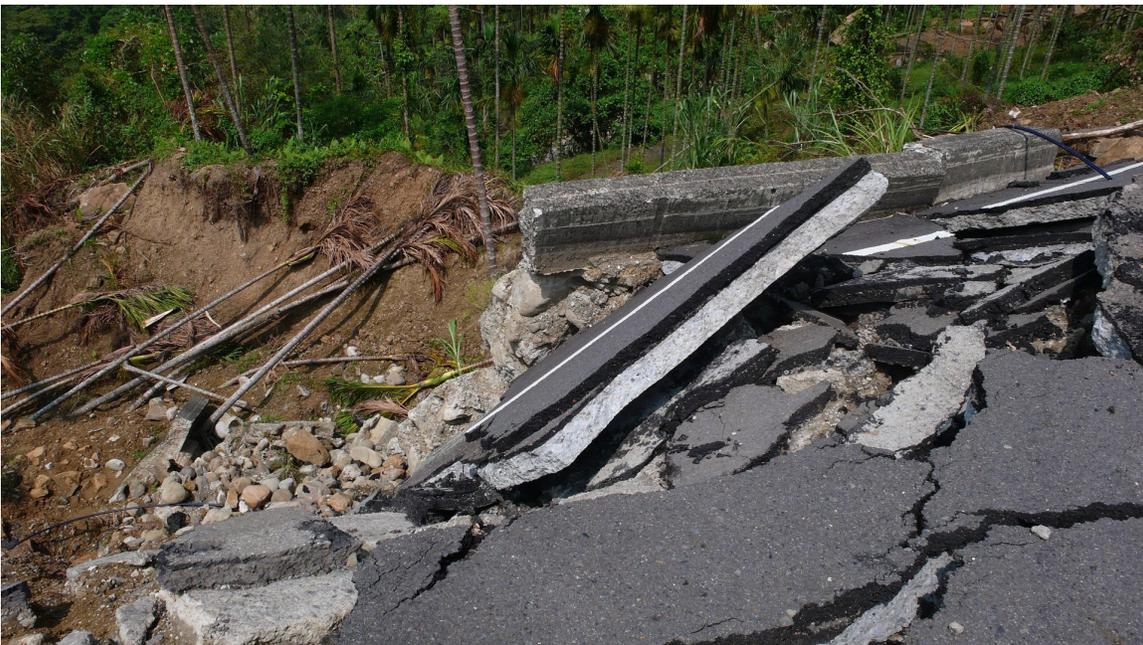
Photo 5-2-5. Pavement damaged by slope movement.

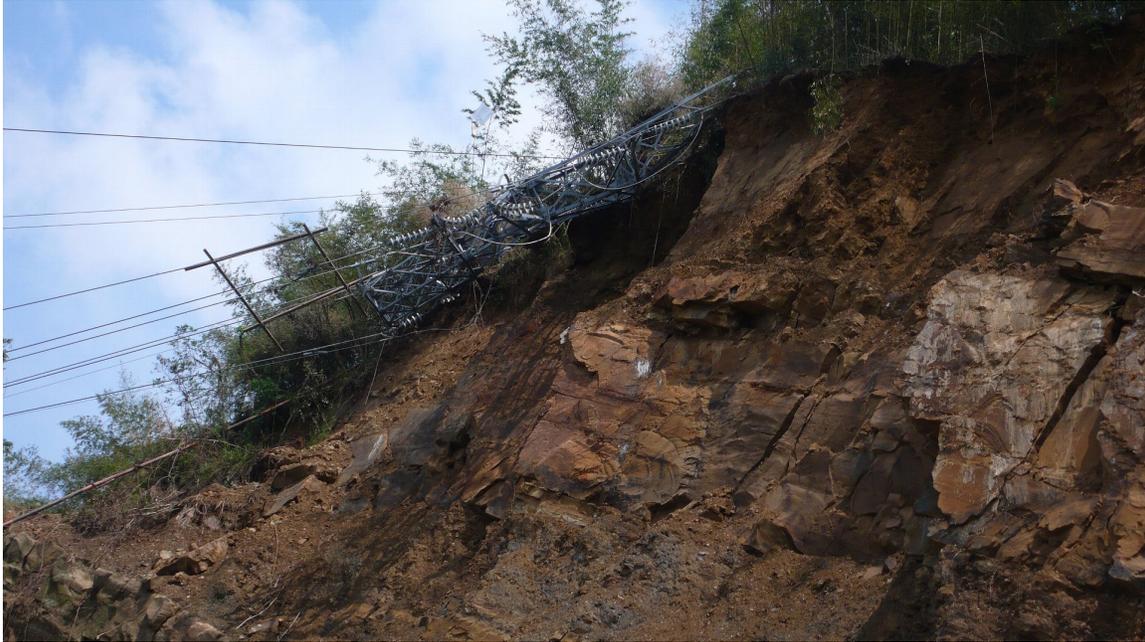
Photo 5-2-6. An electricity transmission tower damaged by landslides.

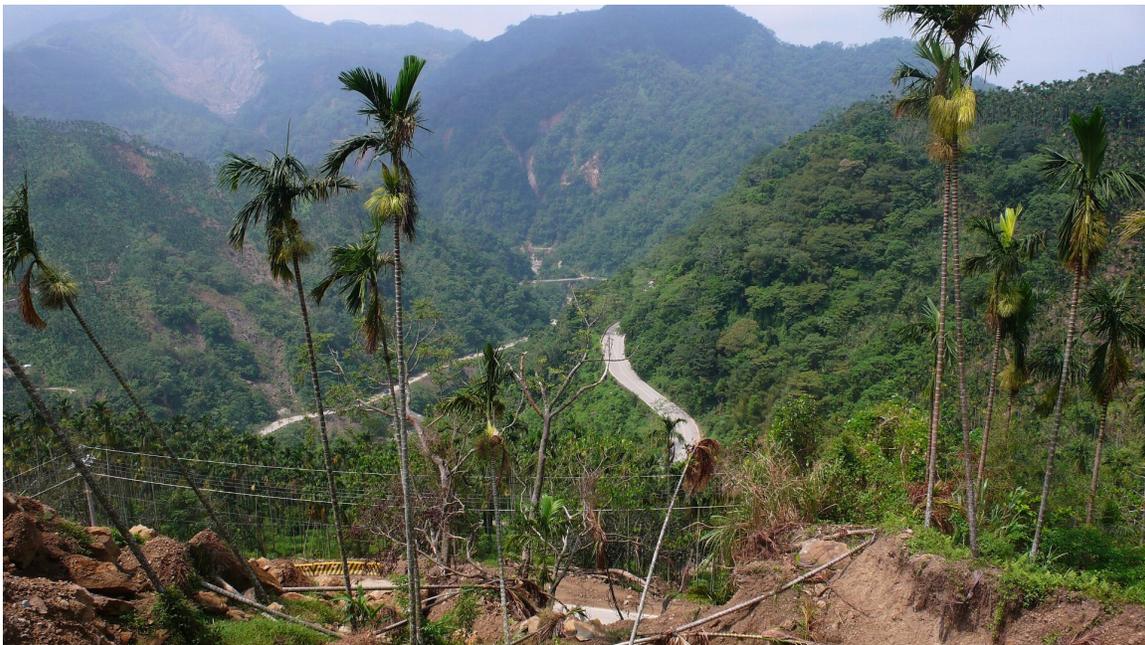
Photo 5-2-7. The beetle nut plantation was damaged by soil movement. Part of Route 18 and other landslide sites can be seen in the photo.

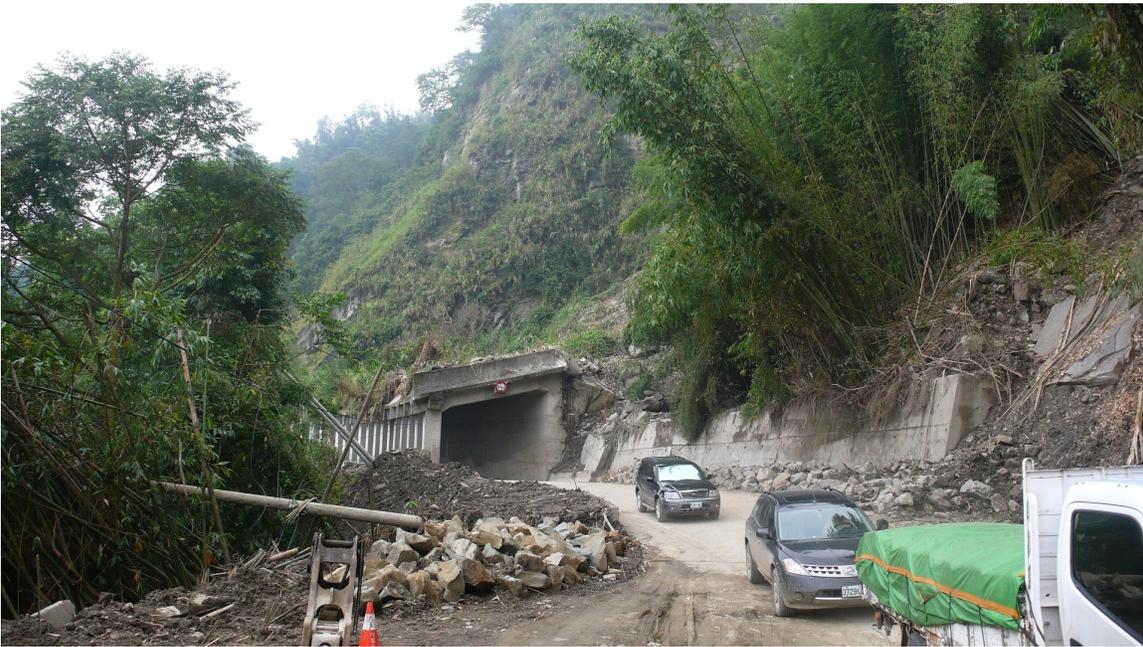
At this site, a shed was constructed to protect the highway from debris flow and to divert the debris toward the valley. Since the shed was built in more than one section, soil movement caused differential settlement of the road within the structure. Part of the shed also moved laterally.

Photo 5-3-1. Debris flow was seen at one end of the shed. Part of the shed was buried.

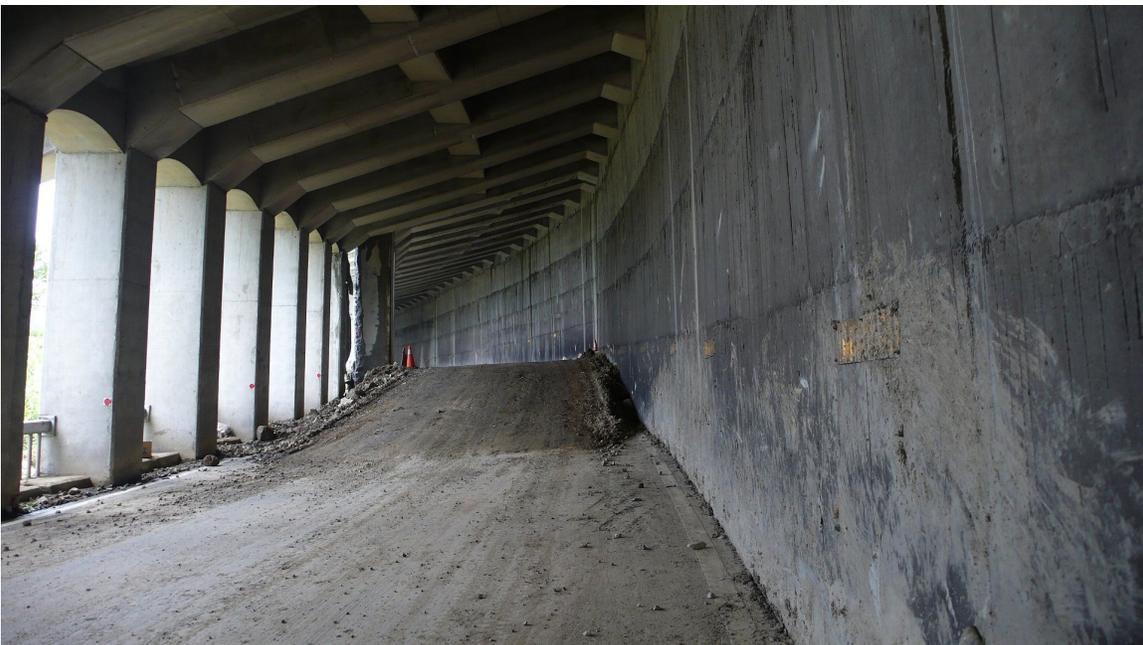
Photo 5-3-2. Differential settlement of road inside the shed.

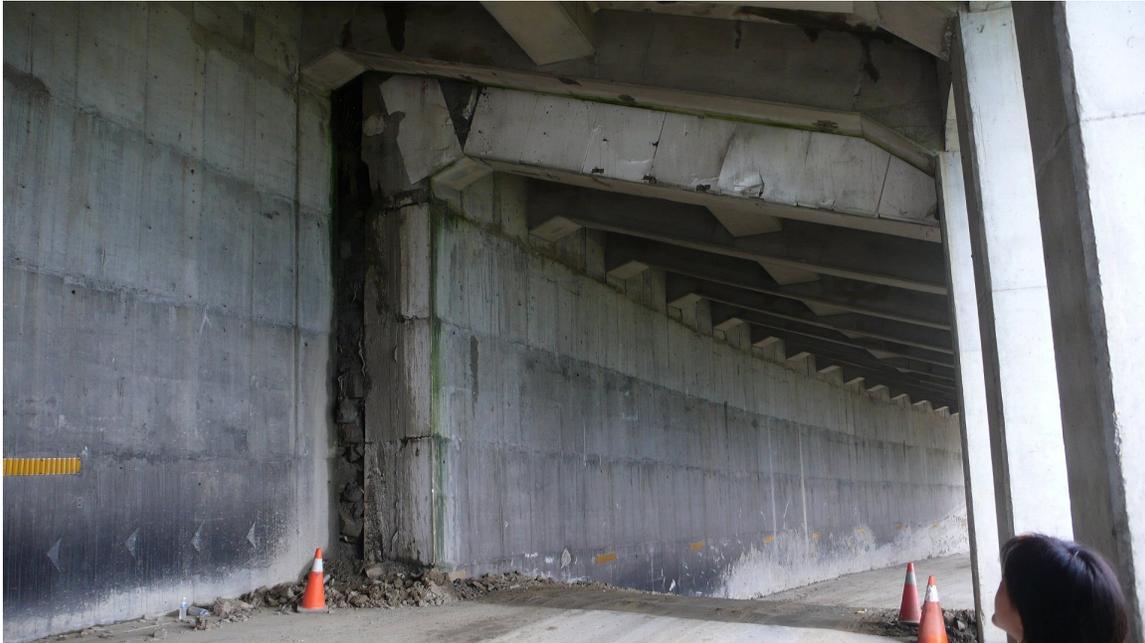
Photo 5-3-3. One of the sections of the shed displaced relative to the stable section.

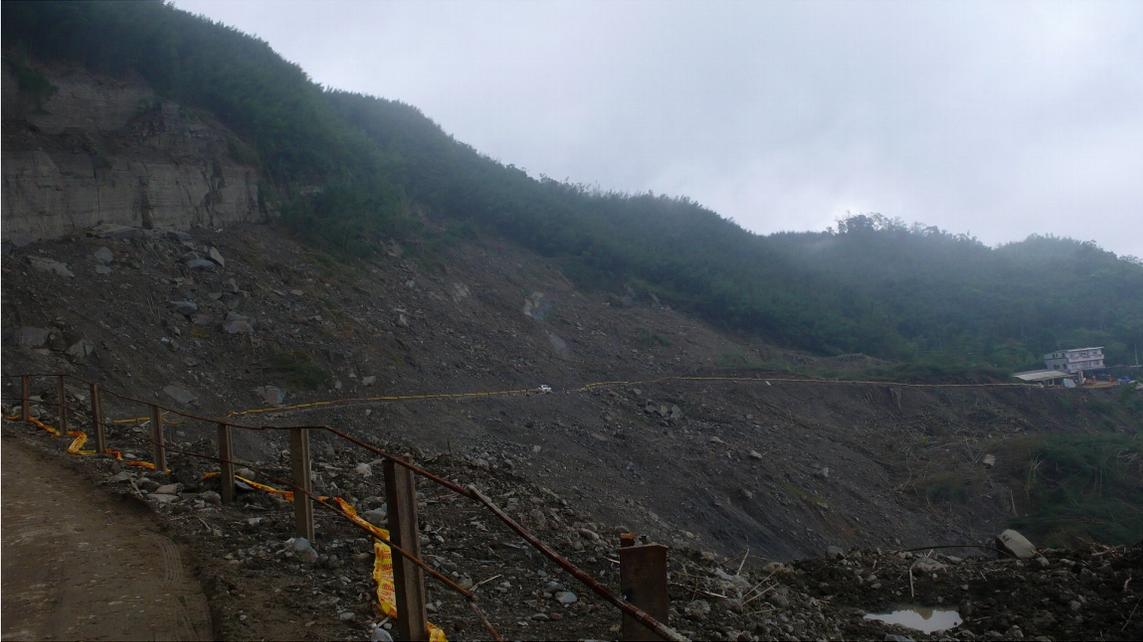
A short distance away from the shed, a large stretch of highway collapsed due to landslides.

Photo 5-3-5. Landslides damaged several hundred meters of the existing roadway. The mountain was cut to create a new access road.

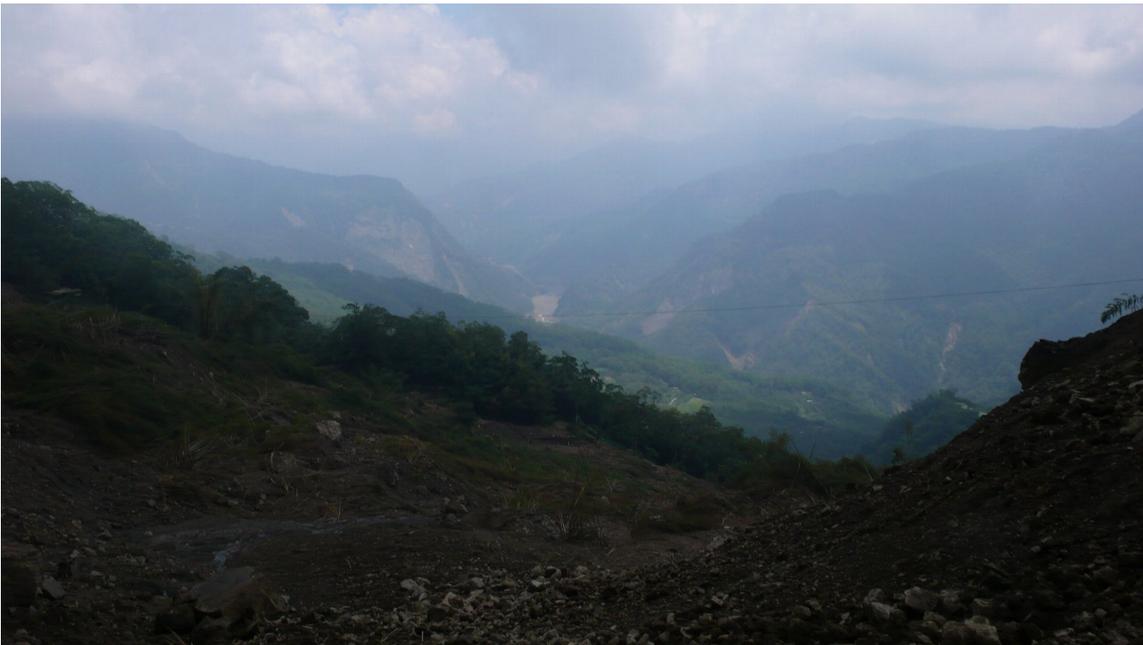
Photo 5-3-6. The surrounding area was dotted with many landslides.

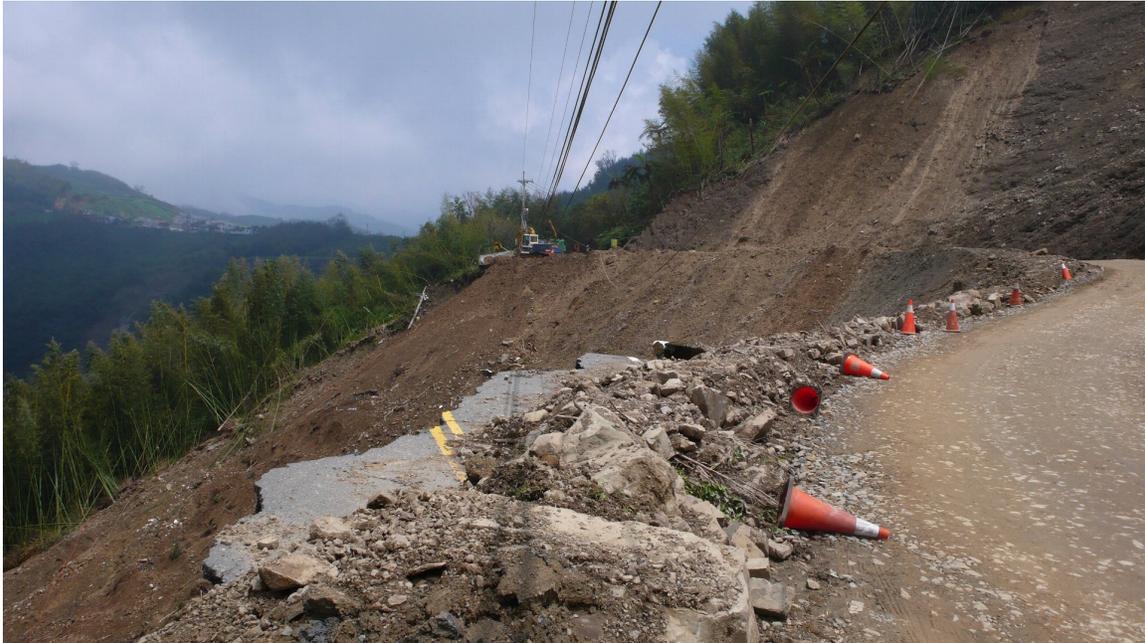
This was the site of a large landslide. The highway was lost and an access road was constructed.

Photo 5-4-1. Landslides. Note the original location of highway and new access road

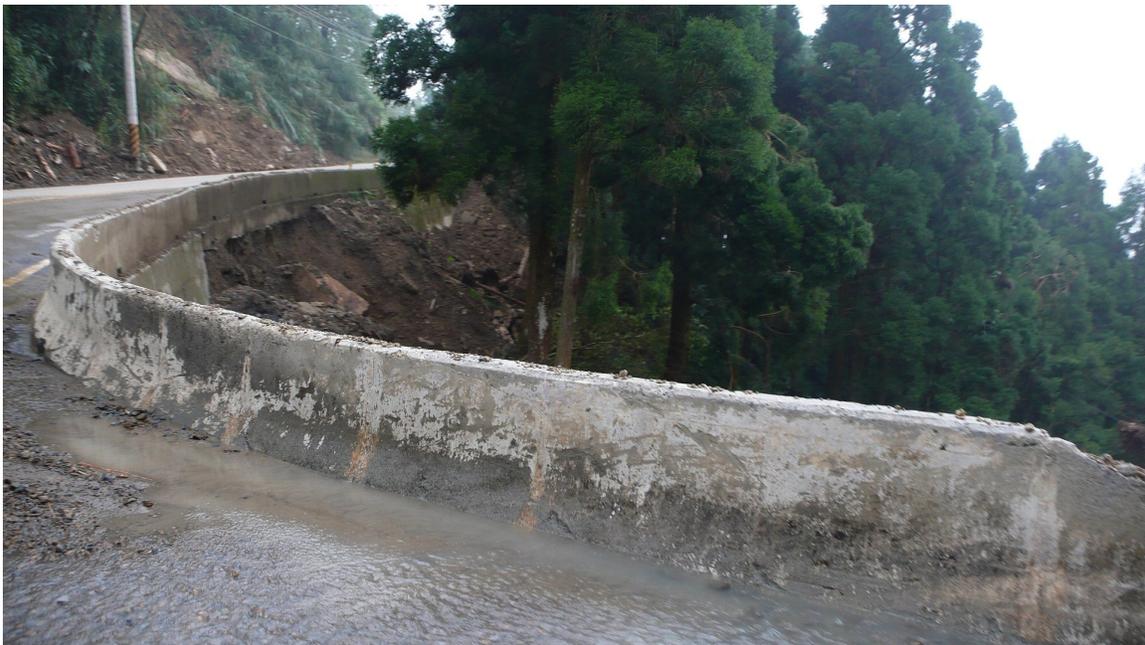
Photo 5-6-4. The Jersey Barrier was reported to have blocked the water from draining during heavy rainfall

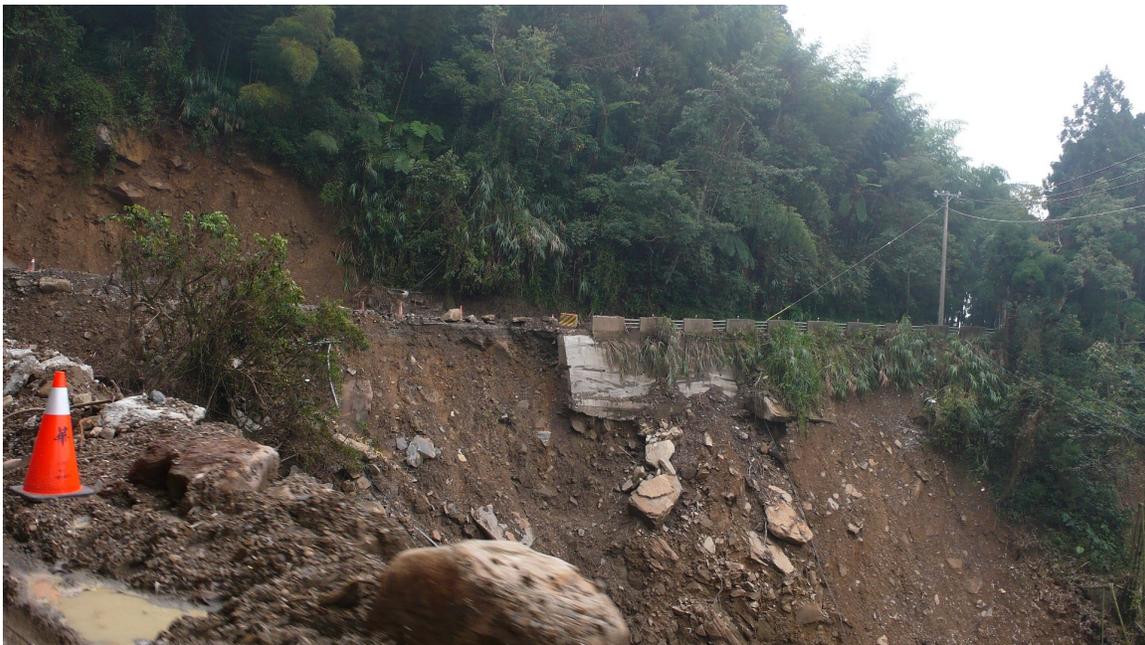
Photo 5-6-6. The loss of foundation due to landslides led to the collapse of many retaining walls.

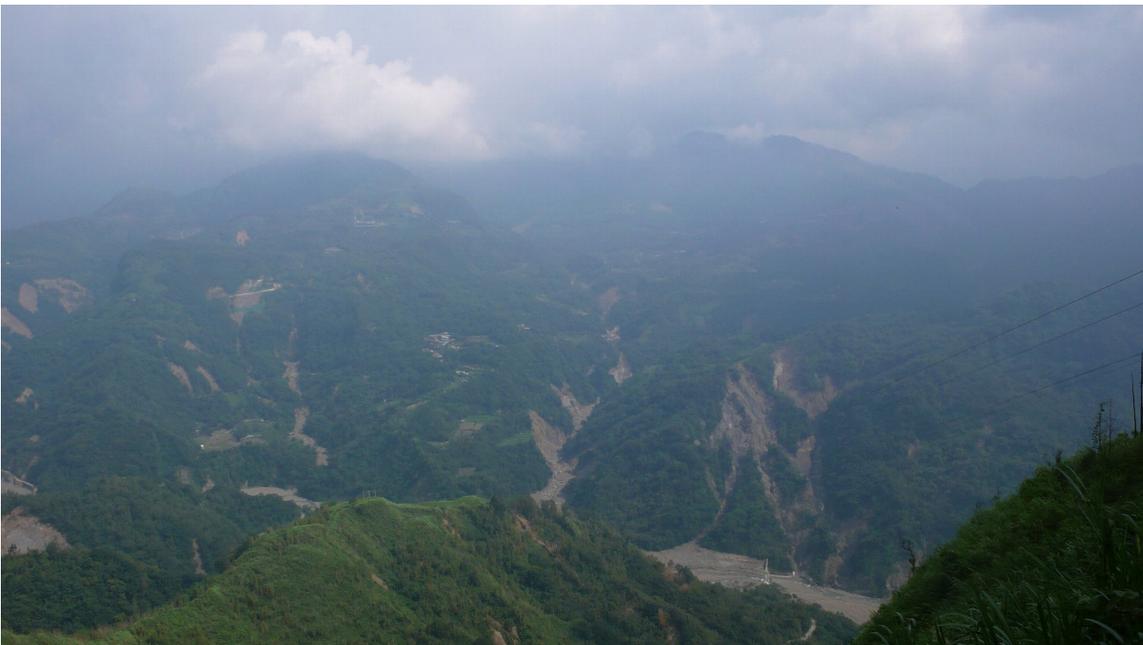
Photo 5-7-4. Landslides
