# February 6, 2023 Türkiye Earthquakes: GEER Phase 3 Team Report on Selected Geotechnical Engineering Effects

GEER Association Report 082-S1

June 30, 2023

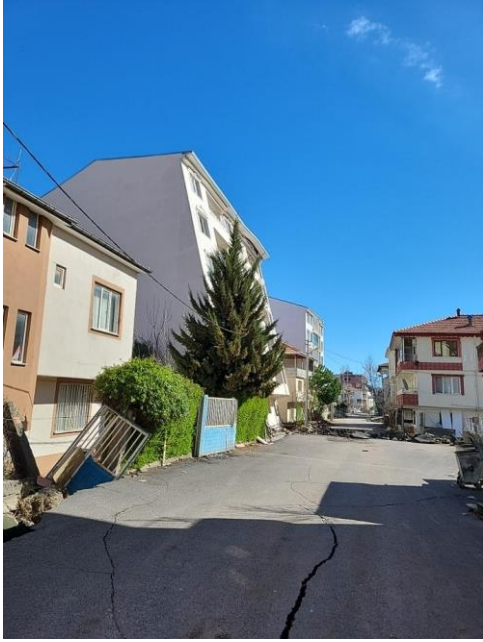
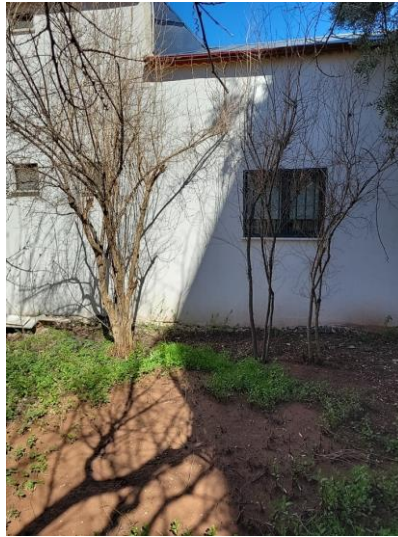
**Figure 2.6.** Reconnaissance photos in Gölbaşı, Adıyaman (a) (37.7874N, 37.6430E; 30MAR2023) building tilting and settlement, and road cracking, (b) ground and sidewalk disturbance (37.7979N, 37.6430E; 30MAR2023), and (c) ejecta (37.7877N, 37.6430E; 30MAR2023).

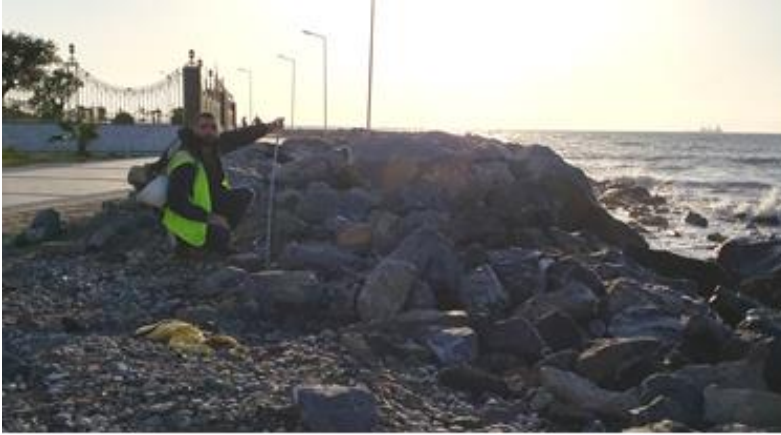
**Figure 2.11.** Photos of lateral spread LS-1: (a) observed 0.5 to 0.8 m reduction in height of rubble mound seawall at start of LS-1 relative to infilled area of Nihal Atakaş Camii mosque (36.5936N, 36.1583E; 28MAR2023), (b) pavement tile separation near shorefront (36.5933N 36.1581E; 28MAR2023), (c) pavement crack extending along southwest bound portion of Atatürk Blvd (36.5930N, 36.1588E; 28MAR2023), and (d) separation between curb and bike lane (36.5934N, 36.1587E; 28MAR2023).

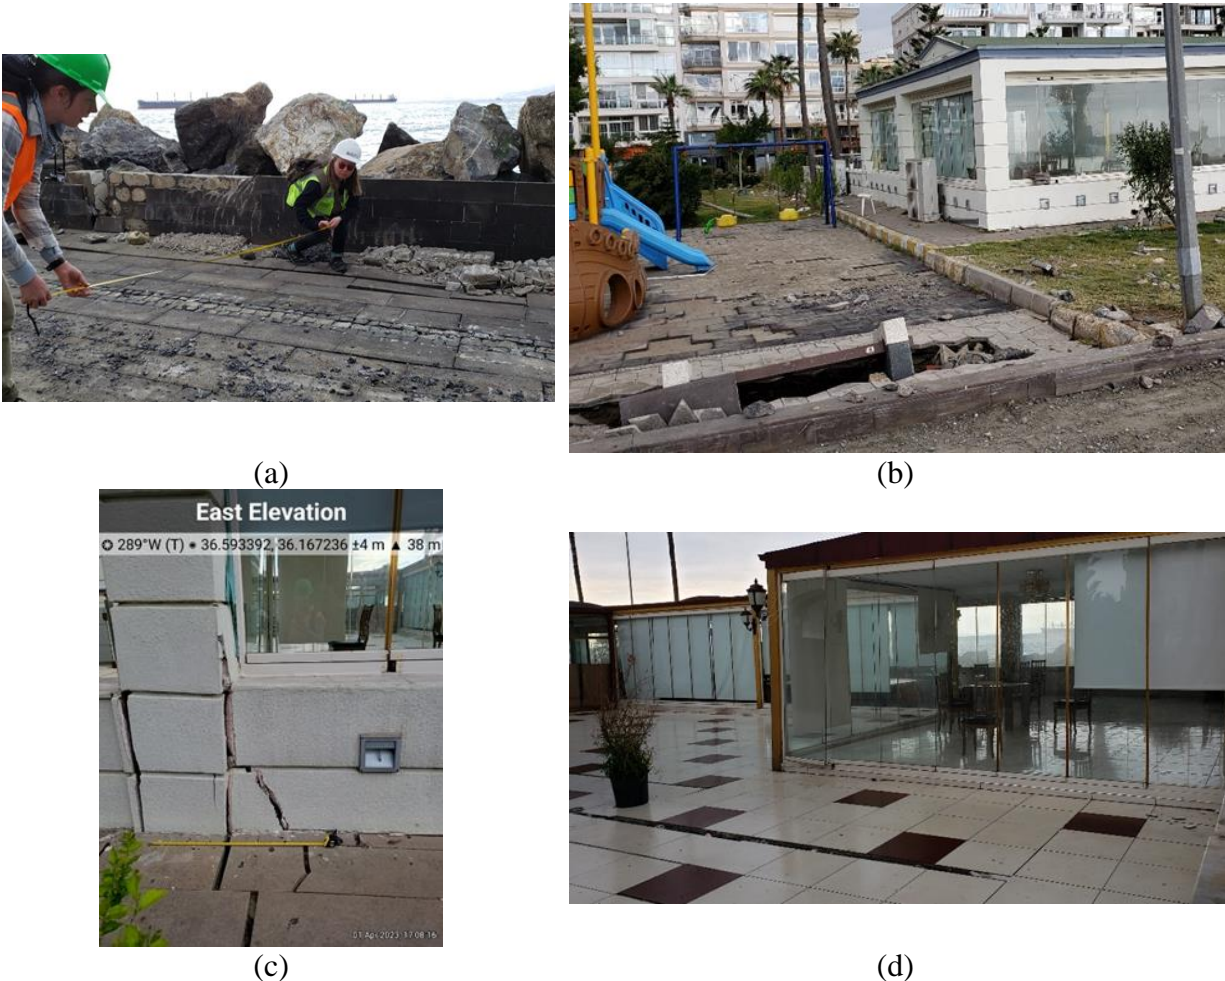
LS-2 (start point: 36.59358N, 36.16731E) was taken along the east side of the Doğan restaurant 1-story patio building as depicted in Figures 2.12a-d. The patio building was not being used, likely due to severe ground cracking within the building and around its exterior. The transect was taken from just inside the seawall behind the building to just south of the main 2-story restaurant building, which appeared structurally sound, but was also not in service. The measured cracks were taken along the concrete pathway adjacent to the restaurant buildings, accumulating to about 76 cm of total lateral movement. Cracking along the base of the patio building wall and extending

guardrail wall approximately matched the adjacent ground cracking at LS-2, with a 30 cm lateral extension over a distance of 19 m along the walls (i.e., extensional strains of over 1.5%).

**Figure 2.12.** Photos of lateral spread LS-2: (a) seawall at start of LS-2 (36.5937N, 36.1672E; 01APR2023), (b) sunken park bench and spreading along eastern wall of Dogun restaurant patio (36.5937N, E36.1672E; 01APR2023), (c) cracks near column at southeast corner of patio (36.5934N, 36.1672E; 01APR2023), and (d) cracking along back of patio (36.5935N, 36.1671E; 01APR2023).

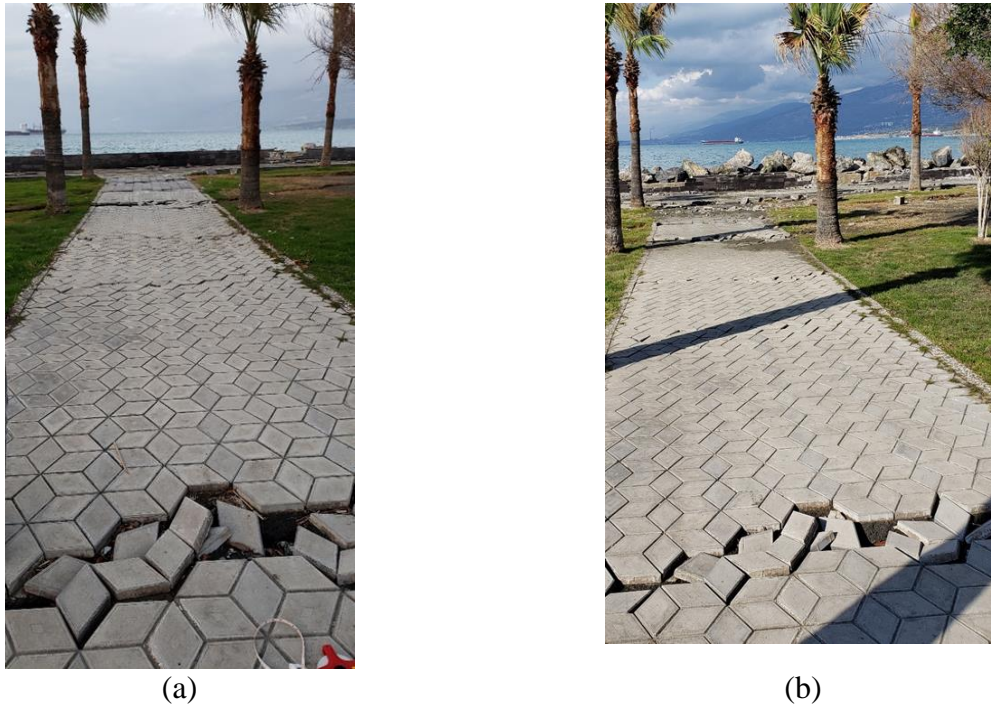
LS-4 (start point: 36.59326N, 36.16883E) was measured initially on March 28 and then again on April 1, 2023. It is depicted in Figures 2.14a-b. The transect extended from inside the seawall to a pedestrian pathway just north of and parallel to Atatürk Blvd. The transect was measured along a tiled concrete walkway perpendicular to the shoreline. The accumulated lateral spreading measured over LS-4 during our visit on March 28 was about 140 cm. During our visit on April 1 (three days after the March 29 storm event), it was observed that the seawall rubble was about 1 m higher and the reinforced concrete parapet wall behind the rubble was much more heavily damaged. Construction equipment wheel tracks were also observed along the waterfront in this area. It is believed that additional rubble was placed for temporary flood mitigation and protection

against future storms. Our measurements indicate that lateral displacements increased by about 7 cm over the intervening period. Despite potential uncertainties in our measurements, this may have been caused by movement or vibrations from heavy machinery used to place the rubble, scour and movement of surficial features (e.g., concrete pavement blocks) during the March 29 storm, or additional ground movements occurring since the previous measurements.

**Figure 2.14.** Photos of lateral spread LS-4 along tiled concrete walkway: (a) before the March 29, 2023 storm event (36.5930N, 36.1687E; 28MAR2023), and (b) three days after the March 29, 2023 storm event (36.5930N, 36.1687E; 01APR2023). Notice damage to seawall and higher rubble mound in more recent photo, presumably caused by additional rubble placement in the intervening time between photos.

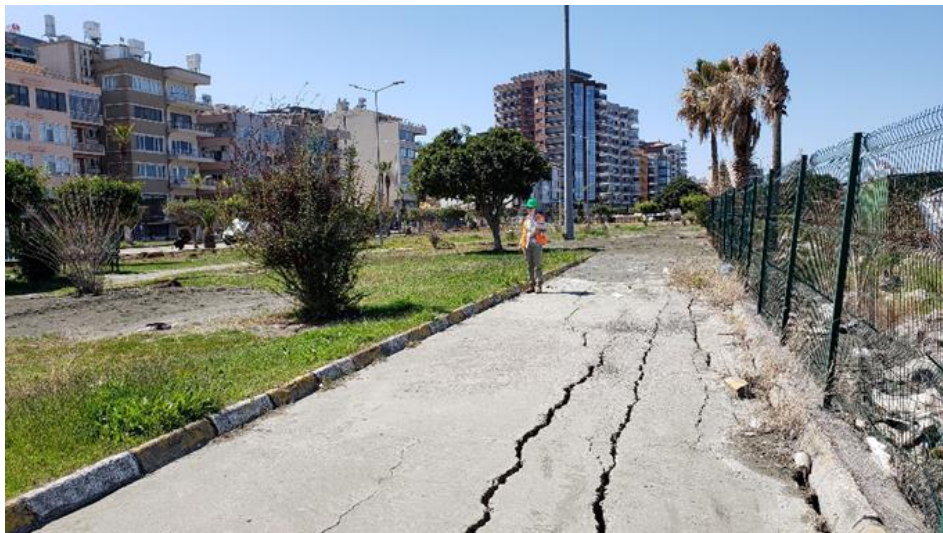
**Figure 2.17.** Sand boils and lateral spreading near boat dock in Çay district of İskenderun, Hatay Province, Türkiye (36.5915N, 36.1789E; 01APR2023).

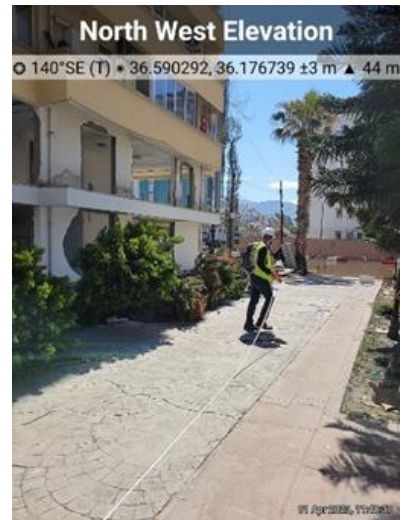
**Figure 2.18.** Photos of lateral spread LS-5 taken April 1, 2023: (a) start of LS-5 at north sidewalk curb along Atatürk Blvd (36.5908N, 36.1769E; 01APR2023), (b) separated pavement block with 3 to 6 cm of vertical displacement bounded by horizontal cracks of 10 to 20 cm along Atatürk Blvd (36.5908N, 36.1767E; 01APR2023), (c) cracks along Atatürk Blvd (36.5908N, 36.1769E; 01APR2023), (d) 5 cm crack aligned with front edge of building foundations along Atatürk Blvd (36.5906N, 36.1768E; 01APR2023), and (e) minor cracking along end of LS-5 (36.5903N, 36.1767E; 01APR2023).

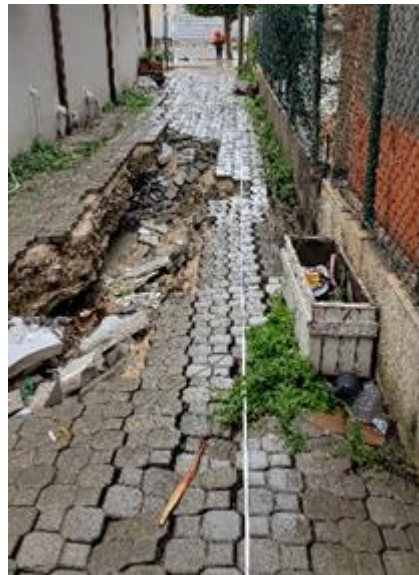
**Figure 2.19.** Photos of lateral spread LS-6: (a) start of LS-6 at south sidewalk along Atatürk Blvd in front of building Belli Apartment #18 (36.5907N, E36.1778E; 29MAR2023), (b) cracking along wall behind buildings (36.5904N, 36.1778E; 29MAR2023), (c) cracking along wall behind buildings (36.5905N, 36.1779E; 28MAR2023), and (d) end of LS-6 along the side of building Kaan Ela #24 (36.5905N, 36.1779E; 29MAR2023).

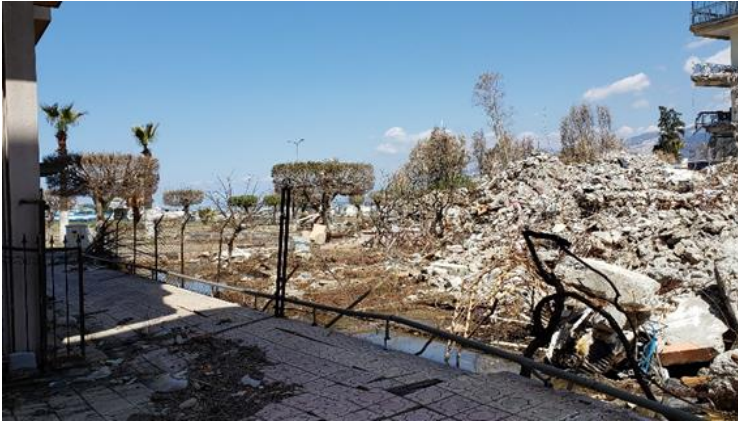
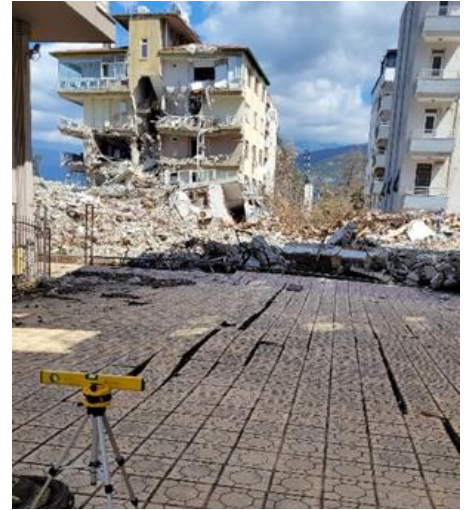
**Figure 2.20.** Photos of lateral spread LS-7 (a) minor cracking along east side of settled building (36.5907N, 36.1791E; 01APR2023), and (b) cracking along courtyard behind buildings (36.5911N, 36.1789E; 01APR2023).

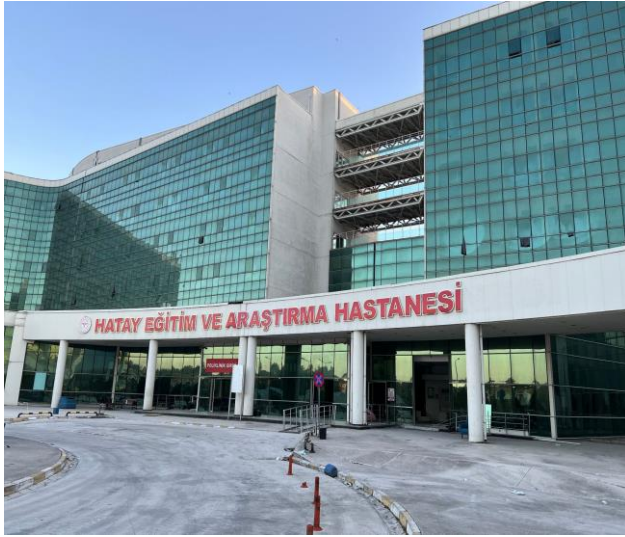
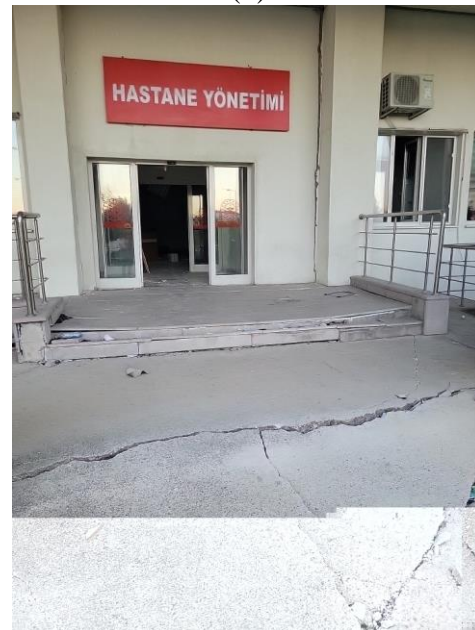
Area "A" is the north side of the north building and appeared to be the main hospital entrance. An overview of this area is shown in Figure 2.23a, including some pavement damage. Closer inspection of the ground close to the structure resulted in measurements of fill settlement from 0 cm to 48 cm. Figure 2.23b pictures an entrance ramp where 48 cm of fill settlement was measured between the entrance and the top of the ramp. Figure 2.23c pictures the ground near the base of the ramp where 0 cm to 18 cm of fill settlement was measured. Figure 2.23d shows another entrance where there was damage to the pavement and stairs.

**Figure 2.23.** Fill settlement on the north side of the main hospital building (area “A” in Figure 2.22): (a) overview of north-facing front of hospital showing some pavement damage (36.2709N, 36.2241E; 31MAR2023), (b) settlement of an entrance ramp about 48 cm relative to the structure and entrance (36.2705N, 36.2244E 31MAR2023), (c) 0 cm to 18 cm of fill settlement relative to the structure (36.2704N, 36.2245E, 31MAR2023), and (d) damage to pavement and stairs at an entrance (36.2709N, 36.2239E, 31MAR2023).

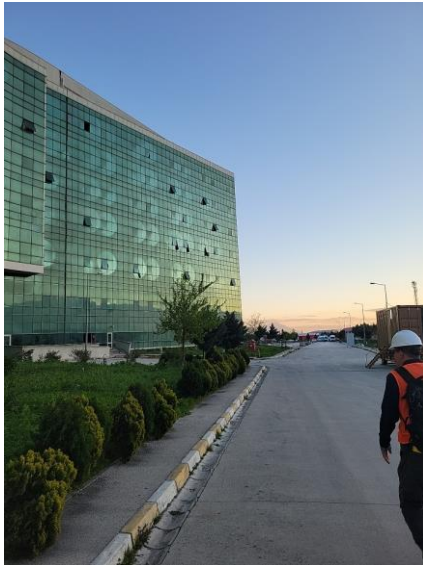
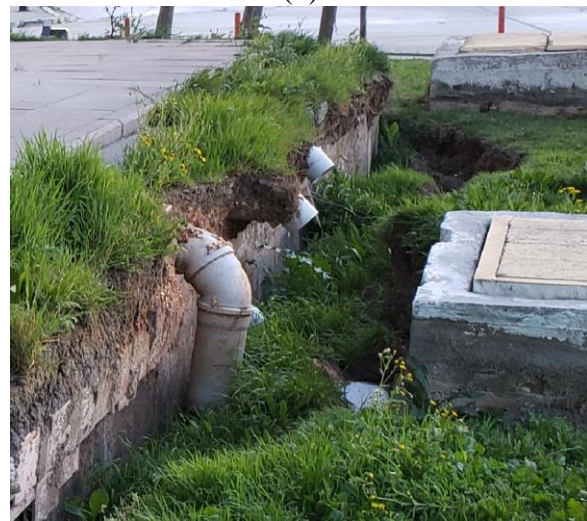
Area “B” is the west side of the north hospital building. Damage to utility connections, likely due to differential fill settlement, was also documented in this area. Figure 2.24a shows an overview of this area including an entrance and a landscaped area. Notable settlements and damage to stairs at the entrance was documented by the picture in Figure 2.24b. There were notable differences in settlement measured between the concrete and grass areas. These deformations also opened up a

gap between the concrete and grass areas, and exposed damaged utility connections (Figures 2.24c,d). The differences in settlement were measured to be 30 to 40 cm, and the opening between the concrete and grass was measured to be up to about 10 cm.

**Figure 2.24.** Fill settlement on the east side of the main hospital building (area “B” in Figure 2.22): (a) view of the east side (36.2711N, 36.2234E, 31MAR2023), (b) damage to entrance stairs (36.2707N, 36.2233E; 31MAR2023), (c) different settlements between the concrete and grass area exposing damaged utility connections (36.2704N, 36.2230E, 31MAR2023), and (d) different settlements between the concrete and grass area exposing utility connections (36.2704N, 36.2231E, 31MAR2023).

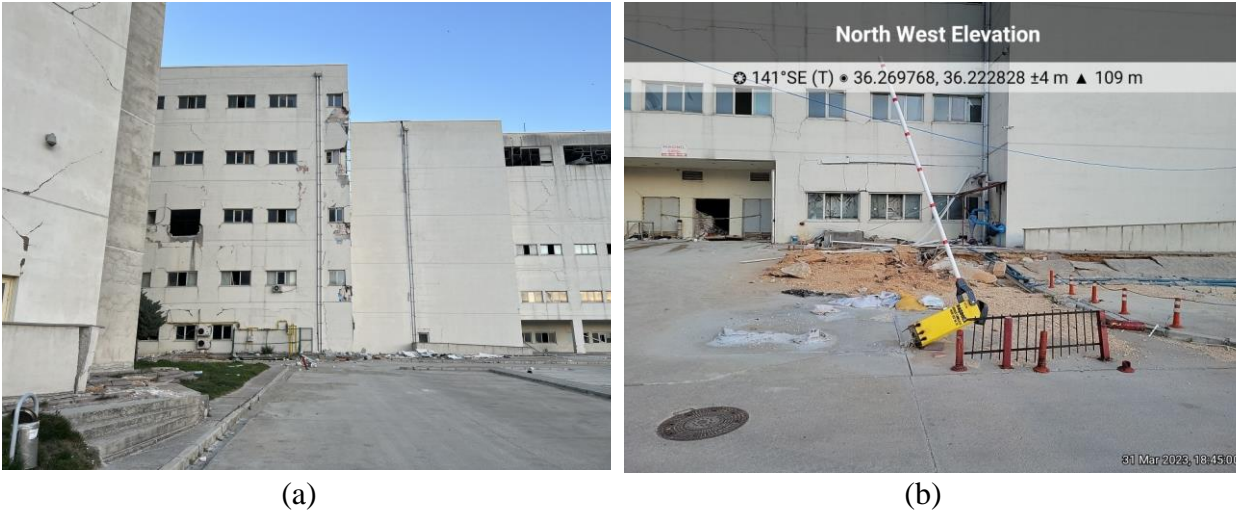
Area “C” includes the south structures of the hospital. Damaged structures in Area C are shown in Figure 2.25a with some evidence of fill settlement. Notable fill settlement was observed near the structure shown in Figure 2.25b. This settlement appears to be focused in an area of utility connections. Although utility lines are exposed in this area, it is not known if they were exposed due to damage or to support the field hospital operations set up in the main parking lot.

**Figure 2.25.** Fill settlement and damage on the east side of the southside hospital structures (area “C” in Figure 2.22): (a) view of damaged buildings (36.2703N, 36.2229E, 31MAR2023), and (b) fill settlement and exposed utility lines (36.2698N, 36.2228E, 31MAR2023).

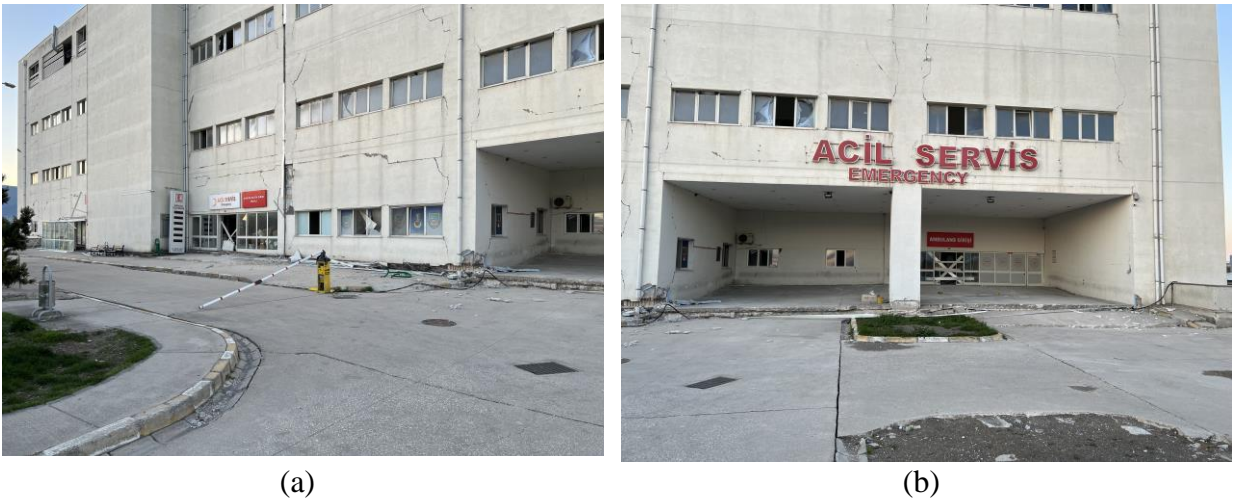
**Figure 2.26.** South side of the hospital (area “D” in Figure 2.22): (a) overview of the south side (36.2691N, 36.2234E, 31MAR2023), and (b) ambulance entrance where up to 40 cm of fill settlement was measured (36.2691N, 36.2234E, 31MAR2023).

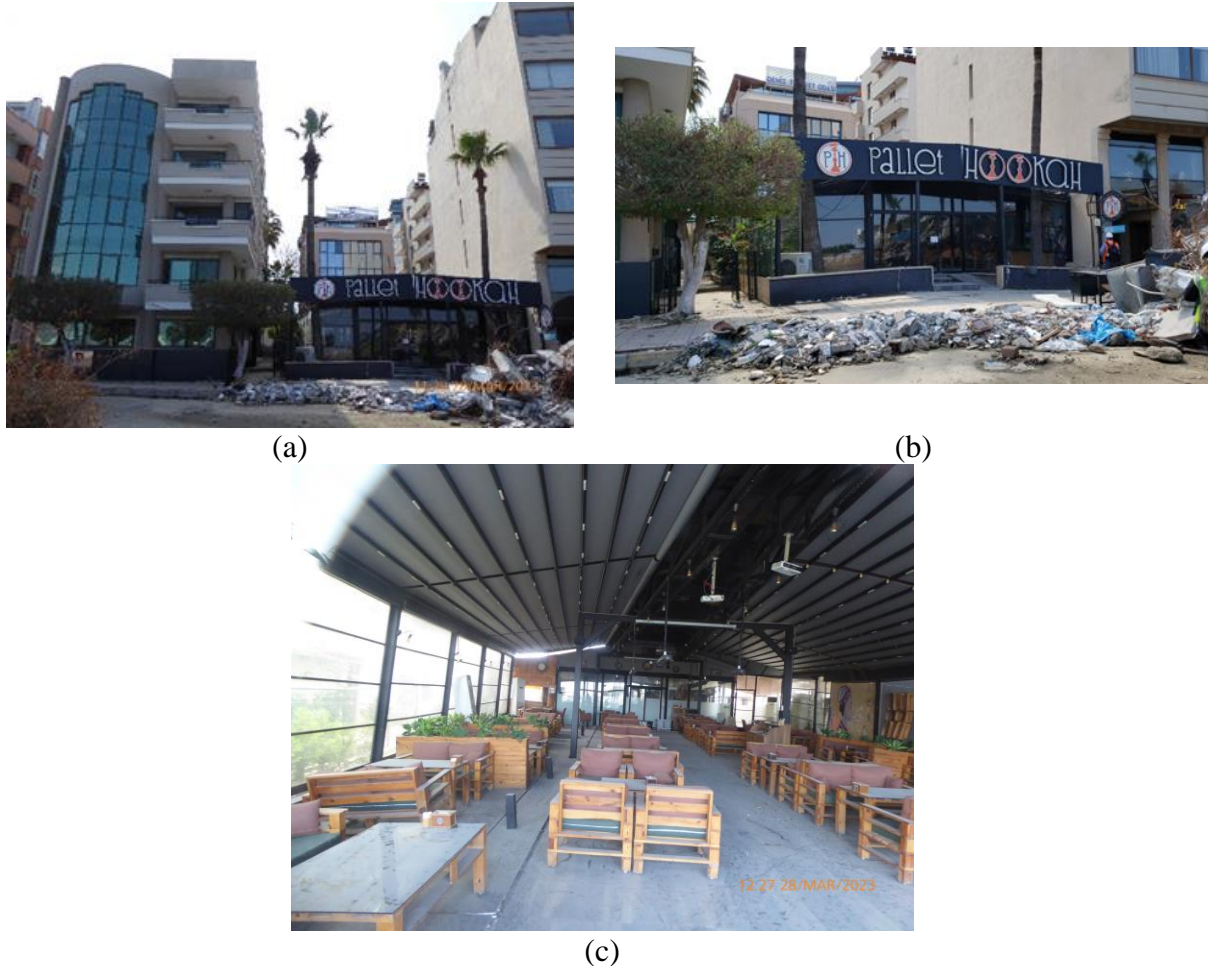
**Figure 3.14** Çay District, İskenderun, Hatay. Photos showing liquefaction settlement building interactions. (a) (36.5907N, 36.1778E; 28MAR2023) The Pallet Hookah building appears to have been affected by settlement of two adjacent buildings, (b) (39.5907N, 36.1778E; 28MAR2023) settlement from the two 5-story buildings resulted in a hogging ground deformation, and (c) (36.5907N, 36.1779E; 28MAR2023) the interior of Pallet Hookah with cracks in the floor slab.

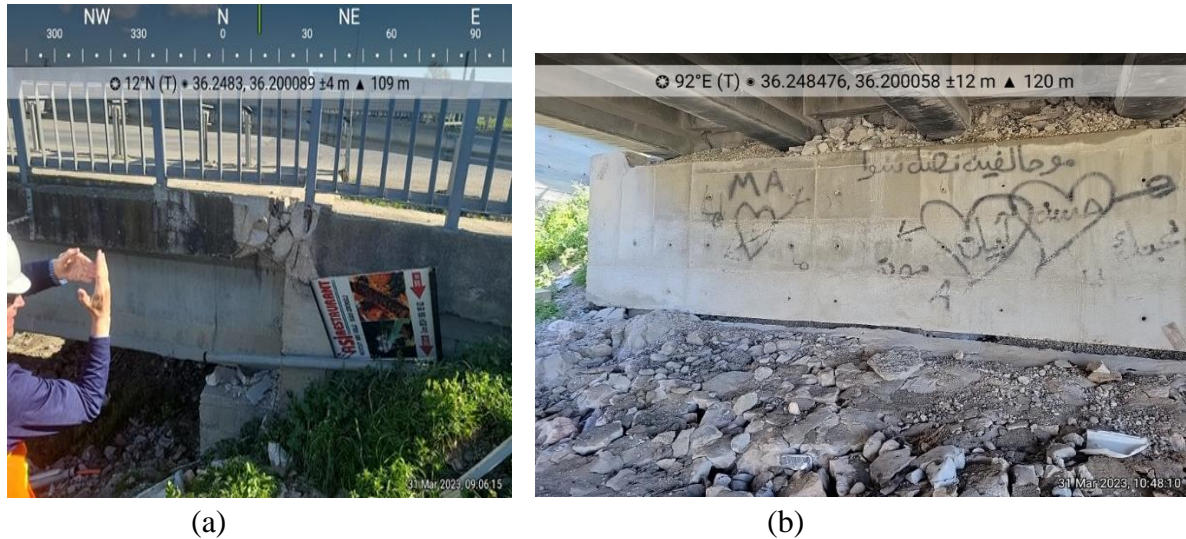
**Figure 4.4.** D817 Bridge damage at south bridge structure east bank abutment: (a) spalled concrete and movement at deck interface (36.2483N, 36.2001E; 31MAR2023), (b) abutment face (36.2485N, 36.2001E; 31MAR2023).

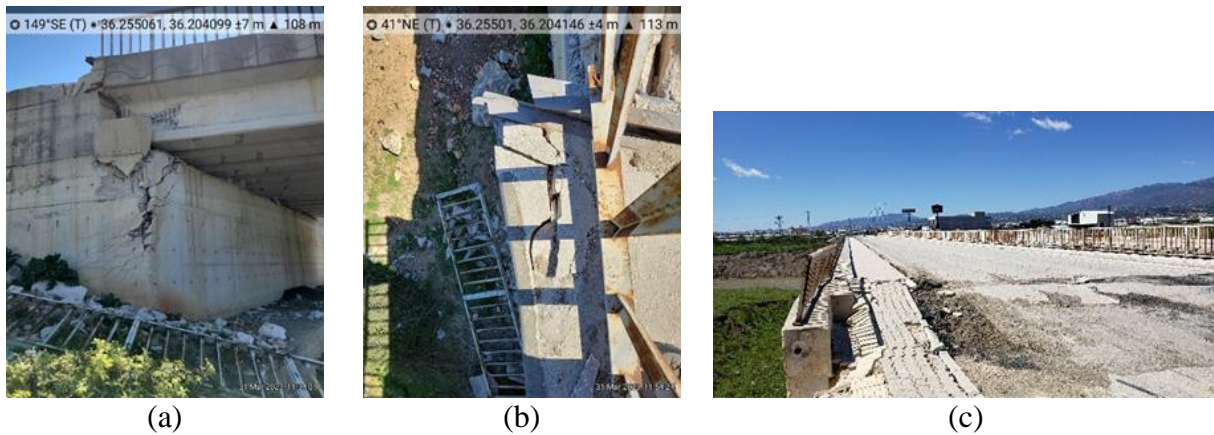
**Figure 4.9.** Damage at east abutment of Hatay Stadium Bridge: (a) cracking and spalling at edge of north bridge deck and abutment (36.2551N, 36.2041E; 31MAR2023), (b) right-lateral offset at edge of north bridge deck (36.2550N, 36.2042E; 31MAR2023), (c) settlement of abutment and misalignment of deck at south bridge (36.2548N, 36.2043E; 31MAR2023).

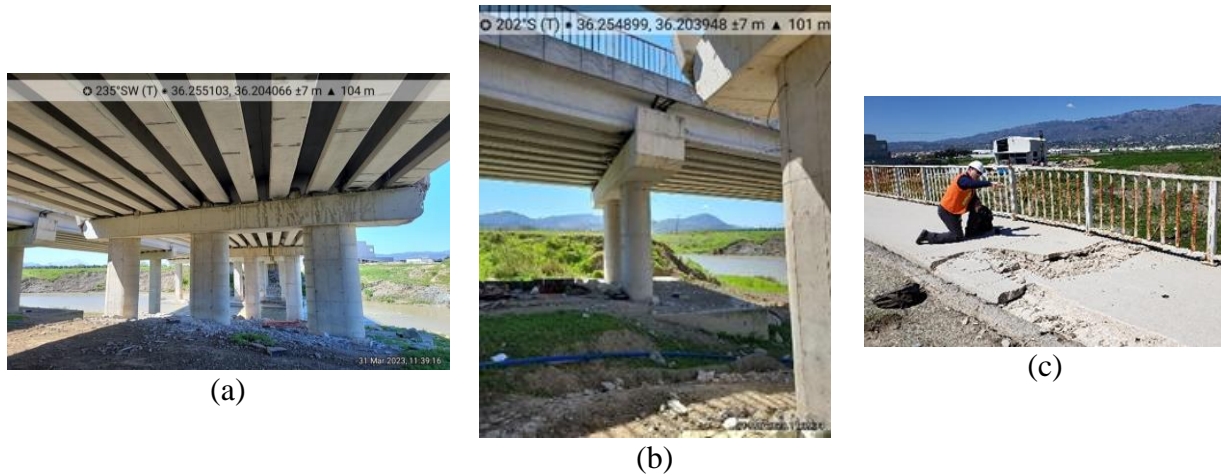
**Figure 4.10.** Damage at eastern-most bent of Hatay Stadium Bridge: (a) damage of shear keys at pier cap and base of columns (36.2551N, 36.2041E; 31MAR2023), (b) pile caps are undamaged (36.2549N, 36.2040E; 31MAR2023), and (c) vertical drop of deck measured by laser level across cracks observed above the bent (36.2548N, 36.2037E; 31MAR2023).

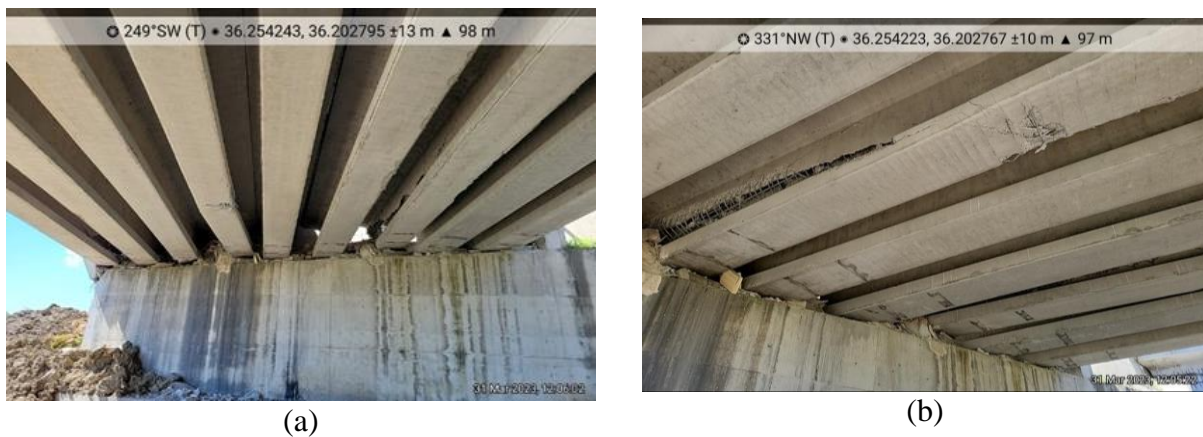
**Figure 4.11.** Damage at west abutment of Hatay Stadium Bridge: (a) south bridge girder damage (36.2542N, 36.2028E; 31MAR2023), and (b) settlement and misalignment of deck at north end of abutment (36.2542N, 36.2028E; 31MAR2023).

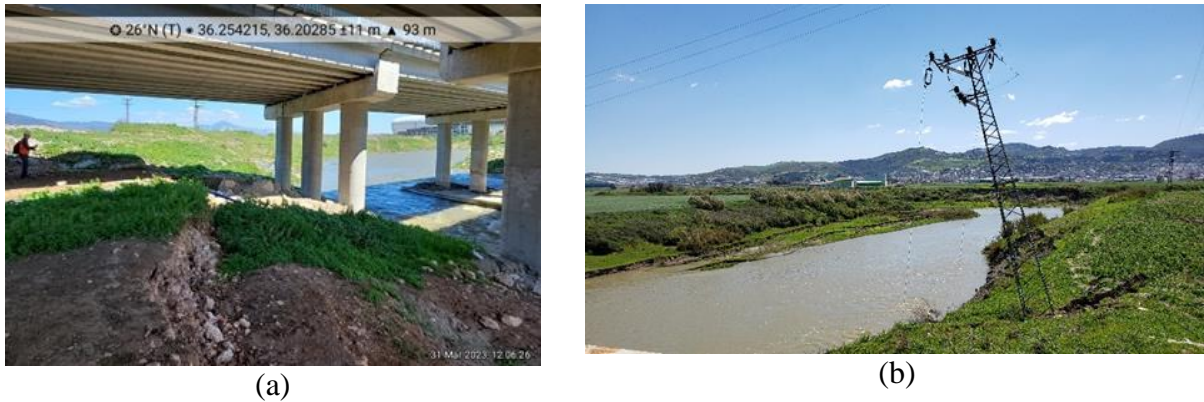
**Figure 4.12.** Local slope failures near Hatay Stadium Bridge: (a) rotational sliding beneath west end of bridge (36.2542N, 36.2029E; 31MAR2023), and (b) lateral spreading along east bank (background) and rotational failure affecting transmission lines on west bank (foreground) of Karasu river (36.2540N, 36.2029E; 31MAR2023).

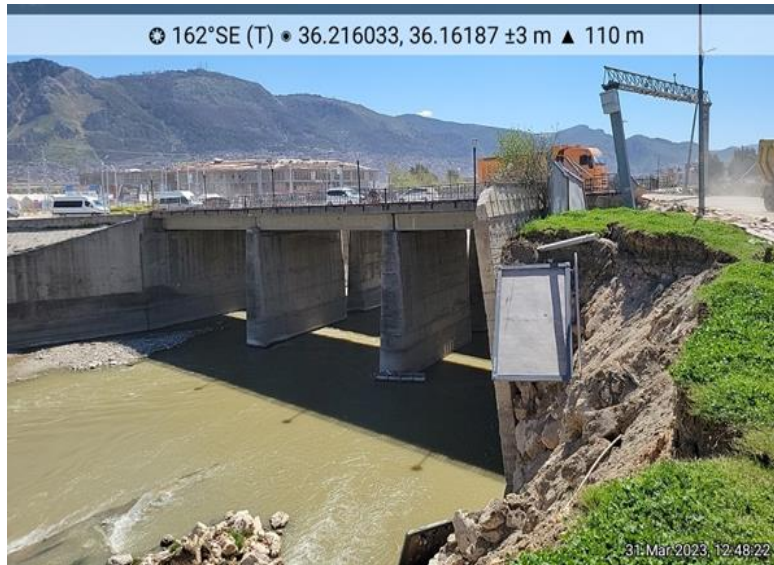
**Figure 4.13.** The Bekir Karabacak Bridge crossing the Orontes River, as viewed from near a retaining wall failure at the northwest wingwall of the bridge (36.2160N, 36.1619E; 31MAR2023).

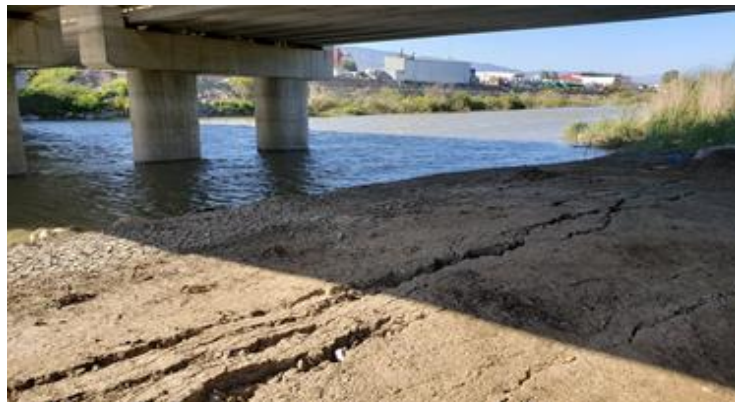
**Figure 4.20.** Ground cracks below the east bridge span in front of the east abutment indicated lateral movement toward the river (36.2327N, 36.1856E; 31MAR2023).

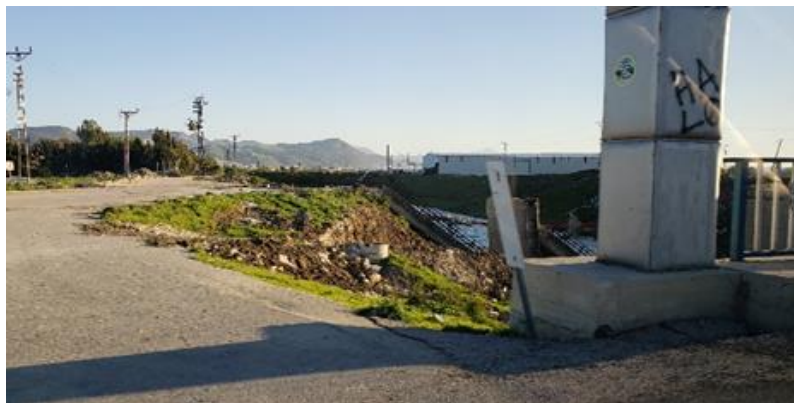
**Figure 4.21.** Local slumping failure and collapse of old bridge deck along east bank to the south (background of photo) of the main ‘Hatay Hospital’ Bridge (foreground of photo) (36.2456N, 36.2047E; 31MAR2023).

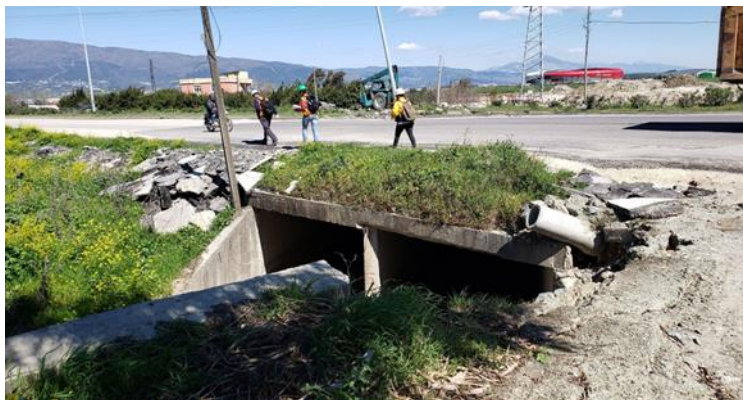
**Figure 4.22.** Retaining wall damage near a culvert beneath the D817 highway (36.2726N 36.2083E; 31MAR2023).

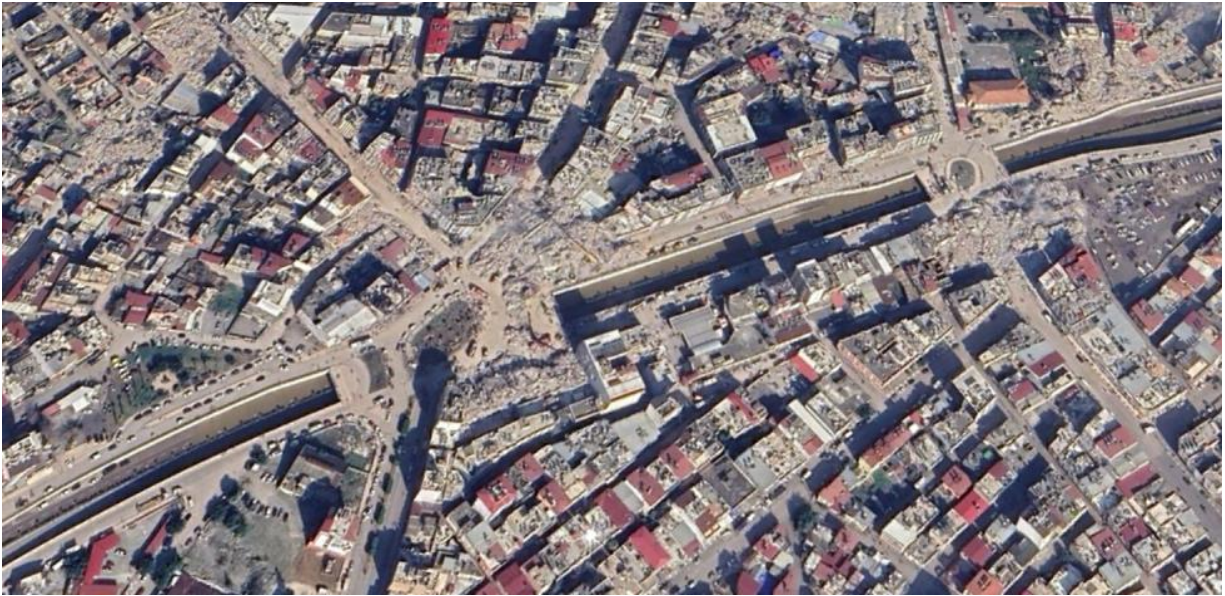
**Figure 4.23.** Image of u-box underpass in İskenderun, Hatay from Google Earth on February 8, 2023, showing flood water in the underpass. Center of the image is approximately 36.5832N, 36.1697E.
