## **Reconnaissance Report of the May 28, 2009 Honduras Earthquake, M 7.3**

*A team sponsored by the Earthquake Engineering Research Institute (EERI) and the Geoengineering Extreme Event Reconnaissance (GEER) Association carried out a field investigation in conjunction with Honduran colleagues from June 18-23 to document effects of the May 28 earthquake. The EERI-GEER team was invited by Mr. Marco Sandoval, Executive Director of the Comisión Ejecutiva Valle de Sula (CEVS). Mr. Sandoval sent a team of engineers to accompany the EERI-GEER team. The team included experts in structural, geotechnical engineering, as well as in disaster response and recovery. The investigators were supported by EERI: Abdeldjelil Belarbi and GEER: Ronaldo Luna and Kermit Applegate, all from Missouri S&T, Rolla. The CEVS team consisted of Humberto Calderon, Osvaldo Rivera, and Luis Alonso Lopez. Observations of other individuals who visited the earthquake-affected region have also been incorporated in this report. This material is based upon work supported by the National Science Foundation through the GeoEnvironmental Engineering and GeoHazards Mitigation Program under Grant No. CMMI-0825734. Any opinion

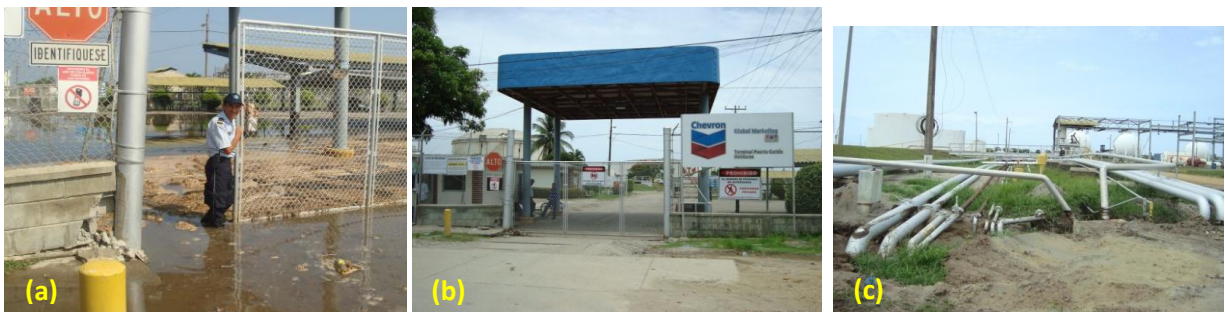
Figure 3 – Chevron Terminal remains closed as of 06/28/2009.

Of particular interest was the damage encountered at the Chevron Terminal in Puerto Cortés. This area was built on sandy fill. Liquefaction sand boils were wide spread throughout the terminal within tanks, pipe racks and small buildings (see Figure 3). Damage to tanks was not evident, except a pressurized vessel that settled more than 2 ft on one side tilting the entire tank, which was supported on shallow foundations (see Figure 4). Small structures supported on shallow foundations were damaged, such as the laboratory and office buildings (see Figure 5). Safety inspection requirements and repairs of tanks and pipeline systems will take more time.

- (a) Note inundation due to wide spread liquefaction [05/28/2009 N15.848287, W87.958041],
- (b) Same entrance location 3-weeks later [06/20/2009 12:40PM, N15.848287, W87.958041], and
- (c) Multiple pipeline deformation and breaks [06/20/2009 1:24PM, N15.849177, W87.959274]

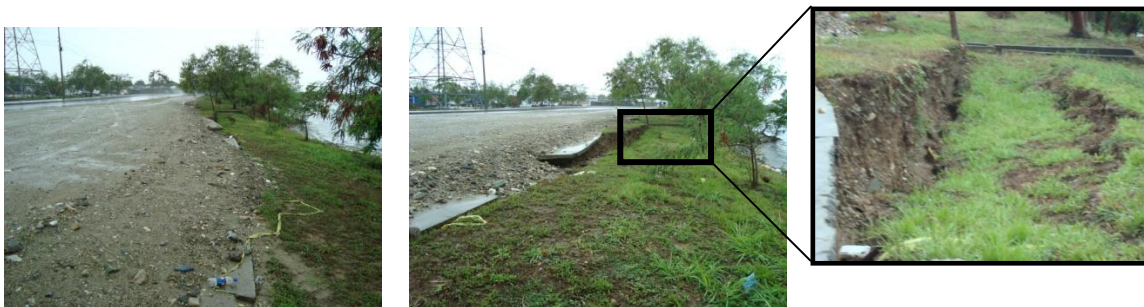
Other buildings and residences were damaged in the central zone of Puerto Cortés due to the wide spread liquefaction and ejected sand. Buildings tilted and became inundated, leaving much sand behind. The surface storm sewer system was clogged for weeks until the municipality and neighbors were able to excavate the drains. A recently build roadway embankment that contains a major utility on the south side of the city was seriously affected by lateral spreading. (Figure 6)

Figure 6 – Temporary repair of roadway embankment, due to lateral spreading [06/20/2009, 1:25 PM, N15.848216, W87.958604].

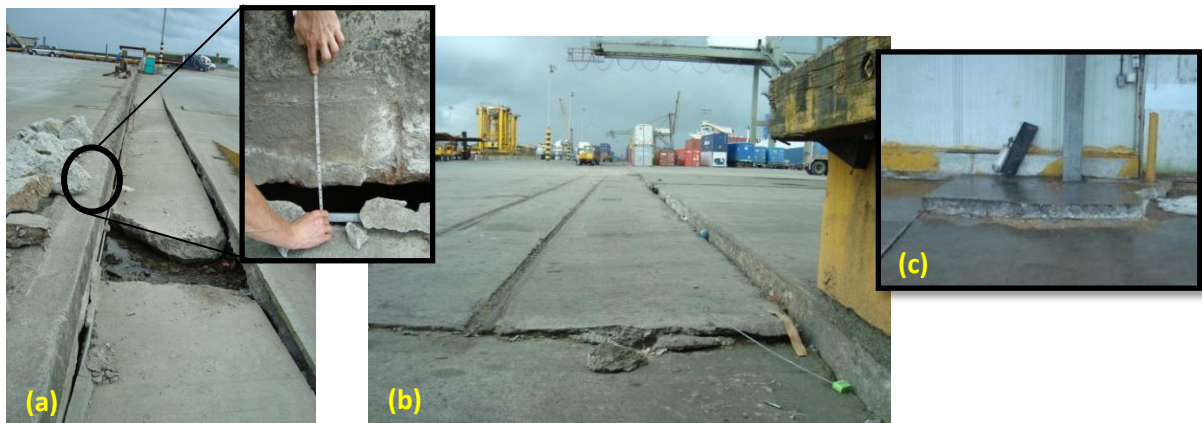
Earthquake damage at the most important port in Honduras was localized even though it remains in operation. Most of the damage was concerning movement of slabs and wharfs causing joints to move in the vertical and horizontal directions. In some cases the slabs collapsed due to the loss of subgrade support (Fig 7a and 7b). It was reported that some of the pile supported wharfs moved upwards by several inches. Some foundations appeared to have moved upward, but this differential movement is all relative to the surrounding ground subsidence, which needs to be confirmed by precision survey (Fig. 7c). Fuel tanks supported on concrete mats experienced large deformations due to widespread liquefaction and surface rupture of fill materials, see Figure 7(d).

(a) Up to 0.46m at the main dock [06/20/2009, 3:37PM, N15.843718, W87.951739],  
(b) 0.2m near port warehouses [06/20/2009, 3:49PM, N15.8424, W87.94941], and  
(c) Relative foundation displacement up to 0.15m [06/20/2009, 4:00PM, N15.841912, W87.941644].

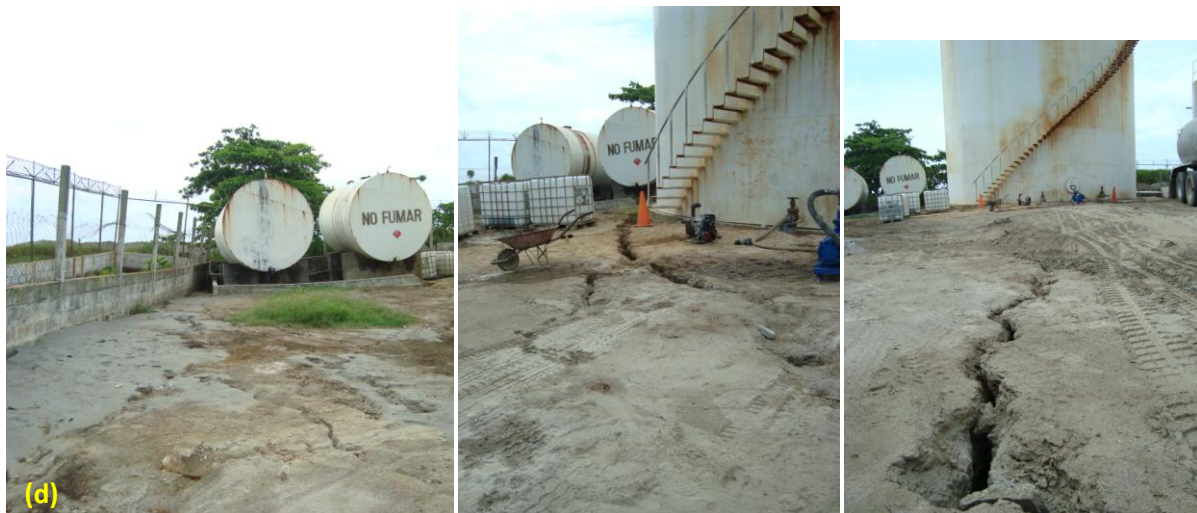
(d) Three view of fuel tanks and multiple ground fissures due to wide spread liquefaction  
[06/20/2009, 3:12PM, N15.846936, W87.963225]

Figure 7 – Liquefaction induced deformations at Puerto Cortés – Slabs on grade and Tanks.

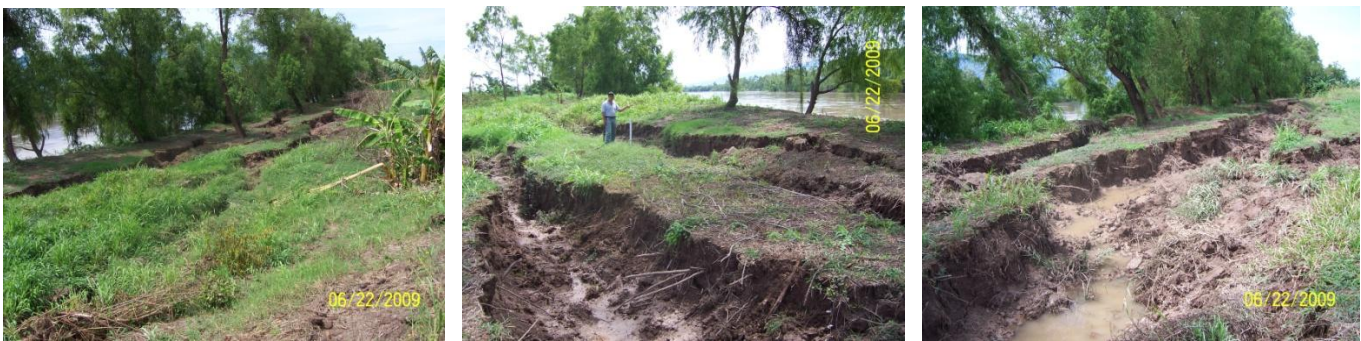
Near the edge of the Ulúa River, on the unprotected zone of the levee system, extreme lateral spreading was evident. Gaping fissures up to 5 meters wide and two meters deep have indelibly altered the landscape (Figure 9). This will have serious consequences as the rainy season approaches and the levee system is not able to keep the flood water out of the protected zones (plantations and rural residences).

Figure 9 – Multiple views of severe lateral spreading between levees and river [06/22/2009, 10:25AM, N15.391266, W87.845191].

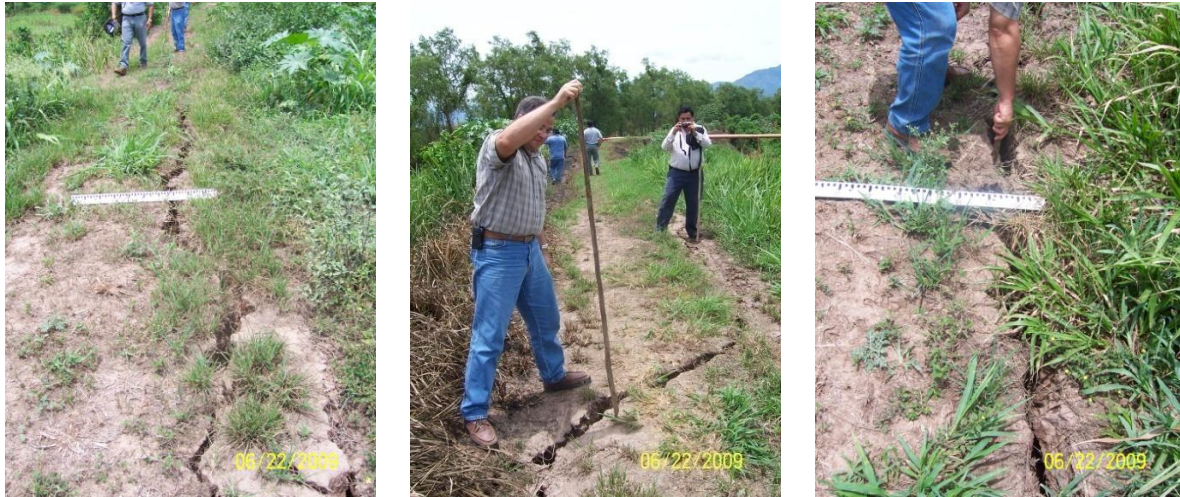
Along the crest of the levee system, a network of smaller cracks (about 5-10 cm wide and several meters deep) has rendered nearly 60 km of the levee system ineffective (Figure 10). CEVS is currently undergoing an emergency earthwork operation to reinstate levee geometries to its pre-earthquake conditions.

Figure 10 – Cracks at the crest of levees exceeding 1.5m deep  
[06/22/2009, 11:57AM, N15.344505, W87.868515].

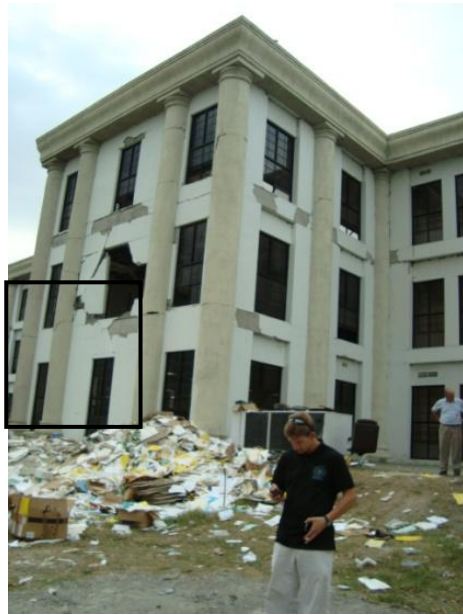
Infill walls, usually located between RC columns and beams, can suffer out-of-plane overturn due to inertial forces during an earthquake. Because infill walls are non-load-bearing elements, they tend to be thin and cannot rely on the additional shear strength that accompanies vertical compressive loads. If infill walls are not properly restrained in out-of-plane direction, walls can collapse during strong ground shaking, producing damages to inhabitants and properties. If walls on the façade of a structure collapse, the consequences could be deadly to pedestrians. Figure 11a shows a typical in-fill wall failure.

(a) Overall damage including out-of-plane failure of masonry infill wall  
[06/19/2009, 5:53PM, N15.472899, W88.018565].

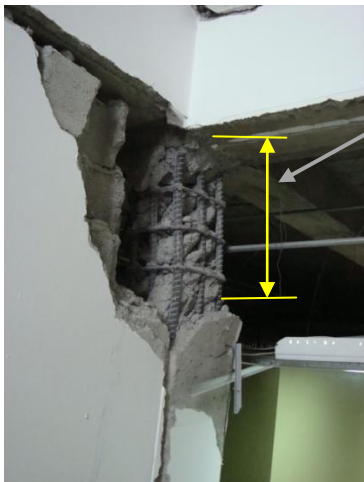
(b) Column failure at the infill wall frame interface  
[06/19/2009, 5:08PM, N15.473038, W88.018103]

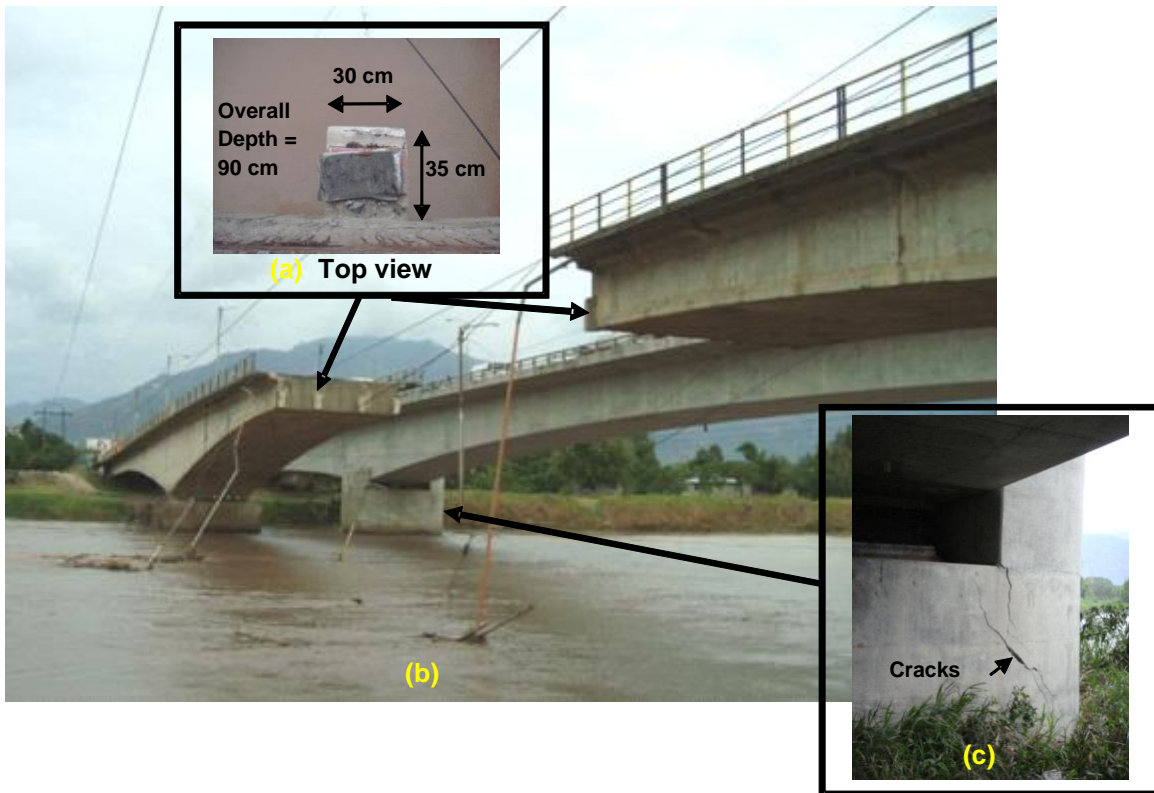
Two bridges suffered serious consequences by the seismic events of May 28<sup>th</sup>, 2009. The reinforced concrete 3-arch bridge, entitled “La Democracia”, crosses the Ulua River near the town of El Progreso. The bridge connects this town to the major city of San Pedro Sula in northern Honduras. The bridge that experience collapse of the middle span was built in 1965 by a team of French engineers. The structure consists of two middle supports with nearly symmetric monolithic arches, with the middle span complemented by a straight beam span. The total length of the bridge was 258 m. The middle span was 36 m. These middle components consist of four simply supported T-beams. All supports, including abutments, consist of steel plate bearings. Figure 12 shows the collapsed middle span and in the background the newer 2005 twin bridge built by the Japanese, which still is in service taking the traffic towards el Progreso. The bearings on the abutments moved more than 250 mm in the horizontal direction. This bridge had shear key only in the longitudinal direction to support the T-beams. This simply supported girder Type Bridge had inadequate seating and no provisions like lateral restraint to prevent unseating. The lack of redundancy in the simply supported beam also prevented formation of alternate load path which resulted in the fall of the beams and consequently the middle span.

Figure 12 – La Democracia twin-bridge with middle span collapsed.

- (a) Top view of shear key [06/19/2009, 6:45PM, N15.404139, W87.820174].
- (b) Overall view of the twin bridge [06/19/2009, 6:45PM, N15.40478, W87.819967], and
- (c) cracking due to lateral restraint in the new bridge [06/19/2009, 6:58PM, N15.40408, W87.820615].

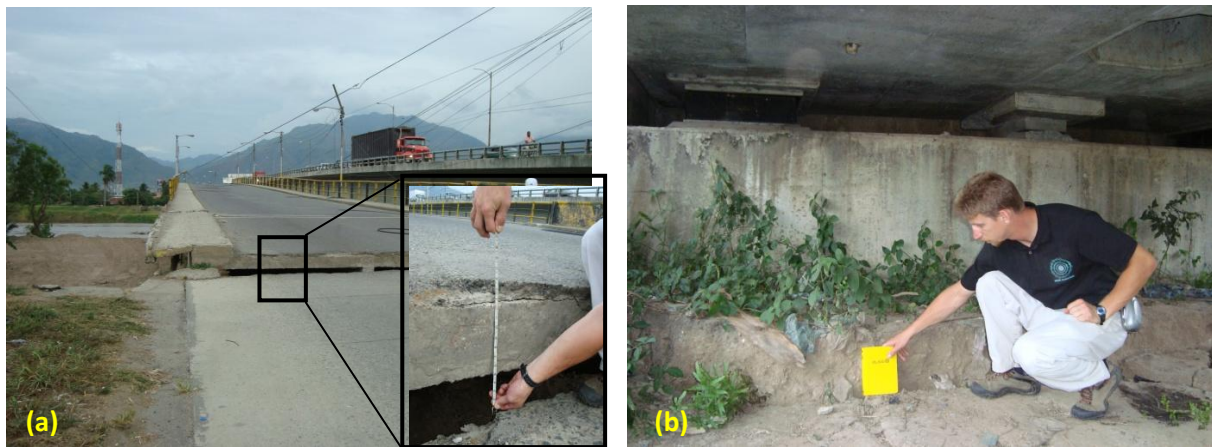
In contrast, the new bridge, which consists of a single monolithic concrete arched structure, has neoprene elastomeric bearings and shear keys at the supports. The shear keys suffered diagonal cracks, evidence that they engaged in keeping the bridge on its bearings during the seismic event. A transverse crack on the bridge (western bank) was identified. Liquefaction sand boils and significant settlement of the banks and possible lateral spreading was evident on the river banks. In some locations cracks and settlement exceeding 250 mm was observed (See Figure 13).

Figure 13 – Settlement of ground around abutments due to liquefaction  
(a) Old bridge westbound [06/19/2009, 6:36PM, N15.404409, W87.821095], and  
(b) New bridge, eastbound [06/19/2009, 6:52PM, N15.40422, W87.821021].

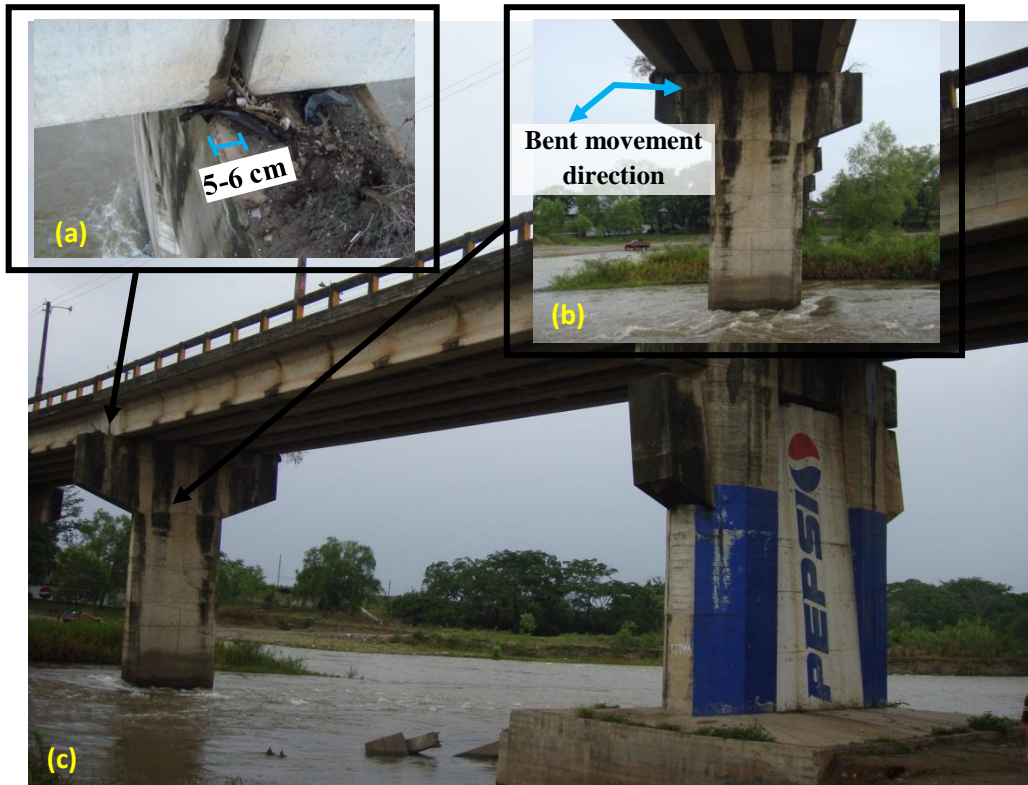
The other bridge that suffered damage during the seismic event was the bridge near Santa Rita over the Humuya River (Figure 14). The foundation support was already weakened due to scour, which historically has damaged the bridge and scour continues to aggravate the situation. The most common cause of bridge failure is structural instability and undermining caused by movement of column bent exaggerated by excessive scouring. Scour is the result of the erosive action of flowing water, excavating and carrying away material from the bed and banks of streams, and from around the piers and abutments of bridges.

This two-lane bridge consists of 8 spans of 5 simply supported reinforced concrete girders (1m x 0.6m x 30m) built in the 1970s. Two supports experienced significant movement and the third column bent was tilted and rotated causing settlement and a reduction in the bearing support of the girders. The fourth span had only about 5 to 6 cm of bearing on the third column bent as shown in Figure 14. The night of June 28<sup>th</sup> several spans collapsed as shown in Figure 15.

Figure 14 – Santa Rita Bridge over the Humuya River after the earthquake and before collapse  
 (a) [06/21/2009, 6:08PM, N15.191548, W87.82559]  
 (b) [06/21/2009, 5:43PM, N15.191017, W87.8922393]  
 (c) [06/21/2009, 5:40PM, N15.190907, W87.892658]

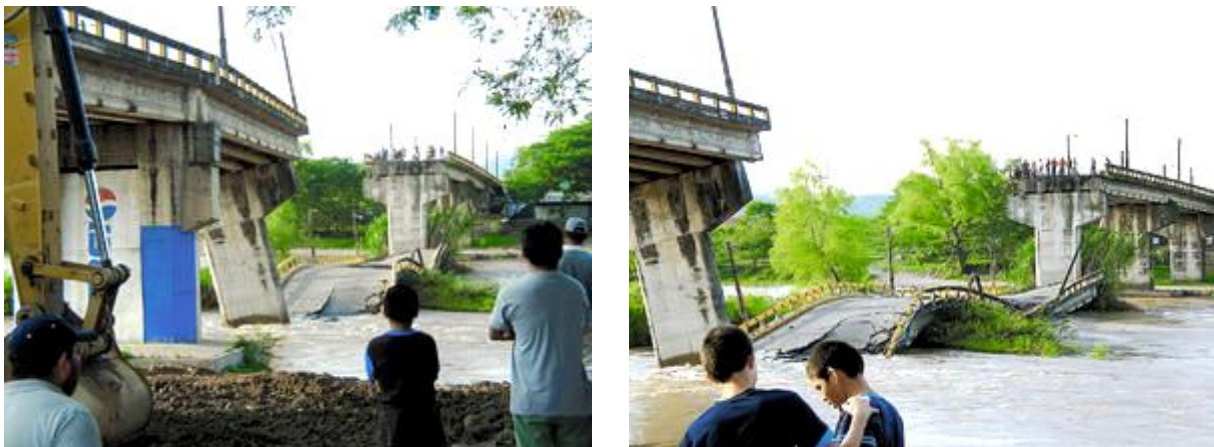
Figure 15 – Collapse of the 2 to 3 spans of the Sta. Rita Bridge over the Humuya River post-earthquake [06/28/2009, N15.191019, W87.892095] (source: LaPrensa.hn).

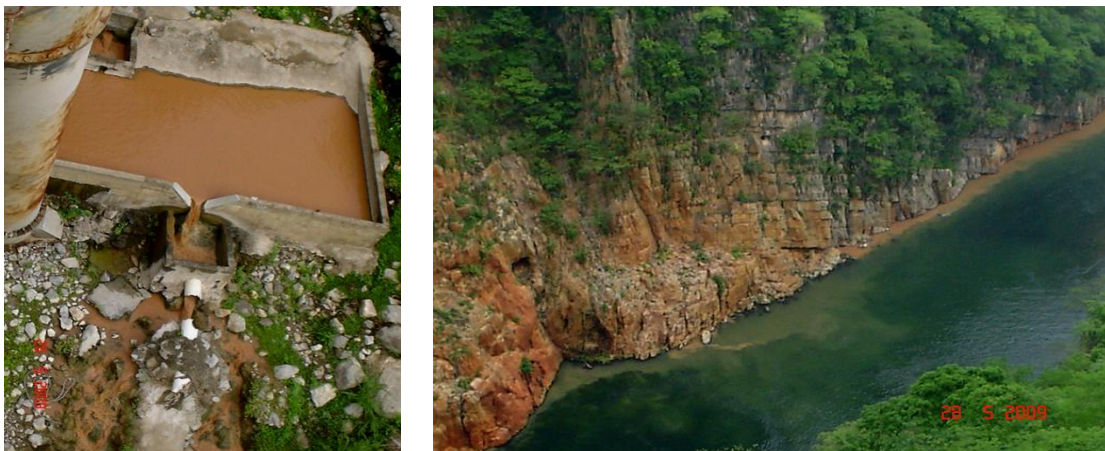
**Filtration Flow and Drainage:** The increments in the flow are not significant. The change in flow after the event was noteworthy, from about 138 lt./sec. to 167 lt./sec. Turbidity was detected in the downstream outflows shortly after the event (3 days), but none was observed during our visit. This is evidence of adjustments within the rock and soil that may promote continued filtration through the curtain.

Figure 16 – (a) Weir passing turbid water at base of dam [05/28/2009, N15.03096, W87.747885], and (b) reflected in downstream river [05/28/2009, N15.03096, W87.747885].

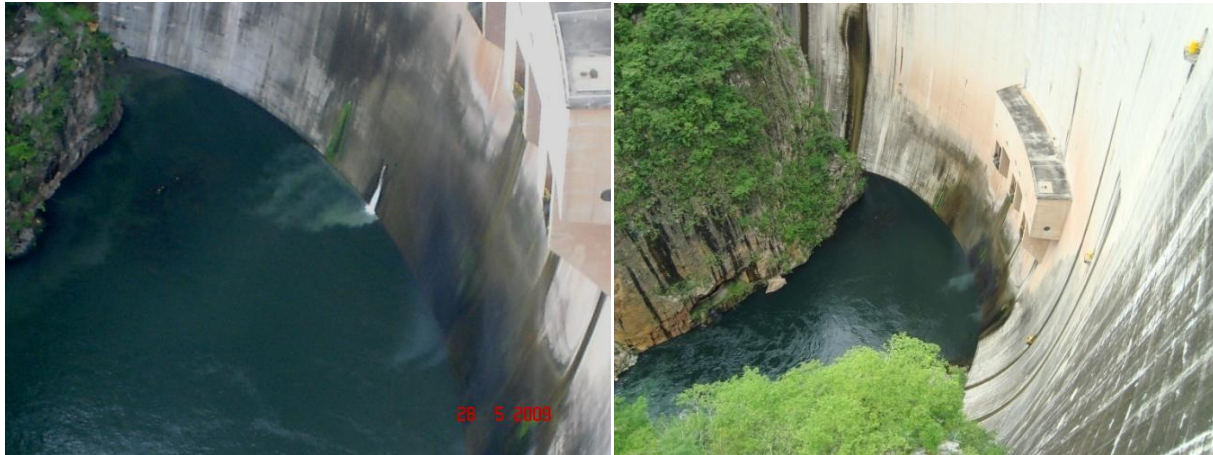
Figure 17 – (a) Turbid seepage at base of dam [05/28/2009, N15.03096, W87.747885], and (b) clear seepage at base of dam [06/21/2009, 11.55AM, 15.03096, -87.747885]
