3. EPICENTRAL REGION

This chapter summarizes the observations made by GEER Team members on the geotechnical/geological aspects of the M_w 5.8 Mineral, Virginia earthquake of 23 August 2011 in the epicentral region. Within hours of the event, members of the team arrived in the epicentral region (i.e., Louisa County, Virginia) to document perishable data that potentially could be used to advance the geo-engineering profession's understanding of the geotechnical/geological aspects of earthquakes in general, and of intra-plate earthquakes more specifically. The team focused on documenting tectonically/seismically-induced ground deformations, evidence of liquefaction and lateral spreading, land/rock slides, ground subsidence, performance of earthen dams, damage to building foundations, and damage to public infrastructure and lifelines, among other effects of the earthquake. The team began collecting data on the night of the main shock (i.e., 23 August 2011) and continued for several months thereafter, with the majority of effort being concentrated in the few days immediately following the main shock. The documentation of the data following the event was time critical because of the hea

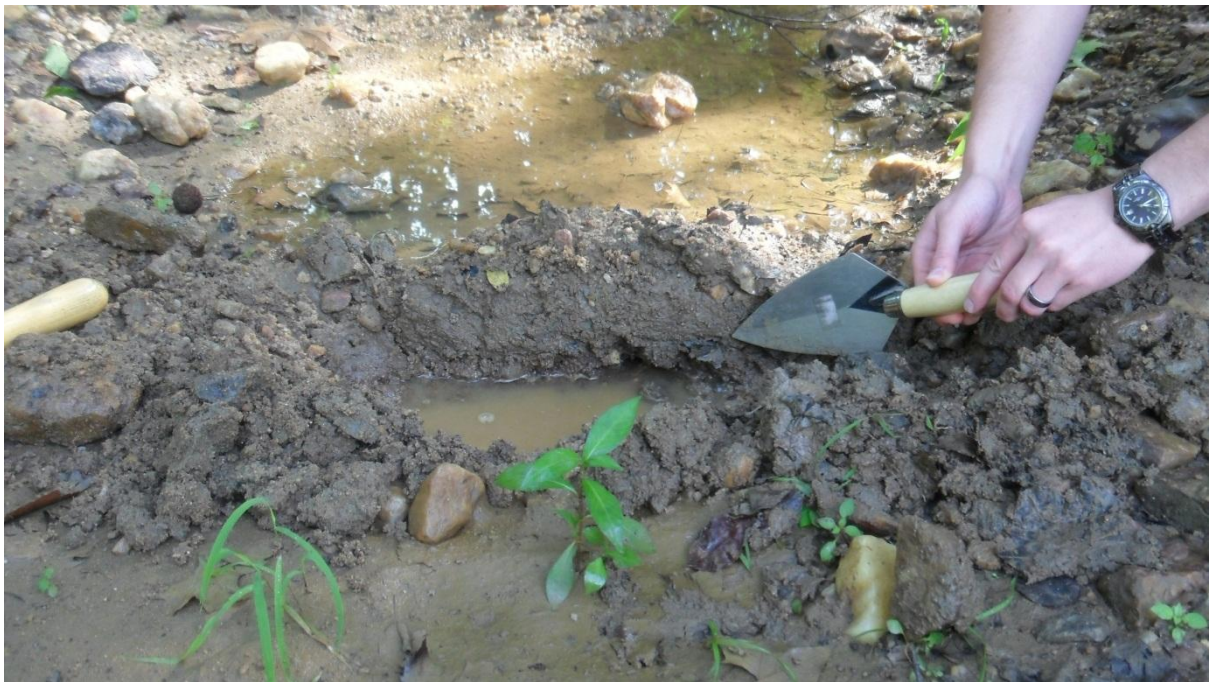
The liquefied soil was coarse sand, with the feature in the drainage channel containing some plasticity. No feeder dikes could be found for the features in the S. Anna River riverbed (Figure 2b), but the riverbed was very gravelly and the water table was only an inch or two below the ground surface. As a result, a clean cut could not be made vertically through the feature and the cut quickly filled with water. The features on the roadside (Figures 2c,d) and the feature in the drainage channel in the woods (Figures 2e,f) both appeared to have vented through existing animal holes or burrows.

Figure 2. Liquefaction sand boils found in the epicentral region: (a) two sand boils in the S. Anna River riverbed near Yancy Mill (features found by Jeff Munsey, TVA) (37.93839, 77.98269); (b) cross-sectional cut through one of the sand boils in the S. Anna River riverbed. The trowel points to a layer of leaves, indicating that the blow material was recently placed; (c) sand boil found across the road from the features in the riverbed (feature found by Ed Harp, USGS) (37.93807, -77.98238); (d) horizontal cut through the roadside feature showing a plan view of the feeder dike; (e) sand boil found in a drainage channel in the woods of Bend

of River Rd (37.95668, -78.00502); (f) horizontal and vertical cut through the drainage channel feature.

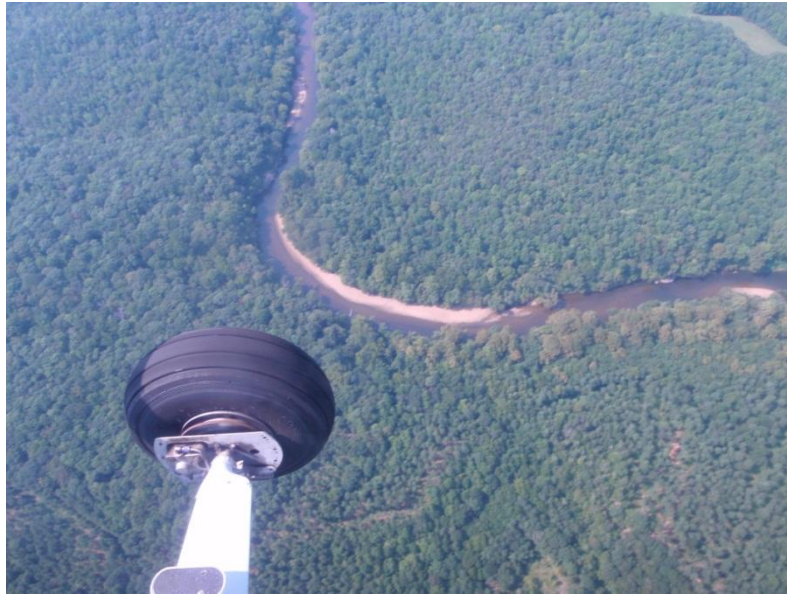
Figure 4. Aerial photo of point bar along Rivanna River near Palmrya, VA, approximately 27 km from the epicenter. No evidence of liquefaction or lateral spreading was observed. (courtesy of F. Syms)

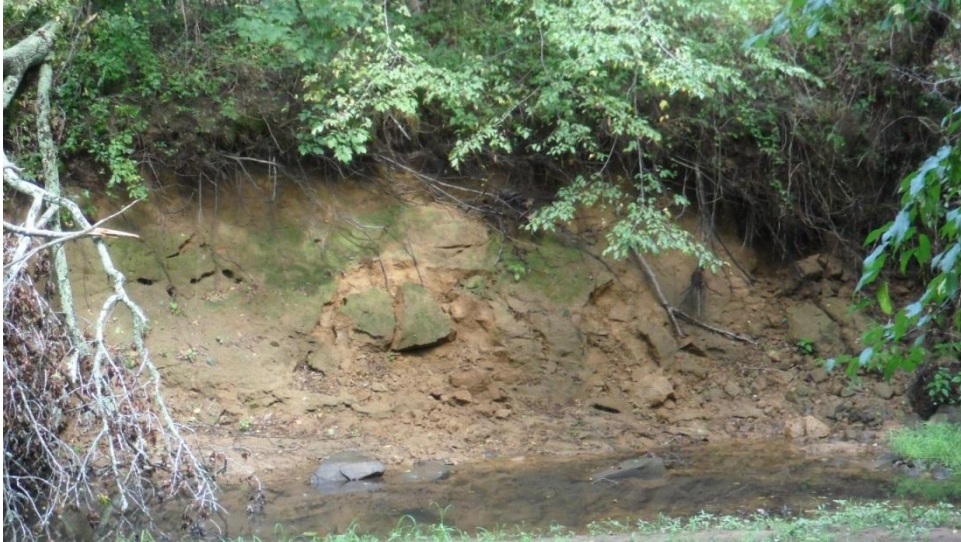
Mark Carter, USGS, searched the South Anna River for slumps in the banks. One small slump was found very close to the liquefaction features shown in Figure 2a, which again is likely located approximately over the rupture plane. This slump is shown in Figure 10. Heavy rains from Hurricane Irene started on 27 August and made it impossible to definitively attribute slumps found subsequently to earthquake shaking.

Figure 10. Slump in the bank of the S. Anna River near the Yancy Mill (37.938495, -77.983203).

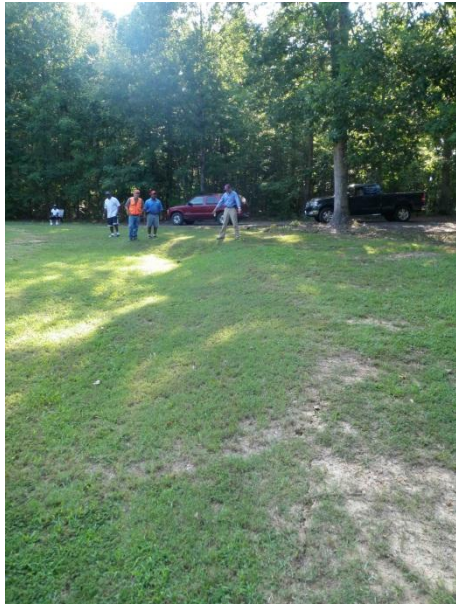
Mark Carter, USGS, found what is believed to be earthquake-induced subsidence of an abandoned gold mine. The location of the subsidence is shown in Figure 11. A photograph of the subsidence is shown in Figure 12.

Figure 12. Photograph of the area that subsided (Photo by Mark Carter) (37.9229, -78.0176).

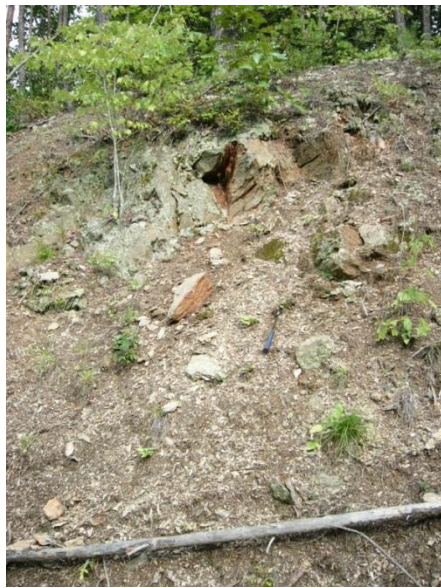
Figure 14. Rock falls found in the epicentral region (source: Mark Carter): (a) rockfall along Shannon Hill Rd (37.93174, -77.96190); and (b) rockfall along Vigor Rd, near the intersection with Yanceyville Rd (37.93802, -77.98245).

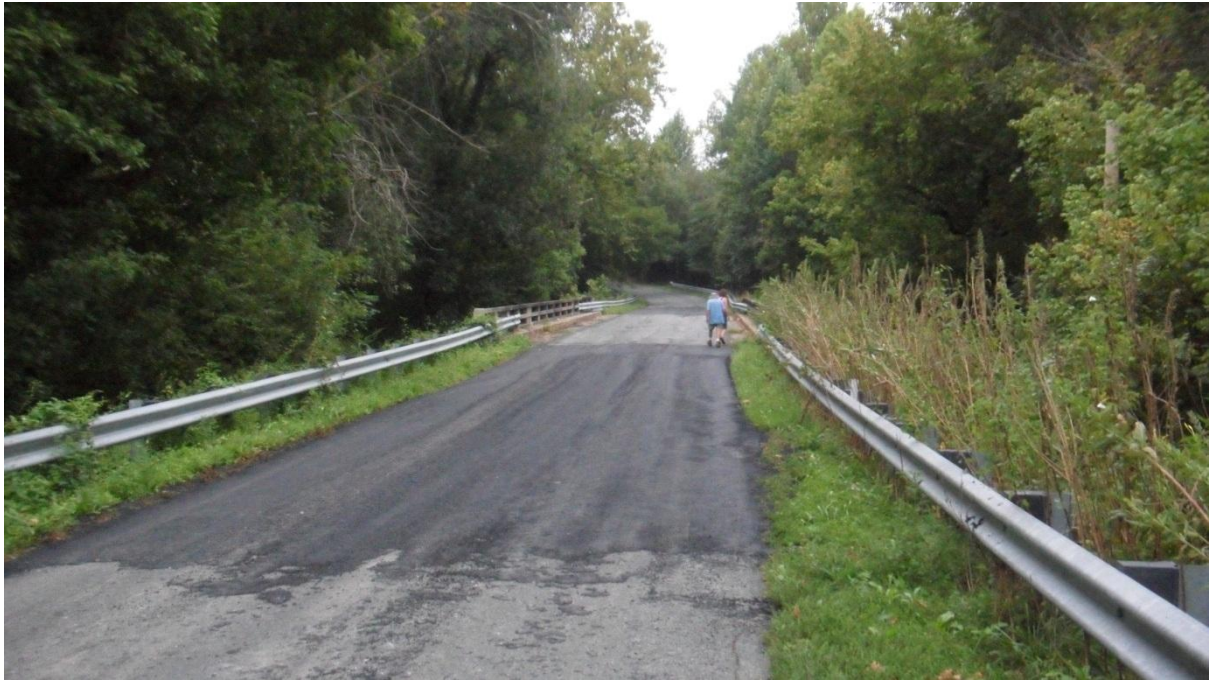
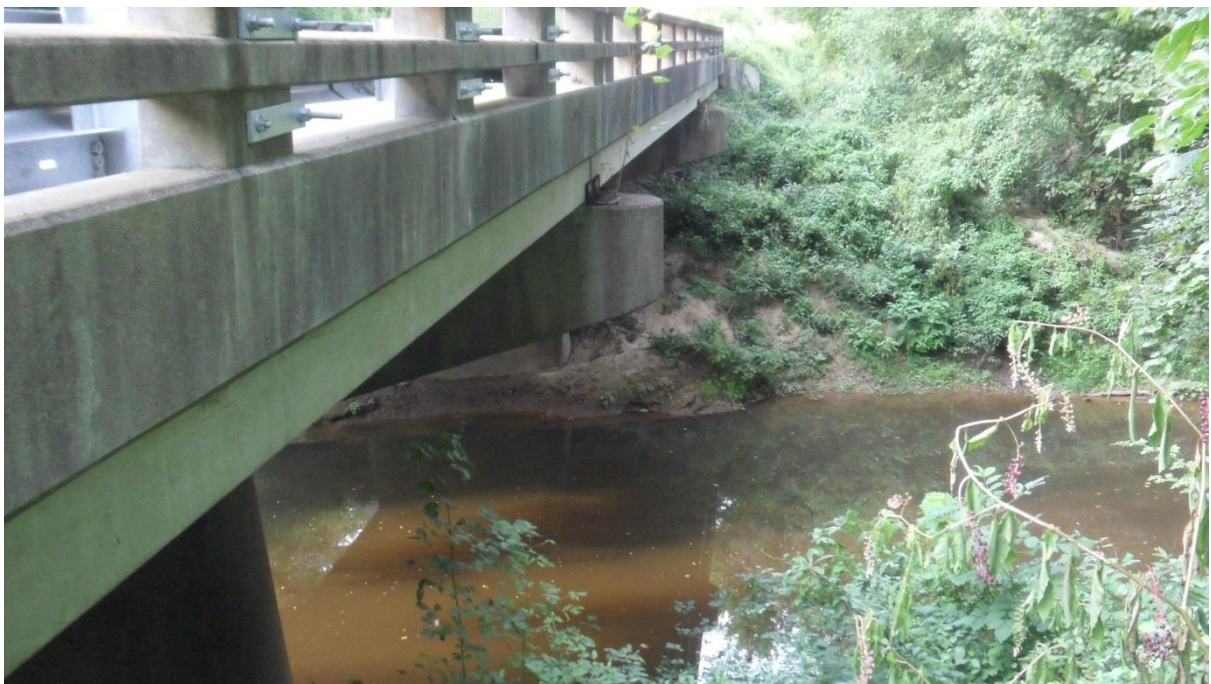
The second bridge that was inspected in detail was the SR 604 bridge, the location of which is shown in Figure 16. This bridge is ~36 m long and crosses the S. Anna River in the NE-SW direction. We inspected this bridge in detail because some of the local residents reported that “bumps” in the road surface of the abutment approaches worsened as a result of the main shock and aftershocks. Photos of the bridge are shown in Figure 18. As with the Yanceyville Rd bridge, this bridge has a two lane concrete deck that sits on two piers, in addition to the NE and SW abutments. Drawings obtained by Mark Carter, USGS, from the VDOT show that the abutments are founded on ~2.75 m (9 ft) of brown sandy silt with an SPT N-values of 5-7 blws/ft. Team members inspected the bridge on 24 August, the day after the main shock, but did not notice any obvious slumping of the abutments or evidence of seismic compression in the approaches (Figure 18a). However, after hearing from additional local residents that the bumps in the abutment approaches had gotten worse as a result of the main shock and aftershock, the bridge was revisited on 2 September, and it was found that the approaches already had been levelled and resurfaced (Figure 18b). Although heavy rains had fallen as a result of hurricane Irene, there was still evidence of a ~2.5 cm gap between SW pier and the soil on the riverside, shown in Figure 18f. As with the Yanceyville Rd bridge, it is uncertain whether the gap was due to movement of the pier due to earthquake shaking (i.e., movement of the bridge in the NE direction relative to the ground) or due to slumping of the river bank. Also, there was ~2.5 cm gap between the bridge deck and the SW abutment, shown in Figure 18e. It is likely that this existed prior to the earthquake to allow thermal expansion of the bridge deck.

Figure 18. SR 604 bridge (37.95915, -77.98269): (a) small bump in the approach to the bridge possibly due to seismic compression; (b) approach after relevelling and resurfacing of the bridge; (c) side view of bridge; (d) bridge abutment; (e) ~2.5 cm gap between bridge deck and the SW abutment; and (e) ~2.5 cm gap between the SW pier and soil (riverside only).

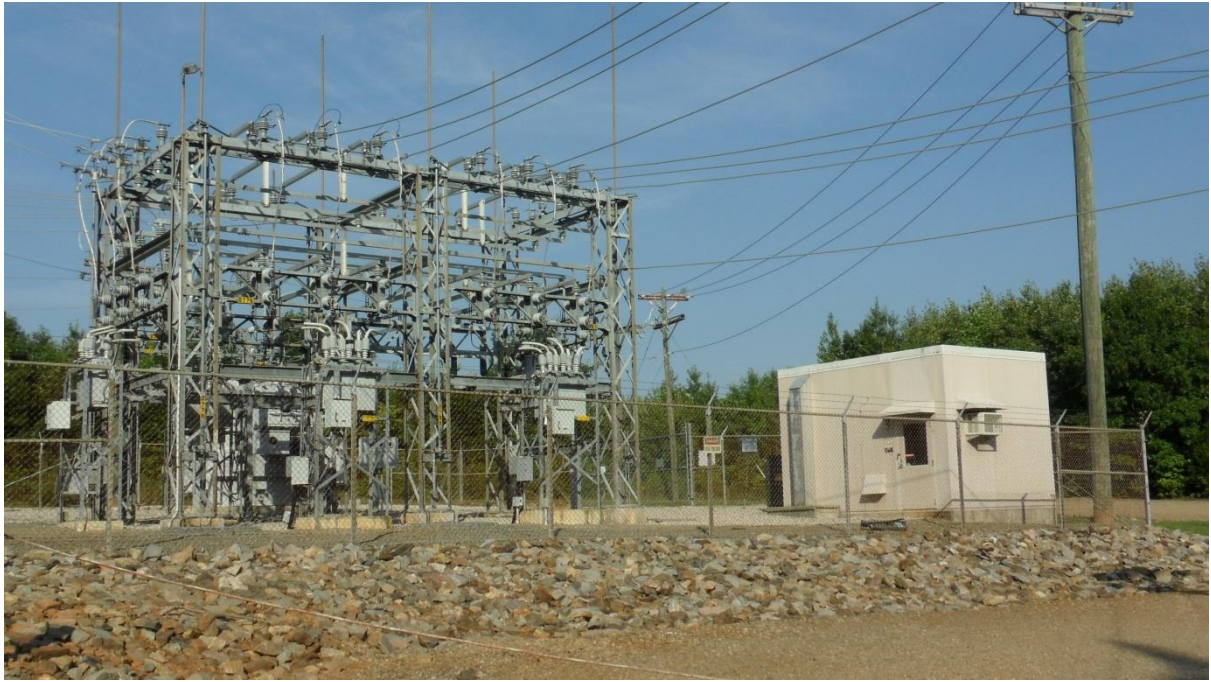
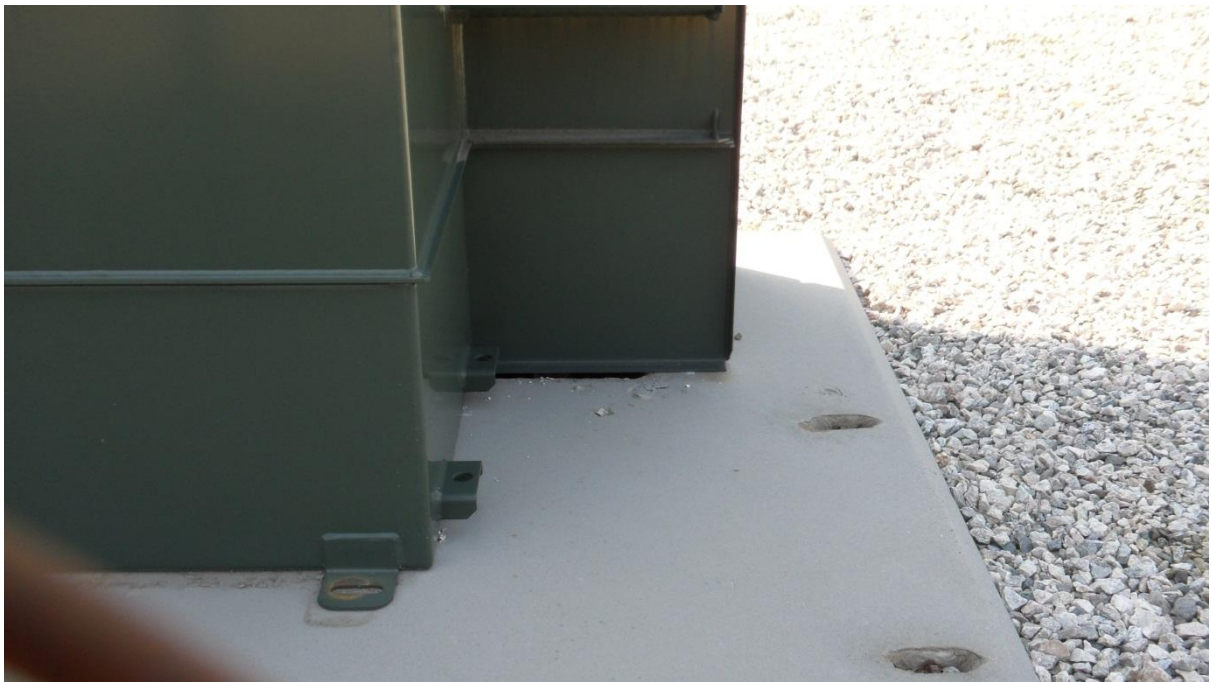
Approximately 3000 customers lost power as a result of the main shock. However, virtually all the power was restored within 4 hrs after the event. Team members inspected the Cuckoo Substation on Jefferson Hwy, the location of which is shown in Figure 19 and photo of the substation shown in Figure 20a. The only evidence of the earthquake shaking on the substation was that a green metal equipment box slid ~2.5 cm to the north, as shown in Figures 20b,c. The box was not anchored to the concrete base slab.

Figure 20. Cuckoo Substation (37.97058, -77.91917): (a) photo of substation; (b) photo showing ~2.5 cm movement of green metal equipment box to the North; and (c) photo showing ~2.5 cm movement of the green metal equipment box to the North.

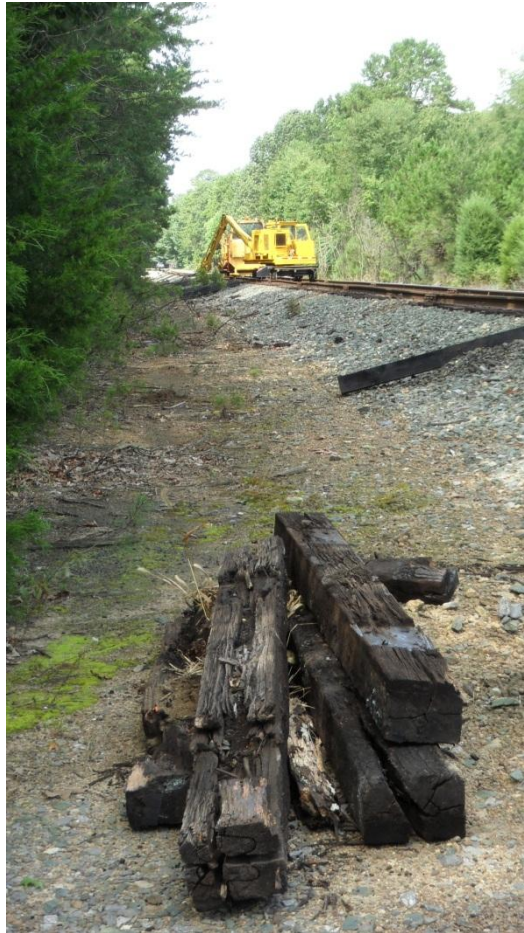
Team members talked with a crew on 24 August who were replacing ties on the railroad tracks in Louisa (Figure 23). The crew chief said that coal trains run about every two hours but were suspended after the main shock until the tracks could be inspected. He said that no damage was found and the ties were being replaced due to age, not due to earthquake damage.

Figure 23. Crew replacing railroad old ties (38.019538, -77.978724).

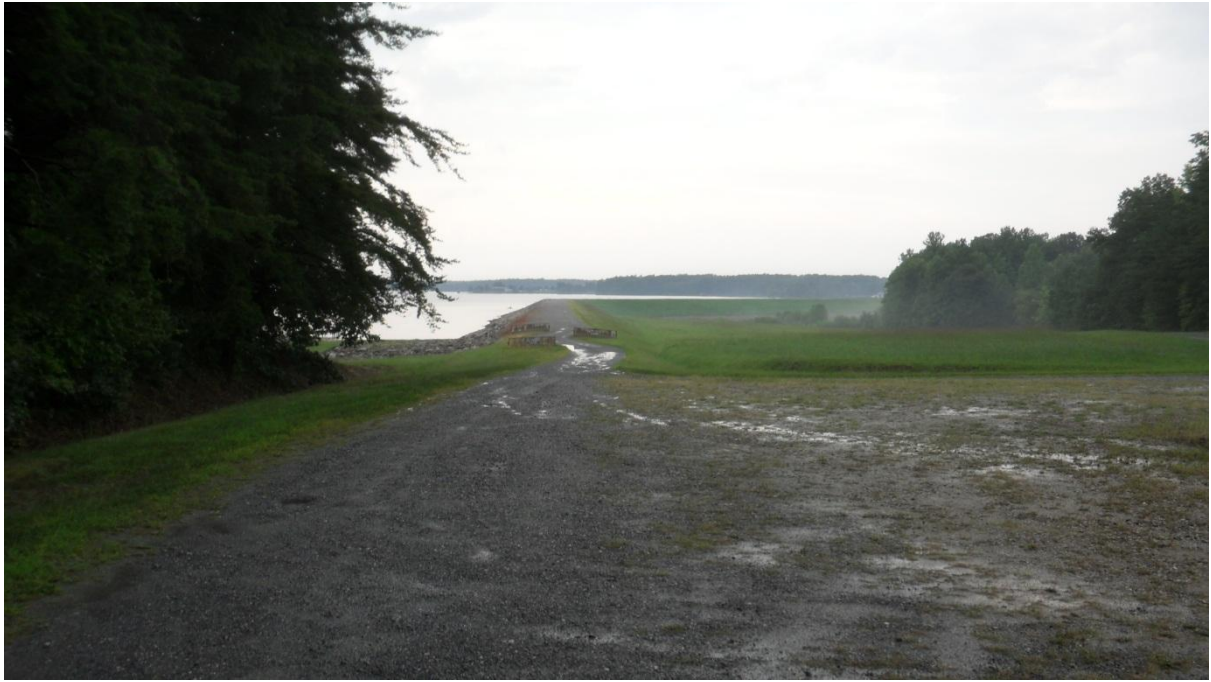
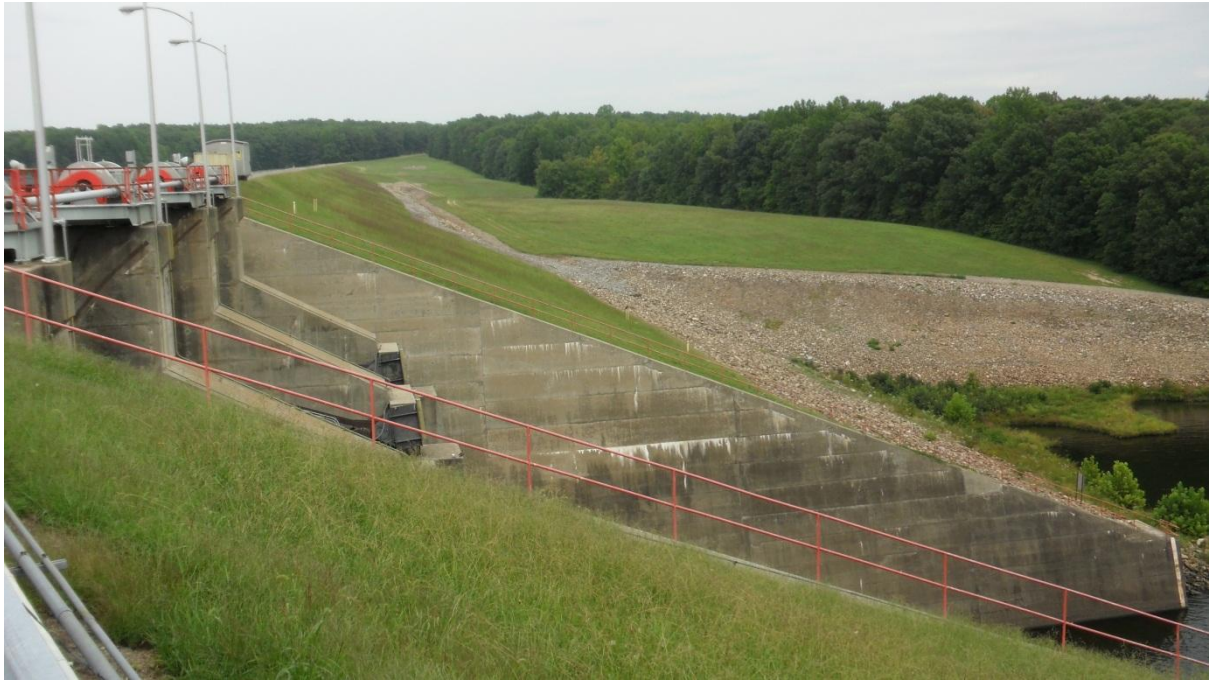
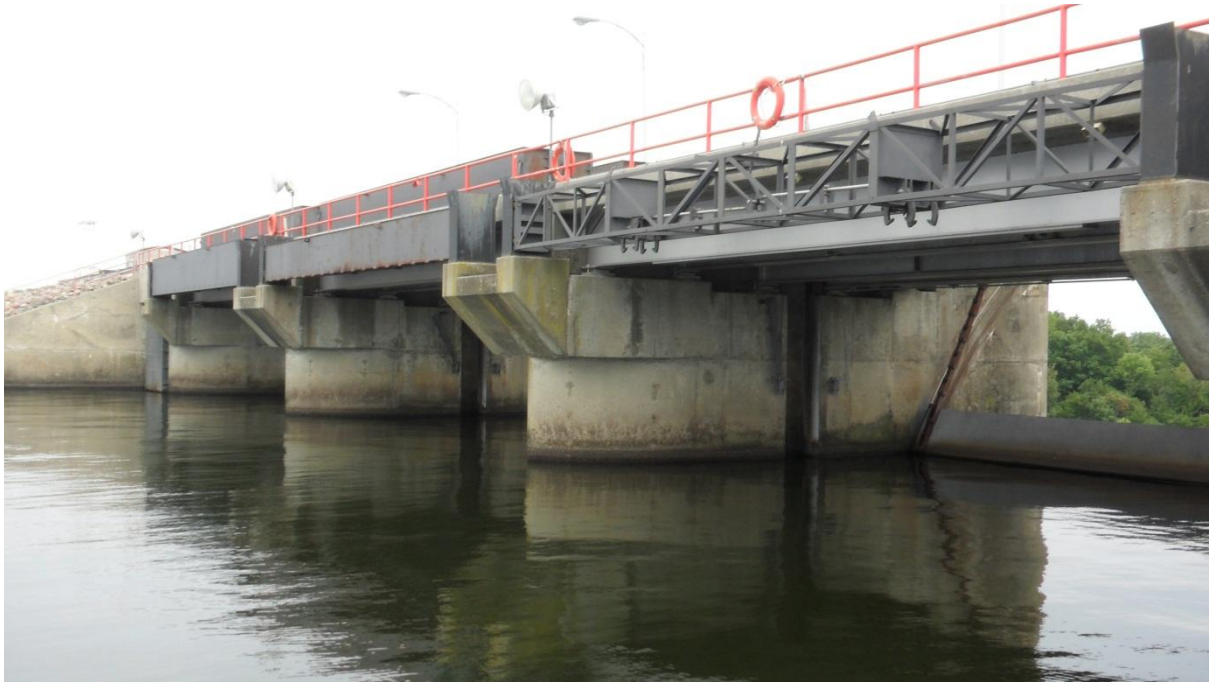
in Figure 26b. As may be observed from this figure, the motions from the Mineral earthquake exceed those of the DBE for oscillator frequencies greater than ~1.2 sec. Despite the DBE being exceeded over a wide range of frequencies, the team inspected the dam on 2 September 2011 and could not see any evidence of distress to the dam from the earthquake (Figure 27).

Figure 27. Lake Anna hydroelectric dam. (a) 38.00621, -77.71210. (b) 38.01739, -77.70918. (c)(d)(e)(f) 38.01315, -77.71297. (g) 38.01259, -77.71347.

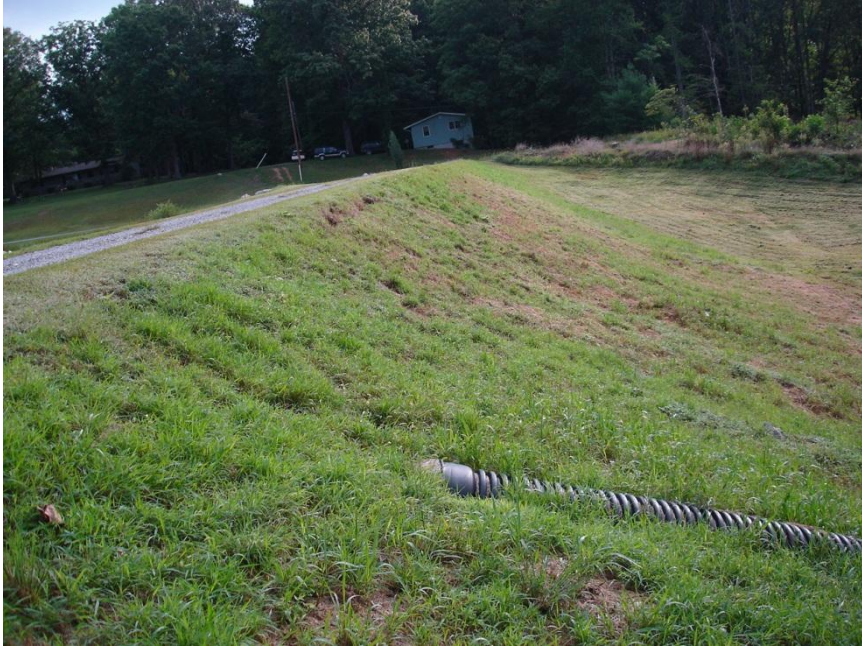
The Elk Garden Lake Dam is located in Bedford County, ~150 km from the epicenter of the main event. The dam is 9.1 m high and has a normal pool capacity of 66 acre feet. One of the homeowners near the dam was weed eating the downstream toe of the dam before the earthquake occurred. He noticed that a scarp started to form on the downstream face of the dam, near the crest. As a result, he stopped weed eating and went home, at which time the earthquake occurred. When he returned to the dam, the scarp had gotten bigger. The shallow slide is oval shaped and is ~6.4 m wide (running along the long axis of the dam) and ~9.1 m long (running down the downstream face of the dam). After the earthquake, the head scarp was ~17.8 cm high. There are no cracks visible at the top of the dam. The center of the slip is ~6.1 m to the left of the principal spillway pipe, looking downstream.

A team member met with W. Gray, the president of the homeowners association that owns the dam, on 9 September and inspected the dam. W. Gray said that 3 days before the earthquake they had 17.8 cm of rain in 12 hours. The saturated ground conditions likely triggered the initiation of the slide that occurred while the homeowner was weed eating, with the earthquake shaking making the slide worse. W. Gray said they covered the slide shortly after the earthquake with a plastic sheet to prevent water from flowing into the scarp. Photos of the slide taken both before and after it was covered with the plastic sheet are shown in Figure 34.

Figure 34. Shallow slide in the Elk Garden Lake Dam (37.4223, -79.5009): (a) photo of the shallow slide on the downstream face of the dam; (b) closer view of the shallow slide on the downstream face of the dam; (c) photo of head scarp of slide; (d) photo of slide taken from downstream toe of the dam; (e) photo showing head scarp covered with plastic sheet; (f) closer view of plastic sheet covering the head scarp; and (g) photo of plastic sheet taken from downstream toe of dam.

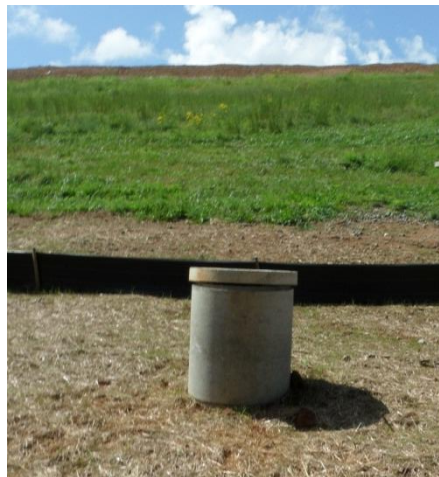
R. Petty said he was checking a leachate monitoring well on the side of the landfill when the earthquake occurred and that the shaking caused the ground to soften considerably, to the point that he thought he was going to sink into the ground. A photo of the leachate monitoring well is shown in Figure 38. The ground around the well is soft clay.

Figure 38. Leachate monitoring well where R. Petty was standing during the earthquake. The soft clay around the well got softer as a result of the earthquake shaking.

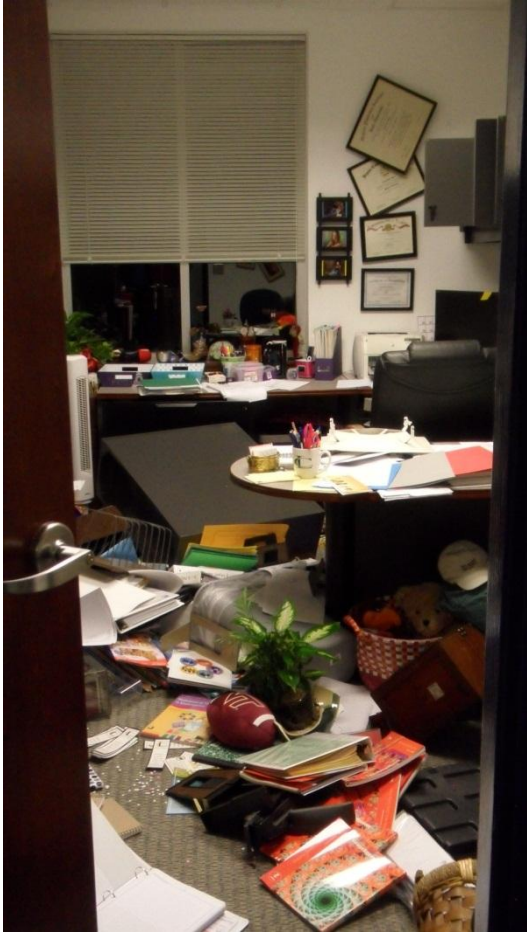
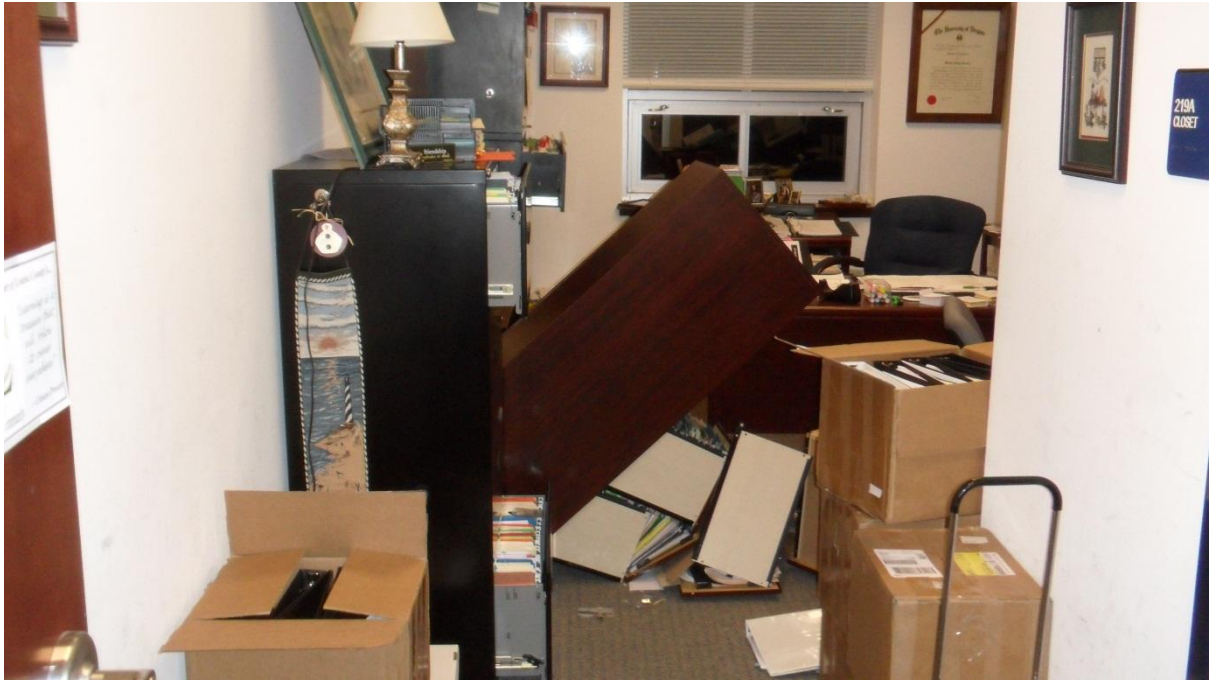
Team members inspected the Louisa County Public School Administration Building and the Louisa County High School on 23 August, about 6 hrs after the main shock and about a half hour after a $M_w 4.2$ aftershock. The two buildings are located in the same complex, ~0.5 km apart. The Administration building only had minor cracking in the walls, but the internal contents of the building were in complete disarray. Photos of some offices in the Administration building are shown in Figure 40. The major axis of the building is in the NW-SE direction and the majority of the items that were tipped over were those along the NW and SE walls.

Figure 40. Typical damage to internal contents of offices in the Louisa County Public School Administration Building (38.02066, -77.92373).

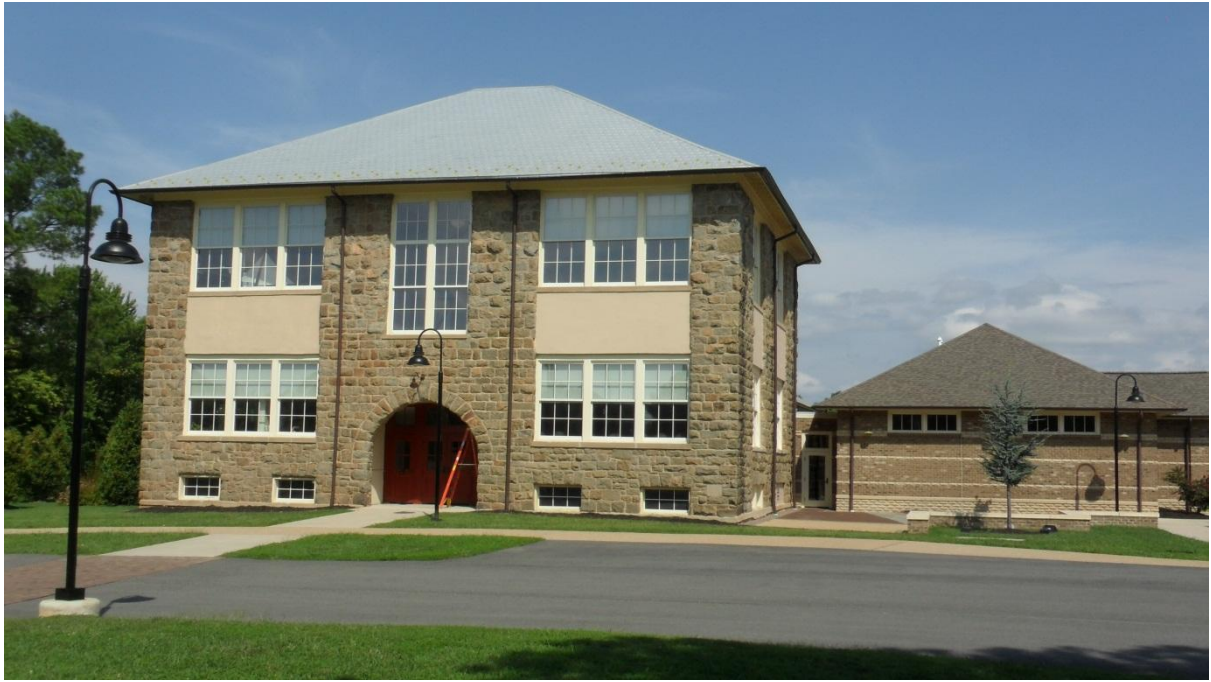
We had received reports on the night of the earthquake that the Louisa Town Hall (Figure 43) had a partial roof collapse. This prompted an inspection of the building on 24 August, the morning after the main shock. The building was constructed in 1907 (Figure 44a) and was damaged by fire in 1924 (Figure 44b); sometime between 1907 and 1924 a second story was added. The reports of damage were grossly exaggerated and most of the damage was cosmetic (e.g., fallen ceiling tiles, cracked plaster); photos of some of the damage are shown in Figure 45. The only structural damage was that the front wall of the building was slightly bowed outward as a result of the earthquake shaking.

Figure 43. Louisa Town Hall (38.02512, -77.99781) the morning after the earthquake.

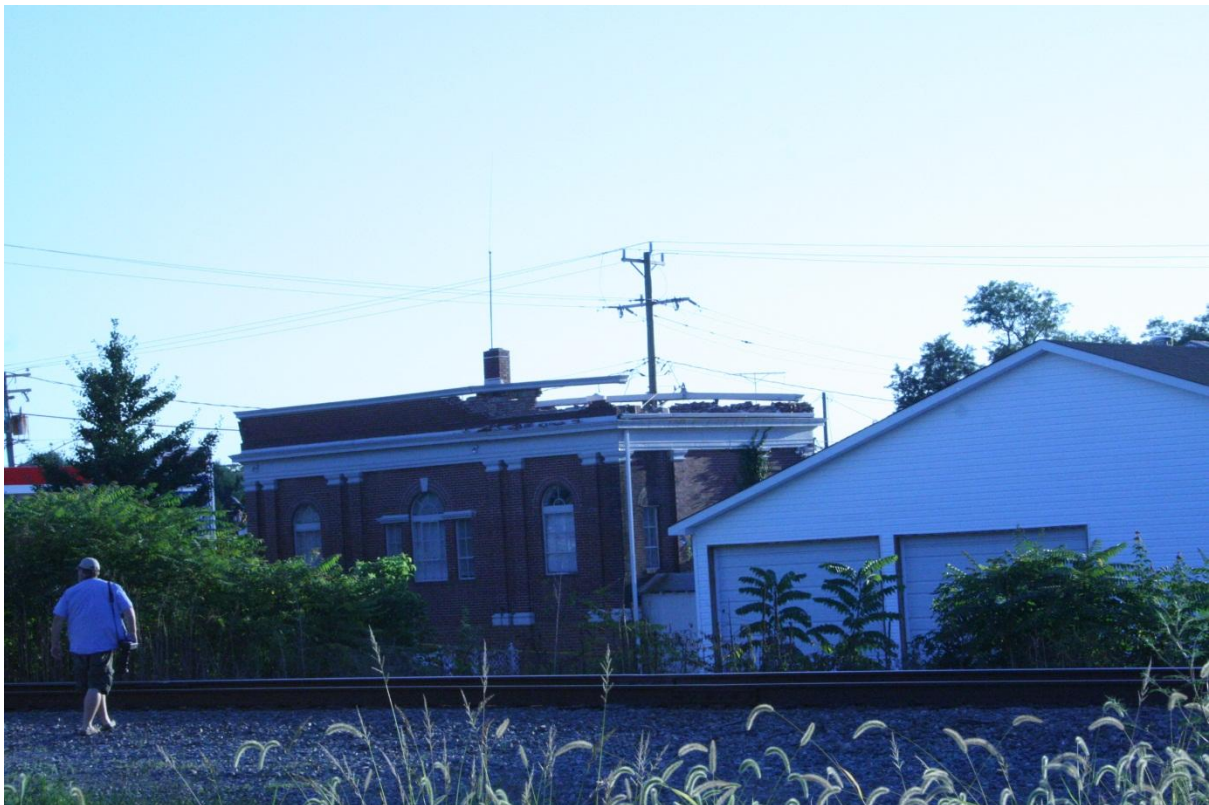
We had received reports on the night of the earthquake that the Mineral Town Hall had completely collapsed during the earthquake. This prompted team members to inspect the building on 24 August, the morning after the main shock. As with the Louisa Town Hall, the initial damage reports for the Mineral Town Hall were grossly exaggerated. A photo obtained from the internet believed to have been taken within hours after the earthquake on 23 August is shown in Figure 46. As shown in this figure, the damage was mainly limited to the brick parapet towards the back of the building. Photos taken by a team member on 24 August are shown in Figure 47. We did not inspect the inside of the building.

Figure 46. Photo of the Mineral Town Hall (38.01090, -77.90848) believed to have been taken within hours after the earthquake (source: internet).

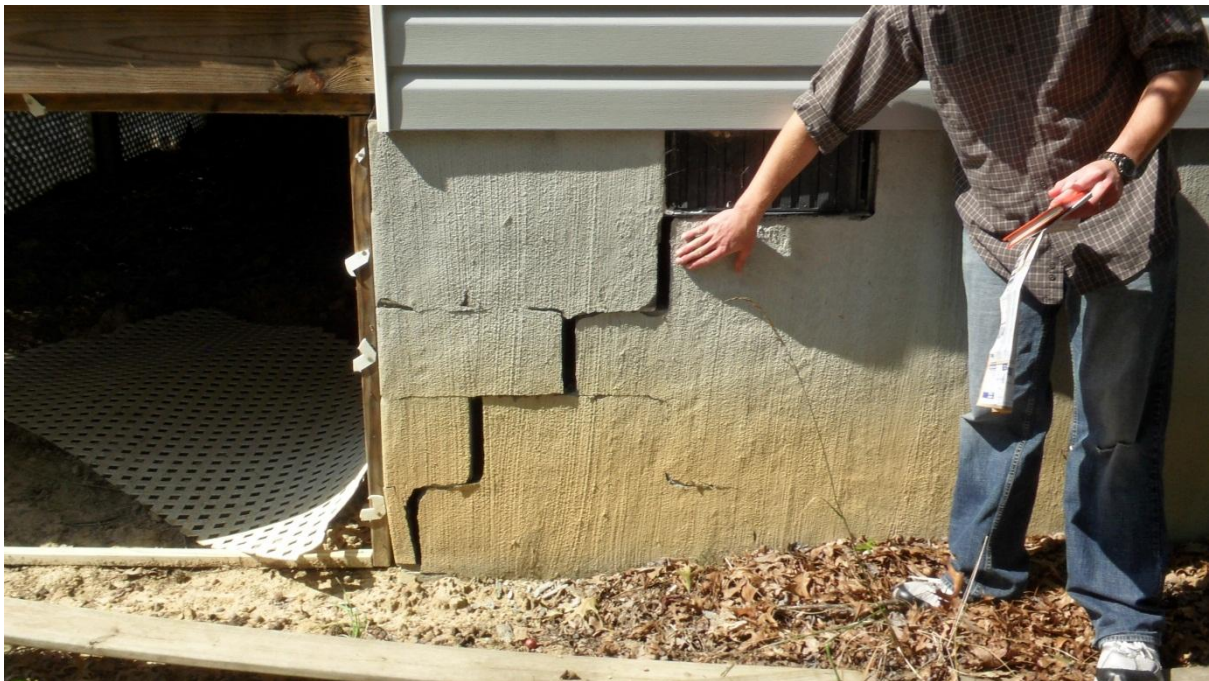
3290 Mt. Airy Rd, Louisa

Figure 51. Typical damage to block foundation walls (37.9790, -77.9692).

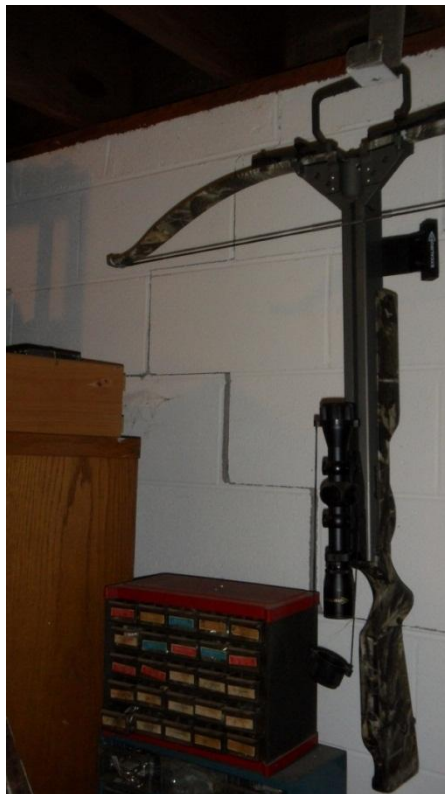
156 Hwy 789, Mineral

Figure 53. Representative severe damage to brick façade and block foundation walls (37.9923, -77.9513).

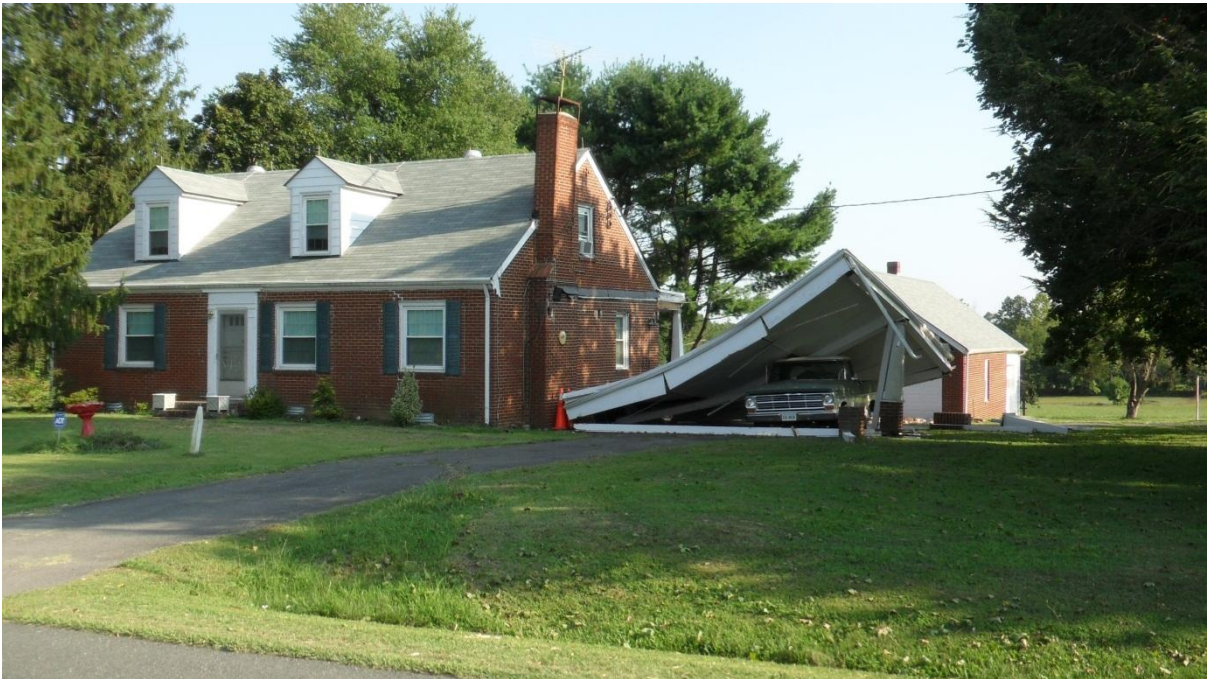
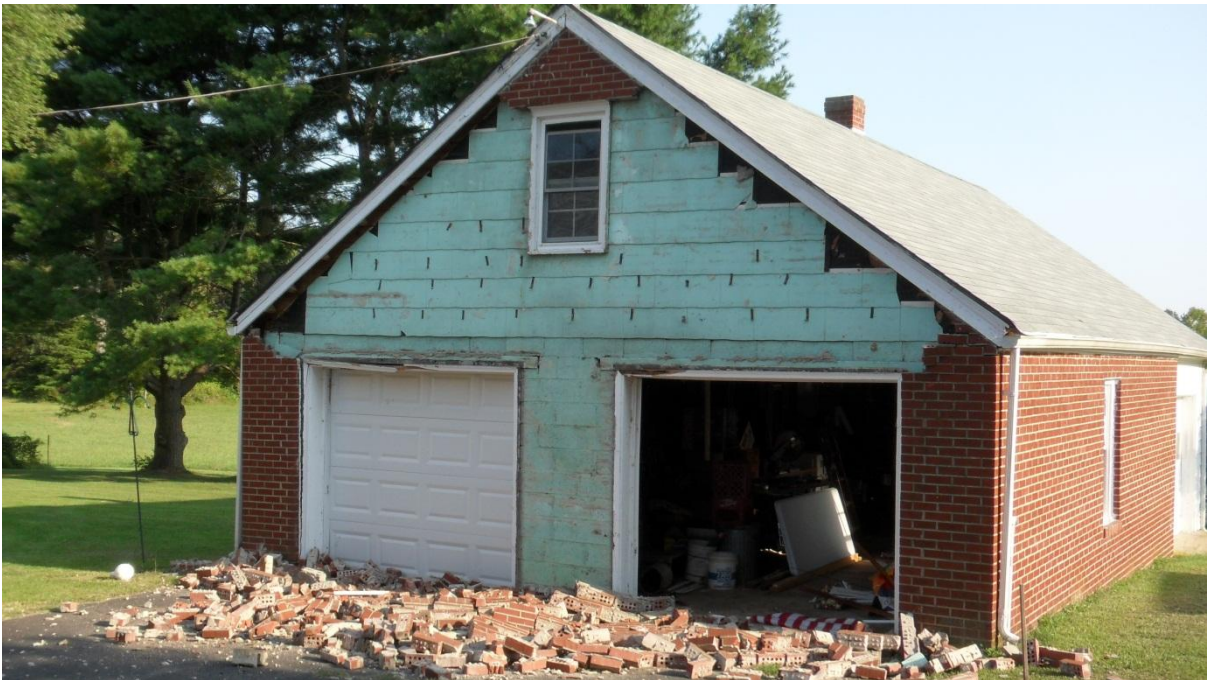
1156 W. Old Mountain Rd, Louisa

Figure 54. Representative severe damage to brick façade (37.9229, -78.0033).

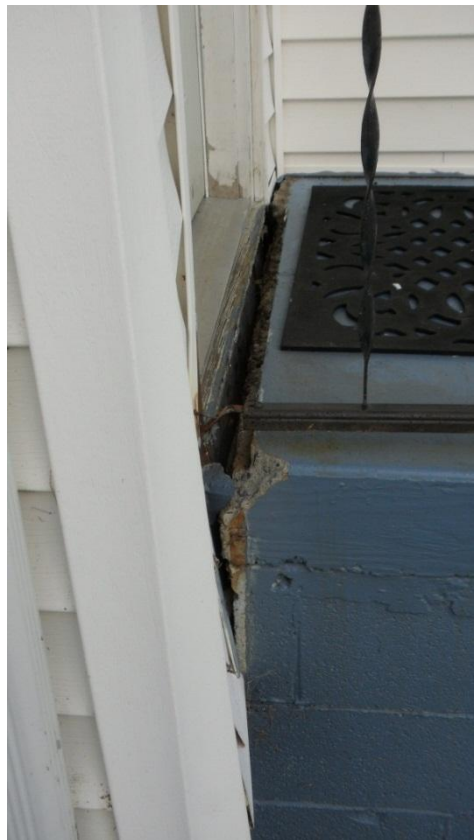
3491 SR 604, Louisa

Figure 55. Typical damage to block foundation (37.9455, -78.0253).

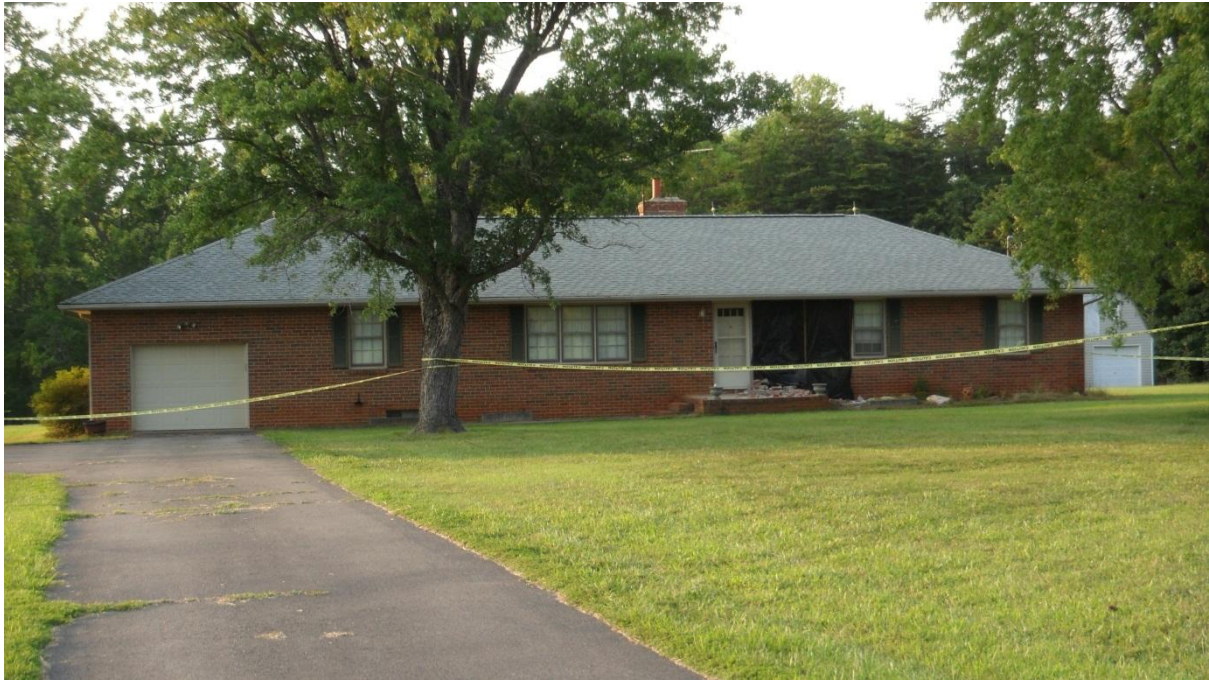
5780 Shannon Hill Rd, Louisa

Figure 56. Representative severe damage to brick façade (37.8878, -78.0267).

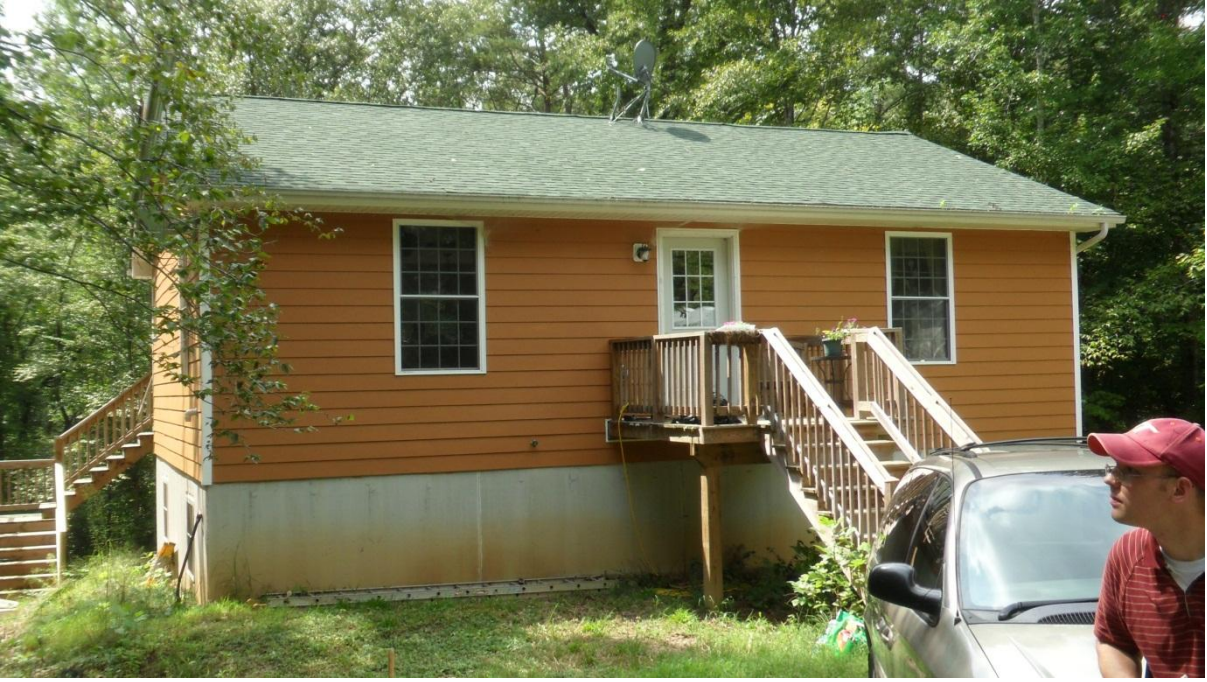
Team members inspected several houses on Bend of River Rd. The house shown in Figure 59 had a Superior Walls foundation system. The system consists of precast panels that are bolted together onsite. The owners of the house were home at the time of the earthquake and described the level of shaking as very intense. However, we could not find any damage to the foundation system.

Figure 59. Small house with a Superior Walls foundation system. We found no damage to the foundation system despite intense shaking. (37.95806, -78.00606)

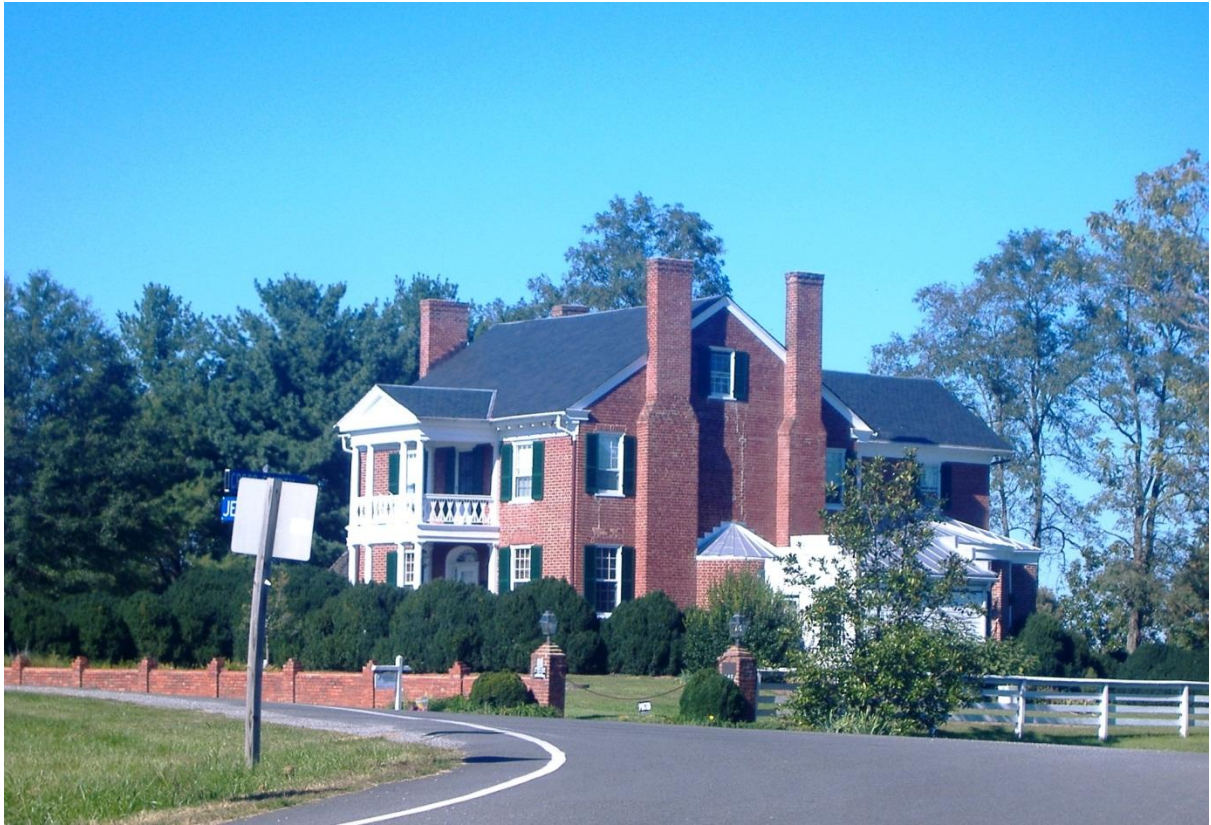
The Pendleton House was inspected on 26 August. The Pendleton House was completed in 1818 and is listed in the National Registry of Historic Places. Figure 60a is a photo obtained from the internet showing the house before the earthquake. The subsequent photos were taken on 26 August, after the earthquake. As may be observed from these photos, the brick chimneys and walls on both sides of the walls suffered significant damage. Team members were unable to inspect the inside of the house.
