5. RICHMOND AND EASTERN VIRGINIA REGION

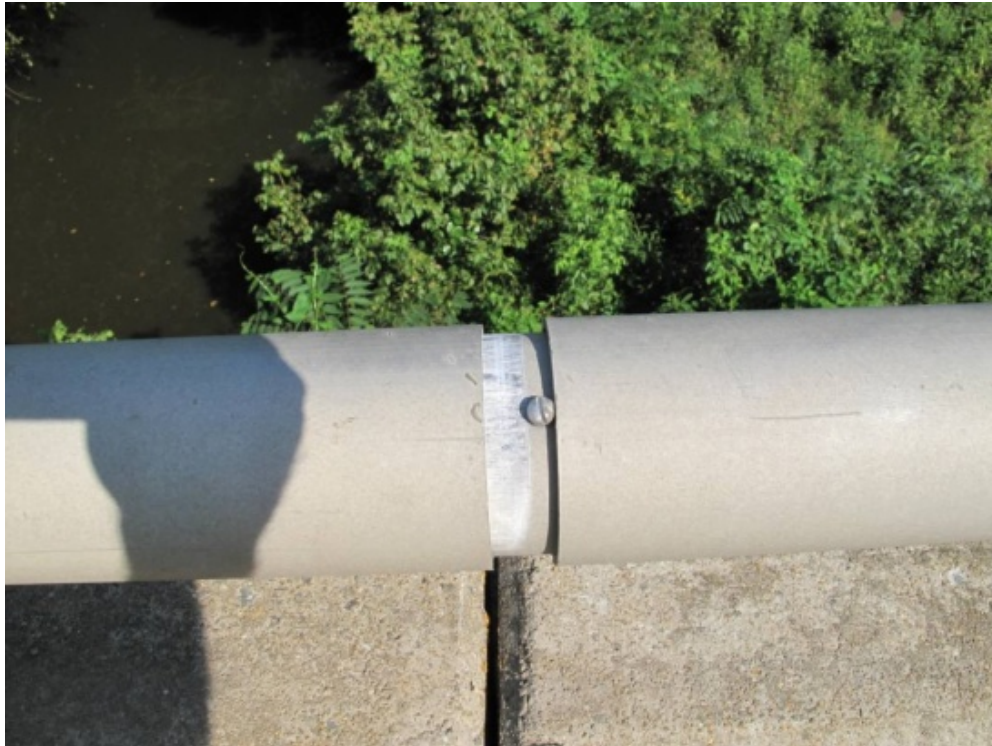
- Courthouse Road (Route 208) over South Anna River (37.98064, -78.04818) – Slight longitudinal movements;
- Courthouse Road (Route 208) over Interstate I-64 (37.94017, -78.10846) – Slight longitudinal movements;
- Parish Road (Route 683) over Interstate I-64 (37.89477, -78.04297) – Concrete spalling of barrier end wall;
- Courthouse Road (Route 1) over Hazel Run (38.28778, -77.48687) – Pier column cracking up to 15 mm wide (this is a City of Fredericksburg bridge).

Figure 5-3 Courthouse Road over South Anna River - displacement of railing (37.98064, -78.04818).

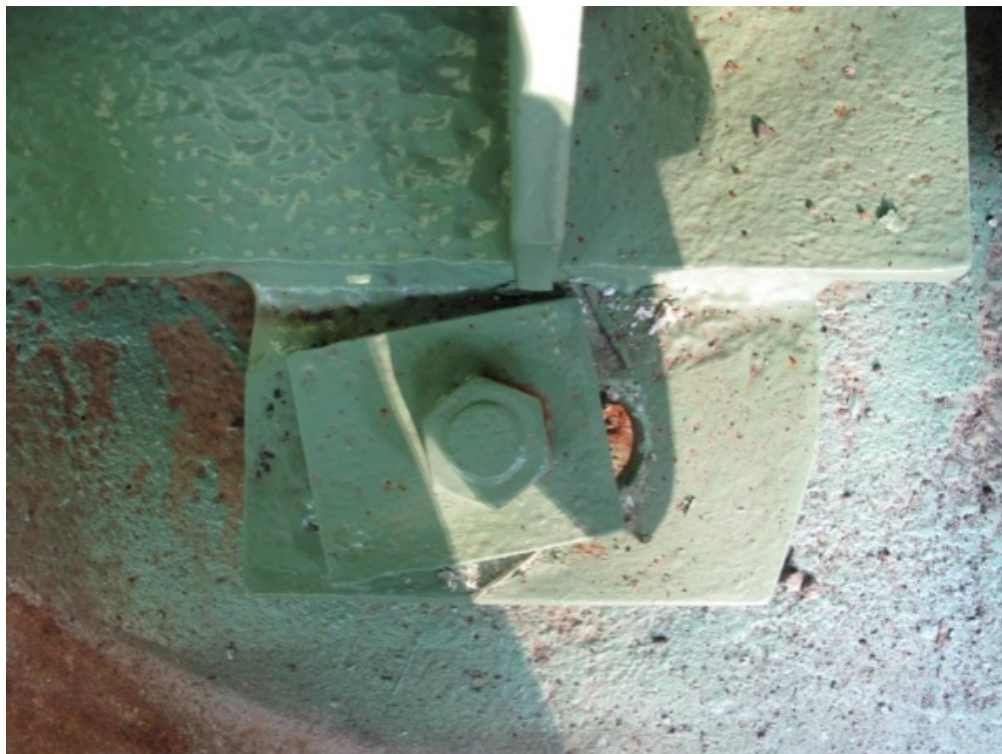
Figure 5-4 Courthouse Road over South Anna River - bearing displacement (37.98064, -78.04818).

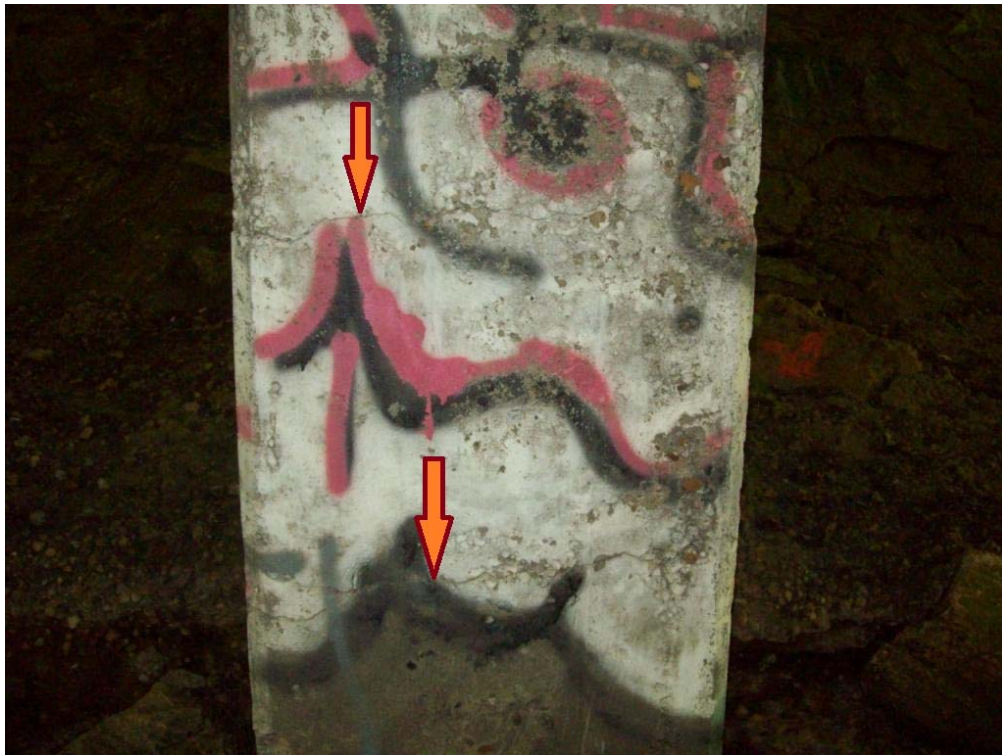
Figure 5-6 Route 1 over Hazel Run- horizontal cracks at Column 4, Pier 1 (38.28778, -77.48687).
