Geotechnical Extreme Events Reconnaissance (GEER)

## **Preliminary Observations of Levee Performance and Damage following the March 11, 2011 Tohoku Offshore Earthquake, Japan**

May 2, 2011

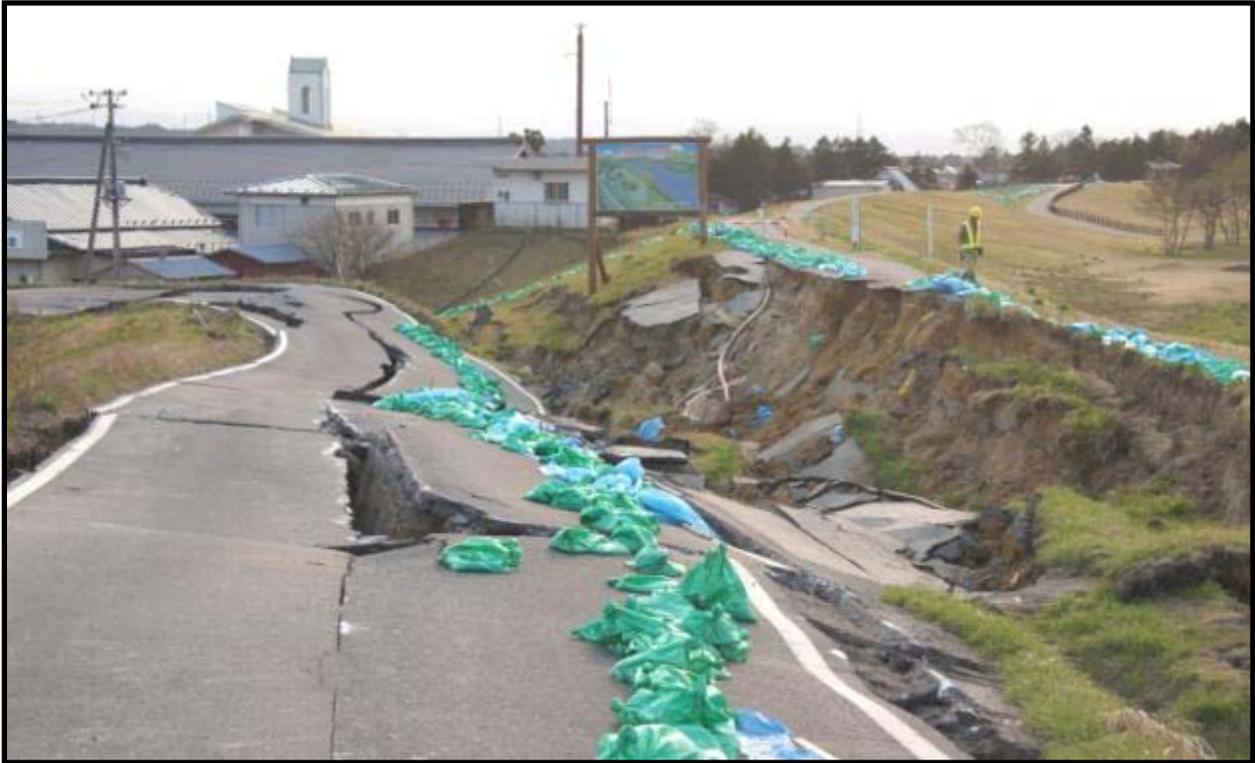
Figure 2: Photograph of Major Slumping of Landside Slope of Naruse River Right Levee and Approach Road at River Kilometer 30.0 (N38.5307, E 141.0064, April 20, 2011) – see Figure 8 for additional views and aerial image

Along the Naruse River near the town of Matsuyama (at River Kilometer 30.0), damage and distress of the right levee involved complex landward deformation with a connected approach road embankment to a concrete-span bridge (see Figure 8 and previously shown Figure 2). The roadway approached the levee crown from the southwest, and the combined embankment failed landward towards the south and damaged adjacent property. The right levee/abutment fill shows evidence of landward extension from the southernmost bridge span (see Figure 8b). The left (northern) levee/abutment fill also was damaged both upstream and downstream of the bridge, and experienced about 10 cm of settlement relative to the bridge (see Figure 8c). In addition, the bridge spans show evidence of small amounts of contraction at deck seams and broad arching (see Figure 8d).

Figure 9 shows the construction of a large waterside berm as part of the initial phase of an interim repair for a levee on the Naruse River. This repair is on the left levee at River Kilometer 30.1, directly across the river from the slumping on the right bank shown in Figure 2 (see also aerial view of left levee in Figure 8a).

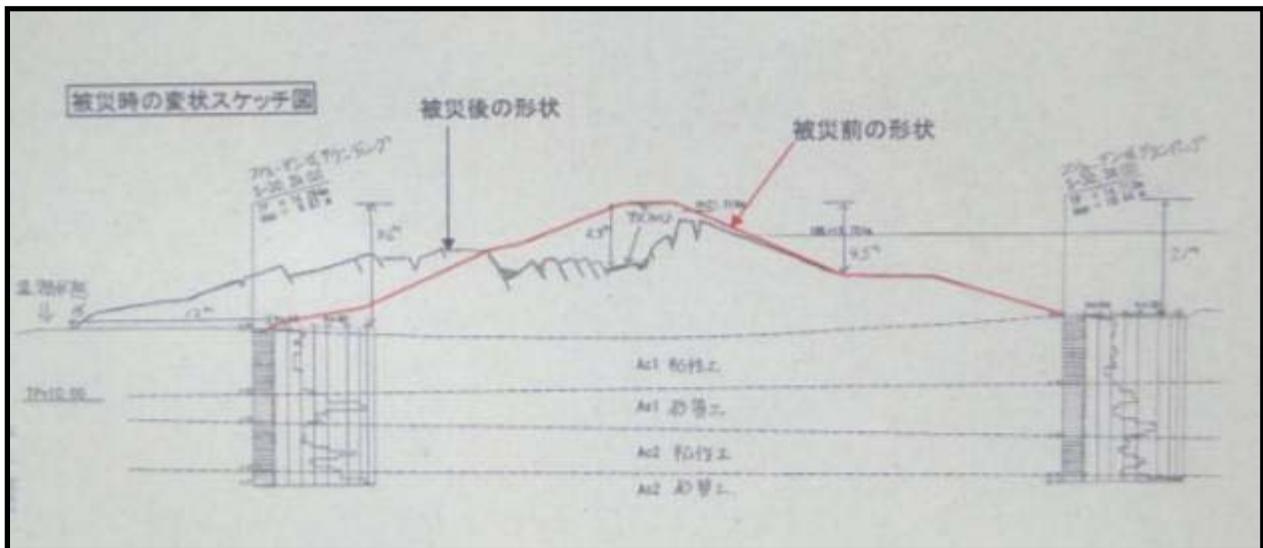
Figure 3: Drawing Depicting Major Levee Damage along Naruse River Due to Earthquake-Induced Foundation Liquefaction (from MLIT, 2011)

Liquefaction was thought to have developed in either foundation sands or in the lower portions of a sandy levee embankment that had settled sufficiently into a clay foundation to be saturated by groundwater. At several distressed levee sections, sand boils were observed along cracks in the levee embankment, or in the foundation beyond the levee. At several sites, groundwater on the landward side of the levee appeared to be significantly higher than the water level in the river, indicating groundwater flow towards the river.

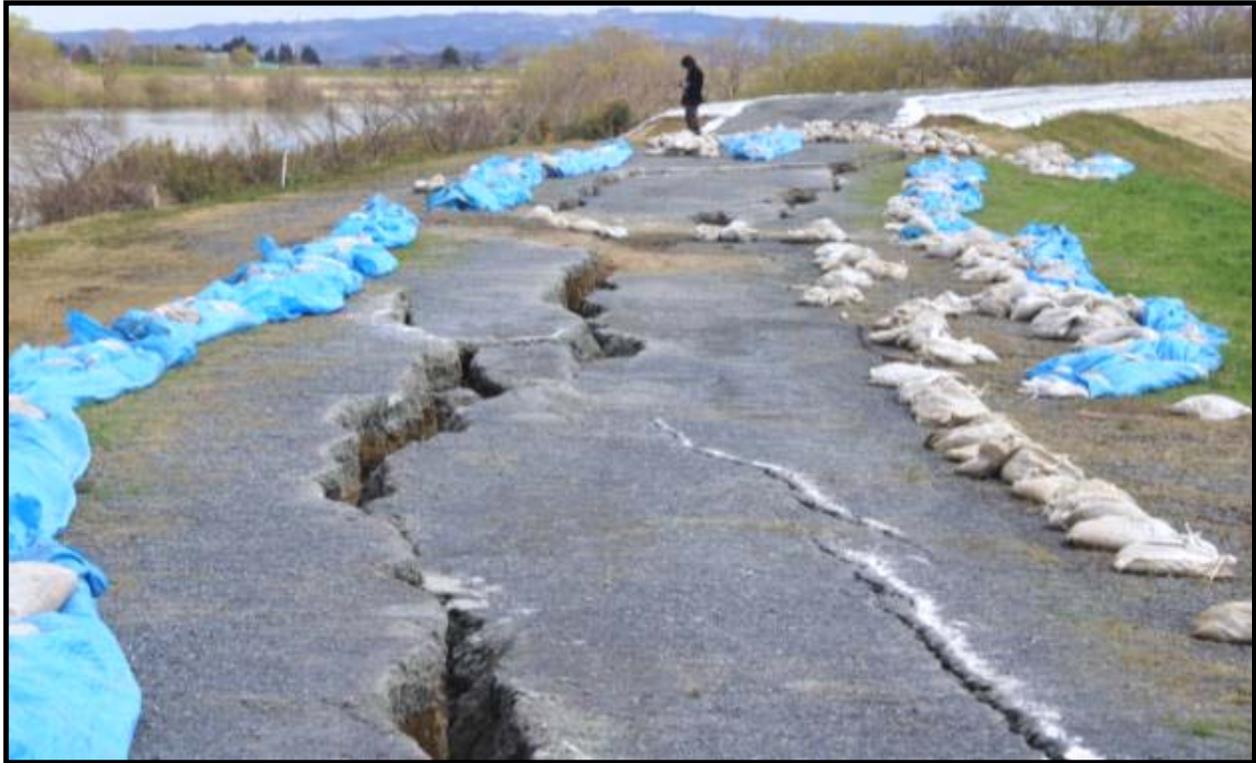
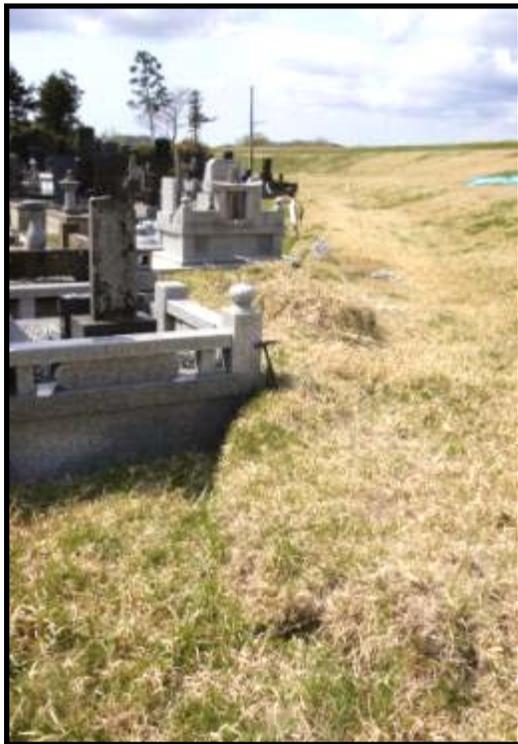
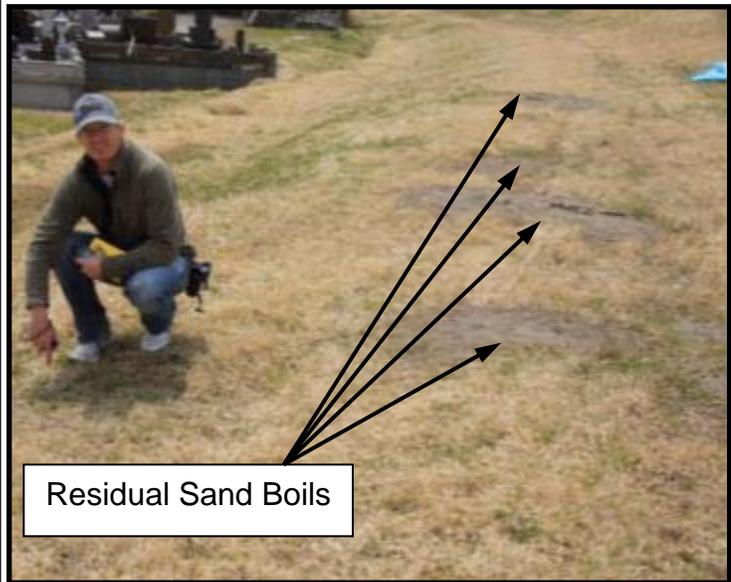
Figures 4 and 5 present additional photographs of levee damage caused by foundation liquefaction in the Miyagi Prefecture. In this area, preliminary results from seismographic recordings indicated peak ground accelerations in this area generally ranging between 0.27g and 0.66g, with a maximum peak acceleration of 0.94g recorded at the coast near the town of Oshika.

Figure 4: (a) Moderate Landward Slumping and Cracking of Levee Crown (note interim repair of more seriously damaged reach in the background, see Figure 12), (b) 30-60 cm Bulge at Landside Toe, and (c) Residual Sand Boils on Landside Berm on Naruse River Left Levee at River Kilometer 11.3-11.1 (N38.4538, E141.1087, April 21, 2011)

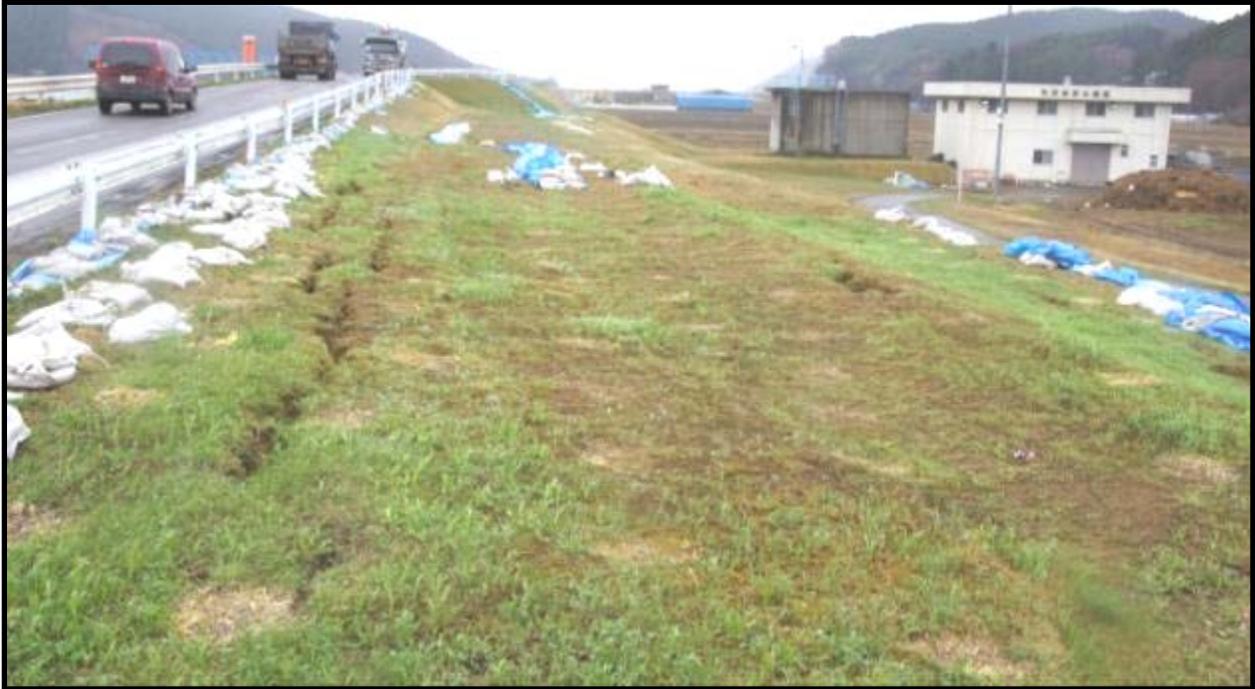
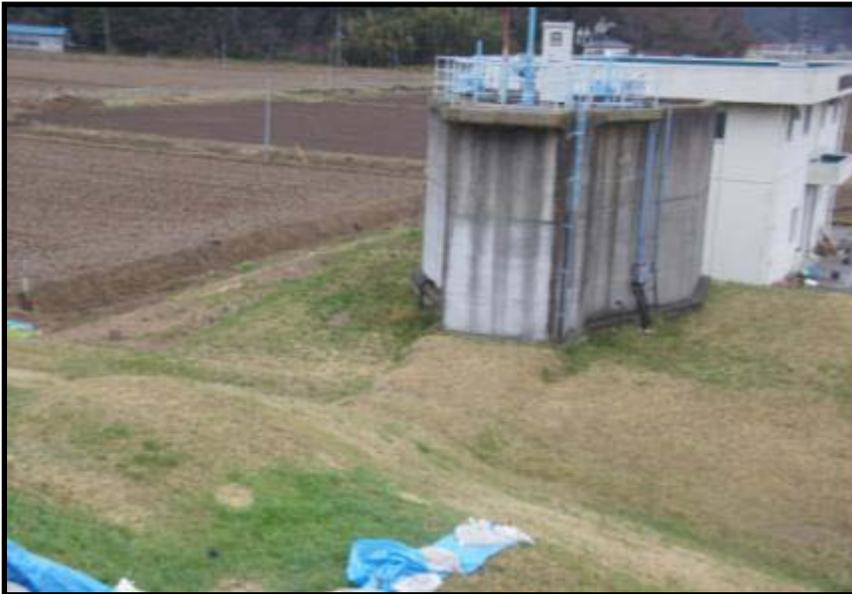
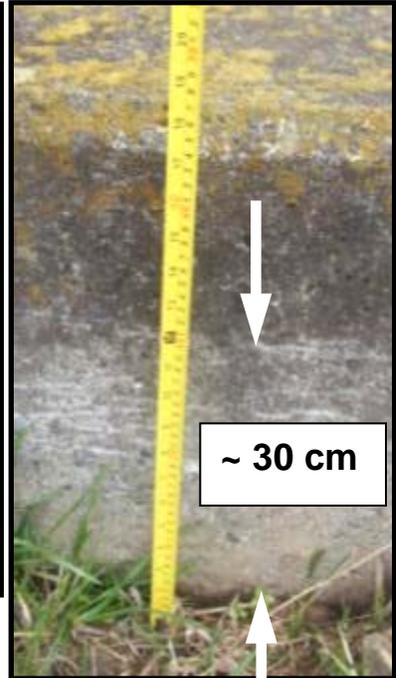
Figure 5: (a) Moderate Longitudinal Cracking and Slumping of Upper Landside Levee Slope, (b) Differential Settlement Over Reinforced Concrete Conduit on Lower Landside Levee Slope, and (c) Approximately 30 cm of Differential Settlement at Concrete Water Tank at Landside Levee Toe on Kitikami River Left Levee at River Kilometer 8.8 (N38.5320, E141.3687, April 22, 2011)

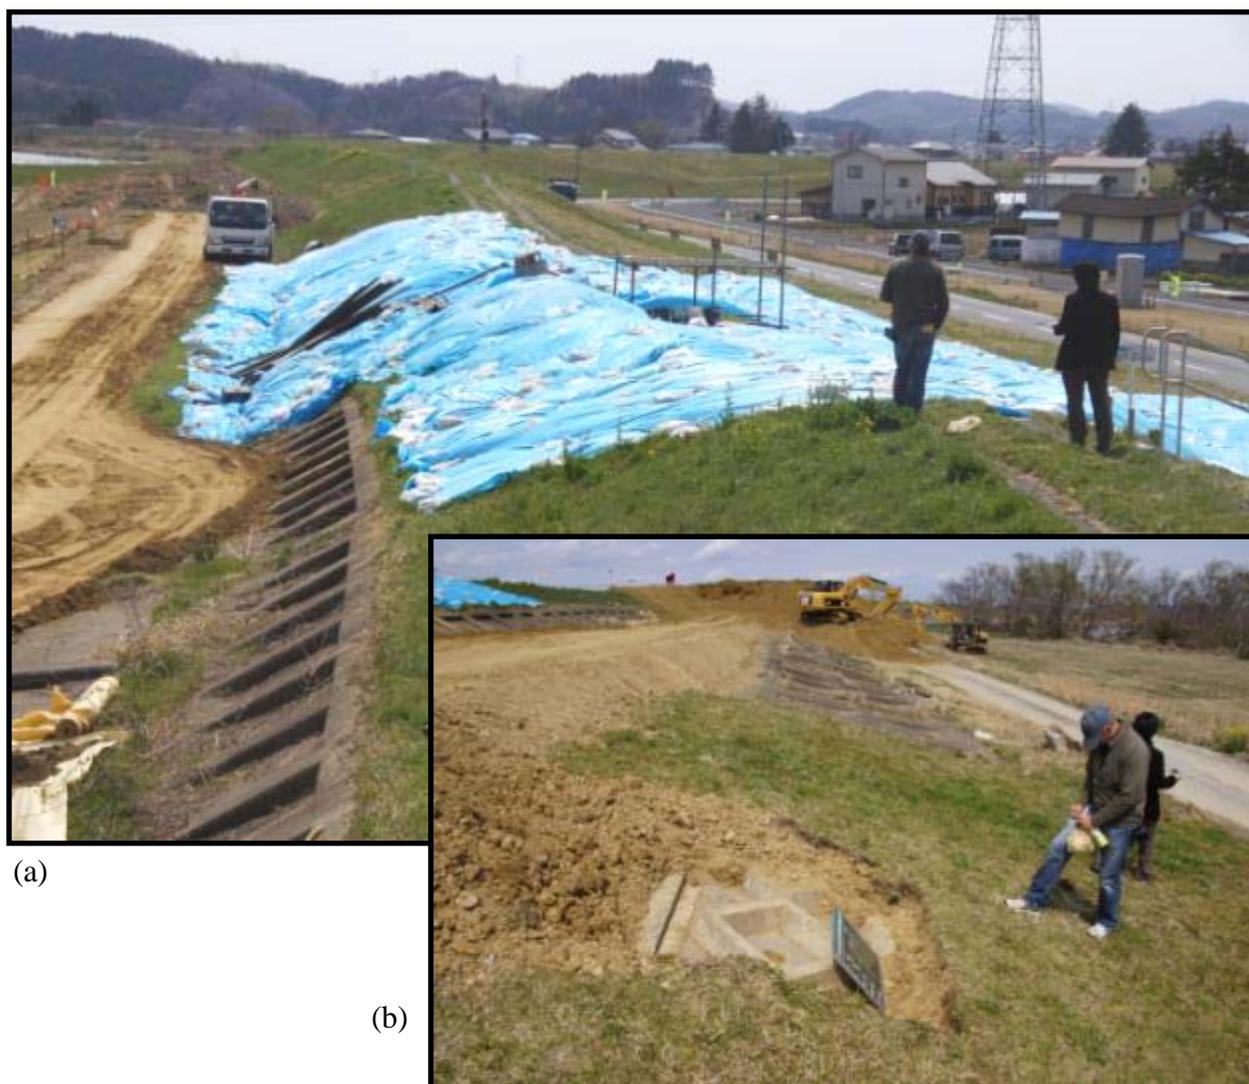
Along the Naruse River, the GEER Team also observed evidence of previous repairs of the right levee at River Kilometer 12 that had been damaged by the 2011 earthquake. Distress of the levee crest and waterside embankment during the 2011 includes cracked and thrust concrete revetments and open cracks on the crest and side slopes (see Figure 6). Pre-2011 distress at this site is suggested by the exposure of a newer, damaged revetment that was inset locally into the older revetment. This location coincides with the mapped location (MLIT, 2011) of a former meander bend of the Naruse River that may extend orthogonally beneath this section of the levee (see Figure 7). This paleochannel may contain different soils than those in the surrounding areas and they may be more susceptible to losses in shear strength. This is important because of a common association of paleochannels with areas of repeated levee deformation in California's Central Valley.

Figure 6: (a) Photograph Looking Downstream of Longitudinal Cracking and Slumping of Levee Crown and (b) Photograph Looking Upstream of Exposed More Recent Revetment on Waterside Slope – Evidence of Previous Repair at Naruse River Right Levee at River Kilometer 12.0 (N38.4596, E141.1088, April 21, 2011)

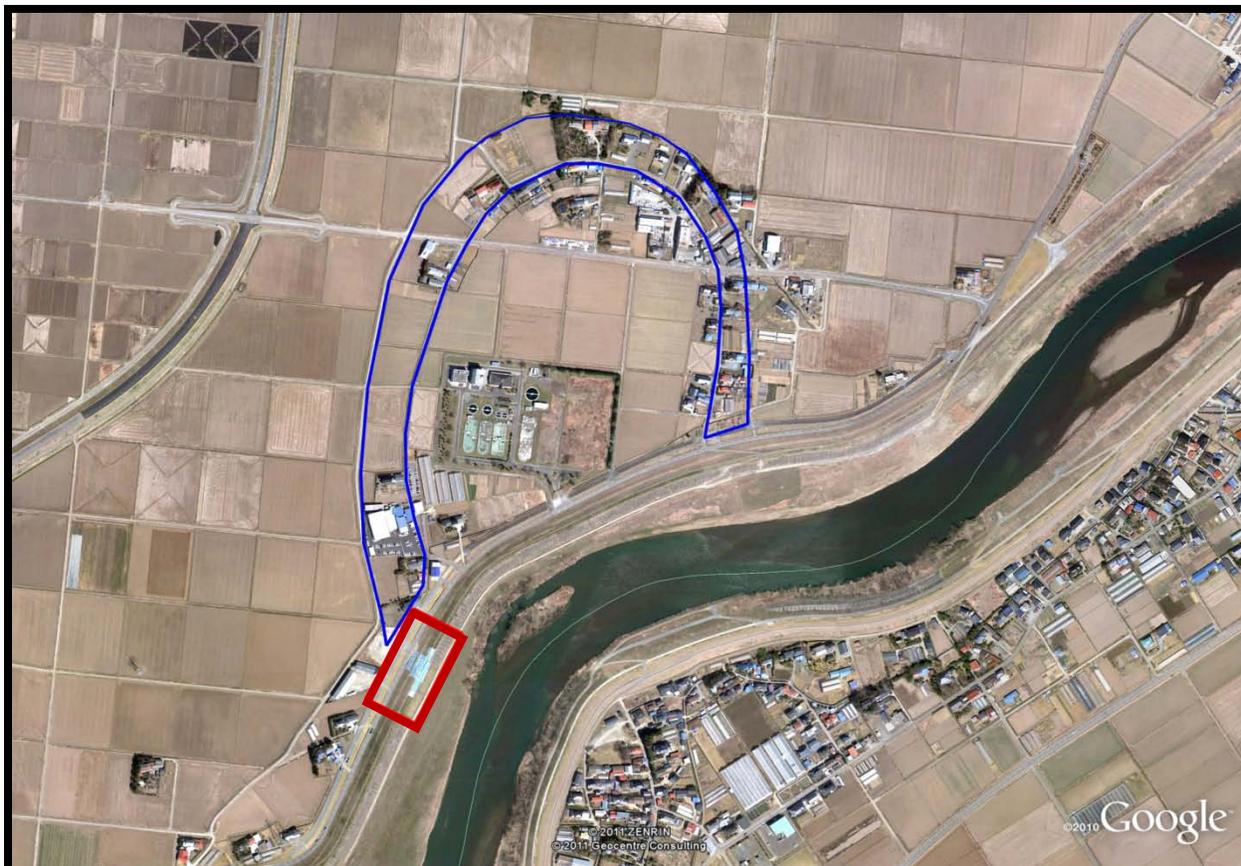
Figure 7: Aerial Image of the Naruse River near River Kilometer 12 Showing Repaired Area of Right Levee (red box) and Shallow Paleochannel with Geomorphic Expression on Northern Side of Levee (blue polygon) – adapted from Google Earth, 2011

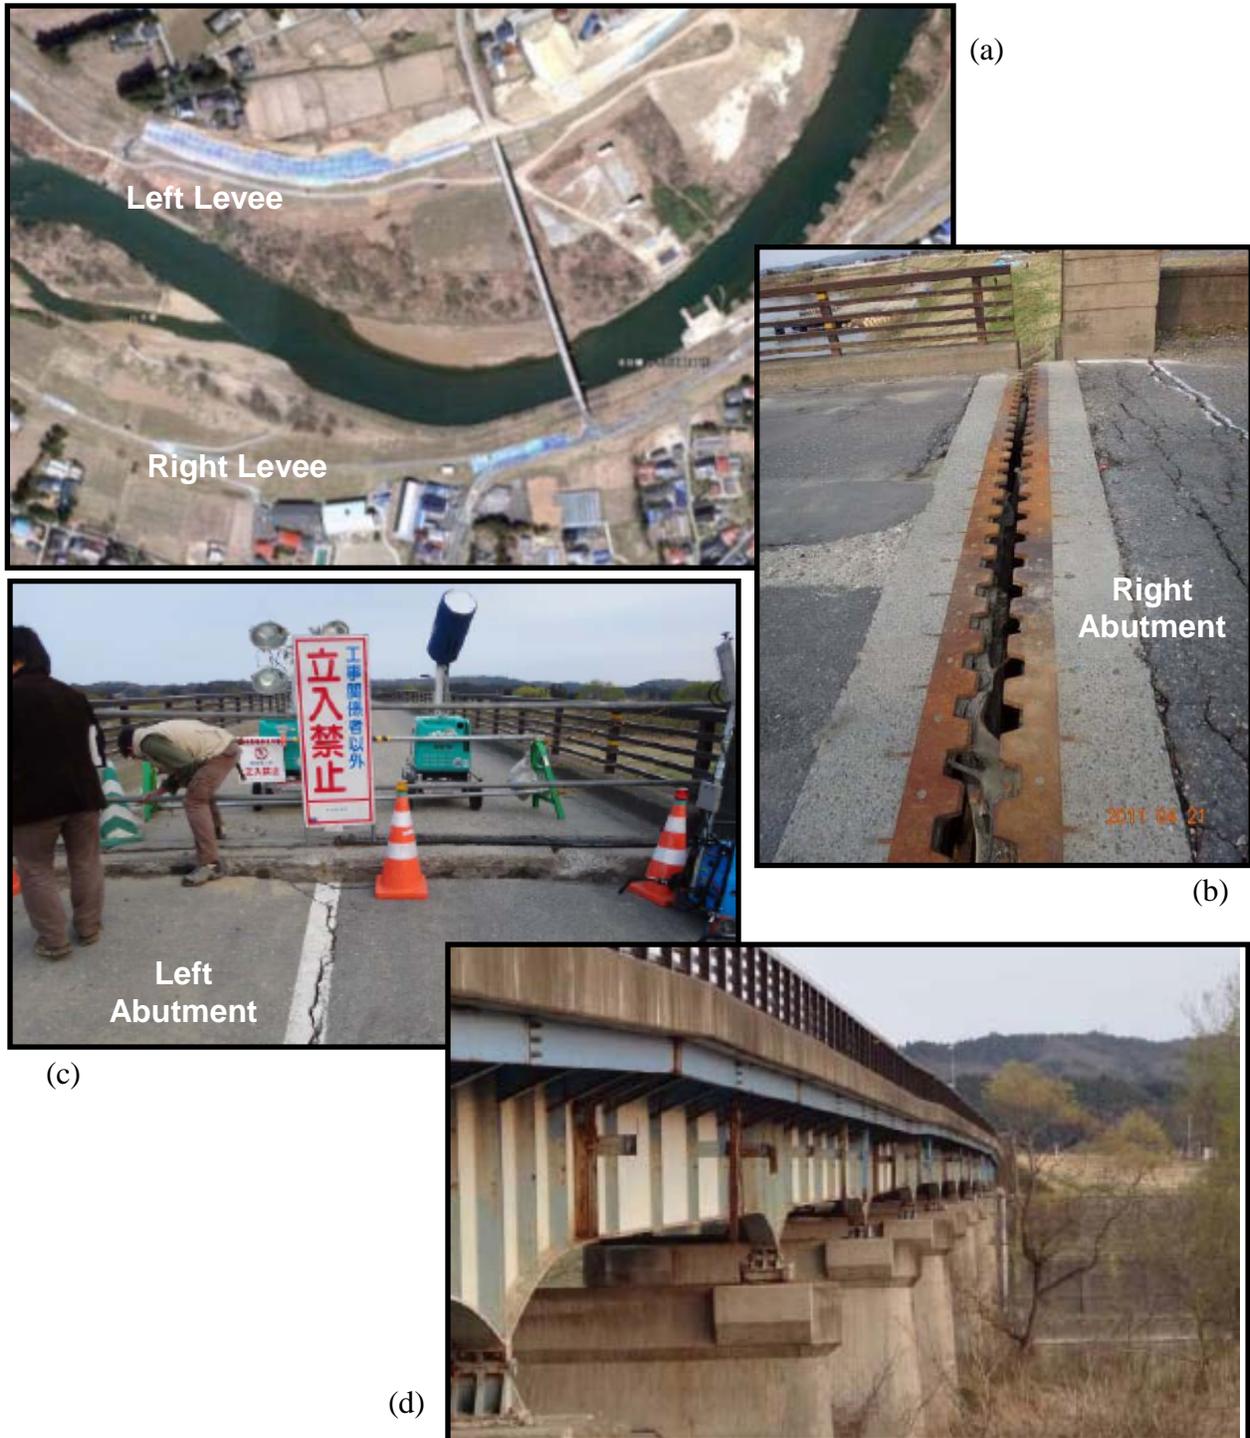
Figure 8: (a) Aerial View of Bridge and Levees (adapted from Google Earth, 2011), (b) View Looking Downstream (east) at Separation Between Bridge Span (on left) and Right Levee/Abutment Fill (on right), (c) View Looking South (across river) at Settlement and Separation of the Left Levee/Abutment Fill, and (d) View of Irregular Bridge Deck of the Matsuyama Bridge Across the Naruse River at River Kilometer 30.0 (N38.5322, E141.0059, April 21, 2011)

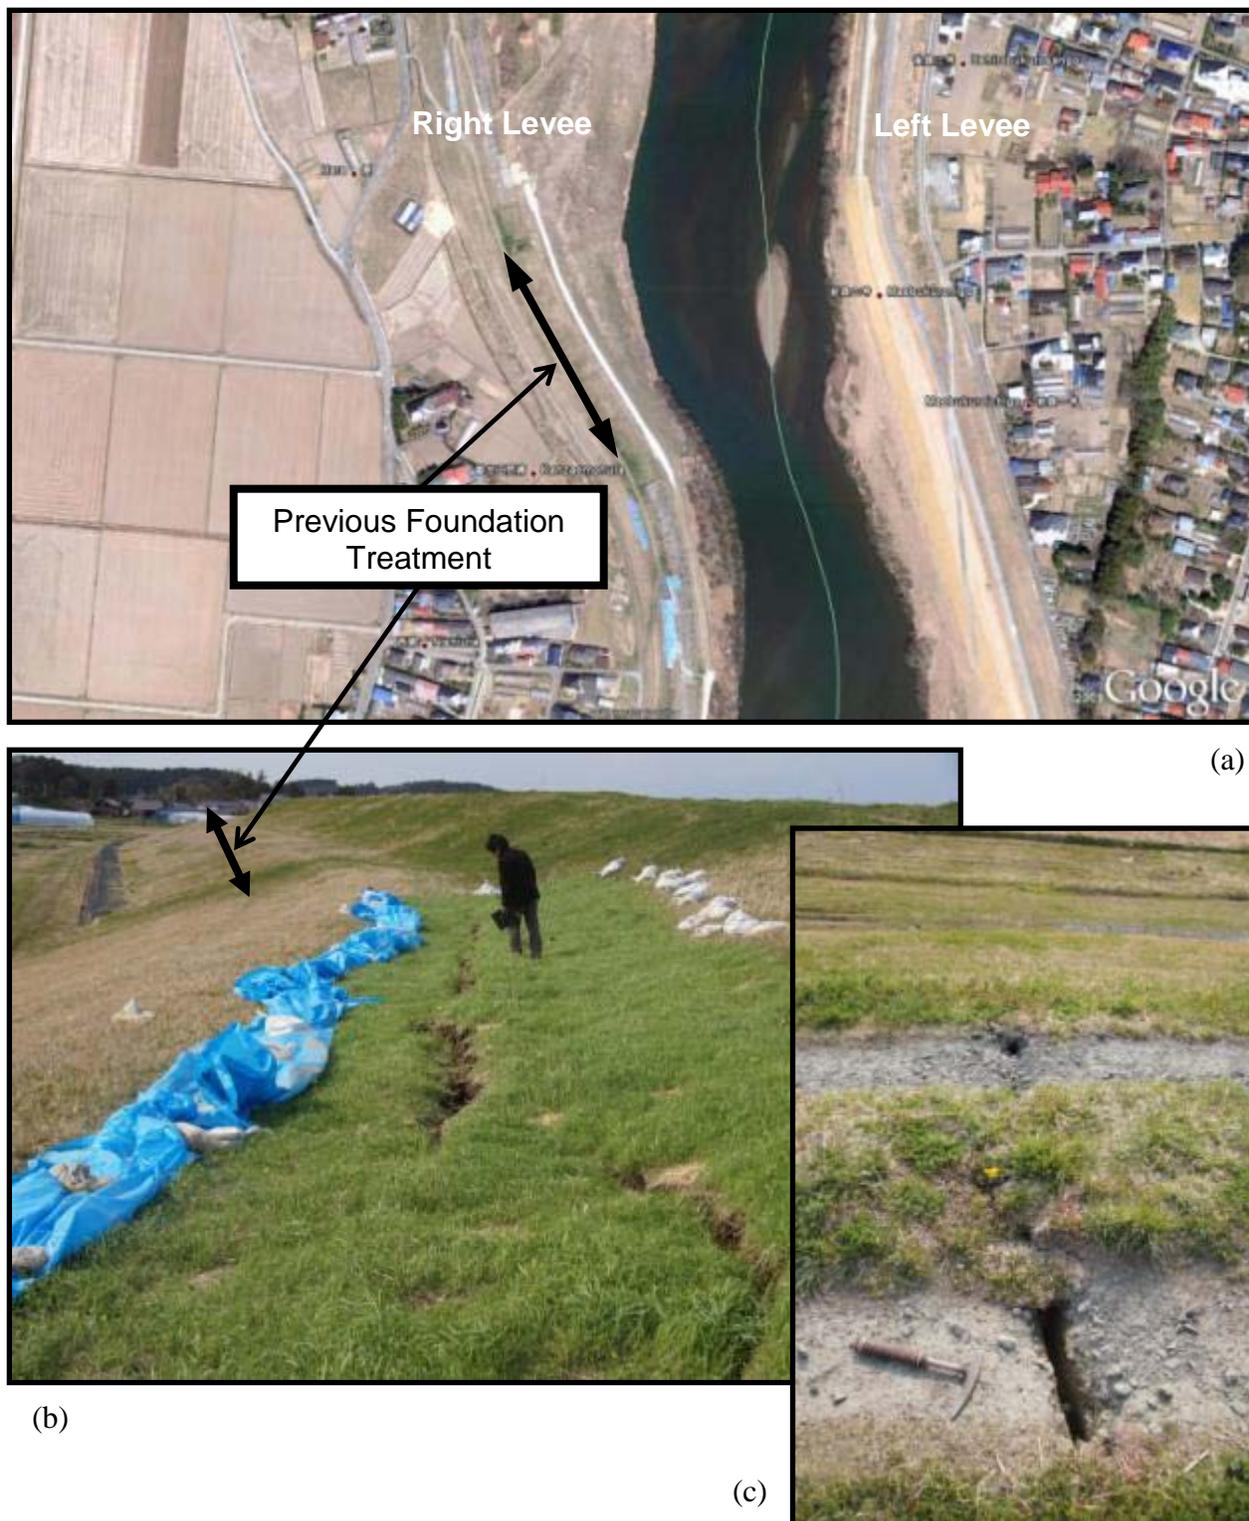
For two of the previously treated levee reaches, levees on either side of the treated lengths developed foundation liquefaction and experienced minor to moderate levee cracking and slumping during the 2011 event. Figure 14 illustrates landside longitudinal cracking and slumping, together with transverse cracking at the levee crown, directly downstream of the treated reach of the Naruse River Right Levee at River Kilometer 14.7.

Figure 13: (a) Aerial View of Treatment Area (adapted from Google Earth, 2011), (b) Longitudinal Cracking and Slumping of Waterside Levee Slope Downstream of Treatment Area, and (c) Transverse Cracking on Levee Crown at Downstream Edge of Treatment Area on Naruse River Right Levee At River Kilometer 15.0 - 14.7 (N38.4784, E141.1259, April 21, 2011)

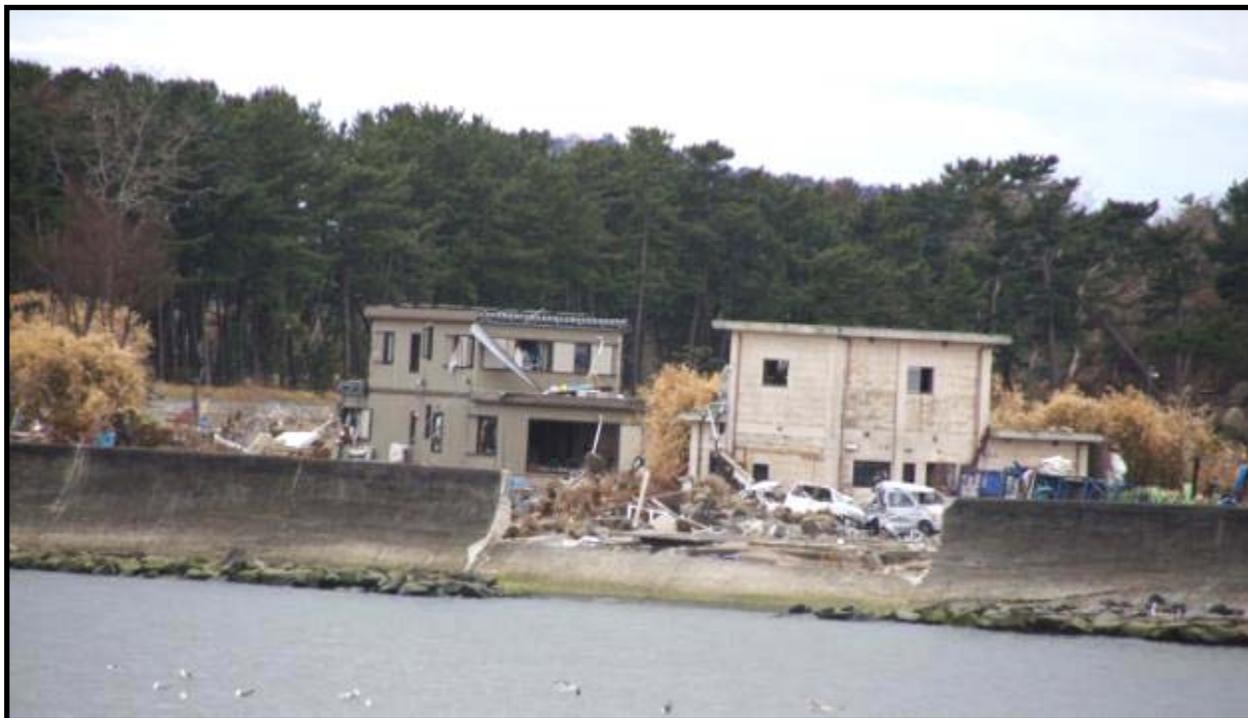
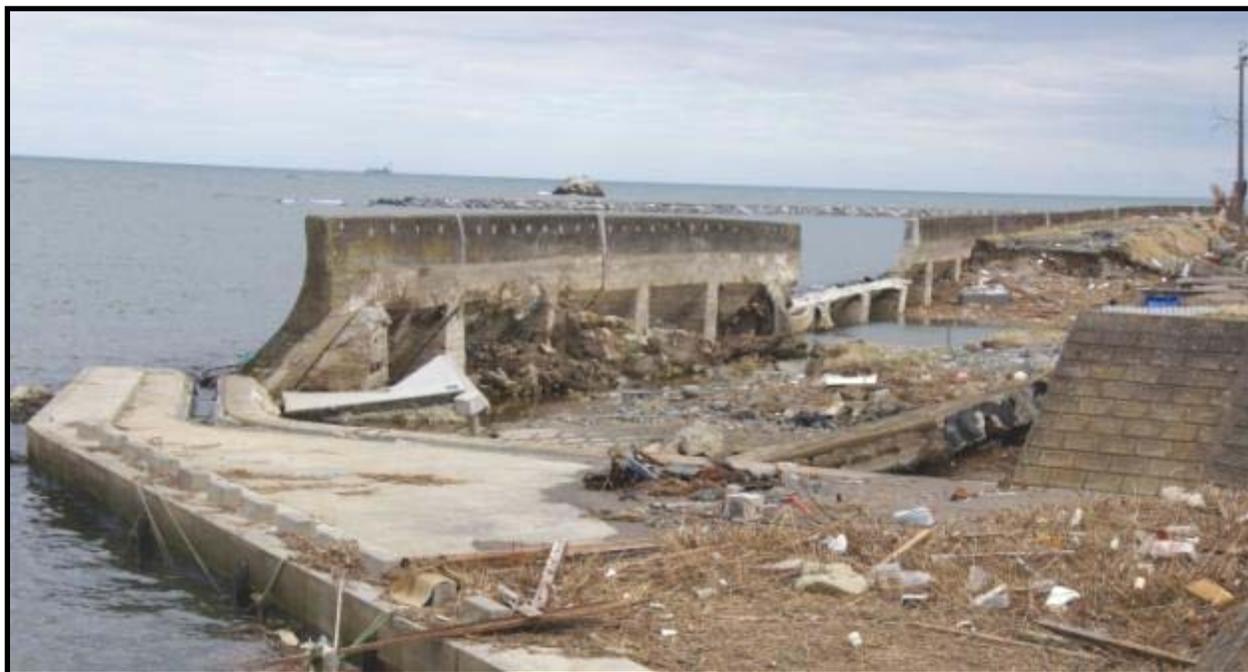
Where overtopped, substantial landside scour occurred into levee embankments, and highlighted the absence of hardened erosion control on the landside surfaces. The damage on the landside contrasted greatly with that on the waterside, which typically exhibited only minor and local scour because of erosion-resistant designs. However, near the ocean, scour did occur on some waterside levee slopes as the tsunami flows receded back towards the river and ocean. Although little or no evidence of liquefaction remains in areas affected by tsunami waves, it seems likely that some of the areas that experienced tsunami overtopping had localized lower crown elevations that had resulted from liquefaction-related lateral spreading in advance of the tsunami waves. In short, in areas where tsunami inundation levels were equal to or higher than the levee crests, liquefaction-induced damage and/or settlement of the levee may have resulted in concentrations of overtopping tsunami flows, which then resulted in increased landside scour, aggravated incision into the embankment, and development of levee breaches that caused additional damage to adjacent landside areas.

Figure 15: (a) Waterside View and (b) Landside View of Levee/Floodwall Sections Damaged by Tsunami Waves Along Right Bank of Naruse River Near the River Mouth (N38.3775, E141.1716, April 20, 2011)

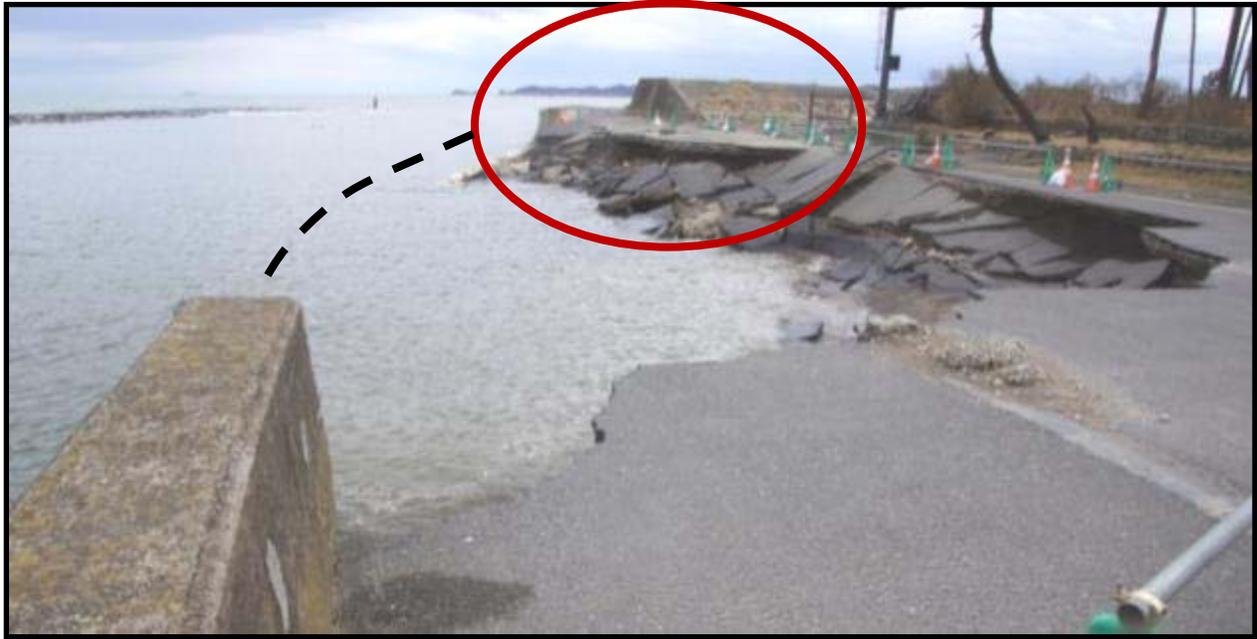
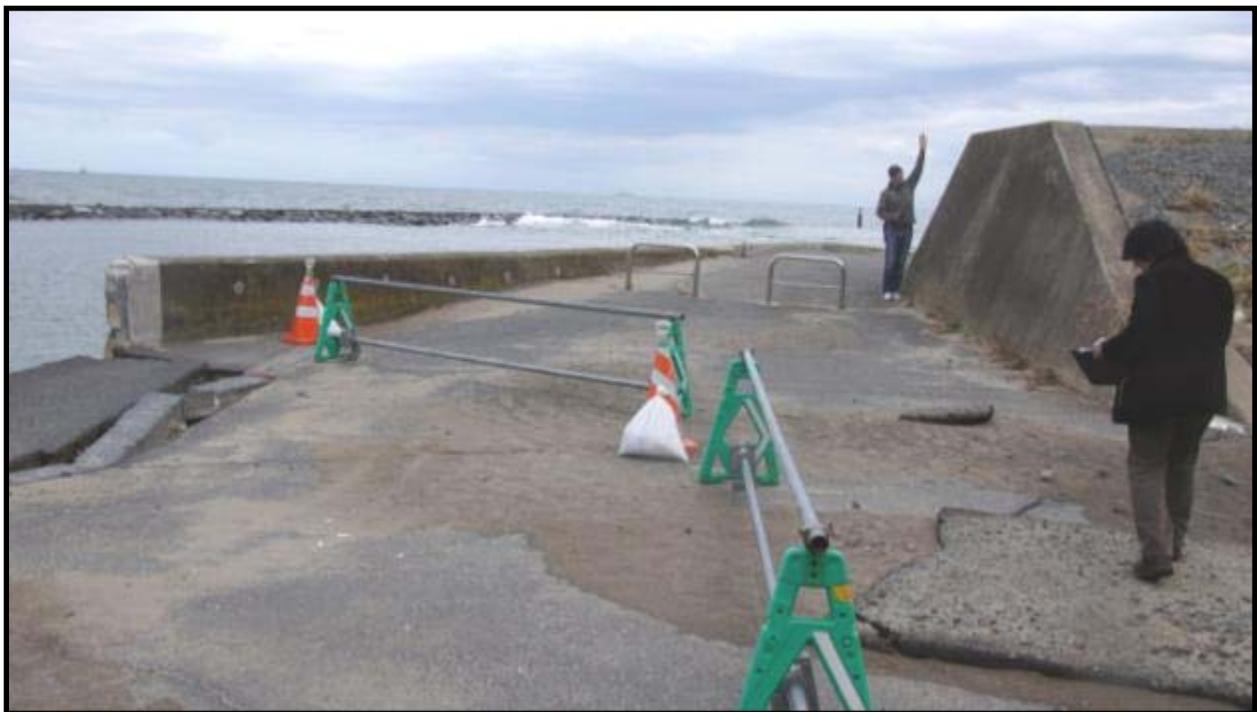
The riverine floodwalls on top of the levees near the mouths of the river sometimes seemed smaller and lower than those placed along the adjacent coast (see Figures 16 and 23). The riverine floodwall along the right levee of the Naruse River was found to be approximately 2 meters lower than the coastal floodwall to which it was connected (see Figure 16). The coastal floodwall at this location appeared to have only minor damage associated with perhaps limited overtopping. However, the much lower riverine levee was extensively damaged and breached by overtopping flows. If all of the riverine levees/floodwalls had the same heights as the coastal floodwalls they were connected to, the tsunami damage might have been smaller.

Figure 16: (a) View of Collapsed Levee/Floodwall Along Right Bank of Naruse River at River Mouth and Connection with Coastal Floodwall and (b) View Illustrating 2-meter Higher Crown Elevation of Coastal Floodwall Above Riverine Floodwall (N38.3756, E141.1727, April 20, 2011)

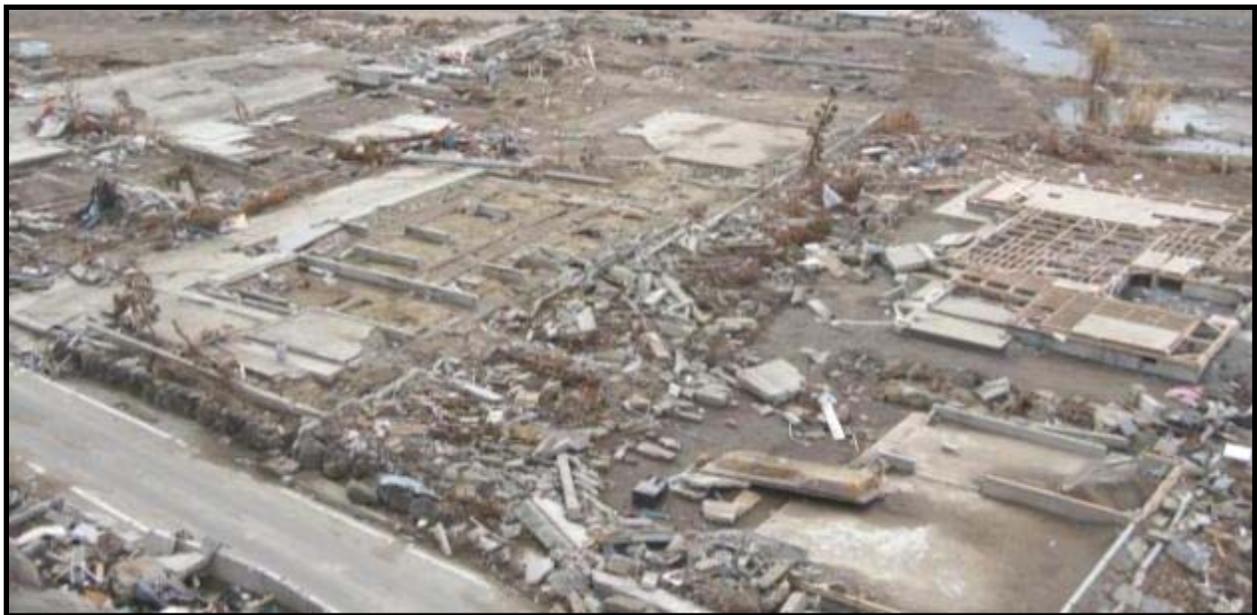
Figure 17: (a) Aerial View (adapted from Google Earth, 2011) and (b) Photograph of Homes Behind Right Levee of Naruse River at the River Mouth Obliterated by Tsunami Waves ((N38.3763, E141.1711, April 20, 2011)

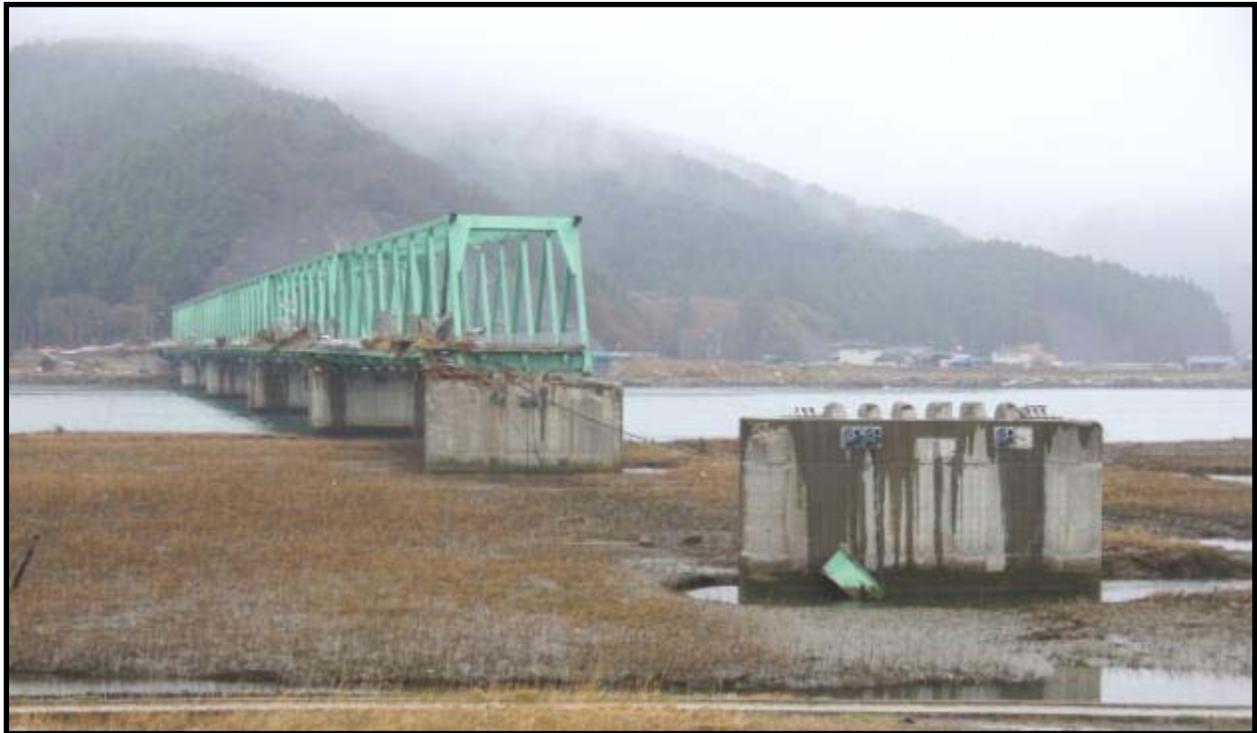
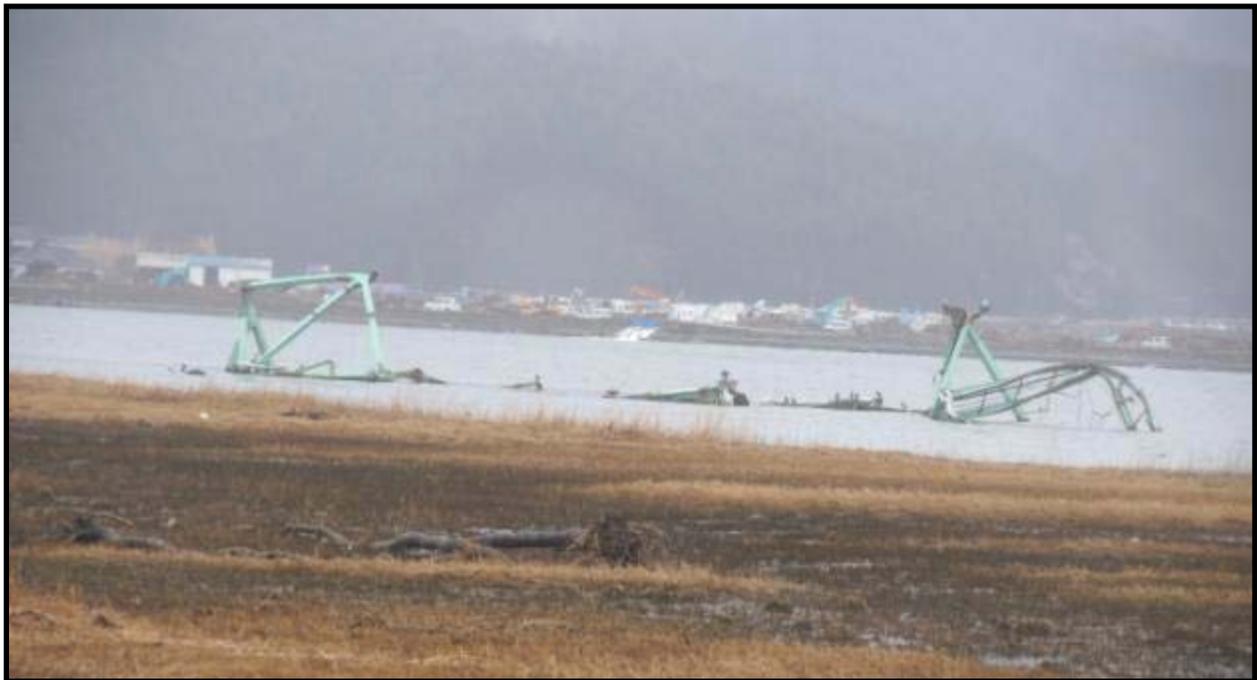
Figure 18: Photographs of Left Bridge Spans Destroyed by Tsunami Waves and Twisted Wreckage Upstream of Kitakami River Bridge at Approximately Kilometer 4 - Tsunami Height Above Bridge Deck ~170 cm (Based on Water Stains on Building on Left Kitakami Levee)

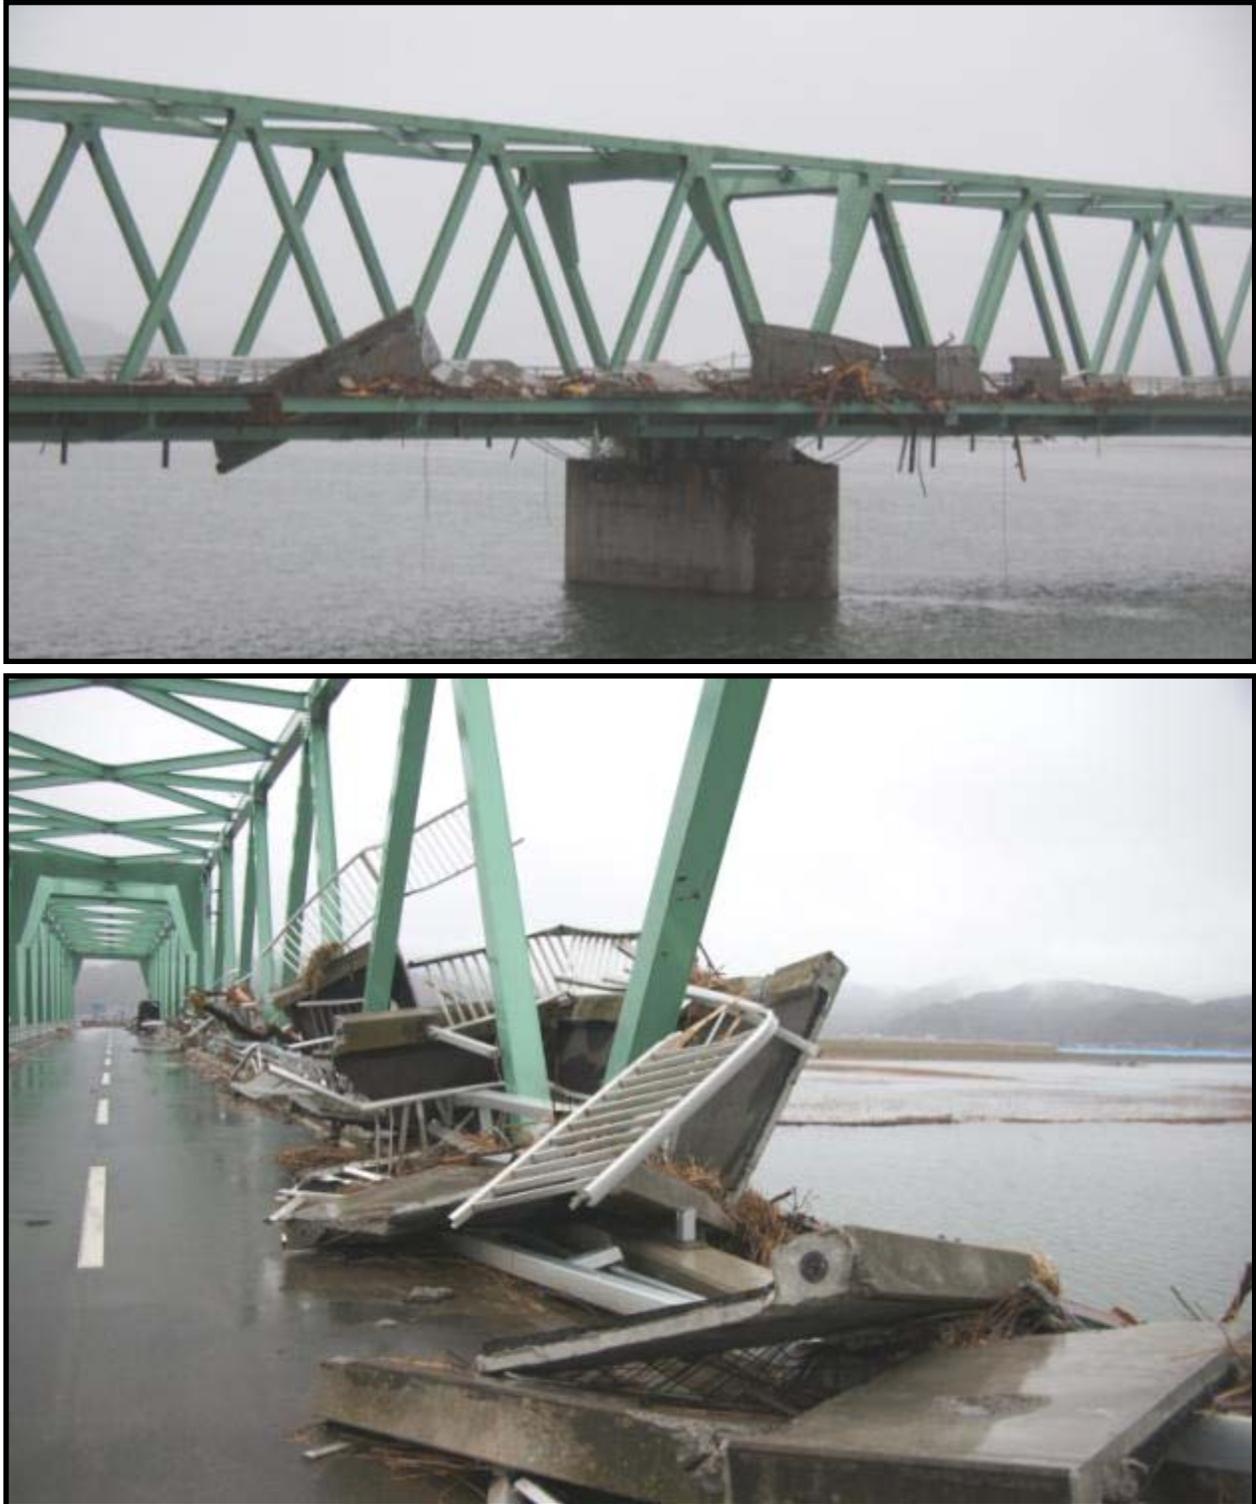
Figure 19: Photographs of Tsunami Debris and Pedestrian Deck/Railing Flipped Up and Against Downstream Side of Kitakami River Bridge at Approximately Kilometer 4 – Tsunami Height Above Bridge Deck ~170 cm (Based on Water Stains on Building on Left Kitakami Levee) ((N38.5458, E141.4257, April 22, 2011)
