Geotechnical Extreme Events Reconnaissance (GEER)

## **Preliminary Observations of Levee Performance and Damage following the March 11, 2011 Tohoku Offshore Earthquake, Japan**

May 2, 2011

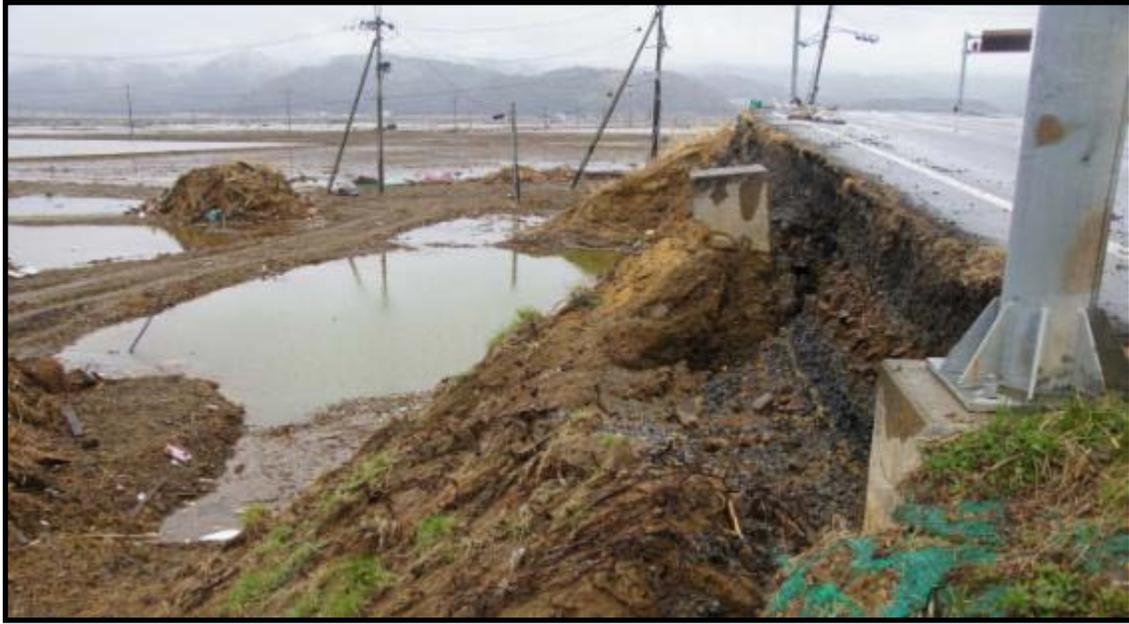
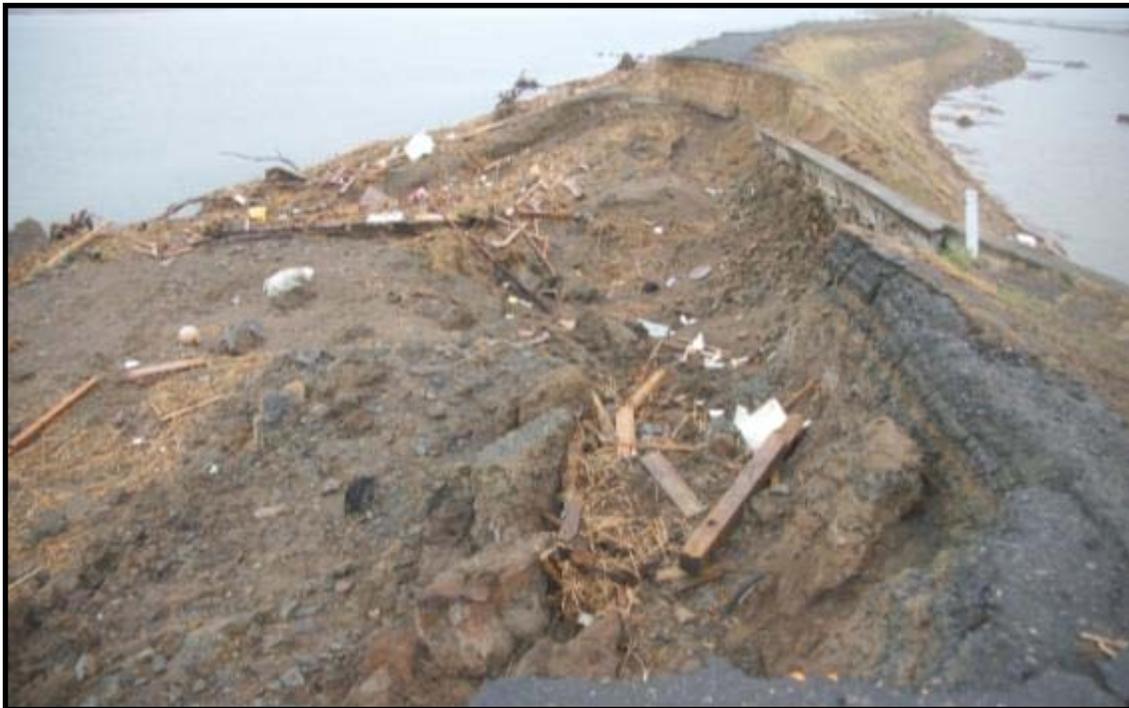
Where overtopped, substantial landside scour occurred into levee embankments, and highlighted the absence of hardened erosion control on the landside surfaces. The damage on the landside contrasted greatly with that on the waterside, which typically exhibited only minor and local scour because of erosion-resistant designs. However, near the ocean, scour did occur on some waterside levee slopes as the tsunami flows receded back towards the river and ocean. Although little or no evidence of liquefaction remains in areas affected by tsunami waves, it seems likely that some of the areas that experienced tsunami overtopping had localized lower crown elevations that had resulted from liquefaction-related lateral spreading in advance of the tsunami waves. In short, in areas where tsunami inundation levels were equal to or higher than the levee crests, liquefaction-induced damage and/or settlement of the levee may have resulted in concentrations of overtopping tsunami flows, which then resulted in increased landside scour, aggravated incision into the embankment, and development of levee breaches that caused additional damage to adjacent landside areas.

Figure 20: Photographs of Erosion and Scour of Levee Slope on (a) Left Levee and (b) Right Levee of Kitakami River at Immediately Downstream of Kitakami River Bridge at Approximately River Kilometer 4 – Tsunami Height Above Levee Crown ~170 cm (Based on Water Stains on Building on Left Kitakami Levee at Bridge) ((N38.5468, E141.4238, April 22, 2011)

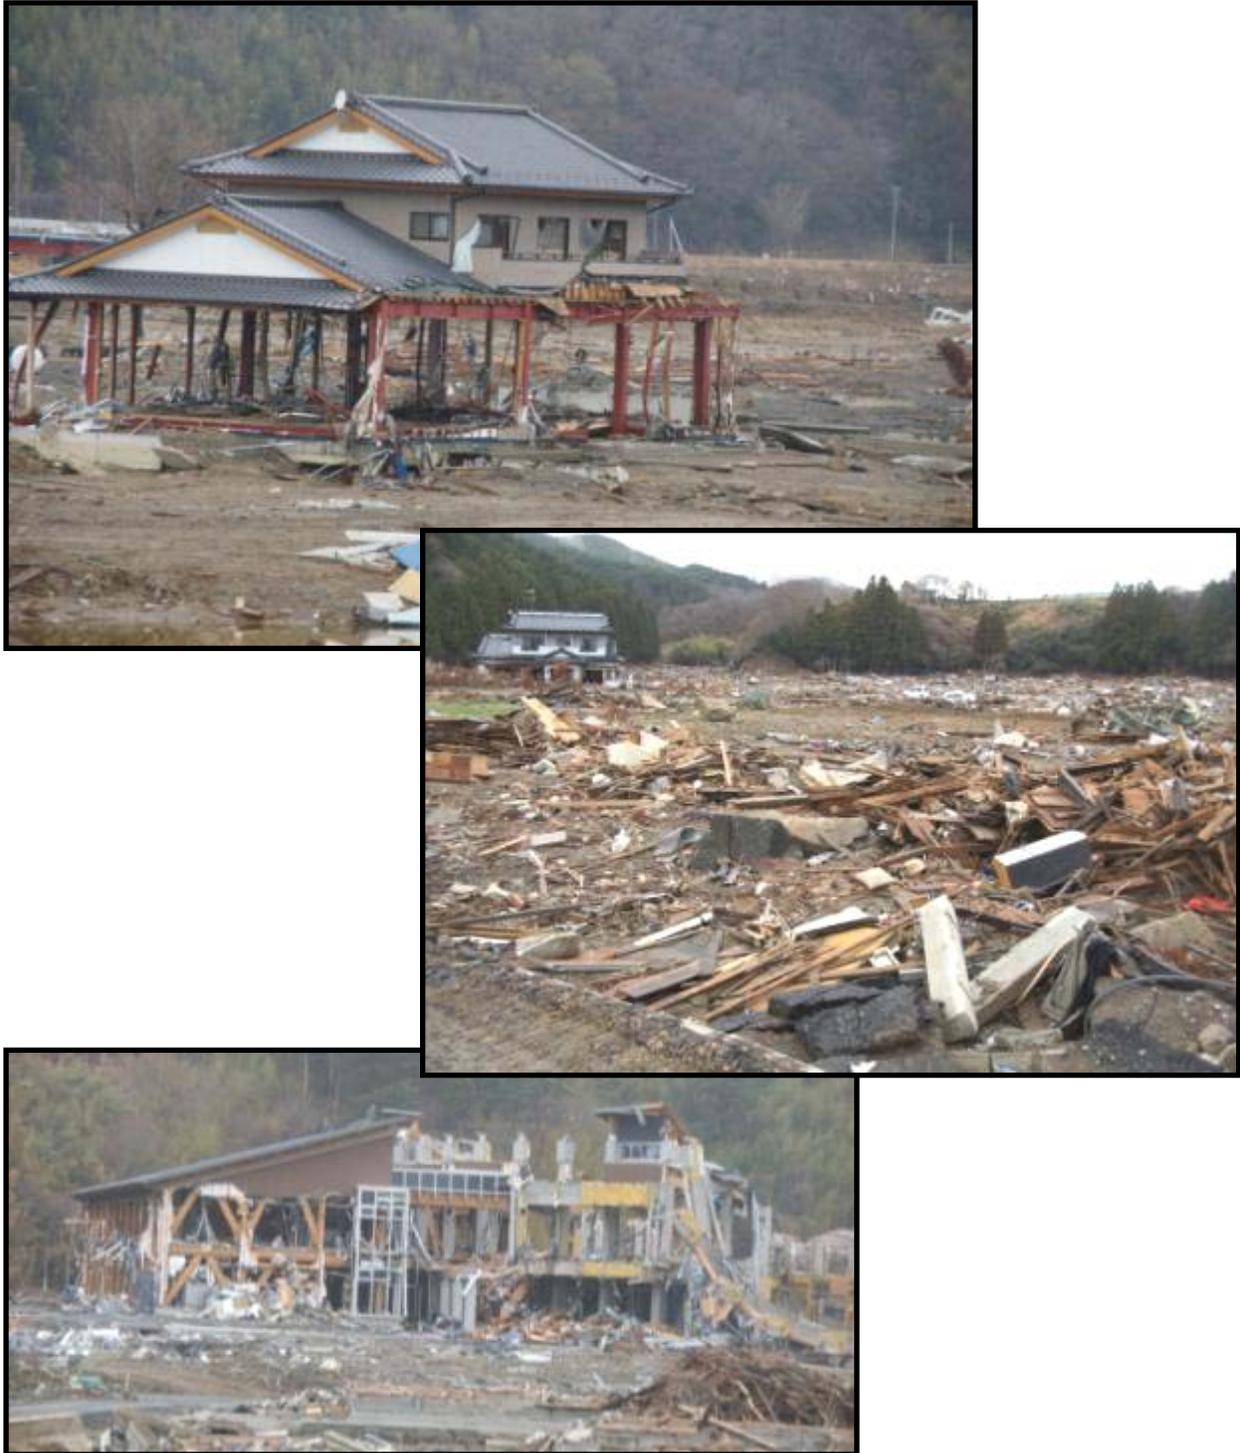
Figure 21: Photographs of Tsunami Damage to Homes and Structures Behind Left Levee of Kitakami River near River Kilometers 2 to 0.5 (N38.5639, E141.4294, April 22, 2011)

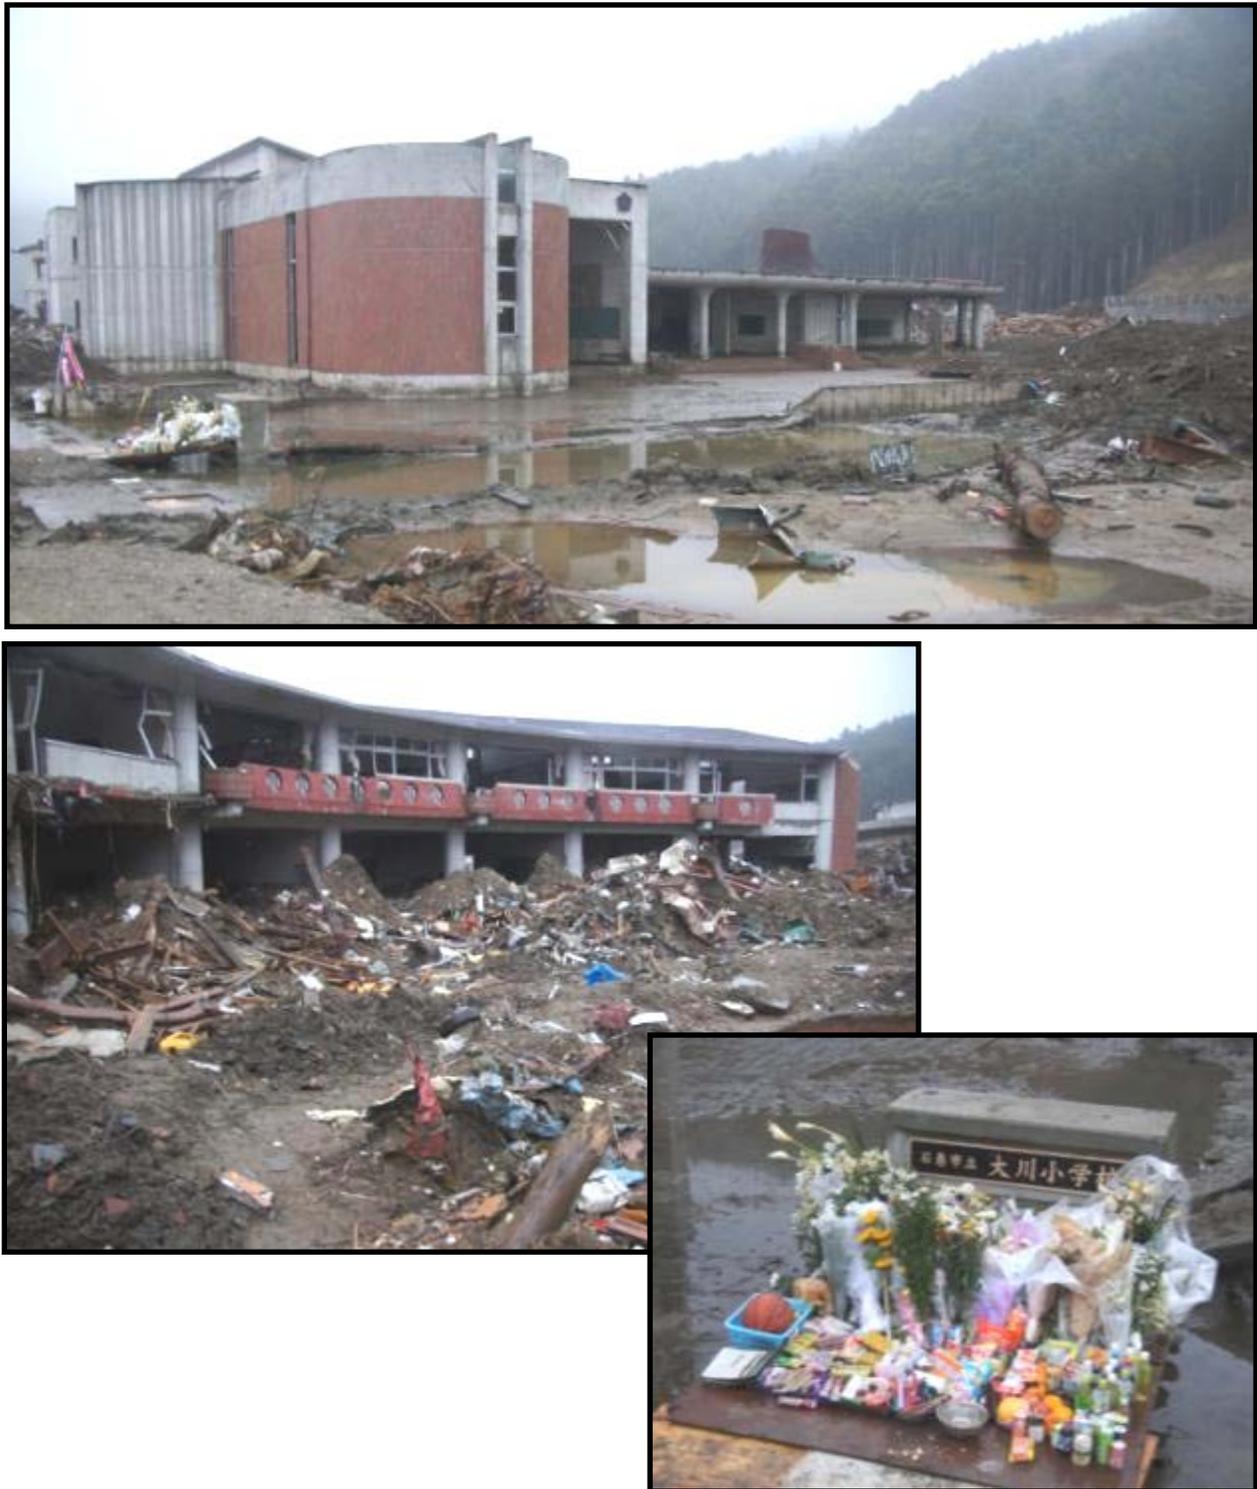
Figure 22: Photograph of Nirashima School (Reinforced Concrete Buildings) Damaged by Tsunami Waves Behind Right Levee of Kitakami River Immediately Downstream of Kitakami River Bridge at Approximately River Kilometer 4 (N38.5460, E141.4283, April 22, 2011)

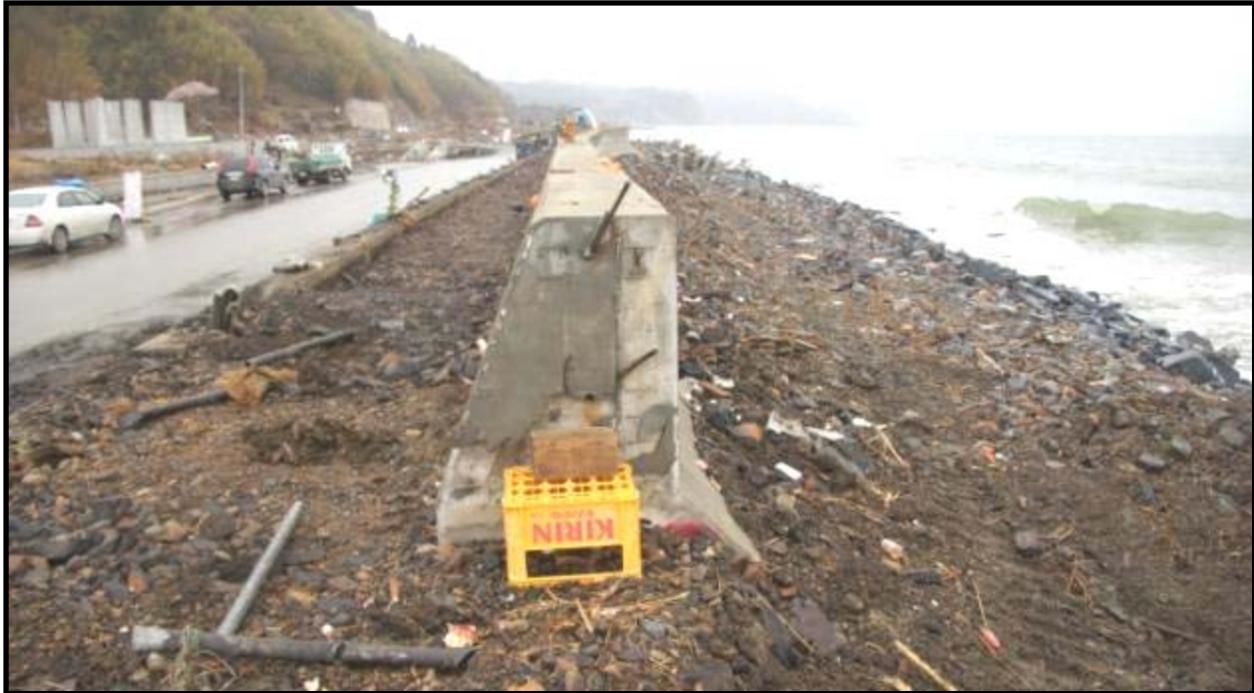
The riverine floodwalls on top of the levees near the mouths of the river sometimes seemed smaller and lower than those placed along the adjacent coast (see Figures 16 and 23). The riverine floodwall along the right levee of the Naruse River was found to be approximately 2 meters lower than the coastal floodwall to which it was connected (see Figure 16). The coastal floodwall at this location appeared to have only minor damage associated with perhaps limited overtopping. However, the much lower riverine levee was extensively damaged and breached by overtopping flows. If all of the riverine levees/floodwalls had the same heights as the coastal floodwalls they were connected to, the tsunami damage might have been smaller.

Figure 23: Photograph of Relatively Low Floodwall on Left Bank of Kitakami River Near River Kilometer 0.5 (N38.5763, E141.4546, April 22, 2011)

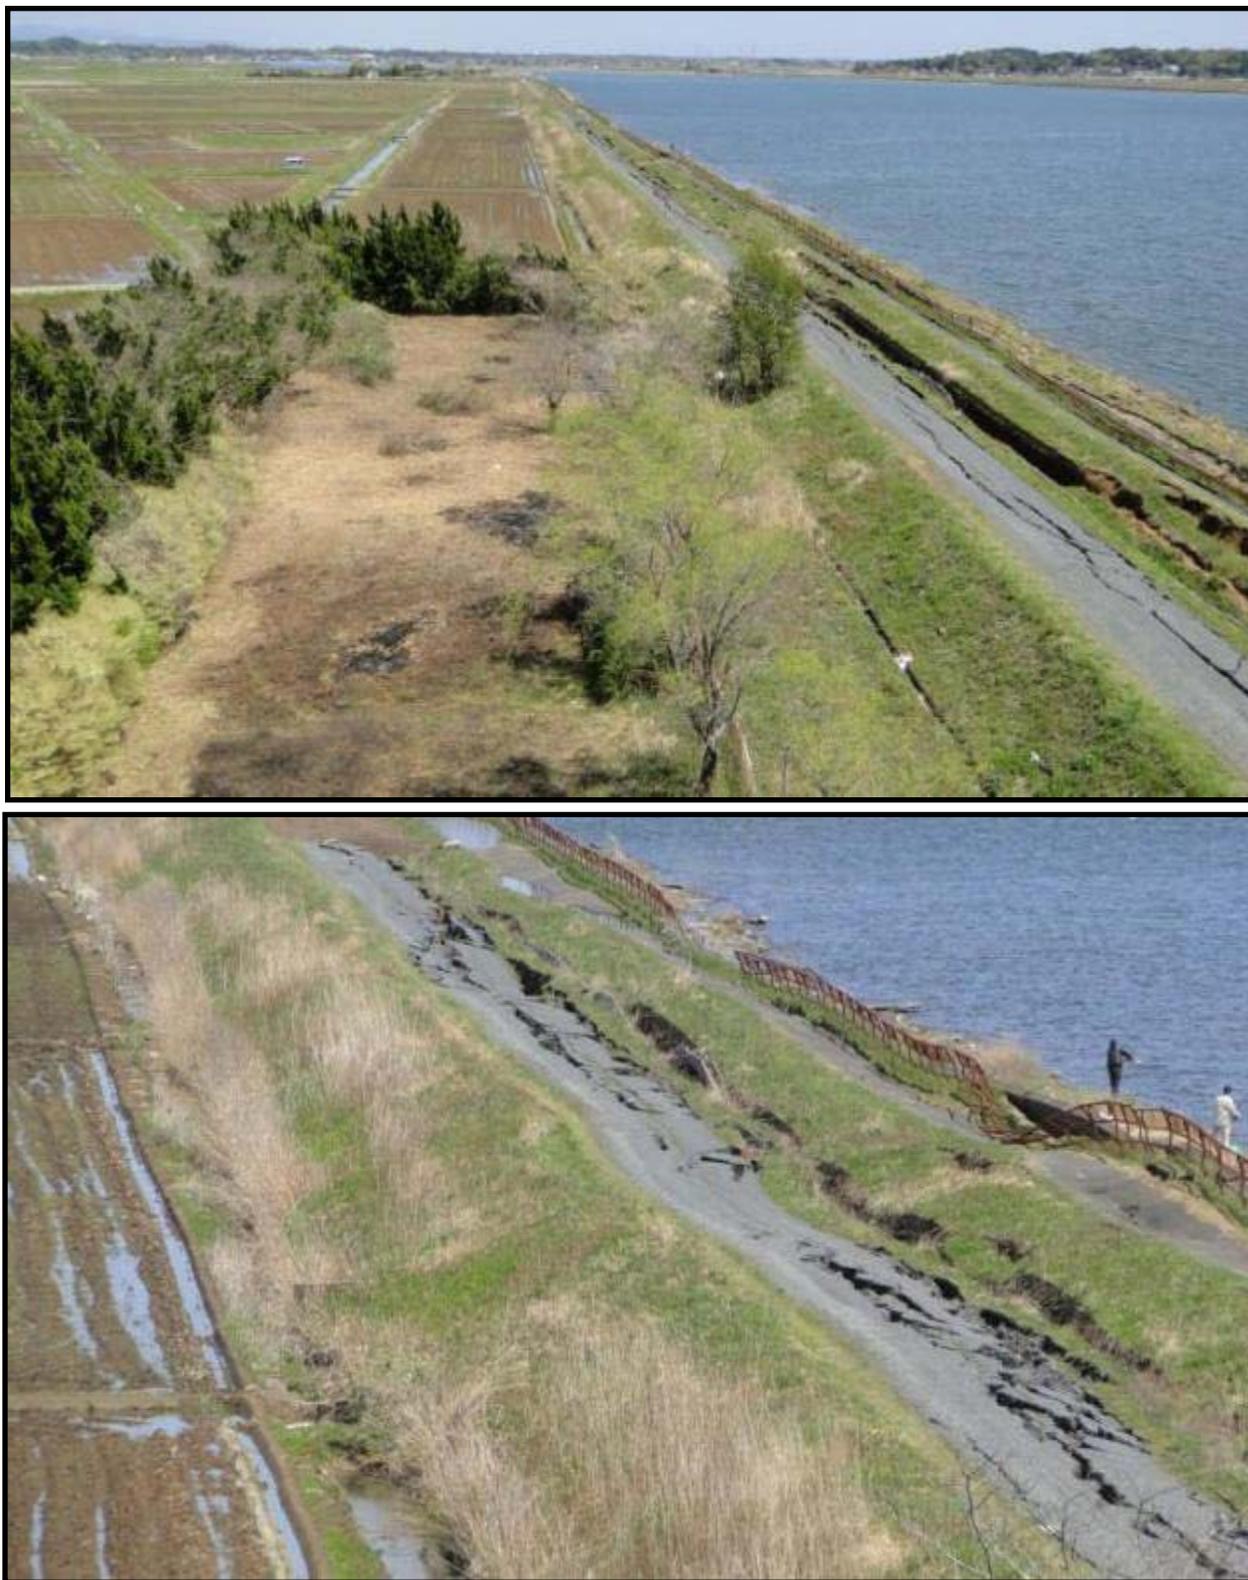
The Hinuma River flows from Lake Hinuma to the ocean near the town of Mito (see Figure 26), and is bordered on the west by levees that experienced relatively extensive damage from foundation liquefaction (see Figures 27 through 31). This levee, apparently founded on dredged fill/reclaimed land, was observed to have extensive cracking and slumping for over 2½ kilometers along the western margin of Lake Hinuma, a shallow, near-coastal lake. In some areas, new fill had been placed into limited reaches where it appeared that the river/lake might breach the slumped levee. The difference in the length of damage along this levee, as opposed to the more limited (but multiple) damaged reaches in the Miyagi Prefecture, and other locations in the Ibaraki Prefecture, appears to reflect the presence of man-made foundation materials and/or the presence of lake water that was high enough to saturate both the foundation and the lower portions of the embankment. In some lengths along the left levee, the Hinuma Lake/River water level was about a meter higher than the landside ground surface. Exposed embankment material in the numerous large cracks indicated that at least the upper fill was composed of clayey sands and gravels. However, the numerous sand boils found in the cracks were generally clean, fine to medium-grained sands – the latter material consistent with dredged or hydraulic fill. The long length of liquefaction damage has significant implications for saturated levees constructed of or on dredged material, such as those in the Sacramento-San Joaquin Delta in California’s Central Valley.

Figure 27: View of Slumped Hinuma River Left Levee Induced by Liquefaction  
(N36.2861, E140.5238., April 24, 2011)

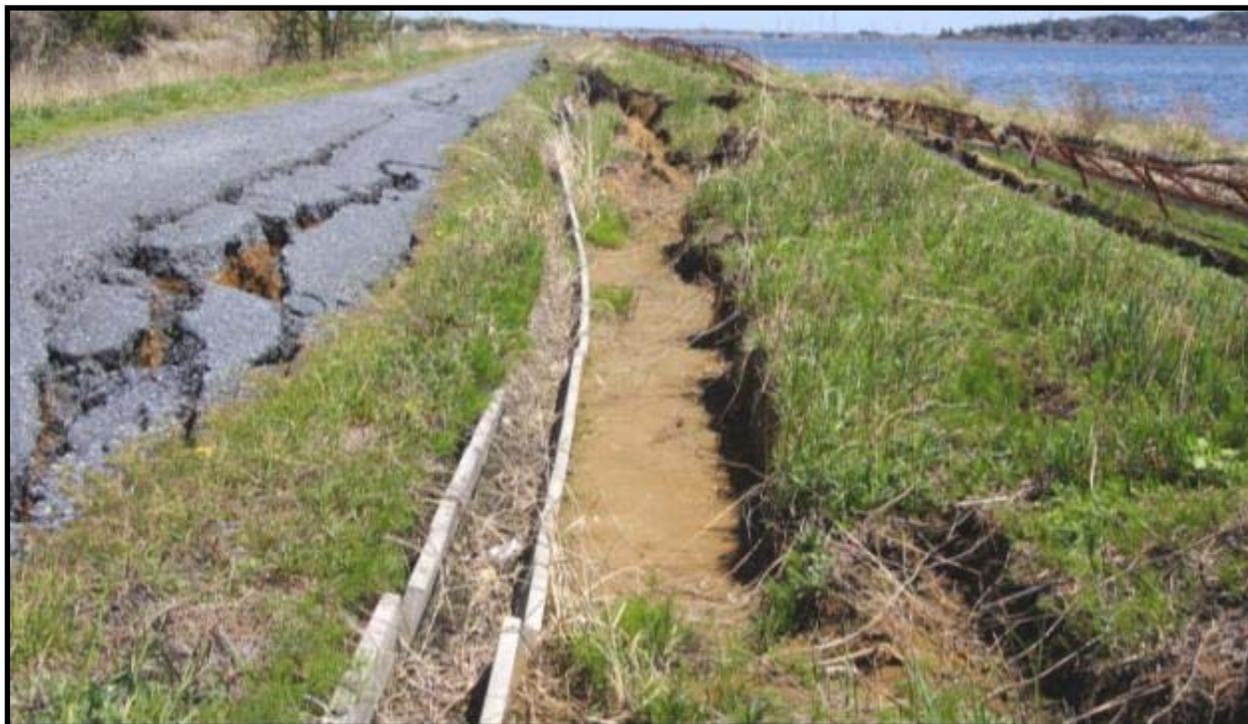
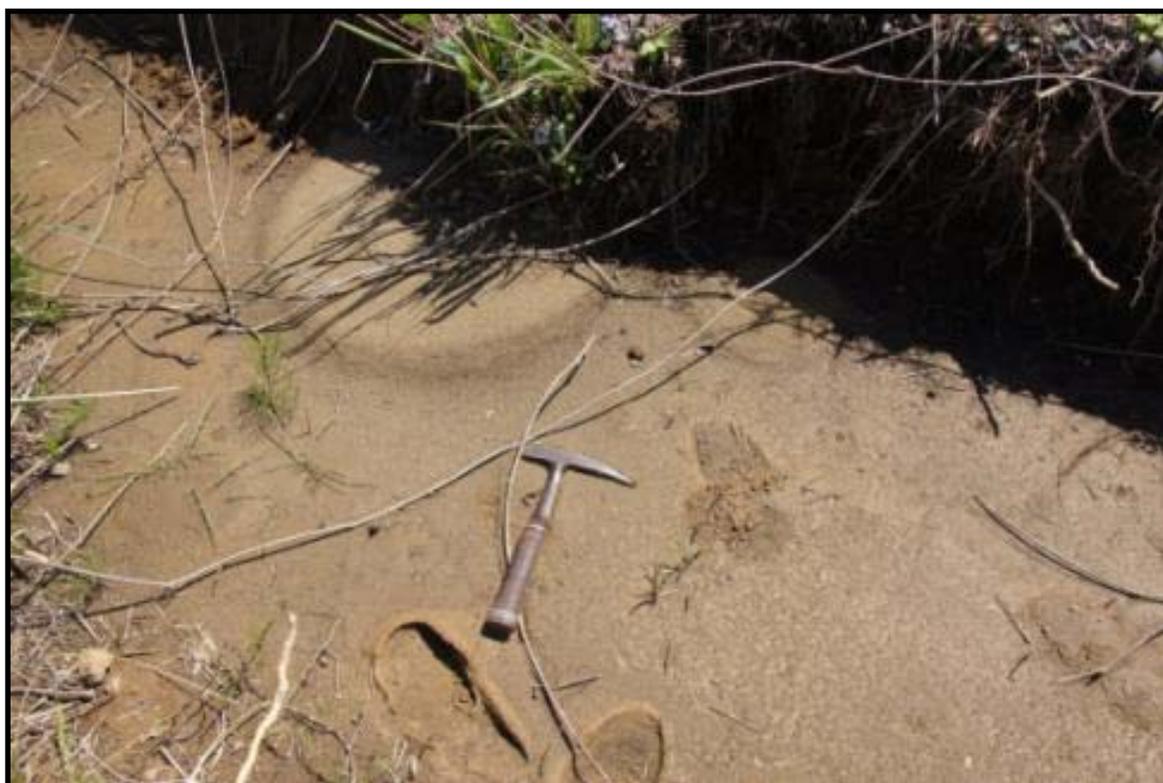
Figure 28: View of Residual Sand Boils Partially Filling Large Crack/Graben of Slumped Hinuma River Left Levee (N36.2861, E140.5238, April 24, 2011)

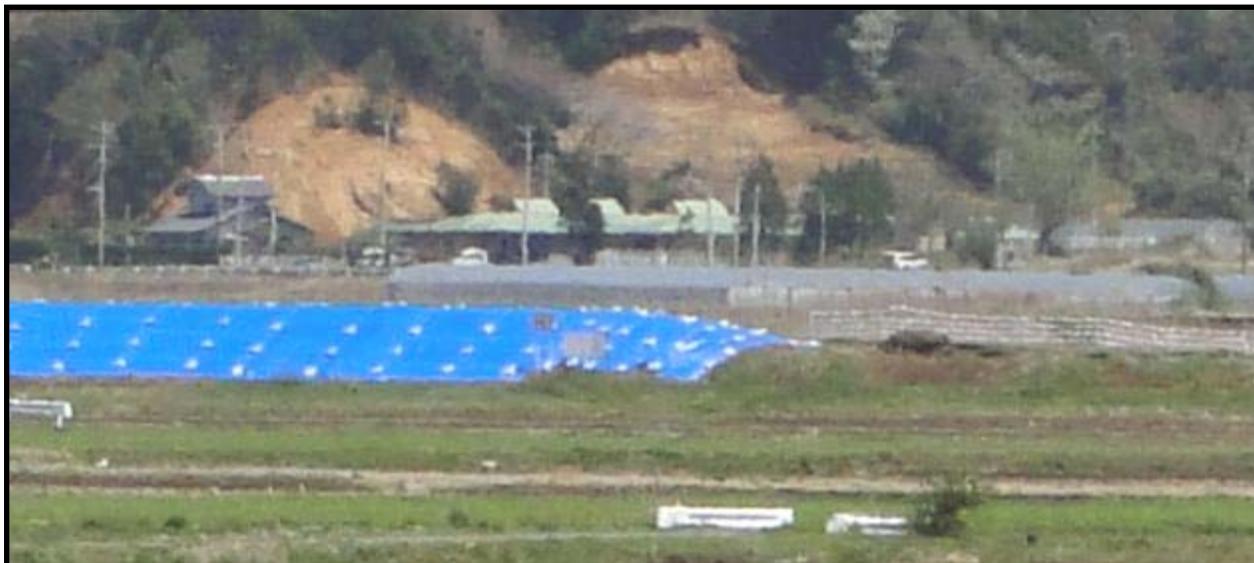
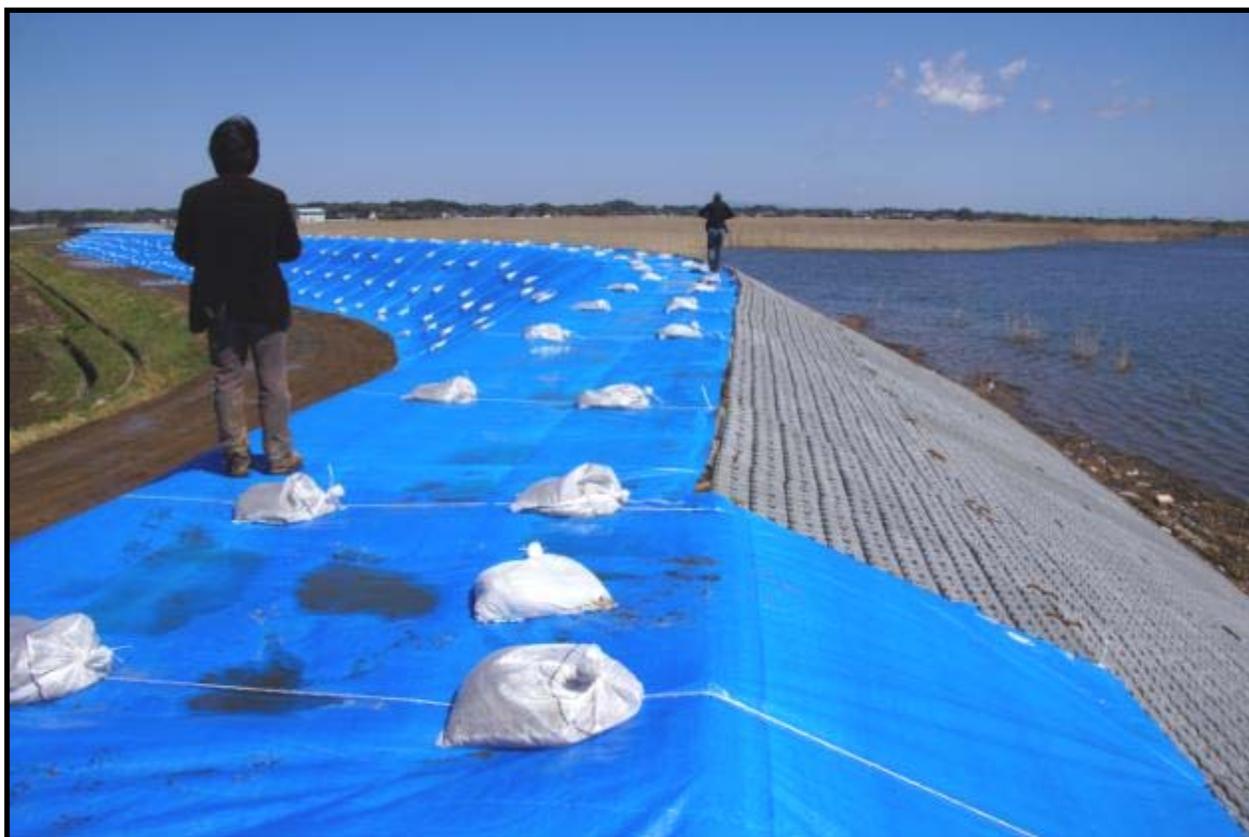
The interim repairs completed by the MLIT are shown in Figure 29. The repaired levee crown is approximately 1½ meters above the unrepaired slumped levee section. If the repaired section restored only the previous height, then this suggests that the Hinuma River Left Levee had an overall general slump of 1½ meters, with additional cracking and slumping on top of this general slump; however, the 1½ meter of general slumping could not be confirmed.

Figure 29: Views of Hinuma River Left Levee Where Interim Repairs had been Completed (N36.3018, E140.5321, April 24, 2011)

At the northern end of the damage along the Hinuma River levee, an interim repair had been completed for a limited reach. This reach apparently is consistent with the section of the levee that the MLIT is responsible for. However, most of the damaged levee was not repaired, apparently because this more southern reach is the responsibility of a local agency and that agency either did not have the resources or time to complete any significant repairs by the time that this reconnaissance took place.

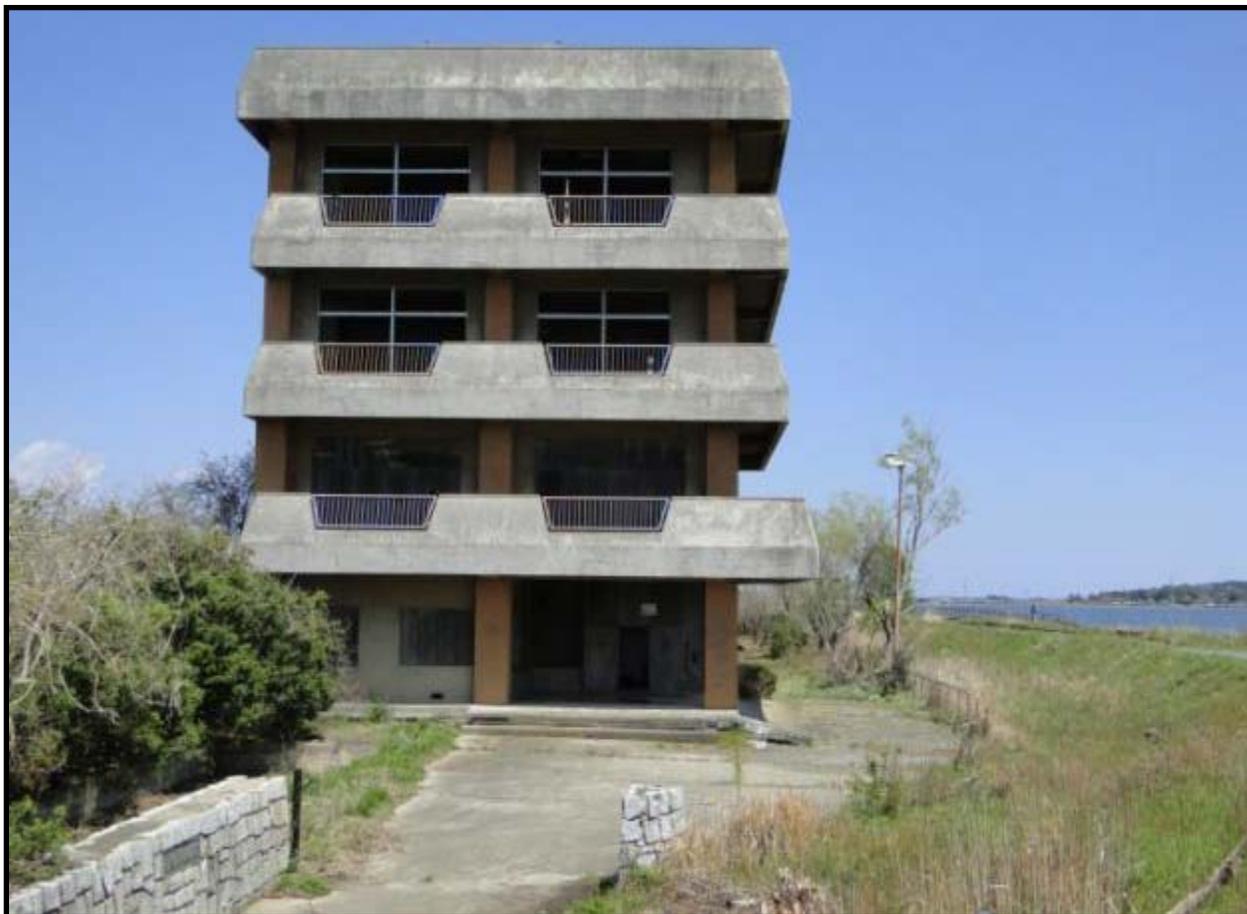
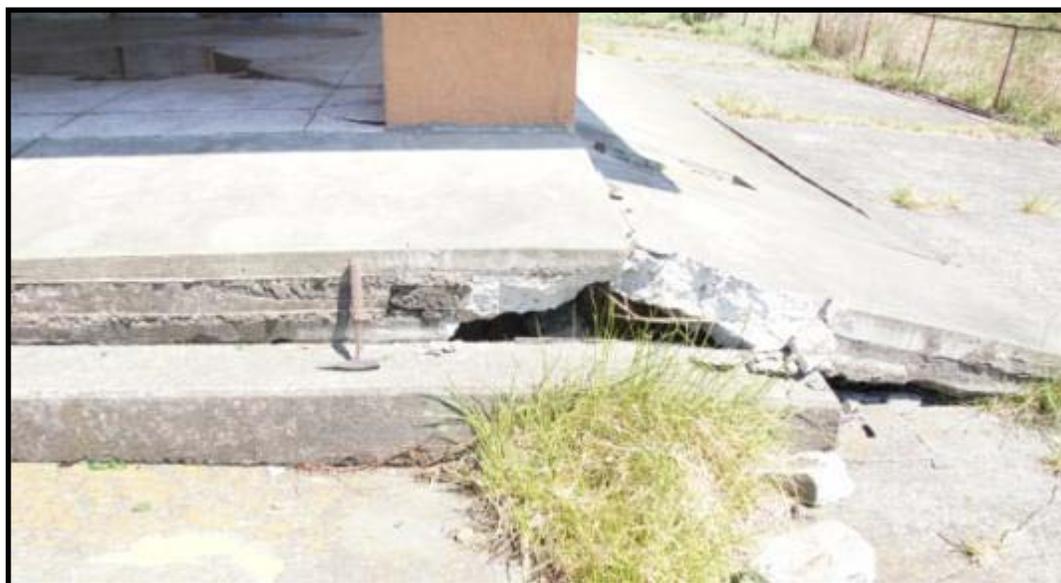
Figure 30: Views of 4-Story Reinforced Concrete Apartment Building Landward of Hinuma River Left Levee Which Experienced Significant Damage and Approximately 20 cm of Ground Settlement Around the Building Foundation ((N36.2861, E140.5238, April 24, 2011)

Near the southern end of the damaged left levee, a 4-story reinforced concrete apartment building had been constructed near the landside levee toe. There was evidence of sand boils and liquefaction within the adjacent levee section, and there was differential settlement evident all around the building. There appeared to be about a 20 cm general settlement of the ground relative to the building all around it (see Figure 30). Inside the building, all of the windows had been broken, and much of the tile in the stairwells and other portions of the building had been shattered to small pieces (see Figure 31). The contents of the residents who had lived there had been almost completely removed. This all suggested that the building experienced both shaking and settlement damage related to the liquefaction of the reclaimed land which the building was founded on.

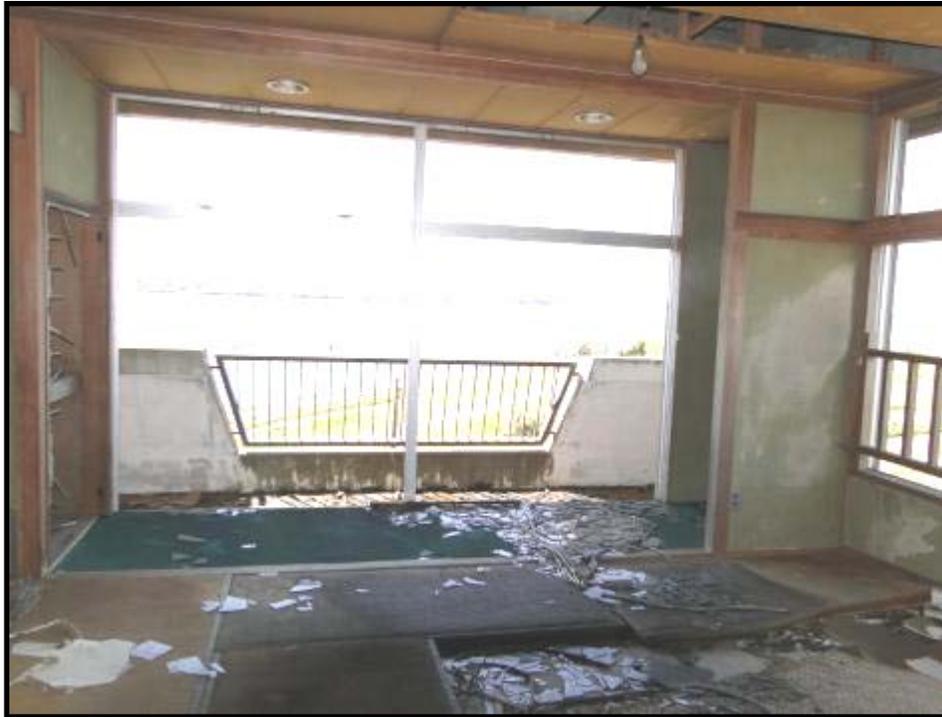
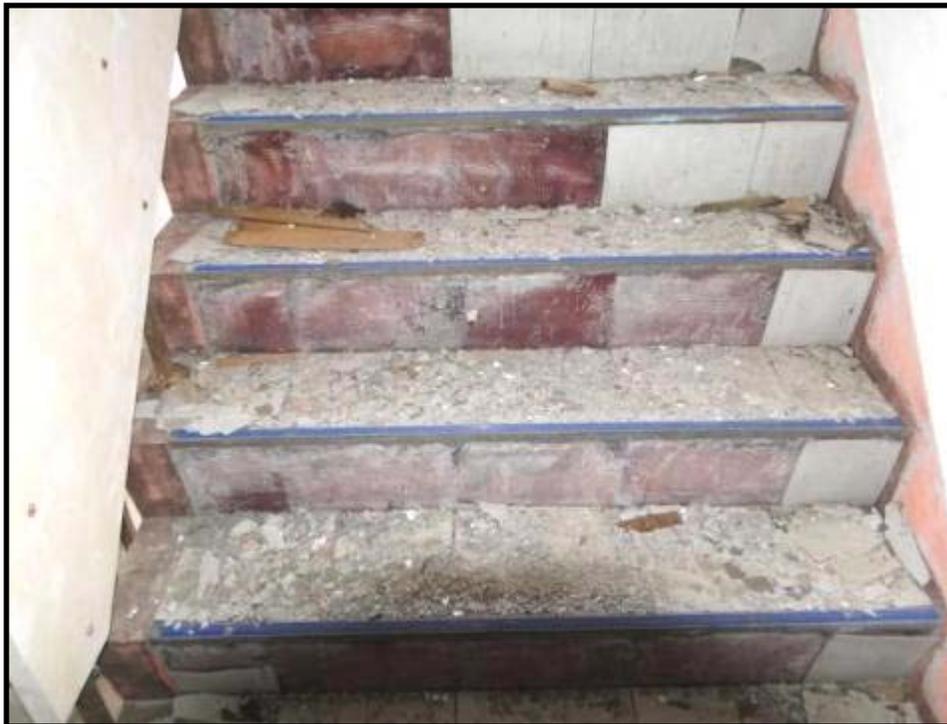
Figure 31: Interior Views of Damaged 4-Story Reinforced Concrete Apartment Building Landward of Hinuma River Left Levee Which Experienced Significant Damage and Approximately 20 cm of Ground Settlement Around the Building Foundation ((N36.2861, E140.5238, April 24, 2011)

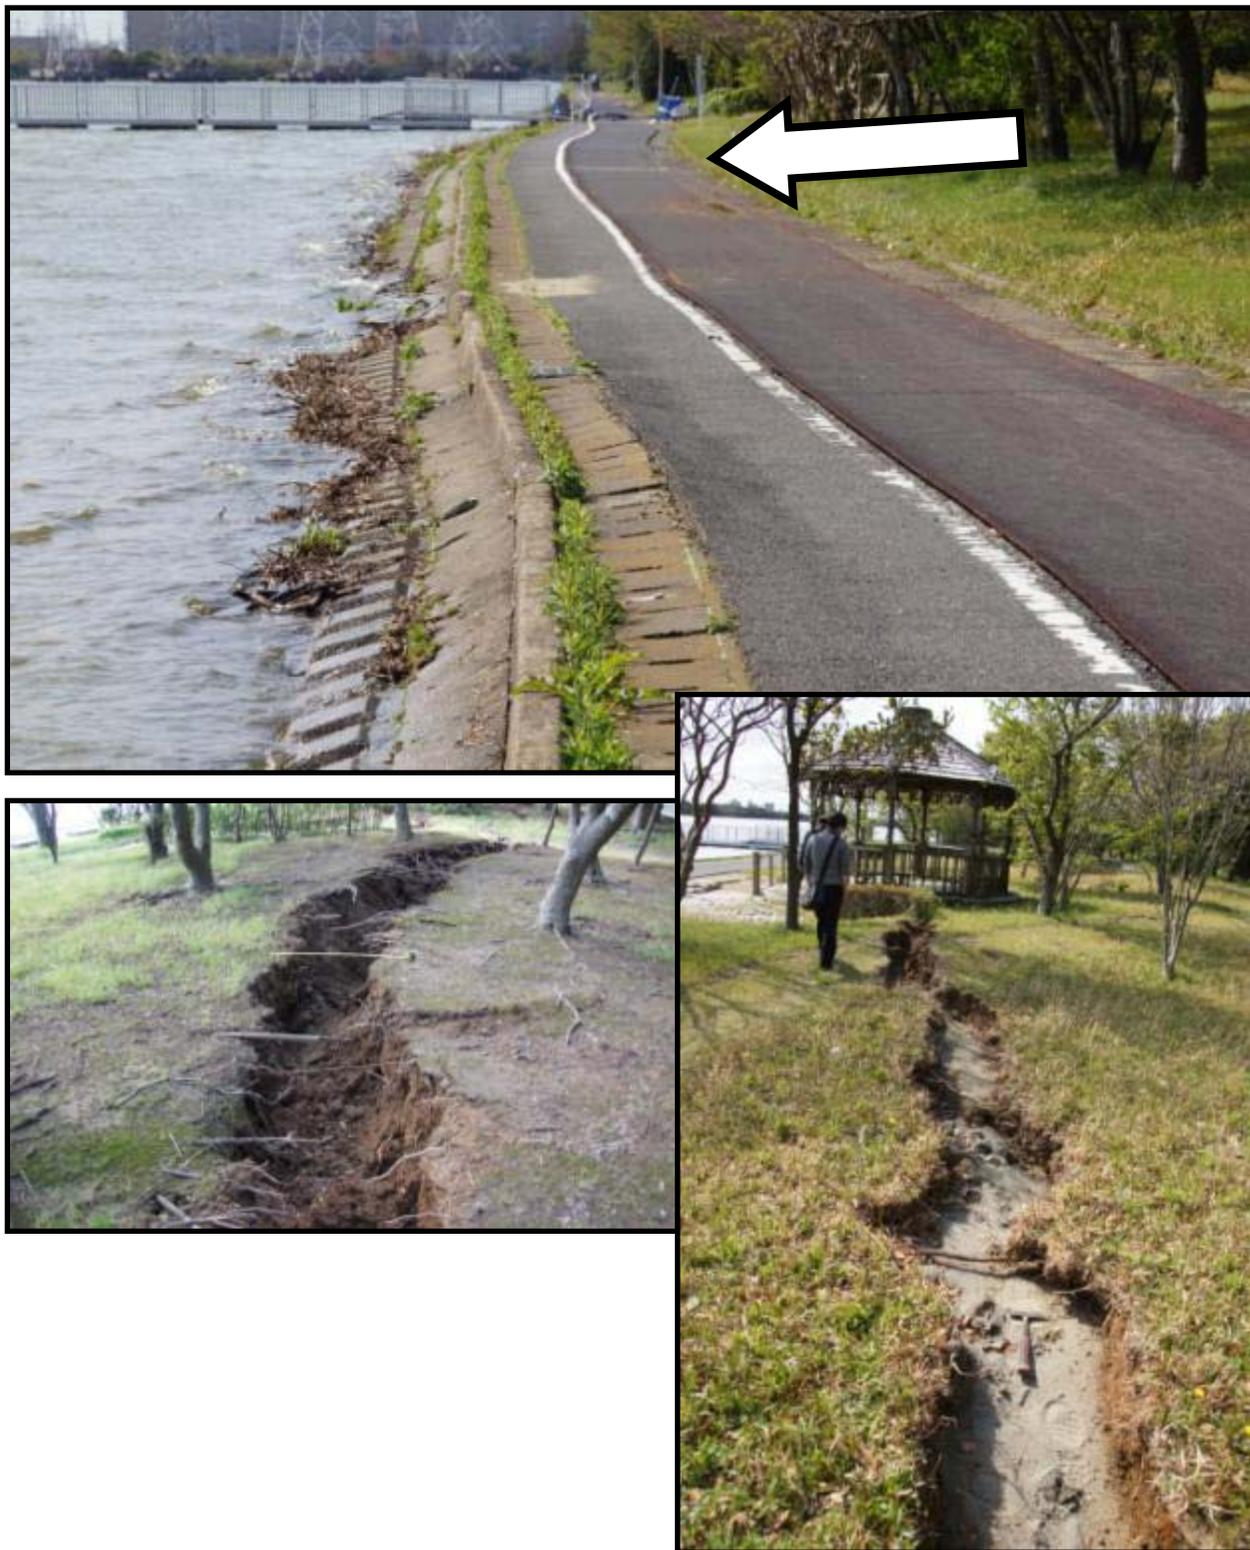
The Kaminoike Green Park is located near the coast near the town of Kamisu City (see Figure 32). The general topography and layout of the park suggests that much of the area is reclaimed land. Within the park along a linear lake, a significant lateral spread of almost flat ground occurred towards the lake. In some locations, the lateral spread appeared to have moved laterally towards the lake by at least as much as 3 meters. In the park area, numerous longitudinal cracks, some as much as a meter wide, paralleled the lake front. Numerous sand boils were also observed in the park area and along railroad tracks immediately behind the park. Compression and buckling of the rails indicated that the surface crust of the foundation had broken up into blocks and experienced ground oscillation and spreading not only towards the lake, but also parallel to the lake. Behind and parallel to the railroad tracks, relative settlement and minor damage was also apparent in a major roadway. Figures 33 and 34 illustrate some of the liquefaction-related damage in the park.

Figure 33: Views of Liquefaction-Induced Lateral Spreading at Kaminoike Green Park  
(N 35.8911, E140.6702, April 24, 2011)

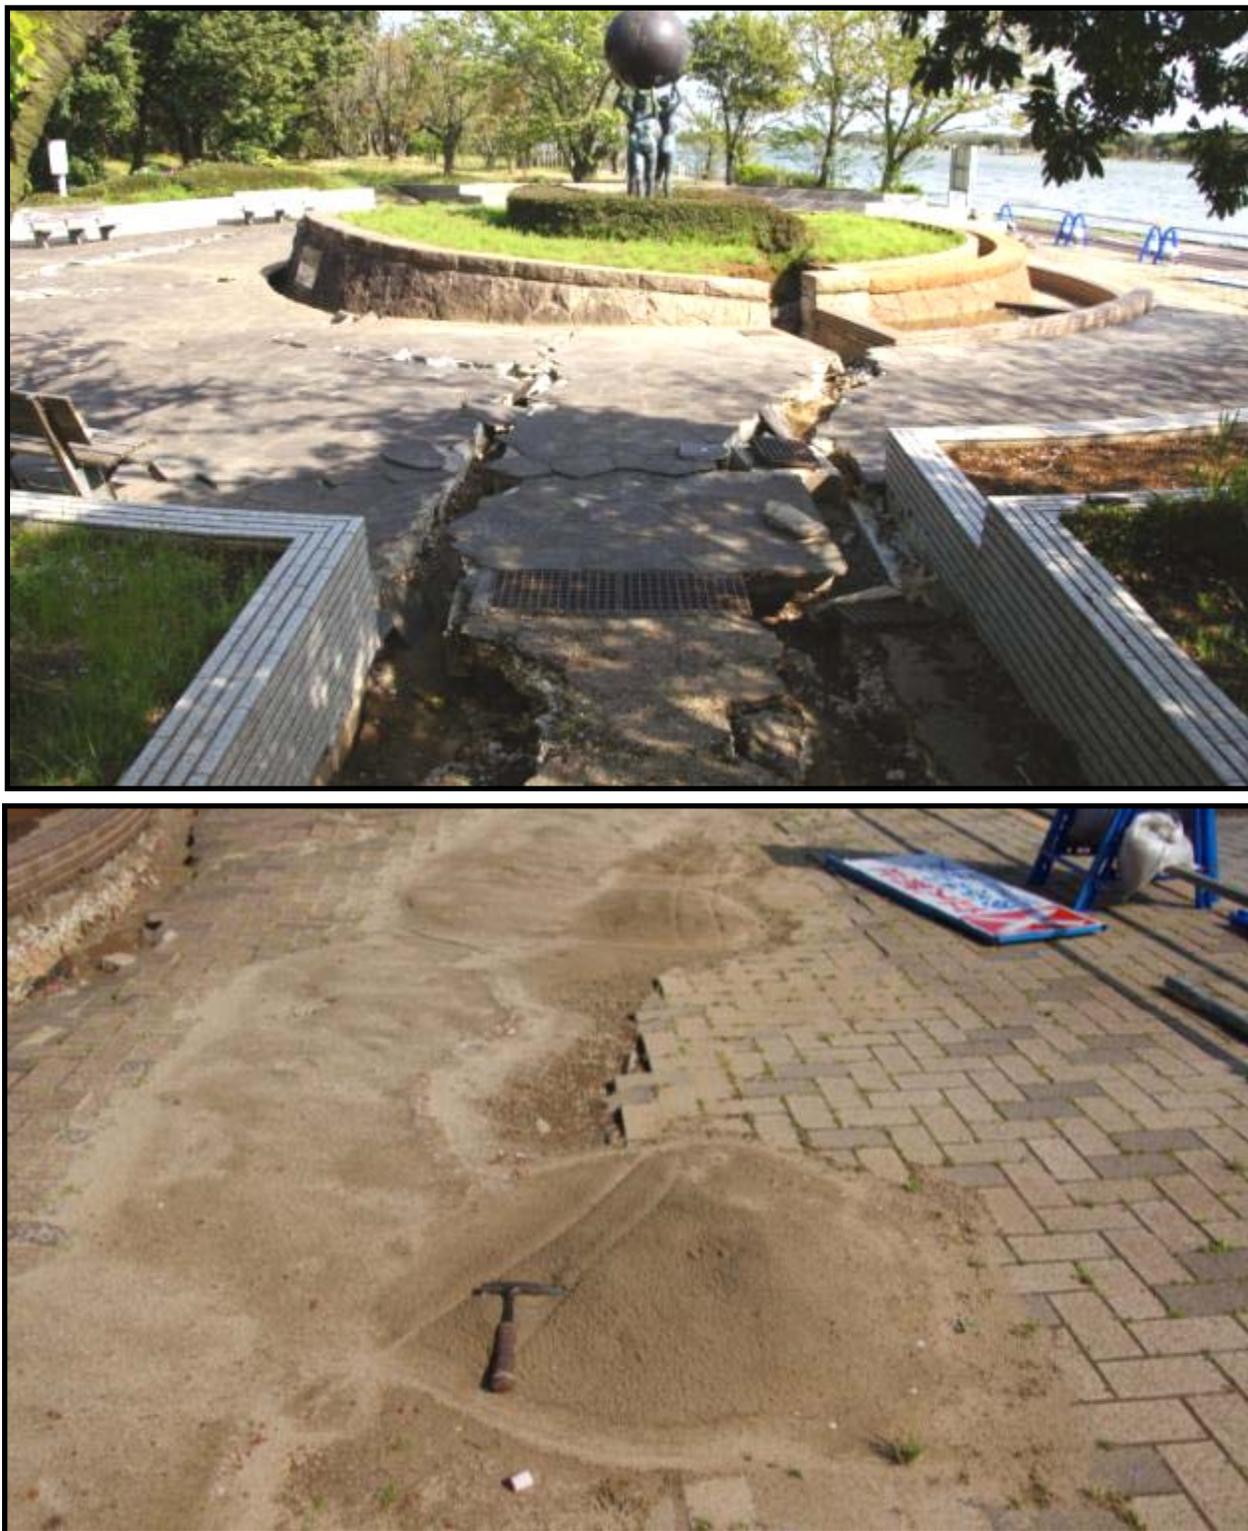
Figure 34: Views of Liquefaction and Lateral Spreading in Three Muses Courtyard  
in Kaminoike Green Park  
(N 35.8915, E140.6696, April 24, 2011)

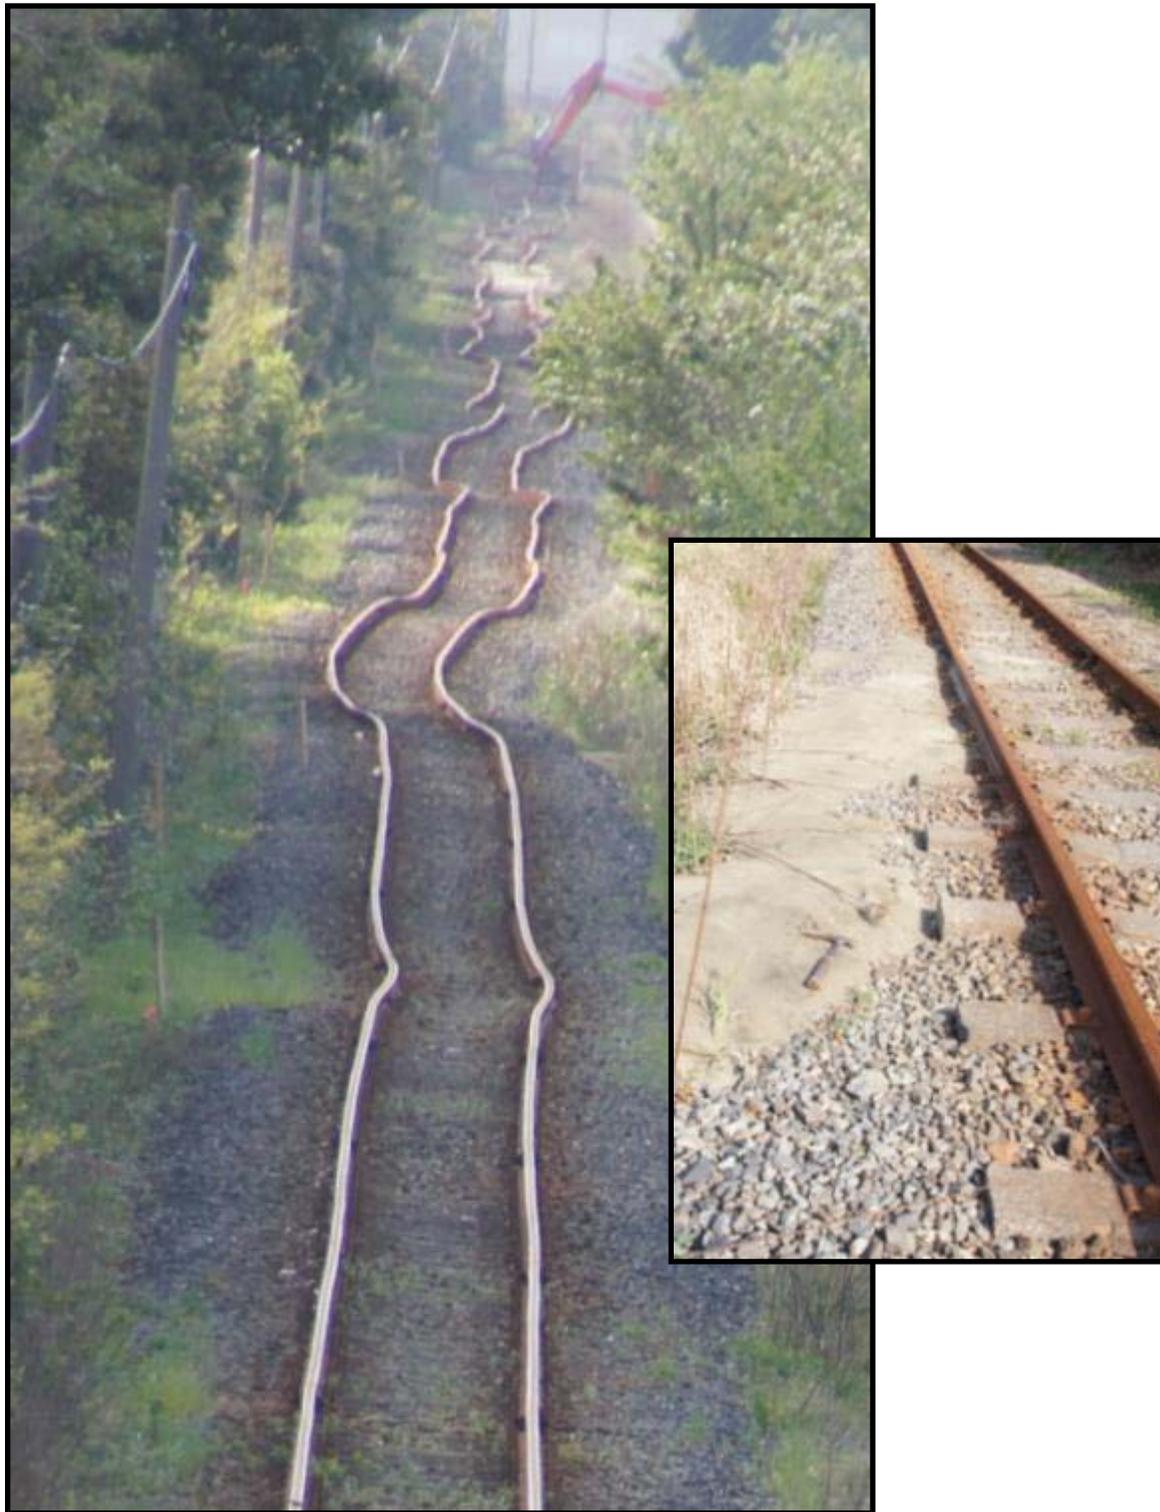
Figure 35: Views of Liquefaction, Lateral Spreading, and Compression along Railroad Tracks  
Behind Kaminoike Green Park  
(N 35.8911, E140.6702, April 24, 2011)
